Richard Wheelock East West Realty 700 Bishop St. Suite 1000 Honolulu, HI 96813-4112 richard@eastwestrealty.org 808-753-3167 8/17/2016

Re: Archaeological Sites Inspection Letter Report for 20 Previously Recorded Archaeological Sites Located on 66.039 Acres of Land in Hōlualoa 1st Ahupua'a, Kailua-Kona, North Kona District, Hawai'i Island [Portions of TMK: (3) 7-6-021:016 and 017].

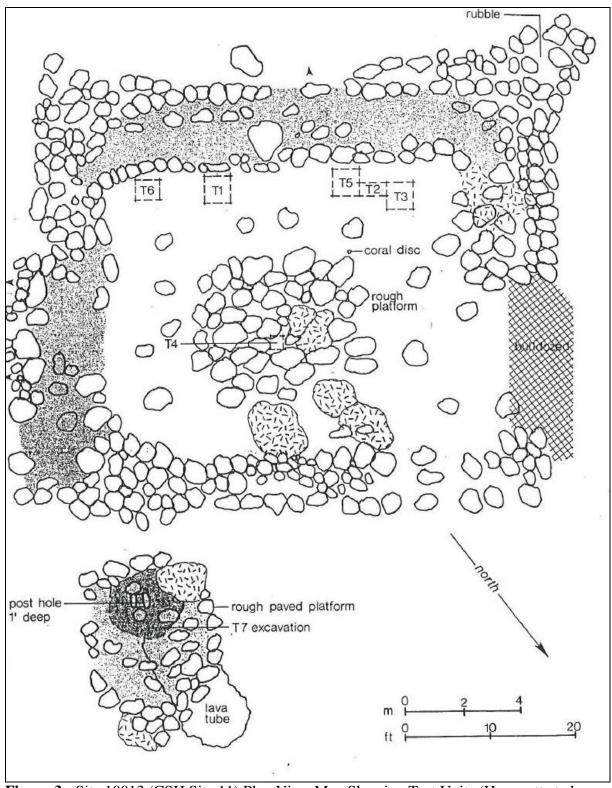
Figure 3: Site 10013 (CSH Site 11) Plan View Map Showing Test Units (Hammatt et al. 1992:69).

DESCRIPTION: Site 11 is a large (60 feet by 60 feet exterior dimensions) nearly square enclosure constructed on almost level ground (Figure 3). The enclosure walls range from five (5) feet wide on the mauka side to nearly ten (10) feet wide on the *makai* side where the outside facing is three (3) feet high relative to the exterior ground surface on the *makai* side of the structure. The enclosure walls were probably higher originally but at present they appear to have been knocked down by previous bulldozing operations. The enclosure interior (measuring 35 feet *mauka-makai* by 45 feet north-south) is predominantly dirt with a rock platform about 20 feet square situated near the center of the interior. Immediately *mauka* (5 feet) of the southeast corner of the enclosure is a low, boulder platform about 15 feet by 20 feet. This structure also appears to have been crossed over by a bulldozer. A notable feature in this structure is a hole approximately one (1) foot square and one (1) feet deep. It is neatly formed by small slabs set on edge. [Hammatt et al. 1992:68]

EXCAVATION RESULTS: Close inspection of the dirt surface in the interior of Site 11 showed that the *makai* area contained a dark grey to black dirt while in the mauka portion the dirt layer was a reddish brown, generally shallow with some parts of the bedrock exposed. The *makai* portion of the site was chosen for the first excavation on the basis of sediment color (grey to black sediments in sites usually being a good indicator of human activity and potential depth. A total of 4.5 square meters (Trenches 1, 2, 3, 5 and 6) were excavated adjacent to the *makai* wall. Trenches 1 and 6 established the presence of a single cultural layer up to 30 cm. thick overlain by 10 cm. to 20 cm. of modern Al horizon. These two (2) trenches produced six (6) basaltic glass flakes, a polished adze flake and two (2) coral file fragments.

A final pit (Trench 7) was excavated in the platform just *mauka* of the enclosure. This involved removal of rocks to a depth of two (2) meters where a capped off entrance to a lava tube was found. The lava tube five (5) feet wide was accessible for fifteen (15) feet in a mauka direction. It was fully explored and was found to exhibit no signs of human use. Slight flow of cool air through the tube and the absence of cultural material within the tube suggest that its primary function may have been a source of ventilation for the platform built over it. On the basis of size, thickness of the cultural layer, complexity of the structural remains and the variety of cultural items present Site 11 is the best example of a semi-permanent or permanent occupation site in the entire study area. The two (2) platforms (one inside and one outside of the enclosure) suggest the former presence of pole and thatch structures. The excavations clearly show the primary work area in the site was along the *makai* edge of the enclosure.

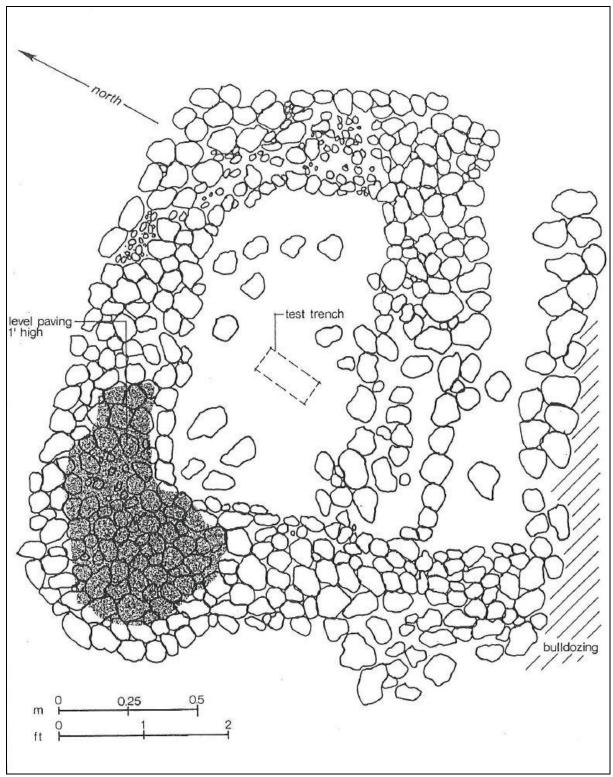
Figure 5: Site 10068 (CSH Site 233) Plan View Map Showing Test Trench (Hammatt et al. 1992:50).

DESCRIPTION: This site is a small rectangular enclosure 14 feet long and 12 feet wide with a maximum height of 1 foot (Figure 5). The internal dimensions are 8 feet by 5 feet. The walls of the enclosure have been collapsed and spread by bulldozing but a portion of the interior alignment remains along the north side.

TESTING RESULTS: A one meter by 50 cm test trench was placed in the approximate center of the enclosure. This trench was excavated to bedrock at a depth of 35 cm. Although there was no distinct cultural deposit, a small amount of midden material was found including cowrie, *pipipi*, sea urchin and fragments of fishbone. Because of the scarcity of material and the disturbed nature of the deposits the excavation was discontinued. However, the site probably functioned as a habitation enclosure. [Hammatt et al. 1992:48]

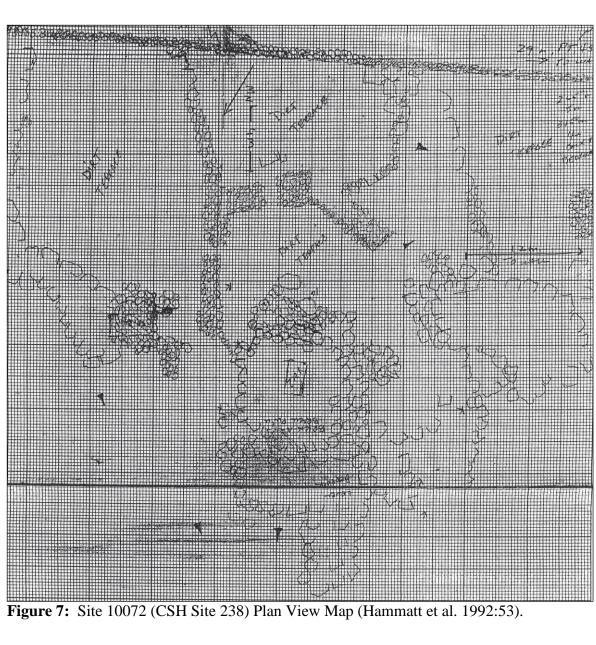
Figure 7: Site 10072 (CSH Site 238) Plan View Map (Hammatt et al. 1992:53).

DESCRIPTION: This site consists of a large (roughly 25 feet by 36 feet) bluff and a small rock mound (about 12 feet square) adjacent to the north of the *pu'u* (Figure 7). The surrounding area displays remnants of low walls along bedrock outcroppings that separate relatively level dirt terraces about 25 feet square or larger.

TEST RESULTS: Test Trench 1 (1.5 meters by 2 meters) was excavated into the middle of the top of the bluff to a depth of 0.5 meters. This consisted of removing basalt boulders and cobbles less than 1 cm. of soil deposit was observed overlying solid bedrock and no midden nor artifacts present. This pu 'u was thus determined to consist almost completely of a natural geological formation used probably as a place to deposit rocks cleared from the surrounding field areas. [Hammatt et al. 1992:51]

A second trench (Trench 2) was excavated into the smaller rock mound to the north. This trench was begun by dismantling a two (2) meter wide section of the south face of the platform, extending it two (2) meters into the structure. A dirt deposit of up to 40 cm was excavated and found to contain some *C. caputserpentis* and *wana* (*echinoid*) fragments. No artifacts or other sign of more than the most transitory human activity was observed at either of the trenches.

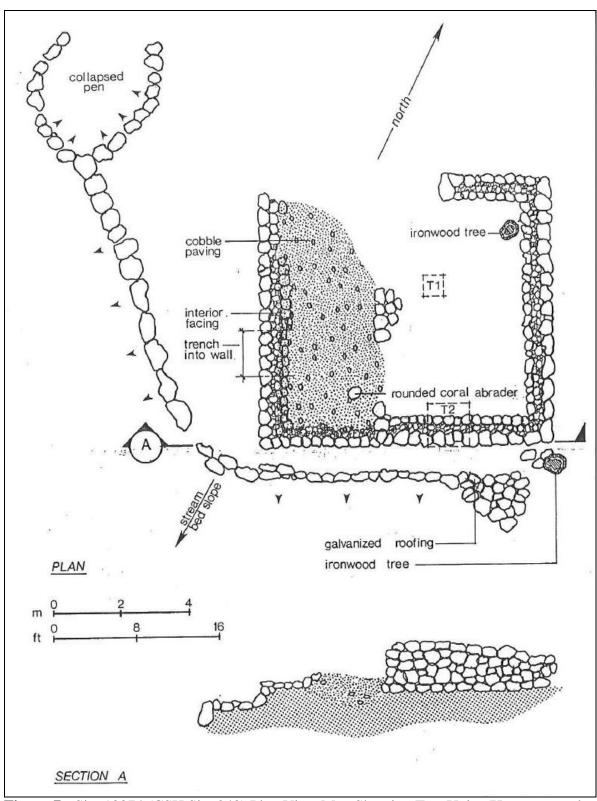
Figure 7: Site 10074 (CSH Site 240) Plan View Map Showing Test Units (Hammatt et al. 1992:55).

DESCRIPTION: This site consists of a rectangular house foundation which measures 28 feet long and 27 feet wide (Figure 8). The maximum height of the remaining walls is 4 feet on the south side. The foundation is neatly faced on the exterior side with core filling. In the interior there is the remnant of a north-south partition with a cobble paving on the west side. The west (*makai*) wall of the foundation has a double facing which may have been constructed as a lanai. The site is situated on a prominent bluff above the stream bed and within a few hundred feet of the railroad berm. The slope to the south and west has mature ironwood trees planted in lines and a small pen connects to the northwest. A section of galvanized roofing lies at the southeast corner.

TEST RESULTS: A 50 cm square test trench was placed in the soil deposit in the south partition of the foundation and was excavated to sterile Pahala ash at a depth of 35 cm. The trench yielded a few fragments of cowrie shell and one basaltic glass flake. These finds are not consistent with the clearly historic age of the foundation and may represent the scattered remains of a prehistoric occupation. A coral abrader was located on the surface of the cobble paving to the north. In addition to this trench a section of the facing of the west wall of the foundation was dismantled. Scattered in the rocks were bottle glass, glazed ceramic sherds, wire nails and fragments of redwood. This foundation, most likely represents a small dwelling or work shed associated with coffee farming. Coffee trees still remain in the stream bed to the south.
