Appendix 2: Coastal Erosion and Volcanic Hazards Report

Coastal Erosion and Volcanic Hazards Report
Barry Property
Hawaiian Paradise Park
Puna, Hawai'i
TMK: (3) 01-5-059:059

J.P. Lockwood, Ph.D.

January 2019

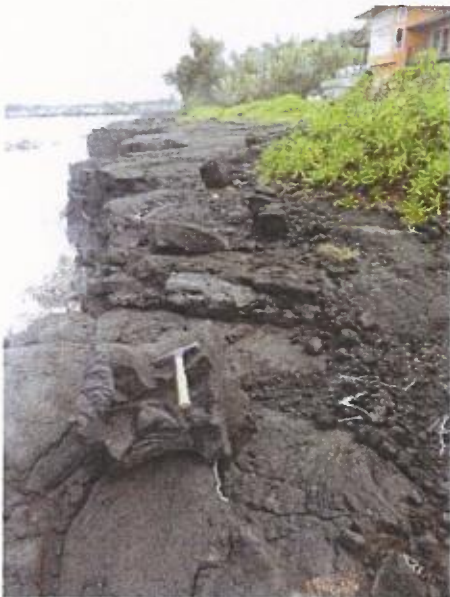
Figure 1. View of coastline fronting the Property – view to south. The vegetation (naupaka) defines the shoreline (“highest reach of waves”) fronting the Property, and is as close as 8’ to the coastline cliff (Figure 2) at the Property’s south boundary. Normal surf does not reach above the coastal cliff, but angular boulders attests to the fact that exceptionally large storms can dislodge cliff edge pahoehoe and place blocks short distances inland, and scour vegetation inland from the cliff face. The coastal bench of bare pahoehoe is as much as 30’ wide at the north Property boundary.

upper limit of debris left by the wash of the waves . . .” (HAR §13-5-2). In this case the shoreline has been assumed to be the edge of vegetation growth (Figures 1-3), which also coincides with the most mauka impact of storm waves. The vegetation-defined shoreline lies 8-30’ back from the sea cliff makai of the Property boundary.

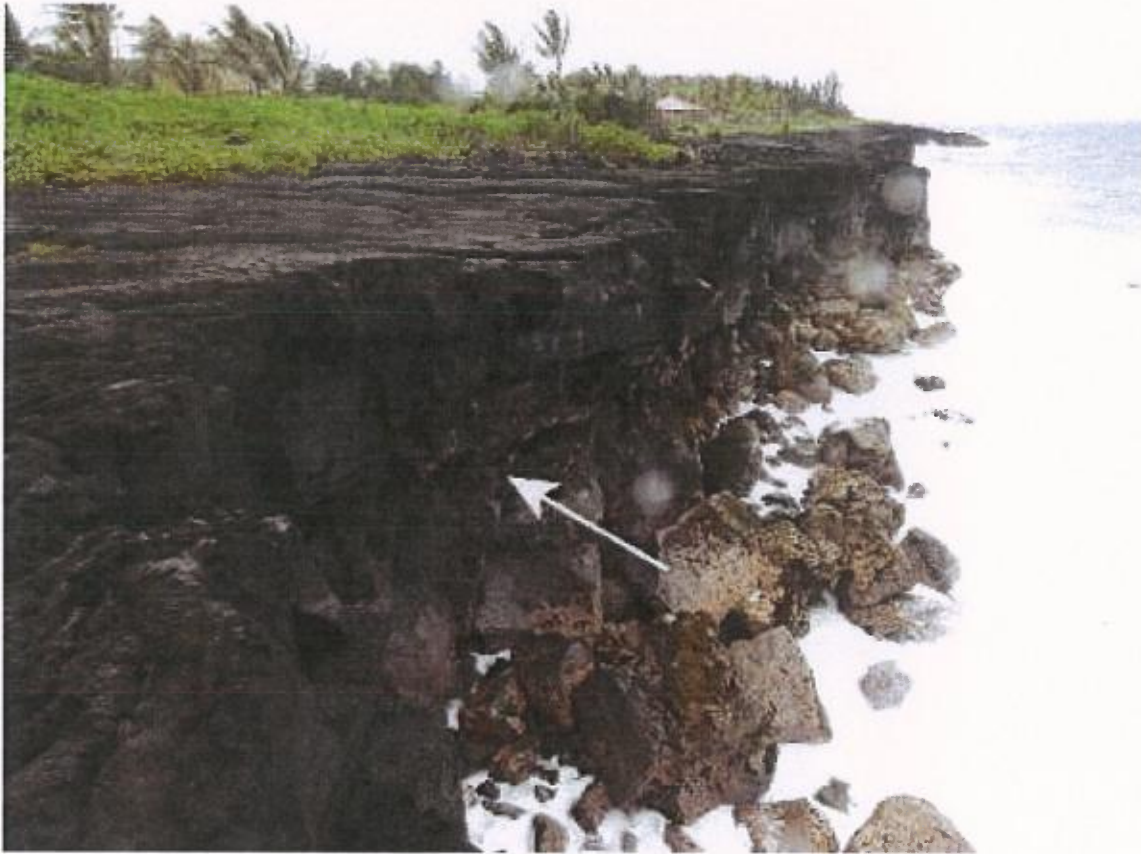
Erosion of the sea cliff fronting the Property reveals that these pahoehoe lobes overlie an older, massive, dense lava, along a sharp contact (Figure 3). This older flow could not be inspected because of dangerous surf conditions, and its origin is uncertain. It was probably erupted by an earlier phase of the same long-term 'Ai-la'āu eruption that formed the overlying pahoehoe. The top of this underlying flow shows red oxidation (Figure 3) indicating some significant passage of time before emplacement of the overlying flow. Its age is not known, but I shall assume it erupted about 1350 CE (about 670 years ago) – one of the earliest 'Ai-la'āu flows.

Figure 3. Seacliff fronting the Property, showing the younger, overlying pahoehoe flow lobes that form the surface of the entire Property (above arrow) – view to northeast. The contact with the underlying dense, massive lava flow is marked by a red oxidized surface zone, which demonstrates substantial time elapsed between emplacement of the two flows.

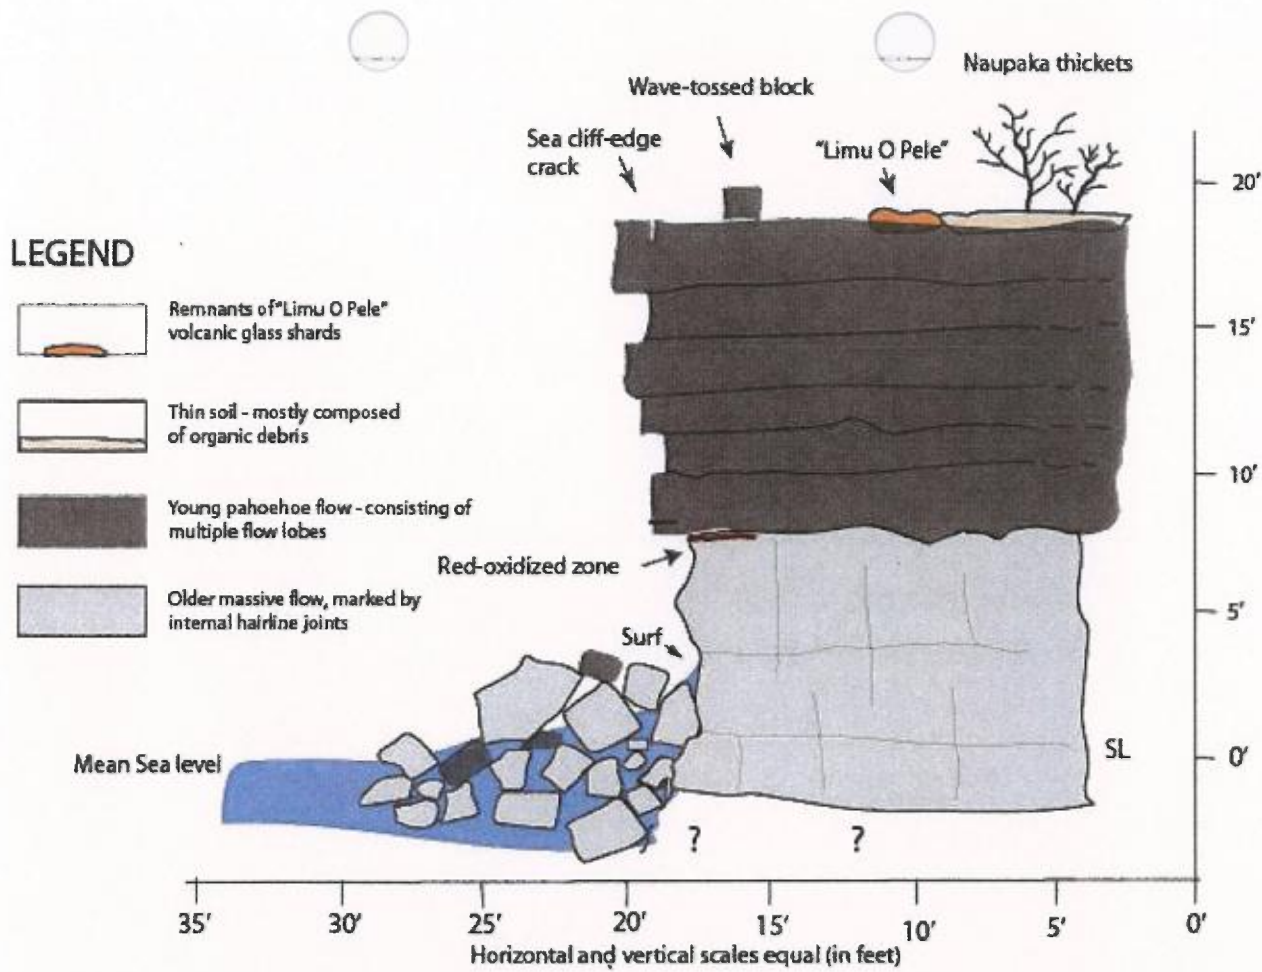
Figure 4. Geologic cross-section of typical coastal cliff fronting the Property - view to southwest.

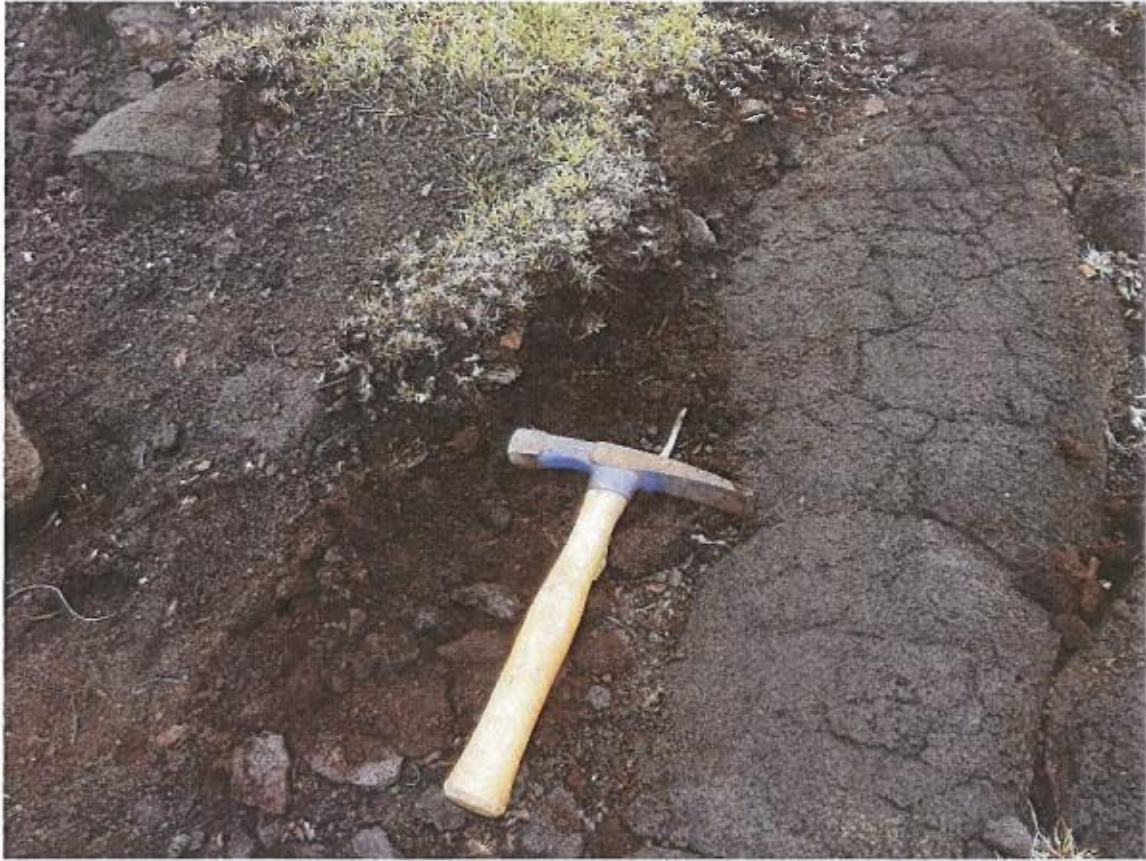
Figure 6. Limu O Pele deposit preserved 10' inland from cliff edge. These deposits, preserved by storm wave erosion by overlying grass mats, consist of sand-size volcanic glass fragments, and were formed by the explosive interaction of the underlying fluid lava with seawater. Their presence indicates that the original coastline when the underlying flows were emplaced could not have been too much farther seaward.

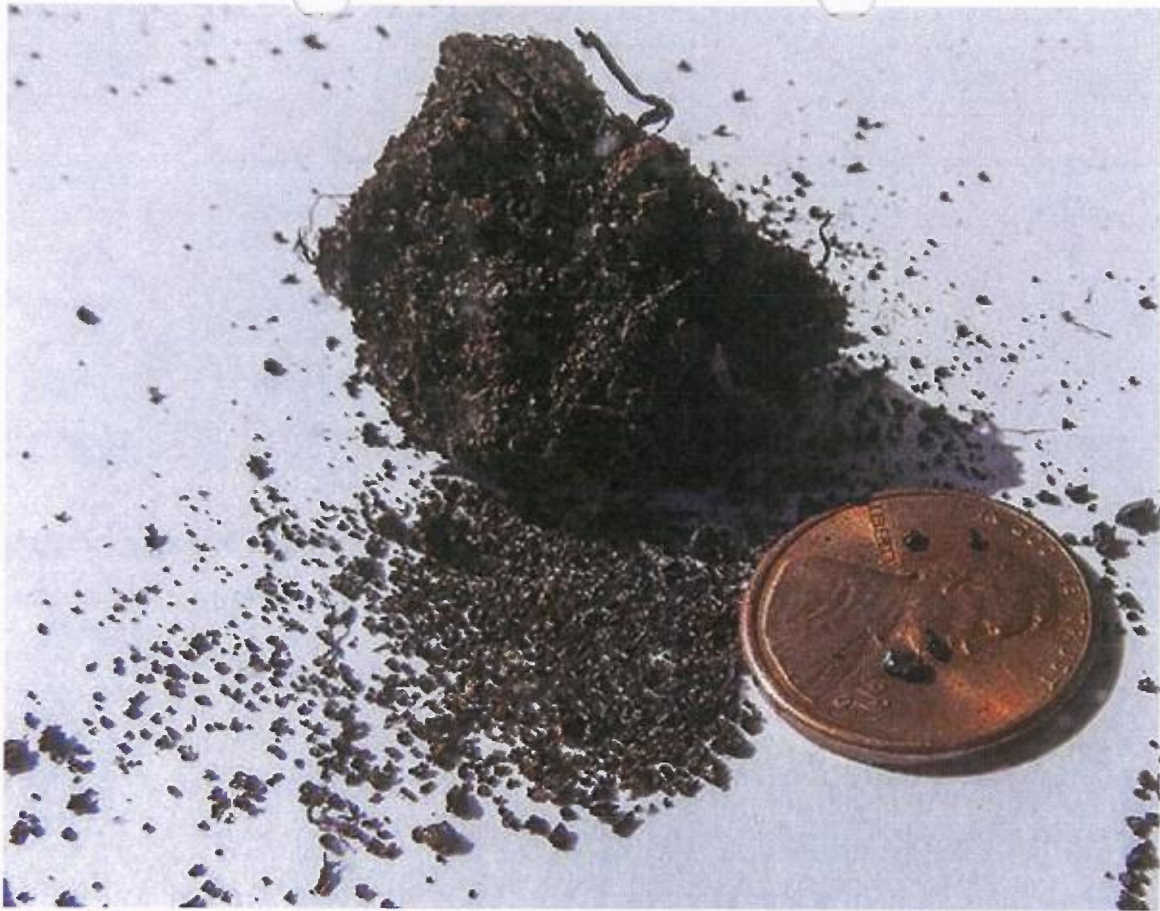
Figure 7. Limu O Pele deposit detail. Fragments consist entirely of fresh, brown volcanic glass fragments up to 1 mm diameter. Note the grass rootlets that permeate the deposit. Thinner glass films common in modern limu O Pele deposits have apparently been dissolved away, leaving only coarser fragments behind.

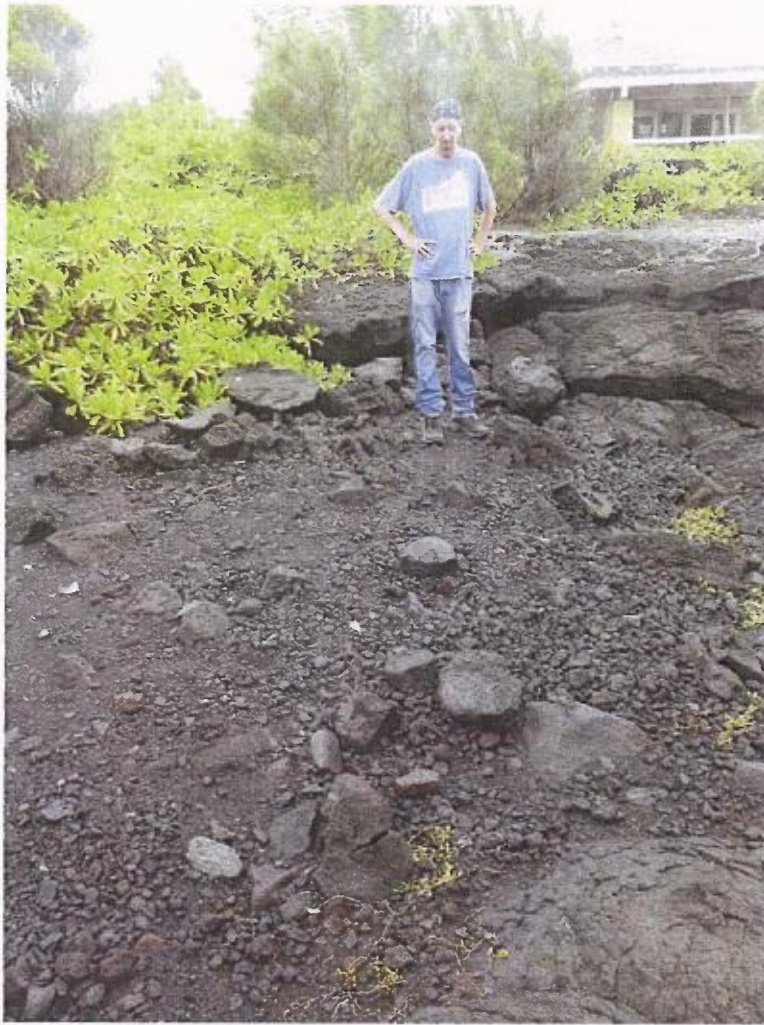
Figure 8. Small area of storm wave-deposited cobbles, gravel, and sand along the northwest-most boundary of the Property.

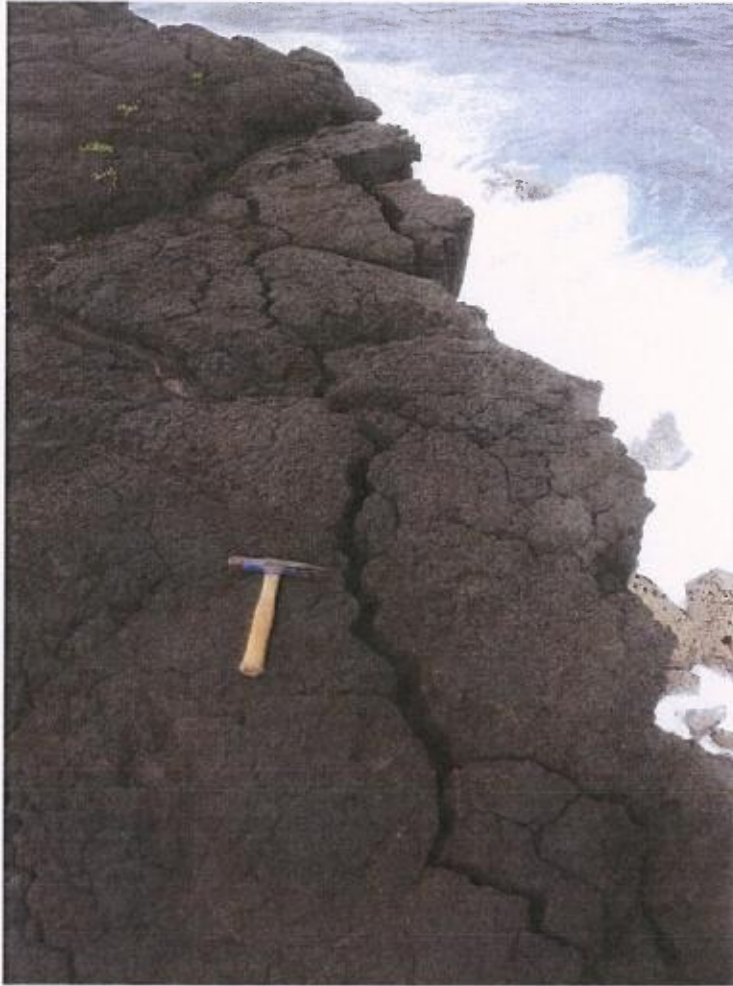
Figure 9. Extension cracks present at the Property's coastal cliff edge. These cracks, which are common along this stretch of coastline, develop as stresses are relieved at the cliff face, and contribute to the susceptibility of this upper pahoehoe flow to rare storm waves that impact the cliff face and force sea water into the horizontal contacts between flow lobes.

These erosional processes are normal for the storm-wave exposed rocky coastlines of Puna, and are of no particular concern for this Property over the short-term (the next several decades).

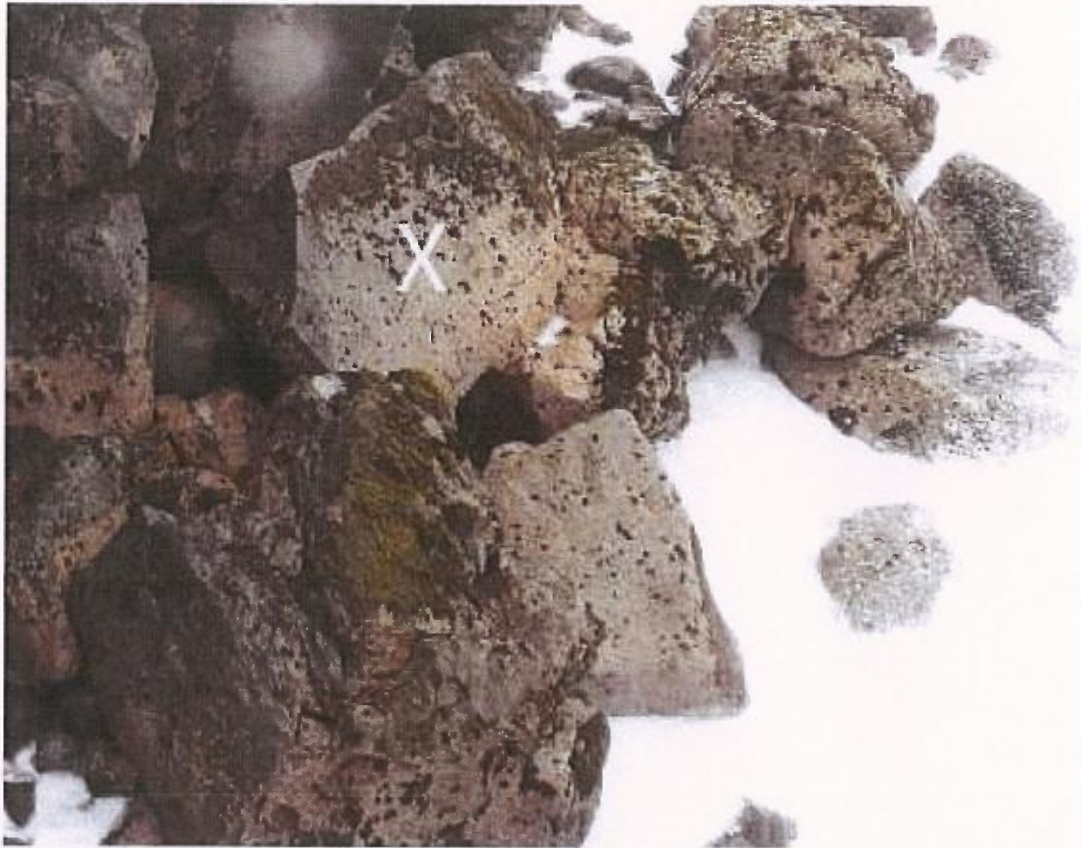
The dense lava underlying the pahoehoe flows is highly resistant to wave impact forces, but also has internal joint fracture planes that can be exploited by the impact of particularly powerful waves. This type of mechanical erosion is rare, but can occur, as indicated by the presence of very large (up to five feet diameter) angular, subangular, and sub-rounded blocks found at the base of the sea cliff fronting the Property (Figures 3, 10).

Figure 10. Detailed view of eroded blocks at the base of the coastline cliff. Most of the blocks have slightly subrounded edges, indicating abrasion by surf action. The large block marked with an “X” is about three feet in diameter, with uniformly angular edges, and must have fallen within the past few years – long ago enough to be covered with marine algae. These large blocks serve to block and attenuate the force of impacting waves – forming protection from erosion.
