Section 5 Historic Property Descriptions

5.1 SIHP # 50-80-08-5593

5.2 SIHP # 50-80-09-2268 Waiahole Ditch System/ post-Contact Irrigation Ditch

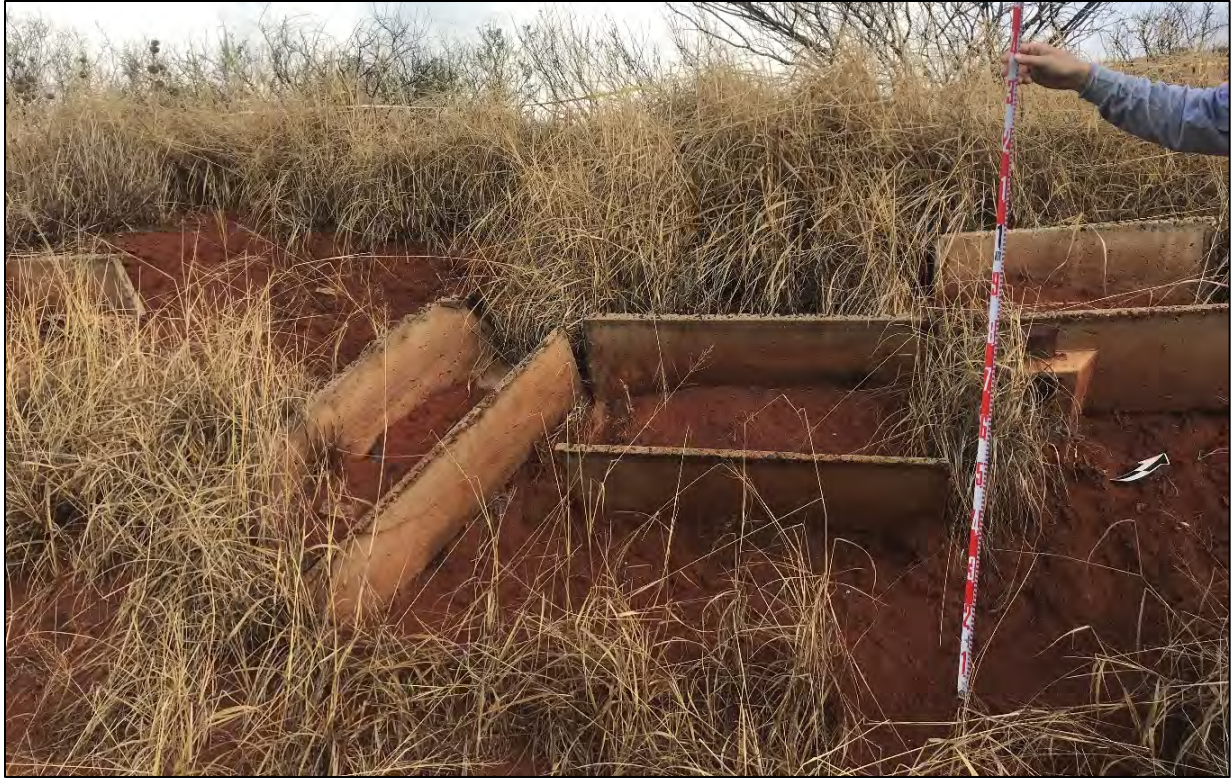
Within the project area, the former roads first recorded on the 1936 U.S. Army War Department map are currently in remnant condition. Temporary water diversion remnants related to the roads, identified as portable concrete flumes, were recorded in two locations along the edge of the former roads, in the west portion of the project area. The first documented portable flume spans approximately 10.6 m long and is oriented northeast-southwest (Figure 31). The second documented portable flume spans approximately 10.5 m in length and is oriented east to west (Figure 32). These remnant sections initially consisted of connected concrete troughs used to divert water from one place to another. As these components were temporary fixtures in remnant condition, they do not retain association with any potential historic properties and are not considered features.

Figure 31. Remnant water diversion flume in southern project area, view to northwest

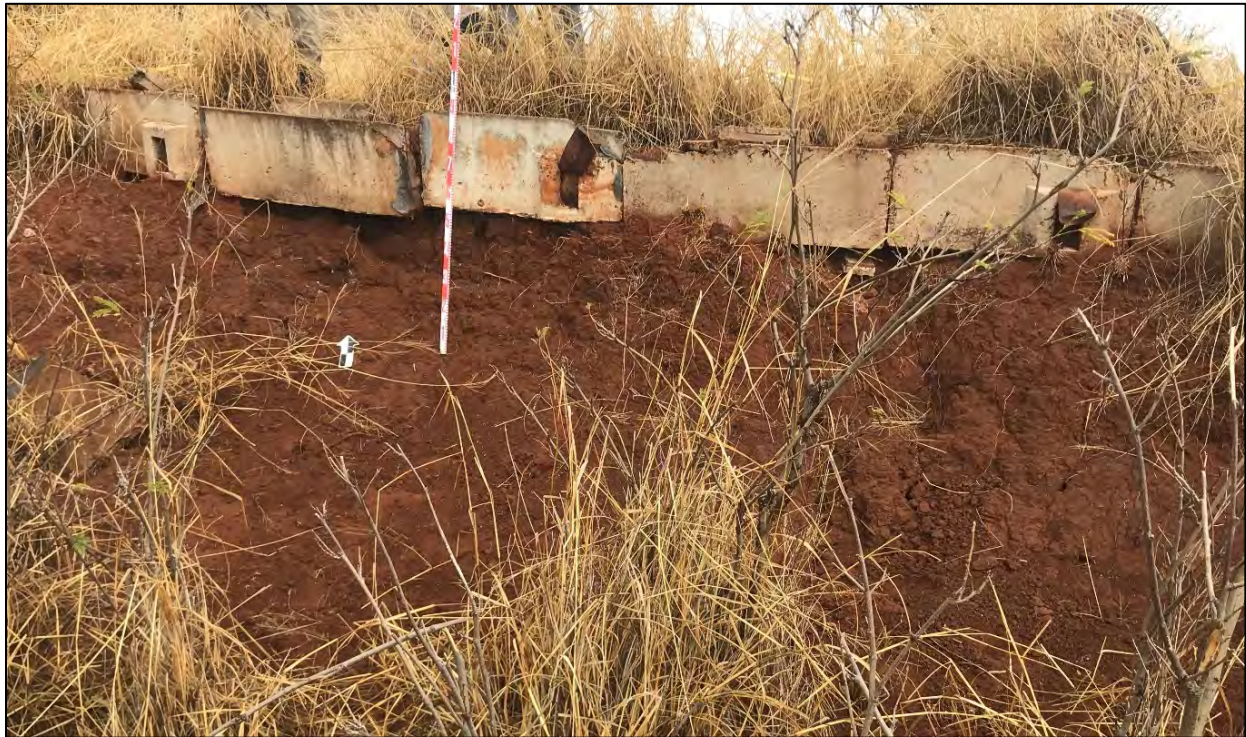
Figure 32. Remnant water diversion flume in southern project area, view to north

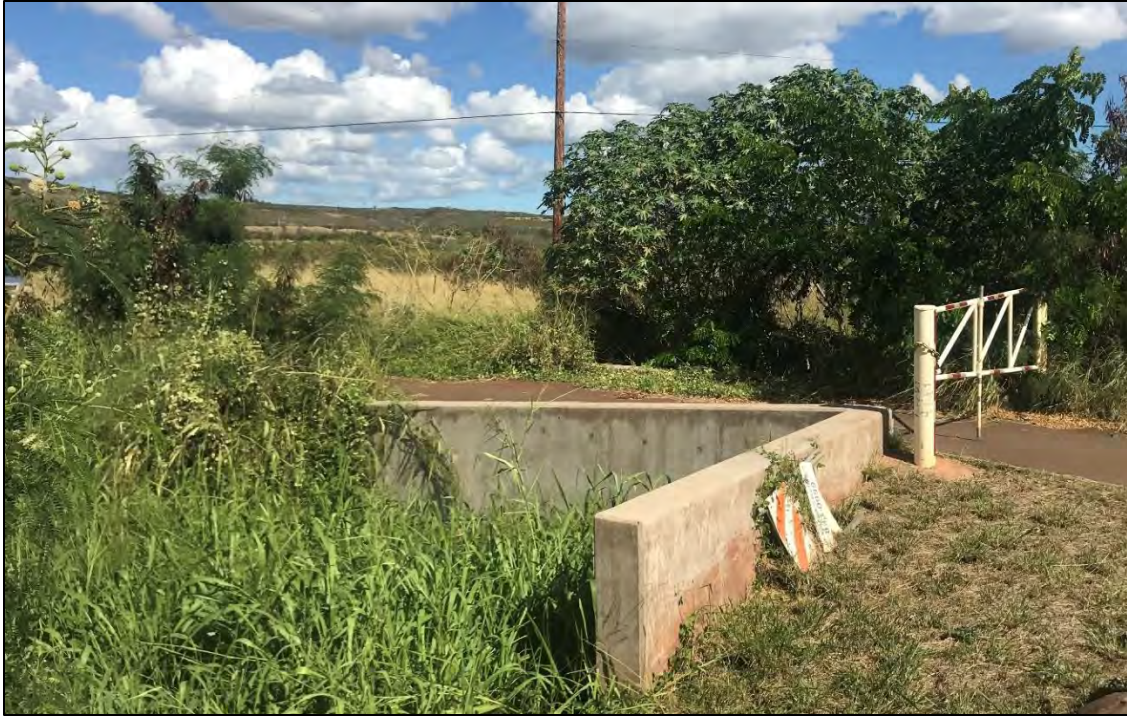
Following the initial pedestrian inspection, the project area boundaries were altered slightly, extending to the north and the west, as well as south to encompass the existing access roads to be used for the project. Additional pedestrian inspection was conducted for these areas. The access roads that may be impacted consist of either paved or gravel roads. It is clear that modifications and upgrades have been made to the various access roads over the years. A portion of the northeast-southwest oriented access road is lined with a concrete curb (Figure 33). Some areas of the access road appear to consist of only dirt, though it may be this is actually material deposited on the road due to rain and erosion, and there may still be paved road underneath (Figure 34). This road reaches a junction, and in one direction the pavement continues, while the other direction is gravel (Figure 35). Access manholes for water lines were noted along the paved access road (Figure 36). A modern concrete culvert was noted at the base of the gravel access road (southernmost tip of the project area, west branch), allowing water flow under the road (Figure 37).

Figure 37. Overview of modern concrete culvert at the base of the access road (junction with Palehua Road), view to northeast

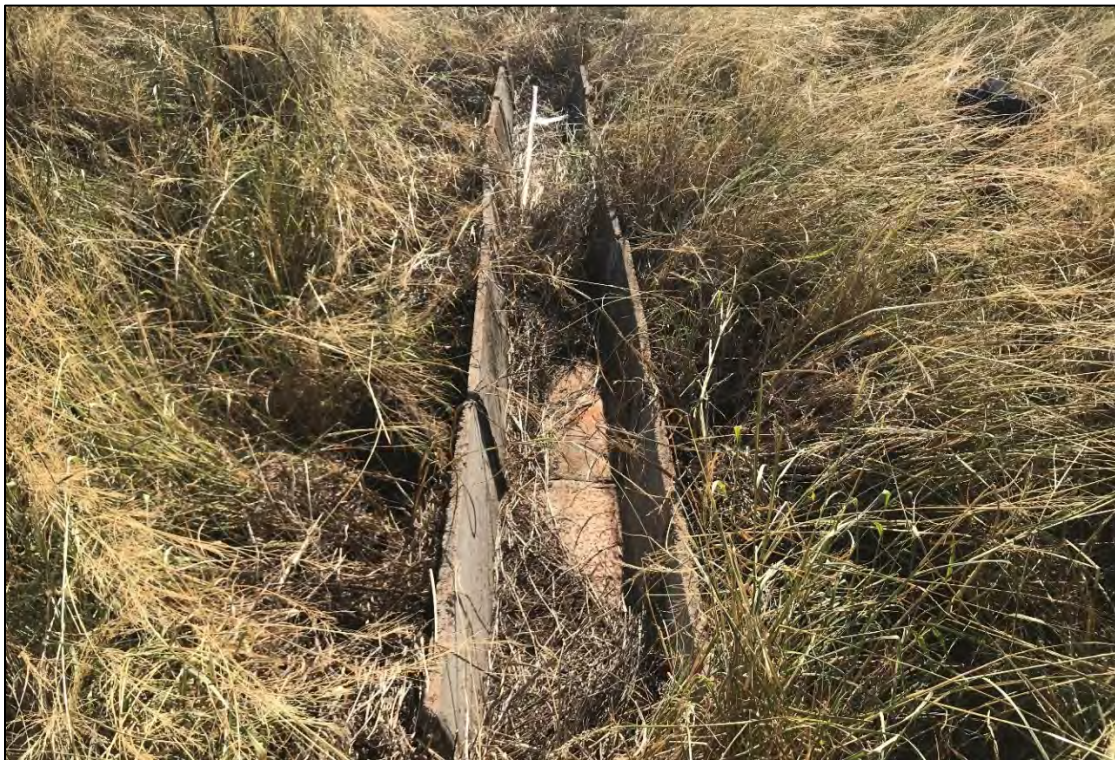
An additional, more intact concrete flume was identified *mauka* (northwest) of SIHP # -2268 Feature H, of similar composition to those noted in the western project area. Oriented east/west, this flume extends for 21 m in length, with each segment measuring 75 cm long, 45 cm wide, and 30 cm tall (Figure 38). Each concrete segment has a square hole near the base on each side, with a metal L-shaped insert, likely used for controlling water flow out of the flume (Figure 39). Again, this flume appears to have been used for water diversion related to the access roads.

Figure 38. Overview of concrete flume in central northern project area, view to southeast

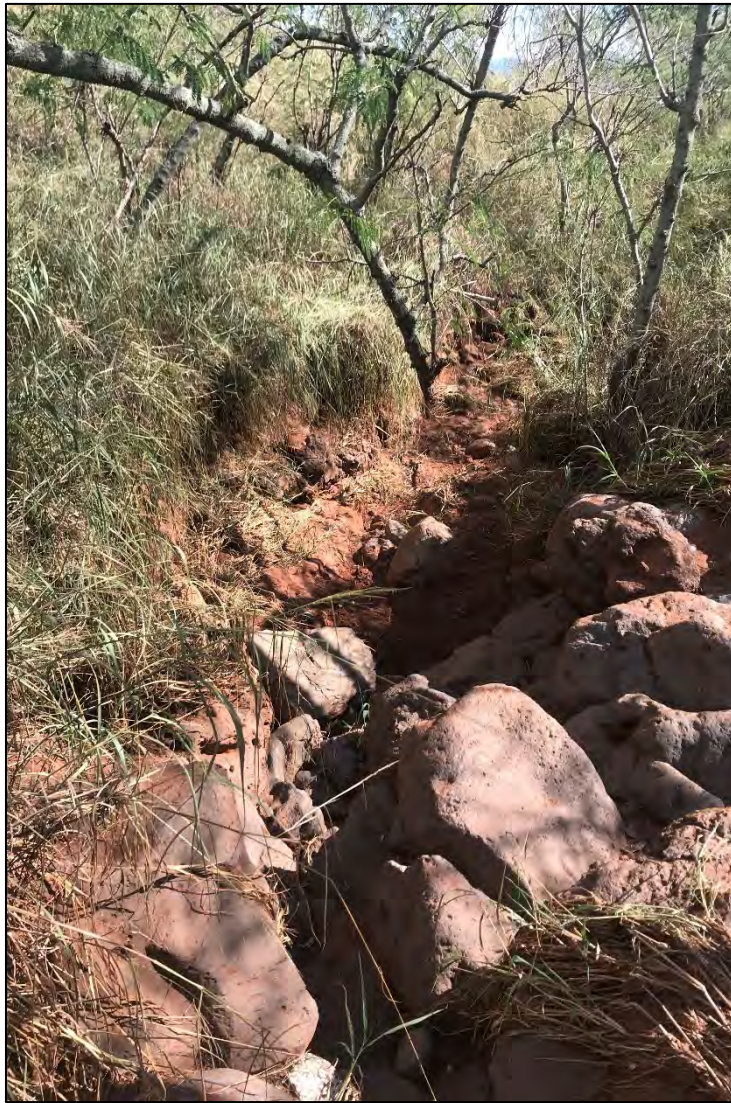
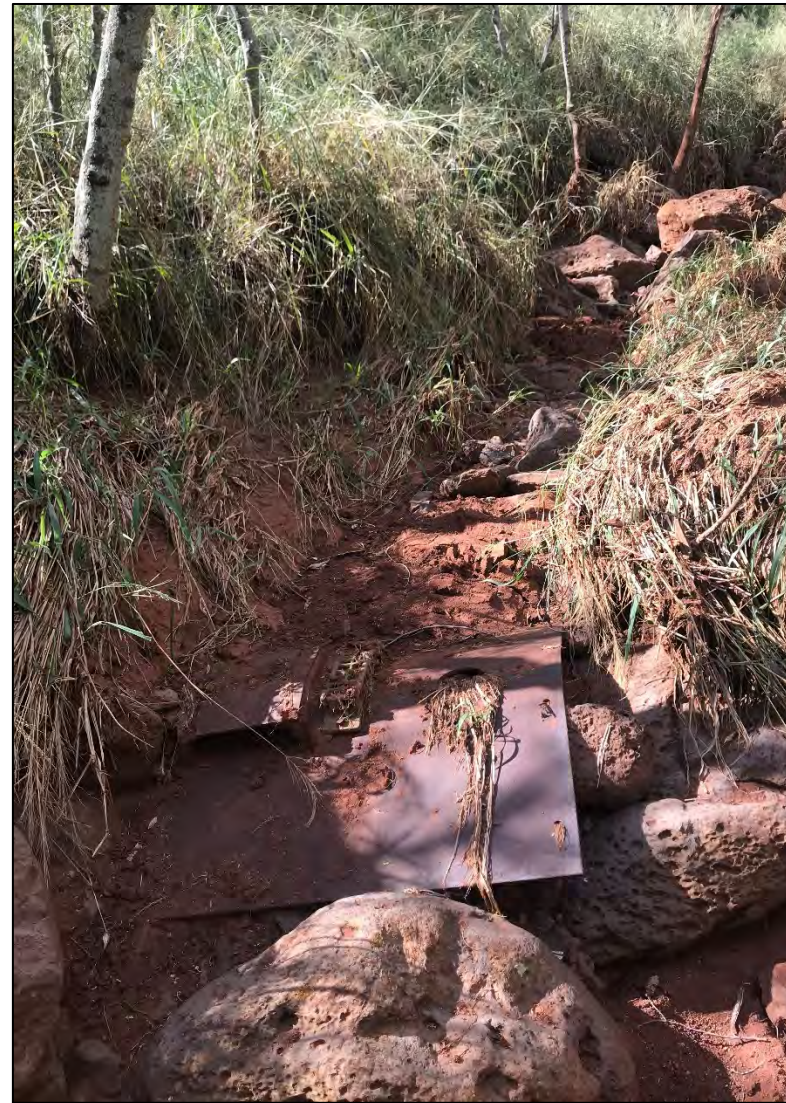
Archaeologists walked a gulch now situated within the project area from the northern boundary down to the access road (Figure 40). Metal debris from an unknown source was noted within the gulch toward the north edge of the project area (see Figure 40); no historic properties were identified.

Figure 40. Overviews of the gulch inside the project area, view to southwest (left), view to northeast with observed metal debris (right)

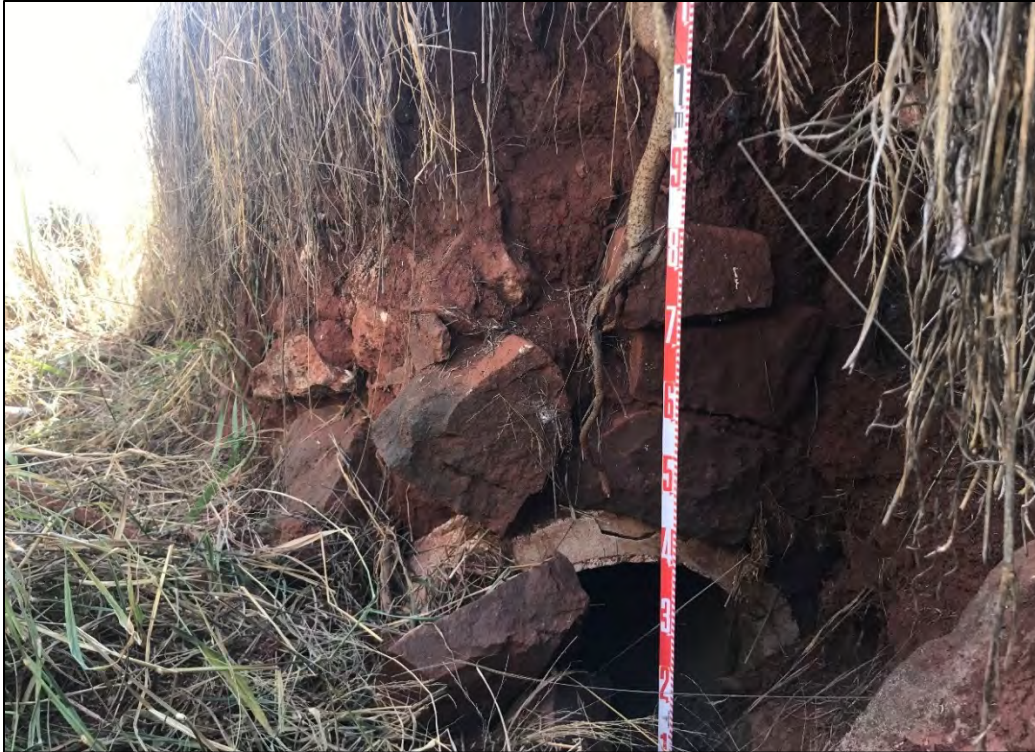
SIHP # 50-80-08-5593 Feature 1 consists of plantation-era drain pipes located within a ditch in the northeast portion of the project area (see Figure 42 for location). It is possible this feature was identified during the Dega et al. (1998) study, however, this could not be definitively discerned based on that documentation. The upper/west end of this feature consists of a single observable concrete pipe approximately 35 cm in diameter (the second pipe is likely obscured by collapsed earth) with overlying concrete rubble and stacked basalt, three stones wide and two to three courses high (Figure 48). This upper portion measures 82 cm tall and 90 cm wide. The east/lower end of Feature 1 consists of two steel pipes (Figure 49 and Figure 50), each approximately 35 cm in diameter, and the exposed portions approximately 40 cm tall. The function of this feature is related to agriculture and water control. Feature 1 is in fair condition, as much of the area is overgrown and heavily eroded.

Figure 48. Upper portion of SIHP # 50-80-08-5593 Feature 1 showing concrete pipes, view to east (collapse to the southwest, at right, may have covered the second pipe)

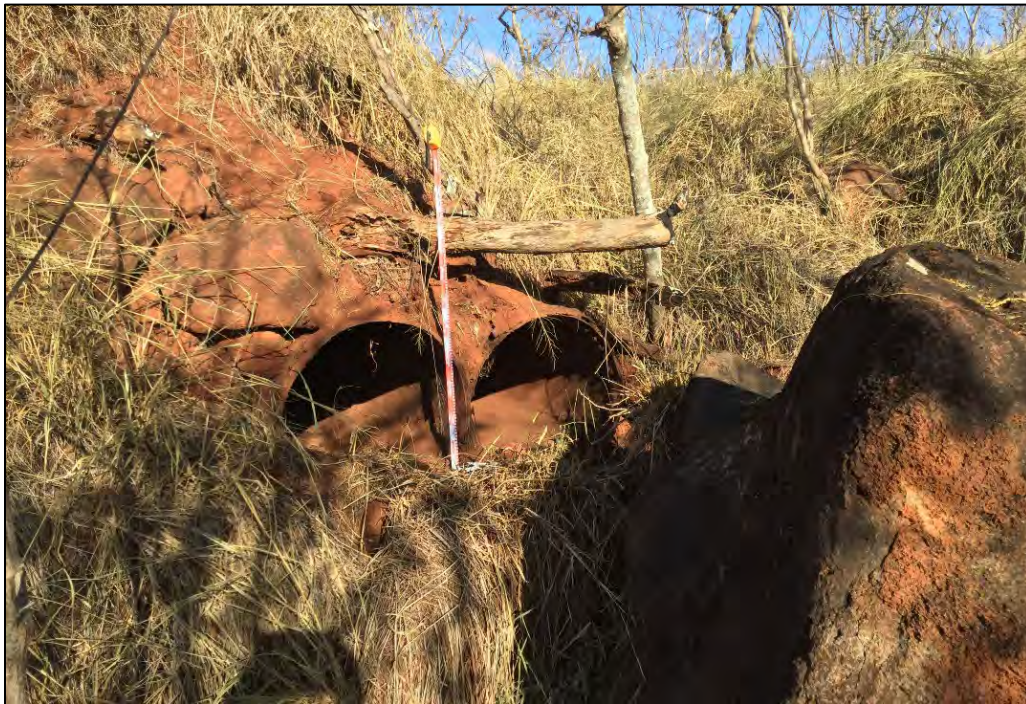
Figure 49. Lower portion of SIHP # 50-80-08-5593 Feature 1 showing metal pipes, view to northwest

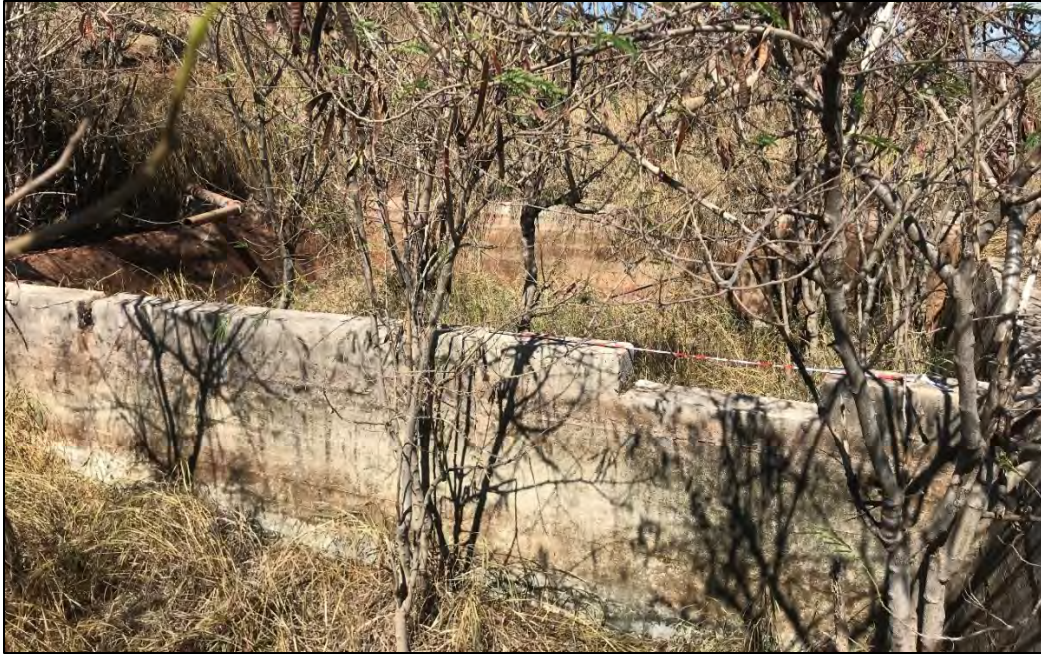
SIHP # 50-80-08-5593 Feature 2B is a rectangular water retention structure into which water from the upper Feature 2A complex/Waiahole Ditch would have been channeled (Figure 63 through Figure 66). Feature 2B measures approximately 15.2 m long, 10.6 m wide, extends 1.38 m above surface, and is a maximum depth of 3 m deep from top to bottom (see Figure 63 and Figure 64). The main structure, constructed entirely of concrete, consists of a large rectangular structure divided into two open rectangles by a concrete wall extending through the middle. The walls of the structure measure 25 cm wide, and the three northwest-southeast oriented walls have notches cut out of the surface that are 18 cm deep and range from 30 cm to 150 cm long. Two metal pipes extend out of the earth into the northeast half of the structure, at one time transporting water from the upper portion of the complex into this retention feature. Attached to the larger structure is a small rectangular portion, measuring 4.25 m long and 2.05 m wide, and containing a metal rung ladder descending into the structure and several metal pipes, which presumably continued transporting the water down the hillside (see Figure 65).

Figure 63. Overview of SIHP # 50-80-08-5593 Feature 2B, showing dividing wall between two large water storage components, view to northeast

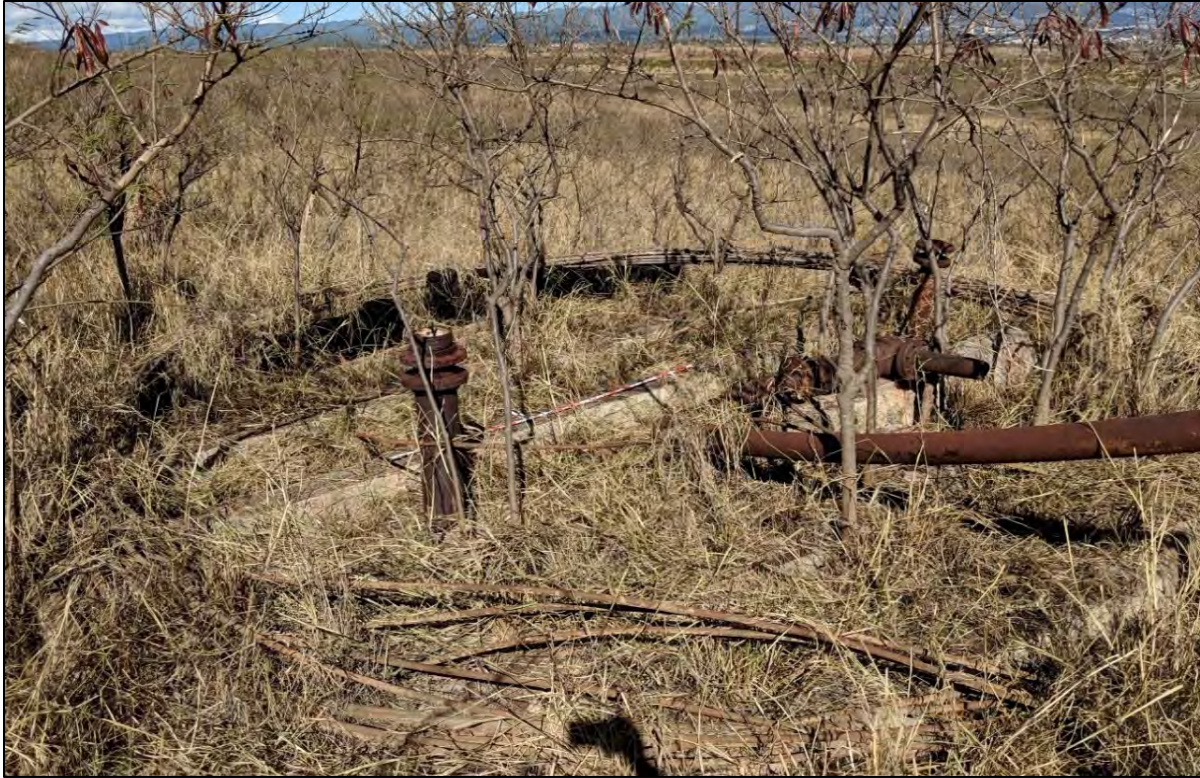
SIHP # 50-80-08-5593 Feature 2C consists of water tank remnants and related components (Figure 67 through Figure 71). The water tank was constructed of a concrete foundation with a wooden structure held together with steel cables. The wooden structure is no longer in place, leaving behind the 11 steel cables, concrete foundation, and several metal pipes (see Figure 67). The connected circular cable remnants measure a maximum 6.2 m in diameter, and the entirety of the remnants cover an area measuring 7.8 m long and 7.4 m wide. Two concrete squares measuring 80 cm by 80 cm and containing valves were documented immediately southwest of the water tower remnants (see Figure 68). A smaller related structure is 2.6 m northwest of the water tower remnants, which consists of a rectangular concrete structure measuring 3.0 m long and 2.8 m wide (see Figure 69). The northeast half of the structure is a solid concrete slab, and the southwest half of the structure is an open concrete rectangle containing metal pipes. The solid slab likely contains additional pipes related to the water control complex. Another 2.8 m northwest is an additional structure of concrete slabs and pipes, measuring 5.2 m long and 3.8 m wide. Additionally, approximately 7.4 m southwest of the water tower remnants is a damaged concrete component (see Figure 70). This concrete feature consists of three concrete walls—15 cm thick and a maximum 80 cm tall—that have broken and collapsed into a triangle shape. One metal pipe remains inside the collapsed walls. The tank is not noted on the 1943 Army War Department terrain map but appears on the 1953 Ewa and Schofield Barracks topographic quadrangles as a

Figure 67. SIHP # 50-80-08-5593 Feature 2C, water tank and associated components, view to northeast

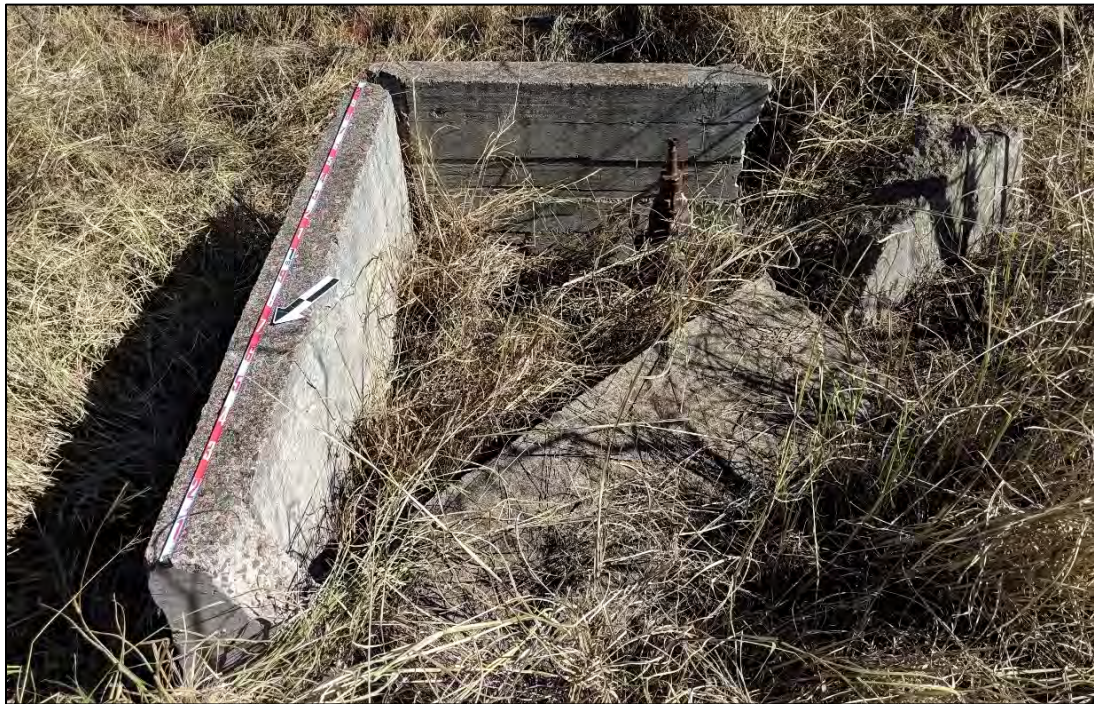
Figure 70. Collapsed walls with pipe, component of SIHP # 50-80-08-5593 Feature 2C, view to southeast

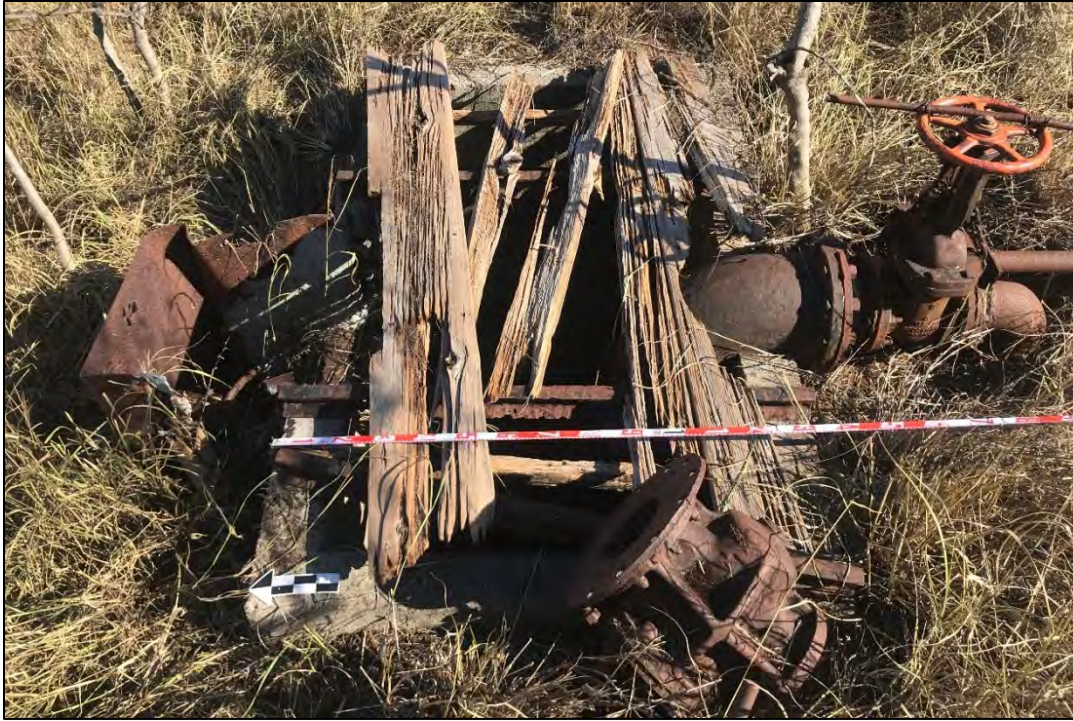
SIHP # 50-80-08-5593 Feature 2D, a rectangular-shaped likely water retention feature, is situated near the base of the slope toward the pump house and mill building (Figure 72 through Figure 76). This is constructed of concrete, metal, and wood. The feature has three components: two rectangular shafts and one concrete culvert. The first portion measures 2.4 m long and 2.0 m wide, consisting of a rectangular shaft extending to a maximum depth of 215 cm with an attached small square shaft extending to a maximum depth of 205 cm (see Figure 72). A metal pipe oriented north-south extends from inside the rectangular shaft out above ground for 3.6 m before extending downward into the shaft of the second rectangular component. The second rectangular shaft measures 2.1 m long and 1.2 m wide, extending to a maximum depth of 215 cm (see Figure 73). This second retention shaft includes notches for an intact wooden sluice gate on the east edge, which leads out into a sloped, mortared basalt channel, possibly for overflow runoff (see Figure 74 and Figure 75). The mortared basalt portion measures 3.6 m long by 1.4 m wide and is two courses high (exposed portion is 50 cm tall on average). This feature may be connected to Feature 2E, described below, as a pipe in the squared shaft on the northeast end appears to extend in the direction of Feature 2E (see Figure 75). Apparent infrastructure is observed in the vicinity of this feature in a 1951 aerial photograph (see Figure 18; UH MAGIS 1951).

Figure 72. Overview of SIHP # 50-80-08-5593 Feature 2D, northeast valve box, view to east

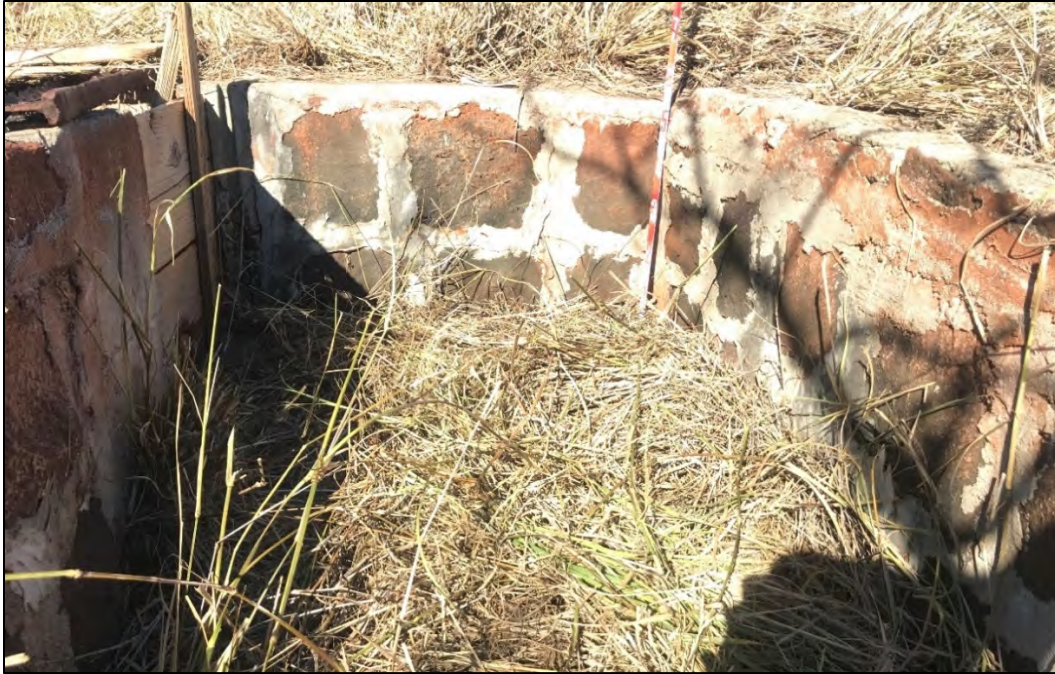
Figure 74. SIHP # 50-80-08-5593 Feature 2D sluice gate and possible water overflow channel, view to northeast

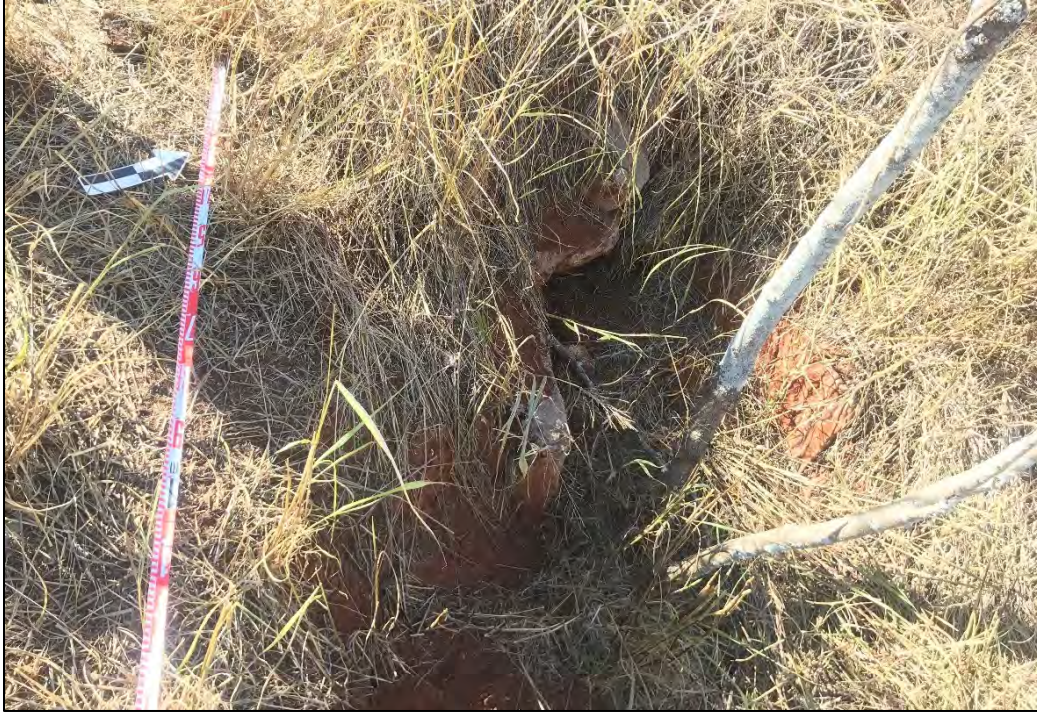
SIHP # 50-80-08-5593 Feature 2E consists of a remnant concrete culvert (see Figure 76 through Figure 78). Feature 2E is in poor condition and measures 2.4 m long and 0.75 m wide. Feature 2E is in the lower portion of the project area and appears to have been used to help channel water overflow runoff. A pipe was observed in a shaft of Feature 2D extending in the direction of 2E, suggesting water overflow was channeled from the retention feature out of Feature 2E.

Figure 77. SIHP # 50-80-08-5593 Feature 2E, culvert remnants, view to northwest

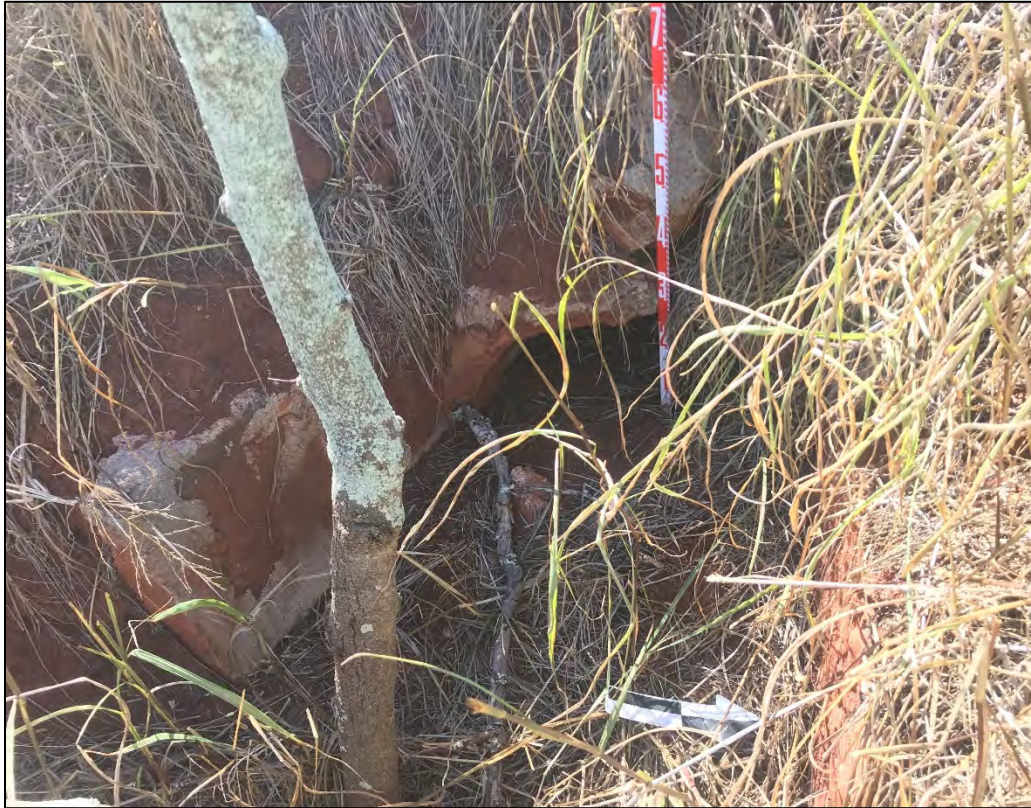
Figure 78. SIHP # 50-80-08-5593 Feature 2E, close-up of culvert remnants, view to west

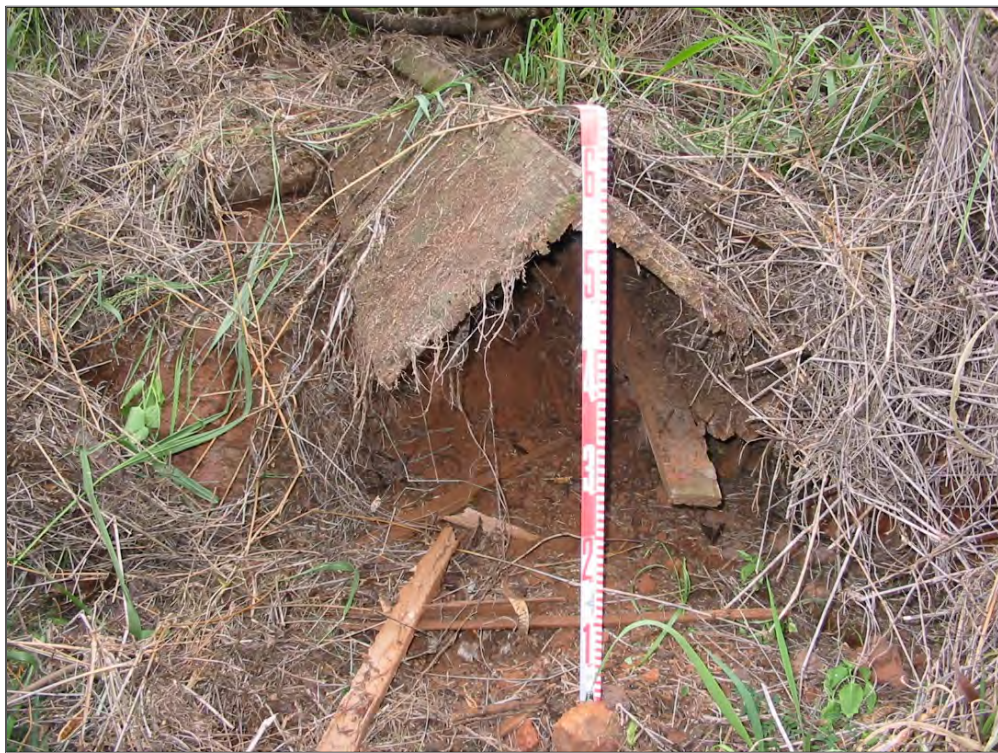
Feature C is an improved drainage channel and short flume section, similar to Feature B. Feature C is located where the Waiahole Ditch crosses a small drainage channel, approximately 100 m east of Feature B. The drainage channel appears to have been improved by excavation of loose soil and stones to improve water flow. Feature C consists of a wooden U-shaped flume section constructed over the Waiahole Ditch (Figure 91 through Figure 90). The flume is oriented perpendicular to the ditch, with the upslope end of the flume located in the center of the drainage channel. The flume is supported on the upslope end by a stone and mortar foundation and retaining walls that direct the water flow from the drainage channel into the flume. The downslope portion of the flume rests on the soil berm downslope of the ditch. Feature C functions as a drainage improvement associated with the Waiahole Ditch. The flume collects storm water from an improved drainage channel and transports the water over the ditch and down the gulch slope, thereby reducing damage to and sedimentation of the ditch during periods of heavy rainfall. Due to its wooden construction, much of the Feature C flume has deteriorated. [Hunkin and Hammatt 2009:47]

Figure 90. SIHP # 50-80-09-2268 Feature C, showing partially intact wooden flume section, view to south (Hunkin and Hammatt 2009:52)
