Figure 39. 2013 Ewa and Schofield Barracks USGS topographic quadrangles showing the historic properties identified during the AIS: SIHP # 50-80-08-2268 Feature E through Feature K (shown in green) and SIHP # 50-80-08-5593 Feature 1, Features 2A through 2E, and Features 3A through 3C (shown in orange) and SIHP # 50-80-08-5593 Features 4A through 4F shown in yellow; Features A through D of SIHP # -2268 identified in previous studies nearby the project area were included for reference

### 5.1.1 Description of SIHP # -5593 by Dega et al. 1998

### **5.1.2 Description of SIHP # -5593 within and adjacent to the Current Project Area**

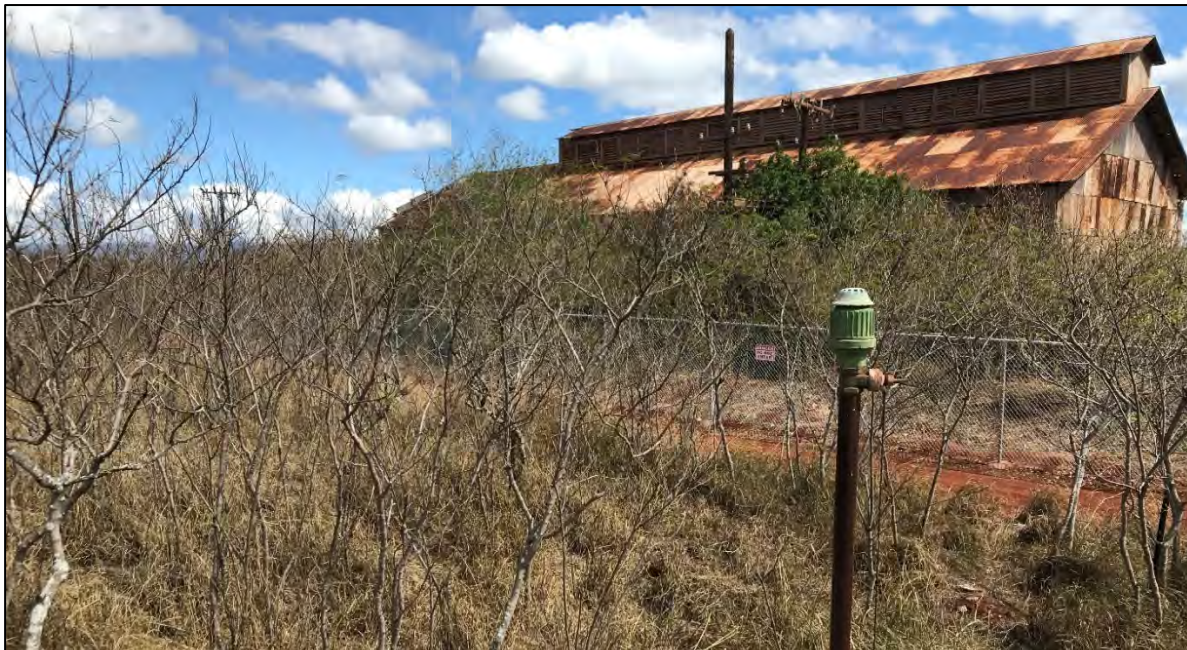
Figure 44. Mill building immediately southeast of the project area boundary (downslope of Feature 2A complex), view to east (Photo L; Figure 27)

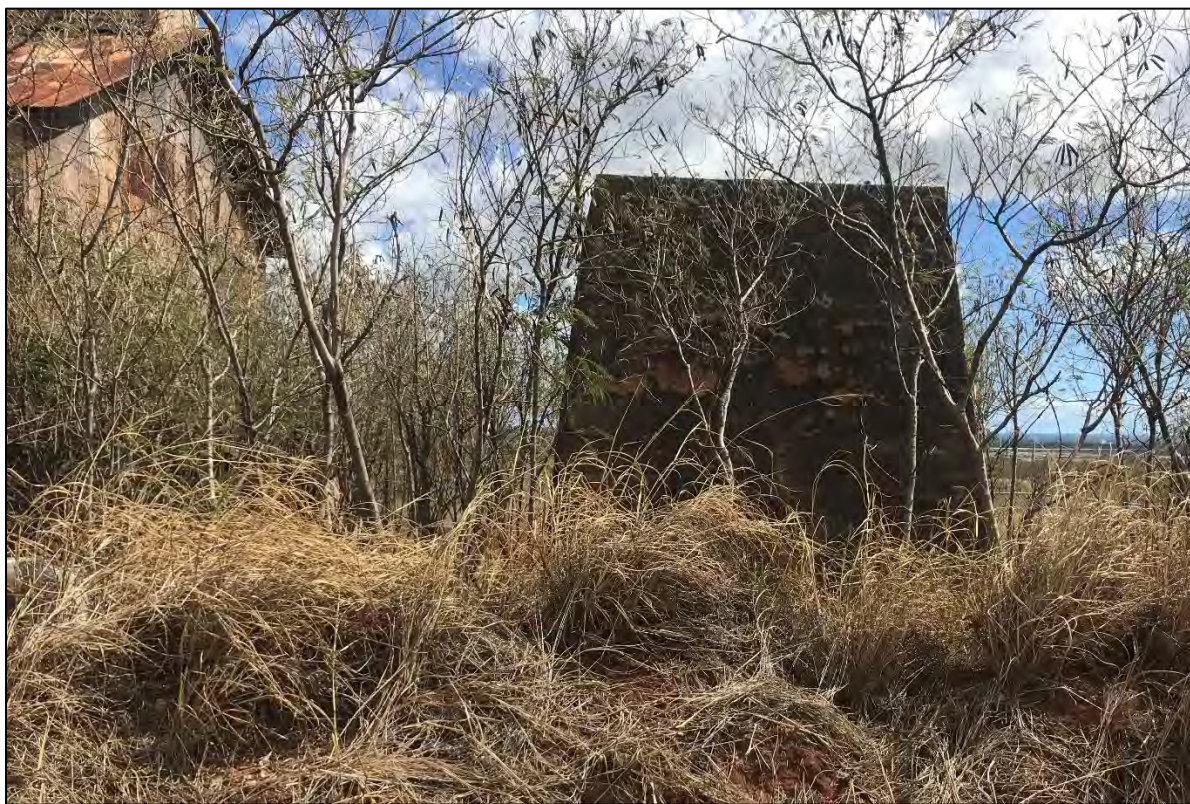
Figure 45. Pump House No. 12, southeast of the project area (mill building to the left), view to southeast (Photo M; Figure 27)

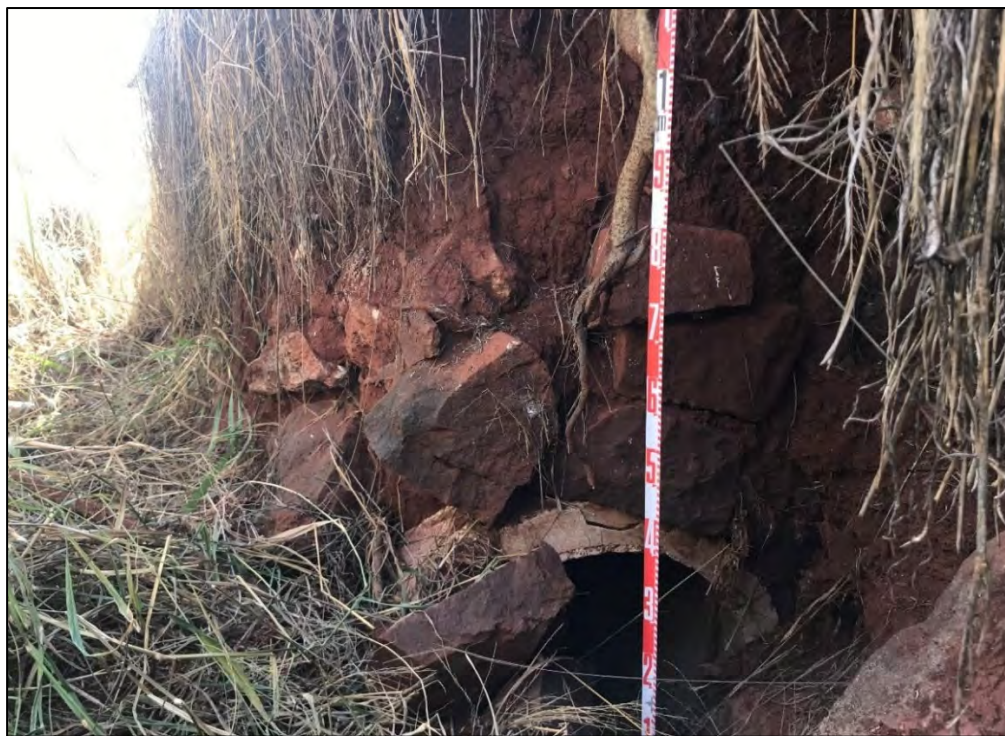
**SIHP # 50-80-08-5593 Feature 1** consists of plantation-era drain pipes located within a ditch in the northeast portion of the project area (see Figure 40 for location). It is possible this feature was identified during the Dega et al. (1998) study, however, this could not be definitively discerned based on that documentation. The upper/west end of this feature consists of a single observable concrete pipe approximately 35 cm in diameter (the second pipe is likely obscured by collapsed earth) with overlying concrete rubble and stacked basalt, three stones wide and two to three courses high (Figure 46). This upper portion measures 82 cm tall and 90 cm wide.

Figure 46. Upper portion of SIHP # 50-80-08-5593 Feature 1 showing concrete pipes, view to east (collapse to the southwest, at right, may have covered the second pipe) (Photo N; Figure 27)

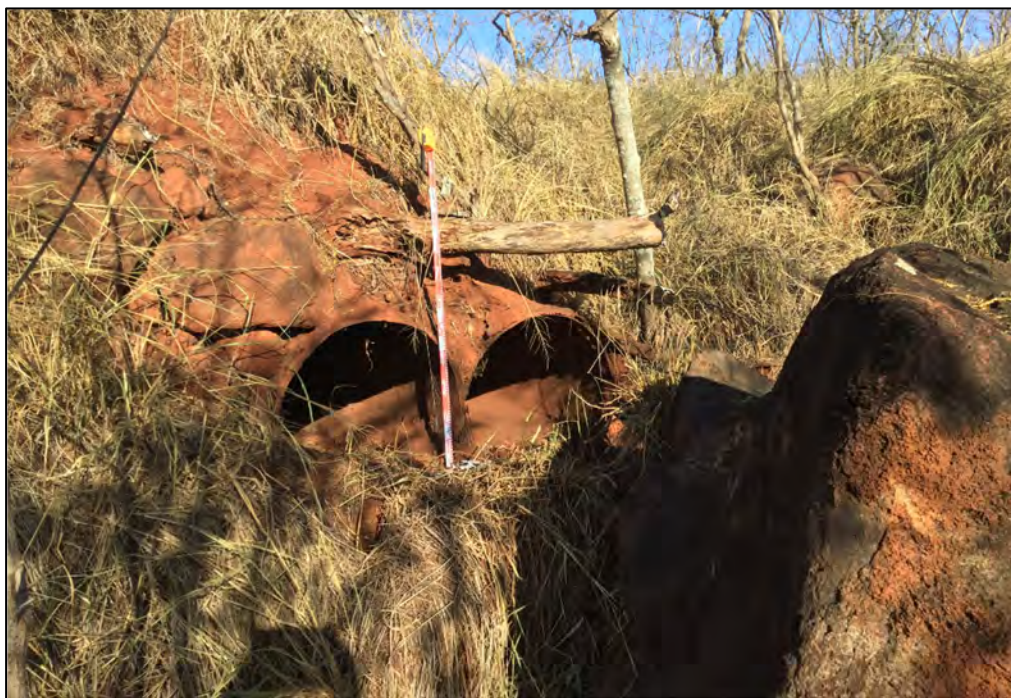
The east/lower end of Feature 1 consists of two steel pipes (Figure 47 and Figure 48), each approximately 35 cm in diameter, and the exposed portions approximately 40 cm tall. The function of this feature is related to agriculture and water control. Feature 1 is in fair condition, as much of the area is overgrown and heavily eroded.

Figure 47. Lower portion of SIHP # 50-80-08-5593 Feature 1 showing metal pipes, view to northwest (Photo O; Figure 27)

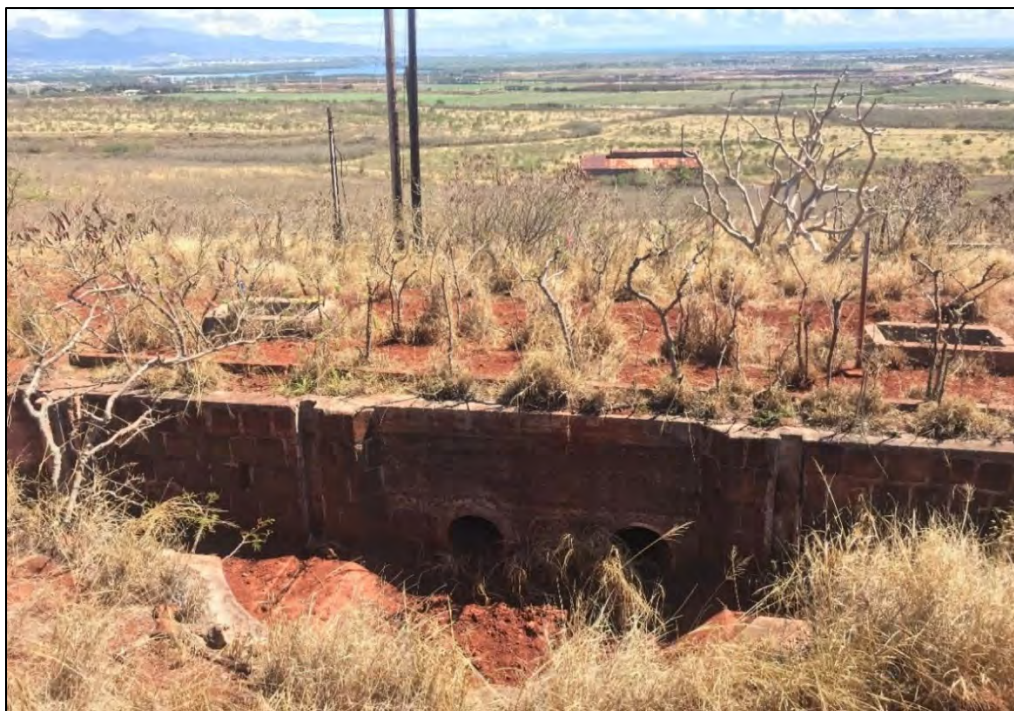
**SIHP # 50-80-08-5593 Feature 2A**, the uppermost portion of the complex, consists of various water catchment features attached to a portion of the Waiahole Ditch, related to the mill and pump house at the base of the slope (see Figure 49, Figure 50, and Figure 60). This portion is oriented northeast-southwest, and constructed of basalt, concrete, and metal pipes. The Feature 2A complex is situated on the northwest boundary of the project area. Portions of this upper complex contain modern rubbish (modern bottles and cans), as well as a cow skeleton, likely a livestock animal that fell, died, and decayed in place. The northeast portion of this section of the Waiahole Ditch consists of a concrete-lined ditch 140 cm wide and 163 cm deep. As it extends toward the Feature 2A complex, there is an overlying addition of mortared basalt three courses high, a portion of which bears the date inscription "MAR 1939" (Figure 51). The ditch then feeds into a large catchment basin measuring a maximum of 4.0 m long and 3.2 m wide, with a maximum depth of 180 cm. The basin is flanked by notches in the concrete on both sides, for former sluice gates which are no longer intact. The basin would have fed into the two drain pipes at the base of the southeast wall of the structure (Figure 52). These pipes extend down slope to the pump house and mill. Portions of these pipes are exposed on the slope's surface, and much of the pipes are likely underground.

Figure 49. Overview of SIHP # 50-80-09-2268 Waiahole Ditch portion, and SIHP # 50-80-08-5593 Feature 2A complex, with the pump house and mill building at the base of the slope, view to southeast

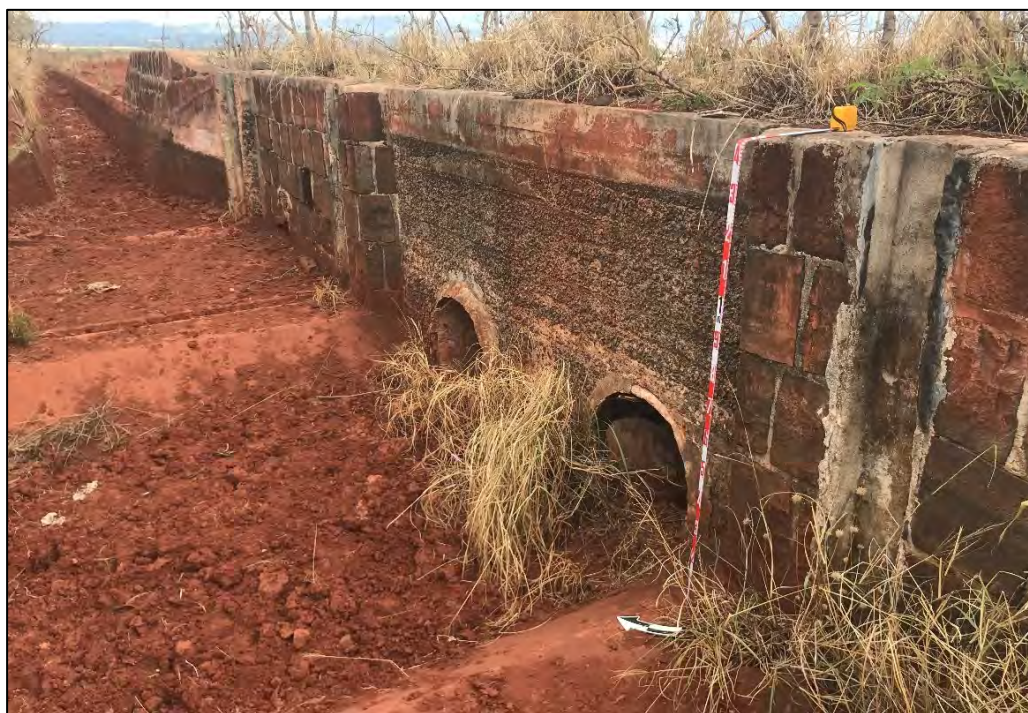
Figure 52. Overview of SIHP # 50-80-08-5593 Feature 2A where SIHP # 50-80-09-2268 Waiahole Ditch flows through the feature (see Figure 60 plan map), with catchment basin (foreground) and drain pipes, view to east

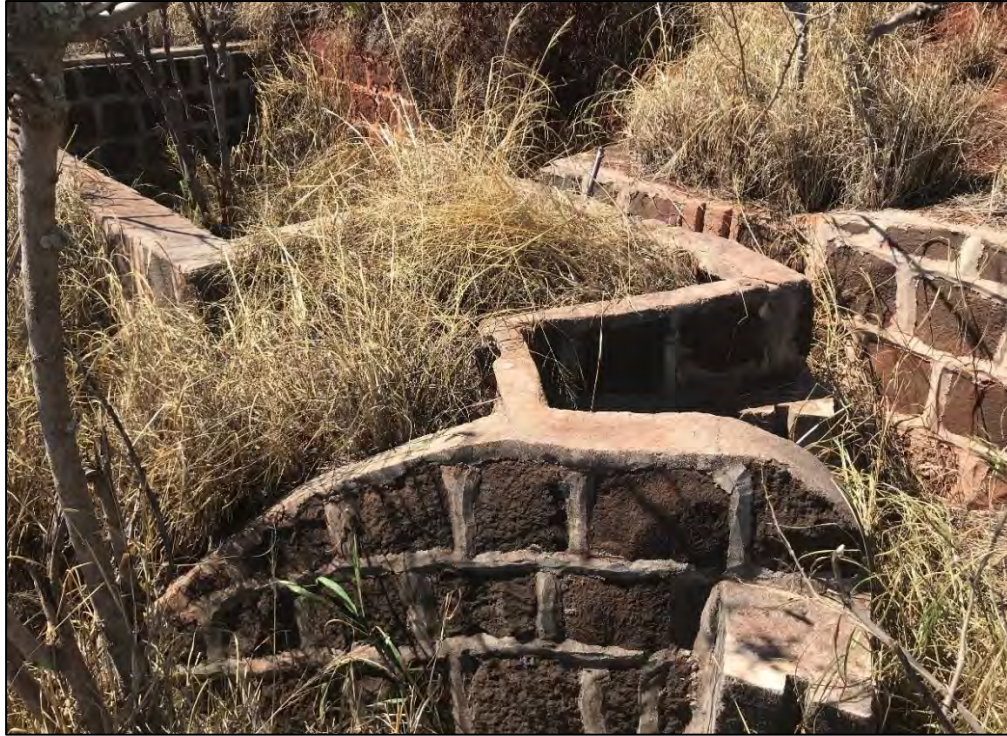
An additional water retention component is positioned directly northwest of this basin. This portion consists of a rectangular mortared basalt catchment area measuring 5.1 m long by 3.8 m wide (Figure 53), feeding into an oval catchment area measuring 6.3 m long and 2.6 m wide (Figure 54), with notches for a sluice gate feature in between (gate not intact). It is possible these catchment areas are gravel traps, which would have served to trap silt and clay (Reeves 1954). This function is suggested based on the complex shape of the structure, which is somewhat similar to a gravel trap from the Iao-Maniania Ditch pictured in a publication on plantation ditches (Figure 55; Wilcox 1996). Three flumes feed from the upper catchment areas into the Waiahole Ditch (Figure 56 and Figure 57). The flumes are oriented north-south and northwest-southeast. The eastern flume

Figure 53. Upper water retention area of SIHP # 50-80-08-5593 Feature 2A complex, view to west

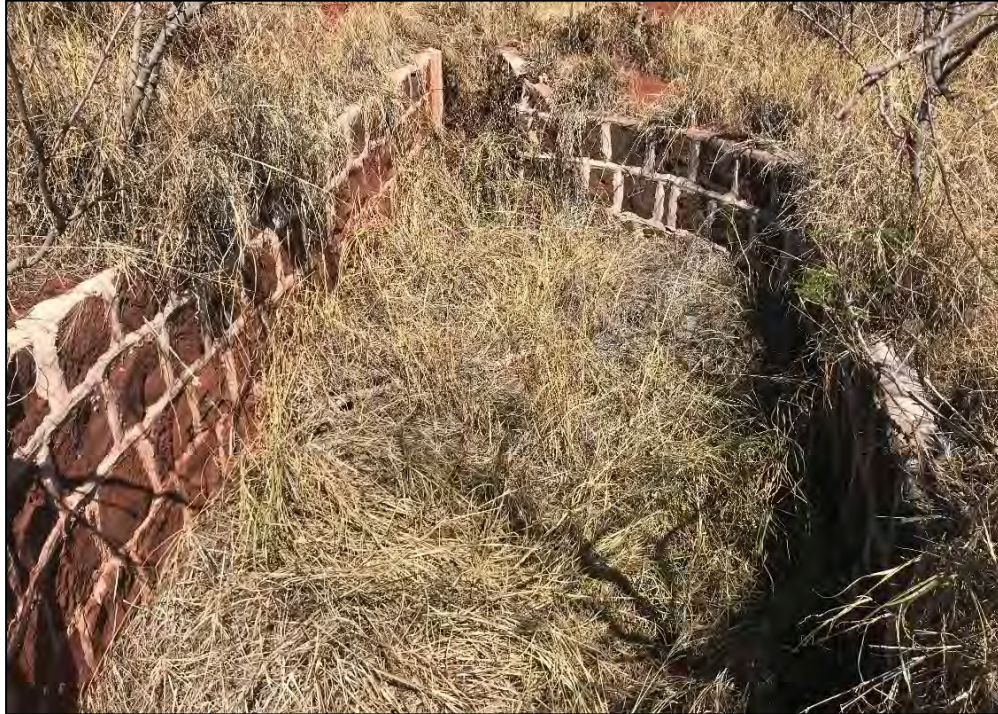
Figure 54. Upper water retention areas (eastern portion) of SIHP # 50-80-08-5593 Feature 2A complex, view to northeast

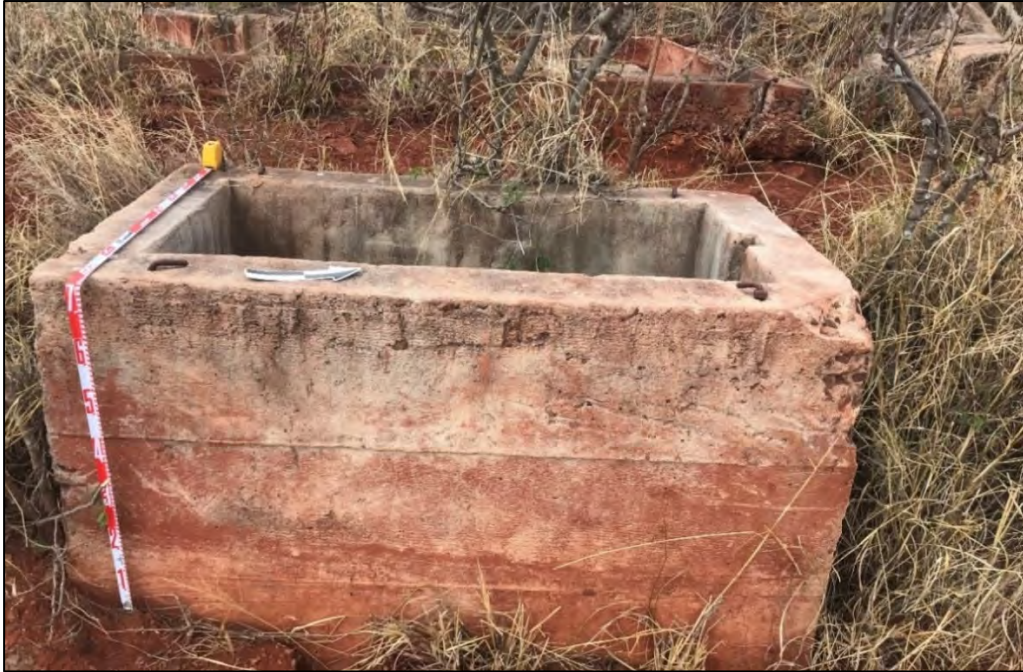
The final components of the Feature 2A complex are two small rectangular water retention features, each measuring 152 cm long, 90 cm wide, and 118 cm deep, with 16-cm thick walls (Figure 58). The south wall of the southwest retention feature contains a slit in the concrete that has a wood insert with an attached steel measuring rod (Figure 59). The wood and steel elements no longer exist in the northeast retention feature, but the slit in the concrete remains on the south wall of this component. Descending the hillside from Feature 2A are various structures related to moving water down to the mill and pump house, including water retention areas, and concrete pads and boxes that housed pumps and pipes.

Figure 58. Water retention component of SIHP # 50-80-09-5593 Feature 2A complex, view to west

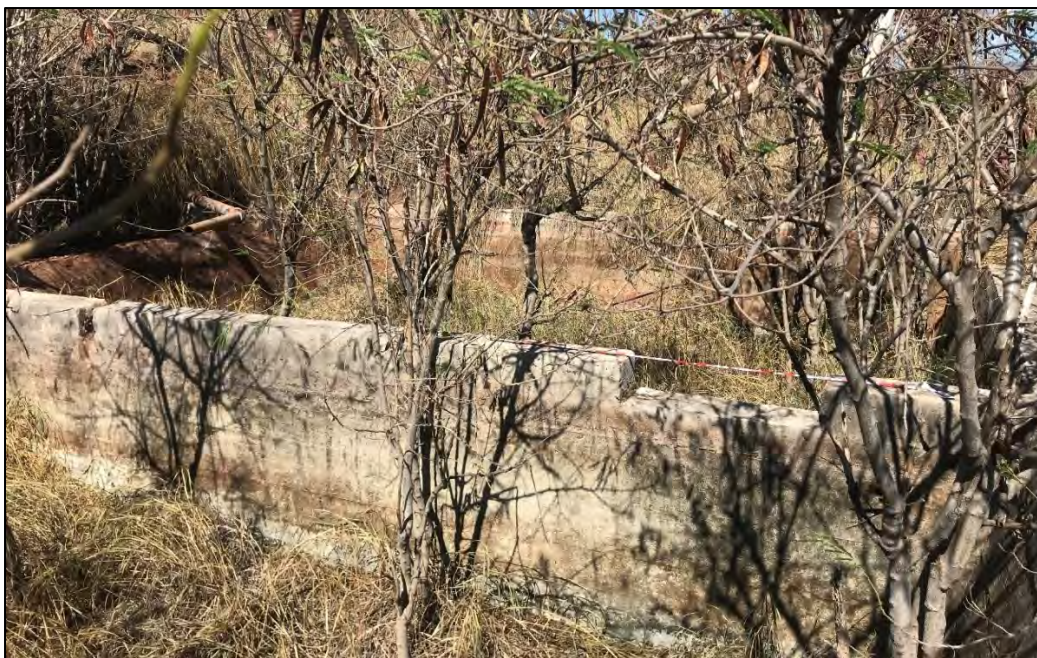
**SIHP # 50-80-08-5593 Feature 2B** is a rectangular water retention structure into which water from the upper Feature 2A complex/Waiahole Ditch would have been channeled (Figure 61 through Figure 64). Feature 2B measures approximately 15.2 m long, 10.6 m wide, extends 1.38 m above surface, and is a maximum depth of 3 m deep from top to bottom (see Figure 61 and Figure 62). The main structure, constructed entirely of concrete, consists of a large rectangular structure divided into two open rectangles by a concrete wall extending through the middle. The walls of the structure measure 25 cm wide, and the three northwest-southeast oriented walls have notches cut out of the surface that are 18 cm deep and range from 30 cm to 150 cm long. Two metal pipes extend out of the earth into the northeast half of the structure, at one time transporting water from the upper portion of the complex into this retention feature. Attached to the larger structure is a small rectangular portion, measuring 4.25 m long and 2.05 m wide, and containing a metal rung ladder descending into the structure and several metal pipes, which presumably continued transporting the water down the hillside (see Figure 63).

Figure 61. Overview of SIHP # 50-80-08-5593 Feature 2B, showing dividing wall between two large water storage components, view to northeast

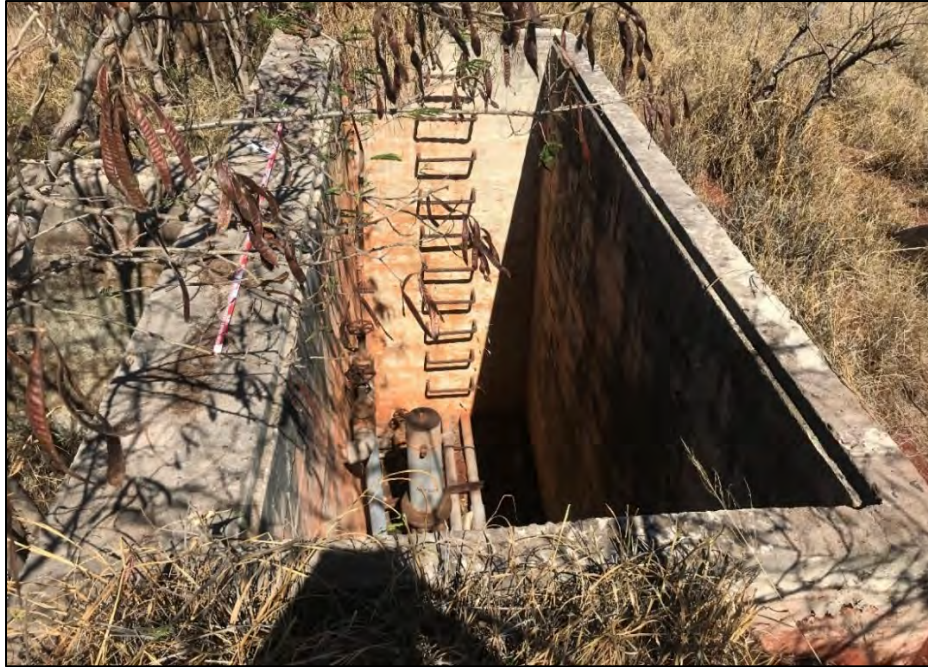
Figure 63. Overview of SIHP # 50-80-08-5593 Feature 2B, smaller southeast portion, view to northeast

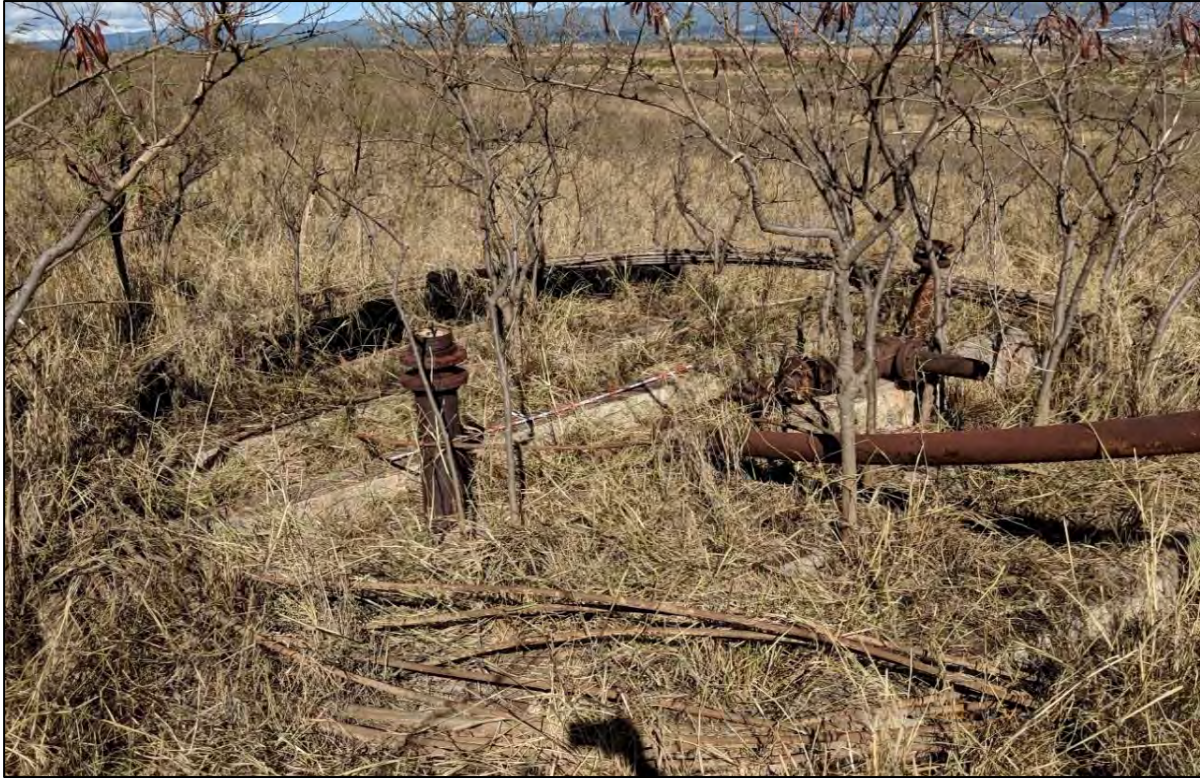
**SIHP # 50-80-08-5593 Feature 2C** consists of water tank remnants and related components (Figure 65 through Figure 69). The water tank was constructed of a concrete foundation with a wooden structure held together with steel cables. The wooden structure is no longer in place, leaving behind the 11 steel cables, concrete foundation, and several metal pipes (see Figure 65). The connected circular cable remnants measure a maximum 6.2 m in diameter, and the entirety of the remnants cover an area measuring 7.8 m long and 7.4 m wide. Two concrete squares measuring 80 cm by 80 cm and containing valves were documented immediately southwest of the water tower remnants (see Figure 66). A smaller related structure is 2.6 m northwest of the water tower remnants, which consists of a rectangular concrete structure measuring 3.0 m long and 2.8 m wide (see Figure 67). The northeast half of the structure is a solid concrete slab, and the southwest half of the structure is an open concrete rectangle containing metal pipes. The solid slab likely contains additional pipes related to the water control complex. Another 2.8 m northwest is an additional structure of concrete slabs and pipes, measuring 5.2 m long and 3.8 m wide. Additionally, approximately 7.4 m southwest of the water tower remnants is a damaged concrete component (see Figure 68). This concrete feature consists of three concrete walls—15 cm thick and a maximum 80 cm tall—that have broken and collapsed into a triangle shape. One metal pipe remains inside the collapsed walls. The tank is not noted on the 1943 Army War Department terrain map but appears on the 1953 Ewa and Schofield Barracks topographic quadrangles as a marked circular feature labeled “Water Tank” in the same location as the documented Feature 2C (see Figure 17 and Figure 19). Structures are visible in this general area as late as 1968, including an apparent circular structure, which is likely the water tank (see Figure 21; UH MAGIS 1968).

Figure 65. SIHP # 50-80-08-5593 Feature 2C, water tank and associated components, view to northeast

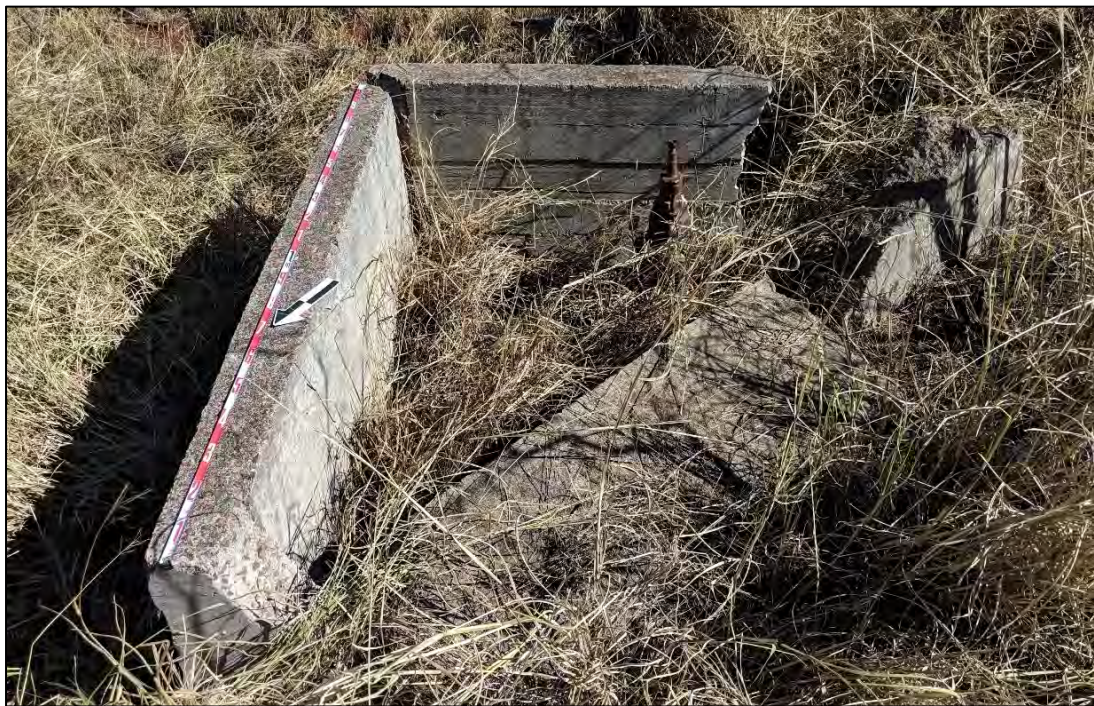
Figure 68. Collapsed walls with pipe, component of SIHP # 50-80-08-5593 Feature 2C, view to southeast

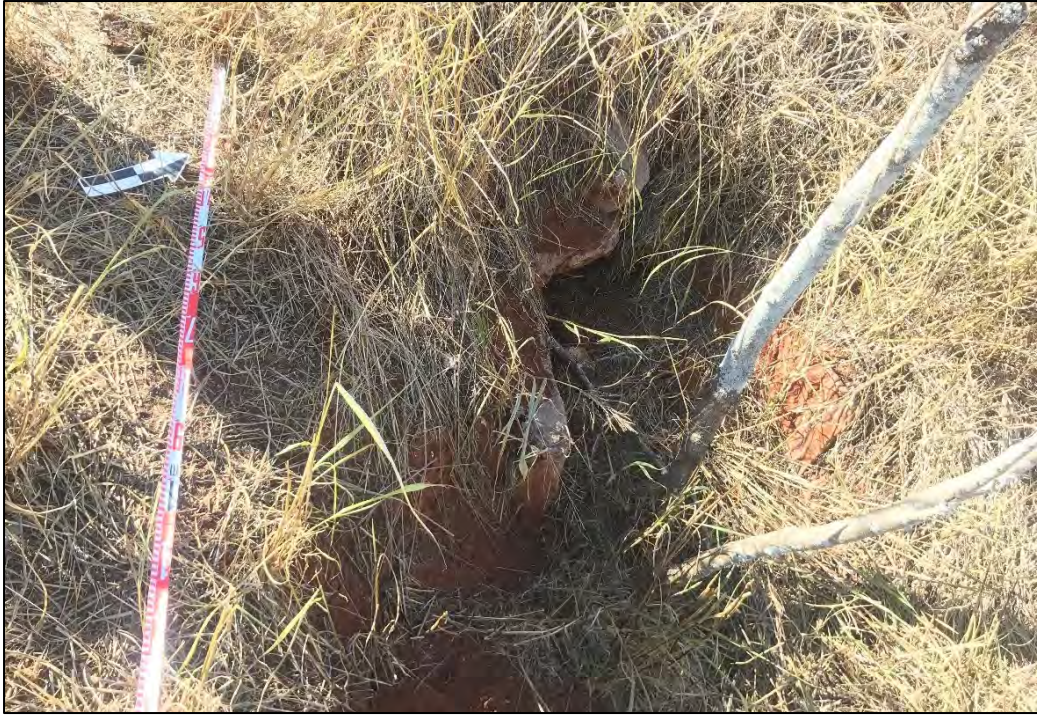
**SIHP # 50-80-08-5593 Feature 2E** consists of a remnant concrete culvert (see Figure 74 through Figure 76). Feature 2E is in poor condition and measures 2.4 m long and 0.75 m wide. Feature 2E is in the lower portion of the project area and appears to have been used to help channel water overflow runoff. A pipe was observed in a shaft of Feature 2D extending in the direction of 2E, suggesting water overflow was channeled from the retention feature out of Feature 2E.

Figure 75. SIHP # 50-80-08-5593 Feature 2E, culvert remnants, view to northwest

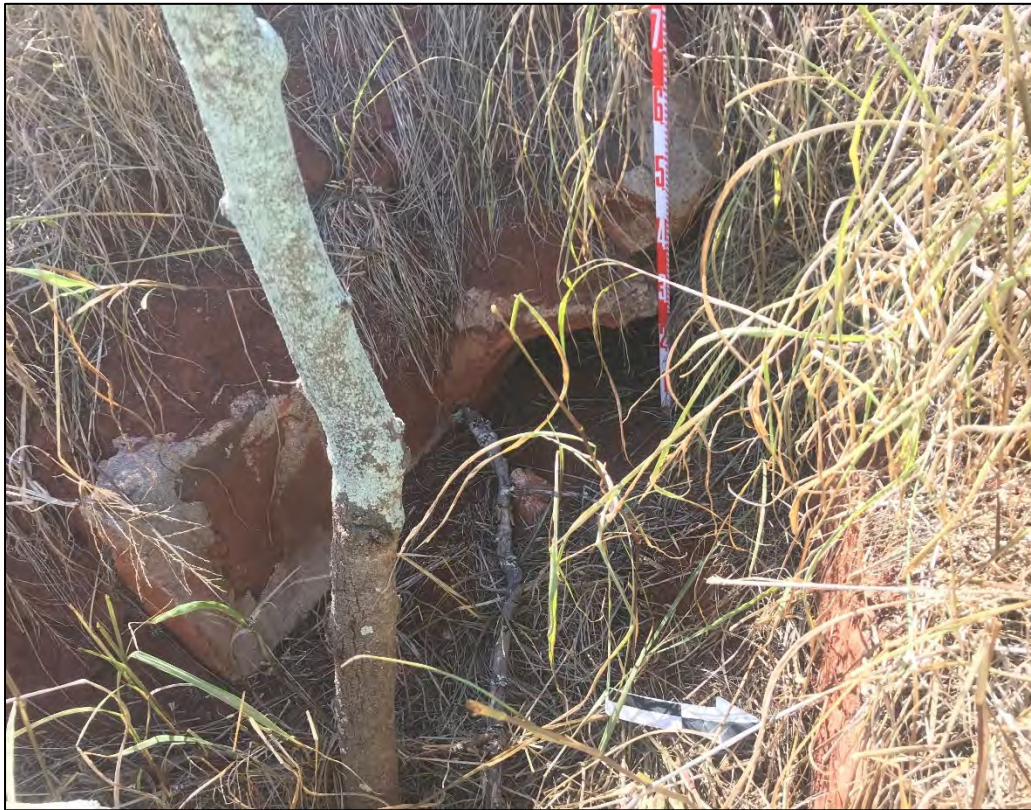
Figure 76. SIHP # 50-80-08-5593 Feature 2E, close-up of culvert remnants, view to west

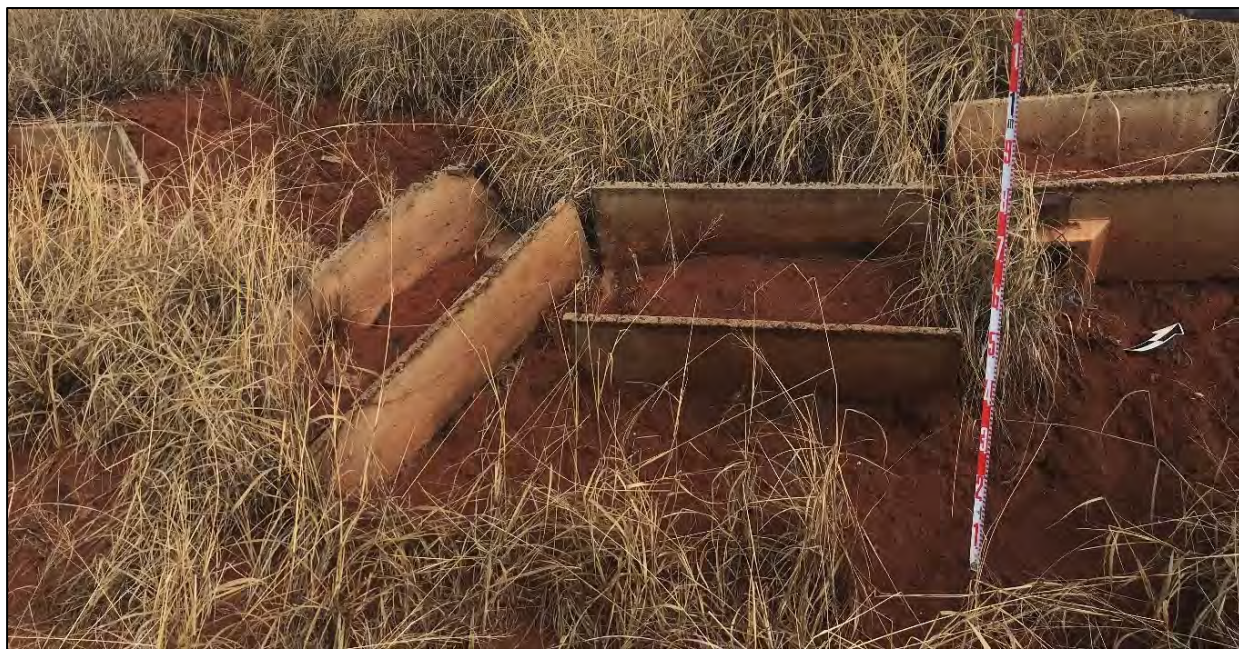
**Feature 3A** consists of a heavily disturbed remnant portable concrete flume along the *makai* side of SIHP # -5593 Feature 4A (see Figure 38, Figure 77 and Figure 78). The feature is disconnected and displaced, with many sections downslope from their original alignment. The documented portion spans approximately 10.6 meters long and is oriented northeast to southwest. The sections are fragmented but those that are intact are U-shaped and measure between 90 cm and 75 cm in length, and are 45 cm in width and 30 cm in height. Many of the sections had a trapezoidal protrusion on the sides with a square hole and steel plate that extended into the hole through a small slit. This is likely designed to allow water to flow out of the portable ditch segments into fields or small field ditches.

Figure 77. SIHP # 50-80-08-5593 Feature 3A, view to northwest

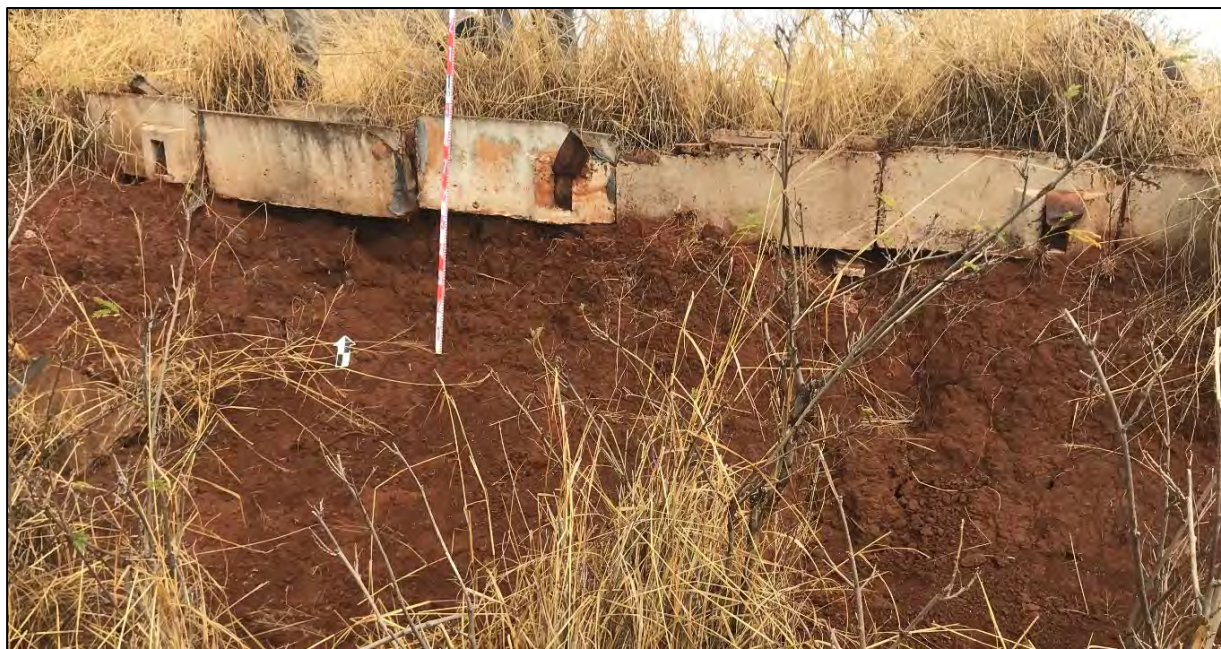
**Feature 3B** consists of the same form and type of concrete U-shaped segments as Feature 3A. Feature 3B is along the north side of SIHP # -5593 Feature 4B on a raised slope at what likely was a field edge (see Figure 38). The feature is approximately 10.5 meters in length and is oriented east to west (Figure 79 and Figure 80). There are 10 somewhat contiguous sections with the east end turning slightly south. One displaced segment is lying just north of the west end near the road (Feature 4B). The downslope side of the feature is eroding.

Figure 79. SIHP # 50-80-08-5593 Feature 3B, view to north
