**County of Maui  
Island of Lanai  
Sewer System**

#### Sewer Line System Analysis ISLAND OF MAUI CCTV 2009

Lanai City Expansion - 200 Housing Units  
Awalua Avenue  
Lanai City, HI 96763

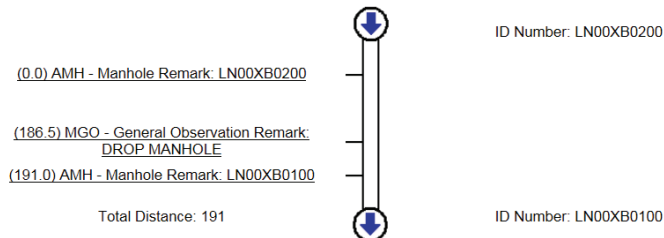
# PO Number: 17

Distance	Video Ref	Code	Cont Defect	Value			Joint	Circumferential Location	
				Dimension		%		At / From	To
				1st	2nd				
0	31	AMH - Manhole							
		LN00XB0200							
186.5	406	MGO - General Observation							
		DROP MANHOLE							
191	440	AMH - Manhole							
		LN00XB0100

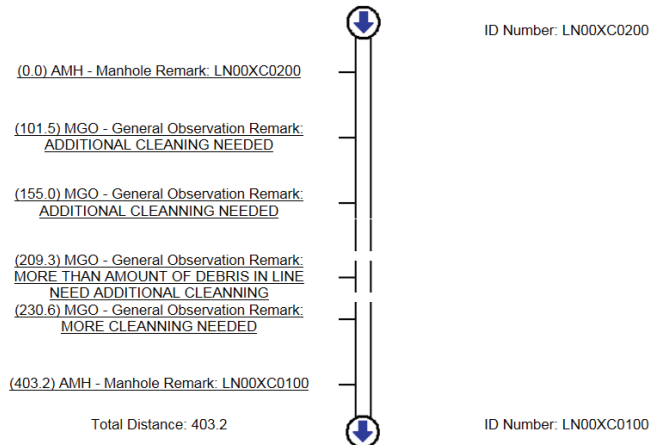
# PO Number: 23

Distance	Video Ref	Code	Cont Defect	Value			Joint	Circumferential Location	
				Dimension		%		At / From	To
0	33	AMH - Manhole							
		LN00XC0200							
101.5	304	MGO - General Observation							
		ADDITIONAL CLEANING NEEDED							
155	832	MGO - General Observation							
		ADDITIONAL CLEANING NEEDED							
209.3	1073	MGO - General Observation							
		MORE THAN AMOUNT OF DEBRIS IN LINE NEED ADDITIONAL CLEANING							
230.6	935	MGO - General Observation							
		MORE CLEANING NEEDED							
403.2	267	AMH - Manhole							
		LN00XC0100

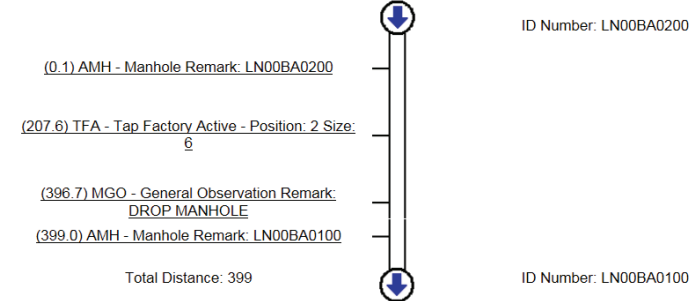
# PO Number: 2

Distance	Video Ref	Code	Cont Defect	Value			Joint	Circumferential Location	
				Dimension 1st	2nd	%		At / From	To
0.1	36	AMH - Manhole							
		LN00BA0200							
207.6	372	TFA - Tap Factory Active		6				2	
396.7	727	MGO - General Observation							
		DROP MANHOLE							
399	759	AMH - Manhole							
		LN00BA0100

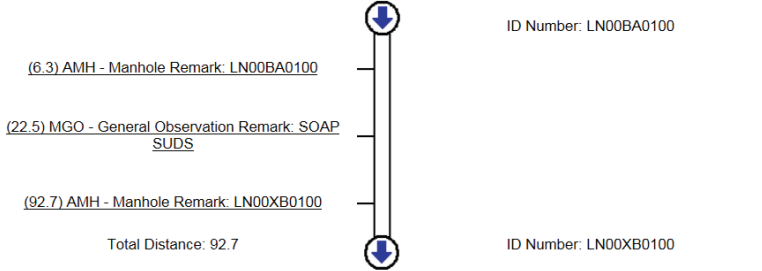
PO Number: 1

Distance	Video Ref	Code	Cont Defect	Value			Joint	Circumferential Location	
				Dimension		%		At / From	To
6.3	29	AMH - Manhole		1st	2nd				
		LN00BA0100							
22.5	80	MGO - General Observation							
		SOAP SUDS							
92.7	455	AMH - Manhole							
		LN00XB0100
