### **SIHP # 50-80-09-2270: Roads and Railroad Rights-of-Way**

FORMAL SITE TYPE:	Roads and Railroad Rights-of-Way
NO. OF FEATURES:	28 (in the project area) <sup>11</sup>
DIMENSIONS:	See Table 4 for individual feature dimensions
CONDITION ABOVE GROUND:	Varies from Good to Poor
FUNCTIONAL INTERPRETATION:	Transport of Crops, Materials & People
AGE INTERPRETATION:	Historic Period— Early to Middle 20 <sup>th</sup> Century

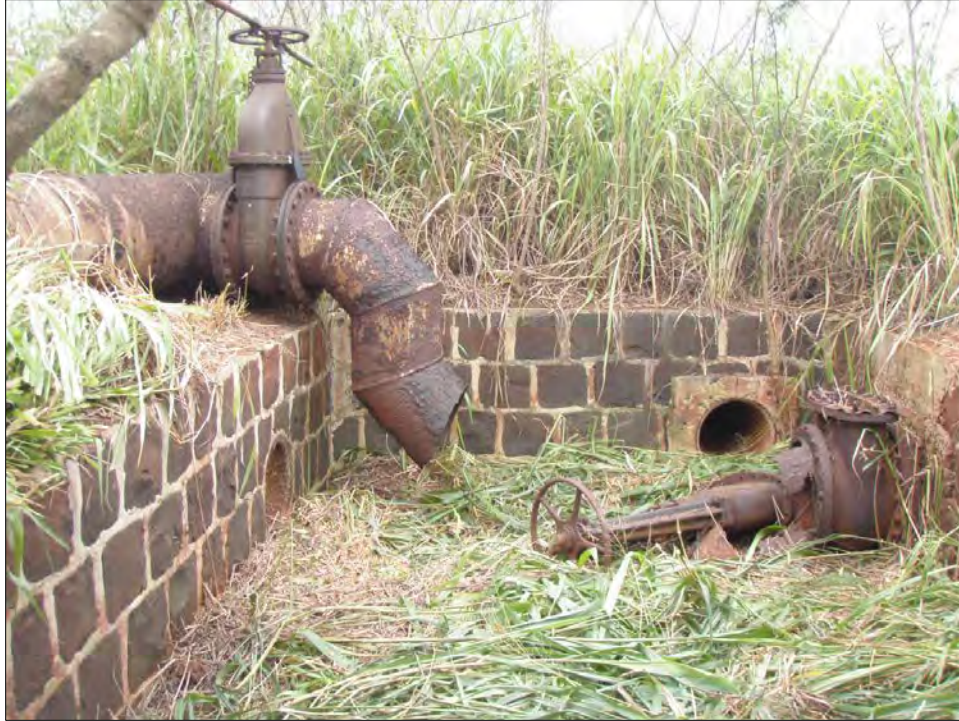
**Figure 16. Main basin at Feature 1, Site 2273, showing large hand-operated valves (intact at left, ruined at right); view southwest; basalt and mortar walls are 107-108 cm high**

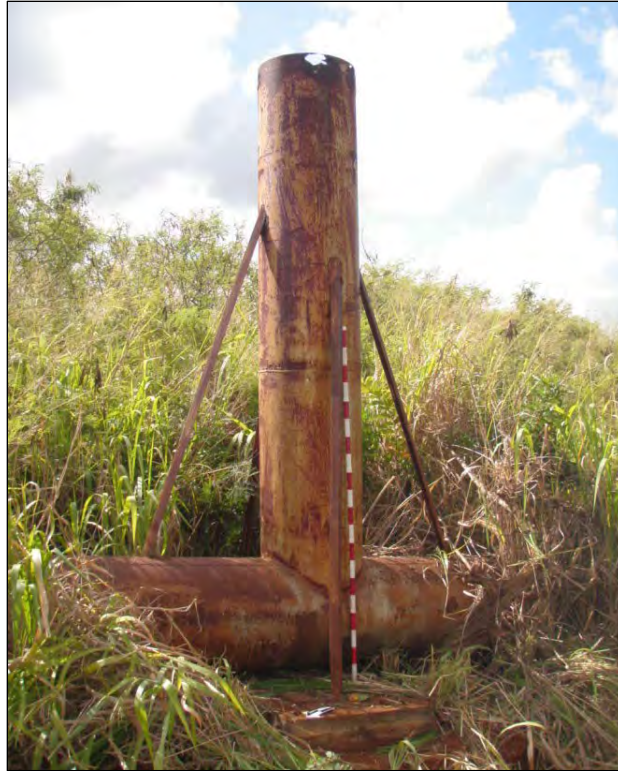
**Figure 21. Feature 2, Sub-feature B, Site 2273, view southeast; scale bar is 2 m high**

Sub-feature B, on the upper (north) portion of the main siphon, is a section of vertical siphon constructed of standard, 80-cm diameter pipe (Figure 21). The vertical section is 3.0 m long; its top is 4.0 m above the adjacent ground surface. This section of siphon is welded into an opening in the main siphon line and reinforced by welded ferrous-metal supports atop a small concrete pad. The name “Floyd” is etched (graffiti-style) into the surface of the pipe. This sub-feature is in good condition.

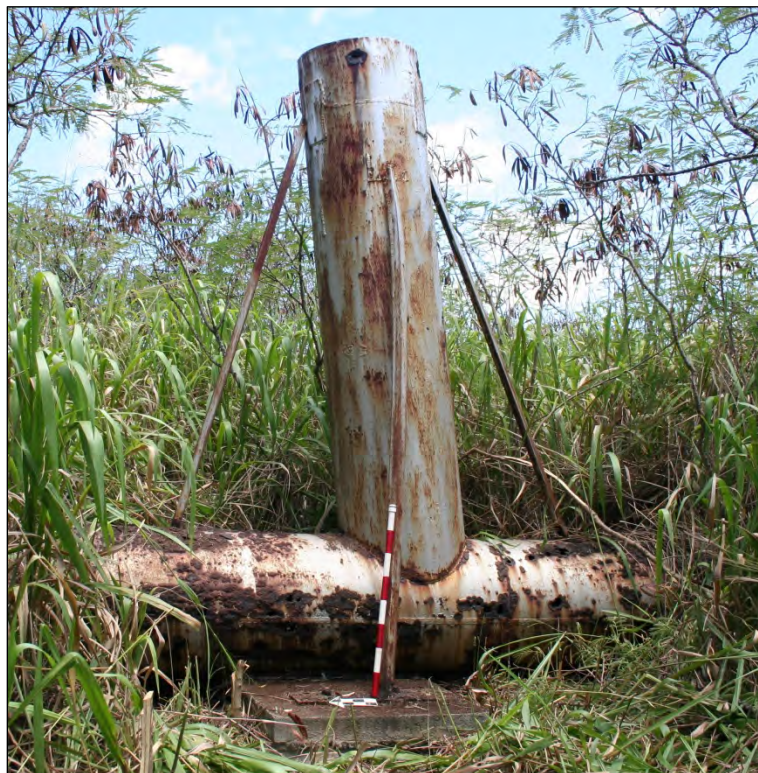
**Figure 22. Feature 2, Sub-feature C, Site 2273, view east; scale bar is 80 cm high**

Sub-feature C, located near the lower (south) portion of the main siphon pipe, is another section of vertical siphon, identical in terms of its constituent materials to Sub-feature B (Figure 22). The vertical section is 2.5 m in length; the top of the vertical section is 3.5 m above the adjacent ground surface. This sub-feature is in good condition.

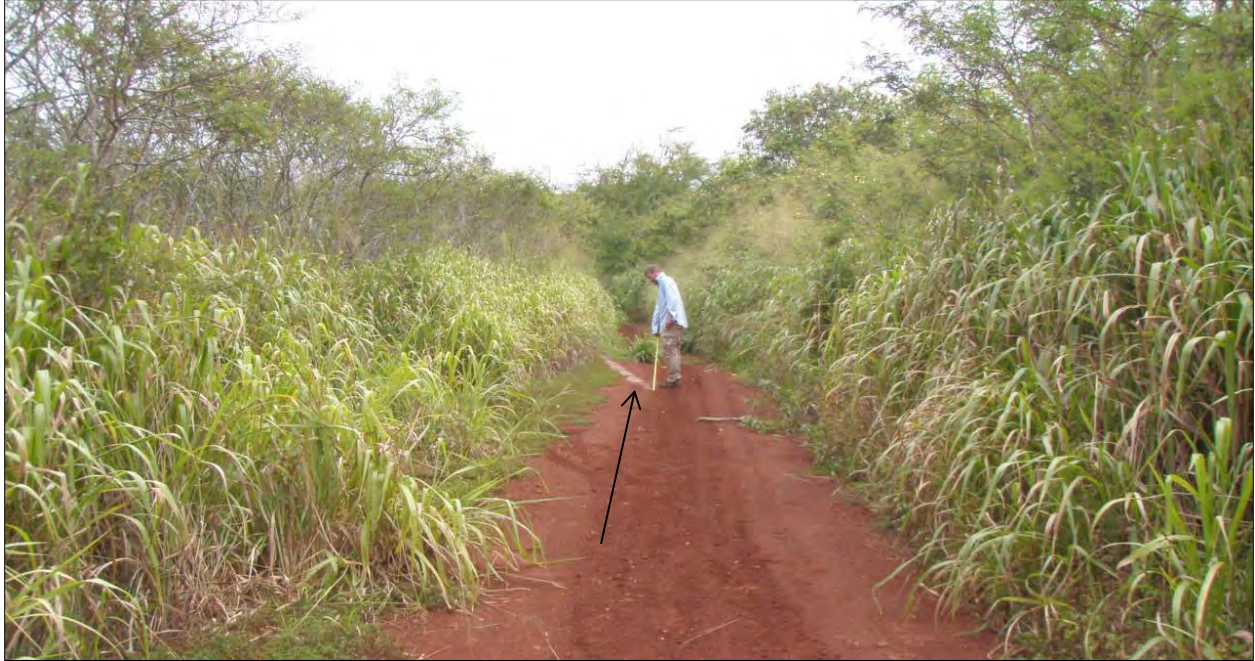
**Feature 3** is another siphon (80-cm pipe) that crosses under road Feature 1 (Site 2270) just north of the Feature 1 water-distribution basin (Figure 23) and continues along (parallel to) the west side of the road. This siphon’s downslope (south) end is at the large water-distribution basin (Feature 1). Its upslope (north) end is at a now-ruined junction with a cross-slope irrigation ditch (Feature 8). The original construction of the upper end of the siphon was designed to catch water coming across slope from Feature 8, but this road intersection has been bulldozed in the recent past. The overall length of this siphon, from its ruined north (upslope) end to its south end where it disappears under road Feature 1 (Site 2270) just north of the Feature 1 water-distribution basin, is approximately 550 m. This feature is in fair to poor physical condition.

**Figure 23. Feature 3, Site 2273, partially-buried (by design) siphon (arrow) under road (Feature 1, Site 2270); view north (this is also depicted in plan map for Feature 1, Site 2273, above)**

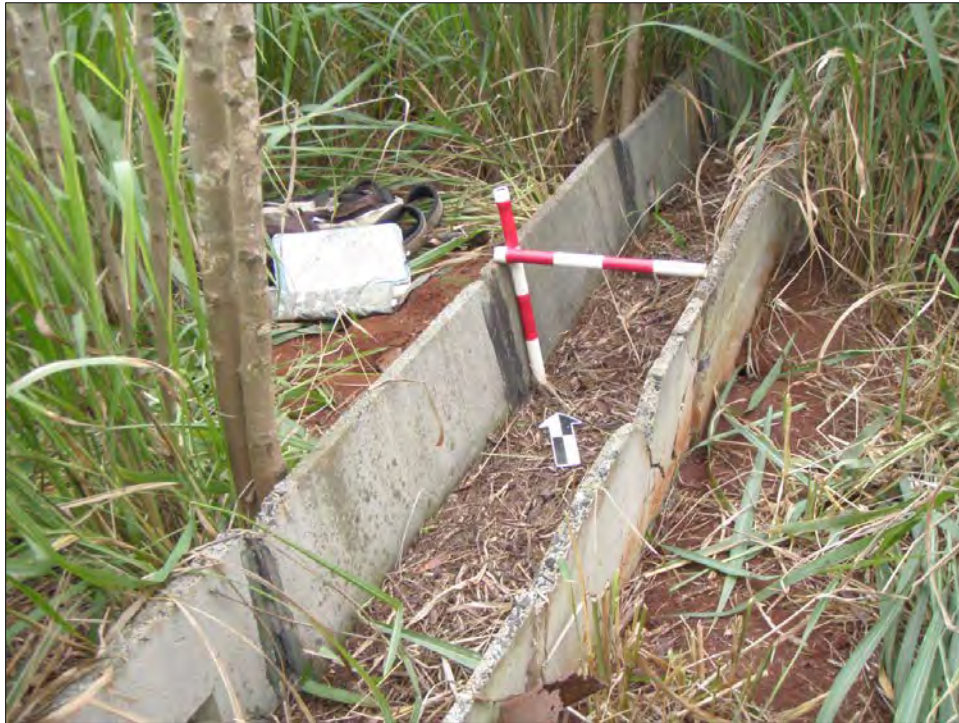
**Feature 4** is a long section of prefabricated flume oriented up- and downslope on the east side of the main mauka-makai earthen road (Feature 1, Site 2270) (Figure 24). The flume is constructed of cast concrete sections with a flared, U-shaped cross section. Each section is 33 cm in height. Its base width is 40 cm measured from the exterior and 30 cm on the inside. At the top, its width is 46 cm measured from the exterior and 36 cm inside. These sections are held together by metal clips and sealed with caulking. The side openings (small sluice gates) measure 12 cm high by 9 cm wide, and could be closed by sliding down a piece of fitted sheet metal into the slotted opening. The overall length of this feature is approximately 850 m. This feature is in fair to good physical condition. According to Goodman and Nees (1991), this type of above-ground flume was portable, capable of being moved around the plateau lands to distribute water through its small sluice gates.

**Figure 24. Representative section of Feature 4, Site 2273; view north; scale bars are 40 cm long**

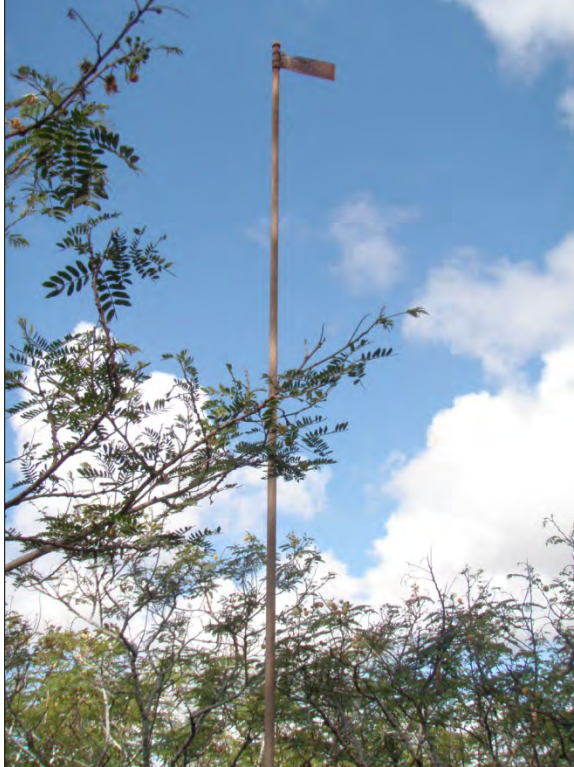
**Feature 6** is a metal pole on a small concrete footing (approximately 20 cm by 35 cm) with a metal marker at the top (Figure 26) approximately 10 m west of the main mauka-makai earthen road (Feature 1, Site 2270). The pole is approximately 5-m tall and consists of a 3-in. diameter ferrous-metal pipe. This unique feature appears to be a marker of some kind that is visible for some distance from the surrounding landscape. There is an earthen ditch running along parallel to the main road near the base of this pole. Because of soil erosion and modern ground disturbance in this area, the ditch cannot be followed, described or mapped with any precision. However, the most likely functional explanation for Feature 6 is that it once marked the location of this ditch. Feature 6 is in good condition.

**Figure 26. Feature 6, Site 2273 (metal pole on small concrete footing with metal marker at top), view west**

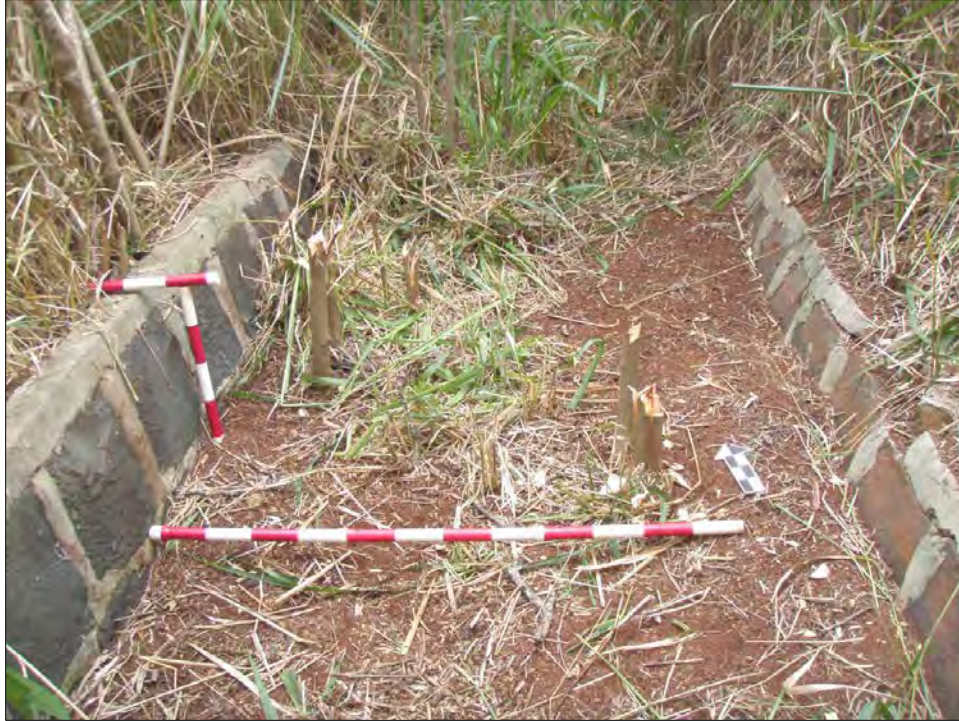
**Feature 7** is a cross-slope ditch with cut basalt and mortar sides and a constructed cut basalt and mortar base on the west side of road Feature 1 (Site 2270) (Figure 27). On its west end, Feature 7 originally started at the south end of Reservoir 3; the ditch at this south end of the reservoir has been destroyed, apparently by a combination of civil engineering (flood control) activities and military activities (in the 1940s). Currently, the west end of Feature 7 is the intersection of road Features 26 and 27, south of Reservoir 3. On its east end, this ditch terminates near road Feature 1, but is currently buried by modern sedimentary deposition and cannot be observed on the ground surface. Paralleling this ditch on its upslope (north) side is another earthen road (Feature 2, Site 2270). The interior dimensions of the ditch are 145 cm wide at the base flaring up to 155 cm wide at the top. The depth of this ditch (to its soil-filled bottom) is currently 40 cm, but it was originally approximately 1.0 m deep. Currently, the overall length of the extant portion of this ditch is approximately 970 m.

**Figure 27. Representative section of cross-slope cut basalt and mortar ditch, Feature 7, Site 2273; view north; horizontal scale bar in the base of the ditch is 120 cm long**

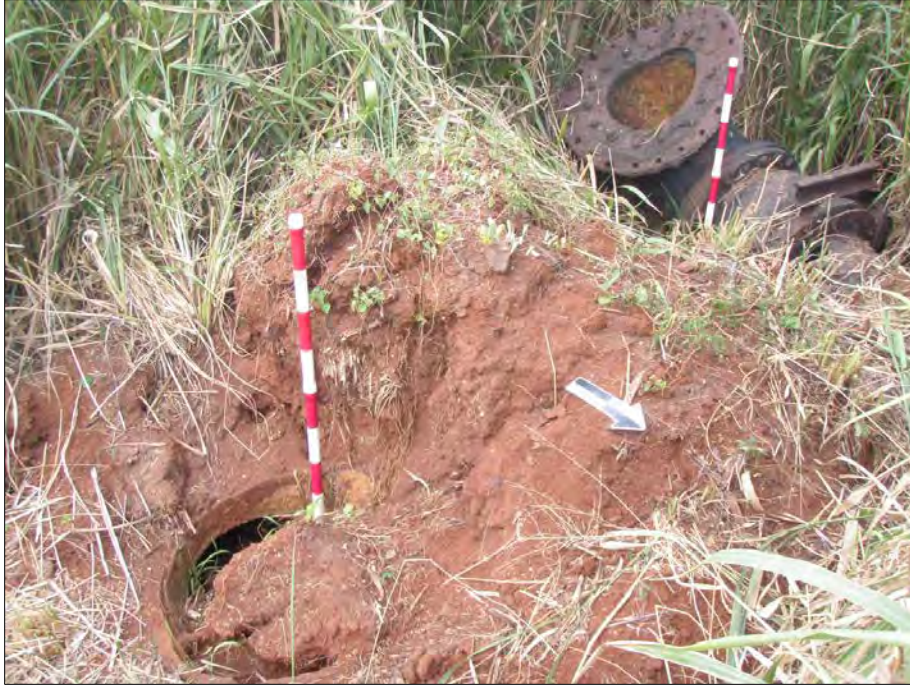
**Figure 29. Bulldozed area at the intersection of Feature 8 (Site 2273) cross-slope ditch and top of Feature 3 (Site 2273) siphon, view southwest; scale bar is 80 cm high**

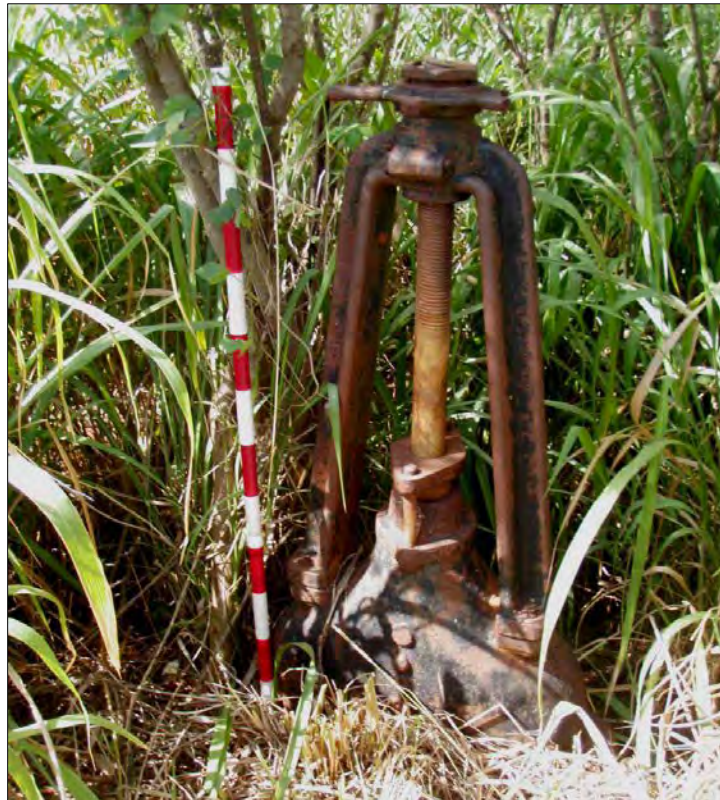
**Figure 30. Destroyed hand-operated valve at the intersection of Feature 8 (Site 2273) and Feature 3 (Site 2273), view southeast; scale bar is 120 cm high**

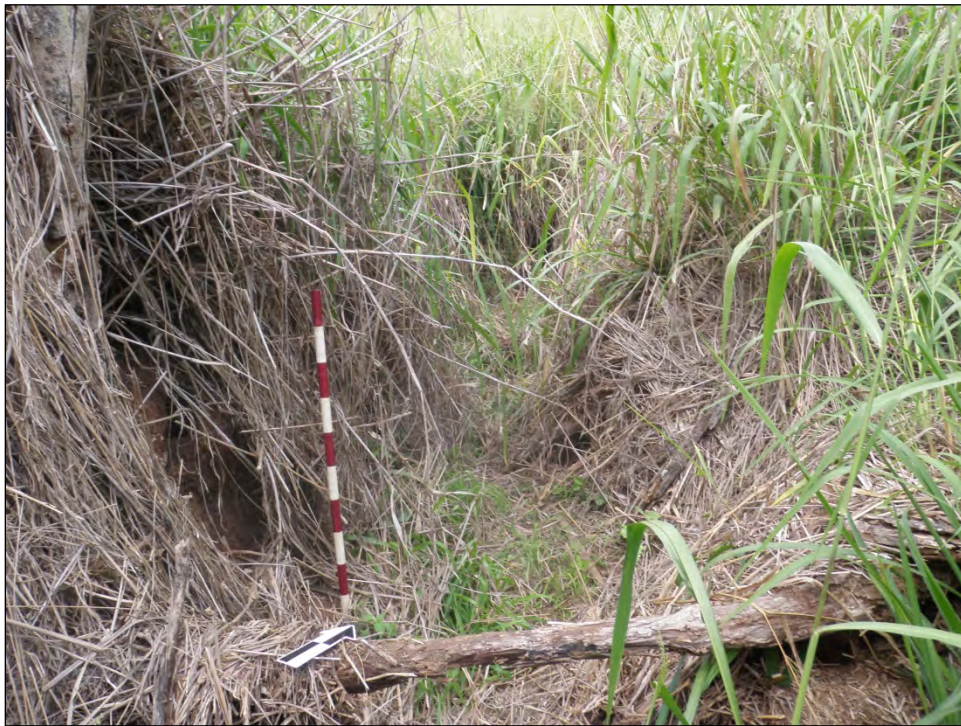
**Figure 32. Feature 10, Site 2273, earthen ditch, view northwest; scale bar marked in 10-cm increments**

**Feature 10** is an earthen ditch lacking constructed materials that begins near the formal cut basalt and mortar water-distribution basin (Feature 1) and heads to the east approximately 530 m before it exits the project area. It ranges from 1.0–1.5 m wide and 50–75 cm deep. This ditch is heavily covered in tall grasses and koa haole and can barely be recognized. It is in fair physical condition (Figure 32).

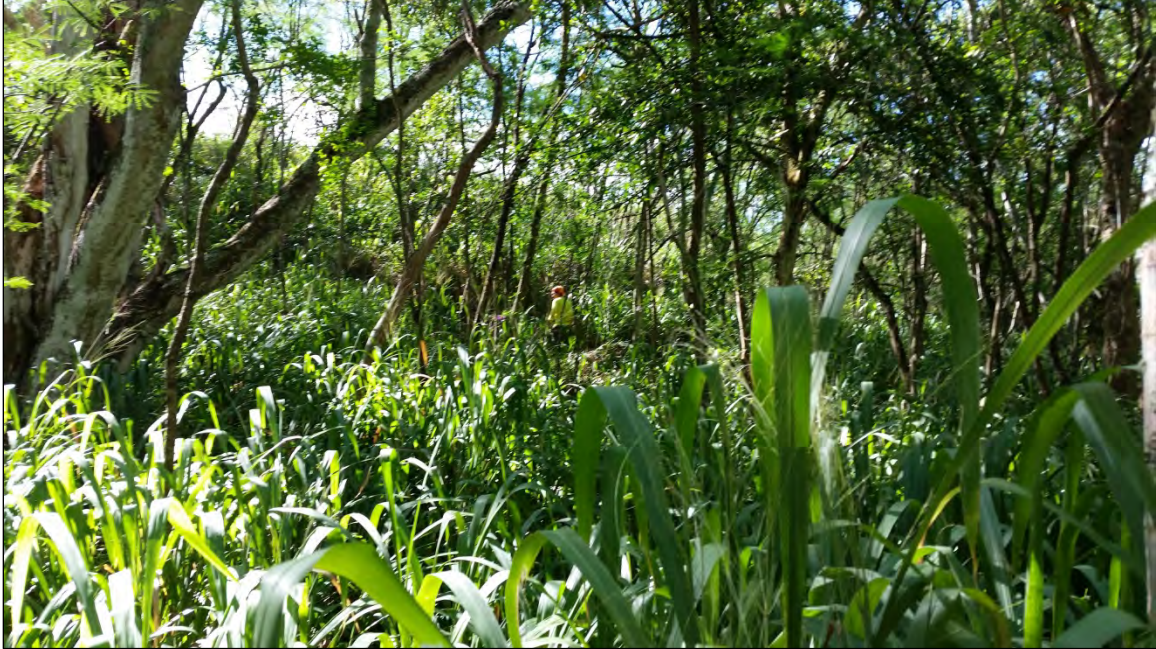
**Feature 11** is an earthen ditch lacking constructed materials (Figure 33). It begins just downslope (south) of Reservoir 2 and heads west approximately 500 m before it becomes completely unrecognizable and filled in with sediment. It ranges from 1.0–1.5 m wide and 50–75 cm deep. This ditch is heavily covered in tall grasses and koa haole and can barely be recognized. It is in fair physical condition.

**Figure 33. Feature 11, Site 2273, view southwest; earthen ditch runs through the center of the image to the archaeologist (for scale) in background**

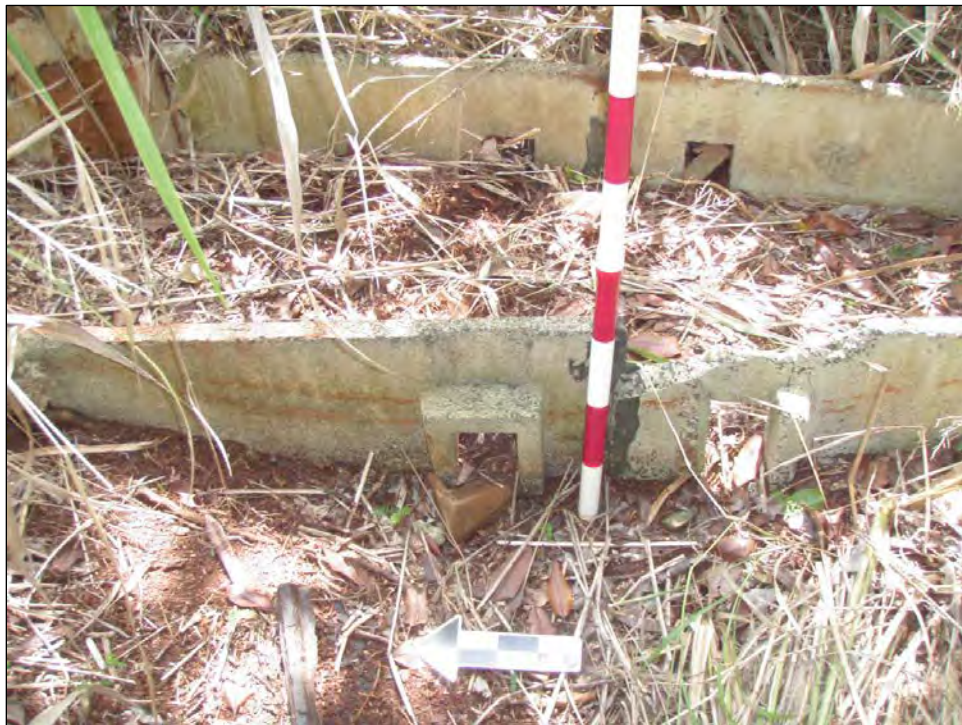
**Figure 34. Feature 12, Site 2273, view east; scale bar marked in 10-cm increments**

**Feature 12** is a prefabricated flume oriented up- and downslope on the east side of road Feature 1 (Site 2270) (Figure 34). The flume's constituent materials and design characteristics are identical to Feature 4. Its overall length is approximately 420 m. At its south end, it empties into a shallow erosional channel whose age (historic or modern) cannot be ascertained. This shallow channel eventually joins up with the earthen ditch Feature 10. Feature 12 is in fair to good physical condition.

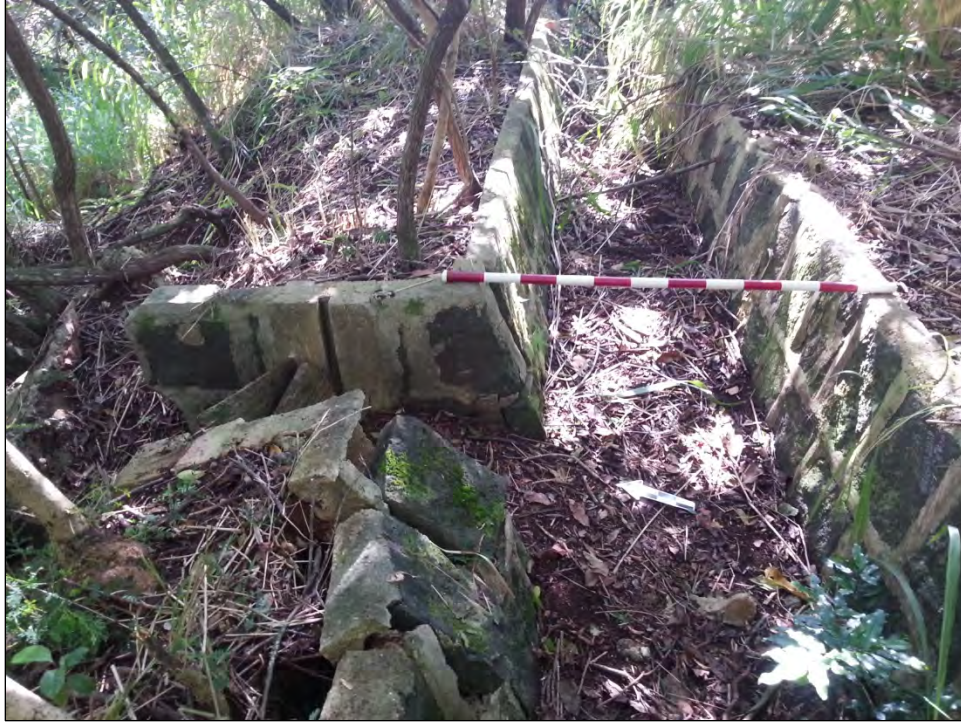
**Figure 44. Main ditch (Sub-feature A) and upper (south) portion of Feature 14, Sub-feature C (damaged sluice gate), Site 2273, view east; horizontal scale bar is 120 cm long**

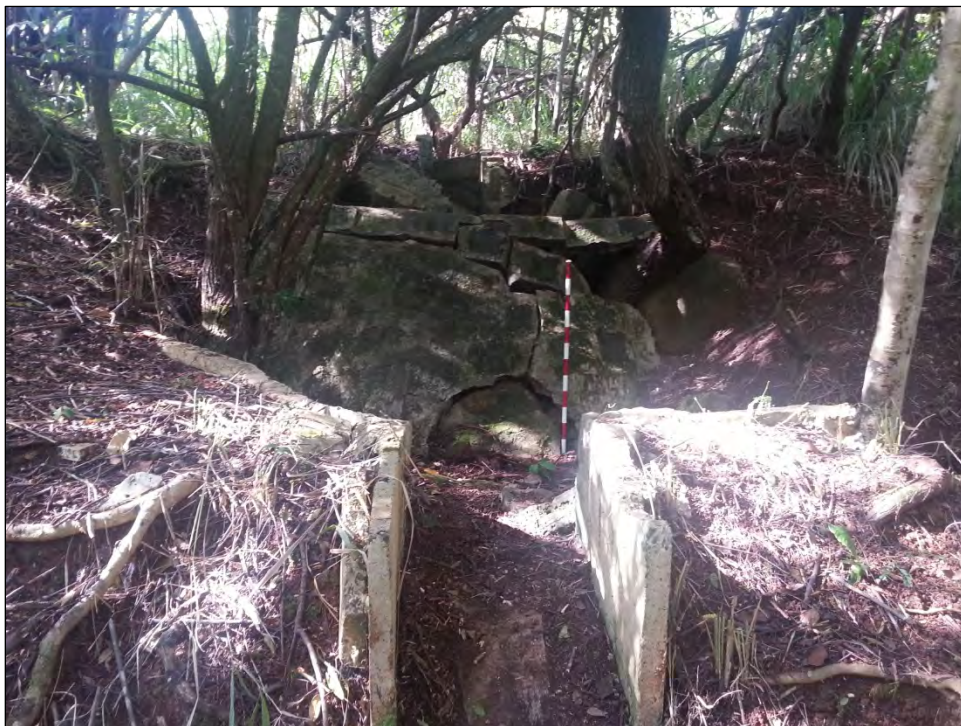
Sub-feature C is a sluice gate along a “switch back” section of the main ditch traversing the southern edge of Gulch B. This sluice gate structure is unusual in the project area as it diverts water from the main ditch to the *north*, rather than the south; in this case, it empties water into the Gulch B drainage which eventually flowed west-southwest into Reservoir 1-B (Figure 43). This sub-feature is in poor physical condition, having sustained extensive damage from being located on a steep slope (down to the north into Gulch B) that has eroded over time.

**Figure 45. Lower (north) portion Feature 14, Sub-feature C, Site 2273, view south; vertical scale bar is 120 cm high; damaged deflection wall is in the middle ground (directly behind the vertical scale bar)**

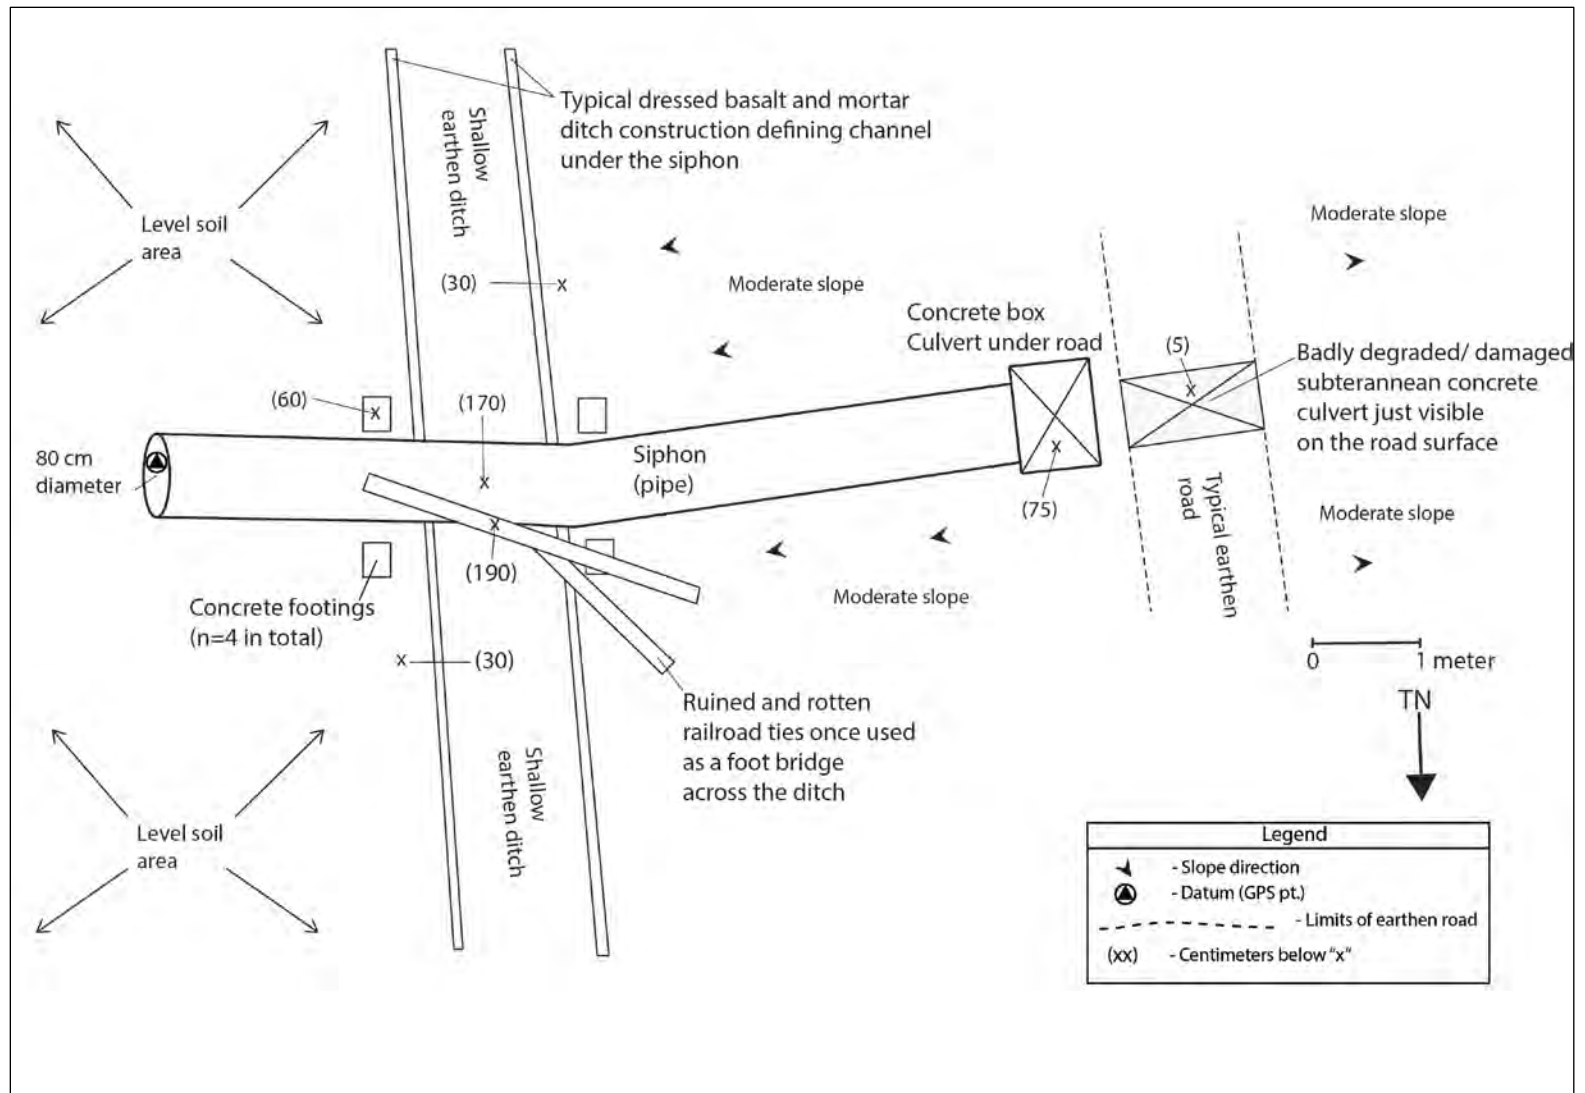
Figure 47. Plan view of a portion of Feature 16, Sub-feature B, Site 2273, where it crosses the drainage channel in the eastern arm of Gulch A

Sub-feature B, a siphon oriented east to west, is approximately 300 m long. It is in poor to fair physical condition with damage from flooding in Gulch A. Figure 47, a plan view of a representative section of the siphon where it crosses the drainage bottom, illustrates some of its design features. The ferrous-metal siphon (80-cm diameter), riveted together in sections, was sealed and weatherized with an outer layer of concrete (Figure 48 and Figure 49). The top of the siphon is 170 cm above the ground surface; its bottom is 80 cm above the ground surface. A pair of wooden railroad ties and smaller lumber once nailed together served as a foot bridge across the drainage. The top of the railroad ties, one of which rests atop the siphon, is 190 cm above the ground surface. The drainage channel passing under the siphon was formalized and stabilized with low cut basalt and mortar sides. This ditch, which measures 6.0 m (N/S) by 1.0 m (E/W) by 0.30 m deep, was built to ensure the meandering gulch channel did not undermine the siphon. Four, small concrete footings were placed to support the siphon across the drainage. Each of the four footings is approximately 60 cm high. The west end of the siphon enters a concrete culvert that crosses under the adjacent (to the west and upslope) earthen road (Feature 12, Site 2270).

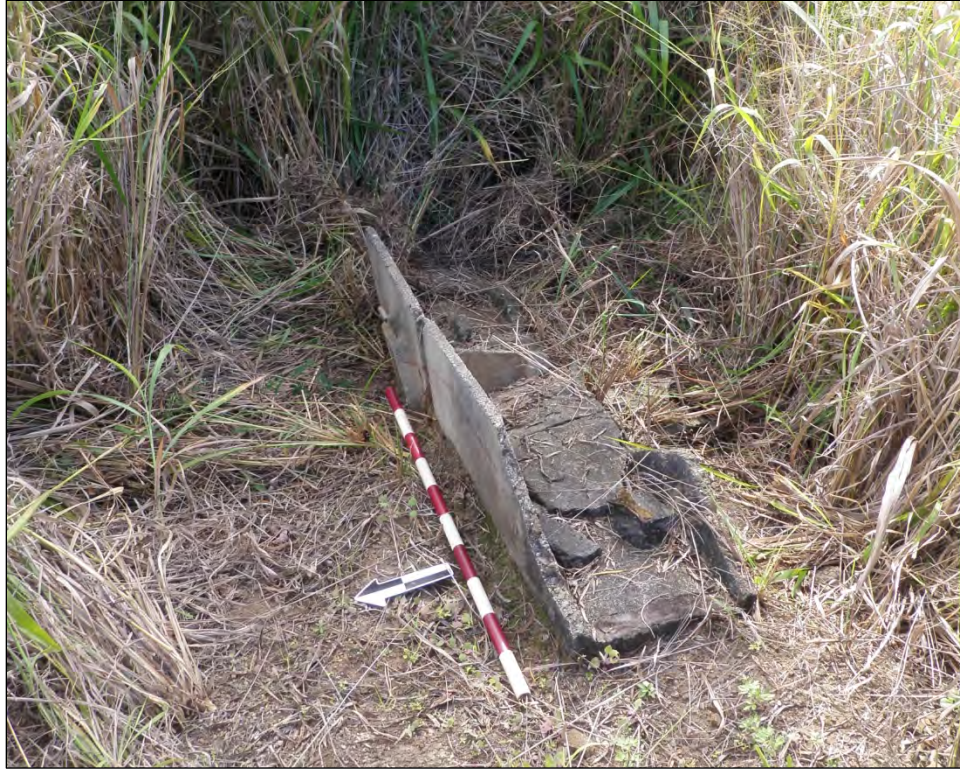
**Feature 20** is a short section of prefabricated flume oriented up- and downslope (NNE/SSW) on the south side of a modern (non-historic-age) earthen road in the western project area between two major cross-slope ditches (Features 13 and 14). The north end of the flume appears to have been damaged by clearing for the modern road (Figure 62). From this north end to the south end, which empties into an open field, the flume is approximately 25 m long. The flume, like other light-duty, portable examples in the project area, is typical in terms of its constituent materials and design. Each section is 33 cm in height. Its base width is 40 cm measured from the exterior and 30 cm on the inside. At the top, its width is 46 cm measured from the exterior and 36 cm inside. These sections are sealed together with caulking. The side openings (small sluice gates) measure 12 cm high by 9 cm wide, and could be closed by sliding down a piece of fitted sheet metal into the slotted opening. This feature is in poor to fair physical condition.

Figure 62. Feature 20, Site 2273, view east-southeast; scale bar is 100 cm long; note, this is north end of flume, which has been dislodged and damaged by a modern (non-historic) road
