Draft Phase 1 Potential Rockfall And Slope Hazard Assessment Hawaiian Memorial Park Cemetery Expansion – January 2018 Prepared by: Geolabs, Inc.

## PHASE 1 POTENTIAL ROCKFALL AND SLOPE HAZARD ASSESSMENT

### HAWAIIAN MEMORIAL PARK CEMETERY EXPANSION

W.O. 7604-00 JANUARY 18, 2018

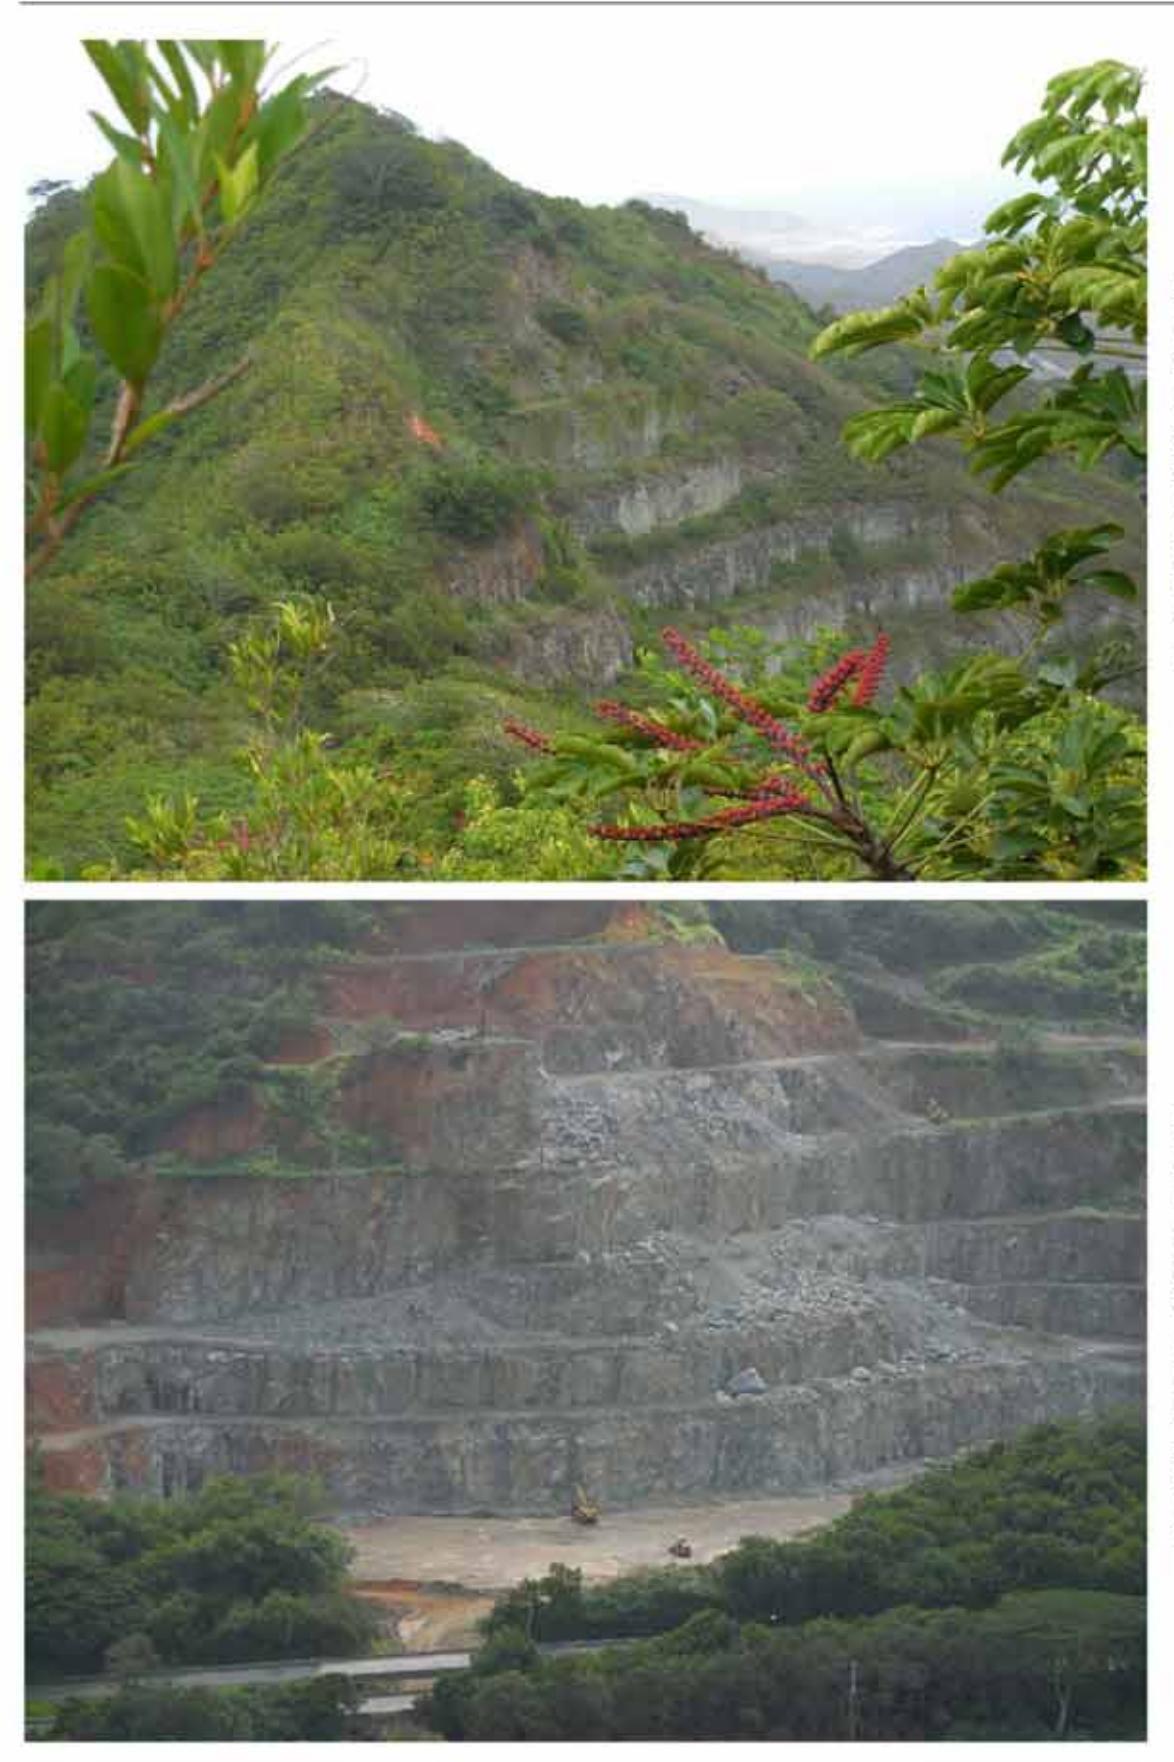
Photograph No. 1: (2356) View toward the north of the steep rock quarry cuts that reach the ridge summit of the Oneawa Hills. The approximate location is on the Kailua side of the ridgeline between our Slope Profile lines "D" and "E" shown on the Site Plan, Plate 2.

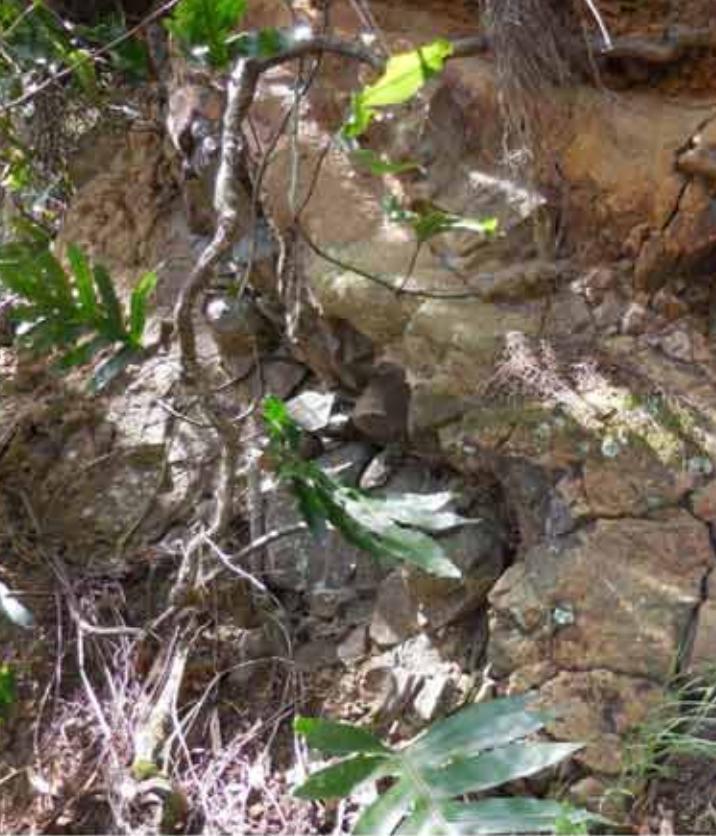
Photograph No. 3: (2359) Existing massive block type rock outcropping near the ridgeline summit at the northern end of the PRSA-1 area and northerly of the Slope Profile "E" shown on the Site Plan, Plate 2.

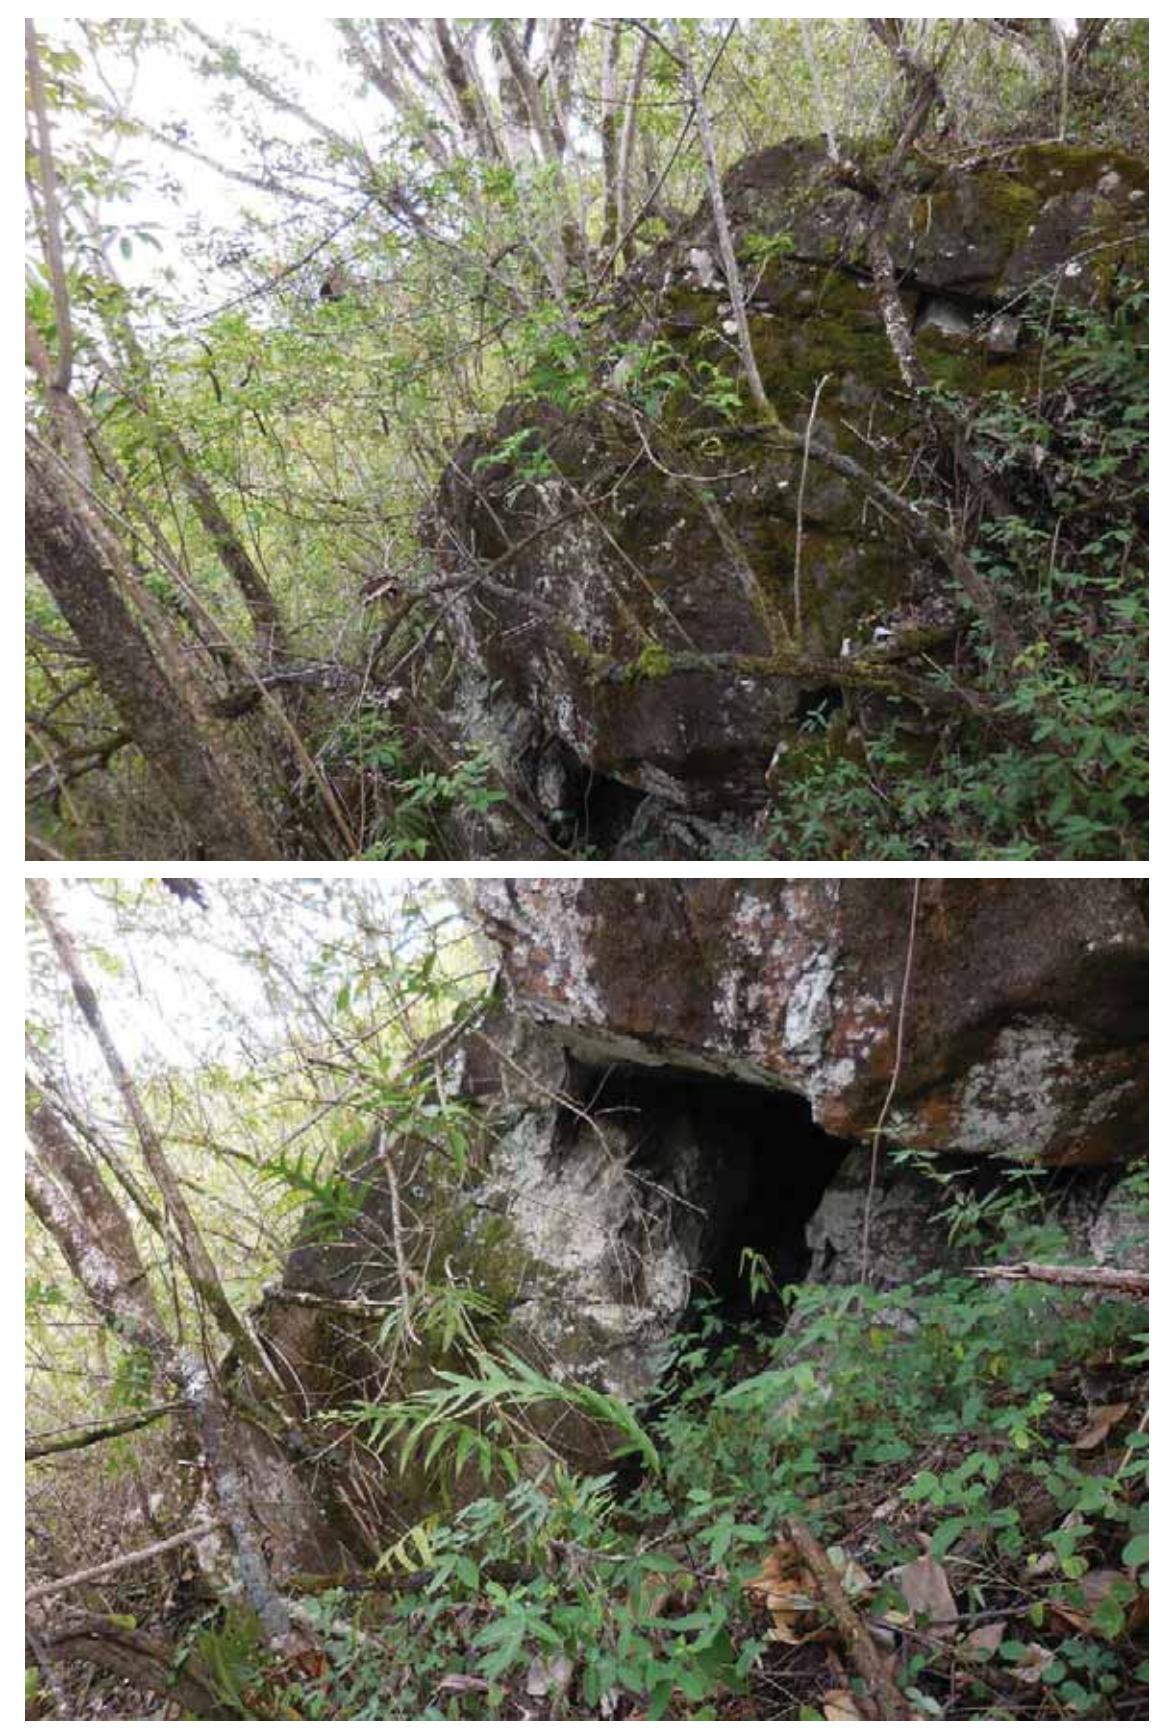
Photograph No. 5: (2366) Existing massive block type rock outcropping near the ridgeline summit at the southern portion of the PRSA-1 area and just northerly of Slope Profile "D" shown on the Site Plan, Plate 2.

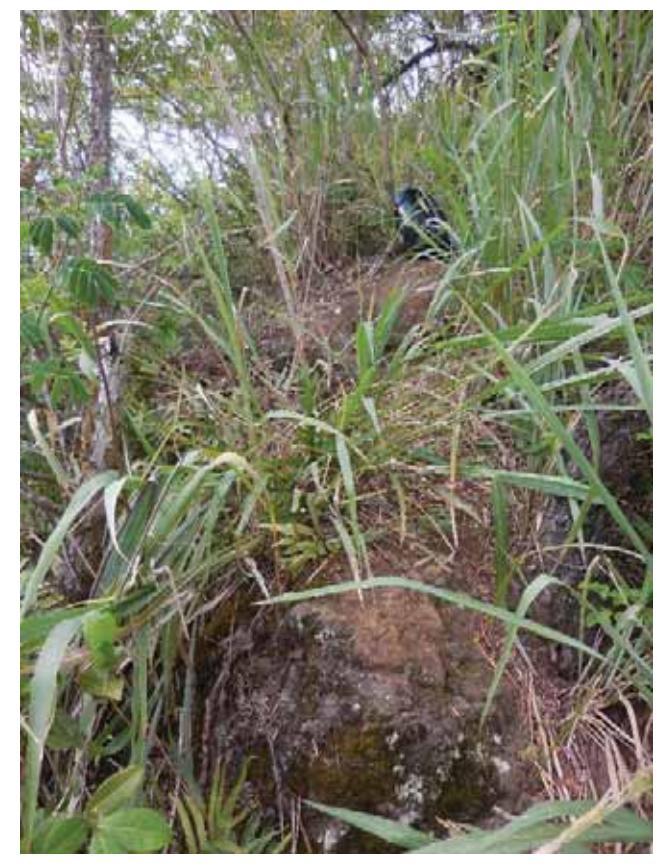
Photograph No. 6: (2368) Another view of the rock outcrop (in Photograph No.5) showing that it is a multi-block outcropping with the major blocks nested together on the sloping terrain just below the ridgeline summit.

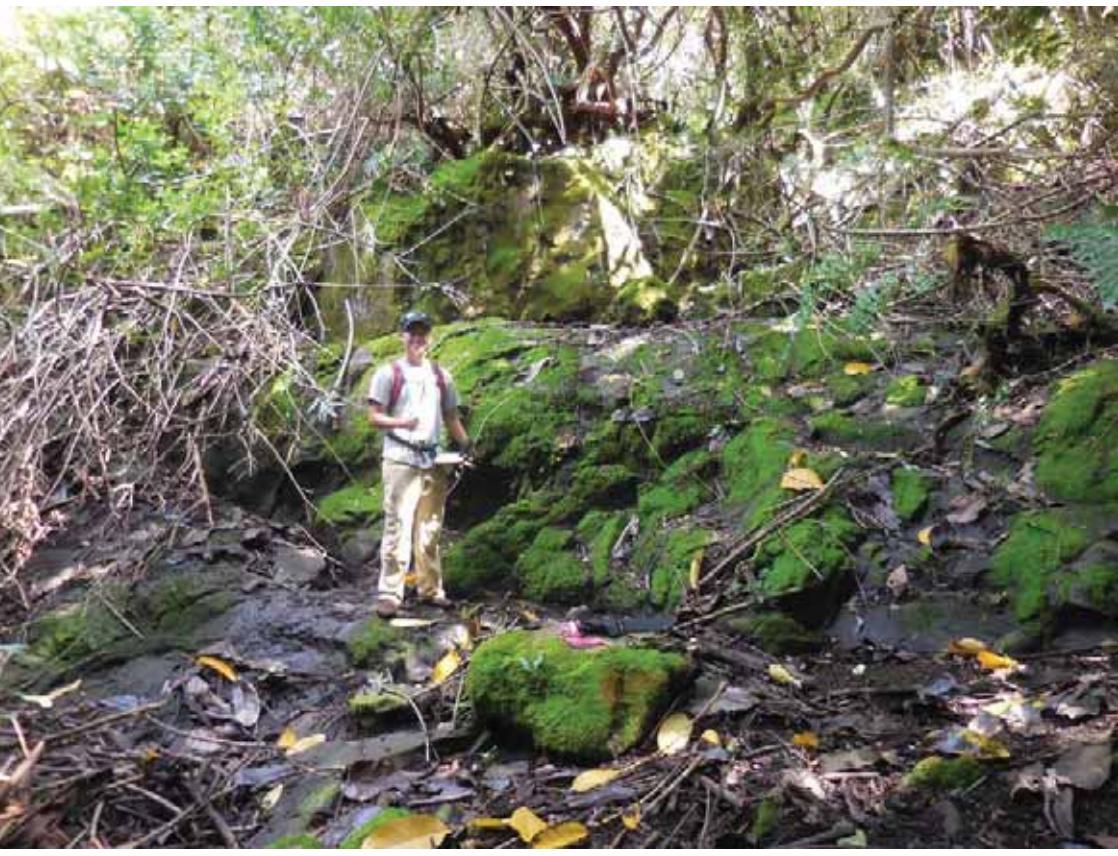
Photograph No. 7: (2371) Other typical low relief, ridgeline summit rock outcropping within the central portion of the PRSA-1 area shown on the Site Plan, Plate 2.

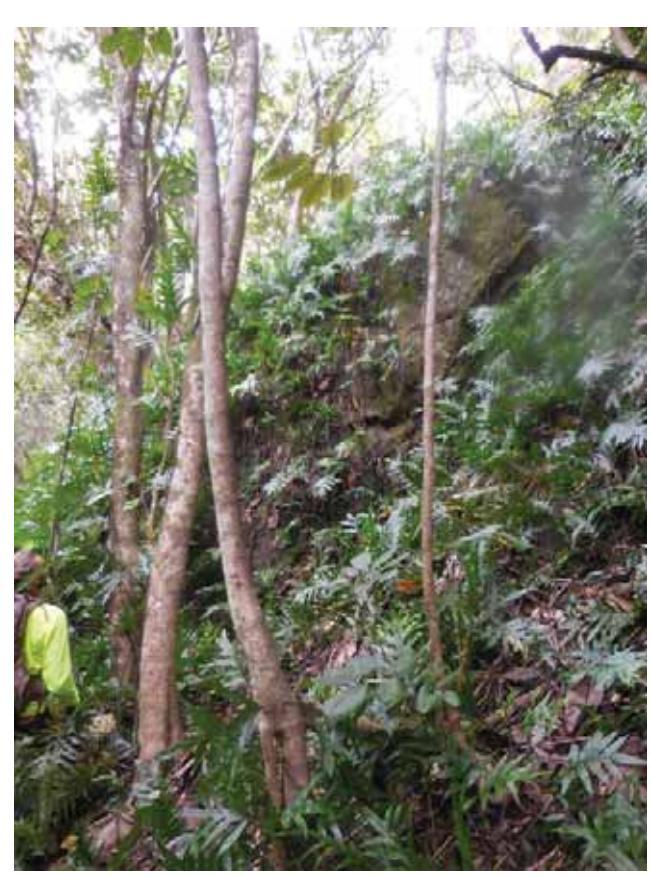
Photograph No. 9: (2576) Fractured and highly weathered rock outcropping on a side slope of a shallow ravine at the northern boundary of the PRSA-1 area shown on the Site Plan, Plate 2. (Wpt. OC8-1).

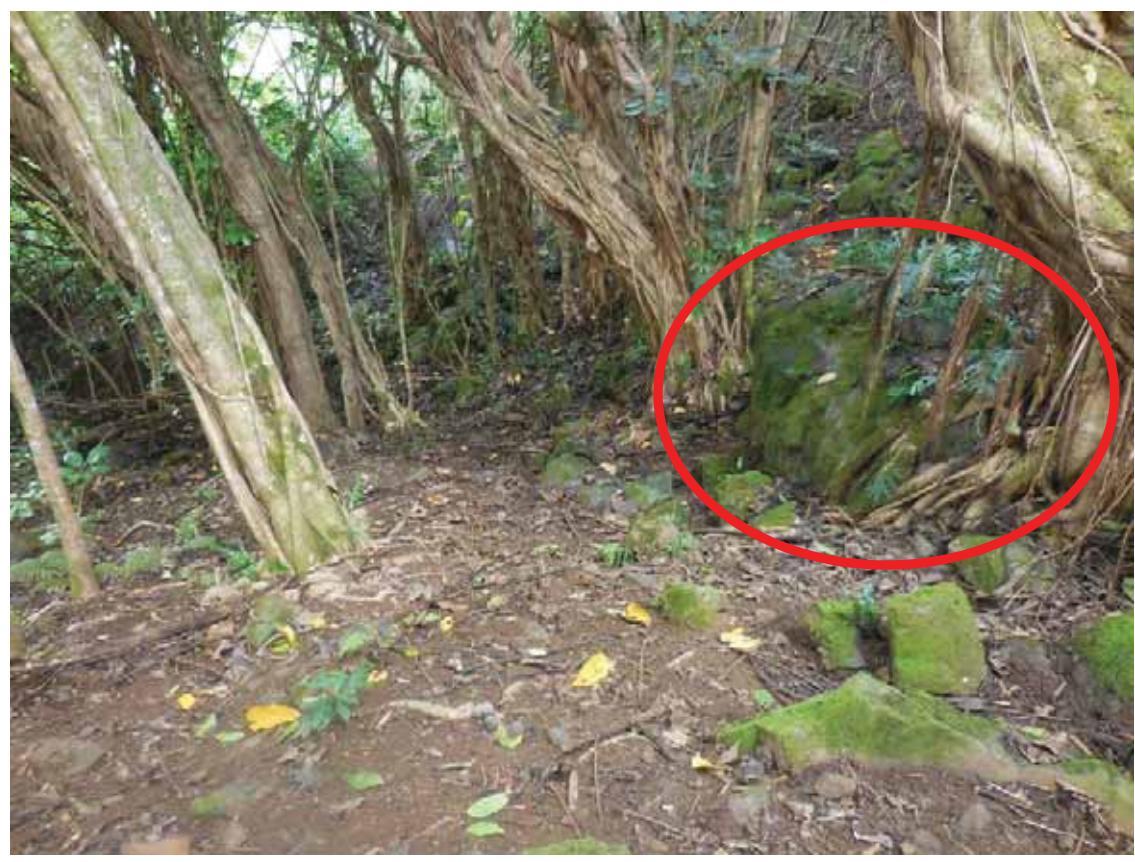
Photograph No. 10: (2581) Isolated large block rock outcropping on gentle terrain at the lower elevation, northern half of the PRSA-1 area shown on the Site Plan, Plate 2. (Wpt. OC9).

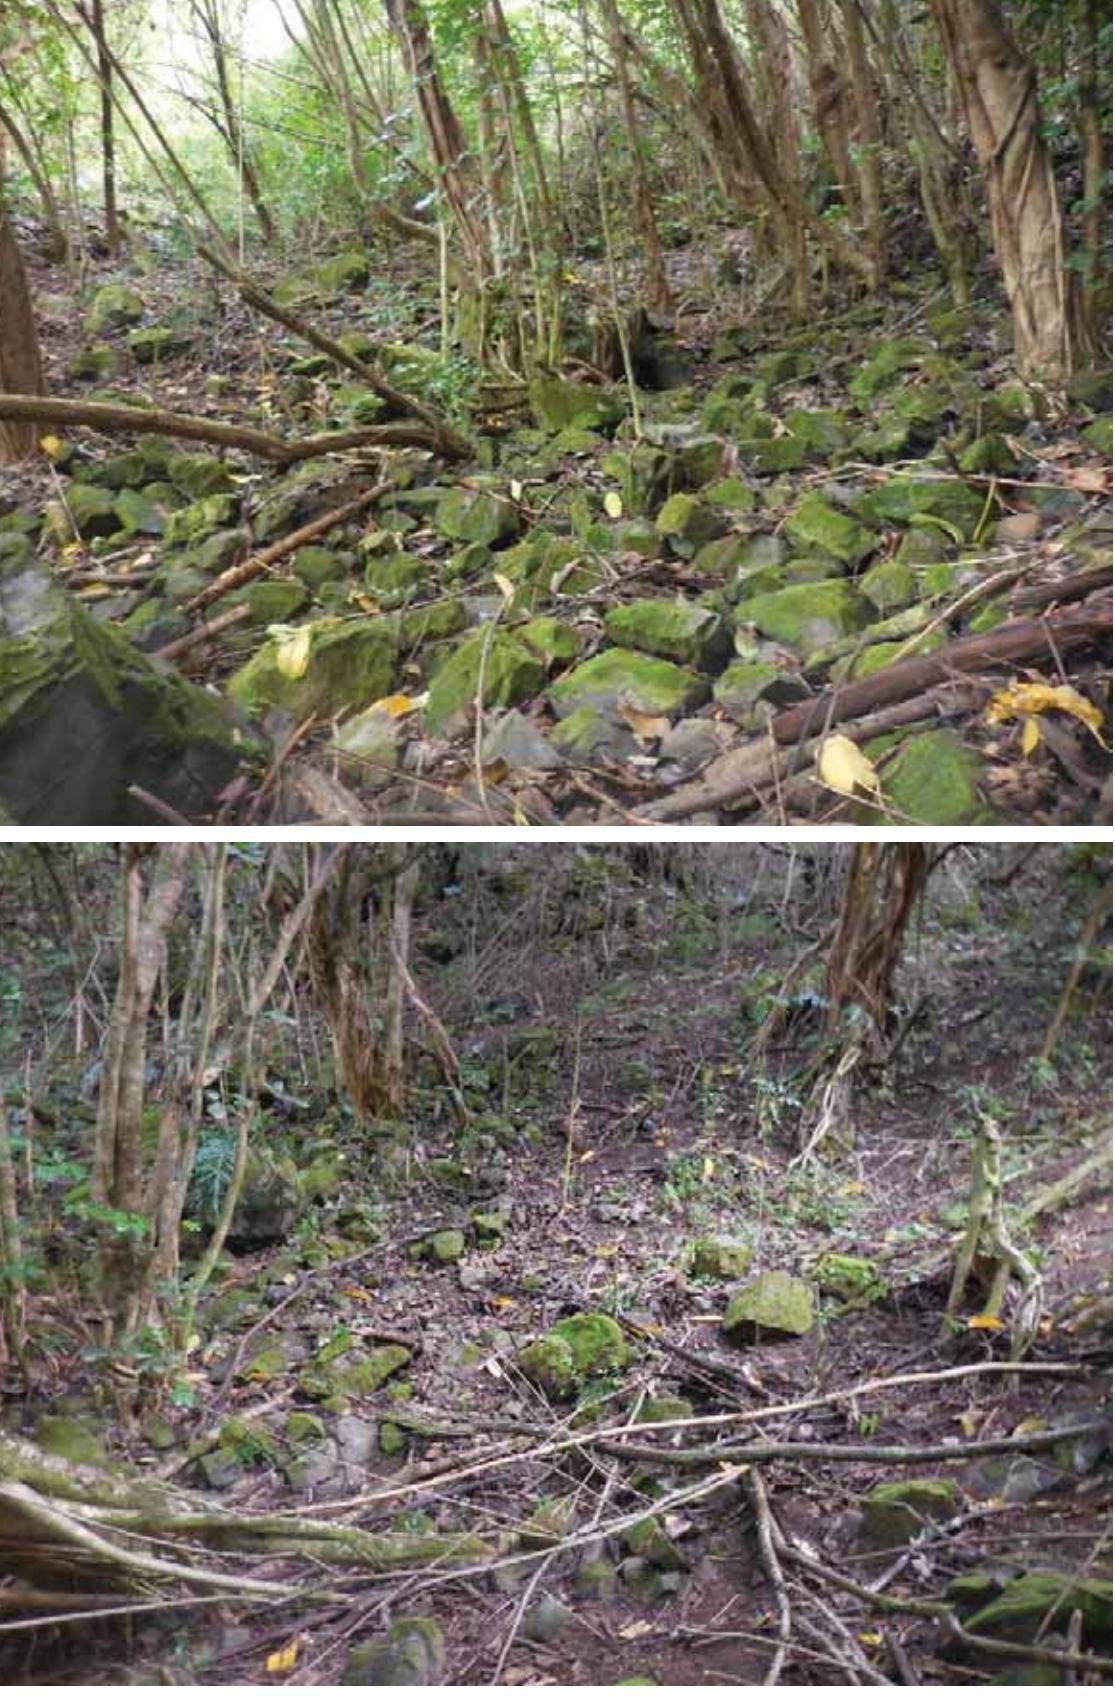
Photograph No. 11: (2583) Accumulation of small boulder talus within a gently sloped ravine on the flatter slopes below the PRSA-1 area shown on the Site Plan, Plate 2. (Wpt. TalusRavine).

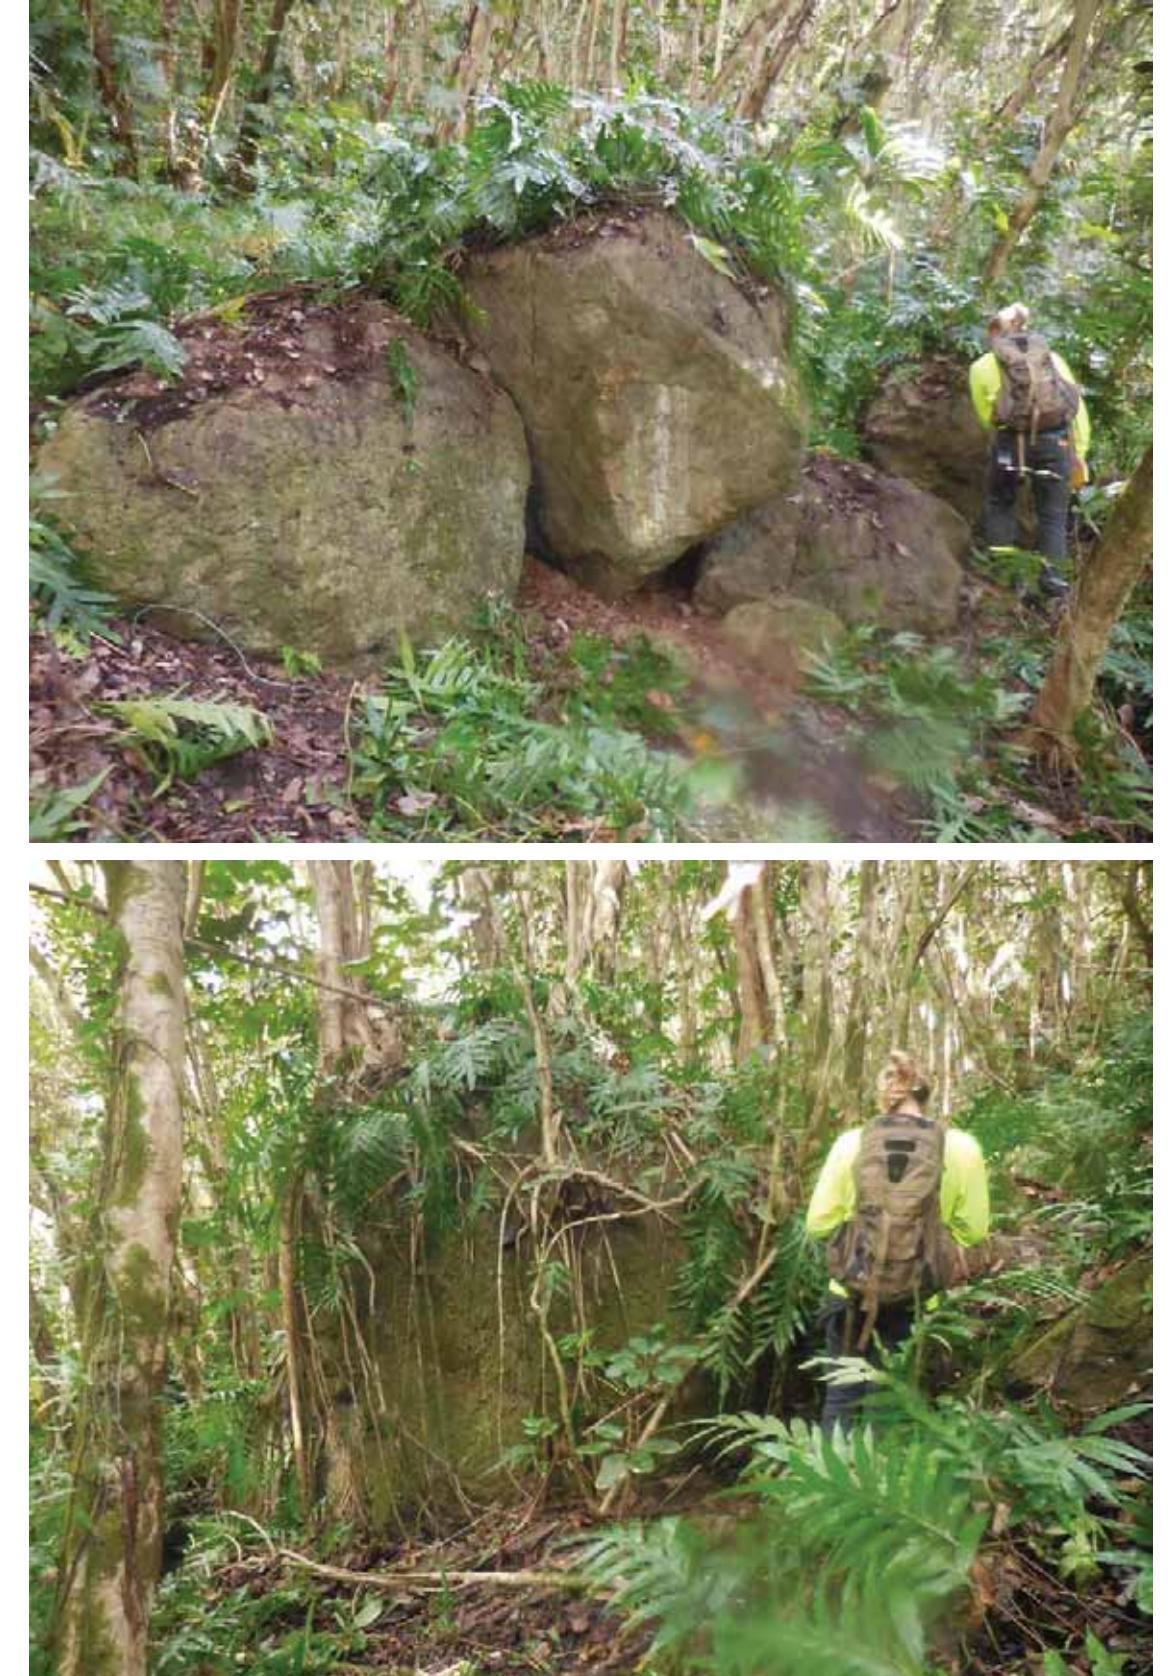
Photograph No. 13: (2571) Nested cluster of large boulders within the deposition zone below the PRSA-1 area and within the proposed Cultural Preservation Area. (Wpt. BoulderBloks).

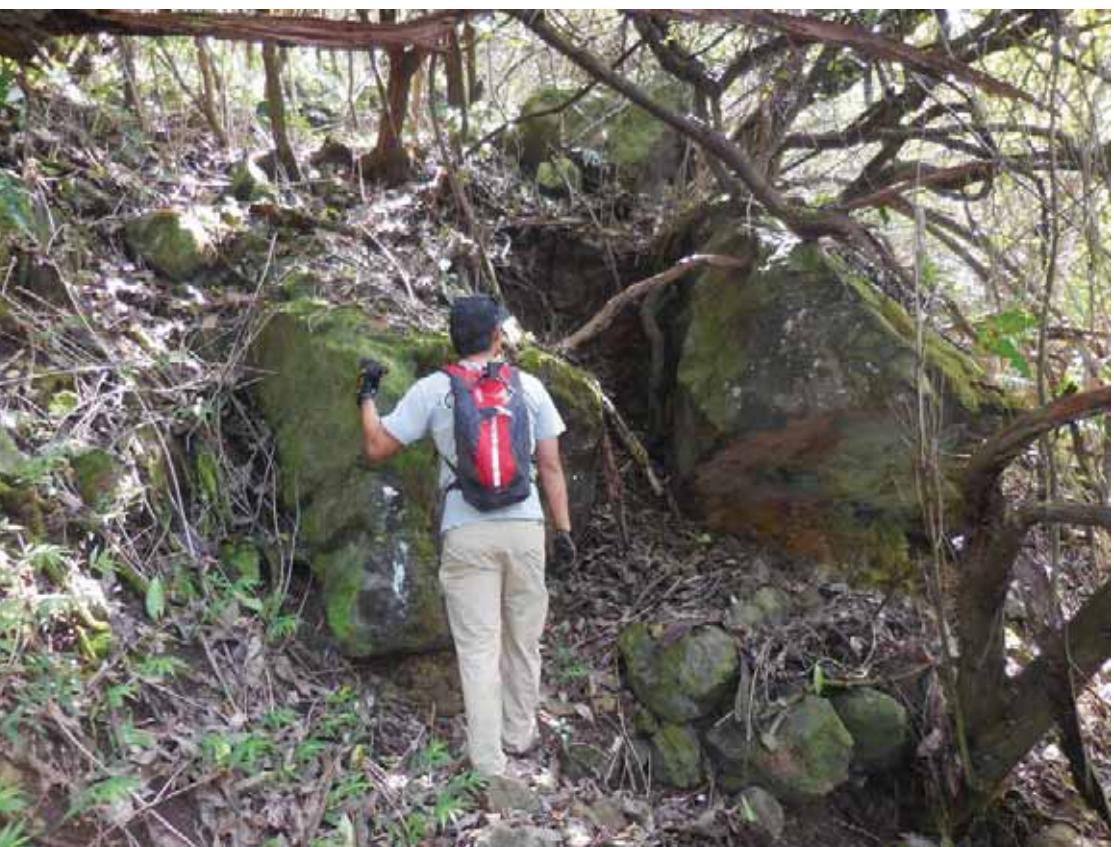
Photograph No. 14: (2574) Isolated large boulder within the deposition zone below the PRSA-1 area and within the proposed Cultural Preservation Area. (Wpt. LargeBlok).

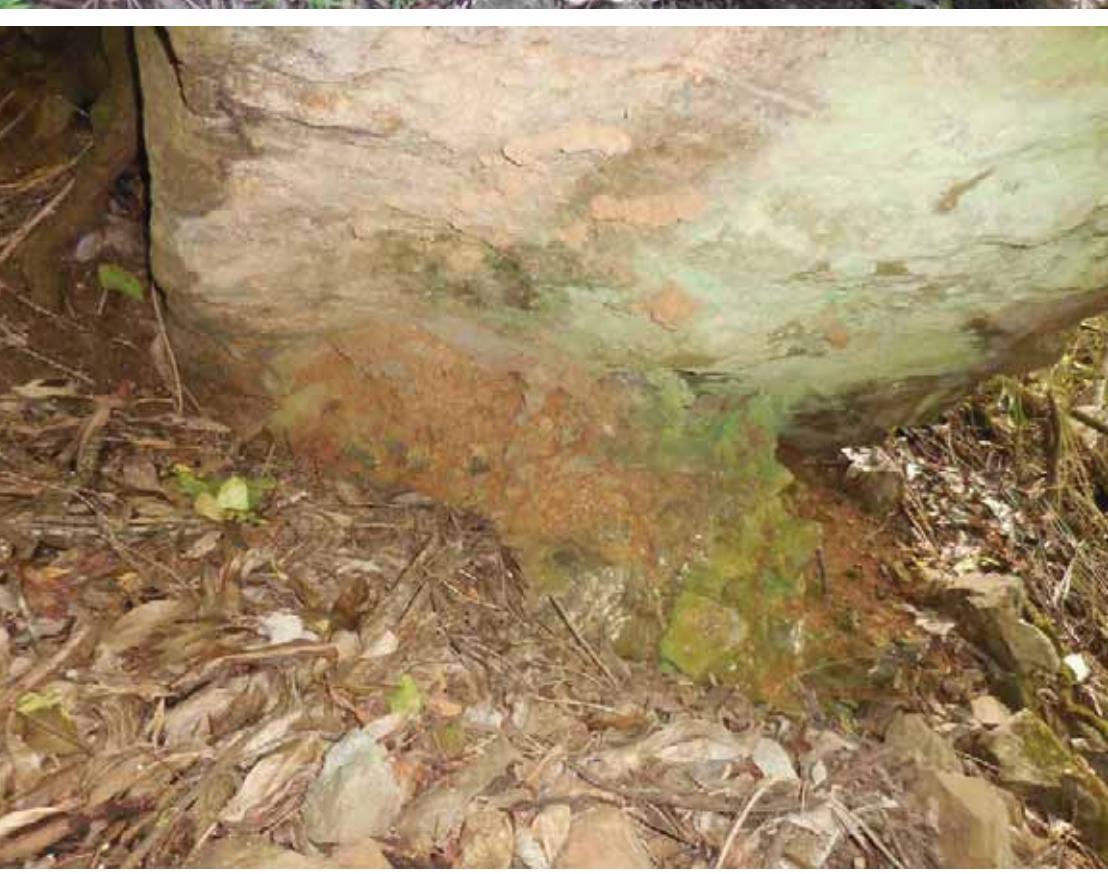
Photograph No. 15: (2416) Talus cluster of large boulders within the deposition zone below the PRSA-1 area and within the proposed Cultural Preservation Area.

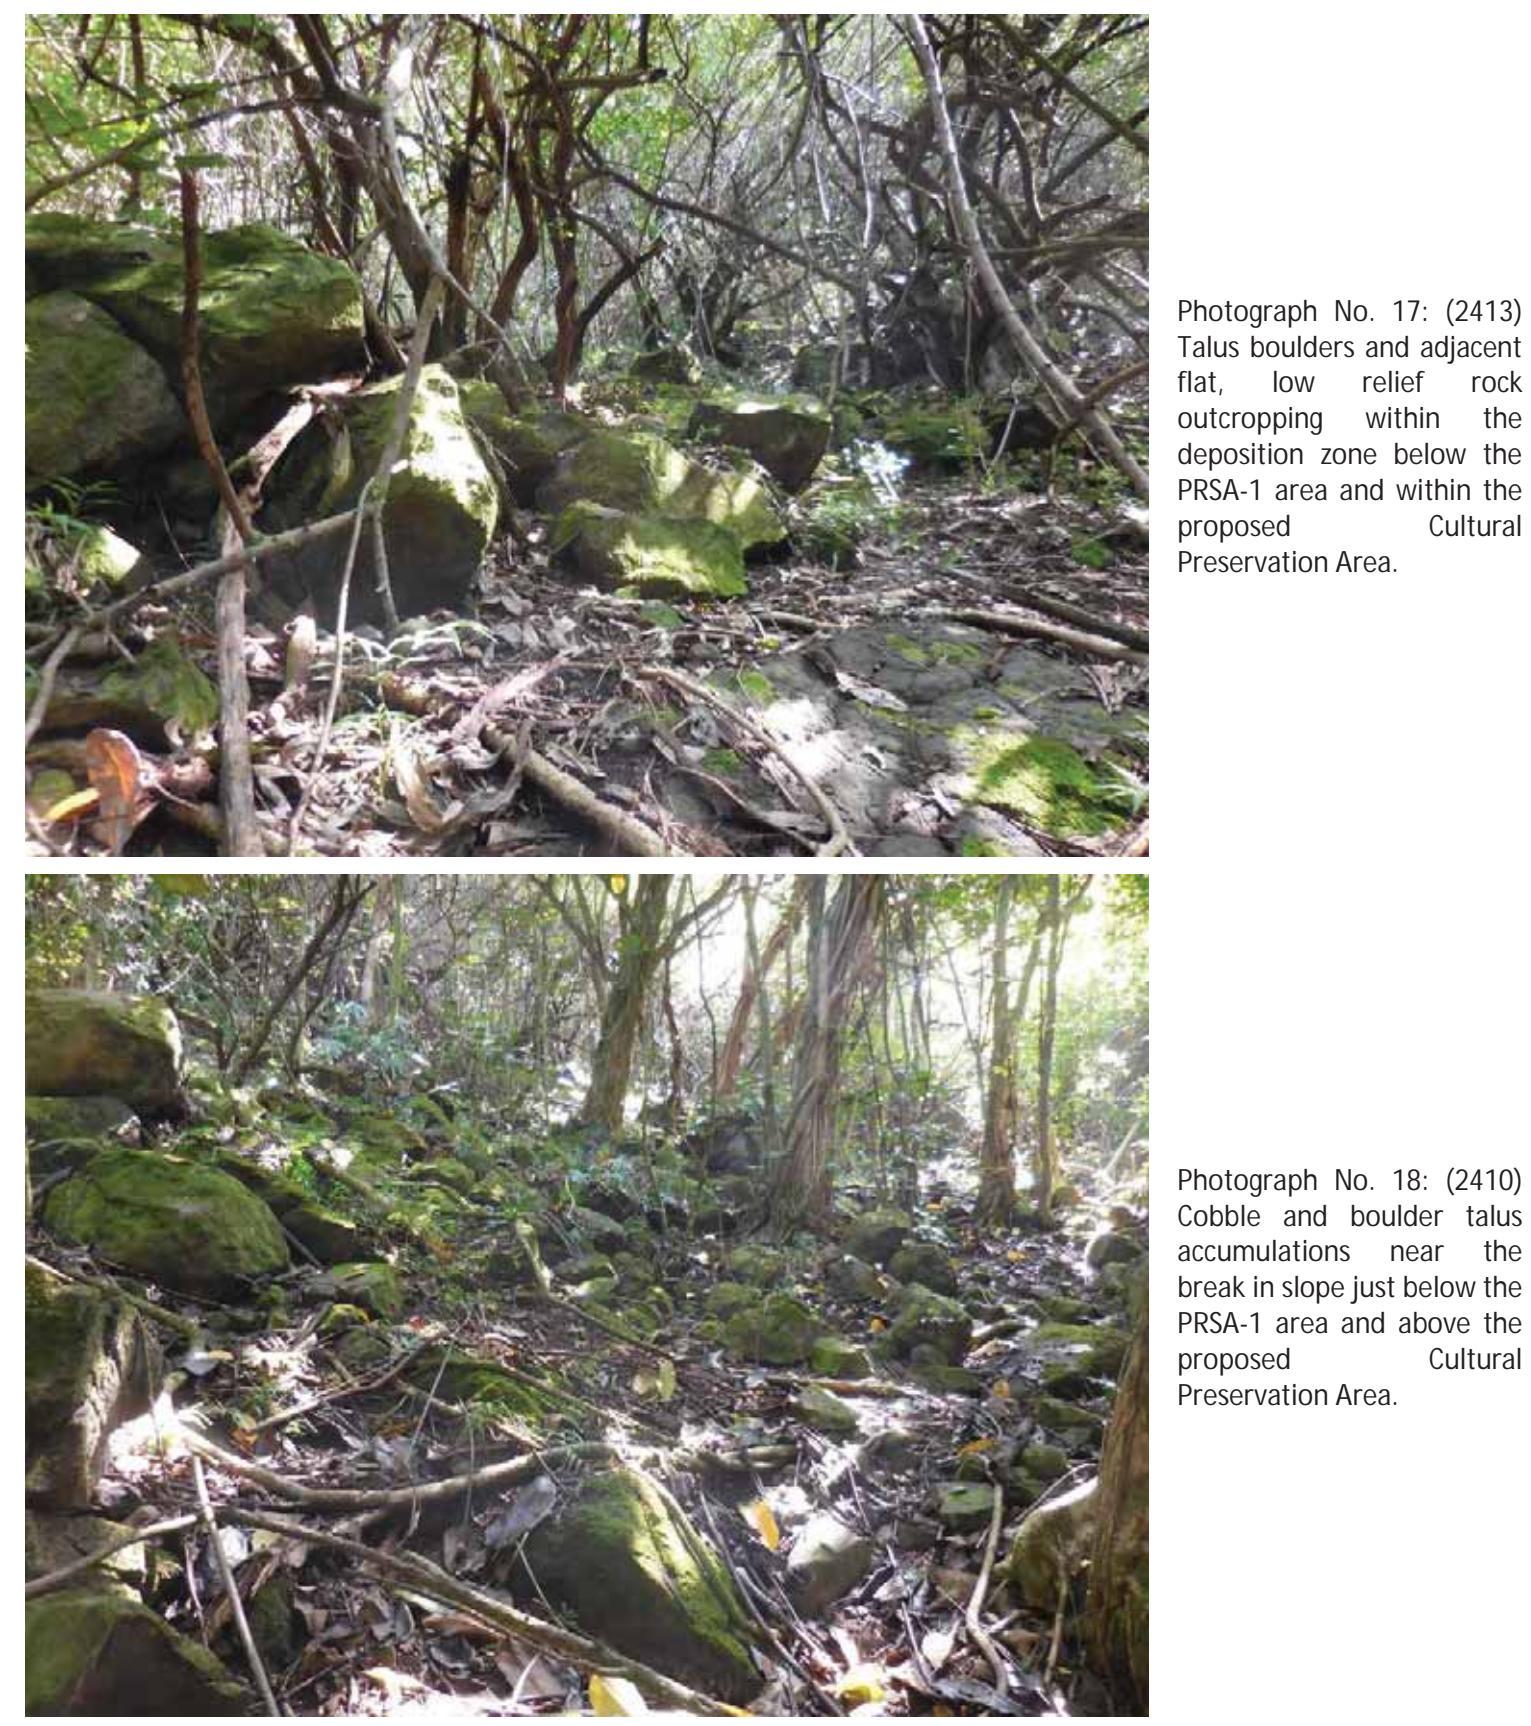
Photograph No. 17: (2413) Talus boulders and adjacent flat, low relief rock outcropping within the deposition zone below the PRSA-1 area and within the proposed Cultural Preservation Area.

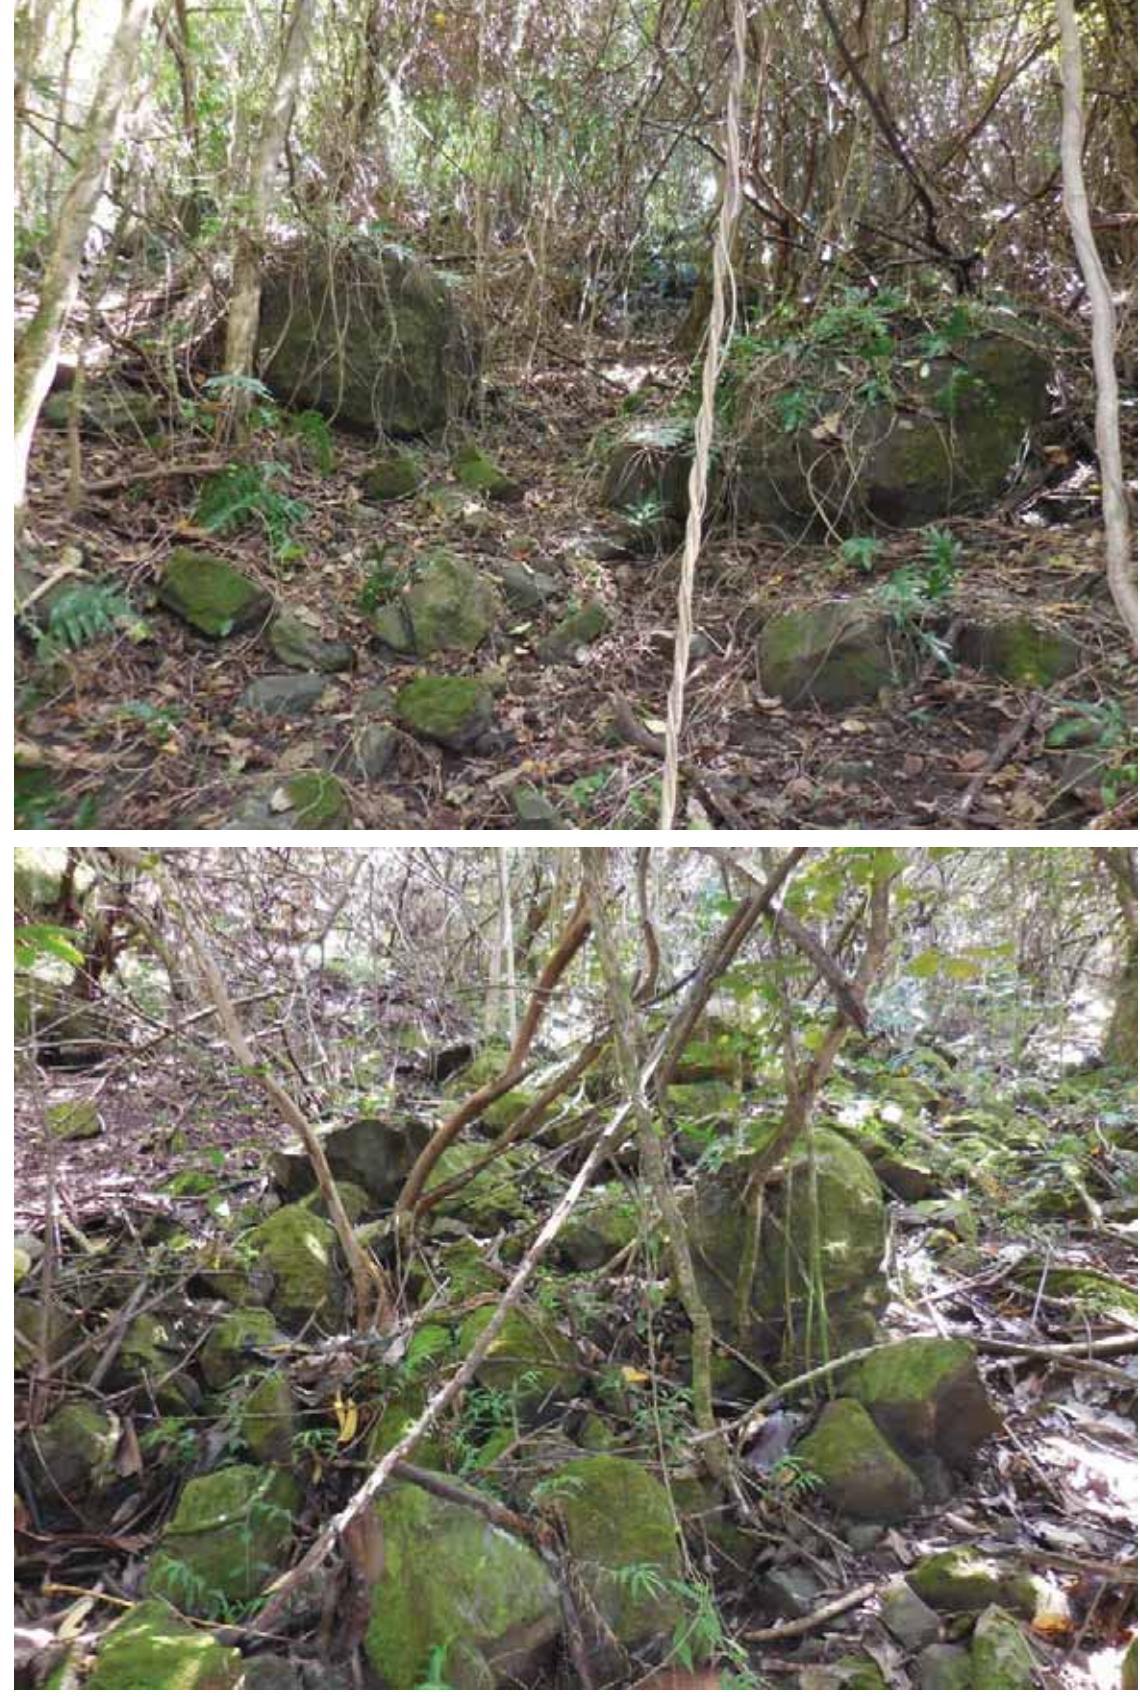
Photograph No. 19: (2407) Scattered boulder deposits on gentle sloping terrain within the deposition zone below the PRSA-1 area and within the proposed Cultural Preservation Area. (Wpt. Boulder1-1).

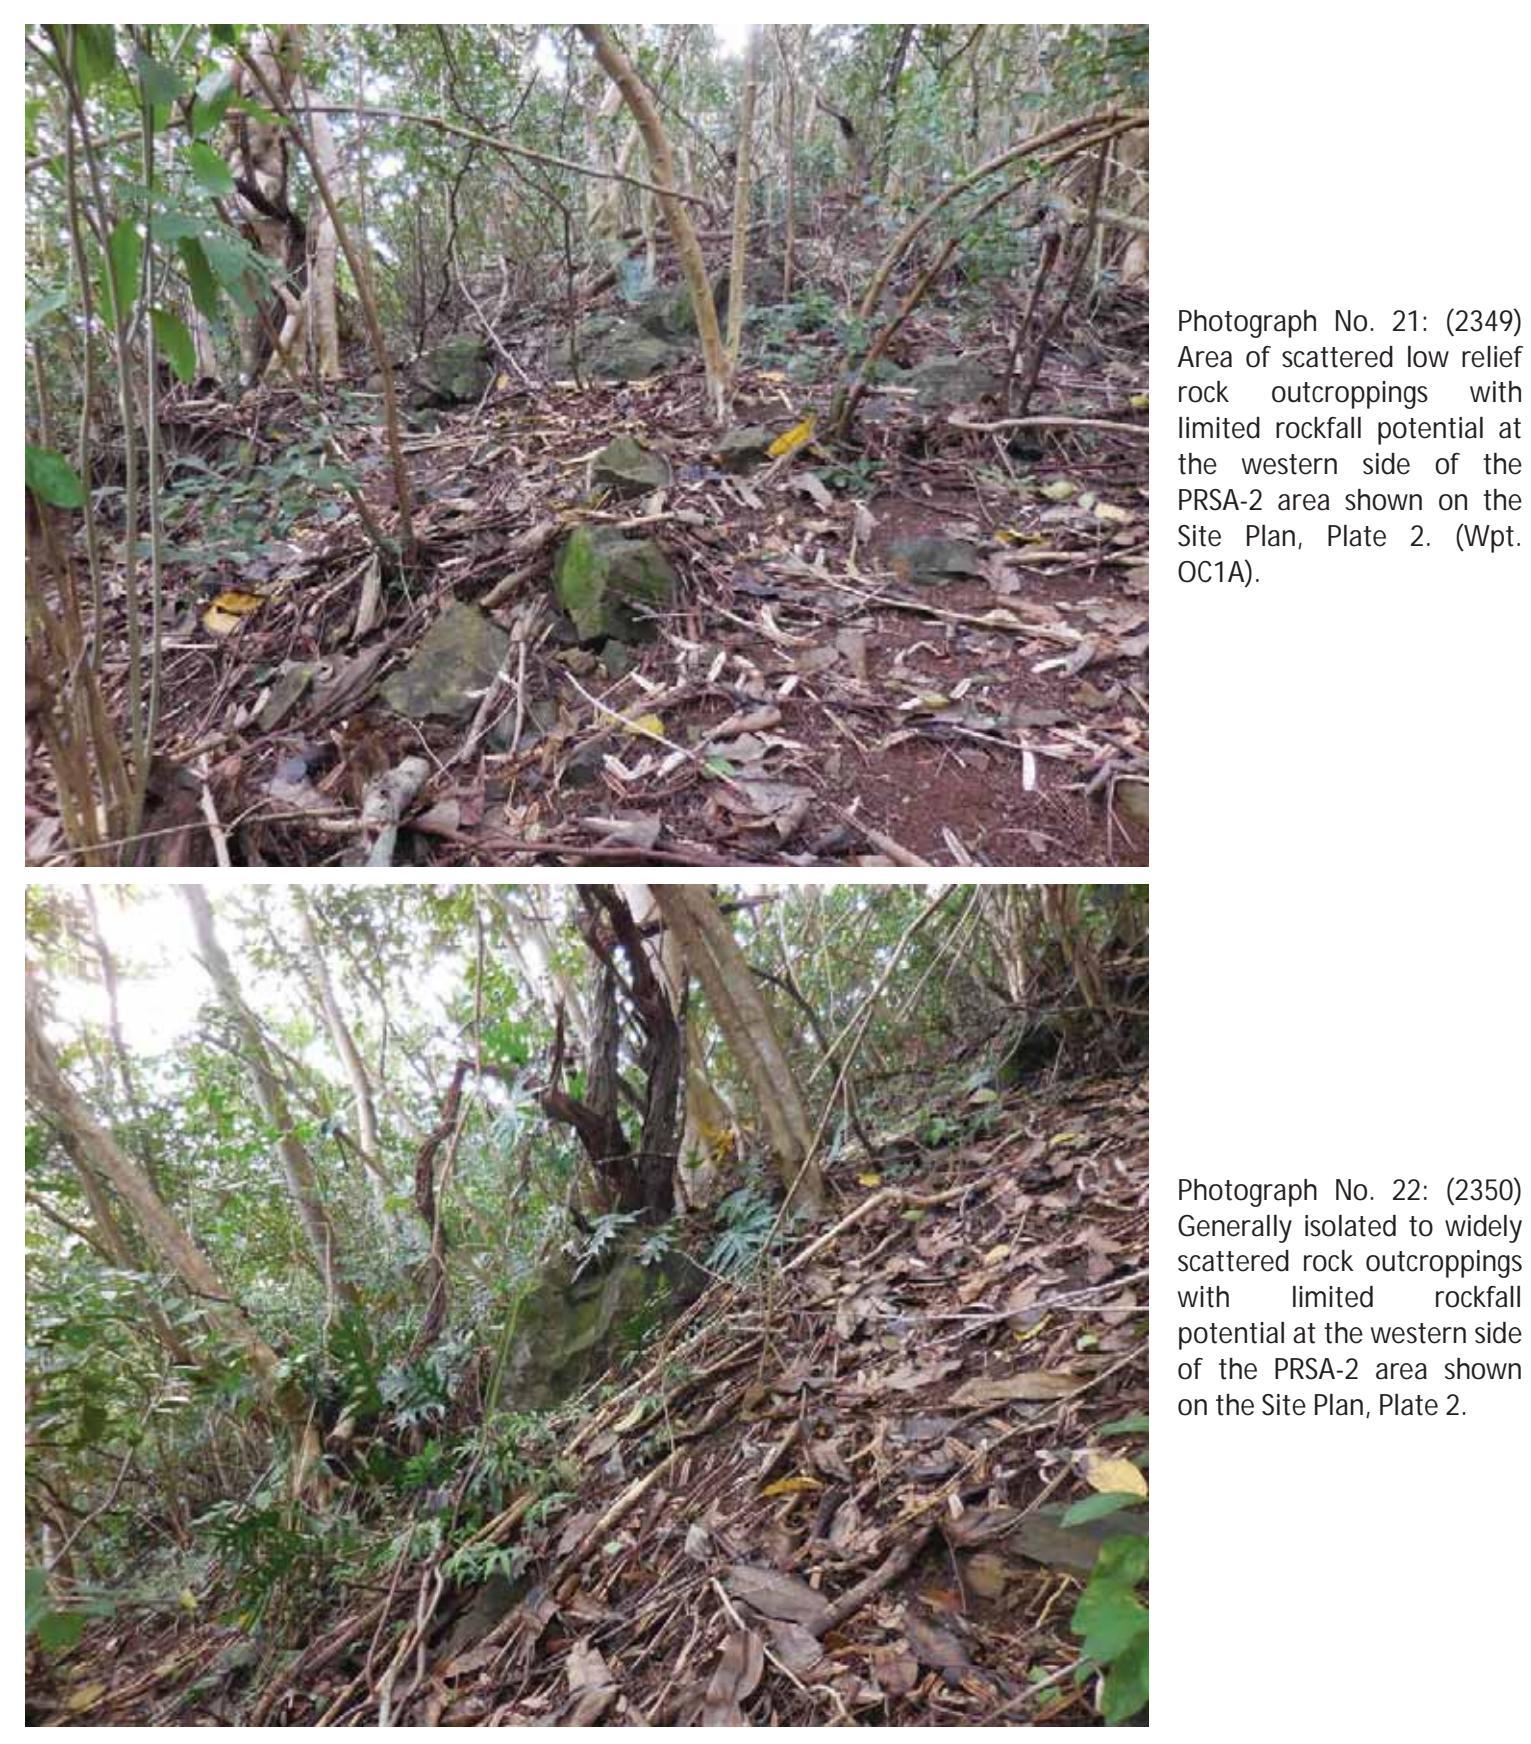
Photograph No. 21: (2349) Area of scattered low relief rock outcroppings with limited rockfall potential at the western side of the PRSA-2 area shown on the Site Plan, Plate 2. (Wpt. OC1A).
