Draft Phase 1 Potential Rockfall And Slope Hazard Assessment Hawaiian Memorial Park Cemetery Expansion – January 2018 Prepared by: Geolabs, Inc.

## PHASE 1 POTENTIAL ROCKFALL AND SLOPE HAZARD ASSESSMENT

### HAWAIIAN MEMORIAL PARK CEMETERY EXPANSION

W.O. 7604-00 JANUARY 18, 2018

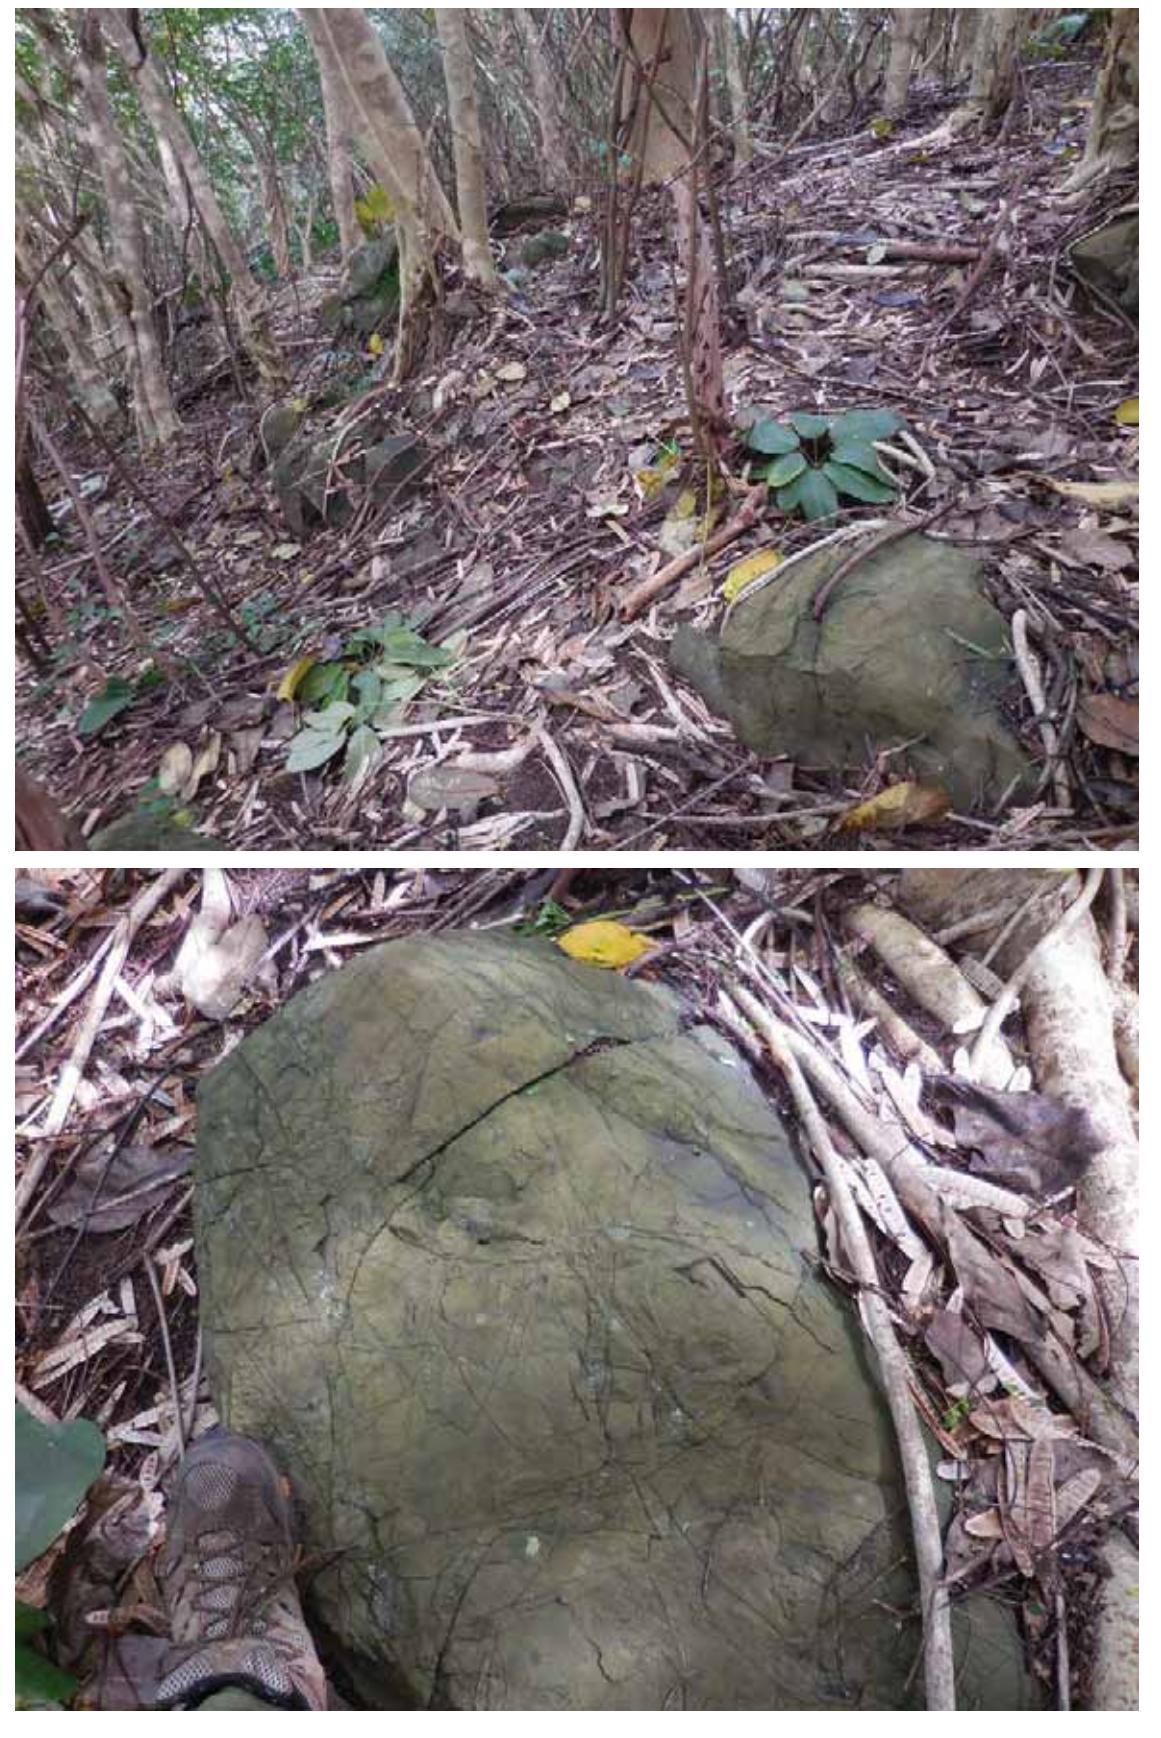
Photograph No. 23: (2374) Other widely scattered low relief rock outcroppings with limited rockfall potential at the western side of the PRSA-2 area shown on the Site Plan, Plate 2.

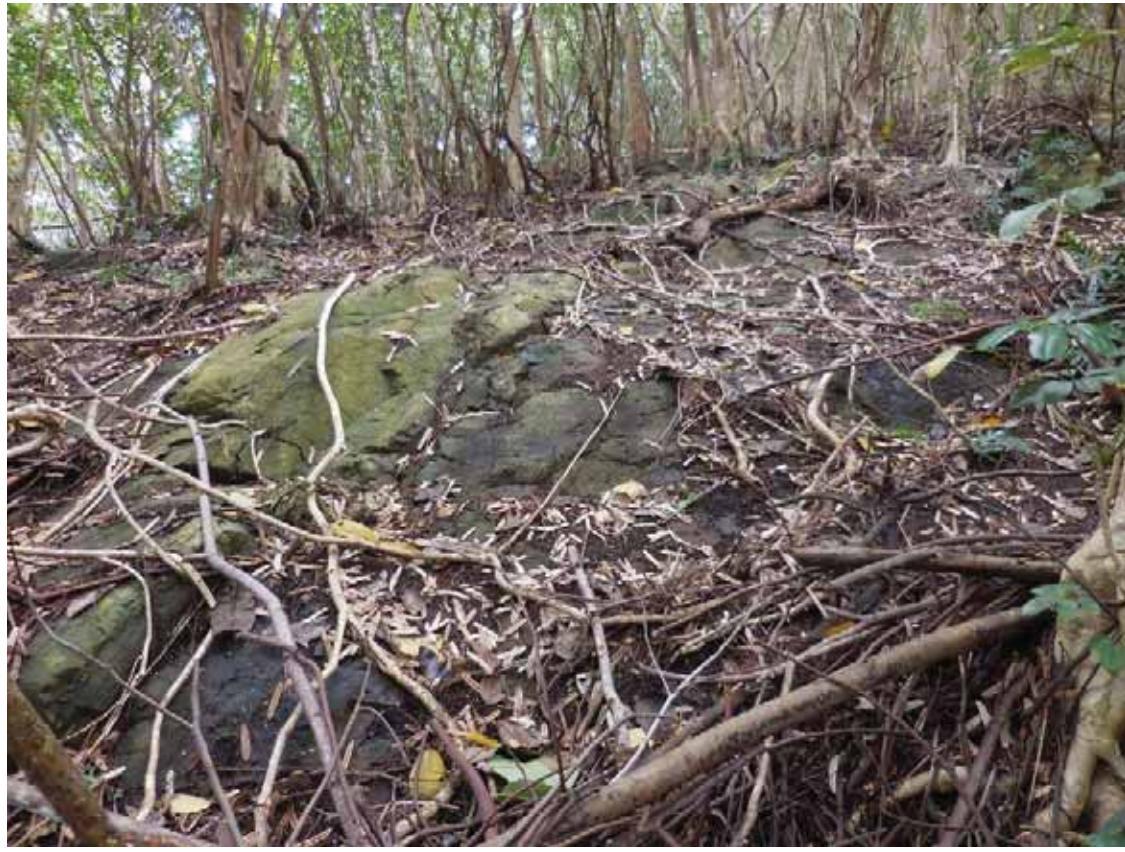
Photograph No. 25: (2376) Flat low relief rock outcropping with very limited rockfall potential at the western side of the PRSA-2 area shown on the Site Plan, Plate 2. (Wpt. OC1A).

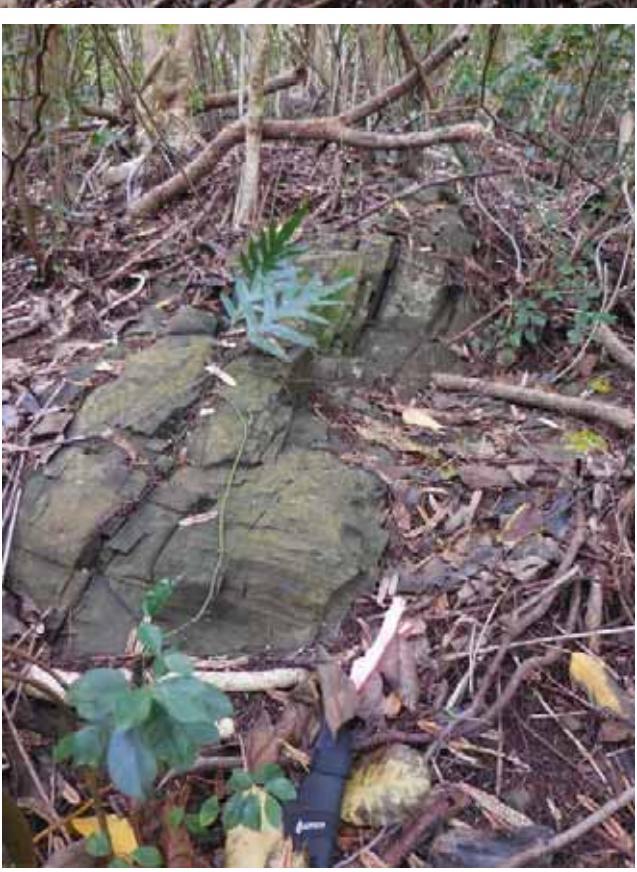
Photograph No. 26: (2351) Other low relief rock outcropping at the western side of the PRSA-2 area. strong Note the microfracturing in the elongated outcropping that resembles a volcanic dike trend.

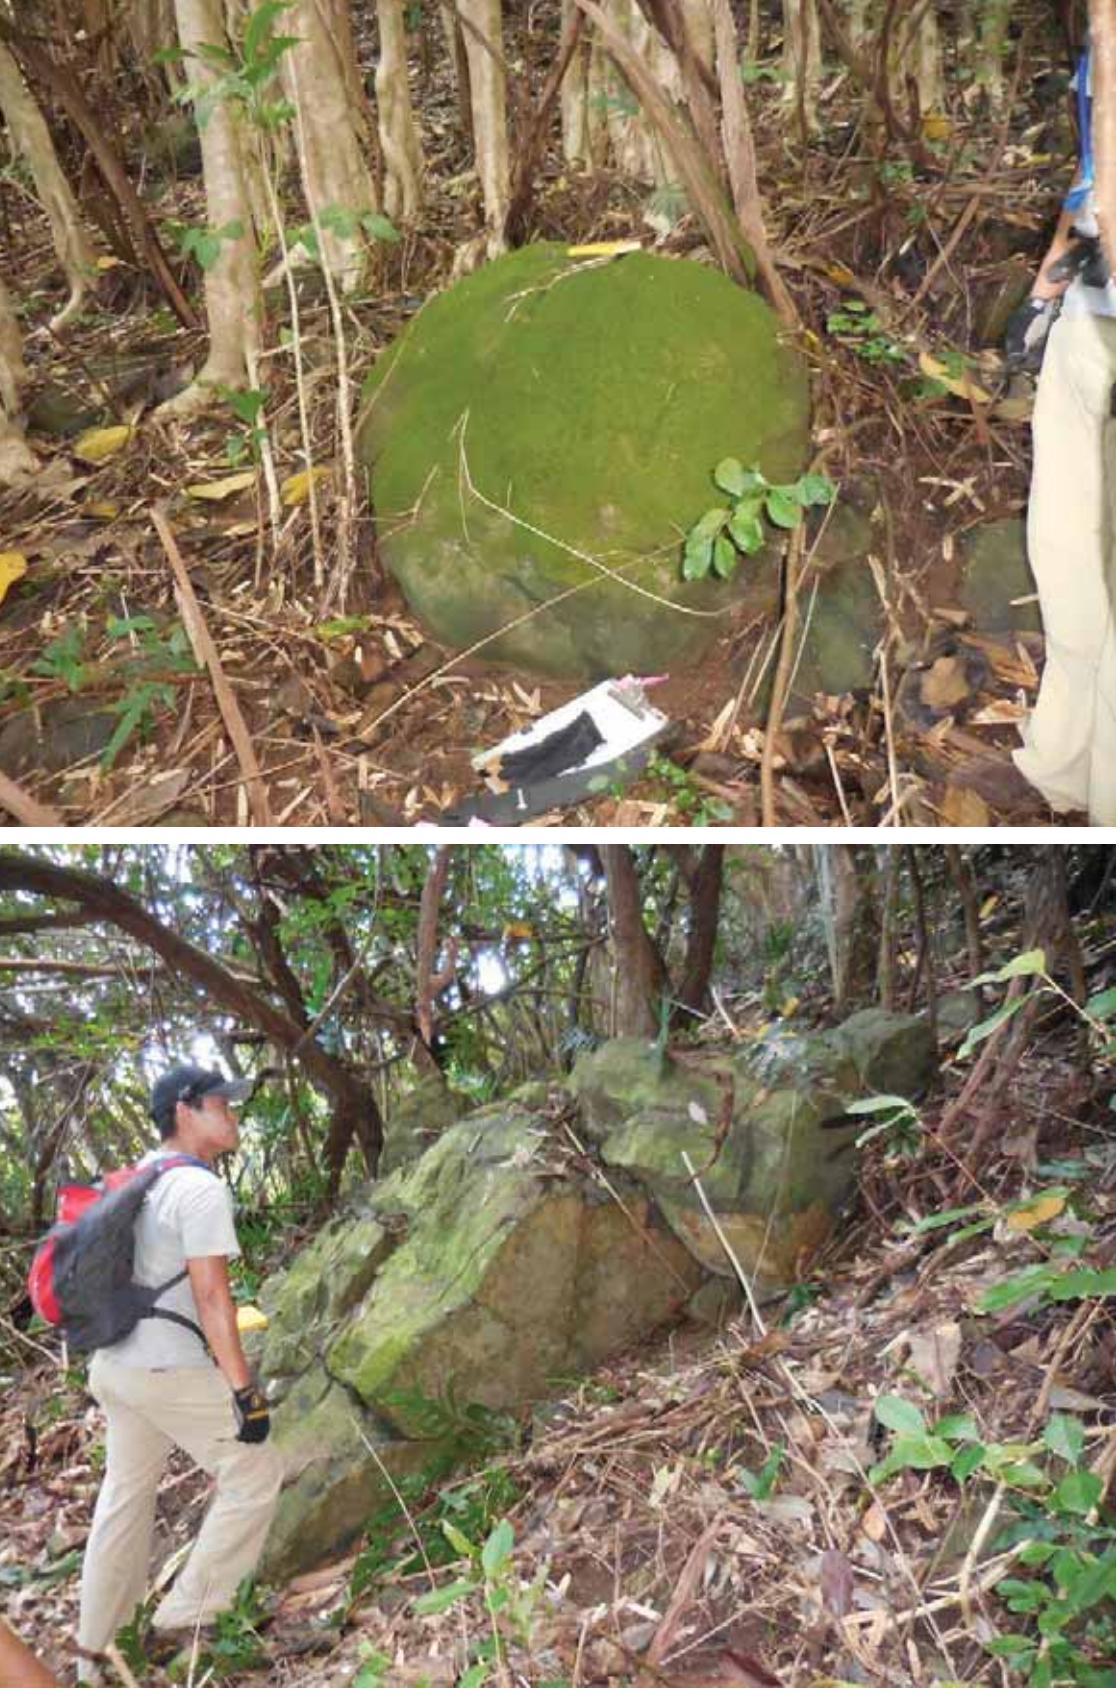
Photograph No. 27: (2388) Isolated protruding spherical rock outcropping within an area of scattered outcroppings at the upper elevation western portion of the PRSA-2 area. (Wpt. OC1-1).

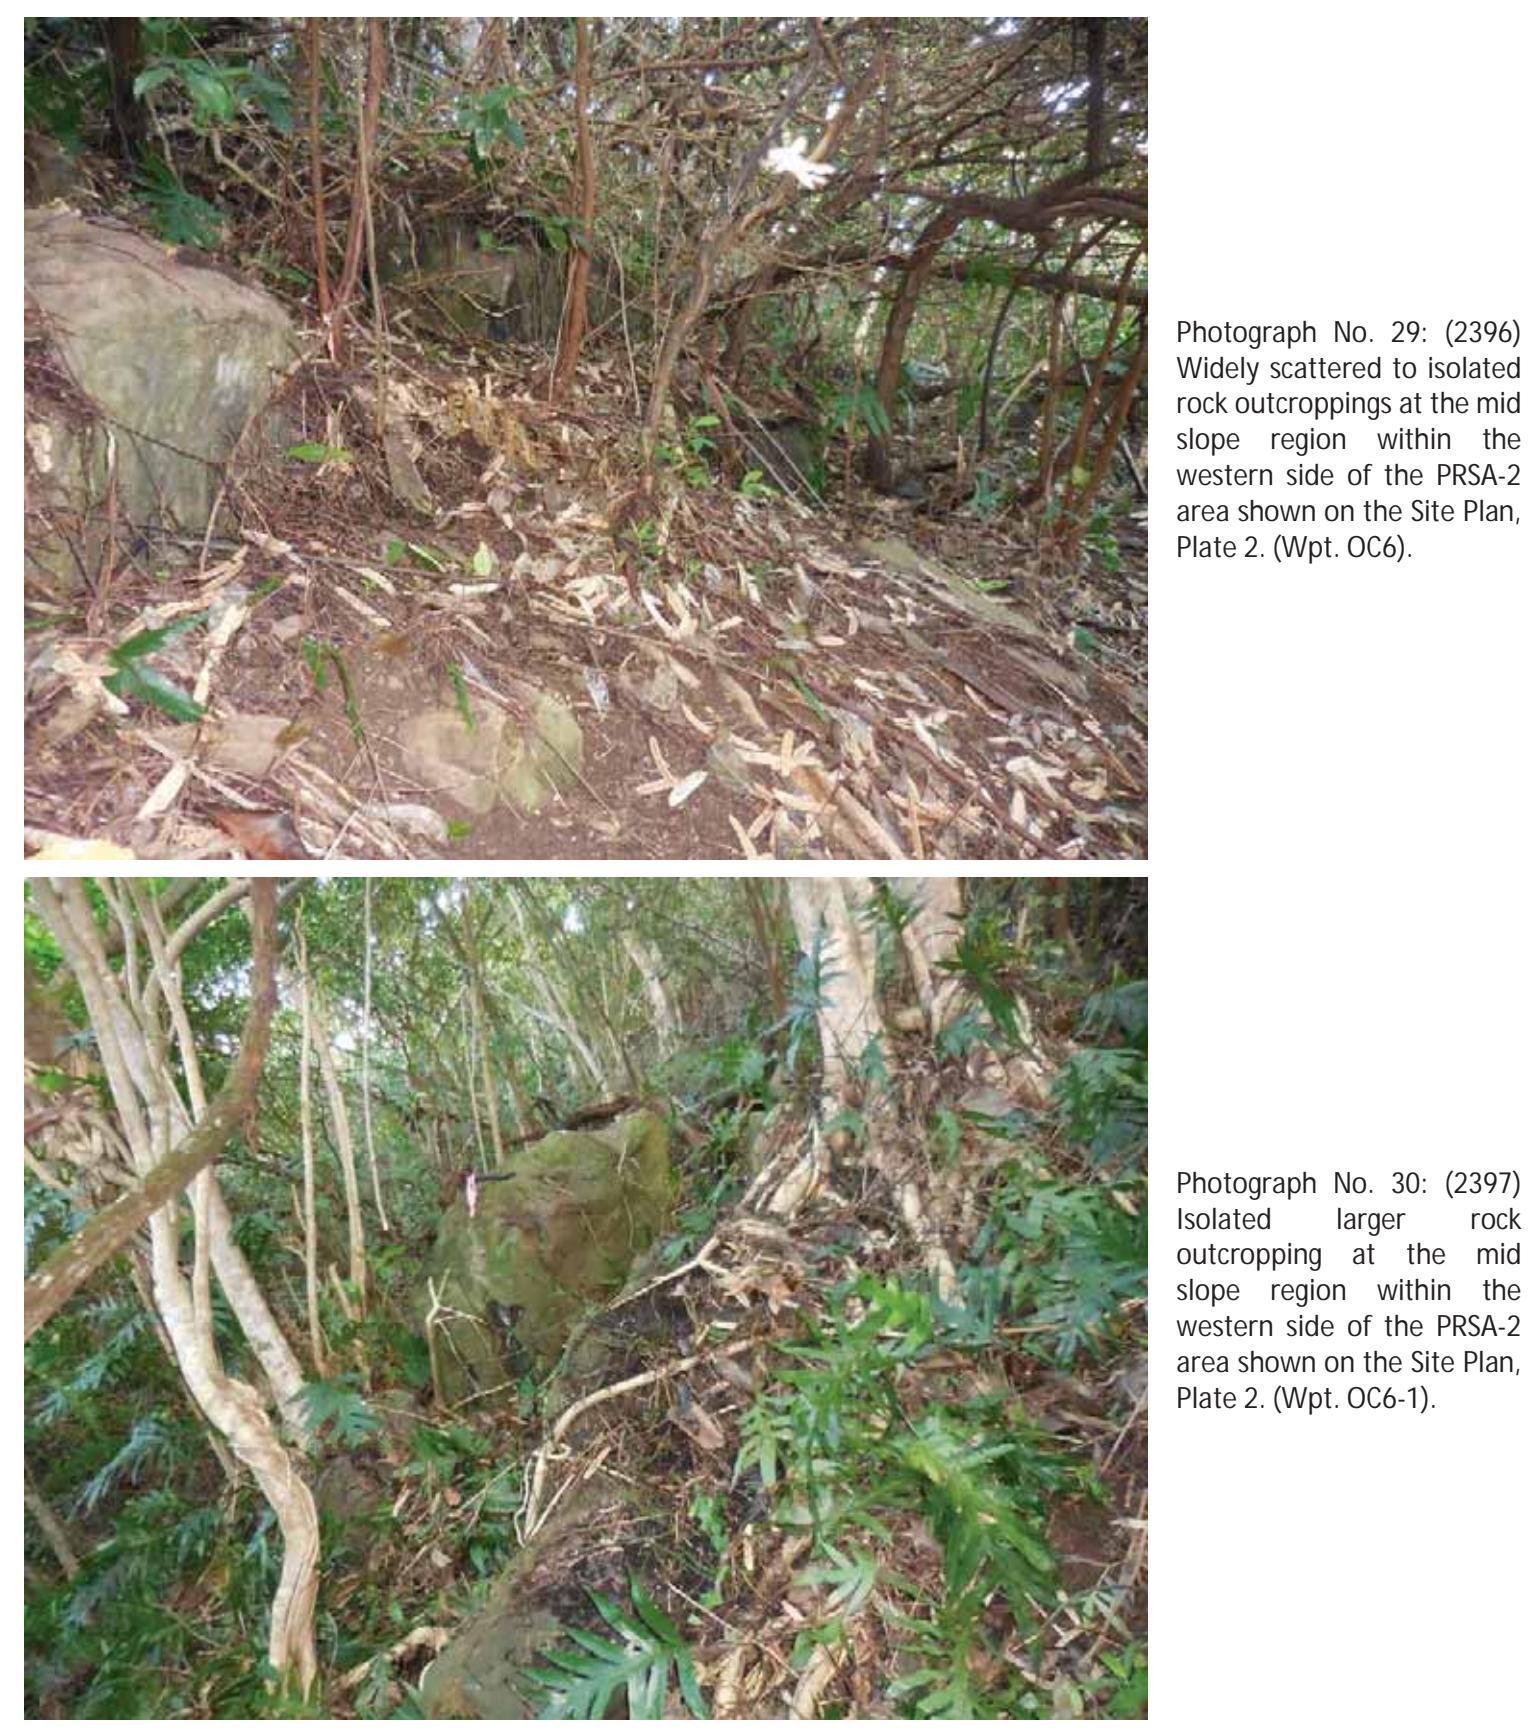
Photograph No. 29: (2396) Widely scattered to isolated rock outcroppings at the mid slope region within the western side of the PRSA-2 area shown on the Site Plan, Plate 2. (Wpt. OC6).

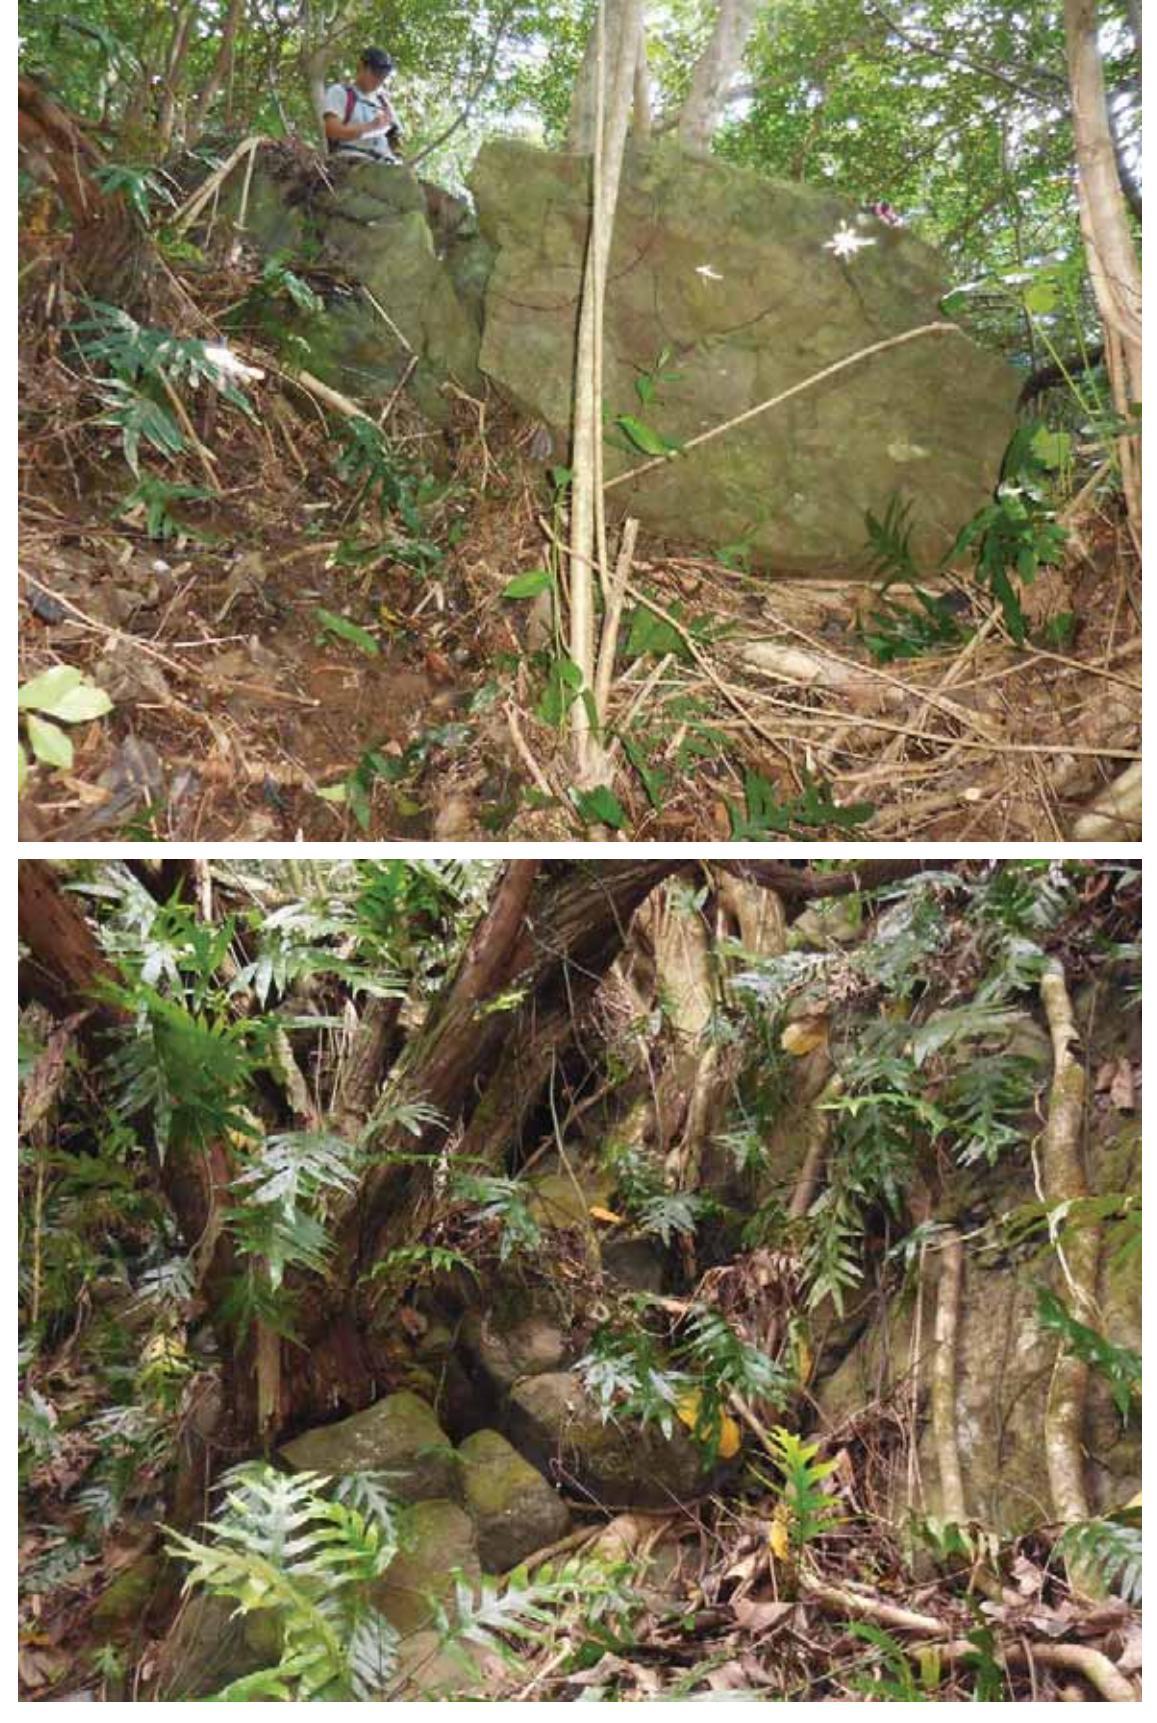
Photograph No. 31: (2399) Opposing view of the outcropping in Photograph No. 30 showing the precarious setting on the sloping terrain.

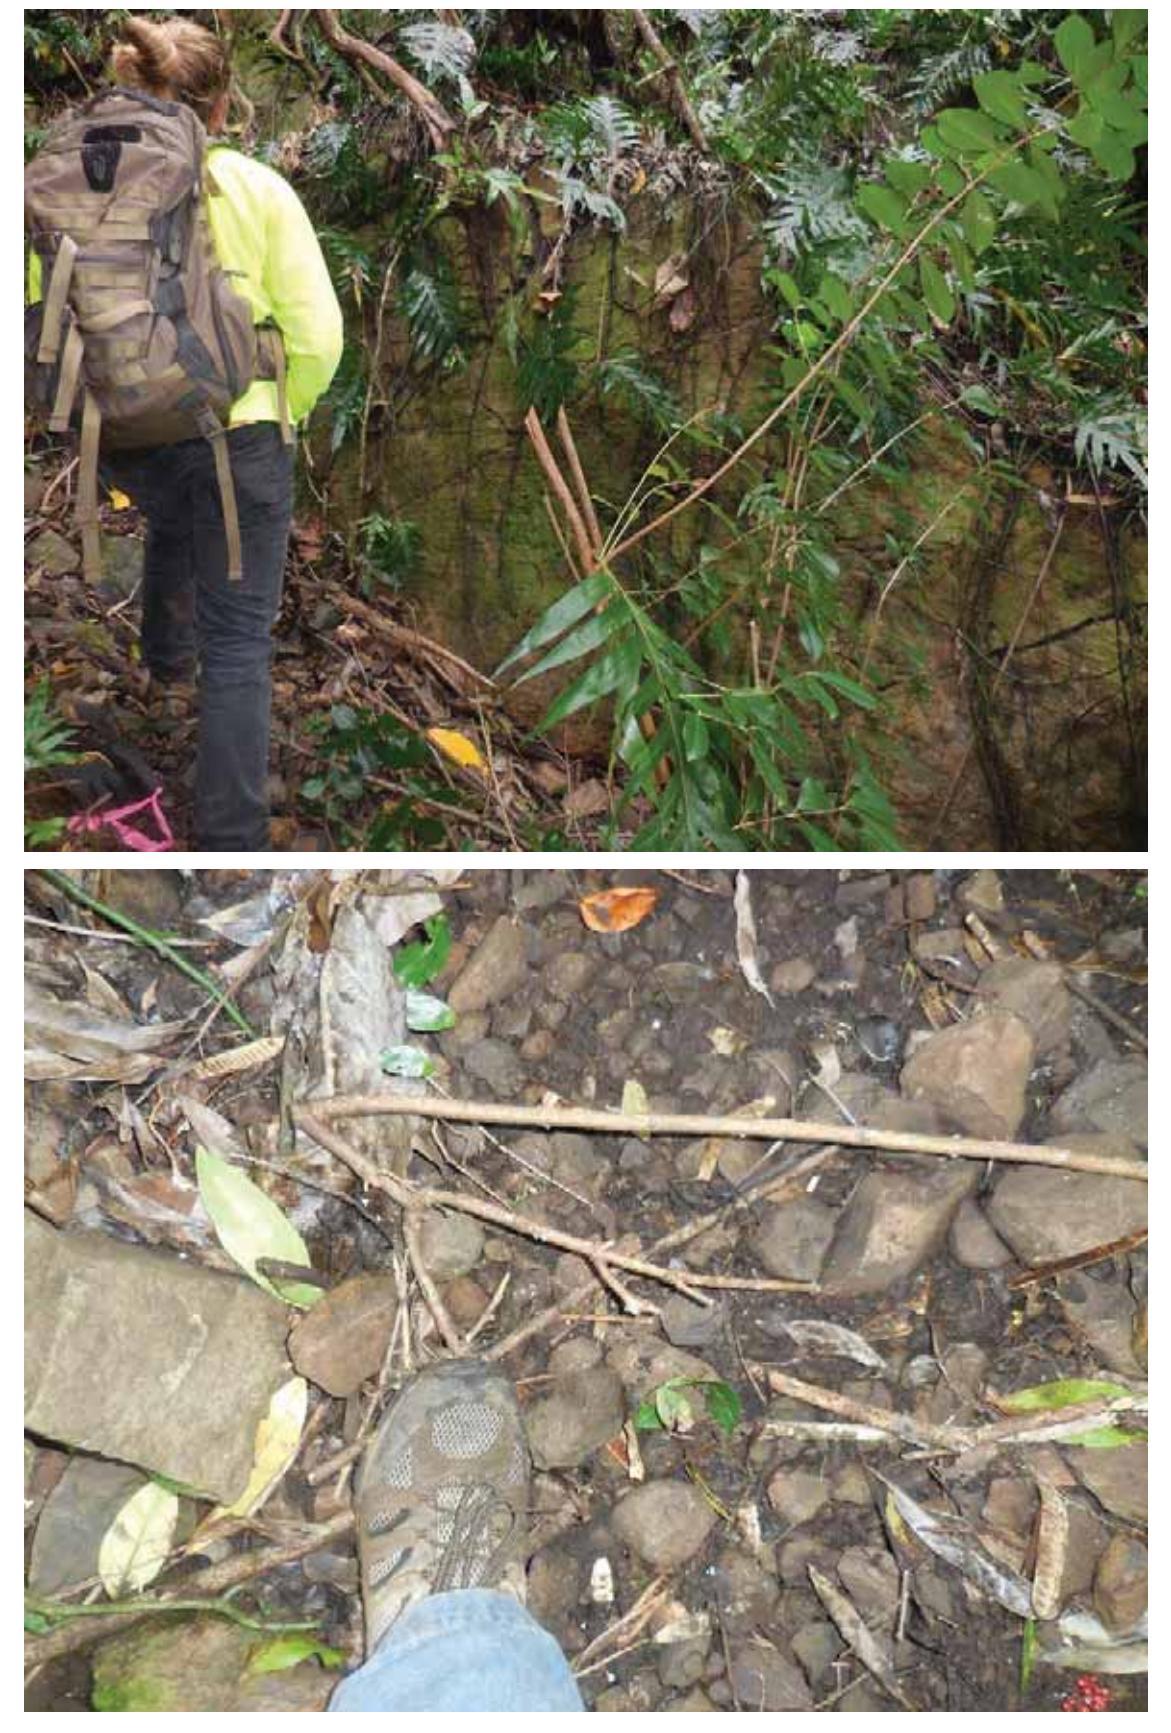
Photograph No. 33: (2607) Another portion of the elongated outcrop described in Photograph No. 32. (Wpt. OCA14).

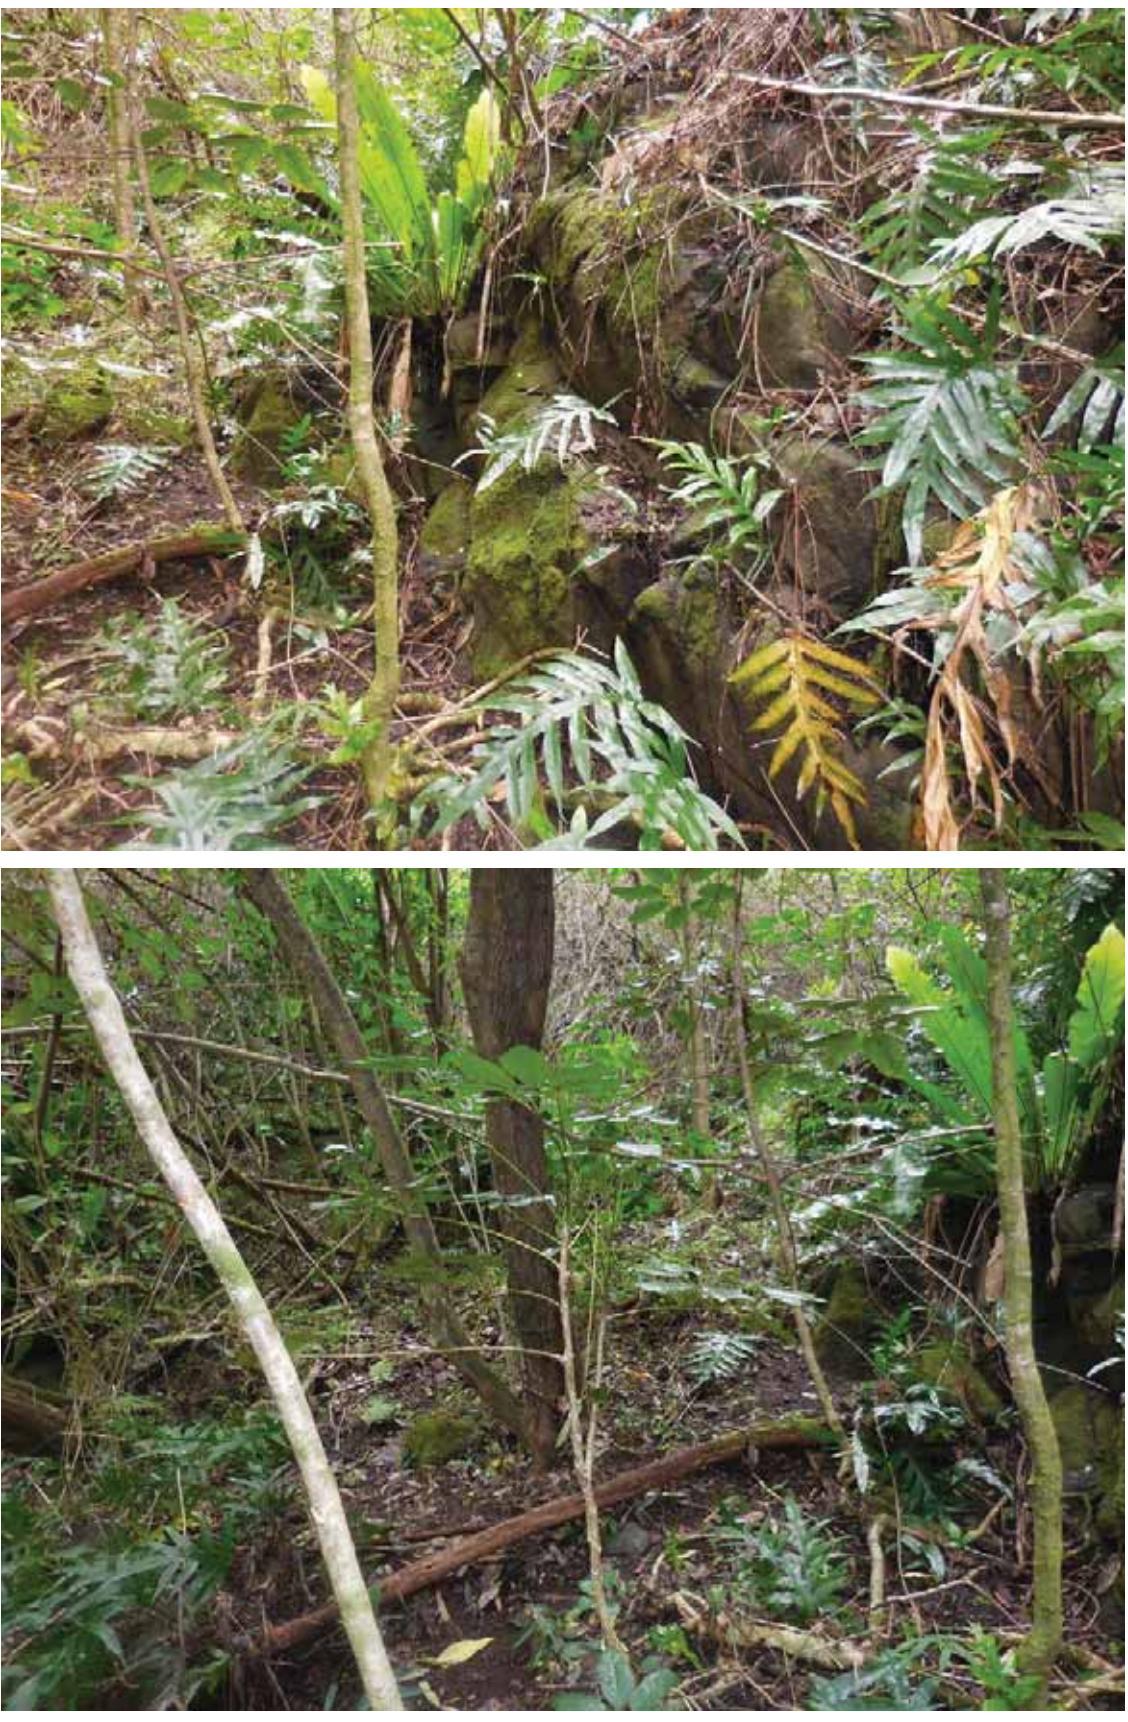
Photograph No. 34: (2605) Typical ground surface in the primary ravine below existing rock outcroppings where some cobble talus accumulations were observed. (Wpt. OCA13).

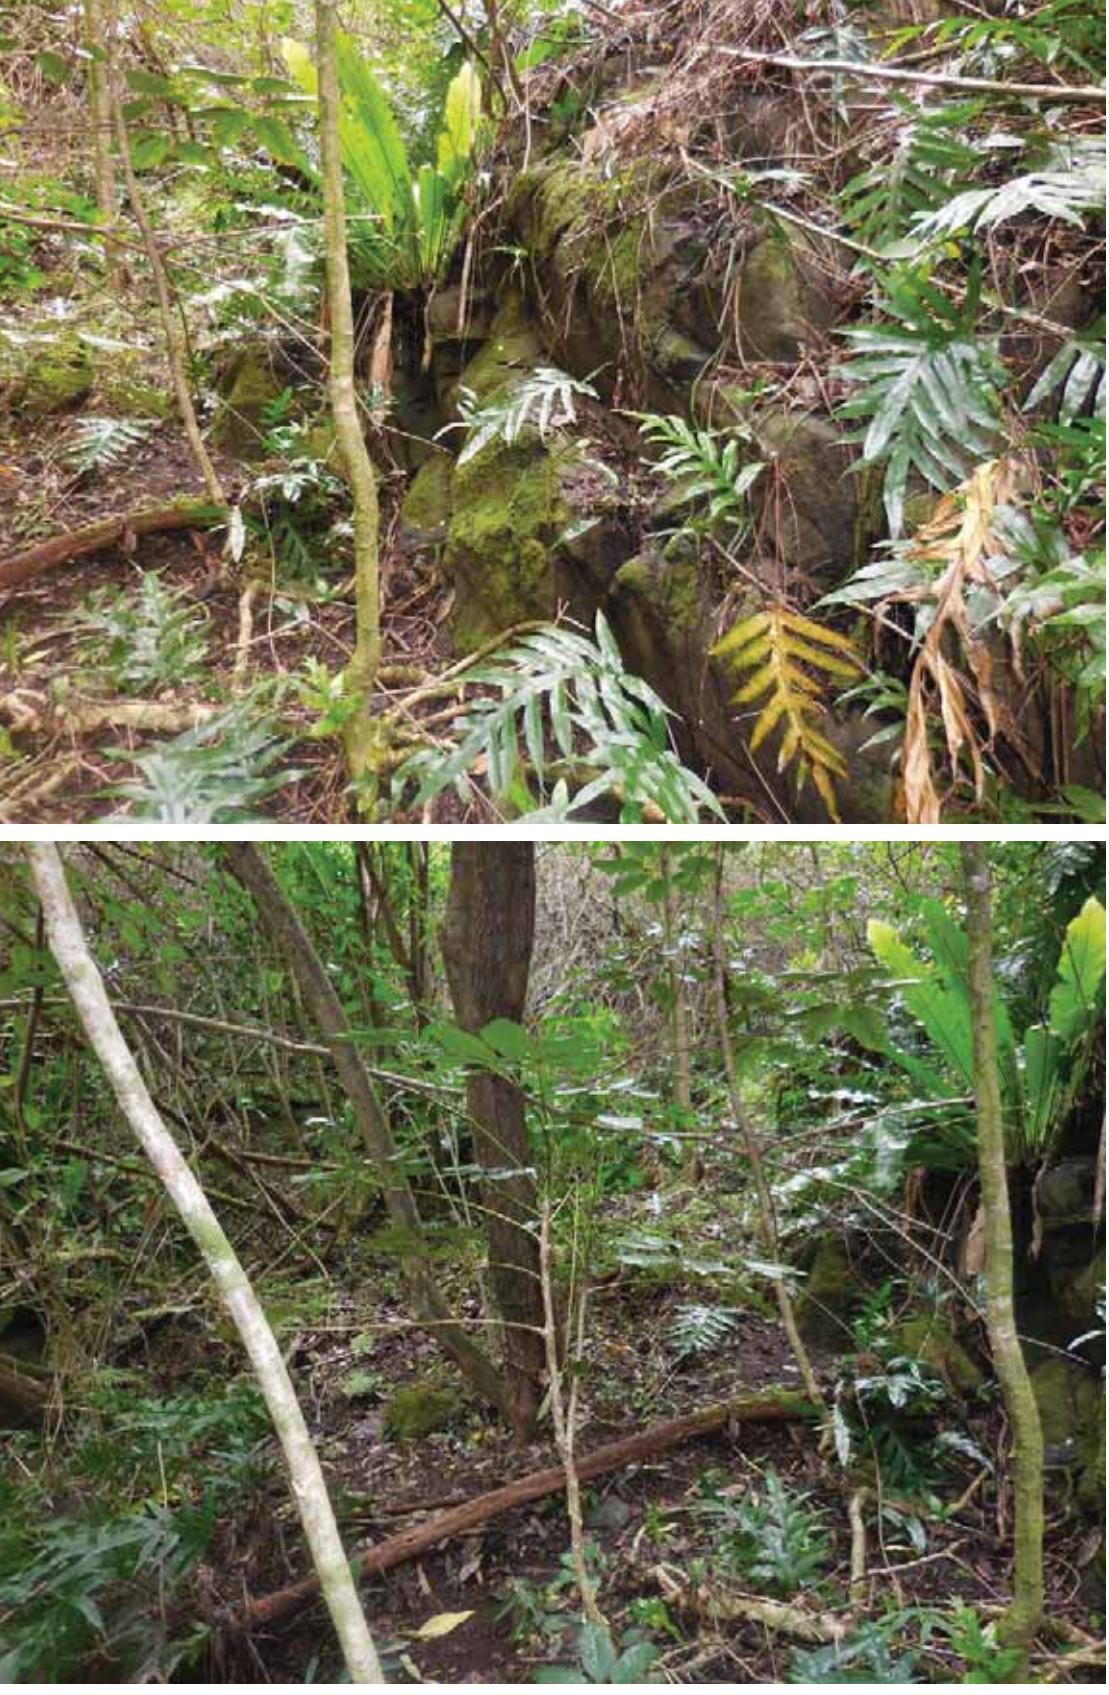
Photograph No. 35: (2603) Fractured rock outcropping on the ravine side slope along Slope Profile "C" and within the central portion of the PRSA-2 area shown on the Site Plan, Plate 2. (Wpt. OCA13).

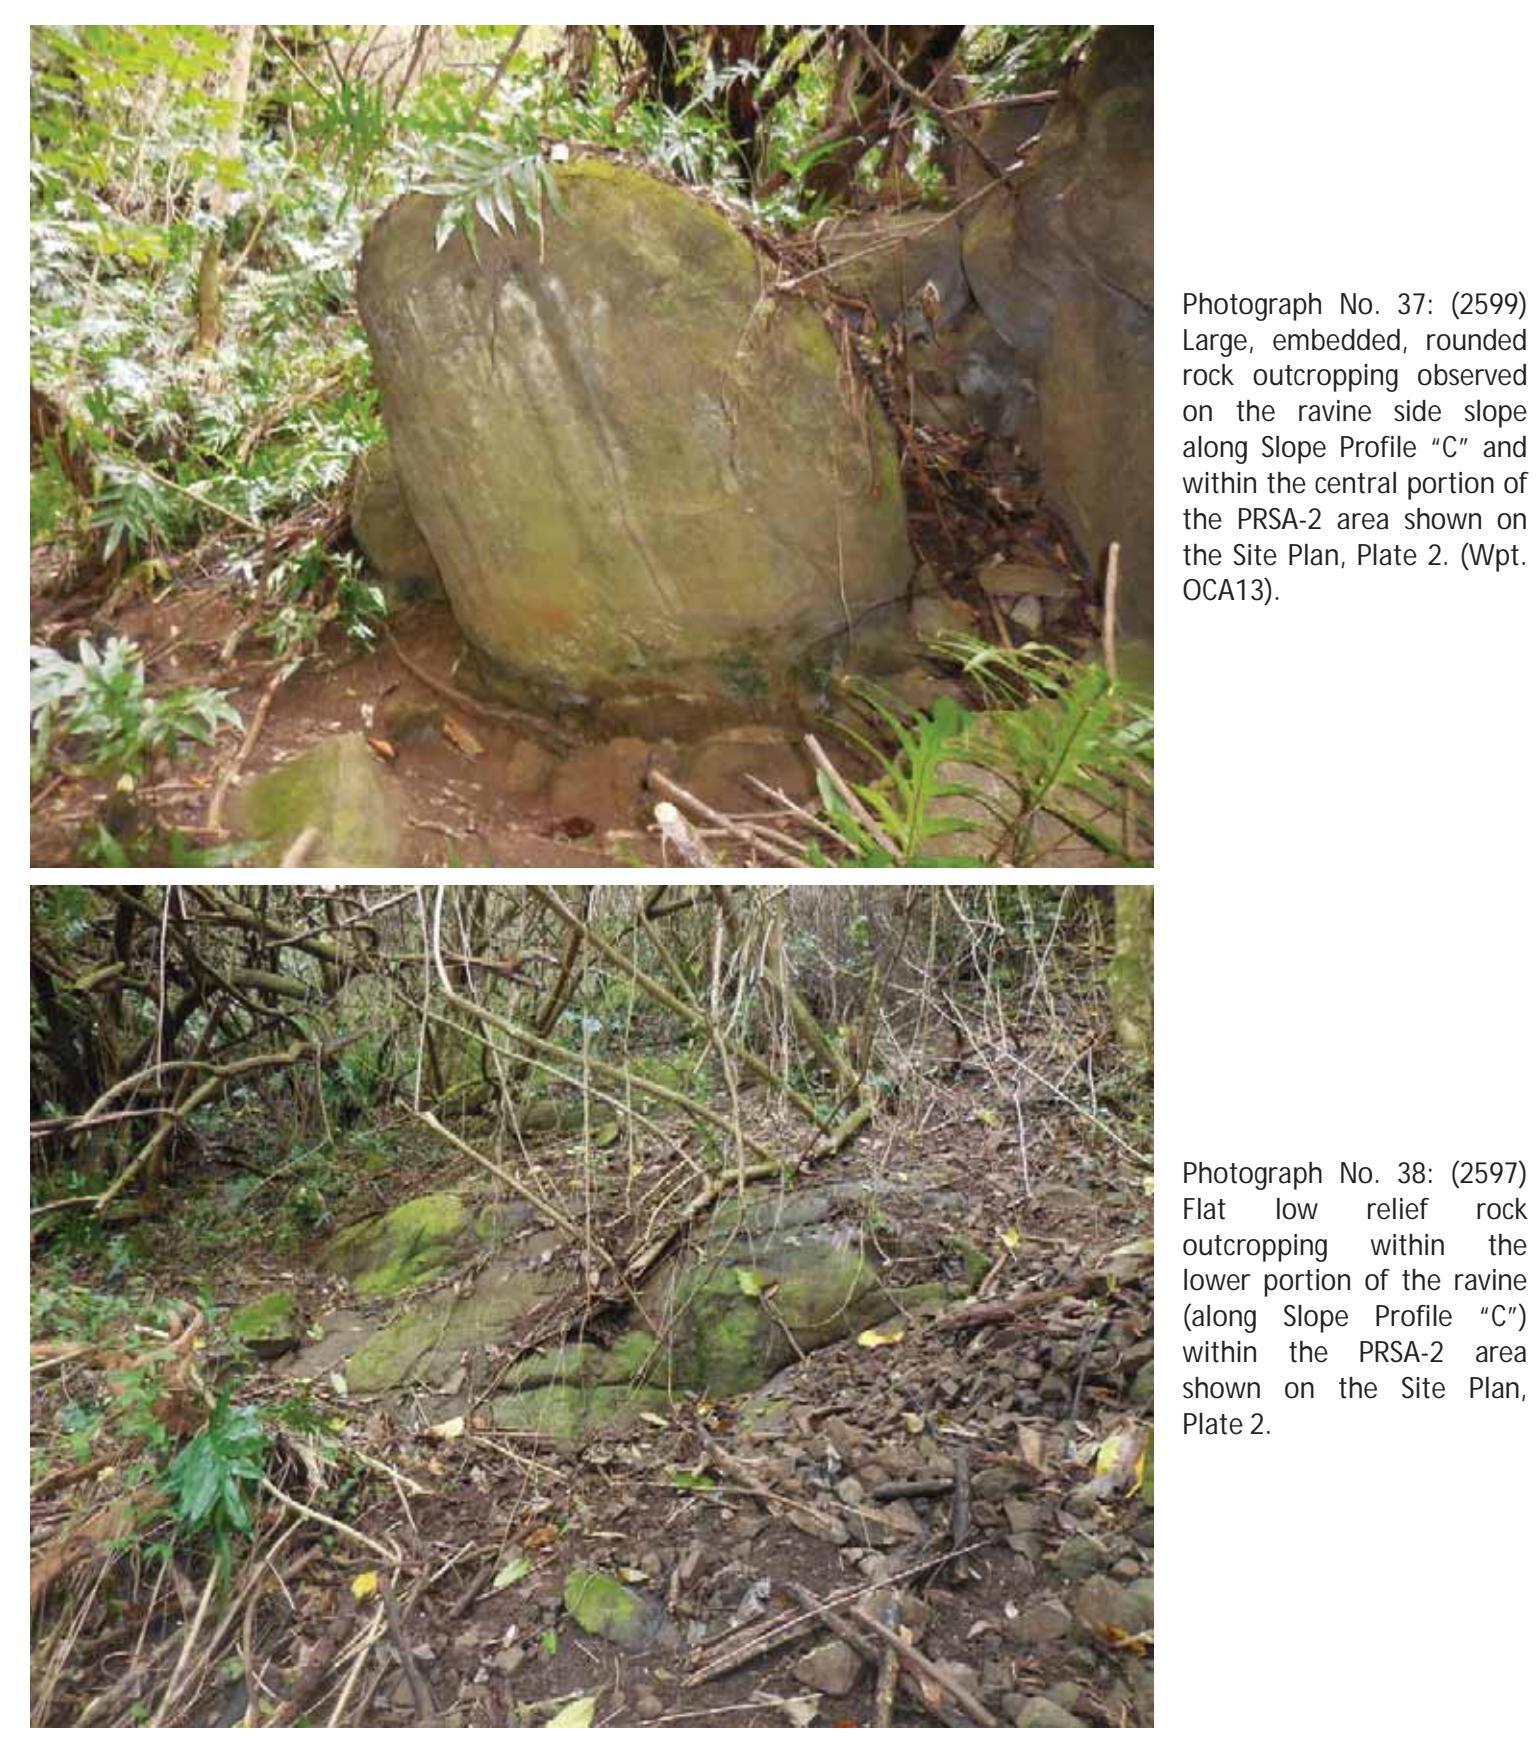
Photograph No. 37: (2599) Large, embedded, rounded rock outcropping observed on the ravine side slope along Slope Profile "C" and within the central portion of the PRSA-2 area shown on the Site Plan, Plate 2. (Wpt. OCA13).

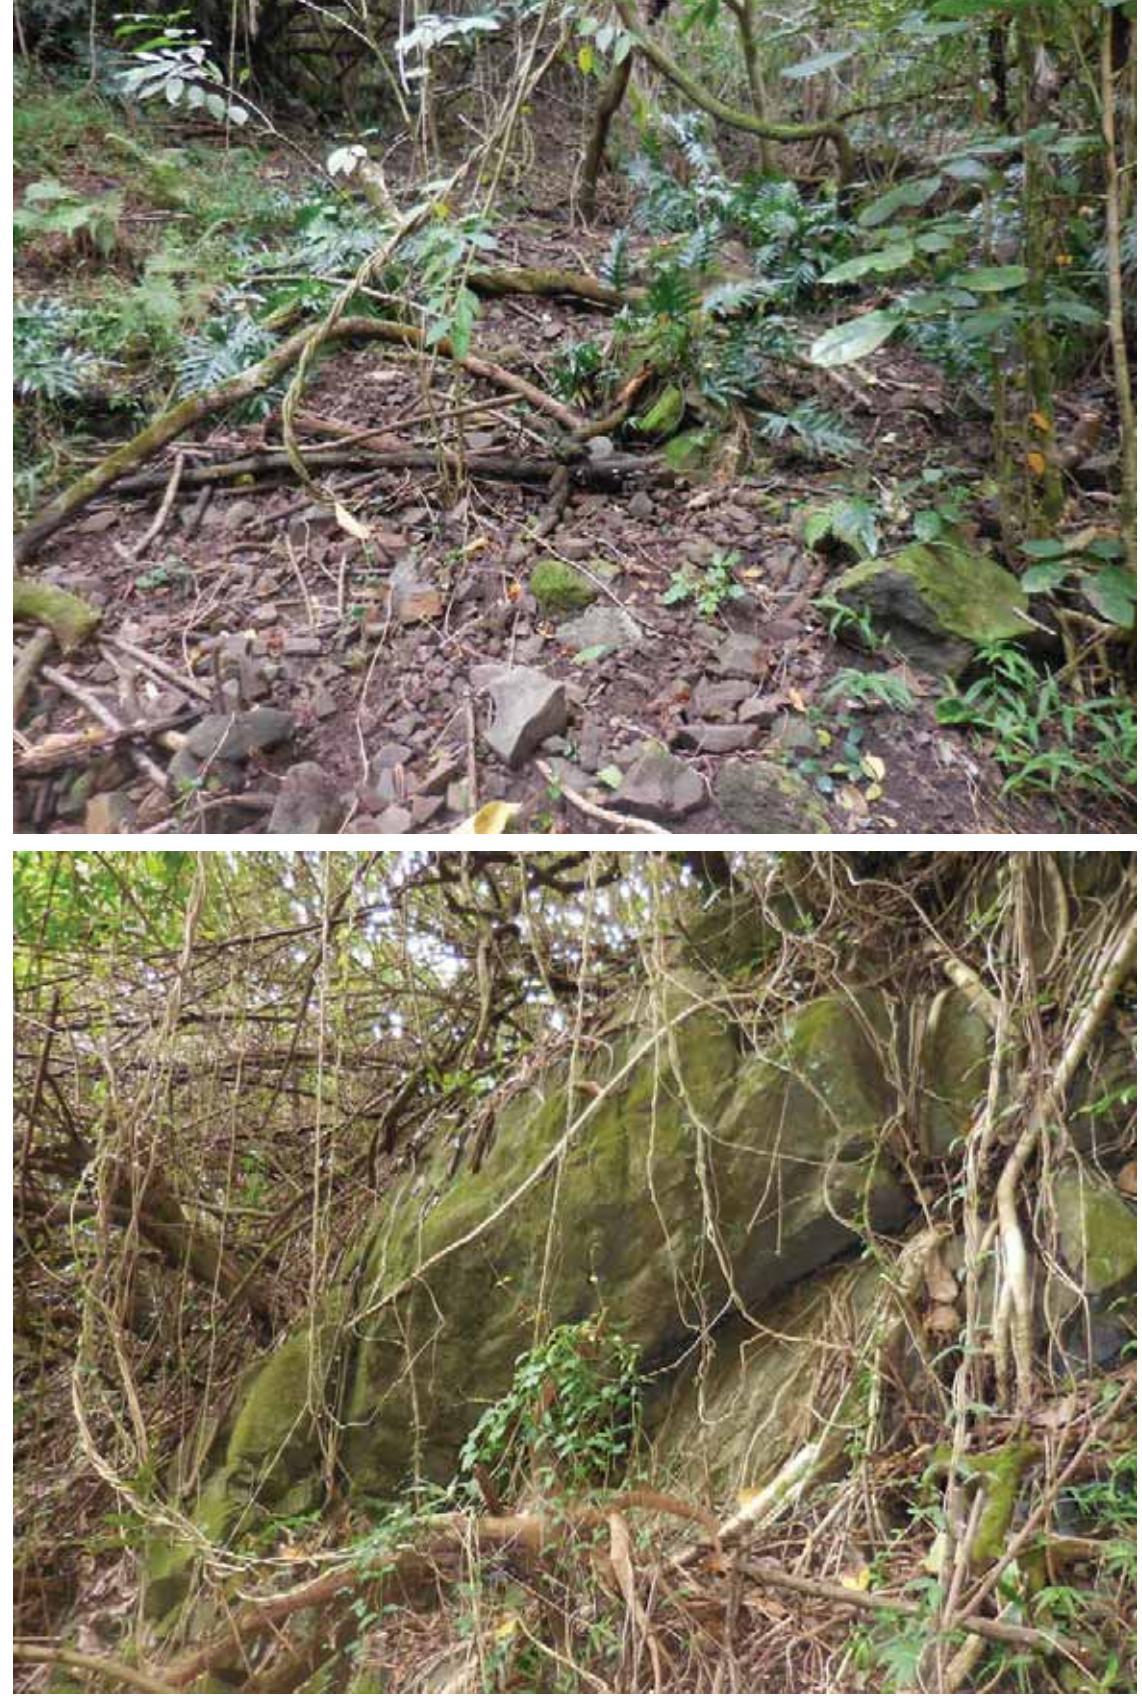
Photograph No. 39: (2596) Typical talus debris accumulations within the mid elevation portion of the ravine at the central portion of the PRSA-2 area shown on the Site Plan, Plate 2.
