Draft Phase 1 Potential Rockfall And Slope Hazard Assessment Hawaiian Memorial Park Cemetery Expansion – January 2018 Prepared by: Geolabs, Inc.

## PHASE 1 POTENTIAL ROCKFALL AND SLOPE HAZARD ASSESSMENT

### HAWAIIAN MEMORIAL PARK CEMETERY EXPANSION

W.O. 7604-00 JANUARY 18, 2018

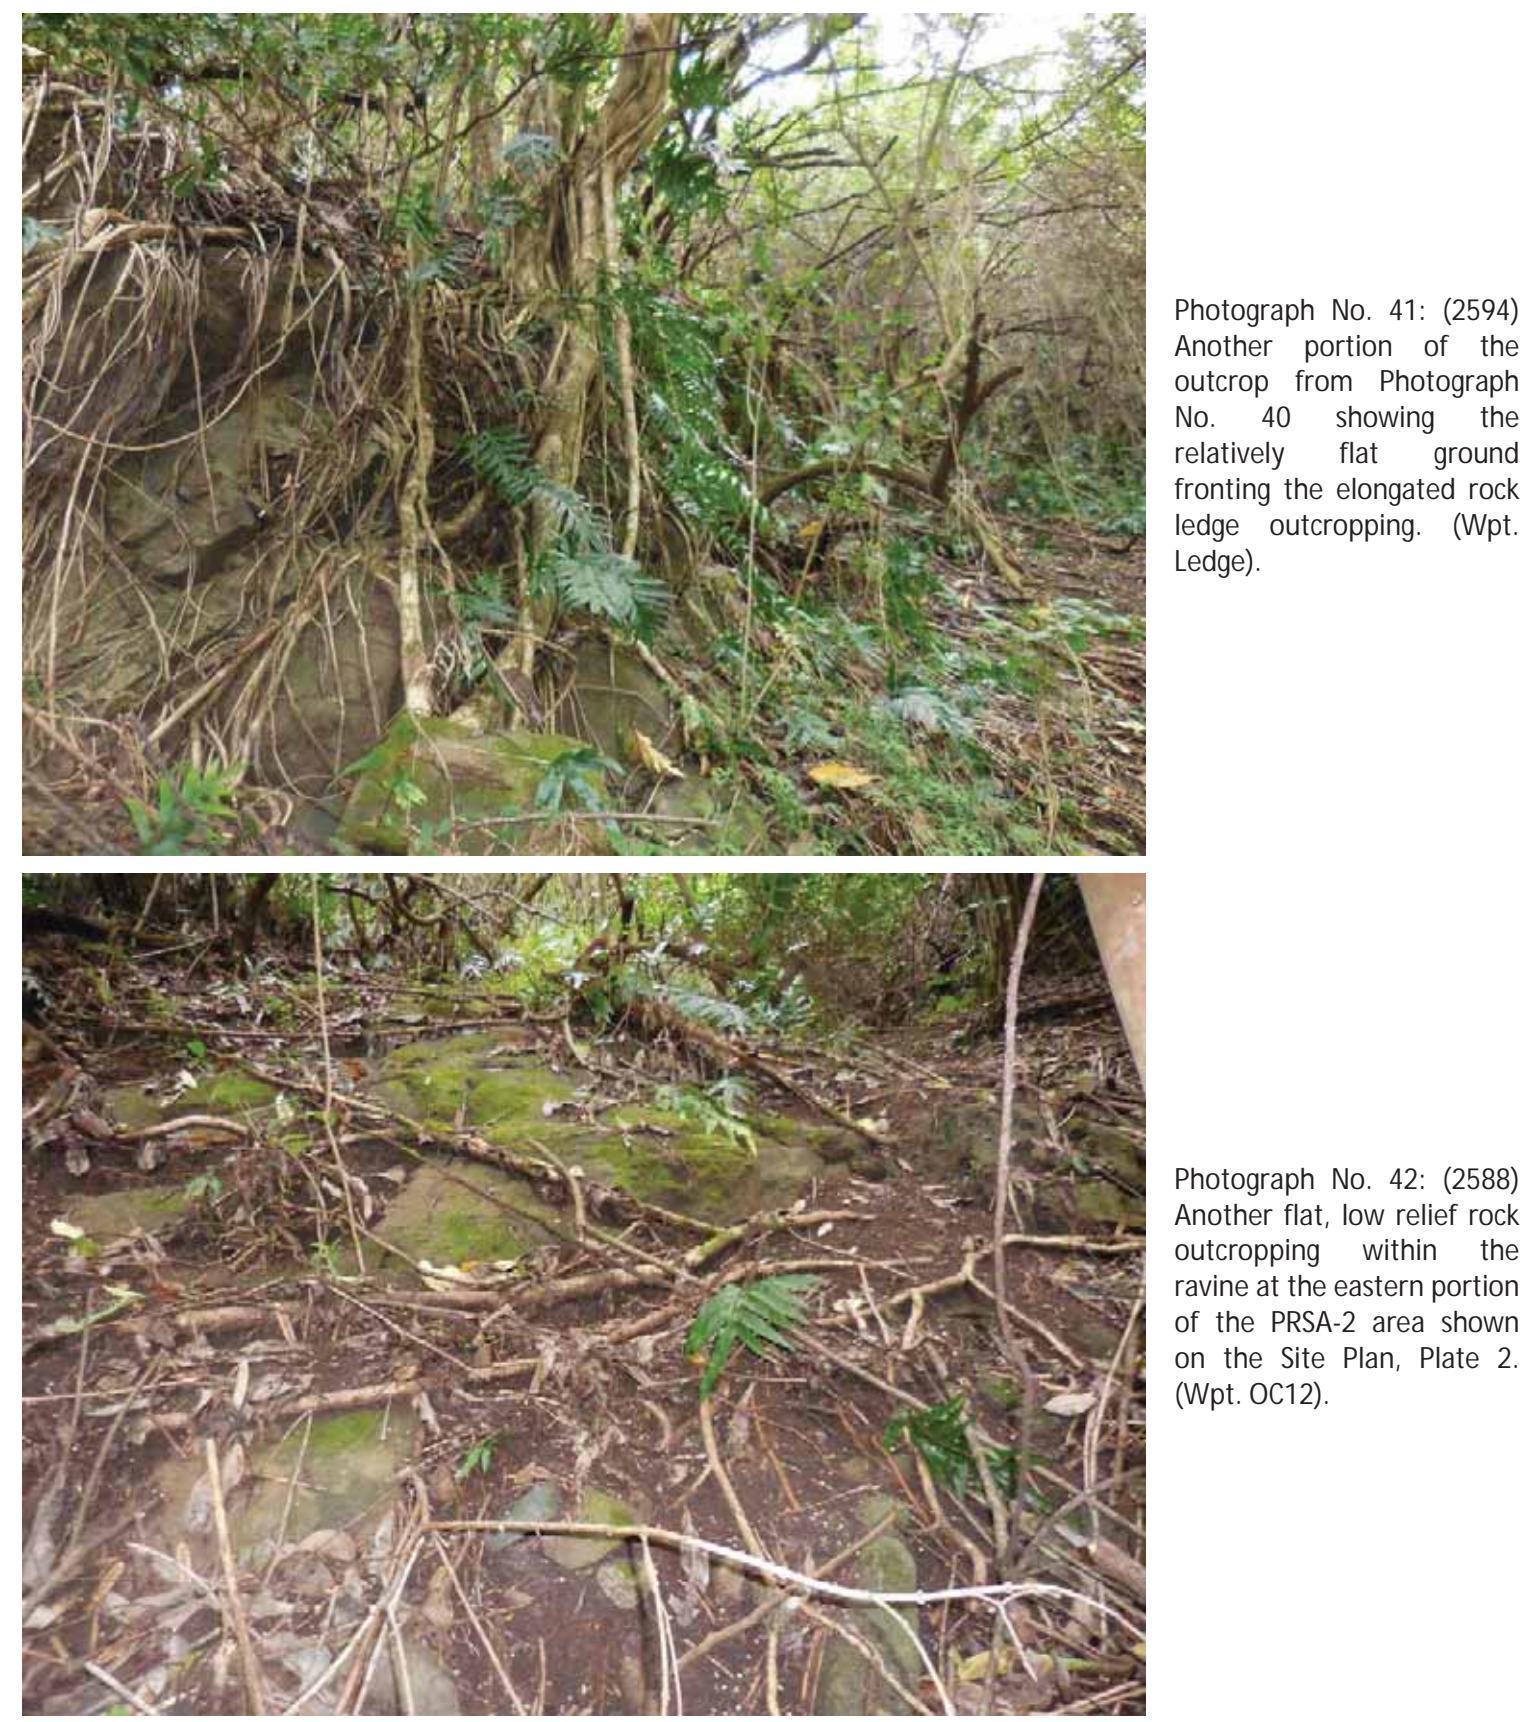
Photograph No. 41: (2594) Another portion of the outcrop from Photograph No. 40 showing the relatively flat ground fronting the elongated rock ledge outcropping. (Wpt. Ledge).

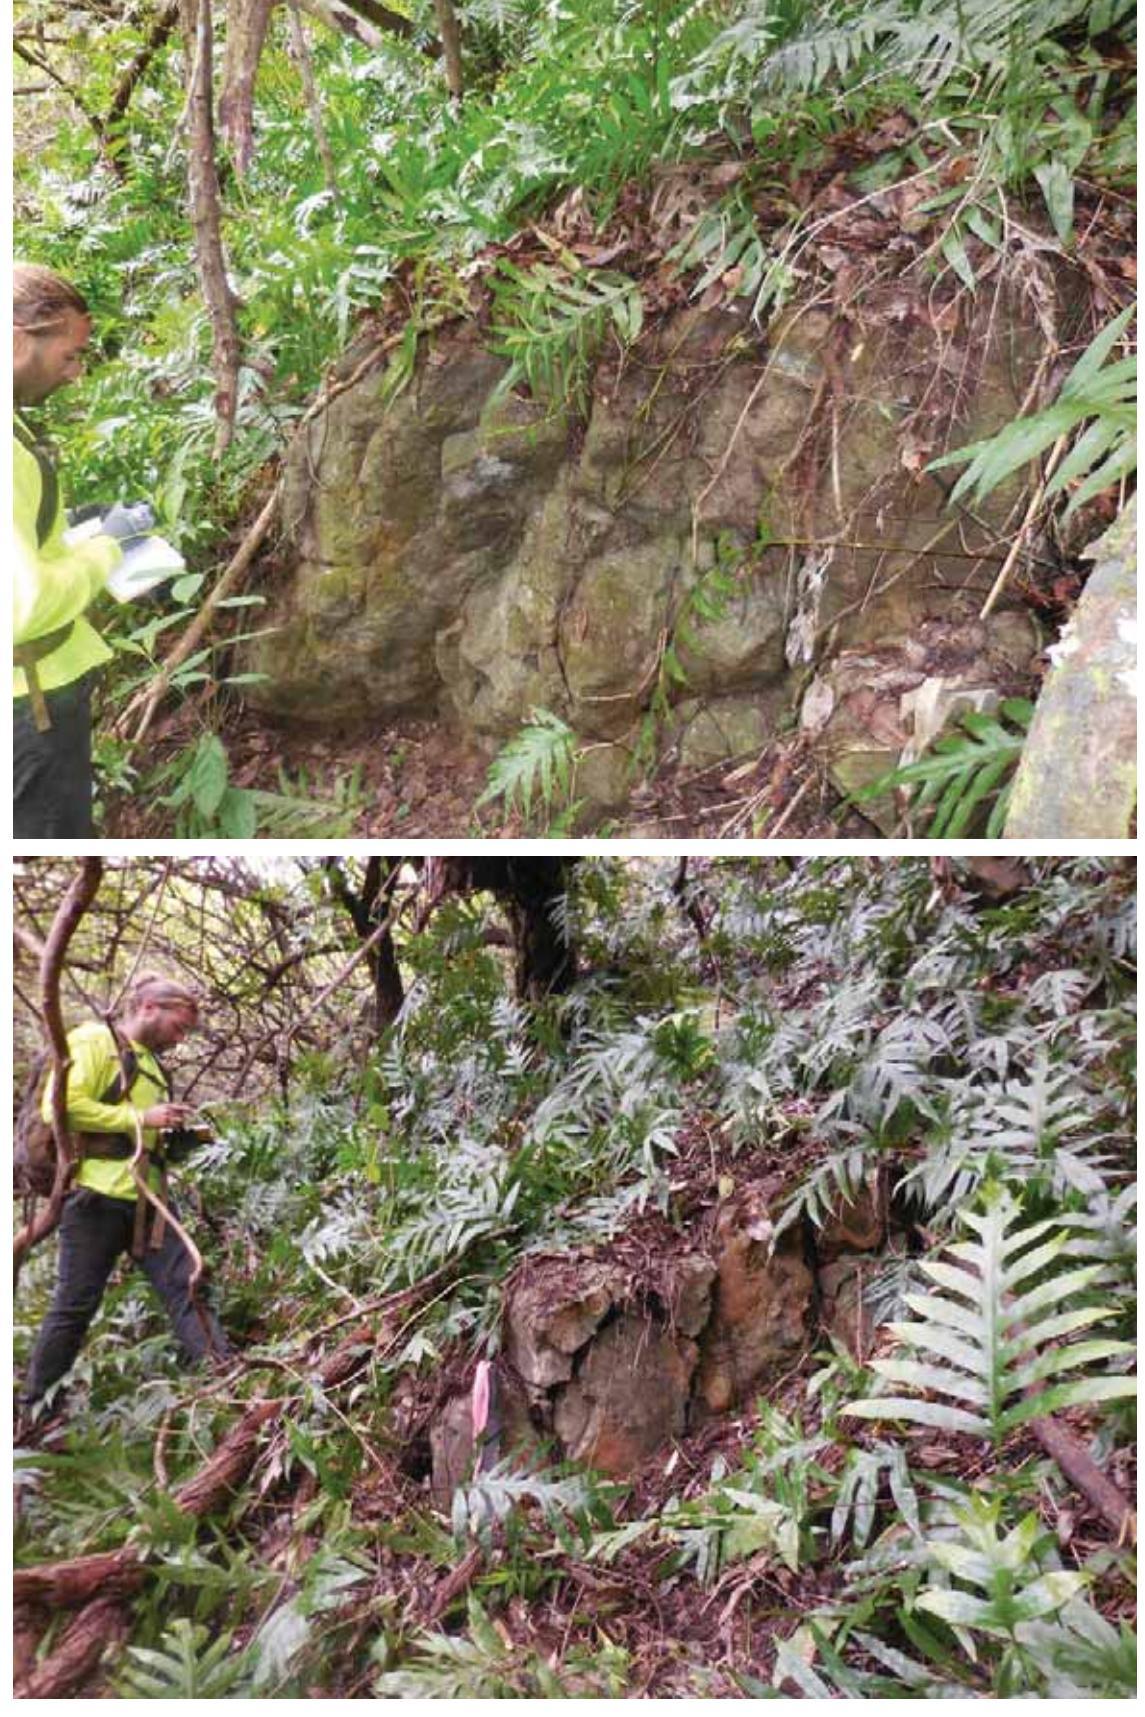
Photograph No. 43: (2587) Fractured and highly weathered rock outcropping at the eastern portion of the PRSA-2 area shown on the Site Plan, Plate 2. (Wpt. OC11).

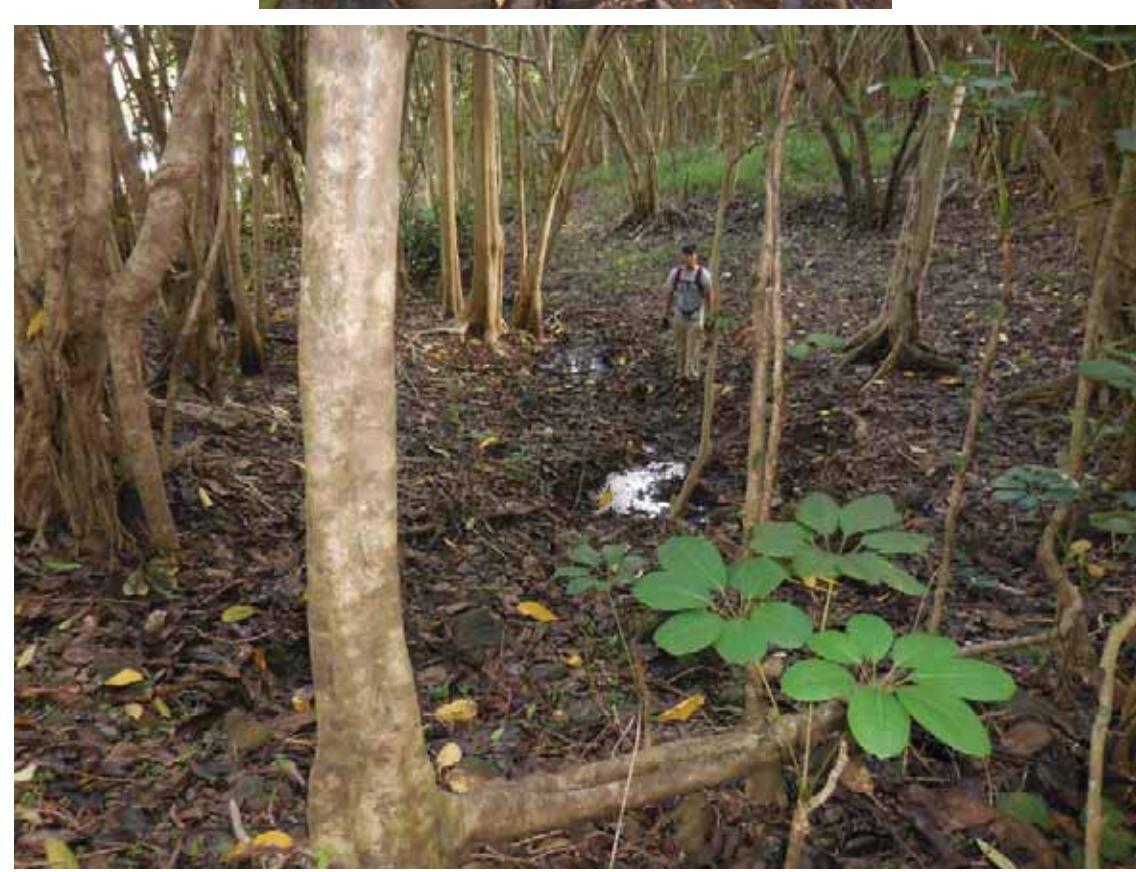
Photograph No. 46: (2383) Stagnant water within a swale located downstream from the groundwater spring well head.

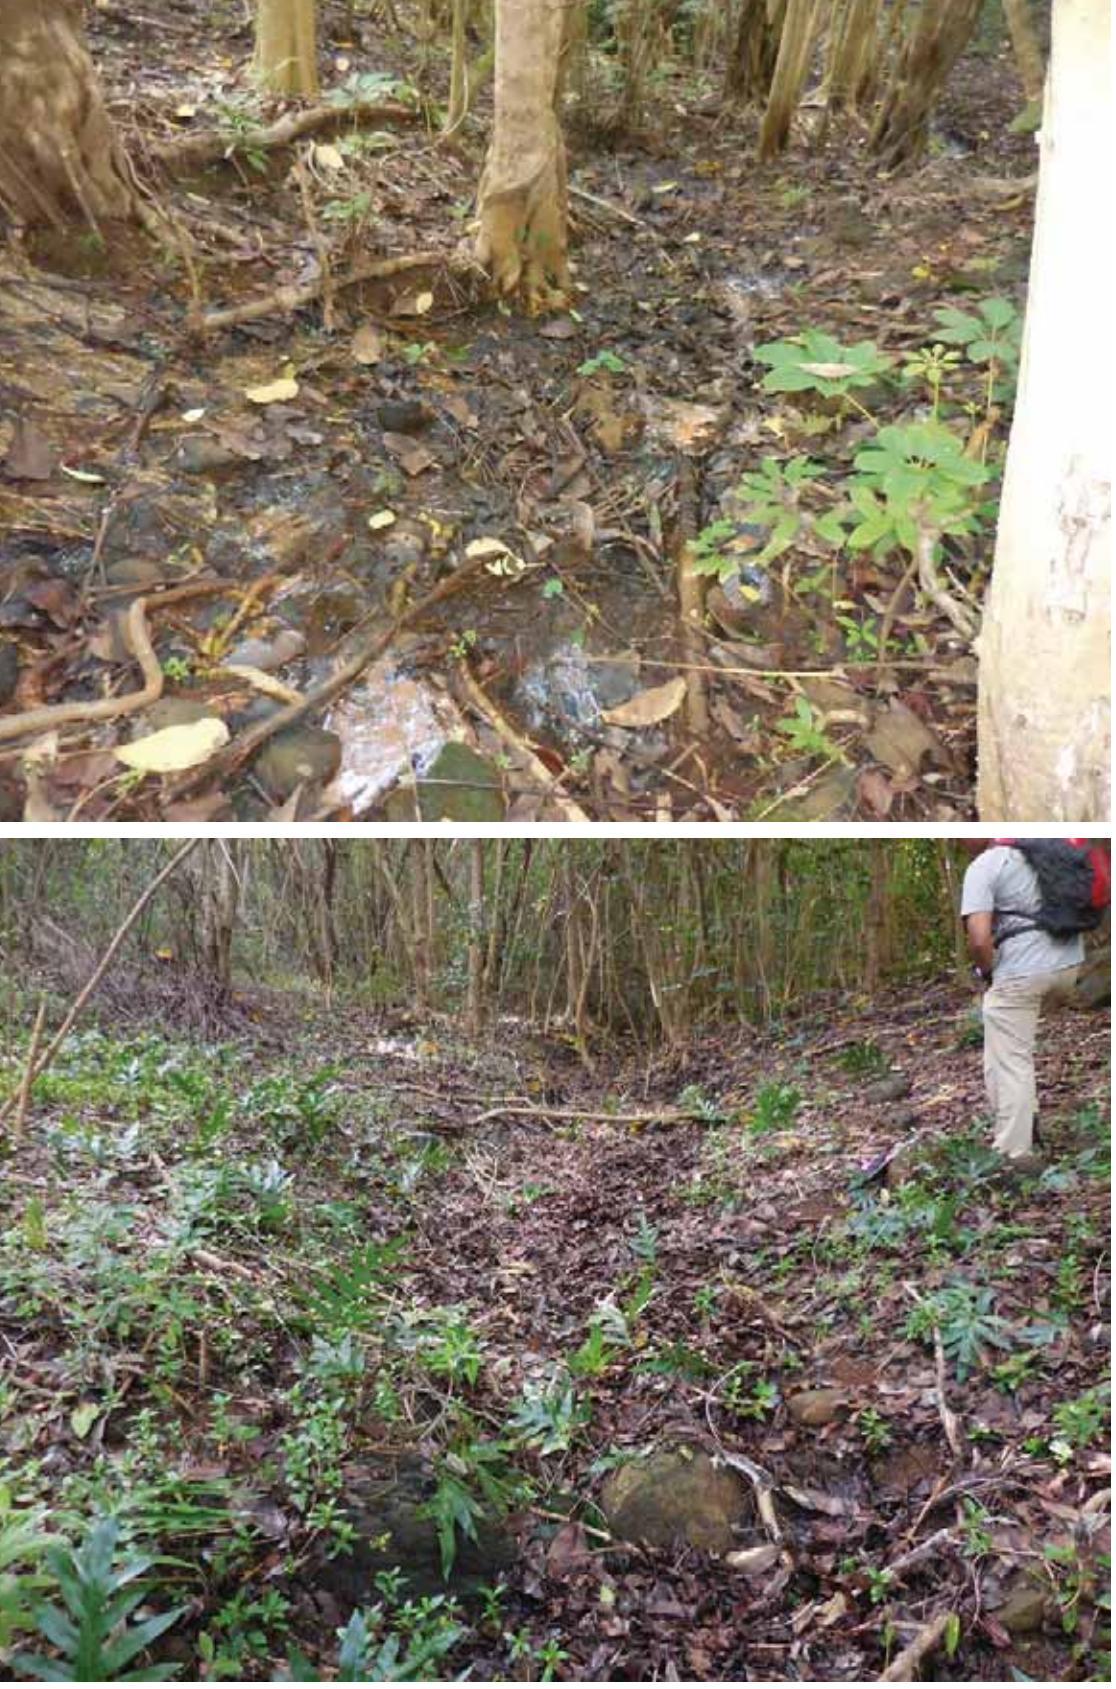
Photograph No. 47: (2382) Other observed groundwater seepage condition in the vicinity of the groundwater spring well head.

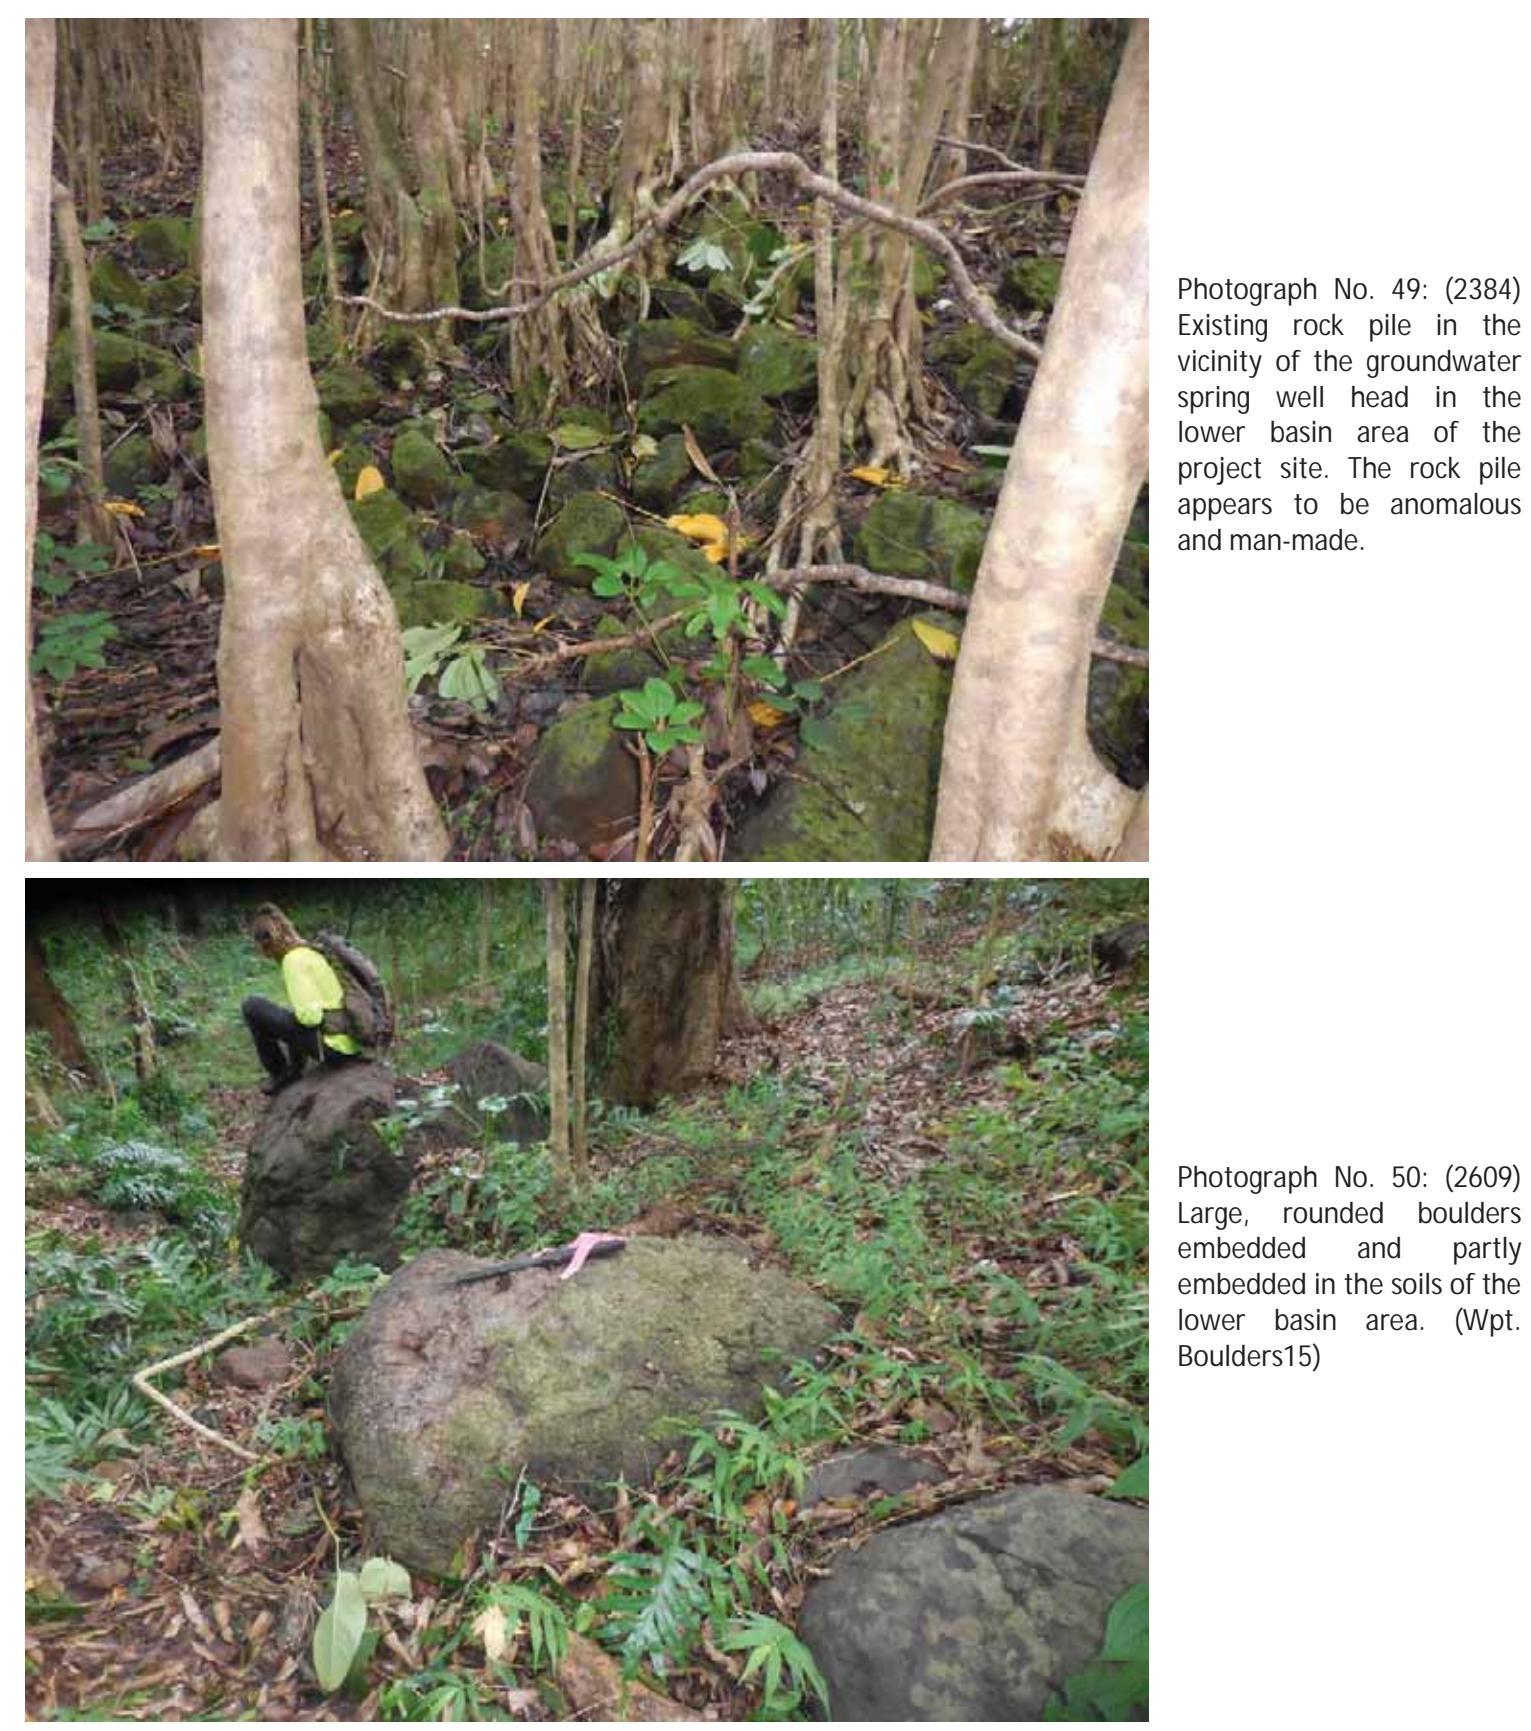
Photograph No. 49: (2384) Existing rock pile in the vicinity of the groundwater spring well head in the lower basin area of the project site. The rock pile appears to be anomalous and man-made.

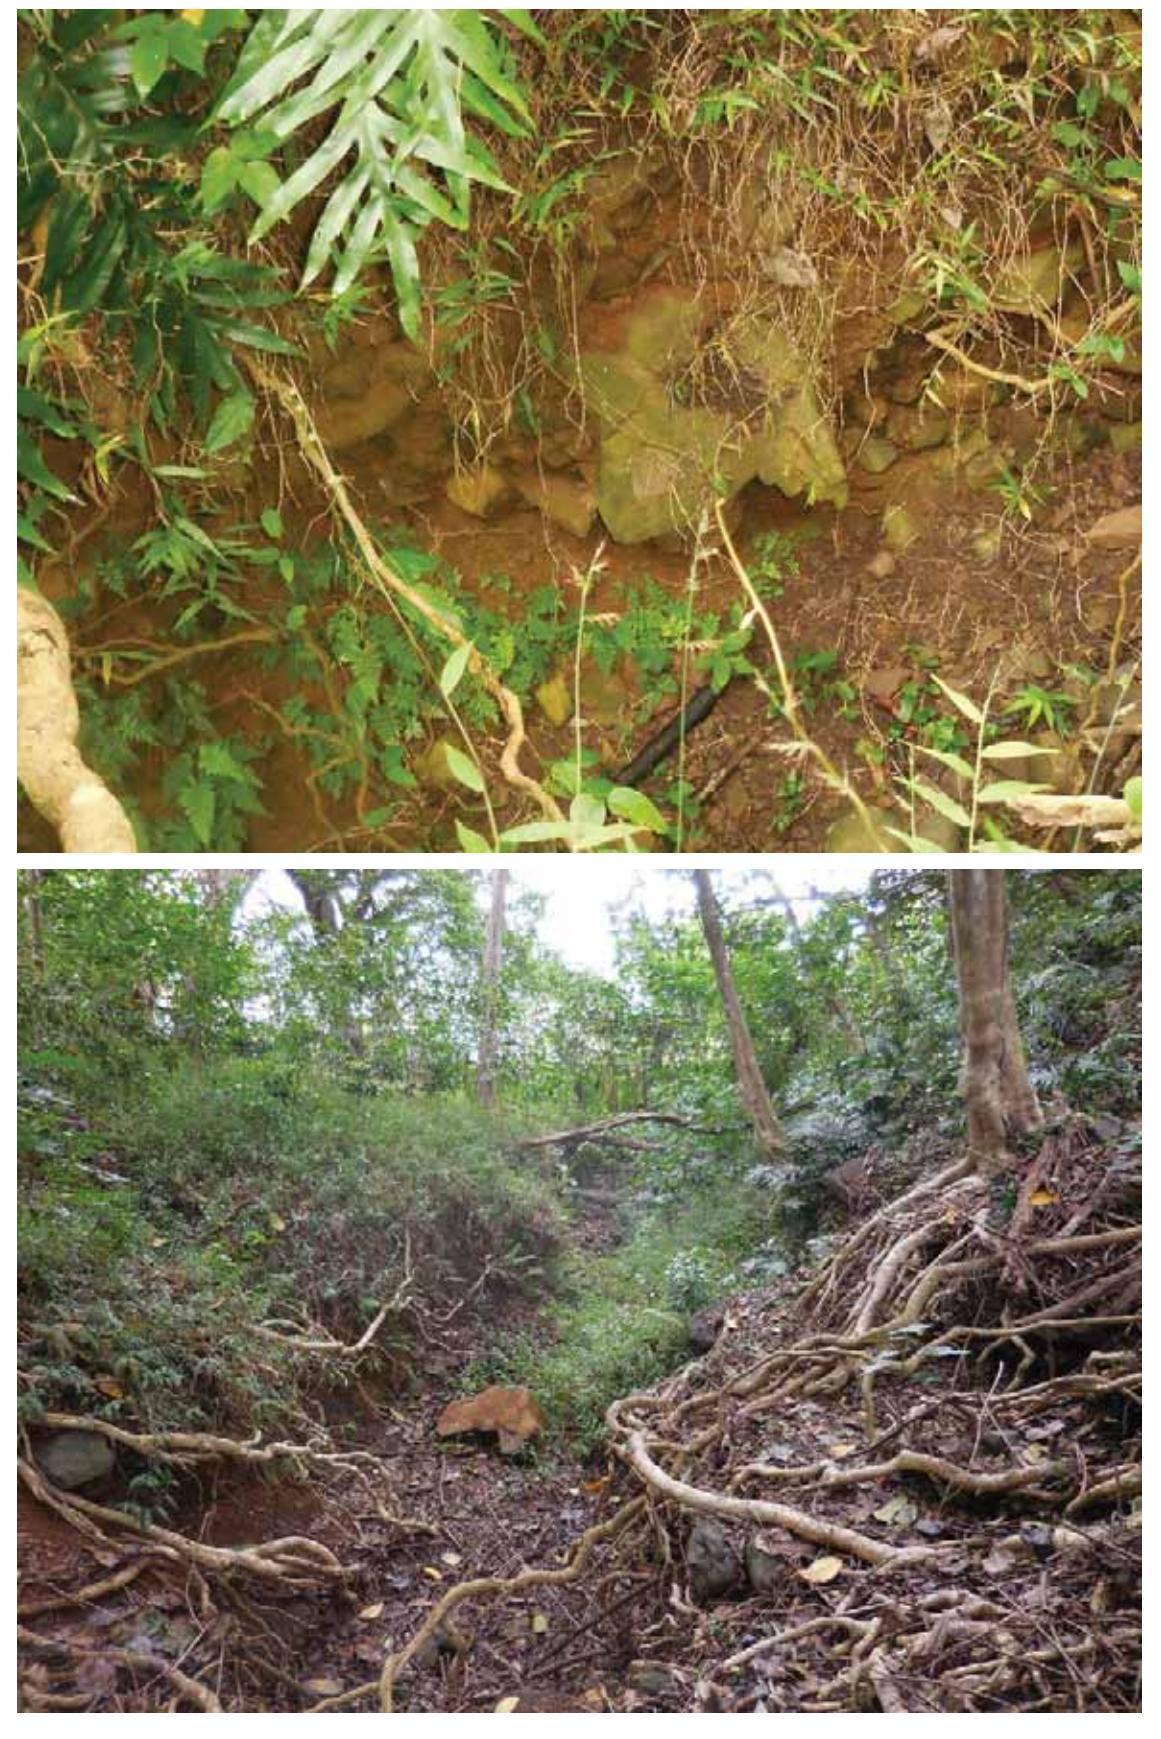
Photograph No. 51: (2612) Existing scoured shallow subsurface exposure showing conditions that appear to represent older alluvial/colluvial soil deposits containing appreciable rock fragments consisting of gravel, cobbles, and boulders. The location is within the lower central basin area. (Wpt. 0161)

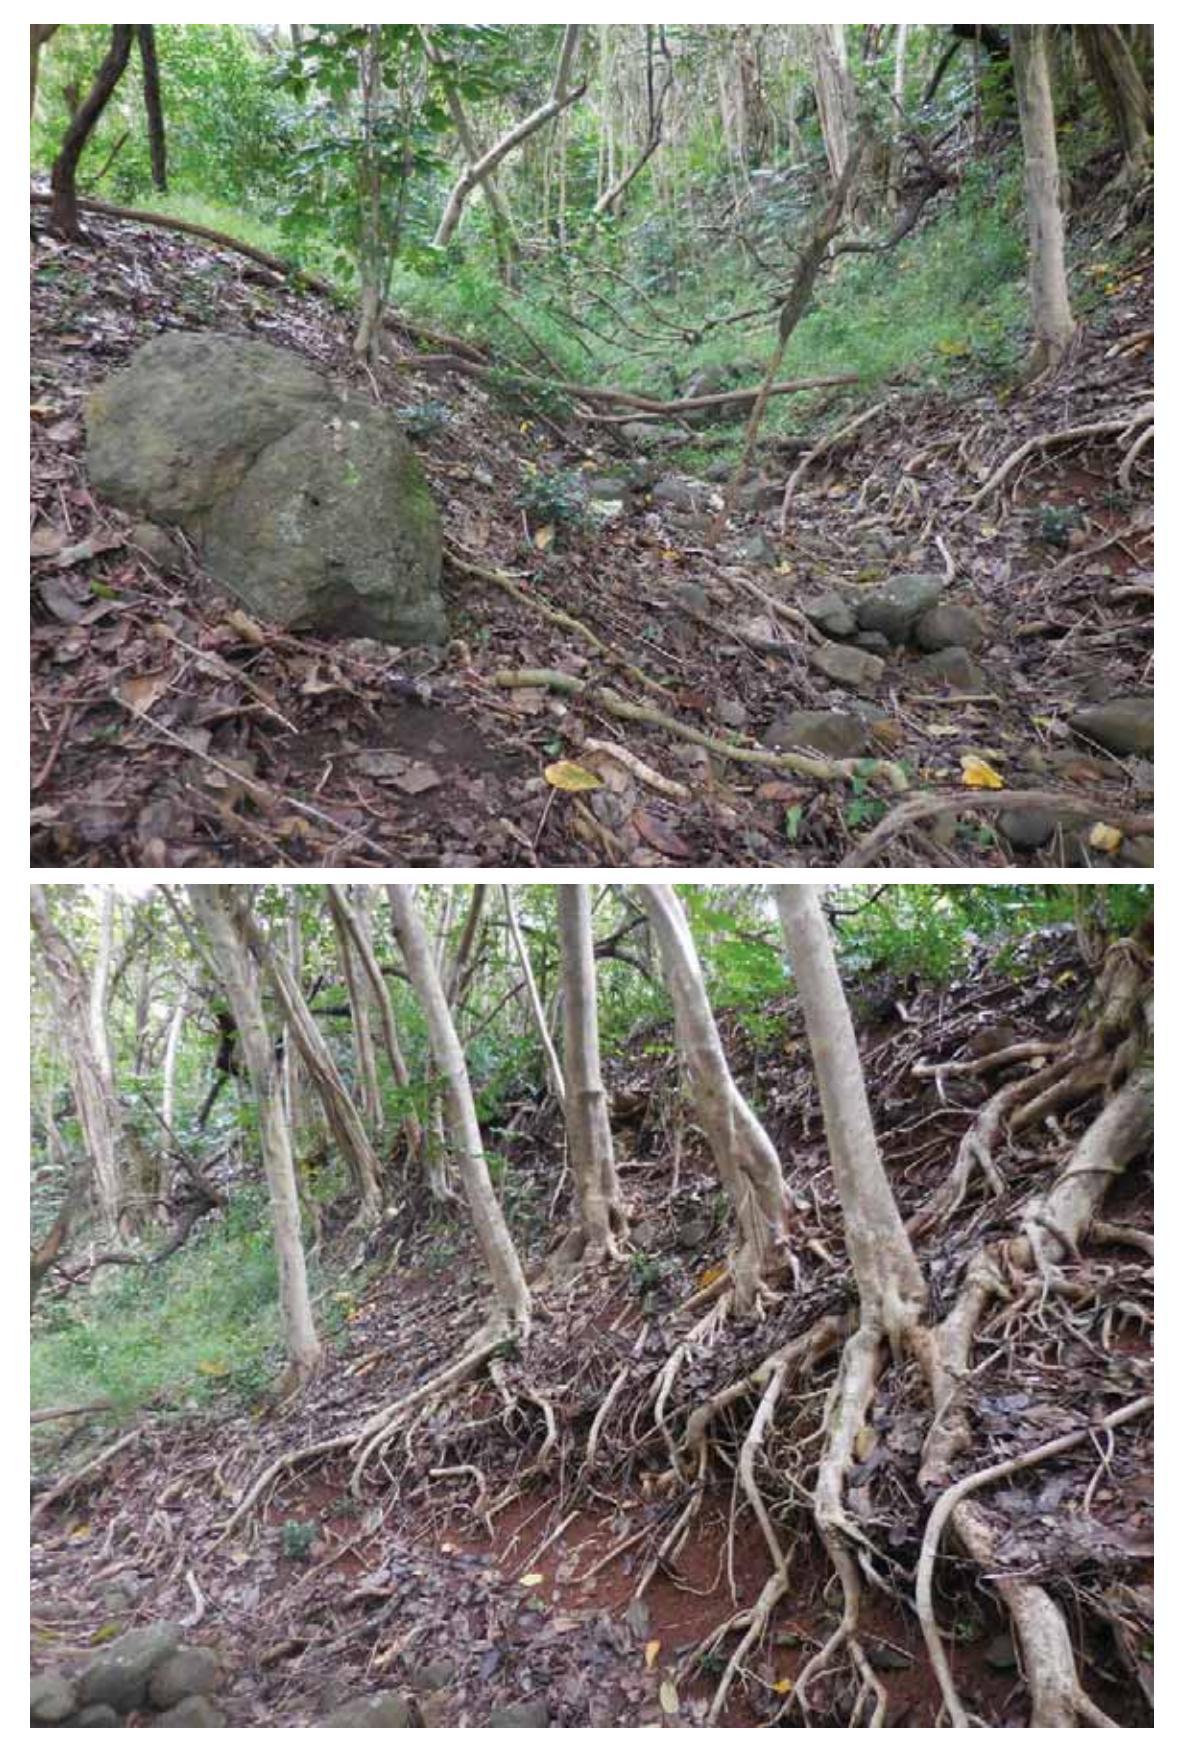
Photograph No. 53: (2614) Another view of the primary basin drainage channel showing various cobbles and boulders within the channel. The deposits are believed to represent rocks scoured from the alluvial and colluvial deposits that comprise portions of the lower basin area.

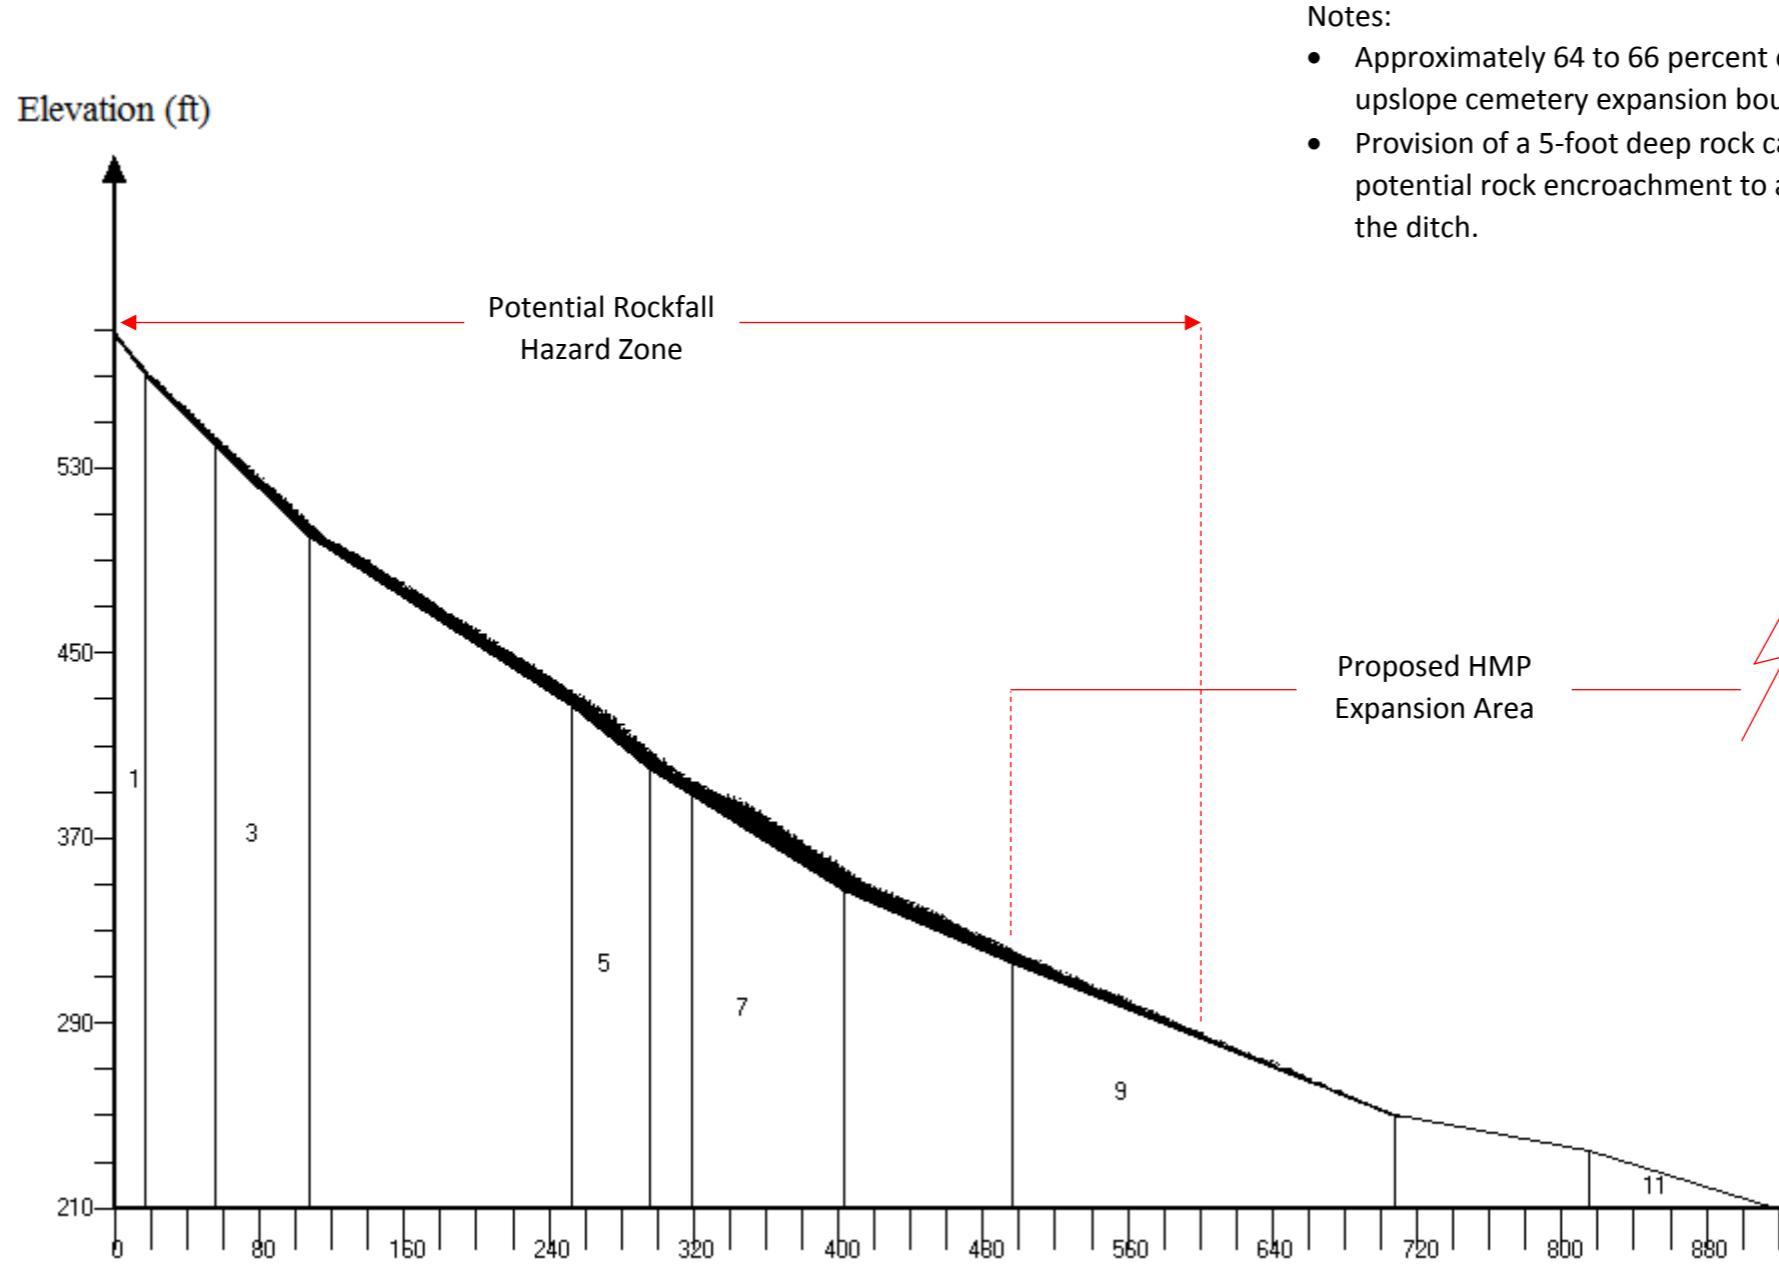
POTENTIAL ROCKFALL SIMULATION - SLOPE PROFILE "A"

boundary with no rockfall mitigation in place.

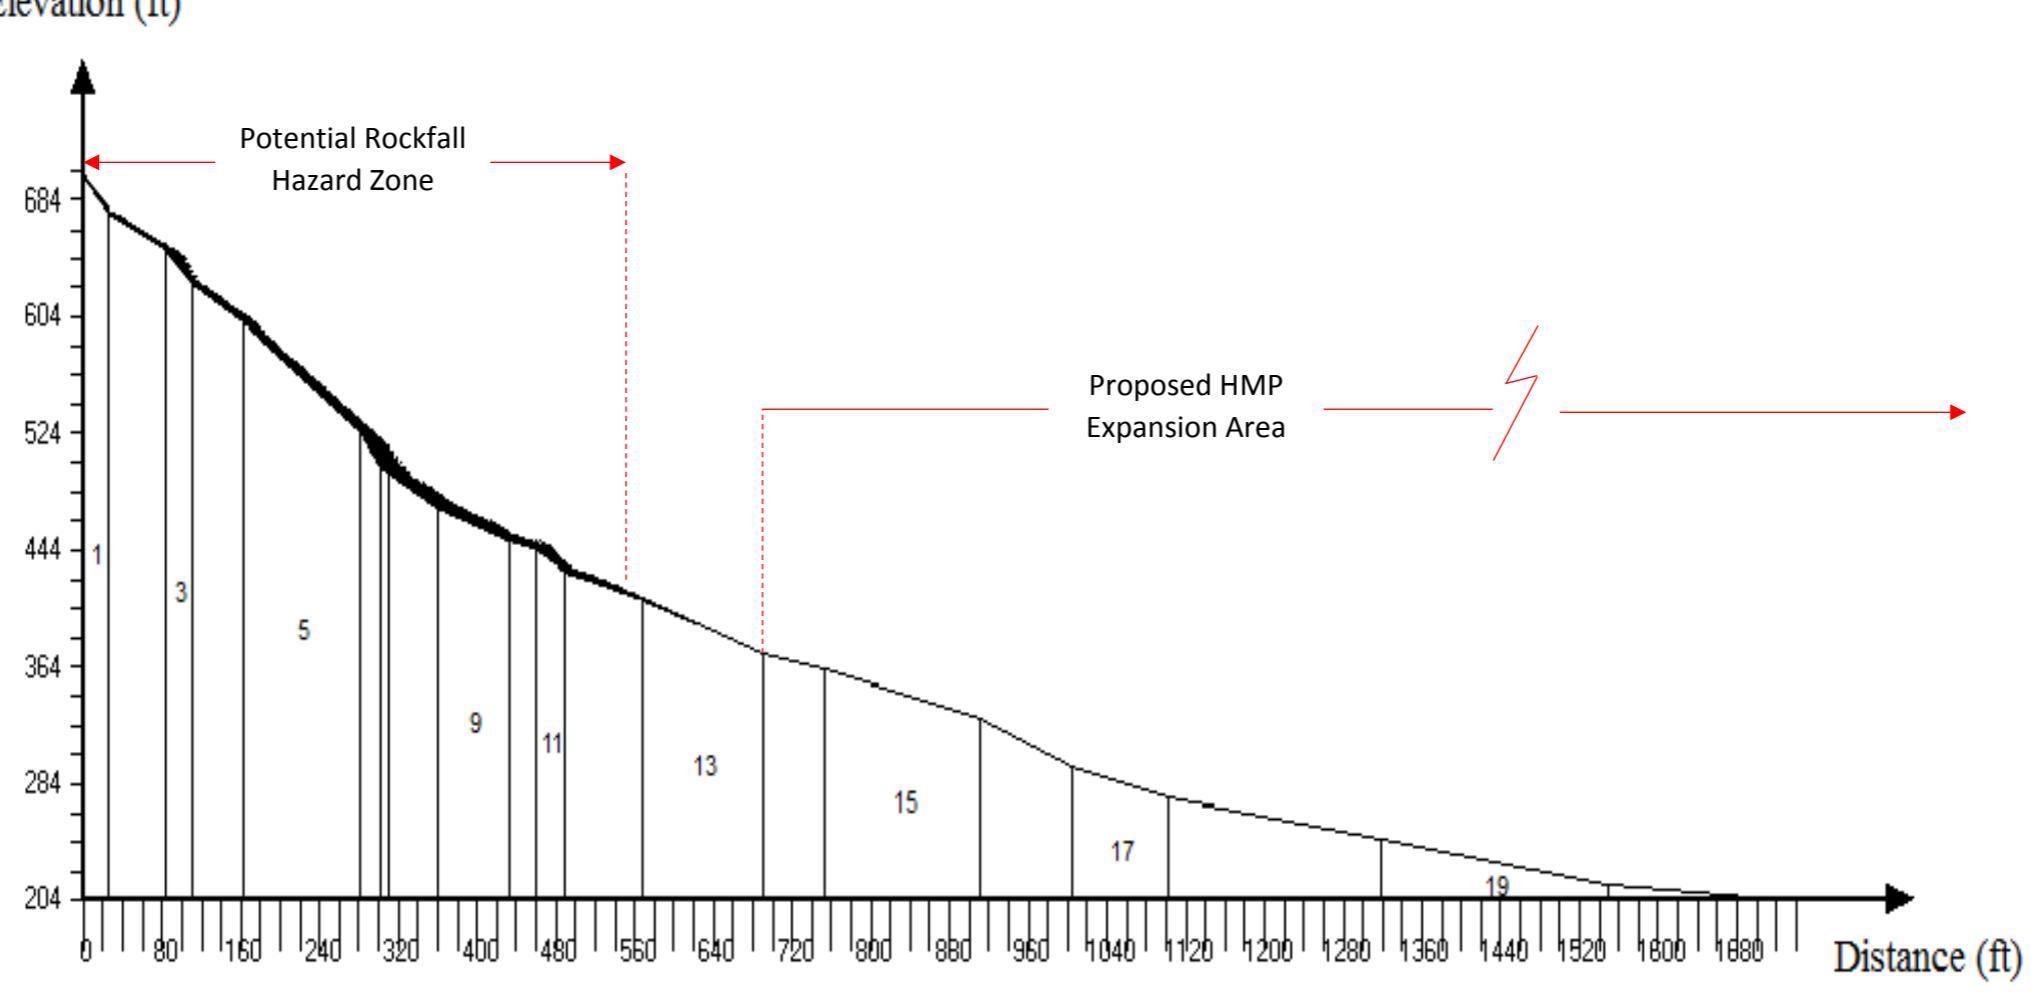
POTENTIAL ROCKFALL SIMULATION - SLOPE PROFILE "B"

boundary with no rockfall mitigation in place.
