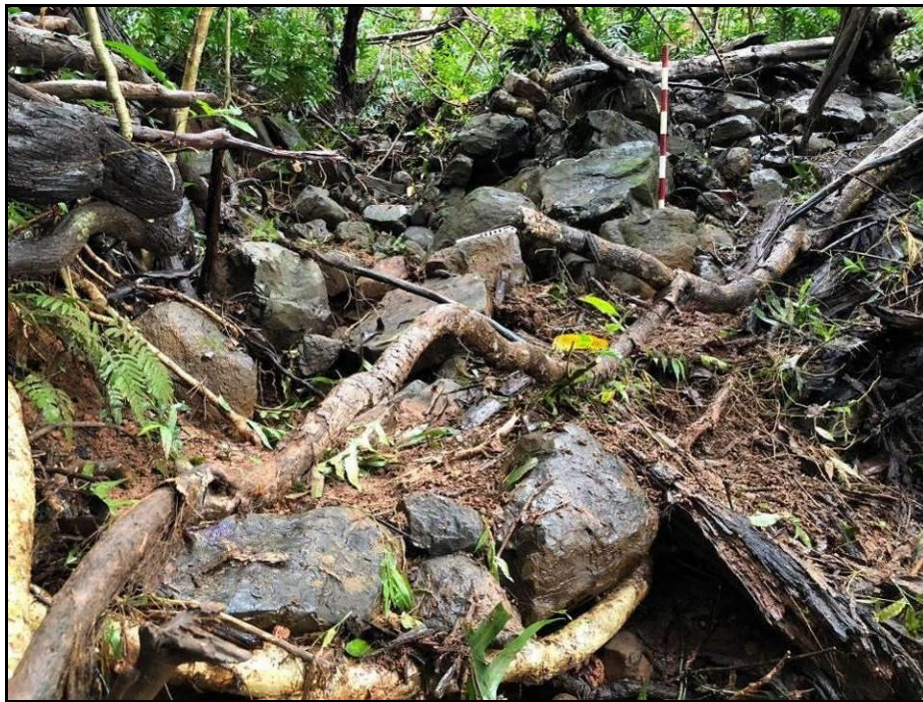
The current investigation found that SIHP # -4680 contains two separate features (A-B) (Figure 128 and Figure 129). Feature A is a historic terrace, approximately 6 m long NW/SE, 4.5 m wide NE/SW, and approximately 115 cm tall, constructed of angular basalt cobbles and

boulders stacked along the top edge of a steeply sloping hillside. The site extends across a steep sided, soil-lined drainage ditch, indicating the purpose of the site was for water control or water retention. The west portion of the feature (Feature A1) is roughly stacked approximately 5 courses high and is in fair condition. A 2-3 course remnant portion of the feature (Feature A2) is observable in the east bank of the ditch and remnants of the foundation of the terrace are observable within the base of the ditch.

Feature B is a small terrace remnant made of basalt boulders and cobbles, measuring approximately 1.5 m long E/W by 40 cm wide N/S and 35 cm tall. Feature B is located approximately 2 m northeast, downslope, of Feature A, within the base of the ditch. Surrounding vegetation includes strawberry guava, octopus tree, Christmas Berry, laua'e fern, and ti.

Figure 128. Photo Showing -4680 Feature A1 in back right, Feature A2 in back left, and Feature B in foreground; view to west

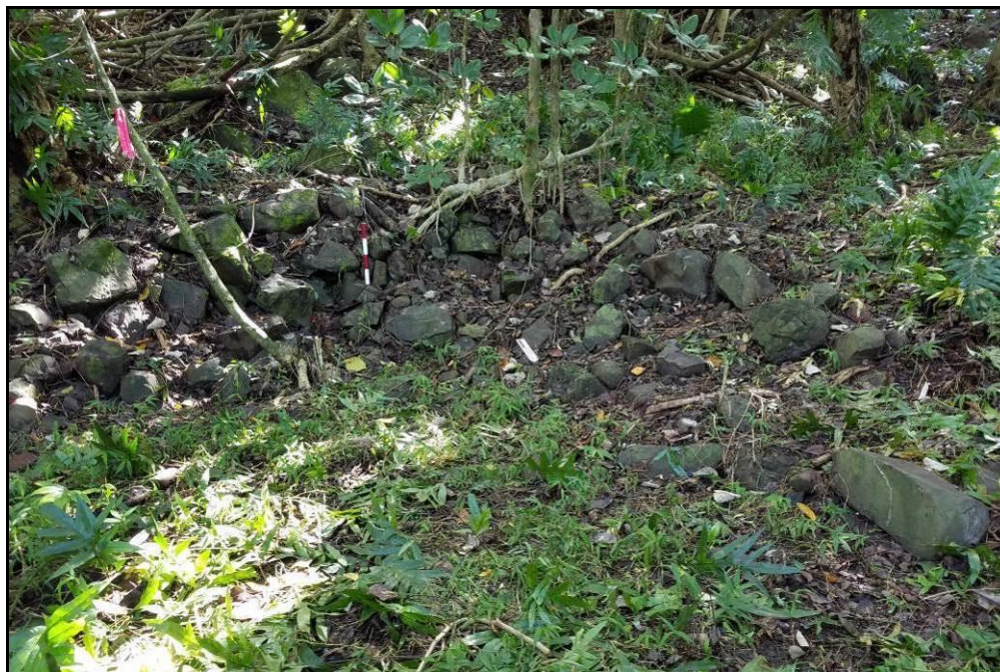
This study found SIHP #50-80-10-4681 to include 8 features (A-H). Feature A is a c-shape structure in fair condition, approximately 5 m N/S by 6 m E/W, constructed of angular basalt cobbles and built into the north-tending hillside (Figure 131). The c-shape is largely constructed by a thick wall, measuring approximately 2.4 m thick along the south side of the feature and a smaller wall, approximately 1.3 m thick, on the west side. The interior, south wall of the structure is approximately 90 cm tall and level with the hillside. Stone paving extends from the top of the south wall onto the relatively level abutting hillside for approximately 1 m. A circular alignment of stones exists within the interior west wall of the structure. The interior ground surface is very level and creates a living space approximately 3 m N/S by 4 m E/W, abutting a large boulder on the north side (Figure 132). To the west side of Feature A is a moderately sloped hillside with an alignment of natural basalt boulders running NE/SW, creating the natural terrace face on which the c-shape is situated. Feature A is downslope (to the NE) of Feature F (ceremonial boulders and terraces), just west of Feature B (circular alignment and terraces), and upslope of Features C-E and G-H (C-D, G-H: terraces, E: c-shape).

Figure 131. Photo showing SIHP # -4681, Feature A (c-shape), view to south

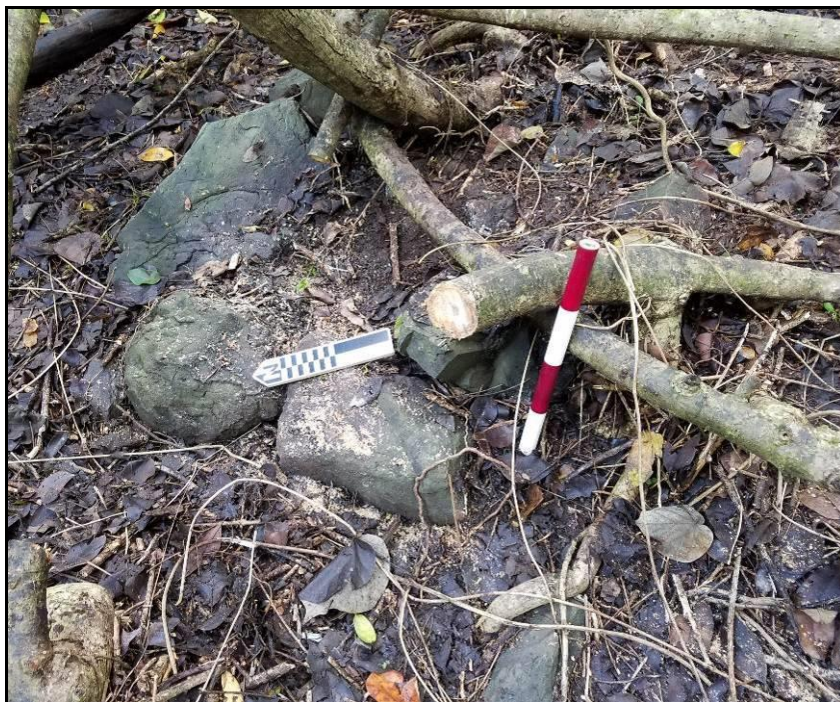
Feature B was found to consist of three sub-features (1-3). Feature B1 is an approximately 1.35 m diameter, 20 cm tall ring of basalt cobbles previously documented as a potential hearth by McCurdy and Hammatt (2009) (Figure 133). The interpretation of Feature B1 as a hearth is plausible. Feature B2 is an approximately 3.5 m N/S by 2.5 m E/W low (20-40 cm tall), irregularly-shaped terrace lined with basalt boulders and cobbles situated just east of Feature B1. Feature B3 is a terrace remnant, approximately 3 m long NE/SW and a maximum of 30 cm tall, composed of basalt cobbles to small boulders and built on the naturally sloping hillside. Feature B3 extends between Feature A (c-shape) and B1.

Figure 133. Photo showing SIHP # -4681, Feature B1 (circular alignment), view to east

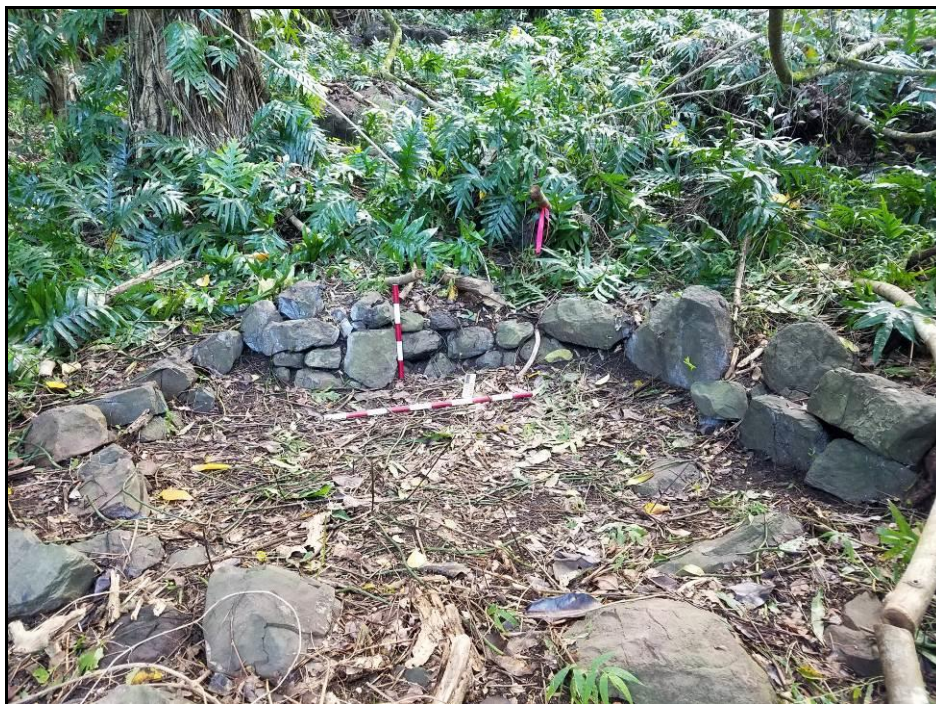
Feature E is a c-shape structure, approximately 2.5 N/S by 3.5 E/W, in good condition (Figure 135). The south, southeast, and southwest sides are built into the hillside and stacked 2-3 courses high, ranging from 16-43 cm tall. The west side is made of a large flat-faced boulder as well as stones stacked 1-2 courses high. The north side is open and level with the rest of the interior of the structure. The interior creates an approximately 2 m N/S by 2.2 m E/W living space. To the north of Feature E is a natural terrace and the topography slopes downward to the north. Thick hau bushes exist to the north and east, laua‘e fern is growing to the south and west.

Figure 135. Photo showing SIHP # -4681, Feature E (c-shape), view to south

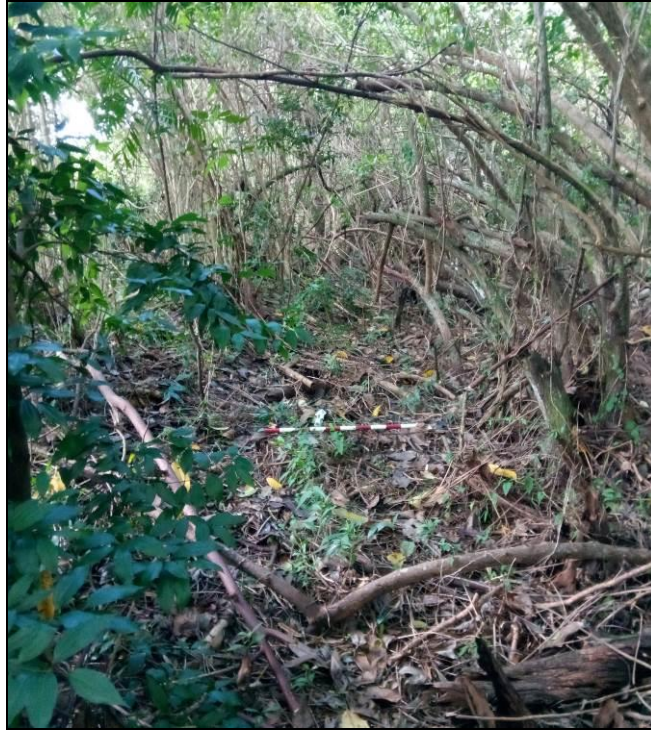
Road 1 and Road 2 were found extending from the west project area boundary, parallel to each other. Road 1 extends for approximately 30 m (98 ft.) and has an interior dimension of 2.15 m wide E/W with a 1.3 m thick, 80 cm tall berm on the inland (mauka) or east side and a 1.4 m wide, 35 cm tall berm on the west side (Figure 143). A steep slope descends westward towards Road 2.

Figure 143. Photo Showing SIHP # -8228, Historic Dairy Road 1, view to north

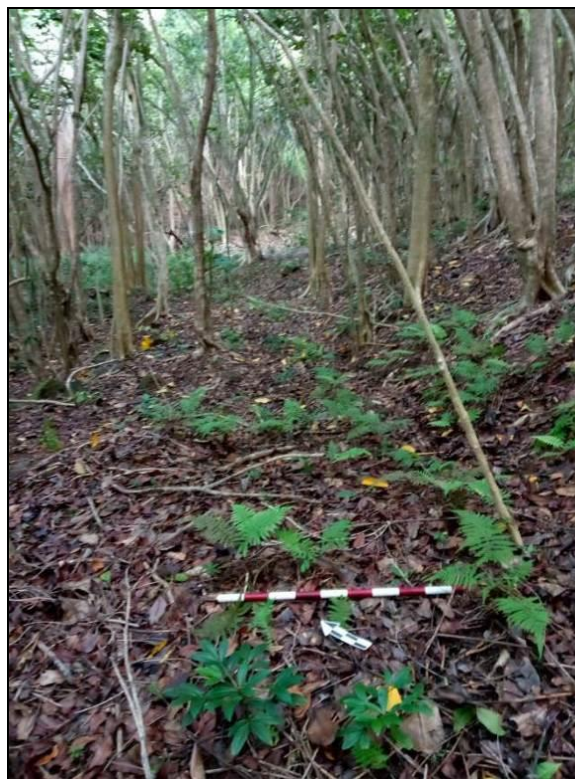
Road 3 extends from Road 2A and runs through SIHP # -8230 (Honua 3), a historic 'auwai. Road 3 is approximately 23 m (75 ft.) long, 2 m wide, and is in poor condition (Figure 146). Road 3 runs along the east side of SIHP # -8230 and then crosses over a section of SIHP # -8230, after which it becomes unobservable.

Figure 146. Photo showing SIHP # -8228, Historic Dairy Road 3 from near SIHP # -8230 (historic 'auwai), view to northeast

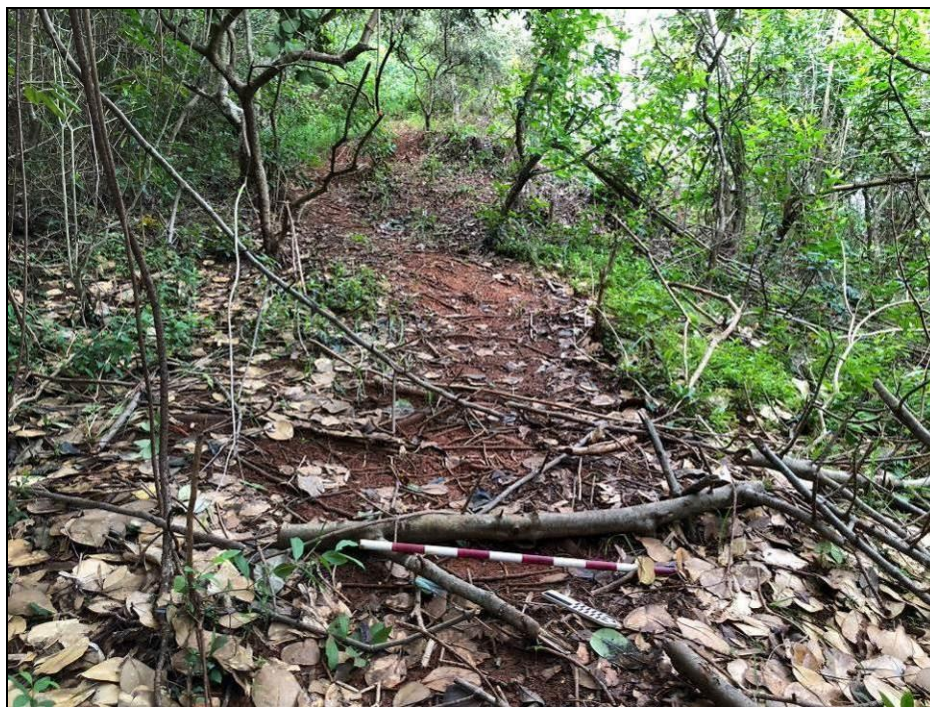
SIHP #50-80-10-8229 is a short segment of an old dirt roadway. The road segment is 3 m (9.8 ft.) wide and runs roughly north-south for approximately 10 m (33 ft.) (Figure 147, refer to Figure 24). The road is relatively level with a steep slope downward adjacent to the east side. The ends of the roadway have been removed, likely bulldozed, leaving only this short segment. The road is surrounded by grasses, fern, ginger, octopus trees, orchids, and medium-sized Albizia trees.

Figure 147. Photo showing **SIHP # -8229** (historic road segment), view to southwest

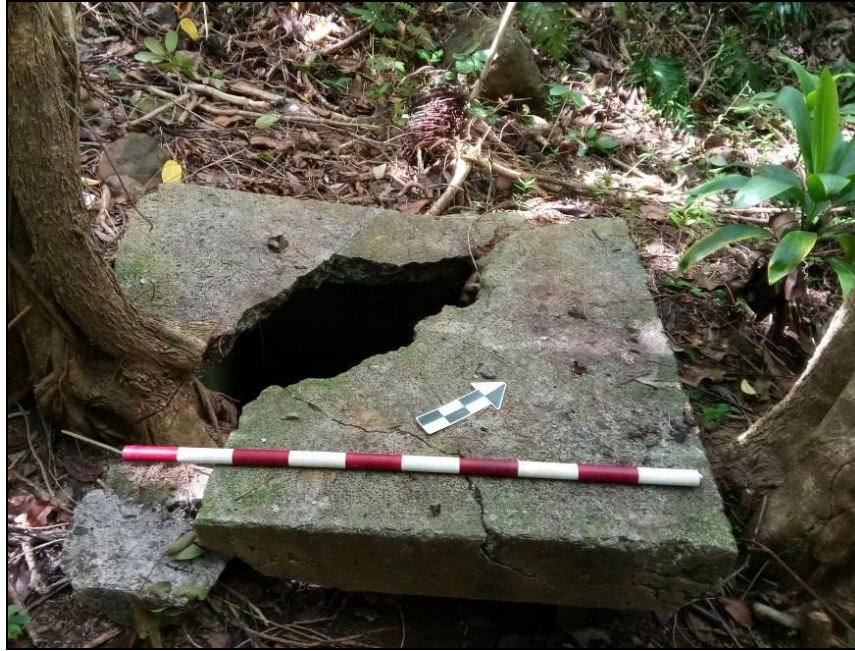
The **SIHP # -8230**, Feature A ‘auwai includes multiple sub-features (Features A1-A6). Feature A1 consists of a concrete capped spring, approximately 1.25 m N/S by 1.25 m E/W, square in shape with a square concrete lid that is broken into two pieces and stands approximately 40 cm above the ground surface (Figure 151). From the top of the concrete cap to the natural spring water below is approximately 60 cm. A spool of rusty barb wire is located just upslope from the feature. The spring water of Feature A1 feed the ‘auwai system which extends downslope from it, supporting taro (*Colocasia esculenta*) saplings, ti plants, and providing an identified native damselfly (*Megalagrion* sp.) habitat. Surrounding vegetation consists mainly of octopus trees.

Figure 151. Photo showing SIHP # -8230, Feature A1 (concrete-capped spring), view northwest

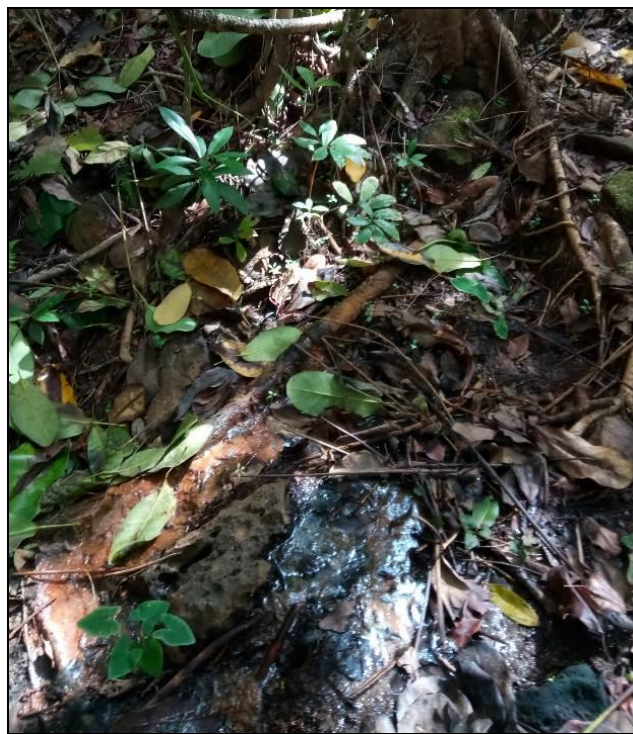
Downslope from the concrete cap (Feature A1) is a small, 2 m N/S by 1 m E/W by 25 cm tall, terrace (Feature A2) formed of basalt cobbles that retains the spring water, creating a small marshy area (Figure 152). Ti trees and a taro variety grow in this area. On the west side of the ‘auwai is an informal, very wet, level soil terrace (Feature A3), approximately 1.5 m long NW/SE, which also supports a taro variety. The ‘auwai continues downslope, keeping a maximum width of approximately 1 m (Figure 153). The naturally seeping stream waters within the ‘auwai have been tapped by an old, corroded metal pipe (Feature A4) (Figure 154). The

corrosion has created an orange, foamy scum in the water surrounding the metal pipe. At a naturally level area of the hillside, the ‘auwai branches southward creating a small, very wet, marshy ditch leading to a relatively circular pool of water (Feature A5) (Figure 155). This pool of water was likely a historic water source for grazing dairy cattle. Currently, orange, foamy scum from an unobserved metal pipe floats atop the pool of water. The ‘auwai continues downslope where it crosses over an old dairy road (SIHP # -8228, Road 3). At this location (Feature A6) the ground is very wet, there is a concentration of basalt cobbles on the downslope side, likely to provide support for the historic roadway (Figure 156). Several taro plants and a grove of shampoo ginger (‘auwapui, *Zingiber zerumbet*) is growing in this area. On the west side of the ‘auwai, atop the old roadway, are piles of manufactured wood, a telephone pole, and ribbed metal pipes (Figure 157). A relatively short, flat area extends past the piles of rubbish, suggesting the old roadway likely continued at one time, prior to residential development of the adjacent parcel. Near the base of the hillside, the ‘auwai widens under modern brush piles, likely dumped by nearby residential homeowners. The ‘auwai and a separate soil-lined drainage ditch converge and empty into a concrete drainage basin (Figure 158). Narrow concrete drainage ditches from surrounding hillsides also connect to the NE and NW sides of the concrete drainage basin. The drainage basin abuts a residential property.

Figure 154. Photo showing **SIHP # -8230**, Feature A4 (old corroded pipe), view to south

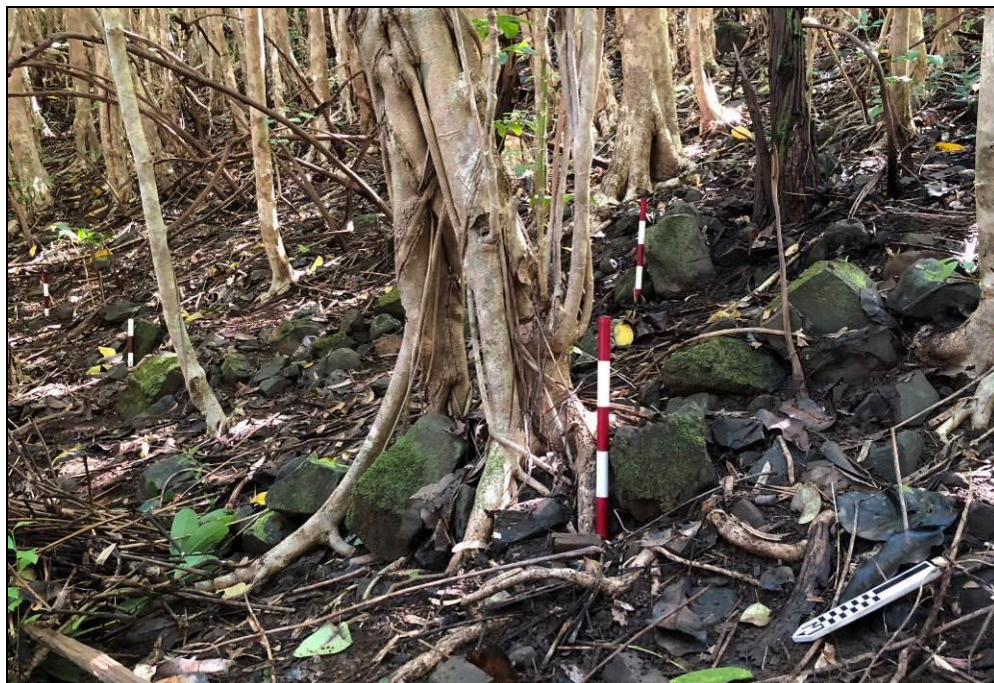
Feature C includes two low stone terraces (Features C1 and C2) in fair condition (Figure 163). Feature C1 is a short segment running northeast/southwest and approximately 2.7 m N/S by 1.2 m E/W by 63 cm tall. Feature C2 is an s-shaped terrace, running parallel to Feature C1 then tending roughly east/west. Feature C2 is approximately 5.5 m N/S by 6 m E/W and ranging from 30-42 cm tall.

Figure 163. Photo showing SIHP # -8232, Feature C1 (terrace, foreground) and Feature C2 (terrace, background), view to east

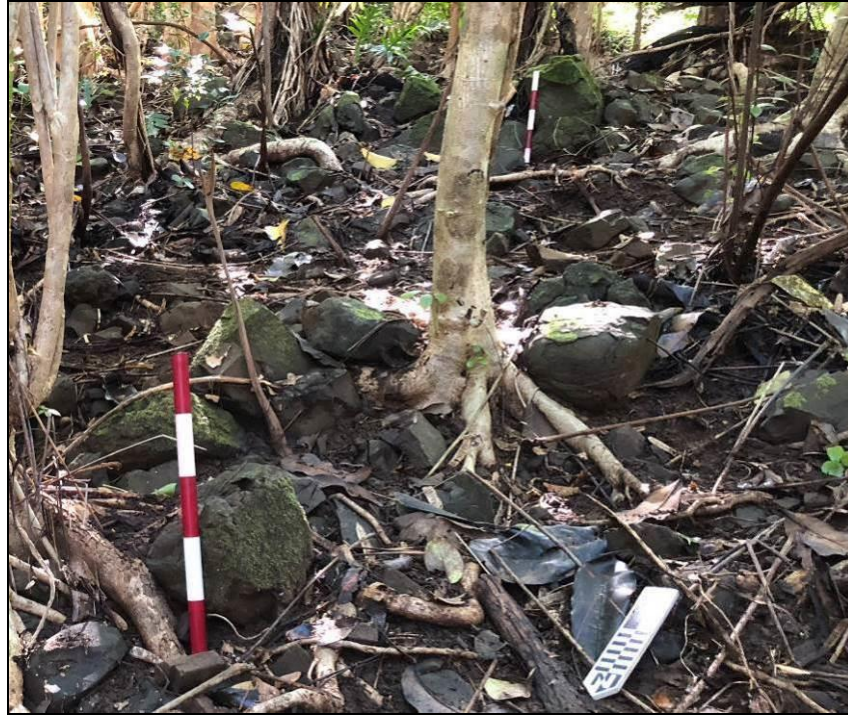
Feature D includes three low stone terraces (Featured D1, D2 and D3). Feature D1 consists of an approximately 4 m N/S by 4 m E/W convex-shaped terrace in relatively good condition, ranging from 27-56 cm tall, and a 6 m long arm in very remnant condition running east/west and ending at a ti plant (Figure 164). The convex-shaped terrace is the best preserved and most apparent feature of the entire site. Feature D2 is a terrace remnant with scattered basalt cobbles, approximately 4.8 m N/S by 0.7 m E/W by 30 cm tall (Figure 165). Feature D3 is a short terrace

in fair condition and measures approximately 2.6 m N/S by 0.5 m E/W and approximately 45 cm tall.

Figure 165. Photo showing **SIHP # -8232**, Feature D2 (terrace remnant, foreground) and Feature D3 (terrace remnant, background), view to southwest

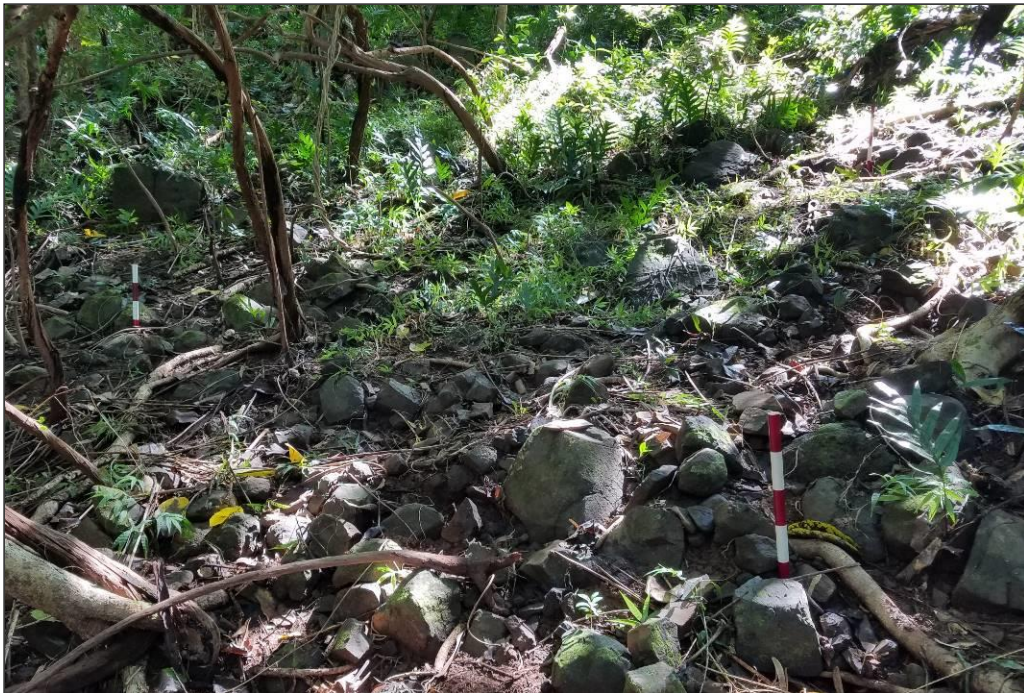
Feature E includes three terrace remnants (Features E1-E3) (Figure 166). Feature E1 is a small terrace remnant, approximately 2.6 m N/S by 30 cm E/W and 30 cm tall. Feature E2 abuts the east side of the ‘auwai and is covered in thick ferns and vines. A N/S portion of Feature E2 appears to be composed mostly of natural basalt cobbles and boulders. An E/W arm of Feature E2 contains aligned basalt cobbles approximately 2.5 m in length E/W by 30 cm wide N/S and 18 cm tall. Feature E3 appears to be a natural terrace within the ‘auwai, composed of basalt cobbles and boulders in an approximate 5.5 m N/S by 0.5 m E/W alignment, approximately 33 cm tall. It is possible Feature E3 was a constructed terrace at one time, however, it is in too remnant of condition to currently be certain.

Figure 166. Photo showing **SIHP # -8232**, Feature E1 (terrace remnant, left background), Feature E2 (terrace, right background), and Feature E3 (natural terrace, foreground), view south

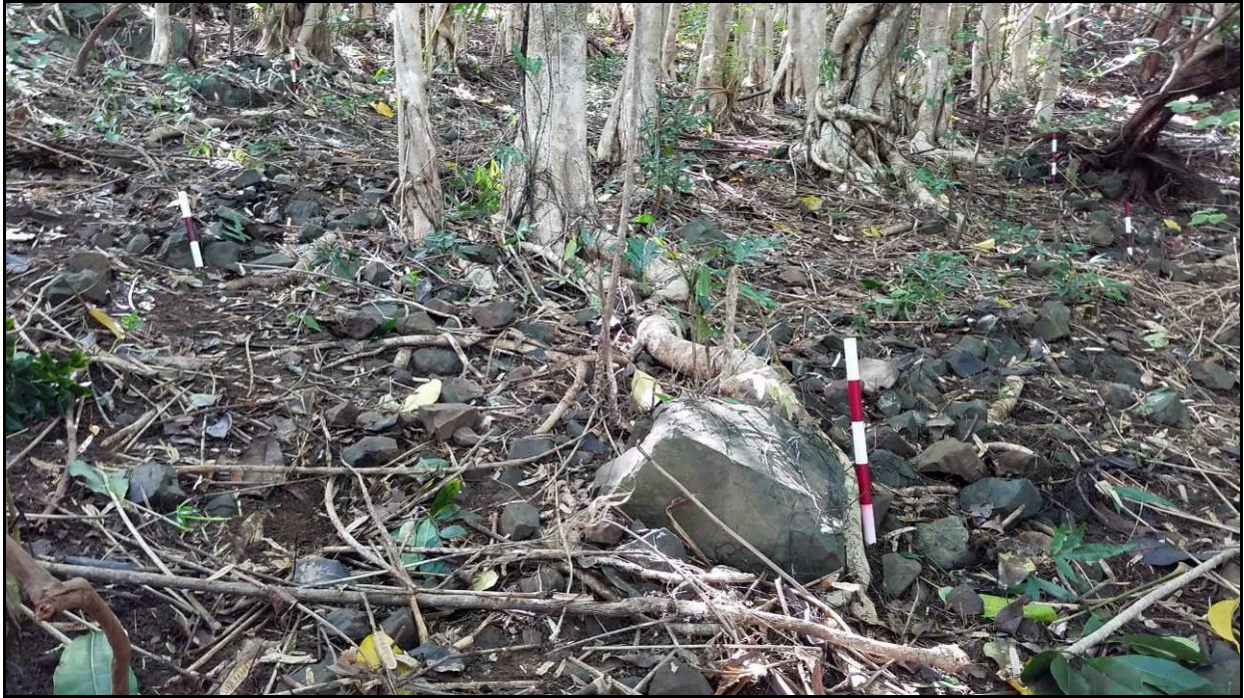
Feature 6A, sub-feature C includes two terrace segments (Features C1 and C2) and a mound (Feature C3) (Figure 170). Feature C1 is approximately 3.8 m N/S by 50 cm E/W, in fair condition, and largely constructed of basalt cobbles. The east surface of Feature C1 contains a concentration of basalt cobbles. Feature C1 and C2 are separated by a 1.5 m gap, were a possible

path may have existed at one time. Feature C2 is approximately 2 m long E/W by 40 cm wide N/S by 30 cm tall and is constructed of basalt cobbles. Just south of Feature C2 is a small stone-stacked mound (Feature C3). Feature C3 is approximately 110 cm in diameter and 33 cm tall (Figure 171). The mound is loosely constructed of angular basalt cobbles and is likely an agricultural clearing mound. A dead Christmas berry tree stump and roots are entangled within Feature C3.

Figure 170, Photo showing **SIHP # -8233A**, Feature C1 (terrace, right foreground), Feature C2 (terrace, right background), Feature C3 (mound, background [furthest photo scale]), and Feature D (left), view to southwest
