November 15, 2021

- To: Lisa Kettley, PM (via email) Tetra Tech, Inc. 737 Bishop St., Suite 2340 Honolulu, Hawaii 96813
- Re: Letter Memo Completion of Installation/Marking of Temporary (Construction) Preservation Buffer around SIHP # 50-80-09-2273, Features 14 (por.) & 19 in Support of Waiawa 2 Solar Project

ARCHAEOLOGICAL PRESERVATION PLAN STATE SITE NO. 50-80-09-2273 FEATURES 14 (PORTION), 19, 22 & 23 (PORTION) KAMEHAMEHA SCHOOLS' LAND IN WAIAWA AHUPUA'A, 'EWA DISTRICT, O'AHU ISLAND, HAWAI'I

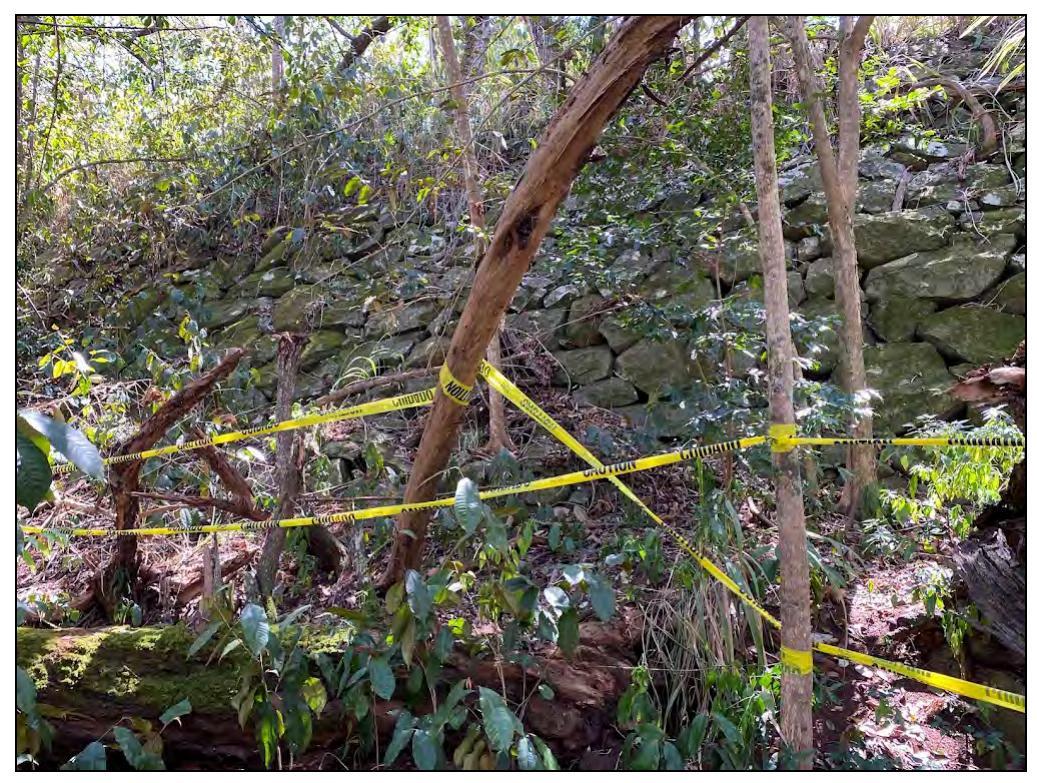
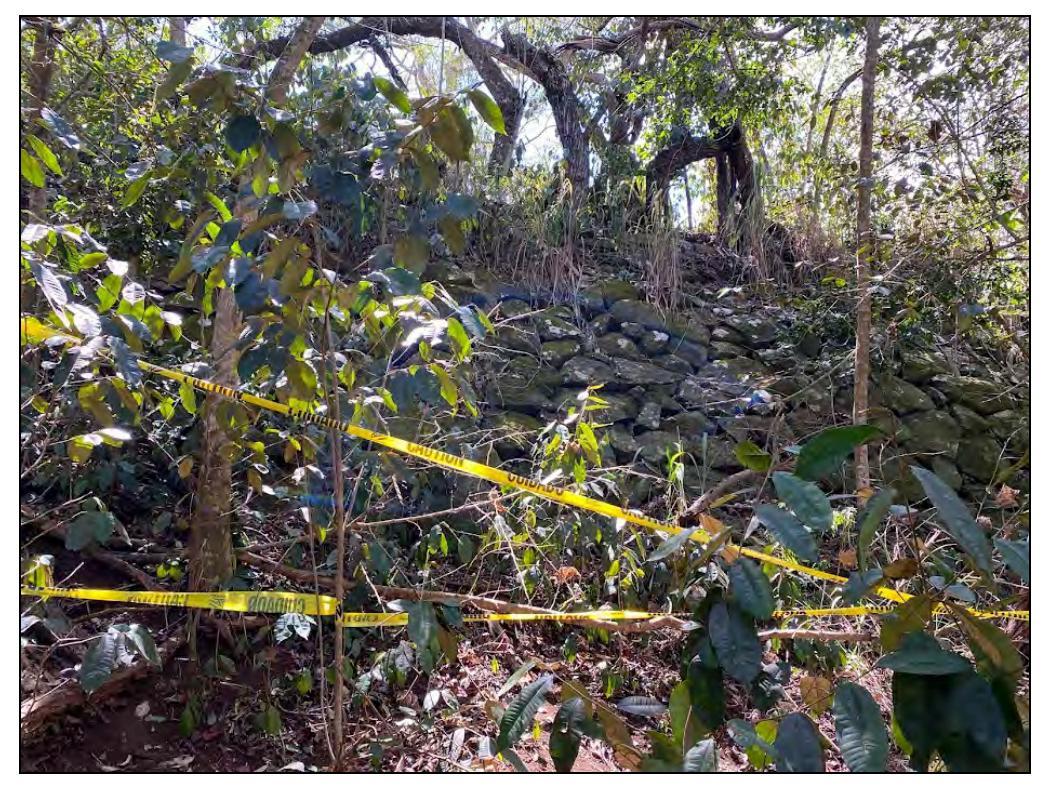
Figures 3 and 4 show a portion of the temporary buffer along the north side of site-feature 19.

Figure 3. North-facing rock-retaining slope at site-feature #19; facing south

Figure 4. Another view of north-facing rock-retaining slope at site-feature #19; facing south

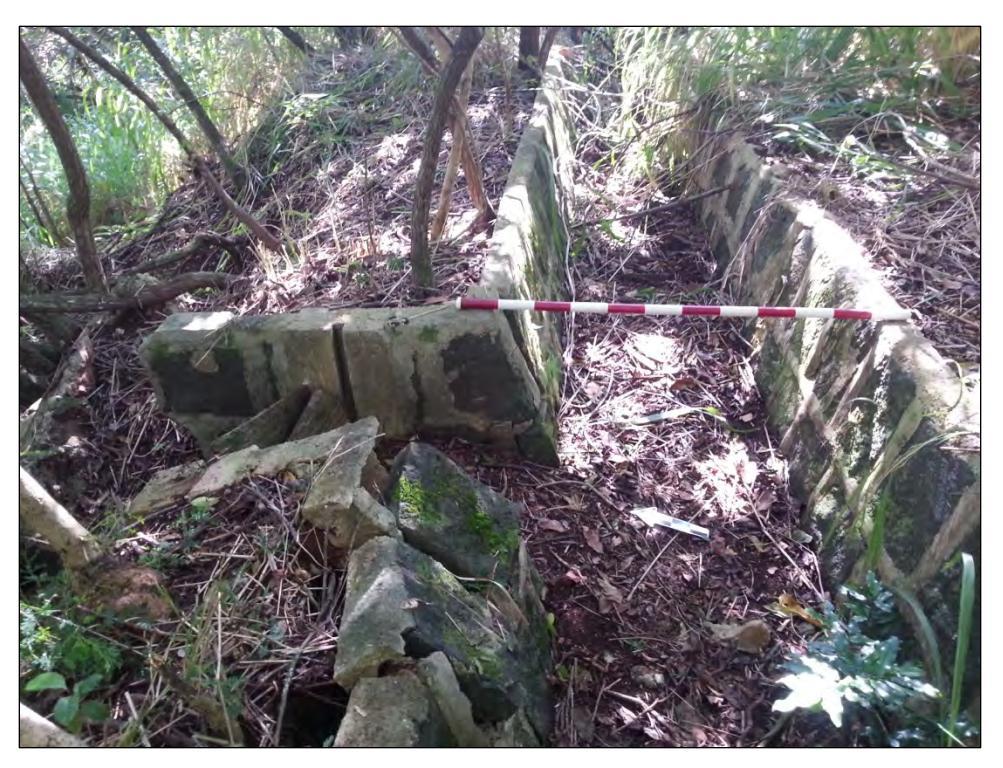
<u>Sub-feature C</u> is a sluice gate along a "switch back" section of the main ditch traversing the southern edge of Gulch B. This sluice gate structure is unusual in the project area as it diverts water from the main ditch to the *north*, rather than the south; in this case, it empties water into the Gulch B drainage which eventually flowed west-southwest into Reservoir 1-B (Figure 19). This sub-feature is in poor physical condition, having sustained extensive damage from being located on a steep slope (down to the north into Gulch B) that has eroded over time.

Figure 20. Main ditch (Sub-feature A) and upper (south) portion of Feature 14, Sub-feature C (damaged sluice gate), Site 2273, view east; horizontal scale bar is 120 cm long

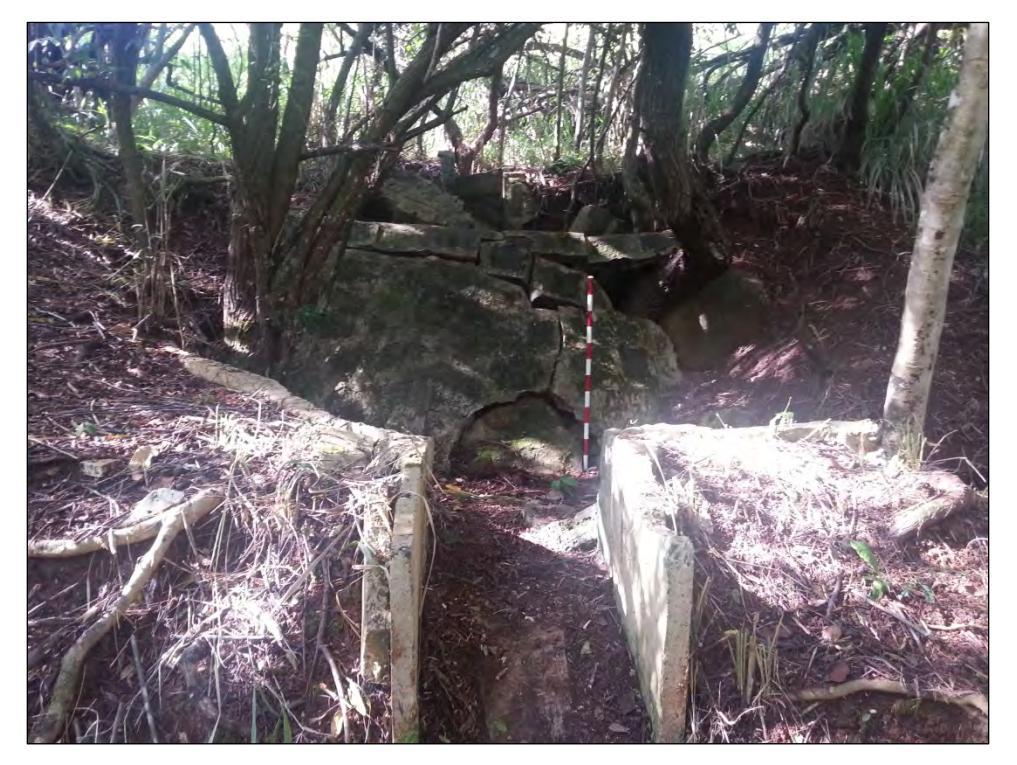
Figure 21. Lower (north) portion Feature 14, Sub-feature C, Site 2273, view south; vertical scale bar is 120 cm high; damaged deflection wall is in the middle ground (directly behind the vertical scale bar)

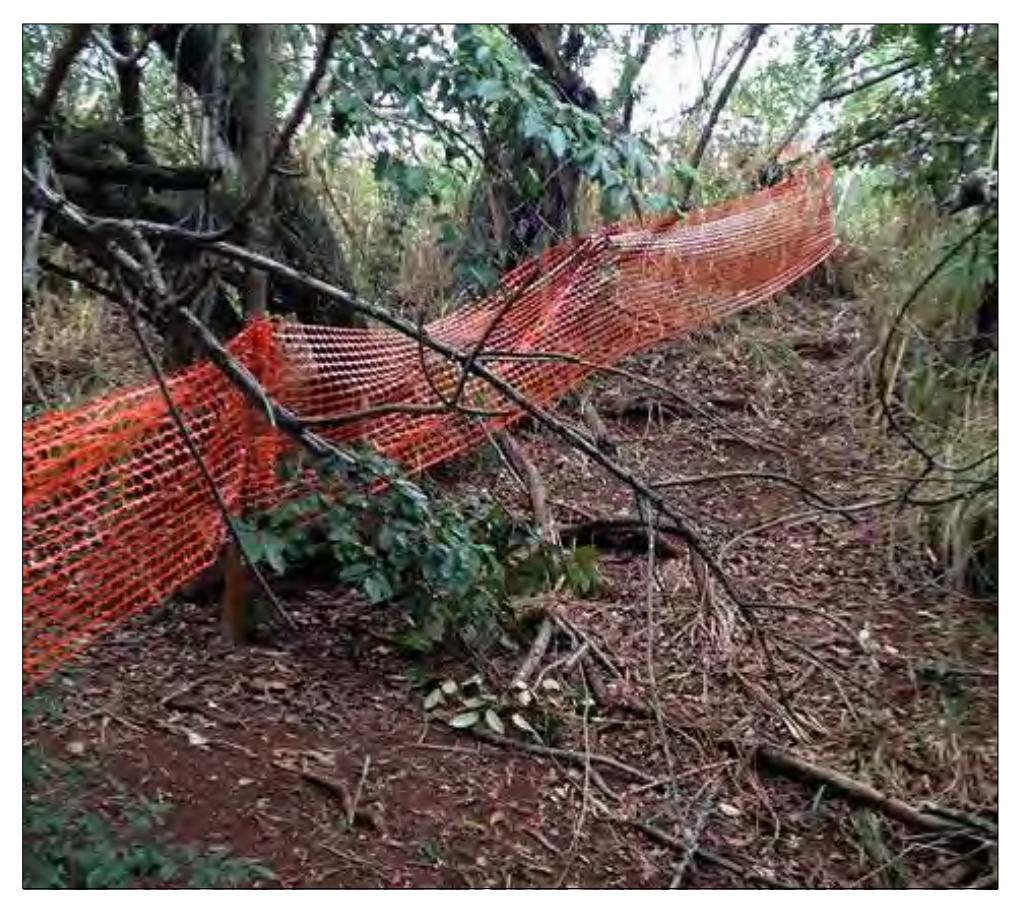
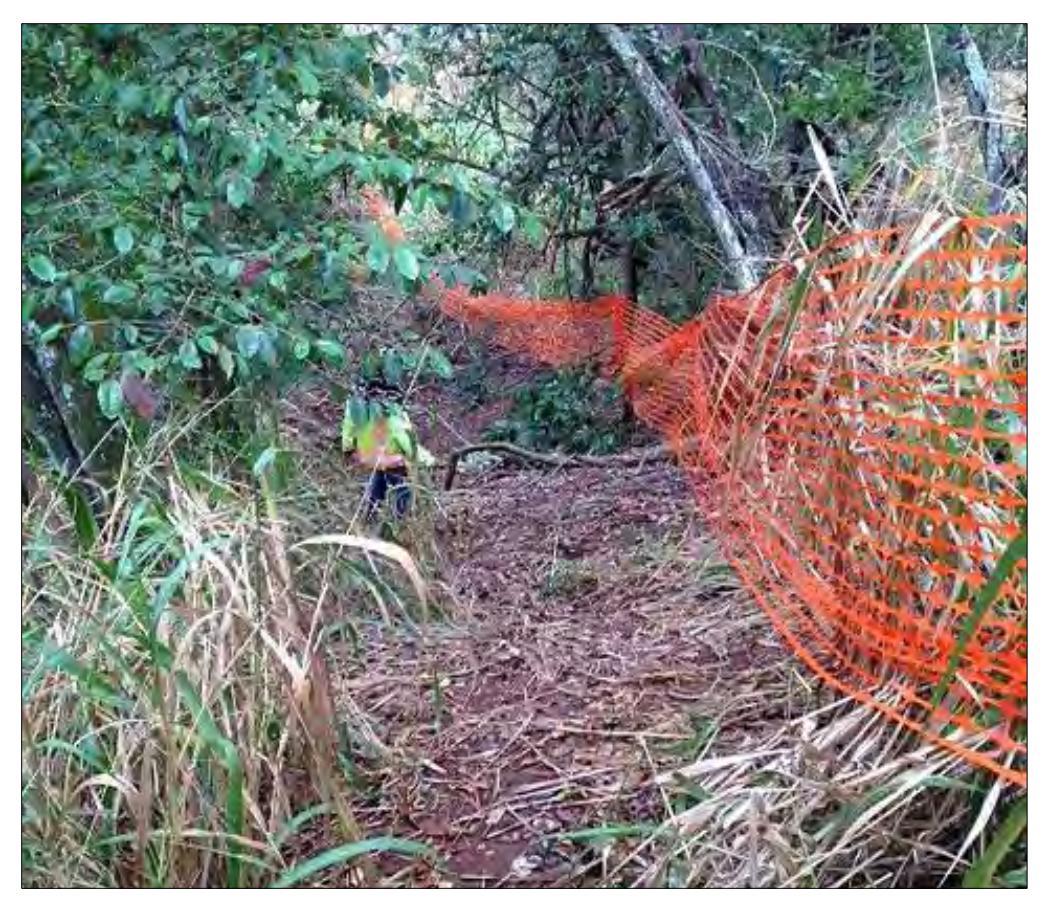
Figure 23. Top (east) end of the south section of fencing installed as a temporary buffer at Feature 19 on March 18, 2015; facing northeast

Figure 24. Looking down the installed fencing at Feature 19 from the east end of the south section (same as above, from a different angle); facing west-southwest

SunEdison shall ensure the orange construction fencing is intact and in good working order throughout the course of construction activities; shall place avoidance instructions on construction plans and specifications; and shall conduct a pre-construction briefing of the hired construction firms to make them aware of the preservation buffer.
