Waikō Baseyard Light Industrial Subdivision
 TMK (2) 3-8-007-102
Soil Association Map

**Preliminary
Engineering Report**

**Phase I - Environmental
Site Assessment Report**

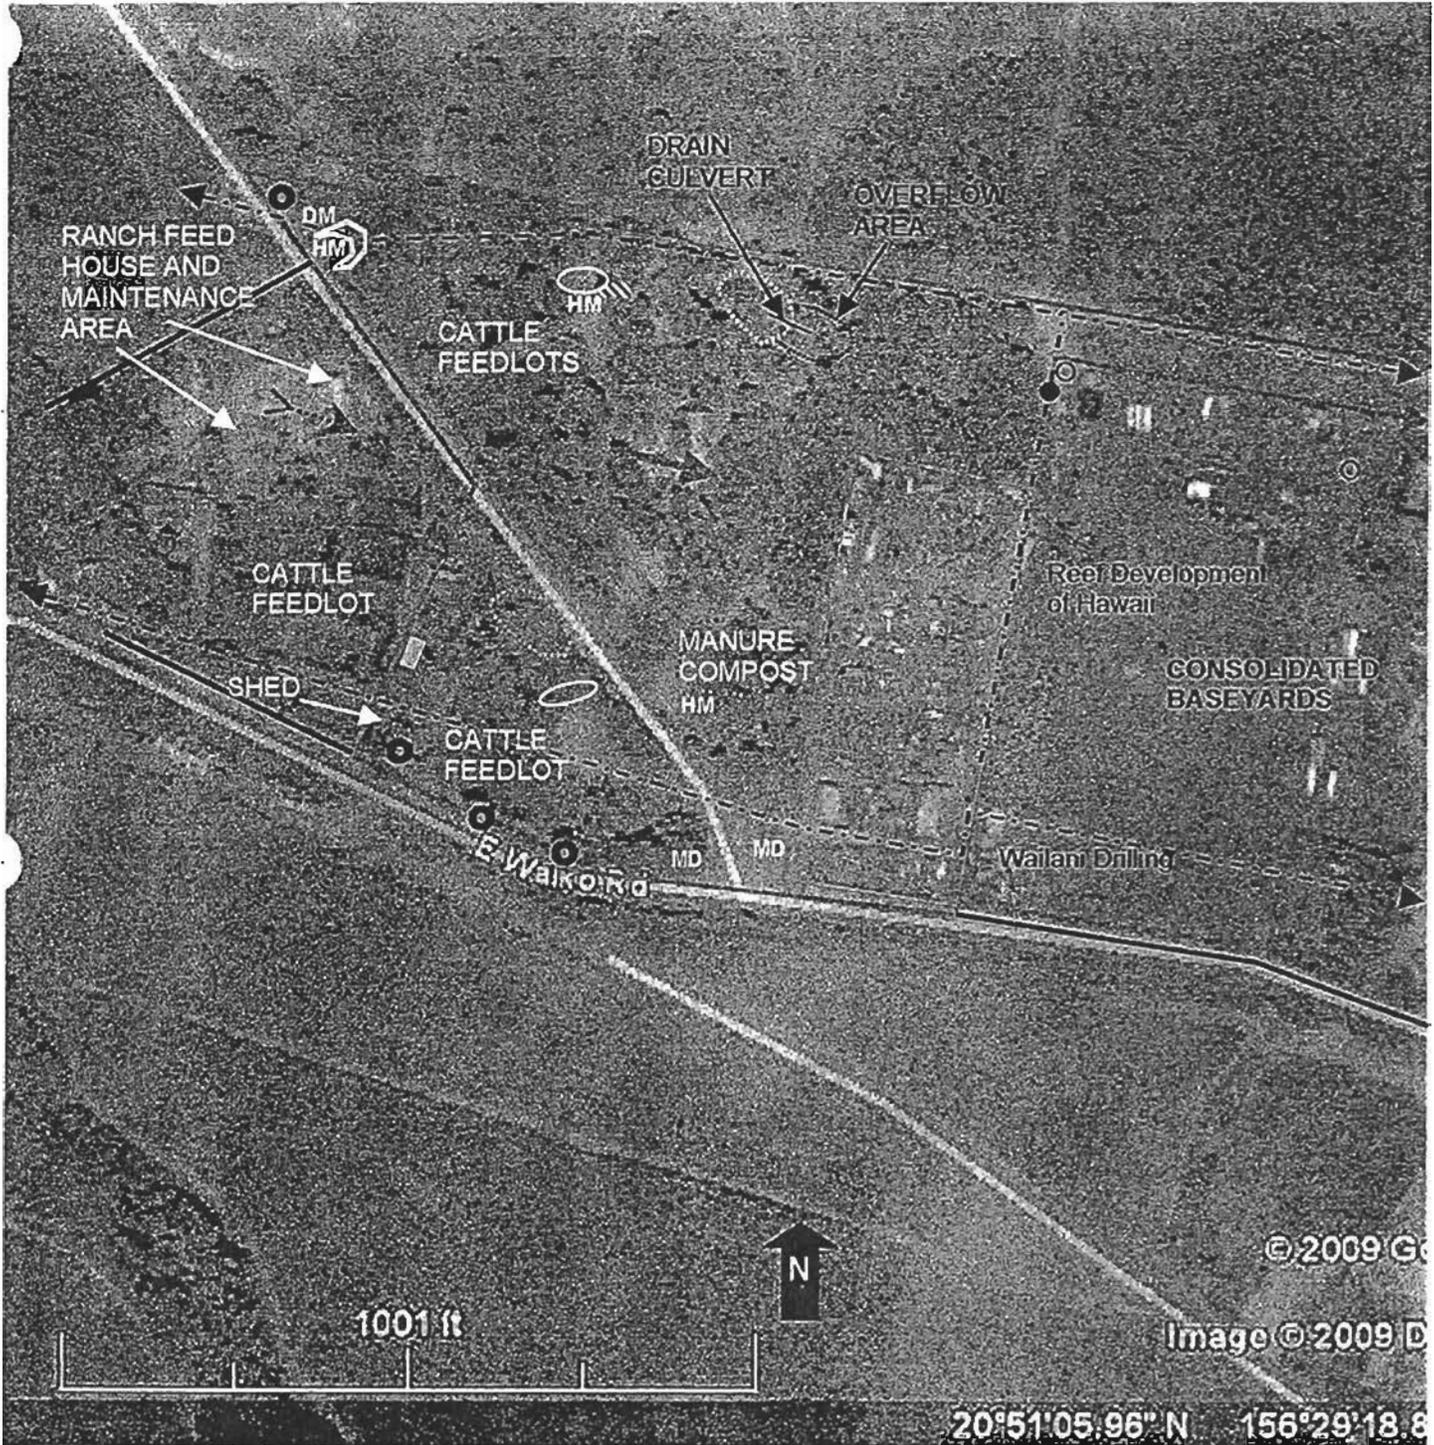
FIGURE 2B: SITE PLAN
Nobriga's Feedlot and Ranch (Western Portion)

SUBJECT PROPERTY BOUNDARIES		DERELICT MACHINERY (BULLDOZER, POSSIBLY LEAKING)
	ADJACENT PROPERTY BOUNDARIES		HEAVY MACHINERY
	PROJECTED GROUNDWATER FLOW DIRECTION		MISCELLANEOUS DEBRIS (tires, construction debris, and household refuse.)
	PROJECTED STORMWATER FLOW DIRECTION		VEHICLE TIRE
	GROUNDWATER WELL		3 POLE-MOUNTED TRANSFORMERS (non-leaking, non-PCB containing)
	TRANSMISSION POWER LINES		Limited soil surface staining
	POND		
	MANURE BERM/PILE		
			CARGO TRAILER (NO ACCESS)
			EARTHEN AND CONSTRUCTION DEBRIS BERM

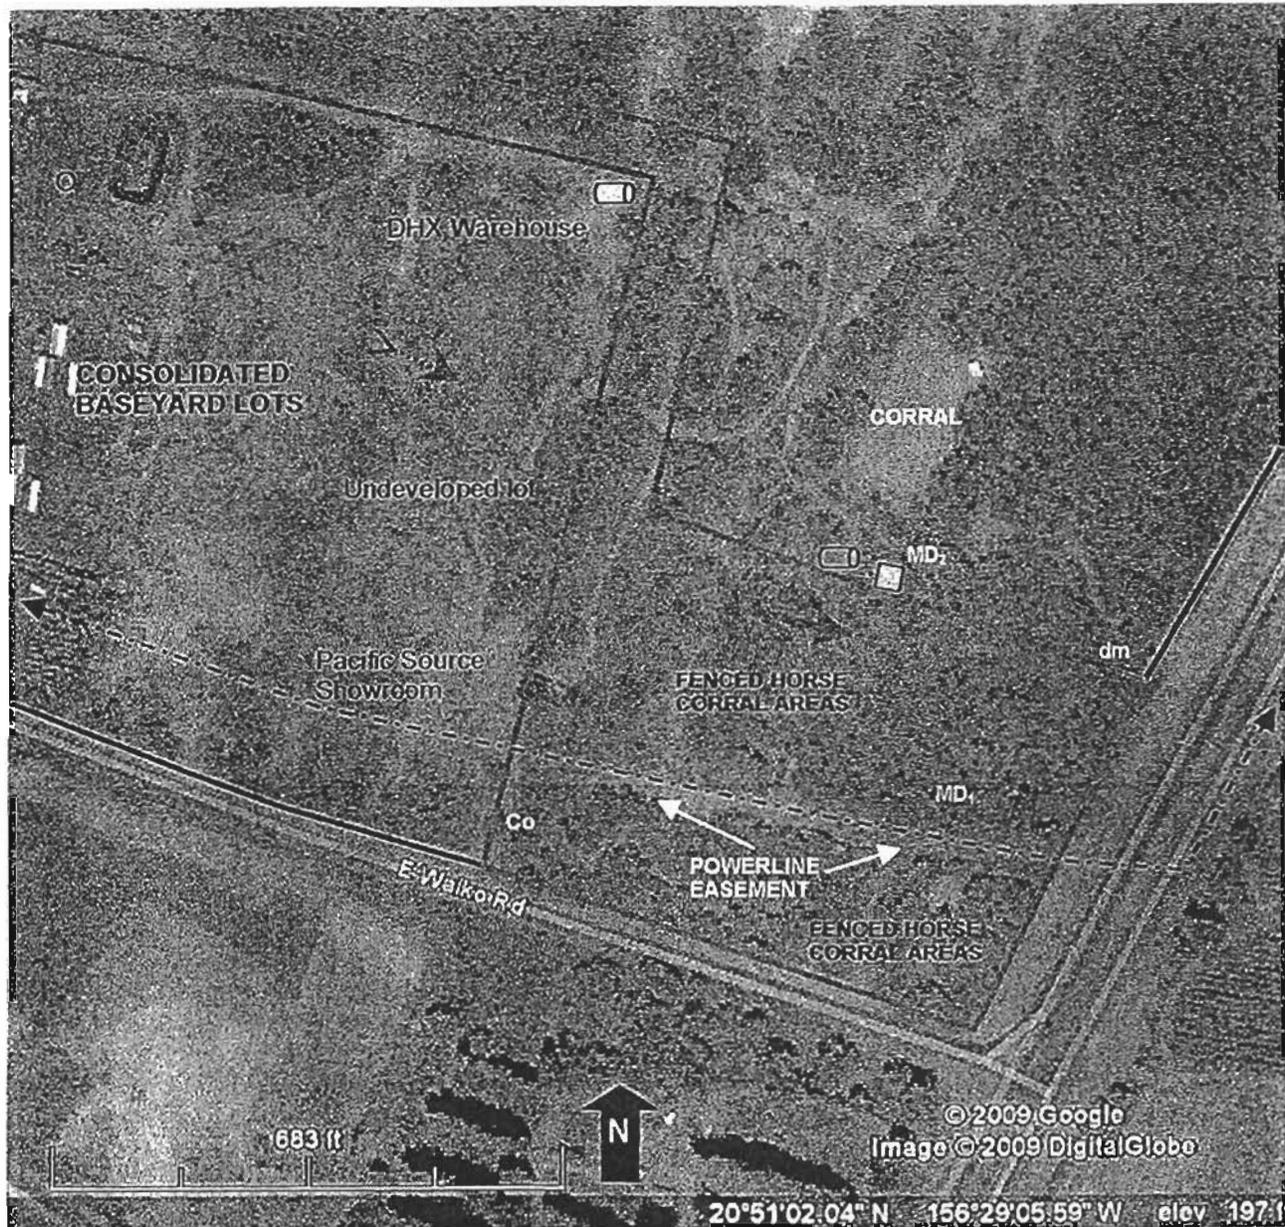
FIGURE 2C: SITE PLAN

SUBJECT PROPERTY BOUNDARIES		GROUNDWATER WELL
	ADJACENT PROPERTY BOUNDARIES		PROPANE TANK (AST)
	PROJECTED GROUNDWATER FLOW DIRECTION		(2) 1000-GALLON (AST) – labeled potable water and
	PROJECTED STORMWATER FLOW DIRECTION		(1) 100-GALLON (AST) (empty)
	TRANSMISSION POWER LINES		(1) 300-GALLON POLY TANK (empty)
<p>MD₁ MISCELLANEOUS DEBRIS - (1) vehicle tire, (1) 55-gallon drum (empty), (2) 5-gallon containers (empty), (1) 5-gallon container (partly full of petroleum product and household refuse).</p>			
<p>MD₂ MISCELLANEOUS DEBRIS – (8) vehicle tires, (1) white good appliance, construction debris, (2) 55-gallon drums (full of unknown substance, (3) 5-gallon containers (empty, but may have contained waste oil), (2) pieces of derelict machinery. No surface staining noted from these materials.</p>			
<p>dm One (1) 55-gallon drum (limited petroleum-based sludge noted)</p>			
<p>POWERLINE EASEMENT – Consists of maintenance materials (primer, wood sealer & wood finish), construction debris, horse feed drums, (7) vehicle tires, (1) 5-gallon cans containing petroleum product, (1) 300-gallon poly tank (small amount of water), (3) ranch trailers.</p>

<p>Co Corral area – consists of (3) vehicle tires, construction debris, (3) 55-gallon drums (empty), (1) vehicle battery, (1) piece of derelict Machinery, (1) 300-gallon poly tank (1/4 full of product – labeled Praestol Flocculant)</p>

- A miscellaneous debris and storage area lies immediately north of the subject site. This area consists of vehicle tires, a white-good appliance, various construction debris, two (2) pieces of derelict machinery, two (2) 55-gallon drums containing an unknown liquid product, three (3) 5-gallon containers with trace petroleum product, one (1) 300-gallon poly tote (empty) and two (2) 1000-gallon AST (labeled potable water) both of which had loose and flakey paint.

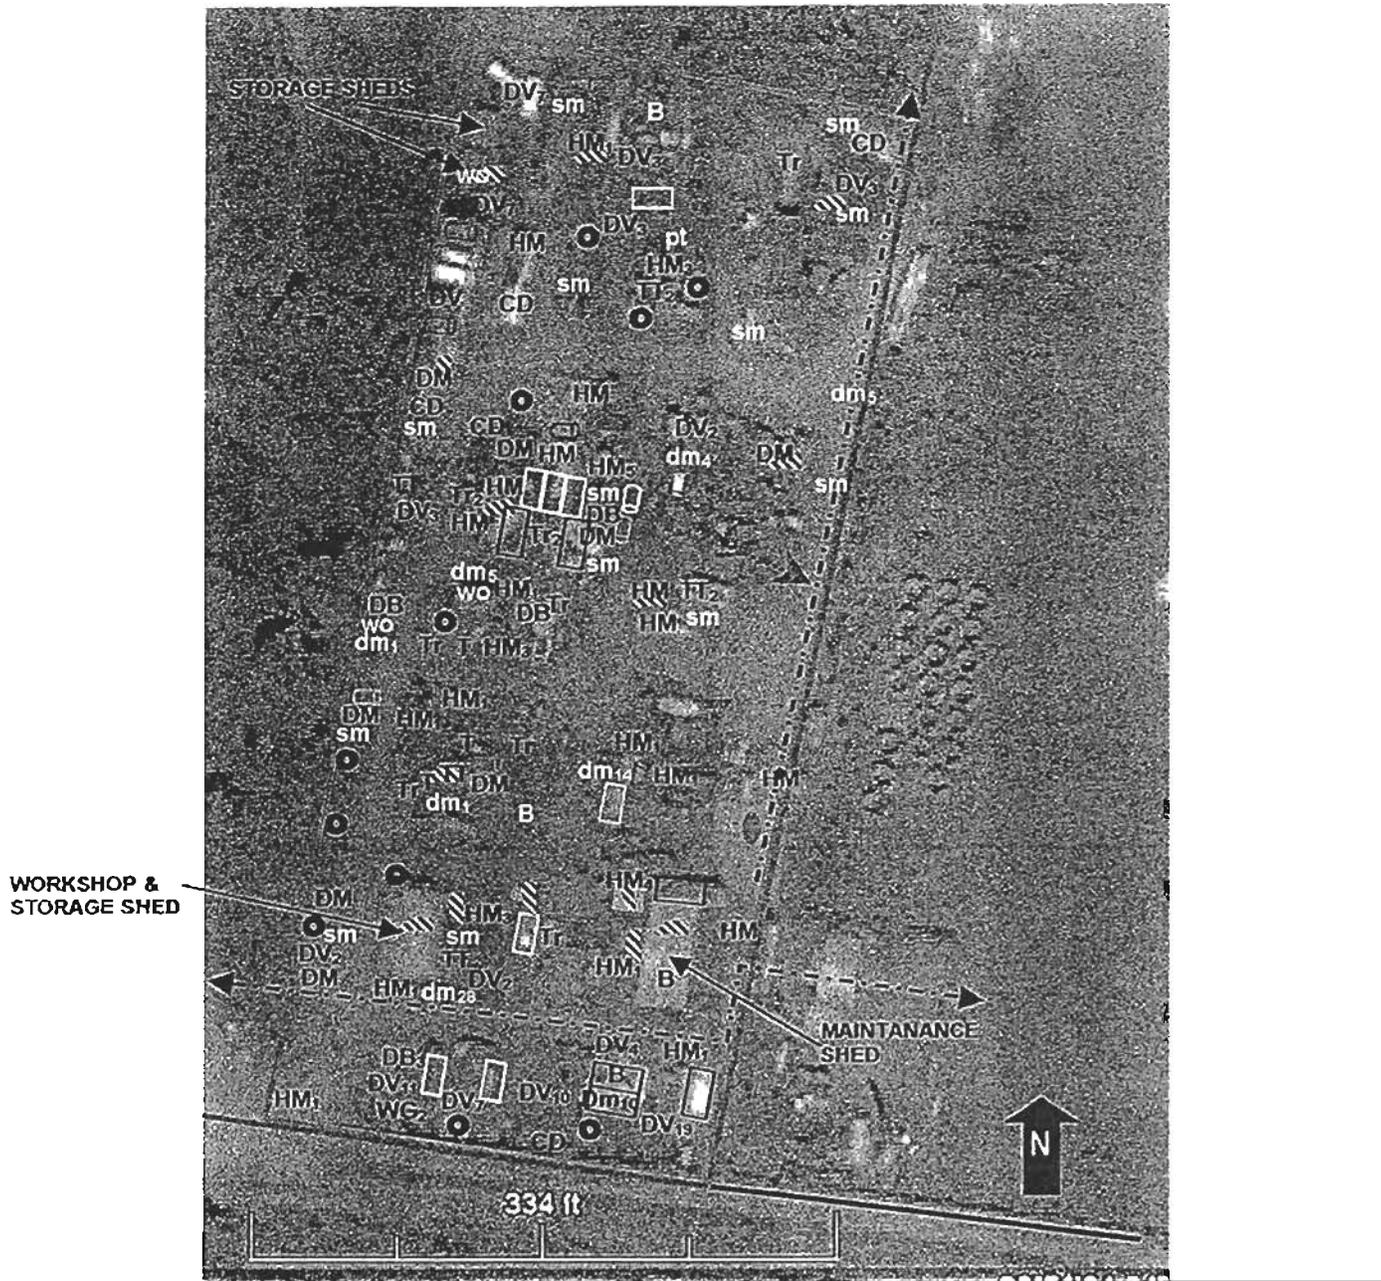
FIGURE 2D: SITE PLAN

Fong Construction Baseyard

WORKSHOP & STORAGE SHED

MAINTANANCE SHED

Drum Storage Shed
Concrete Pad

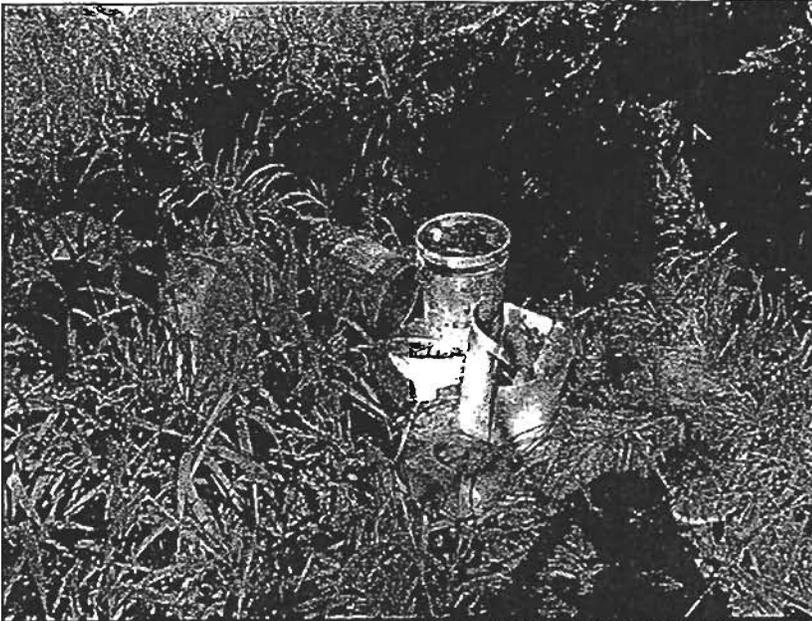
PHOTO 13

Miscellaneous debris area (denoted MD₁ on Figure 2C). Notable items include a vehicle tire, empty containers and one (1) 5-gallon container partly full of a petroleum-based product. This product should be properly managed.

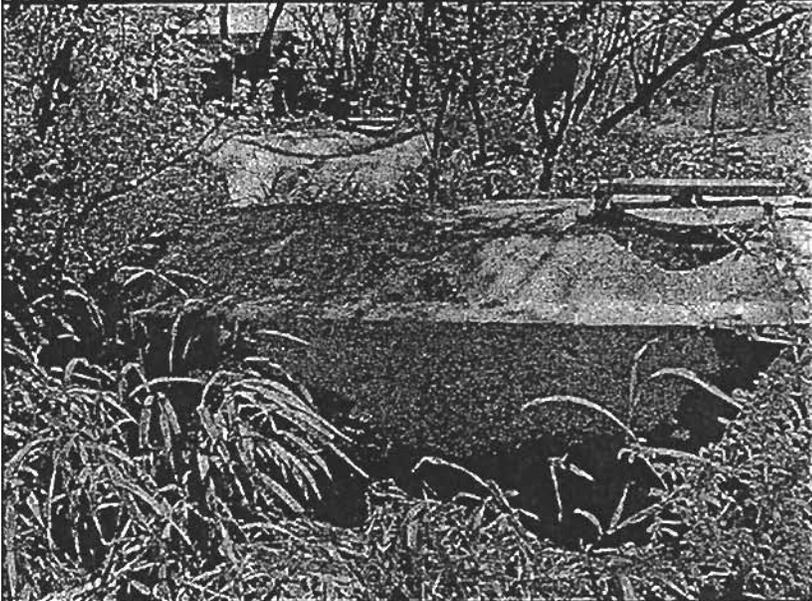
PHOTO 14

Miscellaneous Debris and storage area (denoted MD₂ on Figure 2C) located just north of the northern property boundary. Shown in the photo are two (2) 1000-gallon ASTs. Although the contents could not be determined, these tanks were labeled potable water. Note the loose and flakey paint on the tank in the foreground. This paint could be lead-based.

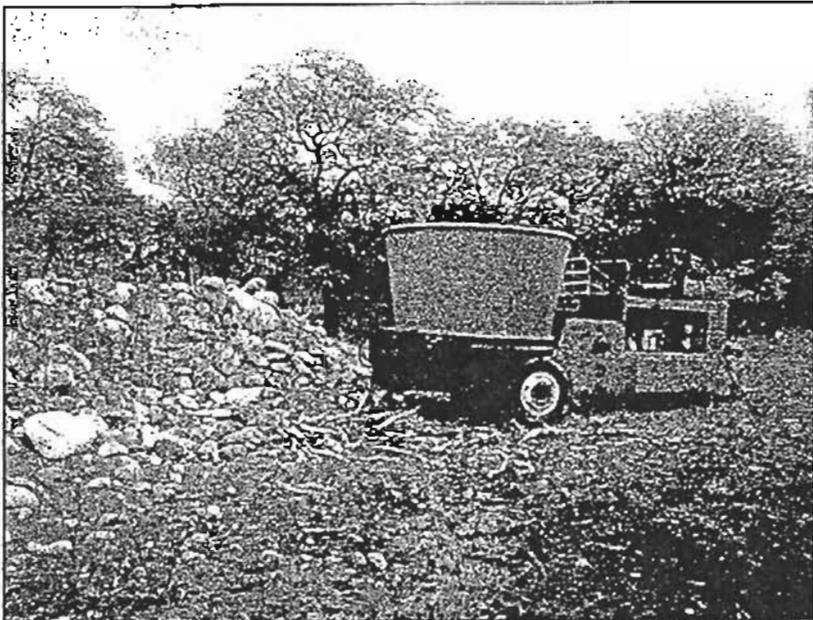
PHOTO 16

Boulder debris pile and heavy machinery located near the north-central property boundary of the western section of the subject site. This piece of heavy machinery was noted to be leaking petroleum-based product, causing limited staining on the ground below.

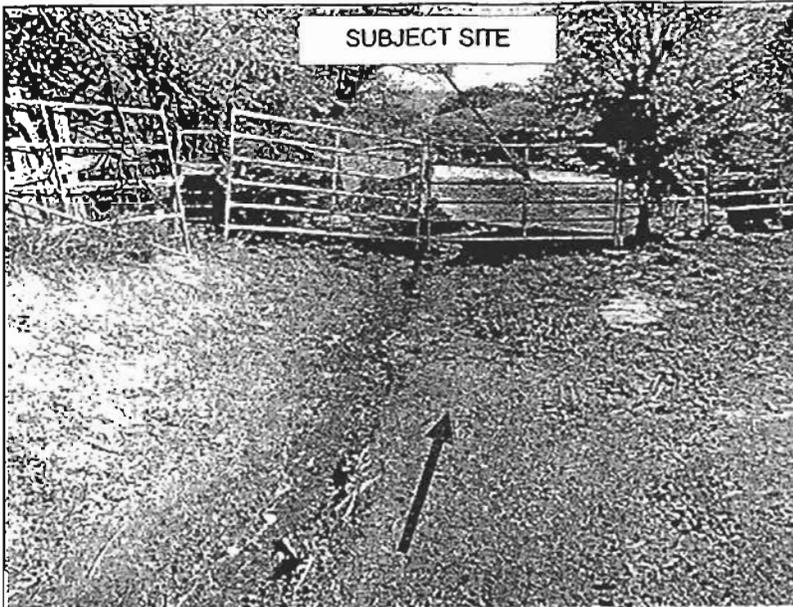
PHOTO 19

View of the on-site catchment lagoon located adjacent to the gravel access road on the western portion of the subject site. This lagoon is very close to the off-site and up-gradient main maintenance area, food production area and off-site feedlot. MEV estimates the parcel boundary for the subject property is located approximately at the bottom of the photo. The blue arrow represents stormwater runoff direction. This runoff originates from the up-gradient location describes above and likely includes cattle urine and other livestock bio-waste products. Although the tenant leases both areas, the up-gradient portion is off-site from the subject investigation.

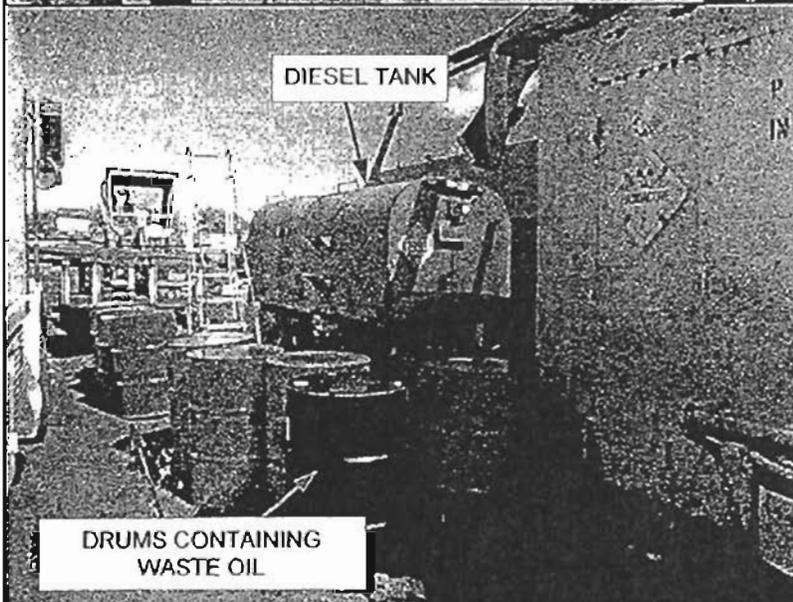
PHOTO 21

Operation diesel AST and approximately fourteen (14) 55-gallon drums. Nine (9) of these drums were empty and five (5) contained product. According to Mr. Henry Fong, these drums are used for waste oil storage. Approximately seventy-five (75) 55-gallon drums and twenty-five (25) 5-gallon containers were noted on the baseyard premises and likely contain regulated substances. The vast majority of these containers were not labeled and lacked secondary containment. See Section 5.3.1 for drum container management.

MEV has outlined some management procedures in Section 5.3.1 that should be followed for the proper storage and management of drums/containers containing hazardous and regulated substances currently taking place on-site.

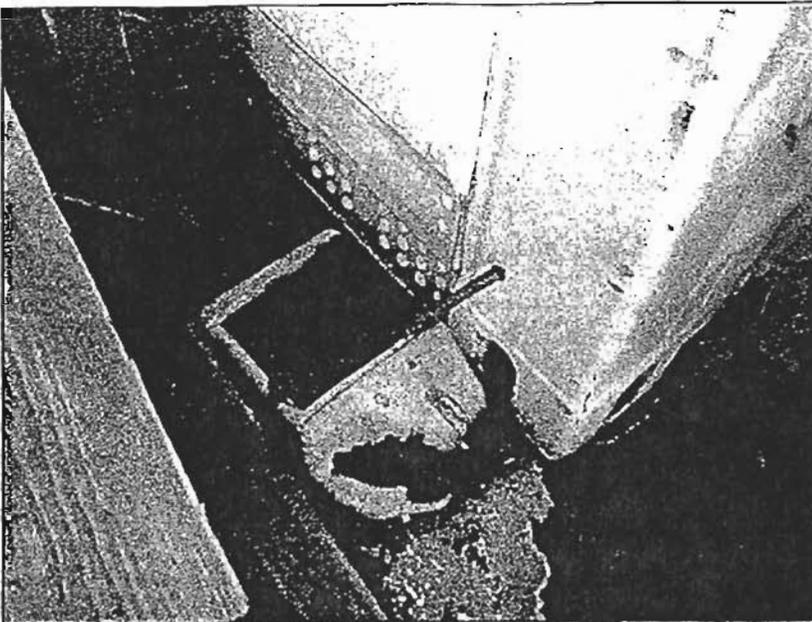
PHOTO 22

Open 2-gallon container of waste oil located on Fong's Baseyard. MEV noted several open containers containing waste oil located on the premises. Note the leakage and surface staining associated with this container. More effective waste oil management and the implementation of spill protection should be undertaken at this facility.

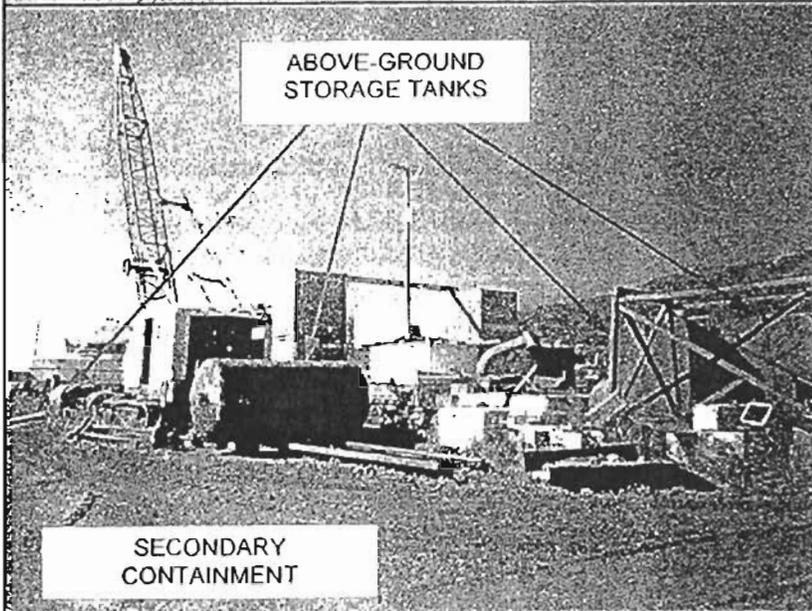
PHOTO 24

MEV noted approximately seventeen (17) above-ground storage tanks being kept at Fong's Baseyard. The majority of these tanks appeared to be empty, MEV suspects that some of these tanks may have historically been use as former fuel tanks. It is possible that limited amounts of residual fuel or sludge remain in some of these tanks.

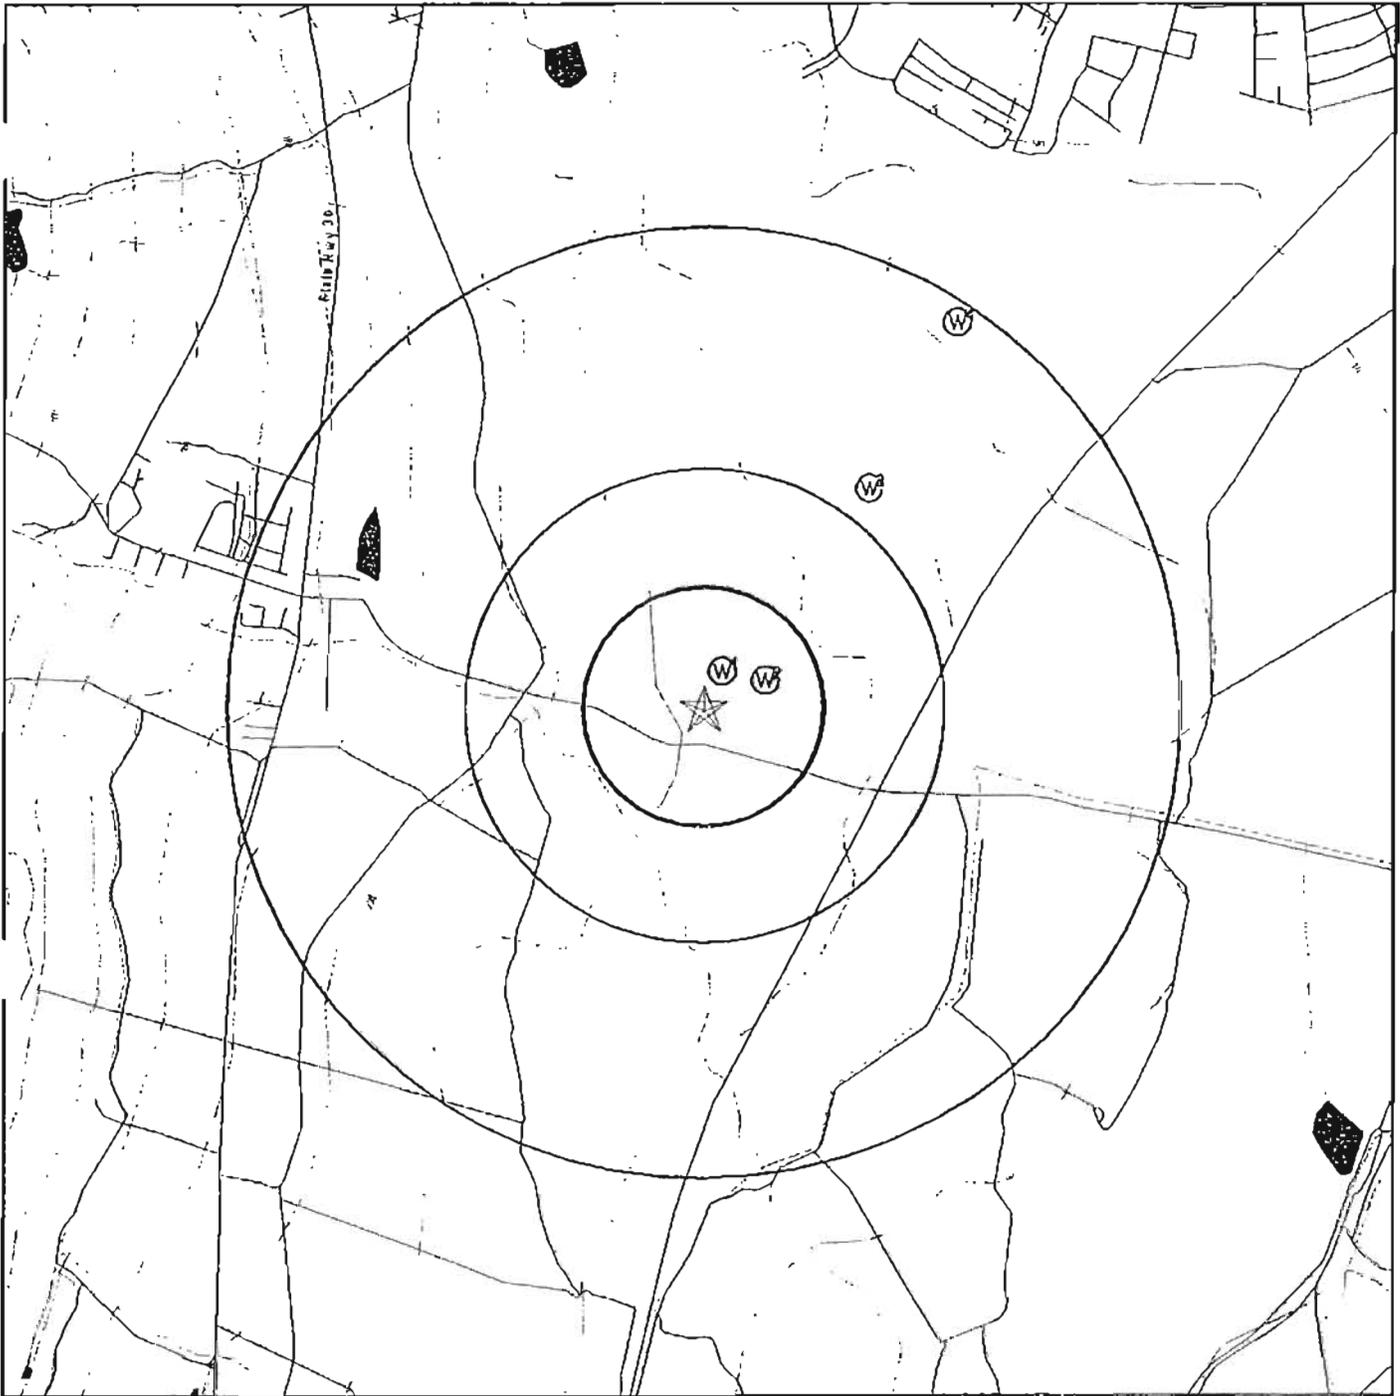
PHYSICAL SETTING SOURCE MAP - 2663266.1s

<u>MAP ID</u>	<u>WELL ID</u>	<u>LOCATION FROM TP</u>
1	HI4000000001157	0 - 1/8 Mile NNE
2	HI4000000001156	1/8 - 1/4 Mile ENE
3	HI4000000001167	1/2 - 1 Mile NE
4	HI4000000001177	1/2 - 1 Mile NNE
