DRAFT ENVIRONMENTAL IMPACT STATEMENT FOR PIILANI PROMENADE

APPENDICES B- H

Environmental Site Assessment

Environmental Site Assessment: *Phase I Investigation - Pi'ilani Promenade LLC*

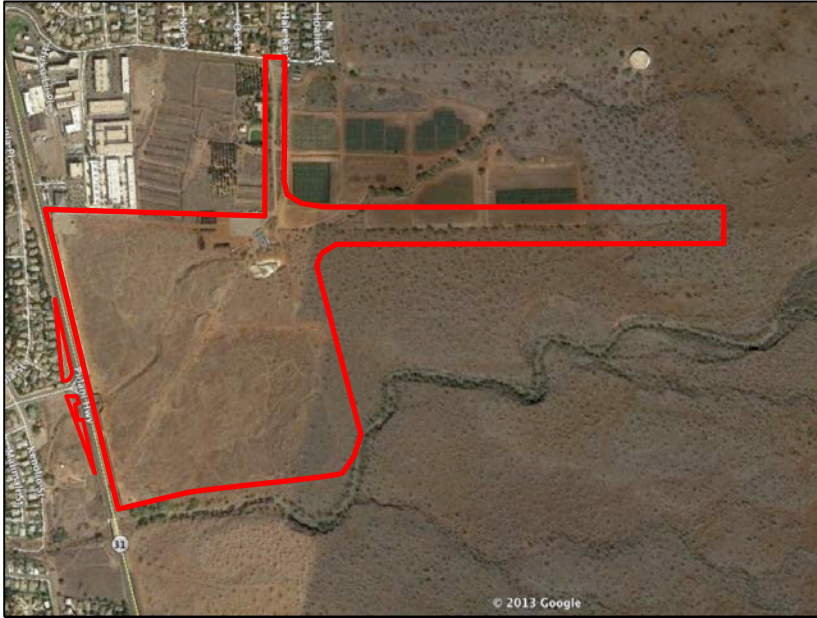
PHOTO 1

Aerial view of the subject property and the immediate adjoining areas.

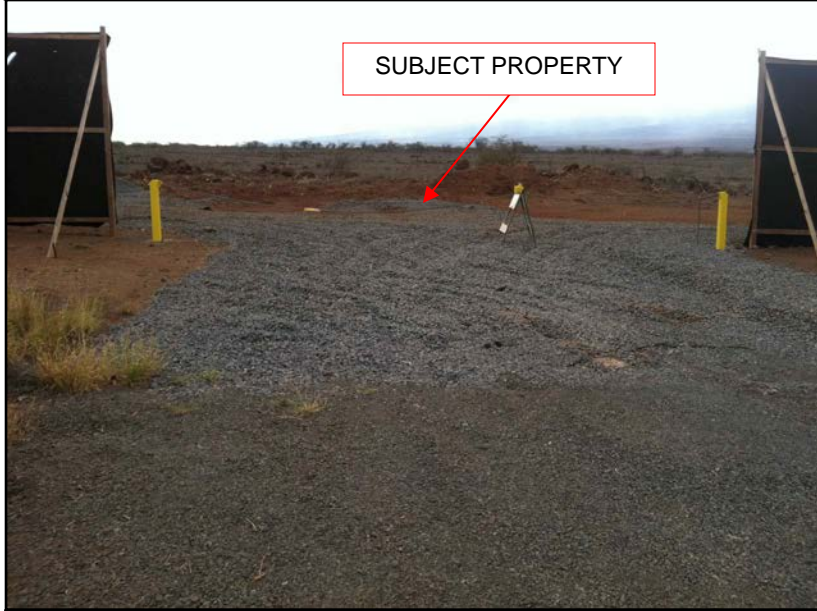
PHOTO 2

Easterly view of the west site access entrance off of Piilani Highway located along the western property boundary.

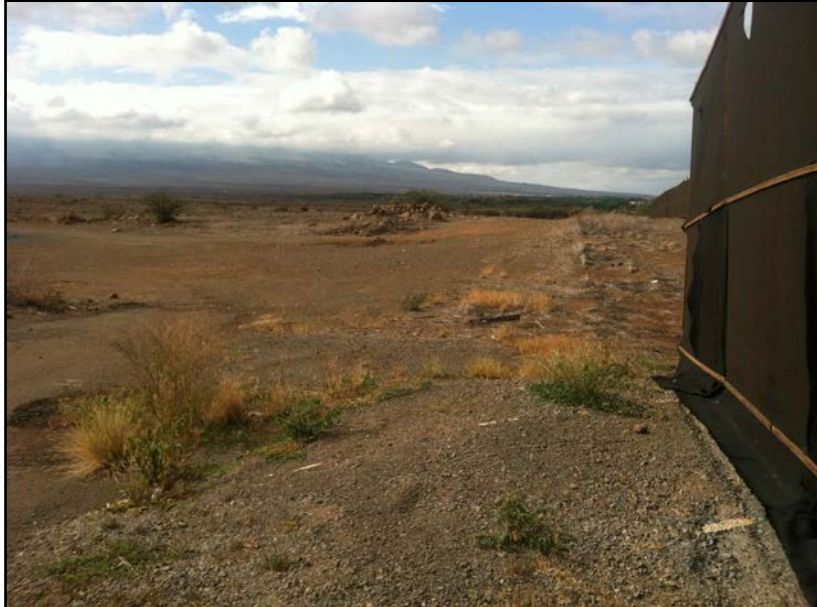
PHOTO 3

Southerly view along the western boundary. This photo was taken from the gravel lot in the northwest corner of the main portion of the Subject Site. Goodfellow Bros., Inc. has installed a 12-foot dust fence along the western property boundary in preparation for development.

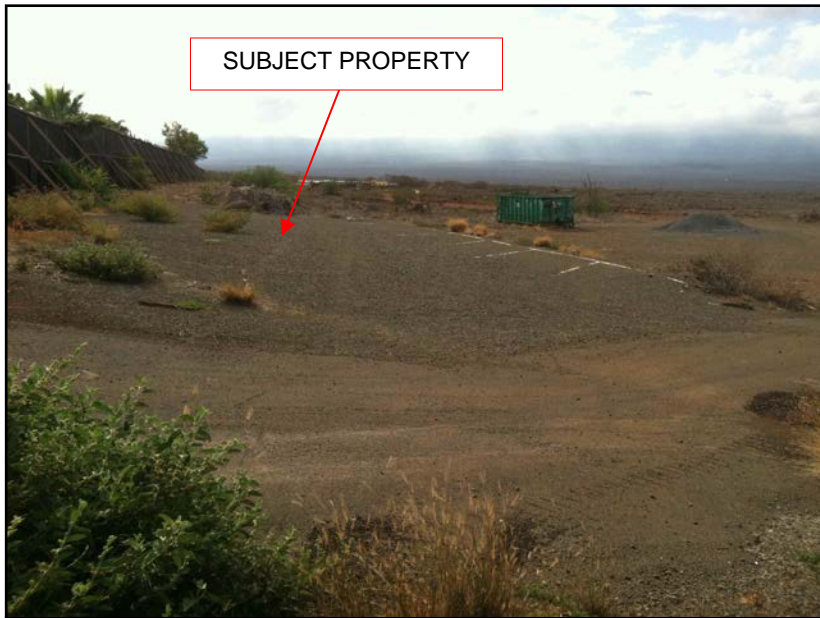
PHOTO 4

Easterly view along the northern property boundary. This photo was taken from the gravel lot in the northwest corner of the subject site. The waste dumpster in the photo is filled with construction debris such as wood and cardboard and does not appear to contain any hazardous materials.

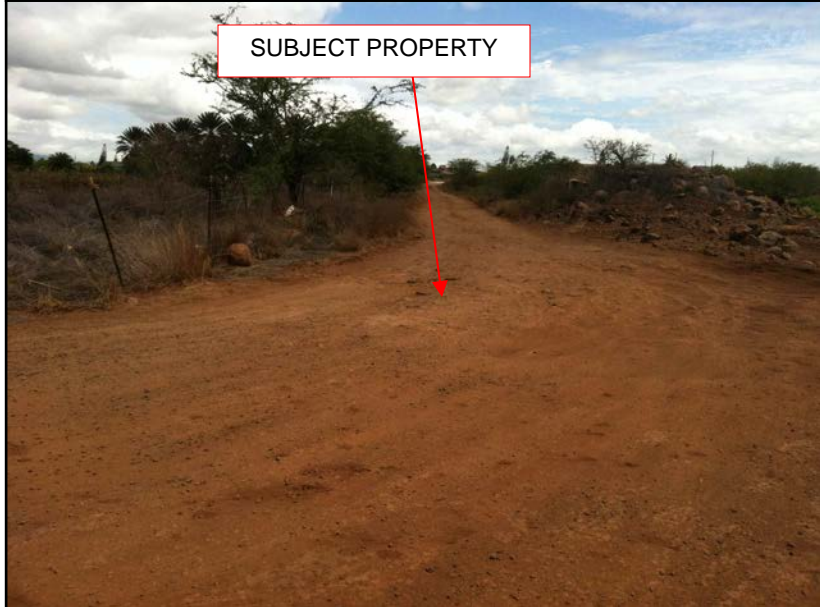
PHOTO 6

Northerly view along the proposed roadway and utility easement that leads toward Ohukai Road. The Monsanto Seed Farm is located east of the gravel road. The Hashimoto residential/agricultural land is located to the west.

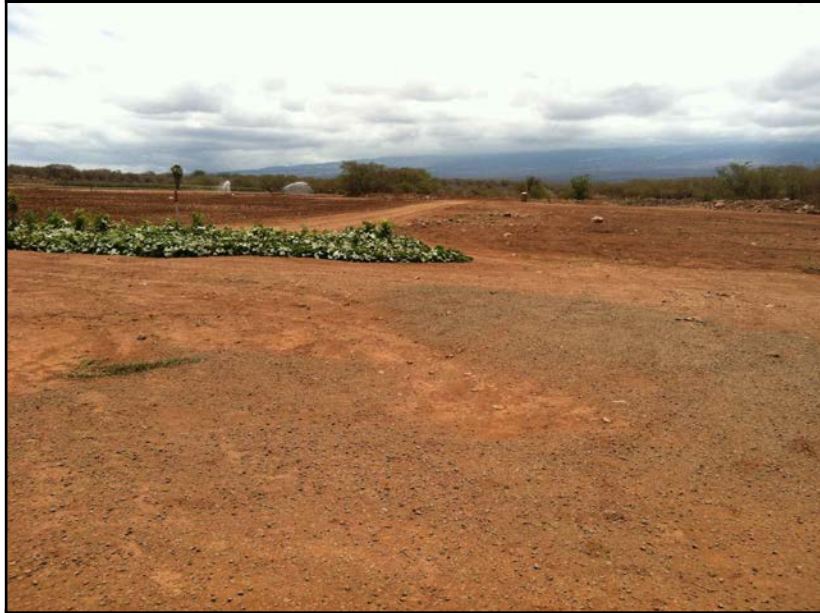
PHOTO 8

Northeasterly view toward the waterline easement immediately south of the Monsanto Seed Farm. The dirt road at the back of the photo is the location of this proposed easement.

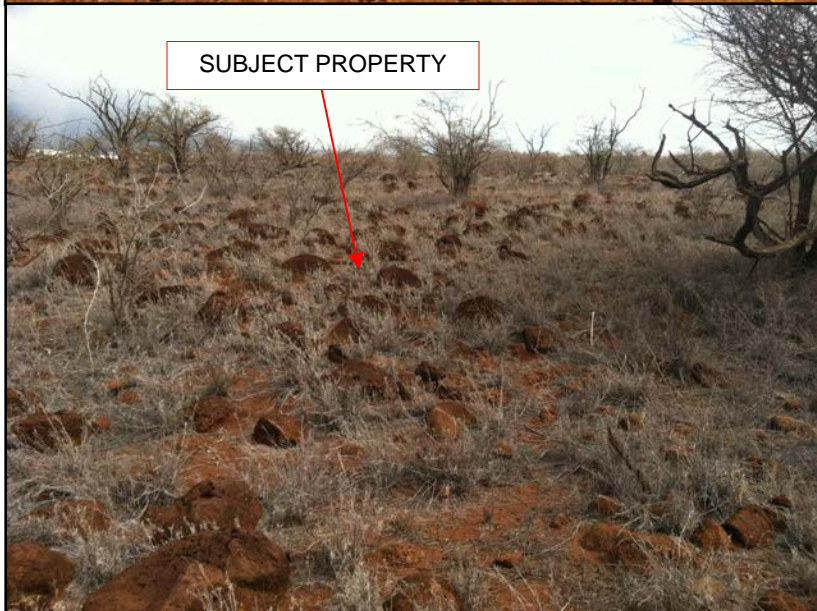
PHOTO 12

Northerly view of the proposed access and utility easement located along the eastern boundary. This photo was taken near the southeastern corner of the subject site.

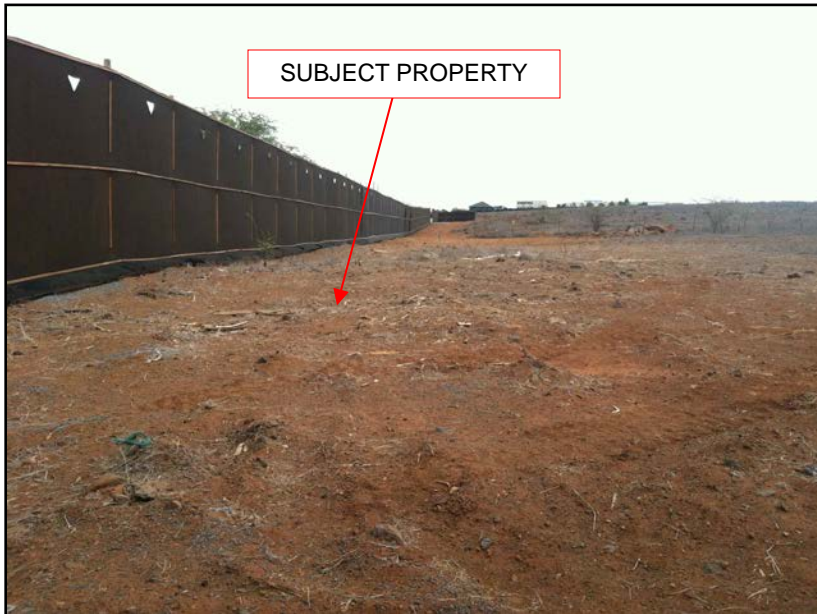
PHOTO 13

Northerly view of the western property boundary. This photo was taken from the southwest corner of the Subject Site.

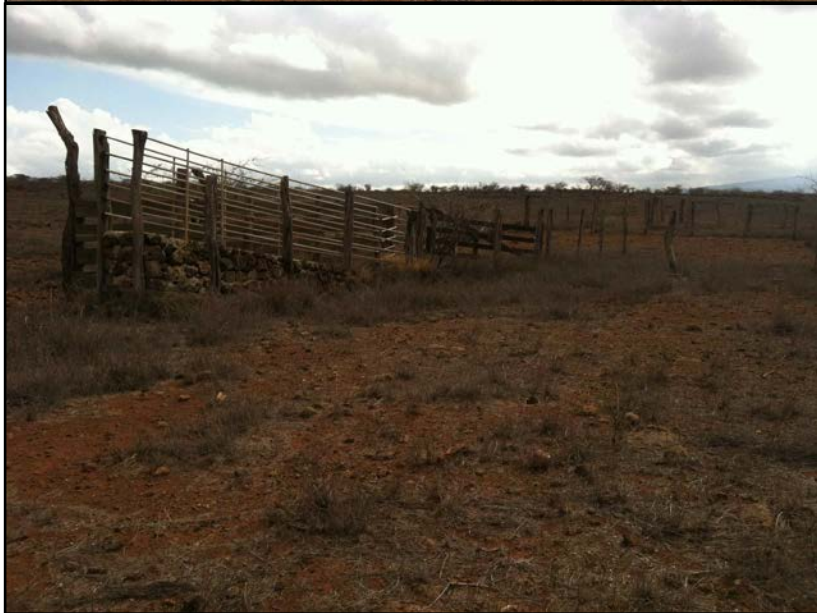
PHOTO 14

Ranch enclosures located near the southwest corner of Parcel 171. MEV noted a water spigot associated with this enclosure. A water line runs from this area and traverses south to the off-site southern adjoining gulch.

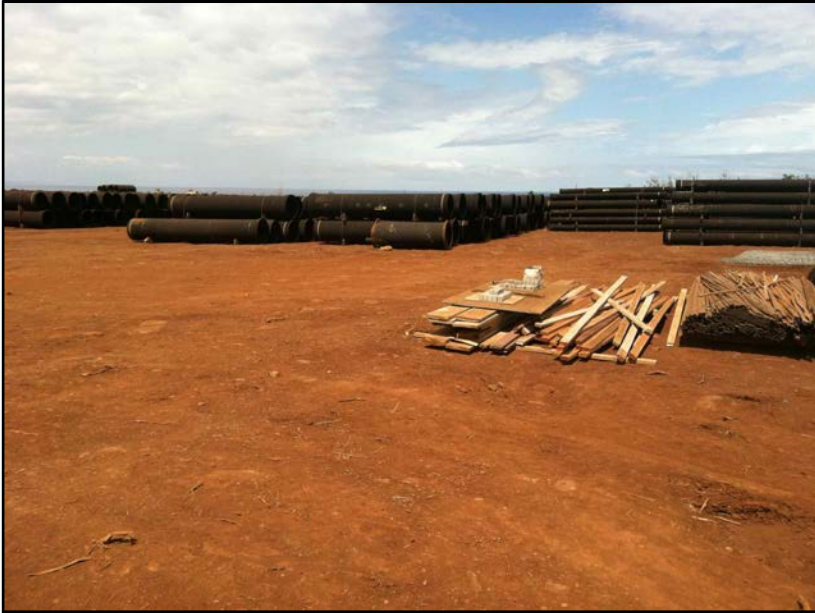
PHOTO 17

View of the Piilani Promenade Baseyard located in the northeast corner of Parcel 169. The baseyard consists of construction materials for water culvert and drain line installation.

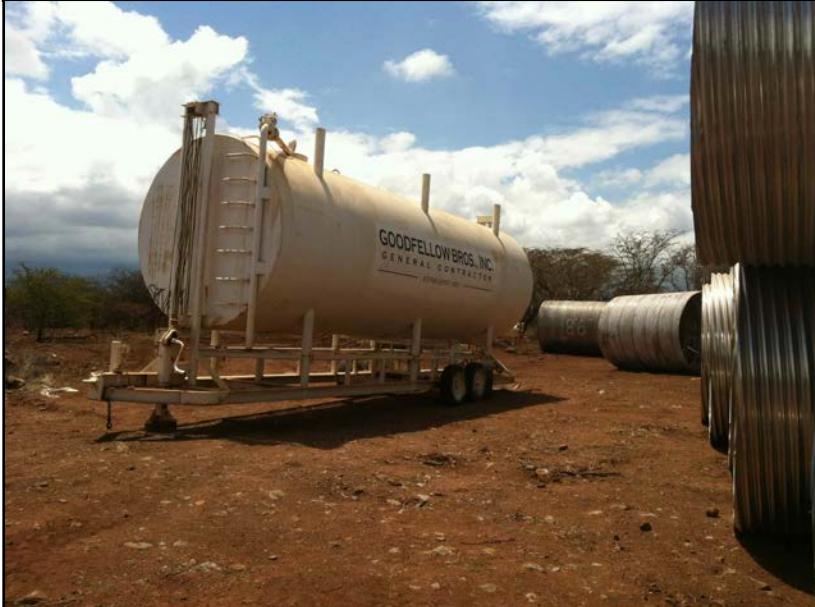
PHOTO 18

Above-ground storage tanker associated with the on-site baseyard. This tanker likely only contained water and is currently empty.

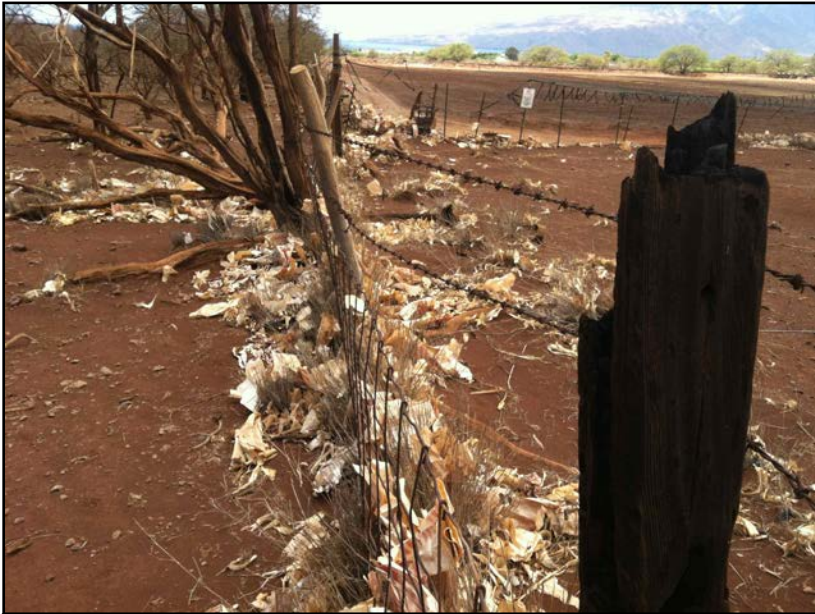
PHOTO 19

Westerly view along the proposed water line easement near the Monsanto Seed Farm. Note the paper bag debris collected near the barbed wire fence. These paper bags were used by Monsanto to prevent cross-fertilization in their seed crops. Large amount of these bags can be found along the southern boundary of the proposed water line easement.

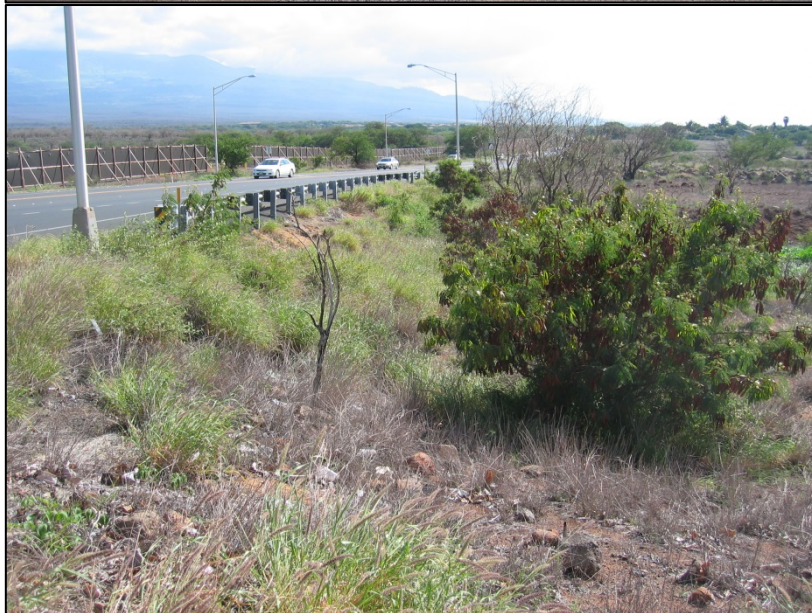
PHOTO 23

Southerly view of Subject Parcel 148 along Piilani Highway. Far left across the highway is fence around Subject Parcel 171.

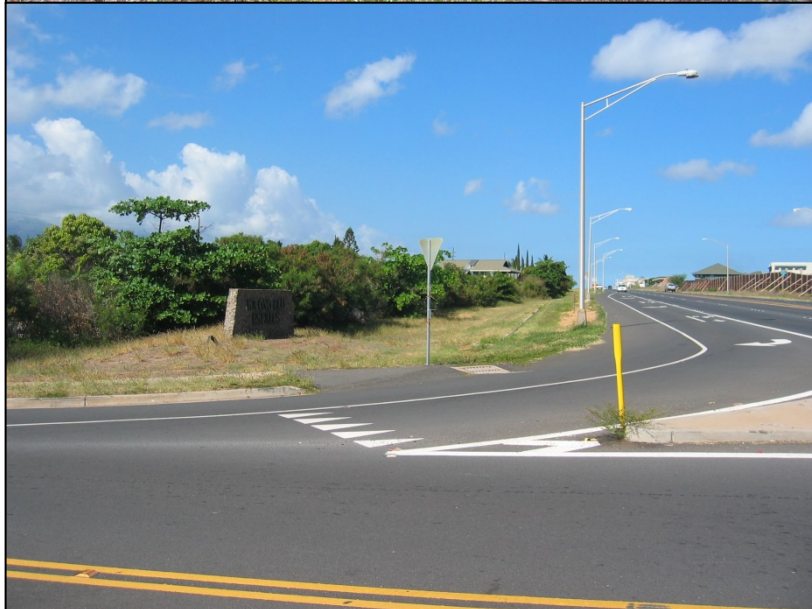
PHOTO 24

Northerly view of Subject Parcel 122 along Piilani Highway. Far right across the highway is fence around Subject Parcel 16.

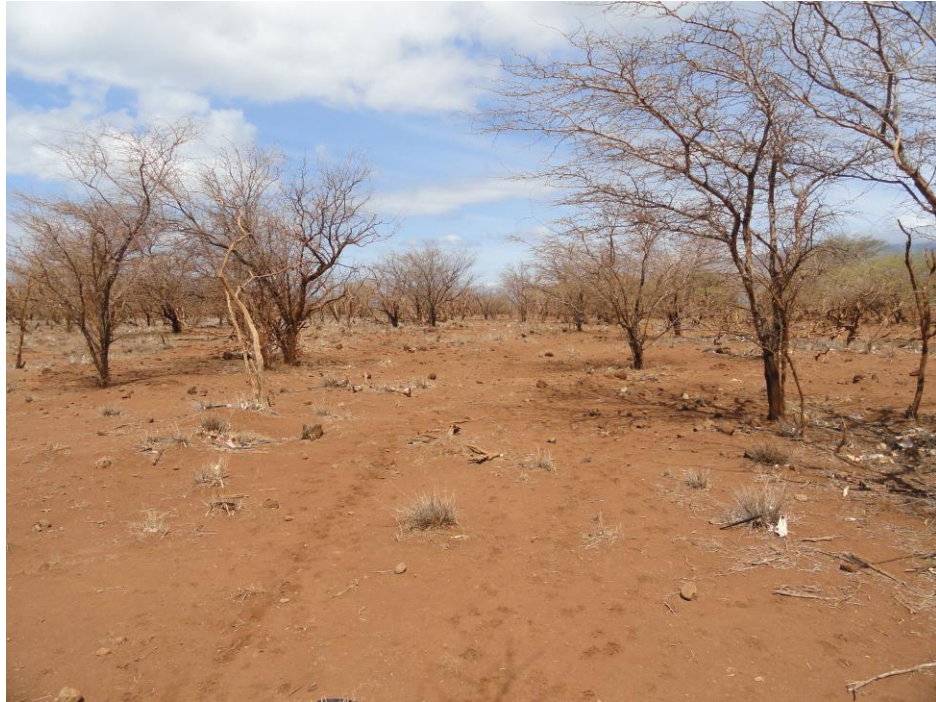
Figure 3. Waterline Corridor –
view west showing area denuded of grass.

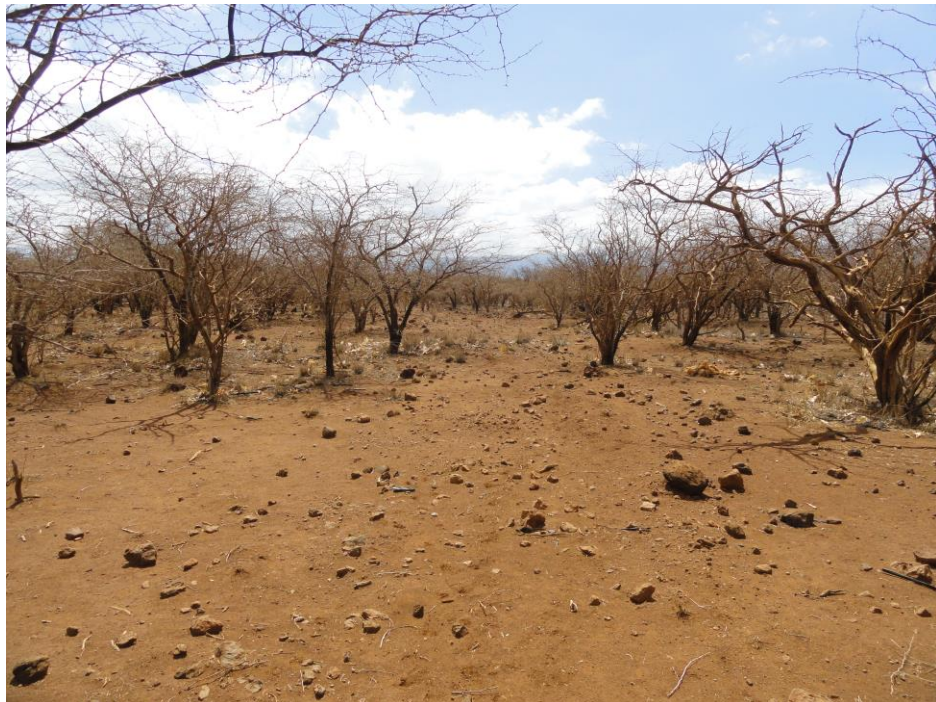
Figure 4. Waterline Corridor –
view east showing denuded rocky landscape.

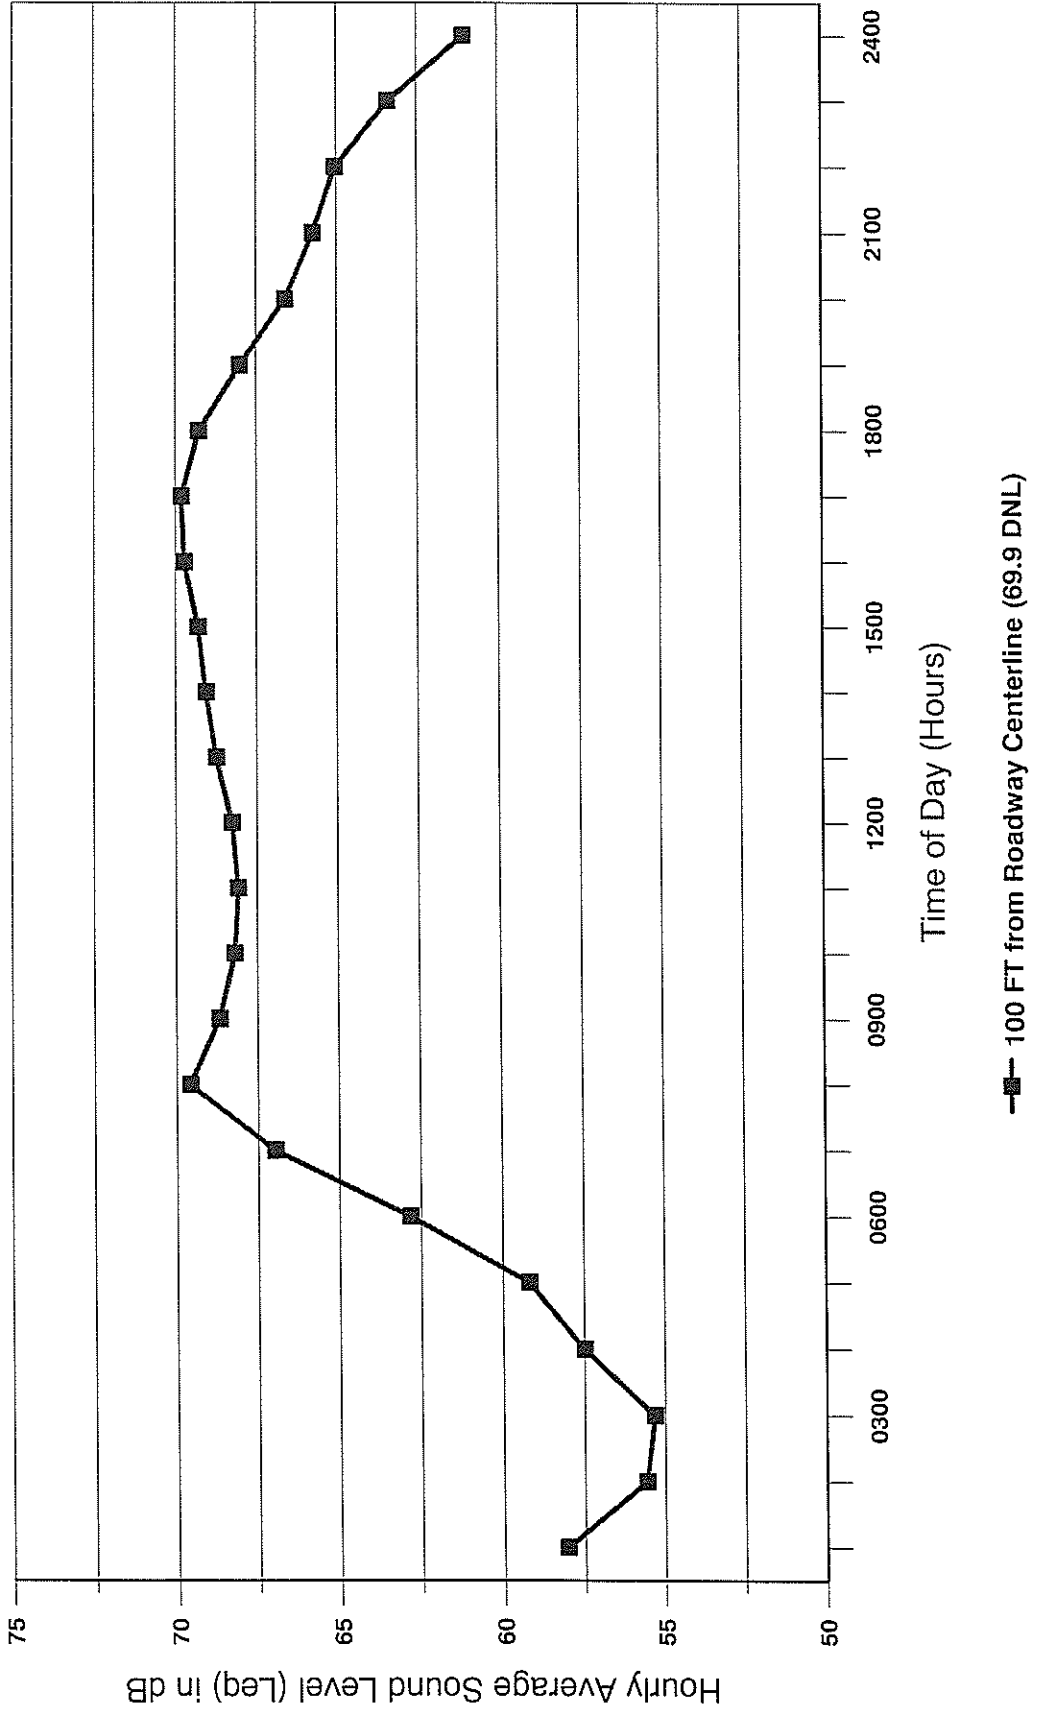
FIGURE 3
HOURLY TRAFFIC NOISE LEVELS VS. TIME OF DAY
STA. B74003100000, PIILANI HIGHWAY BETWEEN KAONOULU ST. AND KULANIHAKOI RD., 9/28/11

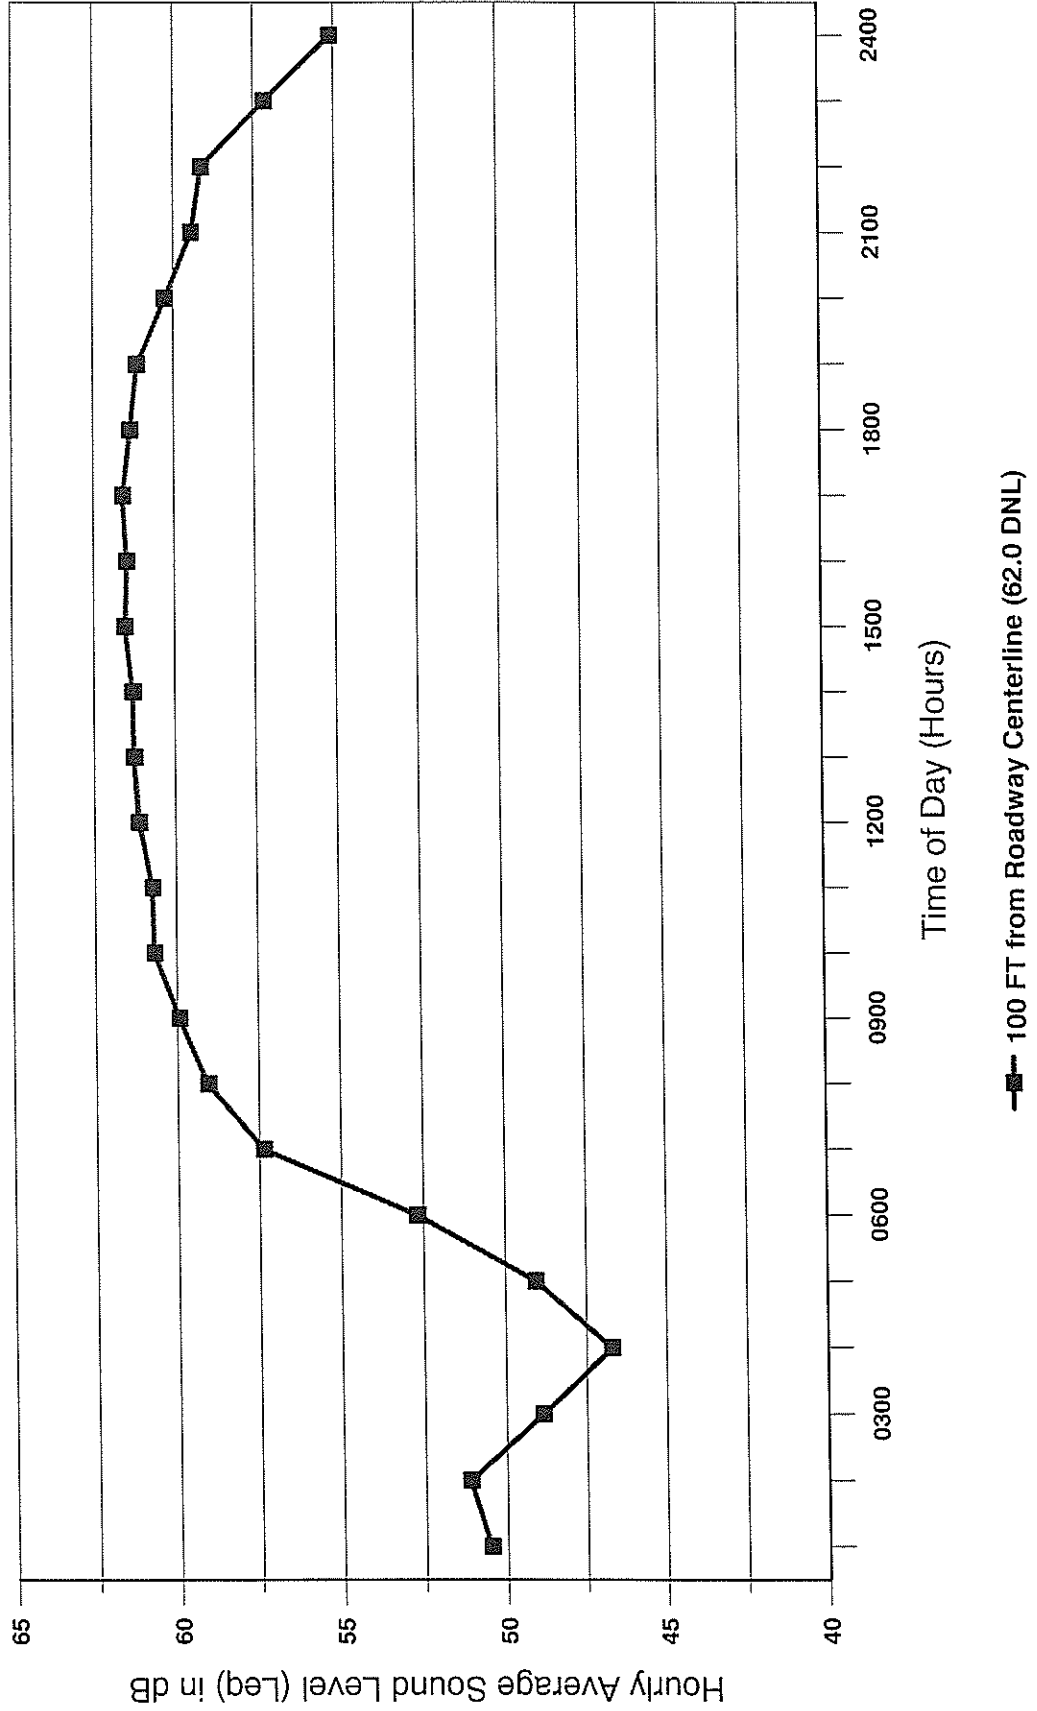
FIGURE 4
HOURLY TRAFFIC NOISE LEVELS VS. TIME OF DAY
STA. B74310000013, SOUTH KIHEI ROAD BETWEEN NOHOKAI ST. AND PIIKEA AVE., 8/19/10

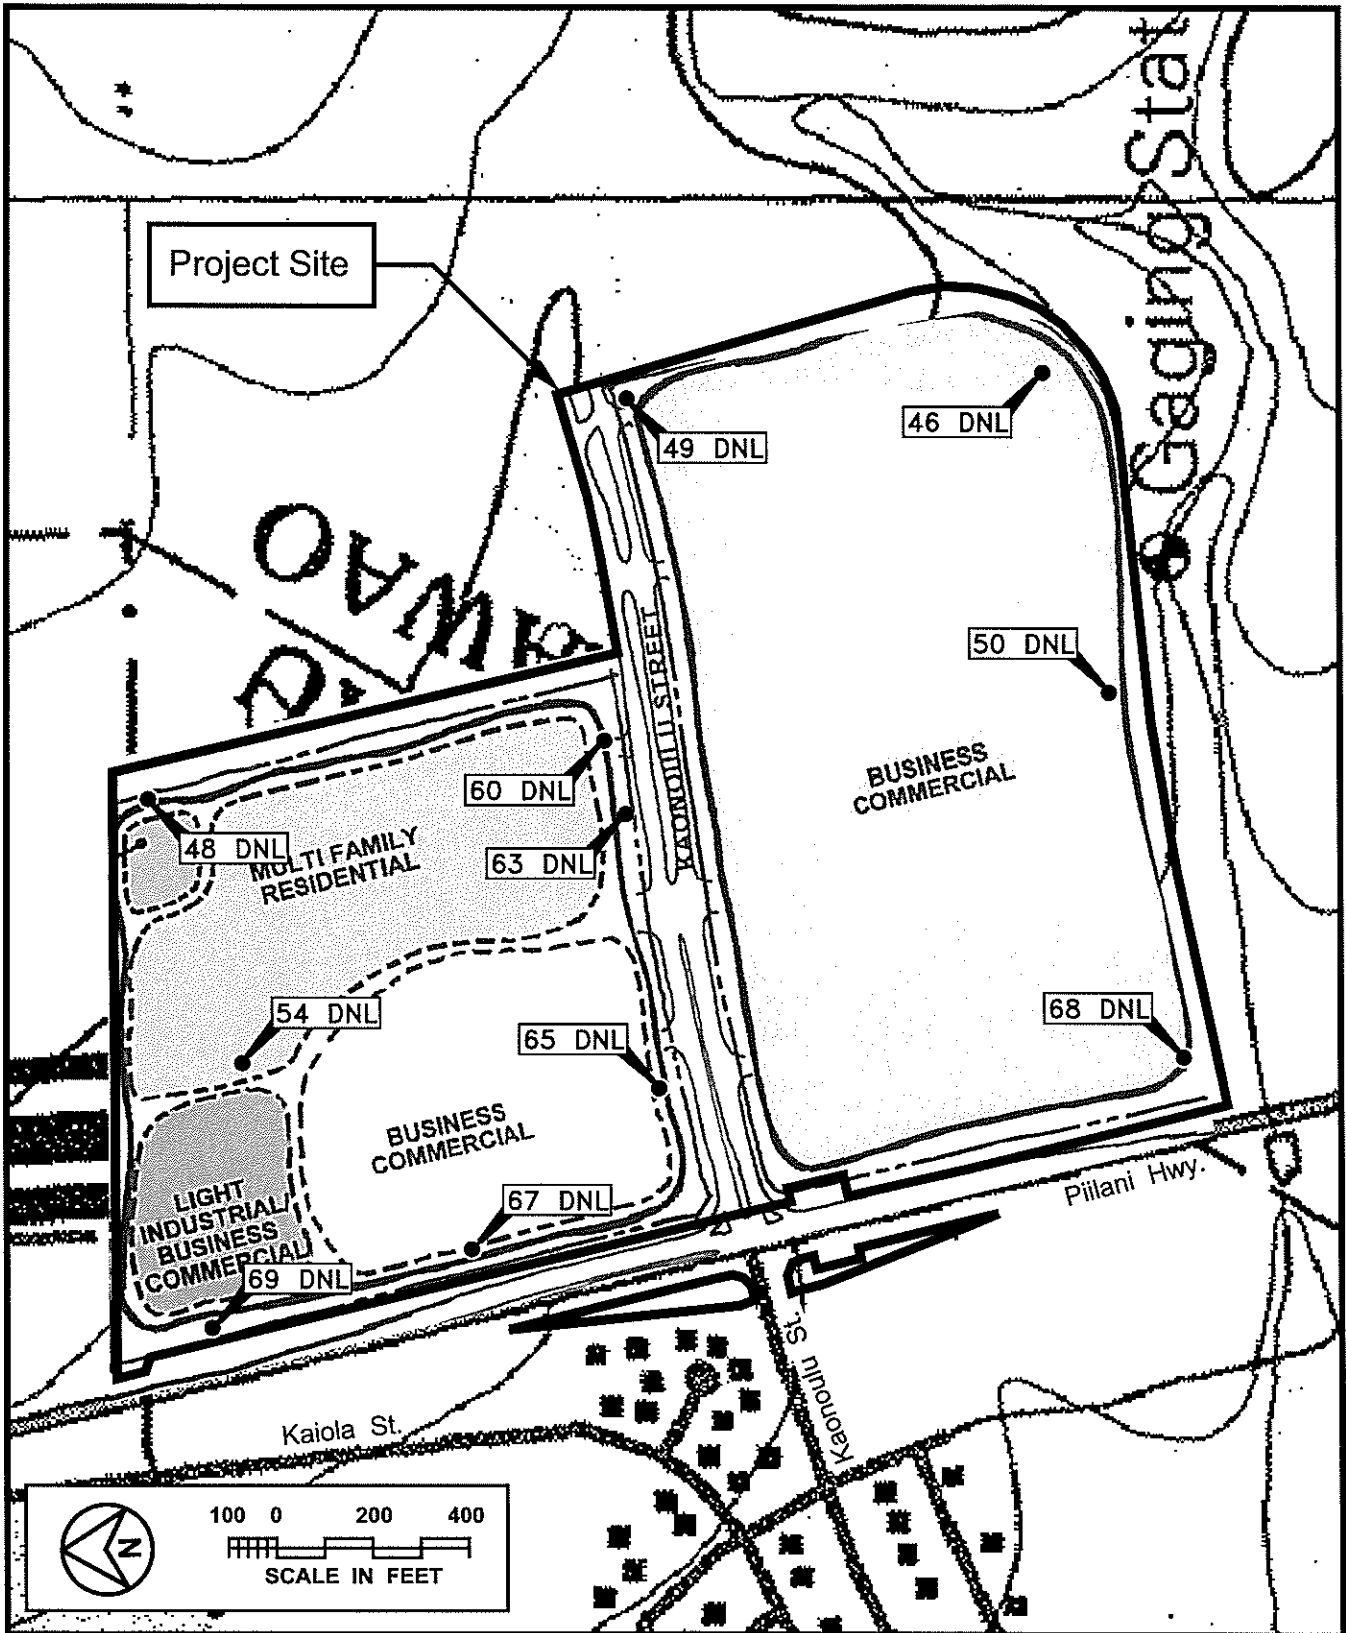
**FIGURE
6**

**PROJECT LOCATION MAP AND
FUTURE (CY 2018) TRAFFIC NOISE LEVELS**

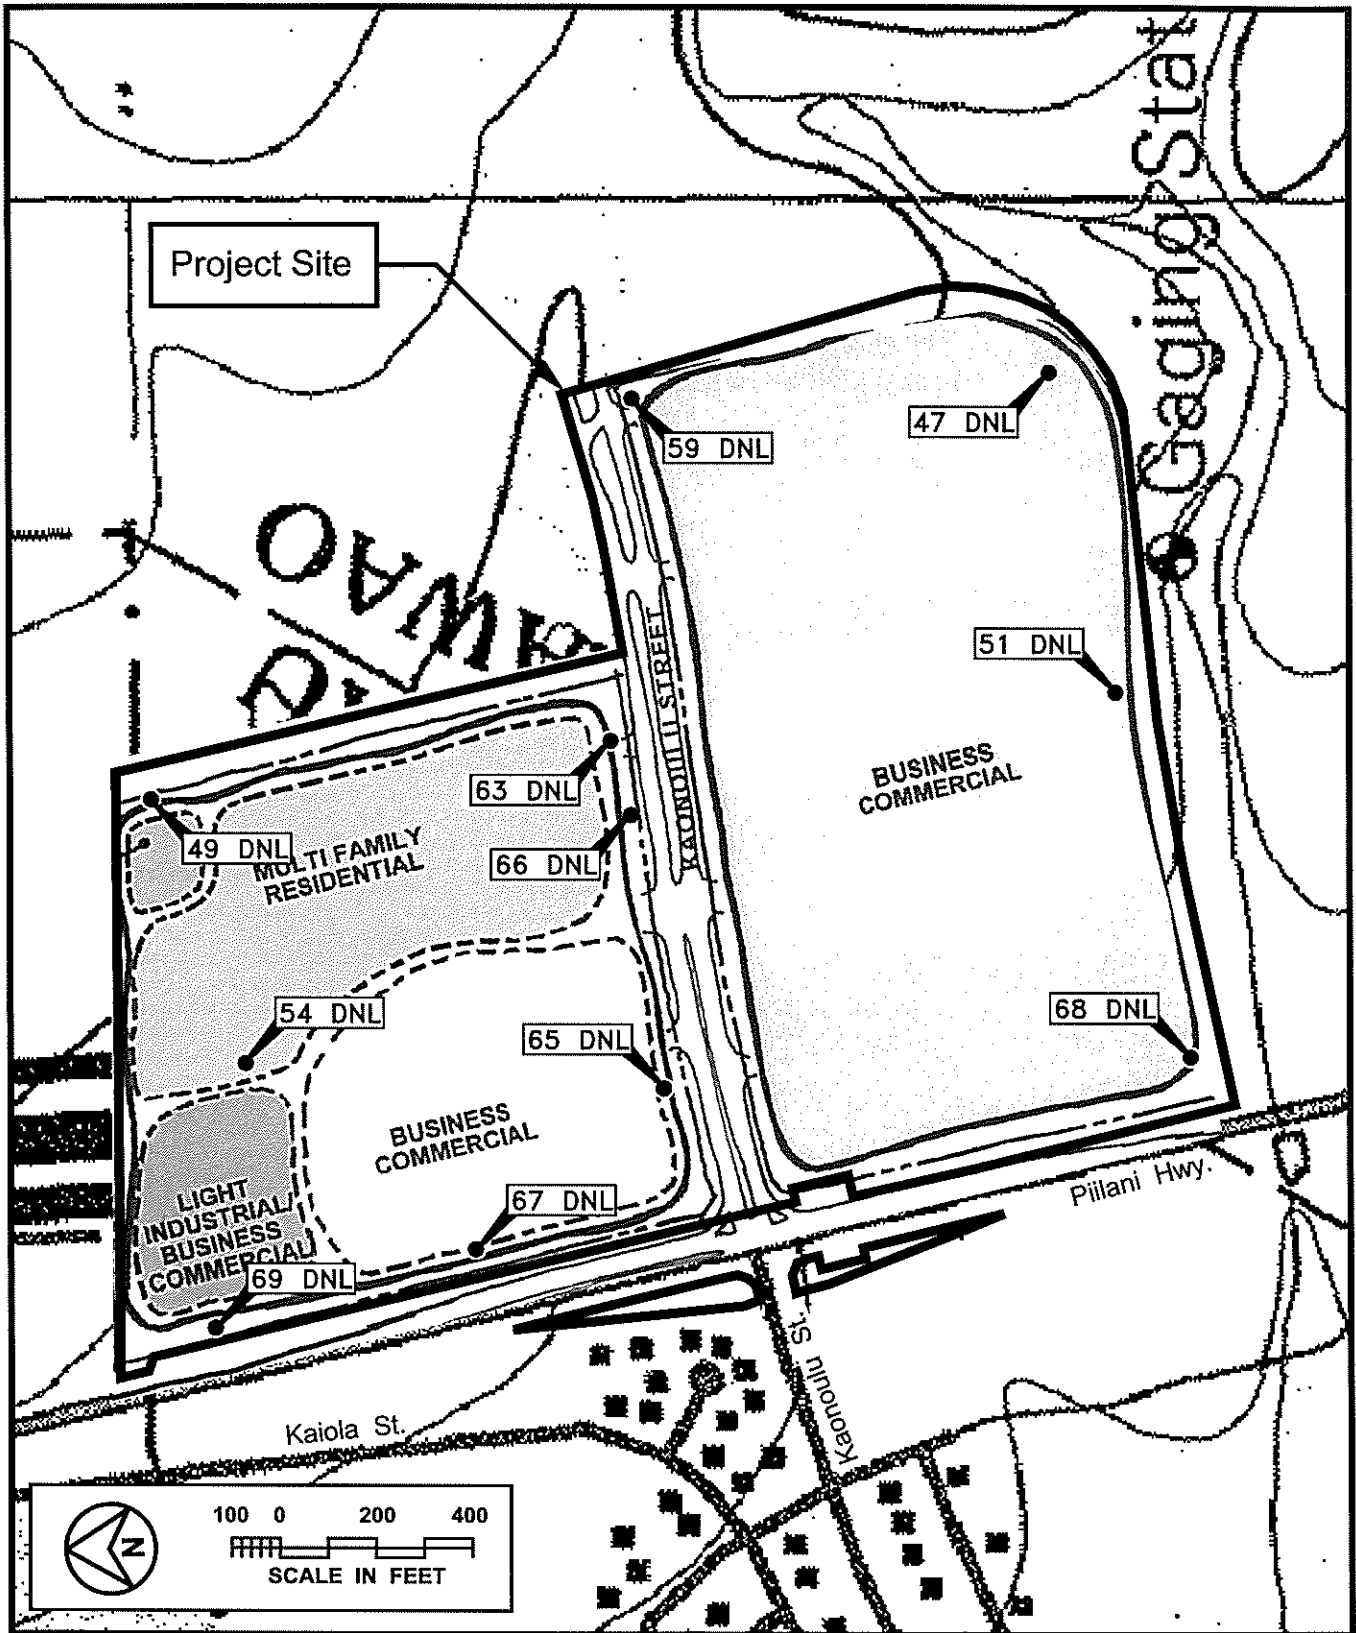
PROJECT LOCATION MAP AND FUTURE TRAFFIC NOISE LEVELS WITH UPCOUNTRY HIGHWAY

Figure 7 depicts the potential traffic noise levels over the project site following completion of the Upcountry Highway and with Kaonoulu Street accommodating the additional traffic from the Upcountry Highway. In Figure 7, the potential traffic noise contributions from Kaonoulu Street were increased in accordance with the traffic forecasts for Kaonoulu Street from Figure 22 of the traffic study (Reference 7). While the traffic noise contributions from Piilani Highway may decline following the completion of the Upcountry Highway, the higher CY 2018 values shown in Table 6A were used to develop the potential traffic noise levels shown in Figure 7 for the post-2018 period. As shown in Figure 7, the potential traffic noise levels along Kaonoulu Street will be approximately 3 DNL higher than those shown in Figure 6. The traffic noise levels at all units of the proposed multifamily residential parcel will not exceed the HDOT's "15 dB increase" noise abatement criteria by CY 2025. For the southernmost buildings of the residential parcel, a minimum setback distance of 81 feet from the centerline of Kaonoulu is required so that traffic noise levels do not exceed 65 DNL or the 66 Leq HDOT noise abatement criteria by CY 2025.

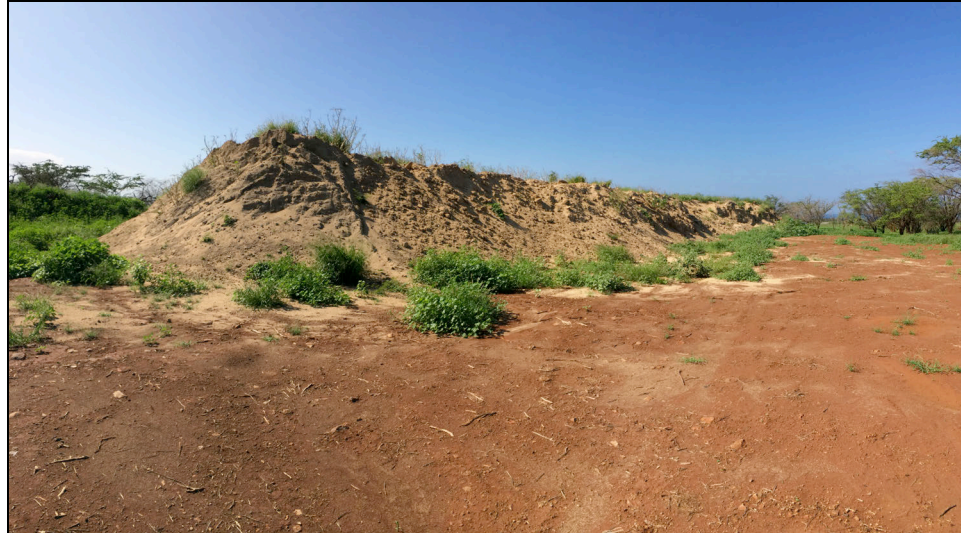
Photo 3: Photo of the sand storage pile, c. 2 meters tall, is stored on northern portion of proposed Piilani Promenade development, near Lot 2B.

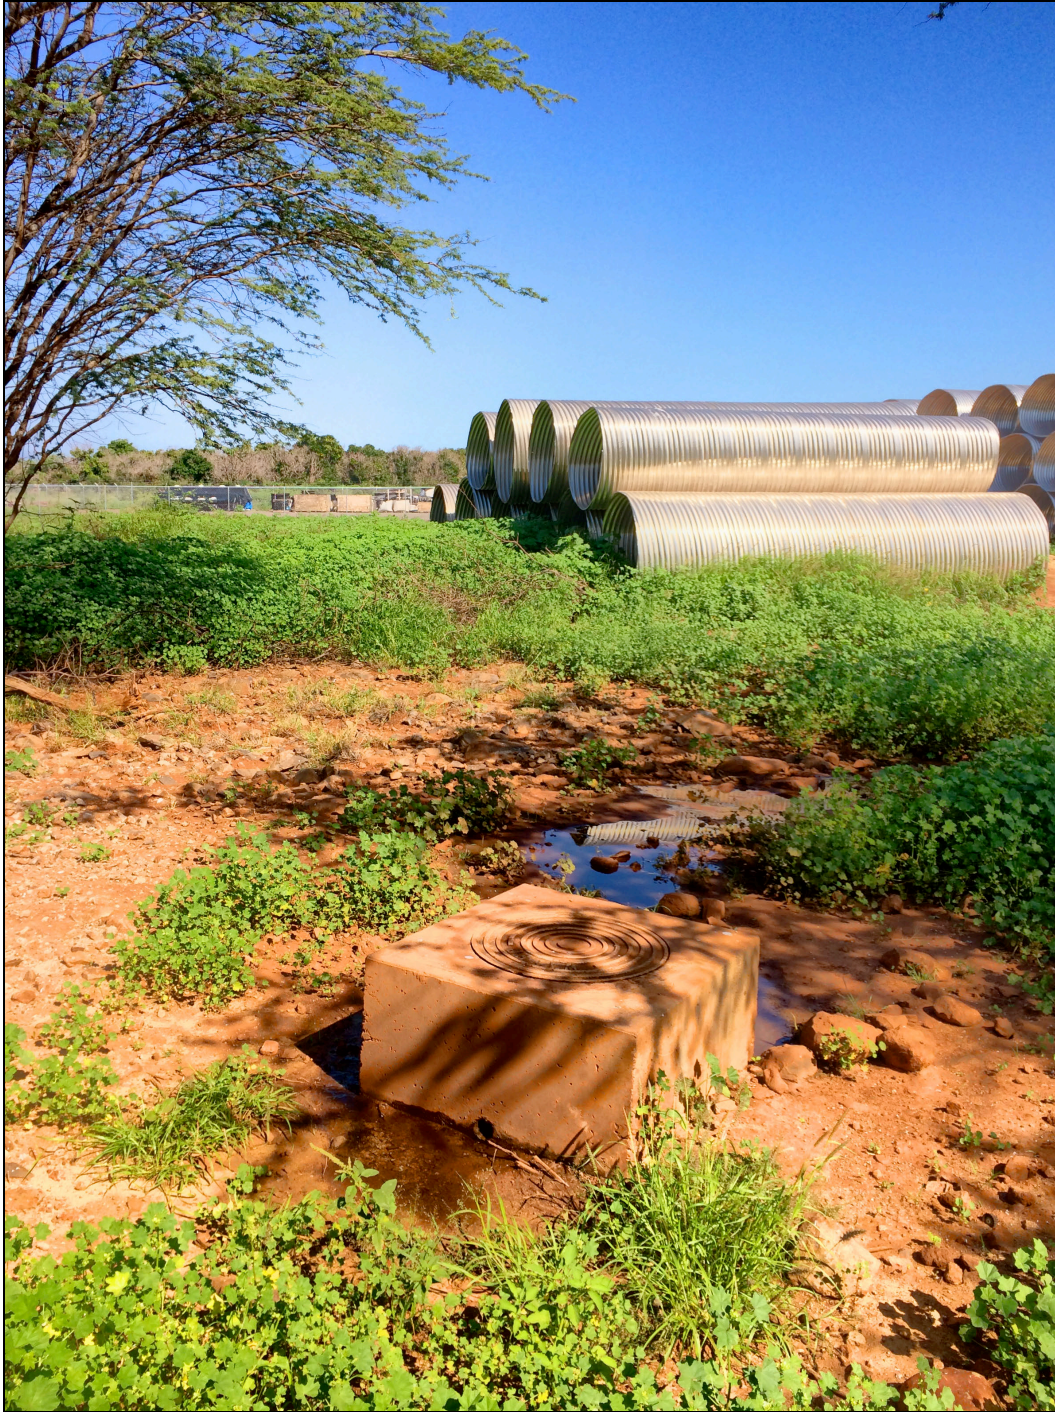
Photo 5: Photo showing the existing waterline manhole near the northeast of the base yard. This water line will be abandoned and a new waterline will be installed along the east and south border of the Piilani Promenade project area.

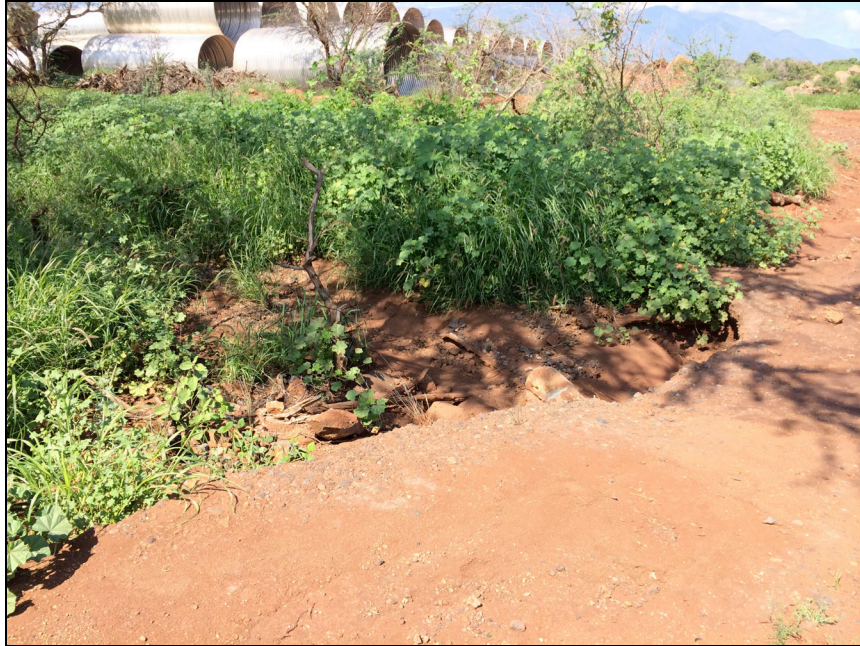
Photo 6: Small drainage gully that crosses Lot 2B near the base yard.

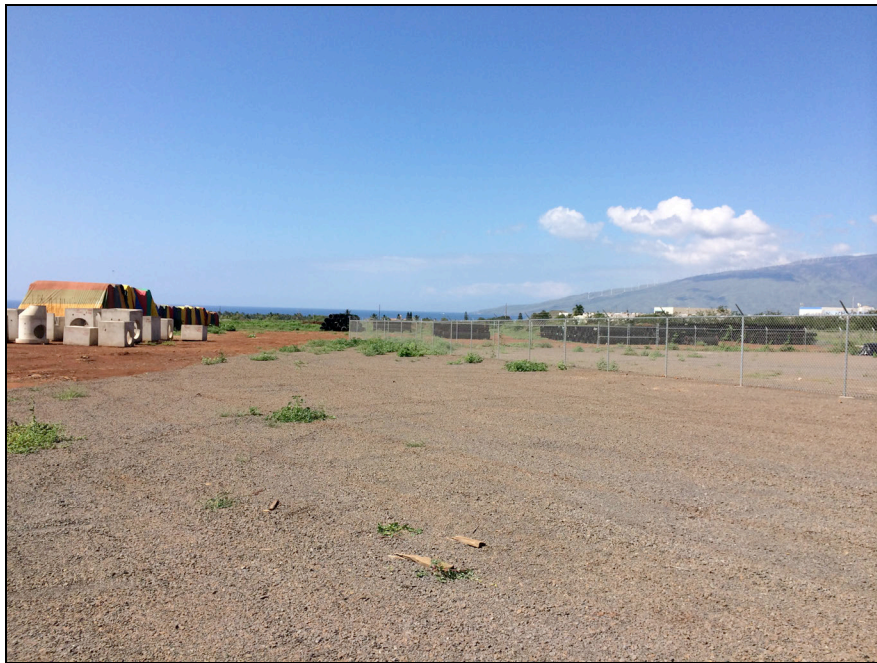
Photo 7: Base yard near Lot 2B. View to the west. Note the chain link fence is within the Lot 2B section owned by Honua`ula Partners, LLC. View to the west.

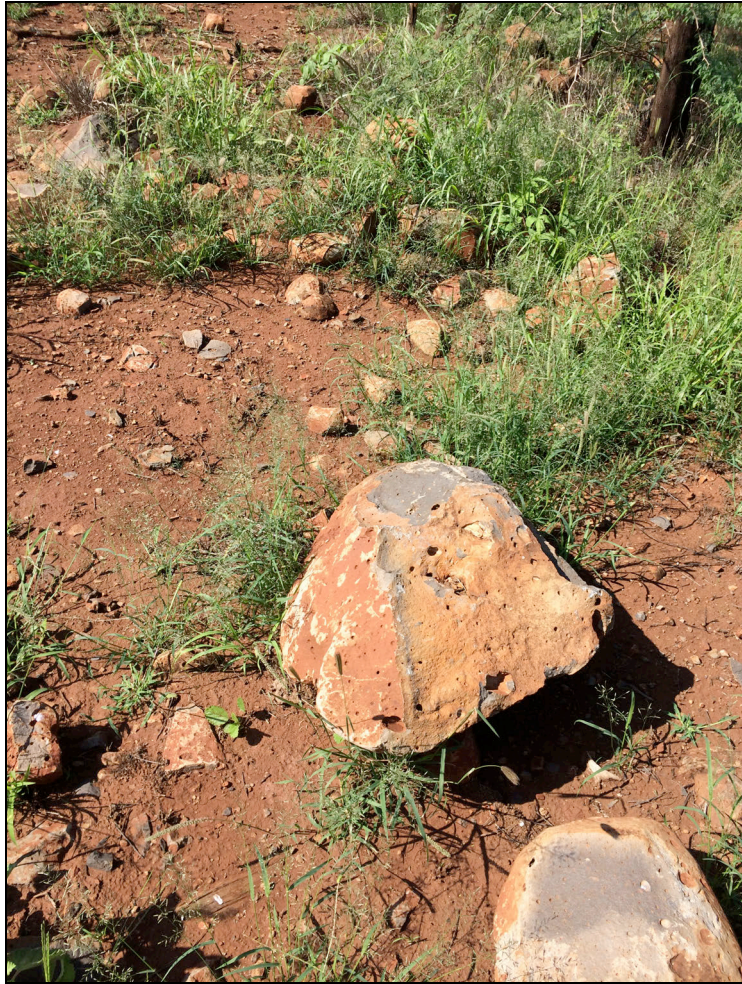
Photo 17: Bulldozer scarring on the rocks.

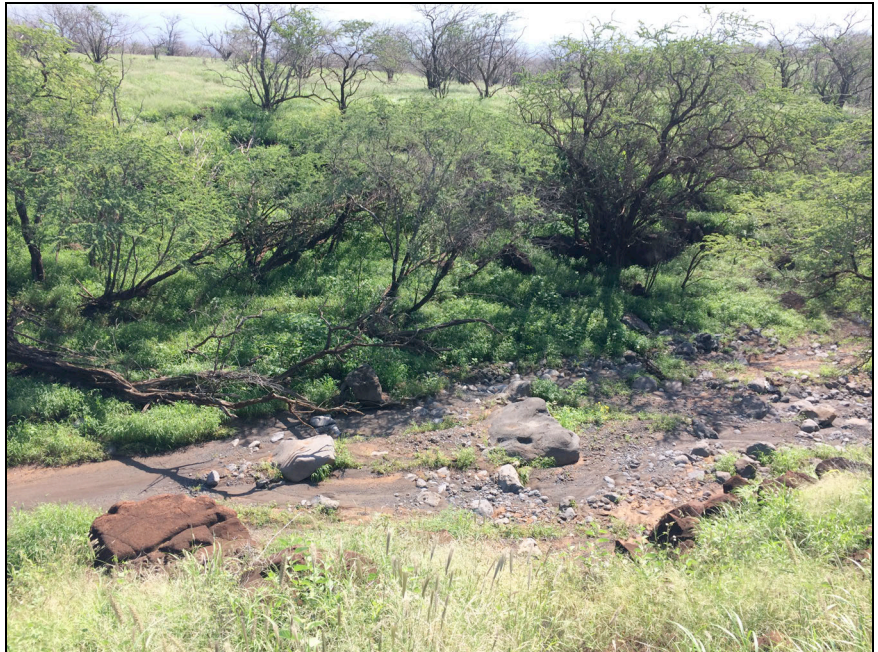
Photo 20: Kulanihakoi Gulch showing the flood washed bottom after the heavy recent rains. This gulch will not be impacted during the construction project.

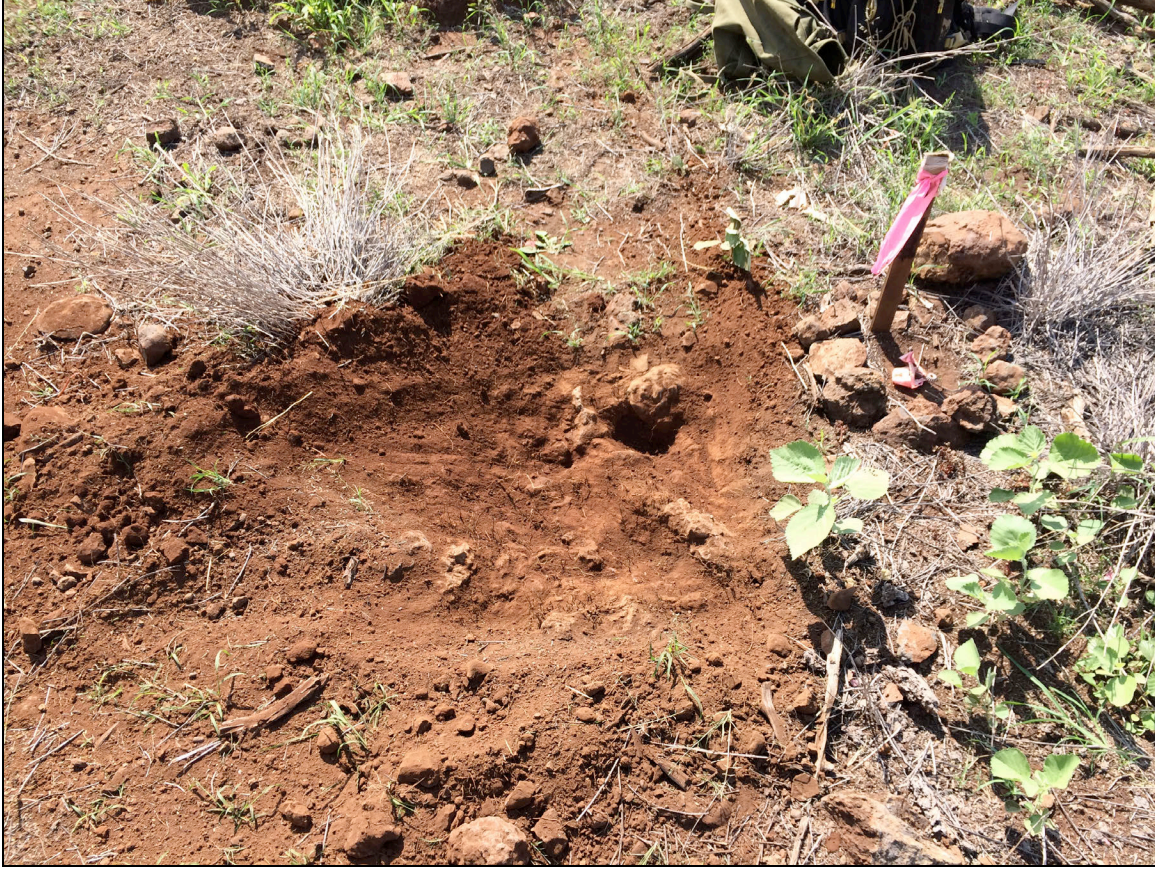
Photo 22: Northeast profile of Shovel Test 1.
