DRAFT ENVIRONMENTAL IMPACT STATEMENT FOR PIILANI PROMENADE

APPENDICES B- H

Environmental Site Assessment

Environmental Site Assessment: *Phase I Investigation - Pi'ilani Promenade LLC*

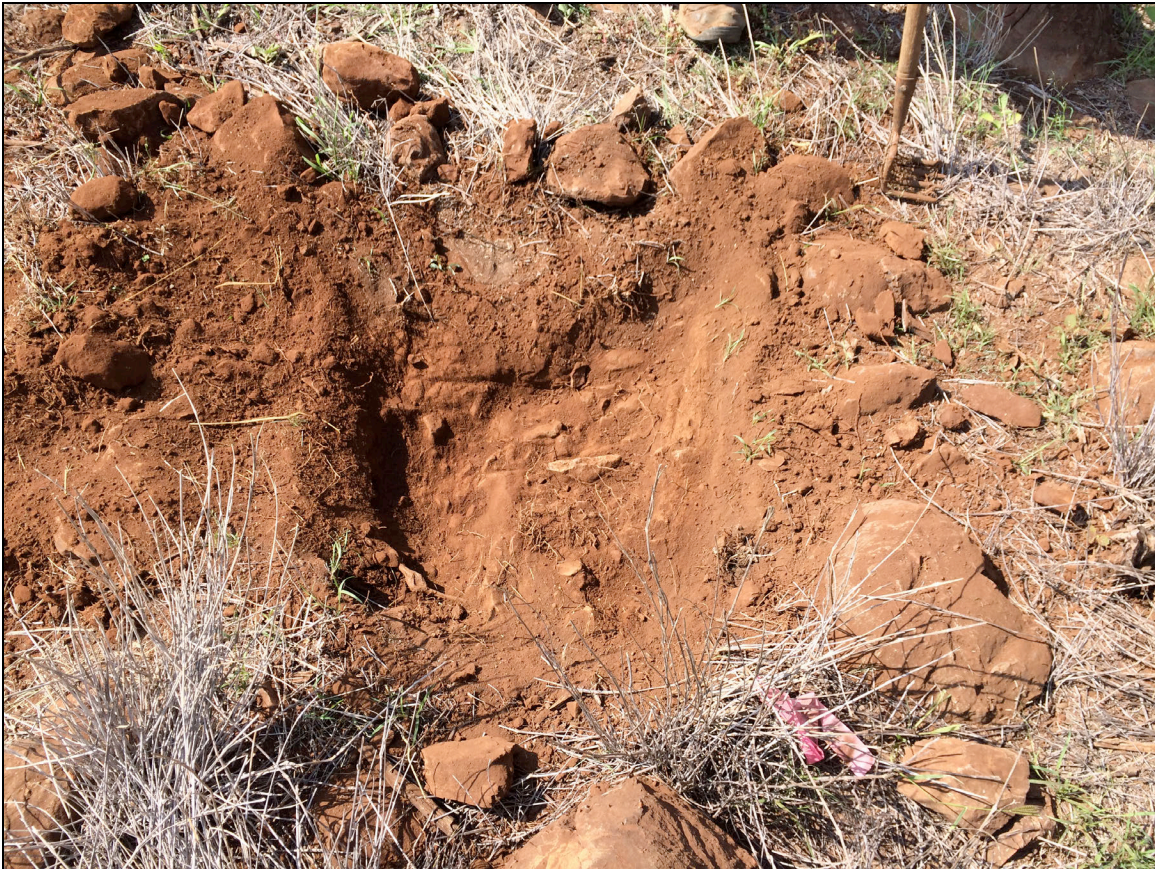
Photo 23: Northwest profile of Shovel Test 2.

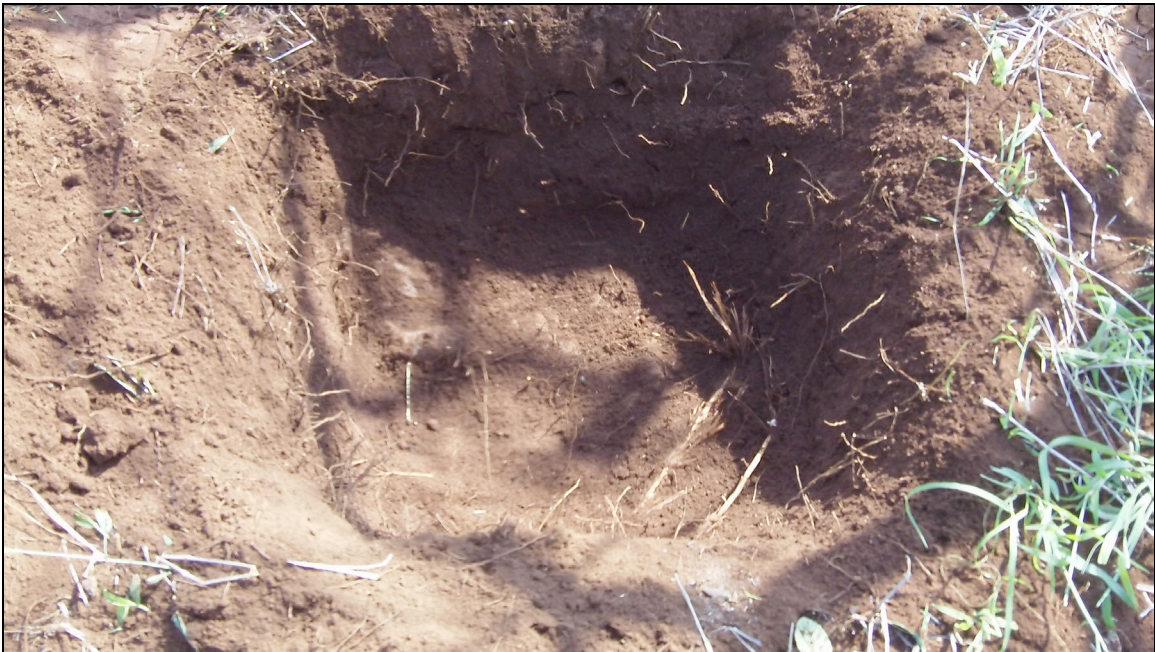
Photo 24: Northeast Profile of Shovel Test 3.

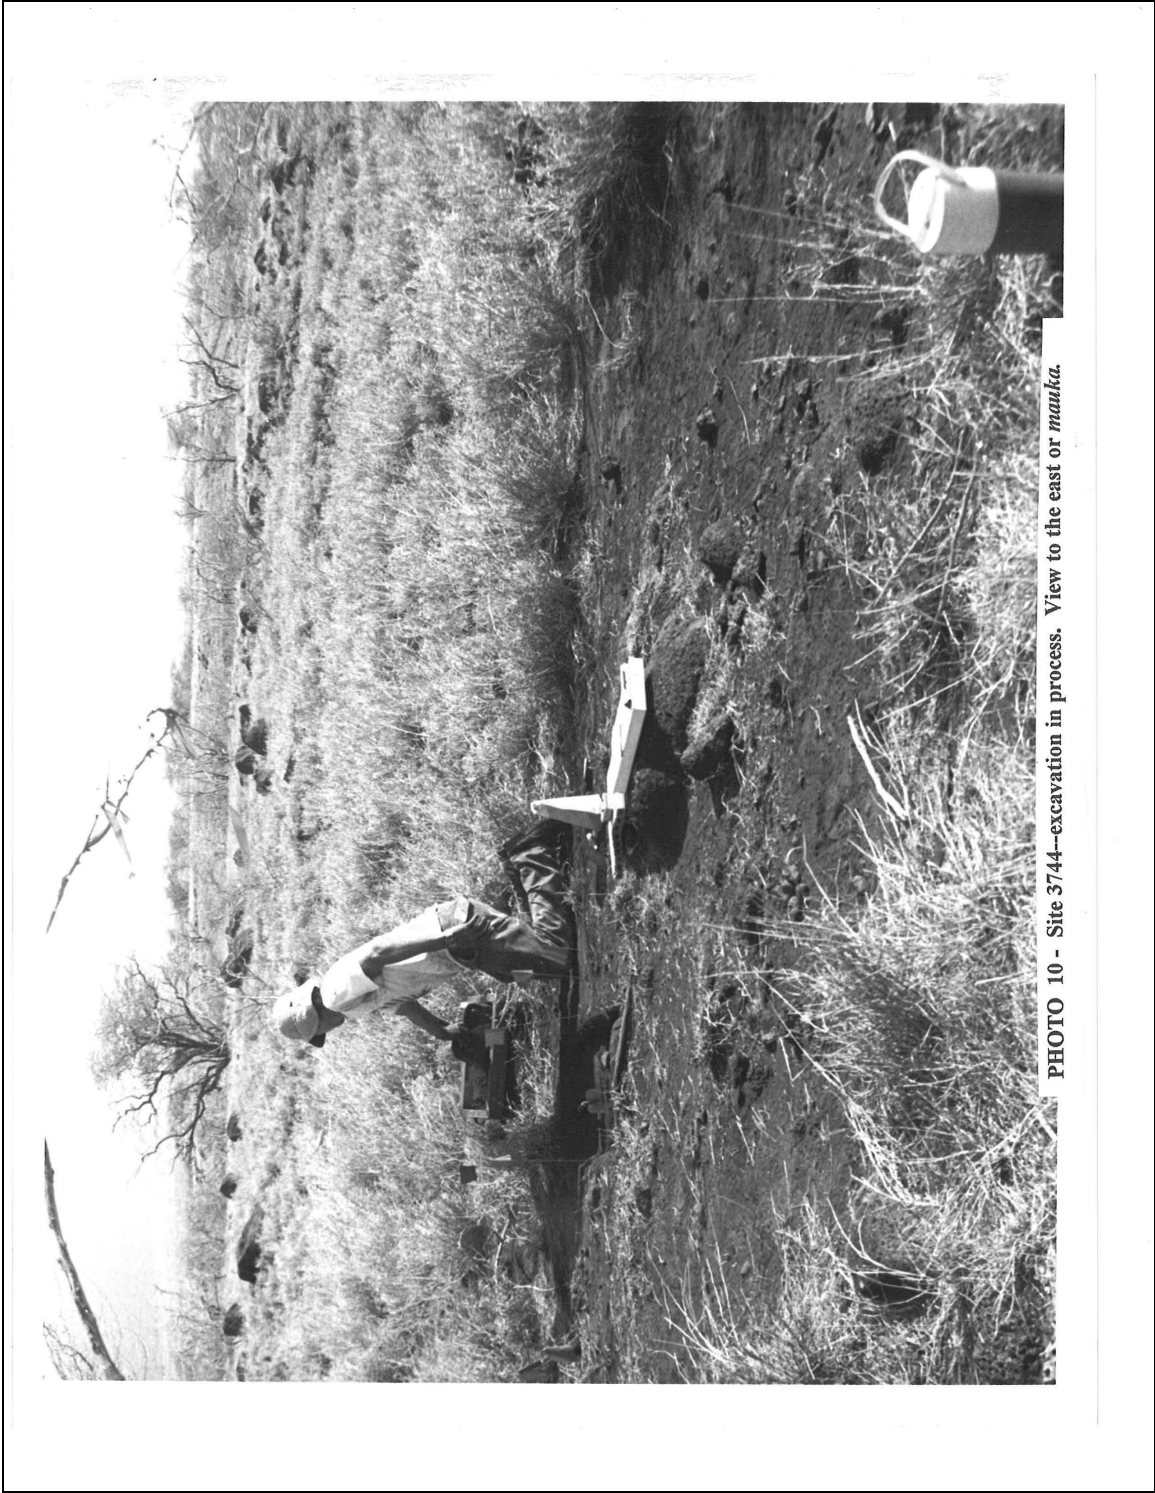
PHOTO 10 - Site 3744--excavation in process. View to the east or *mauka*.

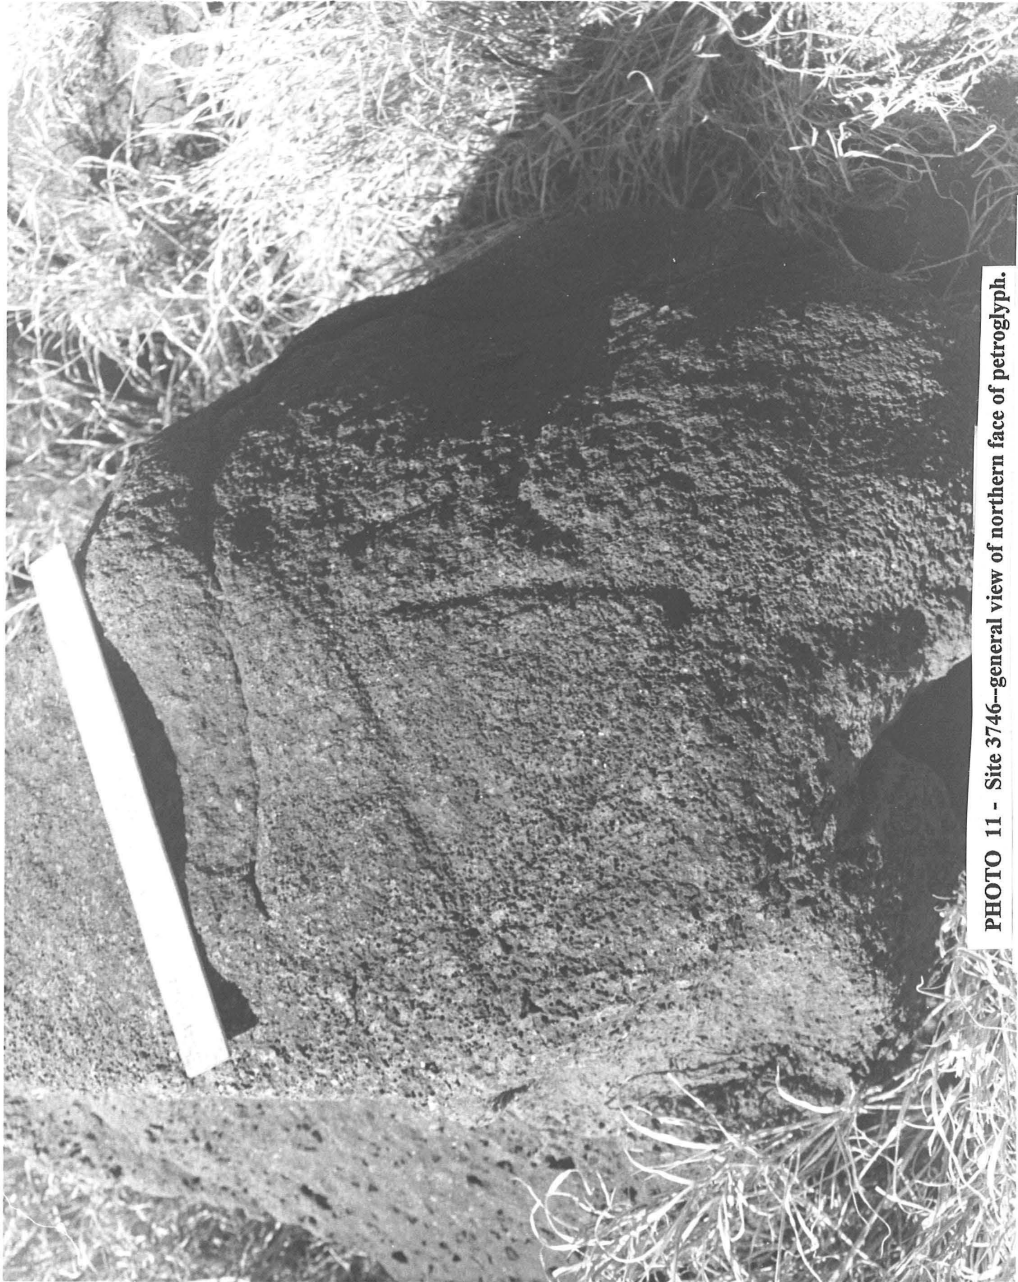
PHOTO 11 - Site 3746--general view of northern face of petroglyph.

Petroglyph Site 3746 (Figure 25; Photo 11)

Site 50-10-3746 (Figure 25)

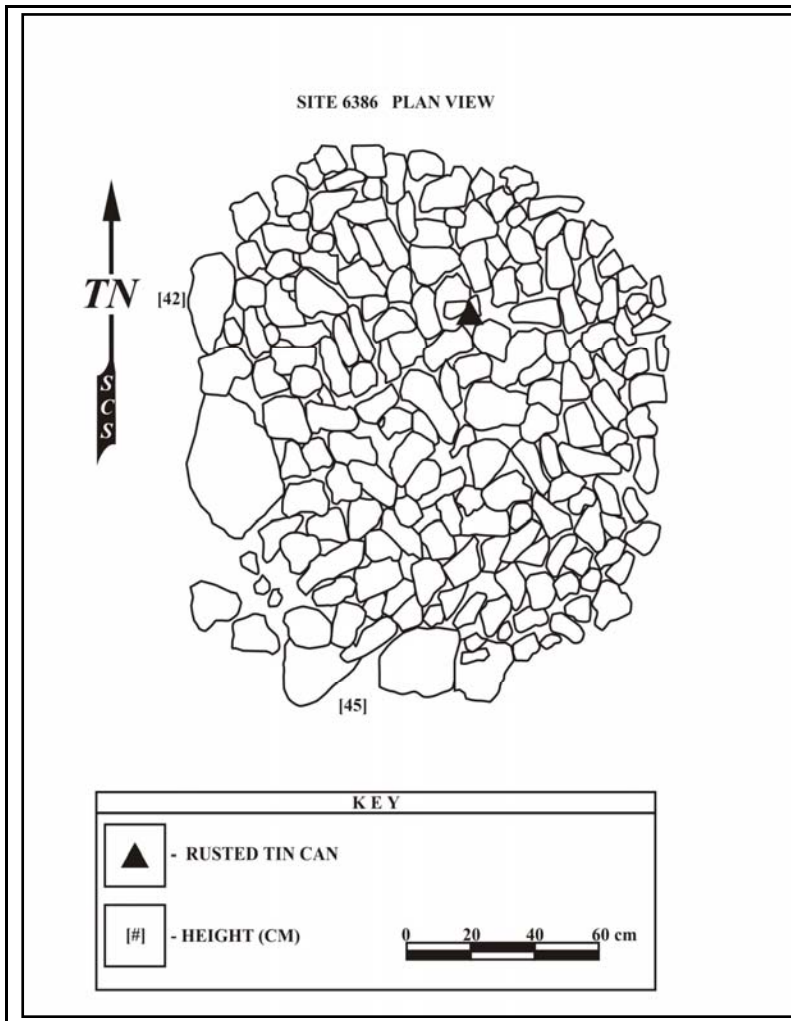
Figure 6: Plan View of Site 6386.

Site 6386 is a circular rock mound measuring approximately 1.6 m in diameter (Figure 6). Located in the western end of the project area, this single-feature site was a military structure. Unlike agricultural mounds, which are typically very close together and loosely stacked and piled, this feature displays orderly construction in which the boulders, though

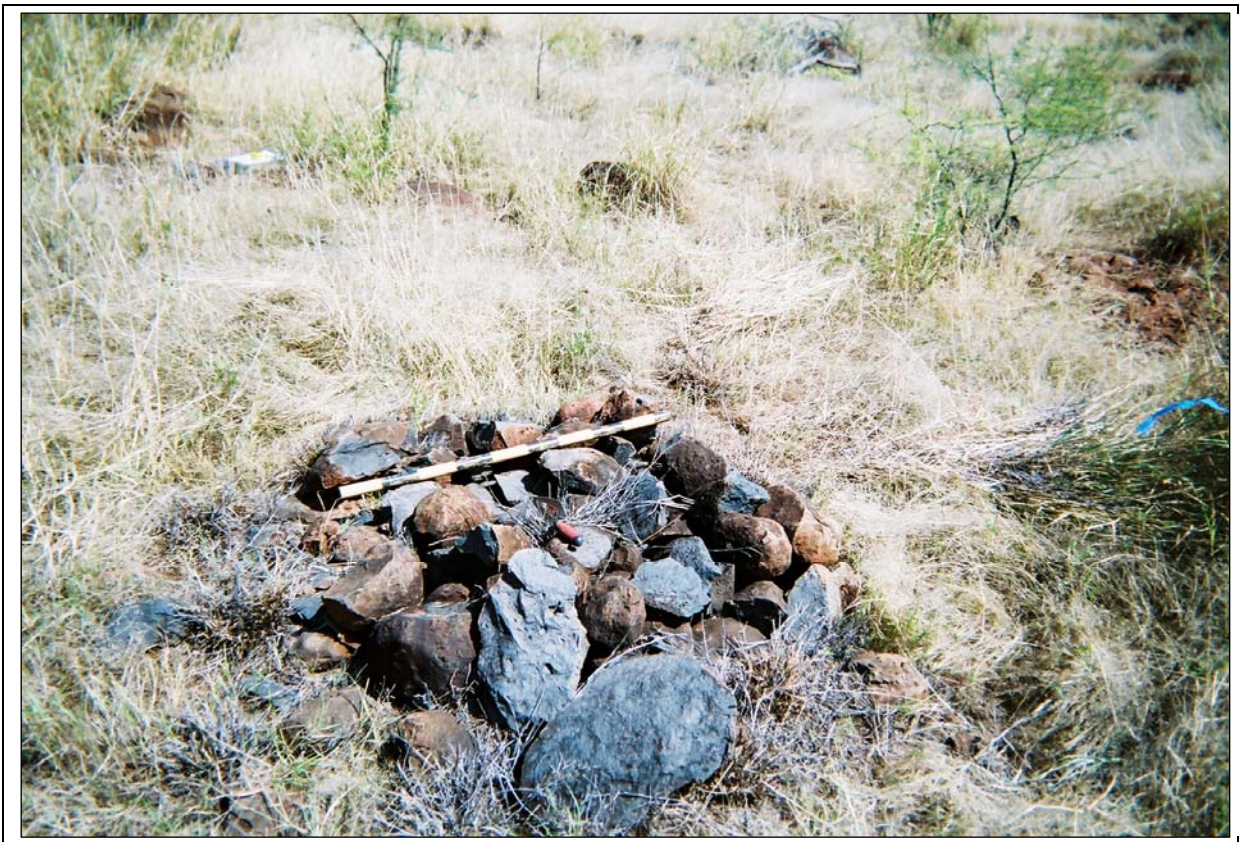
Figure 12: Photographic Overview of Site 6392.

Located approximately 50.0 m southeast of 6386, Site 6392 is a neatly stacked, oval-shaped rock mound that was likely built during the Historic Period using heavy equipment (Figure 12). Similar to 6386, the area around Site 6392 has been grubbed and bedrock is exposed in numerous places around the site. The site is constructed with angular, broken up cobbles and small boulders, though these are neatly stacked so that the top of the feature is relatively flat. The mound measures 1.7 by 1.3 m. Site 6392 is significant under criterion D for its potential to yield information pertinent to the history of Maui and the state of Hawai`i.

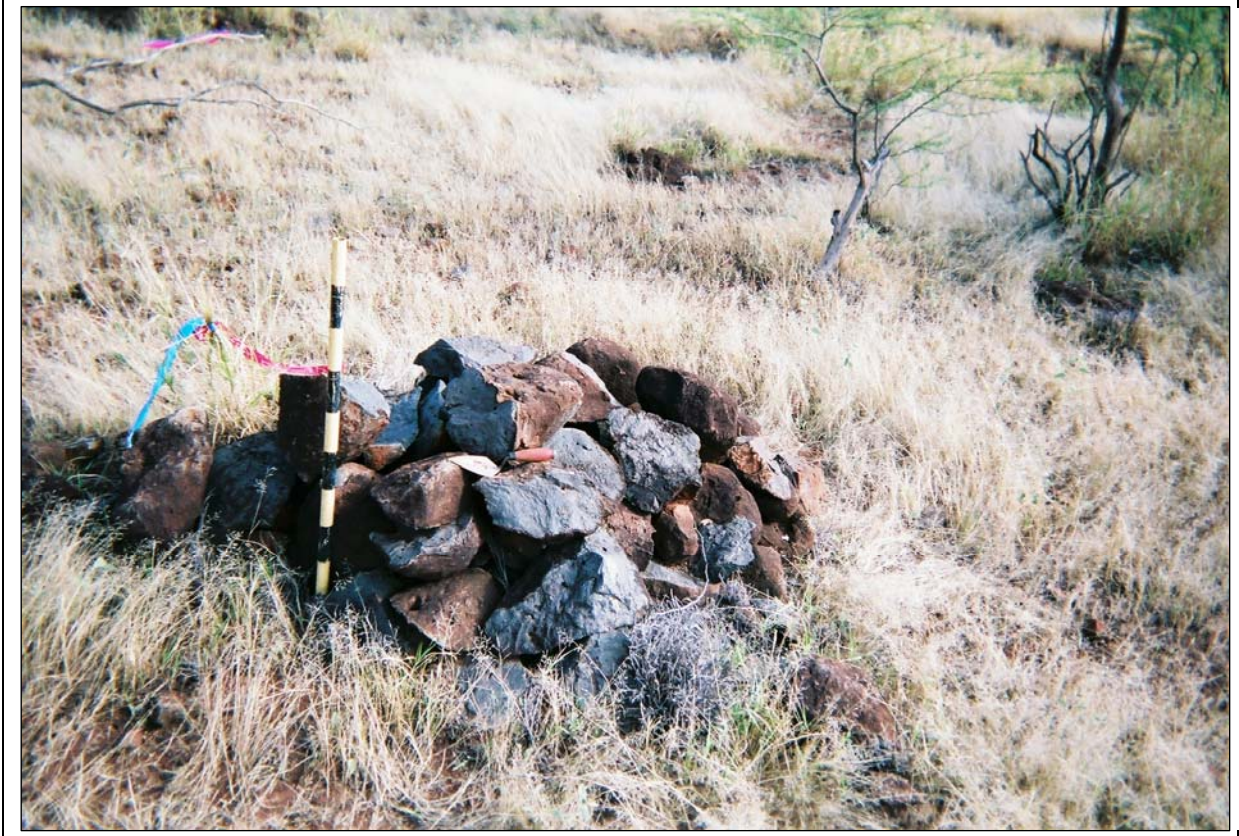
Figure 13: Photographic Overview of Site 6393.

Site 6393 consists of three features, all of which are rock mounds that were likely constructed during bulldozer activities on the lot, due to the angular, broken up condition of stones in the features and the presence of a bulldozed area (possibly an old road) just north of Feature 3 (Figure 13). The site is situated along the southern border of the project area, approximately 250.0 m east of 6392. There is a linear area of exposed bedrock just north of Feature 1. The feature dimensions are as follows: Feature 1 measures 2.6 by 1.6 m and 0.55 m

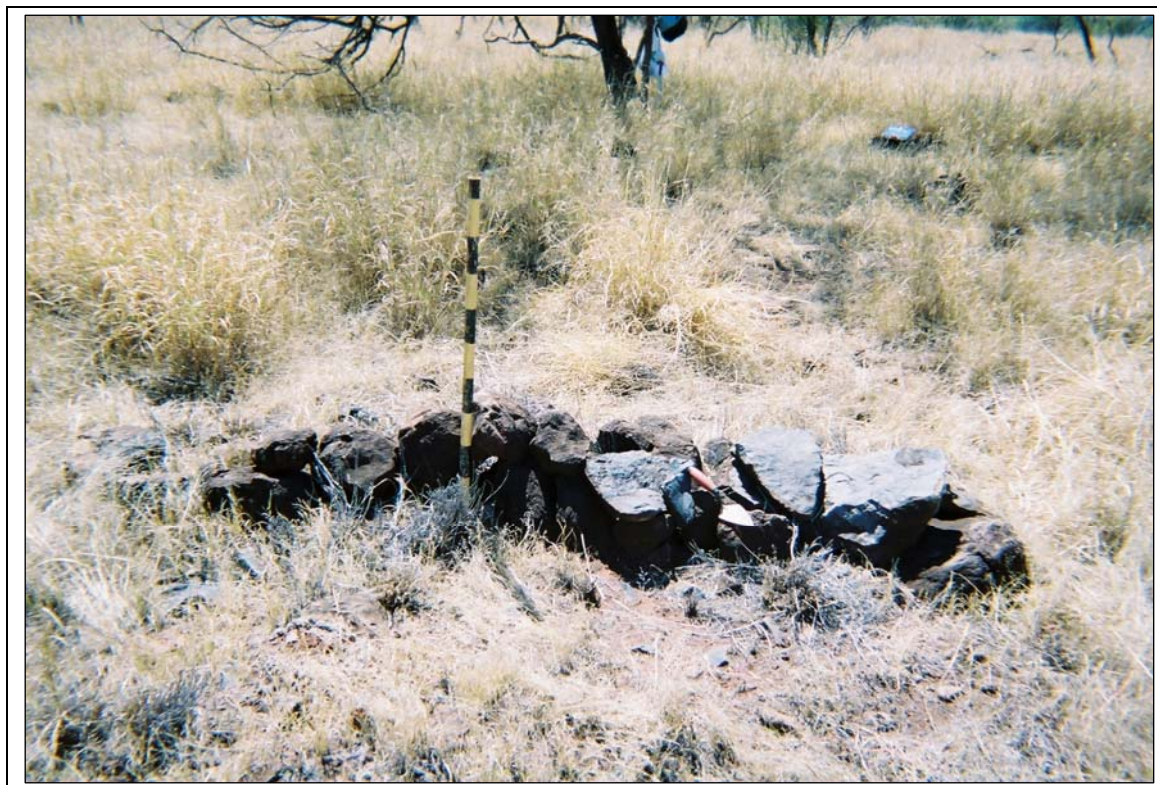
Figure 19: Photographic Overview of Site 6399.

Site 6399, a single-feature site located approximately 150.0 m northeast of Site 6394, is a linear mound consisting of angular, broken up basalt boulders and cobbles piled indiscriminately in a rectangular shape measuring 2.9 by 0.56 m and up to 0.32 m high (Figure 19). Angular broken rocks are included in the construction of this site, indicating that this mound is Historic in age, though its specific function is indeterminate. This site is significant under criterion D due to its potential to yield information pertinent to the history of Maui and the state of Hawaii.

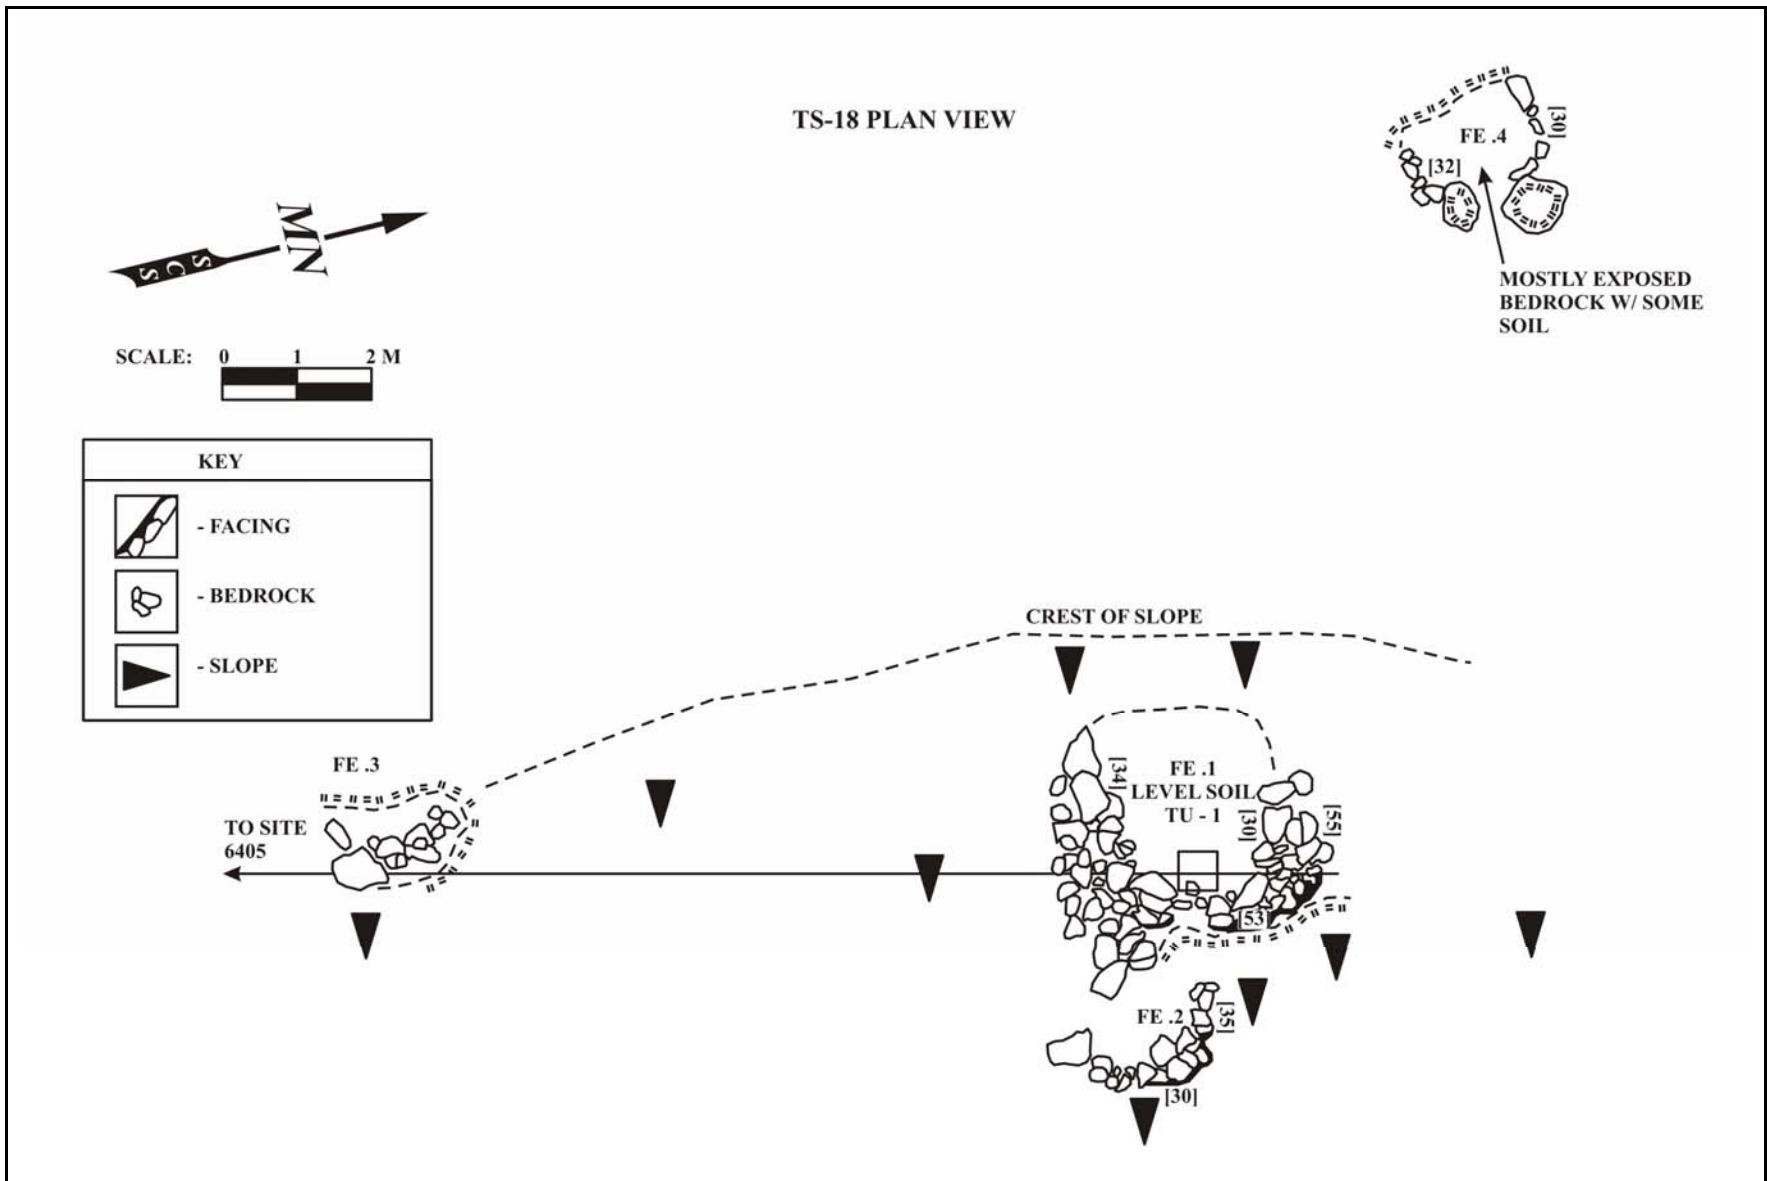
Figure 23: Plan View of Site 6403.

Site 6403 consists of four features: three C-shapes and a linear mound (Figure 23). These features are interpreted as being related to military activities in the area, as evidenced by the informal architectural construction. Each feature consists of piled basalt boulders and cobbles, though some areas show evidence of stacking. The terrain around these features exhibits extensive exposure of basalt bedrock, and each feature lies on a bedrock outcrop. Some scattered basalt flakes were observed on the ground surface between these features, implying that this site may predate military use, having been modified during the military period; the site is significant under criterion D due to its potential to yield information pertinent to the history of Maui and the state of Hawaii.

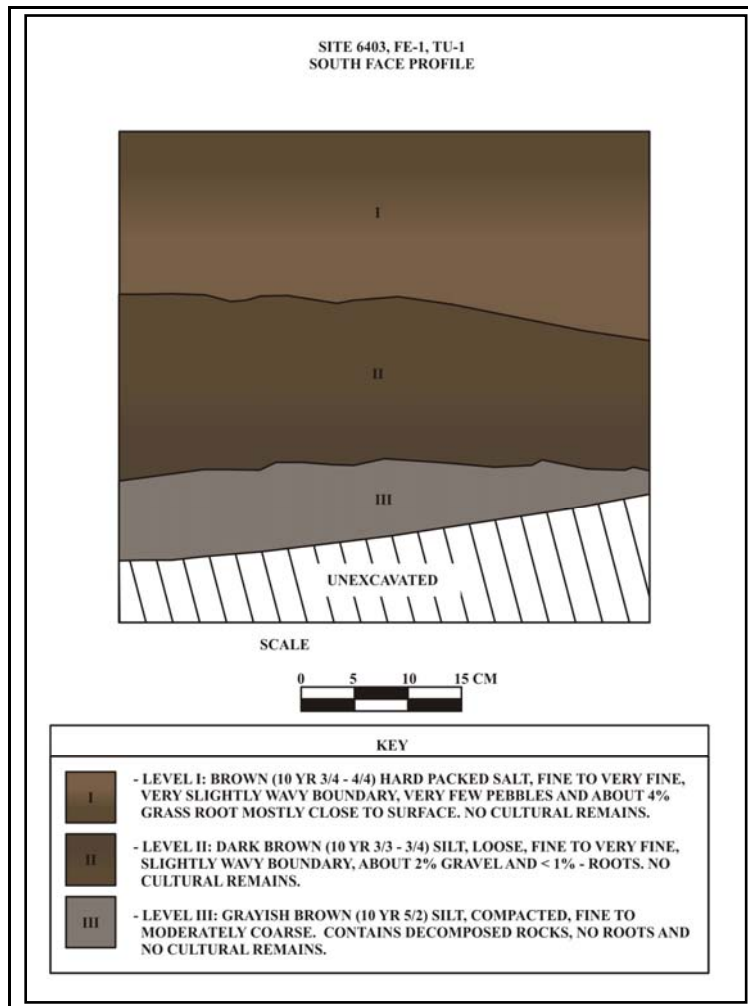
Figure 24: South Profile of Site 6403, TU-1.

TU-1 was a 0.5 by 0.5 m unit excavated against the central interior architecture of Feature 1. The datum for this unit was set at 5 cm above ground level in the southeast corner of the unit. The unit yielded three stratigraphic layers (Figure 24). Layer I (5–19 cmbd) consisted of hard-packed, brown (10 YR 3/4 to 4/4) silt. Layer II (17–36 cmbd) was made up of loose, dark brown (10 YR 3/3 to 3/4) silt. Layer III (22–42 cmbd) consisted of grayish brown (10 YR 5/2) compacted silt. No cultural materials were observed in this unit.

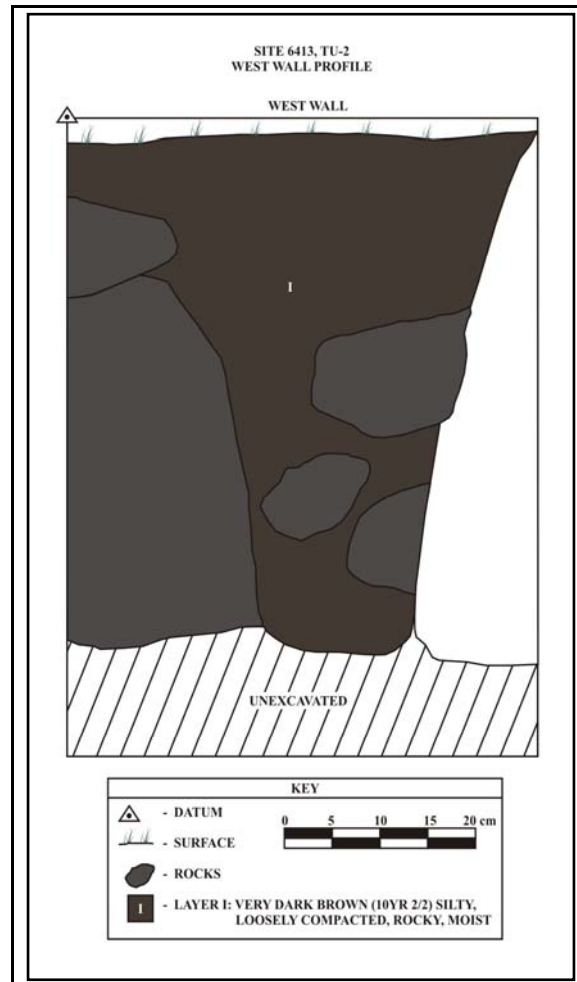
Figure 39: West Profile, 6413, TU-2.

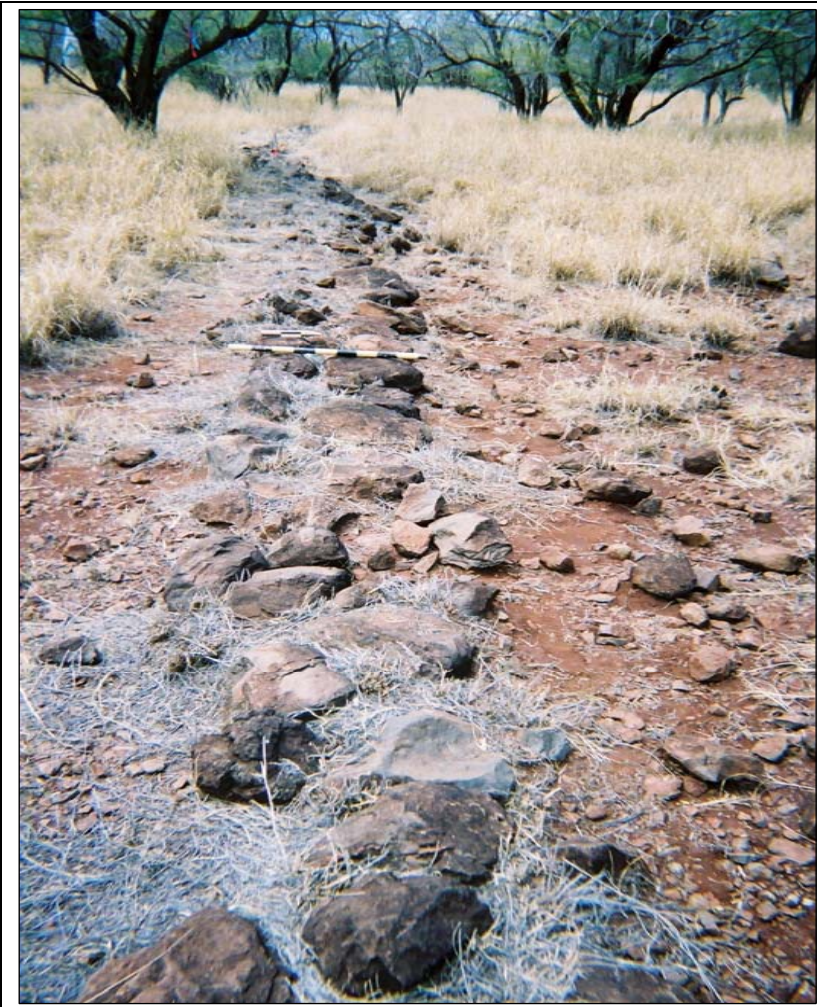
Approximately 100.0 m north of 6414 is Site 6415; a low stone wall that likely dates to the pre-Contact period (Figure 44). This single-feature site measures approximately 42.0 m long, 0.5–1.0 m wide and up to 0.2 m high. The wall meanders on an east-west bearing, showing signs of having been severely damaged by erosion and cattle disturbances. This wall terminates abruptly on the east end, where it has likely been wiped out by erosive and animal activities. Site 6415 is morphologically traditional, with a very short, but stout stacked and faced construction. This type of wall differs from a ranch wall in that it is not core-cobble-filled, but built using medium-sized boulders and large-sized cobbles throughout the wall. Its shape, meandering rather than straight, also indicates that this wall did not relate to ranching activities, and it's apparently heavy-duty (though very short) construction separates it from the roughly-constructed walls associated with military activities in the parcel. The site is significant under criterion D for its potential to yield information pertinent to the prehistory and history of Maui and the State of Hawai'i as a whole.

Figure 44: Photographic Overview of Site 6415.

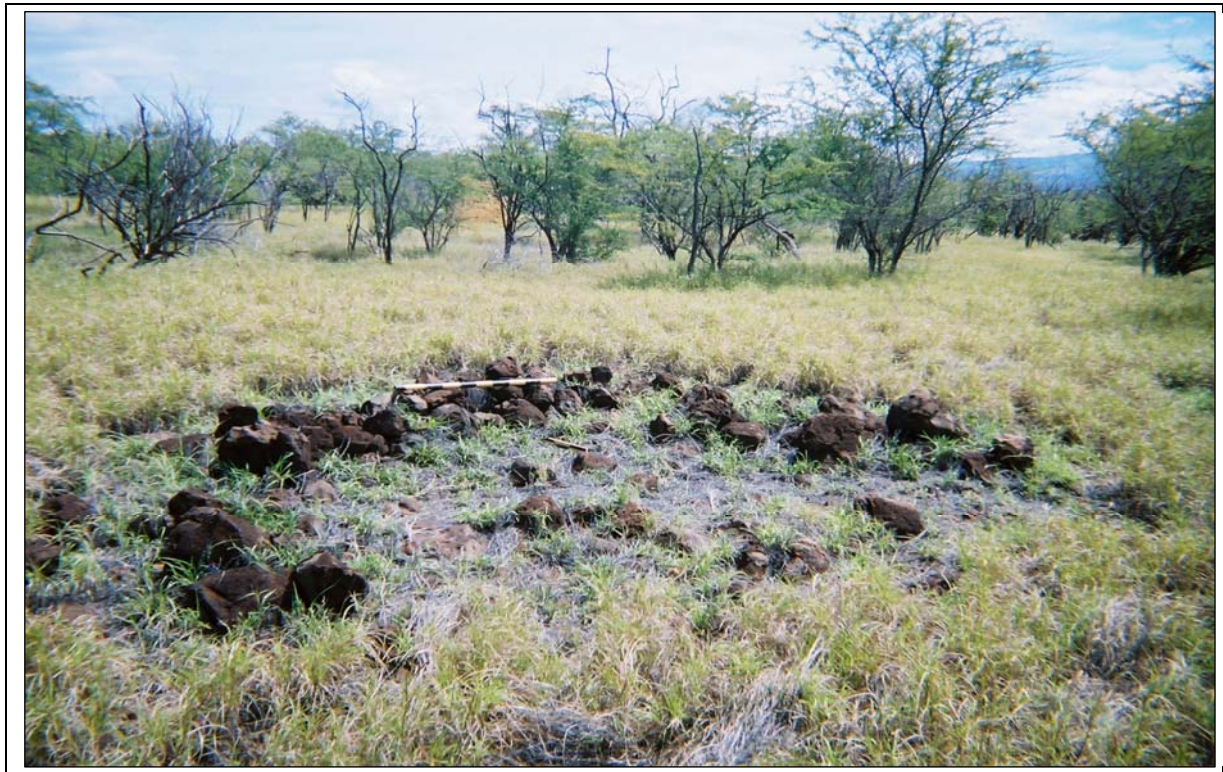
Site 6422 consists of five mounds located on land that has been extensively altered by mechanical activity (Figure 52). As such, each feature is interpreted to be associated with the most recent land clearing activities on the lot. These features are situated in a 625.0 square meter area on the southern flank of lower Kulanihako'i Gulch. As these mounds are amorphous and similar to other mound features described previously for this project area, Site 6422 was not mapped. Feature 1 is a circular mound measuring 1.2 m in diameter and approximately 0.4 m high. Feature 2 measures 1.8 by 1.1 m and 0.37 m high. Feature 3 measures 1.3 by 0.9 m and 0.4 m in height. Feature 4 measures 1.1 by 0.7 m and 0.26 m high. Feature 5 measures 1.7 by 0.8 m and 0.3 m high. The site is significant under criterion D for its potential to yield information important to the history and/or prehistory of Maui and the state of Hawai'i.

Figure 52: Photographic Overview of Site 6422.

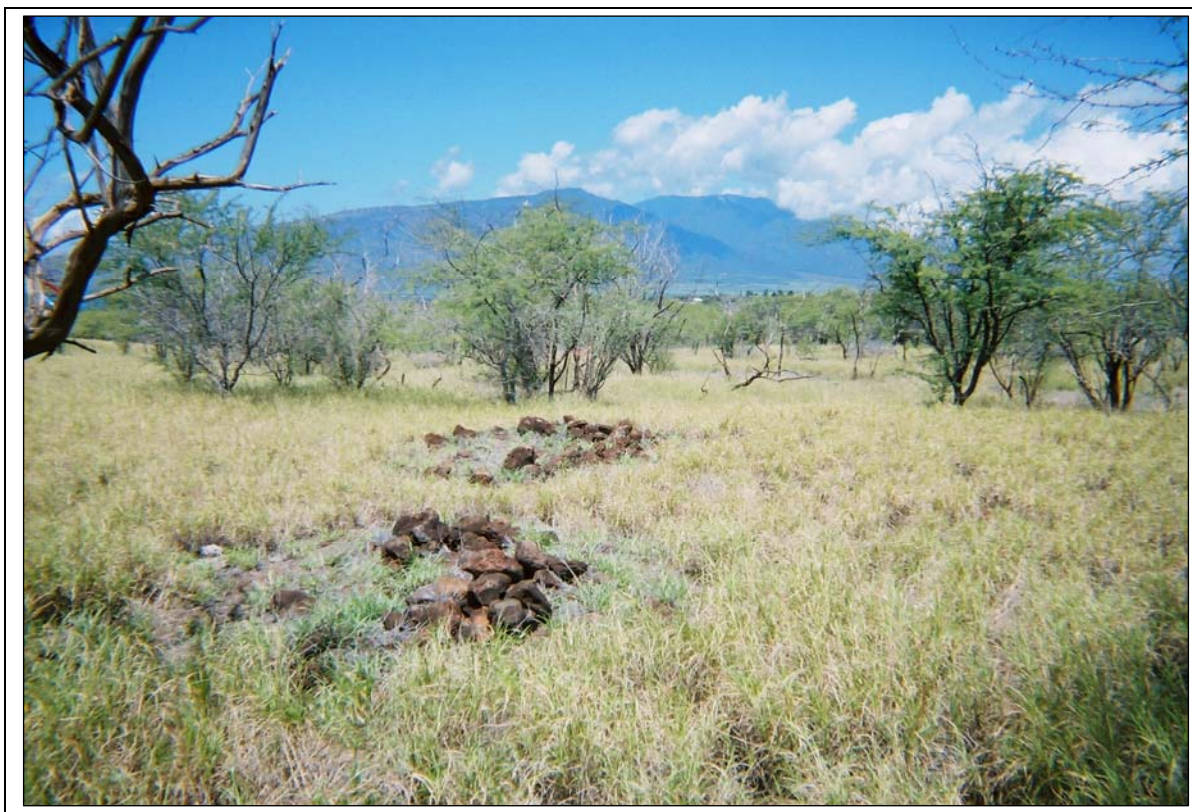
Site 6423 consists of three Historic mounds located between the southern entry road and the southern boundary of the project area (Figure 53). Each of these features is comprised of mechanically scarred boulders, implying late Historic or Modern agricultural activity. The features were not mapped, as they are morphologically similar to other, more extensively recorded features throughout the project area. Feature 1 measured 2.6 by 1.4 m and 0.4 m high. Feature 2 measures 2.0 by 1.3 m and 0.24 m high. Finally, Feature 3 measures 2.26 by 0.9 m and 0.3 m high. The site is significant under criterion D for its potential to yield information pertinent to the history of Maui and the state of Hawai'i.

Figure 53: Photographic Overview of Site 6423.

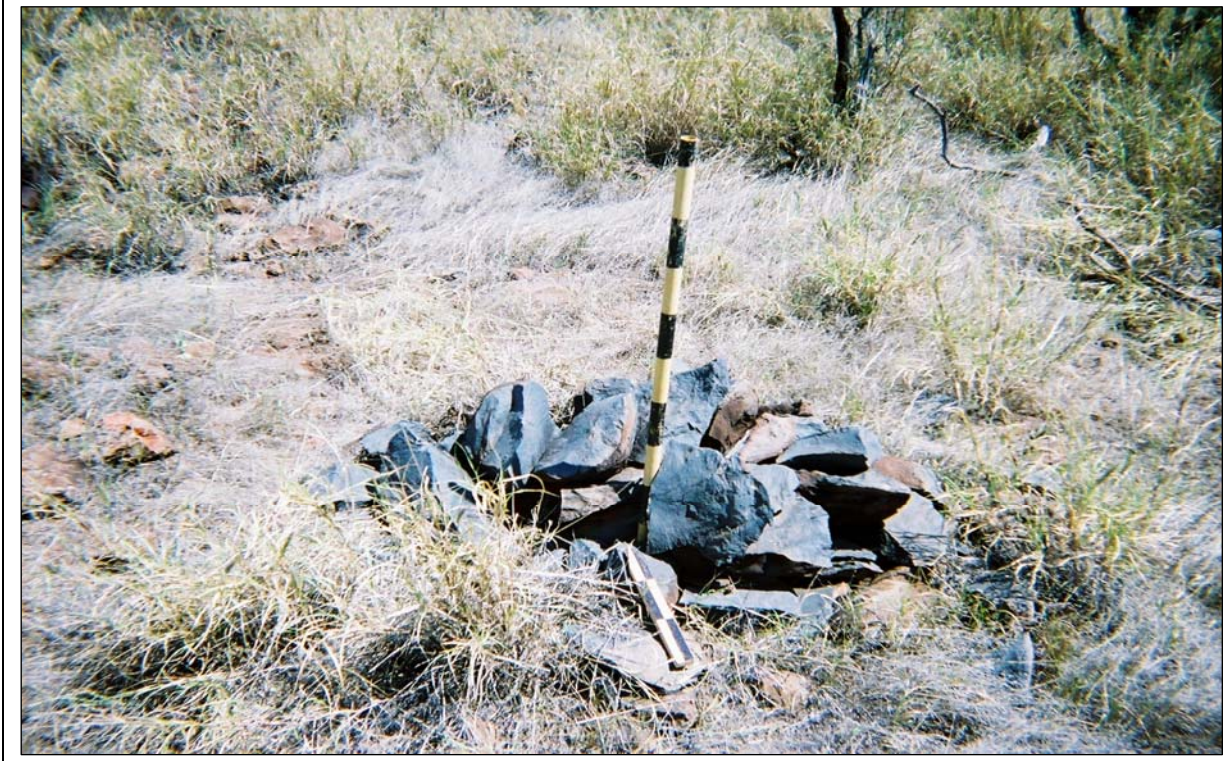
Site 6424 is a single, Historic, linear mound located approximately 4.0 m northwest of Site 6423 (Figure 54). This single-feature site consists of broken up, angular basalt boulders and cobbles mounded mechanically, as evidenced by bulldozer scars on several stones in the feature. The site measures 1.8 by 1.0 and 0.4 m high. Site 6424 was not mapped due to its morphological similarity to other sites in the area. The site's morphology and geographic proximity to 6423 call

Figure 54: Photographic Overview of Site 6424.

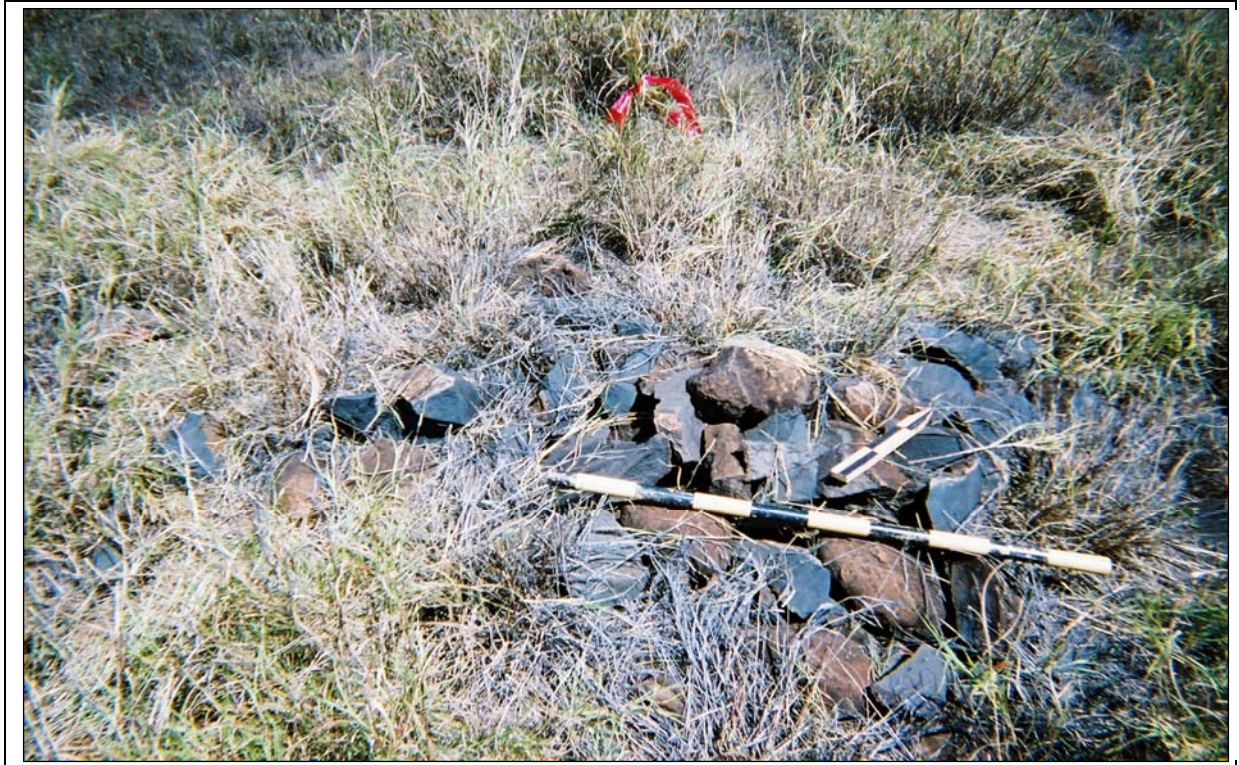
Site 6425 consists of two low rock mounds located about 70.0 m north of the existing access road (Figure 55). These features were constructed of large, subround and subangular basalt cobbles and small boulders loosely piled into low, disorderly mounds. They are interpreted to be agricultural clearing mounds dating to the Historic Period. Water channels around the features and the general area of Site 6425 indicate that the area has been extensively impacted by erosion. The site is significant under criterion D for its potential to yield information pertinent to the history and/or prehistory of Maui and the state of Hawai'i as a whole.

Feature 1 measured 1.8 by 1.2 m and 0.2 m in height. Feature 2 measures 1.7 by 1.4 m and 0.21 m high. The distance between Features 1 and 2 is approximately 9.5 m at a bearing of 142/322°.

Figure 55: Photographic Overview of Site 6425.
