FINAL ARCHAEOLOGICAL ASSESMENT REPORT FOR HAWAIIAN CEMENT QUARRY EXPANSION LOCATED AT TMK: (2) 3-8-004:001 portion PŪLEHU NUI AHUPUA'A, KULA MOKU; WAILUKU DISTRICT ISLAND OF MAUI

UPDATED MARCH 2020 REVISED SEPT 2017 REVISED JULY 2015 OCTOBER 2014

ATLAS ARCHAEOLOGY

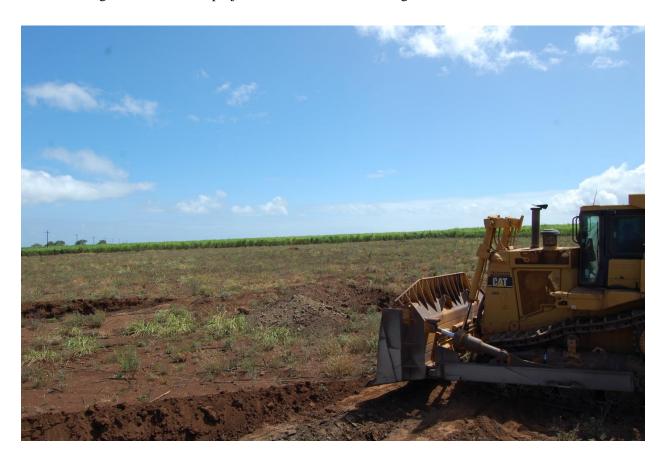
Figure 4. Overview from the south of 8.8 acre portion of Project Area

The subject parcel is presently under various stages of cultivation. The first test area comprised an 8.8-acre section of land in the southwest corner. This portion was previously harvested and a drainage basin was constructed. The area adjacent to the drainage contains large linear stockpiles for safety purposes, to prevent vehicular and pedestrian traffic from entering the drainage area. The remaining 33.0-acres of the project area was cultivated in sugar cane.

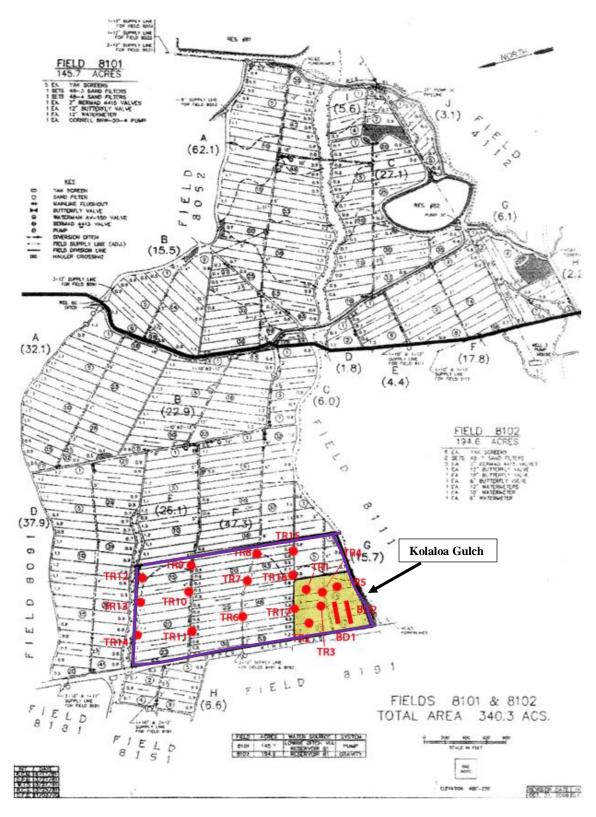
Figure 8. Sugar Cane Field Map Showing Project Area and Test Excavations (TR's 1-17 and BD's 1-2) (note yellow highlighted area is the 8.8 acre section of the project area)

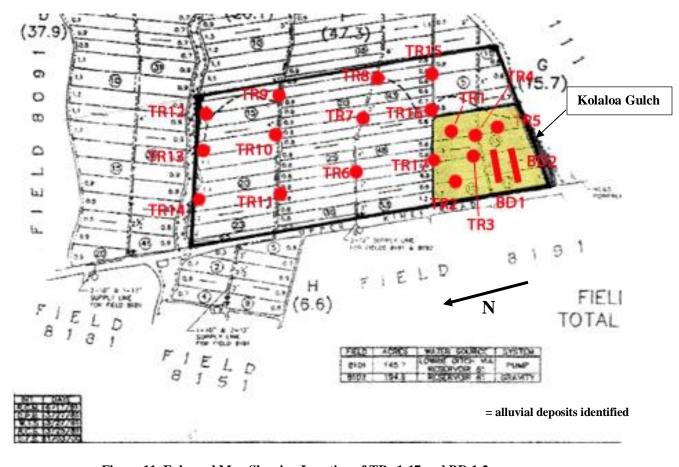
Figure 11. Enlarged Map Showing Location of TRs 1-17 and BD 1-2

Trenches that exhibited the four strata overall project stratigraphy were TRs 1, 2, 4, 5, BD1 and BD2, and the tripartite soil profile was encountered at TRs 6, 10, 11, 13, 15 and 17. The remaining trenches, TRs 3, 7, 8, 12 and 16 with the exception of TR9, contained the above strata; however, the overall general sequence was interrupted by environmental or geological events, exhibited as alluvial layers comprised of water worn pebbles and silt lenses, and subangular, pyroclastic cobbles (similar to the material of small cinders) and/or coarse gravel lenses. TR9 contained a single disturbed layer overlying basalt bedrock (LIV). The stratum, identified at TR9 was Layer III of the overall stratigraphic record and therefore indicated the past disturbances of the area where Layers I and II were removed. Decomposing basalt and or bedrock was observed from 0.46 m (TR2) to 2.90 mbs (TR13) but averaged 0.80 m deep. TRs 1-17 and BD1-2 are discussed below and associated stratigraphic profiles presented in Appendix A.

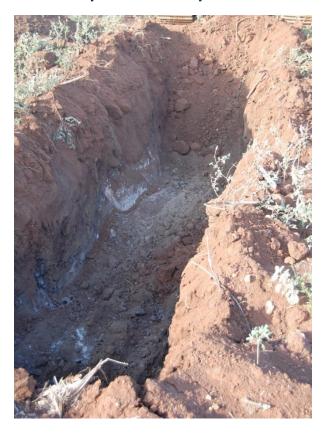
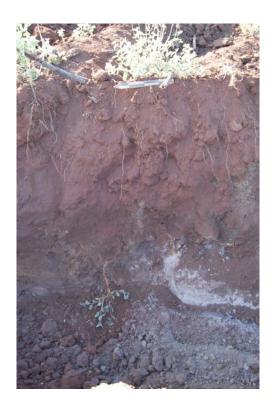
TR-1 was placed within the 8.8 acre area in the NE corner of the project area (see Figure 11, Table I and Appendix A). It measured 8.0 m long by 1.5 m wide by 1.60 m deep and was oriented 360° degrees. This section had been previously grubbed during the harvesting of the sugar cane. Testing revealed a four layer stratigraphic sequence (Figures 12 and 13). No cultural materials were observed.

Layer IV (136-160cmbs+) is a gray (10yr 5/1), basalt layer, non-plastic, non-sticky, massive, indurated. This layer is the bedrock layer.

Figure 12. Overview Photograph of Trench 1 (View to North)

Figure 13. Photograph of Trench 1 West Wall

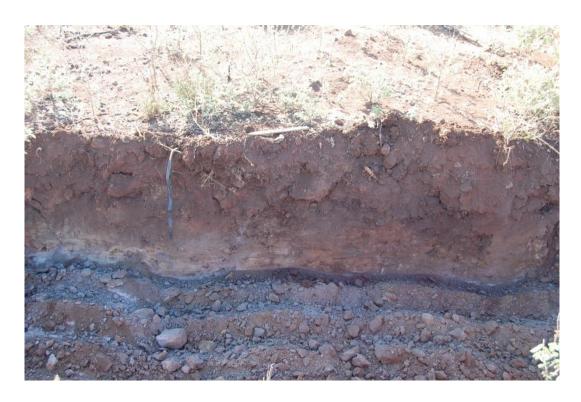
TR-2 was placed within the 8.8acre area in the NW corner of the project area (see Figure 11, Table I and Appendix A). It measured 7.0 m long by 1.5 m wide by 1.60 m deep and was oriented 360° degrees. This section had been previously grubbed during the harvesting of the sugar cane. Testing revealed a four layer stratigraphic sequence (Figure 14). No cultural materials were observed.

Layer IV (120-160cmbs+) is a gray (10yr 5/1), basalt layer, non-plastic, non-sticky, massive, indurated. This layer is the bedrock layer.

Figure 14. Photograph of Trench 2 East Wall

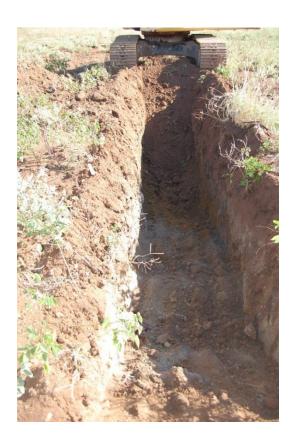
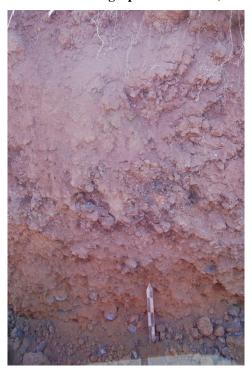
TR-3 was placed within the 8.8acre area in the central portion of the project area (see Figure 11, Table I and Appendix A). It measured 9.0 m long by 1.5 m wide by 2.0 m deep and was oriented 360° degrees. This section had been previously grubbed during the harvesting of the sugar cane. Testing revealed a five layer stratigraphic sequence (Figures 15 and 16). No cultural materials were observed.

Layer V (160-200cmbs+) is a gray (10yr 5/1), basalt layer, non-plastic, non-sticky, massive, indurated. This layer is the bedrock layer and is the target material for the mining operations.

Figure 15. Overview Photograph of Trench 3 (View to East)

Figure 16. Photograph of TR-3 North Wall

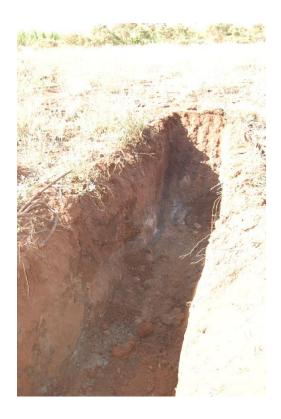
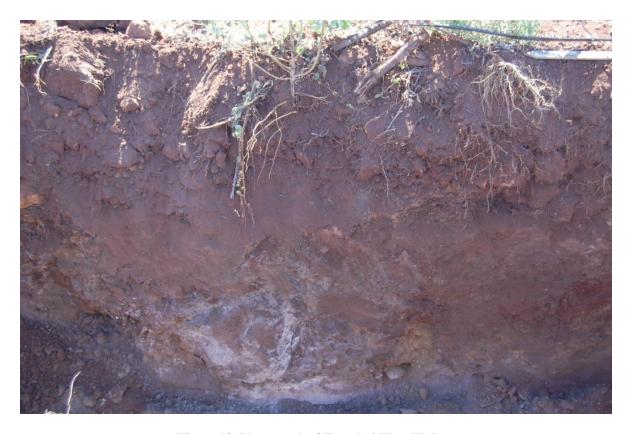
TR-4 was placed within the 8.8acre area in the central portion of the project area (see Figure 11, Table I and Appendix A). It measured 5.0 m long by 1.5 m wide by 2.0 m deep and was oriented 340° degrees (Figure 17). This section had been previously grubbed during the harvesting of the sugar cane. Testing revealed a four layer stratigraphic sequence (Figure 18). No cultural materials were observed.

Layer IV (138-180cmbs+) is a gray (10yr 5/1), basalt layer, non-plastic, non-sticky, massive, indurated. This is the bedrock layer.

Figure 17. Overview Photograph of Trench 4 (View to North)

Figure 18. Photograph of Trench 4 West Wall

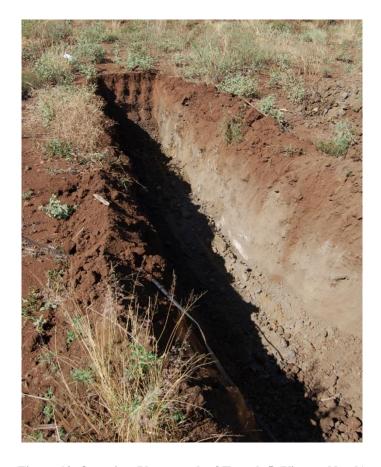
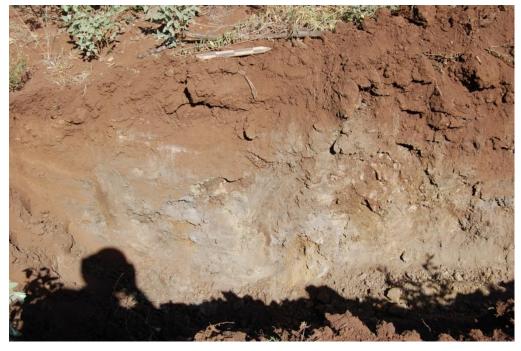
TR-5 was placed within the 8.8 acre area in the SE portion of the project area (see Figure 11, Table I and Appendix A). It measured 9.0 m long by 1.5 m wide by 2.0 m deep and was oriented 360° degrees. This section had been previously grubbed during the harvesting of the sugar cane. Testing revealed a four layer stratigraphic sequence (Figures 19 and 20). No cultural materials were observed.

Layer IV (170-180cmbs+) is a gray (10yr 5/1), basalt bedrock, non-plastic, non-sticky, massive, indurated. This layer is the bedrock layer and is the target material for the mining operations.

Figure 19. Overview Photograph of Trench 5 (View to North)

$Figure\ 20.\ Photograph\ of\ Trench\ 5\ West\ Wall$

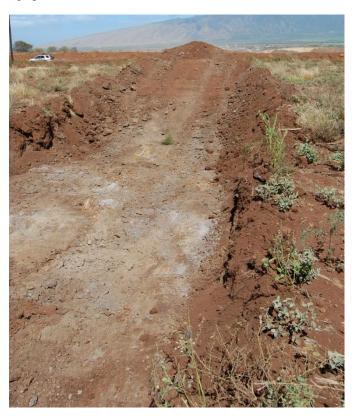
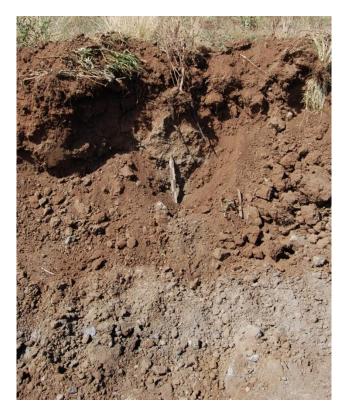
BD-1 was placed within the 8.8 acre area in the SW portion of the project area (see Figure 11, Table I and Appendix A). It measured 12.0 m long by 1.5 m wide by 1.4 m deep and was oriented 270° degrees (Figure 21). This section had been previously grubbed during the harvesting of the sugar cane. Testing revealed a four layer stratigraphic sequence (Figure 22). No cultural materials were observed.

Layer IV (136-140cmbs+) is a gray (10yr 5/1), basalt layer, non-plastic, non-sticky, massive, indurated. This layer is the bedrock layer and is the target material for the mining operations.

Figure 21. Overview Photograph of Bulldozer Cut 1 (View to West)

Figure 22. Photograph of Bulldozer Cut 1 North Wall

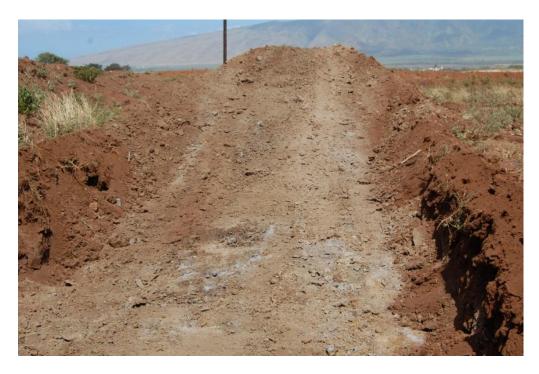
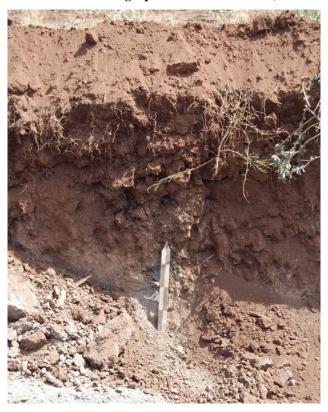
BD-2 was placed within the 8.8 acre area in the SW portion of the project area (see Figure 11, Table I and Appendix A). It measured 15.0 m long by 1.5 m wide by 1.6 m deep and was oriented 270° degrees. This section had been previously grubbed during the harvesting of the sugar cane. Testing revealed a four layer stratigraphic sequence (Figures 23 and 24). No cultural materials were observed.

Layer IV (136-160cmbs+) is a gray (10yr 5/1), basalt layer, non-plastic, non-sticky, massive, indurated. This layer is the bedrock layer and is the target material for the mining operations.

Figure 23. Overview Photograph of Bulldozer Cut 2 (View to West)

Figure 24. Photograph of Bulldozer Cut 2 North Wall

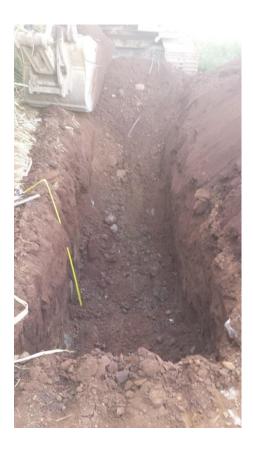
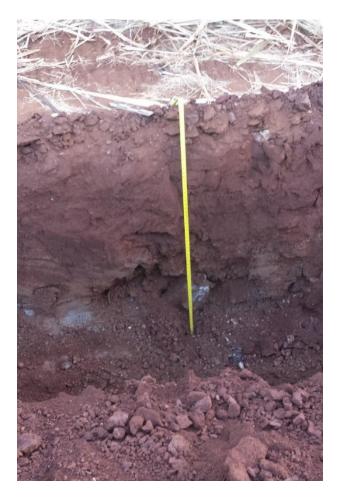
TR-6 was placed within the 33.0 acre area in the central portion of the project area (see Figure 11, Table I and Appendix A). It measured 4.1 m long by 1.5 m wide by 1.6 m deep and was oriented 270° degrees (Figure 25 and Table I). This section was an active cane fields and therefore the location of this trench was along a known haul rd. Testing revealed a three layer stratigraphic sequence (Figure 26). No cultural materials were observed.

Layer III (86-160+cmbs) is a yellowish brown (10yr5/4), silt loam, slightly plastic, slightly sticky, crumb, friable, with a high frequency of decomposing basalt. This layer is undisturbed and referred to as the "saprolytic layer".

Figure 25. Overview Photograph of Trench 6 (View to West)

Figure 26. Photograph of Trench 6 South Wall

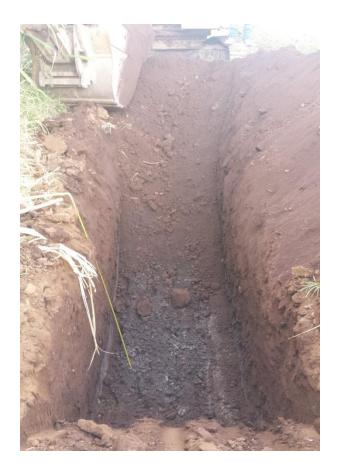
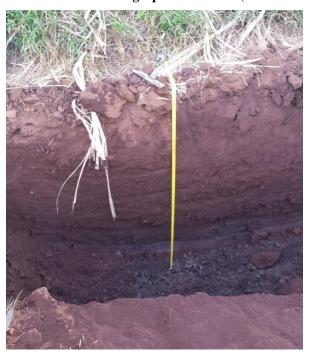
TR-7 was placed within the 33acre area in the central portion of the project area (see Figure 11, Table I and Appendix A). It measured 3.9 m long by 1.5 m wide by 2.0 m deep and was oriented 270° degrees along the existing cane haul road (Figure 27 and Table I). Testing revealed a three layer sequence, where subangular, pyroclastic cobbles, similar to small cinder materials were observed in Layer III (Figure 28). No cultural materials were observed.

Layer III (168-200cmbs+) is a black (7.5yr 2.5/1) coarse gravels and pyroclastic small cobbles with greyish black silty clay, moist, non-plastic, non-sticky, medium grain, firm. This layer was also observed in TR16.

Figure 27. Overview Photograph of Trench 7 (View to North)

Figure 28. Photograph of Trench 7 North Wall

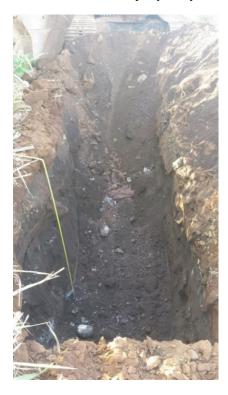
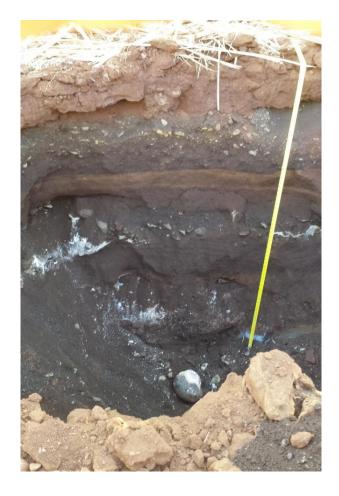
TR-8 was placed within the haul road in the central portion of the 33.0 acre area (see Figure 11, Table I and Appendix A). It measured 4.0 m long by 1.5 m wide by 1.8 m deep and oriented 270° degrees. TR-8 contained a five layer stratigraphic sequence indicative of alluvial and or flood plain deposits (Figures 29 and 30). No cultural materials were observed.

Lens/Layer II (21-80cmbs) is a very dark gray (7.5yr 3/1), gravelly silt, non-plastic, non-sticky, crumb, firm. This layer contained low frequencies of water worn basalt pebbles most likely associated with a former stream, or alluvial event.

Layer/Lens IV (110-146cmbs) is a very dark gray (7.5yr 3/1), gravelly silt, non-plastic, non-sticky, crumb, firm. This layer is the same as Lens/Layer II and contained low frequencies of water worn basalt pebbles. Since Layer III interrupts the alluvial deposits of Layers II and IV, this profile likely exhibits periodic flood events and subsidence.

Layer V (142-180cmbs+) is a yellowish brown (10yr5/4), silt loam, slightly plastic, slightly sticky, crumb, friable, with a high frequency of decomposing basalt. This layer is undisturbed and referred to as the "saprolytic layer".

Figure 29. Overview Photograph of Trench 8 (View to East)

Figure 30. Photograph of Trench 8 North Wall

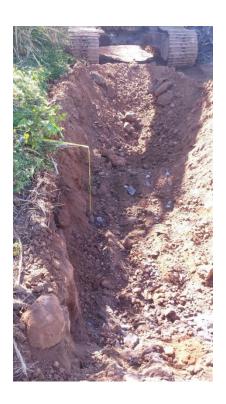
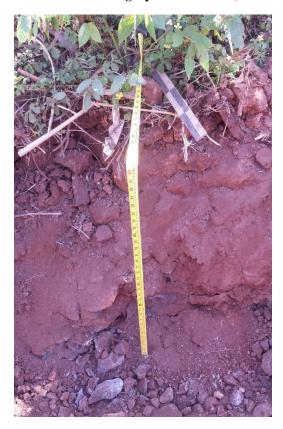
TR-9 was placed within the 33.0 acre area in the eastern portion of the project area (see Figure 11, Table I and Appendix A). It measured 3.9 m long by 1.5 m wide by 0.8 m deep and was oriented 270° degrees (Figures 31 and 32). Testing revealed a single stratum that was negative for cultural materials and similar to Layer III of the overall general stratigraphic sequence. This single stratum terminated upon bedrock with decomposing basalt.

Layer I (0-80cmbs) is a yellowish brown (10yr 5/4), silty loam, slightly plastic, slightly sticky, crumb, friable, with moderate frequency of roots and rootlets. Inclusions consisted of black plastic irrigation indicating this layer was part of the "till zone".

Figure 31. Overview Photograph of Trench 9 (View to East)

Figure 32. Photograph of Trench 9 North Wall

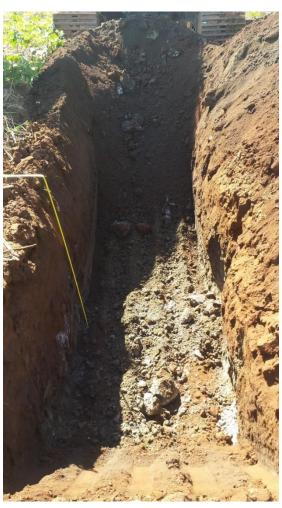
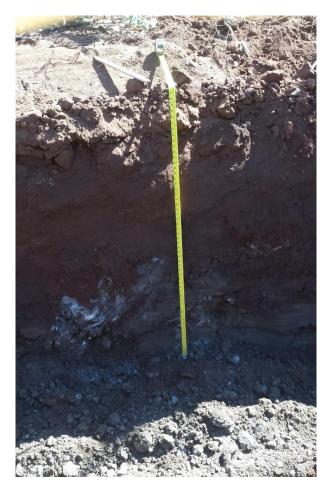
TR-10 was placed within the 33.0 acre area in the central portion of the project area (see Figure 11, Table I and Appendix A). It measured 4.0 m long by 1.5 m wide by 1.5 m deep, oriented 270° degrees and placed in the cane haul road. Testing revealed a three layer stratigraphic sequence (Figures 33 and 34). No cultural materials were observed.

Layer III (60-150+cmbs) is a yellowish brown (10yr5/4), silt loam, slightly plastic, slightly sticky, crumb, friable, with a high frequency of decomposing basalt. This layer is undisturbed and referred to as the "saprolytic layer".

Figure 33. Overview Photograph of Trench 10 (View to East)

Figure 34. Photograph of Trench 10 North Wall

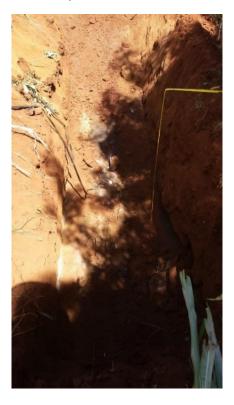
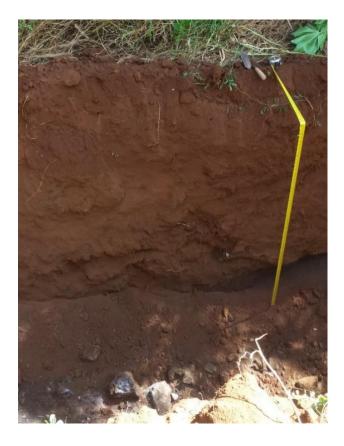
Lens/Layer III (158-186+cmbs) is a yellowish brown (10yr 5/4), gravelly silt loam, non-plastic, non-sticky, crumb, firm. This layer contained low frequencies of water worn basalt pebbles possibly associated with alluvial deposition.

Layer V (189-210 cmbs) is a gray (10yr 5/1), basalt layer, non-plastic, non-sticky, massive, indurated. This layer bedrock.

Figure 35. Overview Photograph of Trench 12 (View to West)

Figure 36. Photograph of Trench 12 North Wall

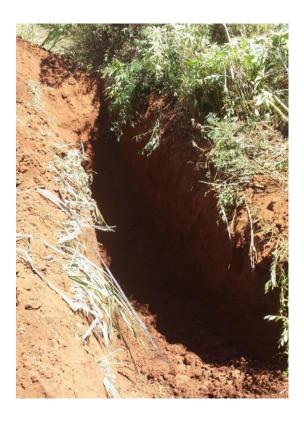
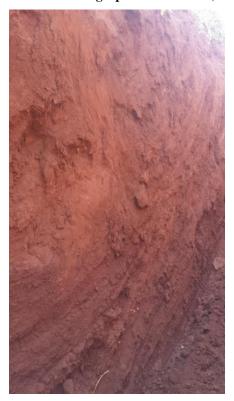
TR-13 was placed within the 33acre area in the north central portion of the project area (see Figure 11, Table I and Appendix A). It measured 4.0 m long by 1.5 m wide by 3.0 m deep and was oriented 270° degrees. This section was an active cane fields and therefore the location of this trench was along a known haul rd. Testing revealed a three layer stratigraphic sequence (Figures 37 and 38). No cultural materials were observed.

Layer III (295-305cmbs+) is a gray (10yr 5/1), basalt bedrock layer, non-plastic, non-sticky, massive, indurated.

Figure 37. Overview Photograph of Trench 13 (View to East)

Figure 38. Photograph of Trench 13 North Wall

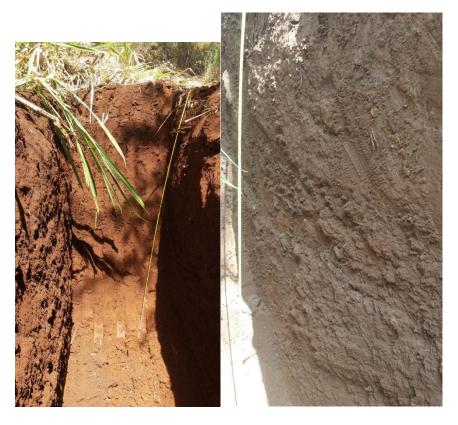
Lens/Layer III (160-1.85cmbs+) is a reddish brown (5yr4/6), pebbly silt loam, non-plastic, non-sticky, crumb, firm. This layer contained low frequencies of water worn basalt pebbles most likely associated with alluvial deposition.

Layer V (195-205cmbs+) is a dark yellowish brown (10yr5/4), gravelly silt loam, slightly plastic, slightly sticky, crumb, friable.

Figure 39. (Left) Overview Photograph of Trench 14 (View to West); (Right) Photograph of North Wall Trench 14 (View to Northwest

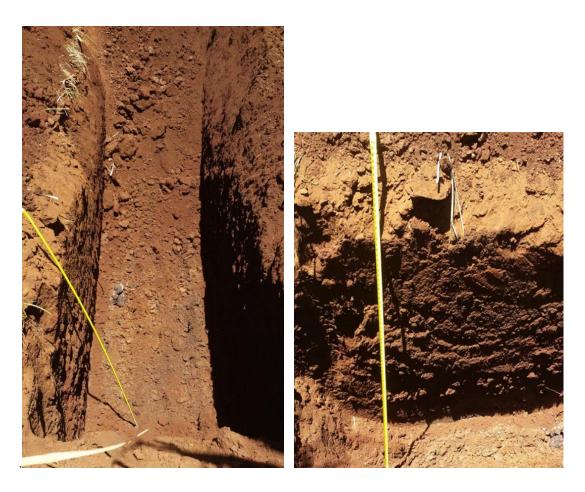
Layer III (81-120cmbs+) is a yellowish brown (10yr5/4), silt loam, slightly plastic, slightly sticky, crumb, friable, with a high frequency of decomposing basalt. This layer is undisturbed and referred to as the "saprolytic layer".

Figure 40. Photographs of TR-15 Overview (View to West) (left); and South Wall (right)

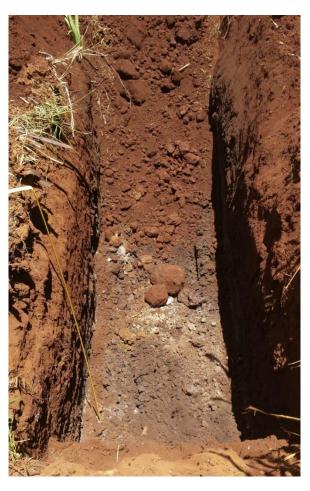
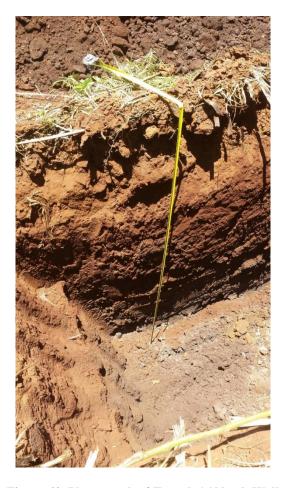
TR-16 was placed within the 33.0 acre area in the south central portion of the project area (see Figure 11, Table I and Appendix A). It measured 4.0 m long by 1.5 m wide by 1.45 m deep, oriented 270° degrees and situated within a haul road. TR-16 contained a three layer stratigraphic sequence with the pyroclastic cobbles observed in TR-7 (Figures 41 and 42). No cultural materials were observed.

Layer III (68-150cmbs+) is a (7.5yr 2.5/1), greyish black silty clay with coarse gravels or small pyroclastic cobbles, non-plastic, non-sticky, medium grain, firm. This layer occurs in pockets and in some cases as lenses throughout the layer (similar to LIII in TR7).

Figure 41. Overview Photograph of Trench 16 (View to West)

Figure 42. Photograph of Trench 16 North Wall

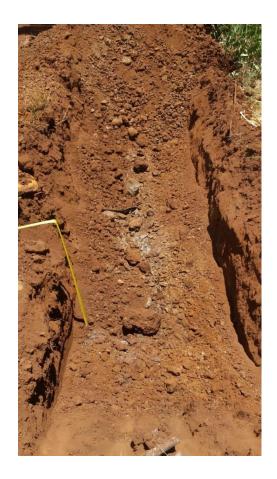
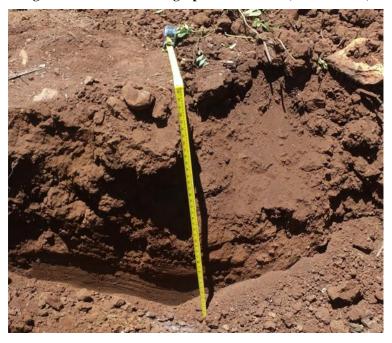
TR-17 was placed along the haul road within the 33.0 acre area in the south central portion of the project area (see Figure 11, Table I and Appendix A). It measured 4.0 m long by 1.5 m wide by 1.0 m deep and was oriented 270° degrees. Testing revealed a three layer stratigraphic sequence (Figures 43 and 44). No cultural materials were observed.

Layer III (85-105cmbs+) is a yellowish brown (10yr5/4), silt loam, slightly plastic, slightly sticky, crumb, friable, with a high frequency of decomposing basalt. This layer is undisturbed and referred to as the "saprolytic layer".

Figure 43. Overview Photograph of Trench 17 (View to West)

Figure 44. Photograph of Trench 17 South Wall
