**APPENDIX E**  
**Archaeological Inventory Survey**  
**(Part 2)**

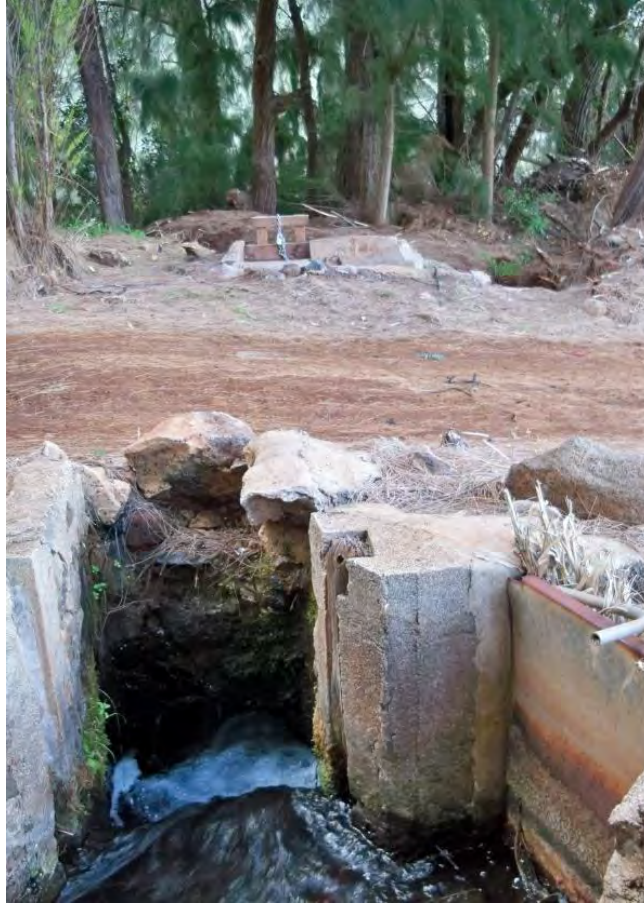
**Figure 37. Site 7881 Feature 7 Sluice Gate in Foreground and Feature 8 Background (View to Northeast)**

Feature 8 is another sluice gate associated with Features 2 and 7 located along the north side of the service access trail. It is an L-shaped structure comprised of formed concrete walls with large cobble inclusions and a modern sluice gate which empties towards Waikapū Stream. Indentions for former railroad rails are present along the out take chute to the east (Figures 38 and 39).

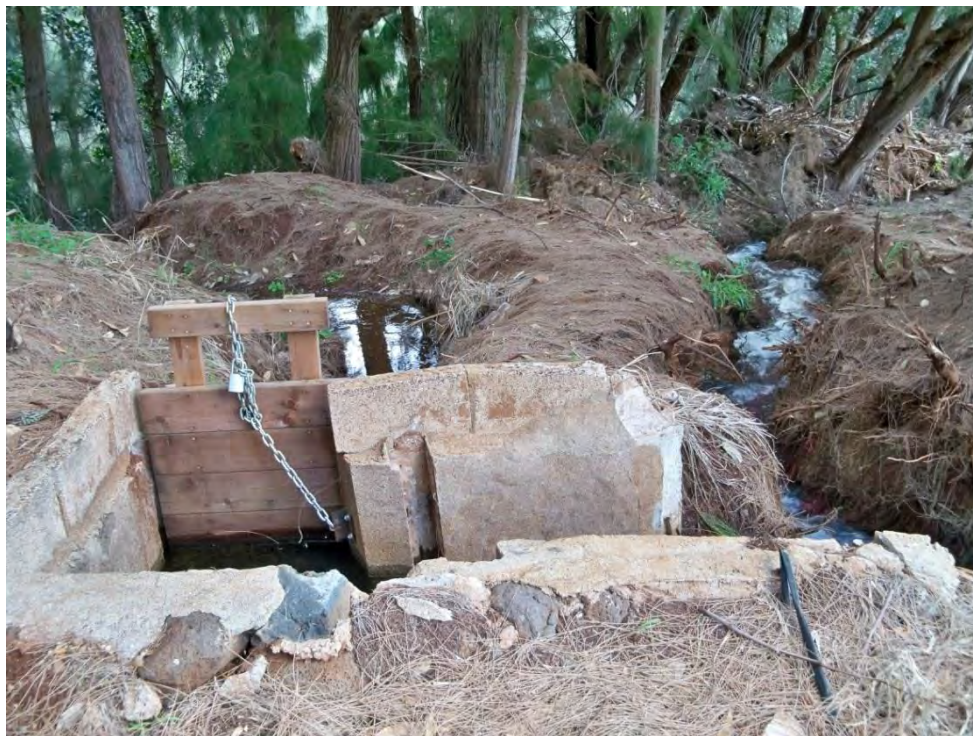
**Figure 38. Photograph of Site 7881 Feature 8 showing Two Channels, Feature 2 Ditch continues East and Overflow beyond Sluice Gate to Waikapū Stream (View to North)**

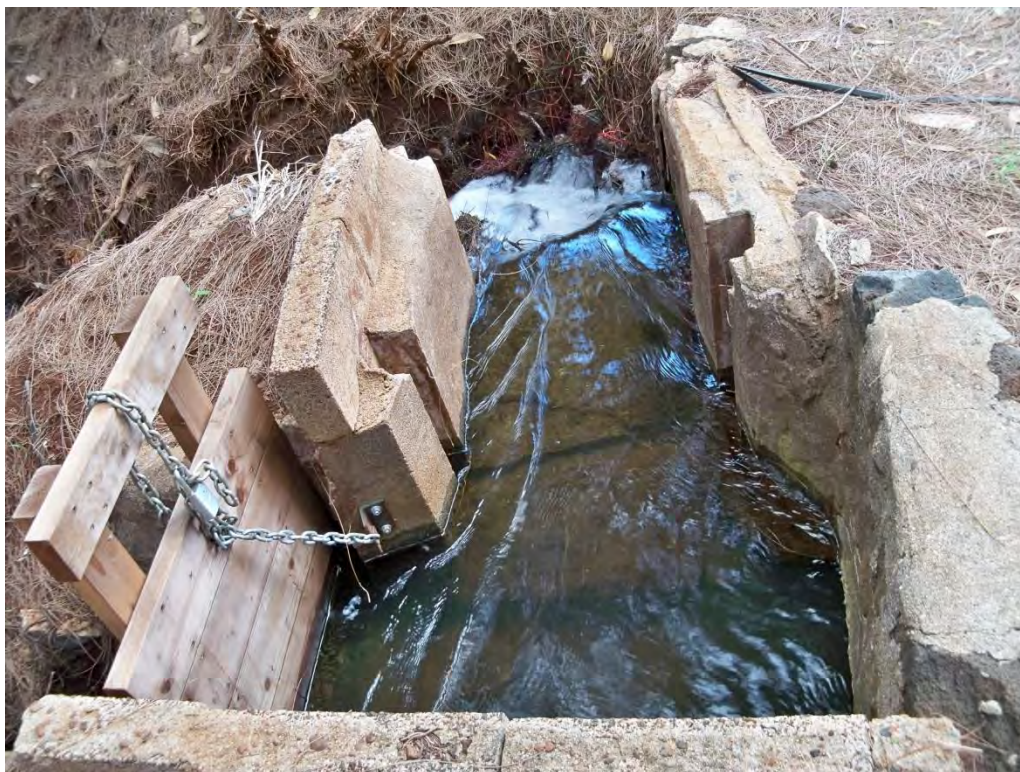
**Figure 39. Up-Close Photograph of Feature 8 (View to east)**

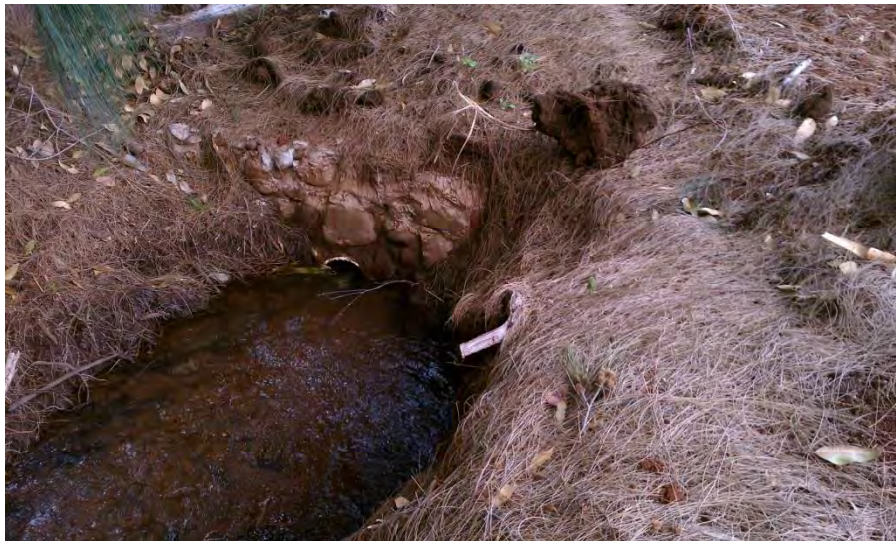
Feature 9 is a culvert associated with Feature 2 ditch. The intake chute on the west contains a 12” metal pipe, reinforced at the opening by the construction of a rock and mortared faced wall. The wall is comprised of basalt water-worn and sub-angular cobbles held together with mortar and concrete containing large grained sand and large angular gravel approximately 1.5 m wide and 0.95 m deep. Along the east side is an open earthen ditch which intersects with Feature 2 on the north and directs any excess flow of water into the Waikapū Stream.

**Figure 40. Photograph of Site 7881 Feature 9 Intake on West side (View to East)**

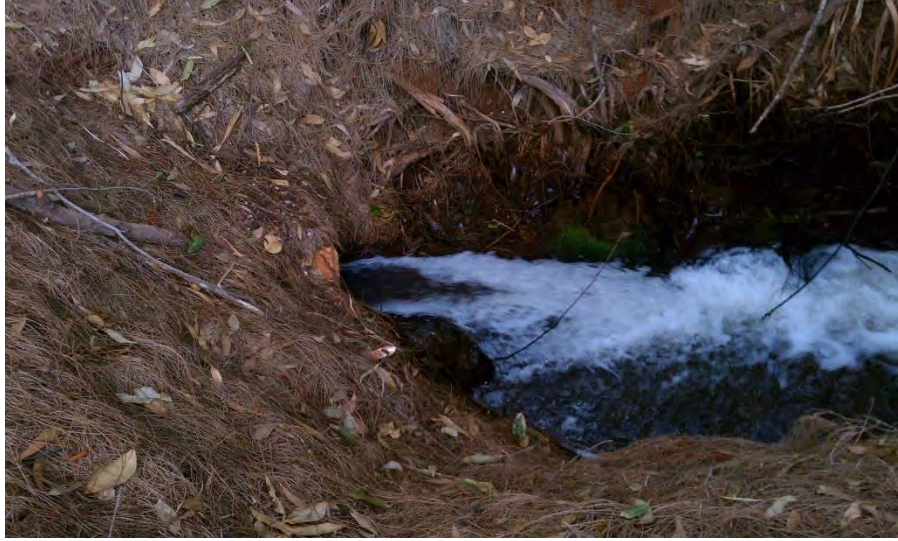
**Figure 41. Photograph of Site 7881 Feature 9 Out take on East (View to North)**

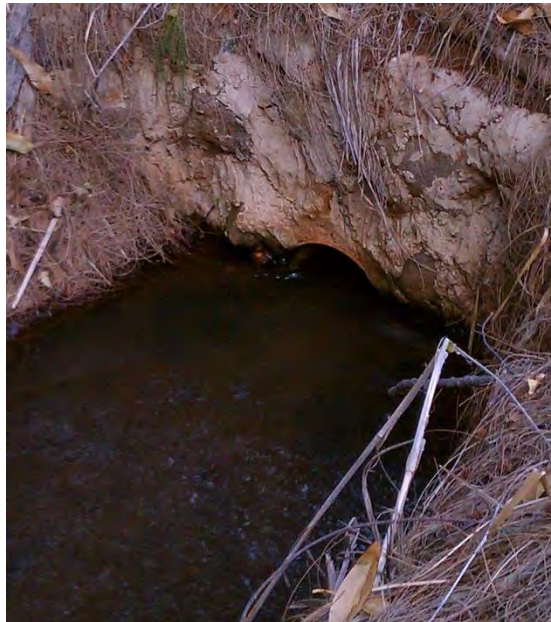
Feature 10 is another culvert associated with Feature 2 east flowing ditch on the north side of the access service road. The water flows into an underground culvert on the west, approximately 15.5 long, and emerges on the east. It is constructed similarly to Feature 9 with a 12" metal pipe, and concrete basalt water-worn and sub-angular cobbles placed against the wall around the pipe and measures 1.4 m long by 0.90 m deep. Another earthen ditch, like Feature 9, is present along the west side for overflow of water which will be directed to Waikapū Stream.

**Figure 42. Photograph of Site 7881 Feature 10 Intake on West (View to East)**

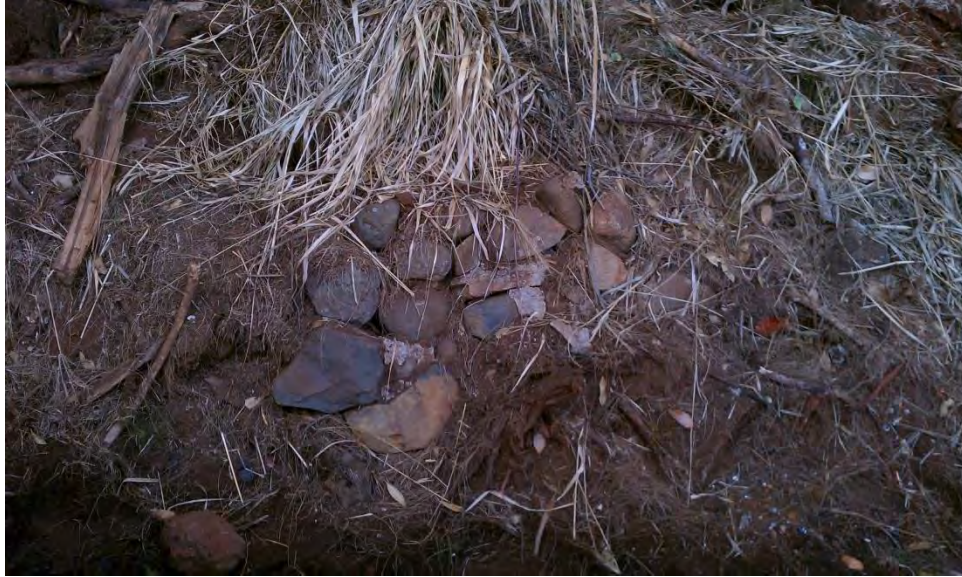
**Figure 43. Site 7881 Feature 2 Ditch along the north side of access road are remnant retention walls, mortar and water-worn cobbles and Sub-angular basalt cobbles, section before Site 7881 Feature 10, View to North**

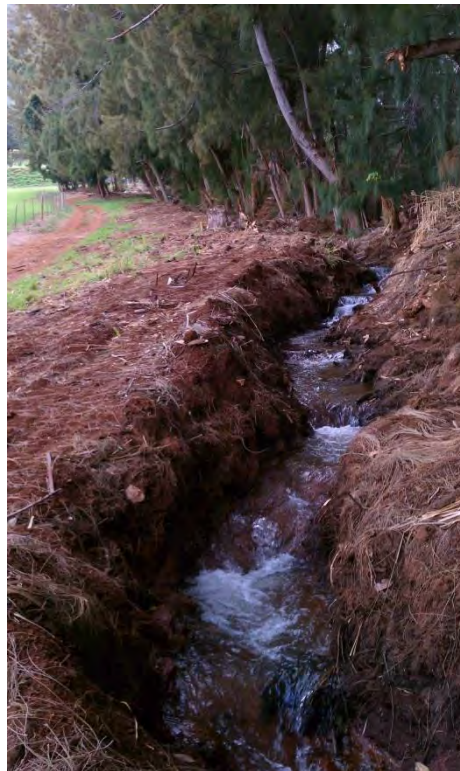
**Figure 44. Feature 2 Ditch flowing into Site 7881 Feature 10 Culvert (View to West)**

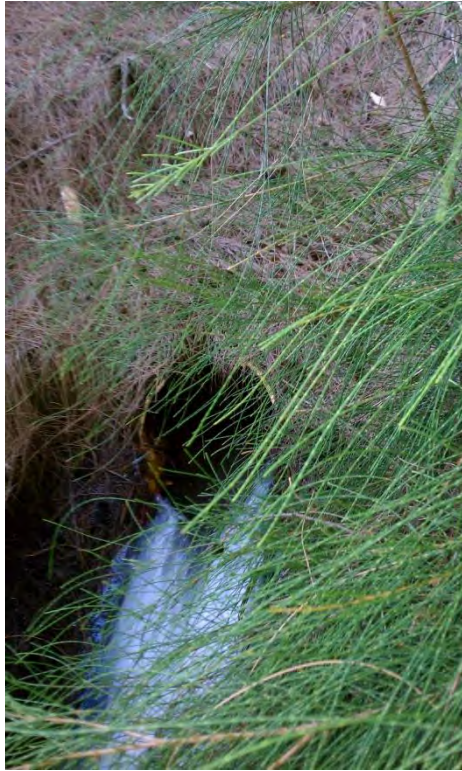
**Figure 46. Photograph of Site 7881 Feature 11 Out-take (View to West)**

Feature 11 is another culvert on the north side of the access road constructed similarly to Features 9 and 10. The water from the west flows into an underground 12” metal pipe culvert approximately 14.5 long and emerges on the east (Figures 45 and 46). The intake (west) side contains the same reinforced wall of basalt water-worn and sub-angular cobbles with concrete faced 1.2 m wide and 1.0 m deep. An open earthen ditch is present on the east for overflow of high volume water which will empty into the Waikapū Stream.

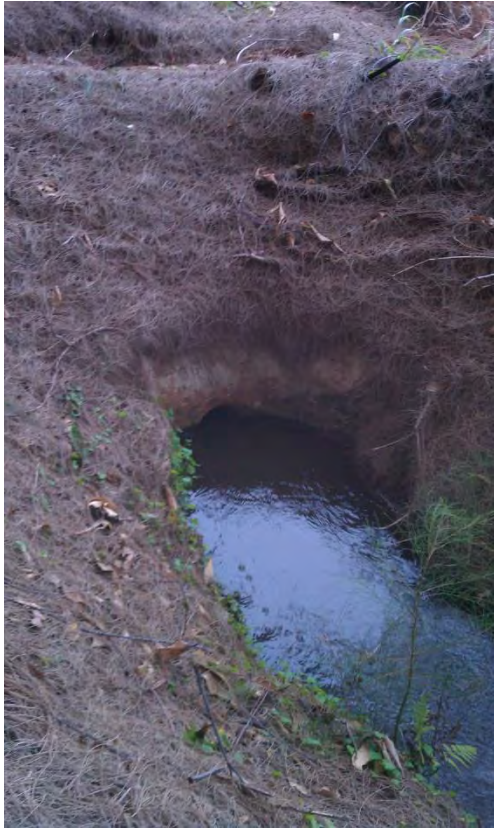
Feature 12 culvert is approximately 15.5 m long and comprised of a 12” metal pipe. The intake (west) side opening is faced with concrete and basalt water-worn and sub-angular cobbles which measures 1.4 m wide and 0.90 m deep (Figure 47). The overflow earthen ditch is present along the east out-take side and directs the high volume of water into the Waikapū Stream on the north.

**Figure 47. Overview Photographs of Site 7881 Feature 12 Intake (View to East) left and Feature 12 Out-take (View to West) right**

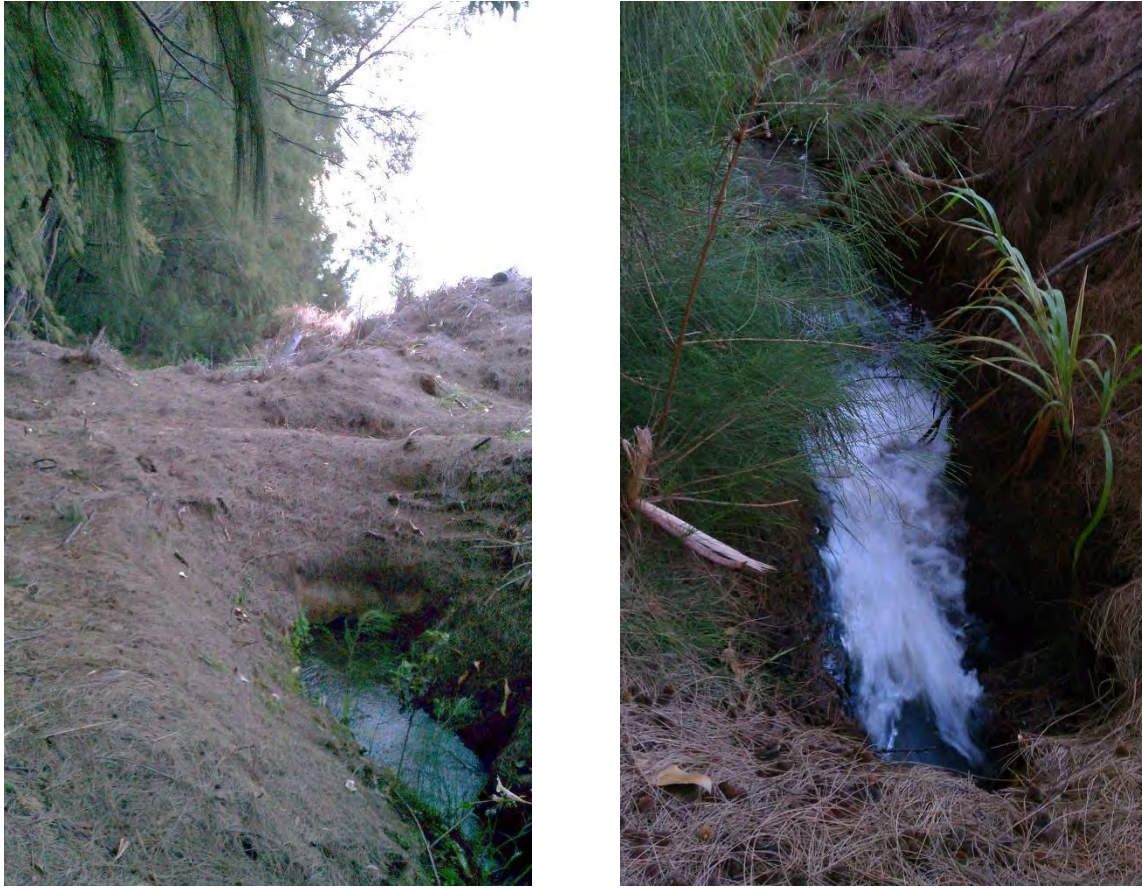
Feature 13 culvert for Feature 2 ditch on the north side of the access service road consists of a 12” PVC pipe which measures approximately 13.5 m long and emerges on the east (Figure 48). The pipe on the west side contains a concaved, concrete faced lining which measures 1.3 m wide by 0.70 m deep. The earthen open ditch is present on the east side and utilized for all excess water which will be re-directed to Waikapū Stream.

**Figure 48. Photographs of Site 7881 Feature 13 Intake (View to East) left; Feature 13 Out-take (View to West) right**

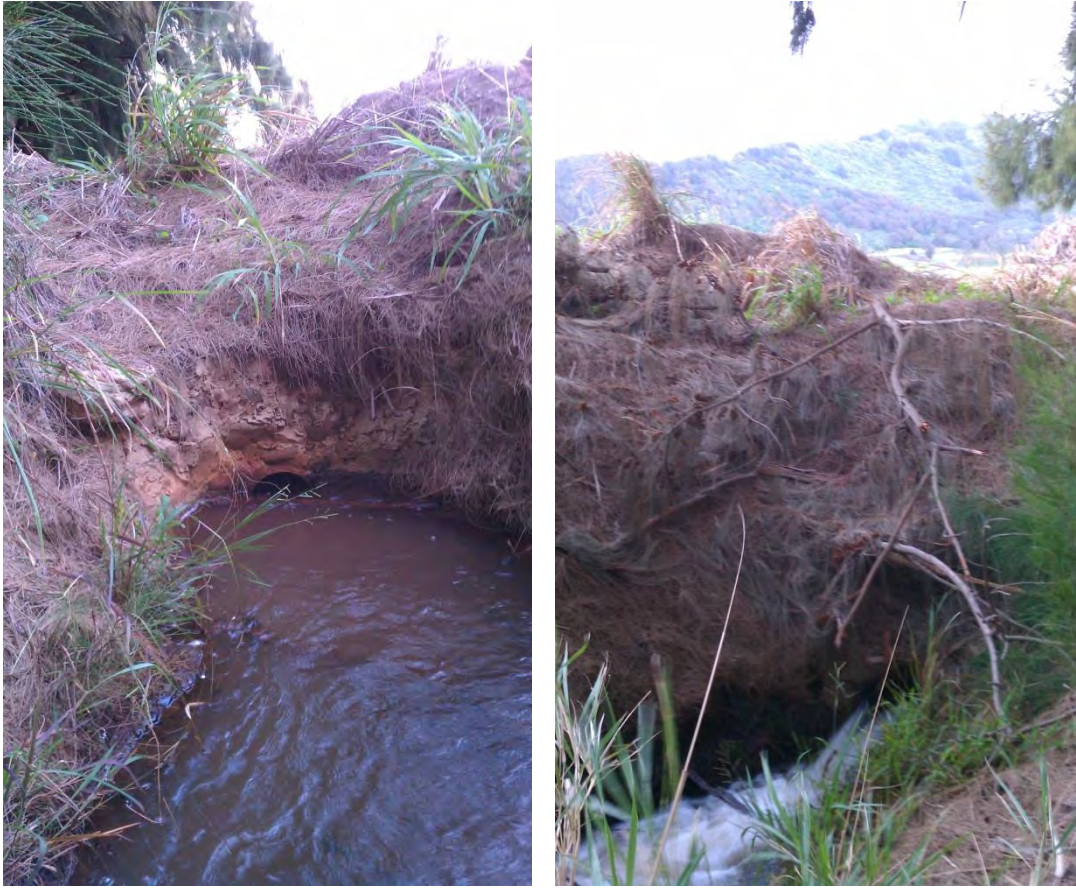
Feature 14 is another culvert situated along the north side of the dirt access road. This culvert, like Feature 13 is comprised of a 12” PVC pipe which runs underground for approximately 13.5 m. At the opening around the intake, the earth is reinforced and lined with concrete which measures 1.6 m wide and 0.80 m deep (Figure 49). The open earthen ditch is present along the east side and re-directs high volume water flow to the north into Waikapū Stream.

**Figure 49. Overview Photographs of Site 7881 Feature 14 Intake (View to East) left; Feature 14 Out-take (View to West) right**

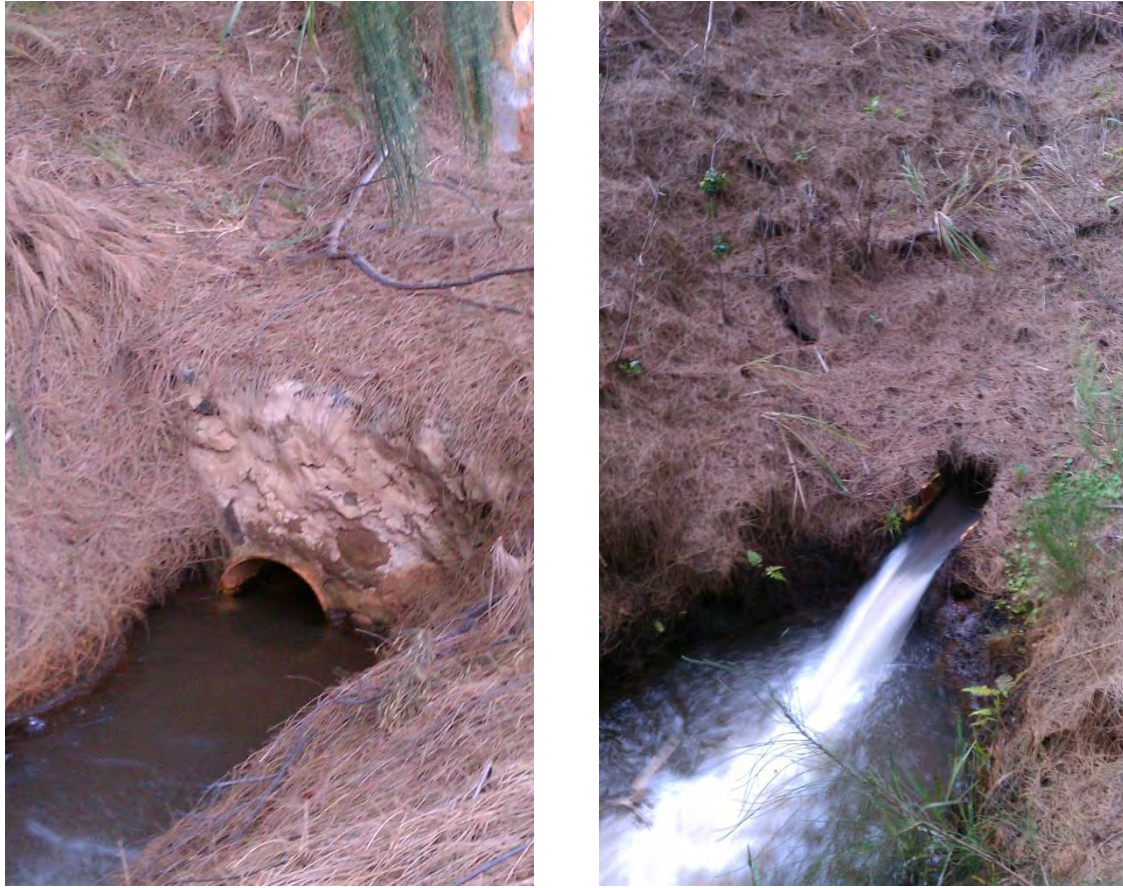
Feature 15 culvert is situated on the north side of the service access road and runs underground for approximately 18.0 m. The culvert consists of a 12" PVC pipe with concrete and rock facing along the west intake side (Figure 50). The reinforced wall around the opening measures 1.4 m wide by 1.0 m deep. The out take side contains the open earthen ditch for overflow of excess water.

**Figure 50. Photographs of Site 7881 Feature 15 In-take (View to East) left and Feature 15 Out-take View to West (right)**

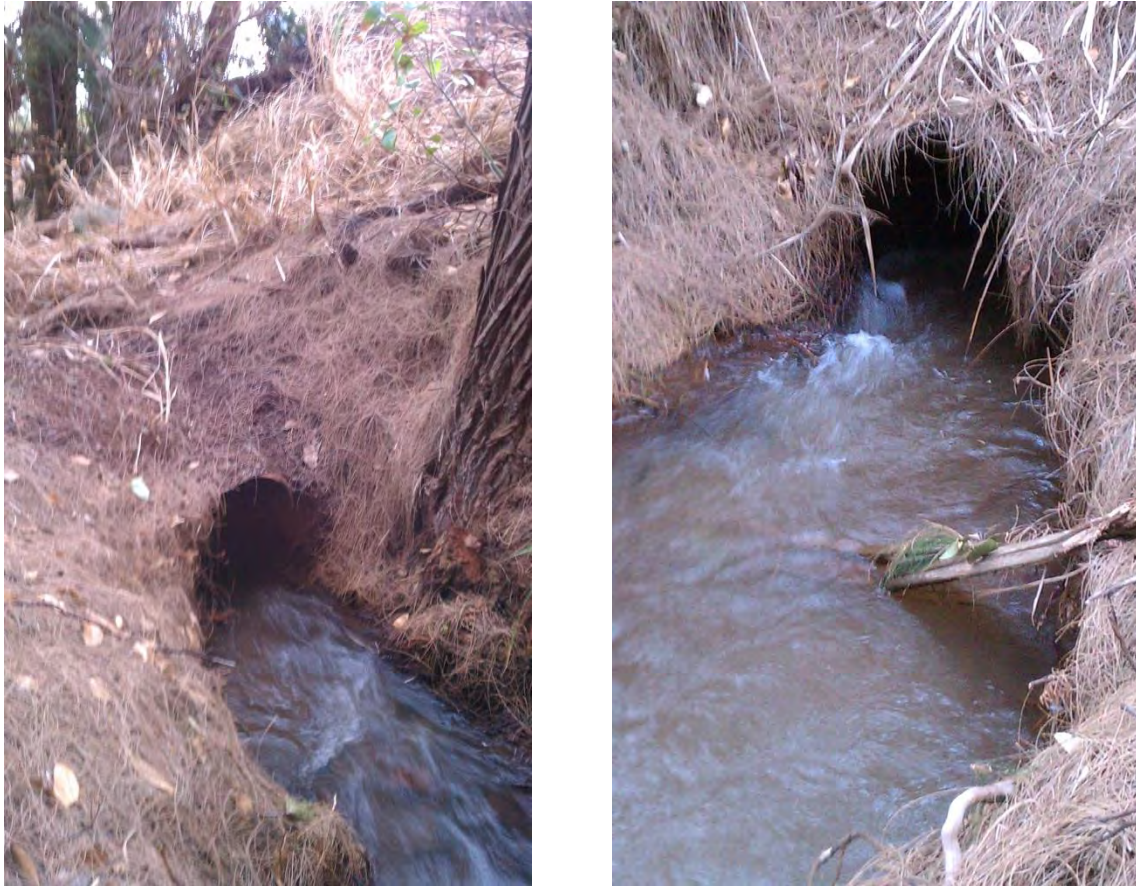
Feature 16 culvert is larger and comprised of a 24" metal pipe which runs underground for approximately 6.2 m and emerges on the east (Figure 51). This culvert does not contain a reinforced faced wall along the intake west side, but may have at one time. An open earthen ditch is present on the east for the over flow of water which will empty into Waikapū Stream.

**Figure 51. Photographs of Site 7881 Feature 16 Intake, View to Southeast (left) Out-Take, View to West**

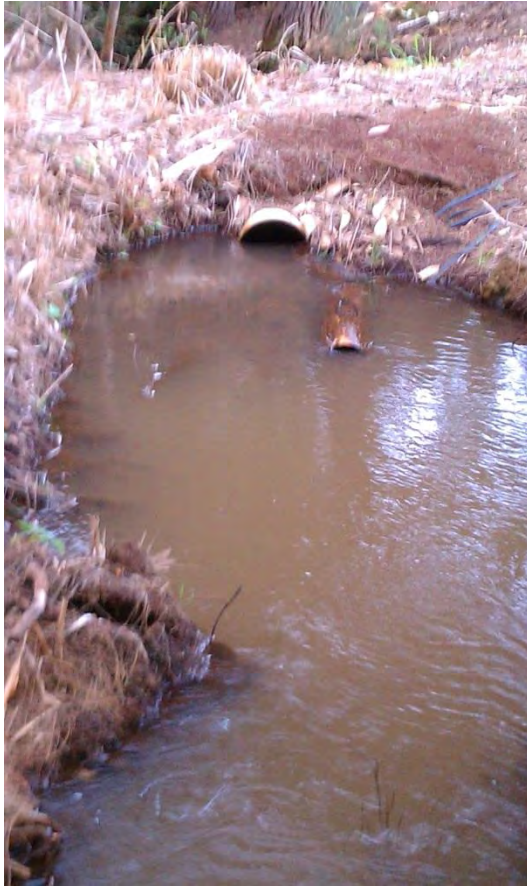
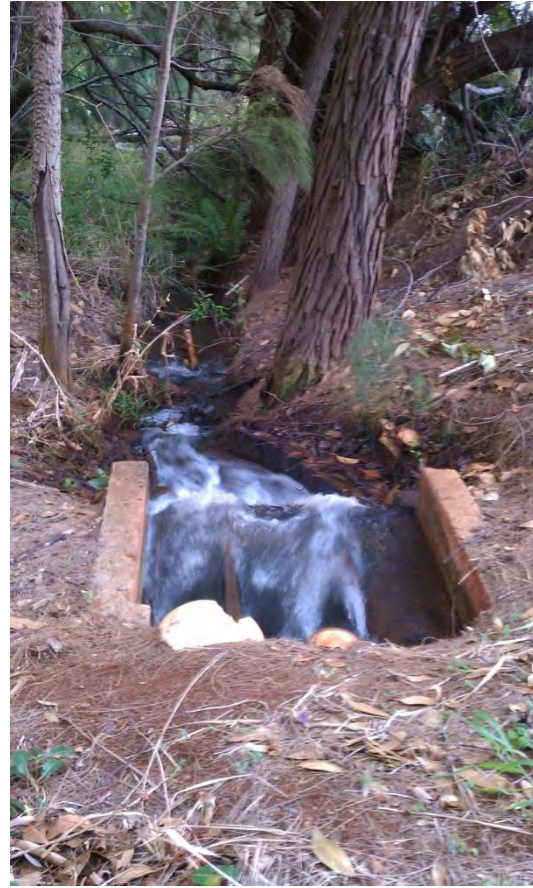
**Figure 52. Overview Photographs of Site 7881 Feature 17 Intake (View to East) left and Feature 17 Out-take (View to East)**

Feature 17 is another culvert comprised of two intake PVC pipes, a 6' and 12' approximately 3.3 m long which emerges on the east into an open rectangular concrete drainage box that measures 1.55 m E/W long by 1.4 m wide N/S by 0.65 m high. Adjacent to the drainage box, the water is further channelized by aligned hollow-tile block walls which extend from the drainage box 1.27 m long by 1.3 m wide 0.25 m high (Figures 52 and 53). Approximately 5.0 m east from the out take east side are two 2 inch pipes with valves which are present within the ditch (Figure 54).

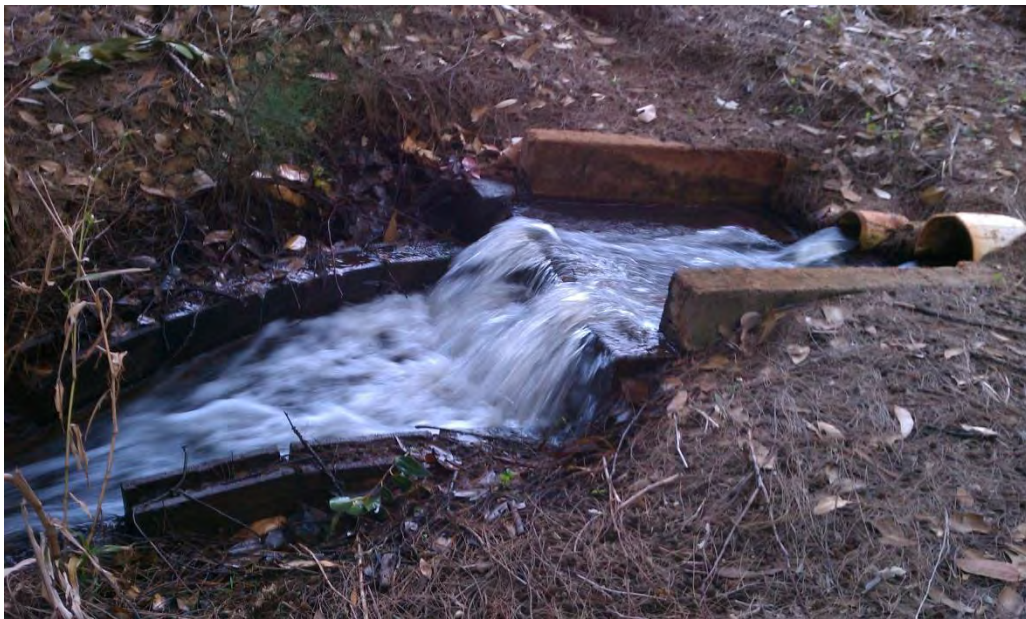
**Figure 53. Photograph of Site 7881 Feature 17 Out-take (View to South)**

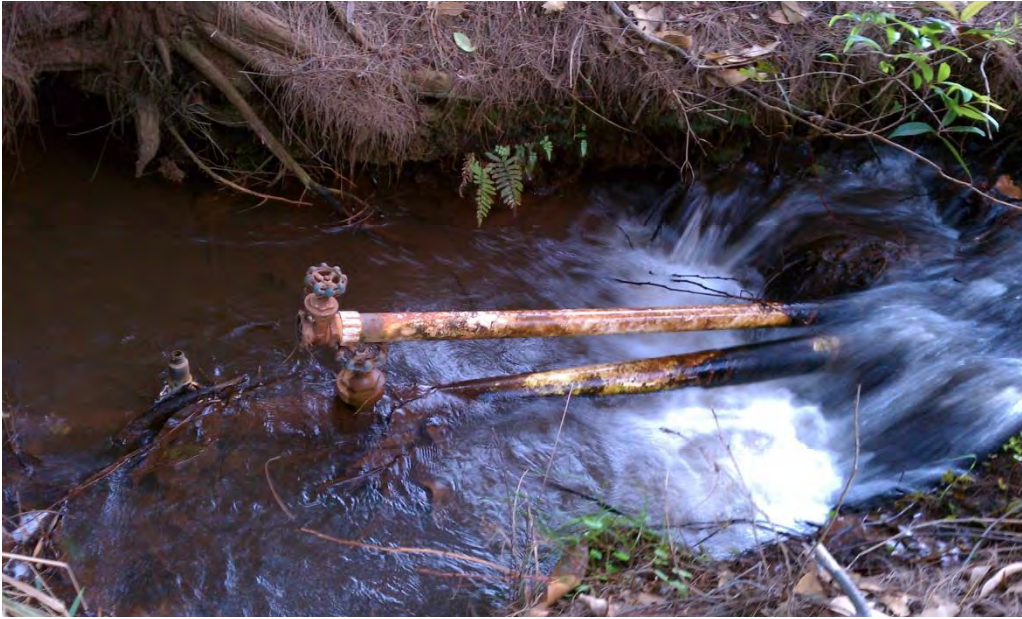
**Figure 54. Photograph of Site 7881 Feature 17 Valves (View to South)**

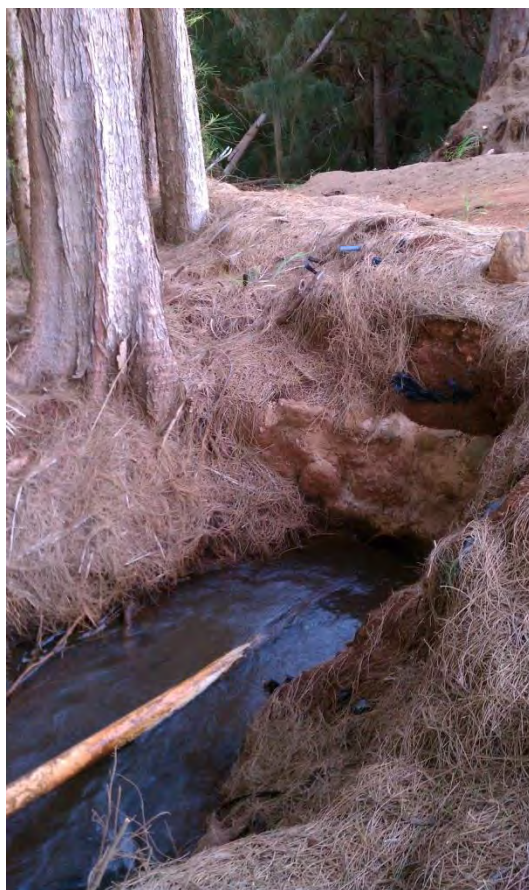
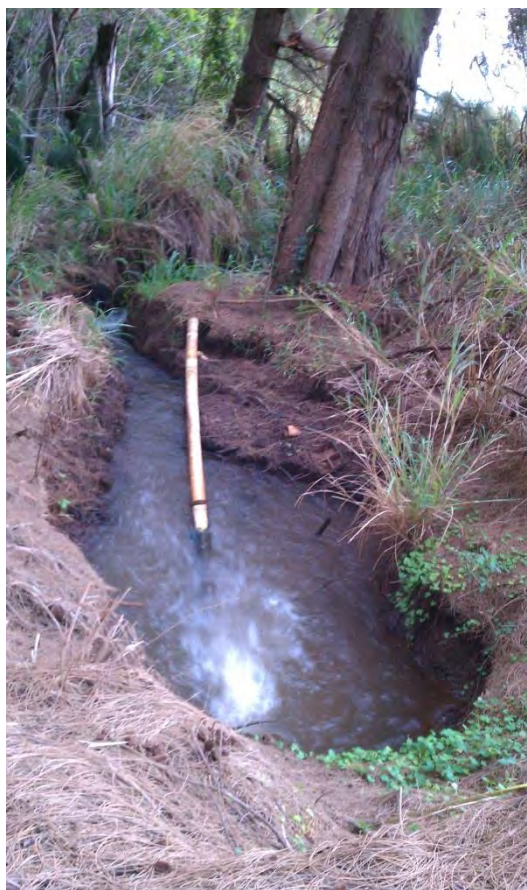
**Figure 55. Overview Photographs of Site 7881 Feature 18 and Faced Wall (left photo) (View to Northeast); Feature 18 East side (right photo) (View to East)**

Feature 18 is the last culvert in a series of underground drainage ditches associated with Feature 2 open ditch along the north side of the service access road. This culvert is comprised of a 12” metal pipe which runs approximately 11.0 m long emerging on the east. Feature 18 culvert also contains a 4-inch PVC pipe which extends from the west and goes through the metal pipe and extends out on the east side. The PVC pipe follows Feature 2 ditch for some distance and then extends out over the south bank of the ditch (Figure 55). The ditch and culvert on the west side are reinforced with a concrete, basalt water-worn and sub-angular cobbles faced wall that measures 1.4 m wide and 0.70 m deep. No open earthen overflow ditch was apparent and the PVC pipe may assist in excess flow. Atop the culvert is an access road utilized to cross Waikapū Stream.

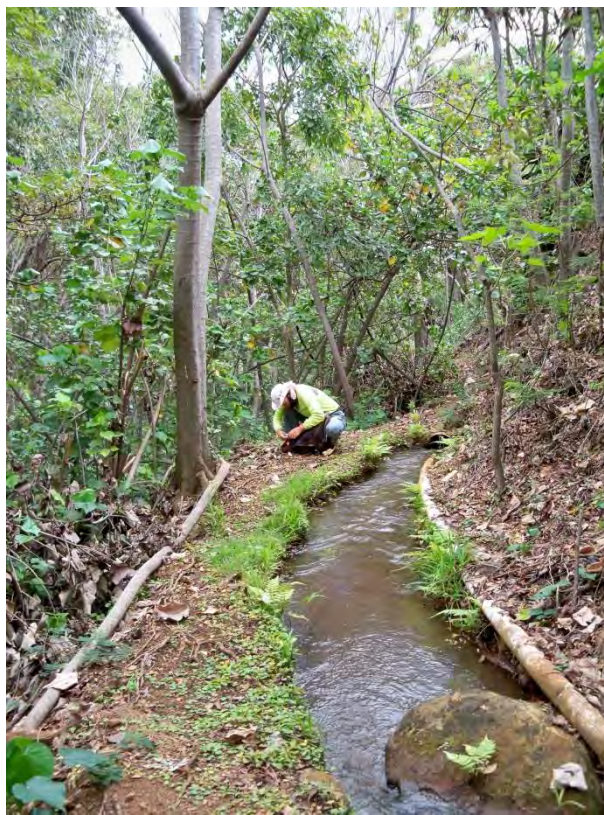
**Figure 57. Site 7884 Feature 1 Historic Scatter along Feature 2 Ditch, View to West**

Site 7884 Feature 1 is one of three secondarily deposited historic refuse scatters located adjacent to; south and west of Feature 2 ditch near the northeastern corner of Parcel 3 Mauka. The refuse deposit covers an area of approximately 4.0 m and appears to have been re-deposited by anthropomorphic or alluvial forces (Figures 56-59). Thus, the materials may have been tossed down slope from the dirt access road or it may have been washed down during heavy flow re-depositing the materials along the sides and within the ditch. Historic materials included bottle glass fragments and ceramic plate sherds. Features 2 and 3 of this Site number are discussed further below within sections Parcel 6 and Parcel 7.

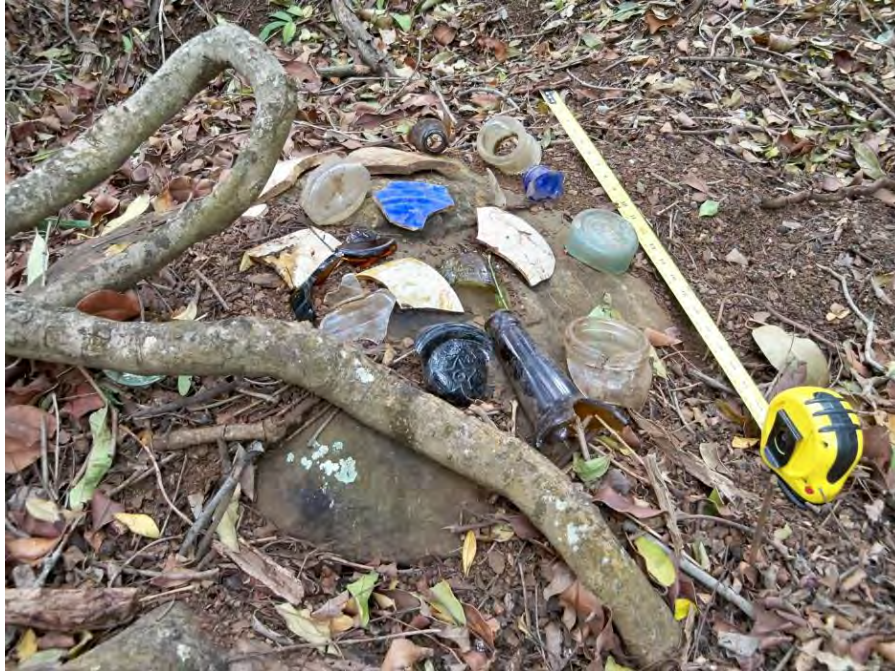
**Figure 58. Site 7884 Feature 1 (TS2) Secondary Deposit of Historic Refuse**

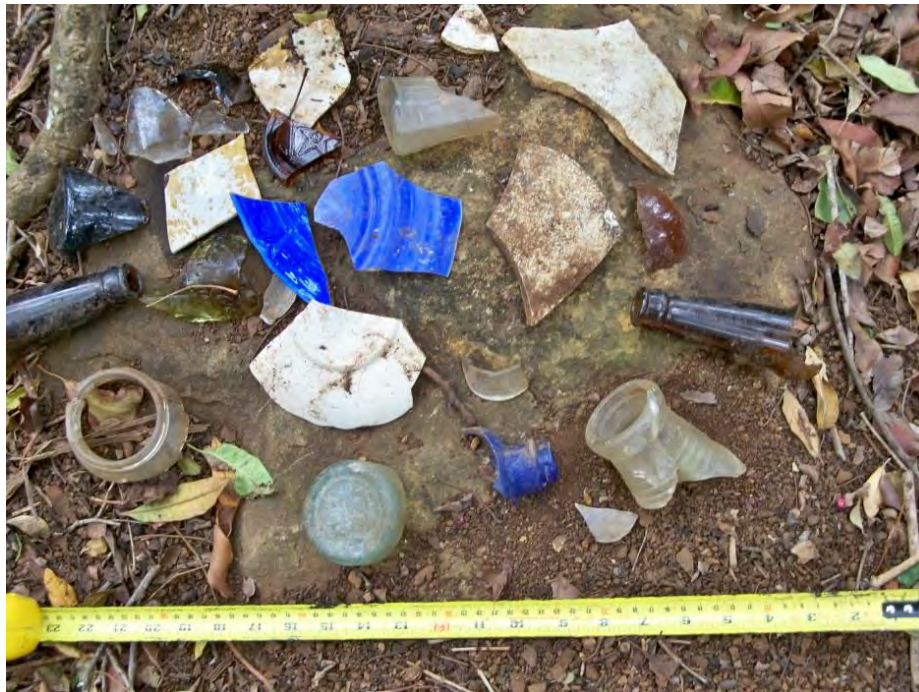
**Figure 59. Overview Photograph of Site 7884 Feature 1 Historic Material**

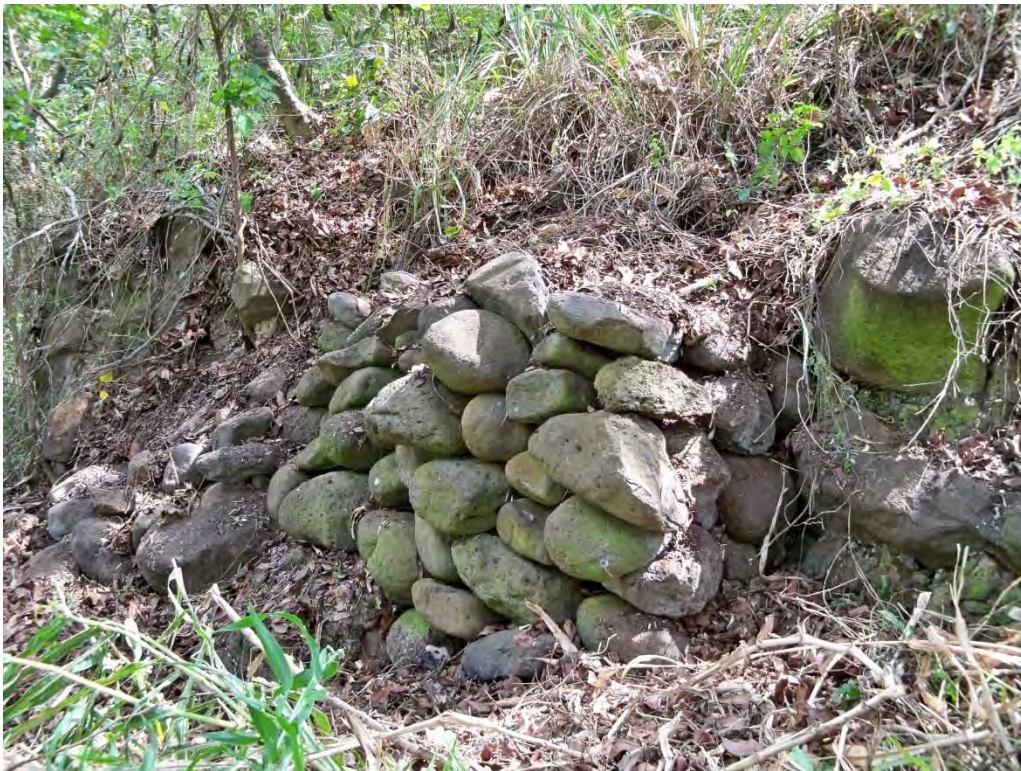
Site 7882 is a remnant L-shaped retaining wall or rock-faced, soil-filled terrace located 5.0 m north of Site 7881 Feature 2 ditch and south of the Waikapū Stream near the boundary between Parcel 6 and Parcel 3 Mauka within LCA 2522. As presented in Table I, LCA 2522 claimed land use of kula and *lo`i kalo* (wetland taro). Site 7882 is constructed along the contour of the slope and retains a small level surface area to the north (Figures 61-64). It incorporates the outcrop into its construction on the east, and is stacked and faced, 6 courses high (1.5 m) with water-worn basalt small boulders and cobbles. The longer leg measures 4.0 m and is oriented east/west and the shorter leg is 1.5 m north/south retaining a level surface area measuring from 0.80 m to 1.0 m. Collapse is present on the east adjacent to the outcrop. Based on the former land use presented in Table I, Site 7882 is likely a remnant terrace formerly utilized during the historic period for the cultivation of taro. Additionally, this site may have initially been constructed during the pre-Contact period, and renovated during historic times.

**Figure 61. Overview Photograph of Site 50-50-04-7882 an L-shaped Retaining Wall, View to Southeast**

Similar to Site 7881, Site 7882 is outside the currently proposed area of potential effect (A.P.E) and will not be adversely affected during development. Regardless, this historic property has been adequately documented and requires no further inventory level work. Archaeological monitoring will be performed in the area if future development occurs.

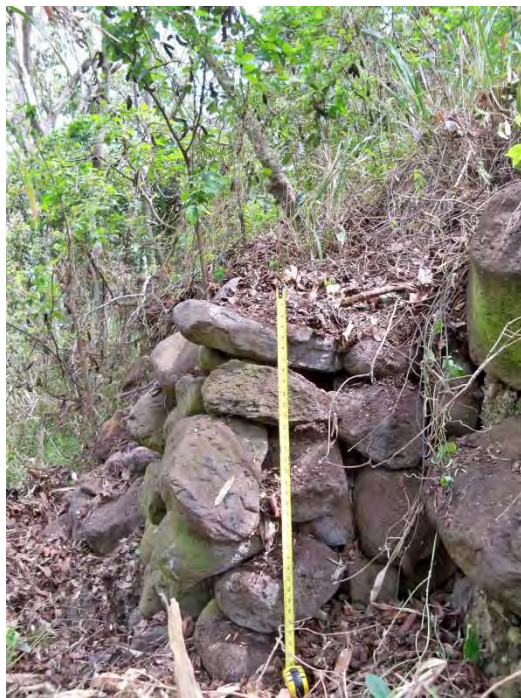
**Figure 62. Overview Photograph of Cross-Section of Site 7882, View to East**

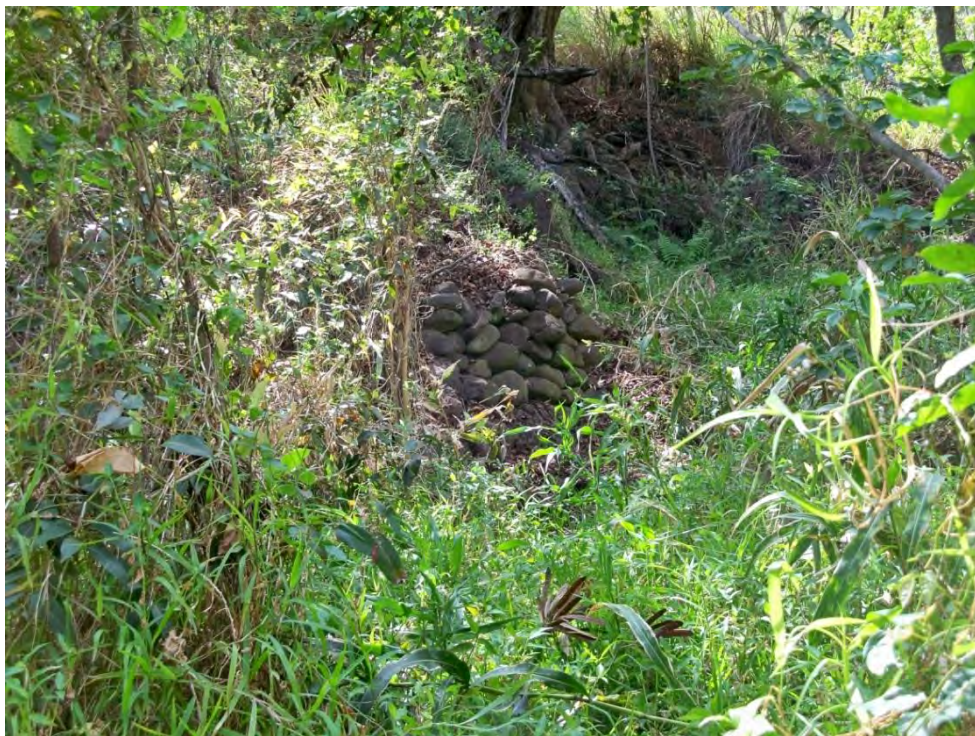
**Figure 63. Site 7882 foreground and Site 7881 Feature 2 background, View to Southwest**

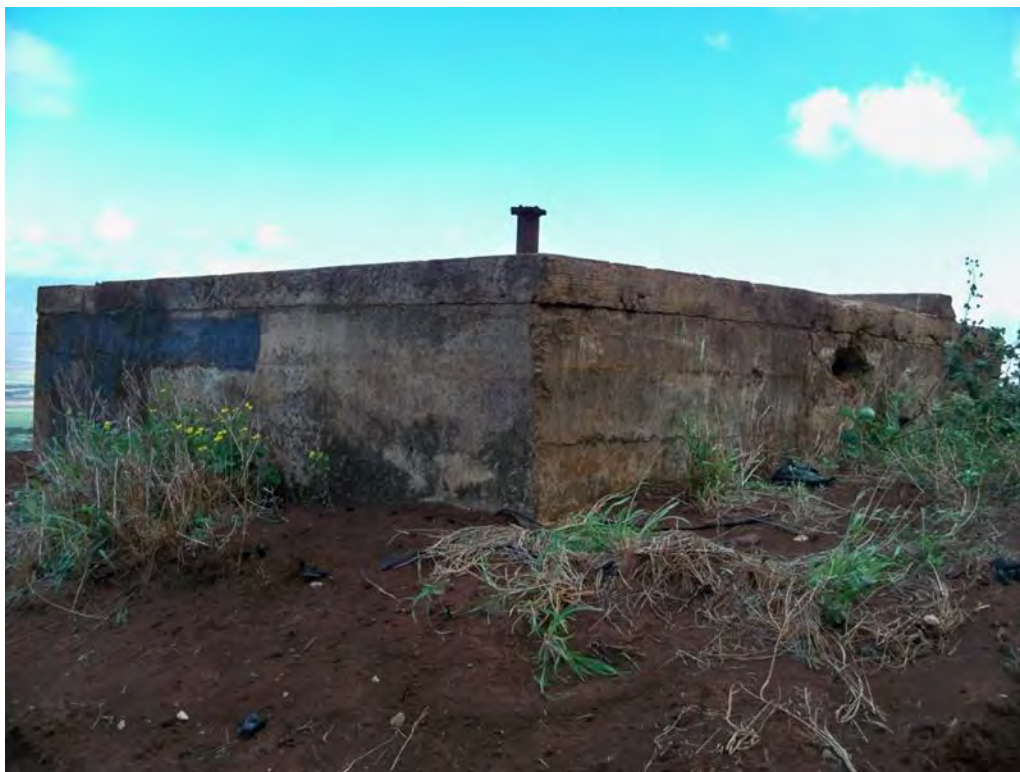
Site 7883 consists of a World War II bunker situated mid-slope at approximately 740 AMSL along the south side of the main access road that bisects Parcel 3 Mauka east/west (see Figure 22). Site 7883 is a square-shaped enclosure constructed of formed concrete walls atop a concrete foundation and roof (Figures 65 and 66). The concrete contains large aggregate gravel inclusions and is reinforced with metal re-bars. The bunker is partially buried into the slope, with the eastern side nearly level with the existing ground surface, and the western portion almost completely buried. It appears that soil from the immediate area was pushed up around the exterior walls of the structure versus complete excavation for the foundation. Site 7883 measures 5.35 m (E/W) by 5.35 (N/S) along the exterior, with a height of 1.58 m above the existing surface on the northeast, 1.45 m on the southeast, 1.1 m along the northwest, and 0.8 m above surface on the southwest. The walls are 0.23 m thick bounding an interior area of 4.89 m<sup>2</sup> with an interior ceiling height of 3.0 m. Centered atop the roof is a square concrete base measuring 0.50 m<sup>2</sup> by

0.13 m thick with a threaded metal pipe 0.15m (diameter) extending through the center, 0.37 m above the concrete pedestal. The metal pipe also extends thru the roof to the interior and was possibly utilized to mount a firearm atop the roof of the bunker. The internal end of the pipe is threaded and contains large corroded bolts.

Figure 65. Overview Photograph of Site 7883 (TS3), View to West (top) View to East (bottom)

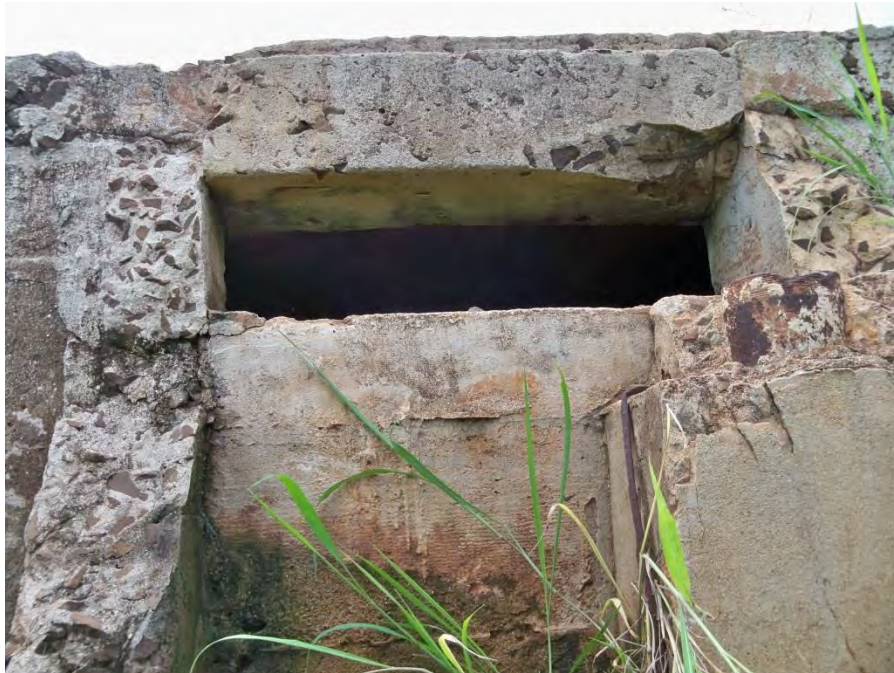
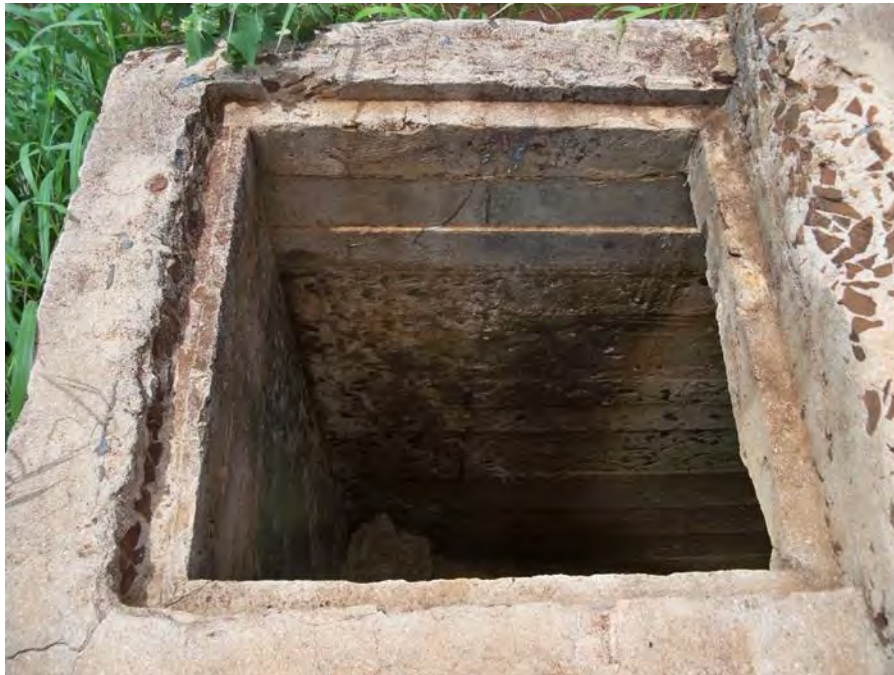
Access to the interior of the structure is atop the southwest corner of the roof, measuring 0.75 m<sup>2</sup> square, and 0.80 m above the exterior existing surface, the interior floor is 2.5 m below the opening (Figure 68). The concrete hatch/door belonging to the opening has collapsed inside the bunker; however it was designed to be inset into the roof (Figure 66) and therefore level and or flush with the exterior roof. Presently the interior contains modern trash, the foundation is deteriorated and the interior walls contain modern graffiti.

**Figure 67. Overview Photograph of Embrasure with Concrete Encased Pipe to Right (top) View to West; Photograph of Access into Site 7883 (TS3) (bottom) View to West**

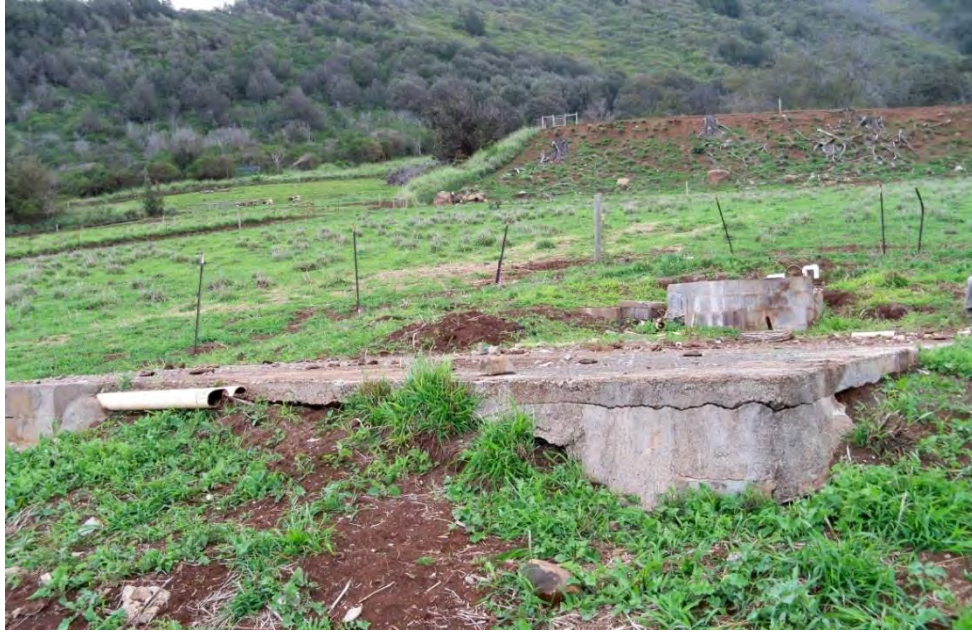
**Figure 69. Overview Photograph of Site 7883 Feature 1, View to West**

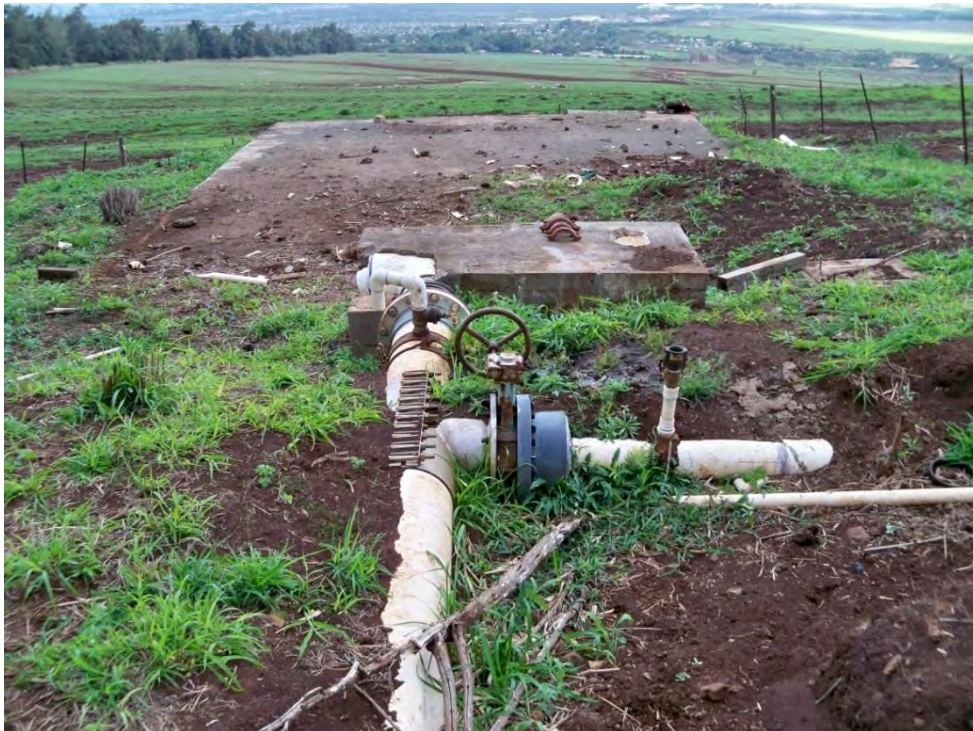
**Figure 70. Overview Photograph of Site 7883 Feature 1 with Modern PVC Valves**
