**APPENDIX E**  
**Archaeological Inventory Survey**  
**(Part 2)**

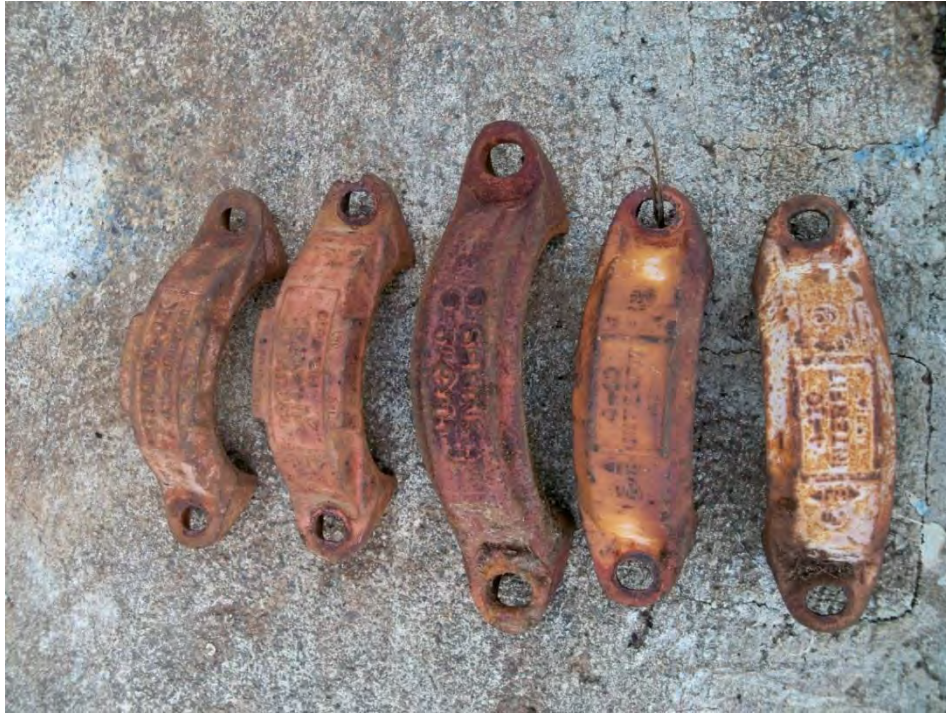
**Figure 71. Site 7883 Feature 1 Pipe Fittings**

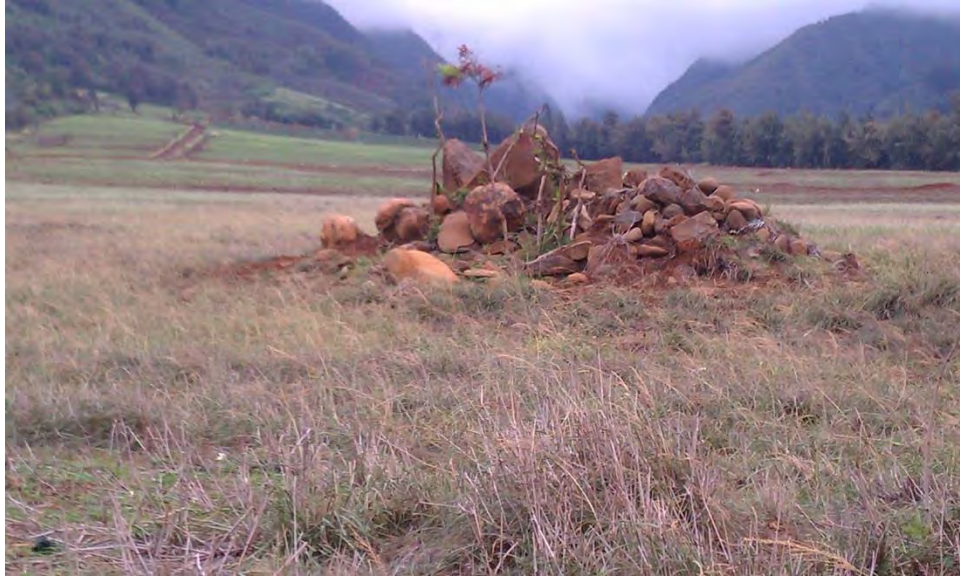
**Figure 75. Photograph of Temporary Site 22 Rock Mound within Parcel 3 Mauka, View to Northwest**

Temporary Sites 22 is the second rock mound presumed to be a sugarcane clearing/push pile comprised primarily of large basalt boulders, cobbles and pushed soil (see Figure 75). This feature is smaller than TS21 and measures 8.0 m in diameter by approximately 1.5 m high.

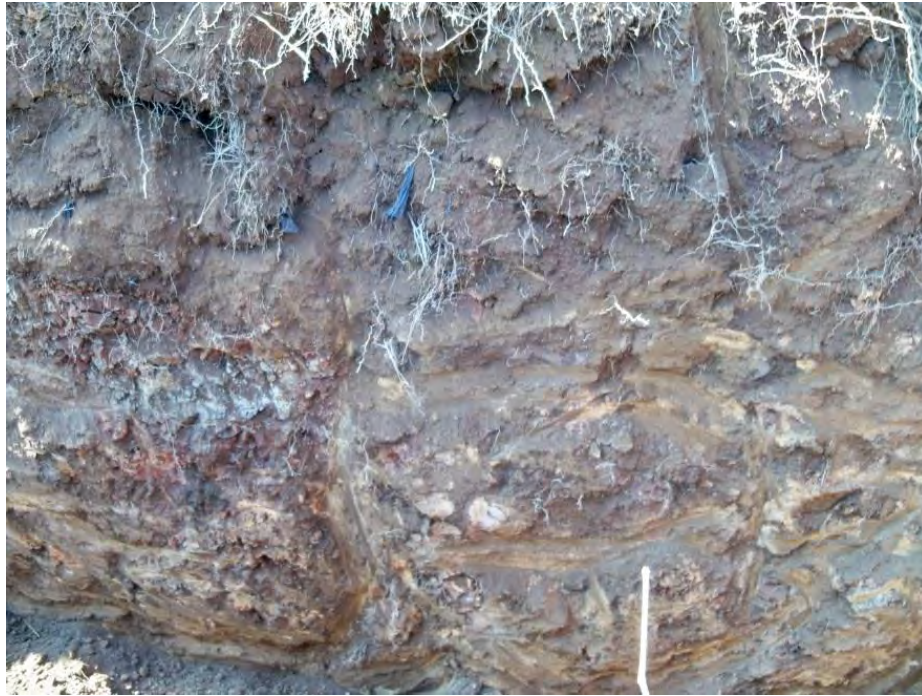
**Layer I** (0-62cmbs): is a dark reddish brown (2.5yr 3/3), clay loam, pastureland and previous agricultural plow zone, with deteriorated drip-lines, slightly-plastic, slightly-sticky, weak, fine to

**Layer II** (59-175cmbs): is a dark reddish brown (2.5yr 3/4), clay loam, slightly-plastic, slightly-sticky, weak, fine to medium grain, blocky, slightly hard. No cultural materials were observed in this layer.

Figure 81. Photograph of TR406 South Wall (Top); Stratigraphic Profile of TR406 South Wall (Bottom)

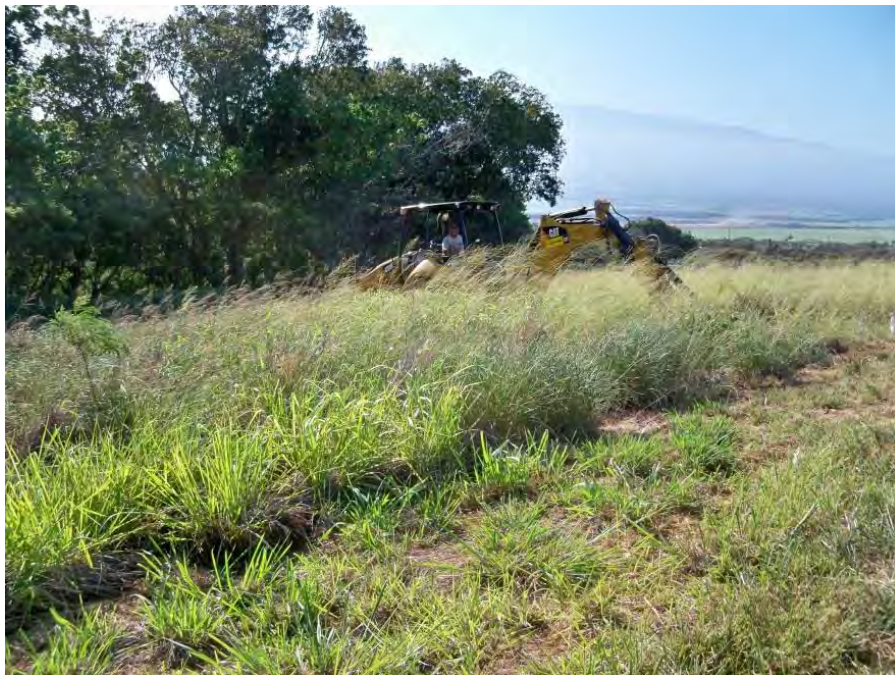
**Figure 83. Overview of TR 412 within Parcel 3 Mauka, View to East**

two layer stratigraphic sequence with excavations terminating within sterile soils containing medium and large sized boulders (Figures 83 and 84). A 4.9 m long by 1.44 m wide by 1.81 m deep, oriented 180° by 360° section of this area was recorded and is further described below. A single clear glass bottle fragment was recovered approximately 30 cmbs within TR 412.

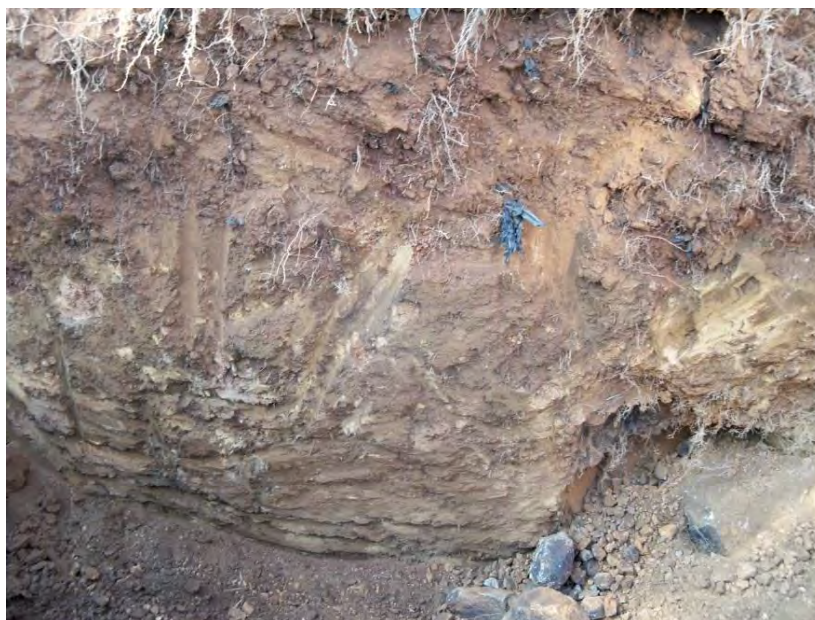
Figure 84. Photograph of TR 412 South Wall (top); and Stratigraphic Profile of TR 412 South Wall (bottom)

**Layer I** (0-78cmbs): is a dark brown (7.5yr 3/3), silt loam, previous agricultural plow zone, with deteriorated drip-lines, slightly-plastic, slightly-sticky, weak, fine to medium grain, slightly hard, blocky, with a high frequency of roots. Boundary was clear and wavy overlying Layer II. A clear glass fragment was recovered.

**Layer II** (60-181cmbs): is brown (7.5yr 3/4), silt loam, slightly-plastic, slightly-sticky, friable, fine to medium grain, blocky, slightly hard. High frequency of decomposing bedrock and large boulders were noted at base of Layer II. No cultural materials were observed in this layer.

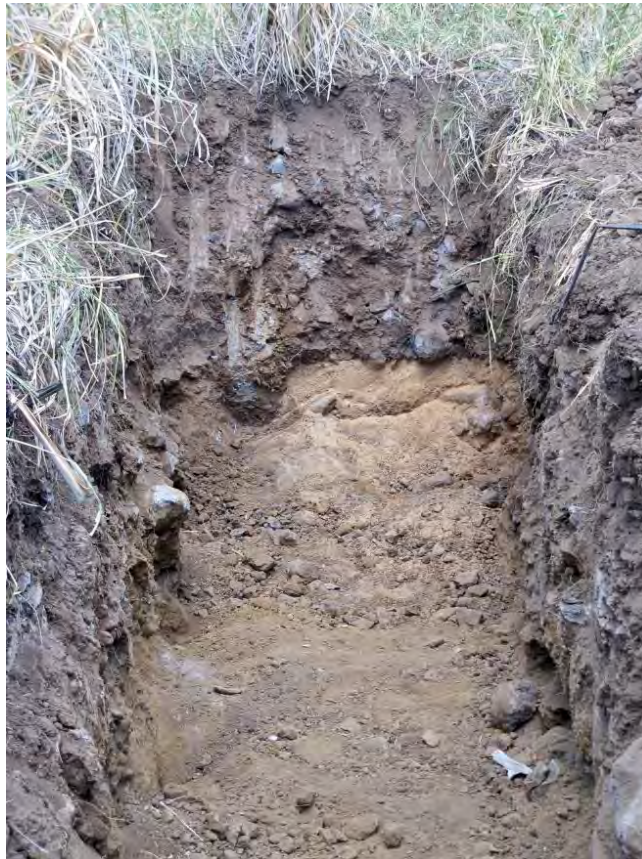
**Layer I** (0-52cmbs): is a very dark grayish brown (10yr 3/2), silt loam, currently a fallow cane field and previous agricultural plow zone, with deteriorated drip-lines, slightly-plastic, slightly-sticky, weak, fine to medium grain, slightly hard, blocky, friable, with a medium frequency of roots. Boundary was clear and wavy overlying Layer II. No cultural materials were observed in this layer.

**Layer II** (41-88cmbs): is a very dark grayish brown (10yr 3/2), stony silt loam, slightly-plastic, slightly-sticky, weak, fine to medium grain, blocky, slightly hard, friable with a medium frequency of rocks, cobbles and gravel. No cultural materials were observed in this layer.

**Layer III** (82-117cmbs): is a dark yellowish brown (10yr 4/4), riverbed stony silt, weakly coherent, non-plastic, non-sticky, loose, single grain to fine to medium grain, with a high frequency of rocks, cobbles and medium to large boulders. Boundary was clear and wavy overlying Layer IV and Layer IIIa along the north, northwest and west section (Figures 90 and 92) overlying Layer IV. No cultural materials were observed in this layer.

**Figure 89. Overview Photograph of TR 1 North Wall Profile**

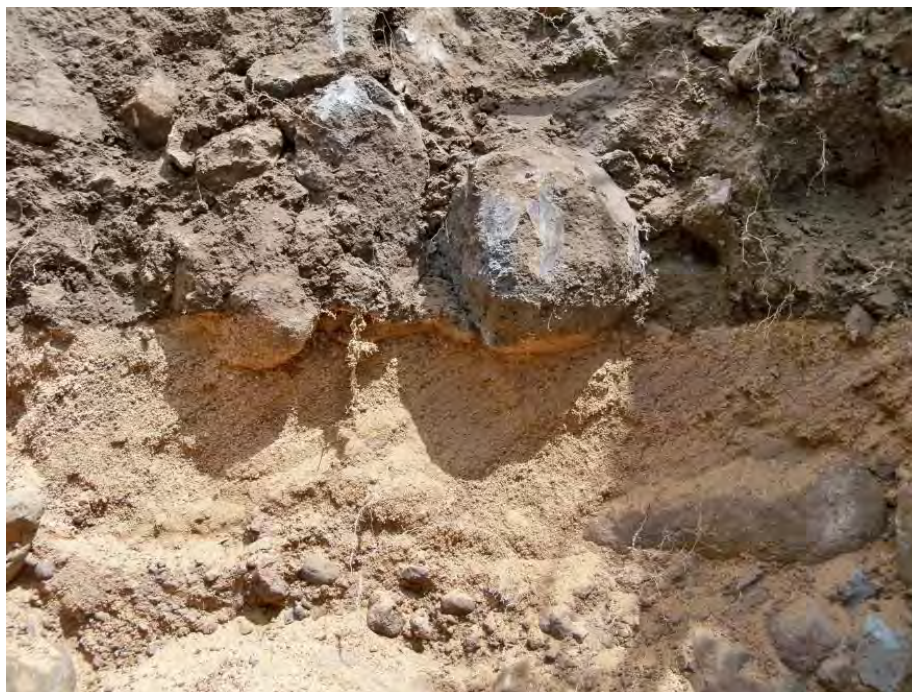
**Lens/Layer IIIa** at 110cmbs a light yellowish brown (10yr 6/4) a fine to medium grain sand deposit was observed in a disturbed context in the north/northeast corner, overlying a sandy gravel extending 1.5 mbs on the north and east, overlying Layer IV on the north, northwest, non-plastic, non-sticky, loose, single grain, structureless, boundary abrupt and broken. No cultural materials were observed in this layer.

**Figure 91. Up Close Photograph of Sand Deposit within TR 1, View to North**

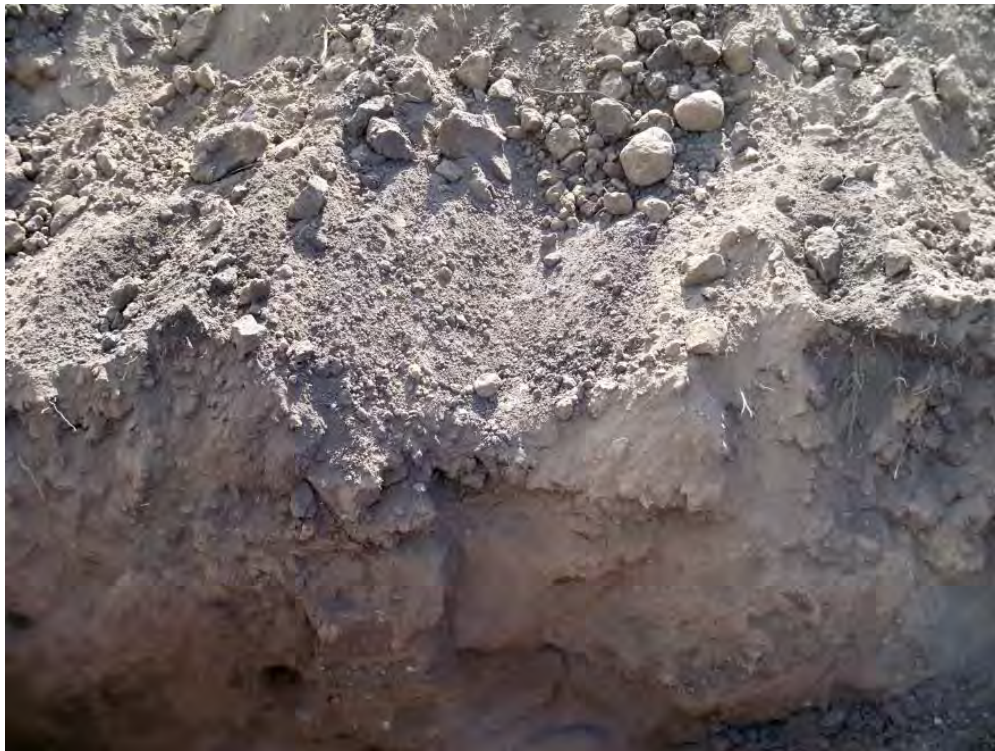
**Layer I** (0-60cmbs): is a dark brown (7.5yr 3/2), silt loam, currently a fallow cane field and previous agricultural plow zone, with deteriorated drip-lines, slightly-plastic, slightly-sticky, weak, fine to medium grain, slightly hard, blocky, with a medium frequency of roots and rocks. Boundary was clear and wavy overlying Layer II. No cultural materials were observed in this layer.

**Layer II** (58-121cmbs): is a dark brown (10yr 3/3), silt loam, slightly-plastic, slightly-sticky, weak, fine to medium grain, blocky, slightly hard, friable, with a medium frequency of rocks, cobbles and gravel. Boundary was clear and smooth overlying Layer III. No cultural materials were observed in this layer.

**Layer III** (116-212cmbs): is a brown (10yr 4/3), silt loam, weak, slightly hard, slightly-plastic, slightly-sticky, single grain with a high frequency of medium to large boulders. Boundary was clear and wavy overlying Layer IV streambed. No cultural materials were observed in this layer.

**Layer IV** (202-232cmbs): is a dark grayish brown (10yr 4/2), streambed, gravel silt, loose, fine to large grain, structureless, cobbles, pebbles and gravel. No cultural materials were observed in this layer.

Figure 93. Photograph of Stratigraphic Profile of TR 11 South Wall

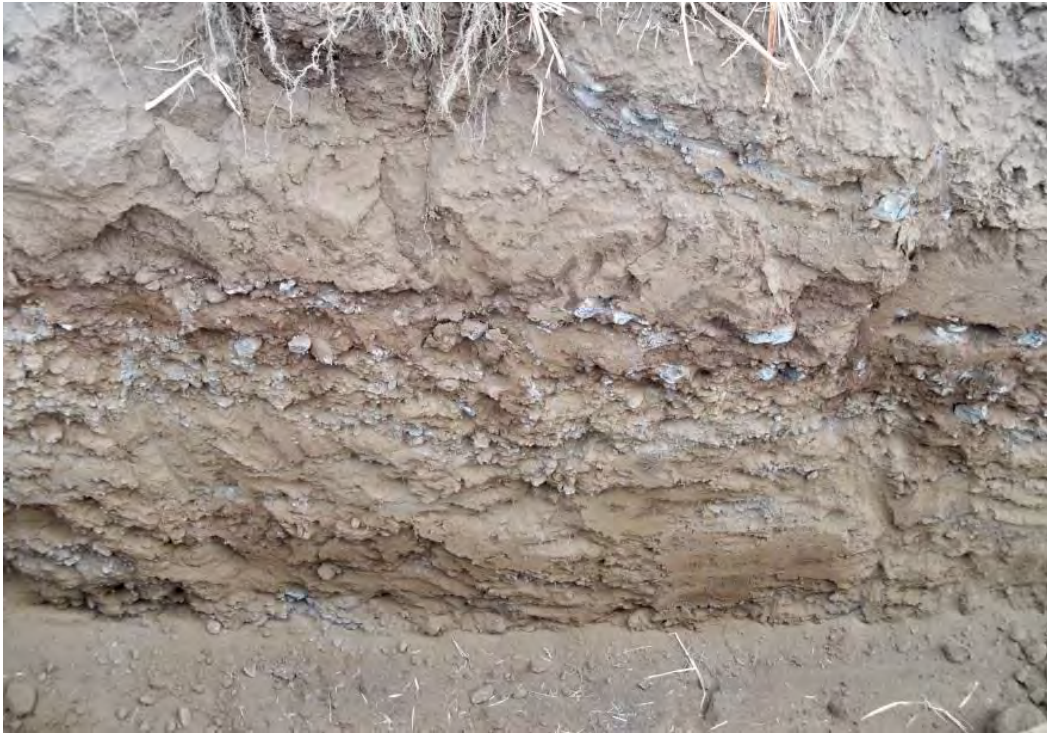
**Layer I** (0-25cmbs): is a dark brown (7.5yr 3/3), silt loam, currently a fallow cane field and previous agricultural plow zone, with deteriorated drip-lines, slightly-plastic, slightly-sticky, weak, fine to medium grain, slightly hard, blocky, friable with a medium frequency of roots. Boundary was clear and wavy overlying Layer II. No cultural materials were observed in this layer.

**Layer II** (24-48cmbs): is a brown (10yr 4/3), silt loam, slightly-plastic, slightly-sticky, weak, very fine to fine grain, blocky, slightly hard, friable with a medium frequency of rocks, cobbles and gravel. Boundary was abrupt and wavy overlying Layer III. No cultural materials were observed in this layer.

**Layer VI** (138-230cmbs): At 110cmbs is a brown (10yr 4/3), silt loam, weak, blocky, slightly-plastic, slightly-sticky, compact, fine grain. No cultural materials were observed in this layer.

**Figure 95. Photograph of Stratigraphic Profile of TR 14 South Wall**

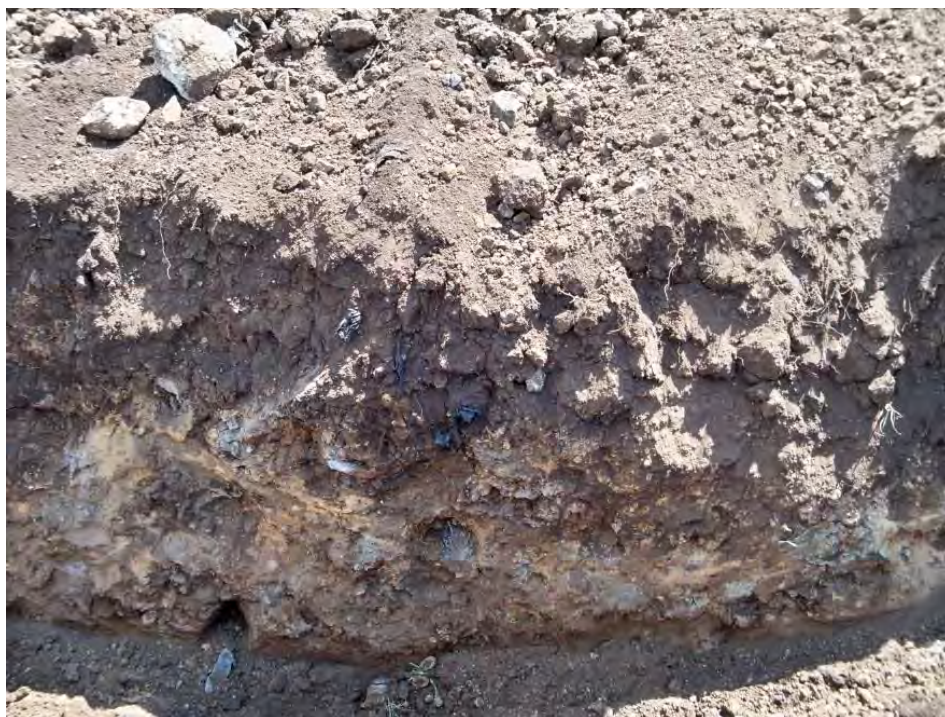
**Figure 97. Photograph of Stratigraphic Profile of TR 23 East Wall**

**Layer I** (0-64cmbs): is a dark brown (7.5yr 3/3), silt loam, within a previous agricultural plow zone, with deteriorated drip-lines, slightly-plastic, slightly-sticky, weak, fine to medium grain, slightly hard, blocky, friable with a medium frequency of roots. Boundary was clear and wavy overlying Layer II. No cultural materials were observed in this layer.

**Layer II** (64-184cmbs): is a dark brown (7.5yr 3/4), stony silt, slightly-plastic, slightly-sticky, weak, fine to medium grain, blocky, slightly hard, friable with a medium frequency of rocks, and decomposing bedrock. No cultural materials were observed in this layer.

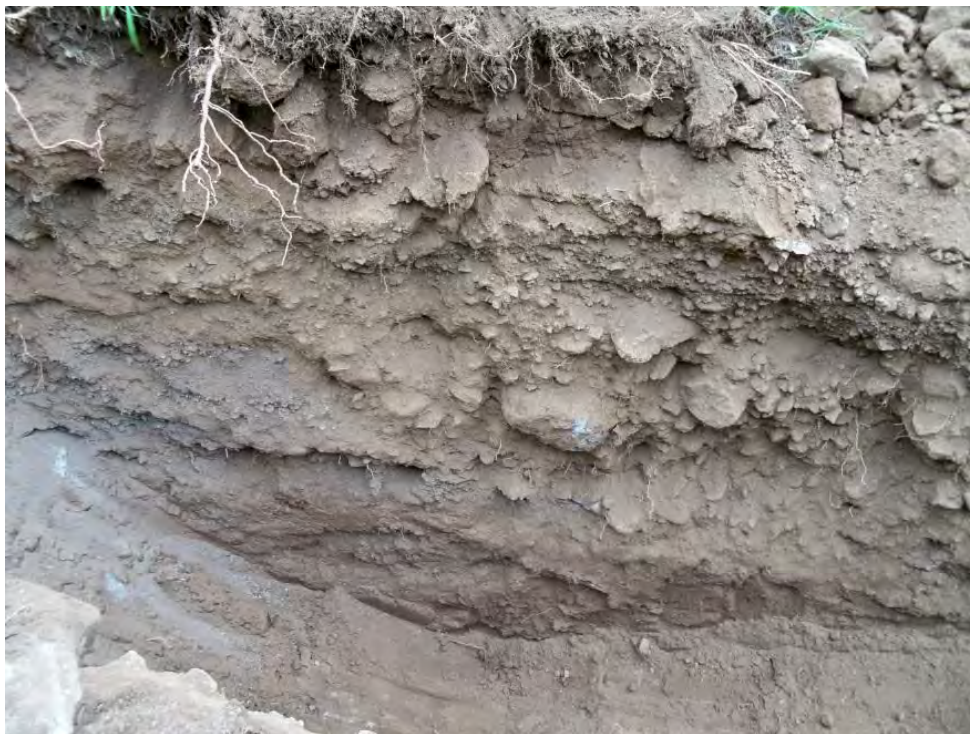
Figure 99. Photograph of Stratigraphic Profile of TR 08 West Wall

**Layer III** (24-100cmbs): is a brown (7.5yr 3/2), streambed, non-plastic, non-sticky, medium to coarse grain, with a low frequency of roots. structureless, weakly coherent with a high frequency of rounded cobbles, pebbles and gravel. No cultural materials observed in this layer. Boundary was clear and a plane overlying Layer IV.

**Layer IV** (92-160cmbs): is a brown (7.5yr 4/2), silt, slightly-plastic, slightly-sticky, blocky, slightly hard, medium grain, with a low frequency of rock and the absence of roots. No cultural materials observed in this layer.

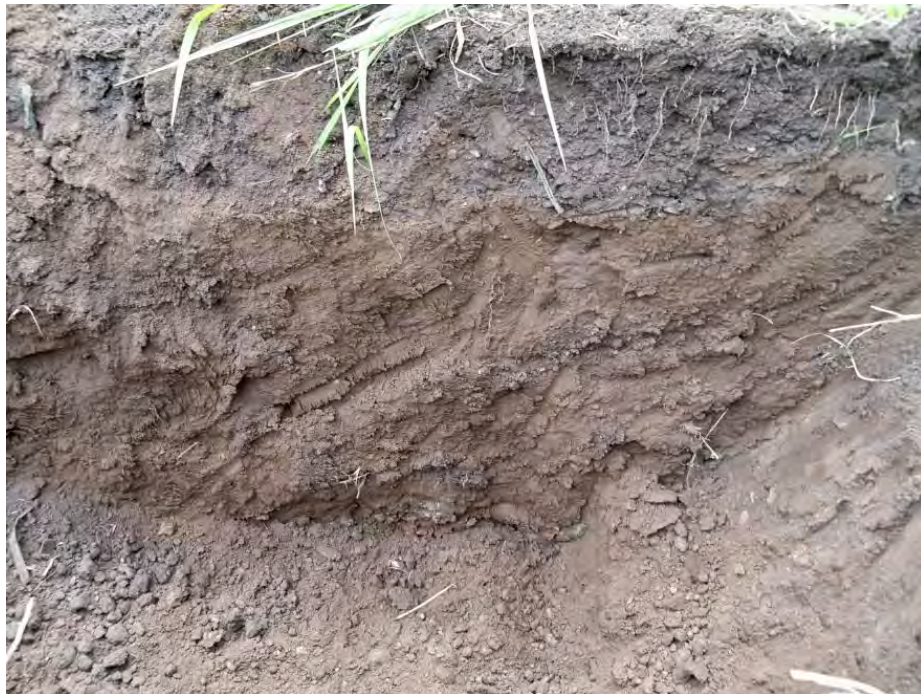
Figure 101. Photograph of Stratigraphic Overview of TR 011 South Wall

**Layer II** (28-157cmbs): is a brown (7.5yr 4/2), silty loam, slightly-plastic, slightly-sticky, blocky, slightly hard, medium to coarse grain, with a high frequency of rounded pebbles and gravel. No cultural materials observed in this layer. Boundary was clear and wavy overlying Layer III.

**Layer III** (157-180cmbs): is a brown (7.5yr 3/2), streambed, non-plastic, non-sticky, medium to coarse grain, with a low frequency of roots. structureless, weakly coherent with a high frequency of rounded cobbles, pebbles and gravel. No cultural materials observed in this layer.

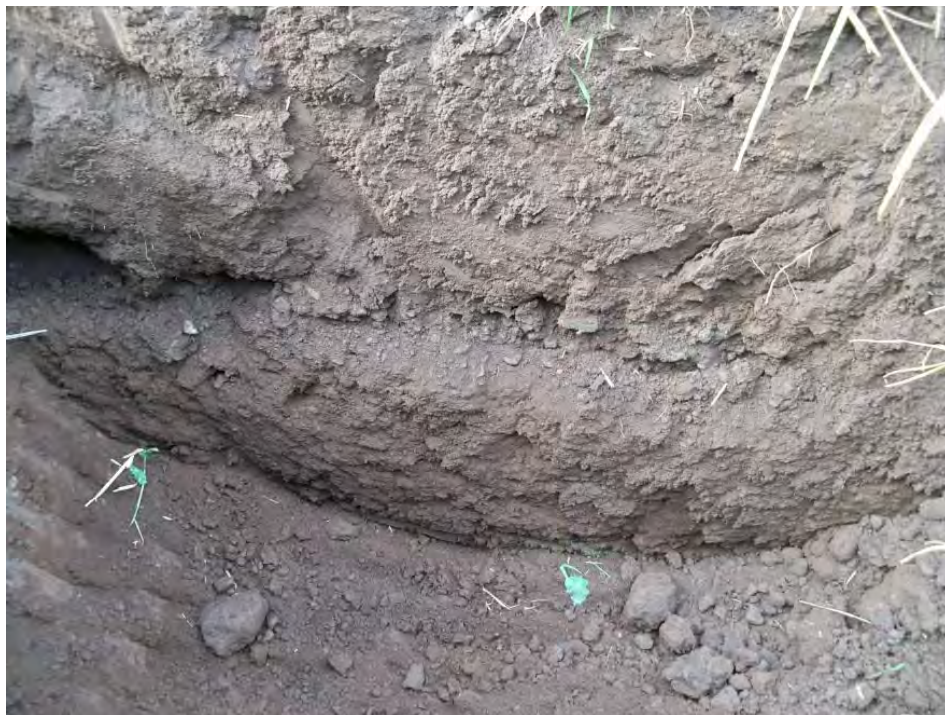
**Figure 103. Photograph of Stratigraphic Profile of TR 015 North Wall Profile**

**Layer IIb** (90-110cmbs): is a dark grayish brown (10yr 4/2), streambed, non-plastic, non-sticky, medium to coarse grain, with an absence of roots, structureless, with a high frequency of rounded cobbles, pebbles and gravel. No cultural materials observed in this layer. Boundary was clear and a plane overlying Layer III.

**Layer III** (100-180cmbs): is a grayish brown (10yr 5/2), silt loam, slightly-plastic, slightly-sticky, blocky, slightly hard, fine to medium grain, with a low frequency of rounded pebbles and gravel. No cultural materials observed in this layer. No cultural materials observed in this layer.

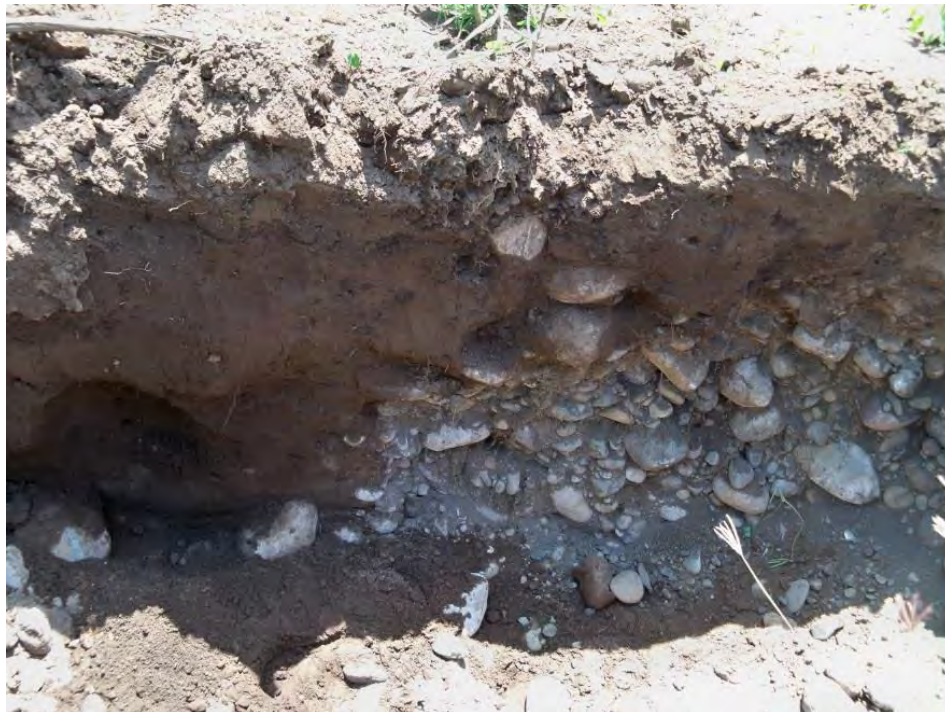
Figure 106. Photograph of Stratigraphic Profile of Trench 100 South Wall with Streambed Deposit

Trench 100 (TR 100) was situated in the northeastern portion of the project area along the western edge of a cultivated sugarcane field (see Figure 86). This section contained a four layer stratigraphic sequence with excavations terminating in sterile streambed soils (Figures 106 and 107). No cultural materials were observed within TR 100 which measured 4.7 m long by 1.41 m wide by 1.5m deep.

**Layer III** (58-150cmbs): is a dark yellowish brown 10 YR 3/6), imported gravelly silt, non-plastic, slightly-sticky, medium to coarse grain. No cultural materials observed in this layer. Boundary was clear and abrupt overlying Layer II.

**Layer IV** (130-150cmbs): is a dark brown (7.5yr 3/3) sandy loam with sub-rounded small basalt cobbles and lithified sand stone peds, non-plastic, slightly-sticky, fine to medium grain, with a low frequency of roots. No cultural materials were observed in this layer. Boundary was clear and broken abutting Layer III on the west.

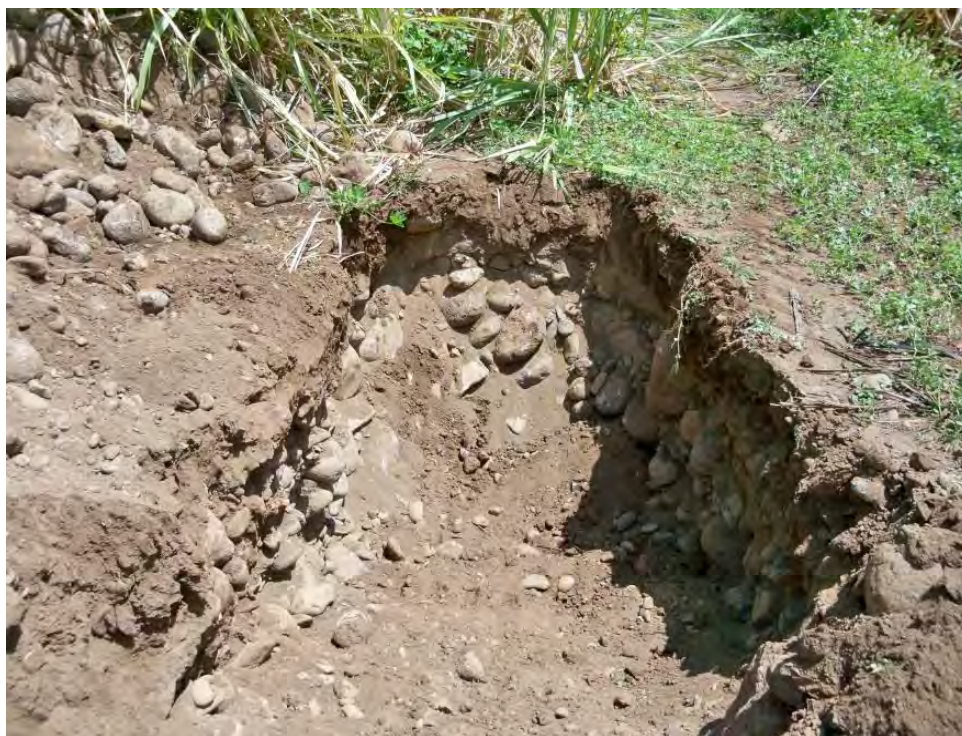
Figure 108. Photograph of Stratigraphic Profile of Trench 102 with Streambed Deposit, View to West

Trench 102 (TR 102) was located in the northeastern portion of the project area within an access road and the edge of a cultivated sugarcane field (see Figure 86). This trench contained a three layer stratigraphic sequence with excavations terminating in sterile silty soil (Figures 108 and 109). Trench 102 was non-cultural and measured 4.7 m long by 1.42 m wide by 1.5m deep.

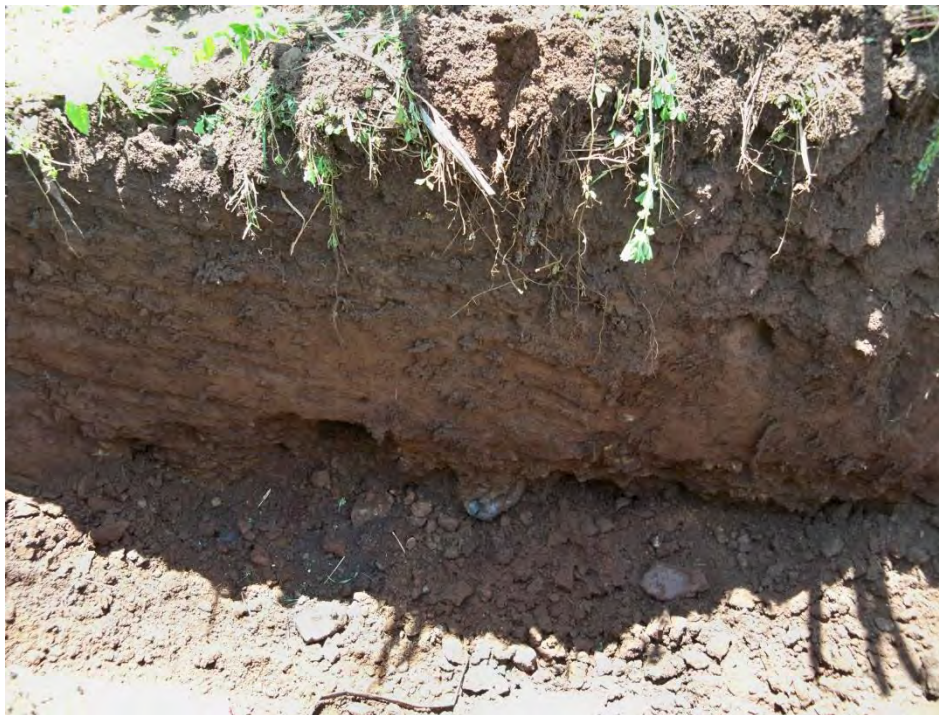
Figure 110. Photograph of South Wall of Trench 110

Trench 110 (TR 110) was situated in the central portion of the project area within Grant 2747:2 to Eugene Bal (see Figure 86 and Table IX). Land use for the grant was listed as sugarcane and a reservoir. The stratigraphic record for TR110 contained four layers which were the similar to TR's 108-109 (Figures 110 and 111). No cultural materials or evidence of the reservoir were observed within the trench which measured 4.7 m long by 1.43 m wide by 1.6 m deep.

**Layer III** (78-101/118 cmbs) is a reddish brown silty clay (5YR3/3), compact, non-plastic slightly sticky, with gravel inclusions. Layer III is non-cultural and has an abrupt, smooth boundary.

**Layer IV** (118-BOE cmbs) is a dark reddish brown (7.5YR4/6) gravelly silty clay with mottling of Layer III saprolitic rock. No roots, linear gravel inclusions and sub angular rock. Layer IV is non-cultural and excavations terminated within this layer.

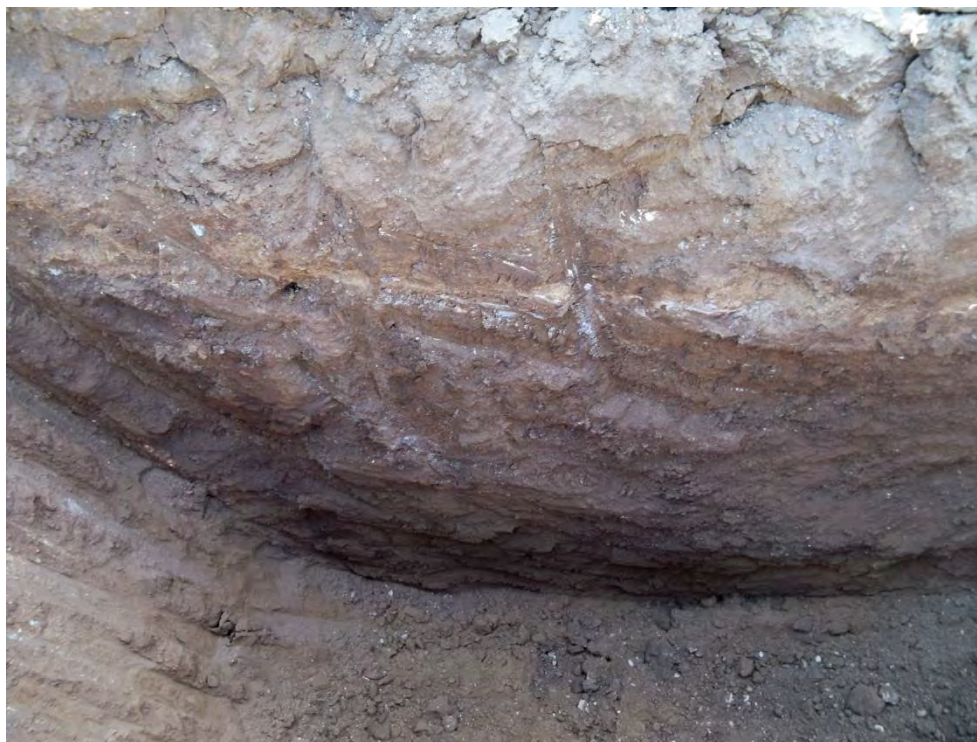
Figure 112. Photograph of West Wall of Trench 116, View to West

Trench 116 (TR 116) was situated in the central portion of the project area also within Grant 2747:2 which was formerly utilized as sugarcane and a reservoir (see Figure 86 and Table IX). The stratigraphic record for TR116 contained four layers including one sand lens which interrupted the upper portion of Layer II (Figures 112 and 113). No cultural materials were observed within this trench which measured 4.7 m long by 1.45 m wide by 2.0m deep.

**Layer IIa** (42/45-55/57 cmbs) is a sand lens which was likely aeolian deposited. Layer IIa is non-cultural.

**Layer III** (150-200 cmbs) is a dark brown, strong brown (7.5YR3/2, 4/3, 4/6) very fine silt loam, non-plastic, non-sticky, fine to medium grain, with a low density of roots. Layer III is non-cultural and excavations terminated within this layer.

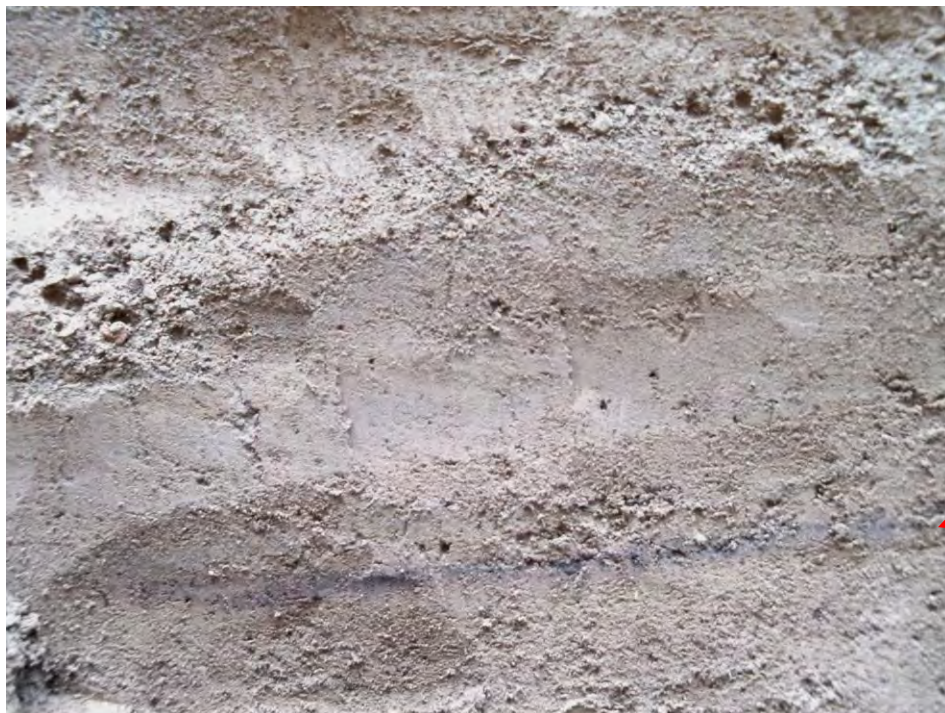
Figure 115. Close-up Photograph of South Wall of TR 121 Showing Charcoal Staining

Trench 121 (TR 121) was located along the eastern edge of the parcel in the southeast portion along an east-west trending cane haul access road (see Figure 86 and Tables XV and XVI). This trench contained a four-layer stratigraphic sequence with a gravel lens indicative of alluvial deposition, as well as a charcoal stained lens near the base of the trench (Figures 114-116). All layers were non-cultural with the charcoal staining likely due to past cane burning activities. Excavations terminated within Layer IV and TR 121 measured 4.7 m long by 1.45 m wide by 1.66 m deep.

**Layer IIIa** (148-BOE) is similar to Layer III but appears to be a finer material. It is comprised of dark brown (10YR 4/2.5) very fine silt and contains the linear charcoal staining at the transition with Layer III. Layer IIIa is non-cultural.

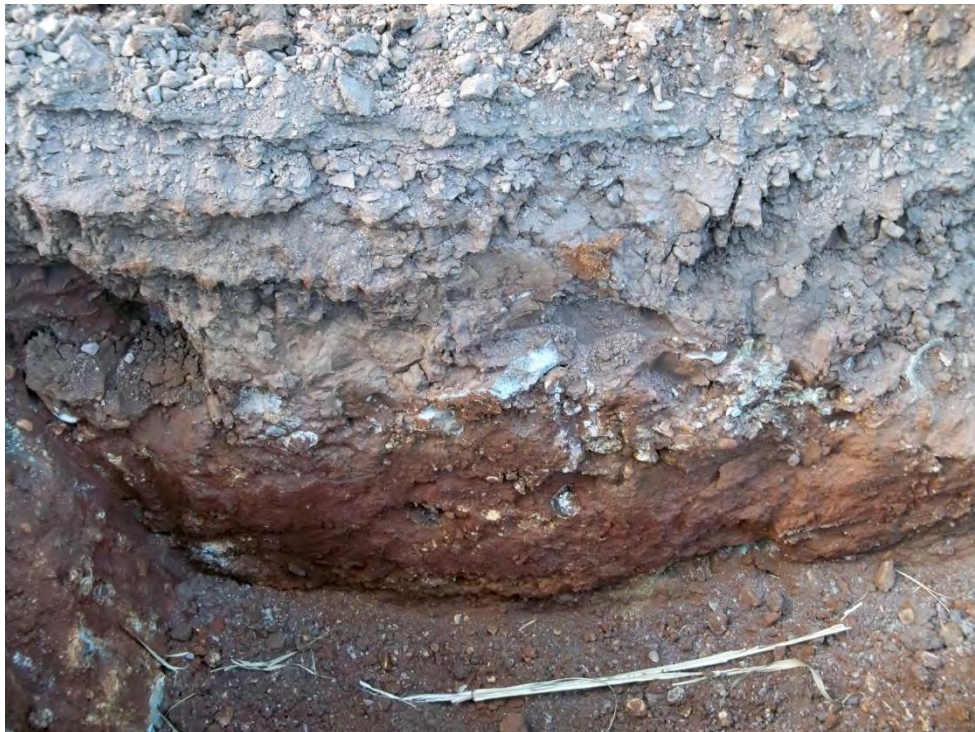
Figure 117. Photograph of West Wall of Trench 125, View to West

Trench 125 (TR 125) was located in the southeastern corner the northern side of a cane haul access road (see Figure 86 and Tables XV and XVI). It contained a four-layer stratigraphic sequence with a storm/flood wash layer represented in stratum 2 (Figures 117 and 118). TR 125 was oriented at 360 and measured 4.9 m long by 1.43 m wide by 1.80 m deep and was non cultural.

**Layer III** (60/70-142/160 cmbs) is a reddish brown (7.5YR4/6) compact silty clay, non-plastic, slightly-sticky, fine to medium grain, with a few sub-angular and rounded small cobbles. Layer III is non cultural with no roots and has a clear, smooth boundary with Layer IV.

**Layer IV** (142/160-BOE) is similar to Layer III but is more compact, and comprised of a very fine, reddish brown silt which is devoid of rock inclusions. Layer IV is non-cultural and B.O.E. is at 180 cmbs.

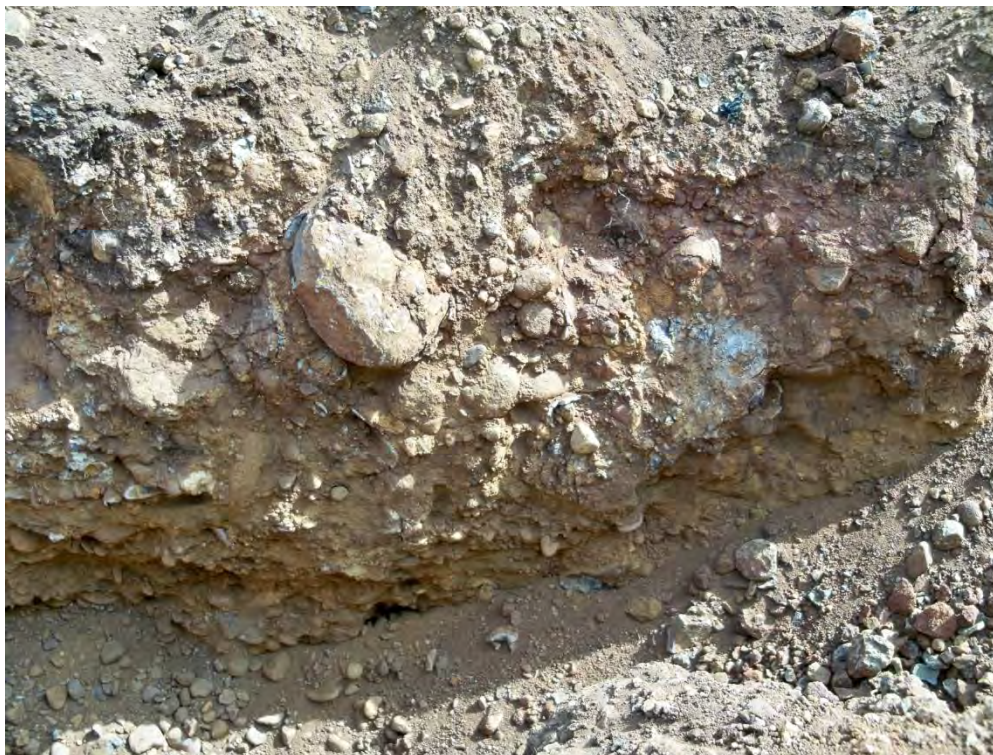
**Figure 119. Photograph of South Wall of Trench 137**

Trench 137 (TR 137) was located in the northwestern corner near a utility storage shed along the northern side of an access road (see Figure 86 and Tables XV and XVI). It contained a four-layer stratigraphic sequence comprised of alluvial deposition that terminated in decomposing basalt (Figures 119 and 120).

**Layer III** (30/60-122) is a yellowish brown (10YR4/3) gravelly silt with pockets of reddish brown silty clay. Many small and large cobbles with a few medium sized boulders and saprolitic rock, non-plastic, non-sticky, fine to medium grain. Layer III is non cultural with no roots. Layer III is non-cultural has a clear, smooth boundary with Layer IV.

**Layer IV** (122-BOE) is comprised of decomposing bedrock and smaller cobbles and pebbles with yellowish brown (10YR4/3) fine silt.
