Section 4 Results of Fieldwork

4.1 Pedestrian Inspection Results

4.2 Subsurface Testing Results

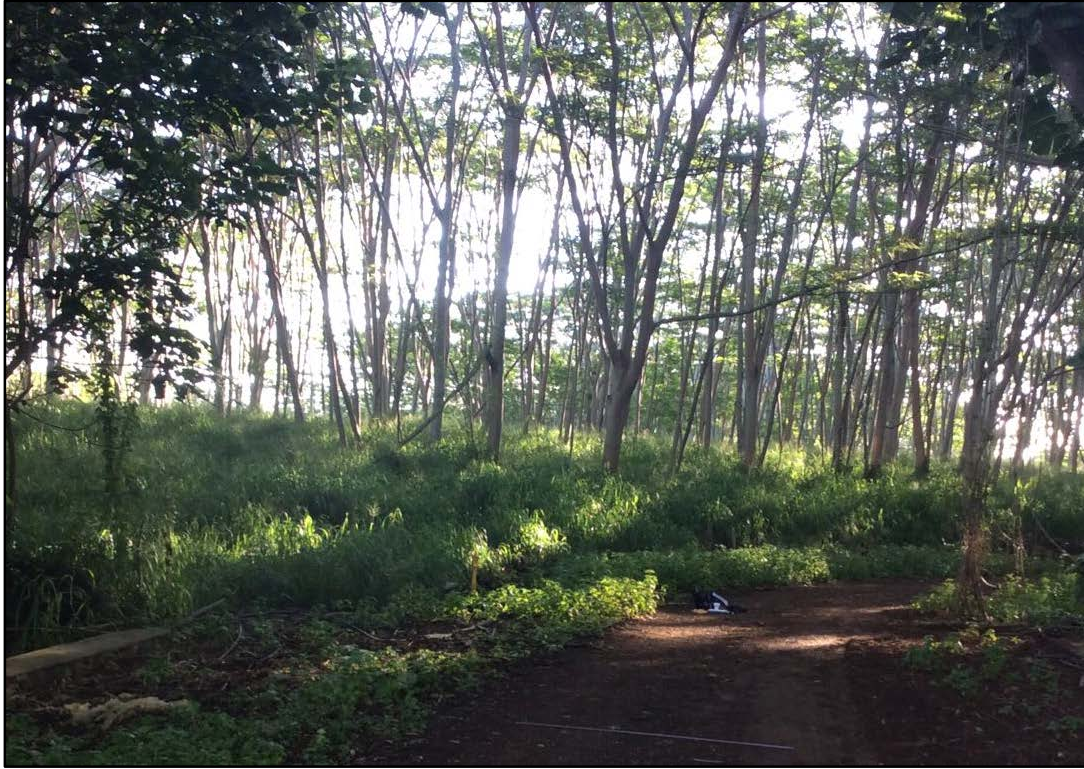
Figure 29. Former agricultural fields showing vegetation in the north portion of the project area, view to east

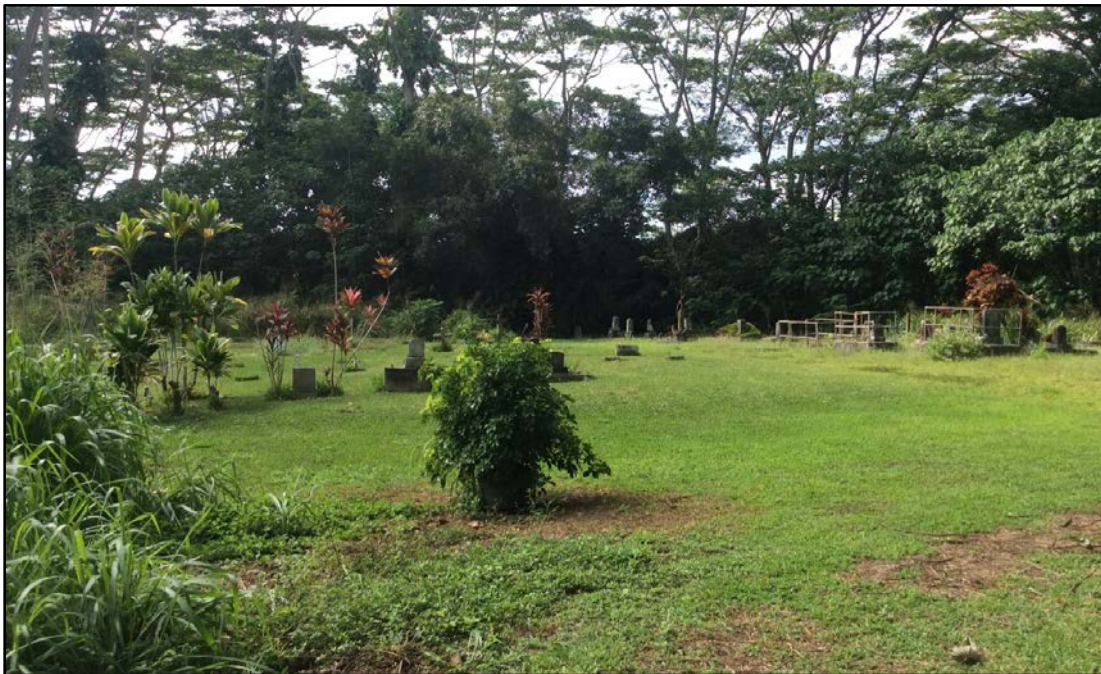
Figure 30. Puhī Camp Cemetery (SIHP # -B006) outside of, but in the center of and surrounded by the project area, view to southwest

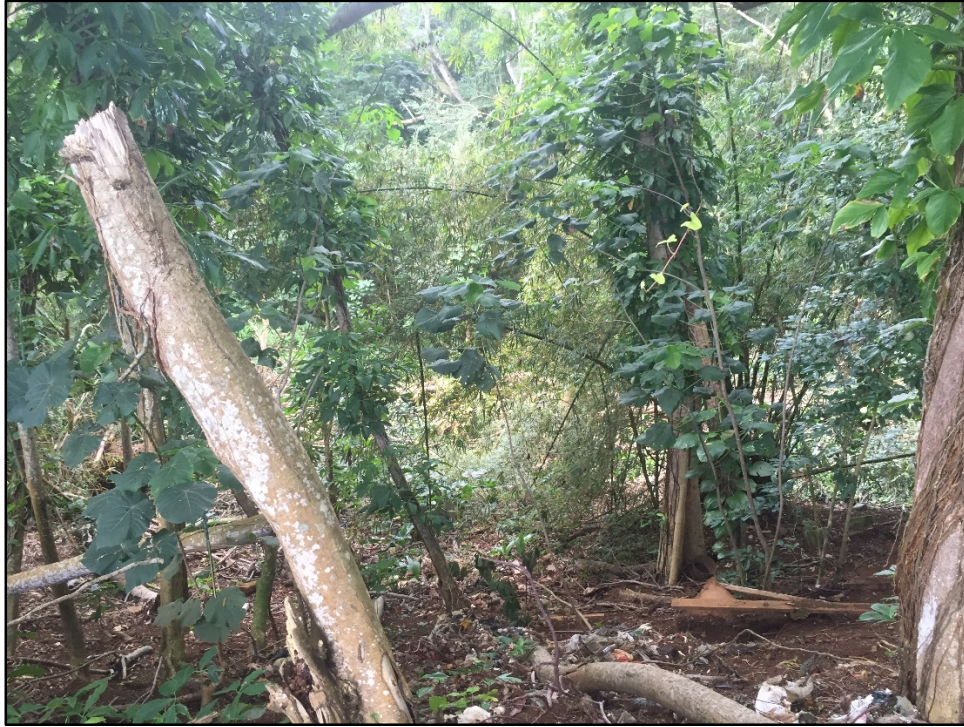
Figure 35. General view of Gulch on west side of project area, view to southwest

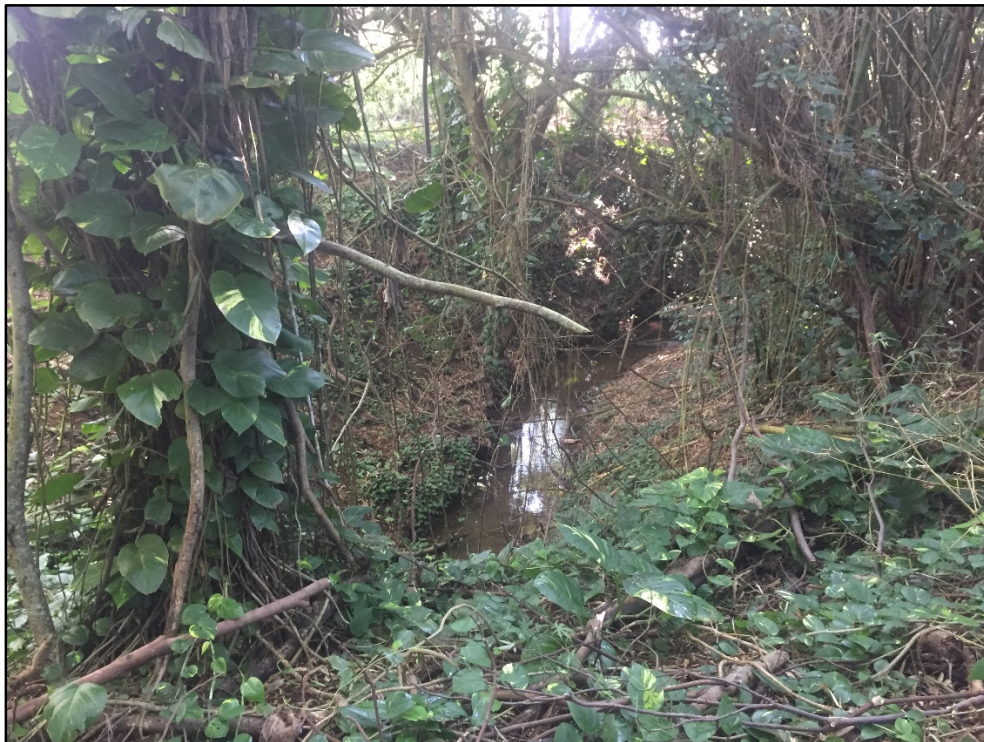
Figure 36. Irrigation ditch, a portion of SIHP # -2179, shown meandering through gulch, view to northwest

The entire western border of the project area is located within a gulch. The vegetation observed is more varied, with previously observed species as well as feral coffee trees (*Coffea* sp.), banyan (*Ficus* sp.), African tulip (*Spathodea Campanulata*) and miconia (*Miconia* sp.) observed (Figure 35). Portions of the irrigation complex (SIHP # -2719) were observed in the gulch (Figure 36).

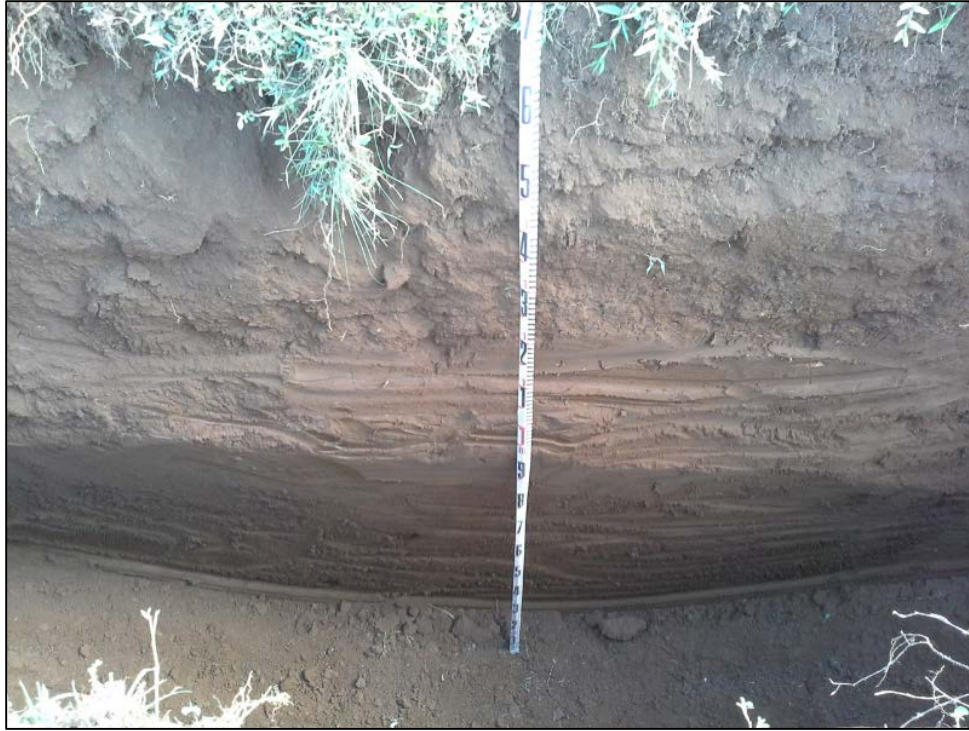
Figure 39. Photograph of T-1 north sidewall, view to north

Figure 41. Profile of T-1 north sidewall

Stratum	Depth (cmbs)	Description of Sediment
I	0–60	Disturbed; 5YR 3/4, dark reddish brown; silty clay; moderate, medium, crumb structure; moist, firm consistence; weak cementation; plastic; terrigenous origin; clear, smooth lower boundary; common fine roots; plow zone
II	55–175 (BOE)	Natural; 5YR 3/4, dark reddish brown; silty clay; strong, medium, granular structure; moist, firm consistence; strong cementation; plastic; terrigenous origin; lower boundary not observed; few fine roots

T-1, located near the eastern portion of the project area (see Figure 37), extends in a northwest/southeast direction. The profile was recorded along the north sidewall with a maximum depth of 175 cmbs. The stratigraphy observed at location T-1 consists of disturbed silty clay (Stratum I) overlying naturally deposited silty clay (Stratum II) (Figure 39 through Figure 41 and Table 3). No traditional Hawaiian or historic cultural material was observed. No significant historic properties were observed.

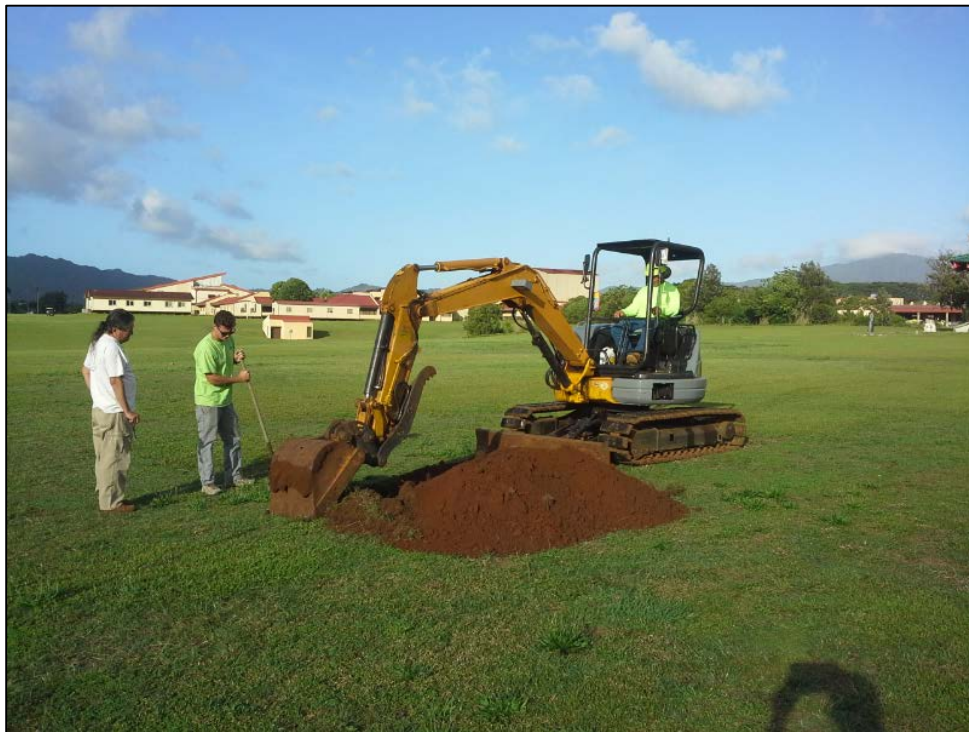
Figure 40. General location of T-1, view to west

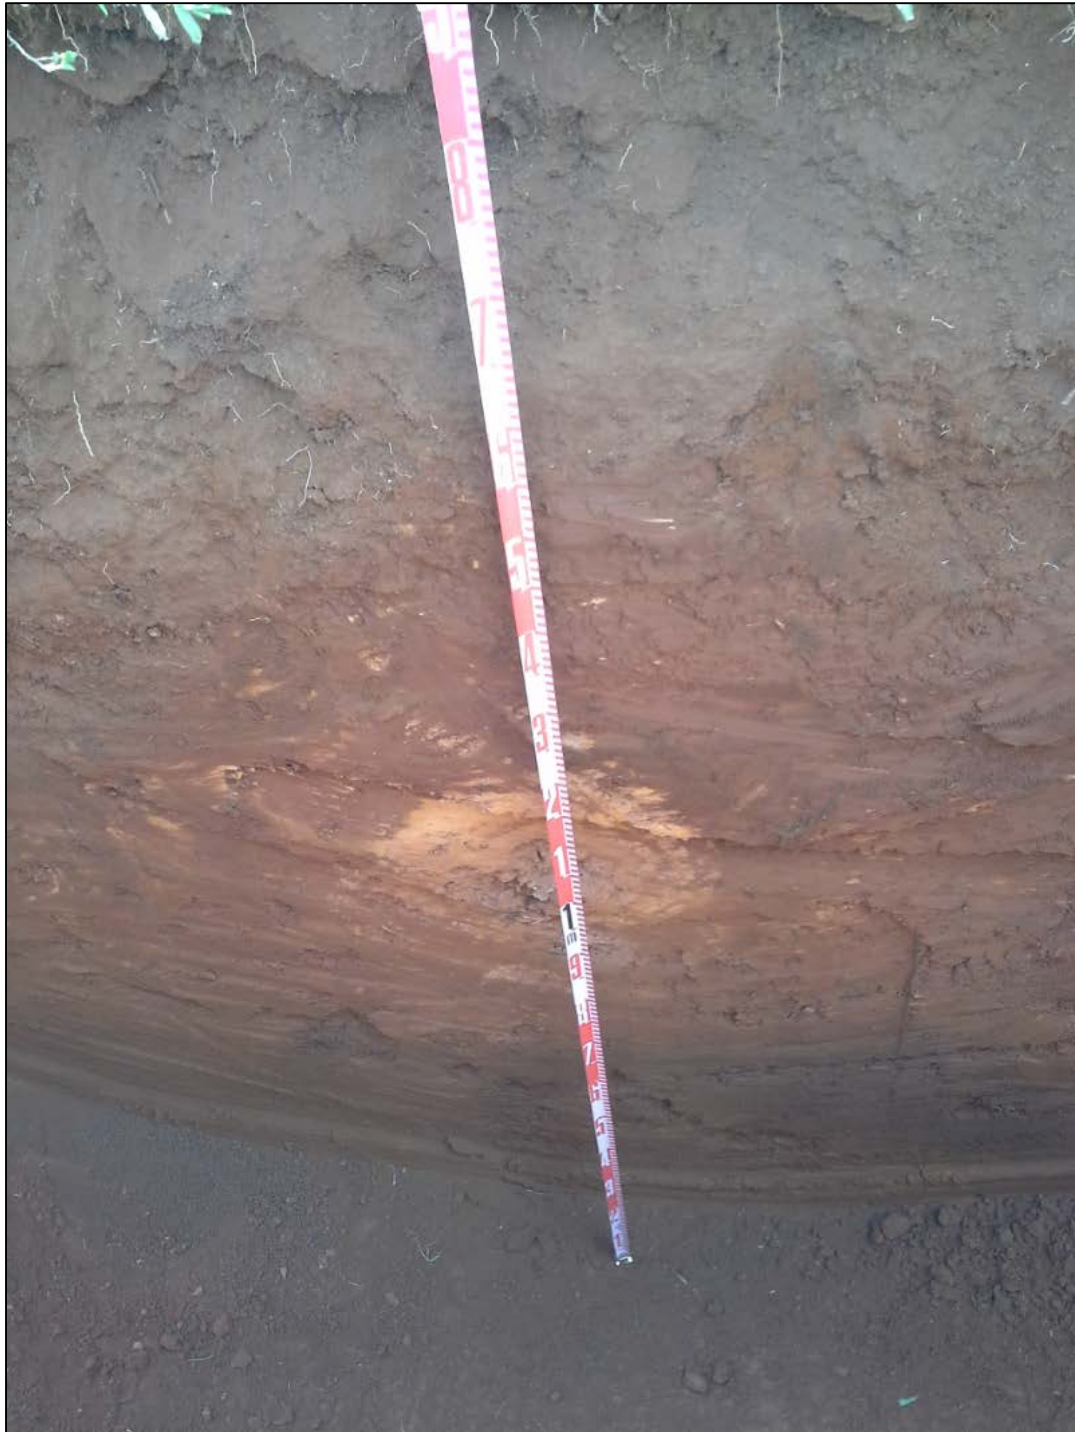
Figure 42. Photograph of T-2 south sidewall, view to southeast

Figure 44. Profile of T-2 southeast sidewall

Stratum	Depth (cmbs)	Description of Sediment
I	0–50	Disturbed; 5YR 3/4, dark reddish brown; silty clay; moderate, medium, crumb structure; moist, firm consistence; weak cementation; plastic; terrigenous origin; clear, smooth lower boundary; common fine roots; plow zone
II	40–125	Natural; 5YR 3/4, dark reddish brown; silty clay; strong, medium, granular structure; moist, firm consistence; strong cementation; plastic; terrigenous origin; clear, smooth lower boundary; few, fine roots
III	120–190 (BOE)	Natural; 5YR 3/2, dark reddish brown; silty clay; strong, medium, granular structure; moist, firm consistence; strong cementation; plastic; terrigenous origin; lower boundary not visible; no roots observed

T-2, located near the southeastern portion of the current project area (see Figure 37), extends in a northeast/southwest direction. The profile was recorded along the southeast sidewall with a maximum depth of 190 cmbs. The stratigraphy observed at location T-2 consists of disturbed silty clay (Stratum I) overlying naturally deposited silty clay (Strata II and III) (Figure 42 through Figure 44 and Table 4). No traditional Hawaiian or historic cultural material was observed. No significant historic properties were observed.

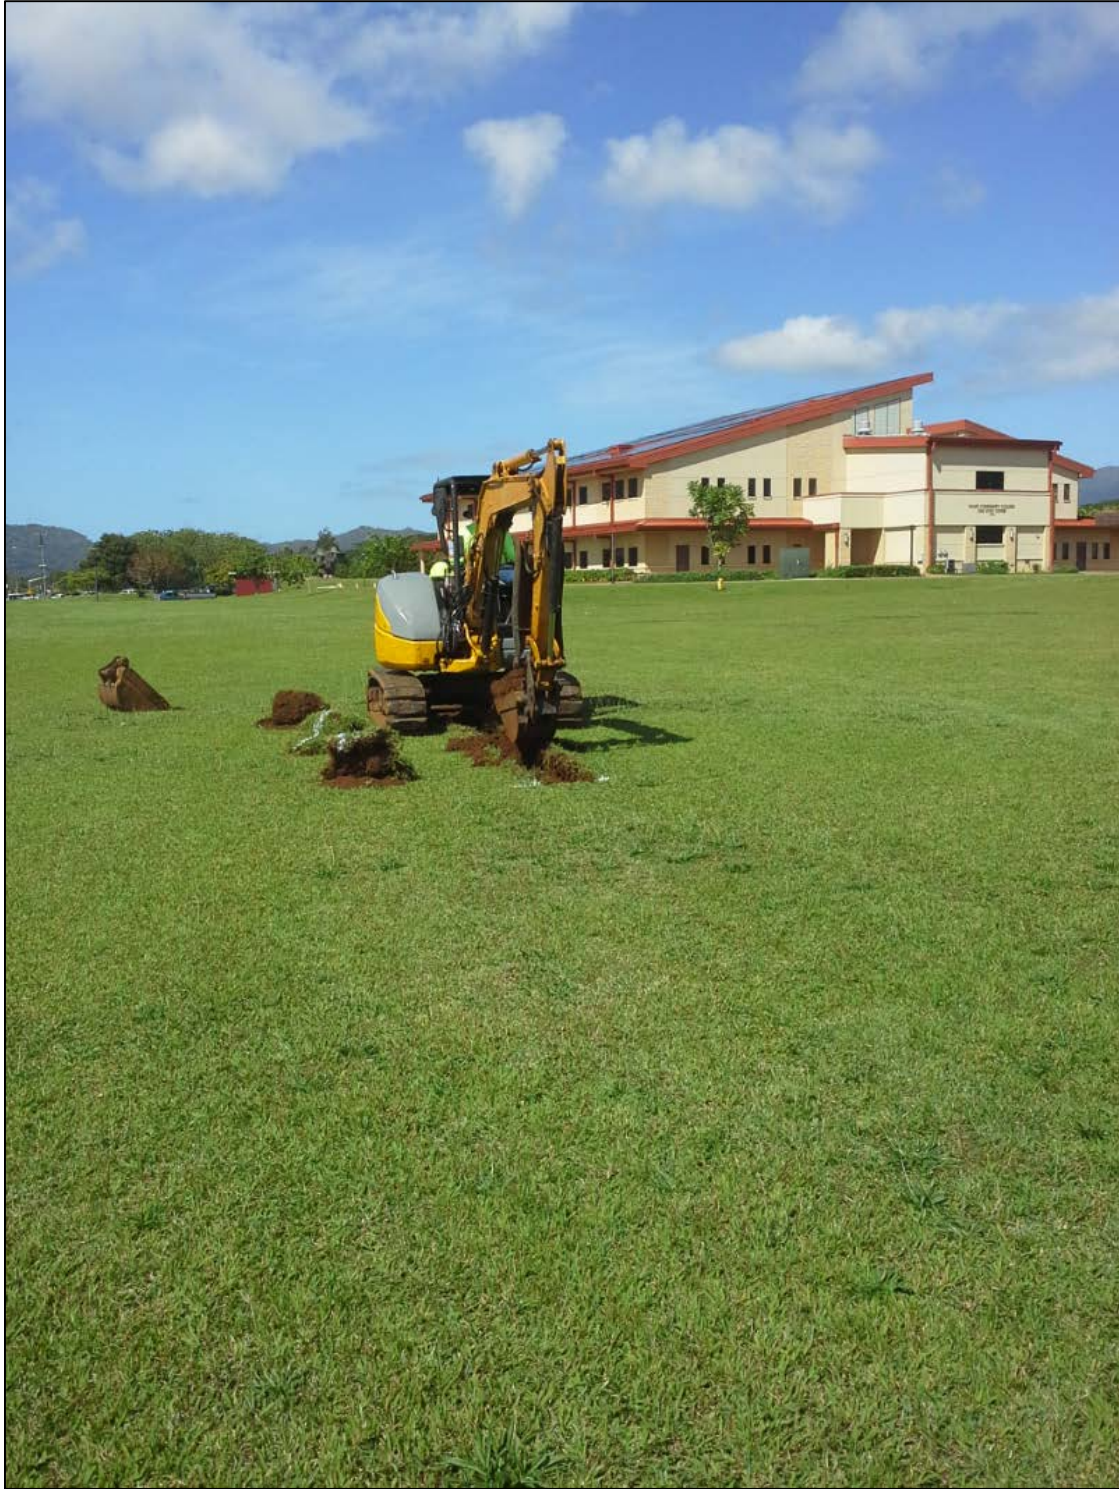
Figure 43. General location of T-2, view to southwest

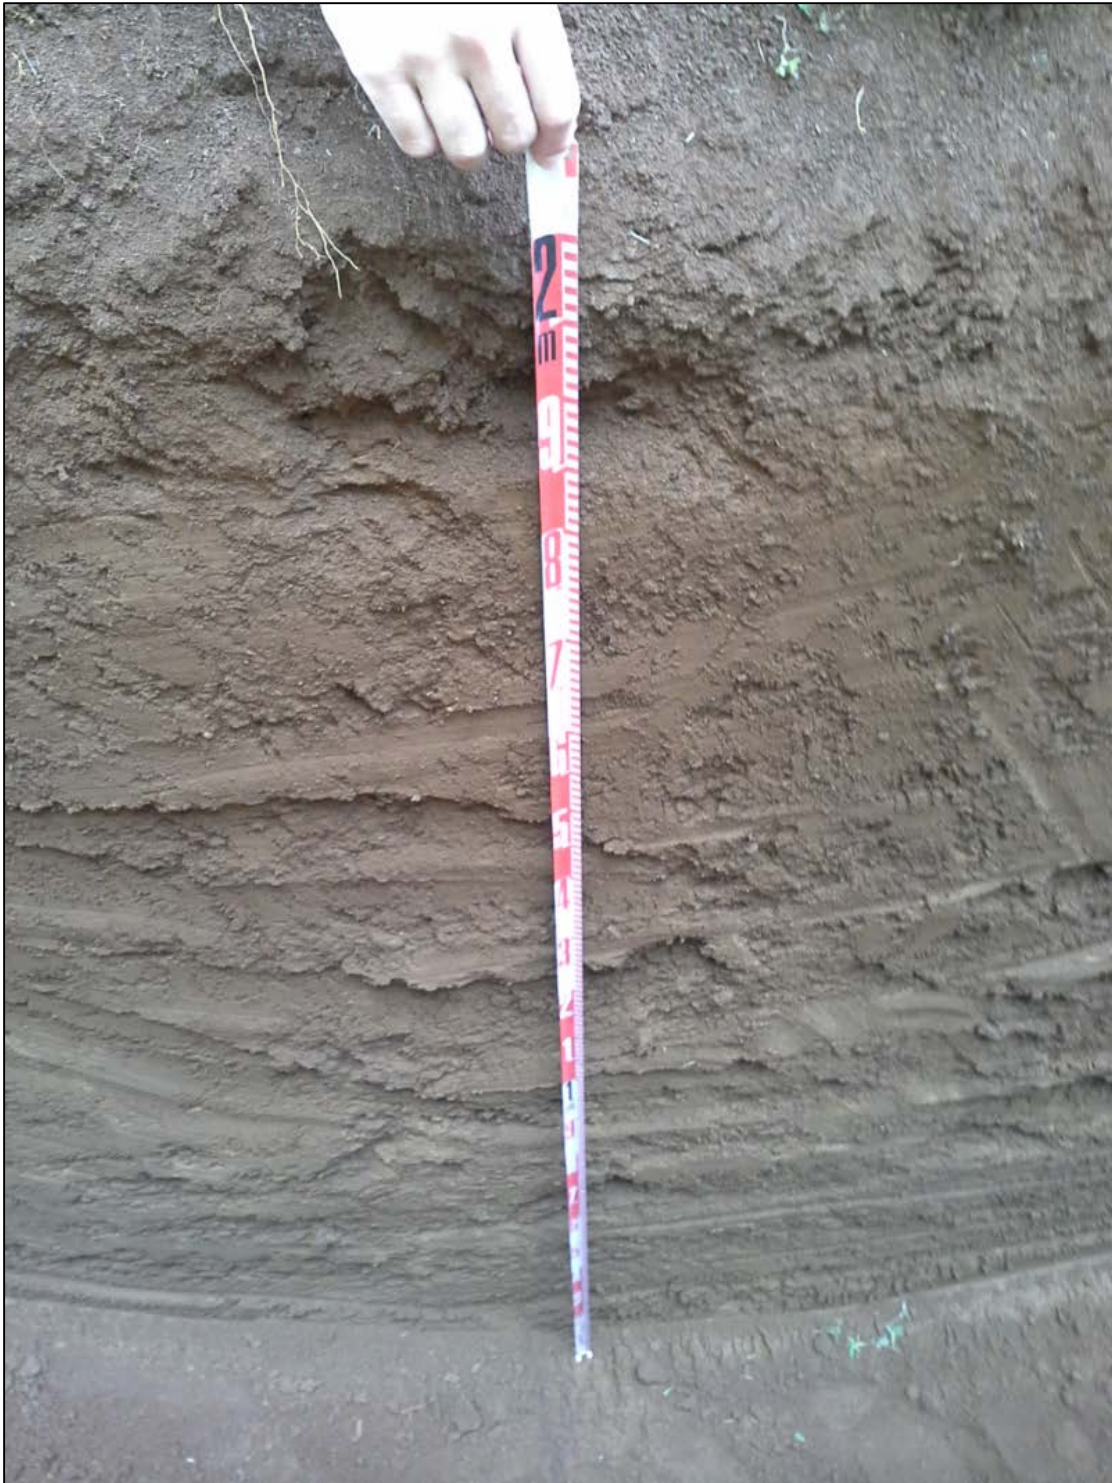
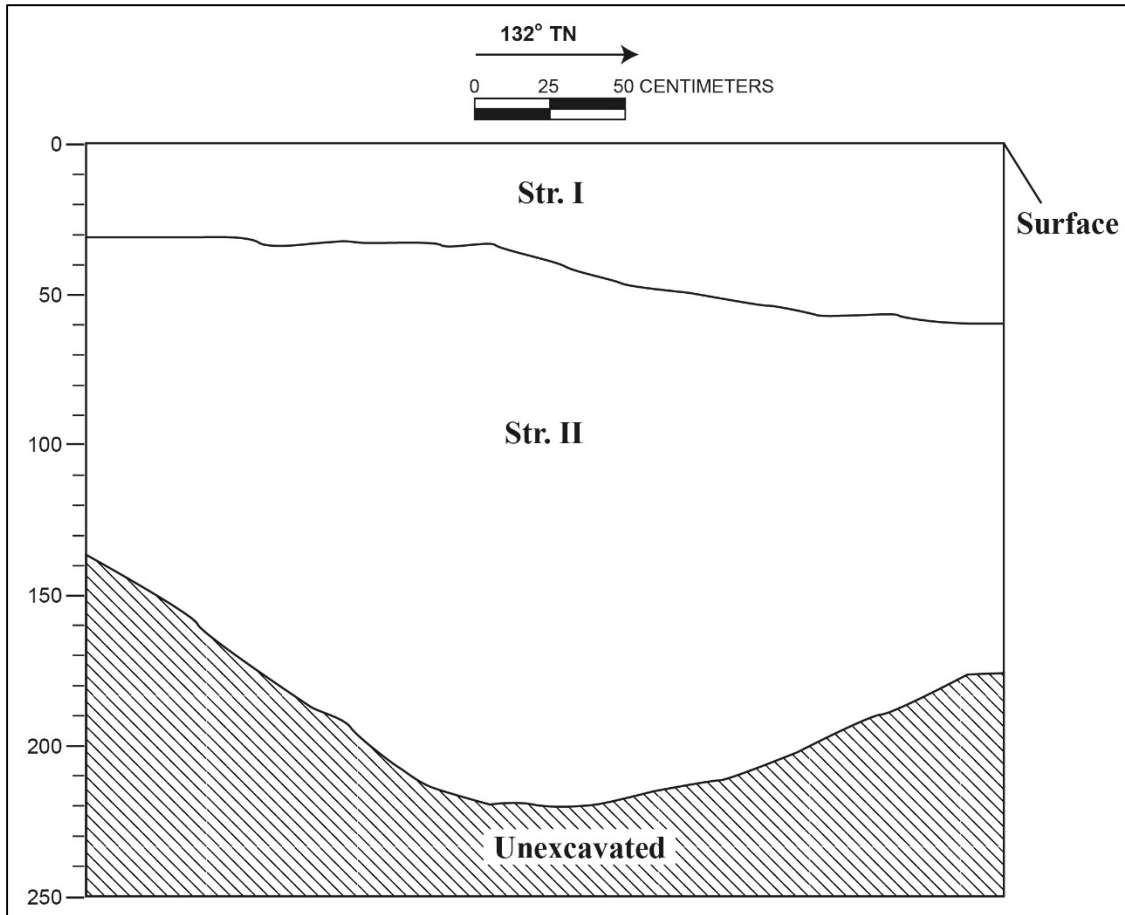
Figure 45. Photograph of T-3 east sidewall, view to east

Figure 47. Profile of T-3 northeast sidewall

Stratum	Depth (cmbs)	Description of Sediment
I	0–60	Disturbed; 5YR 3/4, dark reddish brown; silty clay; moderate, medium, granular structure; moist, firm consistence; weak cementation; plastic; terrigenous origin; clear, smooth lower boundary; common fine roots; plow zone
II	40–215 (BOE)	Natural; 5YR 3/4, dark reddish brown; silty clay; strong, medium, granular structure; moist, firm consistence; strong cementation; plastic; terrigenous origin; lower boundary not visible; no roots observed

T-3, located along the southwestern portion of the current project area within the old Puhi Camp area (see Figure 37), extends in a northwest/southeast direction. The profile was recorded along the northeast sidewall with a maximum depth of 215 cmbs. The stratigraphy observed at location T-3 consists of disturbed silty clay (Stratum I) overlying naturally deposited silty clay (Stratum II) (Figure 45 through Figure 47 and Table 5). No traditional Hawaiian or historic cultural material was observed. No significant historic properties were observed.

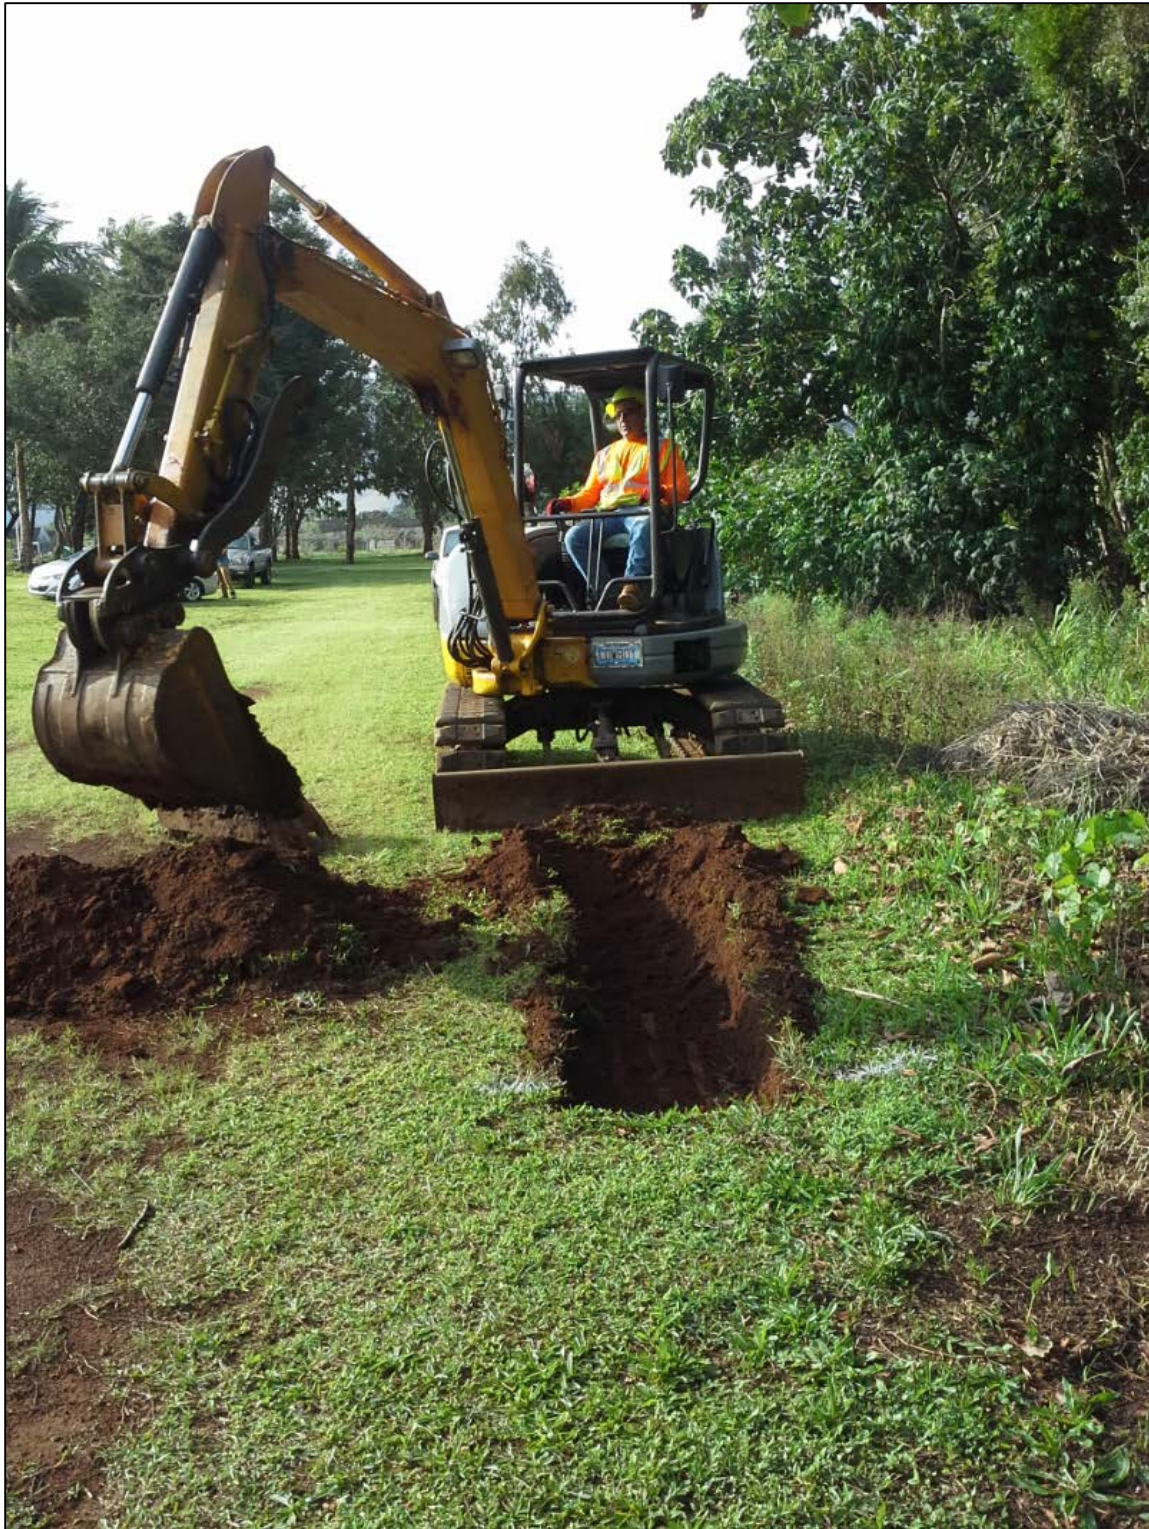
Figure 46. General location of T-3, view to southeast

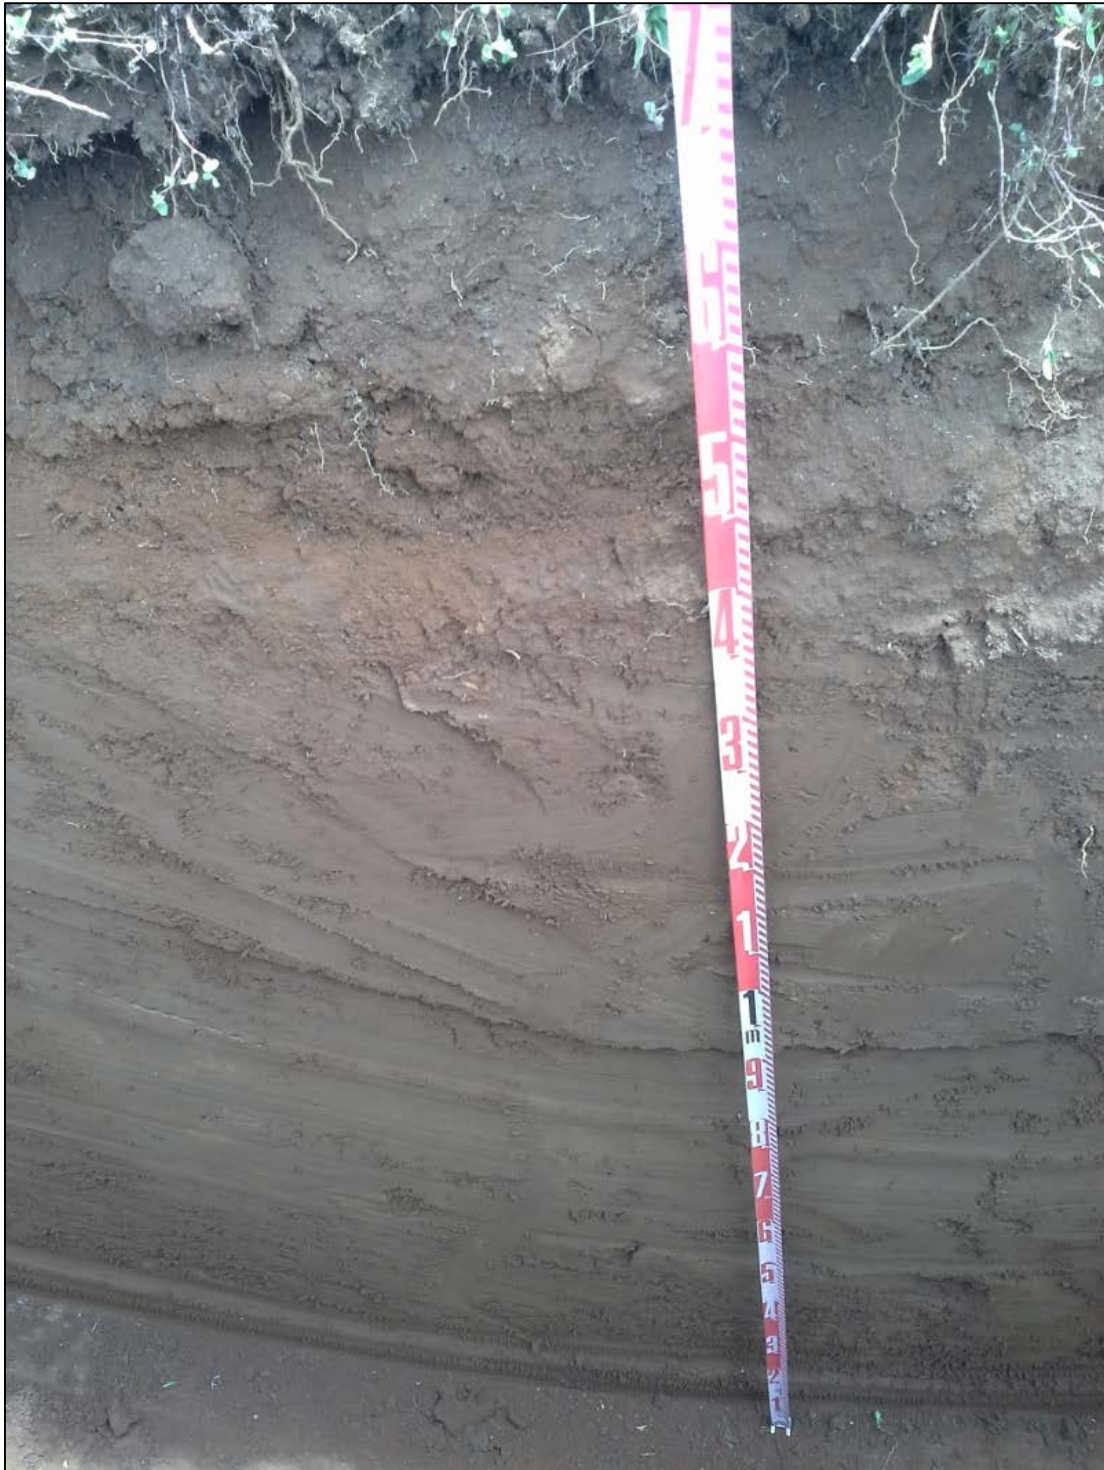
Figure 48. Photograph of T-4 south sidewall, view to south

Figure 50. Profile of T-4 southeast sidewall

Stratum	Depth (cmbs)	Description of Sediment
I	0–35	Disturbed; 5YR 3/4, dark reddish brown; silty clay; moderate, medium, granular structure; moist, firm consistence; weak cementation; plastic; terrigenous origin; clear, smooth lower boundary; common fine roots; plow zone
II	35–170 (BOE)	Natural; 5YR 3/4, dark reddish brown; silty clay; strong, medium, granular structure; moist, firm consistence; strong cementation; plastic; terrigenous origin; lower boundary not visible; few fine roots

T-4, located along the south portion of the current project area (see Figure 37), extends in a northeast/southwest direction. The profile was recorded along the southeast sidewall with a maximum depth of 170 cmbs. The stratigraphy observed at location T-4 consists of disturbed silty clay (Stratum I) overlying naturally deposited silty clay (Stratum II) (Figure 48 through Figure 50 and Table 6). No traditional Hawaiian or historic cultural material was observed. No significant historic properties were observed.

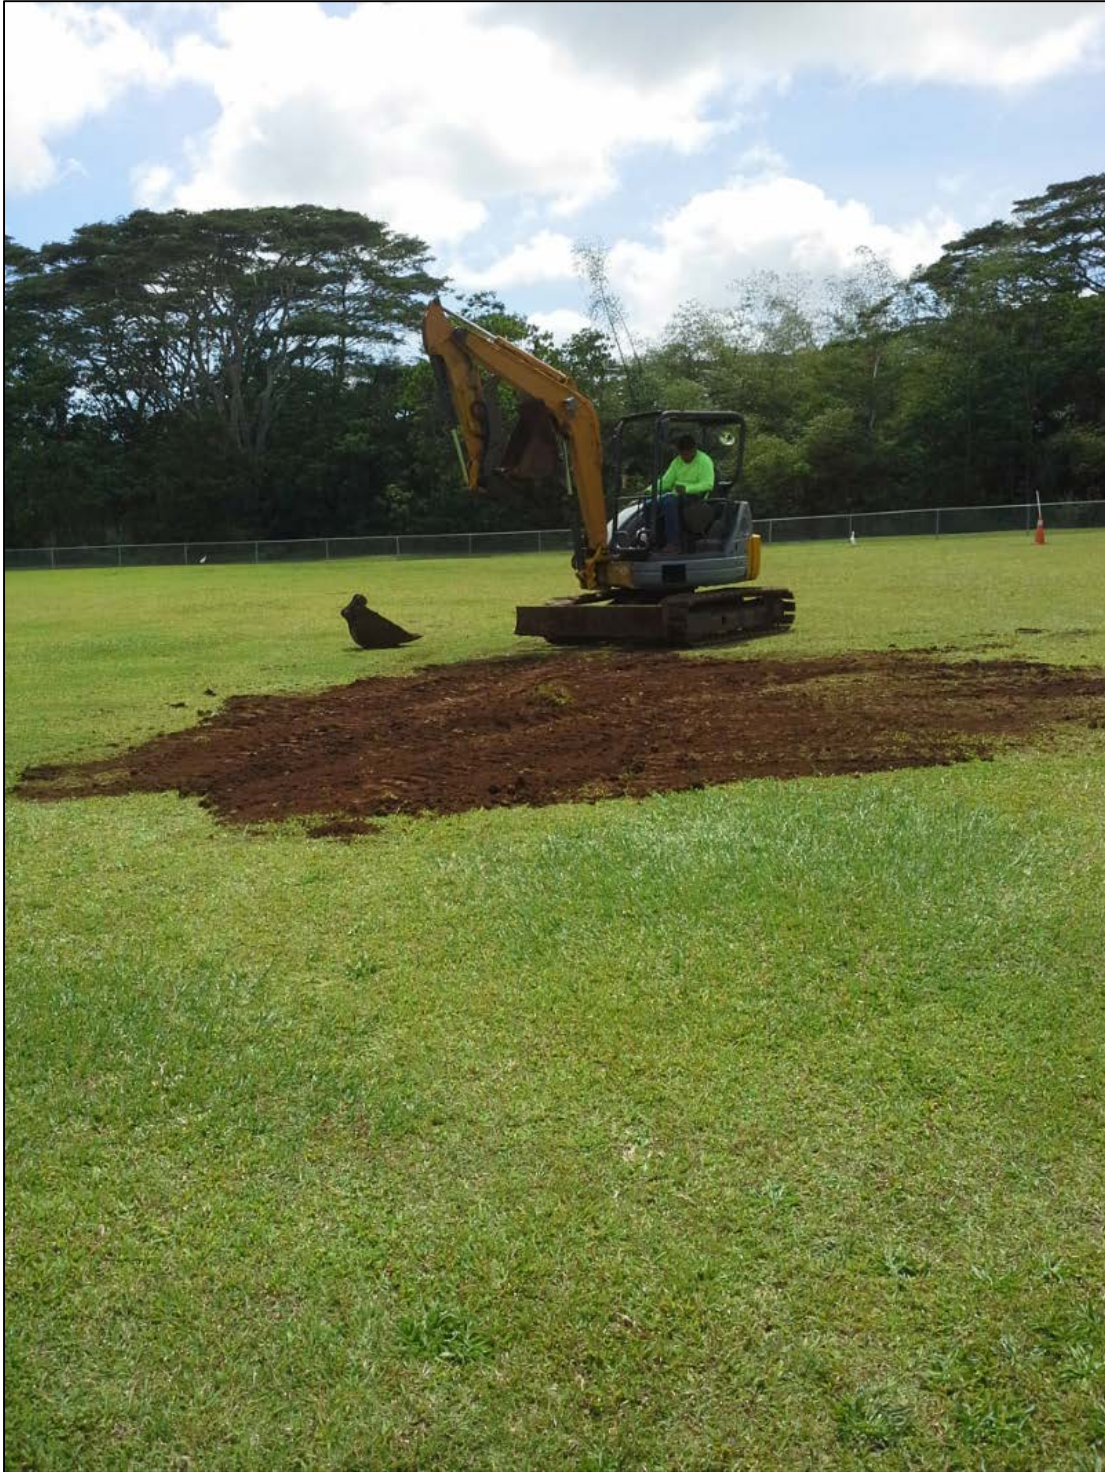
Figure 49. General location of T-4, view to west

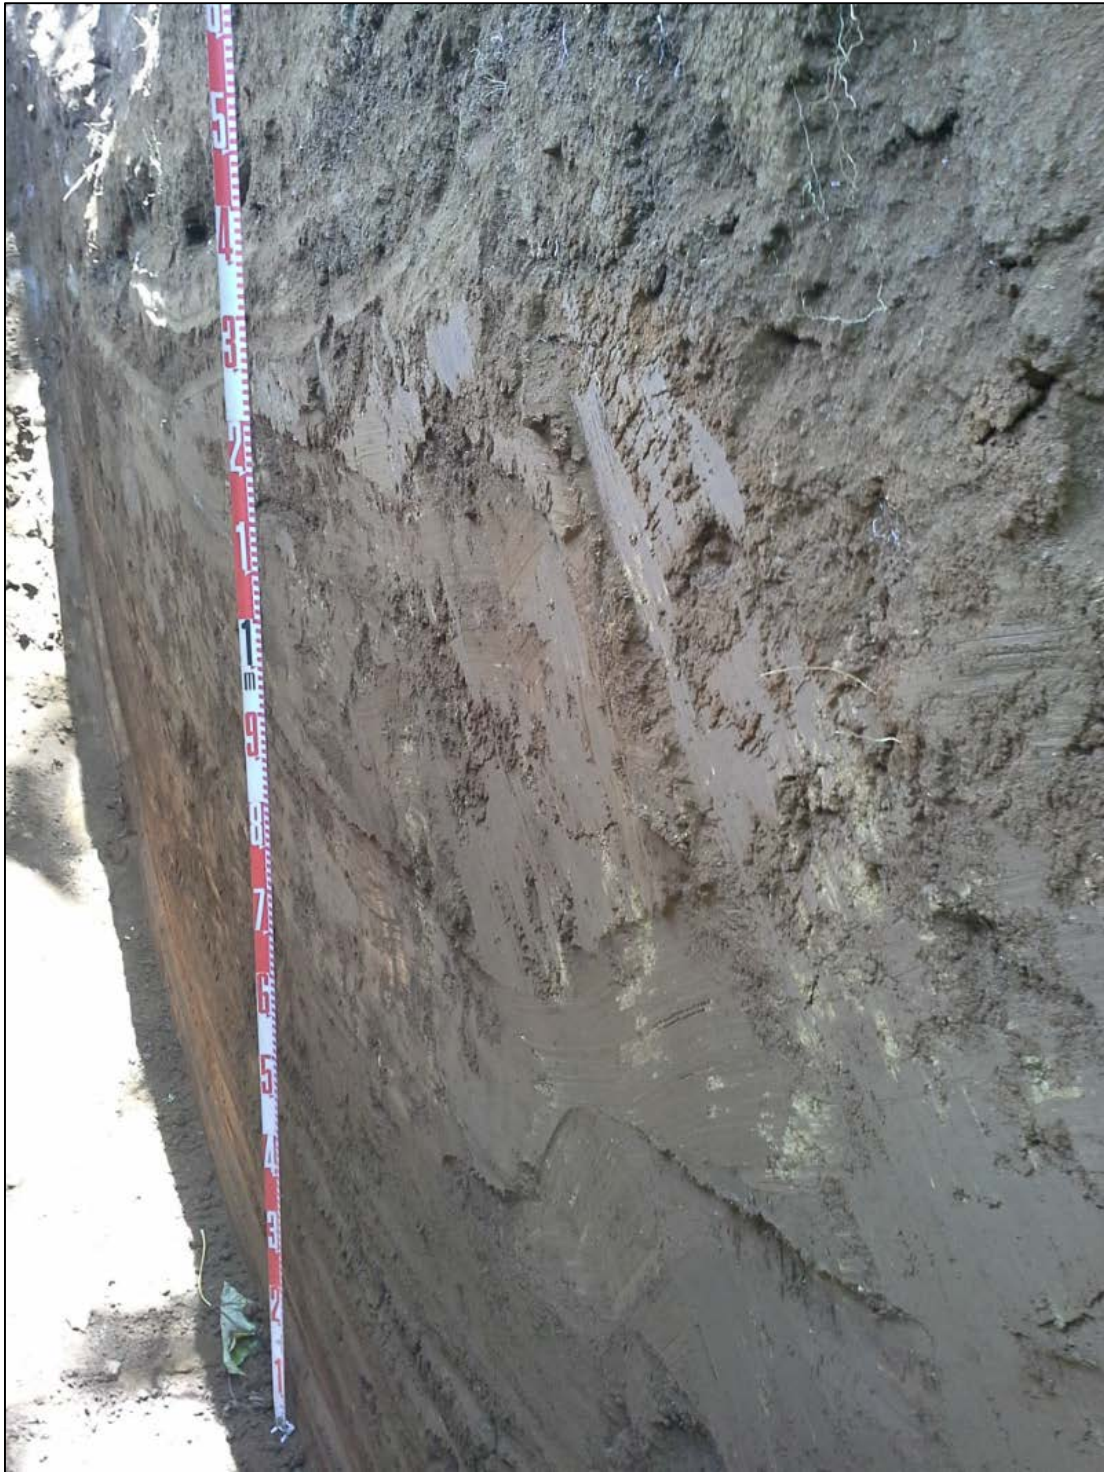
Figure 51. Photograph of T-5 northeast sidewall, view to south

Figure 53. Profile of T-5 northeast sidewall

Stratum	Depth (cmbs)	Description of Sediment
I	0–60	Disturbed; 5YR 3/4, dark reddish brown; silty clay; moderate, fine, granular structure; moist, firm consistence; weak cementation; plastic; terrigenous origin; clear, smooth lower boundary; common fine roots; plow zone
II	55–195 (BOE)	Natural; 5YR 3/4, dark reddish brown; silty clay; moderate grade, medium size, granular type; moist, firm consistence; strong cementation; plastic; terrigenous origin; lower boundary not visible; few fine roots

T-5, located in the northern portion of the day care center within the developed area of the KCC campus (see Figure 37), extends in a northwest/southeast direction. The profile was recorded along the northeast sidewall with a maximum depth of 195 cmbs. The stratigraphy observed at location T-5 consists of disturbed silty clay (Stratum I) overlying naturally deposited silty clay (Stratum II) (Figure 51 through Figure 53 and Table 7). No traditional Hawaiian or historic cultural material was observed. No significant historic properties were observed.

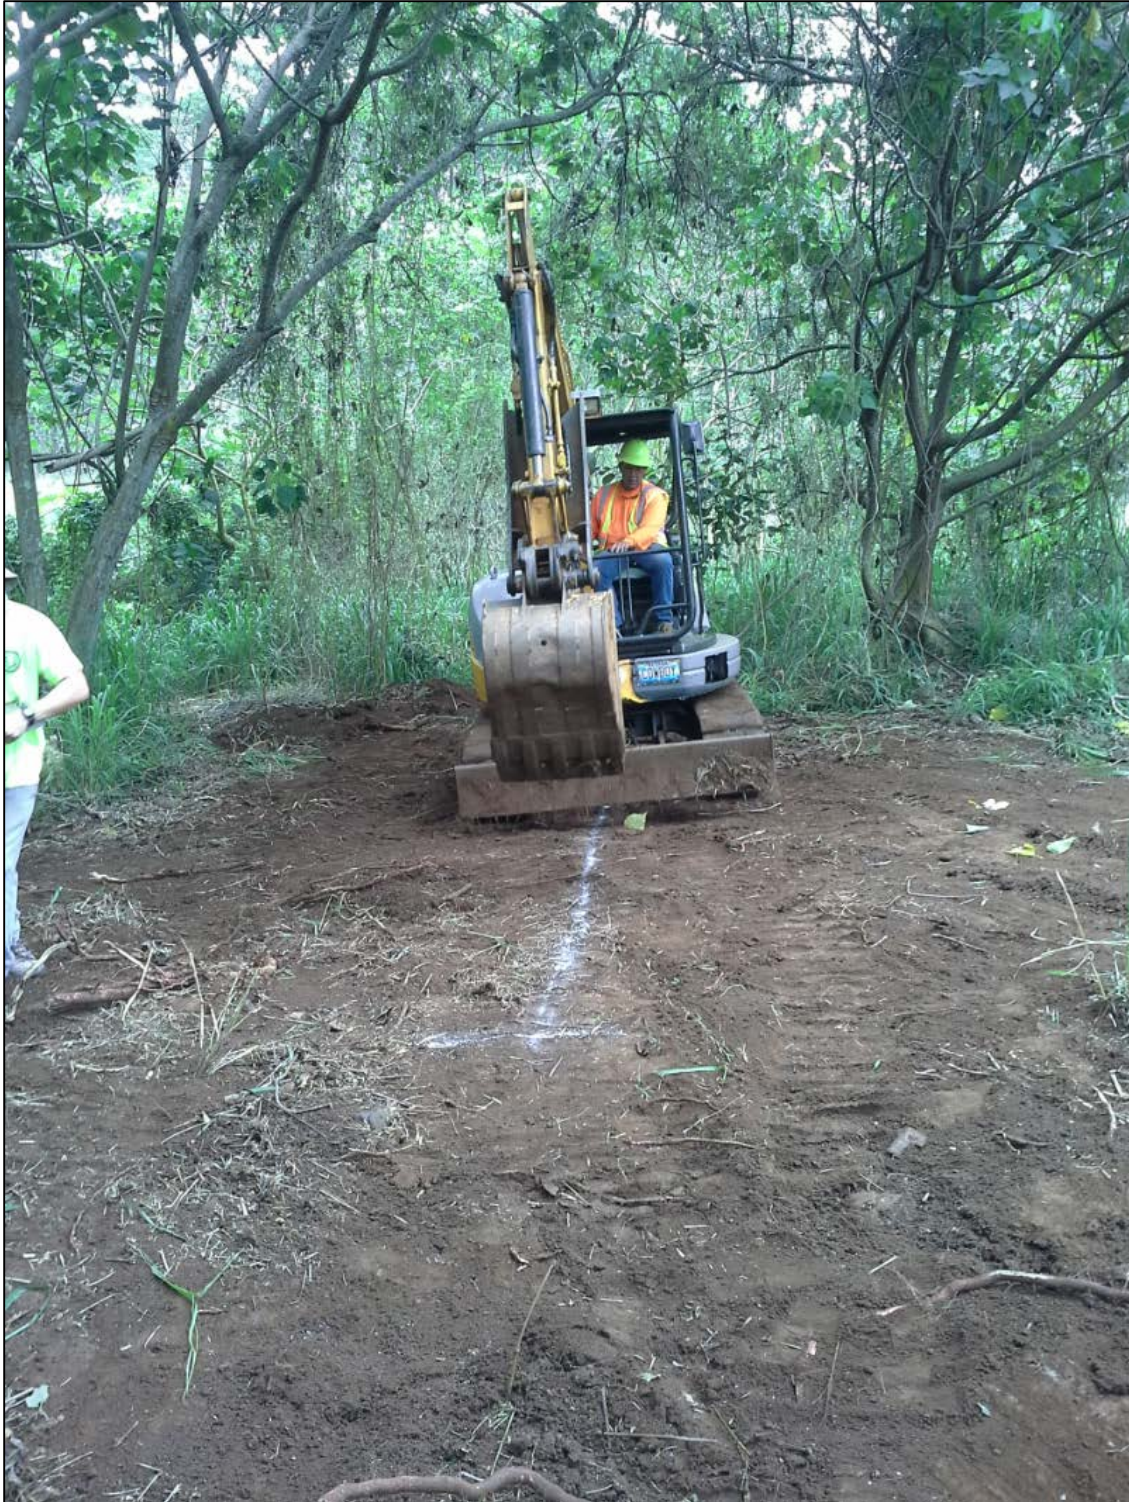
Figure 52. General location of T-5, view to east

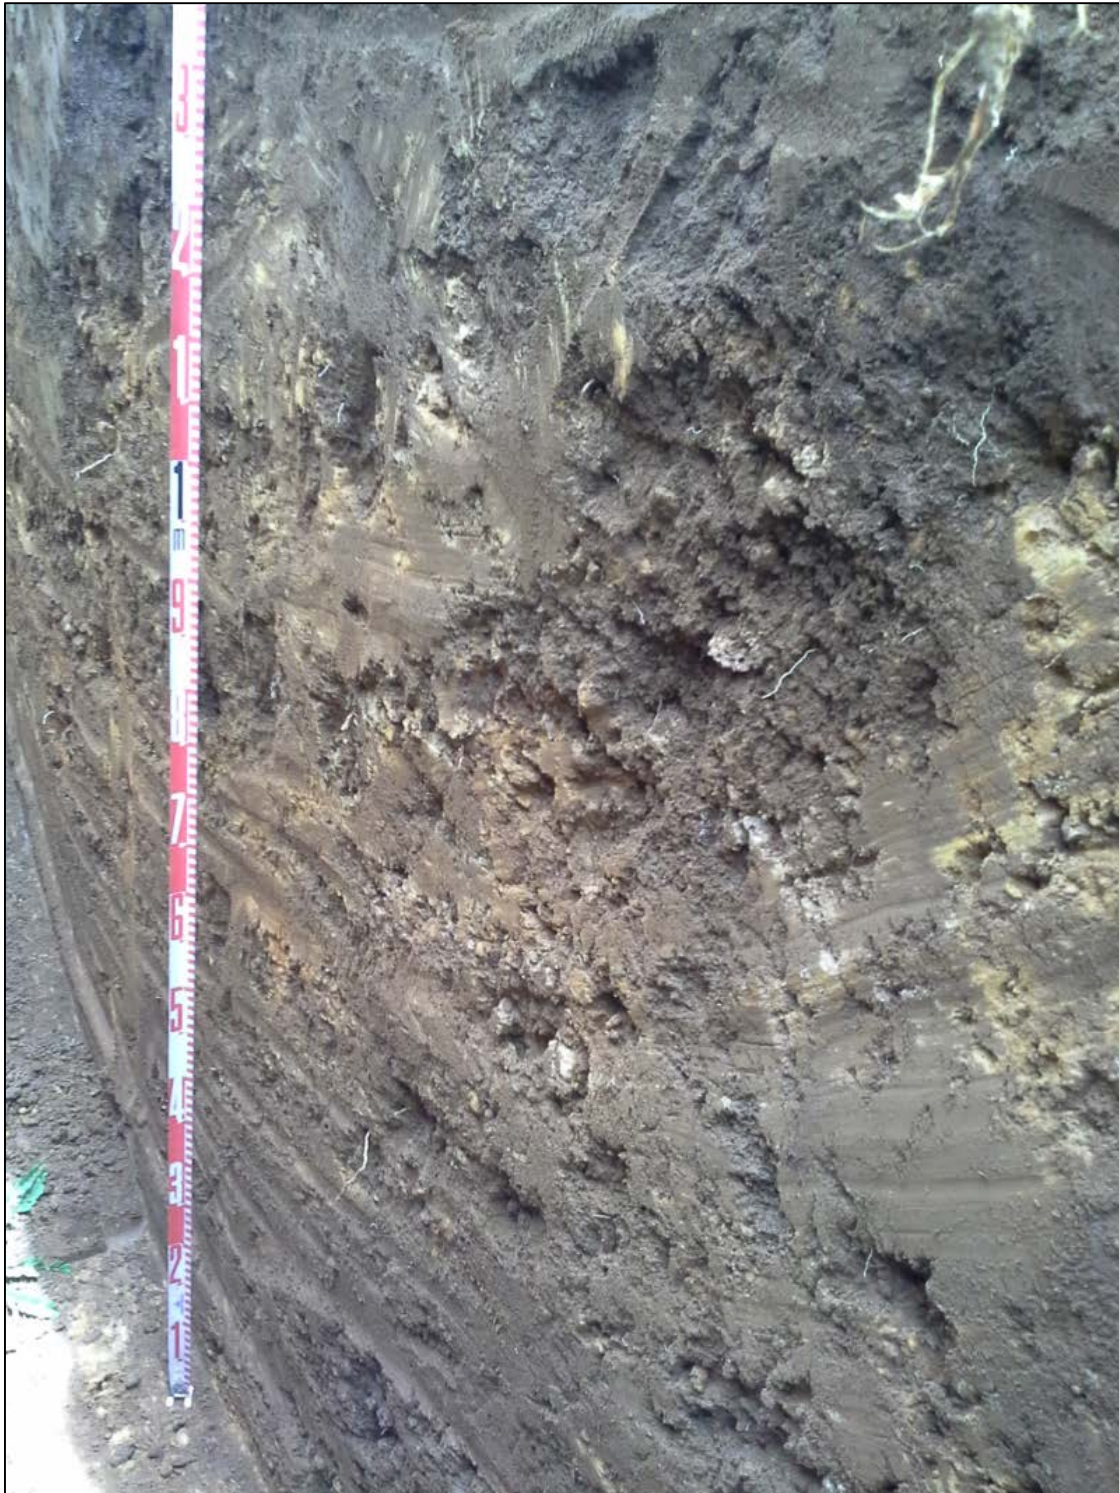
Figure 54. Photograph of T-6 southeast sidewall, view to southeast

Figure 56. Profile of T-6 southeast sidewall

Stratum	Depth (cmbs)	Description of Sediment
I	0–55	Disturbed; 5YR 3/4, dark reddish brown; silty clay; moderate, fine, granular structure; moist, firm consistence; weak cementation; plastic; terrigenous origin; clear, smooth lower boundary; common fine to medium roots; plow zone
II	50–190 (BOE)	Natural; 5YR 3/4, dark reddish brown; silty clay; moderate, medium, granular structure; moist, firm consistence; strong cementation; plastic; terrigenous origin; lower boundary not visible; few fine roots;

T-6, located in the central eastern portion of the current project area (see Figure 37), extends in a northeast/southwest direction. The profile was recorded along the southeast sidewall with a maximum depth of 190 cmbs. The stratigraphy observed at location T-6 consists of disturbed silty clay (Stratum I) overlying naturally deposited silty clay (Stratum II) (Figure 54 through Figure 56 and Table 8). No traditional Hawaiian or historic cultural material was observed. No significant historic properties were observed.
