Section 4 Results of Fieldwork

4.1 Pedestrian Inspection Results

4.2 Subsurface Testing Results

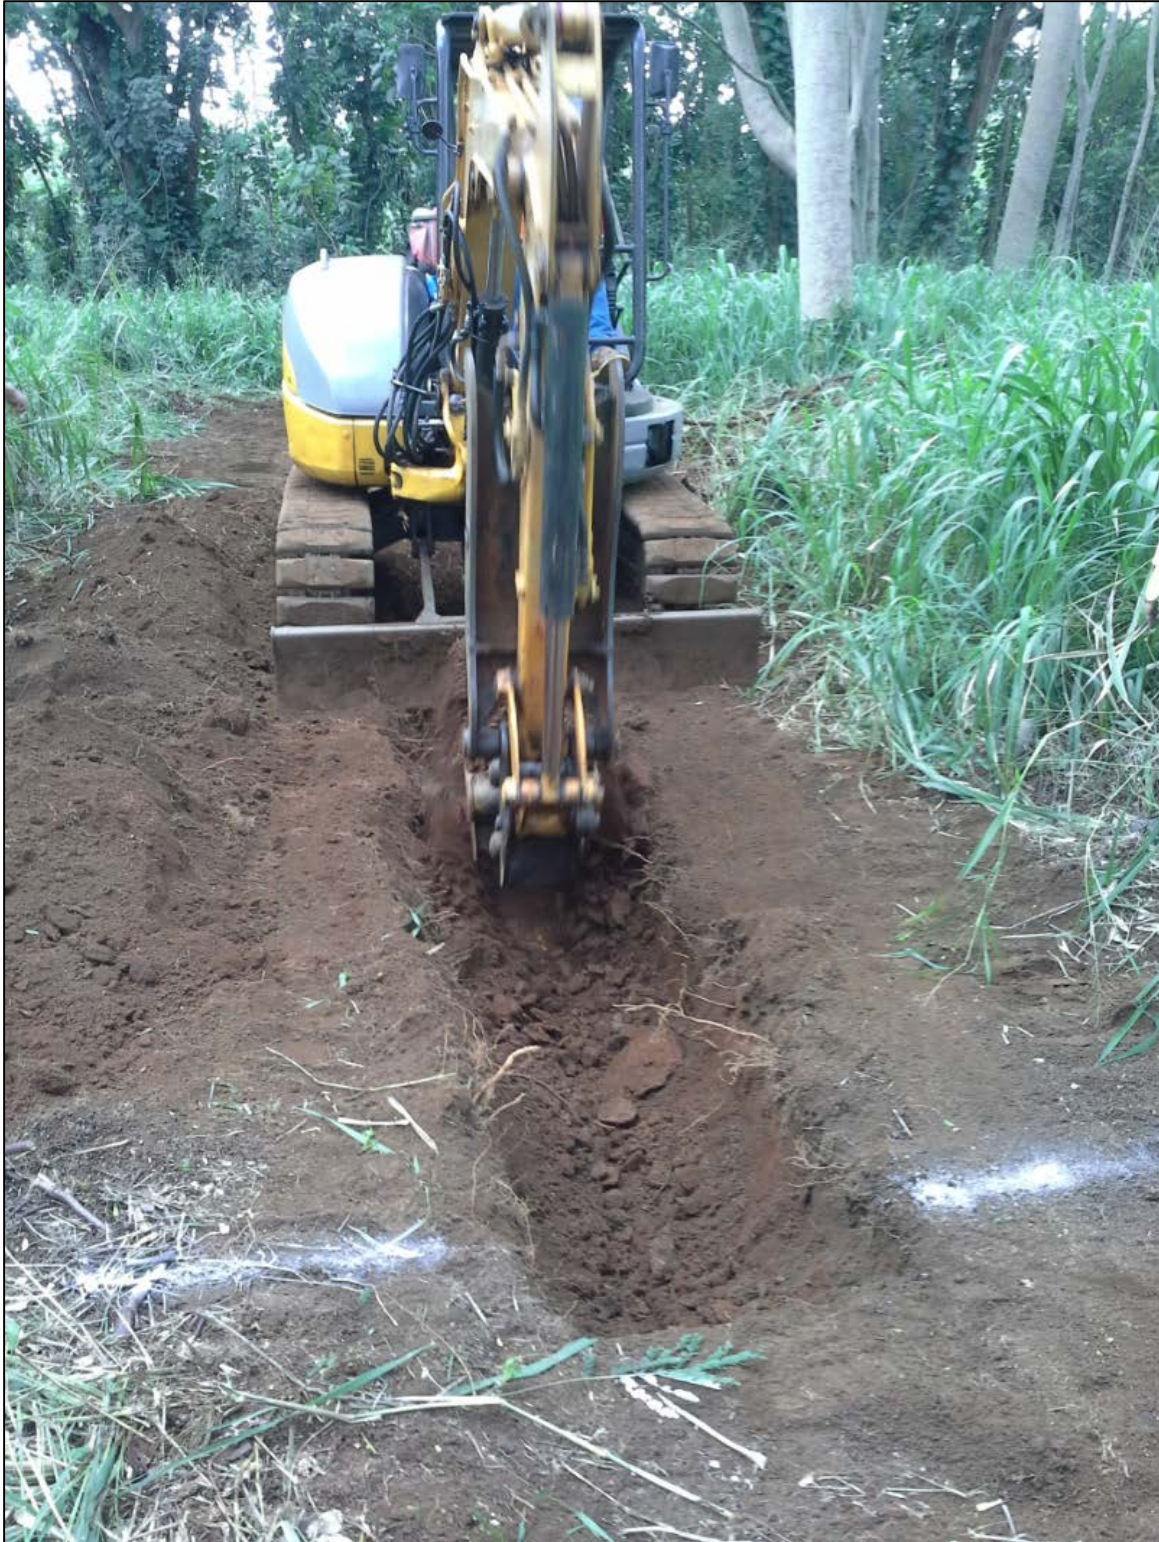
Figure 55. General location of T-6, view to southwest

T-6, located in the central eastern portion of the current project area (see Figure 37), extends in a northeast/southwest direction. The profile was recorded along the southeast sidewall with a maximum depth of 190 cmbs. The stratigraphy observed at location T-6 consists of disturbed silty clay (Stratum I) overlying naturally deposited silty clay (Stratum II) (Figure 54 through Figure 56 and Table 8). No traditional Hawaiian or historic cultural material was observed. No significant historic properties were observed.

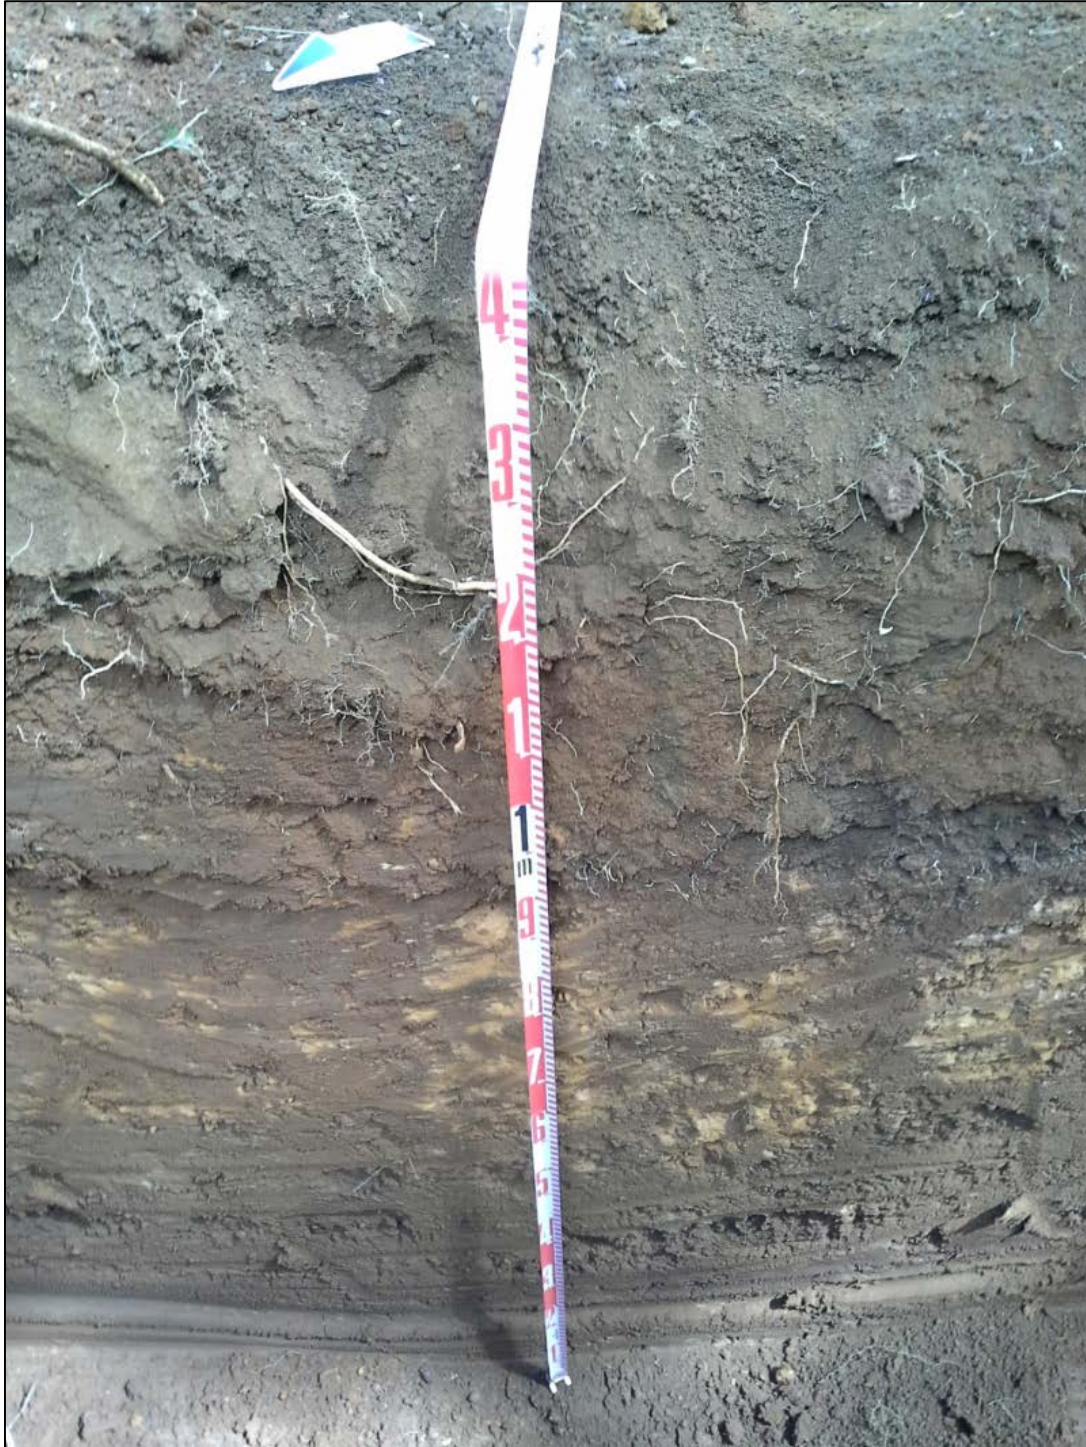
Figure 57. Photograph of T-7 east sidewall, view to southwest

Figure 59. Profile of T-7 east sidewall

Stratum	Depth (cmbs)	Description of Sediment
I	0–53	Disturbed; 5YR 3/4, dark reddish brown; silty clay; weak, medium, granular structure; moist, firm consistence; weak cementation; plastic; terrigenous origin; clear, smooth lower boundary; common fine to medium roots; black plastic sheeting mulch observed
II	50–190 (BOE)	Natural; 5YR 3/4, dark reddish brown; silty clay; moderate, medium, blocky structure; moist, firm consistence; strong cementation; plastic; terrigenous origin; lower boundary not visible; few fine roots

T-7, located near the northern portion of the current project area (see Figure 18), extends in a northeast/southwest direction. The profile was recorded along the east sidewall with a maximum depth of 190 cmbs. The stratigraphy observed at location T-7 consists of disturbed silty clay (Stratum I) overlying naturally deposited silty clay (Stratum II) (Figure 57 through Figure 59 and Table 9). No traditional Hawaiian or historic cultural material was observed. No significant historic properties were observed.

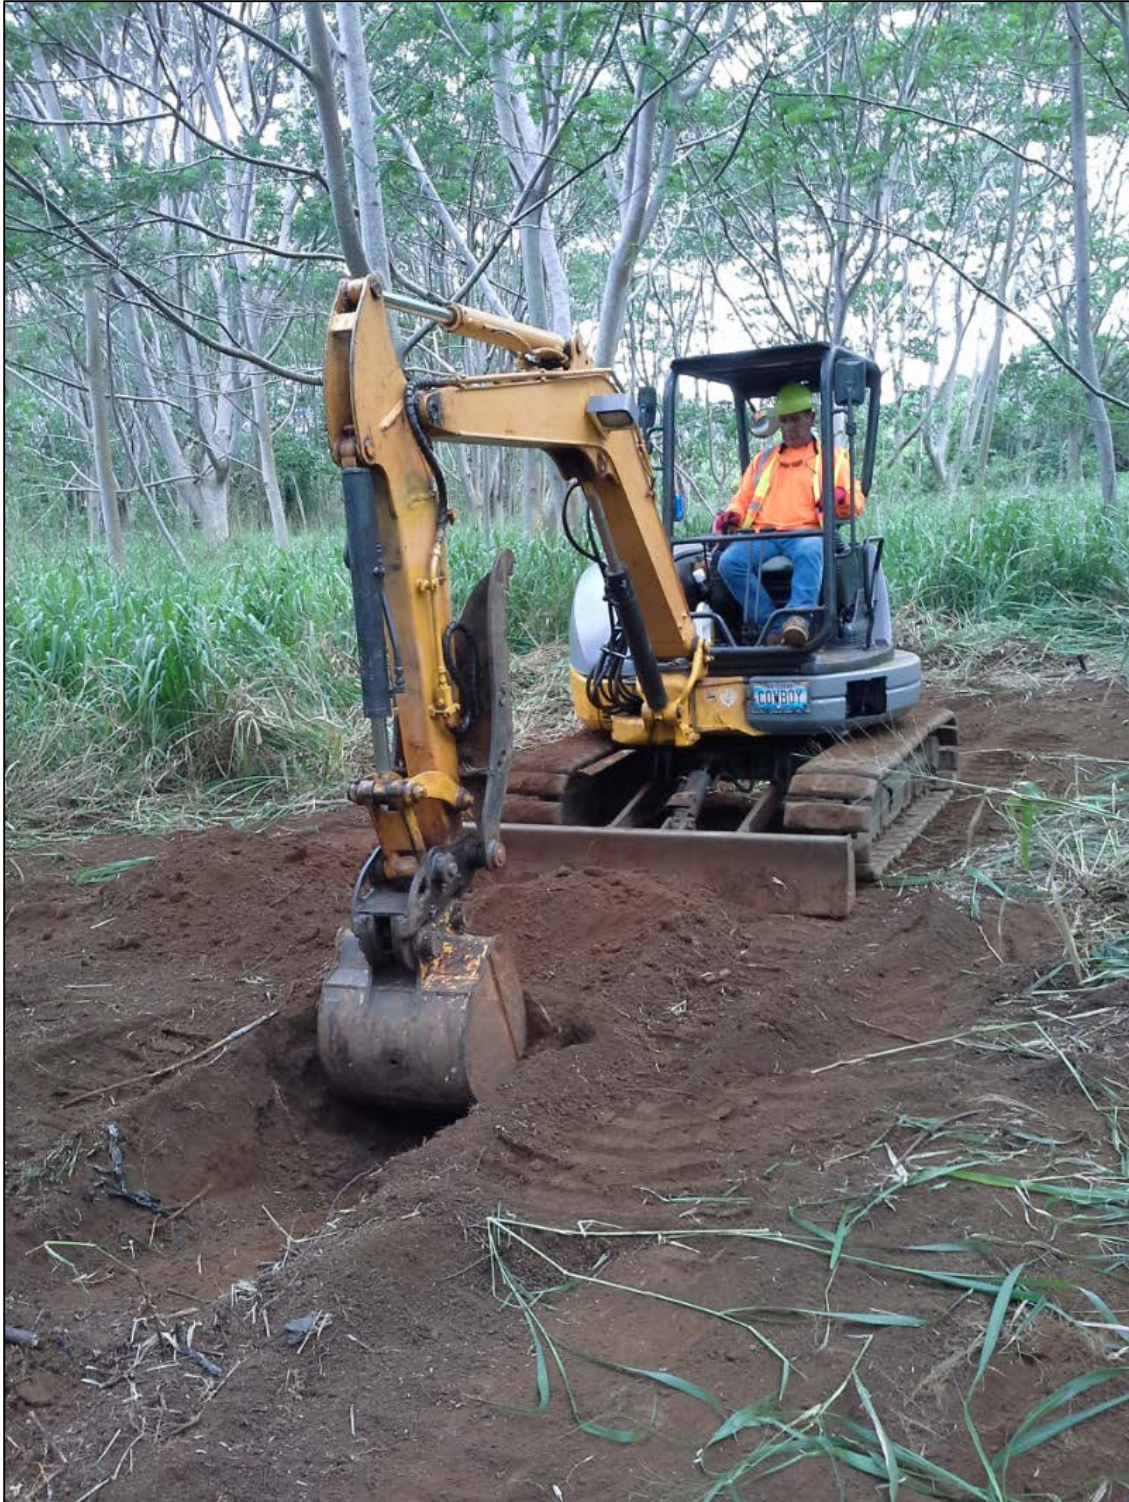
Figure 58. General location of T-7, view to south

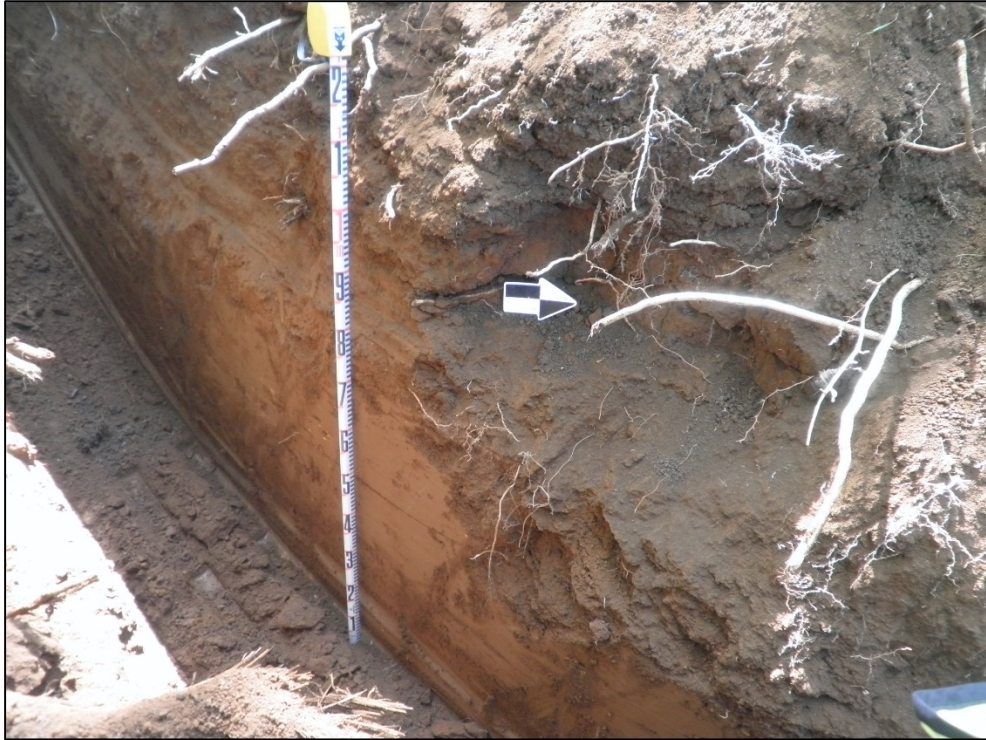
Figure 60. Photograph of T-8 west sidewall, view to southwest

Figure 62. Profile of T-8 west sidewall

Stratum	Depth (cmbs)	Description of Sediment
I	0–23	A horizon; 5YR 2.5/2, dark reddish brown; silty clay loam; weak, medium, granular structure; moist, loose consistence; weak cementation; slightly plastic; terrigenous origin; clear, smooth lower boundary; few fine to medium roots; modern A horizon
II	23–64	Disturbed; 5YR 3/4, dark reddish brown; silty clay; moderate, medium, granular structure; moist, friable consistence; weak cementation; slightly plastic; terrigenous origin; common medium to coarse roots; plow zone
III	64–140 (BOE)	Natural; 5YR 3/4, dark reddish brown; silty clay; strong, medium, blocky structure; moist, firm consistence; strong cementation; plastic; terrigenous origin; lower boundary not visible; few coarse roots

T-8, located within the current project area east of the Puhi Camp Cemetery (see Figure 18), extends in a northeast/southwest direction. The profile was recorded along the west sidewall with a maximum depth of 140 cmbs. The stratigraphy observed at location T-8 consists of a silty clay loam modern A horizon (Stratum I), overlying a disturbed silty clay (Stratum II), and natural silty clay (Stratum III) (Figure 60 through Figure 62 and Table 11). No traditional Hawaiian or historic cultural material was observed. No significant historic properties were observed.

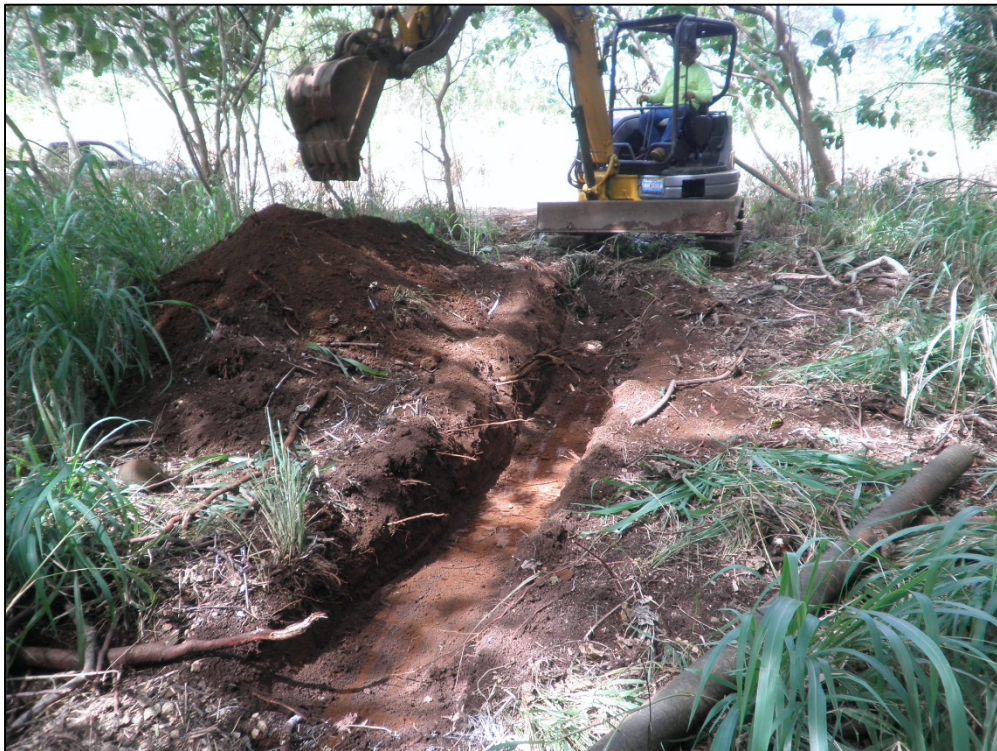
Figure 61. General location of T-8, view to northwest

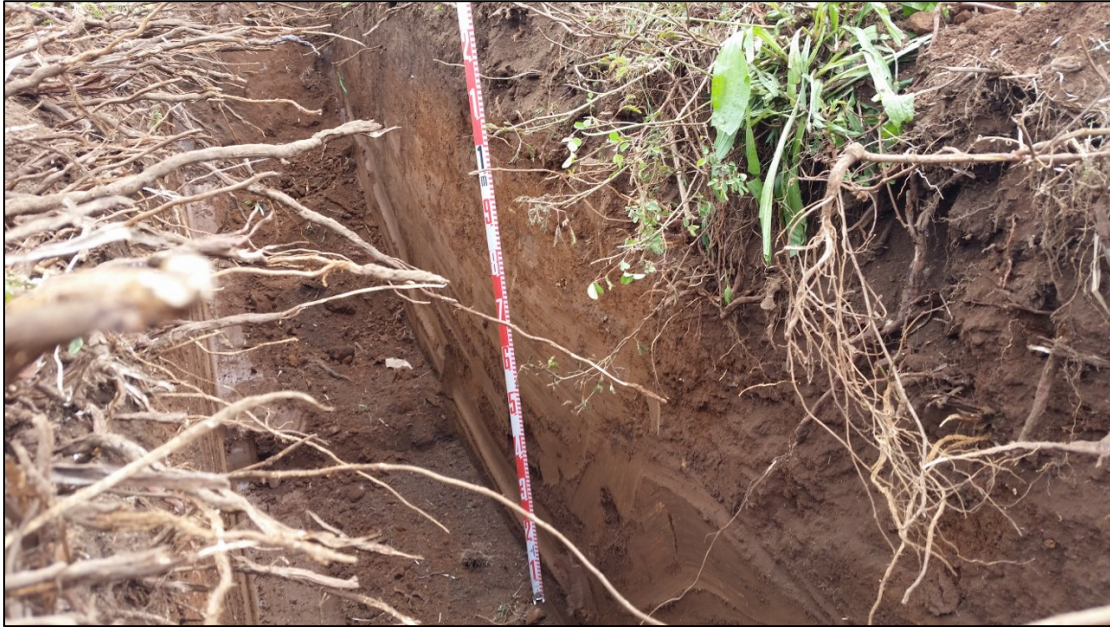
Figure 63. Photograph of T-9 southeast sidewall, view to southeast

Figure 65. Profile of T-9 southeast sidewall

Stratum	Depth (cmbs)	Description of Sediment
I	0-45	Disturbed; 5YR 2.5/2, dark reddish brown; silty clay; moderate, medium, granular structure; moist, firm consistence; weak cementation; slightly plastic; terrigenous origin; clear, smooth lower boundary; many fine to coarse roots; marble (Acc. # 56) and porcelain doorknob fragment (Acc. # 57) observed
II	30-130 (BOE)	Natural; 5YR 3/2, dark reddish brown; silty clay; moderate, medium, blocky structure; moist, firm consistence; strong cementation; plastic; terrigenous origin; lower boundary not visible; few fine roots

T-9, located in the southwest portion of the project area within the former Puhi Camp (see Figure 18), extends in a northeast/southwest direction. The profile was recorded along the southeast sidewall with a maximum depth of 130 cmbs. The stratigraphy observed at location T-9 consists of disturbed silty clay (Stratum I) overlying naturally deposited silty clay (Stratum II) (Figure 63 through Figure 65 and Table 11). No traditional Hawaiian cultural material was observed. Historic artifacts were observed consisting of a marble (Acc. # 56) and half a ceramic doorknob (Acc. # 57). The artifacts were observed very near to the surface. No significant historic properties were observed. For more detail descriptions of artifacts, see Section 5.

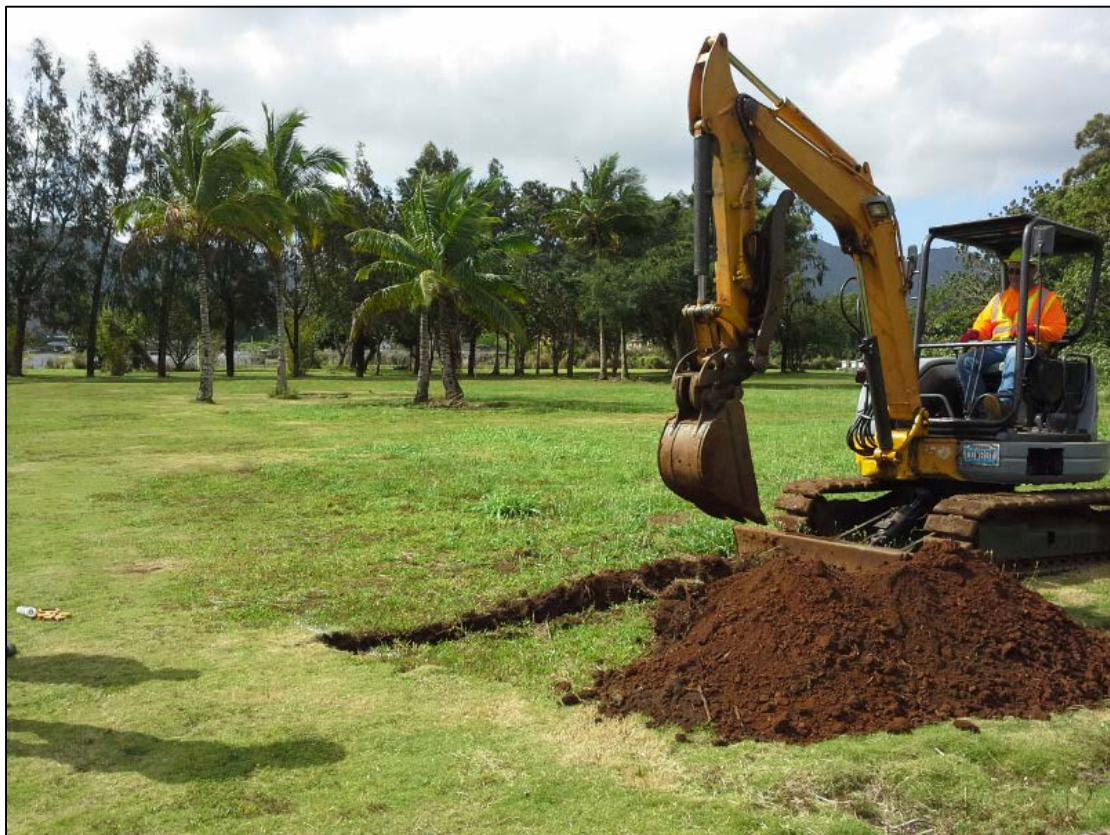
Figure 64. General location of T-9, view to south

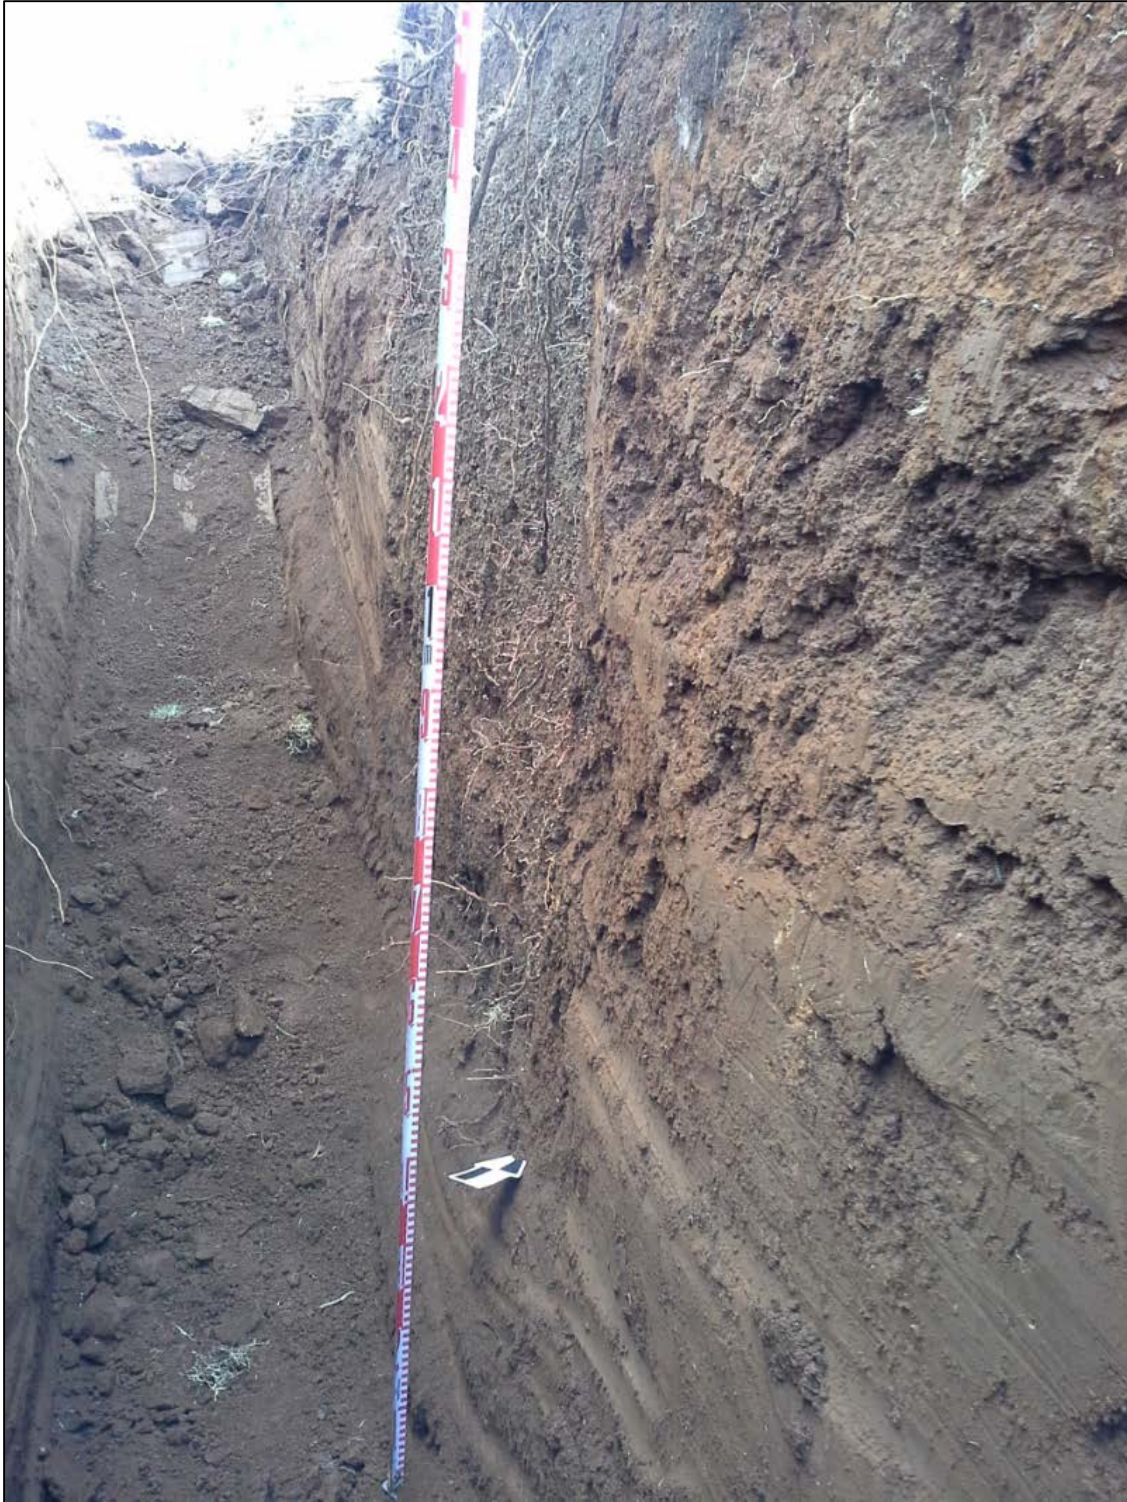
Figure 66. Photograph of T-10 northeast sidewall, view to northwest

Figure 68. Profile of T-10 northeast sidewall

Stratum	Depth (cmbs)	Description of Sediment
I	0–140	Disturbed; 5YR 3/4, dark reddish brown; silty clay; moderate, medium, granular structure; moist, firm consistence; weak cementation; plastic; terrigenous origin; clear, smooth lower boundary; common fine roots; pit observed extending 140 cmbs
II	35–180 (BOE)	Natural; 5YR 3/4, dark reddish brown; silty clay; strong, medium, granular structure; moist, firm consistence; strong cementation; plastic; terrigenous origin; lower boundary not visible; no roots observed

T-10, located in the southwest portion of the project area within the former Puhi Camp (see Figure 18), extends in a northwest/southeast direction. The profile was recorded along the northeast sidewall with a maximum depth of 180 cmbs. The stratigraphy observed at location T-10 consists of disturbed silty clay (Stratum I) overlying naturally deposited silty clay (Stratum II) (Figure 66 through Figure 68 and Table 12). No traditional Hawaiian or historic cultural material was observed.

A pit was observed extending from the surface into Strata I and II, terminating at approximately 140 cmbs. No cultural material was observed within the pit. It is likely the pit is associated with construction/maintenance (or demolition) of the former Puhi Camp. No significant historic properties were observed.

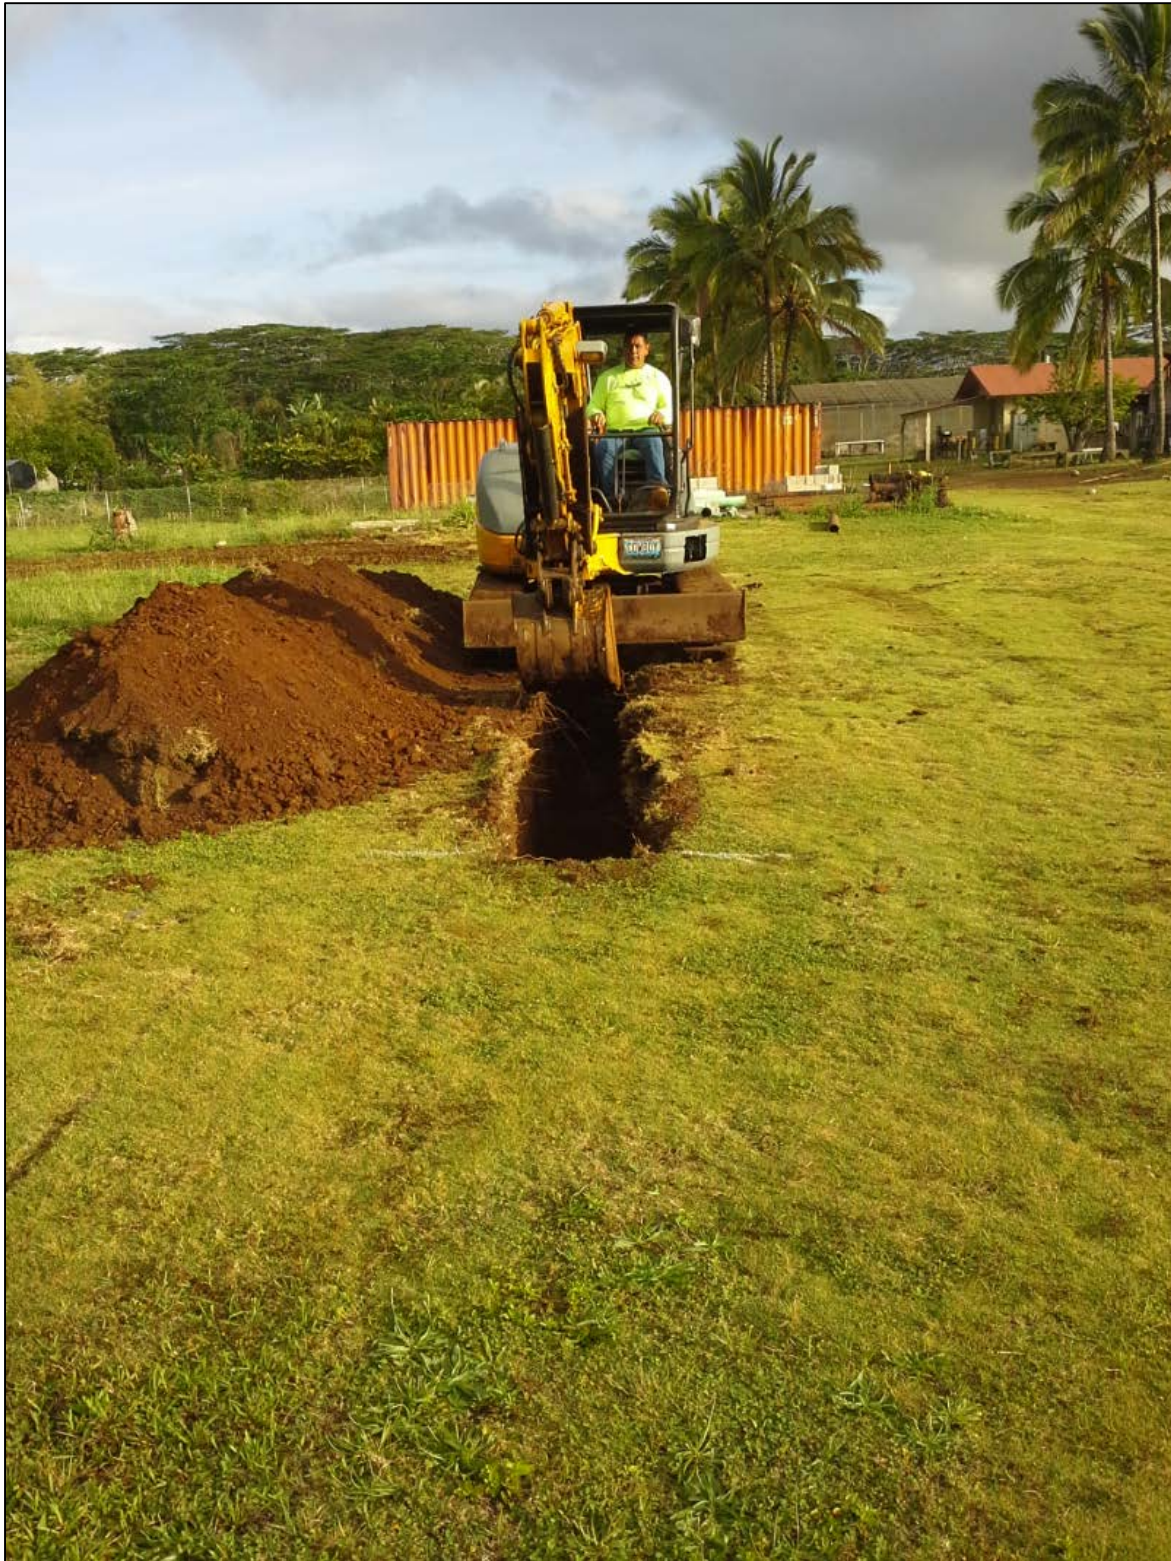
Figure 67. General location of T-10, view to northwest

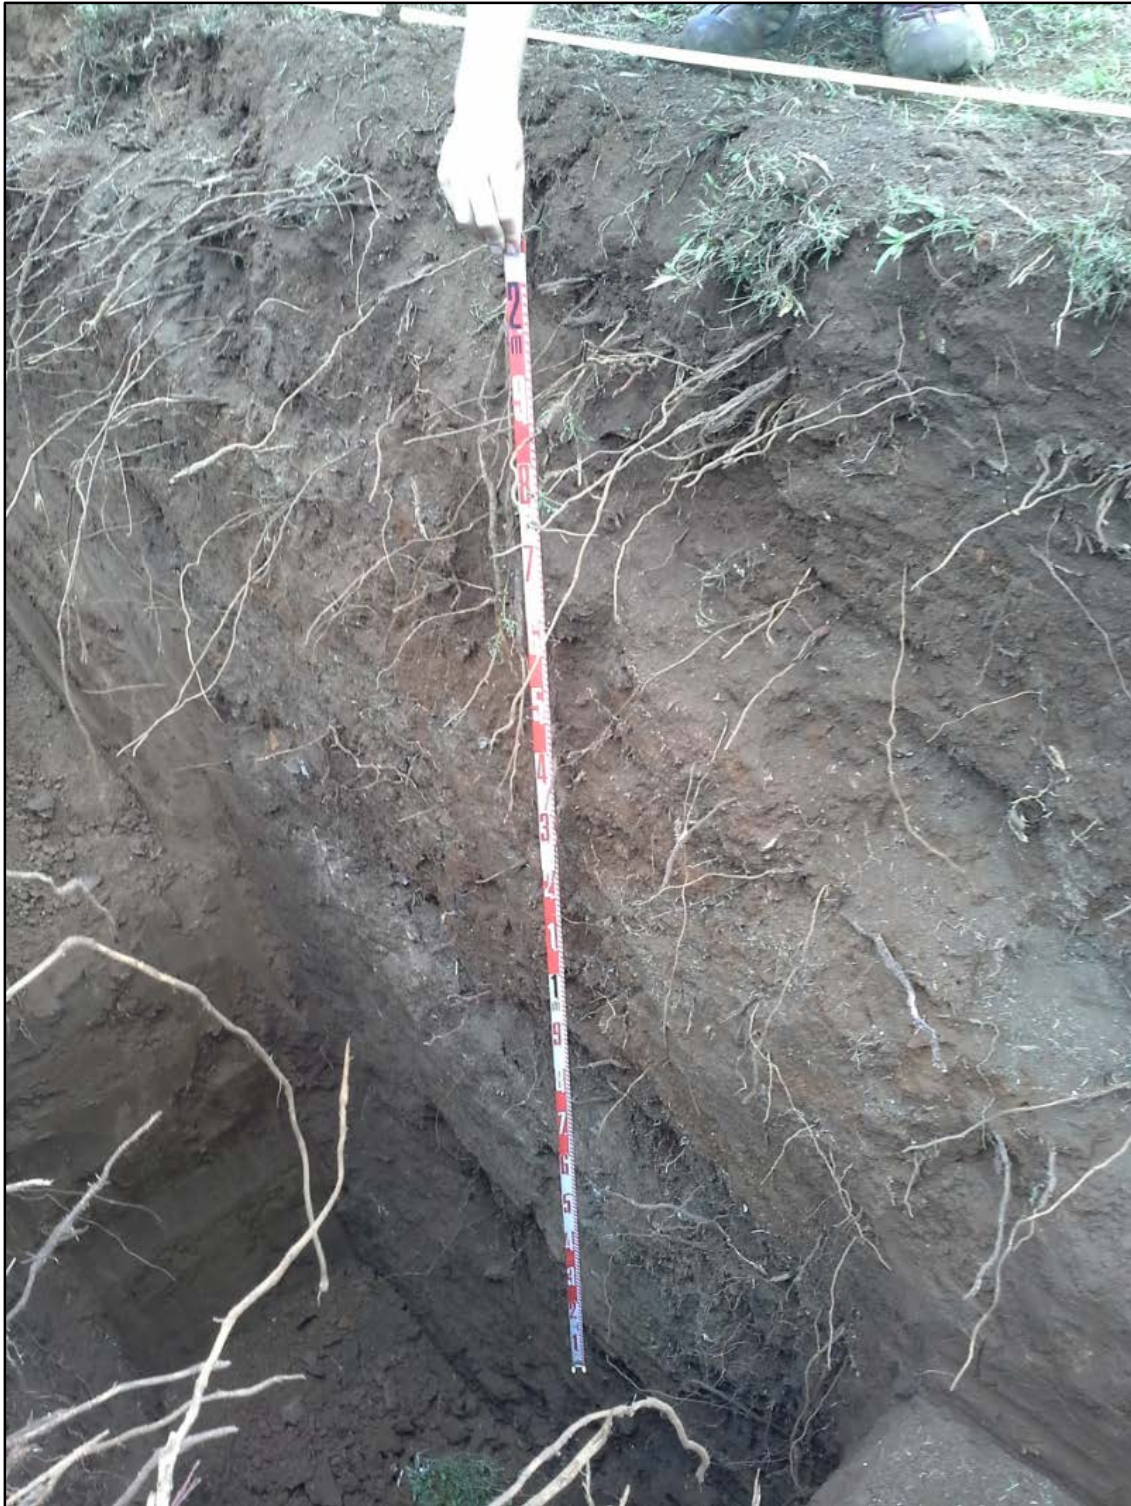
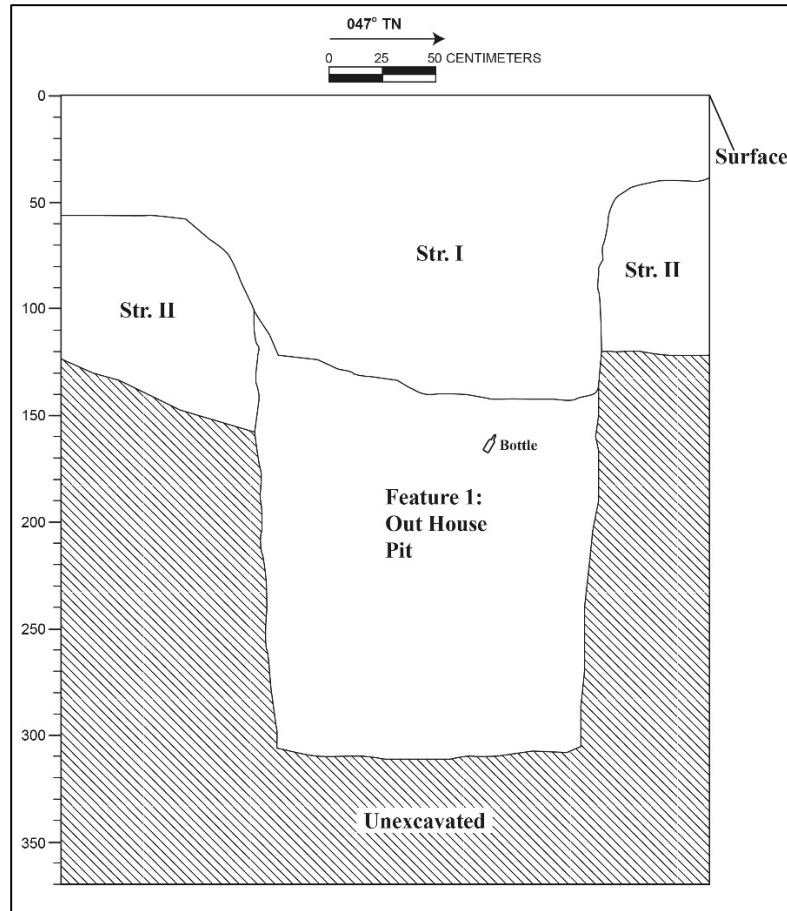
Figure 69. Photograph of T-11 northwest sidewall, view to northwest

Figure 71. Profile of T-11 northwest sidewall

Stratum	Depth (cmbs)	Description of Sediment
I	0–40	Disturbed; 5YR 3/4, dark reddish brown; silty clay; moderate, medium, granular structure; moist, firm consistence; weak cementation; plastic; terrigenous origin; clear, irregular lower boundary; common fine roots; plow zone; SIHP # -2307, subsurface trash pit observed with numerous historic artifacts (Acc. #s 1–55)
II	35–180 (BOE)	Natural; 5YR 3/4, dark reddish brown; silty clay; strong, medium, granular structure; moist, firm consistence; strong cementation; plastic; terrigenous origin; lower boundary not visible; few fine roots

T-11, located in the southwest portion of the project area within the former Puhi Camp (see Figure 18), extends in a northeast/southwest direction. The profile was recorded along the northwest sidewall with a maximum depth of 315 cmbs. The stratigraphy observed at location T-11 consists of disturbed silty clay (Stratum I) overlying naturally deposited silty clay (Stratum II) (Figure 69 through Figure 71 and Table 13).

No traditional Hawaiian cultural material was observed. A pit feature was observed along the trench sidewall, and measures 1.6 m in width and starts at a depth of 100 cmbs extending to 315 cmbs. Historic artifacts were observed and collected from within the pit. The historic artifacts include glass bottles, a tin plate, marbles, and plastic (Acc. #s 1–55). The presence of the artifact assemblage suggests the pit is a former subsurface trash pit associated with the former Puhi Camp and is designated SIHP # -2307. For more detailed descriptions of the artifacts, refer to Section 5. A detailed description of the historic property is located in Section 6.4. No additional significant historic properties were observed.

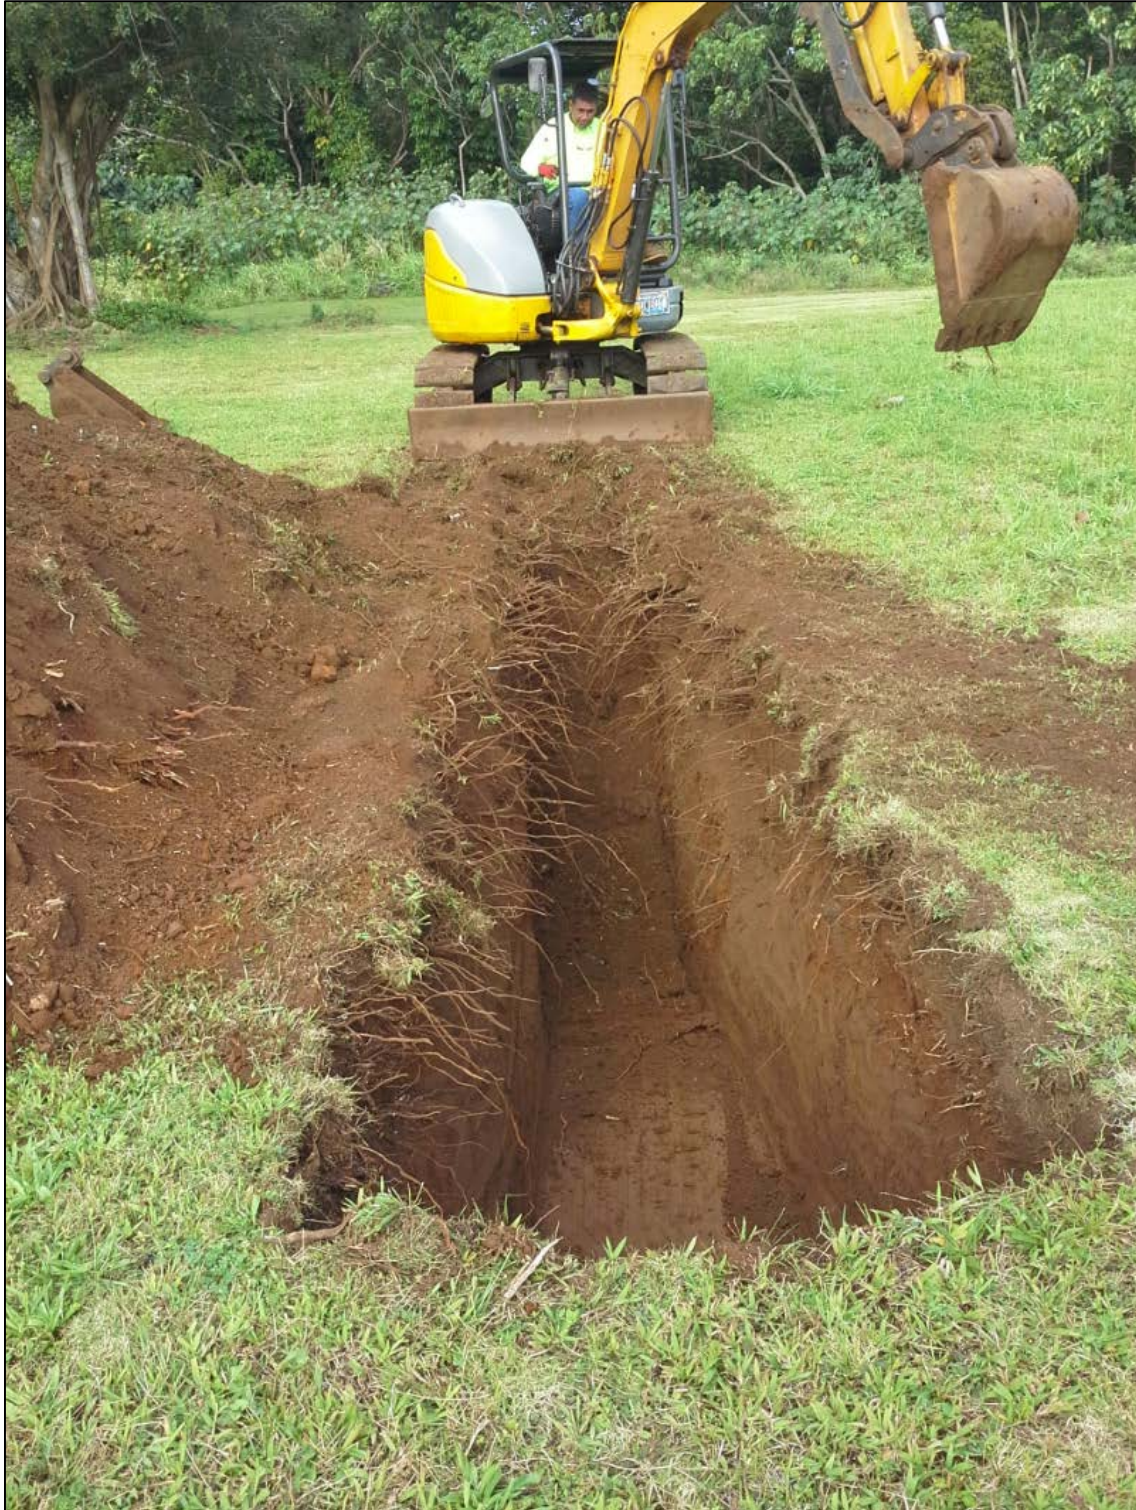
Figure 70. General location of T-11, view to southwest

One significant historic property was identified during subsurface testing. SIHP # -2307, a subsurface trash pit associated with the former Puhi Camp, was observed in T-11. For a detailed description of the historic property, refer to Section 6.4.

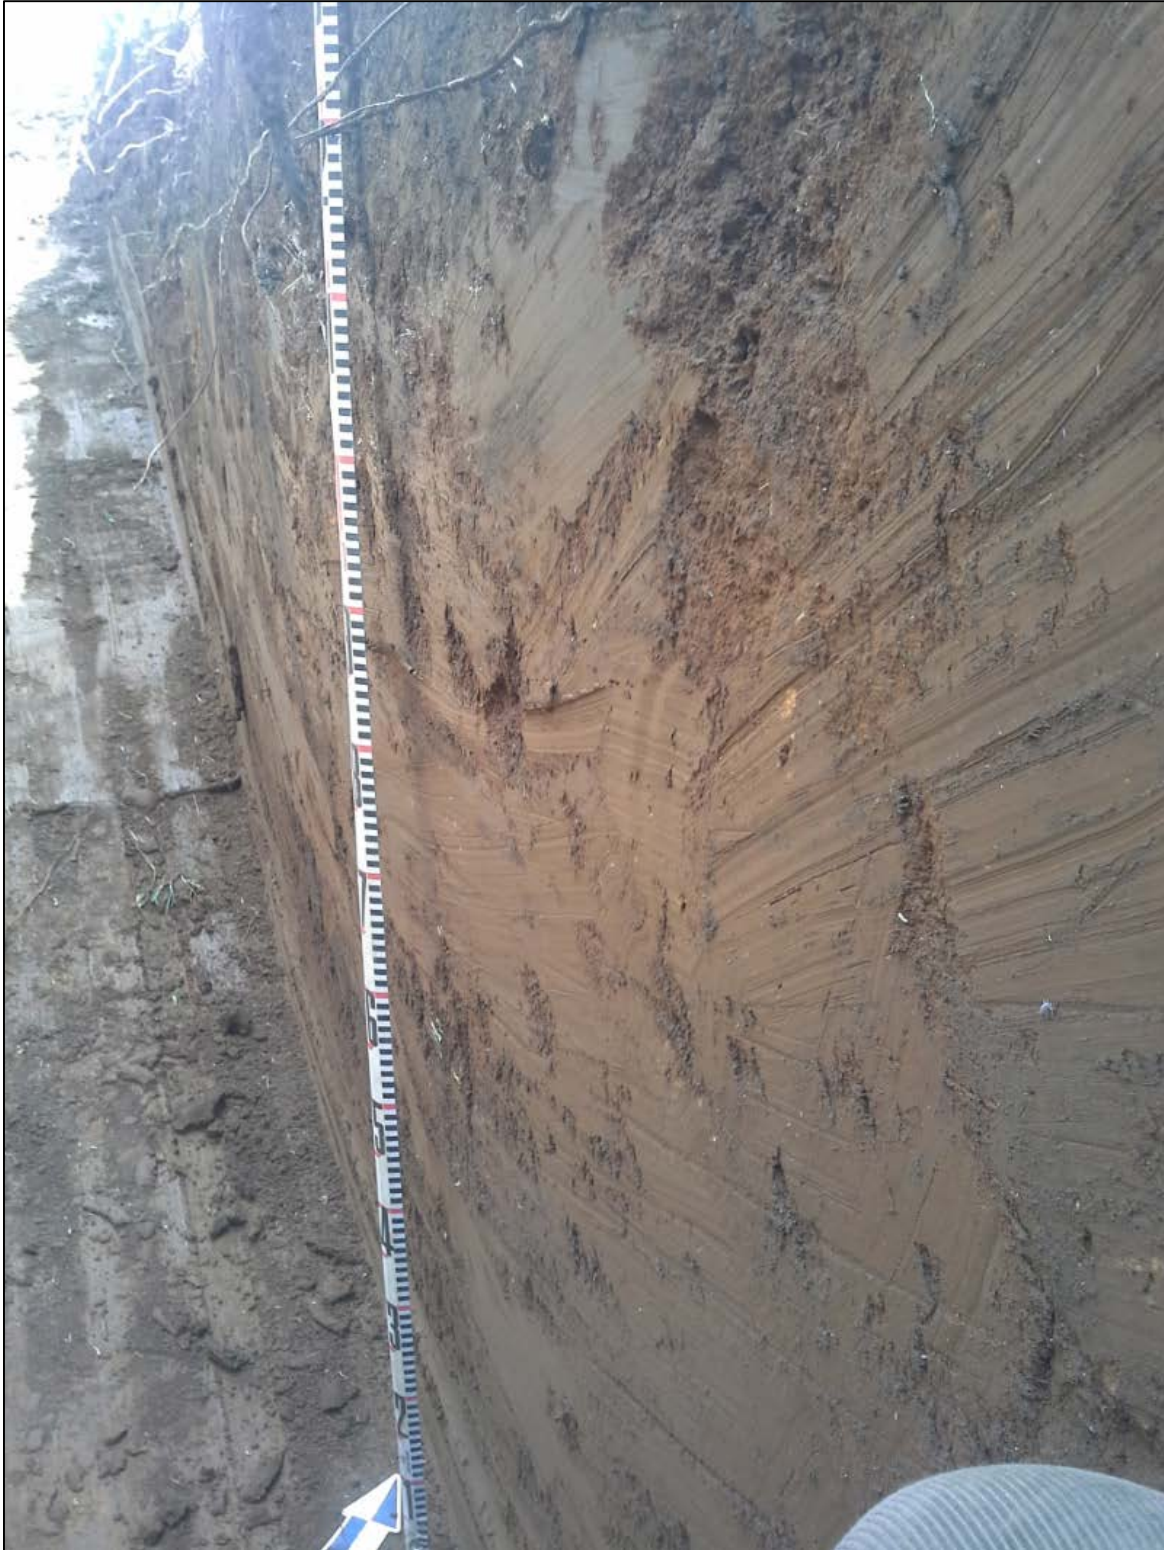
Figure 72. Photograph of T-12 northeast sidewall, view to north

Figure 73. Profile of T-12 northeast sidewall

Stratum	Depth (cmbs)	Description of Sediment
I	0–52	Disturbed; 5YR 3/4, dark reddish brown; silty clay; moderate, medium, granular structure; moist, firm consistence; weak cementation; plastic; terrigenous origin; clear, smooth lower boundary; common fine to medium roots
II	40–160 (BOE)	Natural; 5YR 3/4, dark reddish brown; silty clay; strong, medium, granular structure; moist, firm consistence; strong cementation; plastic; terrigenous origin; lower boundary not visible; few fine roots

T-12, located in the southwest portion of the current project area, within the former Puhi Camp (see Figure 18), extends in a northwest/southeast direction. The profile was recorded along the northeast sidewall with a maximum depth of 160 cmbs. The stratigraphy observed at location T-12 consists of disturbed silty clay (Stratum I) overlying naturally deposited silty clay (Stratum II) (Figure 72, Figure 73 and Table 14). No traditional Hawaiian or historic cultural material was observed. No significant historic properties were observed.

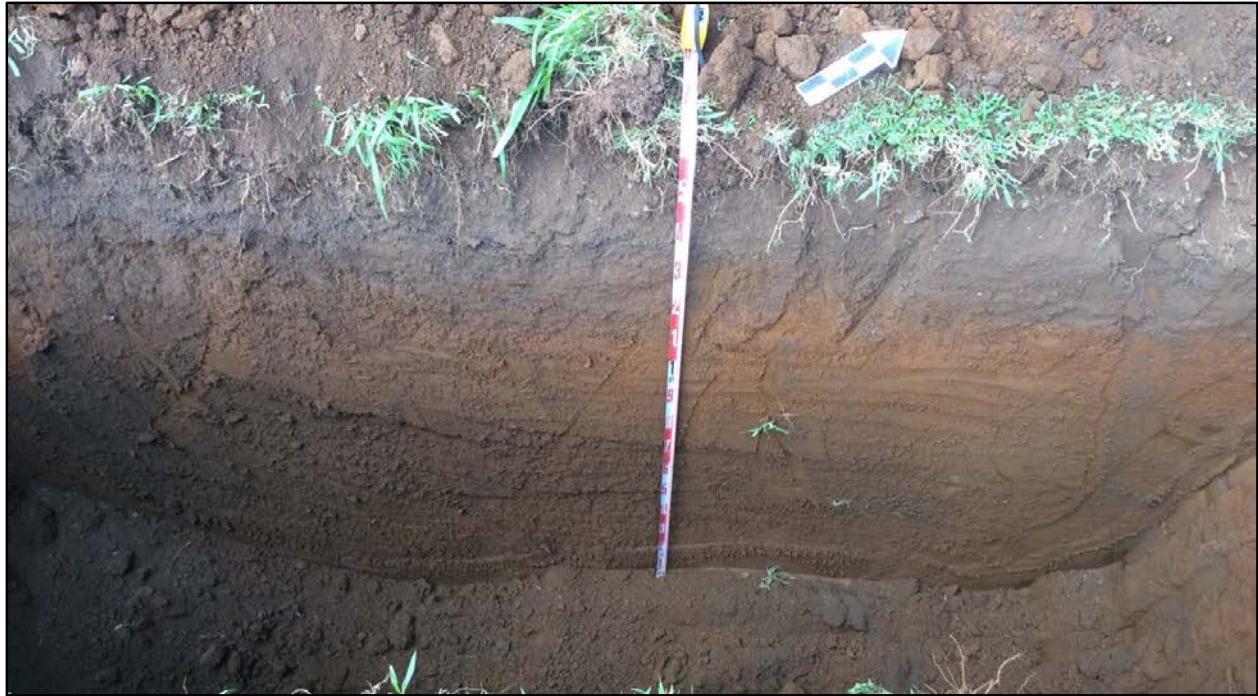
Figure 74. Photograph of T-13 northwest wall, view to northwest

Figure 75. Profile of T-13 northwest sidewall

Stratum	Depth (cmts)	Description of Sediment
I	0–40	Disturbed; 10YR 3/3, dark brown; clay loam; weak, medium, granular structure; moist, friable consistence; slightly plastic; no cementation; terrigenous origin; diffuse, smooth lower boundary; many, fine roots
II	40–155 (BOE)	Natural; 5YR 3/4, dark reddish brown; silty clay; moderate, medium, blocky structure; moist, firm consistence; plastic; no cementation; terrigenous origin; lower boundary not observed; no roots observed

T-13, located in the southwest portion of the project area within the former Puhi Camp (see Figure 37), extends in a northeast/southwest direction. The profile was recorded along the northwest sidewall with a maximum depth of 155 cmbs. The stratigraphy observed at location T-13 consists of a disturbed clay loam (Stratum I) and natural silty clay (Stratum II) (Figure 74, Figure 75, and Table 15). No traditional Hawaiian or historic cultural material was observed. Some modern trash was observed at or near the surface. No significant historic properties were observed.

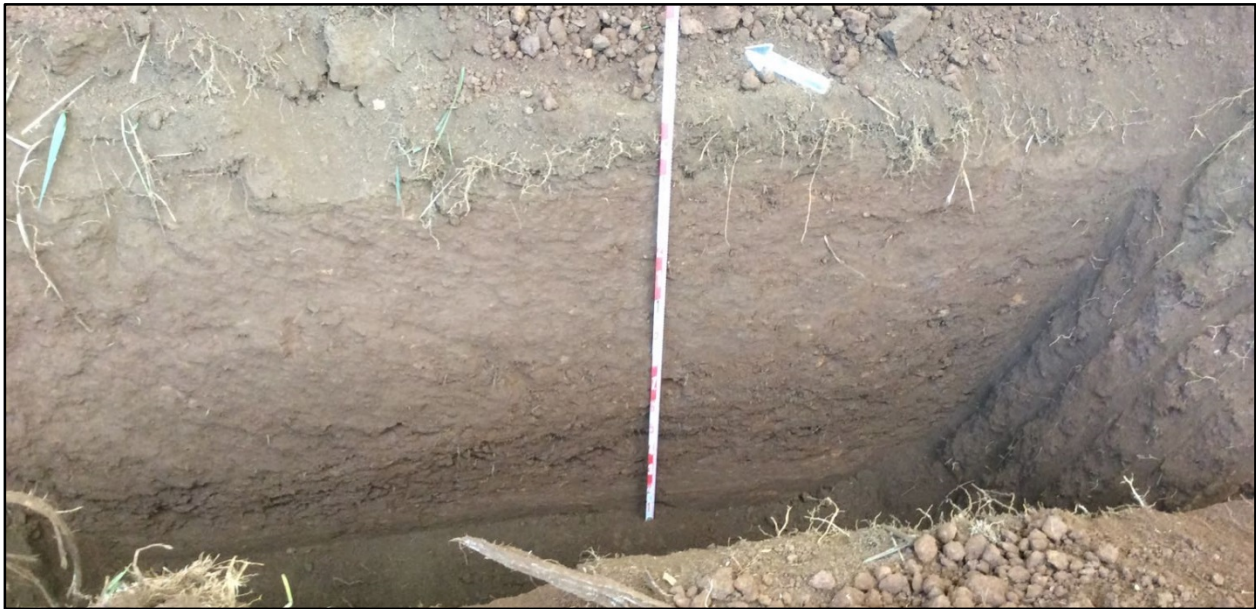
Figure 76. Photograph of T-14 east wall, view to east

Figure 77. Profile of T-14 east sidewall

Stratum	Depth (cmbs)	Description of Sediment
I	0–25	Disturbed; 10YR 3/3, dark brown; silty clay loam; weak, medium, granular structure; moist, friable consistence; slightly plastic; no cementation; terrigenous origin; diffuse, wavy lower boundary; common, fine, medium, coarse roots; plow zone
II	25–160 (BOE)	Natural; 5YR 3/4, dark reddish brown; silty clay; moderate, medium, granular structure; moist, firm consistence; slightly plastic; no cementation; terrigenous origin; lower boundary not observed; few, fine roots; higher clay content at lower depths

T-14, located in the northwest portion of the project area within former cane fields (see Figure 37), extends in a north/south direction. The profile was recorded along the east sidewall with a maximum depth of 160 cmbs. The stratigraphy observed at location T-14 consists of a disturbed silty clay loam (Stratum I) and a natural silty clay (Stratum II) (Figure 76, Figure 77, and Table 16). No traditional Hawaiian or historic cultural material was observed. No significant historic properties were observed.
