Section 4 Results of Fieldwork

4.1 Pedestrian Inspection Results

4.2 Subsurface Testing Results

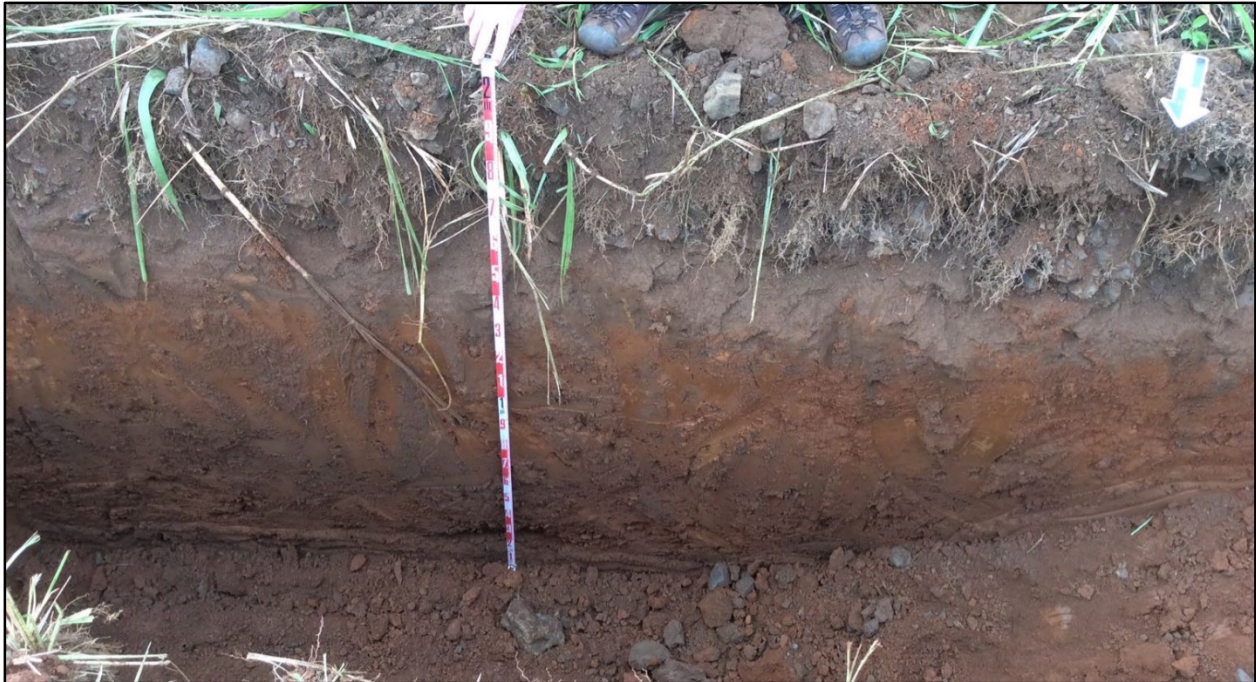
Figure 78. Photograph of T-15 south wall, view to south

Figure 79. Profile of T-15 south sidewall

Stratum	Depth (cmbs)	Description of Sediment
I	0–25	Base course; 10YR 3/3 dark brown; extremely cobbly silty clay; moderate, medium, granular structure; moist, friable consistence; slightly plastic; no cementation; diffuse, smooth lower boundary; many, fine roots; basalt cobble road surface
II	25–55	Disturbed; 10YR 3/3, dark brown; silty clay; moderate, medium, granular structure; moist, firm consistence; slightly plastic; no cementation; terrigenous origin; diffuse, smooth lower boundary; common, fine roots; plow zone
III	55–180 (BOE)	Natural; 5YR 3/4, dark reddish brown; silty clay; moderate, medium, blocky structure; moist, firm consistence; plastic; no cementation; terrigenous origin; lower boundary not observed; no roots observed

T-15, located in the north portion of the project area within former cane fields (see Figure 37), extends in an east/west direction. The profile was recorded along the south sidewall with a maximum depth of 180 cmbs. The stratigraphy observed at location T-15 consists of an extremely cobbly silty clay basalt cobble road surface (Stratum I), a disturbed silty clay (Stratum II), and a natural silty clay (Stratum III) (Figure 78, Figure 79, and Table 17). No traditional Hawaiian or historic cultural material was observed. No significant historic properties were observed.

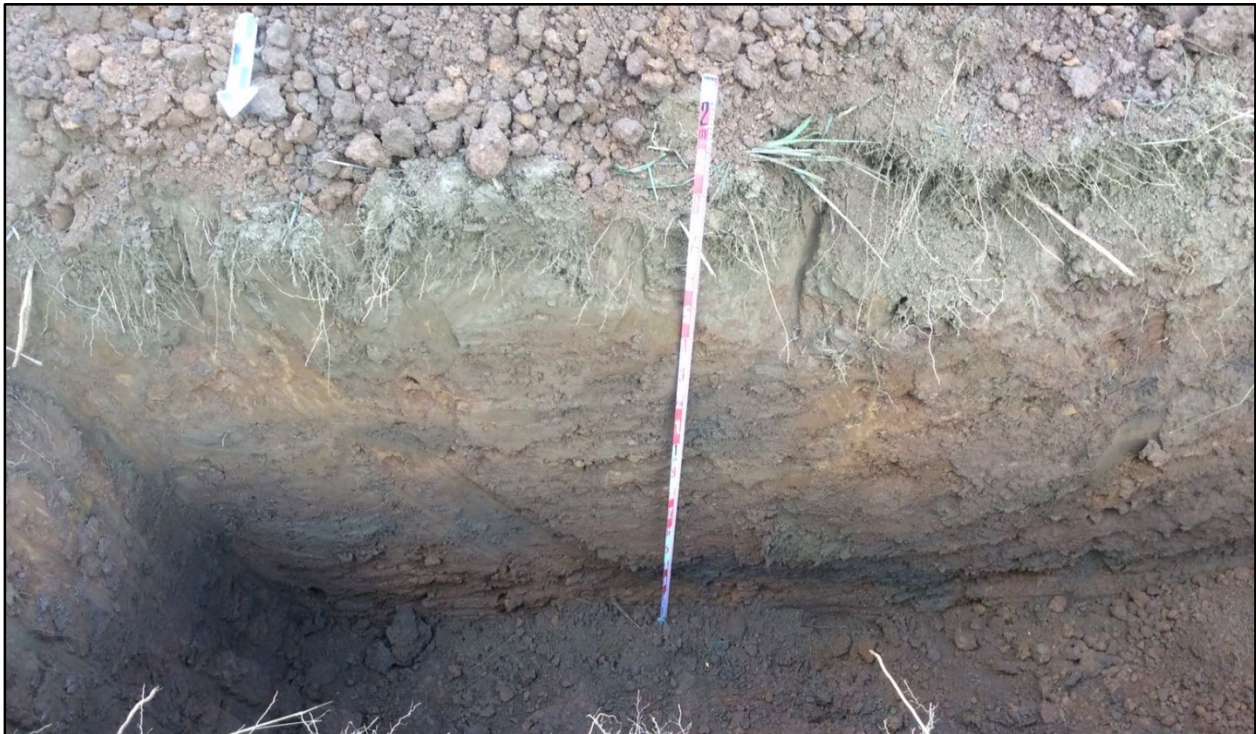
Figure 80. Photograph of T-16 south wall, view to south

Figure 81. Profile of T-16 south sidewall

Stratum	Depth (cmbs)	Description of Sediment
I	0–35	Disturbed; 10YR 3/3, dark brown; clay loam; moderate, medium, granular structure; moist, firm consistence; plastic; no cementation; terrigenous origin; diffuse, smooth lower boundary; many, fine roots; plow zone
II	35–185 (BOE)	Natural; 5YR 3/4, dark reddish brown; silty clay; moderate, medium, blocky structure; moist, firm consistence; plastic; no cementation; terrigenous origin; lower boundary not observed; no roots observed

T-16, located in the north portion of the project area within former cane fields (see Figure 37), extends in an east/west direction. The profile was recorded along the south sidewall with a maximum depth of 185 cmbs. The stratigraphy observed at location T-16 consists of a disturbed clay loam (Stratum I) overlying a natural silty clay (Stratum II) (Figure 80, Figure 81, and Table 18). No traditional Hawaiian or historic cultural material was observed. No significant historic properties were observed.

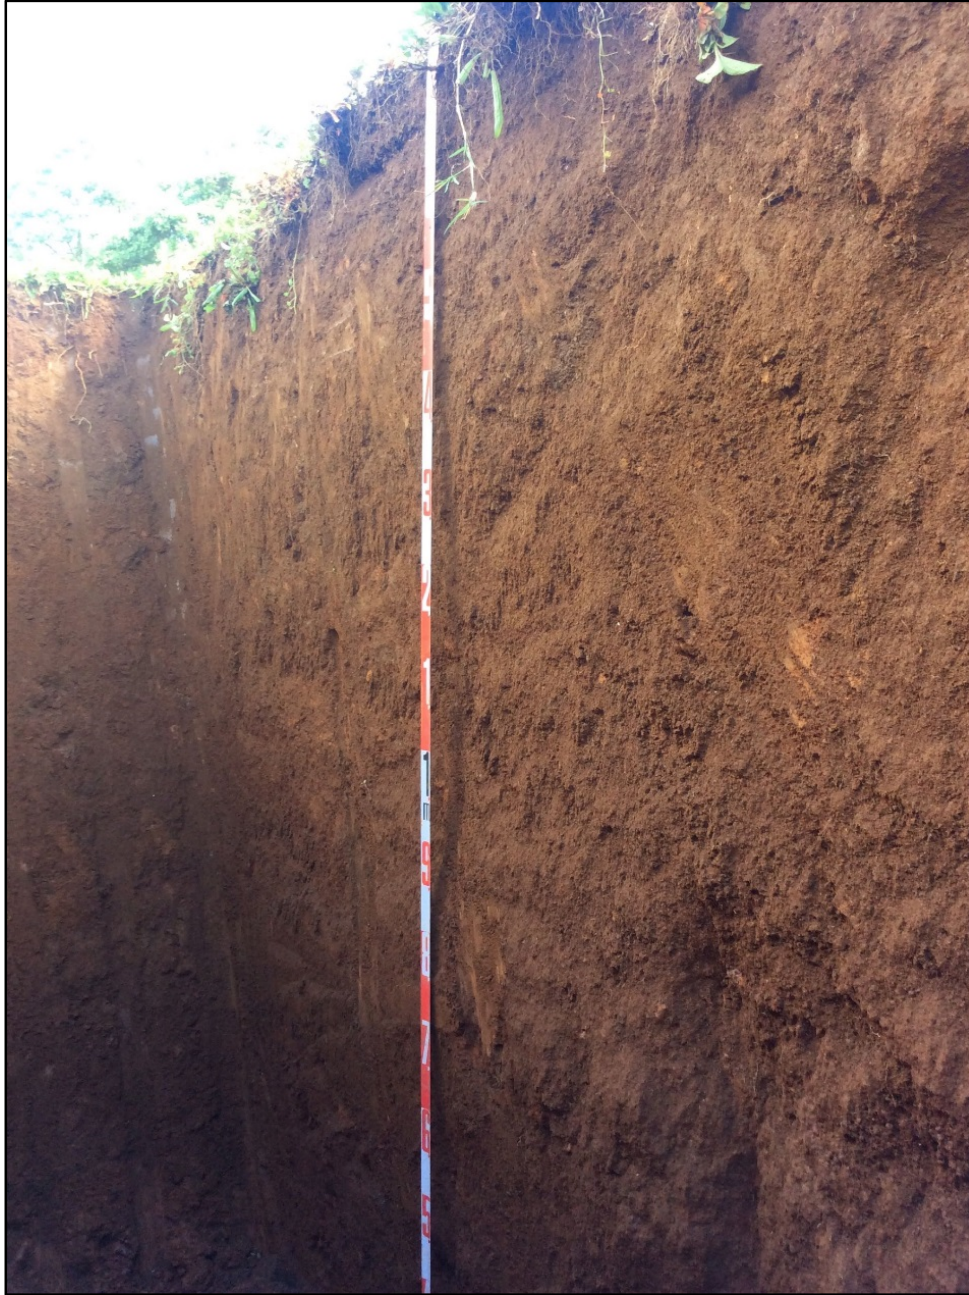
Figure 82. Photograph of T-17 south wall, view to southwest

Figure 83. Profile of T-17 south sidewall

Stratum	Depth (cmbs)	Description of Sediment
I	0–35	Disturbed; 7.5YR 4/4, brown; cobbly clay loam; moderate, medium, granular structure; moist, firm consistence; slightly plastic; no cementation; terrigenous origin; diffuse, smooth lower boundary; many, fine roots; plow zone
II	35–185 (BOE)	Natural; 5YR 4/6, yellowish red; silty clay; moderate, medium, blocky structure; moist, firm consistence; slightly plastic; no cementation; terrigenous origin; lower boundary not observed; no roots observed

T-17, located in the east portion of the project area within the developed portion of the KCC campus (see Figure 37), extends in an east/west direction. The profile was recorded along the south sidewall with a maximum depth of 185 cmbs. The stratigraphy observed at location T-17 consists of a disturbed cobbly clay loam (Stratum I) overlying a natural silty clay (Stratum II) (Figure 82, Figure 83, and Table 19). No traditional Hawaiian or historic cultural material was observed. No significant historic properties were observed.
