### Archaeological Literature Review and Field Inspection for Kauai Community College Rezone Campus Project Cultural Surveys Hawaii, Inc. December 2010

**Subject:** Archaeological Literature Review and Field Inspection for Kaua'i Community College Rezone Campus Project, Niimalu Ahupua'a Lihue District, Island of Kaua'i  
TMK: (4) 3-4-007: 001, 002, 003 and 006

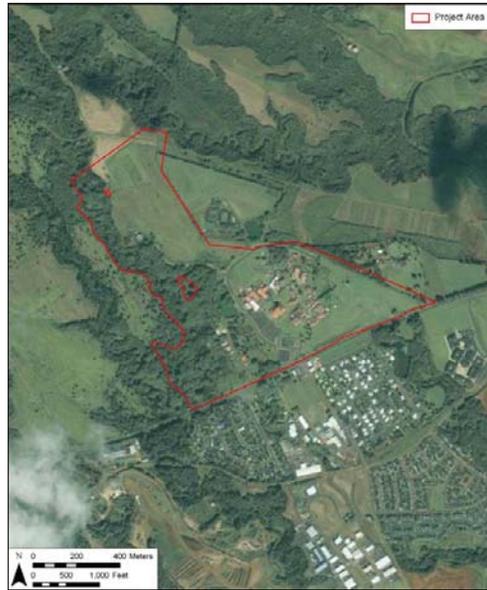
Figure 1. Portion of 1996 U.S. Geological Survey 7.5-Minute Series Topographic Map, Lihū'e quadrangle, showing the project area

At the request of Wilson Okamoto Corporation, Cultural Surveys Hawai'i, Inc. (CSH) completed an archaeological literature review and field inspection study for the Kaua'i Community College Rezone Campus Project, Niumalu Ahupua'a, Lihue District, Kaua'i Island, TMK: [4] 3-4-007: 001, 002, 003 & 006. The project area is shown on a U. S. Geological Survey topographic map (Figure 1), a U.S. Geological Survey aerial photograph (Figure 2), and on a Hawai'i Tax Map Key (Figure 3).

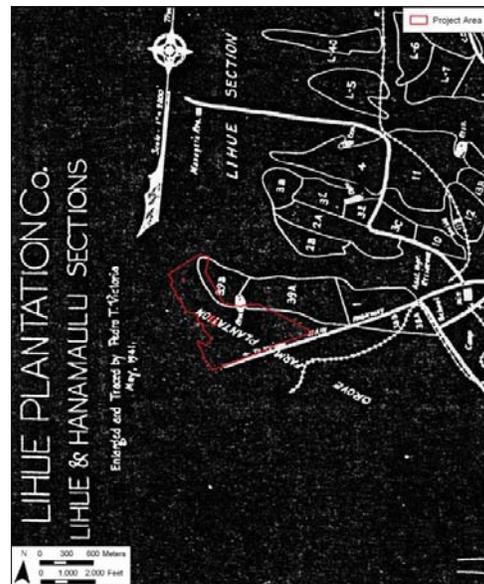
Figure 8. Portion of 1941 Lihue Plantation Co. map showing the location of the project area adjacent to the plantation and within Grove Farm

At the same time that the Belt Road construction program was underway, during the mid-1930s, Grove Farm was further expanding into Puhī with its new headquarters and the construction of a new office building, shop and stables. Figure 8 shows the 1941 location of Grove Farm in relation to Lihue Plantation Co. At that time, Grove Farm was still dependent on Lihue Plantation's mill for processing its sugar.

A 1941 map of Lihue Plantation Co. (see Figure 8) shows CSH 2 forming the western boundary of field 39B, separating Lihue Plantation and Grove Farm.

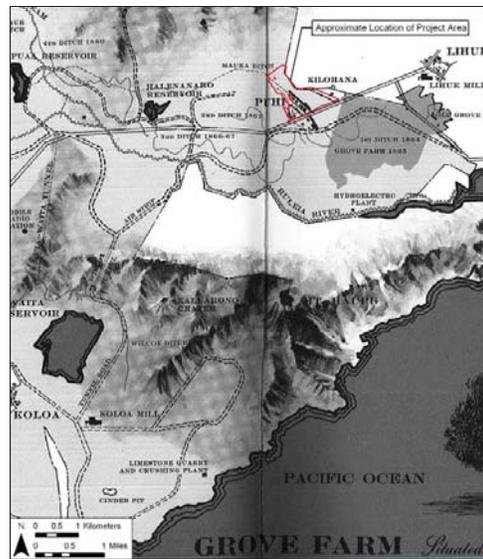
Figure 9. Grove Farm showing the approximate location of the project area within the plantation (adapted from Krauss and Alexander 1984)

In 1948 Grove Farm purchased Koloa Plantation. This doubled the size of Grove Farm, gave Grove Farm its own sugar mill for the first time, and eliminated duplication in manpower, equipment and administrative costs. In 1948/49 a cane haul truck tunnel (the Wilcox Tunnel) was excavated under the Hoary Head Range connecting the sugar cane fields of Ha'ikū to the Kōloa Mill (Krauss and Alexander 1984:366-368). Figure 9 shows Grove Farm, identifying the plantation's original areas and subsequent acquisitions. The graphic also shows "Mauka Ditch" extending north to south through the center of the project area.

This irrigation ditch appears to be a portion of the Grove Farm Mauka Ditch shown on Figure 9.

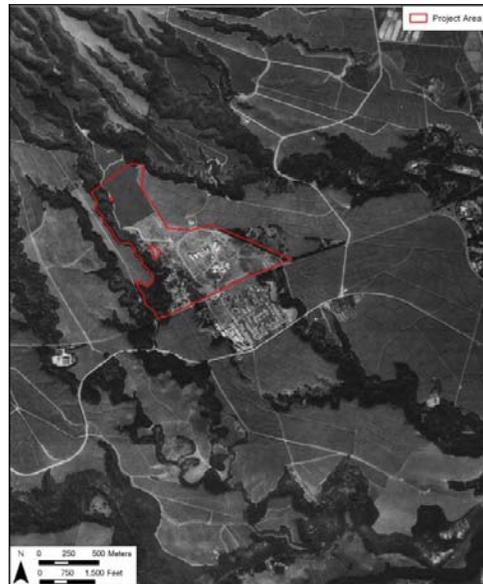
Figure 12. 1977-1978 U.S. Geological Survey aerial photograph of Lihue and vicinity showing the project area and its vicinity

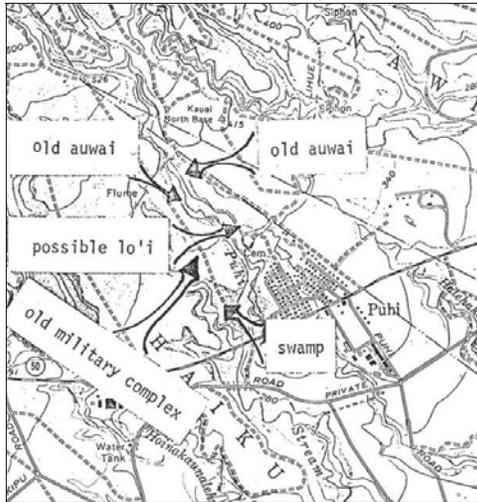
Figure 14. Locations of historic resources found within western portion of current project area during 1973 archaeological reconnaissance (adapted from Palama 1973:4)

In 1973, the Archaeological Research Center Hawaii conducted an archaeological reconnaissance of approximately 57 acres of the gully portion of KCC (Palama 1973), an area north and west of the currently developed portion of KCC. During the archaeological reconnaissance an "old '*auwai*" (conforming to Grove Farm's "Mauka Ditch", see Figure 9), an old military complex, a Japanese Cemetery, old plantation camp remains, an extant plantation camp, and possible *lo'i* were found (Figure 14). Palama (1973:2) asked plantation camp residents whether they ever found evidence of taro cultivation or if they farmed within the gully in the western-most portion of the current project area. Apparently only very limited farming had ever been conducted in the gully, and the plantation workers were not aware of any taro cultivation. Palama (1973:2) "recommended that no further work is warranted" for the historic features he identified and no state site numbers were assigned.

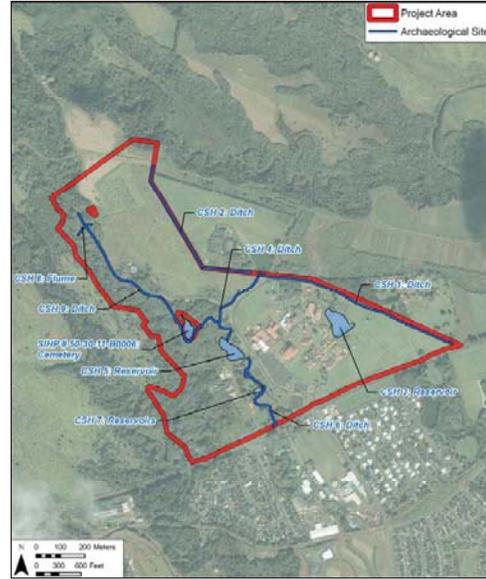
The field inspection consisted of a pedestrian inspection of the KCC campus. Few access restrictions impeded the inspection, however, ground visibility was somewhat obstructed by vegetation and previous development. A total of ten historic surface features, including two previously identified historic features (CSH 9, CSH 10), were found during the field inspection. CSH 9, an "old auwai" that conforms to a portion of Grove Farm's "Mauka Ditch" (see Figure 9) was previously found during an archaeological reconnaissance (Palama 1973, refer to Figure 14) of the western portion of the project area. Palama (1973) also recorded the location of a cemetery that was identified during the current field inspection as CSH 10. The Puhi Camp Cemetery, SIHP # 50-30-11-B006 / CSH 10, is outside of but surrounded by the project area.

The nine features found within the project area appear to be related to Grove Farm and date to the plantation era. The historic surface features consist of five irrigation ditches (CSH 1, CSH 2, CSH 4, CSH 6, CSH 9), one of which (CSH 1) is abandoned; three reservoirs (CSH 3, CSH 5, CSH 7), one of which (CSH 3) is abandoned; and an abandoned wooden flume (CSH 8).

Figure 15. Aerial photograph (source: U.S. Geological Survey Orthoimagery 2005), showing the historic features found within the project area and SIHP # -B006

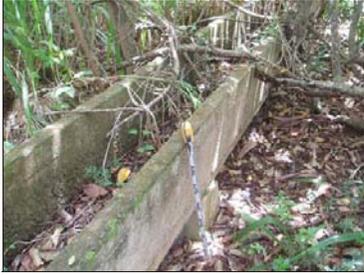
Figure 18. Portion of flume within CSH 1, abandoned irrigation ditch, view to northwest

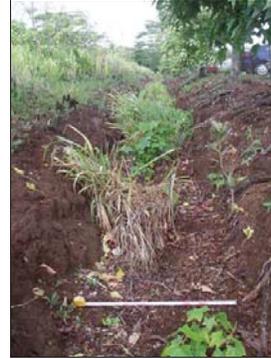
DESCRIPTION: CSH 2 is a plantation era irrigation ditch that forms the northeast boundary of the proposed project area (Figure 19; see Figure 15). The earthen ditch is 703 m long, 0.9 m deep with a maximum width of 2.0 m. The ditch walls are sloped resulting in a bottom width of 1.0 m. The ditch is not currently used for irrigation but collects storm drainage and surface runoff from the Island School campus and its athletic fields, adjacent to and east of KCC.

Figure 19. CSH 2, earthen irrigation ditch, view to west

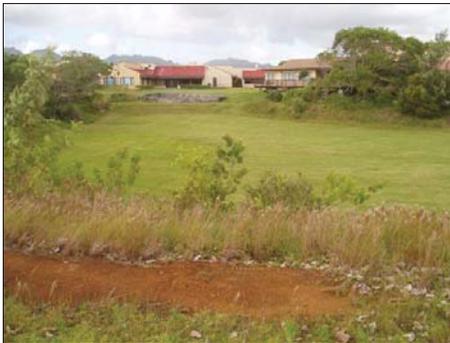
reservoir from the north side may have marked the alignment of the original feeder ditch, but is now a modern flood control feature dug into the reservoir floor. Other modern modifications include several storm drain outlets that flow into the reservoir, and a concrete overflow drain on the southwest side.

Figure 20. CSH 3, former reservoir with KCC buildings in background, view to southwest

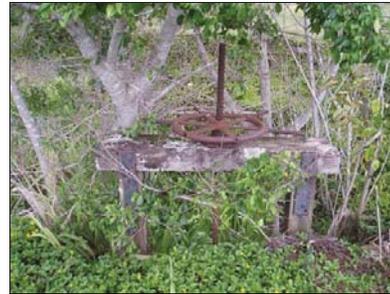
Figure 21. Water exit gate associated with CSH 3, former reservoir

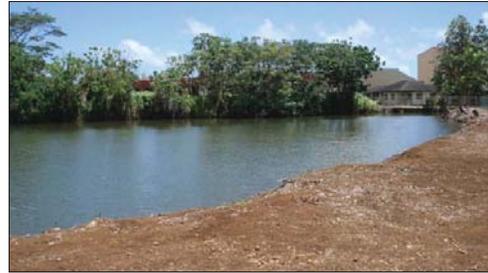
FEATURE TYPE: Reservoir  
FUNCTION: Agriculture, Water Control  
FEATURES: 1  
CONDITION: Excellent  
AGE: Plantation era

Figure 24. CSH 5, reservoir in center of project area, existing Pūnana Leo Pre-School buildings on KCC campus in background, view to southeast

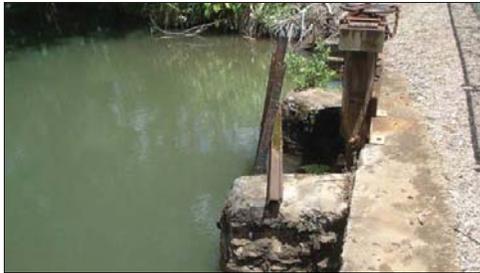
Figure 25. Water control at south side of CSH 5, reservoir, view to east

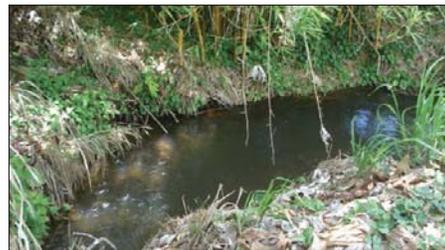
Figure 26. CSH 6a, irrigation ditch, view to east

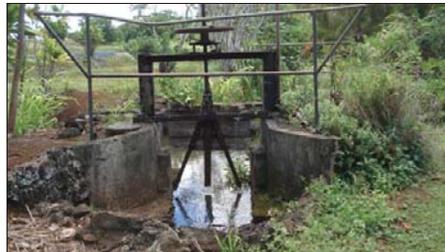
Figure 27. CSH 6b, concrete and metal gate, view to south

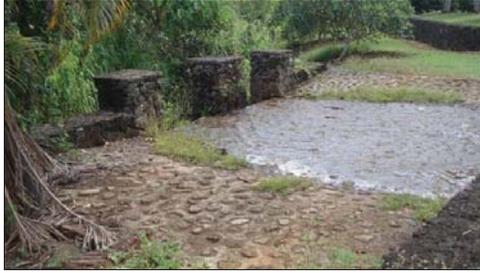
Figure 28. CSH 6a, irrigation ditch flowing through three large stone pillars, CSH 6c, note adjacent cobble and concrete road, 6d in foreground, view to southeast

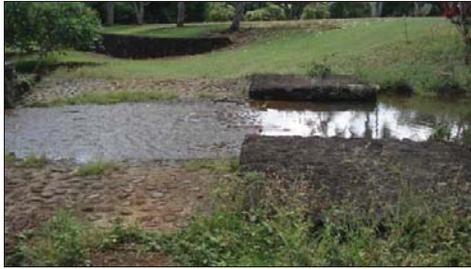
Figure 29 CSH 6a, irrigation ditch, showing additional details of cobble and concrete road CSH 6d, view to south

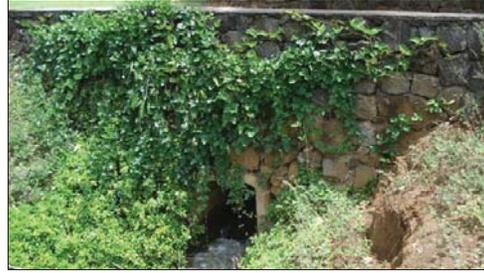
Figure 30. CSH 6e, irrigation ditch flowing beneath rock stacked bridge, view to east

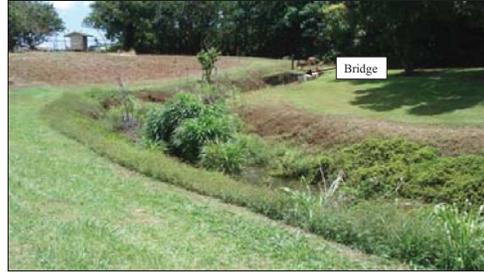
Figure 31. CSH 6f, irrigation ditch, flowing towards second bridge, view to southeast

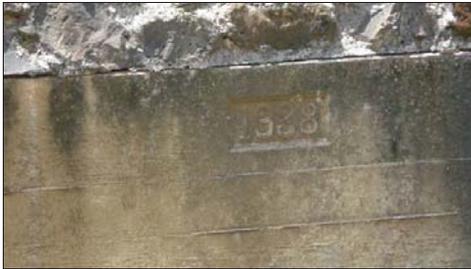
Figure 32. CSH 6f, irrigation ditch flows beneath this bridge (see Figure 31) stamped with a "1938" date, view to south

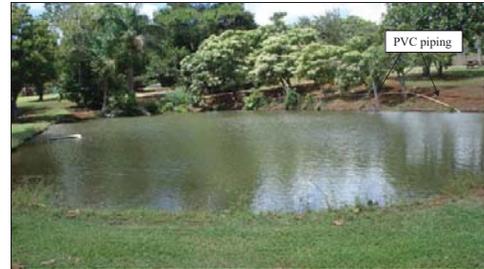
DESCRIPTION: CSH 7 consists of two small reservoirs. The larger of the two, CSH 7a, measures 42.6 by 20.2 m. A small PVC irrigation line was found along the north-northwest end of CSH 7a that appears to be the source of water (Figure 33). No other water source was found. Water flows out on the south side of the reservoir through a modern pipe into CSH 6, irrigation ditch.

Figure 33. CSH 7a, larger of the two reservoirs, note the PVC irrigation line in the background that may be the water source, view to west

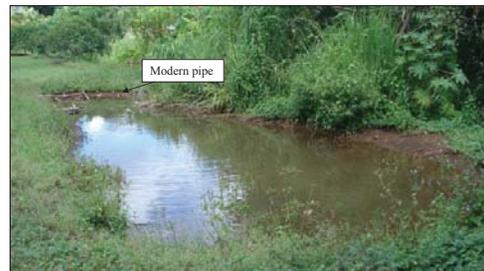
A small modern pipe on the east side of the reservoir flows into the second smaller reservoir, CSH 7b (Figure 34). CSH 7b is located approximately 1.5 m east of CSH 7a. This smaller reservoir measures 18.7 m by 4.9 m. No apparent outlet for the water was found and the function of the smaller reservoir may be for overflow from the larger reservoir.

Figure 34. CSH 7b, smaller of the two reservoirs, note the modern pipe in the background that connects the two reservoirs, view to north

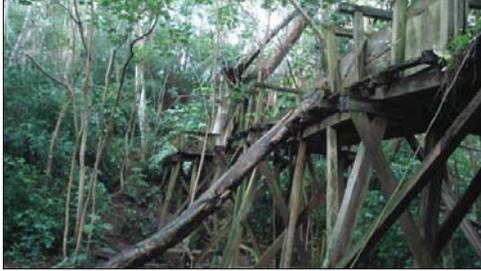
FEATURE TYPE: Flume  
 FUNCTION: Agriculture, Water Control  
 FEATURES: 1  
 CONDITION: Poor  
 AGE: Plantation era

DESCRIPTION: CSH 8 is a plantation era wooden flume that appears to be intact for the most part with a small portion of the central area missing. The flume measures 1.32 m wide and 0.75 m deep, however, the length of the flume beyond the gulch is undetermined due to inaccessibility. The portion of the feature that is accessible is located along the slope of the gulch and extends across the gulch (Figure 35). The flume is approximately 4.8 m above the bottom of the gulch. Retaining walls constructed of concrete and boulders are situated on both sides of the gulch to support the flume (Figure 36). The two retaining walls measure 4.7 m long, 1.8 m high, and 0.32 m thick.

Figure 35. CSH 8, flume, view to northwest

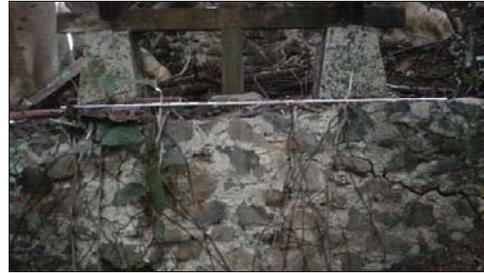
Figure 36. CSH 8, flume, showing concrete and boulder retaining wall beneath flume, view to east

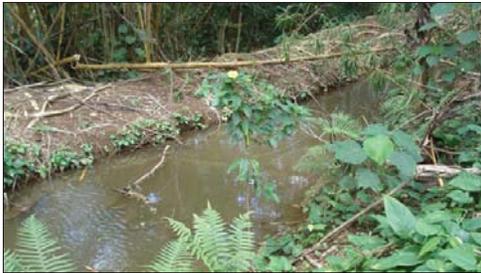
FEATURE TYPE: Irrigation ditch  
 FUNCTION: Agriculture, Water Control  
 FEATURES: 1  
 CONDITION: Good  
 AGE: Plantation era

Figure 37. CSH 9, irrigation ditch, view to west

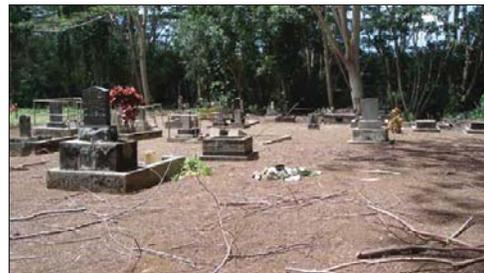
SITE TYPE: Cemetery  
 FUNCTION: Burials  
 FEATURES: 1  
 CONDITION: Good  
 AGE: Historic

Figure 38. CSH 10, cemetery, showing various headstones, view to southwest

The one previously identified historic property, SIHP # 50-30-11-B006, Puhii Camp Cemetery plan, was identified as CSH 10 during the field inspection. SIHP # B006 is outside of the project area, but surrounded by KCC property. Preservation, in the form of avoidance and protection, is recommended for SIHP # 50-30-11-B006.

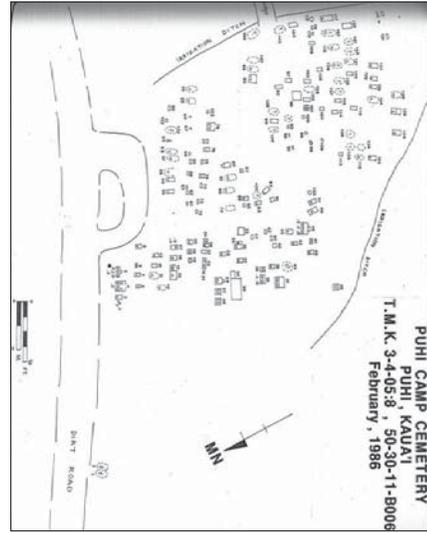
Kikuchi and Remoaldo's (1992) study details information from individual grave markers. The names associated with graves 1 through 97 are listed, and all but seven show a year of death. Dates of death range from 1920 to 1977 with the majority of dates in the 1960s, followed by dates in the 1920s. The majority of the names (graves 1-97) are Filipino, with some Japanese and Chinese names. There does not appear to be any segregating of people into particular areas. Graves 98 through 119 are "written in Japanese characters which could not be translated at this time" (Kikuchi and Remoaldo 1992:140), and therefore these graves lack information regarding date of death. These Japanese graves are situated in the southern portion of the cemetery. Graves that lack information as well as markers were later interred amongst the Japanese graves. They include graves 120 through 127, identified as "unknown graves from Kaiju Camp, March 16, 1967" (Kikuchi and Remoaldo 1992:141); and graves 128 through 153, listed as "Unknown." Many of the unknown burials lack markers but have a "concrete base" or a cross. Graves 154 to 172 "were earthen mounds or depressed areas where a grave may exist or was exhumed" (Kikuchi and Remoaldo 1992:142). The locations of graves 154 to 172 are not noted on the Pūhi Camp Cemetery map (Figure 40).

Figure 30HPuhii Camp Cemetery plan' SIHP # 50-30-11-B006 (I. Haku) an. Rental. o. w/plew3)  
Literature Review and Field Inspection for Kauai's Community College, Niumala Ahupua'a, Kauai's  
TMK [4]3-4-007: 001, 002, 003 & 006
