**FINAL ARCHAEOLOGICAL INVENTORY SURVEY REPORT
FOR SEVERAL PARCELS OF LAND SITUATED WITHIN
WAIKAPŪ AHUPUA`A; WAILUKU DISTRICT
PŪ`ALI KOMOHANA MOKU**

**TMK: [2] 3-6-002:003; [2] 3-6-004:003, [2] 3-6-004:006;
and [2] 3-6-005:007**

**BY: Diane Guerriero (B.A.), Andre`e Conley-Kapoi (M.A.), Lisa J. Rotunno-Hazuka (B.A.)
and Jeffrey Pantaleo (M.A.)**

REVISED SEPTEMBER 2017

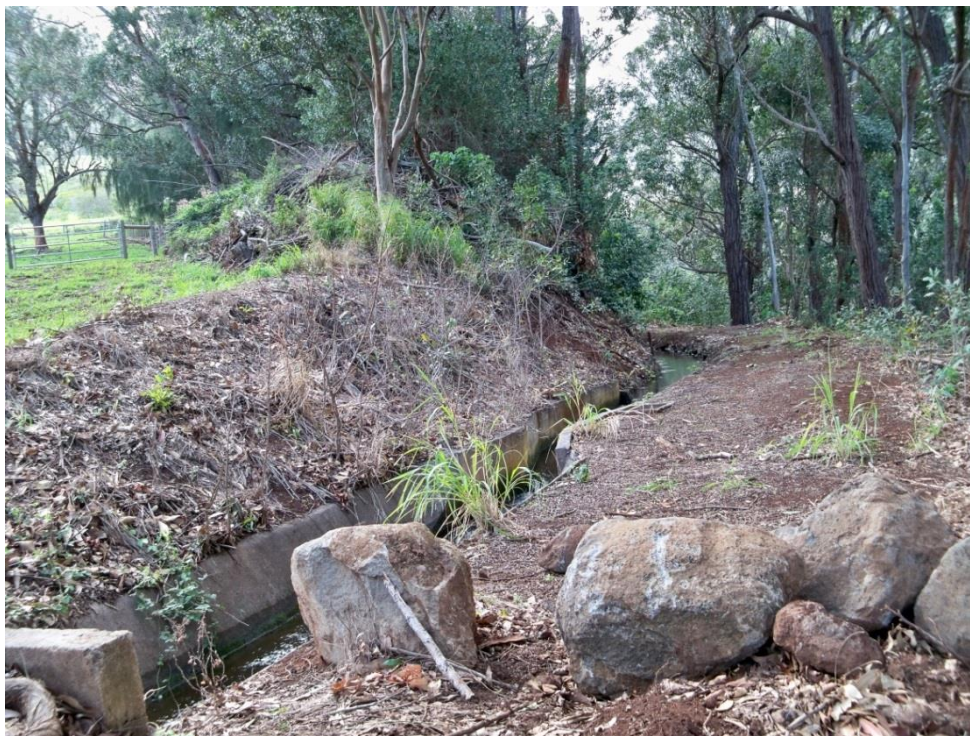
Figure 24. Site 7881 Feature 1 View to Northwest towards Upper Valley

Feature 1 is one of two ditches that originates and or intersects from the un-named ditch, probably Waikapū Ditch South in the upper Waikapū Valley (Figures 22-23). The total length of the Waikapū Ditch South from the origin of the water source in the upper valley to Feature 3-reservoir is approximately 1.6 km (1 mile) long. Waikapū Ditch South in the upper valley is an open earthen canal and at the point that it becomes improved and concrete lined, it is designated as Feature 1 (Figures 24 and 25). This improved portion (Feature 1) flows in a west/southeast direction (J-shaped) down slope towards the reservoir (Feature 3) for a length of 21.2 meters at an elevation of approximately 1017 AMSL. Feature 1 is concrete reinforced along the base of the banks and measures 21.2 m long by 1.6 m wide by 1.0 deep with exterior concrete bank heights of 0.30 m on the west and 1.2 m on the east. The service trail/access

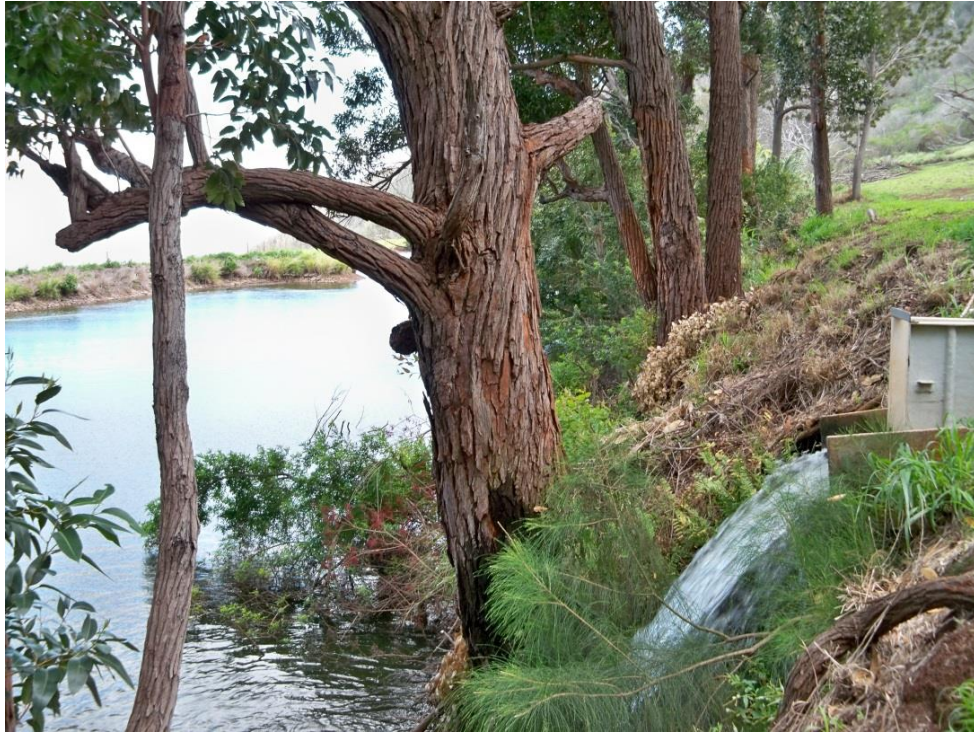
Figure 26. Site 7881 Feature 1 Emptying into Reservoir (Feature 3) through modernized Chute (Feature 3a) (View to South)

road which bounds the project area to the north and is parallel to Waikapū Stream on the north bisects Feature 1 at 15.7 m just before it curves to the south and empties into Feature 3 (reservoir) (Figure 26). The bridge measures 5.3 m in width east/west by 2.44 m in length northeast/southwest with an interior height of 0.30 m and exterior height of 0.55 m. Southeast of this service trail road bridge are three water diversion features (Features 4-6) or sluice gates, which intersect with Feature 1 and are discussed in detail below. Feature 4 is located 2.3 m southeast of the bridge, Feature 4a and Feature 5 are 4.1 m and Feature 6 is 7.7 m southeast of the bridge. Features 5 and 6 are abandoned and no longer divert water; however Features 4 and 4a re-channelize a portion of Feature 1 water east to another *`auwai* designated Feature 2 (see Figure 25). Feature 2 flows east, parallel along the south and north sides of the dirt access road bounding Parcel 3 Mauka, and Feature 1 continues south emptying into the Feature 3 reservoir (see Figure 23 below).

Feature 3a is modernized chute that empties directly into (Feature 3) Reservoir from Feature 1 (see Figure 23). This feature utilizes wooden sluice gates with metal chains and locks, reinforced fiberglass chute walls with an 8-inch PVC piping that funnels the ditch (Feature 1) water into the reservoir.

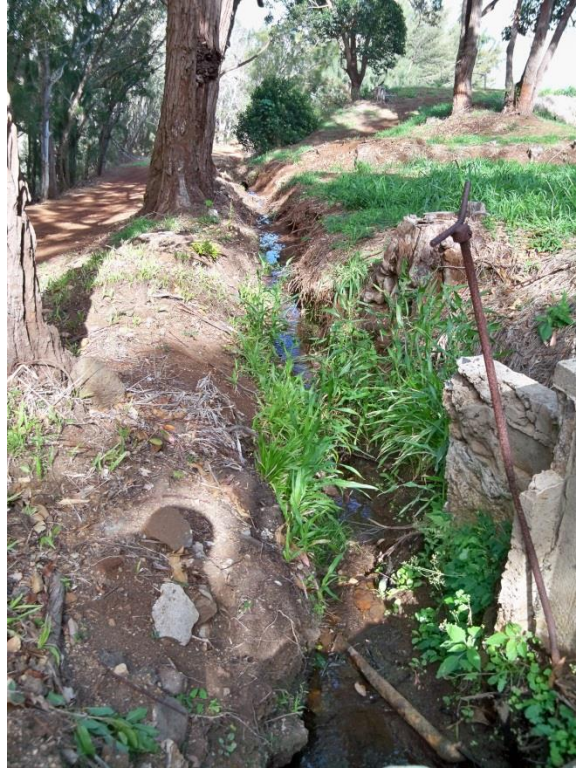
Figure 27. Site 7881 Feature 2 Ditch with Feature 5 in the foreground right (View to West)

Feature 2 is the primary ditch of Site 7881 that is parallel to the service access road that bounds the north side of Parcel 3 Mauka. It is oriented east-west and runs along the south side of the access road and eventually crosses under the road through Features 7 and 8 culverts and runs along the north side of the service access road from Feature 8 to Feature 18 (see Figures 6 and 22). Feature 2 contains water diverted from Feature 1 (Waikapū South in the valley) through a sluice gate (Feature 4) and water chute (Feature 4a). This ditch appears to be much older and in a dilapidated condition when compared with Feature 1. It is narrower, approximately 0.65 m in width, and comprised primarily of earthen banks with sporadic concrete and mortared rock lining along portions of the banks with concrete partially lining the base of the ditch (Figures 27-28). Feature 2 averages 0.60 m deep and continues for an approximate 214.0 m along the south side of the dirt access road, where it enters another diversion feature, Feature 7 (see Figure 28).

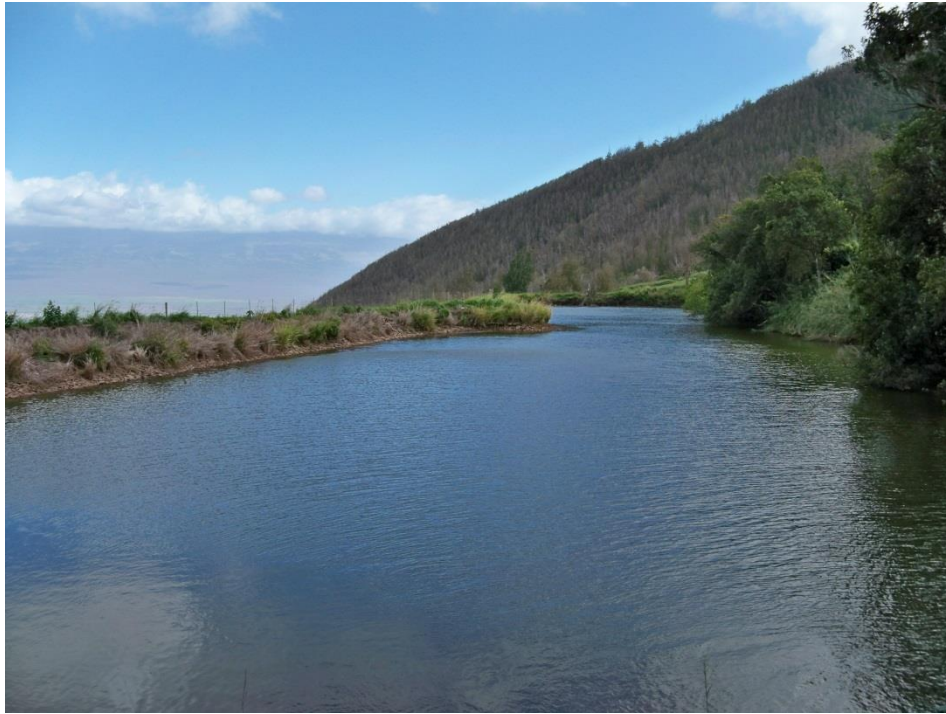
Figure 29. Site 7881 Feature 3 Reservoir, View to South

Feature 3 is the reservoir that is located just outside of the project area at the top (western) edge of Parcel 3 Mauka at an elevation of 1017 AMSL (see Figures 22 and 30). Feature 1, the improved portion of Waikapū Ditch South empties into the reservoir on the west (see Figure 26). The water source originates from the upper the Waikapū Valley and flows through various `auwai and sluice gates to provide water to the agricultural endeavors below.

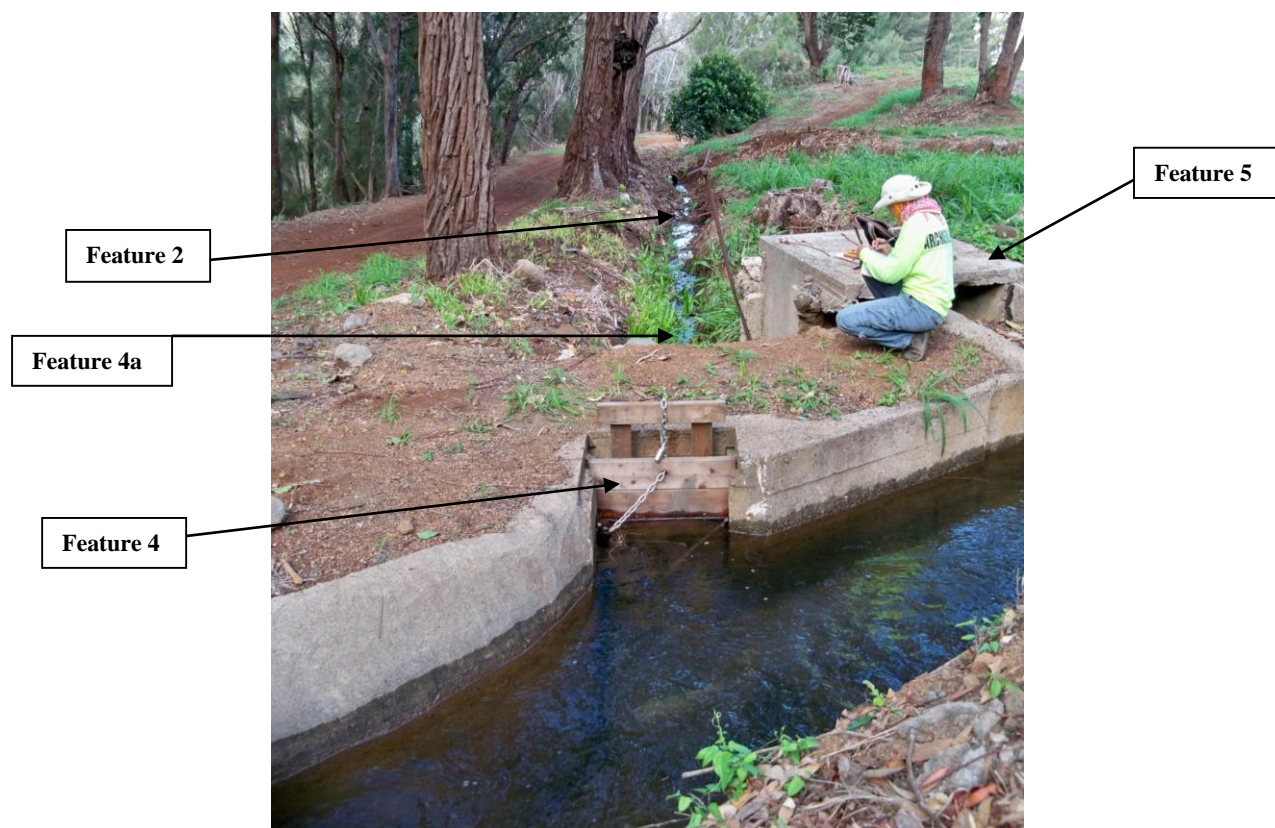
**Figure 31. Photograph of Site 7881 Features 1 and 2 ditches and diversion structures Features 4, 4a and 5
(View to South)**

Feature 5 is an abandoned concrete water diversion and containment feature situated 1.8 m at 36° NE of Feature 4 and shown in Figures 31-33. It is a formed concrete structure with a box shaped, intake well that measures 1.2 m long by 1.2 m wide by 1.0 m high on the interior and 1.1 to 1.2 m on the exterior and an adjoining concrete culvert that measures 1.35 N/S long by 1.25 m E/W wide by 1.2 m high. If operational, Feature 5 would have diverted water into Feature 2, the down slope eastern channel.

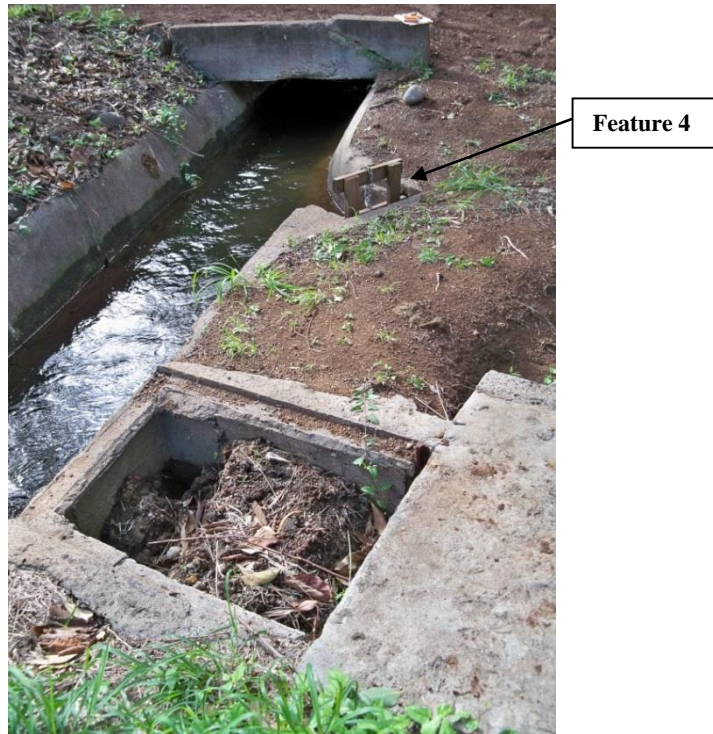
**Figure 33. Site 7881 Feature 1 (ditch), Feature 5 (Water Containment Feature) and Feature 4 (Sluice Gate)
(View to North)**

Feature 4 is the water diversion feature comprised of a sluice gate and concrete box culvert which directs water from Feature 1 ditch to Feature 2 ditch. The sluice gate is a modern wooden gate located along the northeast side of Feature 1 approximately 2.3 m northeast from the bridge (see Figures 22, 23 and 31). It is secured with chains and a key lock and diverts water to the east through the associated concrete box culvert. The concrete culvert measures 1.2 m E/W by 1.2 m N/S, with an interior height of 1.35 m N/S and an exterior height of 1.1 m to 1.2 m that appears to have been connected to Feature 5, an abandoned concrete containment and diversion box culvert to the south further discussed below (Figure 32).

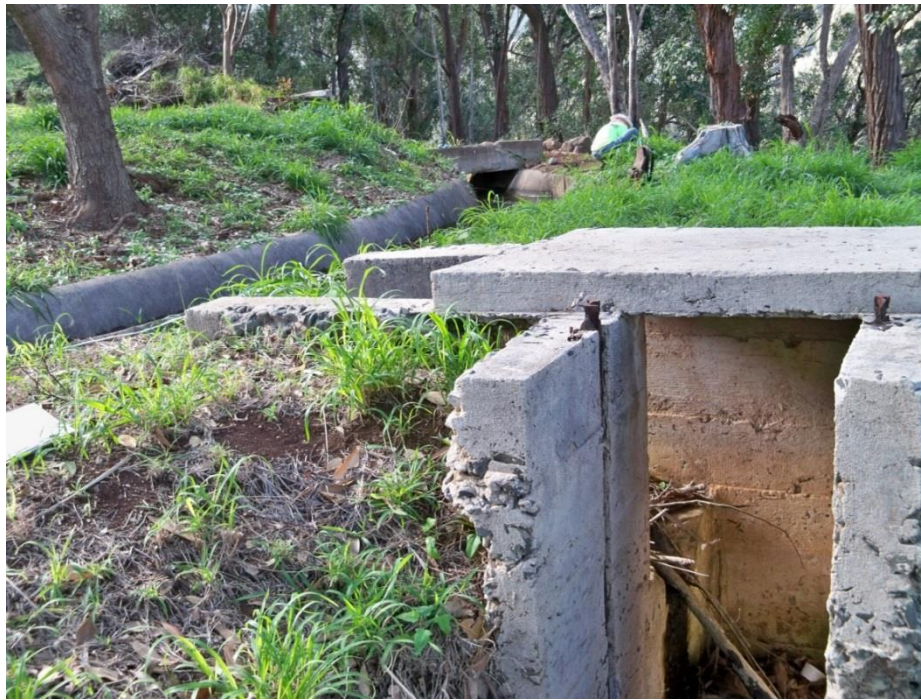
Figure 35. Photograph of Site 7881 Feature 6 foreground with Feature 1 ditch background (View to North)

Feature 6 is the last abandoned water diversion feature also situated along the east side of Feature 1 outside the project area. It is an L-shaped structure similar to the other water features made of formed concrete which contains large aggregate gravel inclusions (Figures 35 and 36). The intake and out take walls range from 0.96 to 1.2 m long by 0.62 m to 1.1 m wide by 1.0 m to 1.4 m high with a concrete cap measuring 0.90 m long (north/south) by 0.80 wide m wide and 1.1 m high. Incised into the concrete out take walls are metal railroad rails in which the sluice gate could slide up and down along the rails to control the flow of water. The embedded rails were observed within several sluice gate or water diversion features in the area. Feature 6 would have diverted water east into another *`auwai* (ditch) that flowed further down slope to irrigate sugarcane.

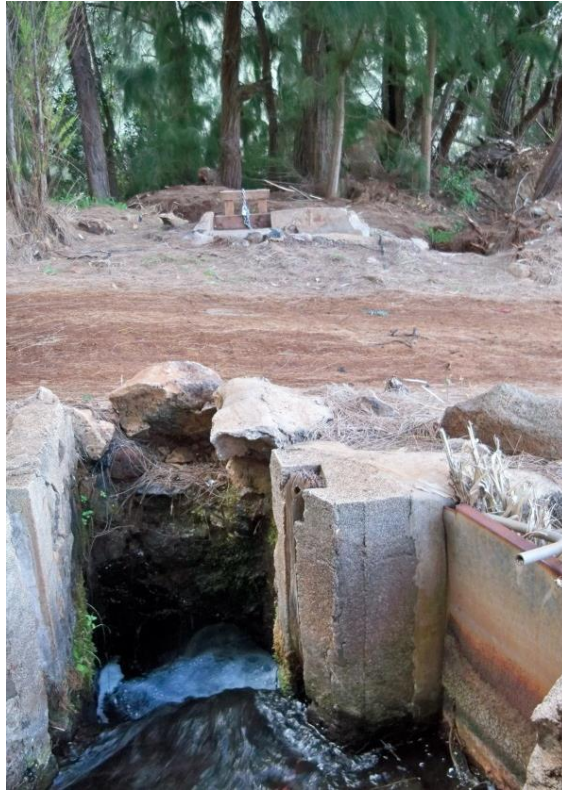
Figure 37. Site 7881 Feature 7 Sluice Gate in Foreground and Feature 8 Background (View to Northeast)

Feature 7 is one of two sluice gates associated with Feature 2 ditch. It is located 214 m east of the juncture from Features 2 and 4 (sluice gate). Feature 7 has concrete lined walls with two chutes, one is open and water flows under the service road to Feature 8 on the north side of the service access road. The other chute is closed with a metal sluice gate and appears to have been closed for some time (Figure 37).

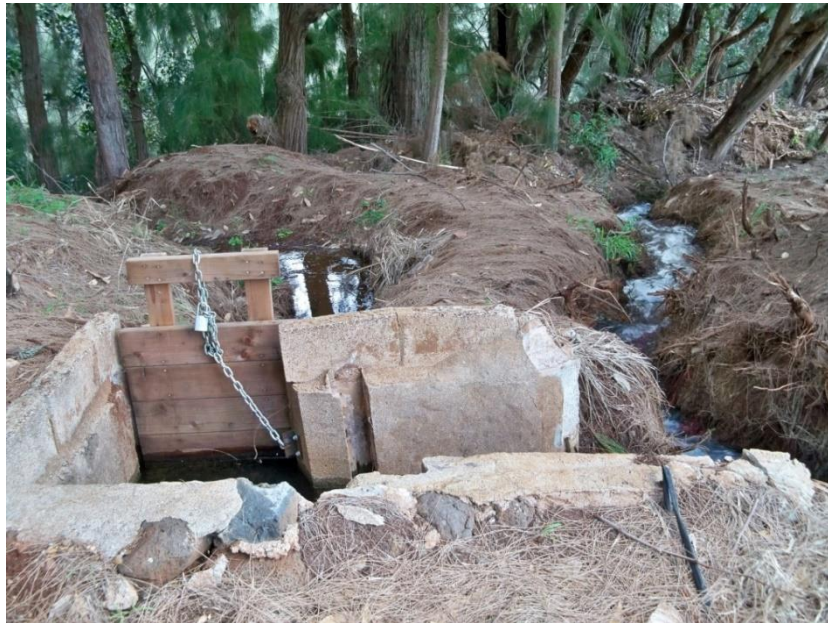
Figure 38. Photograph of Site 7881 Feature 8 showing Two Channels, Feature 2 Ditch continues East and Overflow beyond Sluice Gate to Waikapū Stream (View to North)

Feature 8 is another sluice gate associated with Features 2 and 7 located along the north side of the service access trail. It is an L-shaped structure comprised of formed concrete walls with large cobble inclusions and a modern sluice gate which empties towards Waikapū Stream and Feature 2 main ditch. Indentions for former railroad rails are present along the out take chute to the east (Figures 38 and 39).

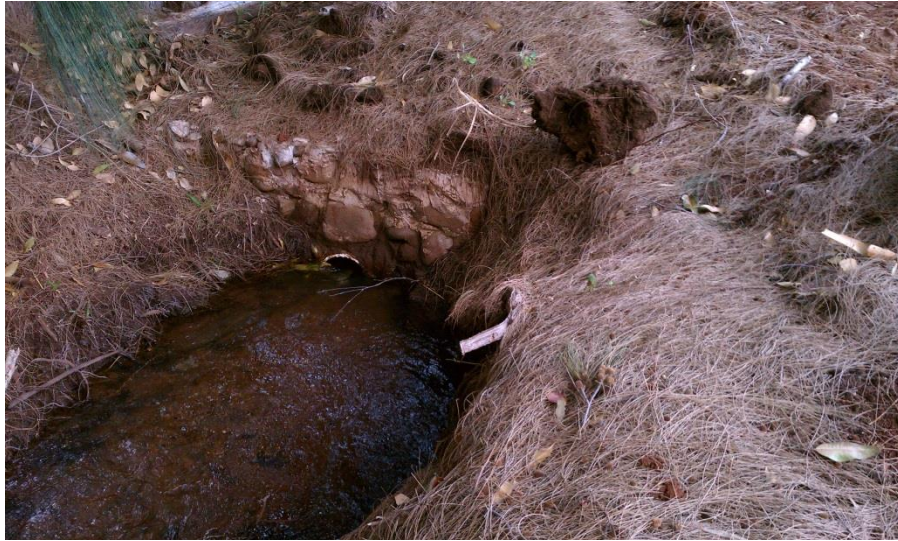
Figure 40. Photograph of Site 7881 Feature 9 Intake on West side (View to North)

Feature 9 is a culvert associated with Feature 2 ditch which continues to direct water downslope to the east, with overflow directed to the north into Waikapū Stream. The intake chute on the west contains a 12” metal pipe, reinforced at the opening by the construction of a rock and mortared faced wall. The wall is comprised of basalt water-worn and sub-angular cobbles held together with mortar and concrete containing large grained sand and large angular gravel approximately 1.5 m wide and 0.95 m deep. Along the east side is an open earthen ditch which intersects with Feature 2 on the north and directs any excess flow of water into the Waikapū Stream.

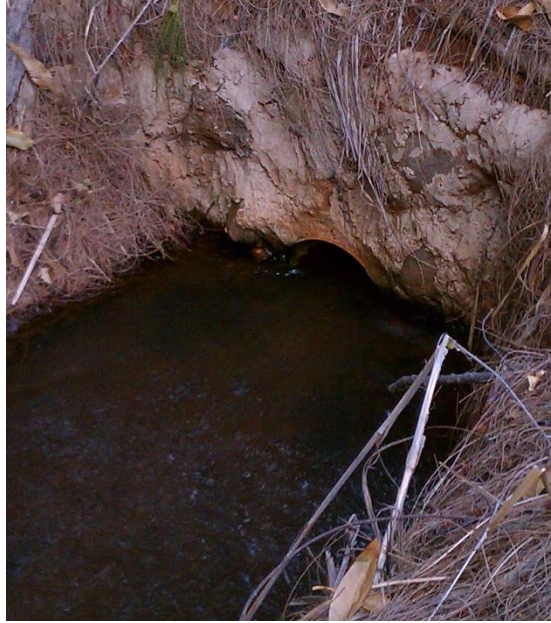
Figure 42. Photograph of Site 7881 Feature 10 Intake on West (View to East)

Feature 10 is another culvert within the Feature 2 east flowing ditch on the north side of the access service road. The water flows into an underground culvert on the west, approximately 15.5 long, and emerges on the east. It is constructed similarly to Feature 9 with a 12" metal pipe, and concrete basalt water-worn and sub-angular cobbles placed against the wall around the pipe and measures 1.4 m long by 0.90 m deep. Another earthen ditch, like Feature 9, is present along the west side for overflow of water which will be directed to Waikapū Stream.

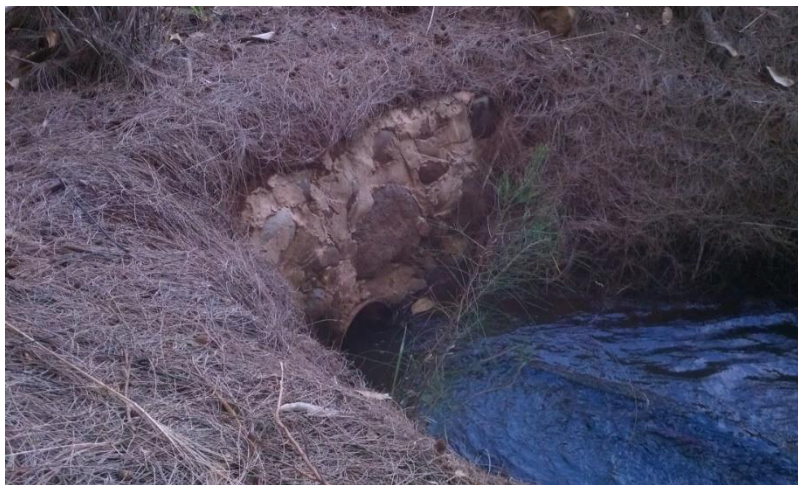
Figure 45. Photograph of Site 7881 Feature 11 Intake on West (View to East)

Feature 11 is another culvert on the north side of the access road constructed similarly to Features 9 and 10. The water from the west flows into an underground 12” metal pipe culvert approximately 14.5 long and emerges on the east (Figures 45 and 46). The intake (west) side contains the same reinforced wall of basalt water-worn and sub-angular cobbles with concrete faced 1.2 m wide and 1.0 m deep. An open earthen ditch is present on the east for overflow of high volume water which will empty into the Waikapū Stream.

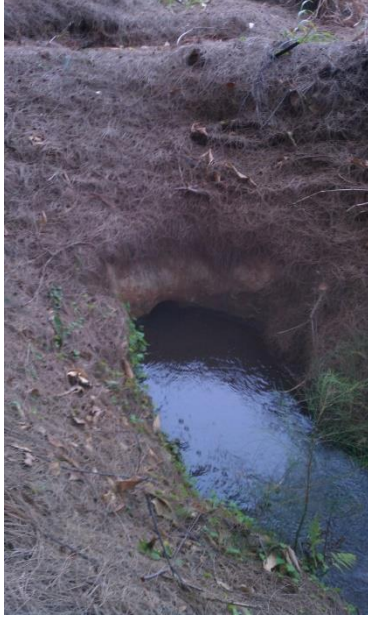
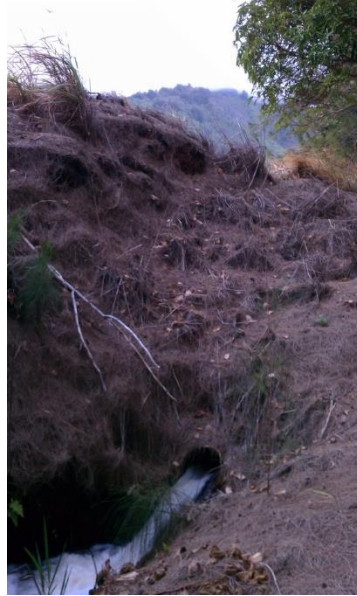
Figure 47. Overview Photographs of Site 7881 Feature 12 Intake (View to East) left and Feature 12 Out-take (View to West) right

Feature 12 culvert is approximately 15.5 m long and comprised of a 12” metal pipe. The intake (west) side opening is faced with concrete and basalt water-worn and sub-angular cobbles which measures 1.4 m wide and 0.90 m deep (Figure 47). The overflow earthen ditch is present along the east out-take side and directs the high volume of water into the Waikapū Stream on the north.

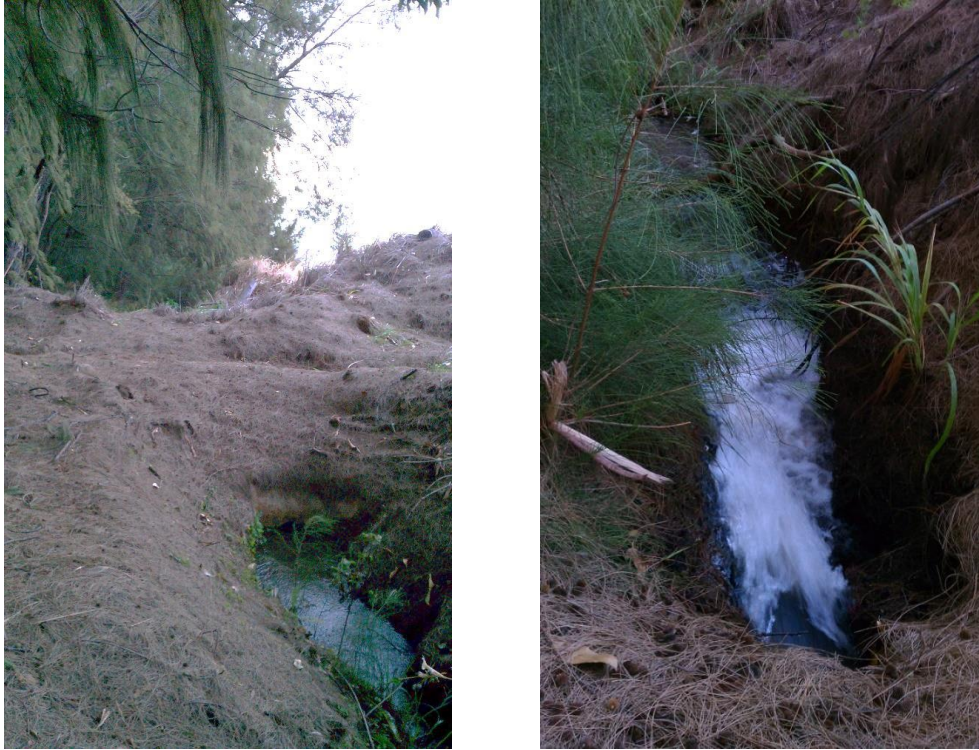
Figure 48. Photographs of Site 7881 Feature 13 Intake (View to East) left; Feature 13 Out-take (View to West) right

Feature 13 culvert for Feature 2 ditch on the north side of the access service road consists of a 12" PVC pipe which measures approximately 13.5 m long and emerges on the east (Figure 48). The pipe on the west side contains a concaved, concrete faced lining which measures 1.3 m wide by 0.70 m deep. The earthen open ditch is present on the east side and utilized for all excess water which will be re-directed to Waikapū Stream.

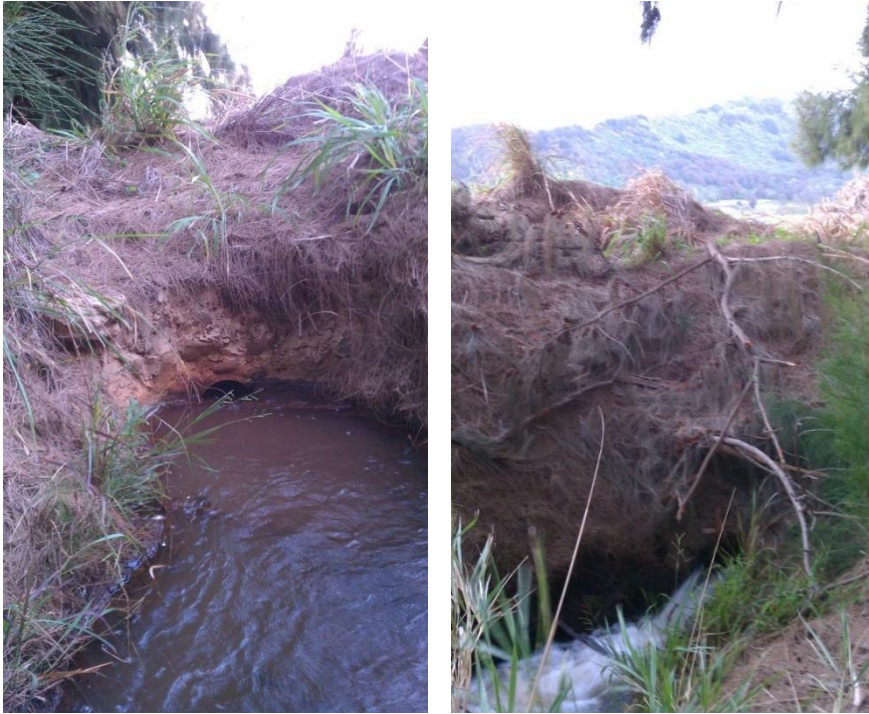
Figure 49. Overview Photographs of Site 7881 Feature 14 Intake (View to East) left; Feature 14 Out-take (View to West) right

Feature 14 is another culvert situated along the north side of the dirt access road. This culvert, like Feature 13 is comprised of a 12" PVC pipe which runs underground for approximately 13.5 m. At the opening around the intake, the earth is reinforced and lined with concrete which measures 1.6 m wide and 0.80 m deep (Figure 49). The open earthen ditch is present along the east side and re-directs high volume water flow to the north into Waikapū Stream.

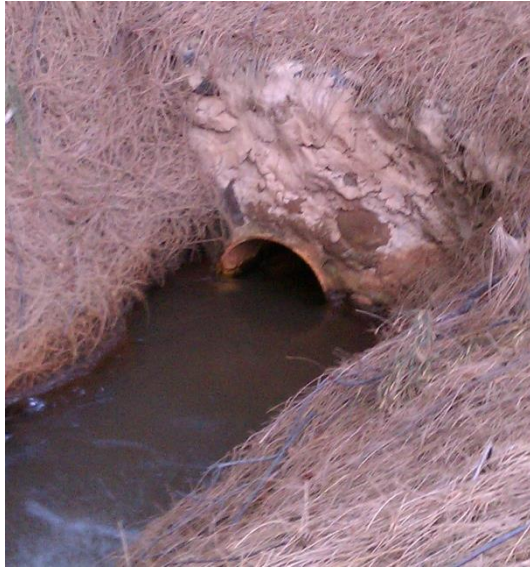
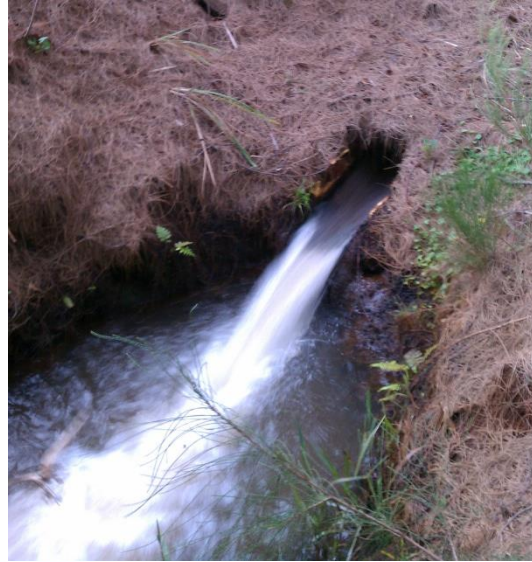
Figure 50. Photographs of Site 7881 Feature 15 In-take (View to East) left and Feature 15 Out-take View to West (right)

Feature 15 culvert is situated on the north side of the service access road and runs underground for approximately 18.0 m. The culvert consists of a 12" PVC pipe with concrete and rock facing along the west intake side (Figure 50). The reinforced wall around the opening measures 1.4 m wide by 1.0 m deep. The out take side contains the open earthen ditch for overflow of excess water.

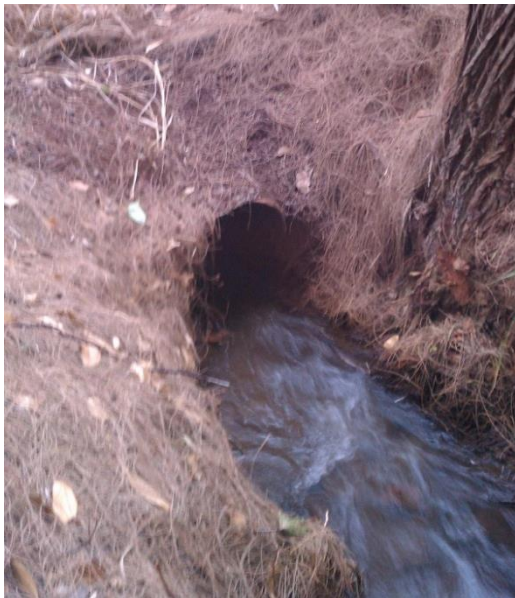
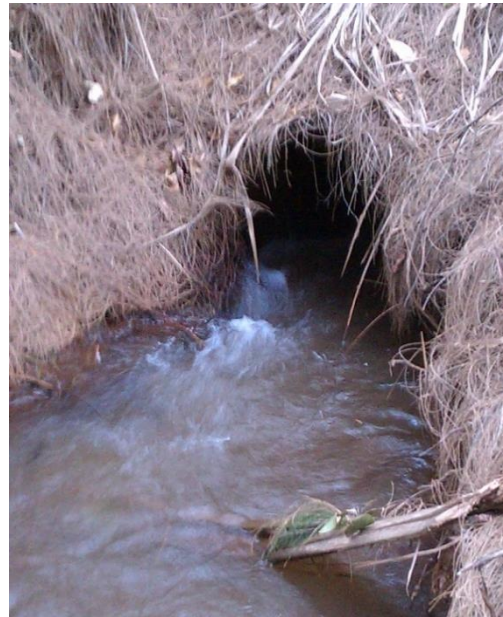
Figure 51. Photographs of Site 7881 Feature 16 Intake, View to Southeast (left) Out-Take, View to West

Feature 16 culvert is larger and comprised of a 24” metal pipe which runs underground for approximately 6.2 m and emerges on the east (Figure 51). This culvert does not contain a reinforced faced wall along the intake west side, but may have at one time. An open earthen ditch is present on the east for the over flow of water which will empty into Waikapū Stream.

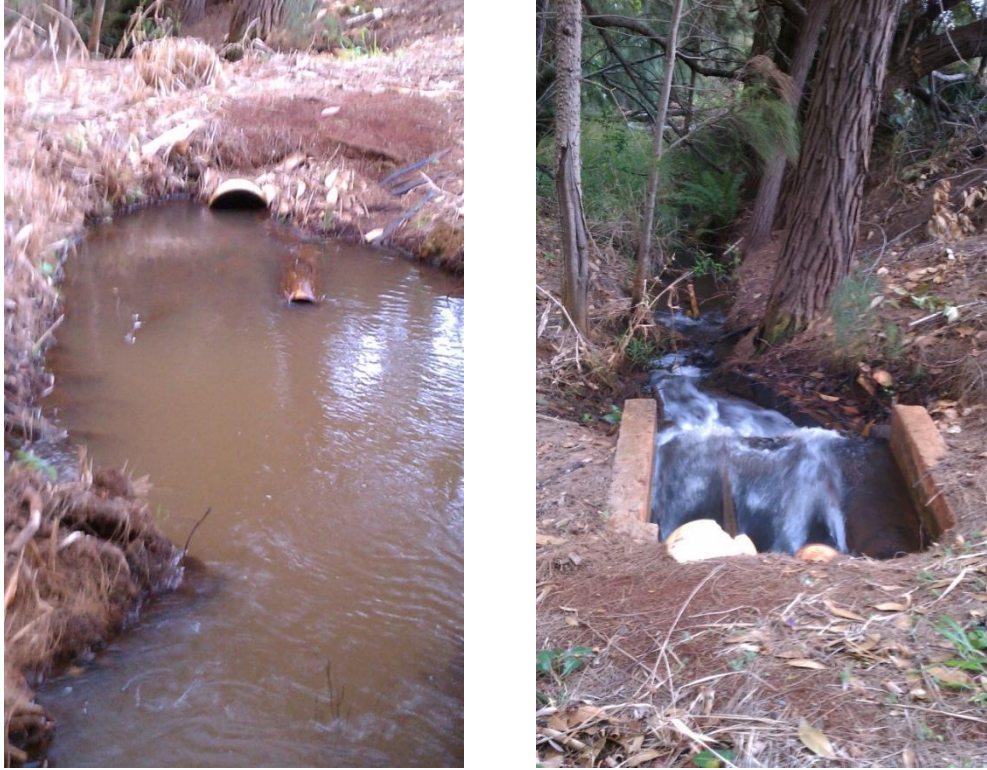
Figure 52. Overview Photographs of Site 7881 Feature 17 Intake (View to East) left and Feature 17 Out-take (View to East)

Feature 17 is another culvert comprised of two intake PVC pipes, a 6'' and 12'' approximately 3.3 m long which emerges on the east into an open rectangular concrete drainage box that measures 1.55 m E/W long by 1.4 m wide N/S by 0.65 m high. Adjacent to the drainage box, the water is further channelized by

aligned hollow-tile block walls which extend from the drainage box 1.27 m long by 1.3 m wide 0.25 m high (Figures 52 and 53). Approximately 5.0 m east from the out take east side are two 2 inch pipes with valves which are present within the ditch (Figure 54).

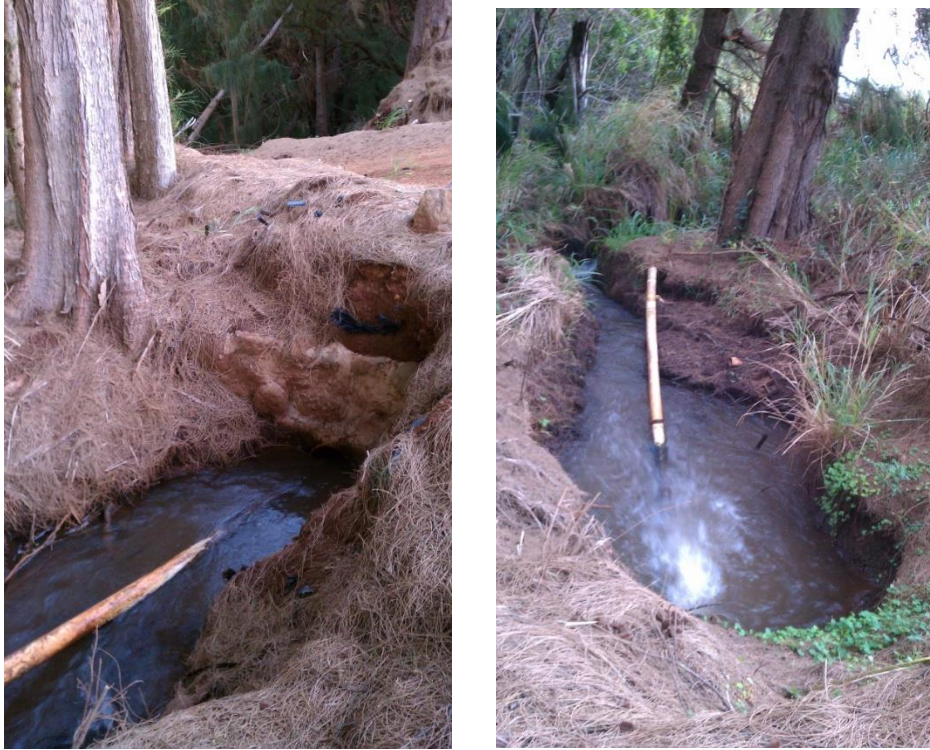
Figure 55. Overview Photographs of Site 7881 Feature 18 intake and faced concrete and cobble wall (left photo) (View to Northeast); Feature 18 east side out take (right photo) (View to East)

Feature 18 is the last culvert in a series of underground drainage ditches associated with Feature 2 open ditch along the north side of the service access road. This culvert is comprised of a 12” metal pipe which runs approximately 11.0 m long emerging on the east. Feature 18 culvert also contains a 4-inch PVC pipe which extends from the west and goes through the metal pipe and extends out on the east side. The PVC pipe follows Feature 2 ditch for some distance and then extends out over the south bank of the ditch (Figure 55). The ditch and culvert on the west side are reinforced with a concrete, basalt water-worn and sub-angular cobbles faced wall that measures 1.4 m wide and 0.70 m deep. No open earthen overflow ditch was apparent and the PVC pipe may assist in excess flow. Atop the culvert is an access road utilized to cross Waikapū Stream.

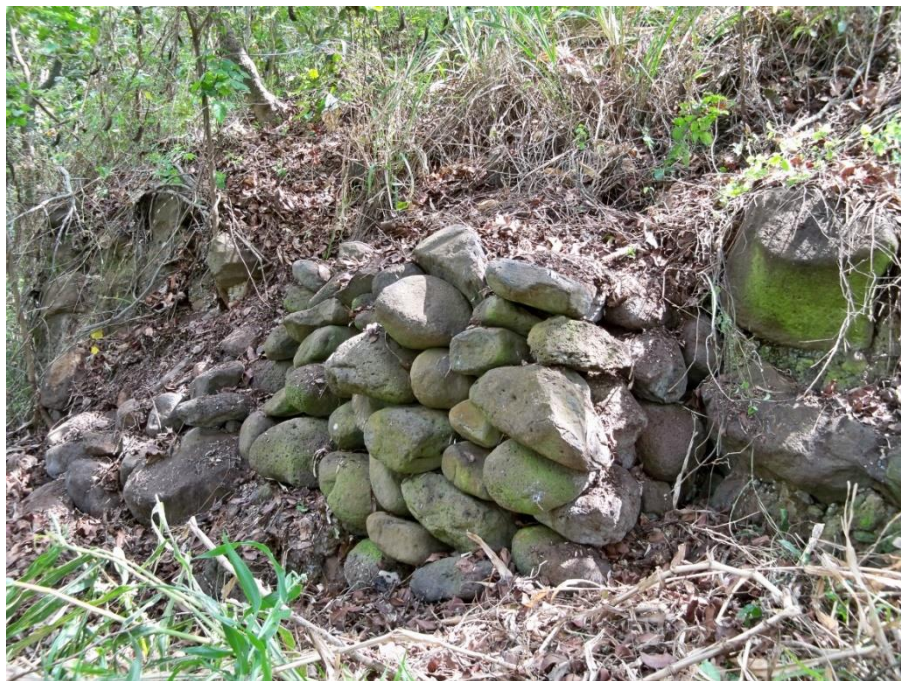
Figure 57. Overview Photograph of Site 50-50-04-7882 an L-shaped Retaining Wall, View to Southeast

Site 7882 is a disturbed remnant L-shaped retaining wall or former rock-faced, soil-filled terrace in fair condition. It is located 5.0 m north of Site 7881 Feature 2 ditch and south of the Waikapū Stream (see Figure 56). It encompasses approximately 8.0 sq. meters and appears to be near the boundary line of the project area within LCA 2522. As presented in Table I, LCA 2522 exhibited land use of *kula* and *lo`i kalo* (wetland taro). Site 7882 is constructed along the contour of the slope and retains a small level surface area to the north (Figures 57-60). It incorporates the outcrop into its construction on the east, and is stacked and faced, 6 courses high (1.5 m) with water-worn basalt small boulders and cobbles. The longer leg measures 4.0 m and is oriented east/west and the shorter leg is 1.5 m north/south retaining a level surface area measuring from 0.80 m to 1.0 m. Collapse is present on the east adjacent to the outcrop. Based on the former land use presented in Table I, Site 7882 may have been a remnant terrace utilized during the historic period for the cultivation of taro, or it may have been constructed against the slope to retain the soil for the ditch, Site 7881 Feature 2. Additionally, this site may have been constructed during the pre-Contact period, and renovated during historic times.

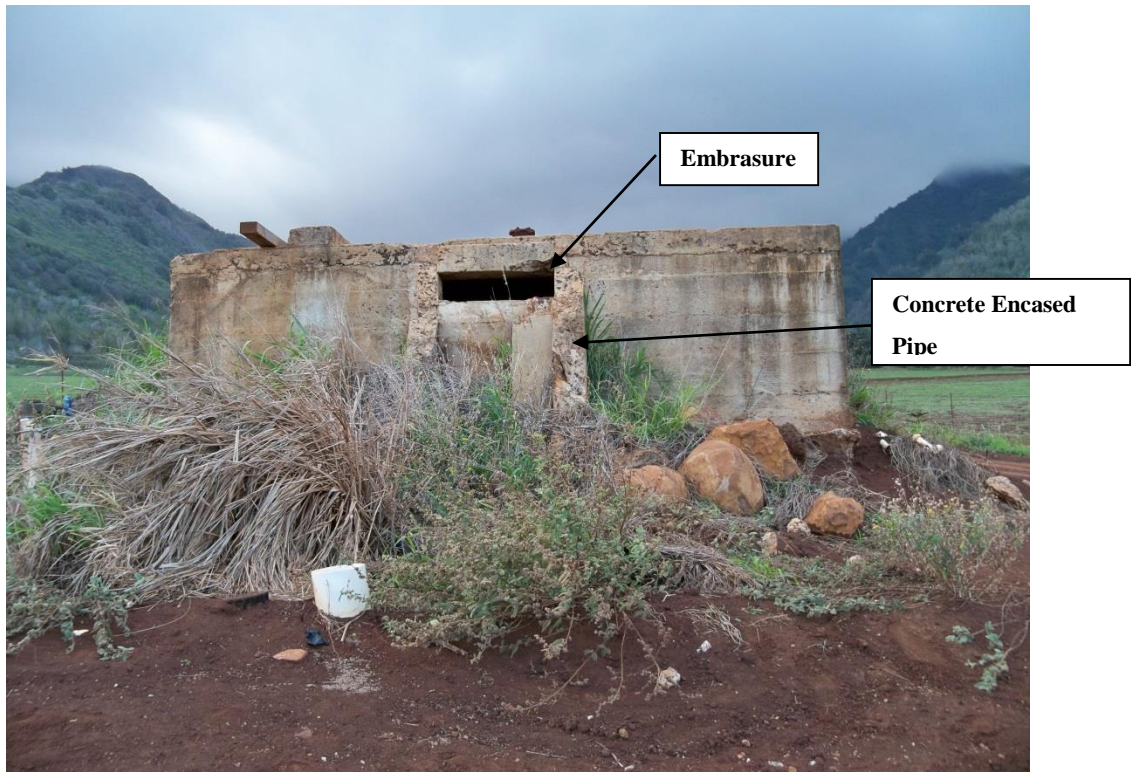
Figure 61. Overview Photograph of Site 7883 (TS3), View to West (top) View to East (bottom)

Site 7883 is a World War II bunker, specifically designated as a horizon aviation observation bunker situated in the east central portion of Parcel 3 Mauka. It is in good condition positioned mid-slope at approximately 740 AMSL adjacent to the south side of the main access road that bisects Parcel 3 Mauka east/west (see Figure 56). Site 7883 is a square-shaped enclosure constructed of formed concrete walls and roof, atop a concrete slab/foundation. The concrete contains large aggregate gravel inclusions and is reinforced with metal re-bars. The base of the structure was partially built into the slope, and partially buried by pushing and mounding up soil around the exterior (Figures 61 and 62). The bunker measures 5.35 m (E/W) by 5.35 (N/S) along the exterior and occupies an area approximately 8.5 m by 8.5 m that includes the mounded up soil along the exterior. The structure is 1.58 m above the existing surface on the northeast, 1.45 m on the southeast, 1.1 m along the northwest, and 0.8 m above surface on the southwest. The concrete walls are 0.23 m thick bounding an interior area of 4.89 m² with an interior ceiling height of 3.0 m. Centered atop the roof is a square concrete base measuring 0.50 m² by 0.13 m thick with a threaded metal pipe 0.15 m (diameter) extending through the center, 0.37 m above this concrete pedestal. The metal pipe also extends through the roof to the interior of the enclosure and this internal end of the pipe is threaded and contains large corroded bolts.

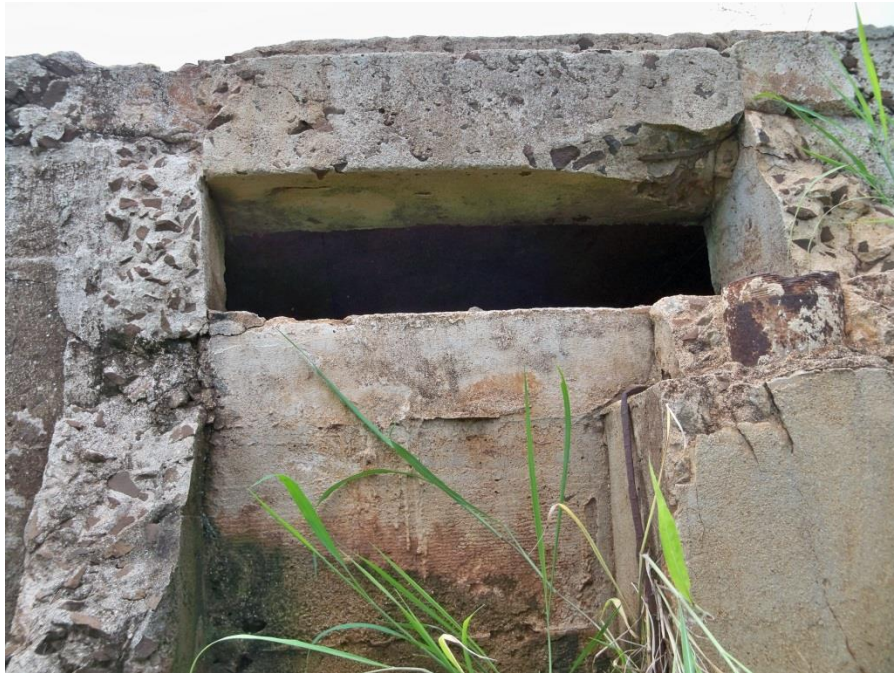
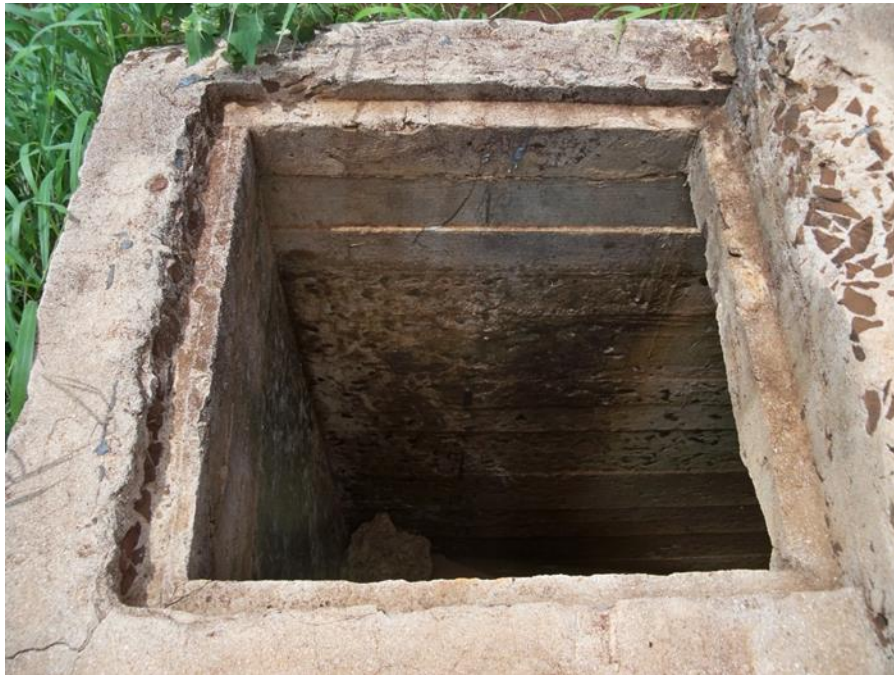
**Figure 63. Overview Photograph of Embrasure with Concrete Encased Pipe to Right (top) View to West;
Photograph of Access into Site 7883 (TS3) (bottom) View to West**

Along the eastern exterior wall is a narrow opening or embrasure (opening for gun fire) that measures 0.91 m long by 0.23 m wide and 1.7 m above the existing surface (Figure 63-top). The architectural design and function of an embrasure typically allows weapons to be fired out from the interior while providing maximum coverage for the rifleman. Since this bunker was designated as a horizon aviation observation bunker the embrasure or opening also provided a protected view of the shoreline. Along the northern edge of the embrasure is a concrete encased metal pipe, 0.22 m in diameter and 0.90 m above the existing surface and 0.18 m below the top of the roof. The pipe extends subterranean into the interior of the structure and may have functioned as a possible vent. Access to the interior of the structure is atop the southwest corner of the roof, measuring 0.75 m² square, and 0.80 m above the exterior existing surface, the interior floor is 2.5 m below the opening (Figure 63-bottom). The concrete hatch/door belonging to the opening has collapsed inside the bunker; however it was designed to be inset into the roof (see Figure 63) and therefore level and or flush with the exterior roof. Presently the interior contains modern trash, the foundation is deteriorated and the interior walls contain modern graffiti.

Site 7883 is a WWII bunker that will be preserved in place through conservation (avoidance and protection) and interpretation. Based on this sites association with the WWII Era, potential to yield important historical information and embodies the distinct characteristics of a period and or type of bunker, Site 50-50-04-7883 is assessed an initial significance of Criteria “a”, “c” and “d”.

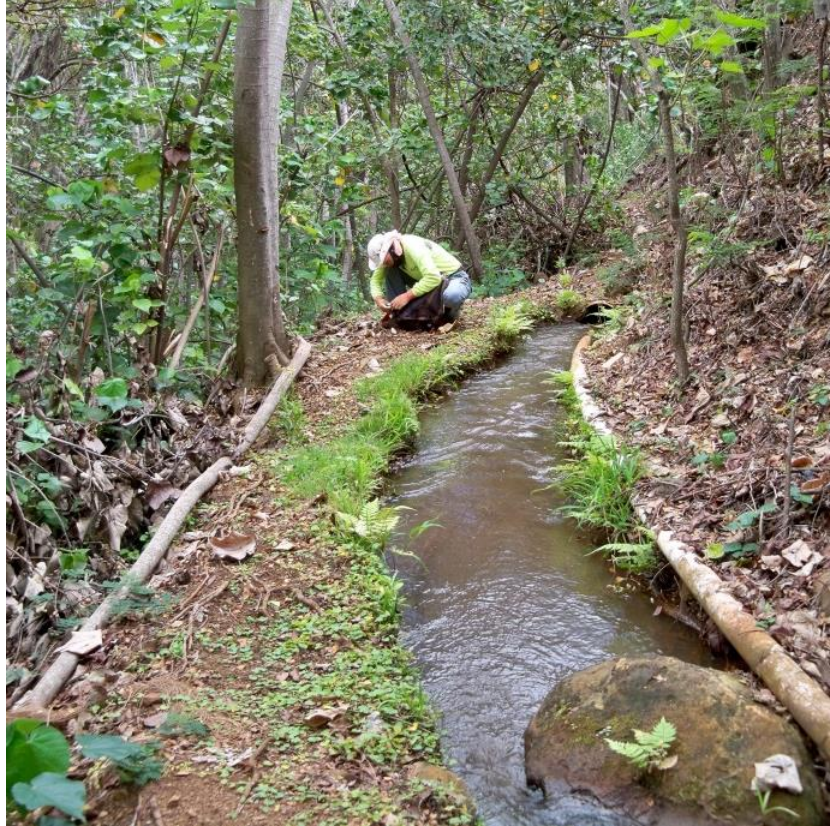
Figure 65. Site 7884 Feature 1 Historic Scatter along Feature 2 Ditch, View to West

Site 7884 Feature 1 is one of three secondarily deposited historic refuse scatters and or deposit located adjacent to; south and west of Feature 2 ditch near the northeastern corner of Parcel 3 Mauka. The refuse deposit covers an area of approximately 4.0 m and appears to have been re-deposited by anthropogenic or alluvial forces (Figures 65-68). Therefore, the materials may have been tossed down slope from the dirt access road or it may have been washed down during heavy flow re-depositing the materials along the sides and within the ditch. Historic materials included bottle glass fragments and ceramic plate sherds.

Site 7884 Feature 1 has been adequately documented and requires no further work. Based on its disturbed context, it minimally meets a significance of Criterion D. Site 7884 Features 2 and 3 are discussed further below within sections Parcel 6 and Parcel 7.

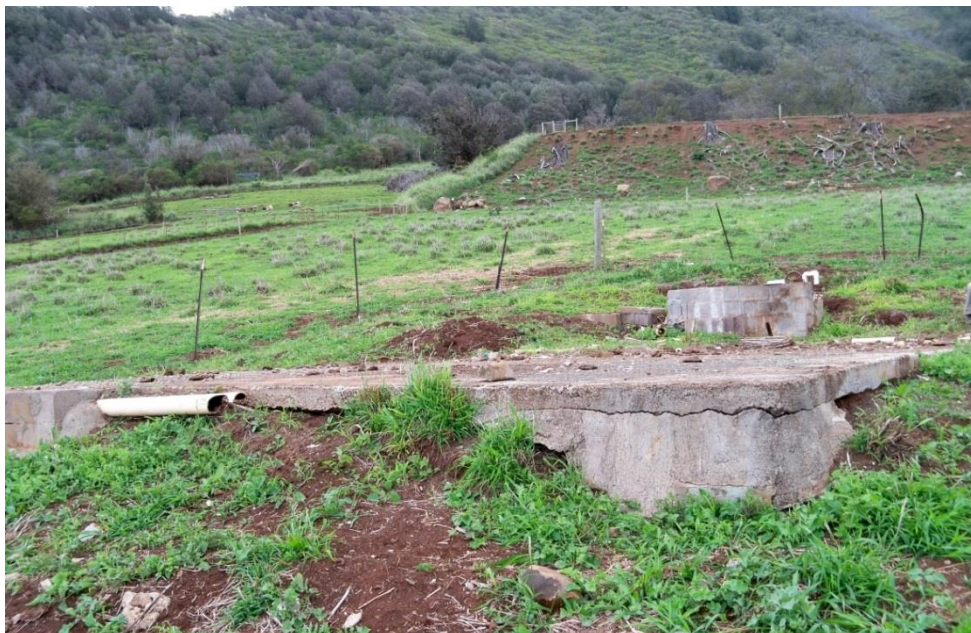
Figure 69. Overview Photograph of Temporary Site 4 (TS4), View to West

Temporary Site 4 is located within the subject parcel along the western portion of Parcel 3 Mauka at an elevation of 1017 AMSL orientated at 76° by and positioned 81.0 m east, *makai* of the reservoir (Site 7881 Feature 3) and west (*mauka*) of Site 7883. It consists of a rectangular shaped concrete slab atop CMU blocks on the downslope (east) side and flush with ground surface on the upslope (west) side (Figures 69 and 70). The slab is constructed of concrete with large aggregate gravel inclusions and likely dates to the early to mid-1900 (see Figures 9 and 22). TS4 measures 8.8 m long by 6.1 m wide by 0.53 high (east side) by 161 degrees. To the west and east of the slab are recent, add-on structures which contain CMU block encasing and encircling PVC piping and metal valves. The western modern structure is a small rectangular CMU concrete structure and to the east is an additional small slab. Discarded historic and modern materials were observed in the area and atop the concrete slab and consist of tar shingles, a “coke” bottle, metal pipe fittings and PVC pipe fragments (Figures 71 and 72). The shingles may represent the remains of a former roof although no indication of perimeter walls were evident within the slab. TS4 is positioned atop the possible former location of Site 7881 Feature 1 (Waikapū Ditch South) that extends roughly east/west along the central portion of Parcel 3 Mauka. TS4 may have housed a former water diversion structure; however this supposition is indeterminate.

No formal SIHP number was assigned to TS4, an historic concrete slab with recent additions, as it does not meet any significance criteria. TS4 has been adequately documented and requires no further work beyond construction monitoring if removed.

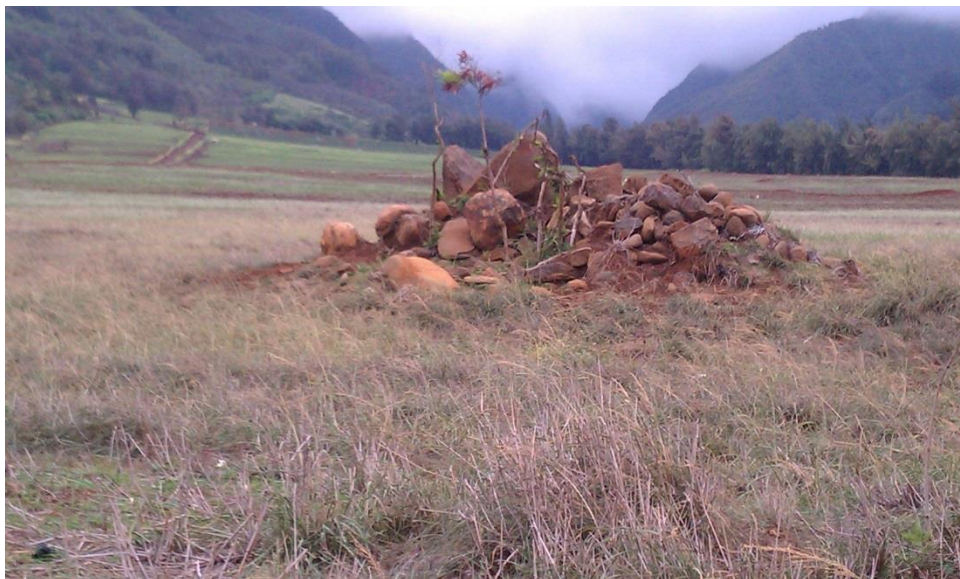
Figure 75. Photograph of Temporary Site 22 Rock Mound within Parcel 3 Mauka, View to Northwest

Temporary Sites 22 is the second rock mound presumed to be a sugarcane clearing/push pile comprised primarily of large basalt boulders, cobbles and pushed soil (see Figure 75). This feature is smaller than TS21 and measures 8.0 m in diameter by approximately 1.5 m high.
