**FINAL ARCHAEOLOGICAL INVENTORY SURVEY REPORT
FOR SEVERAL PARCELS OF LAND SITUATED WITHIN
WAIKAPŪ AHUPUA`A; WAILUKU DISTRICT
PŪ`ALI KOMOHANA MOKU**

**TMK: [2] 3-6-002:003; [2] 3-6-004:003, [2] 3-6-004:006;
and [2] 3-6-005:007**

**BY: Diane Guerriero (B.A.), Andre`e Conley-Kapoi (M.A.), Lisa J. Rotunno-Hazuka (B.A.)
and Jeffrey Pantaleo (M.A.)**

REVISED SEPTEMBER 2017

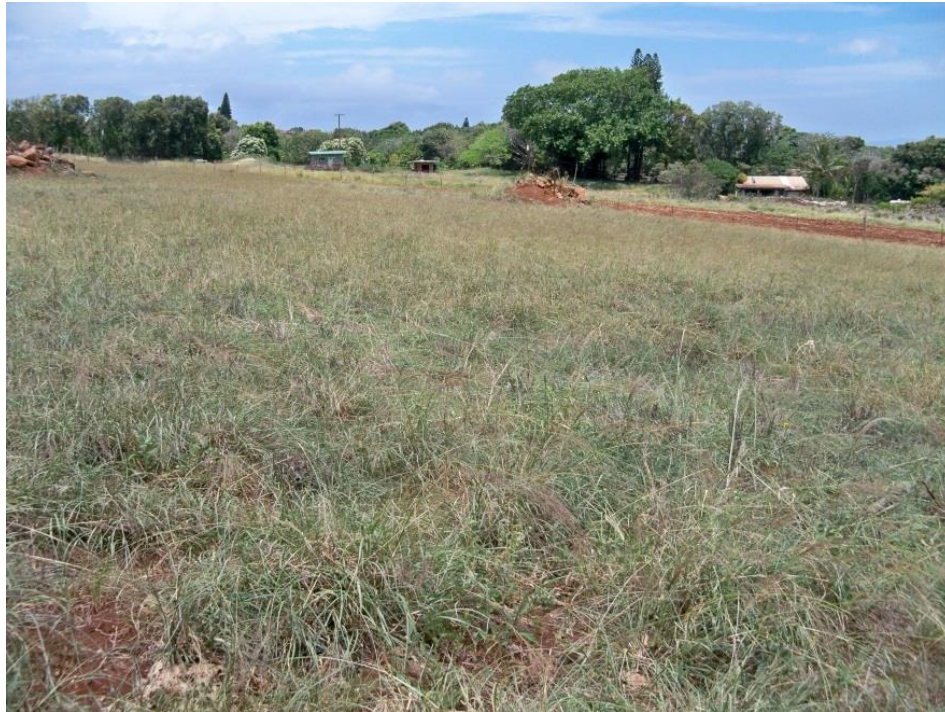
Figure 78. Overview of Parcel 3 Mauka North from TR-401, View to Northeast

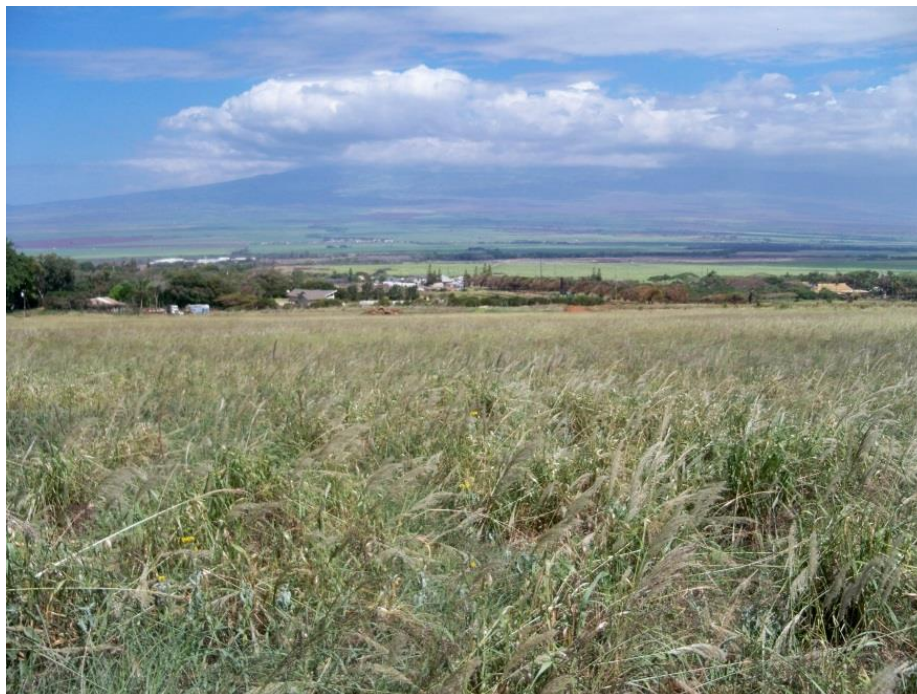
Figure 79. Overview Parcel 3 Mauka North, View to East

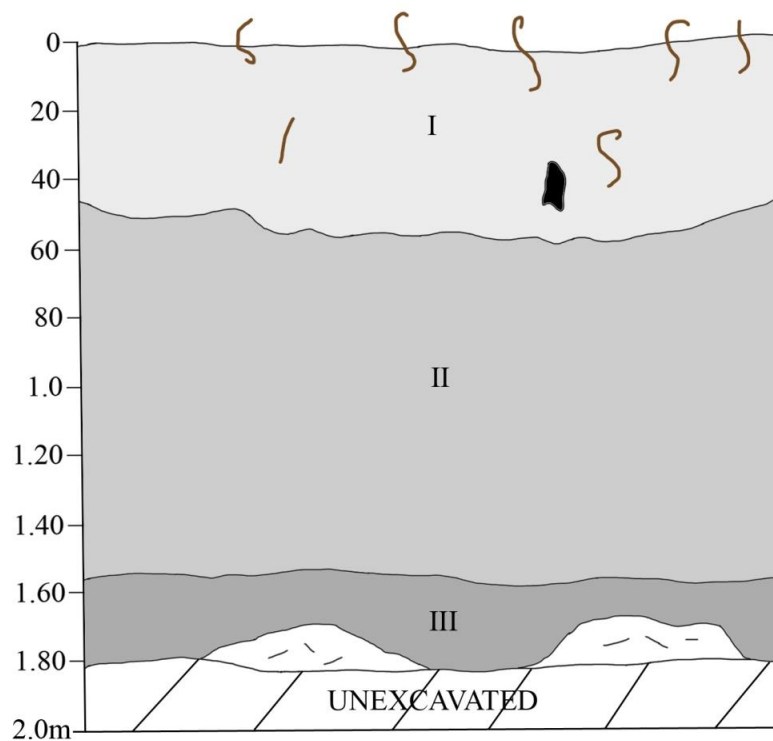
Figure 80. Stratigraphic Profile of TR 400 North Wall

this area but is actually pointing to a smaller 0.06 acre lot near TR 409. TR 400 measured 4.9 m long by 1.4 m wide by 1.81 m deep and was oriented at 90°. It contained a tripartite stratigraphic sequence with excavations terminating in sterile soil and saprolitic bedrock (Figure 80). No cultural materials were observed within TR 400.

Layer I (0-56cmbs): is a dark reddish brown (2.5yr 3/3), clay loam, pastureland and previous agricultural plow zone, with deteriorated drip-lines, slightly-plastic, slightly-sticky, weak, fine to medium grain, slightly hard, blocky, with a low frequency of roots. Boundary was clear and wavy overlying Layer II. No cultural materials were observed in this layer.

Layer II (56-158cmbs): is a dark reddish brown (2.5yr 3/4), clay loam, slightly-plastic, slightly-sticky, weak, fine to medium grain, blocky, slightly hard. No cultural materials were observed in this layer.

Layer III (158-BOE) consisted of a clay loam strong brown (7.5YR 4/4) overlying decomposing bedrock.

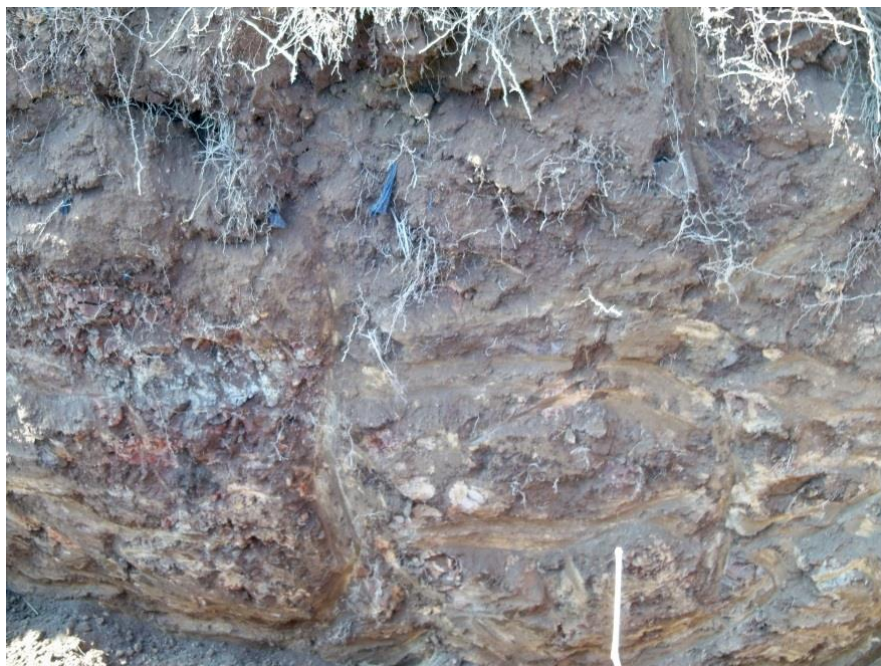
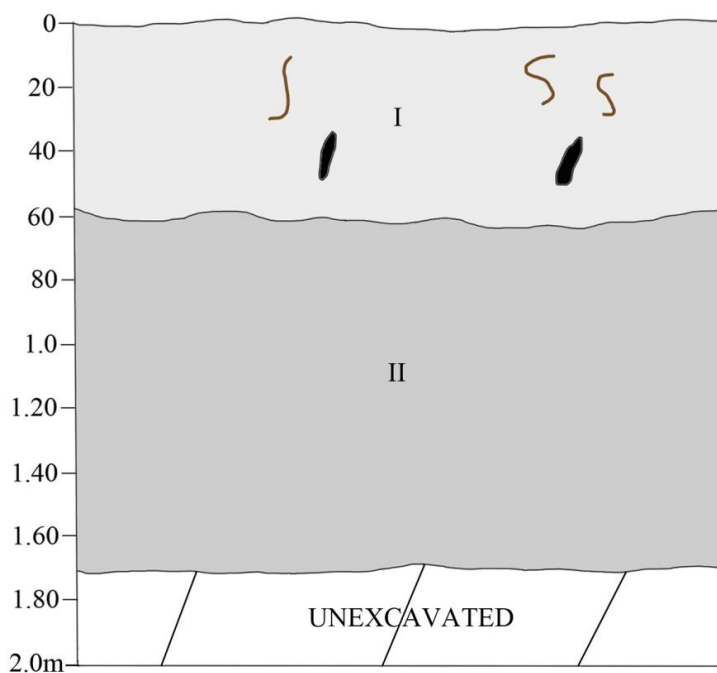
Figure 81. Photograph of TR406 South Wall (Top); Stratigraphic Profile of TR406 South Wall (Bottom)

Trench 406 was centrally located at the base of the slope in Parcel 3 Mauka, south of Waikapū Stream (see Figure 77). It was placed within LCA 3202:2 and possibly within GR 1711 (see Figure 76 and Table XII). LCA 3202:2 claimed land use of kula and *lo'i kalo*; however no evidence of this land use was observed within the trench. TR 406 contained a two-layer stratigraphic sequence with excavations terminating in sterile soil (Figure 81). It measured 4.8 m long by 1.4 m wide by 1.75 m deep, and was oriented at 90°. No cultural materials were observed within TR 406.

Layer I (0-62cmbs): is a dark reddish brown (2.5yr 3/3), clay loam, pastureland and previous agricultural plow zone, with deteriorated drip-lines, slightly-plastic, slightly-sticky, weak, fine to medium grain, slightly hard, blocky, with a low frequency of roots. Boundary was clear and wavy overlying Layer II. No cultural materials were observed in this layer.

Layer II (59-175cmbs): is a dark reddish brown (2.5yr 3/4), clay loam, slightly-plastic, slightly-sticky, weak, fine to medium grain, blocky, slightly hard. No cultural materials were observed in this layer.

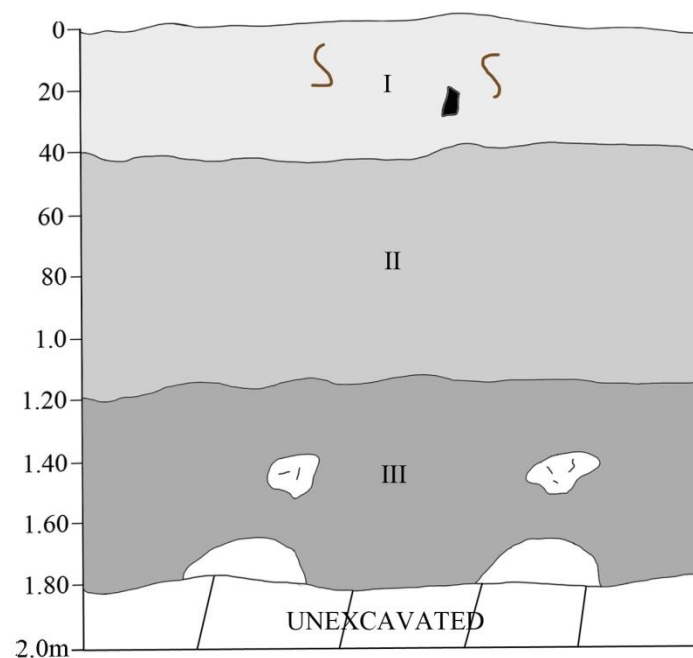
Figure 82. Stratigraphic Profile of TR 409 East Wall

Trench 409 was located in the southwest portion of Parcel 3 Mauka within GR 1513; south of Waikapū Stream (see Figures 76 and 77). No land use data was available for this Grant, thus trench excavations were performed to ascertain presence/absence of cultural materials. TR 409 measured 4.8 m long by 1.4 m wide by 1.80 m deep and was oriented at 180°. It contained a three layer stratigraphic sequence with excavations terminating in sterile soil and saprolytic bedrock (Figure 82). No cultural materials were observed within TR 400.

Layer I (0-42cmbs): is a dark reddish brown (2.5yr 3/3), clay loam, pastureland and previous agricultural plow zone, with deteriorated drip-lines, slightly-plastic, slightly-sticky, weak, fine to medium grain, slightly hard, blocky, with a low frequency of roots. Boundary was clear and wavy overlying Layer II. No cultural materials were observed in this layer.

Layer II (42-121cmbs): is a dark reddish brown (2.5yr 3/4), clay loam, slightly-plastic, slightly-sticky, weak, fine to medium grain, blocky, slightly hard. No cultural materials were observed in this layer.

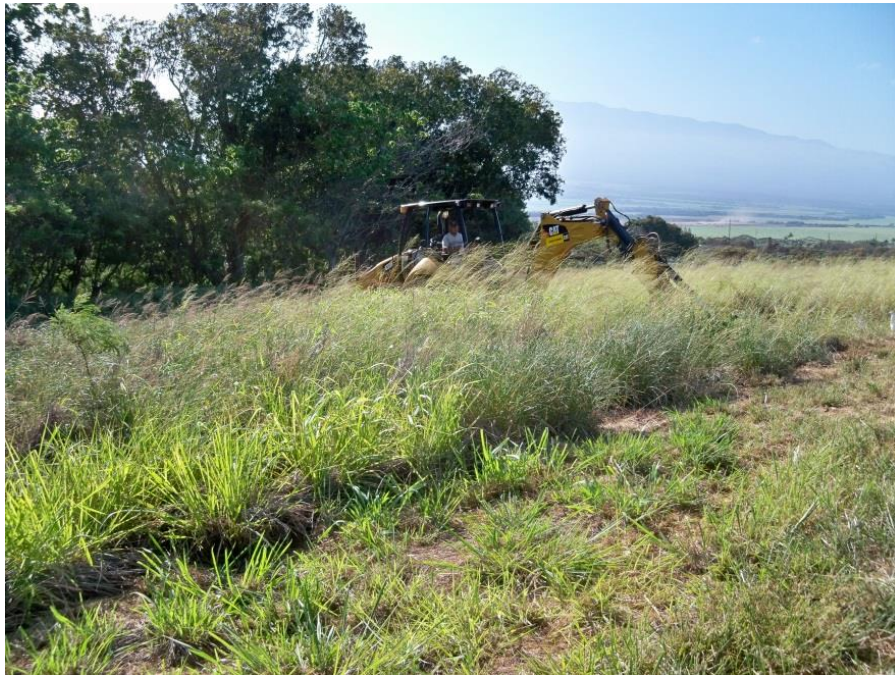
Figure 83. Overview of TR 412 within Parcel 3 Mauka, View to East

large sized boulders (Figures 83 and 84). A 4.9 m long by 1.44 m wide by 1.81 m deep, oriented 180° by 360° section of this area was recorded and is further described below. A single clear glass bottle fragment was recovered approximately 30 cmbs within TR 412.

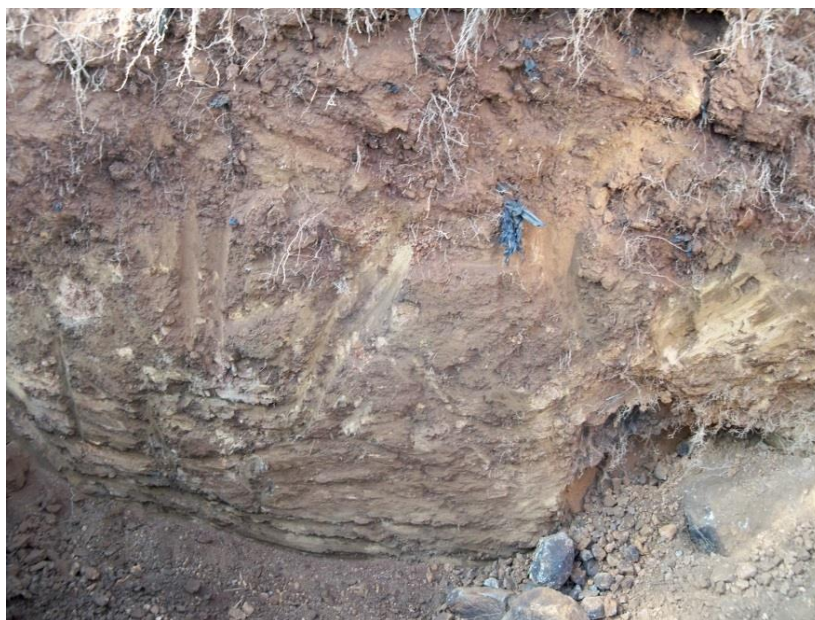
Figure 84. Photograph of TR 412 South Wall (top); and Stratigraphic Profile of TR 412 South Wall (bottom)

Layer I (0-78cmbs): is a dark brown (7.5yr 3/3), silt loam, previous agricultural plow zone, with deteriorated drip-lines, slightly-plastic, slightly-sticky, weak, fine to medium grain, slightly hard, blocky, with a high frequency of roots. Boundary was clear and wavy overlying Layer II. A clear glass fragment was recovered.

Layer II (60-181cmbs): is brown (7.5yr 3/4), silt loam, slightly-plastic, slightly-sticky, friable, fine to medium grain, blocky, slightly hard. High frequency of decomposing bedrock and large boulders were noted at base of Layer II. No cultural materials were observed in this layer.

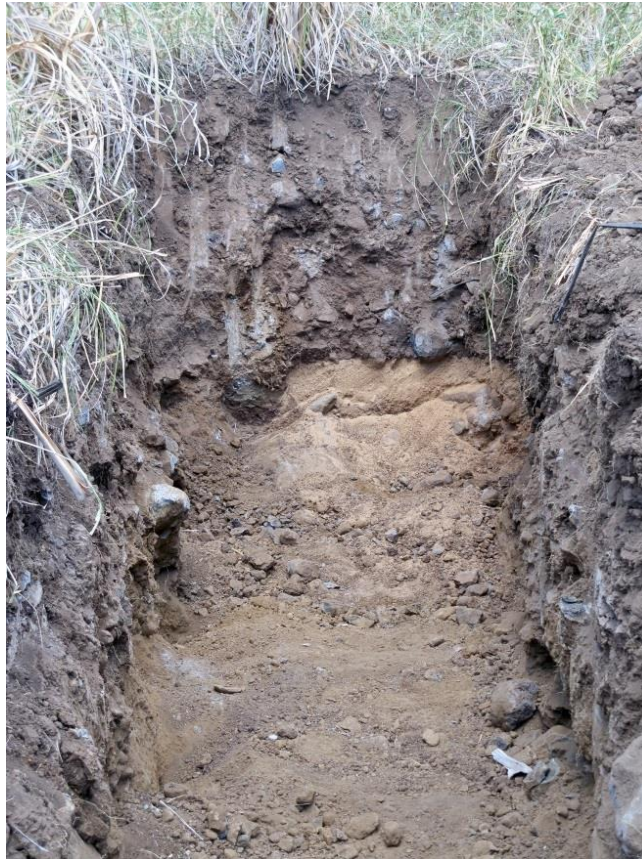
Figure 89. Overview Photograph of TR 1 North Wall Profile

Layer I (0-52cmbs): is a very dark grayish brown (10yr 3/2), silt loam, currently a fallow cane field and previous agricultural plow zone, with deteriorated drip-lines, slightly-plastic, slightly-sticky, weak, fine to medium grain, slightly hard, blocky, friable, with a medium frequency of roots. Boundary was clear and wavy overlying Layer II. No cultural materials were observed in this layer.

Layer III (82-117cmbs): is a dark yellowish brown (10yr 4/4), riverbed stony silt, weakly coherent, non-plastic, non-sticky, loose, single grain to fine to medium grain, with a high frequency of rocks, cobbles and medium to large boulders. Boundary was clear and wavy overlying Layer IV and Layer IIIa along the north, northwest and west section (Figures 90 and 92) overlying Layer IV. No cultural materials were observed in this layer.

Lens/Layer IIIa at 110cmbs a light yellowish brown (10yr 6/4) a fine to medium grain sand deposit was observed in a disturbed context in the north/northeast corner, overlying a sandy gravel extending 1.5 mbs on the north and east, overlying Layer IV on the north, northwest, non-plastic, non-sticky, loose, single grain, structureless, boundary abrupt and broken. No cultural materials were observed in this layer.

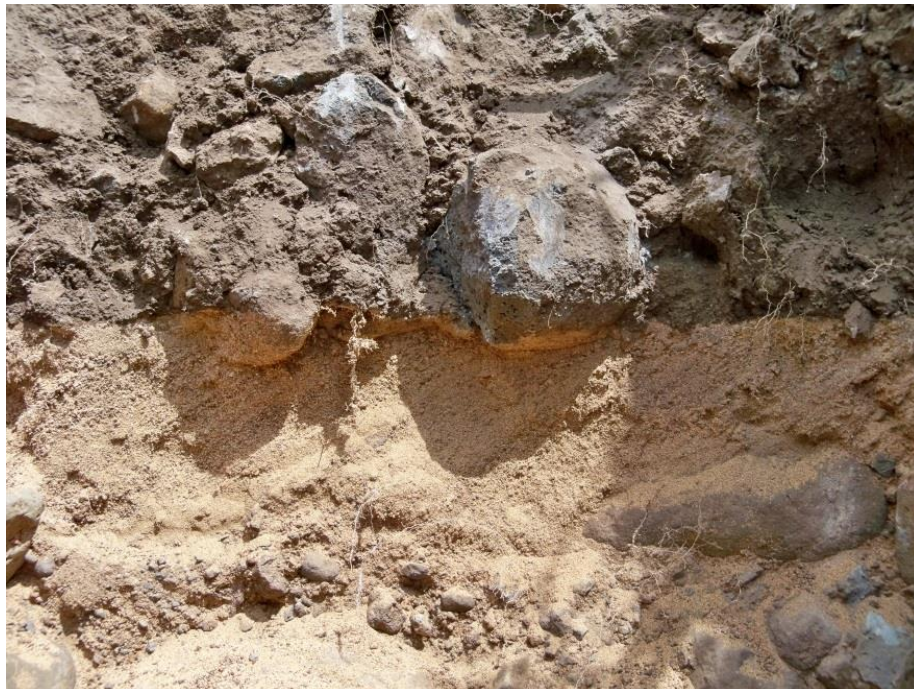
Figure 91. Up Close Photograph of Sand Deposit within TR 1, View to North

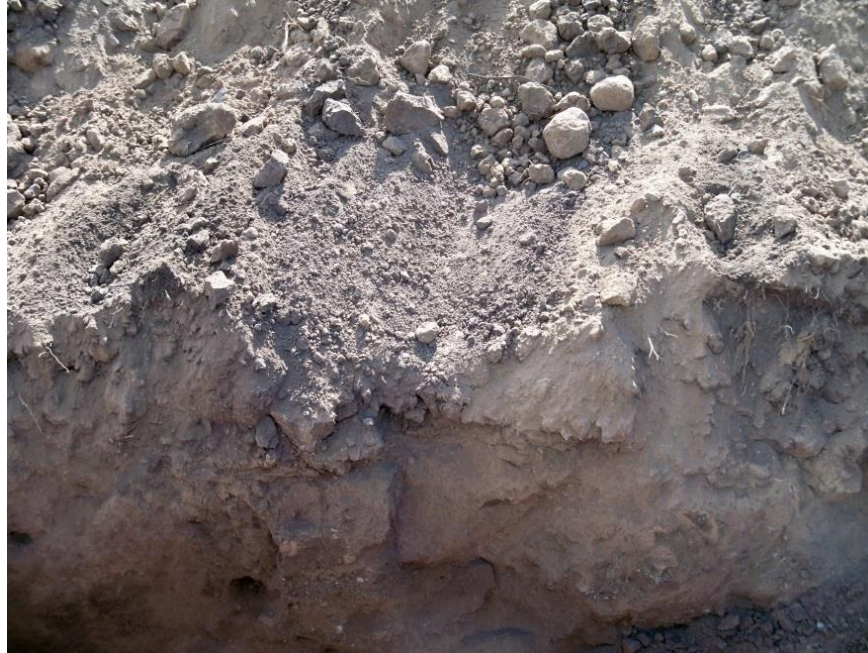
Figure 93. Photograph of Stratigraphic Profile of TR 11 South Wall

Trench 11 (TR 11) was situated in the central southwestern portion of Parcel 3 Waena, east of Kamehameha Golf Course and west of Site 5197 (Waihe'e Ditch) in an area currently utilized for individual agricultural pursuits (see Figure 86 and Table XIII). It contained a four layer stratigraphic sequence with excavations terminating within sterile streambed soils (Figure 93 and 94). TR 11 measured 4.7 m long by 1.42 m wide by 2.32 m deep, oriented 190°. No cultural materials were observed within Trench 11 (TR 11).

Layer III (116-212cmbs): is a brown (10yr 4/3), silt loam, weak, slightly hard, slightly-plastic,

slightly-sticky, single grain with a high frequency of medium to large boulders. Boundary was clear and wavy overlying Layer IV streambed. No cultural materials were observed in this layer.
Layer IV (202-232cmbs): is a dark grayish brown (10yr 4/2), streambed, gravel silt, loose, fine to large grain, structureless, cobbles, pebbles and gravel. No cultural materials were observed in this layer.

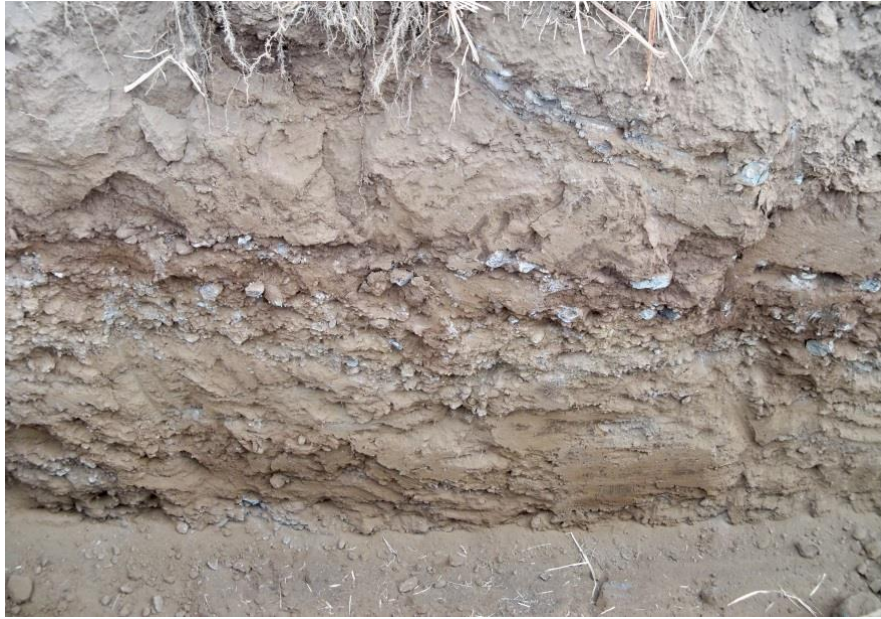
Figure 95. Photograph of Stratigraphic Profile of TR 14 South Wall

Trench 14 (TR 14) was situated along the eastern boundary of Parcel 3 Waena, west of Waihe'e Ditch and the associated access road (see Figure 86 and Table XIII). It contained a six layer/lens stratigraphic sequence with excavations terminating in sterile soils (Figures 95 and 96). Storm wash episodes were identified between 0.65-1.46 mbs and designated Layers Va-Vc. TR14 measured 4.6 m long by 1.42 m wide by 2.3 m deep, oriented 270°. No cultural materials were observed within Trench 14.

Layer Vc (106-146cmbs): is a dark grayish brown (10yr 4/2), riverbed stony silt, non-plastic, non-sticky, structureless, with a high frequency of bedded rounded cobbles, pebbles and gravel overlying Layer VI. Boundary was abrupt and wavy. No cultural materials were observed in this layer.

Layer VI (138-230cmbs): At 110cmbs is a brown (10yr 4/3), silt loam, weak, blocky, slightly-plastic, slightly-sticky, compact, fine grain. No cultural materials were observed in this layer.

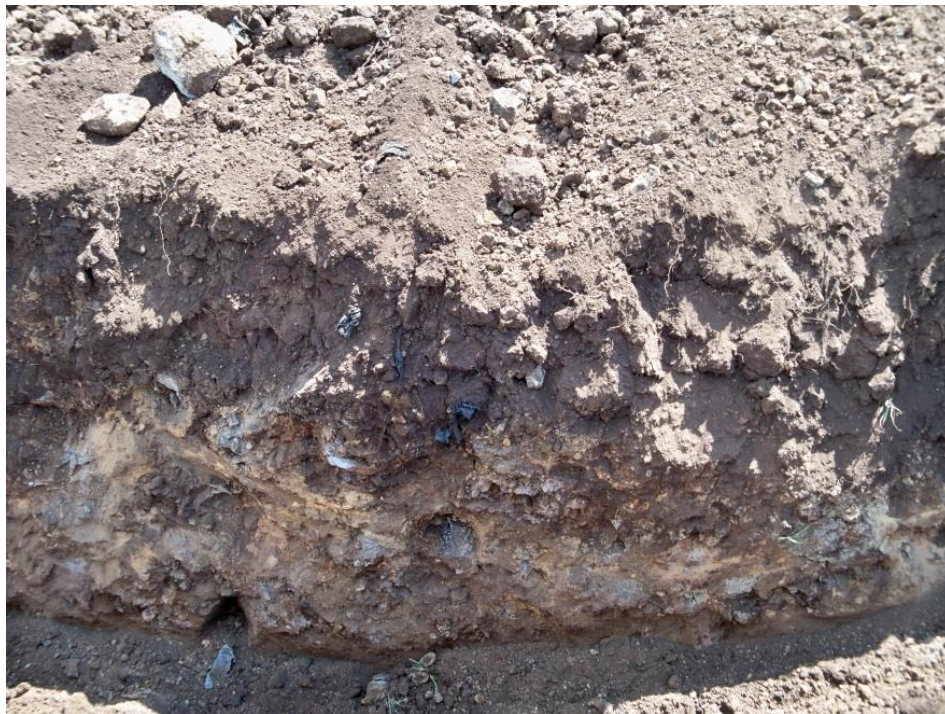
Figure 97. Photograph of Stratigraphic Profile of TR 23 East Wall

Trench 23 (TR 23) was situated in the extreme northeastern portion of Parcel 3 Waena, juxtaposed by Parcel 3 Mauka and Parcel 6 to the north (see Figure 86). It contained a two layer stratigraphic sequence with excavations terminating in decomposing bedrock (Figures 97 and 98). Trench 23 measured 4.7 m long by 1.4 m wide by 1.76 m deep, oriented 360° by 180° section of this area was recorded and is further described below. No cultural materials were observed within Trench 23 (TR 23).

Layer I (0-64cmbs): is a dark brown (7.5yr 3/3), silt loam, within a previous agricultural plow zone, with deteriorated drip-lines, slightly-plastic, slightly-sticky, weak, fine to medium grain, slightly hard, blocky, friable with a medium frequency of roots. Boundary was clear and wavy overlying Layer II. No cultural materials were observed in this layer.

Layer II (64-184cmbs): is a dark brown (7.5yr 3/4), stony silt, slightly-plastic, slightly-sticky, weak, fine to medium grain, blocky, slightly hard, friable with a medium frequency of rocks, and decomposing bedrock. No cultural materials were observed in this layer.

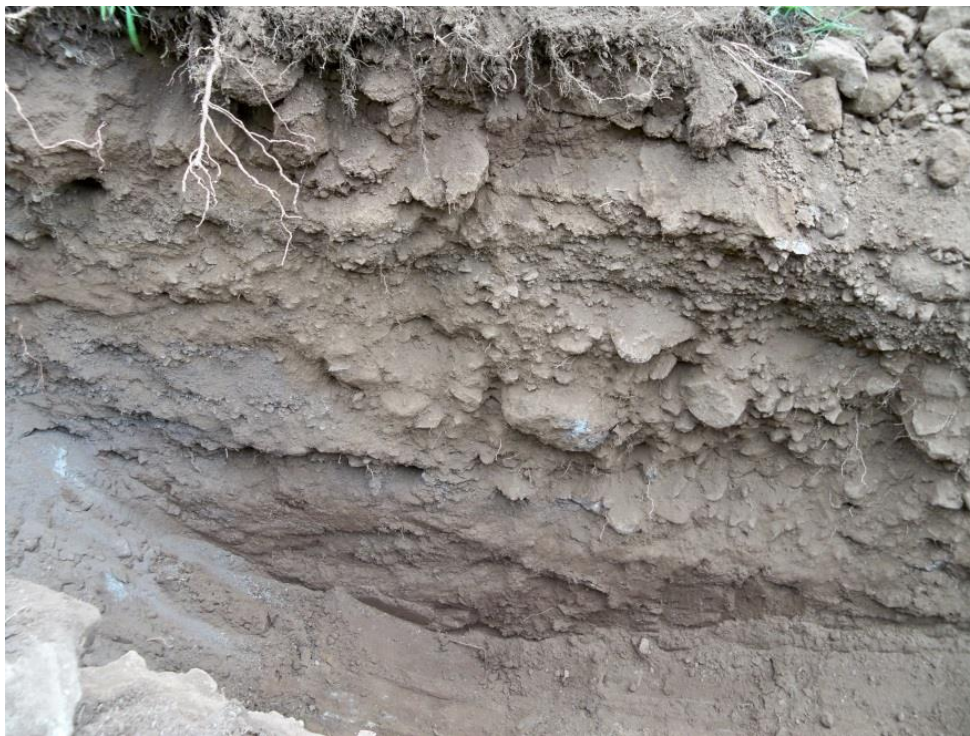
Figure 99. Photograph of Stratigraphic Profile of TR 08 West Wall

Layer III (24-100cmbs): is a brown (7.5yr 3/2), streambed, non-plastic, non-sticky, medium to coarse grain, with a low frequency of roots. structureless, weakly coherent with a high frequency of rounded cobbles, pebbles and gravel. No cultural materials observed in this layer. Boundary was clear and a plane overlying Layer IV.

Layer IV (92-160cmbs): is a brown (7.5yr 4/2), silt, slightly-plastic, slightly-sticky, blocky, slightly hard, medium grain, with a low frequency of rock and the absence of roots. No cultural materials observed in this layer.

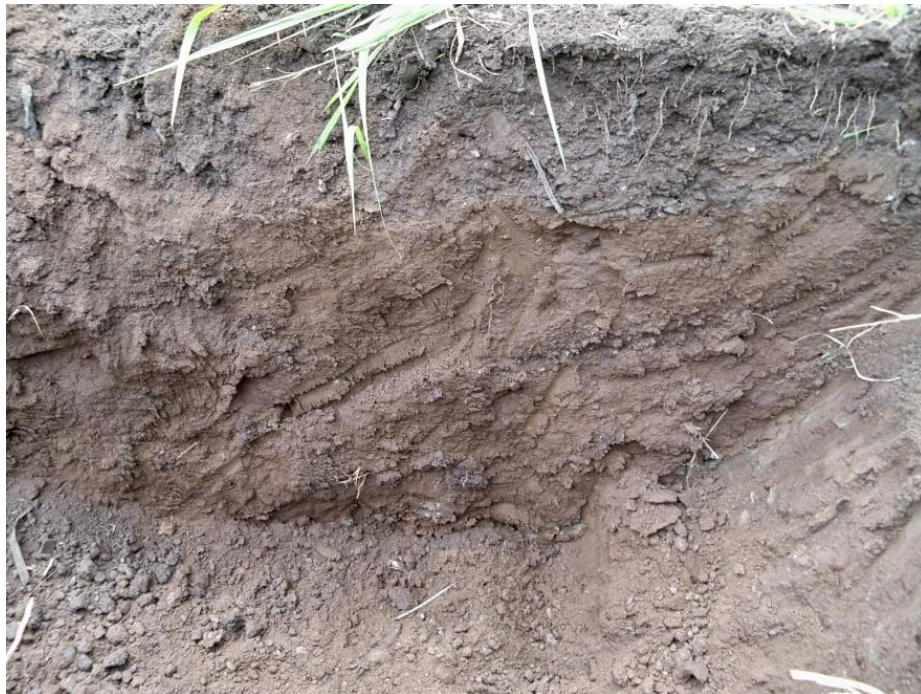
Figure 101. Photograph of Stratigraphic Overview of TR 011 South Wall

Layer II (28-157cmbs): is a brown (7.5yr 4/2), silty loam, slightly-plastic, slightly-sticky, blocky, slightly hard, medium to coarse grain, with a high frequency of rounded pebbles and gravel. No cultural materials observed in this layer. Boundary was clear and wavy overlying Layer III.

Layer III (157-180cmbs): is a brown (7.5yr 3/2), streambed, non-plastic, non-sticky, medium to coarse grain, with a low frequency of roots. structureless, weakly coherent with a high frequency of rounded cobbles, pebbles and gravel. No cultural materials observed in this layer.

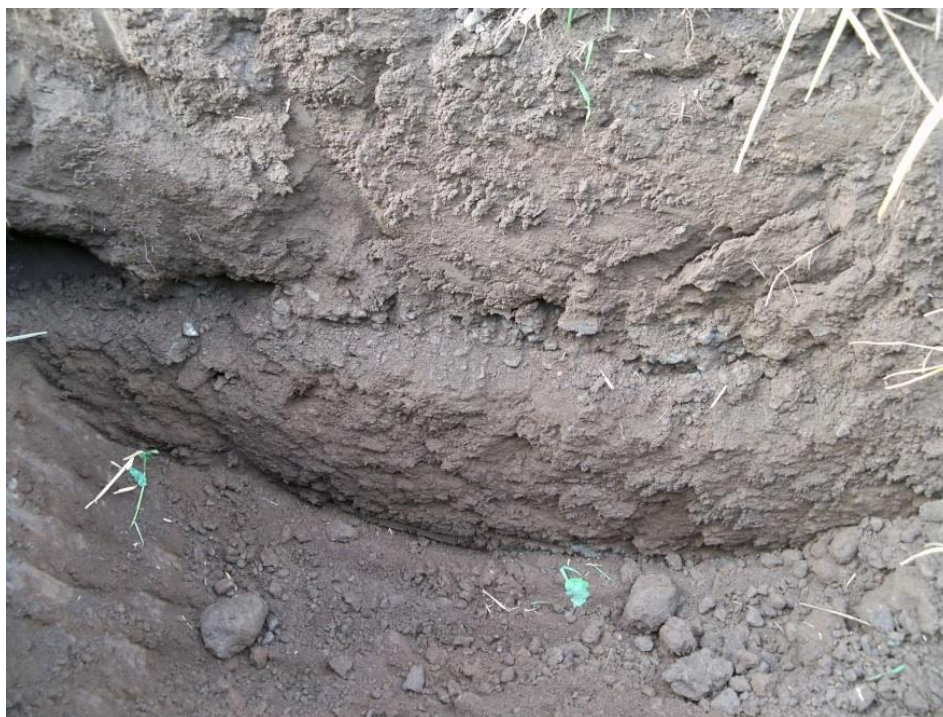
Figure 103. Photograph of Stratigraphic Profile of TR 015 North Wall Profile

Layer IIb (90-110cmbs): is a dark grayish brown (10yr 4/2), streambed, non-plastic, non-sticky, medium to coarse grain, with an absence of roots, structureless, with a high frequency of rounded cobbles, pebbles and gravel. No cultural materials observed in this layer. Boundary was clear and a plane overlying Layer III.

Layer III (100-180cmbs): is a grayish brown (10yr 5/2), silt loam, slightly-plastic, slightly-sticky, blocky, slightly hard, fine to medium grain, with a low frequency of rounded pebbles and gravel. No cultural materials observed in this layer. No cultural materials observed in this layer.

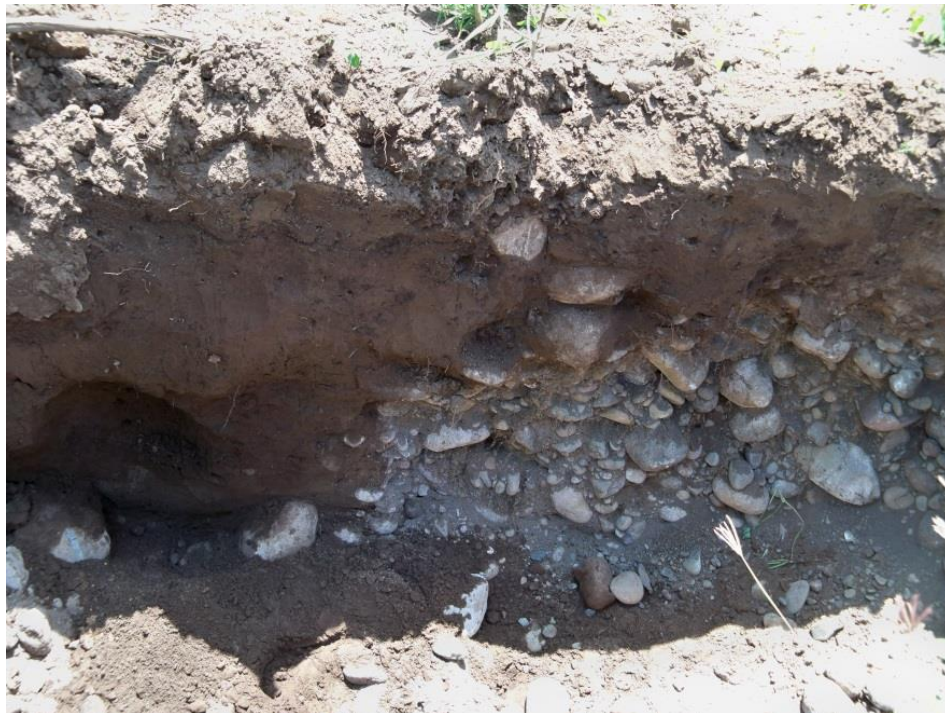
Figure 106. Photograph of Stratigraphic Profile of Trench 100 South Wall with Streambed Deposit

Layer III (58-150cmbs): is a dark yellowish brown 10 YR 3/6), imported gravelly silt, non-plastic, slightly-sticky, medium to coarse grain. No cultural materials observed in this layer. Boundary was clear and abrupt overlying Layer II.

Layer IV (130-150cmbs): is a dark brown (7.5yr 3/3) sandy loam with sub-rounded small basalt cobbles and lithified sand stone peds, non-plastic, slightly-sticky, fine to medium grain, with a low frequency of roots. No cultural materials were observed in this layer. Boundary was clear and broken abutting Layer III on the west.

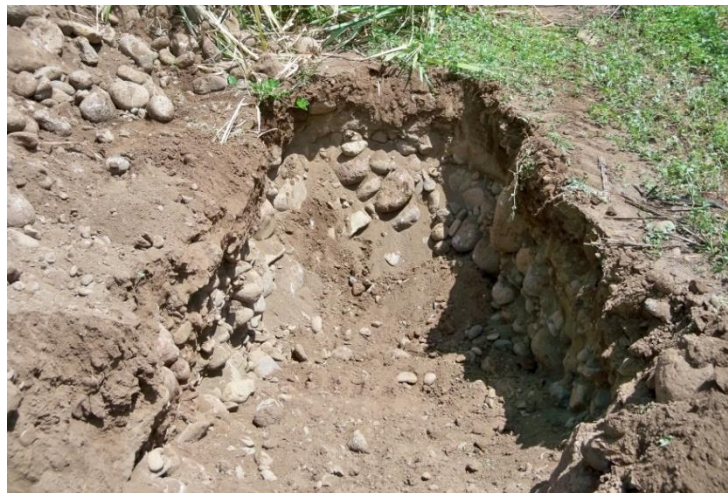
Figure 108. Photograph of Stratigraphic Profile of Trench 102 with Streambed Deposit, View to West

Trench 102 (TR 102) was located in the northeastern portion of the project area within an access road and the edge of a cultivated sugarcane field (see Figure 86 and Table XVI). This trench contained a three layer stratigraphic sequence with excavations terminating in sterile silty soil (Figures 108 and 109).

Trench 102 was non-cultural and measured 4.7 m long by 1.42 m wide by 1.5m deep.

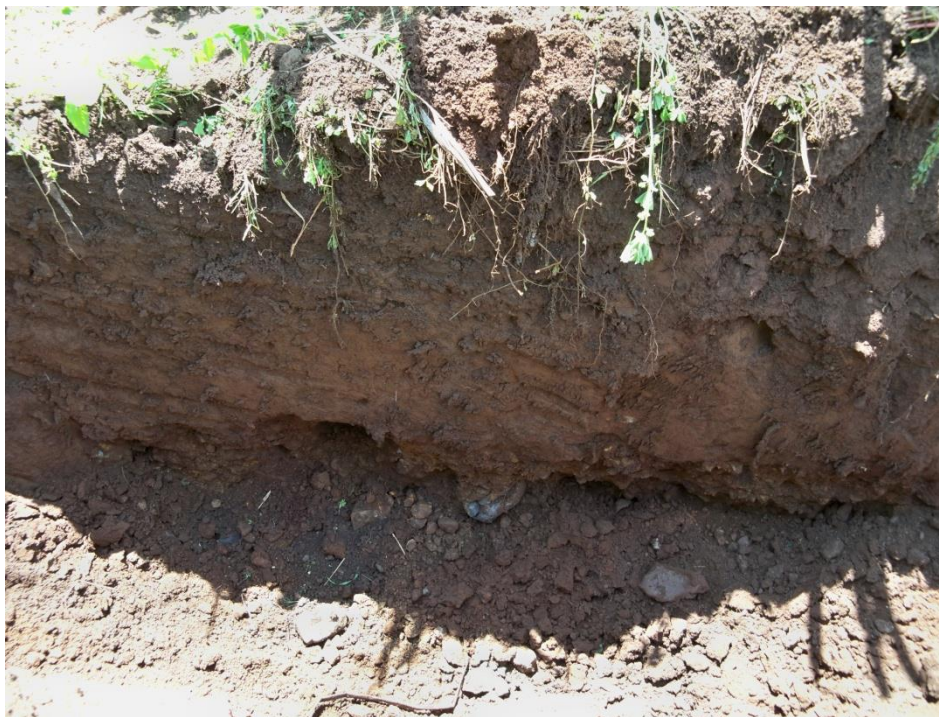
Figure 110. Photograph of South Wall of Trench 110

Layer III (78-101/118 cmbs) is a reddish brown silty clay (5YR3/3), compact, non-plastic slightly sticky, with gravel inclusions. Layer III is non-cultural and has an abrupt, smooth boundary.

Layer IV (118-BOE cmbs) is a dark reddish brown (7.5YR4/6) gravelly silty clay with mottling of Layer III saprolitic rock. No roots, linear gravel inclusions and sub angular rock. Layer IV is non-cultural and excavations terminated within this layer.

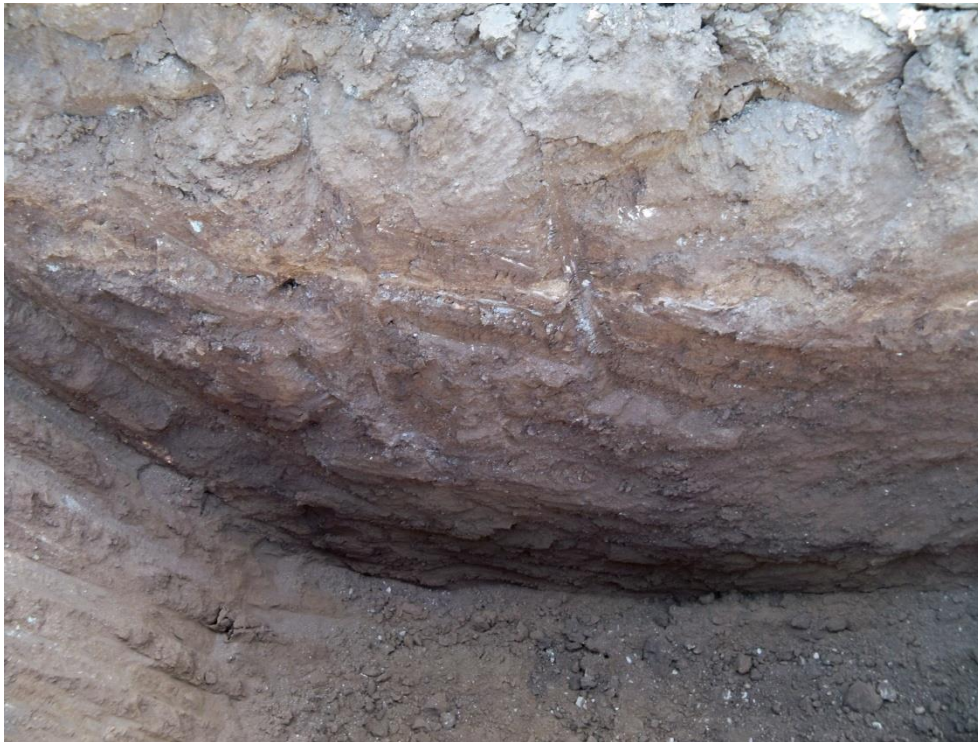
Figure 112. Photograph of West Wall of Trench 116, View to West

Trench 116 (TR 116) was situated in the central portion of the project area also within Grant 2747:2 which was formerly utilized as sugarcane and a reservoir (see Figure 86 and Table XVI). The stratigraphic record for TR116 contained four layers including one sand lens which interrupted the upper portion of Layer II (Figures 112 and 113). No cultural materials were observed within this trench which measured 4.7 m long by 1.45 m wide by 2.0m deep.

Layer IIa (42/45-55/57 cmbs) is a sand lens which was likely aeolian deposited. Layer IIa is non-cultural.

Layer III (150-200 cmbs) is a dark brown, strong brown (7.5YR3/2, 4/3, 4/6) very fine silt loam, non-plastic, non-sticky, fine to medium grain, with a low density of roots. Layer III is non-cultural and excavations terminated within this layer.

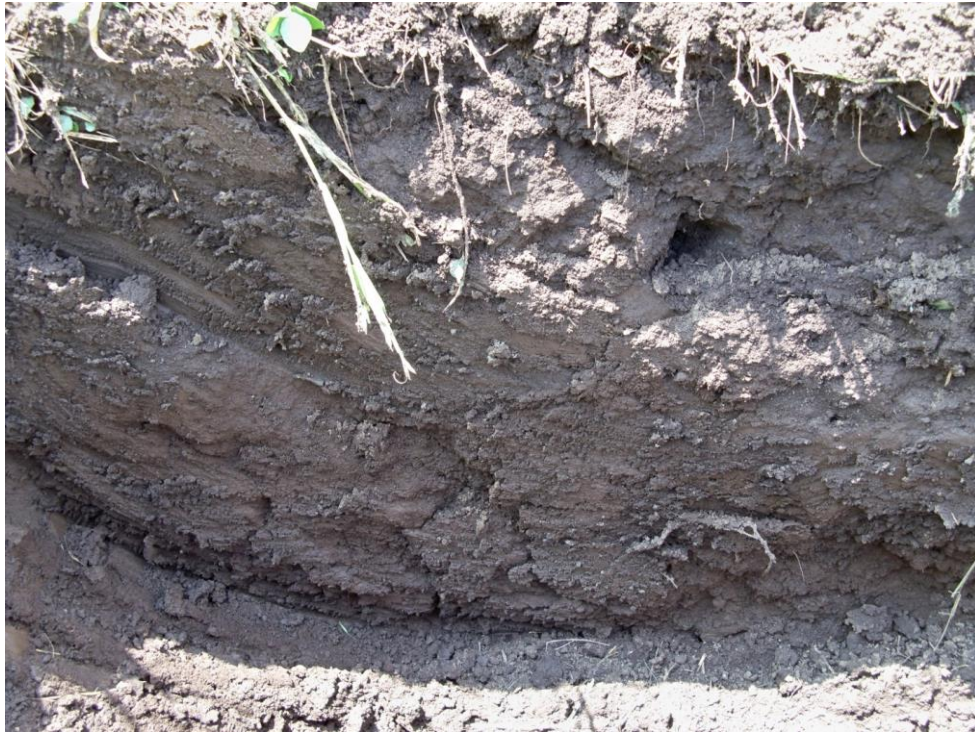
Figure 114. Overview Photograph of Trench 121, View to South

Layer III (60/75-148) is a very fine silt, dark brown (10YR 4/2, 4/3) few to no roots, non-plastic, non-sticky, fine to medium grain, with gravel lenses identified at 90, 100 and 140 cmbs. No cobble inclusions. Near the bottom of Layer III, the soil becomes finer with depth and charcoal stained lens is apparent at 144 to 148 cmbs, which is the beginning of Layer IV. Layer III is non-cultural with a clear abrupt boundary.

Layer IIIa (148-BOE) is similar to Layer III but appears to be a finer material. It is comprised of dark brown (10YR 4/2.5) very fine silt and contains the linear charcoal staining at the transition with Layer III. Layer IIIa is non-cultural.

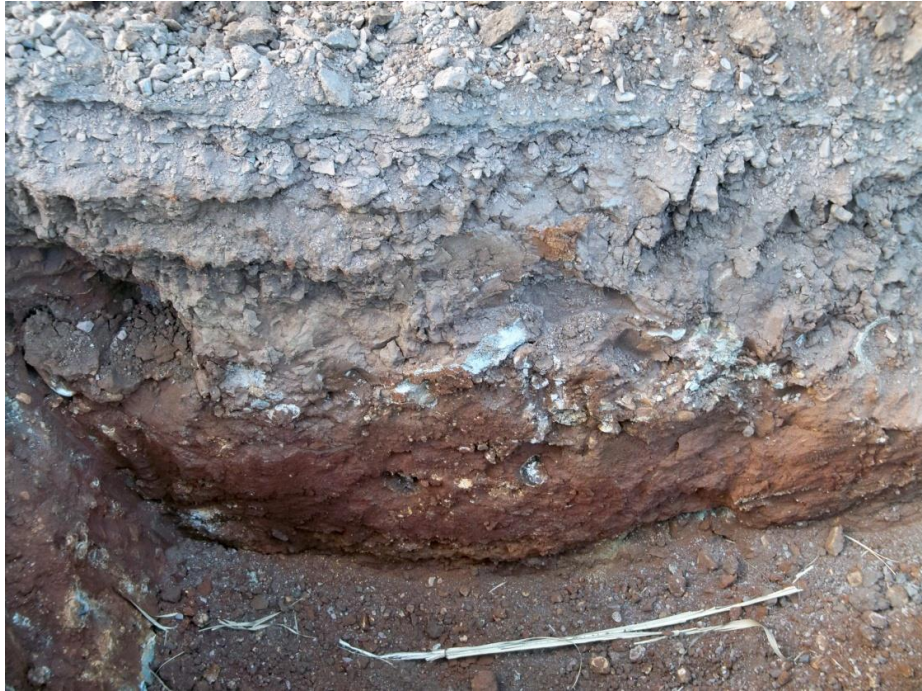
Figure 117. Photograph of West Wall of Trench 125, View to West

Trench 125 (TR 125) was located in the southeastern corner the northern side of a cane haul access road (see Figure 86 and Tables XVII). It contained a four-layer stratigraphic sequence with a storm/flood wash layer represented in stratum 2 (Figures 117 and 118). TR 125 was oriented at 360 and measured 4.9 m long by 1.43 m wide by 1.80 m deep and was non cultural.

Layer III (60/70-142/160 cmbs) is a reddish brown (7.5YR4/6) compact silty clay, non-plastic, slightly-sticky, fine to medium grain, with a few sub-angular and rounded small cobbles. Layer III is non cultural with no roots and has a clear, smooth boundary with Layer IV.

Layer IV (142/160-BOE) is similar to Layer III but is more compact, and comprised of a very fine, reddish brown silt which is devoid of rock inclusions. Layer IV is non-cultural and B.O.E. is at 180 cmbs.

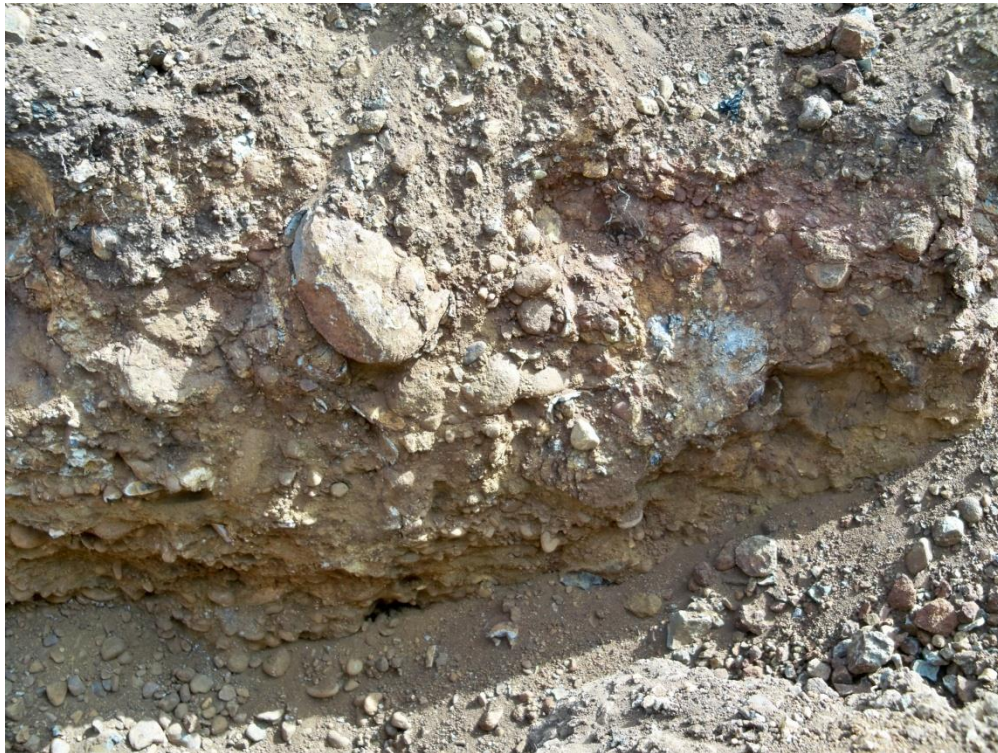
Figure 119. Photograph of South Wall of Trench 137

Trench 137 (TR 137) was located in the northwestern corner near a utility storage shed along the northern side of an access road (see Figure 86 and Tables XVII). It contained a four-layer stratigraphic sequence comprised of alluvial deposition that terminated in decomposing basalt (Figures 119 and 120). TR 137 measured 4.8 m long by 1.44 m wide by 1.50 m deep and was non cultural.

Layer III (30/60-122) is a yellowish brown (10YR4/3) gravelly silt with pockets of reddish brown silty clay. Many small and large cobbles with a few medium sized boulders and saprolitic rock, non-plastic, non-sticky, fine to medium grain. Layer III is non cultural with no roots. Layer III is non-cultural has a clear, smooth boundary with Layer IV.

Layer IV (122-BOE) is comprised of decomposing bedrock and smaller cobbles and pebbles with yellowish brown (10YR4/3) fine silt.

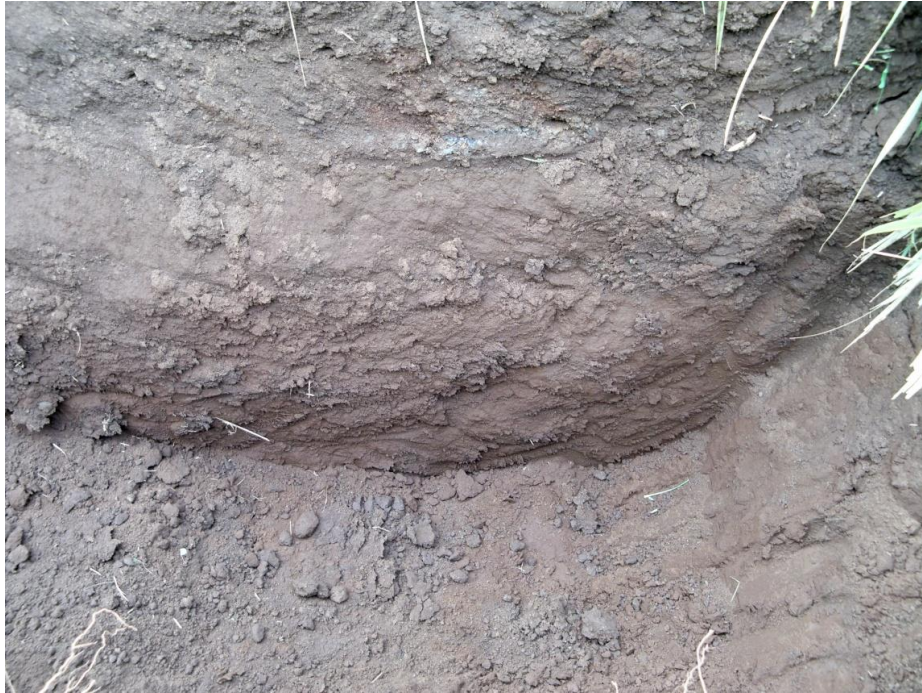
Figure 126. Photograph of North Wall near Base of Excavation of Test Unit 202

TR 202 was situated within the south, central portion of Parcel 6 along a cane access road within an area currently utilized for sugarcane (see Figures 121 and 125). TR 202 was placed within Grant 2960 which was granted to Boardman for Sugarcane (see Table VIII and Figure 125). This section contained a tripartite stratigraphic sequence terminating on saprolitic bedrock (Figures 126 and 127). TR 202 was oriented east/west and measured 4.6 m long by 1.40 m wide by 2.00 m deep. No cultural materials were observed within Trench 202 which is further presented below.

Layer II 21-88/140 cmbs) compact very fine silt clay yellowish to dark brown (10YR 4/3 and 3/2), low density of roots and a low frequency of subangular and rounded rocks. Layer II is non-plastic, slightly sticky, non-cultural. Layer II boundary is abrupt and wavy overlying Layer III.

Layer III (88/140-1.80/194 cmbs) very fine silty clay, dark reddish brown (5YR 3/3-3/4). No roots medium frequency of subangular cobbles with decomposing bedrock at the base. Excavations terminated on the discovery of saprolitic rock (Layer IV).

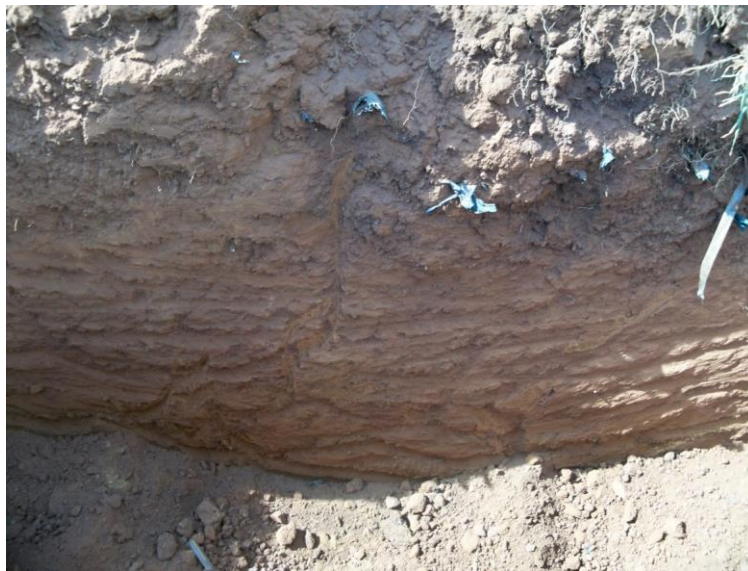
Figure 128. Photograph of South Profile of TR 205 (top); Stratigraphic Profile of South Wall TR 205

TR's 205, 207 and 209 were placed within LCA's 10160:1, 11022:3 and 10481:1, respectively and these *kuleana* were utilized as house lots (10160:1 and 10481:1), *lo'i kalo* and *kula* lands. The trenches contained a similar three layer stratigraphic sequence, yet TR's 207 and 208 contained more yellowish brown mottling (Figures 128-130). One glass fragment was found on the surface of TR 208 but was secondarily deposited. Thus, no clear evidence of domestic or agricultural activities (beyond sugarcane) was recorded.

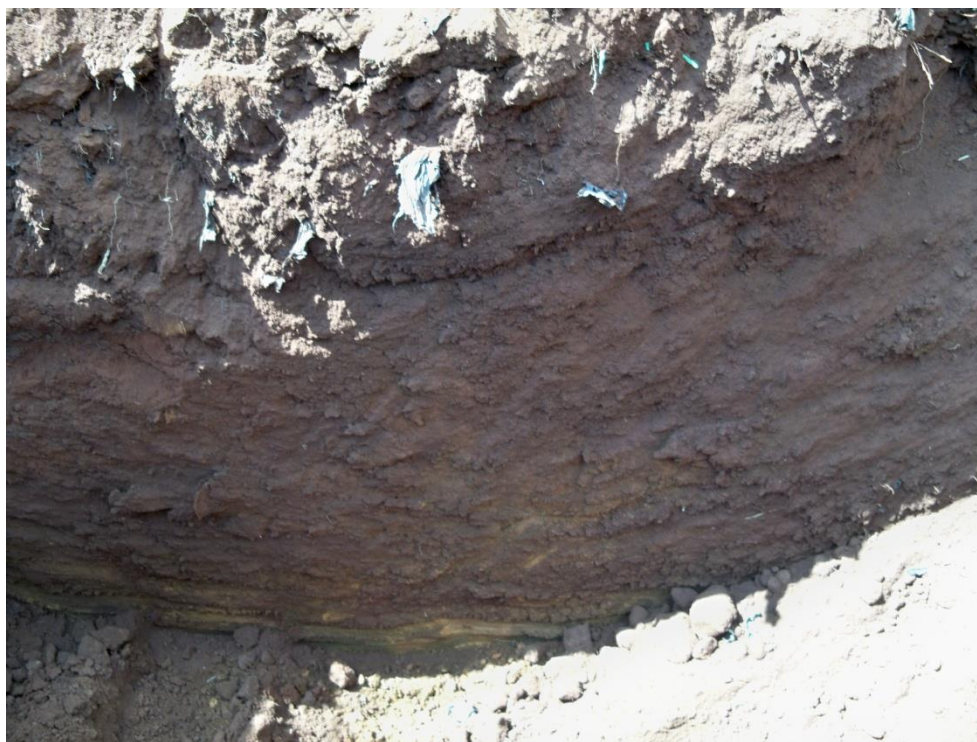
Figure 129. Photograph of South Wall of TR 207

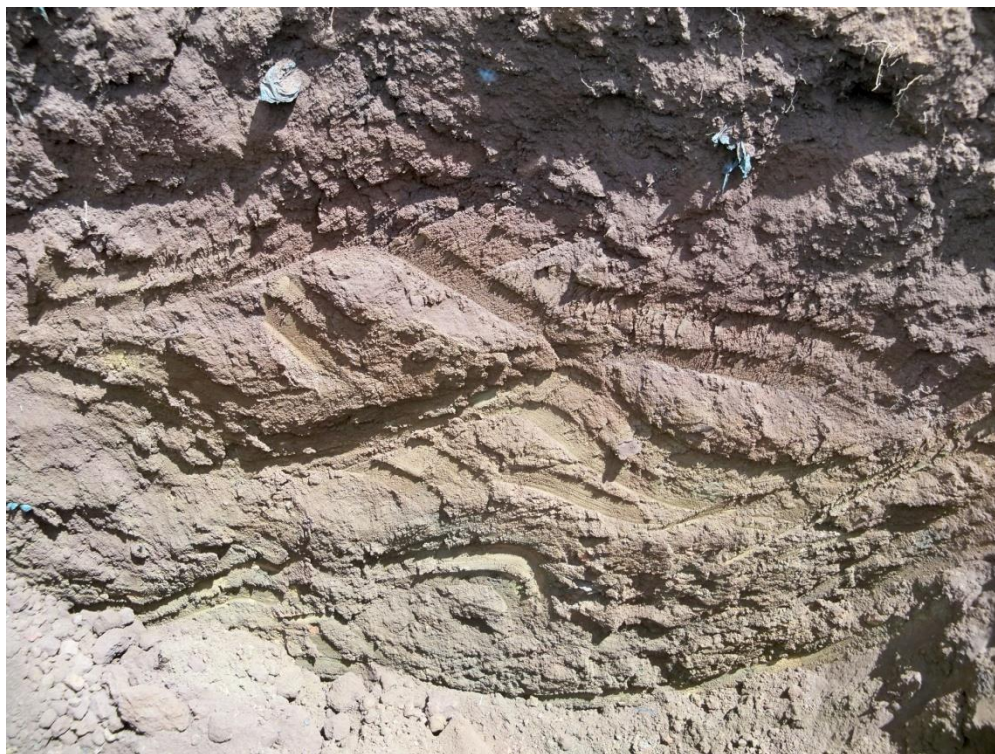
Figure 130. Photograph of South Wall of TR 209

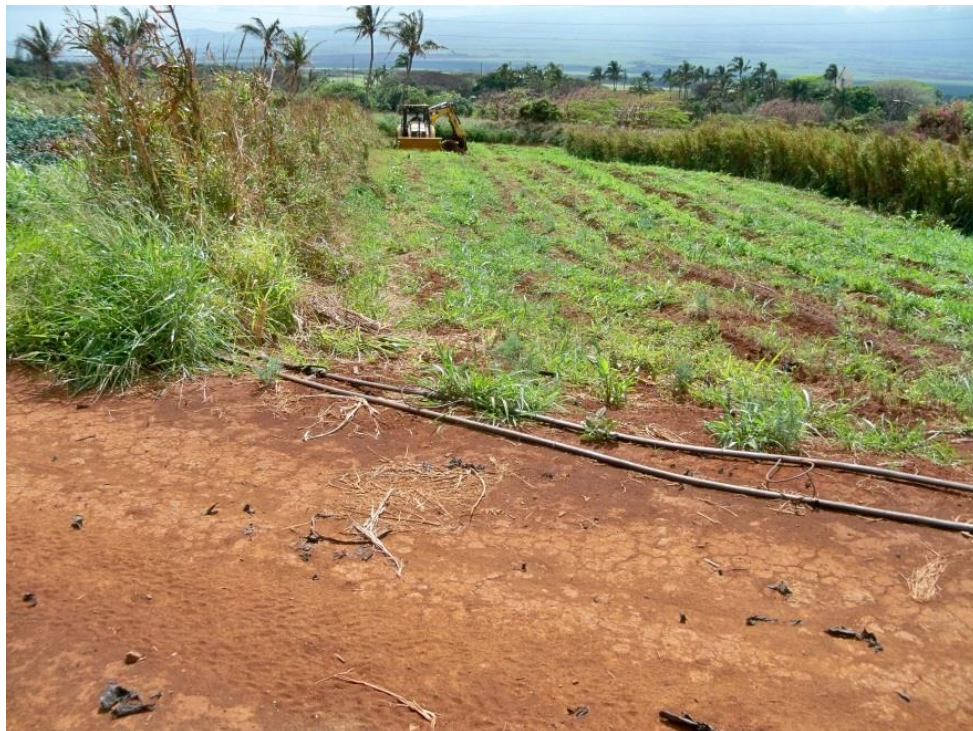
Figure 131. Overview Photograph of Trench 208 Pre-excavation within Parcel 6, View to East

Trench 208 (TR 208) was situated within the central portion of Parcel 6 within Grant 1844 and possibly within LCA 10160:1 currently utilized for small scale commercial agriculture (see Figures 121, 125 and 128 and Table XVII). The grant was used for sugarcane and the LCA House lot, kula, *lo`i*) This section contained a four layer stratigraphic sequence with excavations terminating within sterile soils (Figures 131 and 132). A 4.8 m long by 1.44 m wide by 1.81m deep, oriented 270° by 90° section of this area was recorded and is further described below. No cultural materials were observed within TR 208.
