**FINAL ARCHAEOLOGICAL INVENTORY SURVEY REPORT
FOR SEVERAL PARCELS OF LAND SITUATED WITHIN
WAIKAPŪ AHUPUA`A; WAILUKU DISTRICT
PŪ`ALI KOMOHANA MOKU**

**TMK: [2] 3-6-002:003; [2] 3-6-004:003, [2] 3-6-004:006;
and [2] 3-6-005:007**

**BY: Diane Guerriero (B.A.), Andre`e Conley-Kapoi (M.A.), Lisa J. Rotunno-Hazuka (B.A.)
and Jeffrey Pantaleo (M.A.)**

REVISED SEPTEMBER 2017

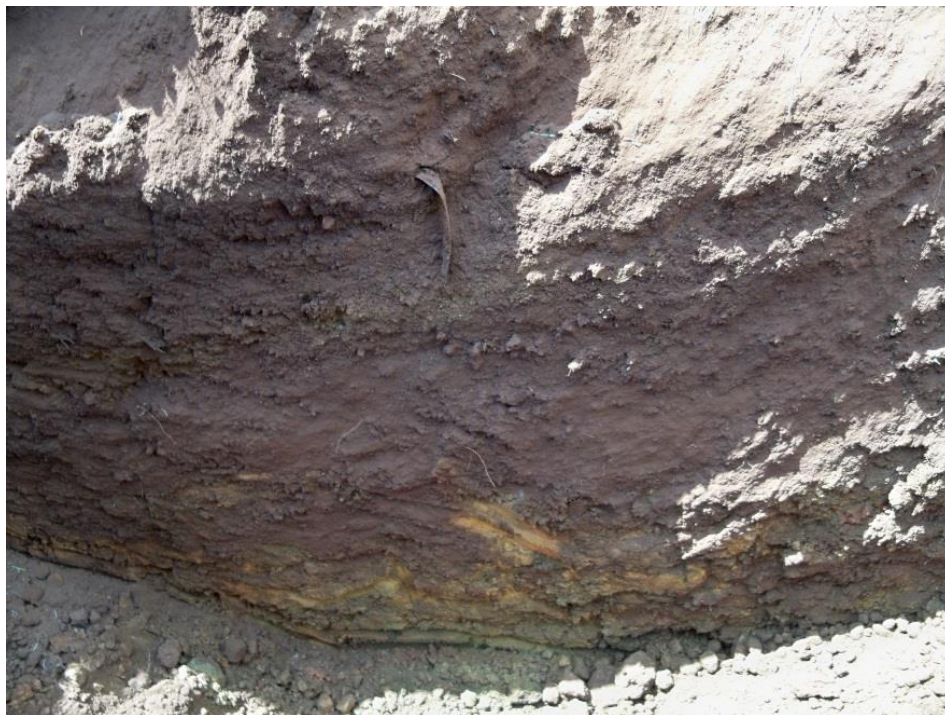
Layer I (0-62cmbs): is a dark reddish brown (2.5yr 3/3), silt loam, agricultural plow zone, with deteriorated black drip-lines, slightly-plastic, slightly-sticky, weak, fine to medium grain, blocky, with a medium frequency of roots. No cultural materials were observed in this layer. Boundary was clear and wavy overlying Layer II.

Layer II (58-160cmbs): is a very dark brown to dark reddish brown (2.5yr 3/3), clay loam, disturbed layer, mottled with decomposing bedrock inclusions, slightly-plastic, slightly-sticky, weak, fine to medium grain, blocky. No cultural materials observed in this layer. Boundary was clear and wavy overlying Layer III.

Layer III (110-160cmbs): is a dark brown (7.5yr 3/3), clay loam, mottled with yellowish brown (10YR4/3), slightly-plastic, slightly-sticky, medium to coarse grain, slightly hard, and friable. No cultural materials observed in this layer. Boundary was clear and wavy overlying Layer IV.

Layer IV (119-181cmbs): is a strong brown (7.5yr 4/6) silty clay, weak, fine to medium grain, blocky, slightly hard, friable, slightly-plastic, slightly-sticky, with a low frequency of decomposing bedrock. No cultural materials were observed in this layer.

Figure 132. Photograph of Stratigraphic Profile of Trench 208 (TR 208), North Wall

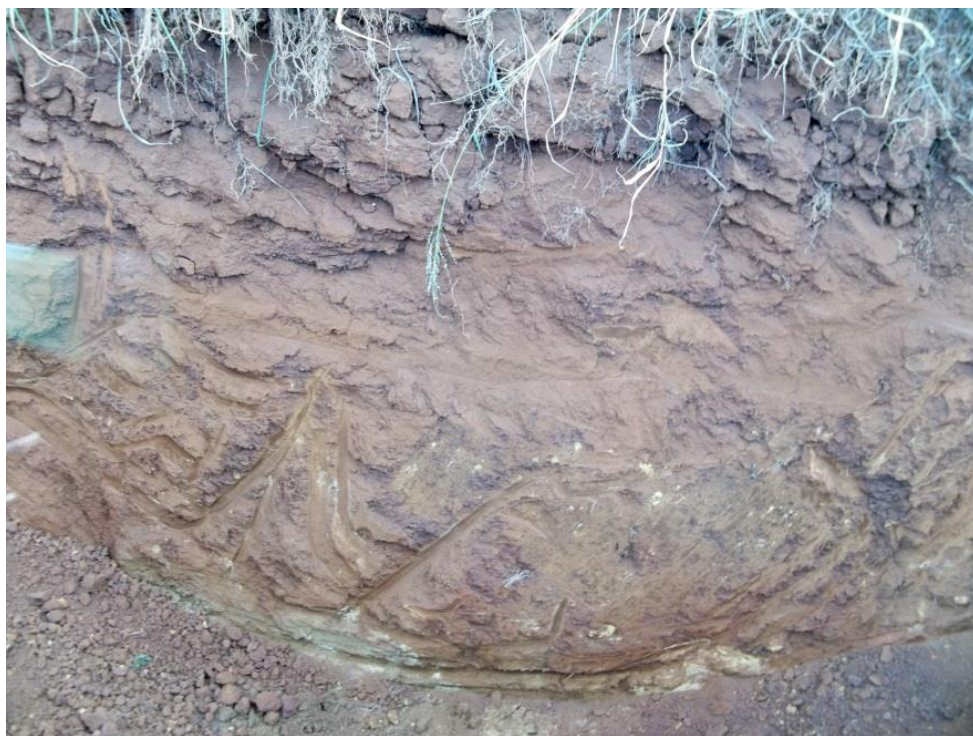
Layer I (0-52cmbs): is a dark reddish brown (2.5yr 3/3), silt loam, agricultural plow zone, with deteriorated drip-lines, slightly-plastic, slightly-sticky, weak, fine to medium grain, slightly hard, blocky, with a medium frequency of roots. Boundary was clear and wavy overlying Layer II. No cultural materials were observed in this layer.

Layer II (41-138cmbs): is a dark red (2.5yr 3/6), clay loam, mottled with a high frequency of decomposing bedrock inclusions, slightly-plastic, slightly-sticky, weak, fine to medium grain, blocky. Boundary was clear and wavy overlying Layer III. No cultural materials were observed in this layer.

Layer III (138-179cmbs): is a brown (7.5yr 4/4) silty clay, weak, fine to medium grain, blocky, slightly hard, weakly coherent, slightly-plastic, slightly-sticky, with a high frequency of medium and large boulders. No cultural materials were observed in this layer.

Figure 135. Photograph of West Wall of Trench 218 (top) Stratigraphic Profile of Trench 218 (TR 218) West Wall

Trench 218 (TR 218) was situated within the extreme northwestern portion of Parcel 6, within LCA 5774:2 award, utilized for *lo`i kalo*, and a portion of the cane flume easement (see Figures 121, 125 and Table XVIII). TR 218 measured 4.9 m long by 1.45 m wide by 1.79m deep and was oriented 360° by 180°. No *in situ* cultural materials were observed; however secondarily deposited domestic items (bottle base, comb and rice bowl sherds) were recovered from the surface area around TR 218 and assigned Site 7884 Feature 2 (Figure 134). These materials may have been from the house lots LCA's to the south where TR's 205, 207 and 209 were placed. Trench 218 contained a tripartite stratigraphic sequence with excavations terminating in sterile soils and decomposing bedrock (Figure 135).

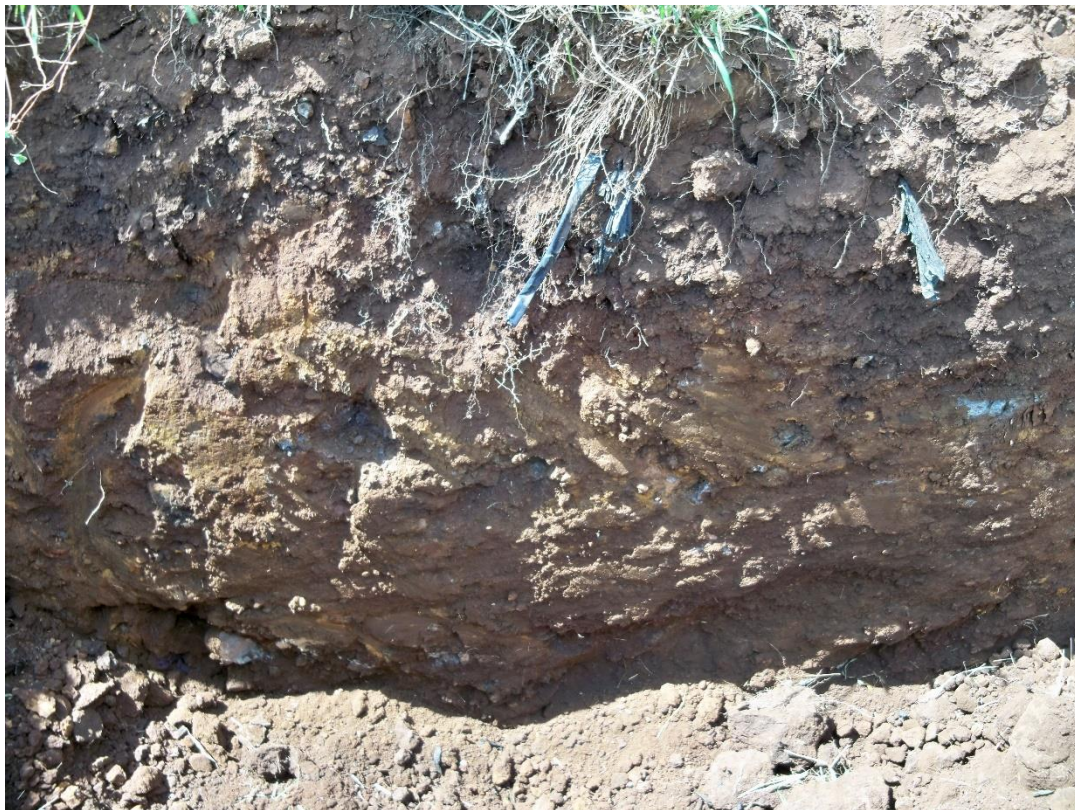
Layer I consisted of a loamy silt very dark grayish brown (7.5 YR4/3) till zone from sugarcane cultivation activities Layer I contained numerous roots and irrigation black plastic drip-lines with few rocks. The soil was slightly sticky, slightly plastic, blocky texture. Boundary was clear and wavy overlying layer II.

Layer II dark reddish brown (5YR 3/3, 3/4) stony silt loam and clay loam deposit that varied 60-150 cm thick with a few trenches containing decomposing bedrock, with a low density of roots and a medium frequency of rocks.

Figure 136. Photograph of West Wall of Trench 222 within Parcel 6

Trench 222 (TR 22) was situated within the northern portion of Parcel 6, within fallow sugarcane field (see Figures 121, 125 and Table XVIII). The trench contained a two layer stratigraphic sequence with excavations terminating within decomposing bedrock (Figures 136 and 137). TR 222 measured A 4.9 m long by 1.45 m wide by 1.79m deep, oriented at 360° and was non-cultural and is further described below.

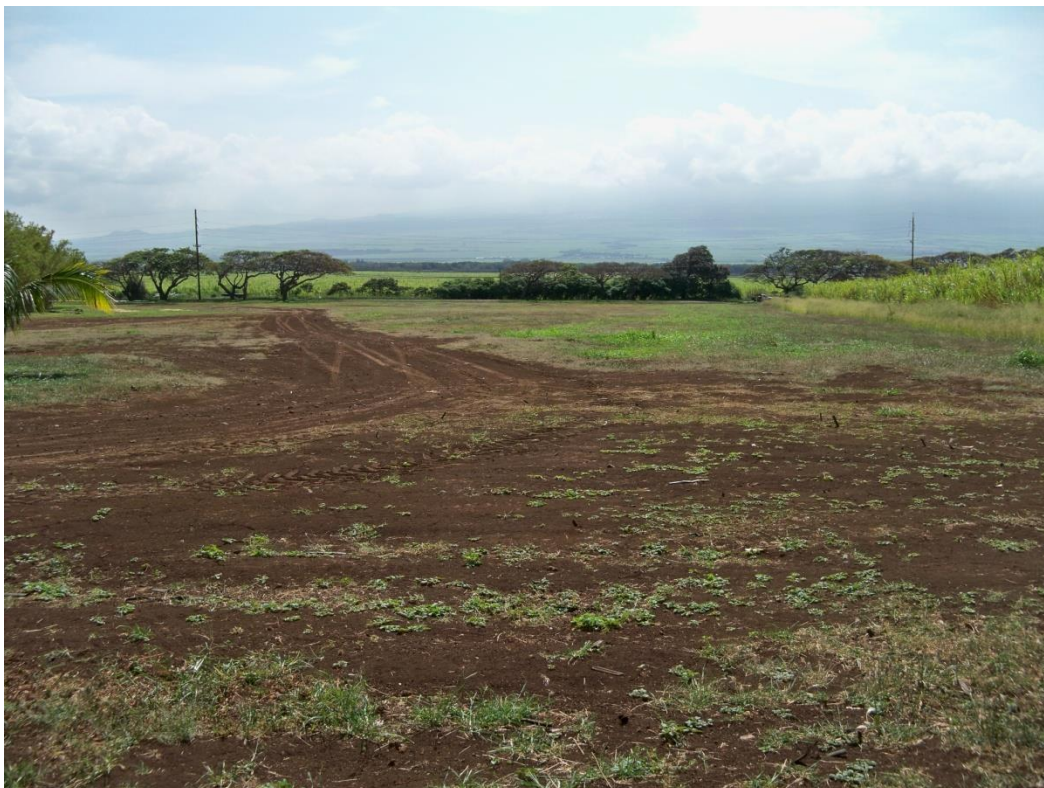
Figure 142. Overview Photograph of Trench 302 Pre-Excavation within Parcel 7, View to East

Trench 302 (TR 302) was situated within the open fields of the southern portion of Parcel 7 within former Grant 2960 (see Figures 141 and 142). No land use information was available for this Grant; however TR 302 contained a three layer stratigraphic sequence with excavations terminating at 1.82 mbs (Figures 143-144). No cultural materials were observed within TR 302 which measured 4.9 m long by 1.44 m wide by 1.8 m deep and was oriented north south. The stratigraphic sequence is further described below.

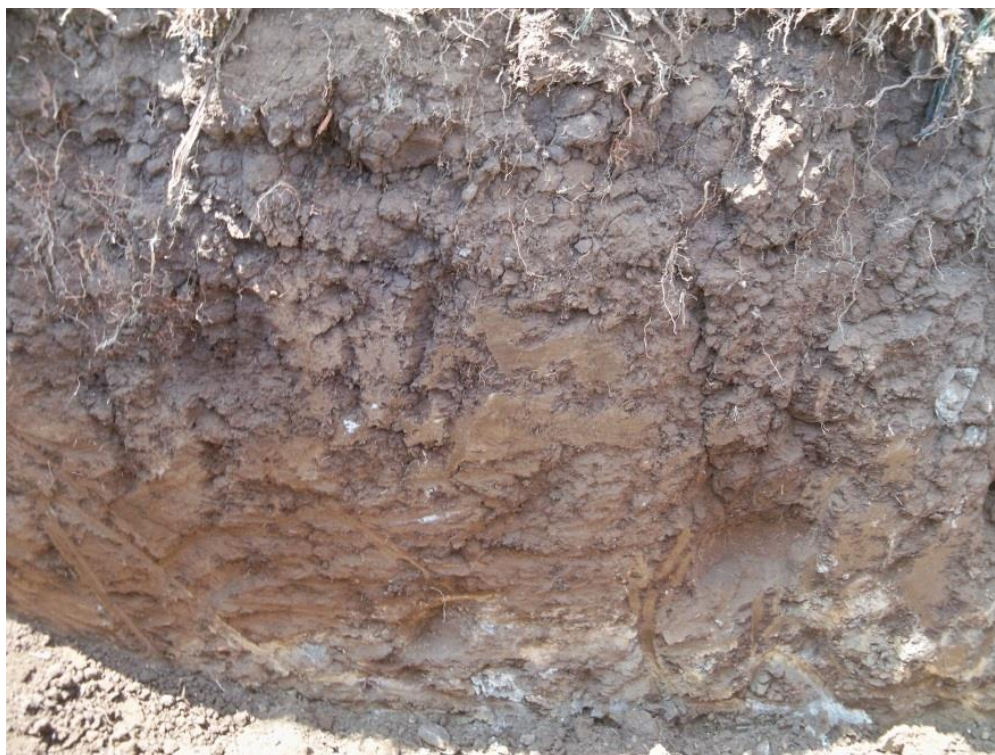
Layer I (0-51cmbs): is a dark brown (7.5yr 3/3), silt loam, agricultural plow zone, slightly-plastic, slightly-sticky, blocky, fine to medium grain, with a high frequency of coconut roots and a high frequency of rocks. No cultural materials were observed in this layer. Boundary was clear and wavy overlying Layer II.

Layer II (40-143cmbs): is a dark brown (7.5yr 3/4), clay loam, slightly-plastic, slightly-sticky, blocky, weak, fine to medium grain, with a low frequency of rocks and a high frequency of coconut roots. No cultural materials were observed in this layer. Boundary was clear and a plane overlying Layer III.

Layer III (140-182cmbs): is a brown (10yr 4/3), clay loam, slightly-plastic, slightly-sticky, blocky, slightly hard, fine to medium grain, with a low frequency of roots and a high frequency of rocks and decomposing bedrock. No cultural materials were observed in this layer.

Figure 143. Photograph of East Wall of TR 302 within Parcel 7

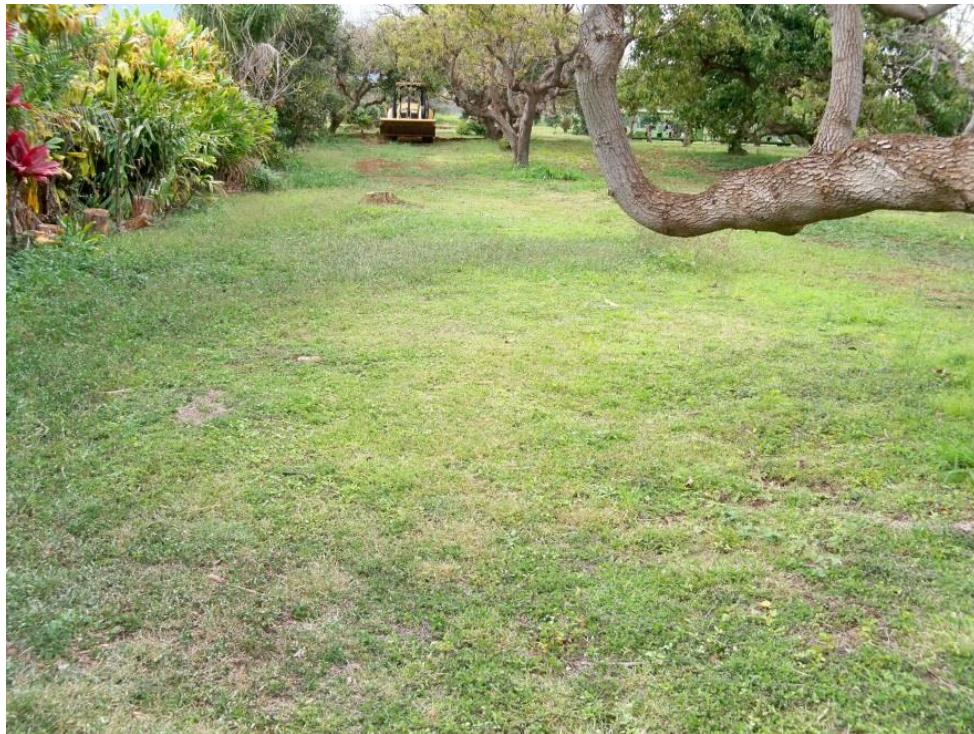
Figure 145. Overview Photograph of TR 306 Pre-Excavation, View to South

Trench 306 (TR 306) was situated within the north eastern portion of the project area along the cane flume easement within LCA's 491:3 and 3527:1 (see Figures 141 and 146 and Table XX). LCA 491:3 was for *lo'i* and 3527:1 was claimed for *kula* and taro *pauku*. This section contained a four layer stratigraphic sequence within an area that contained silt and clay dark soil loams (Figures 147 and 148). A 4.8 m long by 1.45 m wide by 1.45 m deep, oriented at 360°. The testing within TR 306 was negative for cultural materials.

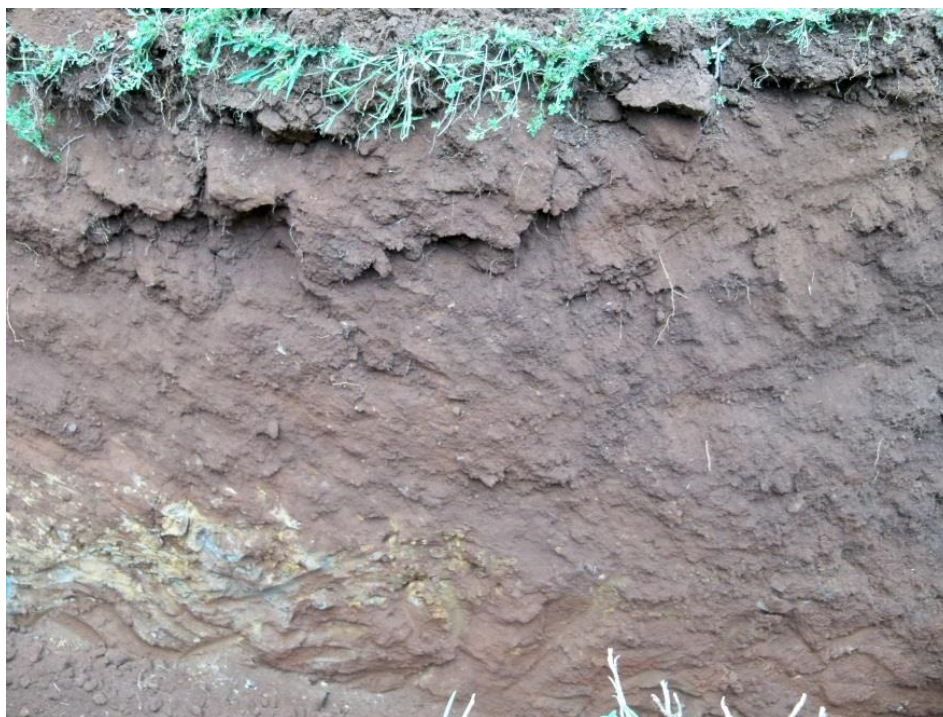
Layer I (0-30cmbs): is a dark reddish brown (2.5yr 3/3), silt loam, within a previous agricultural plow zone, with deteriorated drip-lines, slightly-plastic, slightly-sticky, weak, fine grain, blocky, friable with a medium frequency of roots. Boundary was clear and a plane overlying Layer II. No cultural materials were observed in this layer.

Layer III (99-123cmbs): is a dark reddish brown (2.5yr 2.5/3), clay loam, slightly-plastic, slightly-sticky, weak, fine to medium grain, blocky, slightly hard, with a low frequency of roots and rocks. Boundary was clear and wavy overlying Layer III. Charcoal flecks were noted scattered in layer.

Layer IV (120-155cmbs): is a dark reddish brown (2.5yr 2.5/4), clay loam, slightly-plastic, slightly-sticky, weak, fine to medium grain, blocky, slightly hard, with a low frequency of roots with a high frequency of rocks and yellowish brown decomposing bedrock along the northern edge. No cultural materials were observed in this layer.

Figure 146. Photograph of East Wall of TR 306

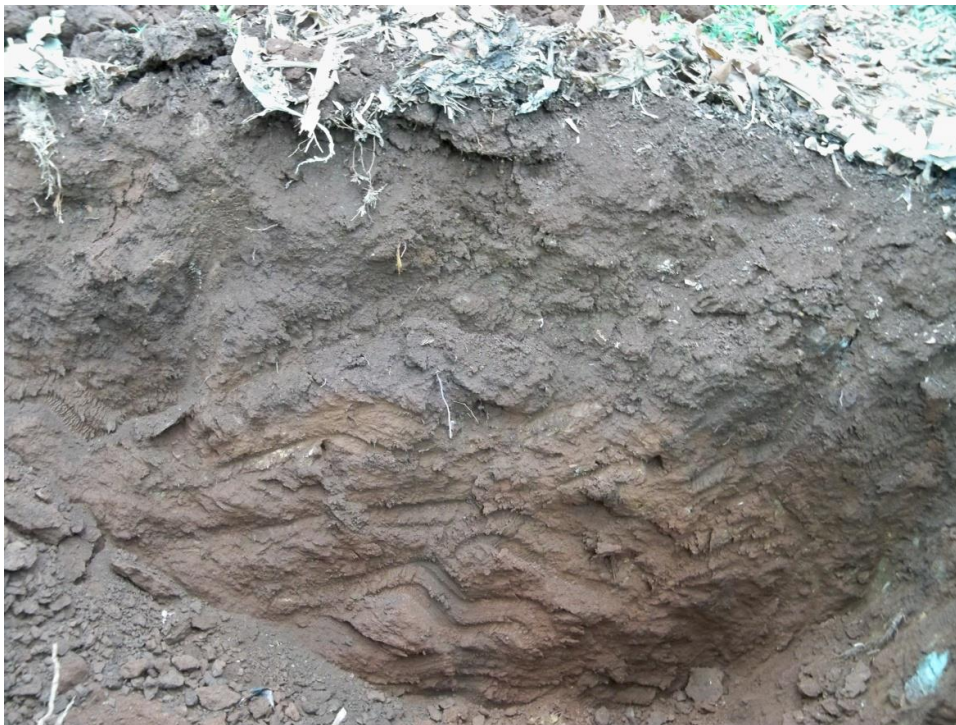
Layer I (0-21cmbs): very dark gray brown (10YR4/3) silt loam within a previous agricultural plow zone, slightly-plastic, slightly-sticky, weak, fine grain, blocky, friable with a medium to high frequency of roots and low frequency of rock. Boundary was clear and smooth overlying Layer II. No cultural materials were observed in this layer.

Layer II (21-77cmbs): is a dark gray brown (7.5 YR 3/2) with dark reddish brown (2.5yr 3/4) silt clay loam, slightly-plastic, slightly-sticky, weak, fine to medium grain, slightly compact, a low frequency of roots and rocks. Boundary was clear and wavy overlying Layer III. Non-cultural.

Layer III (77-175cmbs): is a dark reddish brown (2.5yr 2.5/3), clay loam, slightly-plastic, slightly-sticky, weak, fine to medium grain, blocky, slightly hard, with a low frequency of rocks and decomposing bedrock.

Figure 148. Photograph of South Wall of Trench 309

Trench 309 (TR 309) was situated within the north eastern portion of the project area along the cane flume easement in the vicinity of 305-308 within LCA's 8874:2 and Grant 2747:2 (see Figures 141 and 146 and Table XX). LCA 8874:2 was for a house lot and taro *pauku* (section) and Grant 2747:2 was claimed for sugarcane and reservoir. TR 309 contained a tripartite layer stratigraphic sequence that was negative for cultural remains (Figures 148 and 149). A 4.8 m long by 1.45 m wide by 1.75 m deep, oriented at 360°. The testing within TR 309 was negative for cultural materials.

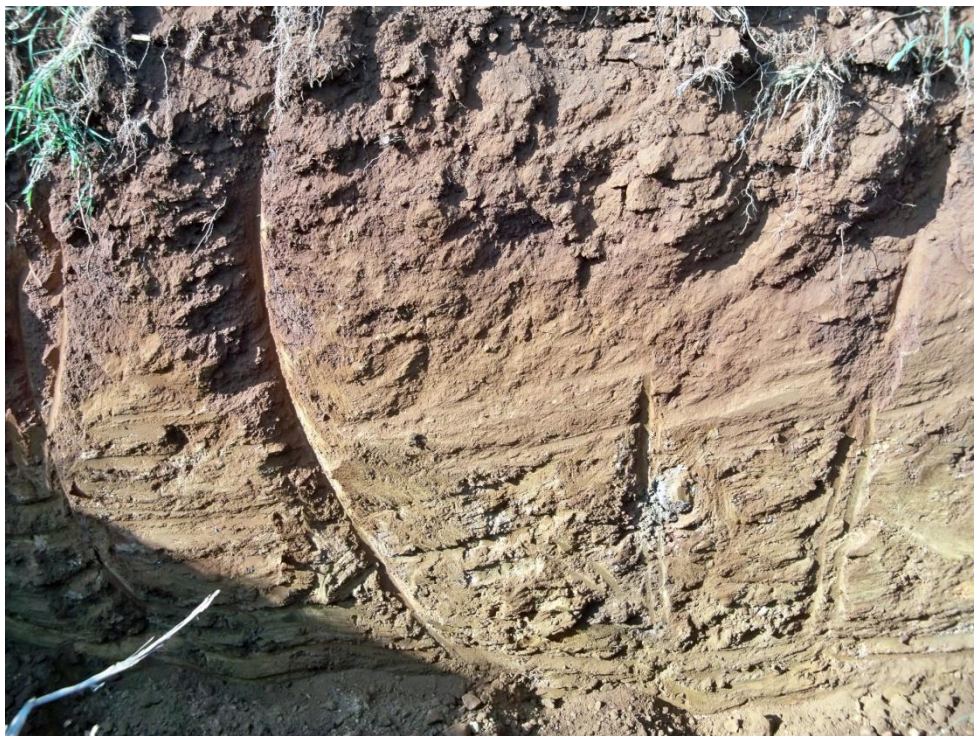
Layer II (18-41 cmbs) is a silt loam, reddish brown to yellowish brown (2.5yr ¾ to 10YR4/3). It contained low frequency of rocks and roots, non-sticky, non-plastic, slightly compact. Boundary is gradual and smooth.

Layer III (41-BOE) consisted of a silty clay brown to yellowish brown (10YR3/4 and 4/3) with saprolitic rock and decomposing bedrock.

Figure 150. Photograph of South Wall of Trench 310

Trench 310 (TR 309) was situated near the western boundary and Waihe`e Ditch within the southwestern quadrant and Grant 2609 (see Figure 141 and Table XXI). There was no land use information about this Grant however no cultural materials were noted in any of the strata. TR 310 contained a three-layer soil profile with Layers I and II exhibiting a gradual transition between the lower boundaries (Figures 150 and 151). It measured 4.9 m long by 1.45 m wide by 1.75 m deep, oriented east/west.

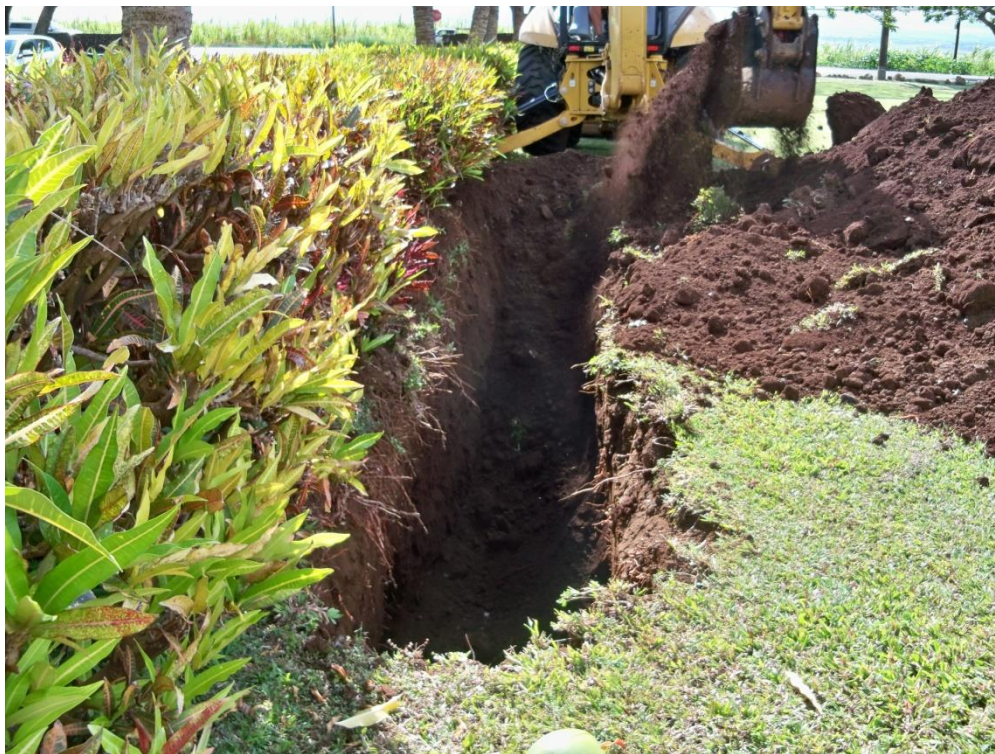
Figure 152. Overview Photograph of Trench 318 Base of Excavation

Trench 318 (TR 318) was situated along the southern side of the entrance road within LCA 455:2 and Grant 2842 (see Figures 141, 152 and Table XXI). LCA 455:2 was claimed as a house lot and for sugarcane; although no land use information was available for Grant 2842 a “pie shaped” reservoir was noted on the tax map key in the area of TR 318 and 317 (see Figure 141). TR 318 measured 4.8 m long by 1.32 wide by 1.85 m deep and was oriented east/west. It contained a four layer stratigraphic sequence (Figures 153 and 154) which included lenses of alluvium gravel designated Layer III. No cultural materials were observed within the soil profile.

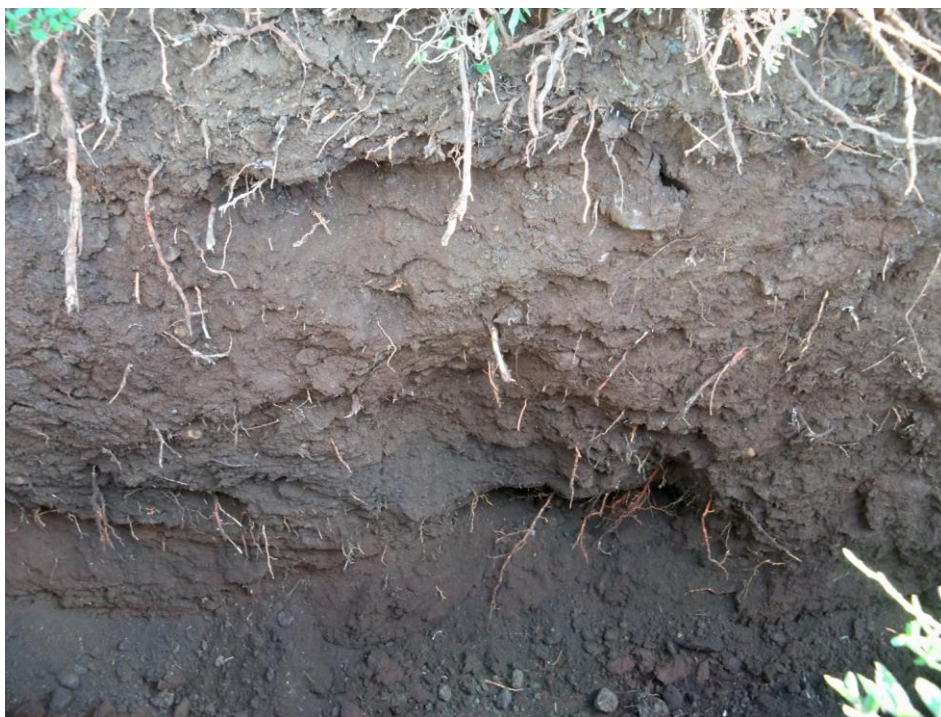
Lens/Layer III disturbed gravelly silt (10YR 4/3) numerous roots, low frequency of sub rounded cobbles, high frequency of pebbles, appears to be an alluvial deposit possibly from a streambed or the former reservoir. The deposit was thickest in the central portion tapering at both ends.

Layer IV is a silty clay, dark reddish brown (2.5YR 3/4), slightly plastic, slightly sticky, few sub rounded cobbles and gravel, very low frequency of roots. Non-cultural. Layer IV is similar to Layer II in color and soil texture but not content (rock and roots) and may represent an undisturbed portion of Layer II.

Figure 153. Photograph of South Wall of Trench 318

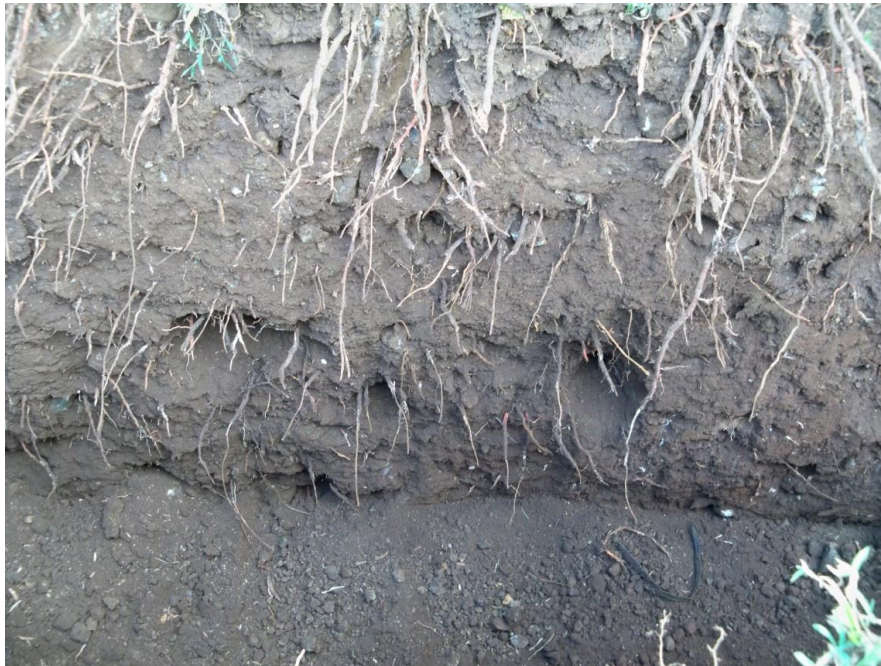
Figure 155. Photograph of TR 319 West Wall

Trench 319 (TR 319) was situated along the southern side of the entrance road to capture a portion of LCA 8874:3 which stated *lo`i* for land use and LCA 5734:4 that had no information (see Figures 141, 156 and Table XXI). Unfortunately, the entire area was previously disturbed as evidenced by the numerous roots and presence of a cable near the base of the trench (see Figure 156). No cultural materials or gleyed soils indicative of *lo`i kalo* were recorded. TR 319 measured 4.9 m long by 1.33 wide by 1.75 m deep and was oriented north/south. It contained three layers, of which Layers I-II and upper portion of III were disturbed.

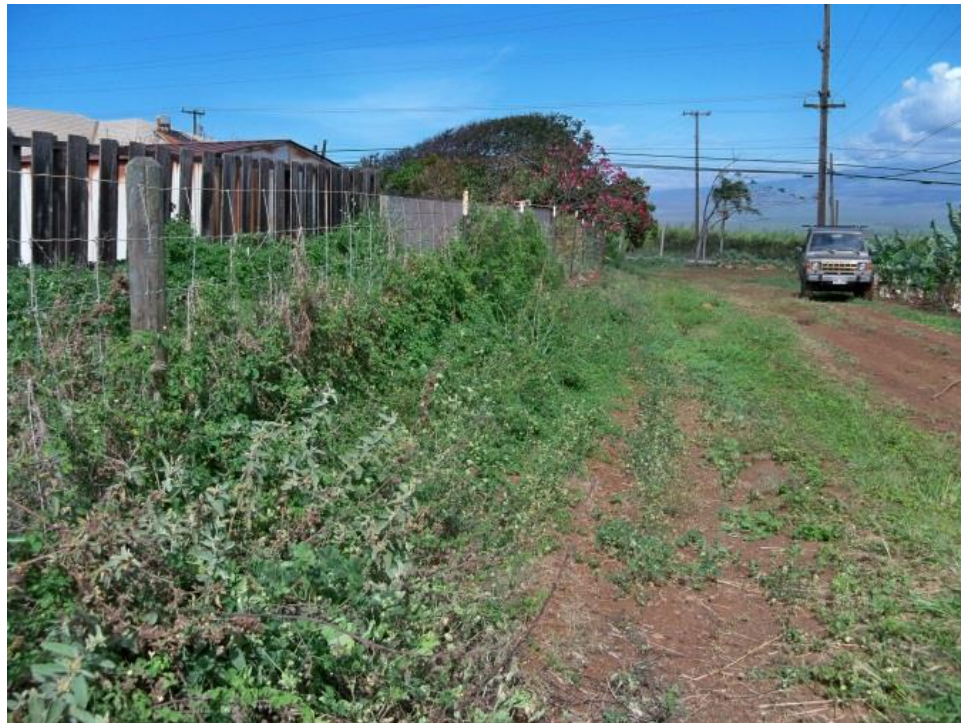
Figure 156. Overview Photograph of TR 324 Pre-excavation, View to East

Trench 324 (TR 324) was placed along in the northeastern corner of Parcel 7 within LCA 416:2 which was claimed as a house lot (see Figure 141, 156 and Table XXI). It contained a four layer stratigraphic sequence within an area where alluvial deposits (stream and or flood episodes) were documented within TR 320, 322 and 323 (Figure 157). At the interface of Layers I and II, a small historic trash deposit was identified from 20-40 cmbs and designated Site 7884 Feature 3. This refuse deposit contained marginal amounts of glass shards from the same bottle and a few pieces of ceramics, metal and charcoal and was presumed to be a portion a trash pit that was burned (Figures 158-159). Layers III and IV were comprised of rounded small cobbles and boulders, interspersed with smaller pebbles and gravel surmised to be from an intermittent streambed or episodic flood events. TR 324 measured 4.8 m long by 1.43 m wide by 1.55

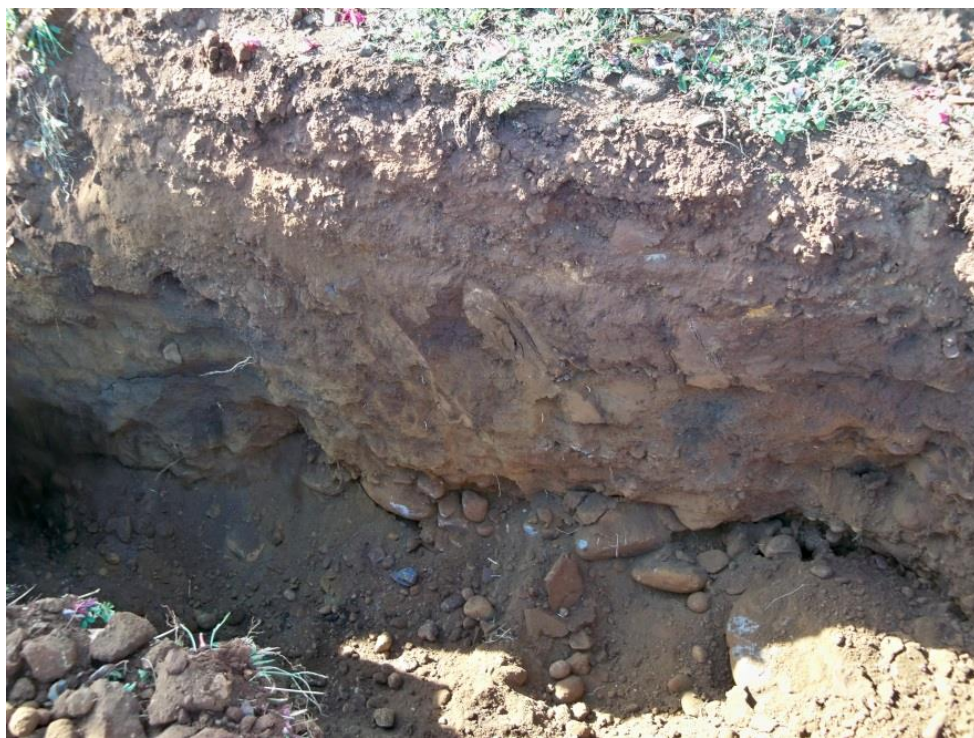
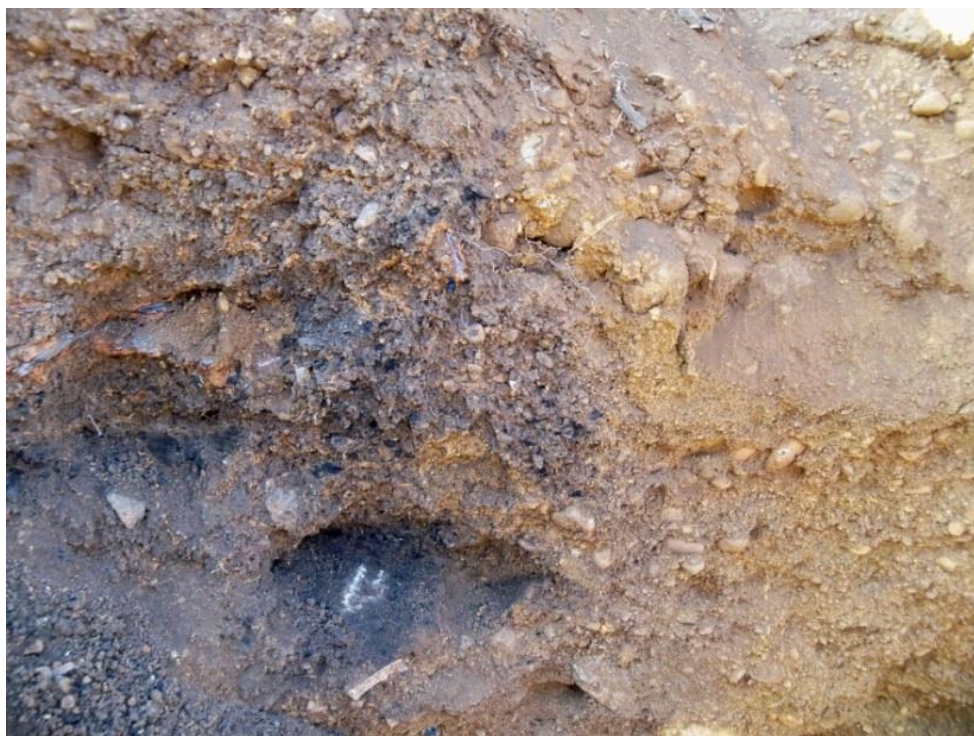
Layer I (0-20cmbs): is a dark brown (7.5yr 3/3), silt loam, within a previous agricultural plow zone, with deteriorated drip-lines, slightly-plastic, slightly-sticky, weak, fine to medium grain, slightly hard, blocky, friable with a medium frequency of roots. Boundary was clear and wavy overlying Layer II. No cultural materials were observed in this layer.

Layer II (22-120cmbs): is a brown (7.5yr 4/4), is a disturbed layer a silt loam, slightly-plastic, slightly-sticky, weak, fine to medium grain, blocky, slightly hard, a low frequency of rocks. Cultural materials were observed in this layer at 20-40cmbs in the form of a burned deposit of bottle glass and ceramics identified along the north eastern profile. At ca. 102-118cmbs and 120 to 130cmbs water affected pebbles, gravel and cinder were identified along the northwestern wall. Boundary was clear and broken overlying Layer III on the west and overlying Layer IV on the east

Layer III (82-117cmbs): is a dark yellowish brown (10yr 4/4), riverbed stony silt, structureless, non-plastic, non-sticky, loose, single grain to fine to medium grain, with a high frequency of rocks, cobbles. Boundary was clear and wavy overlying bedrock. No cultural materials were observed in this layer.

Layer IV (120-155cmbs): is a dark yellowish brown (7.5/6), riverbed stony silt, weakly coherent, non-plastic, non-sticky, loose, single grain to fine to medium grain, with a high frequency of rocks, cobbles, structureless. No cultural materials were observed in this layer.

Figure 157. Photographs of North Wall of TR 324 (top); and Close-up of Gravel/Cinder Deposit along North Wall

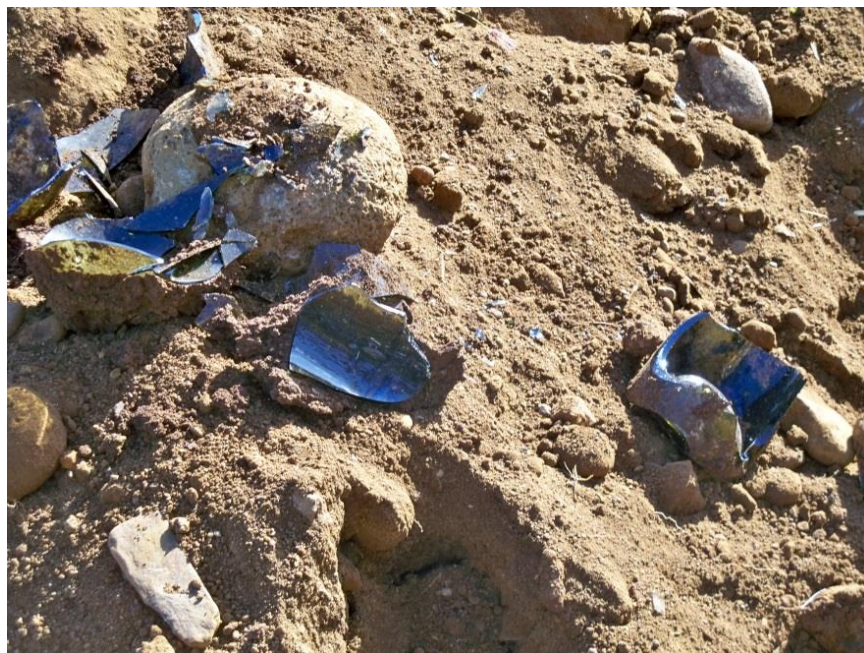
Figure 159. Historic Material from Site 7884 Feature 3 (TR 324) North Wall

Although several LCA's and Grants were present within the subject property, the backhoe test excavations were primarily negative with the exception of a small historic trash dump, Site 7884 Feature 3, near the surface of TR's 323 and 324 in the northeast corner of the parcel. The negative results are likely due to several factors, consisting of the compounded disturbances across the parcel from prior sugarcane cultivation, the development of the Maui Tropical Plantation and the inherent bias from backhoe sampling.

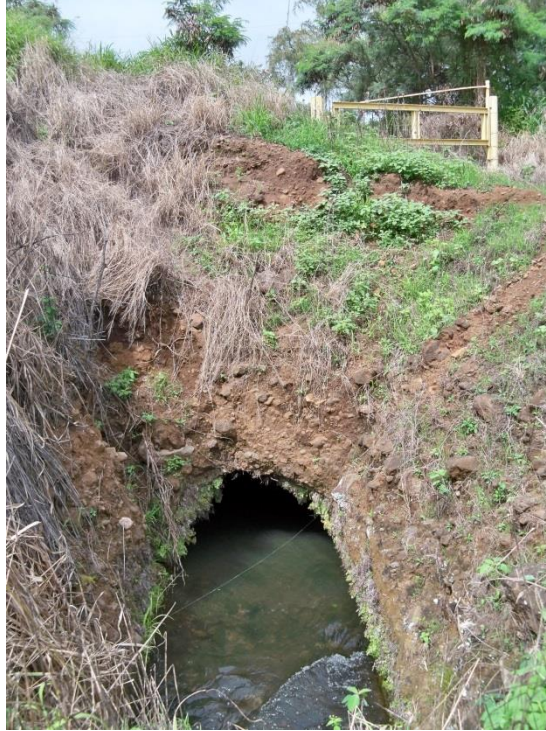
Figure 162. Overview Photograph Site 5197 Waihe'e Ditch Emerging from an Underground Culvert from the Northern Property Boundary, View to North

At the extreme northern property boundary the Waihe'e Ditch (Site 5197) emerges from an earthen underground tunnel (Figure 162) from an adjoining parcel that is located adjacent to the Waikapū Stream. It is at this juncture that Waihe'e Ditch (Site 5197) emerges into an open earth ditch on the south for a length of 6.0 m and continues thru a basalt keystone arched and faced tunnel for a length of 8.5 m and emerges on the south from an arched basalt keystone and faced tunnel (Figures 163-164). This tunnel appears to have supported a possible bridge in the past as it is covered with a dirt access road. The tunnel measures 3.1 m wide and 2.2-2.4 m in high above the active water course. The keystone faced arch is constructed of keystone cut basalt blocks that measure 45 cm in length and 40 cm in width. The interior of the tunnel is concrete lined. The southern section of the Waihe'e Ditch following the southern end of the tunnel for a distance of 29.5 m is presumably original construction consisting of a concrete lined ditch with the upper slopes stacked, faced, basalt water-worn and sub-angular cobbles, four courses high, measuring 1.3 m above the cement lined base that measures 1.1 m above the water level (Figures 165-166). The width at this juncture measures 2.1 m to 3.1 m. The ditch transitions from stacked, faced sides into being completely cement lined, (a modern modification) measuring 2.1 m wide, and 1.1 m in height above the water level with sections along the southern water course containing remnants of previous construction of rock faced sides.

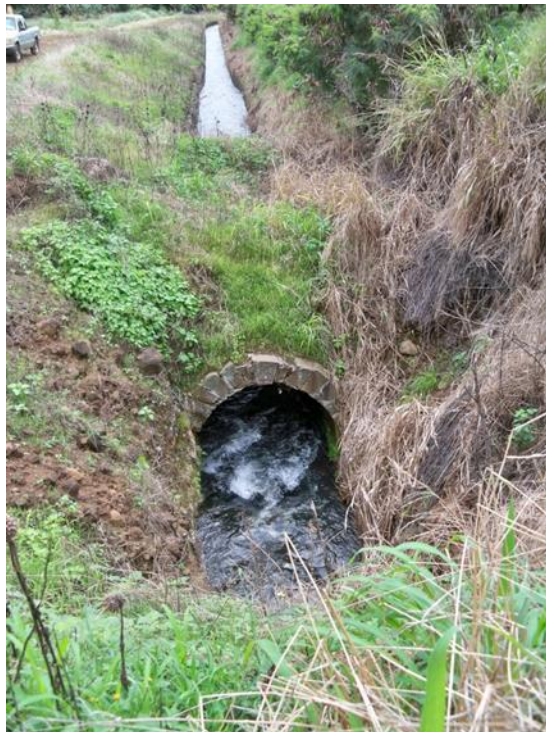
Figure 163. Overview Photograph of Waihe'e Ditch from an Underground Keystone Tunnel/Bridge, View to South

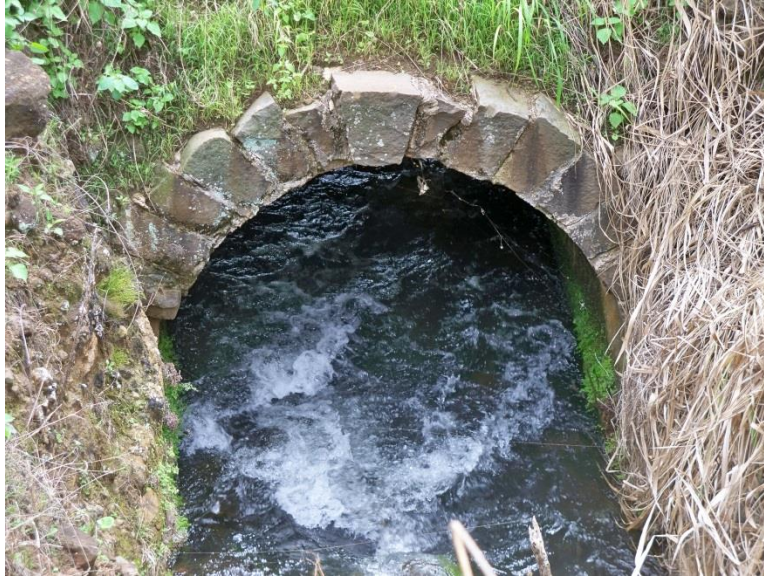
Figure 164. Overview Photograph of Keystone Arched Tunnel/Bridge, View to South

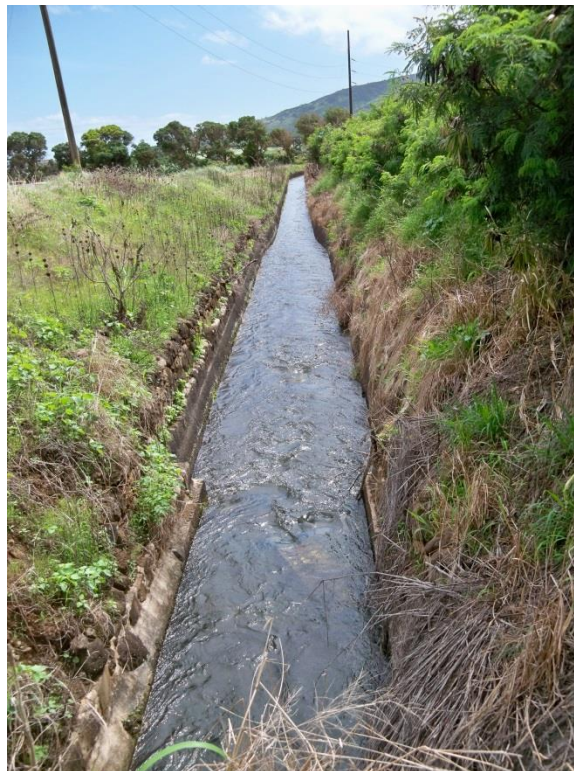
Figure 165. Overview Photograph of Site 5197 Waihe`e Ditch Showing two Types of Construction along the Ditch (photo from atop the keystone arched tunnel/bridge), View to South

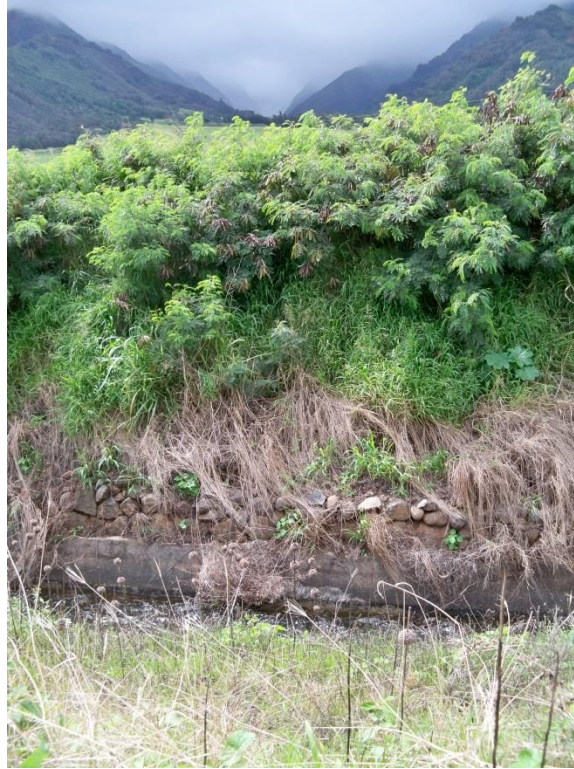
Figure 166. Overview Photograph of Site 5197 Waihe'e Ditch Showing Older Construction with Stacked Rock Atop the Concrete Lined Ditch (View of Western Side Wall

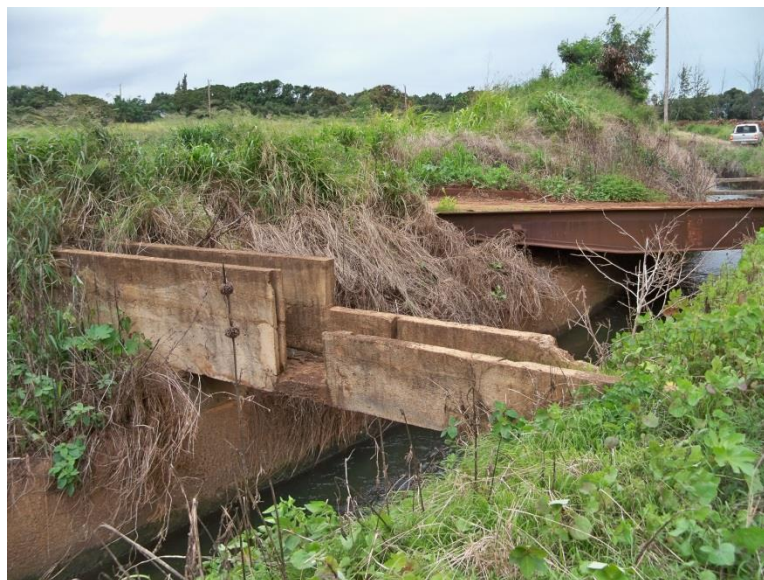
Figure 167. Overview Photograph of Second Bridge from the North, Metal Beam and Cement Construction (background), Older Drainage Culvert (foreground), View to Northeast

Bridges are located along the central and southern sections of the ditch within the project area crossing over to Parcel 3 Mauka. Figures 167 and 168 depict the construction of concrete and re-bar reinforced, metal beamed and wooden bridges, the last being the more recently constructed.

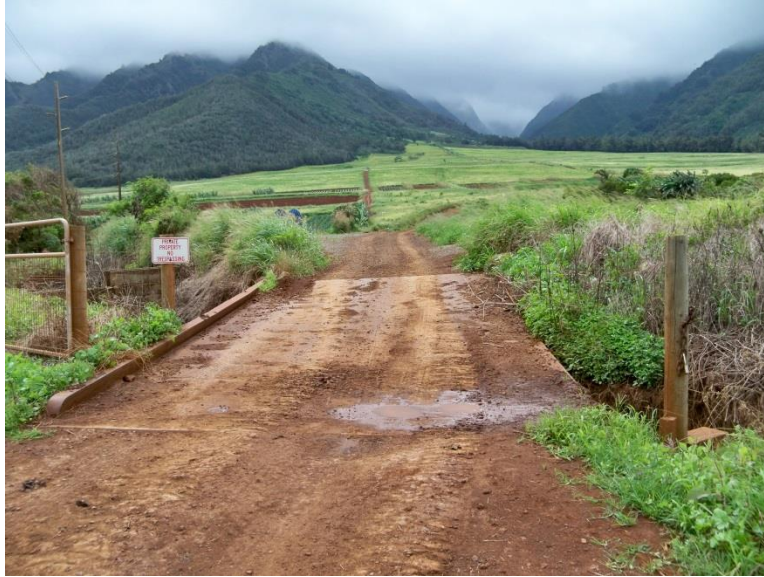
Figure 168. Photographic Overview Second Bridge, Metal Beam and Concrete Construction, View to West

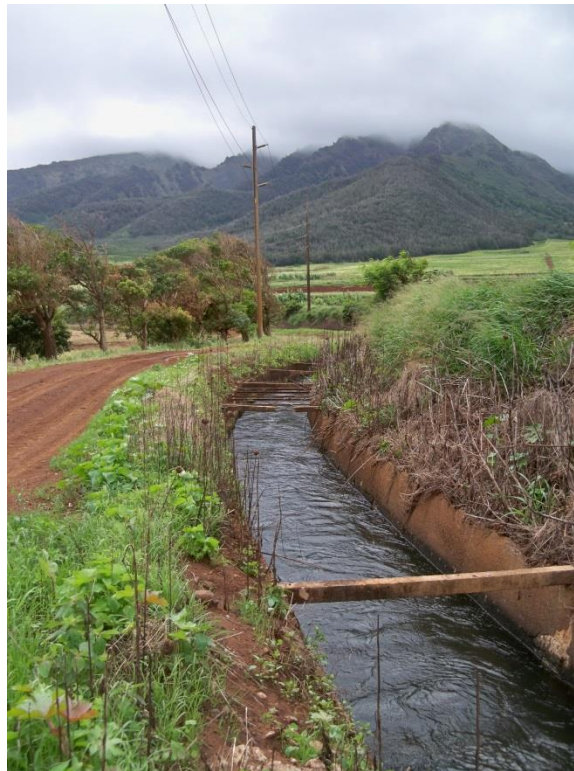
Figure 169. Photographic Overview from Second Bridge with Tee-Bar Reinforcements Across Ditch, View to Southwest

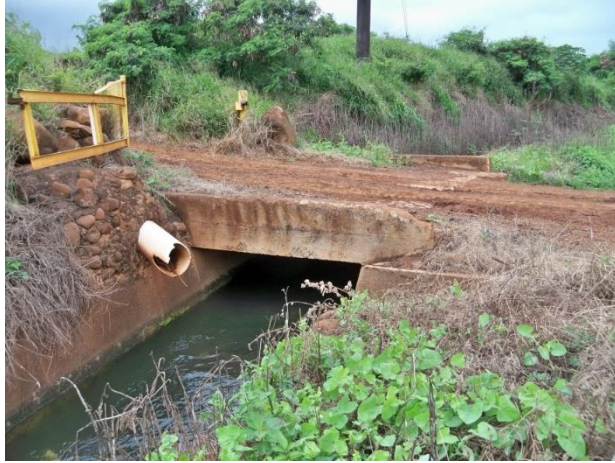
Figure 170. Overview Photograph of Third Bridge from North, Cement Construction with PVC Drainage, View to North

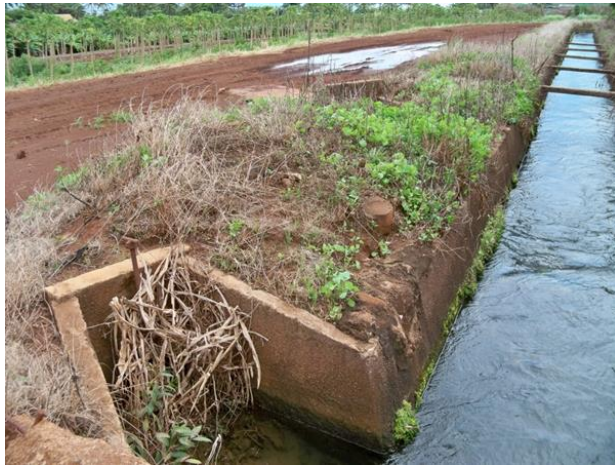
Figure 171. Overview Photograph of Third Bridge with Older Penstock with Metal Shut-off Valve (left), View to South

Site 5197 is in good condition and is maintained by HC&S. The ditch remains consistent in terms of construction all along the water course towards the southern terminus of the project area beginning after the first 44 m from the northern section. The first 44 meters beginning from the northern property boundary is the only area of the ditch that exhibits a difference in construction, that being, an earlier original construction with stacked rock and faced sides and a tunnel with keystone arches. The continuing ditch along the southern portion of the project area clearly exhibits modern modifications and modern penstocks (PVC pipes, sluice gates and pipe valves) to existing irrigation routes and reservoirs. Tee bars are located atop the ditch as reinforcements and are primarily located along the southern sections as depicted on Figures 169-170. Along the southern route of the ditch are remnants of older penstocks, drainage culverts and shut-off valves that are predominately located near the bridges. Figures 171-174 show these areas.

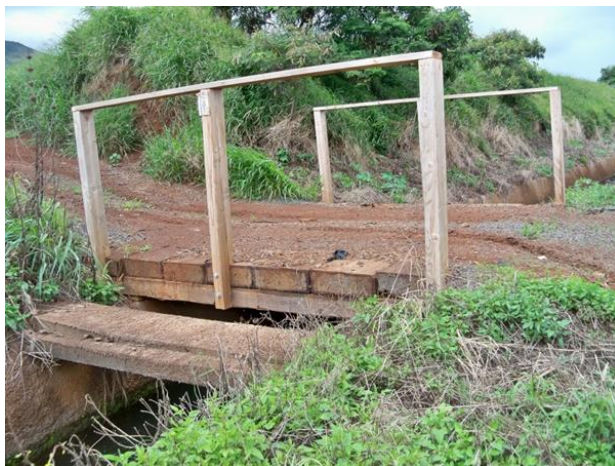
Figure 172. Overview Photograph of Fourth Bridge from North, West of Maui Tropical Plantation and Reservoir with Modern Wooden Construction, View to North

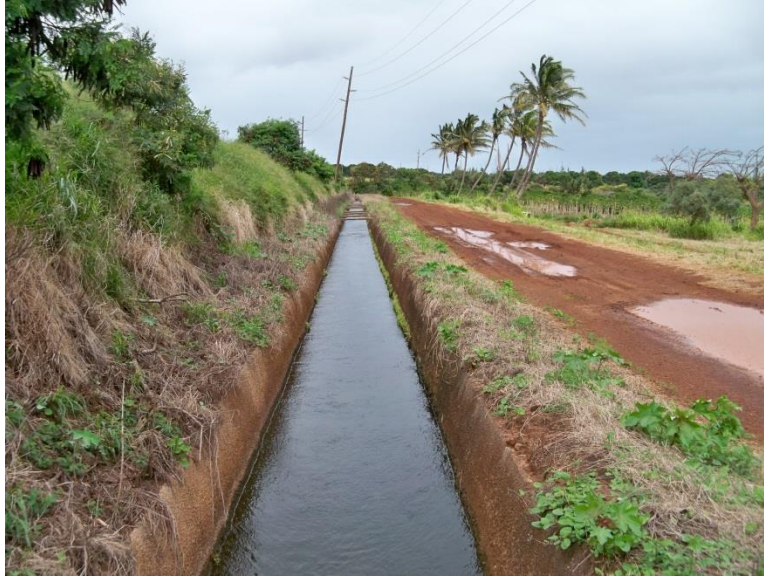
Figure 173. Overview Photograph of Site 5197 Waihe'e Ditch with Modern Concrete Lining, View to Northeast

Sites 5197 (Waihe`e Ditch) has been assessed an initial significance of Criterion “a” and “d” due to its association with the Sugar Era and may yield important information on the history of the area. The site will remain in operation but will be covered in certain localities for safety reasons. Discussions will be performed with the landowner to ascertain how the site will be covered and secured and to determine if any adverse impacts will occur that need to be mitigated.

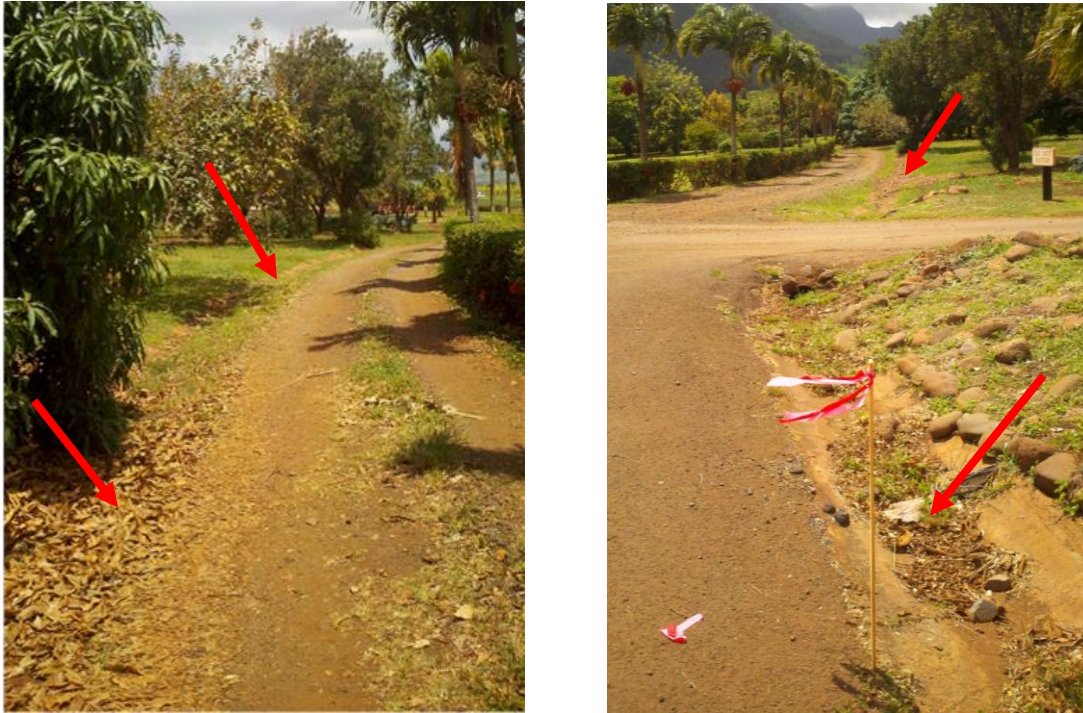
Figure 174. Overview Photographs of Extant Concrete Swales along Designated Cane Flume Easements in Parcel 7
