**FINAL ARCHAEOLOGICAL INVENTORY SURVEY REPORT
FOR SEVERAL PARCELS OF LAND SITUATED WITHIN
WAIKAPŪ AHUPUA`A; WAILUKU DISTRICT
PŪ`ALI KOMOHANA MOKU**

**TMK: [2] 3-6-002:003; [2] 3-6-004:003, [2] 3-6-004:006;
and [2] 3-6-005:007**

**BY: Diane Guerriero (B.A.), Andre`e Conley-Kapoi (M.A.), Lisa J. Rotunno-Hazuka (B.A.)
and Jeffrey Pantaleo (M.A.)**

REVISED SEPTEMBER 2017

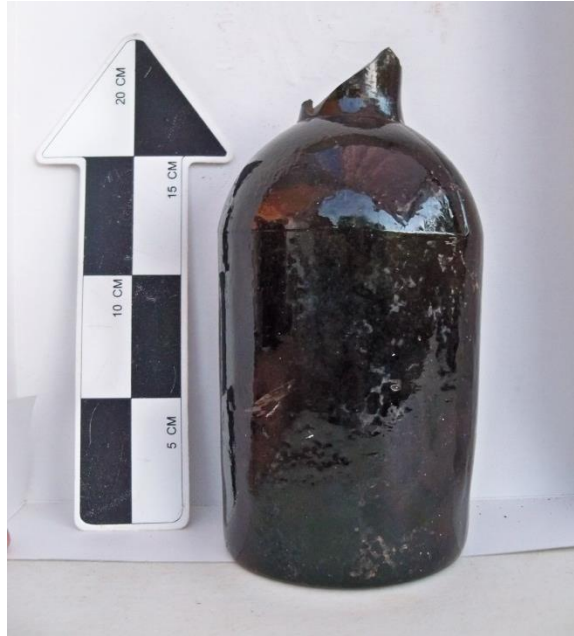
Dating analysis was based on the key manufacturing techniques developed during the 19th century. Manufacturing techniques changed considerably during the 19th and early 20th century, and at the end of the 19th century, mechanization began. The manufacturing technique utilized for most of the bottle types recovered was mechanization. The bottle openings from TR 324 are applied lips and a blown in mold for

the dark olive green colored wine bottle had a push up bottom with a pontil scar, and the aqua colored bottle was machine made molds for the body. Bottle types include medicinal, wine or whiskey and unidentifiable. The colors were dark brown, dark olive green, olive green, aqua and clear.

Figure 175. Photograph of a Dark Olive Green Wine Bottle from Site 7884 Feature 3 at Parcel 7 TR324

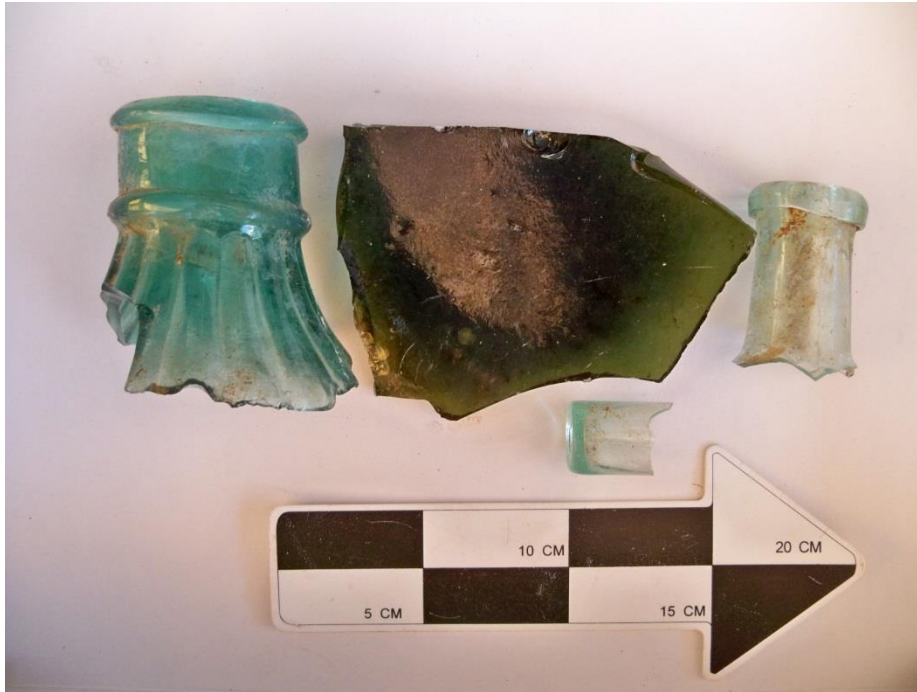
Figure 177. Photograph of Glass Assemblages from Site 7884 Feature 3 Parcel 7 TR324
