APPENDIX Q

Soil Investigation Reports

SUBSURFACE INVESTIGATION REPORT
MASS GRADING FOR LOT 2A
PIILANI PROMENADE NORTH SHOPPING CENTER
KIHEI, MAUI, HAWAII

August 15, 2011

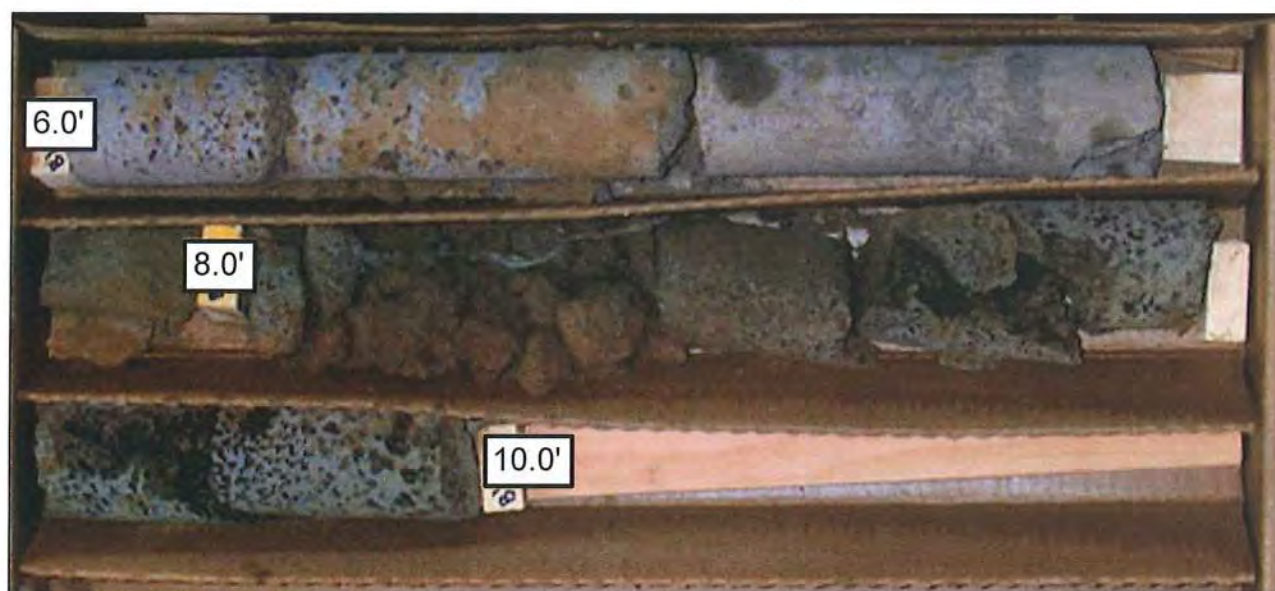
Boring 1: 6.0'-10.0'

ROCK CORE PHOTOGRAPH

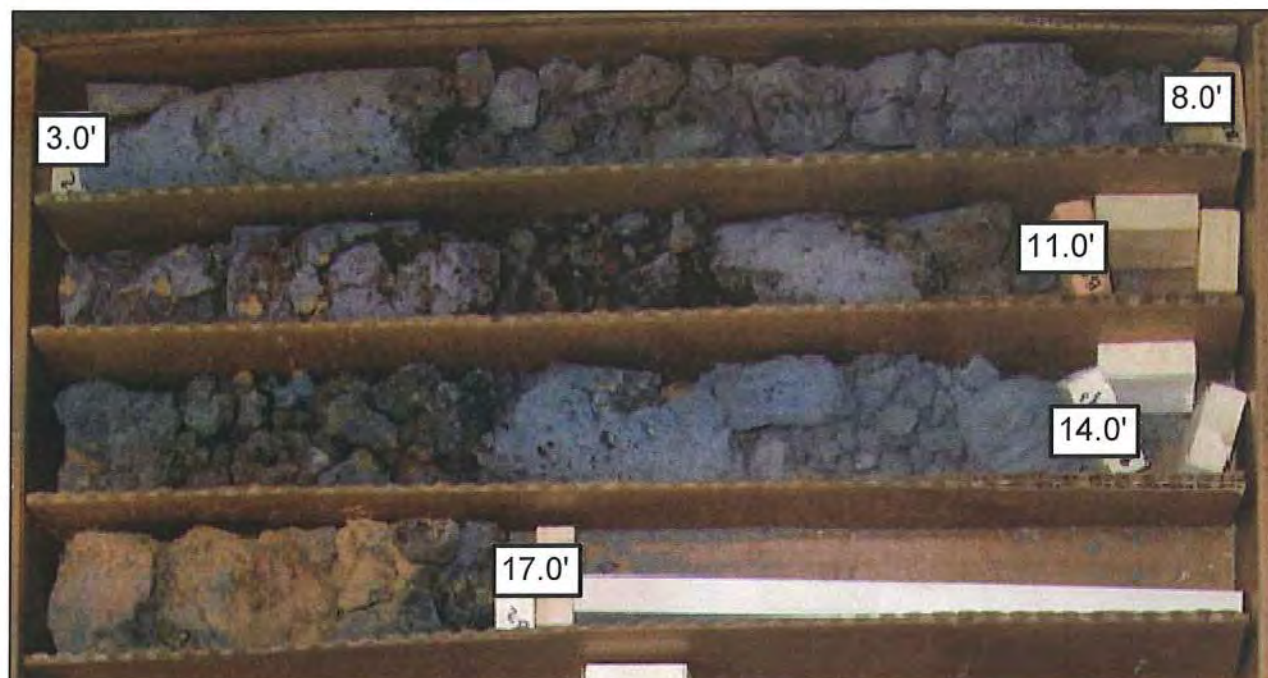
Boring 2: 3.0'-17.0'

ROCK CORE PHOTOGRAPH
