7.2 Survey Results

Section 8 Historic Property Description

8.1.1 SIHP #50-80-10-354 (NR #72000427), Kawa‘ewa‘e Heiau

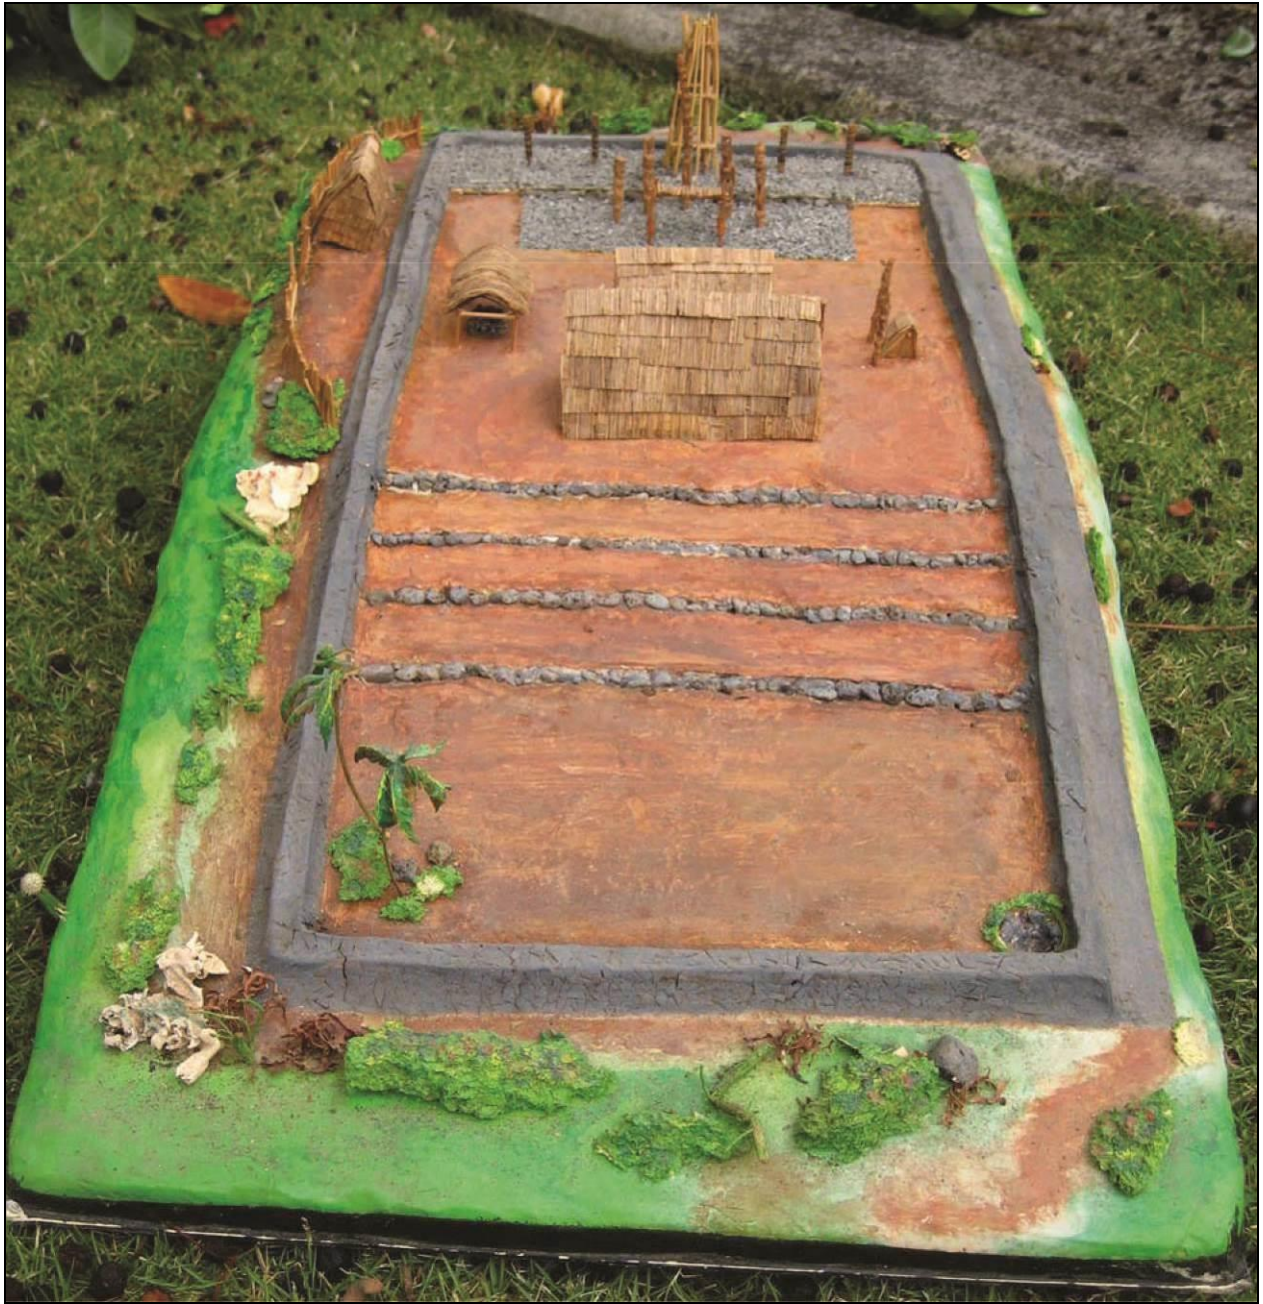
Figure 29. Sketches of Kawa'ewa'e Heiau (SIHP # -354) drawn by Mr. Charlie Ogata (1992) (Hammatt 2008:66)

Mr. Charlie Ogata was a long-time caretaker of Kawa'ewa'e Heiau; this is discussed in a Cultural Impact Assessment written for the property (Hammatt 2008). In 1992, he mapped, diagramed, and created a model replica of Kawa'ewa'e Heiau (Figure 29 and Figure 30) (Hammatt 2008:65-66).

The current investigation found the heiau to be largely covered with low lying vegetation and vines. The current study assessed and ground-truthed Mr. Ogata's (1992) map of the heiau and found it to be quite accurate. The map was amended during the current AIS to include additional features, elevations, and site details recorded using GPS and tape and compass (Figure 34). The heiau walls and previously documented Feature A (small enclosure) were observed to be in good condition (Figure 33 through Figure 38). Several additional features were documented and added to the plan map, including terraces (possible ramp) along the southeast exterior of the heiau (Feature 2A & 2B), a low L-shaped stone terrace within the northeast interior of the heiau (Feature 4A), rock-lined, circular pits in the southwest interior corner of the heiau (Features 6A1-6A4), a large stone-faced terrace running parallel to the west exterior heiau wall (Feature 6B), a stepped wall with circular planting alignments on the northwest exterior of the heiau wall (Feature 7A), and several earthen pits located outside the heiau walls on the north side of the site (Features 8A-D). Feature designations are based off McAllister's (1933) site description, with Feature 2 being the southeast wall, Feature 4 being the interior of the heiau, Feature 6 being the west, downslope walls, and Feature 8 being an exterior terrace area on the north side of the heiau (refer to Figure 28).

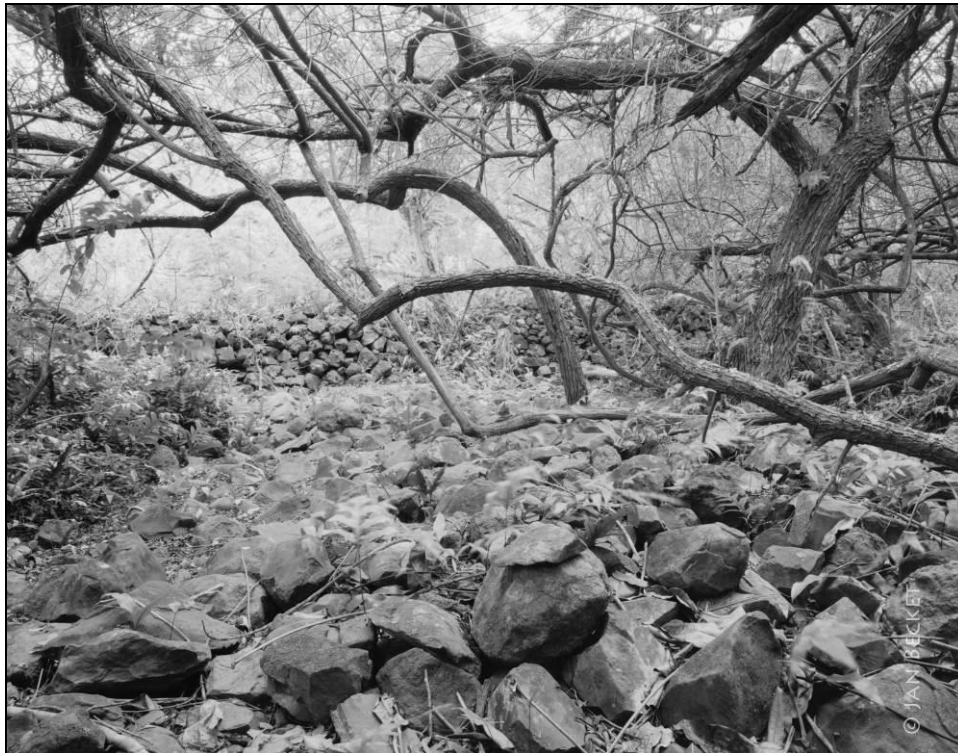
Figure 31. Photo of Kawa'ewa'e Heiau, view to north (Jan Becket 1995, permission of author)

From the 1990s to early 2000, the site was maintained by local community stewards. Photographs taken in 1995 by historian and photographer Jan Becket provide an unobstructed view from the site towards Kāne'ohē Bay and show stone-paved surface features within the ground surface of the heiau (documented during the current study as Feature 4A) (Figure 31 and Figure 32).

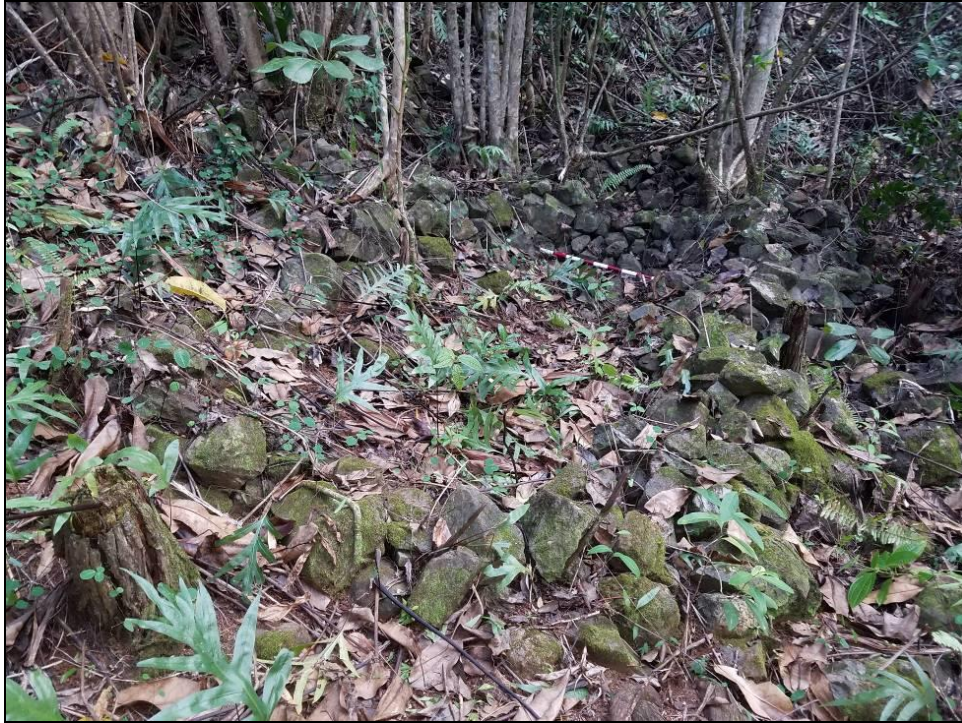
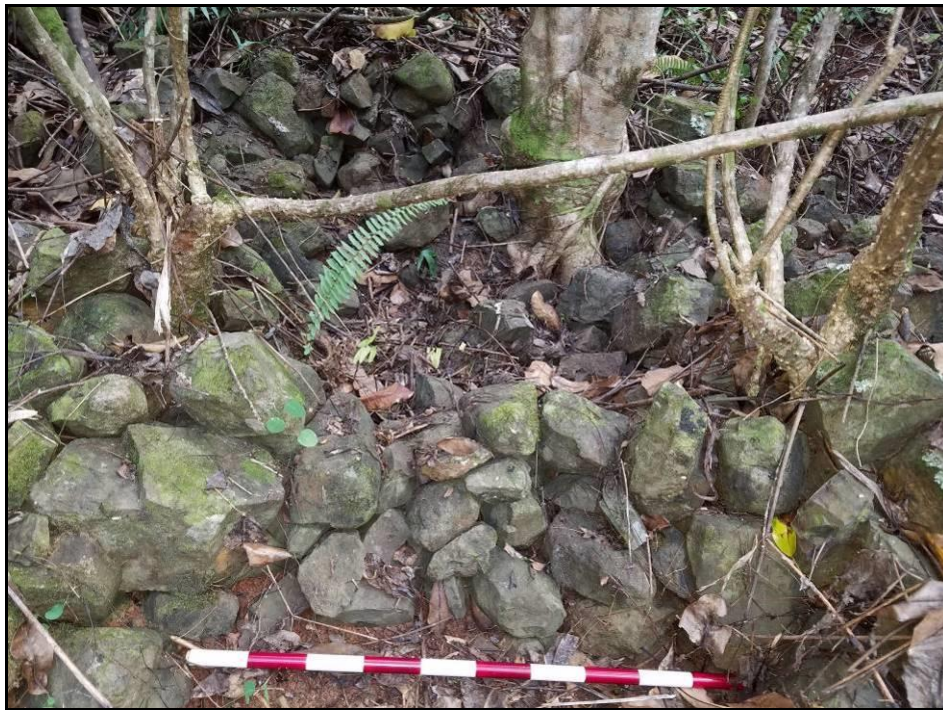
Figure 36. Photo of SIHP -354, Feature A (two-sectioned enclosure) (Section 1), view to west

Figure 37. Photo of SIHP -354, Feature A (two-sectioned enclosure) (Section 2) from inside the feature, view to northwest

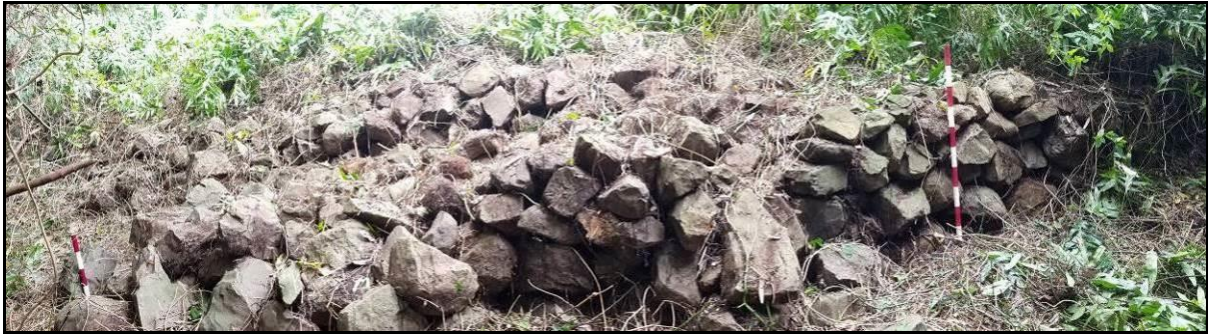
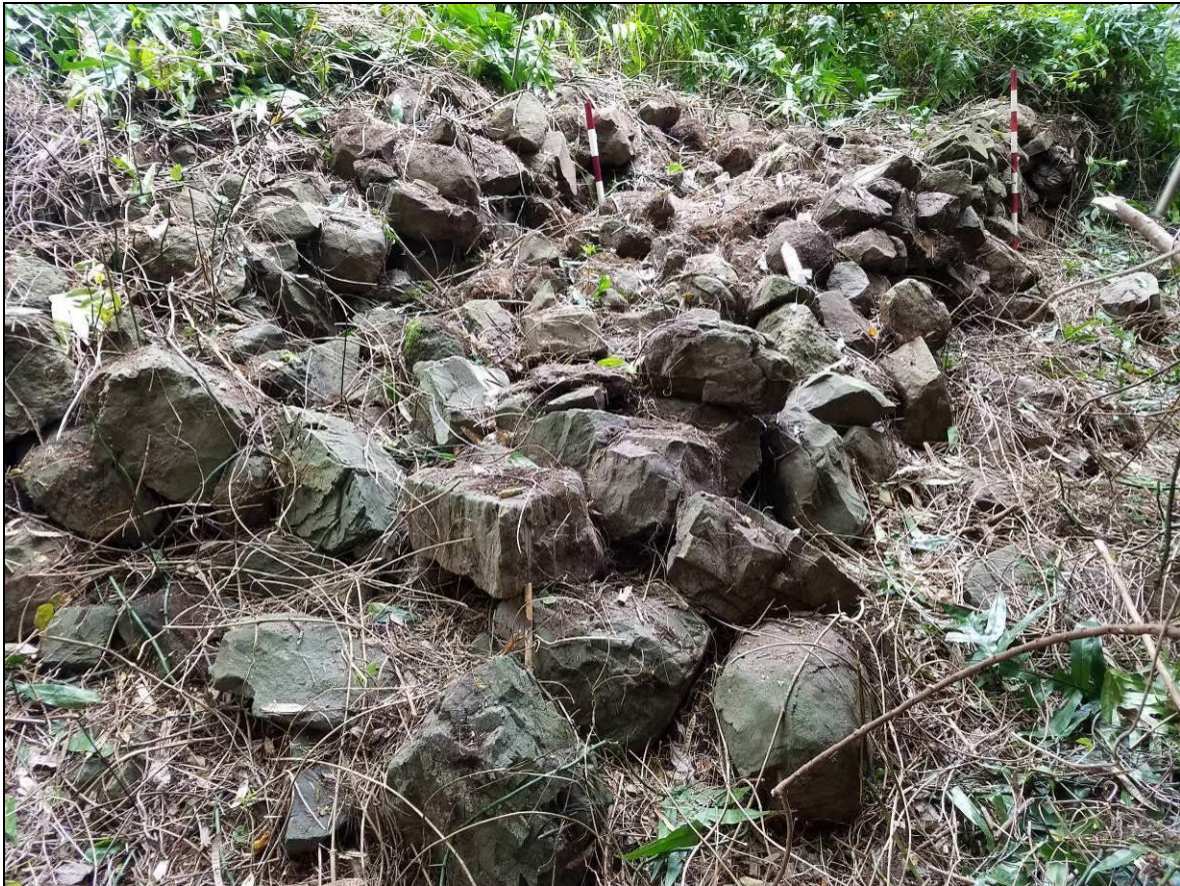
Feature 2A and 2B are well constructed stone terraces located on the southeast exterior of the heiau. Feature 2A is constructed with a downward incline to the east, similar to a ramp, and is built adjacent to the exterior of the heiau wall (Figure 39 and Figure 40). Feature 2A is constructed of small to medium-sized basalt boulders stacked 3-5 courses high, measuring approximately 160 cm wide N/S, and ranging in height from approximately 76 cm near the west end and 43 cm at the east end. Feature 2A was originally documented by McAllister (1933:180) as “the last 20 feet on [the] east end of [the] south wall has [the] appearance of a double wall, the smaller, outer additional wall rising in an incline to height of regular wall, together the walls are 10 feet wide”. This also matches the account provided by Mr. Ogata recorded within the Hammatt (2008:63) CIA which describes a possible ramped entrance along the southeast exterior of the heiau wall.

Figure 39. Photo showing the exterior of Kawa'ewa'e Heiau, SIHP # -354, Feature 2 (heiau wall, in background) and Feature 2A (ramped wall terrace, in foreground), view to northwest (panorama)

Figure 40. Photo showing SIHP # -354, Feature 2 (exterior heiau wall, on left) and Feature 2A (ramped terrace, in center), view to north

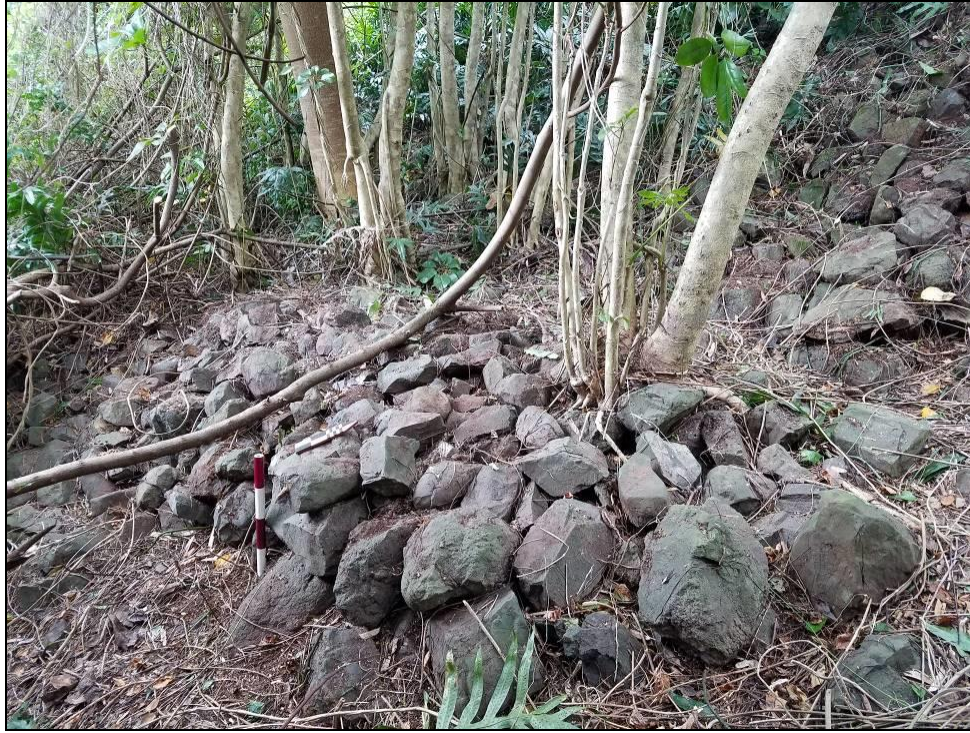
Feature 2B is a large terrace that is not continuous with Feature 2A, rather it is approximately 1.5 m to the southwest. Feature 2B consists of small boulders and cobbles piled 3-4 courses in height, measuring between 1.5-2 m in width N/S by approximately 10 m long E/W, and ranging from approximately 20-60 cm tall. The length of Feature 2B is only approximated due to the very dense surrounding vegetation. Feature 2B was photographed without as thick of vegetation during the Hammatt (2008:69) study (see Figure 42).

Figure 41. Photo showing Feature 2B (terrace), view to west

Figure 42. Photo from Hammatt (2008:69) showing Feature 2B (terrace), view to northeast

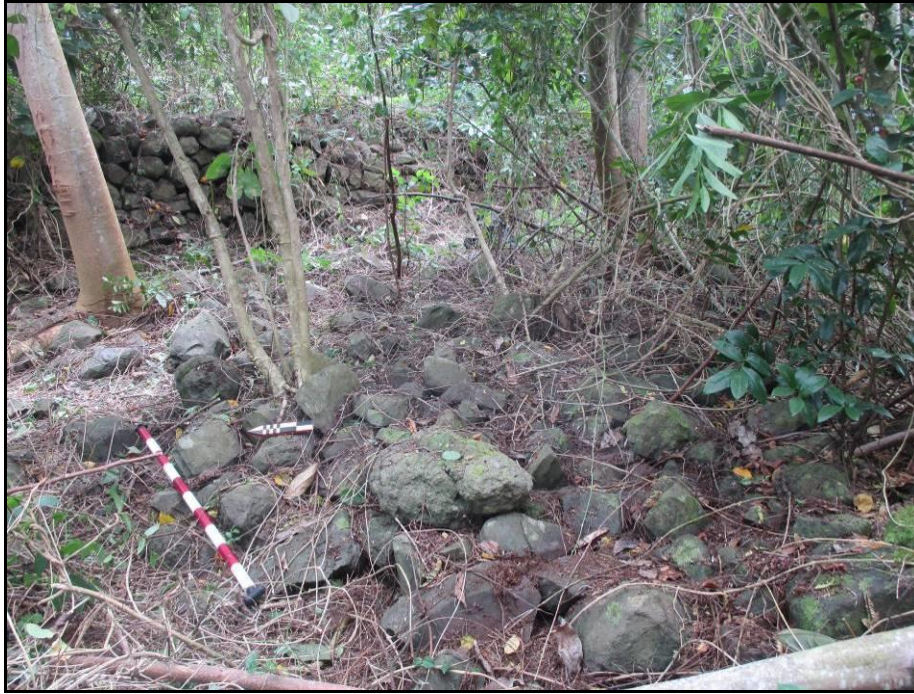
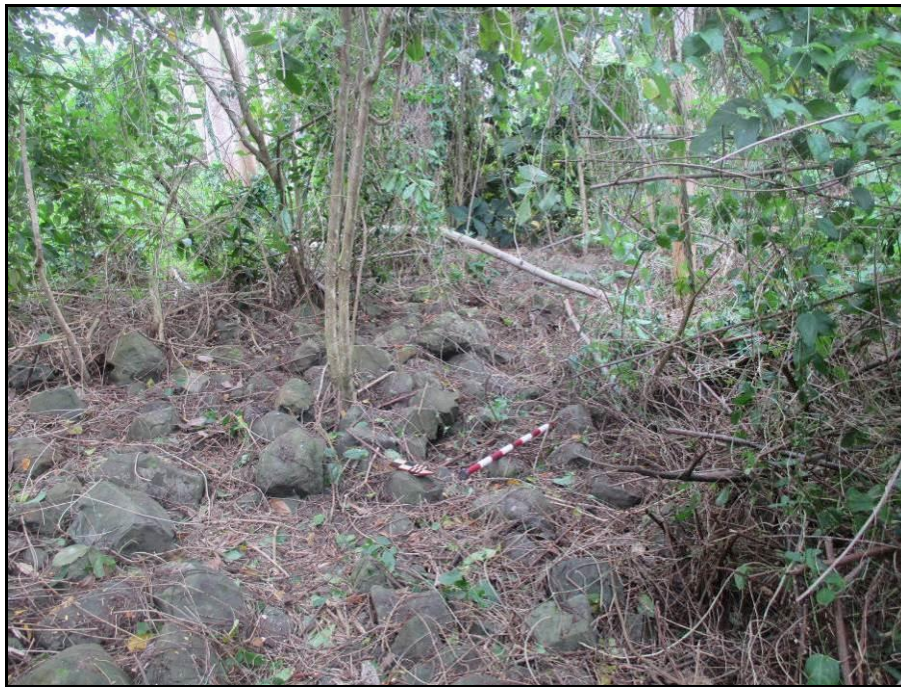
Feature 4A is an L-shaped, low stone terrace within the northeast interior of Kawa‘ewa‘e Heiau (Figure 43 and Figure 44). The terrace measures approximately 12 m N/S by 12 m E/W by 42 cm tall and stretches from the east wall of the heiau to the north wall. The function of the feature is likely for ceremonial activities. A 75 cm diameter pit, approximately 34 cm deep, is situated within the west corner of the stone-paved terrace surface. The pit may be a refuse feature, fire pit, or have another unknown function. This terrace is the same feature photographed by Jan Becket in 1995 (refer to Figure 32).

Figure 43. Photo within SIHP # -354, showing Feature 4A (low stone terrace, in foreground) and the east interior wall of the heiau (Feature 3) (in background), view to east

Figure 44. Photo within SIHP # -354, showing Feature 4A (low stone terrace) and a circular pit constructed within the feature (at photo scale), view to southeast

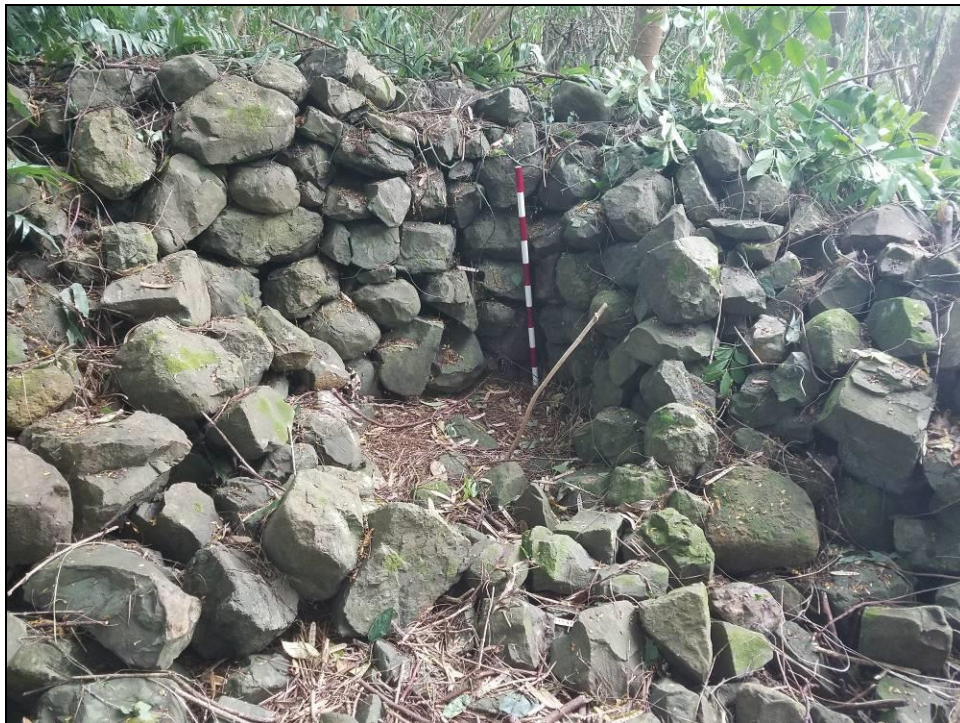
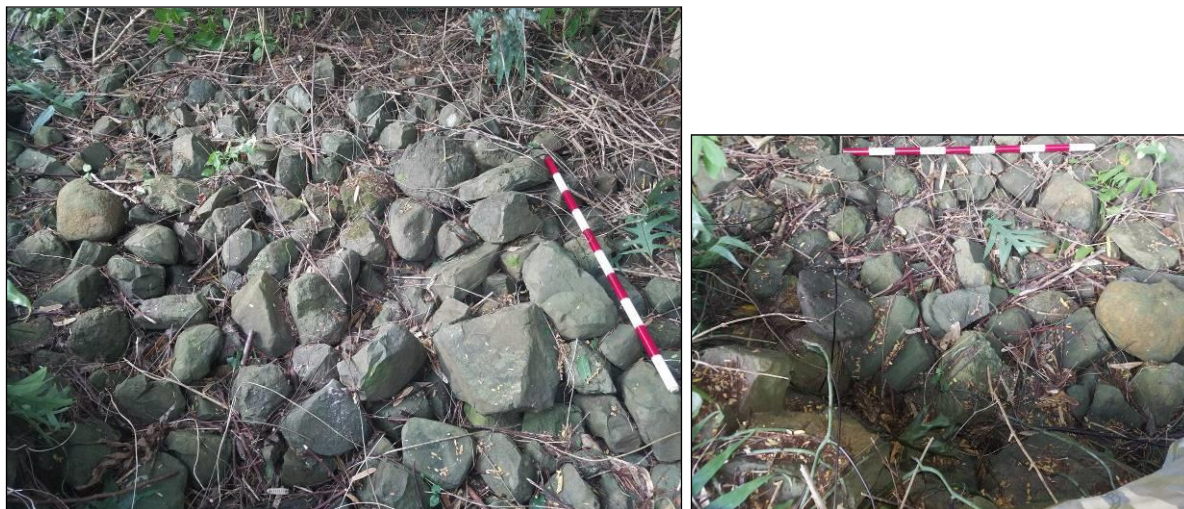
Feature 6A includes several stone-lined circular pits within the southwest interior corner of the heiau (Features 6A1-6A4) (Figure 45 and Figure 46). Feature 6A1 is a large, stone-lined pit measuring approximately 120 cm in diameter and ranging from 25-45 cm in depth, situated adjacent to the intersection of the well-constructed and nicely faced, south and west walls of the heiau. Feature 6A1 is discussed by Mr. Ogata in Hammatt (2008: 63, 68) as a lua pit, for disposal of temple offerings. Adjacent to Feature 6A1 and the west wall of the heiau is a stone pavement with several circular, stone-lined features resembling filled pukas (holes) (Features 6A2-6A4). Feature 6A2 is approximately 25 cm in diameter and 30 cm deep. Feature 6A3 is approximately 15 cm in diameter and 22 cm deep. Feature 6A4 is approximately 1 m in diameter and 15 cm deep. The pits may have been used to support carved images.

Figure 45. Photo showing SIHP # -354, Feature 6A1 (circular alignment), view to south

Figure 46. Photos showing SIHP -354, Feature 6A2-A4 (stone paving containing circular alignments), view to northwest (left photo: notice two circular alignments, Features 6A2 [center of photo] and 6A3 [center left]; right photo: shows one large circular alignment, Feature 6A4)

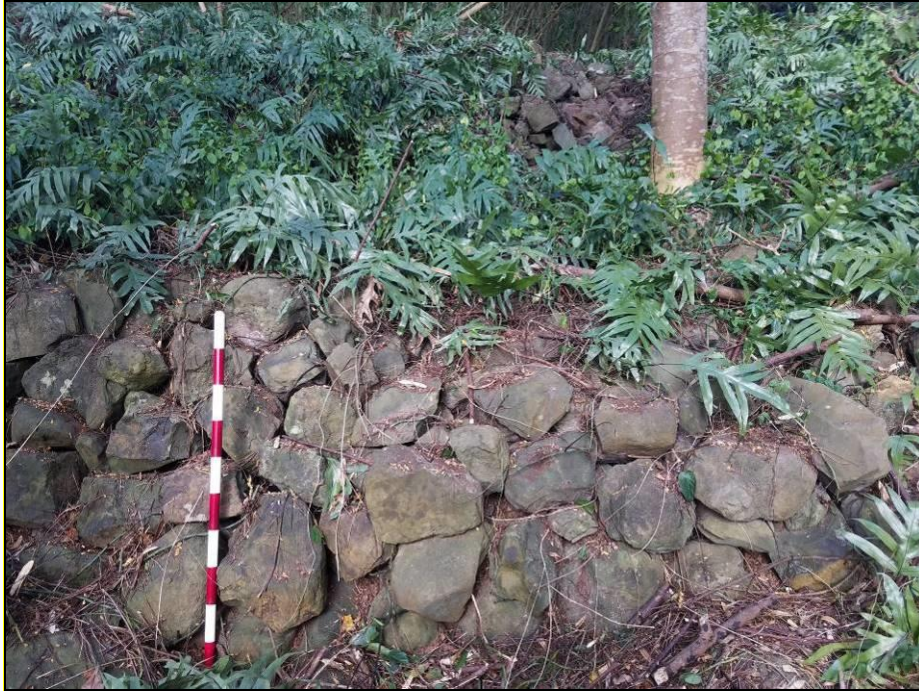
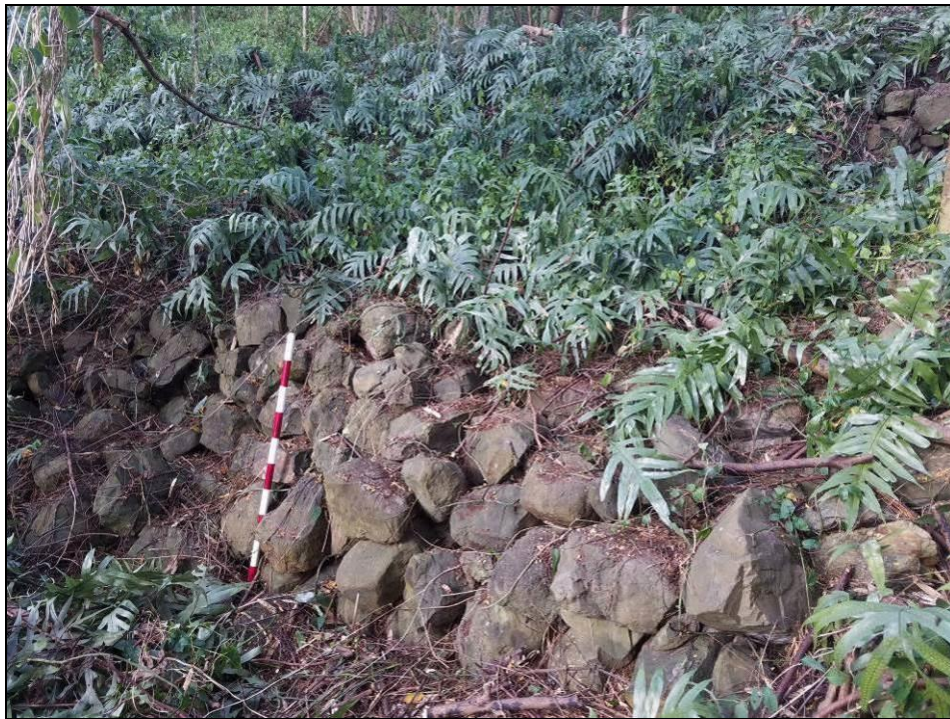
Feature 6B is a large stone-faced terrace that runs parallel to the exterior of the west heiau wall (Figure 47 and Figure 48). The terrace measures approximately 20 m long N/S by 3 m wide E/W and ranges from approximately 108 cm tall on the south end to 20 cm tall on the north end. The surface of the terrace is relatively flat and covered in thick laua‘e fern.

Figure 47. Photo showing SIHP # -354, Feature 6B (terrace), view to northeast (notice the west wall of Kawa'ewa'e Heiau in background)

Figure 48. Photo showing SIHP # -354, Feature 6B (terrace), view to north

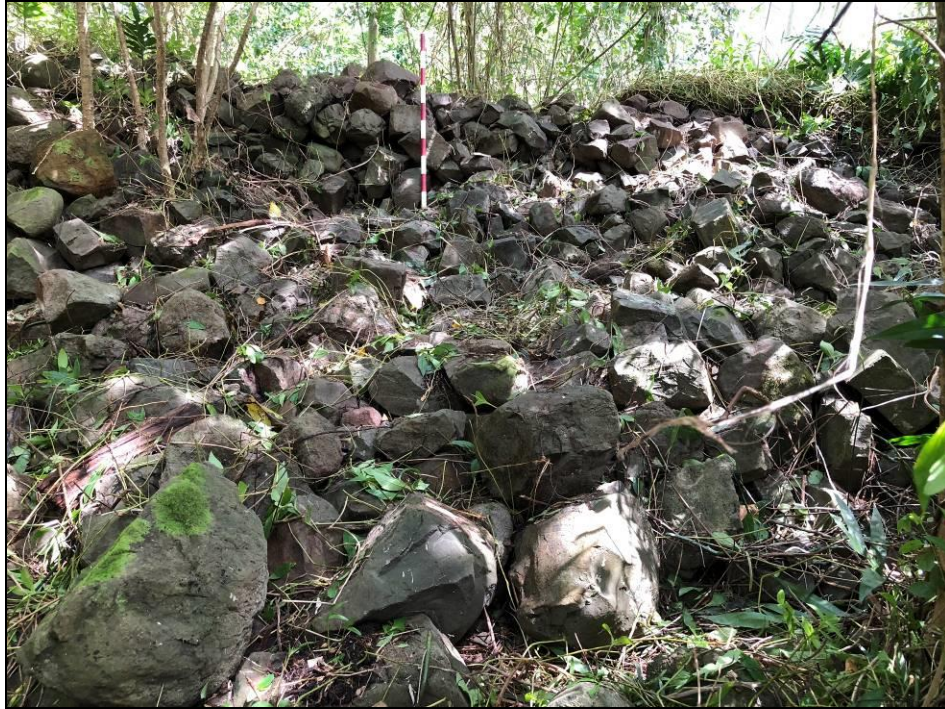
Feature 7A is a stepped, stone wall on the exterior of the northwest side of the heiau (Figure 49). The step is shown on the McAllister (1933) plan map (refer to Figure 28). The stepped wall is not well defined. However, on the northwest exterior wall (Feature 7A) the step is in relatively good condition and is approximately 60 cm in height, abutting the adjacent northwest wall (Feature 7) which is 160 cm tall. The stepped-wall on the northwest exterior contains a semi-

Figure 49. Photo showing SIHP # -354, Feature 7A (stepped heiau wall), view to south

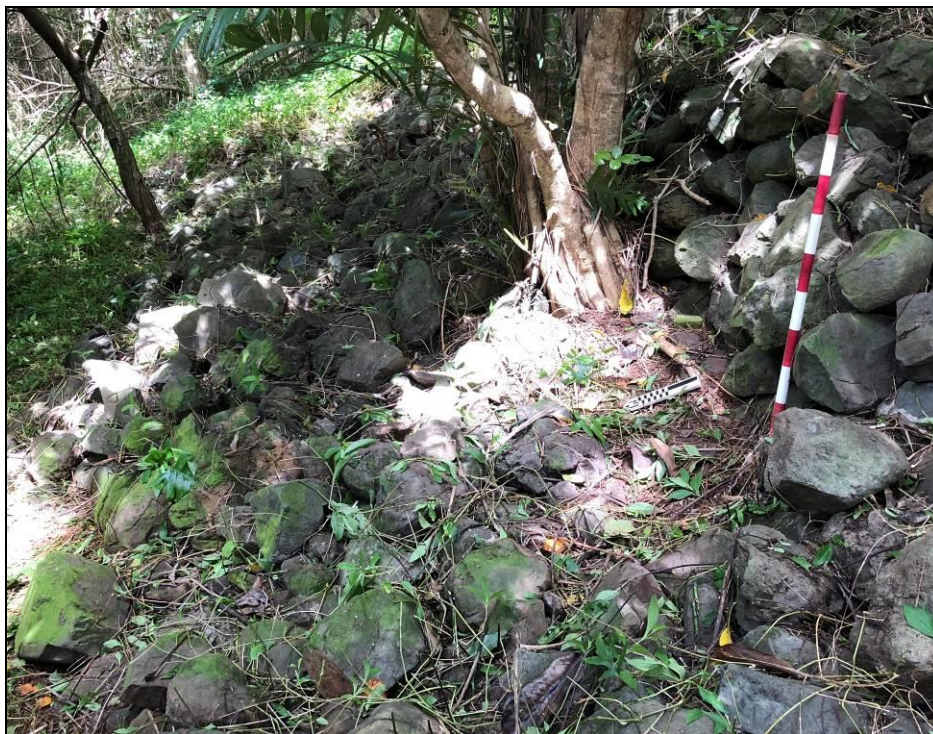
circular construction containing several circular alignments which appear to be potential planting circles (Figure 50). This area likely corresponds with the account provided by Mr. Ogata, recorded within the Hammatt (2008:63) CIA, which describes possible steps leading to the heiau adjacent to the northwest exterior.

Figure 50. Photo showing SIHP # -354, Feature 7A (circular alignments [center and lower left foreground]), view to east

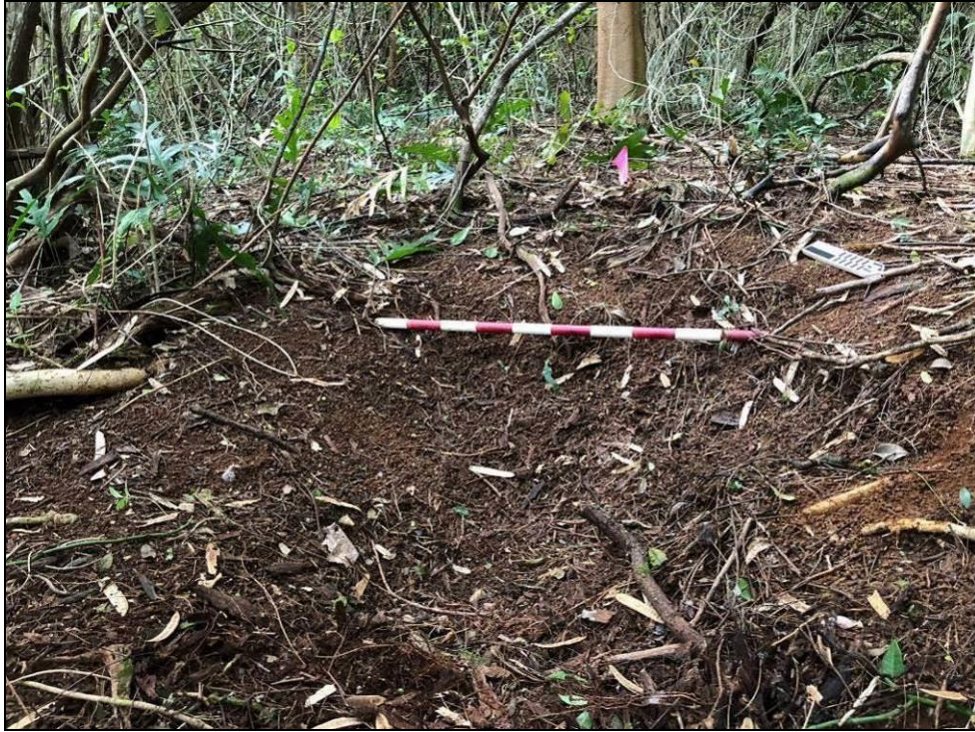
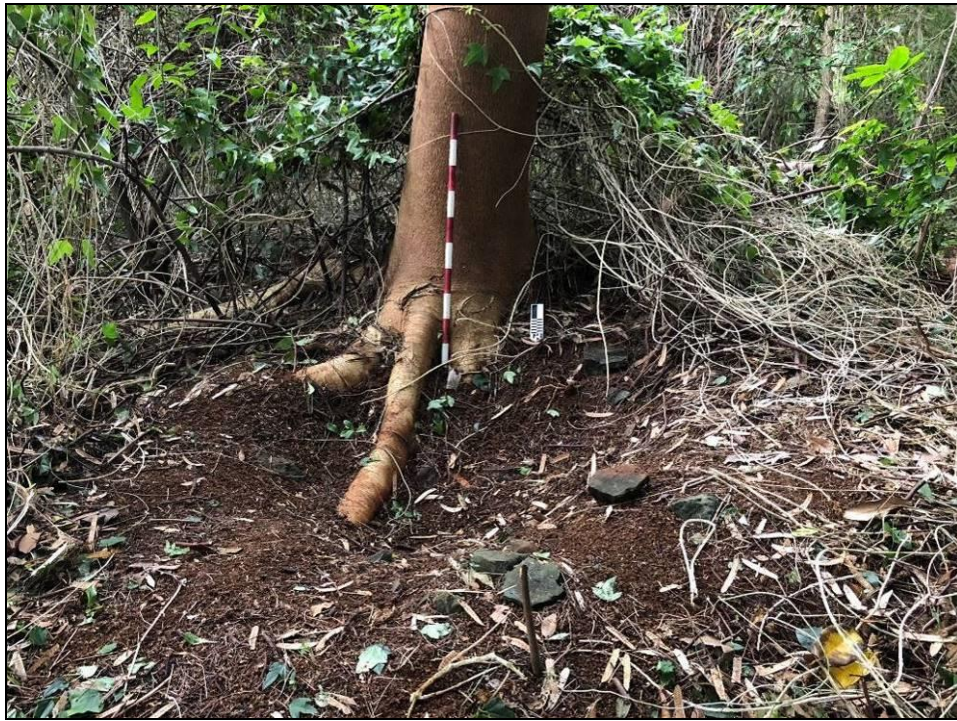
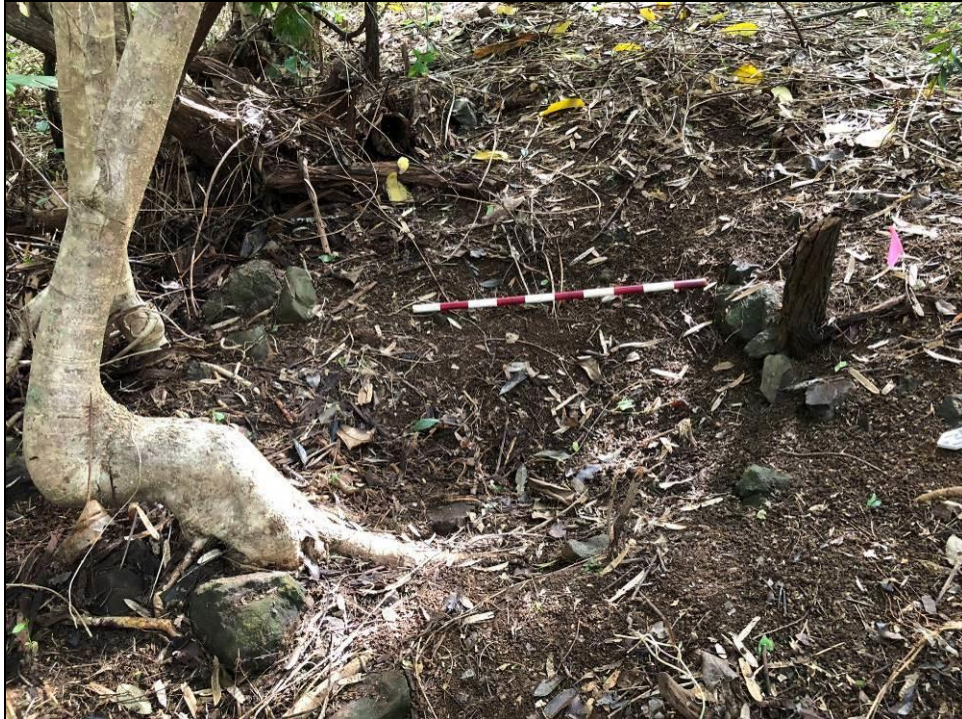
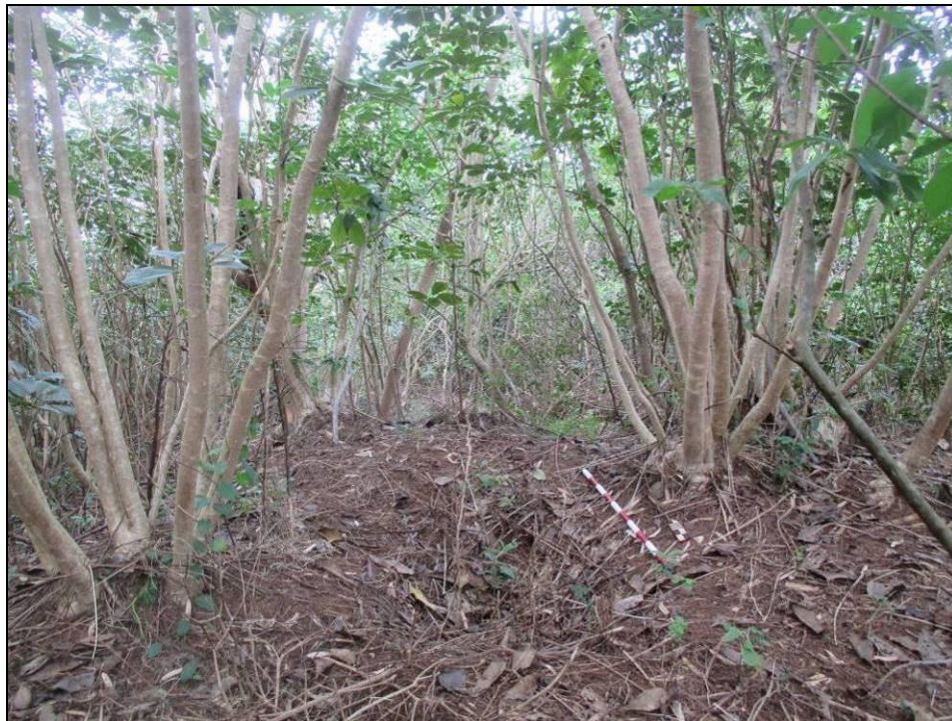
Features 8A-D include four earthen pits located just north of the heiau (Figure 51 through Figure 54). The earthen pits range from 1-1.65 m in diameter and 40-65 cm deep. Similar earthen pits, referred to as lua, are found near heiau throughout Hawai'i and are thought to have been used for disposal of temple offerings (Buck 1957, Shimizu 1980).

Figure 51. Photo of SIHP # -354, Feature 8A (earthen pit), view to southwest

Figure 52. Photo showing SIHP # -354, Feature 8B (earthen pit), view to south

Figure 53. Photo showing SIHP # -354, Feature 8C (earthen pit), view to east

Figure 54. Photo showing SIHP # -354, Feature 8D (earthen pit), view to north

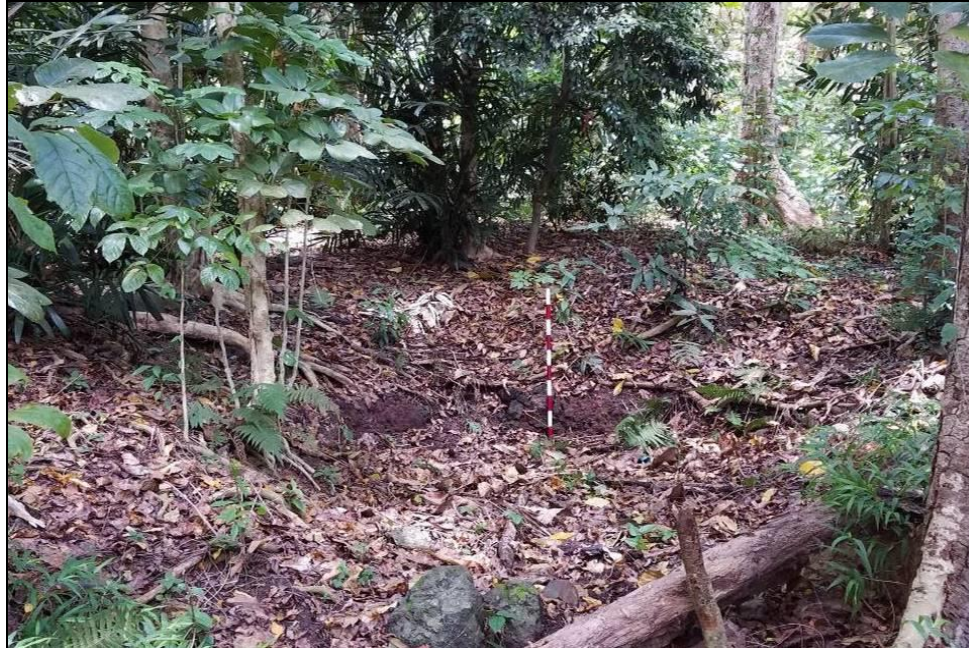
The current investigation re-located SIHP # -4683 and found the site to be quite similar as previously described, except rather than the site being described as in “poor” condition, it was assessed as being in “fair” condition (Figure 55). The plan map for Feature A (historic charcoal kiln) was amended to include slopes, elevations, and level areas (Figure 56).

Figure 55. Photo of SIHP # -4683, Feature A (pit feature), view to northeast
