8.1.3 SIHP #50-80-10-4684, Traditional Habitation Complex

FORMAL TYPE:	Complex- Enclosures & terracing
FUNCTION:	Habitation
TIME PERIOD:	Pre-Contact
# OF FEATURES:	8 (Features A-H): A (enclosure), B (terrace), C (terrace), D (C-shape), E (circular stone feature), F (C-shape), G (C-shape), H (alignment)
SITE DIMENSIONS:	33 m north/south by 56 m east/west
CONDITION:	Good to Fair
UTM:	N 2366503, E 626091/ 21°23'46.9"N, -157°47'0.9"W

8.1.4 SIHP #50-80-10-6930, Traditional Ceremonial Stone Enclosure

8.1.5 SIHP #50-80-10-6931, Traditional Ceremonial Area

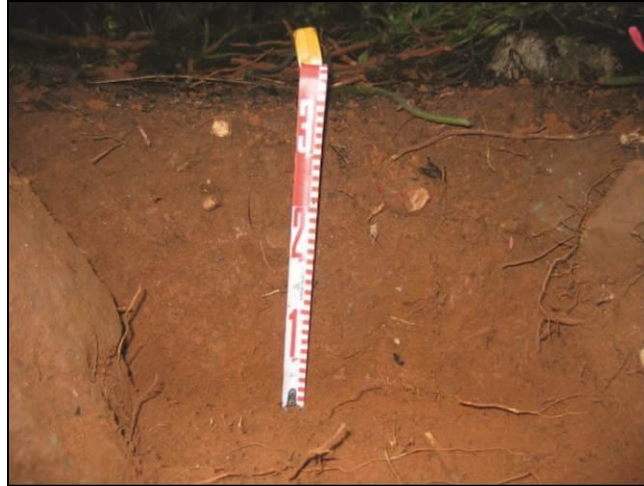
Figure 57. Photo of SIHP # -4684, Feature A, Test Unit 1 Northeast Profile Wall (McCurdy and Hammatt 2009:58)

The test excavation was located in the eastern corner of the enclosure. The test unit was excavated to a terminal depth of 35 cmbs (13.7 in.). A total of three strata were observed, Stratum I was very dark brown, clay loam sediment composed of leaf litter and humus accumulated on and within the basalt stones, mixing with the clay soil below. Stratum II consisted of a dark reddish brown silty clay generally represented soils developed from material filtering down through Features A's construction. Stratum III was dark red silty clay consisting of saprolite developed from the decomposition of the underlying basalt bedrock. The test excavation terminated at sterile Stratum III sediments.

A total of four artifacts were recovered from the excavation, three basalt flakes and a small piece of brown bottle glass. Two of the basalt flakes were recovered from between 10 and 20 cmbs (4-8 in.). The remaining flake and a single piece of brown bottle glass were recovered from 20 to 30 cmbs (8-11.8 in.). All artifacts were recovered from Stratum II.

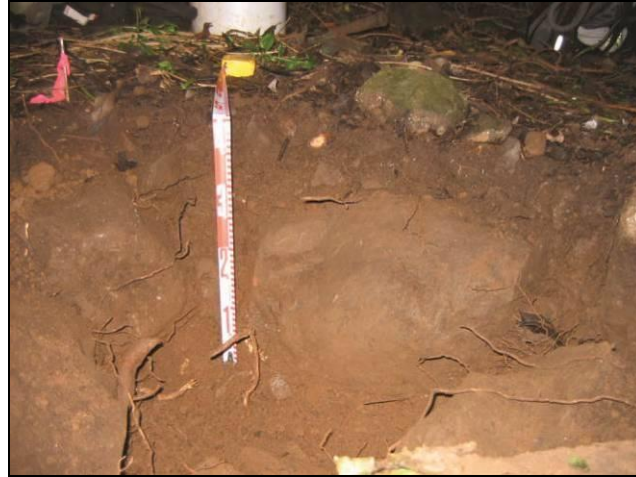
Figure 59. Photo of SIHP # -4684, Feature F, Test Unit 2 Southeast Profile Wall (McCurdy and Hammatt 2009:61)

The test excavation was placed within Feature F, along the southeastern wall. The test unit was related to a terminal depth of 40 cmbs (15.7 in.). The stratigraphy was similar to Test Unit 1. Stratum I was very dark brown, clay loam with greater than fifty percent basalt stone inclusions. Stratum II consisted of a dark reddish brown silty clay and Stratum III was dark red silty clay. The test excavation terminated at sterile Stratum III sediments. No artifacts were recovered from this excavation.

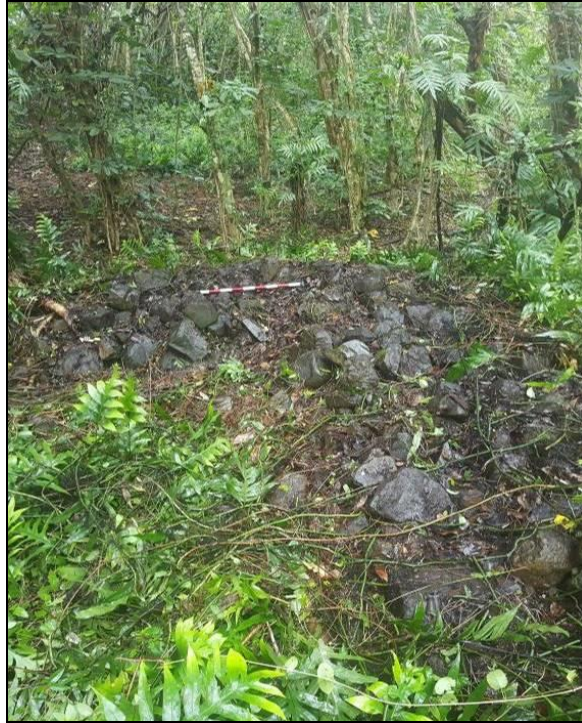
Feature A is an enclosure consisting of stacked basalt walls, the eastern corner is the highest standing approximately 45 cm above the ground surface. The north wall measures 7 m with the disturbed NW corner having little to no height; the west wall measures 4.2 m, and is badly disturbed with no height. The east collapsed wall measures 7.5 m by 40 cm high, and the southern wall measures 7 by 3.5 m. The interior of the enclosure provides a space of approximately 5 x 7 m and is mostly soil with scattered rocks. A 1 by 1 m test unit (TU1) was placed inside Feature A in the eastern corner.

Figure 62. Photo showing SIHP # -4684, Feature A (c-shape), view to east

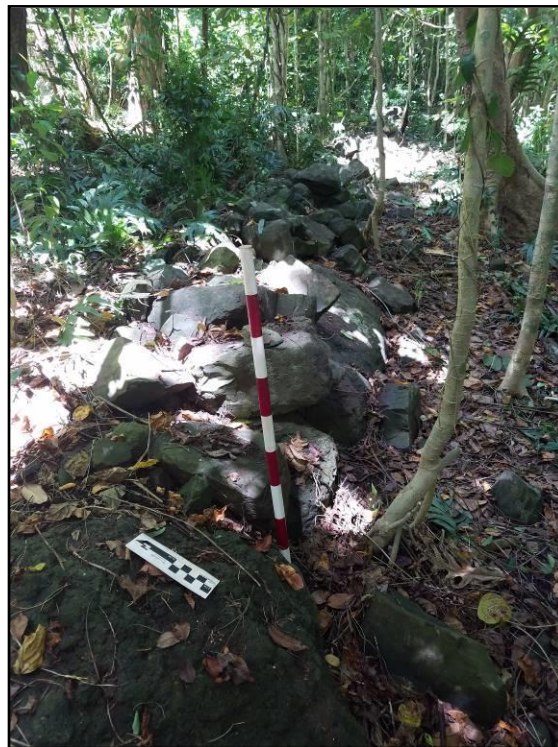
Feature B is a stacked basalt cobble/boulder terrace wall located southwest of Feature A. It measures 19 m long running at 262 degrees east of north and ranges in height from 0 to 80 cm.

Figure 63. Photo showing SIHP # -4684, Feature B (terrace), view to southeast

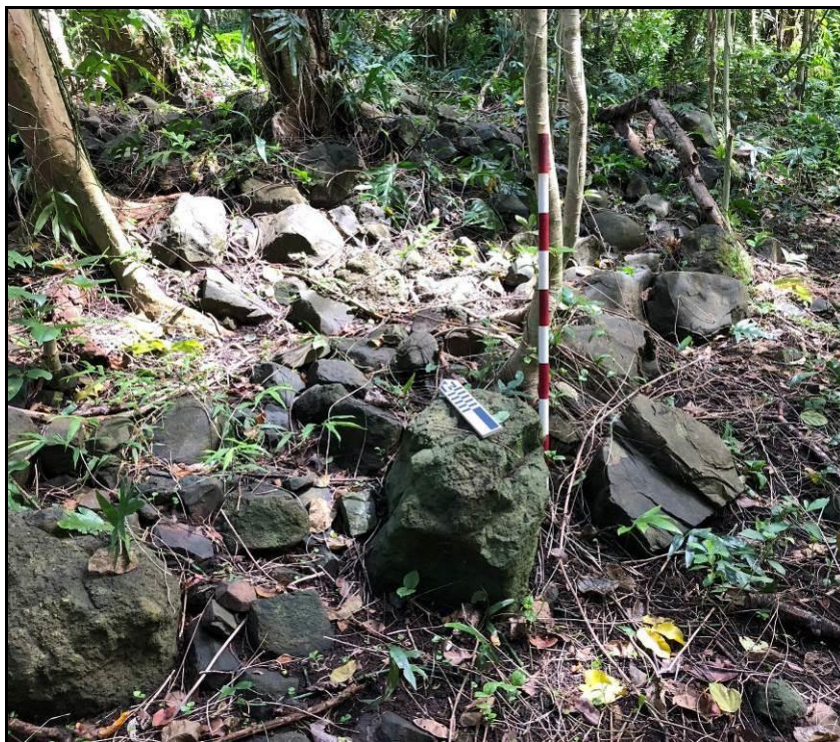
Feature C is a stacked basalt cobble and boulder wall forming an “L” shaped terrace with the long segment measuring 20 m oriented at 333 degrees and the shorter segment measuring 7 m oriented at 252 degrees. This feature appears to be mostly collapsed, with the highest portion at 50 cm. It encloses 3 apparent c-shaped features and a possible hearth.

Figure 64. Photo showing SIHP # -4684, Feature C (terrace) (south portion), view to northeast

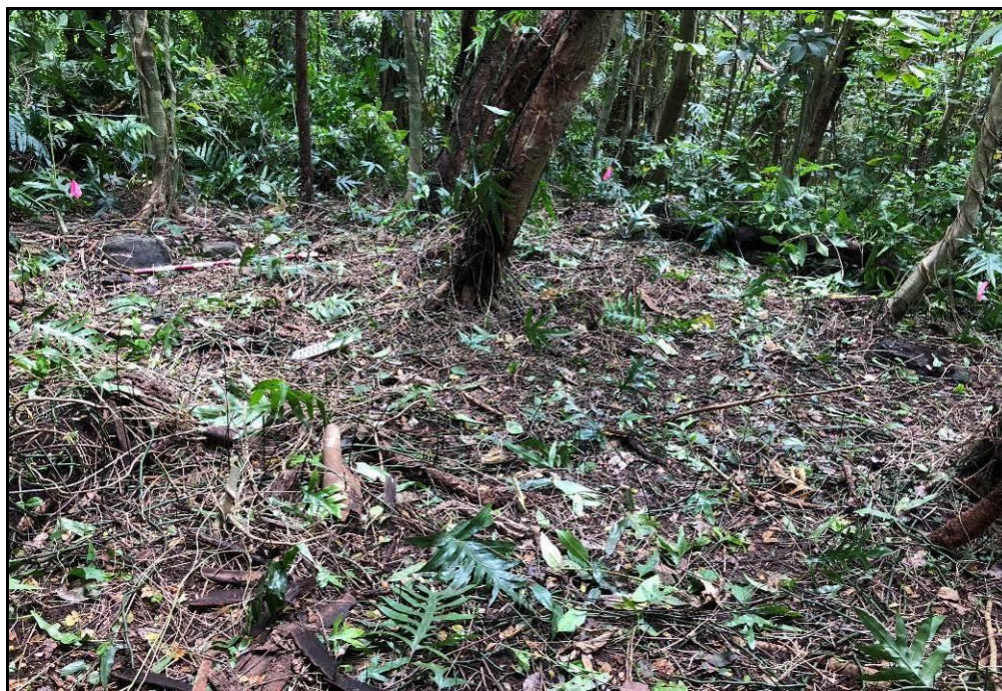
Feature D is a c-shaped feature consisting of basalt boulders and large cobbles. It measures 4 by 3.5 m and opens to the southwest.

Figure 65. Photo showing SIHP # -4684, Feature D (c-shape), view to southeast

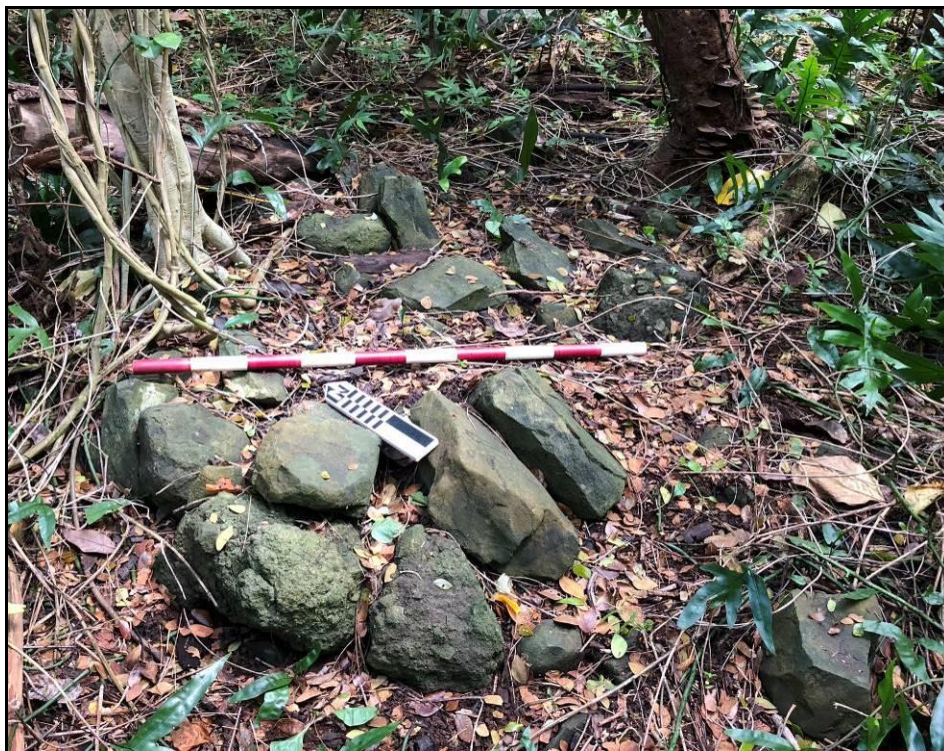
Feature E is a circular rock feature, possibly a hearth, measuring 2.3 m in diameter and 30 cm in height. It is located near the 3 c-shaped habitation features (Features D, F and G).

Figure 66. Photo showing SIHP # -4684, Feature E (circular stone feature), view to northeast

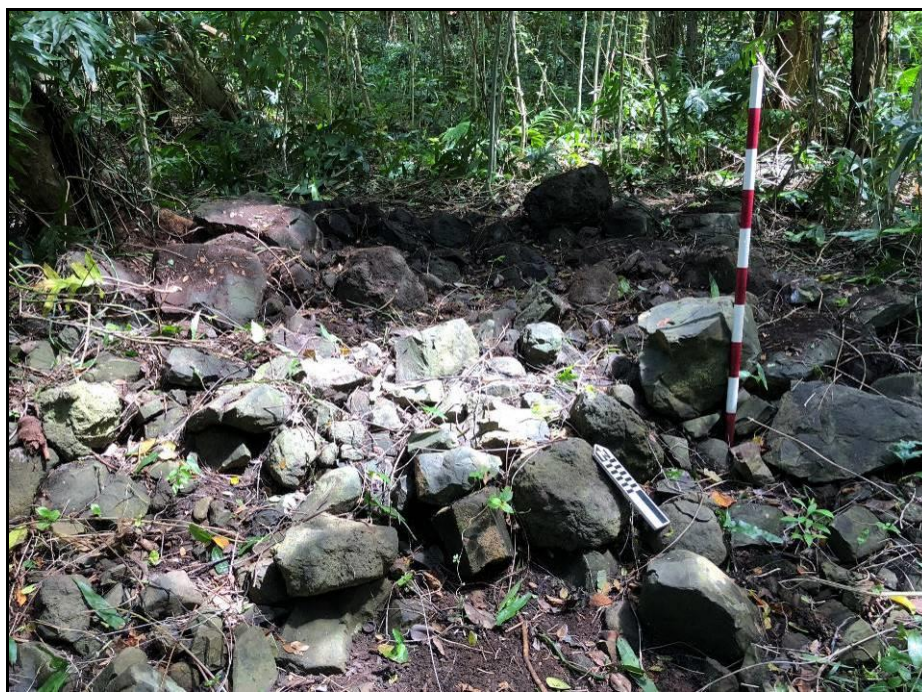
Feature F is a c-shaped feature consisting of basalt boulders and large cobbles. It measures 4 by 4 m and opens to the southwest. Contiguous to the southwest is Feature C and about 4.5 m to the Northwest is Feature E. A 1 by 1 m test unit (TU2) was placed in the middle of Feature F.

Figure 67. Photo showing SIHP # -4684, Feature F (c-shape), view northeast

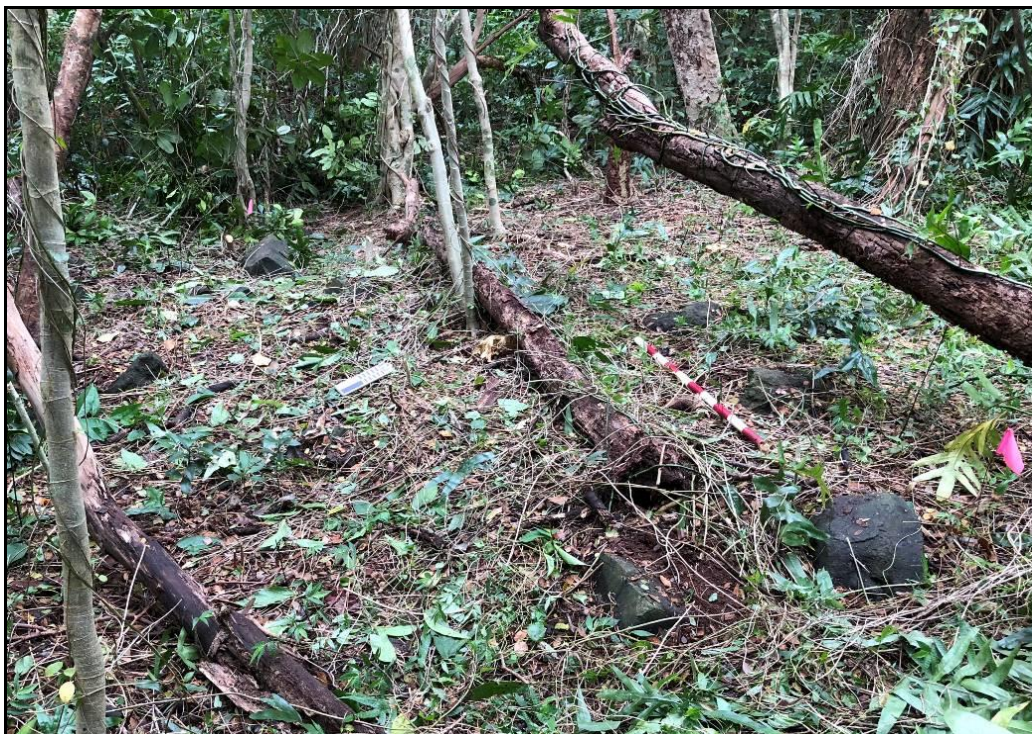
Feature G is a highly eroded c-shaped feature (damaged from unknown processes) consisting of basalt boulders and large coal cobbles. It is located about 6 m NW of Feature F, about 3 m north of Feature E. Feature G measures approximately 4 m in diameter and a single course of cobbles/boulders is intermittently present along its circumference.

Figure 68. Photo showing SIHP # -4684, Feature G (c-shape), view to northwest

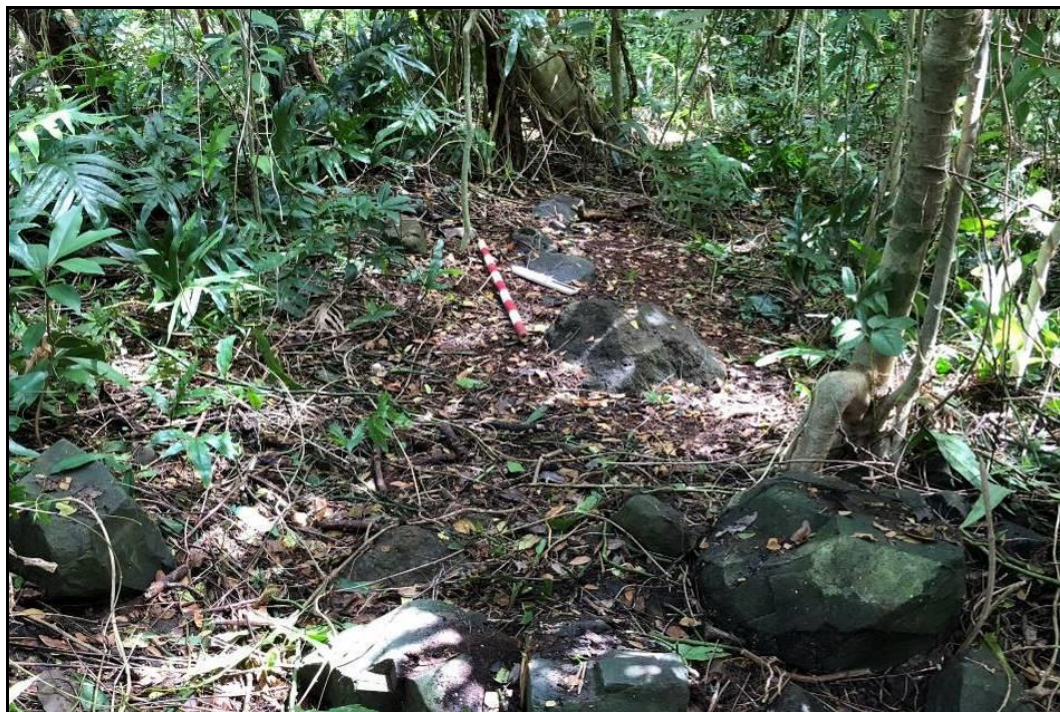
Figure 69. Photo showing SIHP # -4684, Feature H (stone alignment), view to east

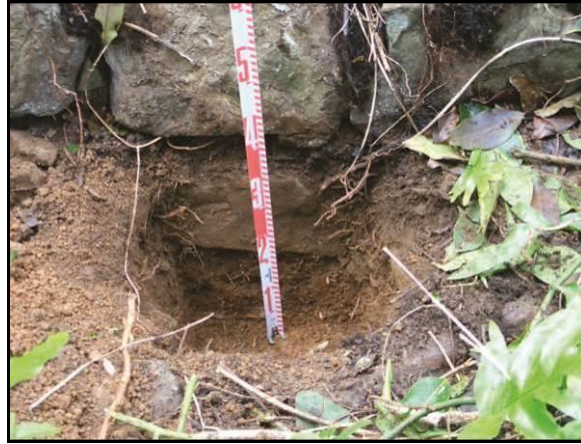
Test Unit 1 was excavated to a depth of 37 cmbs (14.5 in). A total of three strata were observed, Stratum I was dark brown, clay loam sediment composed of leaf litter and humus. Stratum II consisted of a strong brown silty clay and Stratum III was yellow red clay. The wall of the enclosure continues at least one course, 20 cm (7.9 in) below the ground surface. No artifacts or cultural features were observed during this excavation.

Figure 70. Photo of SIHP # 6930 (enclosure), Test Unit 1, view south (McCurdy and Hammatt 2009:71)

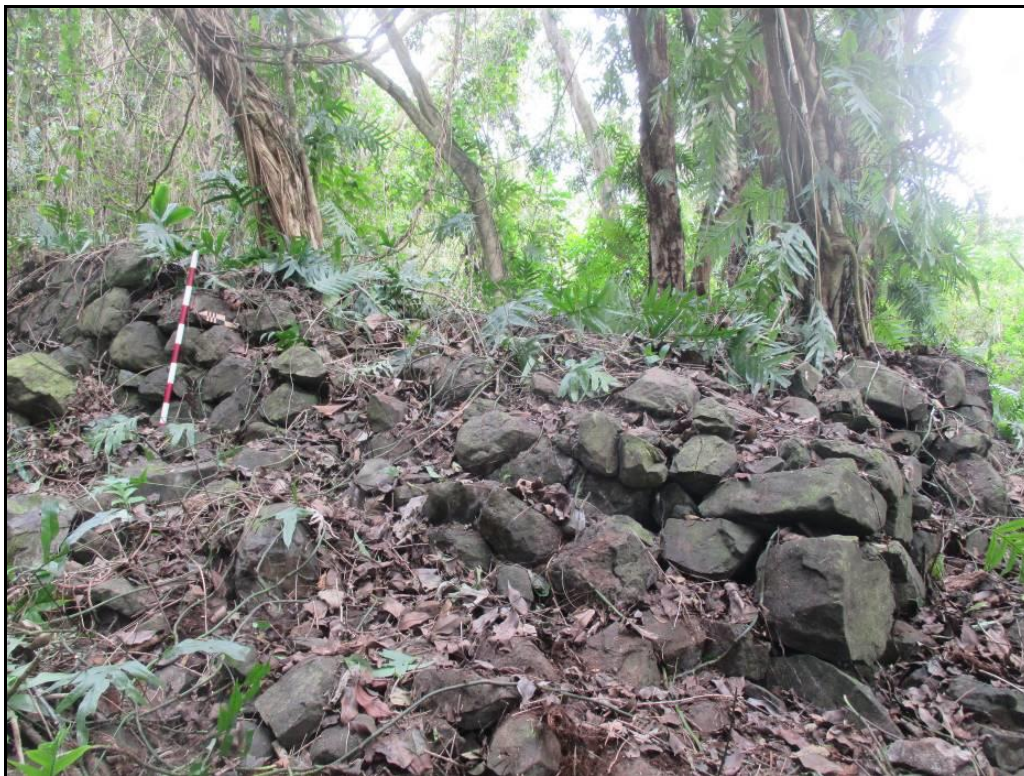
Figure 73. Photo of SIHP # -6930 (enclosure, north wall in foreground), view to south

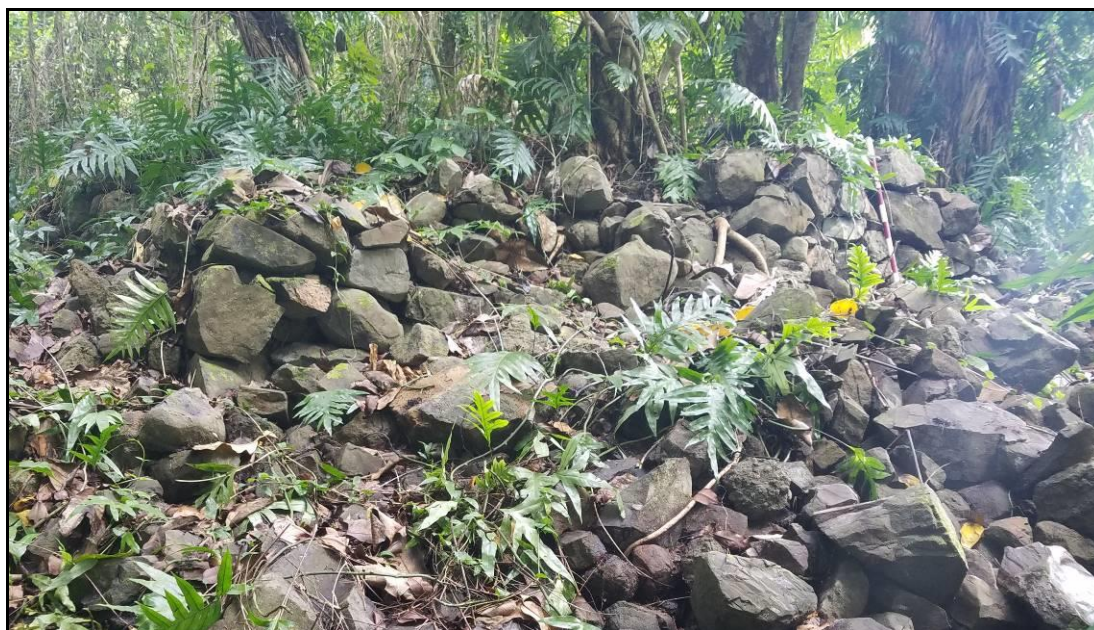
Figure 74. Photo of SIHP # -6930 (enclosure, west wall), view to southeast

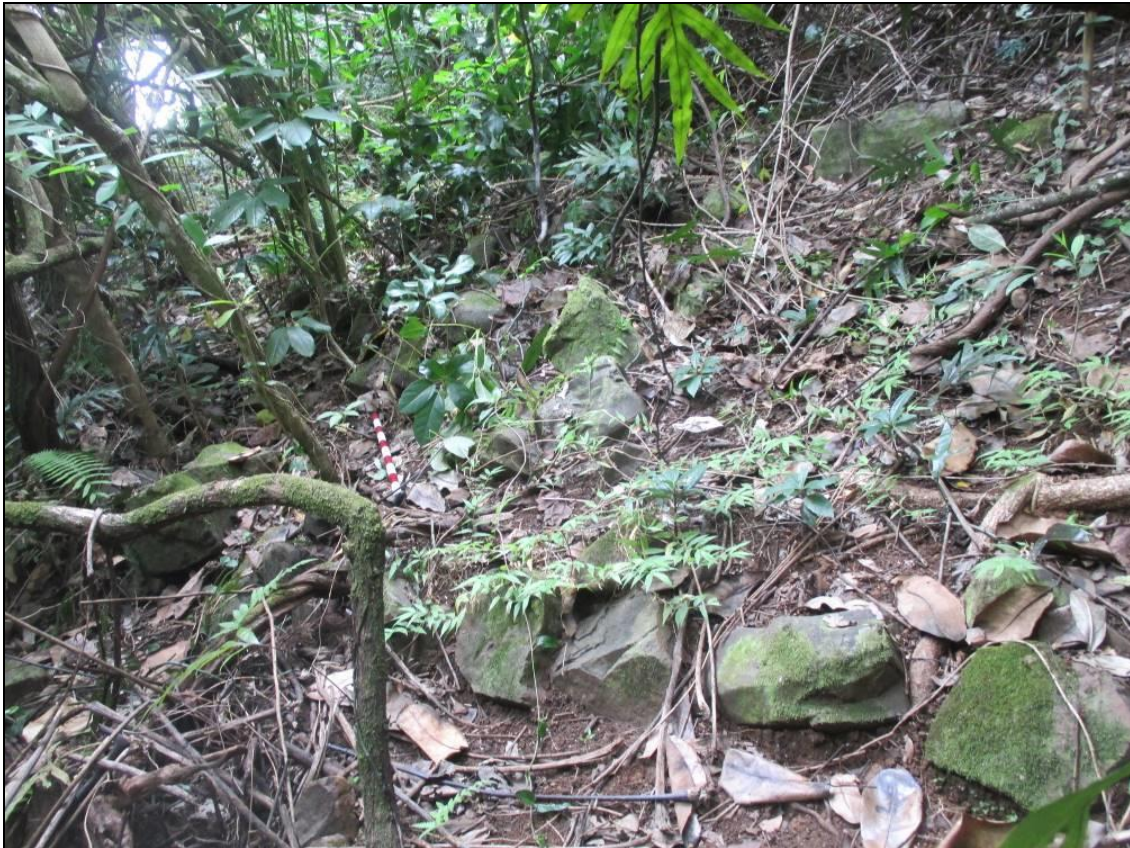
Figure 75. Photo showing SIHP # -6931, Feature A (terrace, in foreground), Feature B (terrace, center), and Feature C (terrace in background), view to northwest

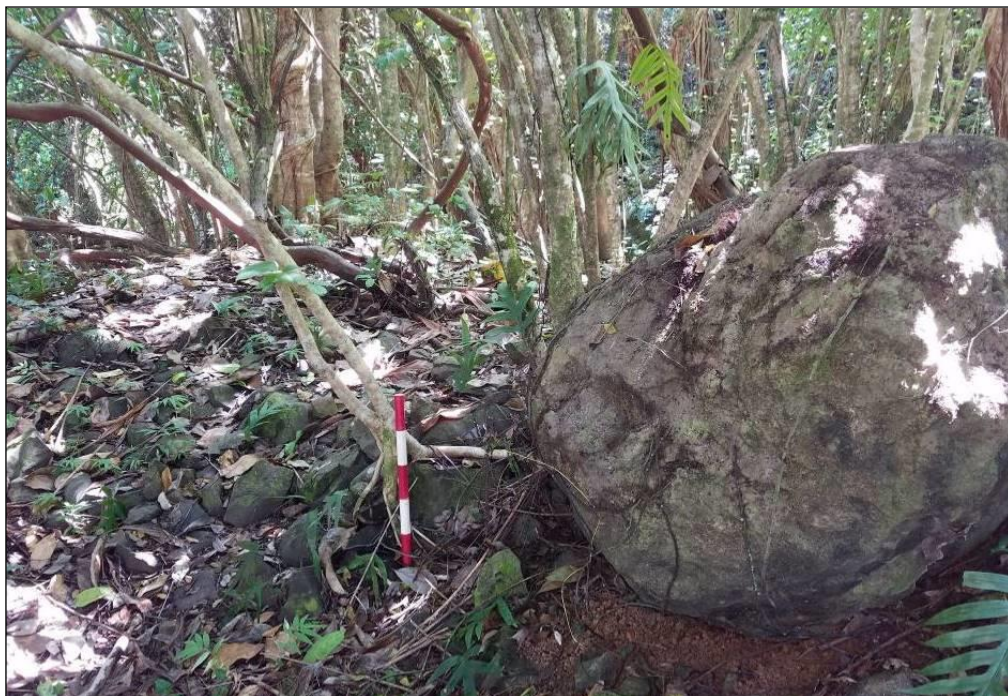
Figure 77. Photo showing SIHP # -6931, Feature D (ceremonial area, terrace), view to northeast

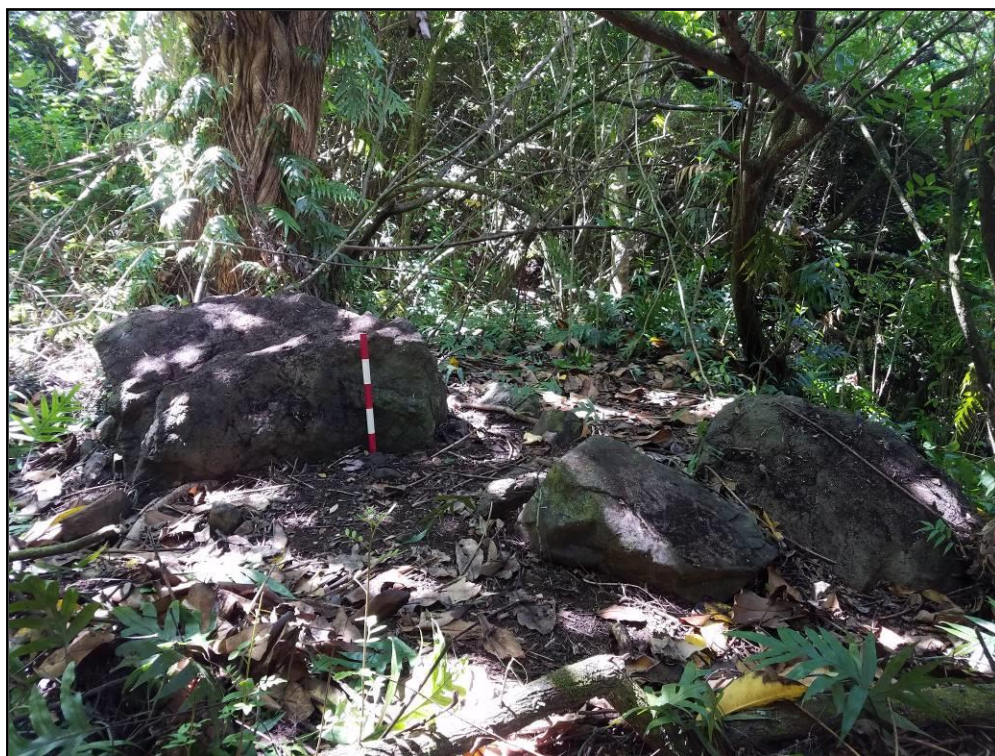
Figure 78. Photo showing SIHP # -6931, Feature D (ceremonial area, top of hill), view to south

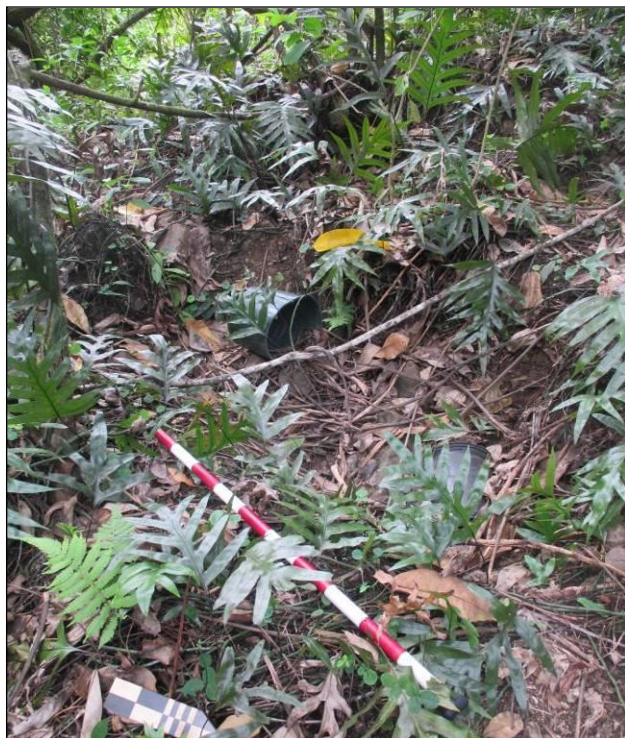
Figure 79. Photo taken just south of SIHP # -6931, Feature D, showing a modern earthen pit (west pit) and black plastic planting pot, view to west

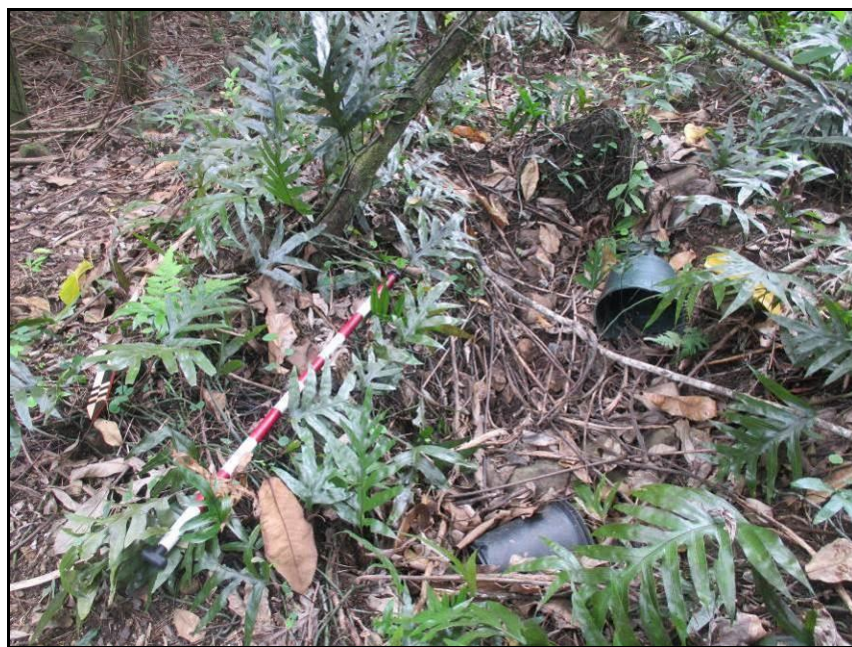
Figure 80. Photo taken just south of SIHP # -6931, Feature D, showing a modern earthen pit (east pit) and black plastic planting pots, view to south

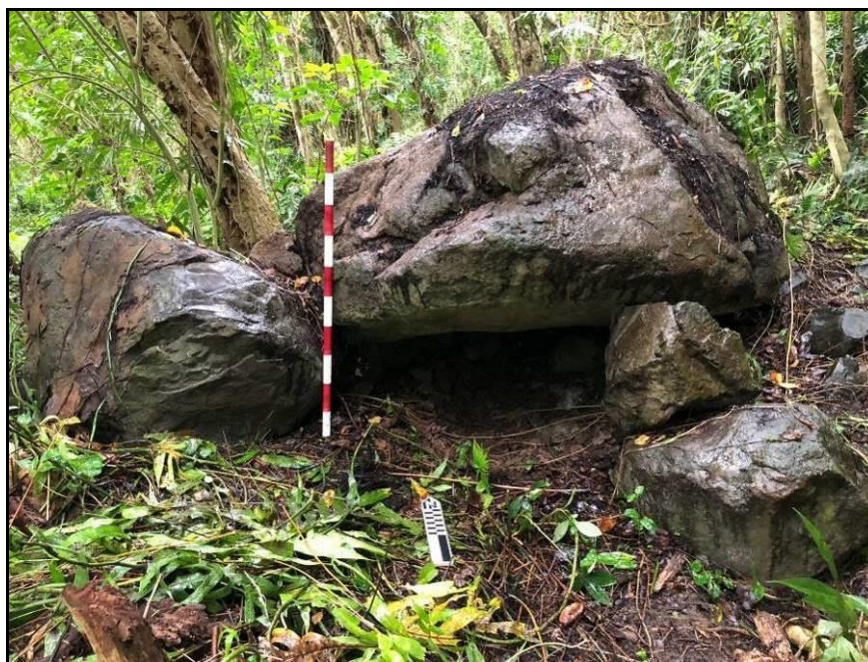
Figure 82. Photo of SIHP # -6932 (Storage Feature), view to north

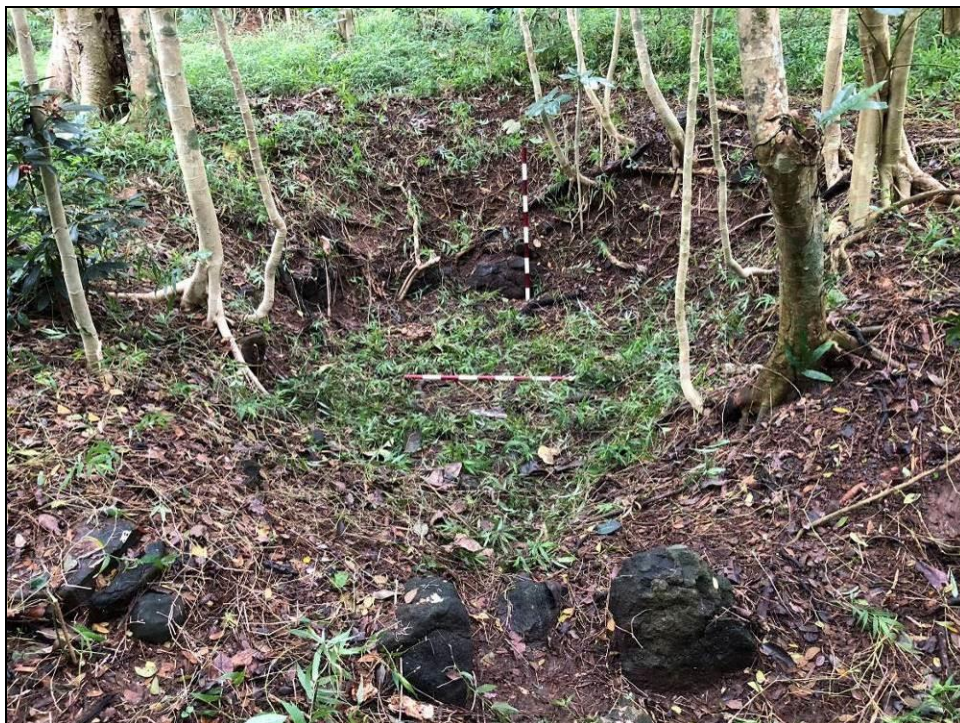
Figure 84. Photo showing SIHP # -6933, Feature A (historic charcoal kiln), view to northeast

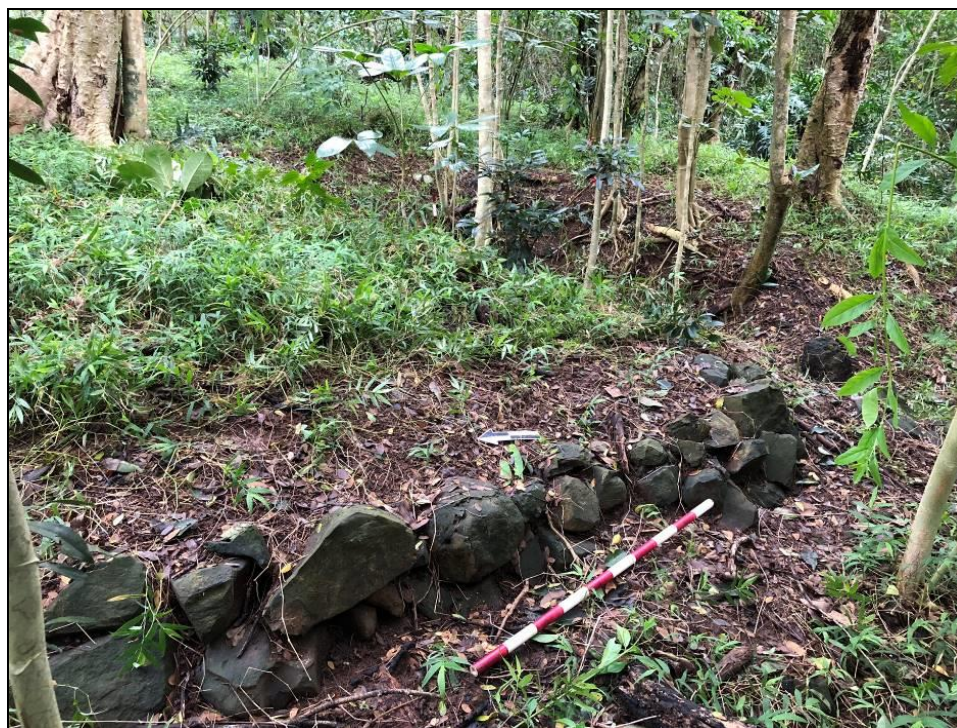
Figure 85. Photo showing SIHP # -6933, Feature B (terrace facing), view to east
