**Jurisdictional waters determination  
Hawaiian Memorial Park  
Kāneʻohe, Oʻahu**

# Jurisdictional waters determination Hawaiian Memorial Park, Kāneʻohe, Oʻahu

February 12, 2019

AECOS No. 1567

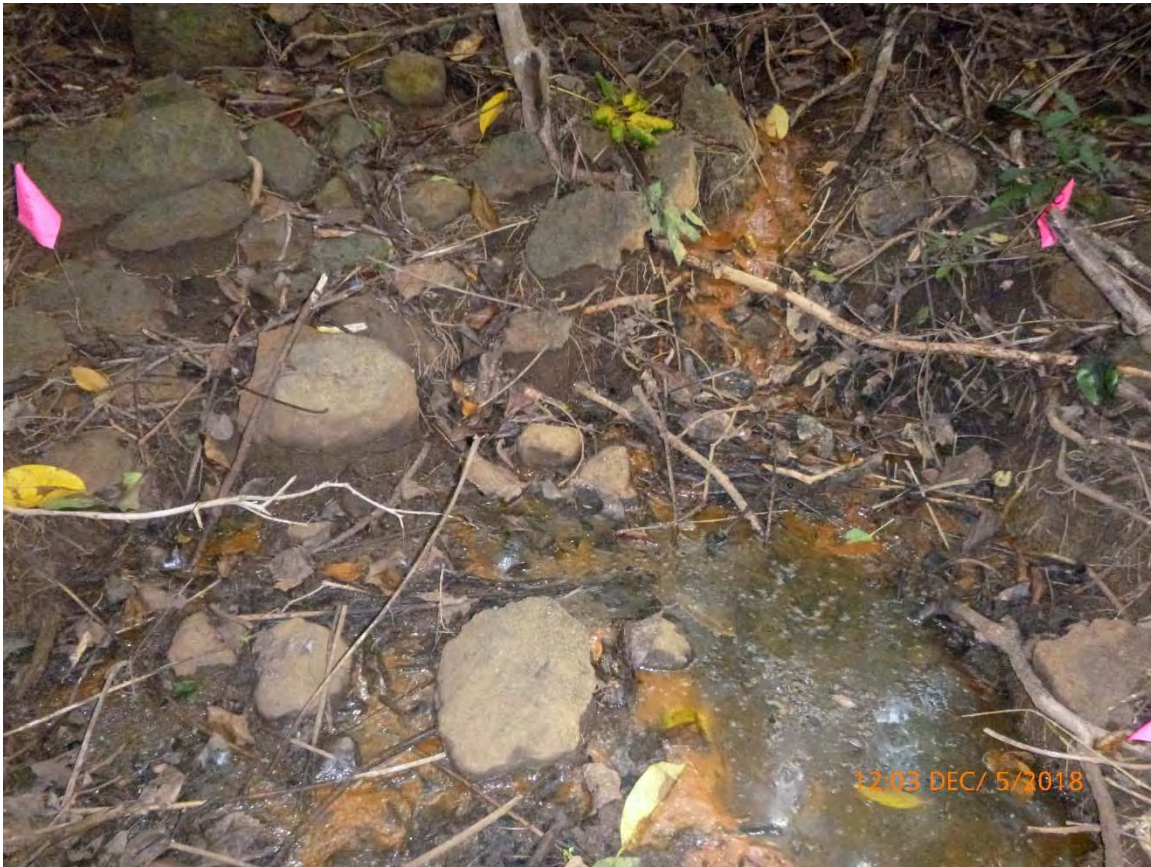
Figure 3. Groundwater seeps are indicated by biofilms that appear as oily sheens and rust-colored floc.

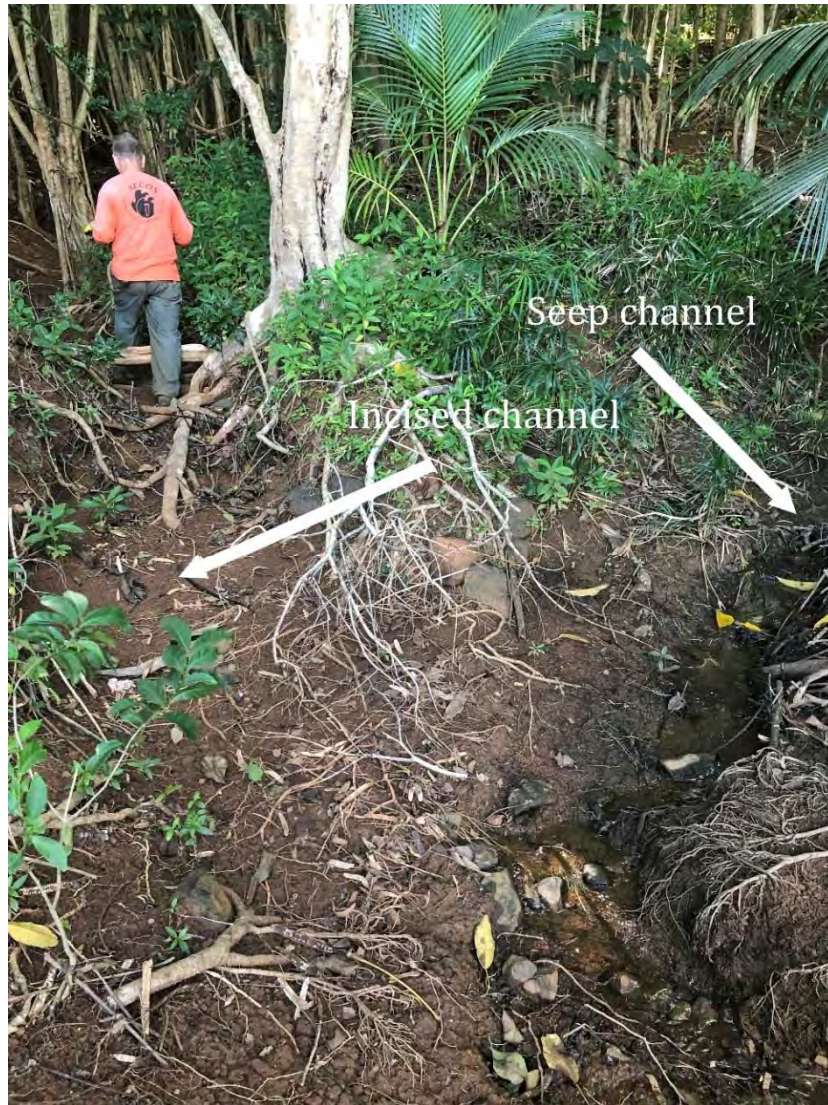
The seep channel enters the lower end of a more deeply incised channel (“incised channel”) that carries intermittent flow from channels upslope (Figure 4). Flow is directed across a concrete apron and into a culvert (Figure 5) that is part of the City and County of Honolulu storm water system. The incised

Figure 4. View looking upstream where flow from the shallow seep channel joins the larger incised channel just upstream of the inlet to the City and County storm drain system.

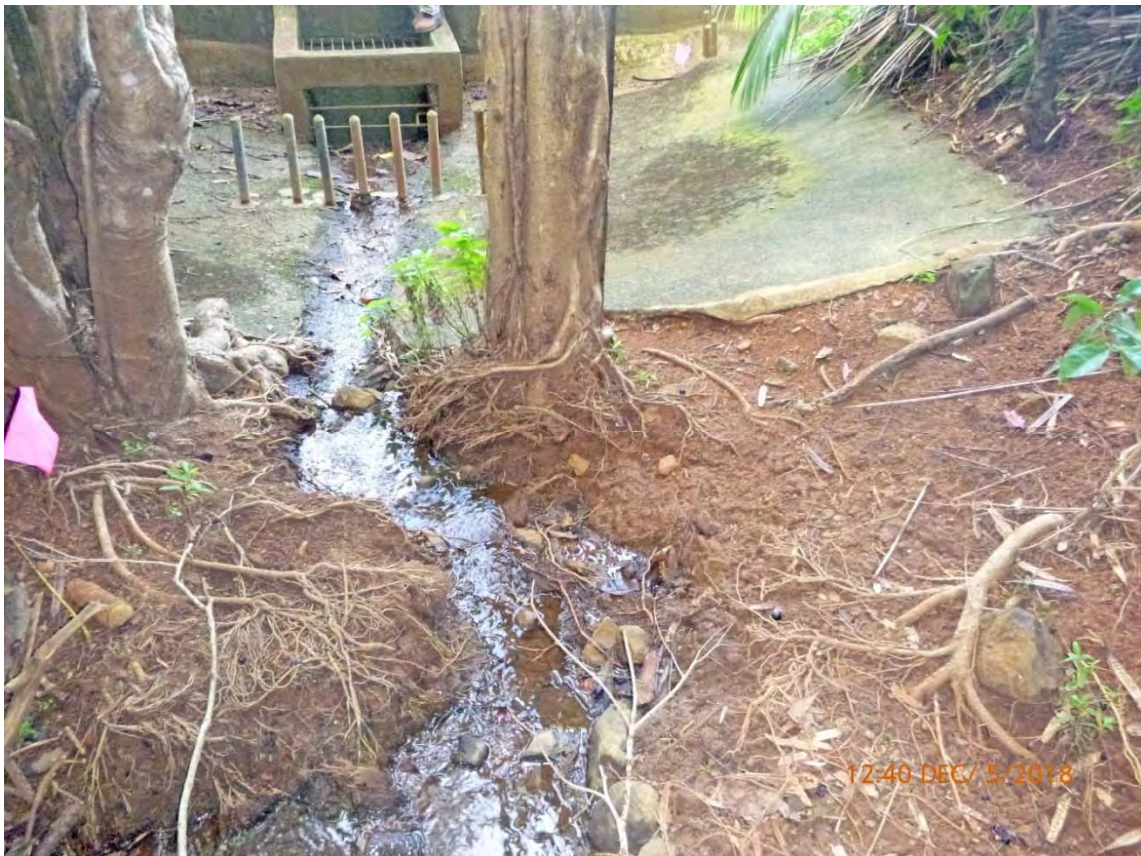
Figure 5. Flow from the perennial seep channel within the larger incised channel is directed to an inlet of the City and County storm drain system in Pikoiloa.

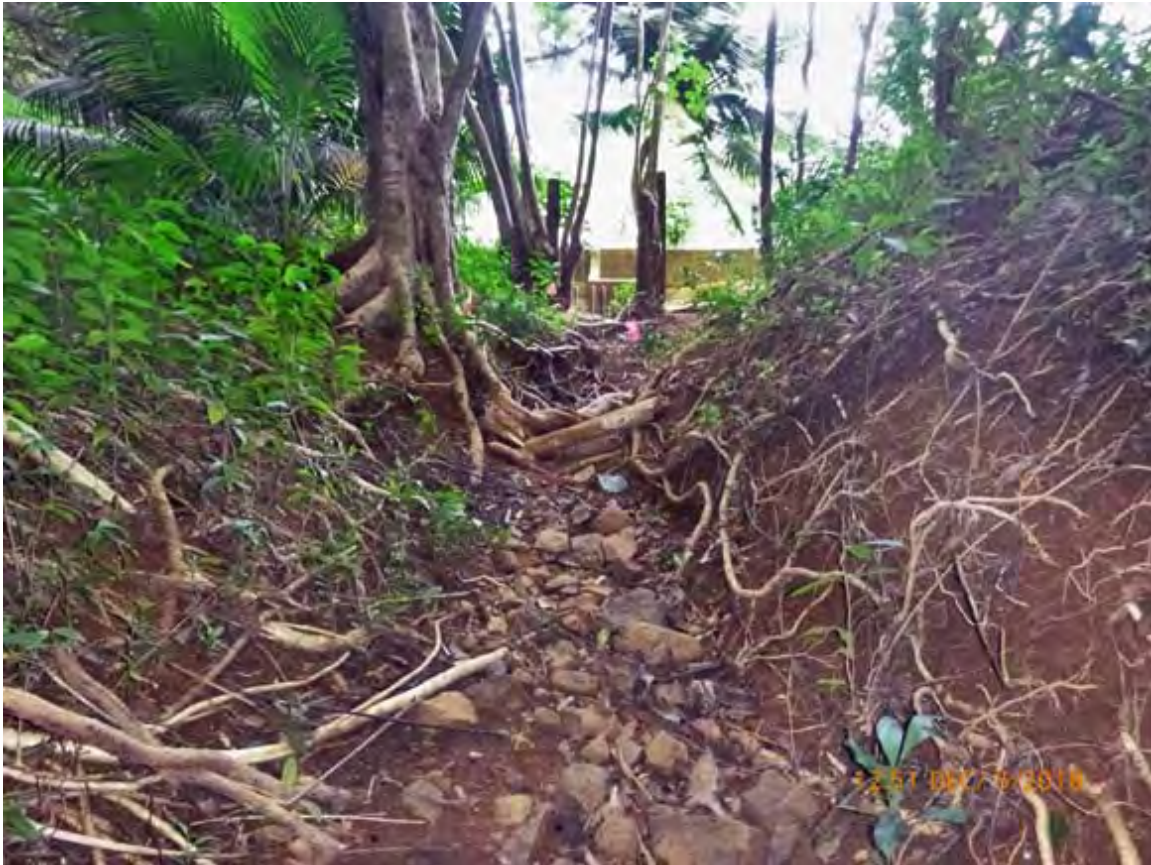
channel above the confluence with the seep channel appears to contain flow only after large storm events (freshets) and is fed by multiple erosional gullies. The incised channel is between one and three meters (3 to 10 ft) wide and nearly vertical banks are up to 1.5 m (4.9 ft) high. Boulders are on the channel bottom and tree roots growing on the stream banks are exposed (Figure 6).

Figure 6. View towards the storm drain inlet from the incised channel.

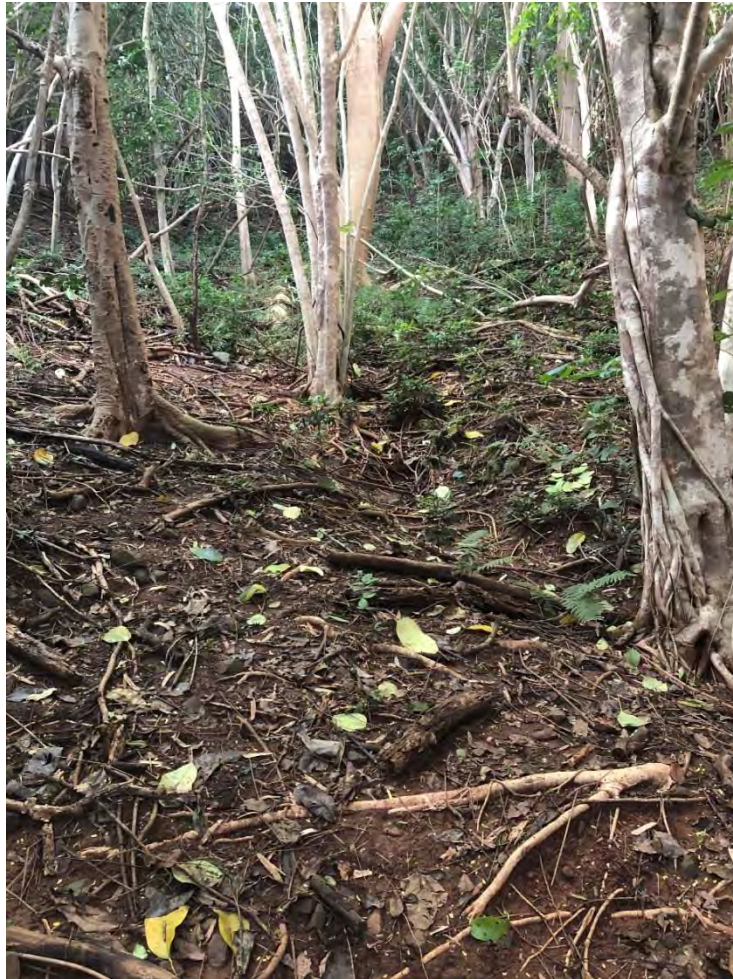
Upslope, erosional gullies (Figure 7) on the hillslope direct runoff into the incised channel. Flow in these small gullies is ephemeral and not of sufficient volume and duration to create physical indicators of flow, such as a stream bed and banks.

Figure 7. Small erosional gullies through upland in the Project area that direct stormwater runoff from the surrounding hillslopes towards the incised channel.

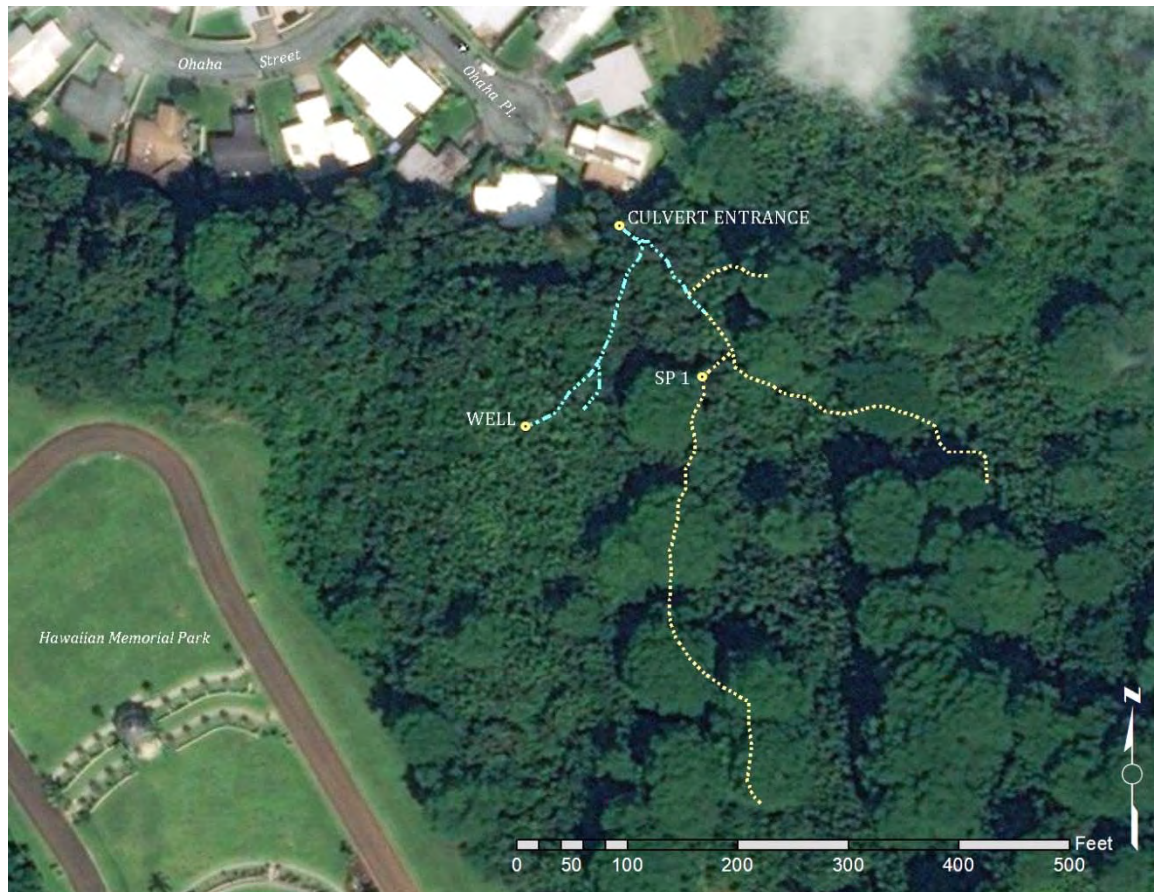
Figure 8 depicts the features we surveyed in the area in November and December 2018. The jurisdictional seep channel is 68 m (223 ft) long (to the culvert entrance) and the jurisdictional segment of the incised channel is 33 m (100 ft) long above the confluence with the seep channel.

Figure 8. Map of survey area showing extent of jurisdictional limits (stream course rendered in blue) and erosional gullies (non-jurisdictional) as dashed yellow lines.

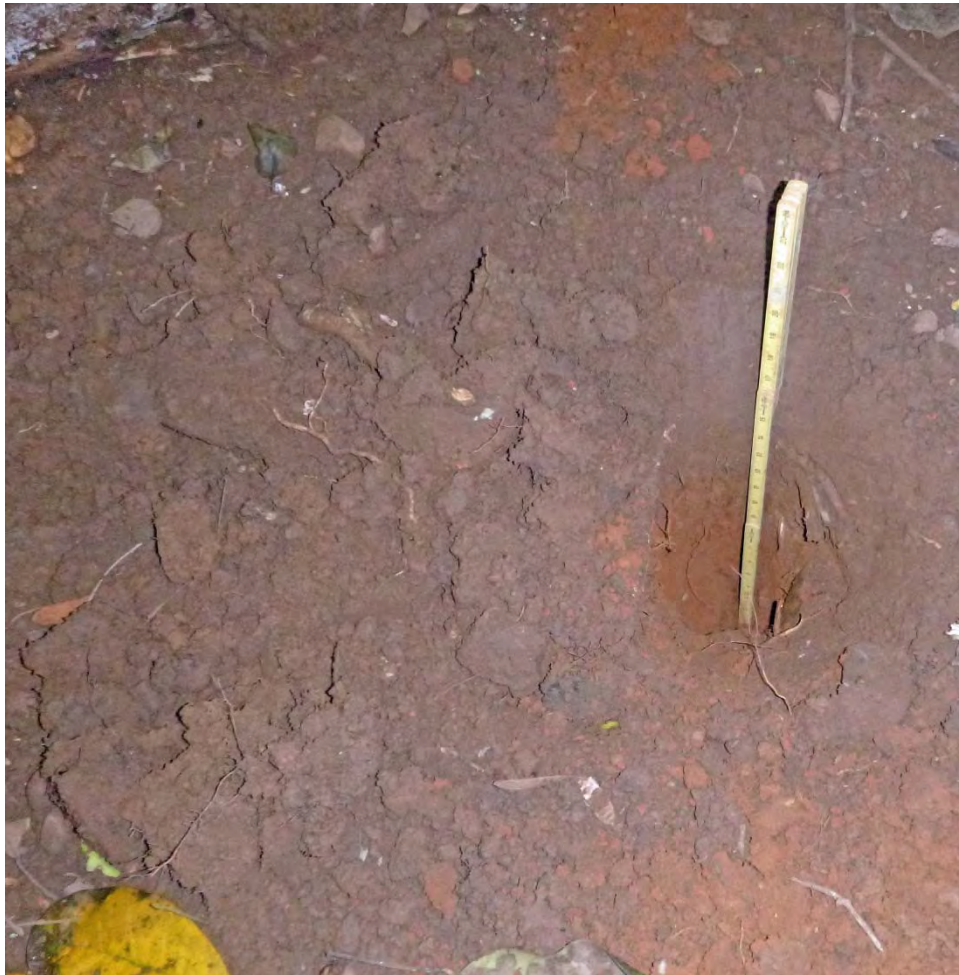
ground of a flat area (SP 1) for the presence of a wetland. The absence of ground cover here is due to shading by the closed canopy of octopus (*Schefflera actinophylla*) and Java plum (*Syzygium cumini*) trees. The soil (see Figure 9) conforms with the mapped soil type of Kaneohe silty clay and is not on the list of hydric soils (soils that could be associated with wetlands for O‘ahu; USDA-NRCS, 2018b). This area is not a wetland.

Figure 9. Soil at SP 1 is a non-hydric silty clay loam.

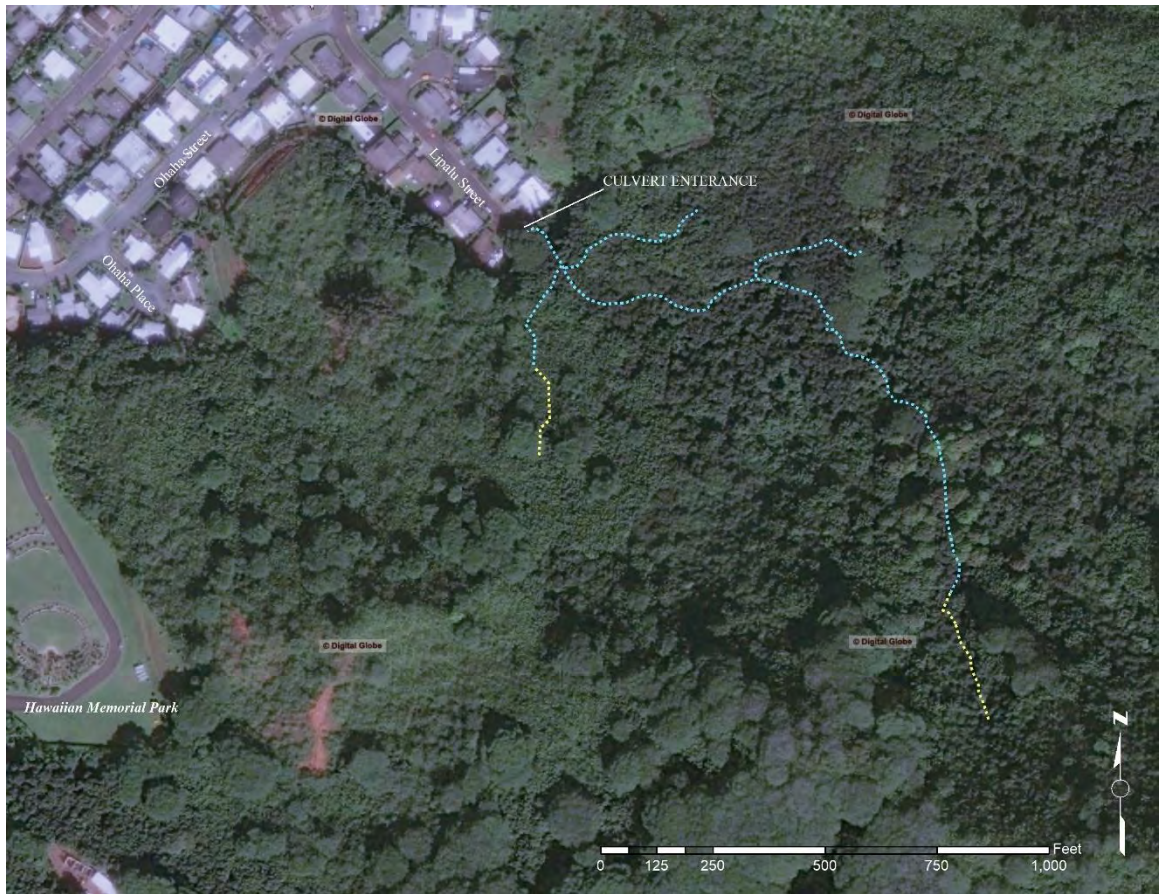
of each channel (indicated as blue dashed lines in Fig. 2) is approximately 1 m (3 ft) and the channels are incised to mostly less than 1 m (3 ft), becoming broader and deeper near the Lipalu Street culvert entrance. Sediment sorting, destruction of terrestrial vegetation, and a break in bank slope were the most frequently observed indicators of OHWM.

Figure 2. Map of survey area showing estimated extent of jurisdictional limits (stream course rendered in blue dashed lines) and non-jurisdictional channels (rendered in yellow dashed lines).
