## **3.4 AVIAN AND MAMMALIAN RESOURCES**

Hawaiian Memorial Park Cemetery Expansion Project Final Environmental Impact Statement  
 Kaneohe, O'ahu, Hawaii

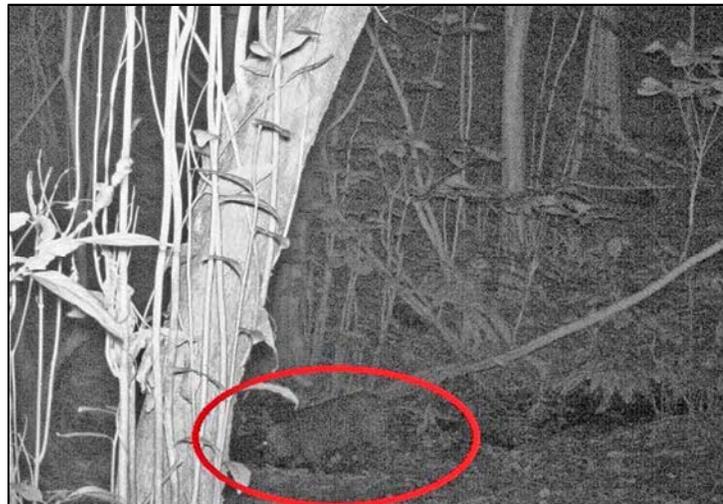
Exhibit 3.13 Night Camera Photo of Feral Pig Disturbing Spring Area (Montgomery, 2017)

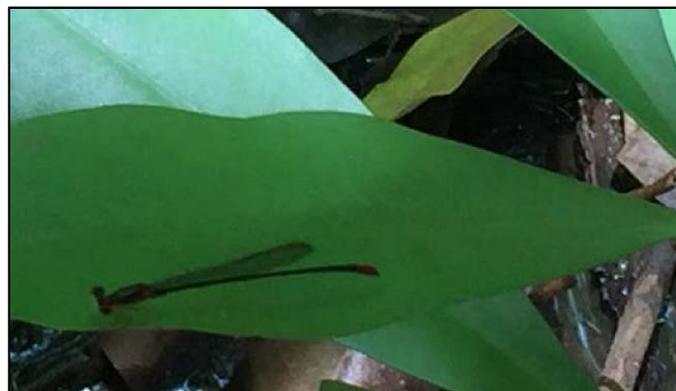
**Exhibit 3.14 Blackline Hawaiian Damselfly Resting on Site.  
 Photo Montgomery 2017**

The brown, inch-long damselfly nymphs favor a concealed existence clinging under stones or hiding in algae masses, both in moving and quiet waters, for long intervals. Exhibit 3.14 shows a native damselfly specimen resting on a leaf. The Hawaiian Damselfly’s diet includes bloodworms, which are the larvae of *Chironomus hawaiiensis*, *Forcipomyia howarthi*, *Tanytarsus*, *Culex*, *Limonia* and *Scatella* shore flies, sowbugs (*Philoscia angusticauda*), and oribatid mites. Kalo is

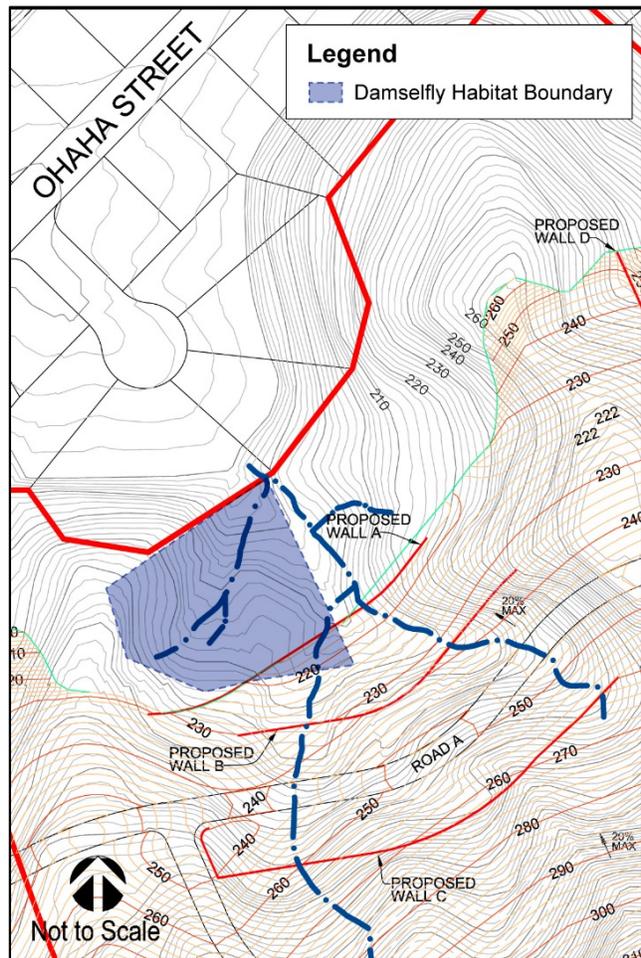
**Exhibit 3.14a Habitat Area for Blackline Hawaiian Damselfly**

The boundaries of the damselfly habitat area along the seep were determined by Dr. Montgomery based upon his study and several additional site visits. The habitat boundary is shown in Exhibit 3.14a. The habitat of damselfly young, or naiads, does not extend from the water’s edge, but the foraging and roosting home ranges of adults does. Undisturbed emergent wetland plants (e.g. sedges) can serve as ant-free perches for larvae molting into damselflies in their few hours of flightless vulnerability to predators. However, the present seep area lacks much foliage and ground cover primarily due to the repeated rooting of feral pigs for worms and wallowing in mud.

Therefore, topographic conditions influence the movement patterns of the damselfly in relation to the surrounding area along the course of the seep. The higher elevation areas along the seep influence and establish the general extent of their habitat area. Based upon site visits and available topographic data, the boundary in Exhibit 3.14a reflects these characteristics with the high points along and above the seep channel establishing the habitat boundary (e.g. Photo of west section, Exhibit 3.14b). The habitat boundary does not include an incised ephemeral drainageway located east of the seep. This drainage feature is normally dry except for brief flows after heavy rainfall events, and does not serve as a habitat for damselfly young or naiads. After freshets, the drainageway also lacks residual plunge pools where damselfly could ovipost.

Habitat boundaries would be refined during final project design when more accurate topographic survey data would be obtained. For example, the habitat boundary on the west side may not extend as far west based upon actual site conditions from that shown on Exhibit 3.14a. Based upon this habitat boundary, grading improvements would need to remain outside of this area. Further discussion of the cemetery expansion in relation to this habitat boundary is discussed in Section 3.5.2.

to identify higher points. It is possible the habitat boundary on the west side may not need to extend as far west based upon actual site conditions since a site visit indicated the top of the western embankment was only about 30 feet away from the seep instead of that currently shown on Exhibit 3.14a using GIS data. The mauka boundary above the well and seep may also not need to extend as far based upon site visits. Refinement of preliminary habitat boundaries based upon more detailed and accurate topographic conditions would occur during project design to ensure cemetery expansion grading plans would avoid encroaching within the damselfly habitat boundary.

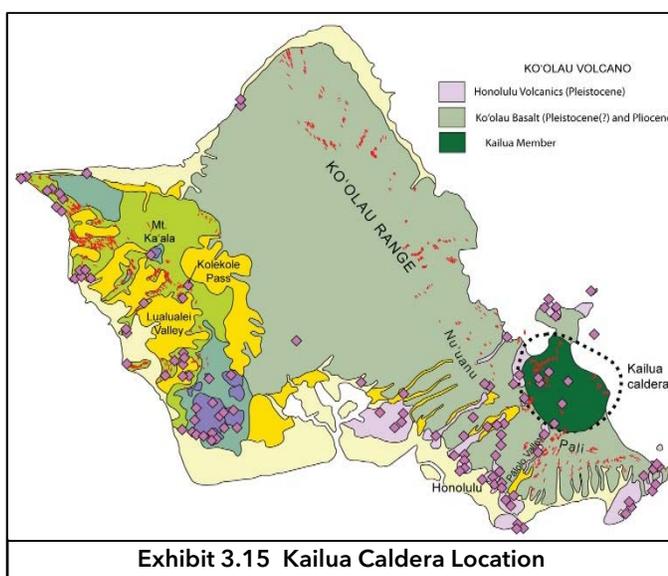
Exhibit 3.15 Kailua Caldera Location

The existing HMP and Petition Area are located within the former caldera of the Ko’olau Mountain (referred to as the Kailua Caldera). The caldera filling lavas beneath the Petition Area are a part of the Kailua Member of the Ko’olau volcanics (Exhibit 3.15). The basalt flows are dense, massive, and relatively impermeable due to almost complete filling of interstices with secondary minerals resulting from hydrothermal alteration. Clinker beds, where they occur, have been cemented into hard and essentially impermeable breccia. Joints of intruded dikes are also filled with secondary minerals. Therefore,

development of even a moderate capacity well anywhere in the Kailua volcanics beneath the Petition Area or other HMP property would not be possible. It is significant that the deep weathering of the Kailua volcanics across the Petition Area has resulted in stiff silt and clay residual soils underlain by saprolite to depths exceeding 50 feet (TNWRE, 2018).

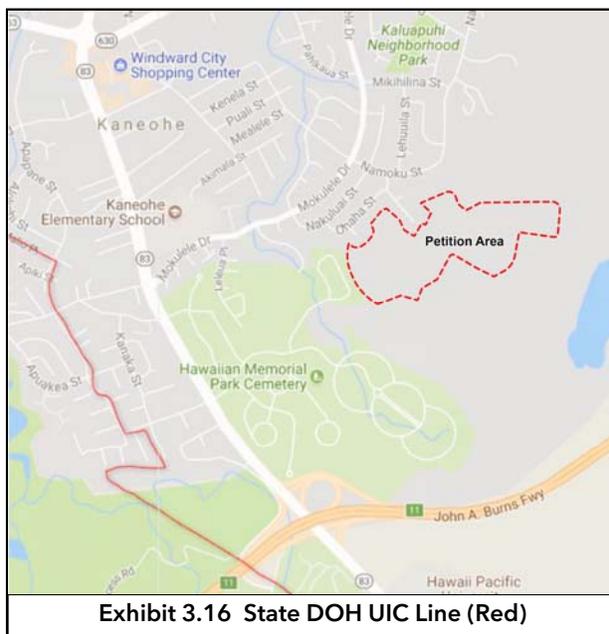
**Exhibit 3.16 State DOH UIC Line (Red)**

The UIC line generally runs mauka of Kamehameha Highway as shown on Exhibit 3.16. Therefore, the Petition Area is located below and well away from this UIC line indicating it is situated above an exempt portion of the Ko‘olaupoko Aquifer.

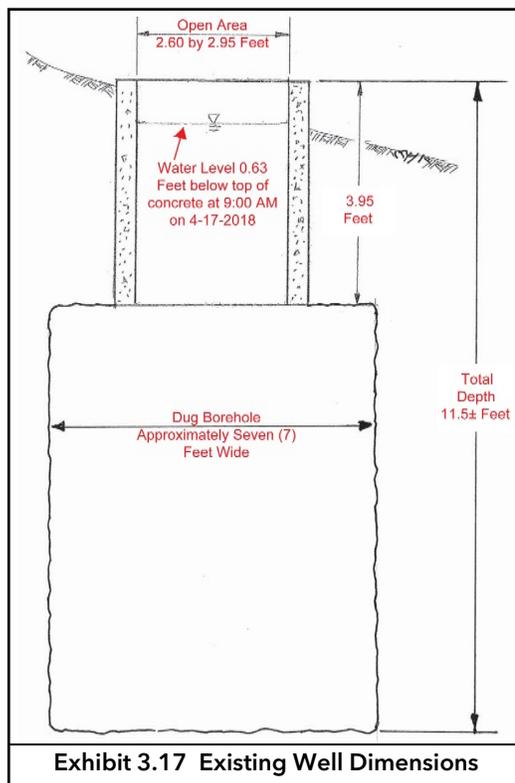
**Exhibit 3.17 Existing Well Dimensions**

There is an existing shallow well and perennial seep within the northwest corner of the Petition Area, located about 300 feet east of the roadway serving the Ocean View Garden as shown on Figure 3.10. The well is 11.5 feet deep below the top of its square-shaped concrete rim. The opening of the concrete top is 2.65 by 2.90 feet in dimension. The dug borehole below the concrete is substantially larger than this opening. Exhibit 3.17 is a schematic cross section of the well portraying its probable dimensions. Exhibit 3.18 includes a photo of the well concrete rim.

As measured a number of times during the field investigation, the water level in the well was consistently above the ground level on the downstream side of the well. The well is not registered with the CWRM, and no information about its installation or past use could be found. Based on an old pipe laying nearby, it may at one time have been a modest source of supply.

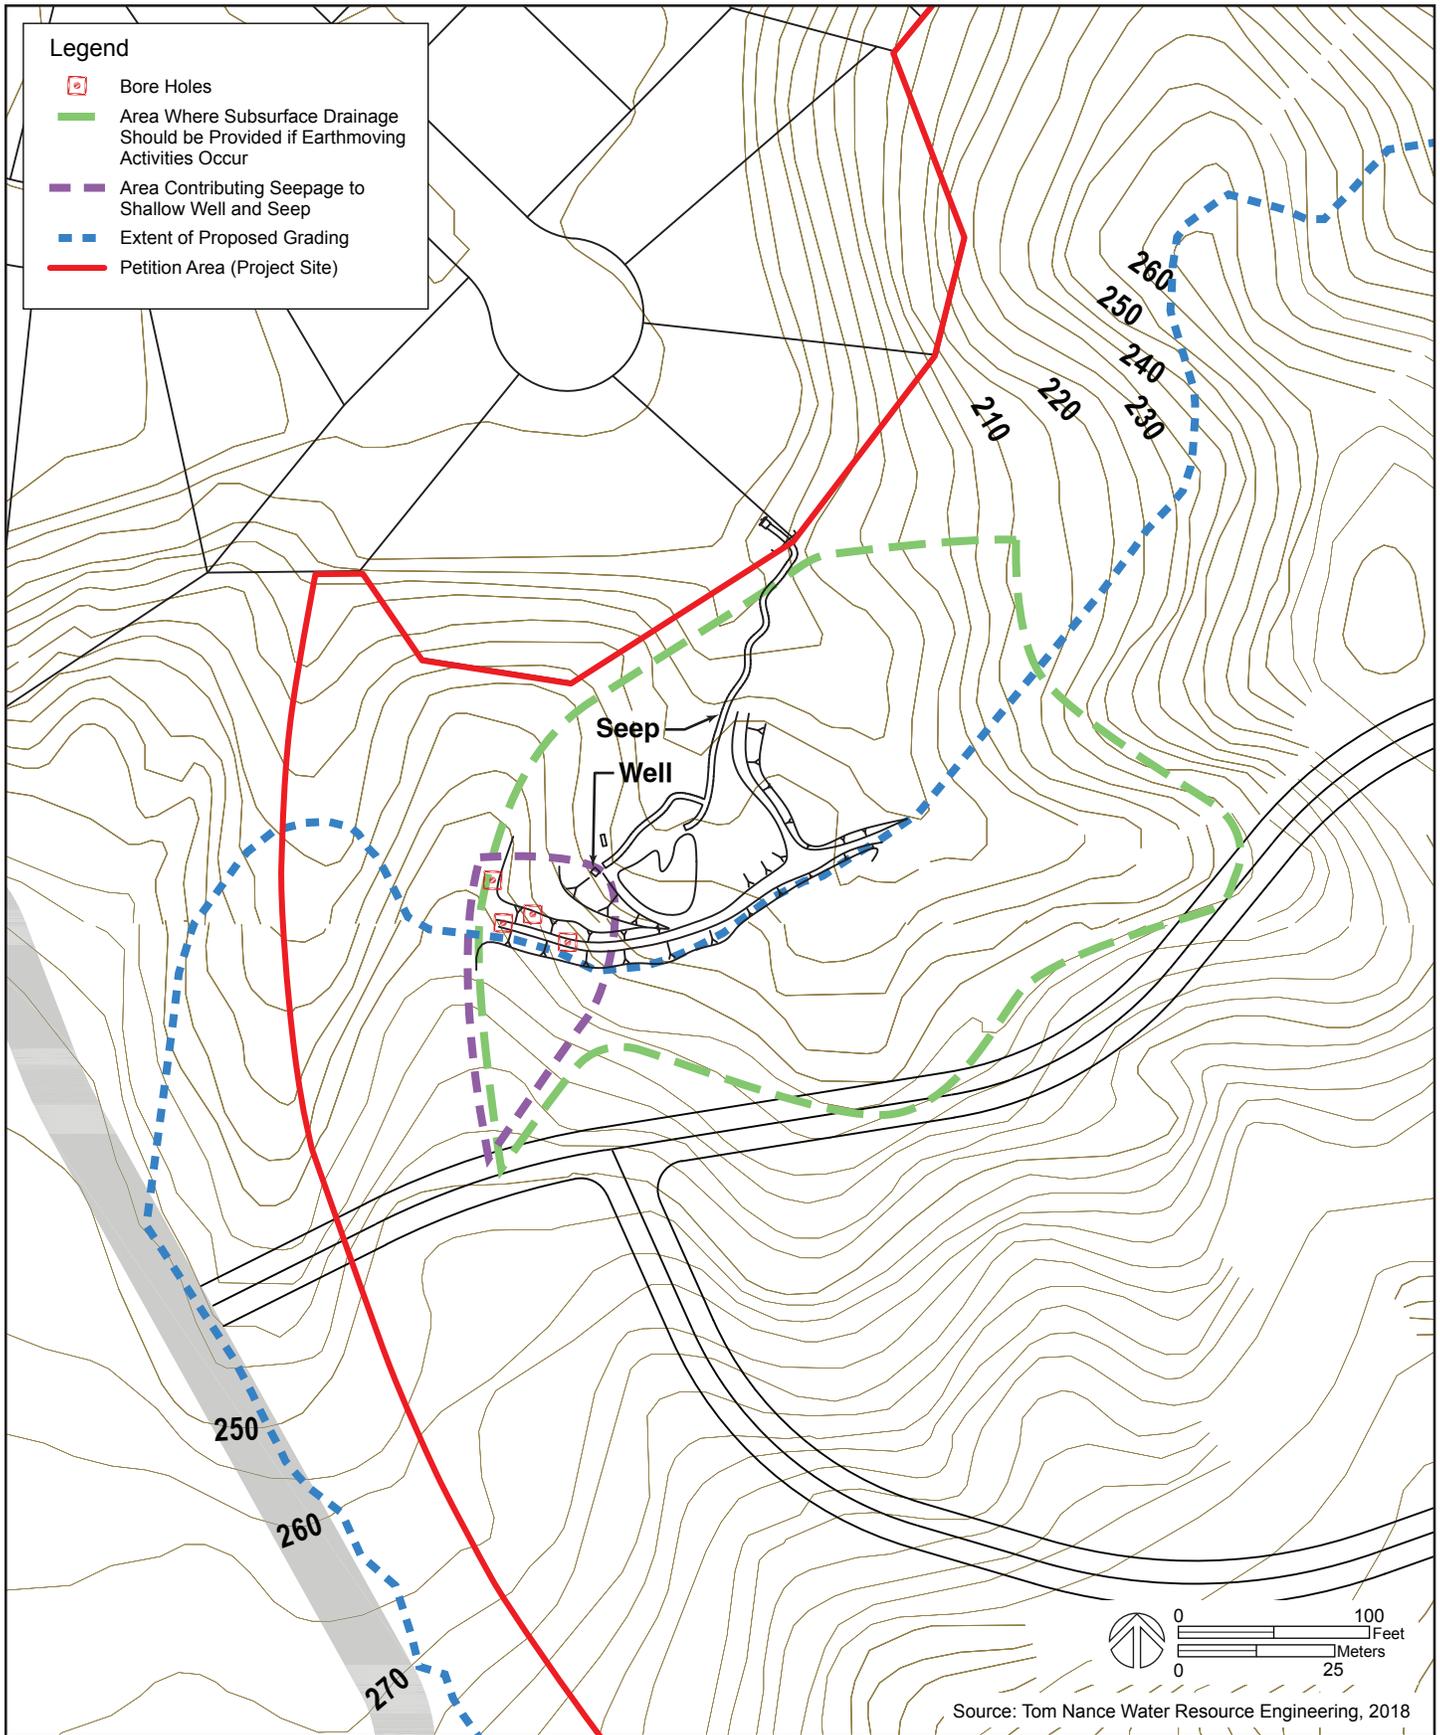
**Figure 3.10**

**Location of Well, Seep and Borings**

Two types of field investigation were undertaken to assess whether the well and seep are from a shallow perched water source. This investigation consisted of: 1) drilling four boreholes directly upslope of the well and seep; and 2) conducting a siphon and pump test of the well to determine if subsurface leakage from the well is creating the seep that emerges just four feet downslope.

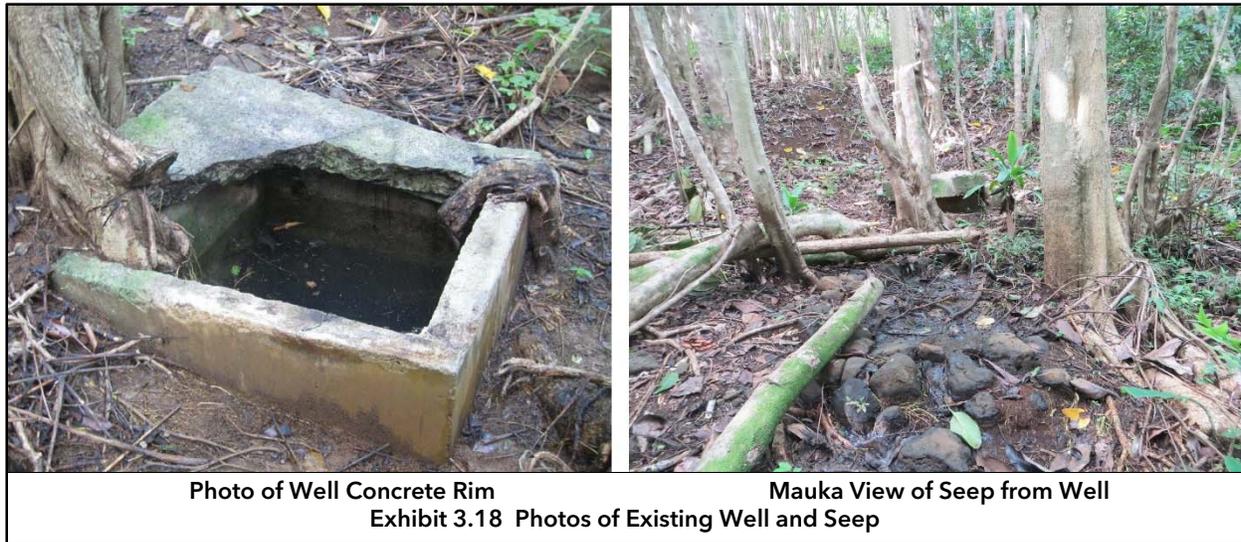
A small but perennial seep emerges about four feet downslope from the well (see Exhibit 3.18). Further down the waterway, the flowrate in the waterway continuously increases along the route to its ultimate discharge into the drain inlet at the end of Ohaha Place. Given the additions to the flowrate enroute downslope, it is more accurate to describe the seep as an area of discharge rather than a discharge from a single point (TNWRE, 2018).

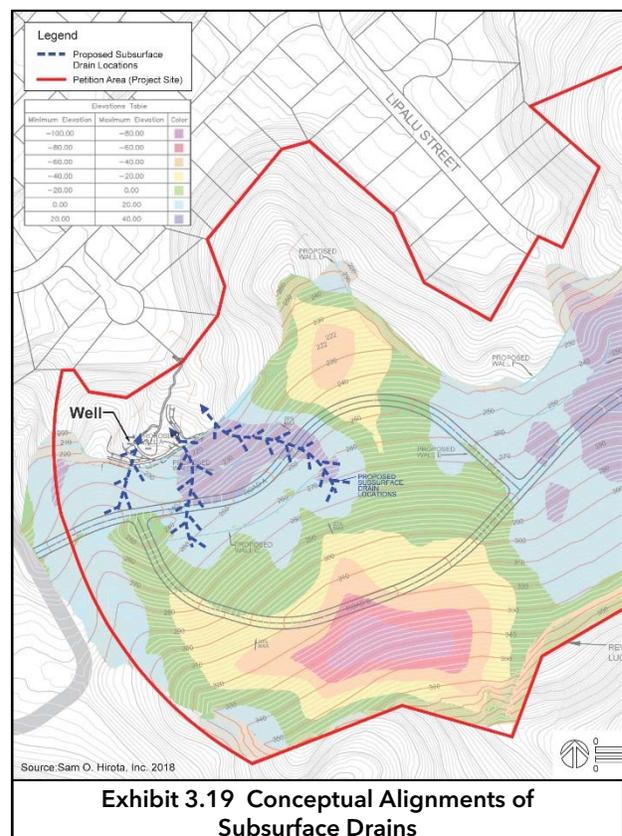
1. A subsurface drainage system designed utilizing a herringbone configuration would be implemented in the cemetery expansion area planned for fill activities above the seep. The system would be comprised of three subsurface drainage mainlines with smaller subdrains branching laterally from them. ~~Possibly three deeper subsurface drains would be constructed within the fill area above the seep. These drains~~ This drainage system would generally be aligned perpendicular to the retaining walls and installed at depths to intercept and convey the flow of subsurface water~~groundwater~~ to the well and seep. Their possible alignments are shown conceptually on Exhibit 3.19 (also shown on Figure 2.3).

2. Their exact locations, alignments, and depths would be determined with the drilling of additional boreholes as part of the project's design phase in developing final grading plans. However, the subsurface drains would likely be between 10 to 15 feet below the existing surface.

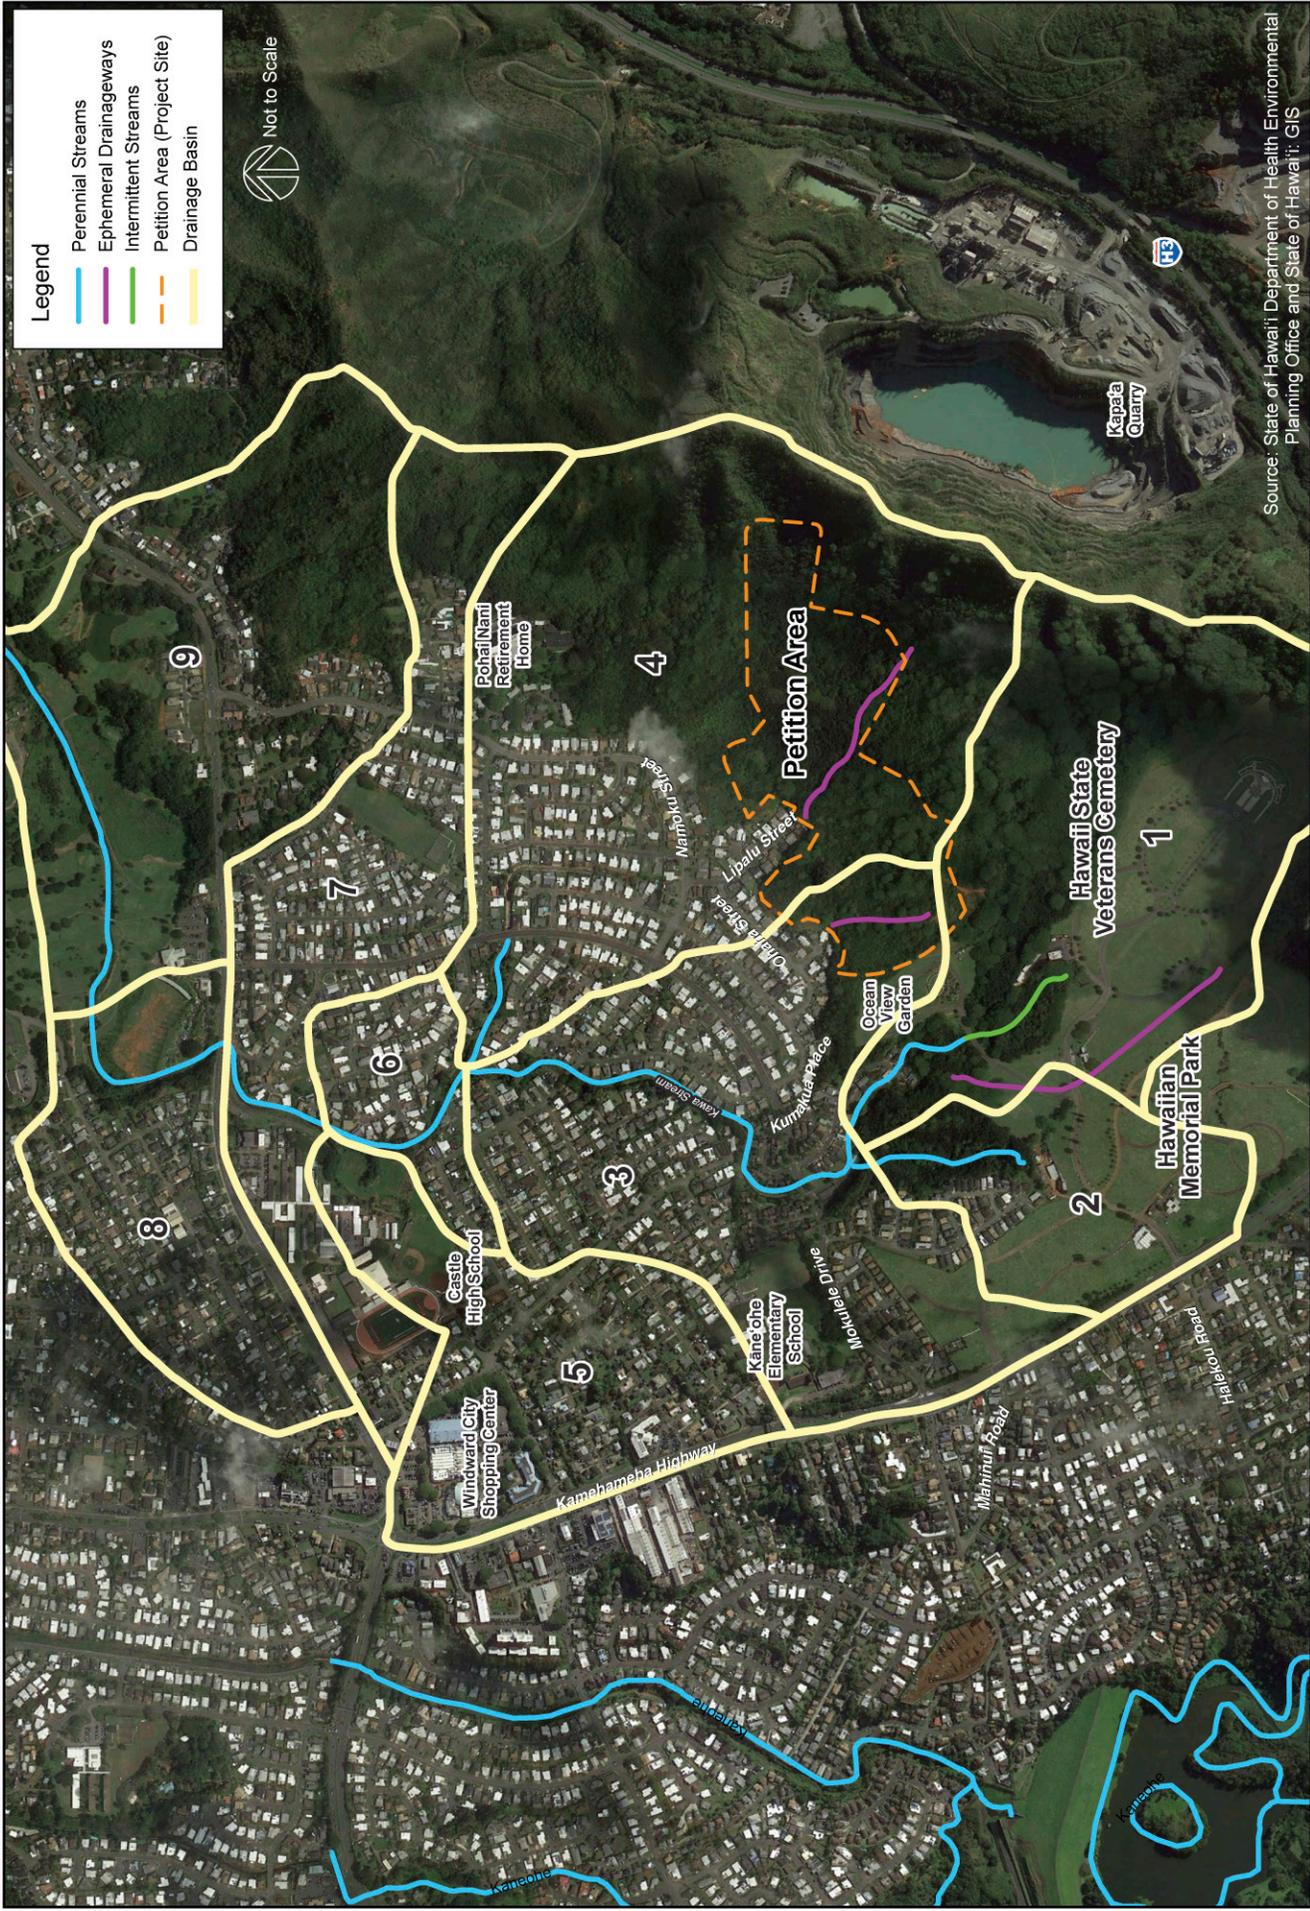
**Figure 3.11**

There are no perennial or intermittent streams within the Petition Area. The most proximate surface water resource to the Petition Area is Kāwā Stream, and its location is shown in Figure 3.11. The Petition Area is generally located within a broad natural drainage basin created by the topography of the surrounding hillside. As a result, stormwater runoff flowing from upland areas sheet flows across the site following natural drainage patterns, and merges in low lying portions of the site during periods of heavy rainfall. Ephemeral drainageways within the Petition Area carry stormwater runoff into the City's drainage system, which eventually feeds into Kāwā Stream.

There are two existing ephemeral drainageways within the Petition Area that carry stormwater runoff from upland and surrounding areas into the lower basin. ~~as~~ The general extent of these ephemeral drainageways were previously shown on Figure 3.11. Discharges from these drainageways eventually enter two City catchment basins situated at the Petition Area’s boundary with residences at the end of Ohaha Street and Lipalu Street.

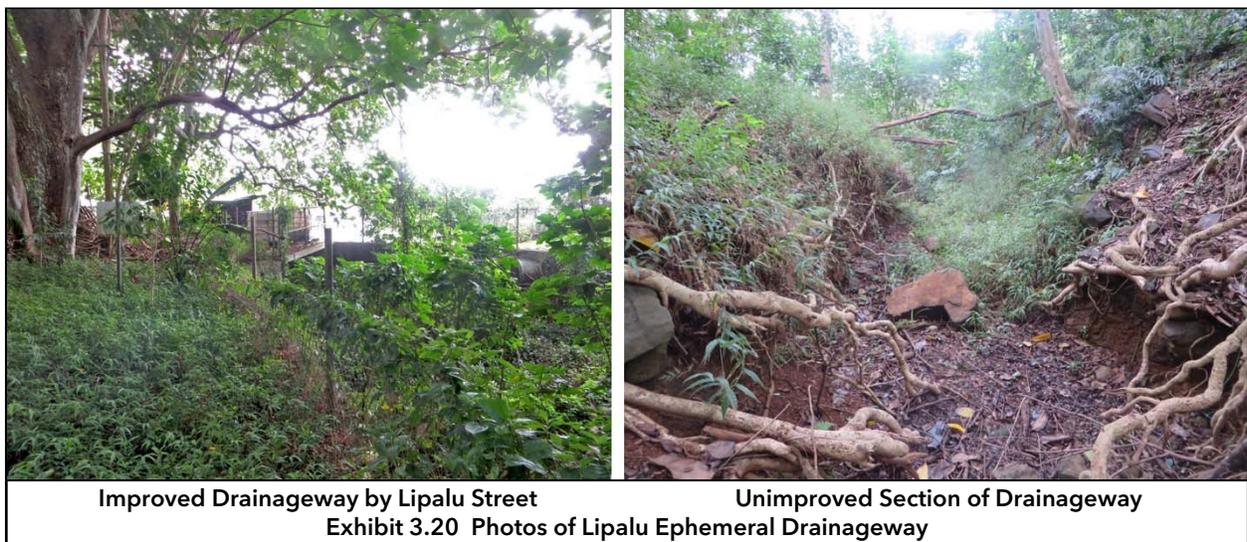
One ephemeral drainageway generally serving the central and eastern end of the Petition Area, including the Cultural Preserve, discharges runoff into a catchment basin at the end of Lipalu Street. This drainageway is unimproved within the Petition Area except near the catchment basin where there is a concrete wall, rock wall, and fencing (Exhibit 3.20). This drainageway serves a

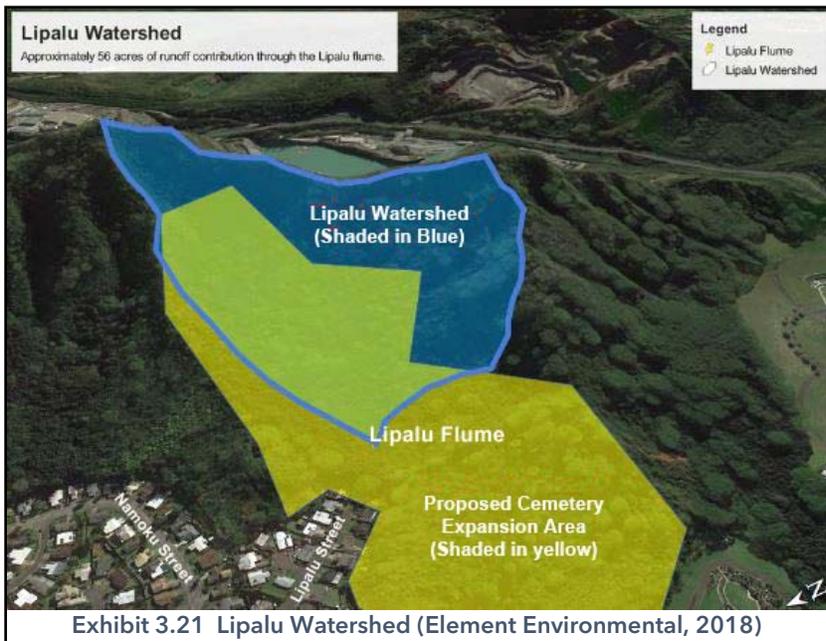
watershed area (referred to as the Lipalu watershed) estimated to be approximately 73-acres in size. Less than half of this watershed includes the Petition Area (Exhibit 3.21).

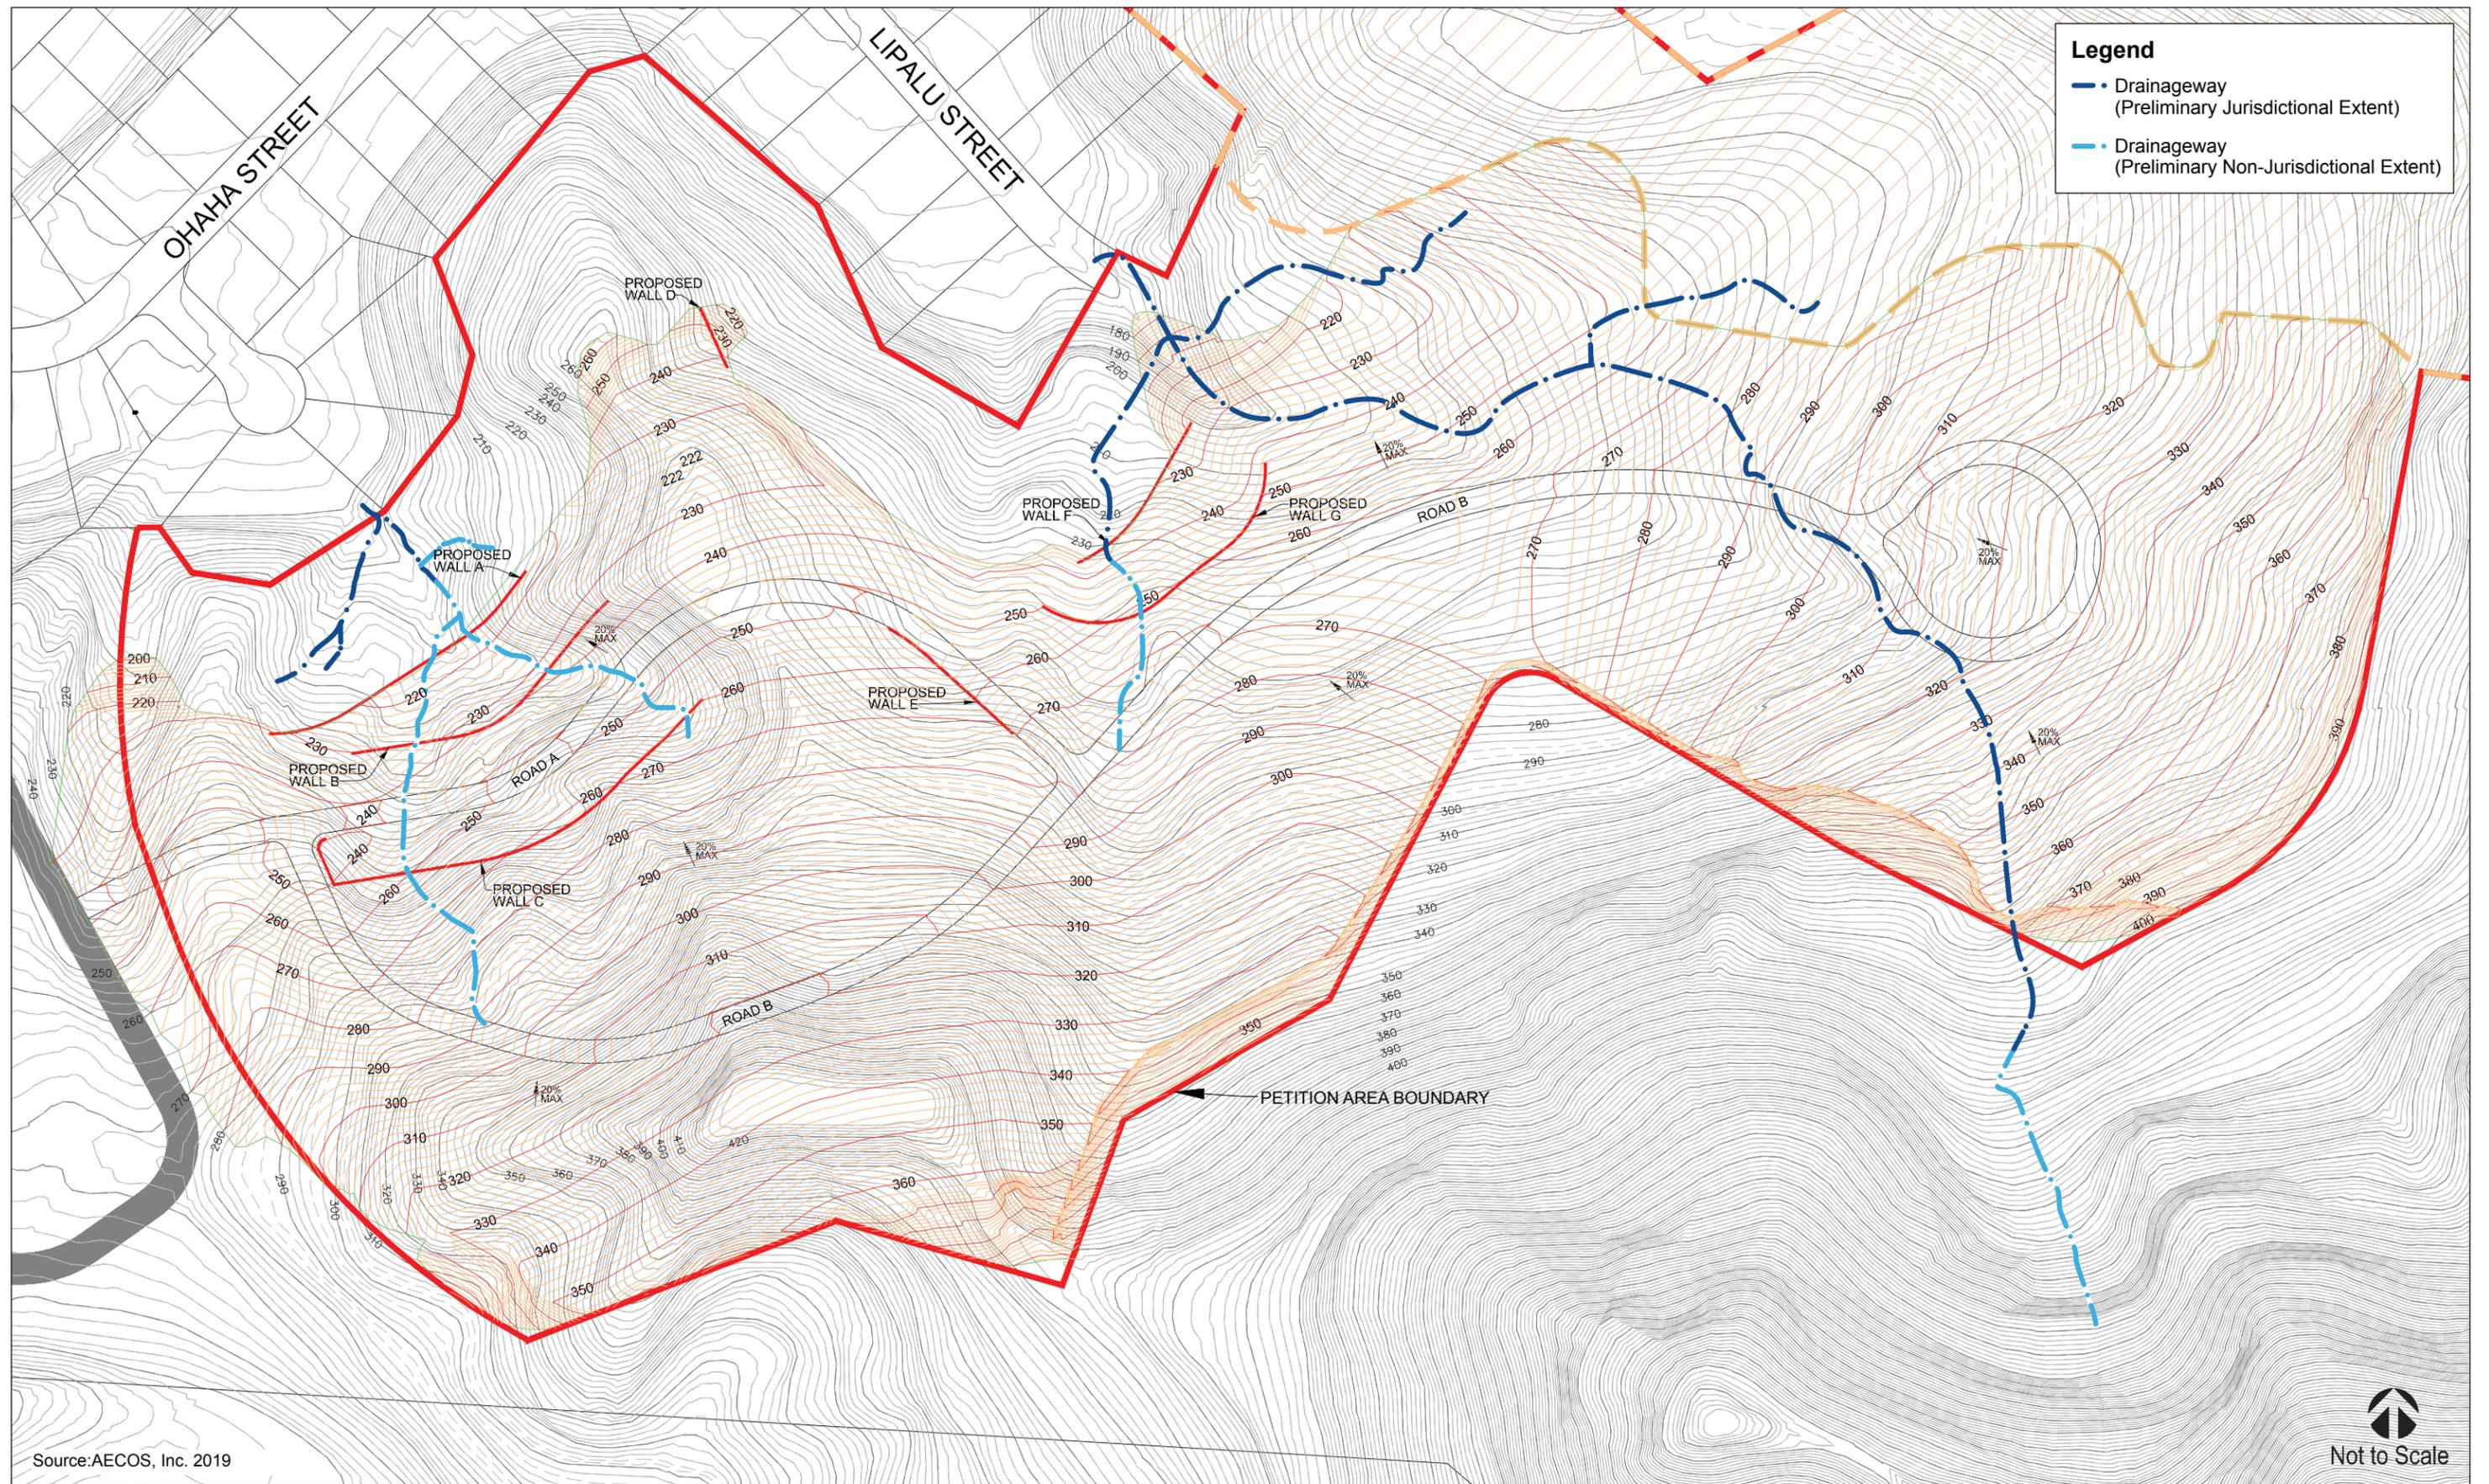
**Petition Area Drainageways**

For description purposes, the drainageway upslope of Lipalu Street is referred to as the “Lipalu Channel.” Within this area, Lipalu Channel and three unnamed branches appear to be jurisdictional under the CWA as shown on Figure 3.11a. This channel is routed through the eastern section of the Petition Area generally near the Cultural Preserve. Lipalu Channel is likely a tributary to Kāwā Stream, which discharges into Kāne‘ohe Bay, and would thus be jurisdictional by rule. Lipalu Channel enters the City’s storm drain system through a culvert underneath Lipalu Street and then discharges into a channelized tributary of Kāwā Stream. However, a more formal survey would still need to be conducted and submitted to the USACE for their review and official jurisdictional determination.

Lipalu Channel is a non-relatively permanent waterbody (non-RPW), with physical flow sufficient to create discontinuous indicators of an ordinary high water mark (OHWM). The channel has bed and banks, which are not continuous throughout the length of the channel like the OHWM. The average width of each channel is approximately 3 feet wide, and the channels are incised to mostly less than 3 feet, becoming broader and deeper near the Lipalu Street culvert entrance. Sediment sorting, destruction of terrestrial vegetation, and a break in bank slope were the most frequently observed indicators of OHWM.

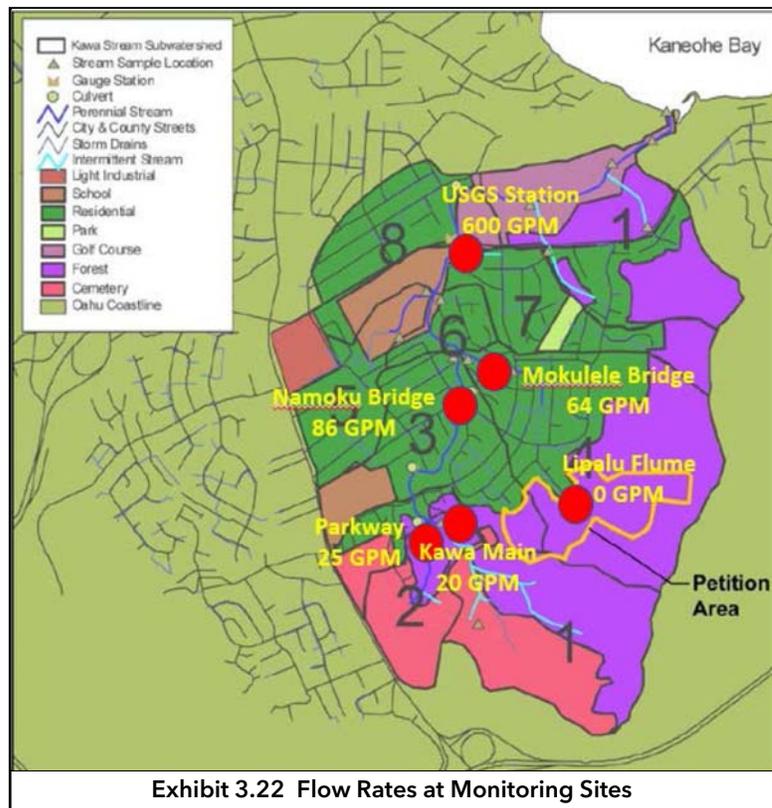
Exhibit 3.22 Flow Rates at Monitoring Sites

A seepage run conducted in the residential basin (Cascade Spring) measured spring flow of 5 gpm at the slope below HMP's existing maintenance facility; 2 gpm from the buried culvert draining HMP's existing cemetery and receiving groundwater input; and about 8 gpm of perched groundwater inflow across the course of the small tributary flowing northeast from the spring and culvert behind the Parkway residential recreational center.

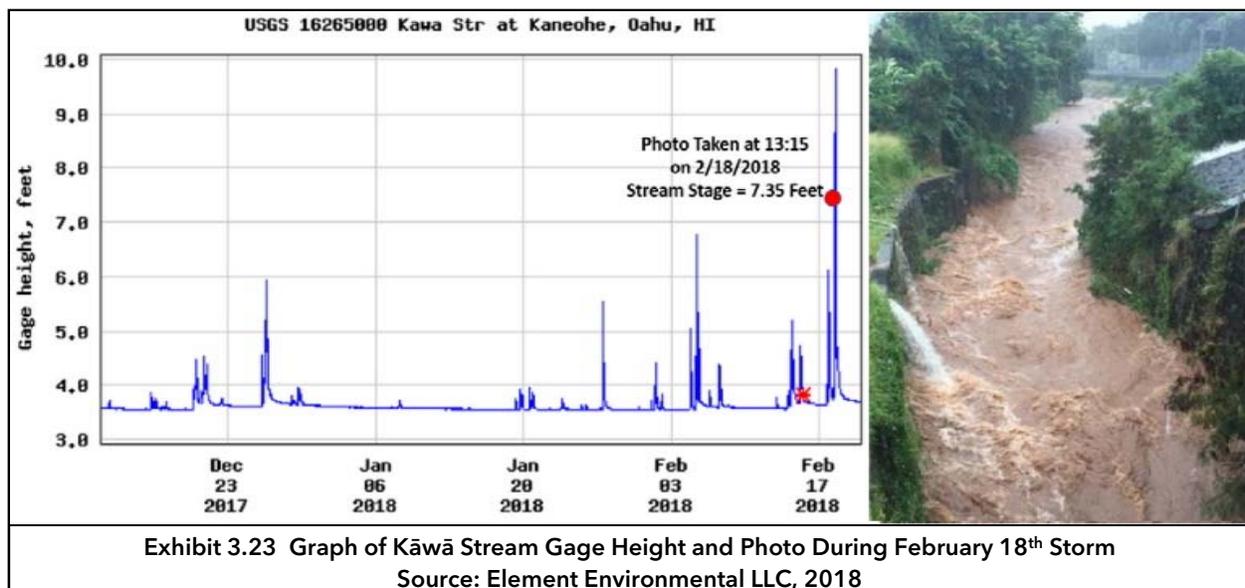
**Lipalu Watershed Load Contribution**

The intense rainfall event beginning around noon on February 18, 2018 accounted for about 74% of TSS yield, TP load, and over 52% of TN load measured over the entire monitoring period (Exhibit 3.23). Water flow at the Kāwā Stream USGS station rose 100-fold (from 10 to 1,000 cfs) in a 15-minute period during this storm. The resulting stream flow likely scoured unhardened portions of drainageways and Kāwā Stream leading to changes in the size, shape, and composition of the channel. Therefore, it can be concluded by data collected that the vast majority of sediment and nutrient loads entering Kāne‘ohe Bay from Kāwā Stream does occur during these significant storm events.

The smaller Lipalu watershed area within the larger Kāwā watershed contributes nutrients and suspended solids to Kāwā Stream from within the Petition Area. The Lipalu flume set up in the existing ephemeral drainageway provides information on storm runoff volumes along with nutrient and TSS loads. The contribution of streamflow, total suspended solids and nutrients generated from the Lipalu watershed, where much of the cemetery’s expansion would occur, is summarized on Table 3.7. The flow data and mass estimates of nutrient and suspended sediments for the large storm event on February 18 are not accurate because the flume collapsed, but do show that the volume of runoff from this single storm dwarfed the volume of runoff generated during the previous eight runoff events.

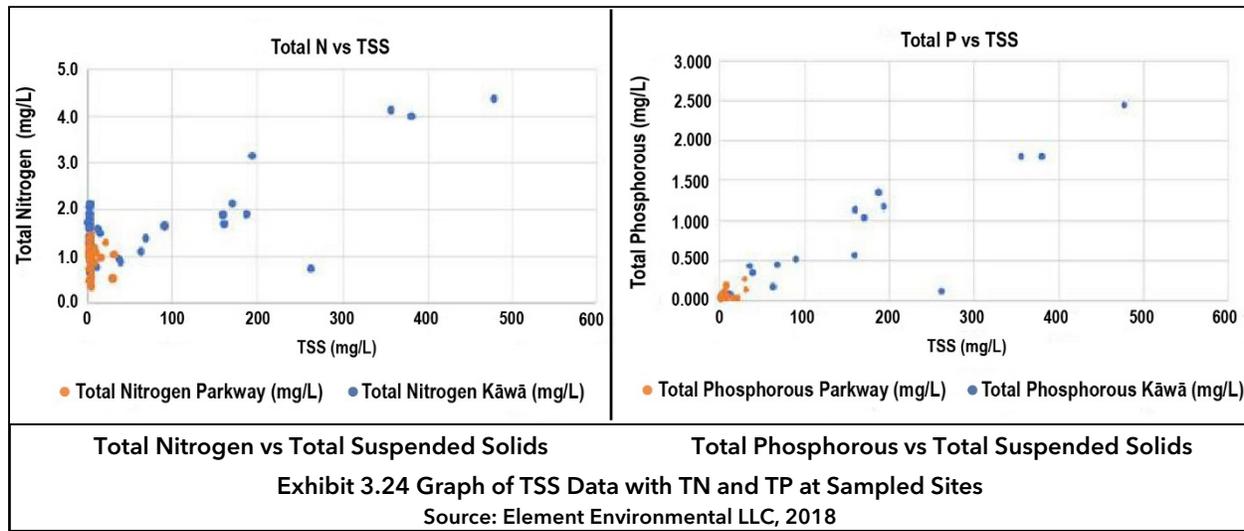
Exhibit 3.24 illustrates a positive relationship between TN and TSS concentrations for samples graphed. The pattern shown indicates TN concentrations generally increase as TSS concentrations rise. This pattern suggests groundwater dominant samples, possessing lower TSS concentrations, also have comparatively lower nitrogen concentrations. Elevated nitrogen concentrations result from the presence of stormwater runoff in samples. Exhibit 3.24 also illustrates a positive relationship for TP concentrations that generally increase as TSS concentrations rise. This relationship suggests phosphorous may be present in solids transmitted to the stream during runoff events.

Examined collectively, these graphs illustrate that samples from the USGS Kāwā Stream station and the Parkway site follow similar variation trends. This suggests nutrient and TSS contributions to Kāwā Stream from the existing HMP cemetery area are not elevated compared to contributions to this stream from the lower urbanized portions of the watershed. Although HMP lands are only a portion of the larger watershed, the pattern may indicate existing areas of HMP do not contribute high nutrient concentrations to Kāwā Stream affecting its water quality.

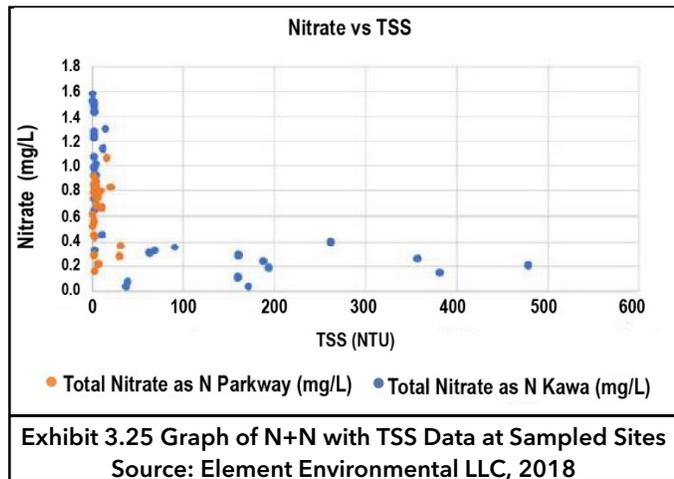
Exhibit 3.25 Graph of N+N with TSS Data at Sampled Sites  
Source: Element Environmental LLC, 2018

Exhibit 3.25 shows the relationship between N+N and TSS, indicating a negative relationship between both constituents as N+N concentrations generally decline as TSS increases. This pattern suggests groundwater, which generally has lower TSS concentrations, is the primary source of nitrates to Kāwā Stream.

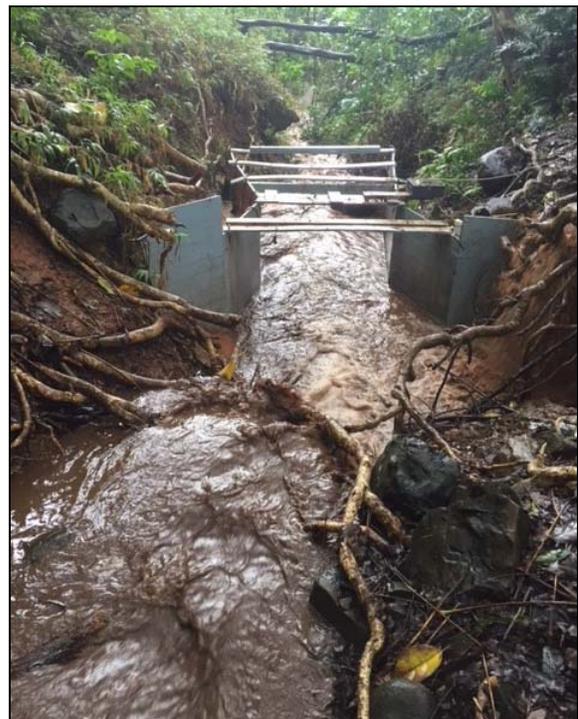
Exhibit 3.26 Photo of Turbid Runoff  
at Flume on February 5, 2018

Exhibit 3.26 is a photo showing the turbid, chocolate-brown runoff that passed through the flume during a storm event. The TSS concentrations present in the runoff from this undeveloped forestland is particularly elevated compared to concentrations measured elsewhere. The elevated concentrations may partially reflect the higher amounts of rainfall and rainfall intensity required to initiate flow within this forested watershed.

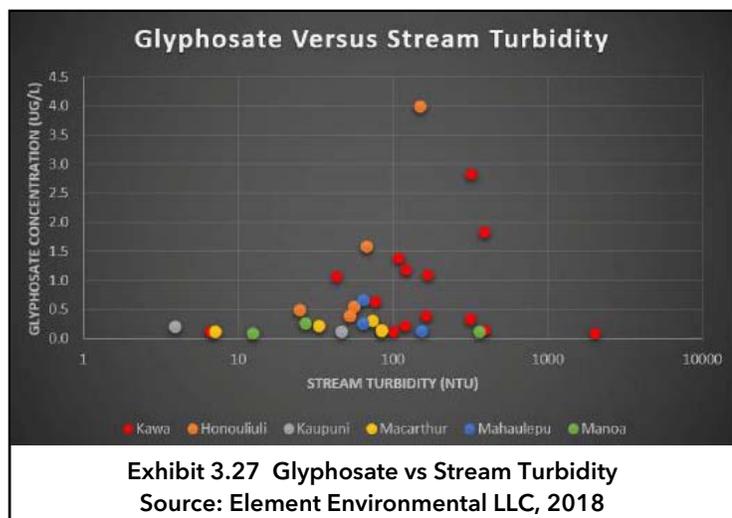
Exhibit 3.27 compares the relationship between turbidity and glyphosate concentration. The graph illustrates this relationship for samples obtained for this project and those obtained in other studies from drainage ditches and streams on O‘ahu and Kaua‘i. Although variation is apparent, stream samples containing over 0.5 parts per billion glyphosate are generally moderately to highly turbid (>50 NTU). This pattern observed aligns with findings of other studies indicating that glyphosate is

commonly detected in stream bed sediments, supporting the suggested conclusion that glyphosate may be found in Kāwā Stream from the runoff related resuspension of contaminated sediments.
