STRATIGRAPHIC TRENCH 10 (ST-10)

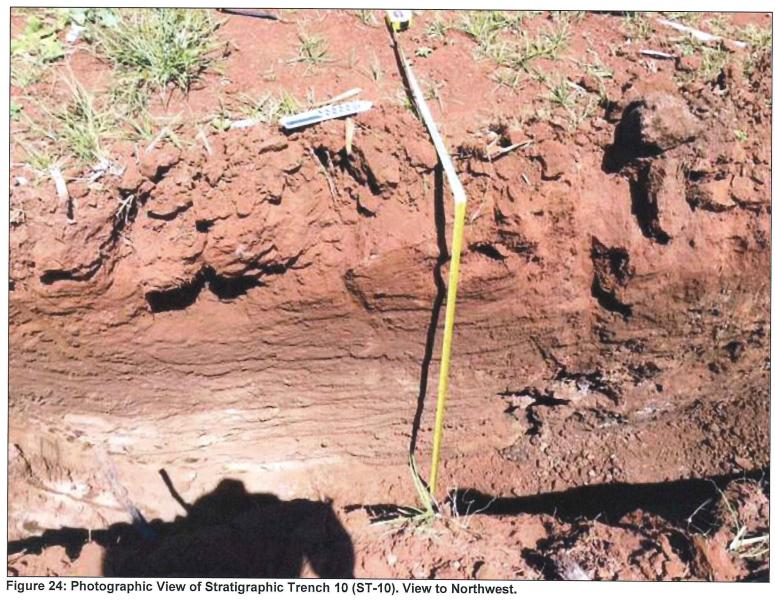
Stratigraphic Trench 10 (ST-10) ($400 \times 100 \times 180 \text{ cm}$) was located on a northeast/southwest axis ($20^{\circ}/200^{\circ}$). The surface of ST-10 contained sporadic sugar cane, along with scattered grass patches and previously disturbed top soil. ST-10 contained two stratigraphic layers (Figure 24 and Figure 25).

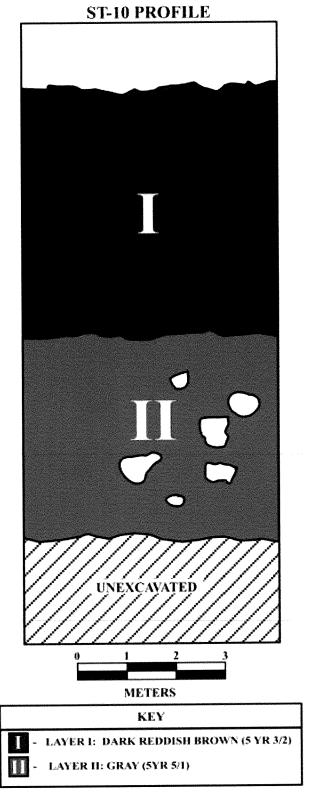
Figure 25: Stratigraphic Trench 10 (ST-10) Profile.

Layer I (0-100 cmbs) consisted of dark reddish brown (5YR 3/2) dry, compacted and wet semi-plastic silty clay. No roots or stones were present throughout Layer I. The lower boundary was abrupt and smooth.

Layer II (100-180 cmbs) consisted of gray (10YR 5/1) compacted silt and semi-plastic silty clay. Stones were present throughout Layer II.

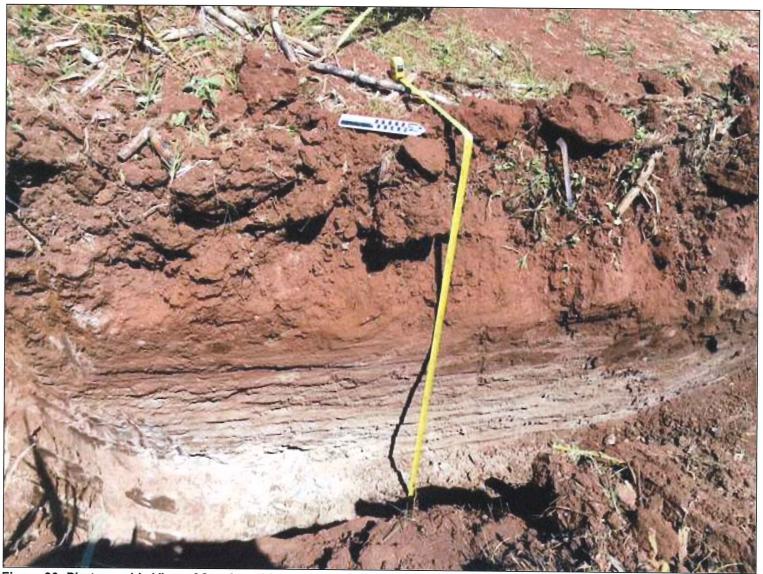
Figure 26: Photographic View of Stratigraphic Trench 11 (ST-11). View to Northwest.

Stratigraphic Trench 11 (ST-11) (380 x 90 x 160 cm) was located on a northwest/southeast axis (340 $^{\circ}$ /160 $^{\circ}$). The surface of ST-11 contained sporadic sugar cane, along with scattered grass patches and previously disturbed top soil. ST-11 contained two stratigraphic layers (Figure 26 and Figure 27).

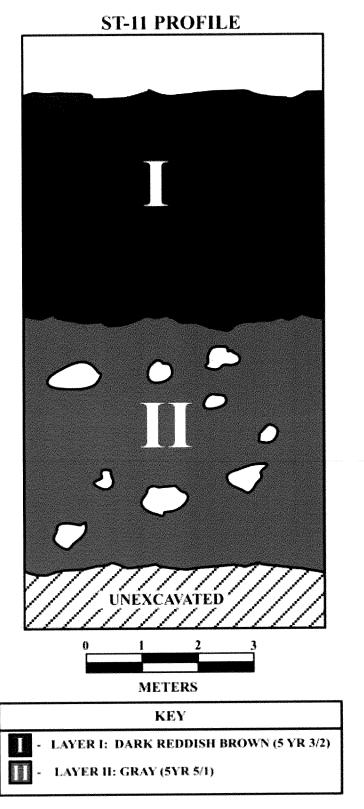
Figure 27: Stratigraphic Trench 11 (ST-11) Profile.

Layer I (0-80 cmbs) consisted of dark reddish brown (5YR 3/2) dry, compacted and wet semi-plastic silty clay. No roots or stones were present throughout Layer I. The lower boundary was abrupt and smooth.

Layer II (80-160 cmbs) consisted of gray (10YR 5/1) compacted silt and semi-plastic silty clay. Stones were present throughout Layer II.

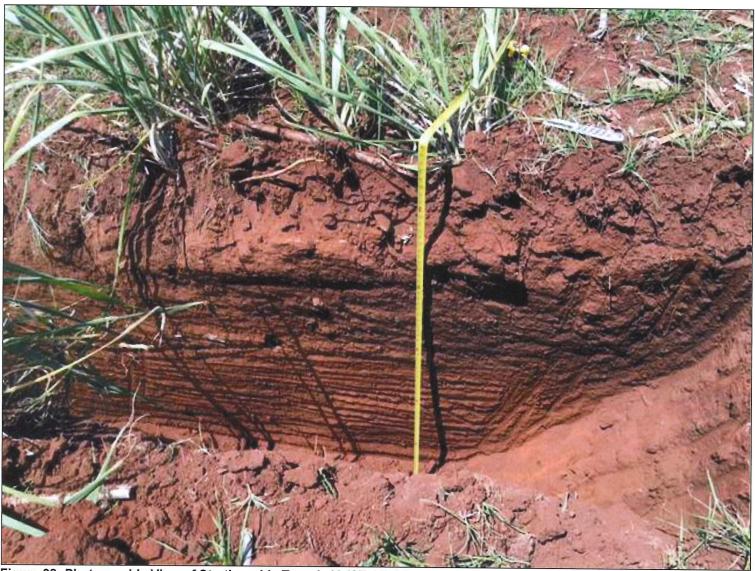
Figure 28: Photographic View of Stratigraphic Trench 12 (ST-12). View to Northwest.

Stratigraphic Trench 12 (ST-12) ($470 \times 100 \times 165 \text{ cm}$) was located on a southeast/northwest axis ($160^{\circ}/340^{\circ}$). The surface of ST-12 contained sporadic sugar cane stalks, along with scattered grass patches and previously disturbed top soil. ST-12 contained two stratigraphic layers (Figure 28 and Figure 29).

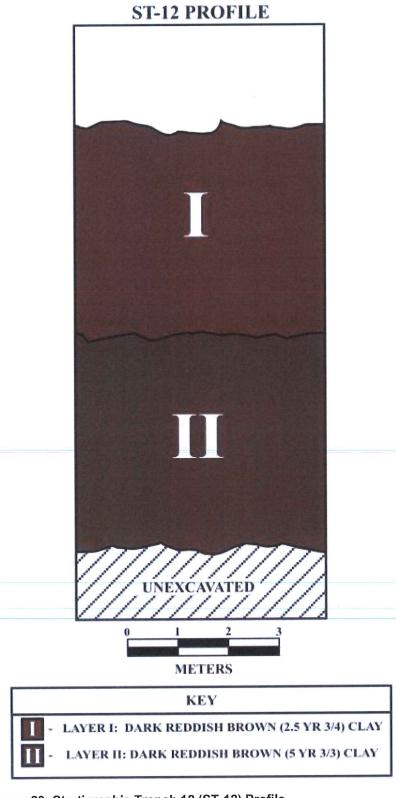
Figure 29: Stratigraphic Trench 12 (ST-12) Profile.

Layer I (0-80 cmbs) consisted of dark reddish brown (2.5YR 3/4) dry, compacted and wet semi-plastic silty clay. No roots or stones were present throughout Layer I. The lower boundary was abrupt and smooth.

Layer II (80-165 cmbs) consisted of gray (5YR 3/3) compacted silt and semi-plastic silty clay. Stones were present throughout Layer II.
