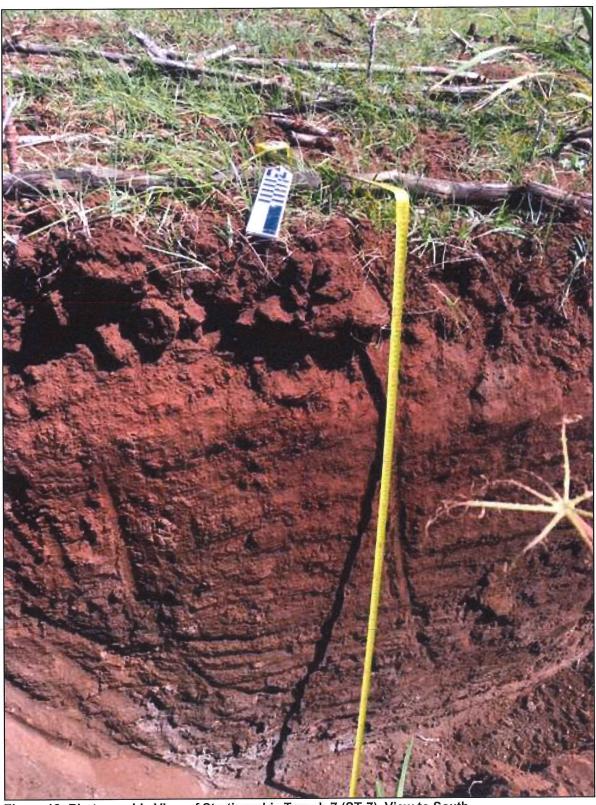
Figure 18: Photographic View of Stratigraphic Trench 7 (ST-7). View to South.

Stratigraphic Trench 7 (ST-7) (460 x 100 x 170 cm) was located on a northwest/southeast axis (130 $^{\circ}$ /310 $^{\circ}$ ). The surface of ST-7 contained sporadic sugar cane stalks, along with scattered grass patches and previously disturbed top soil. ST-7 contained two stratigraphic layers (Figure 18 and Figure 19).

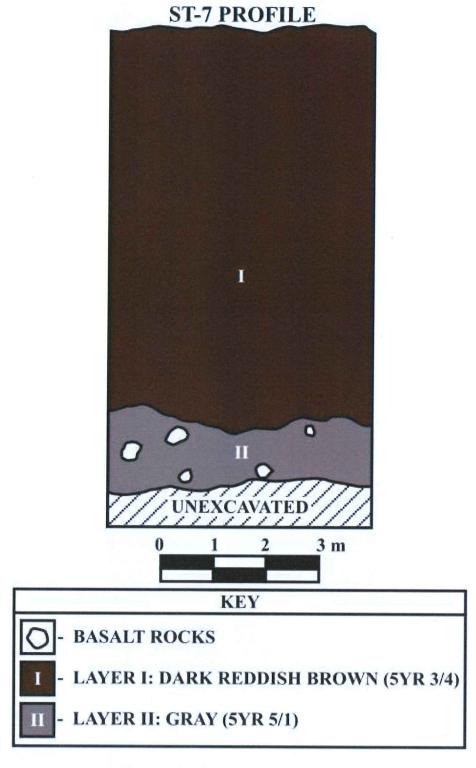
Figure 19: Stratigraphic Trench 7 (ST-7) Profile.

Layer I (0-150 cmbs) consisted of dark reddish brown (5YR 3/2) dry, compacted silt and semi-plastic silty clay. No roots or stones were present throughout Layer I. The lower boundary was gradual and wavy.

Layer II (150-170 cmbs) consisted of gray (5YR 5/1) wet plastic. Stones were present throughout Layer II and ended the excavation.

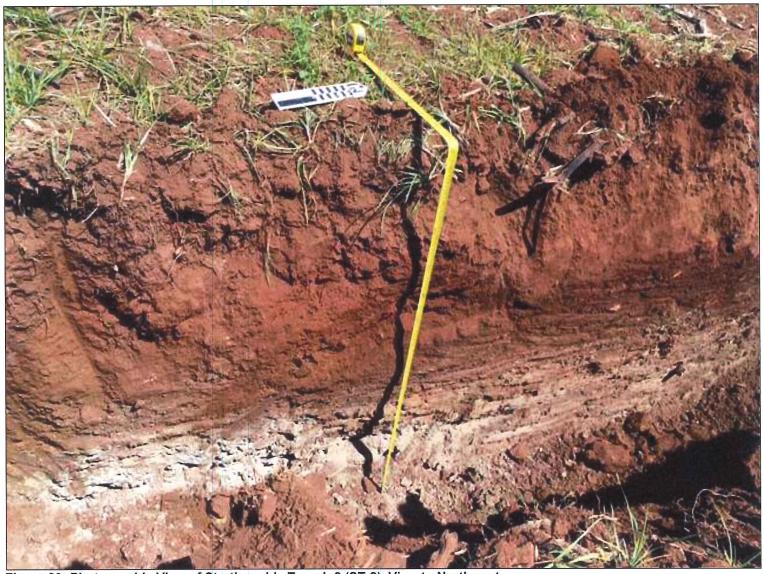
Figure 20: Photographic View of Stratigraphic Trench 8 (ST-8). View to Northwest.

Stratigraphic Trench 8 (ST-8) ( $440 \times 90 \times 145 \text{ m}$ ) was located on a northeast/southwest axis ( $20^{\circ}/200^{\circ}$ ). The surface of ST-8 contained sporadic sugar cane, along with scattered grass patches and previously disturbed top soil. ST-8 contained two stratigraphic layers (Figure 20 and Figure 21).

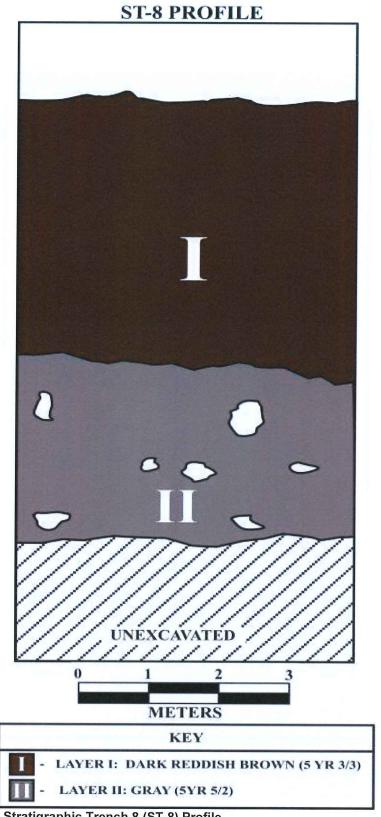
Figure 21: Stratigraphic Trench 8 (ST-8) Profile.

Layer I (0-90 cmbs) consisted of dark reddish brown (5YR 3/3) dry, compacted silt and semi-plastic silty clay. No roots or stones were present throughout Layer I. The lower boundary was gradual and wavy.

Layer II (90-145 cmbs) consisted of reddish gray (5YR 5/2) compacted silt and semiplastic silty clay. No roots or stones were present throughout Layer II.

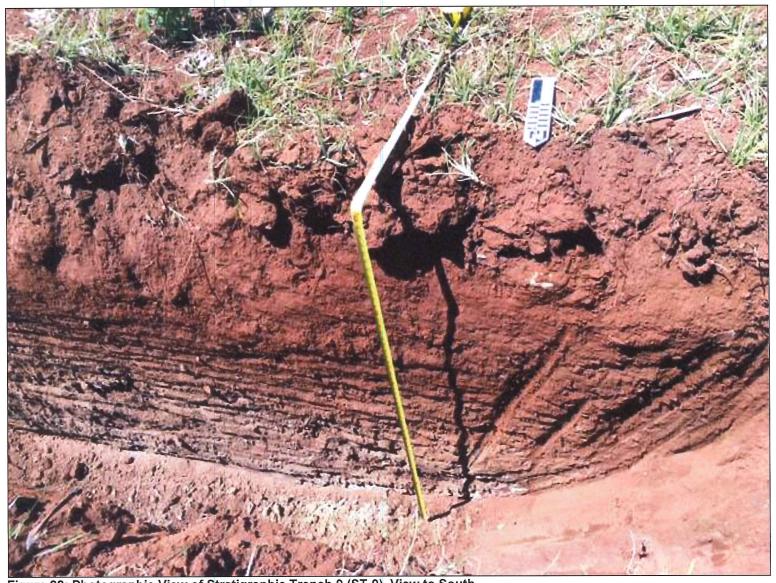
Figure 22: Photographic View of Stratigraphic Trench 9 (ST-9). View to South.

Stratigraphic Trench 9 (ST-9) ( $440 \times 90 \times 145 \text{ cm}$ ) was located on a northeast/southwest axis ( $20^{\circ}/200^{\circ}$ ). The surface of ST-9 contained sporadic sugar cane, along with scattered grass patches and previously disturbed top soil. ST-9 contained two stratigraphic layers (Figure 22 and Figure 23).

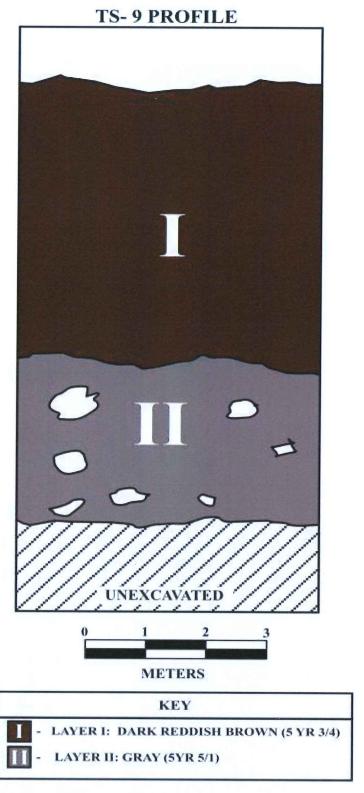
Figure 23: Stratigraphic Trench 9 (ST-9) Profile.

Layer I (0-90 cmbs) consisted of dark reddish brown (5YR 3/3) dry, compacted silt and semi-plastic silty clay. No roots or stones were present throughout Layer I. The lower boundary was gradual and wavy.

Layer II (90-145 cmbs) consisted of gray (5YR 5/2) compacted silt and semi-plastic silty clay. No roots or stones were present throughout Layer II.
