Re: Public Comment Period for Draft Environmental Assessment for
Reclassification of Approximately 0.51 Acres of Land Located at Tax
Map Key No.: (3) 1-5-059:059, Island, County and State of Hawai'i

SUBJECT: **Republished** Draft Environmental Assessment for the Proposed
Barry Family Project located at Keaau, Puna, Island of Hawaii;
TMK: (3) 1-5-059:059

Appendix 2: Coastal Erosion and Volcanic Hazards Report

Coastal Erosion and Volcanic Hazards Report

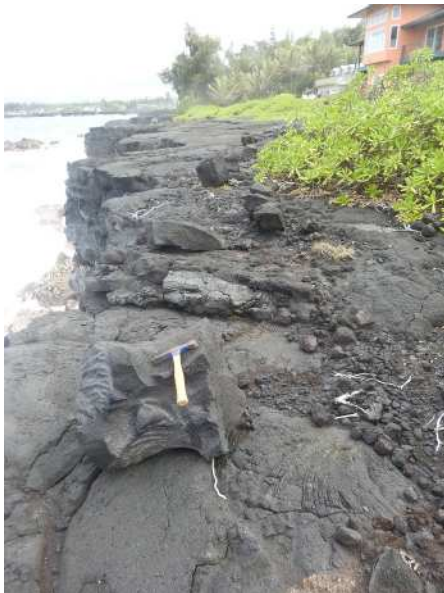
Figure 1. View of coastline fronting the Property – view to south. The vegetation (naupaka) defines the shoreline (“highest reach of waves”) fronting the Property, and is as close as 8’ to the coastline cliff (Figure 2) at the Property’s south boundary. Normal surf does not reach above the coastal cliff, but angular boulders attests to the fact that exceptionally large storms can dislodge cliff edge pahoehoe and place blocks short distances inland, and scour vegetation inland from the cliff face. The coastal bench of bare pahoehoe is as much as 30’ wide at the north Property boundary.

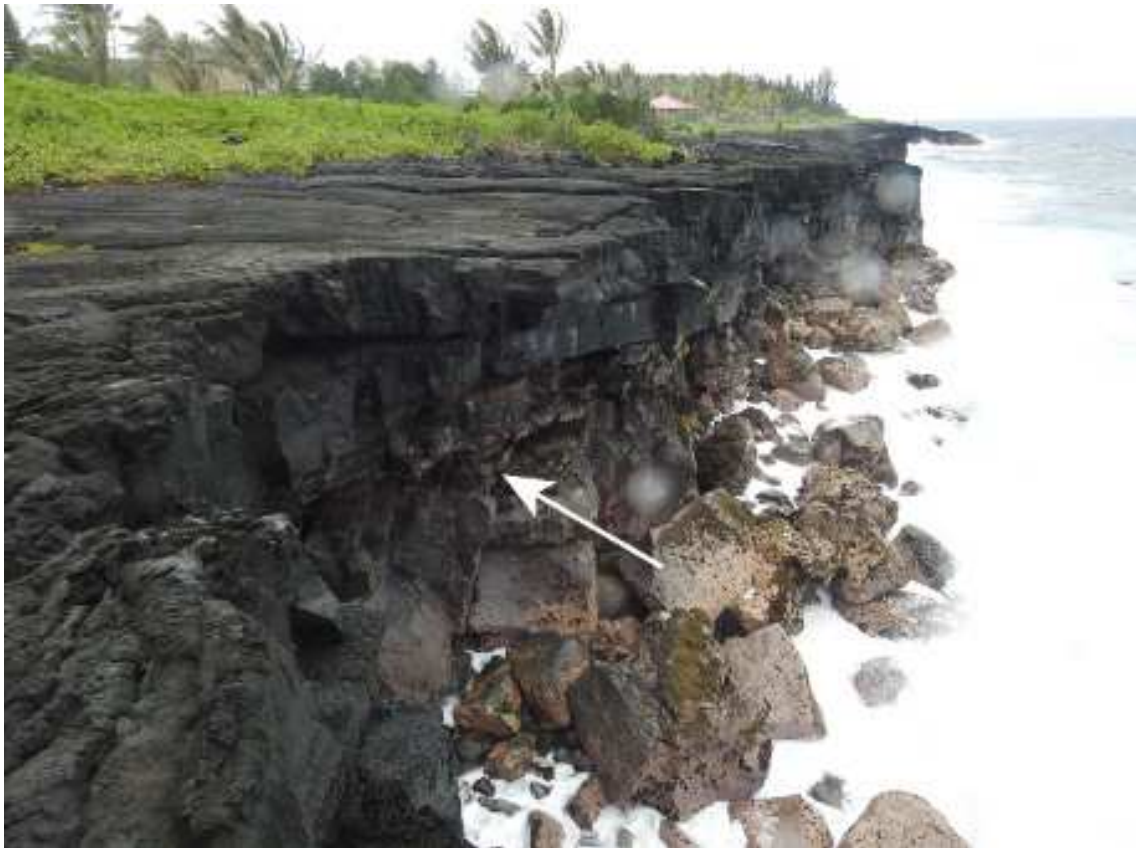
Erosion of the sea cliff fronting the Property reveals that these pahoehoe lobes overlie an older, massive, dense lava, along a sharp contact (Figure 3). This older flow could not be inspected because of dangerous surf conditions, and its origin is uncertain. It was probably erupted by an earlier phase of the same long-term 'Ai-la'āu eruption that formed the overlying pahoehoe. The top of this underlying flow shows red oxidation (Figure 3) indicating some significant passage of time before emplacement of the overlying flow. Its age is not known, but I shall assume it erupted about 1350 CE (about 670 years ago) – one of the earliest 'Ai-la'āu flows.

Figure 3. Seacliff fronting the Property, showing the younger, overlying pahoehoe flow lobes that form the surface of the entire Property (above arrow) – view to northeast. The contact with the underlying dense, massive lava flow is marked by a red oxidized surface zone, which demonstrates substantial time elapsed between emplacement of the two flows.

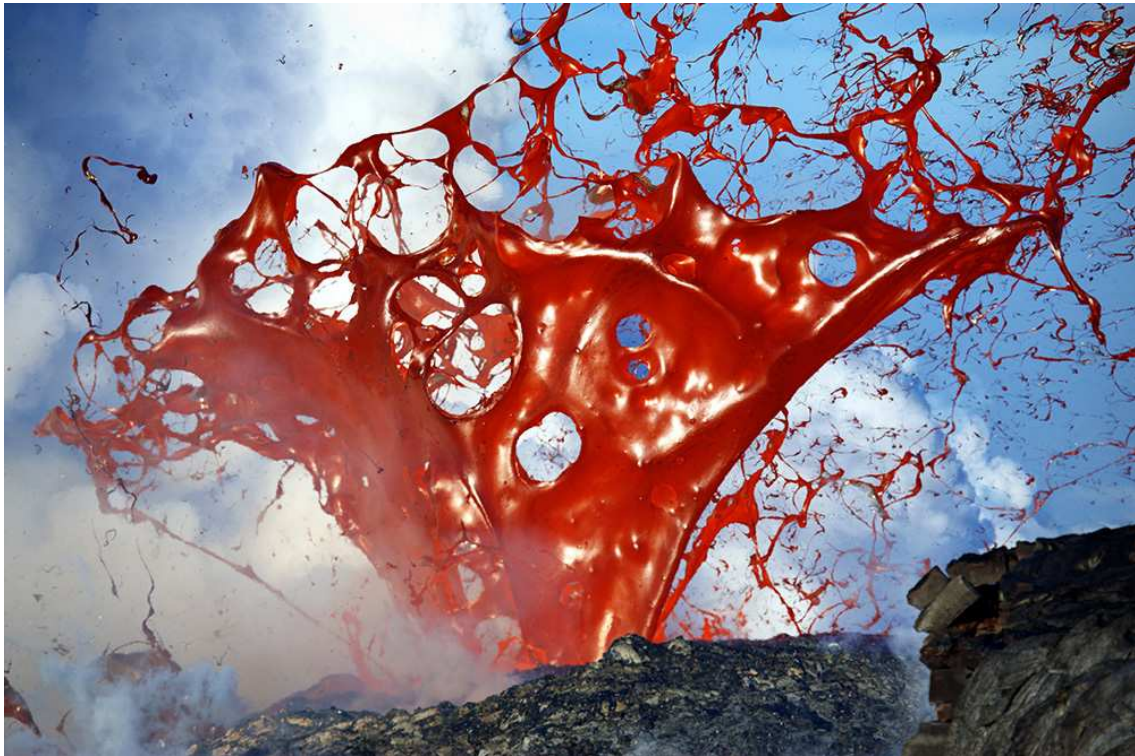
Discontinuous deposits of volcanic glass fragments in deposits up to three inches in thickness are found in grass-covered pockets just makai of the naupaka-defined shoreline. These deposits consist of a unique material called “limu o Pele” (Mattox and Mangan, 1997), and were formed by the explosive interaction of seawater and fluid pahoehoe when the underlying flow entered the ocean 300-500 years ago. The rapid expansion of steam entering molten lava formed large “lava bubbles”, which formed thin sheets of glass and fine particles as they exploded (Figure 5).

Figure 5. Bursting bubble of molten lava where seawater interacted explosively with fluid pahoehoe lava entering the sea along Kilauea's south coast during a 1990's eruption. Such explosions form the windborn fragmental debris uncommonly preserved on the Property as "limu O Pele". Photograph supplied by Tari Mattox, but photographer unknown.

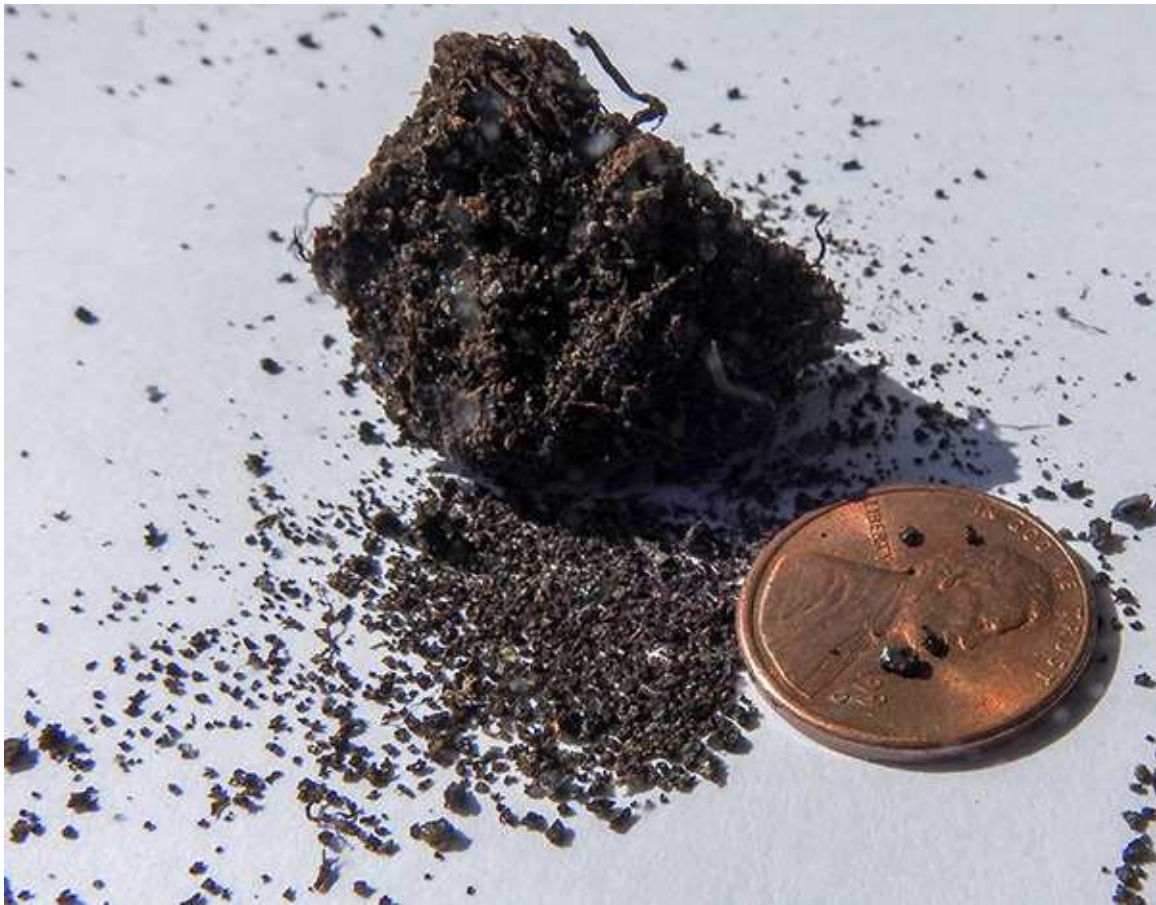
Figure 7. Limu O Pele deposit detail. Fragments consist entirely of fresh, brown volcanic glass fragments up to 1 mm diameter. Note the grass rootlets that permeate the deposit. Thinner glass films common in modern limu O Pele deposits have apparently been dissolved away, leaving only coarser fragments behind.

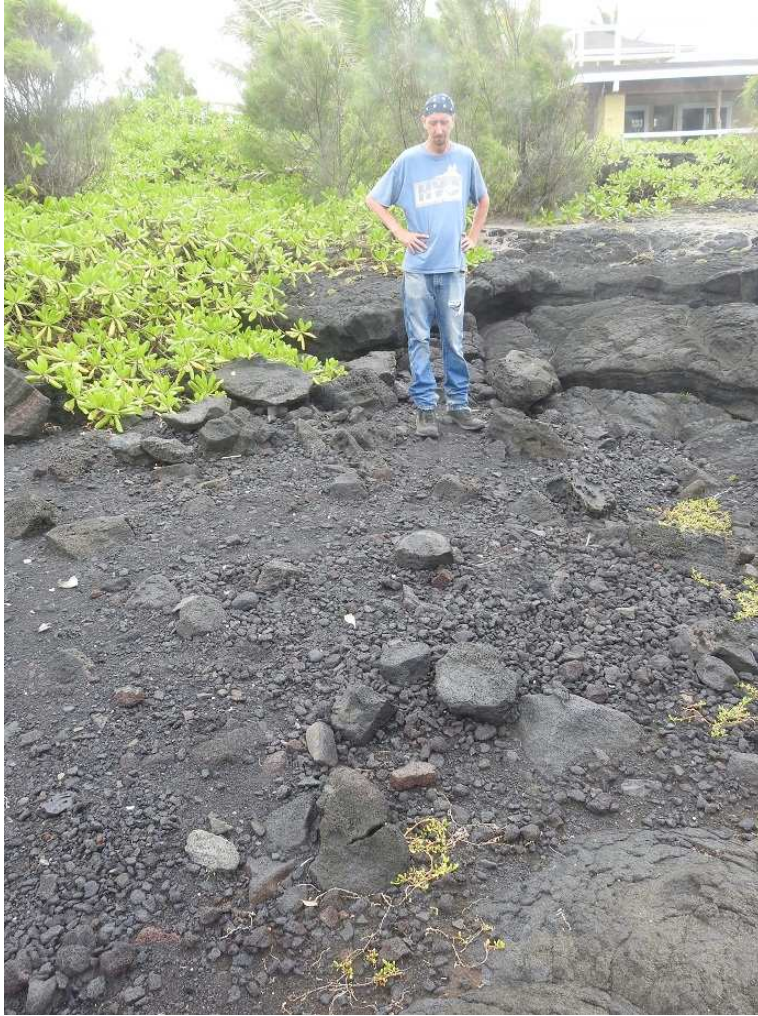
Figure 8. Small area of storm wave-deposited cobbles, gravel, and sand along the northwest-most boundary of the Property.

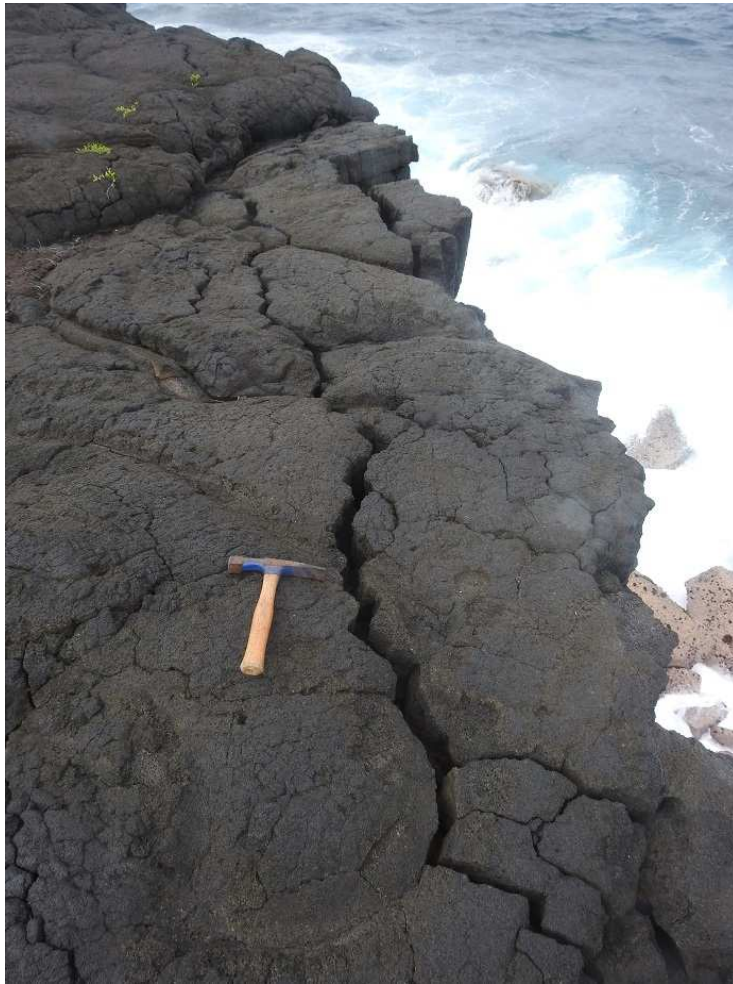
The sea cliff fronting the Property is resistant to erosion, and negligible erosion occurs during normal sea conditions. During times of major storms, however, the impact of waves can cause some mechanical and abrasional erosion, although even this is likely rare. Cracks near the edge of the sea cliff in several places (Figure 9) indicate where the cliff edge is unstable, and susceptible to failure when impacted by powerful storm waves. A few scattered blocks of angular pahoehoe up to two feet diameter were noted above the coastal plain and as much as ten feet inboard of the shoreline (Fig. 1). These were formed when powerful waves impacted the top of the sea cliff, injected high-pressure water into the contacts between flow lobes, and through the process of “hydraulic ramming” loosened blocks and moved them short distances inland.

Figure 9. Extension cracks present at the Property’s coastal cliff edge. These cracks, which are common along this stretch of coastline, develop as stresses are relieved at the cliff face, and contribute to the susceptibility of this upper pahoehoe flow to rare storm waves that impact the cliff face and force sea water into the horizontal contacts between flow lobes.

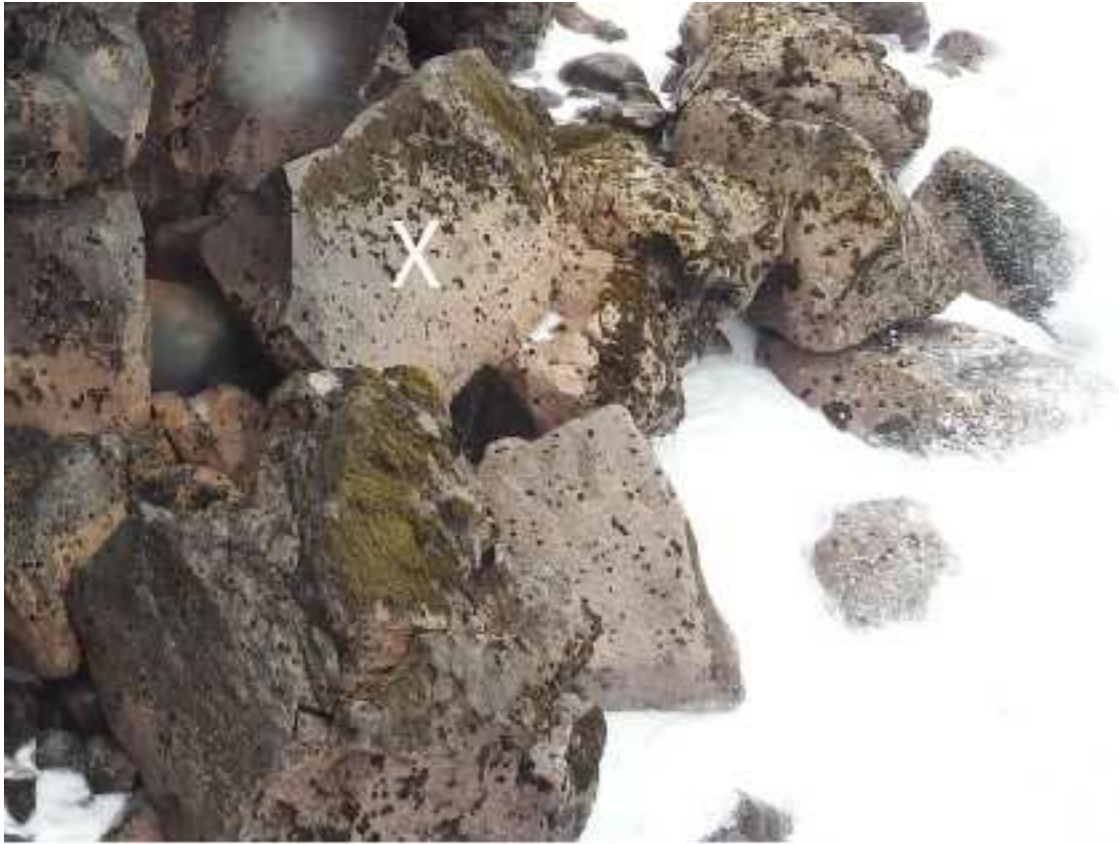
The dense lava underlying the pahoehoe flows is highly resistant to wave impact forces, but also has internal joint fracture planes that can be exploited by the impact of particularly powerful waves. This type of mechanical erosion is rare, but can occur, as indicated by the presence of very large (up to five feet diameter) angular, subangular, and sub-rounded blocks found at the base of the sea cliff fronting the Property (Figures 3, 10).

These erosional processes are normal for the storm-wave exposed rocky coastlines of Puna, and are of no particular concern for this Property over the short-term (the next several decades).

Figure 10. Detailed view of eroded blocks at the base of the coastline cliff. Most of the blocks have slightly subrounded edges, indicating abrasion by surf action. The large block marked with an “X” is about three feet in diameter, with uniformly angular edges, and must have fallen within the past few years – long ago enough to be covered with marine algae. These large blocks serve to block and attenuate the force of impacting waves – forming protection from erosion.
