Land Use Commission Meeting June 9-10, 2021

**RE: Testimony SP06-400 Pōhākea Quarry (Maui)**

To Consider Hawaiian Cement Pōhākea Quarry Application for 15-year Time Extension Request for Special Use Permit to Continue Operation of Pōhākea Quarry in the State and County Agricultural Districts at Mā'alaea, Island of Maui, Hawai'i; TMK: (2) 3-6-004:007 (SUP1 2006/0001) (CUP 2006/0001)

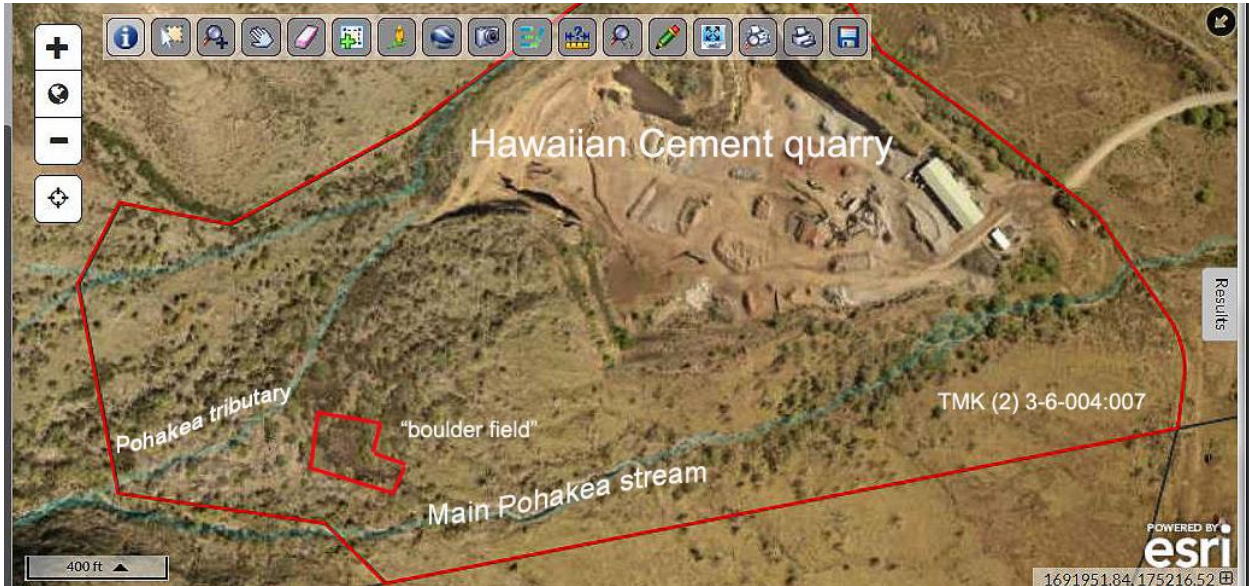
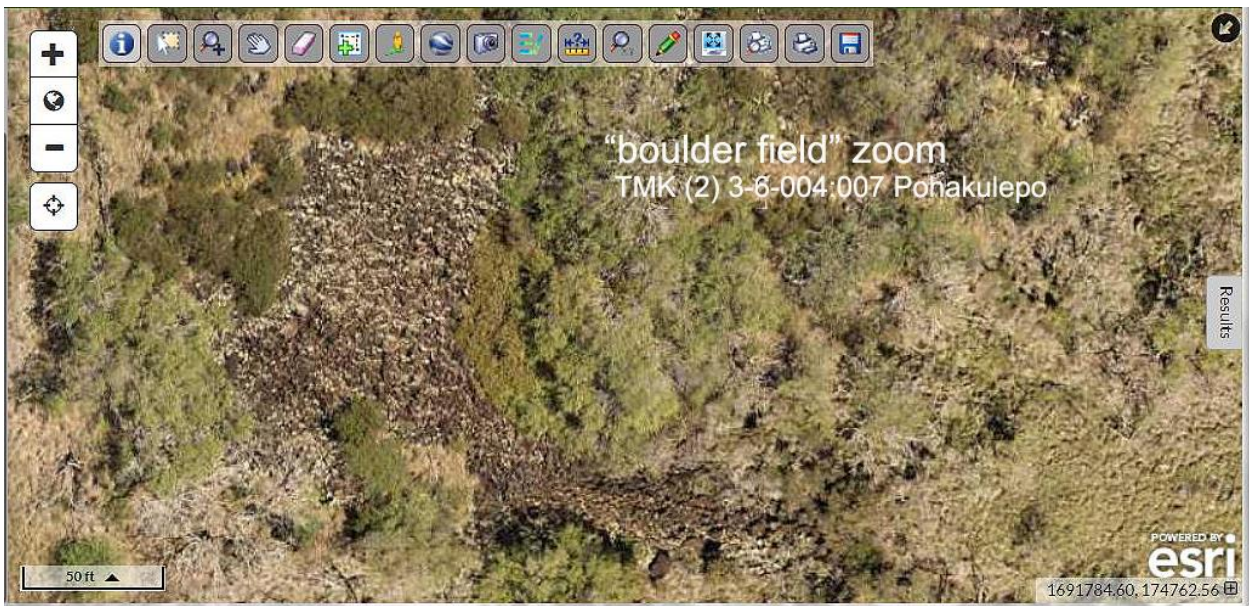
TMK (2) 3-6-004:007 Pohakulepo LLC – Hawaiian Cement quarry  
Exhibit A: “Boulder field” feature and Pohakea stream and tributaries

As with many streams in Maui, Pohakea brings together and disperses several small tributaries at various points along its trajectory from the back of the valley to its gathering point at TMK (2) 3-6-004:007 (see Exhibit A, top image; two small tributaries and the main streambed marked in light blue). Culverts under the road at Honoapi’ilani Highway facilitate movement of water from the main Pohakea streambed to Kealia fishpond and salt ponds (Sterling 1998; now Kealia Pond National Wildlife Refuge). Surface flows from Pohakea gulch during high rain events reach

This SUP/CP/CUP has never allowed for the alteration of a stream bed, yet, at least one tributary of Pohakea has been terminated by the quarry (readily visible in aerial images), and has been known to be the source of water flooding into the quarry during major storm events (see Exhibit

A, top image). No action has been taken by any agency despite the fact that these channels have never been “erosional features,” either historically or in the present day (convenient language that sidesteps additional permit requirements and responsibility for the care of natural streambeds). NOAA has predicted that flood events, along with hurricanes, will increase in regularity and impact in our islands with Climate Change. Expansion of the quarry will only exacerbate such conditions.

The “modified boulder field” is clearly visible from aerial pictometry images available to the County and to the LUC (Exhibit A attached; it should be noted the images are outdated and do reflect the current expansion of the quarry). The site measures an estimated 75 x 90ft with what appears to have been an thick wall or narrow platform extending from the west corner of the site running E/SE estimated at least 100ft in length. While we may not be able to determine if this is truly a heiau site based on current knowledge and technology, such a structure so near the moku boundaries of Lahaina and Wailuku makes sense (similar to Walker site 1; in Sterling, maps [pg16 and 62] suggest the moku boundary touches Pohakea stream at or near TMK (2) 3-6-004:007). It would behoove the LUC (and SHPD) to err on the side of caution with a wide buffer to this portion of the parcel so that future generations of Hawaiians and the broader community are not further short-changed of the important cultural heritage the complex represents.
