TRENCH 4

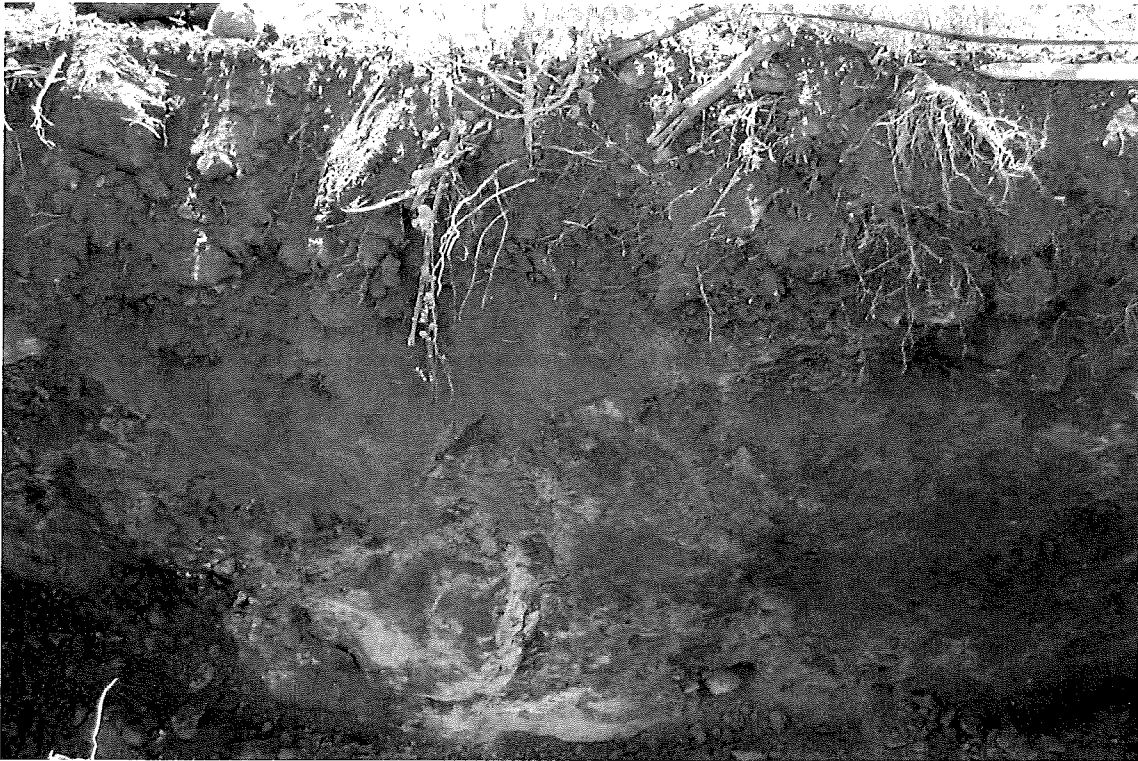
Figure 18. Photograph of Trench 4 West Wall

TR-4 was placed within the 8.8acre area in the central portion of the project area (see Figure 11, Table I and Appendix A). It measured 5.0 m long by 1.5 m wide by 2.0 m deep and was oriented 340° degrees (Figure 17). This section had been previously grubbed during the harvesting of the sugar cane. Testing revealed a four layer stratigraphic sequence (Figure 18). No cultural materials were observed.

Layer I (0-58cmbs) is a dark brown (7.5yr 3/3), silty loam, slightly plastic, slightly sticky, crumb, friable, with moderate frequency of roots and rootlets. Inclusions consisted of black plastic irrigation. This heavily disturbed layer is commonly referred to as the "till zone"..

Layer II (40-100cmbs) is a dark reddish brown (5yr3/4), silt loam, slightly plastic, slightly sticky, crumb, friable. This layer appears to be disturbed.

Layer III (98-142cmbs) is a yellowish brown (10yr5/4), silt loam, slightly plastic, slightly sticky, crumb, friable, with a high frequency of decomposing basalt. This layer is undisturbed and referred to as the "saprolitic layer".

Layer IV (138-200cmbs+) is a gray (10yr 5/1), basalt layer, non plastic, non sticky, massive, indurated. This is the bedrock layer.

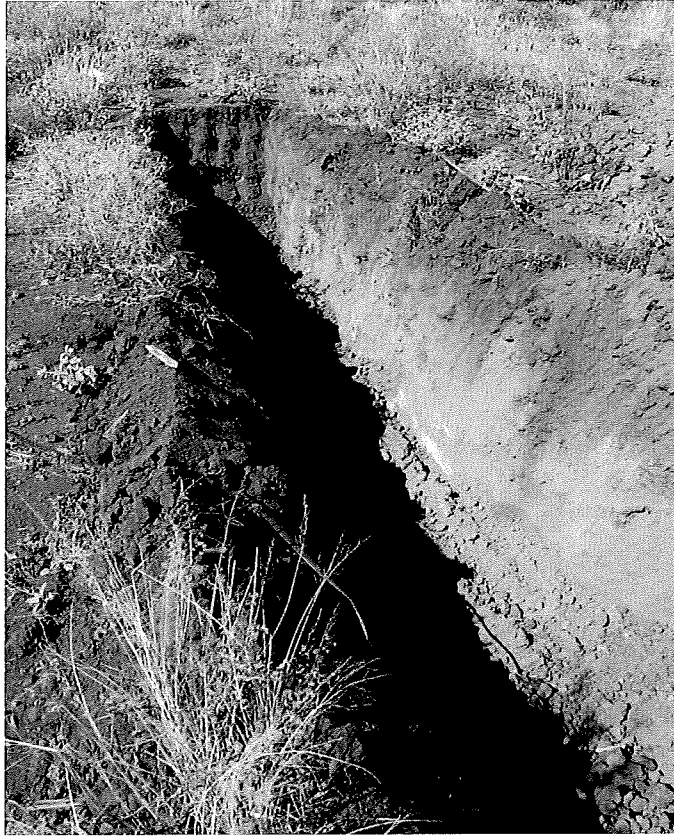
Figure 19. Overview Photograph of Trench 5 (View to North)

TR-5 was placed within the 8.8 acre area in the SE portion of the project area (see Figure 11, Table I and Appendix A). It measured 9.0 m long by 1.5 m wide by 2.0 m deep and was oriented 360° degrees. This section had been previously grubbed during the harvesting of the sugar cane. Testing revealed a four layer stratigraphic sequence (Figures 19 and 20). No cultural materials were observed.

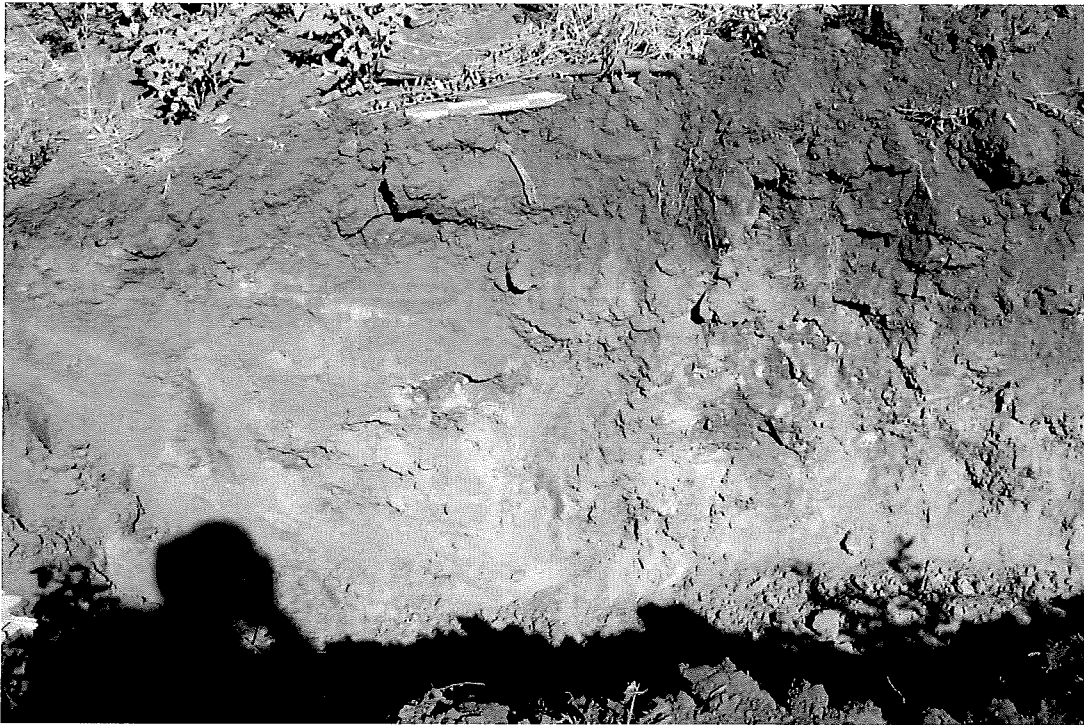
Figure 20. Photograph of Trench 5 West Wall

Layer I (0-42cmbs) is a dark brown (7.5yr 3/3), silty loam, slightly plastic, slightly sticky, crumb, friable, with moderate frequency of roots and rootlets. Inclusions consisted of black plastic irrigation. This heavily disturbed layer is commonly referred to as the "till zone".

Layer II (38-45/102cmbs) is a dark reddish brown (5yr3/4), silt loam, slightly plastic, slightly sticky, crumb, friable. This layer does not appear to be disturbed.

Layer III (98-184cmbs) is a greyish brown (10YR5/1) and yellowish brown (10yr5/4), silt loam, slightly plastic, slightly sticky, crumb, friable, with a high frequency of decomposing basalt. This layer is undisturbed and referred to as the "saprolitic layer".

Layer IV (180-200cmbs+) is a gray (10yr 5/1), basalt bedrock, non-plastic, non-sticky, massive, indurated. This layer is the bedrock layer and is the target material for the mining operations.

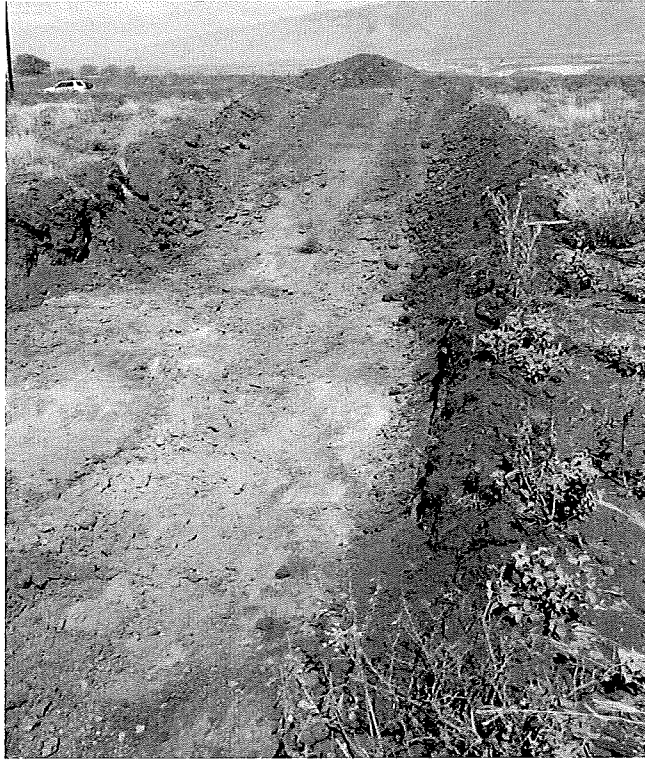
Figure 21. Overview Photograph of Bulldozer Cut 1 (View to West)

BD-1 was placed within the 8.8 acre area in the SW portion of the project area (see Figure 11, Table I and Appendix A). It measured 12.0 m long by 1.5 m wide by 1.4 m deep and was oriented 270° degrees (Figure 21). This section had been previously grubbed during the harvesting of the sugar cane. Testing revealed a four layer stratigraphic sequence (Figure 22). No cultural materials were observed.

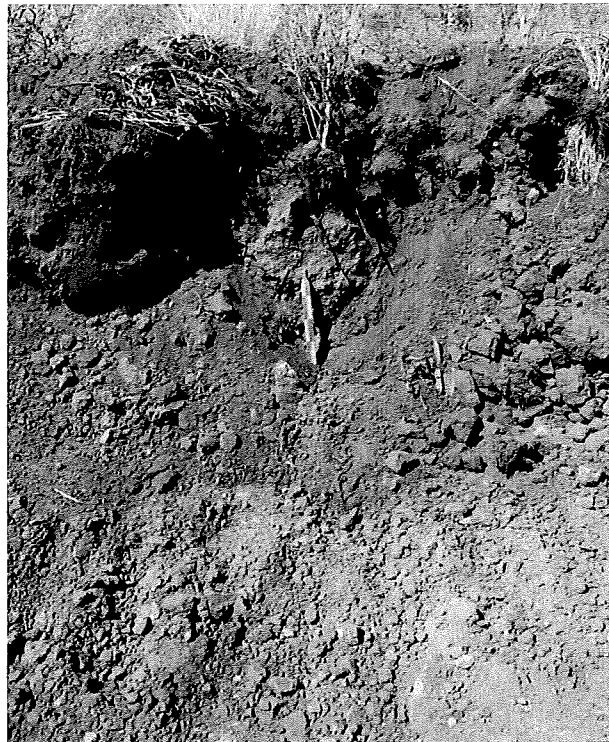
Figure 22. Photograph of Bulldozer Cut 1 North Wall

Layer I (0-32cmbs) is a dark brown (7.5yr 3/3), silty loam, slightly plastic, slightly sticky, crumb, friable, with moderate frequency of roots and rootlets. Inclusions consisted of black plastic irrigation. This heavily disturbed layer is commonly referred to as the "till zone".

Layer II (30-50cmbs) is a dark reddish brown (5yr3/4), silt loam, slightly plastic, slightly sticky, crumb, friable. This layer does not appear to be disturbed.

Layer III (50-136cmbs) is a yellowish brown (10yr5/4), silt loam, slightly plastic, slightly sticky, crumb, friable, with a high frequency of decomposing basalt. This layer is undisturbed and referred to as the "saprolitic layer".

Layer IV (136-140cmbs+) is a gray (10yr 5/1), basalt layer, non-plastic, non-sticky, massive, indurated. This layer is the bedrock layer and is the target material for the mining operations.

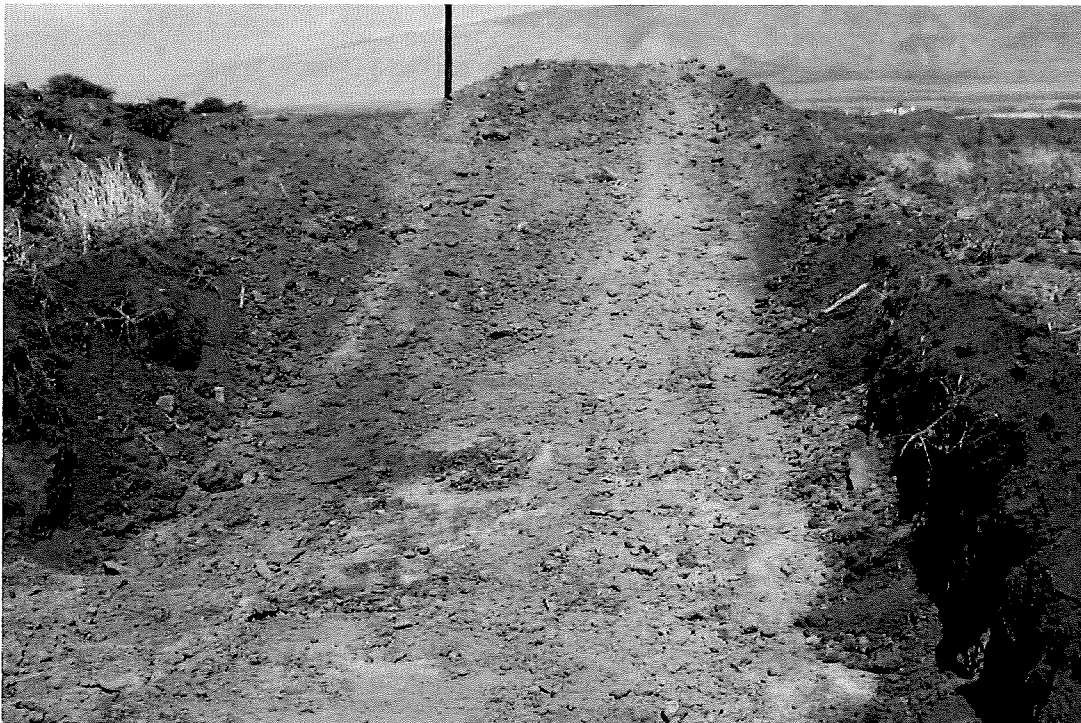
Figure 23. Overview Photograph of Bulldozer Cut 2 (View to West)

BD-2 was placed within the 8.8 acre area in the SW portion of the project area (see Figure 11, Table I and Appendix A). It measured 15.0 m long by 1.5 m wide by 1.6 m deep and was oriented 270° degrees. This section had been previously grubbed during the harvesting of the sugar cane. Testing revealed a four layer stratigraphic sequence (Figures 23 and 24). No cultural materials were observed.

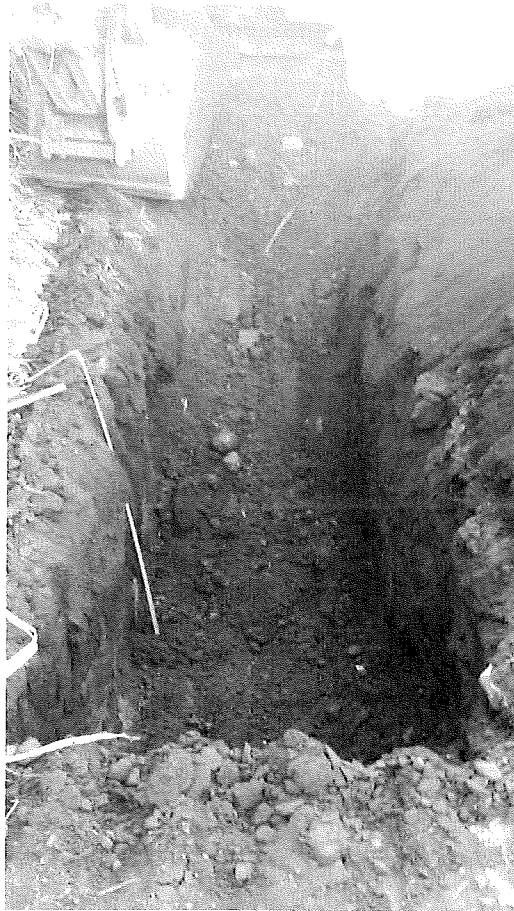
Figure 25. Overview Photograph of Trench 6 (View to West)

TR-6 was placed within the 33.0 acre area in the central portion of the project area (see Figure 11, Table I and Appendix A). It measured 4.1 m long by 1.5 m wide by 1.6 m deep and was oriented 270° degrees (Figure 25 and Table I). This section was an active cane fields and therefore the location of this trench was along a known haul rd. Testing revealed a three layer stratigraphic sequence (Figure 26). No cultural materials were observed.

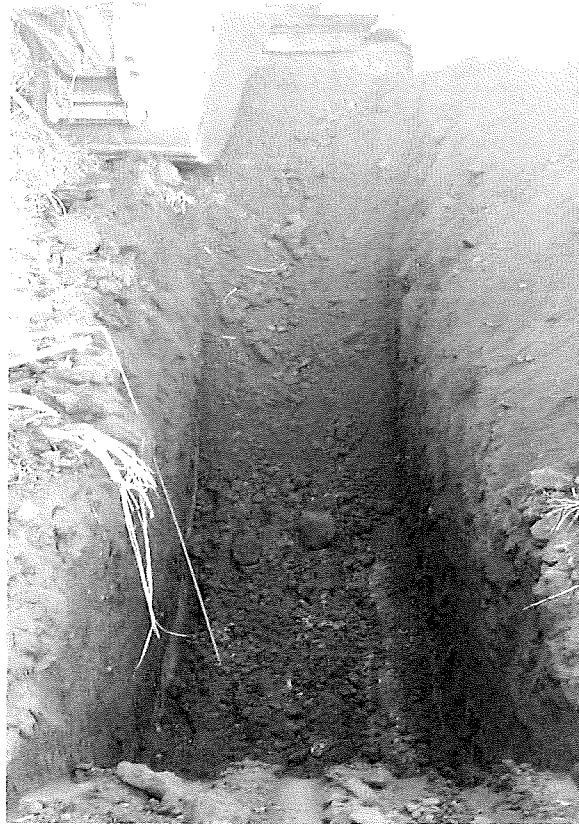
Figure 27. Overview Photograph of Trench 7 (View to North)

TR-7 was placed within the 33acre area in the central portion of the project area (see Figure 11, Table I and Appendix A). It measured 3.9 m long by 1.5 m wide by 2.0 m deep and was oriented 270° degrees (Figure 27 and Table I). This section was an active cane fields and therefore the location of this trench was along a known haul rd. Testing revealed a three layer stratigraphic sequence (Figure 28). No cultural materials were observed.

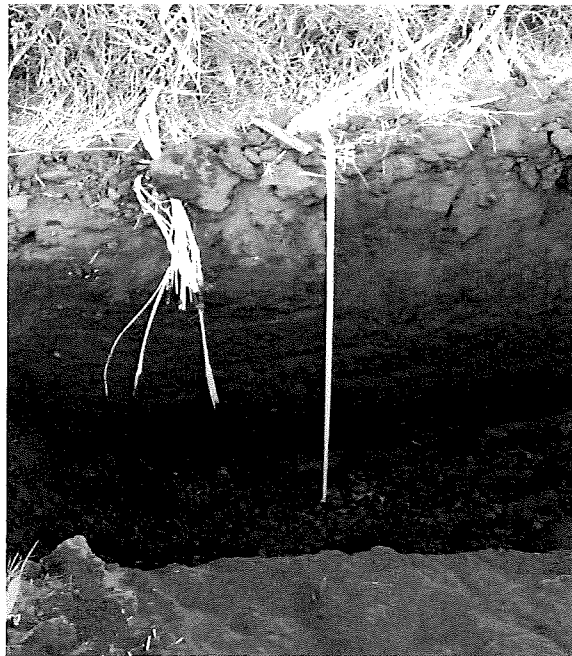
Figure 28. Photograph of Trench 7 North Wall

Layer I (0-20cmbs) is a dark brown (7.5yr 3/3), silty loam, slightly plastic, slightly sticky, crumb, friable, with moderate frequency of roots and rootlets. Inclusions consisted of black plastic irrigation. This heavily disturbed layer is commonly referred to as the "till zone"..

Layer II (18-170cmbs) is a dark reddish brown (5yr3/4), silt loam, slightly plastic, slightly sticky, crumb, friable. This layer does not appear to be disturbed.

Layer III (168-200cmbs+) is a black (7.5yr 2.5/1) cinder and greyish black silty clay, moist, non-plastic, non-sticky, medium grain, firm. This layer/lens was also observed in TR16.

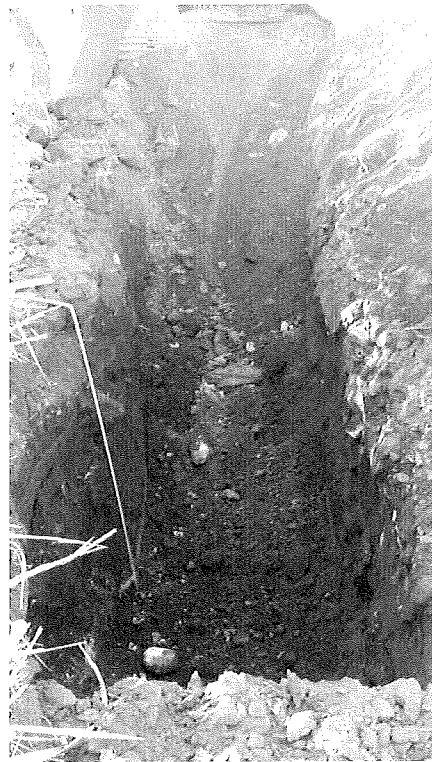
Figure 29. Overview Photograph of Trench 8 (View to East)

TR-8 was placed within the haul road in the central portion of the 33.0 acre area (see Figure 11, Table I and Appendix A). It measured 4.0 m long by 1.5 m wide by 1.8 m deep and oriented 270° degrees. TR-8 contained a five layer stratigraphic sequence indicative of alluvial and or flood plain deposits (Figures 29 and 30). No cultural materials were observed.

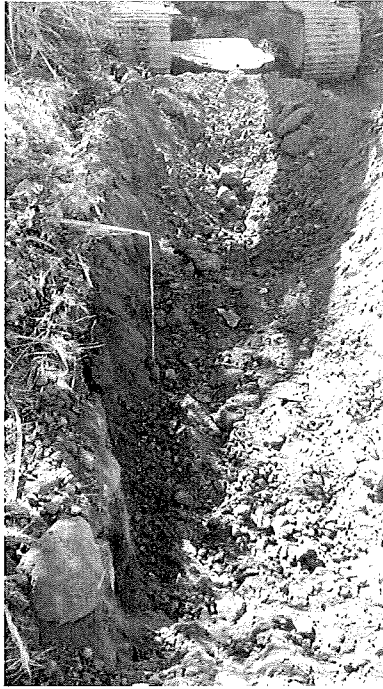
Figure 31. Overview Photograph of Trench 9 (View to East)

TR-9 was placed within the 33.0 acre area in the eastern portion of the project area (see Figure 11, Table I and Appendix A). It measured 3.9 m long by 1.5 m wide by 0.8 m deep and was oriented 270° degrees (Figures 31 and 32). Testing revealed a single stratum that was negative for cultural materials and terminated on decomposing bedrock, Layer II.

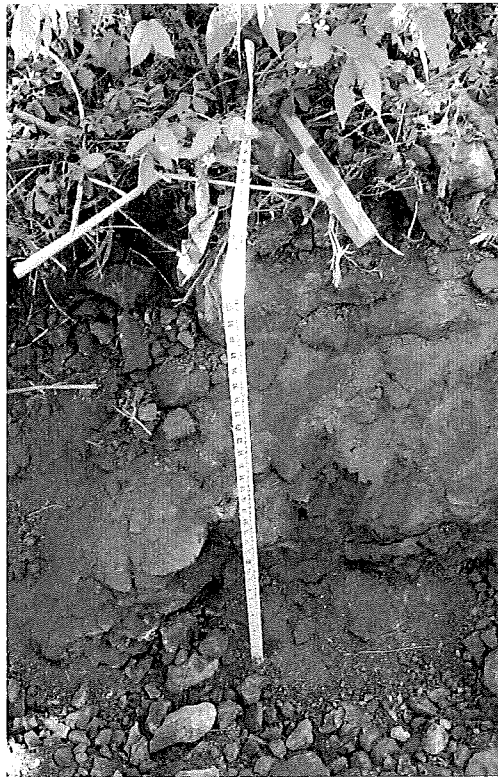
Figure 32. Photograph of Trench 9 North Wall

Layer I (0-80cmbs) is a yellowish brown (10yr 5/4), silty loam, slightly plastic, slightly sticky, crumb, friable, with moderate frequency of roots and rootlets. Inclusions consisted of black plastic irrigation. This heavily disturbed layer is commonly referred to as the "till zone". The bedrock was encountered at base.

Layer II (80cmbs+) is yellowish brown (10yr5/4), gravelly, silt loam, slightly plastic, slightly sticky, crumb, friable, with decomposing basalt.

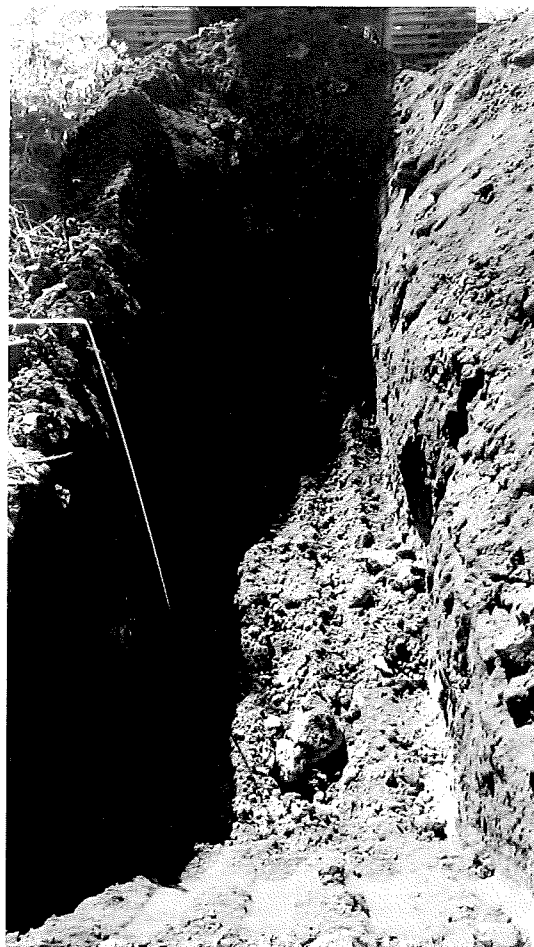
Figure 33. Overview Photograph of Trench 10 (View to East)

TR-10 was placed within the 33.0 acre area in the central portion of the project area (see Figure 11, Table I and Appendix A). It measured 4.0 m long by 1.5 m wide by 1.5 m deep, oriented 270° degrees and placed in the cane haul road. Testing revealed a three layer stratigraphic sequence (Figures 33 and 34). No cultural materials were observed.

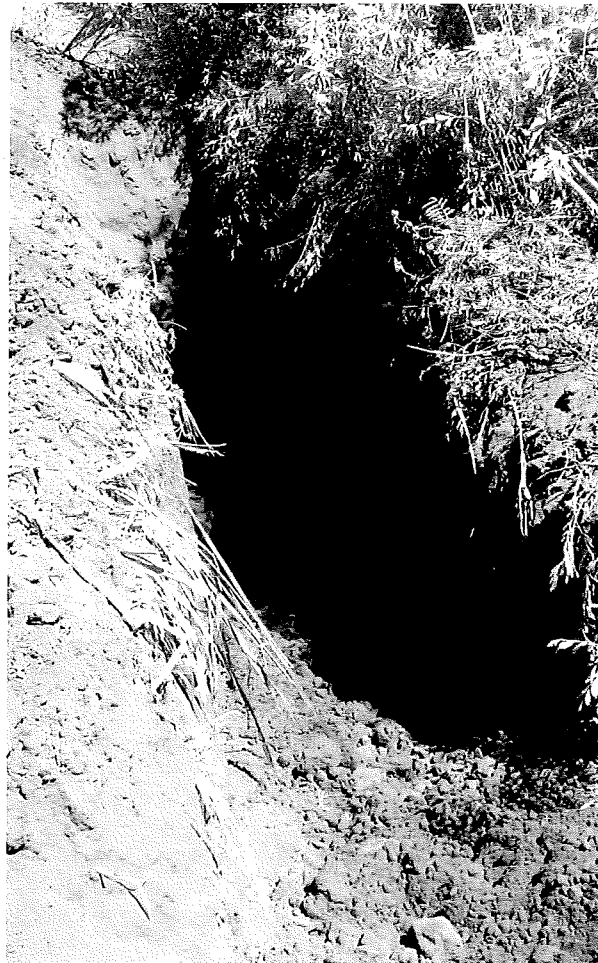
Figure 37. Overview Photograph of Trench 13 (View to East)

TR-13 was placed within the 33acre area in the north central portion of the project area (see Figure 11, Table I and Appendix A). It measured 4.0 m long by 1.5 m wide by 3.0 m deep and was oriented 270° degrees. This section was an active cane fields and therefore the location of this trench was along a known haul rd. Testing revealed a three layer stratigraphic sequence (Figures 37 and 38). No cultural materials were observed.

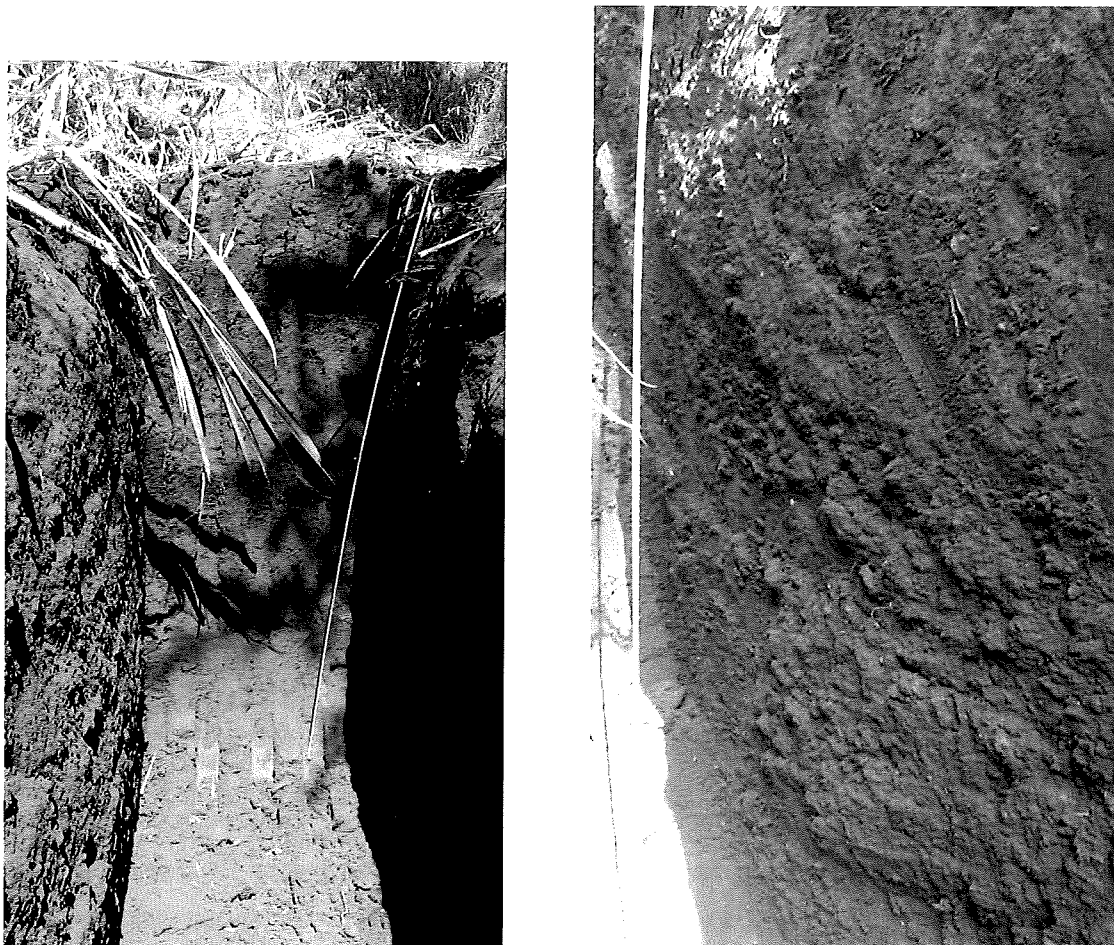
Figure 39. Overview Photograph of Trench 14 (View to West) (Left); and Photograph of North Wall Trench 14

TR-14 was placed along haul road within the 33.0 acre area in the north central portion of the project area (see Figure 11, Table I and Appendix A). It measured 4.0 m long by 1.5 m wide by 2.05 m deep and was oriented 270° degrees. TR-14 contained a five layer stratigraphic sequence and no cultural materials were observed (Figure 39).

Layer I (0-9cmbs) is a dark brown (7.5yr 3/3), silty loam, slightly plastic, slightly sticky, crumb, friable, with moderate frequency of roots and rootlets. Inclusions consisted of black plastic irrigation. This heavily disturbed layer is commonly referred to as the "till zone".

Layer II (8-160cmbs+) is a dark reddish brown (5yr3/4), silt loam, slightly plastic, slightly sticky, crumb, friable. This layer does not appear to be disturbed.

Lens/Layer III (160-1.85cmbs+) is a reddish brown (5yr4/6), pebbly silt loam, non-plastic, non-sticky, crumb, firm. This layer contained low frequencies of water worn igneous basalt pebbles most likely associated with a former stream.

Layer IV (185-195cmbs+) is a dark reddish brown (5yr3/4), silt loam, slightly plastic, slightly sticky, crumb, friable. This layer does not appear to be disturbed.

Layer V (195-205cmbs+) is a dark yellowish brown (10yr5/4), gravelly silt loam, slightly plastic, slightly sticky, crumb, friable. This layer does not appear to be disturbed.

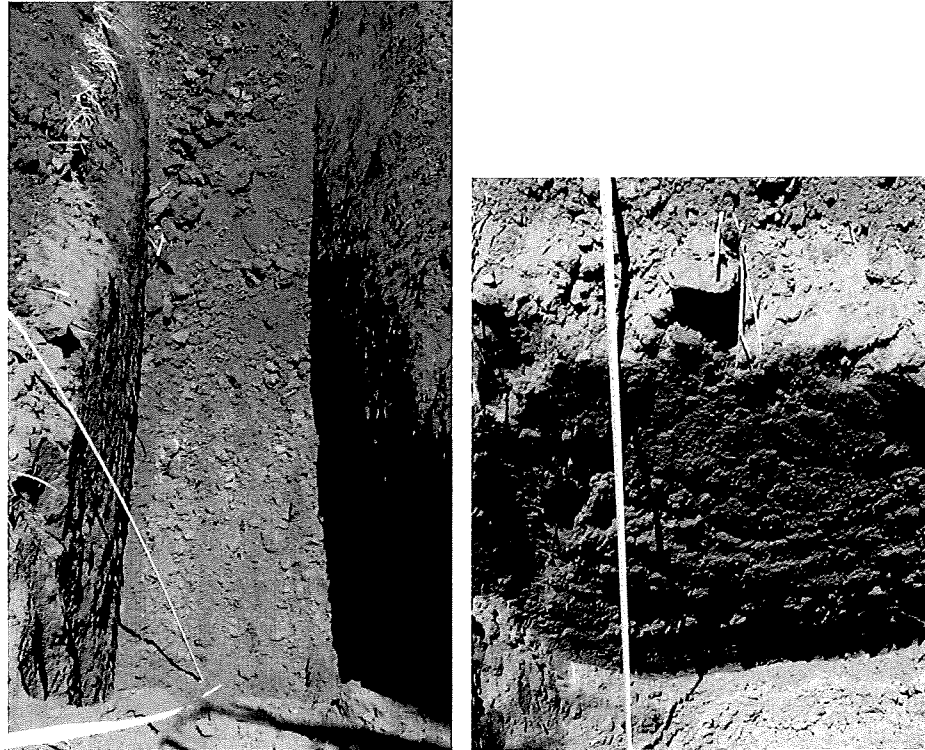
Figure 40. Photographs of TR-15 Overview (View to West) (left); and South Wall (right)

TR-15 was placed within the 33.0 acre area within the cane haul road located in the eastern portion of the project area (see Figure 11, Table I and Appendix A). It measured 4.0 m long by 1.5 m wide by 1.2 m deep, oriented 270° degrees and contained a three layer stratigraphic sequence that was negative for cultural materials (Figure 40).

Layer I (0-20cmbs) is a dark brown (7.5yr 3/3), silty loam, slightly plastic, slightly sticky, crumb, friable, with moderate frequency of roots and rootlets. Inclusions consisted of black plastic irrigation. This heavily disturbed layer is commonly referred to as the "till zone".

Layer II (18-81cmbs) is a dark reddish brown (5yr3/4), silt loam, slightly plastic, slightly sticky, crumb, friable. This layer does not appear to be disturbed.

Layer III (81-120cmbs+) is a yellowish brown (10yr5/4), silt loam, slightly plastic, slightly sticky, crumb, friable, with a high frequency of decomposing basalt. This layer is undisturbed and referred to as the "saprolitic layer".

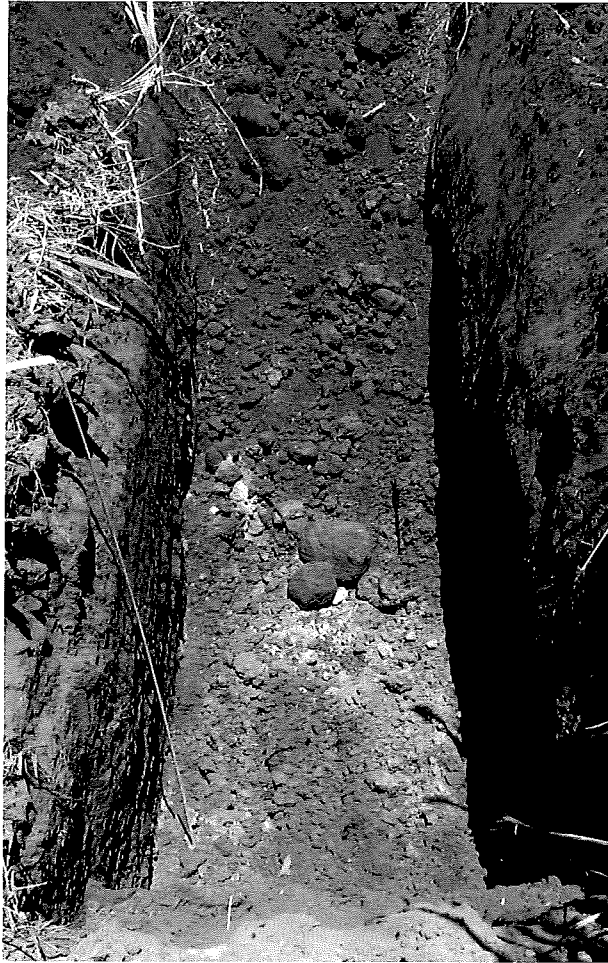
Figure 41. Overview Photograph of Trench 16 (View to West)

TR-16 was placed within the 33.0 acre area in the south central portion of the project area (see Figure 11, Table I and Appendix A). It measured 4.0 m long by 1.5 m wide by 1.45 m deep, oriented 270° degrees and situated within a haul road. Trench-16 contained a three layer stratigraphic sequence (Figures 41 and 42). No cultural materials were observed.

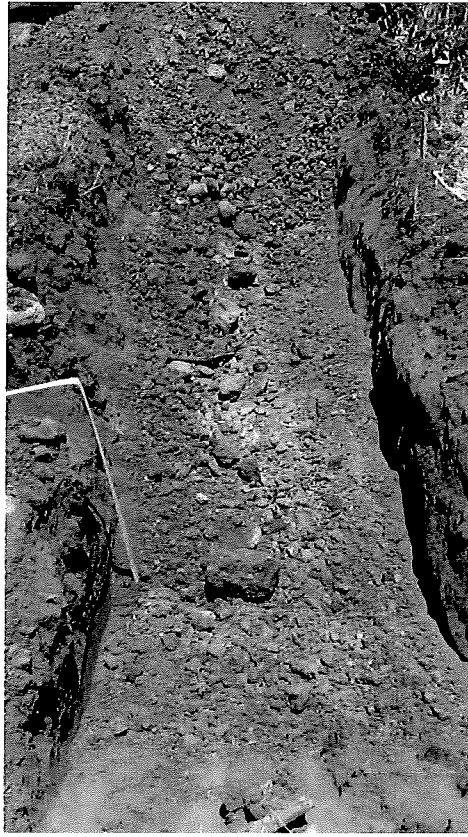
Figure 43. Overview Photograph of Trench 17 (View to West)

TR-17 was placed along the haul road within the 33.0 acre area in the south central portion of the project area (see Figure 11, Table I and Appendix A). It measured 4.0 m long by 1.5 m wide by 1.0 m deep and was oriented 270° degrees. Testing revealed a three layer stratigraphic sequence (Figures 43 and 44). No cultural materials were observed.
