Draft Phase 1 Potential Rockfall And Slope Hazard Assessment Hawaiian Memorial Park Cemetery Expansion – January 2018 Prepared by: Geolabs, Inc.

## PHASE 1 POTENTIAL ROCKFALL AND SLOPE HAZARD ASSESSMENT

### HAWAIIAN MEMORIAL PARK CEMETERY EXPANSION

W.O. 7604-00 JANUARY 18, 2018

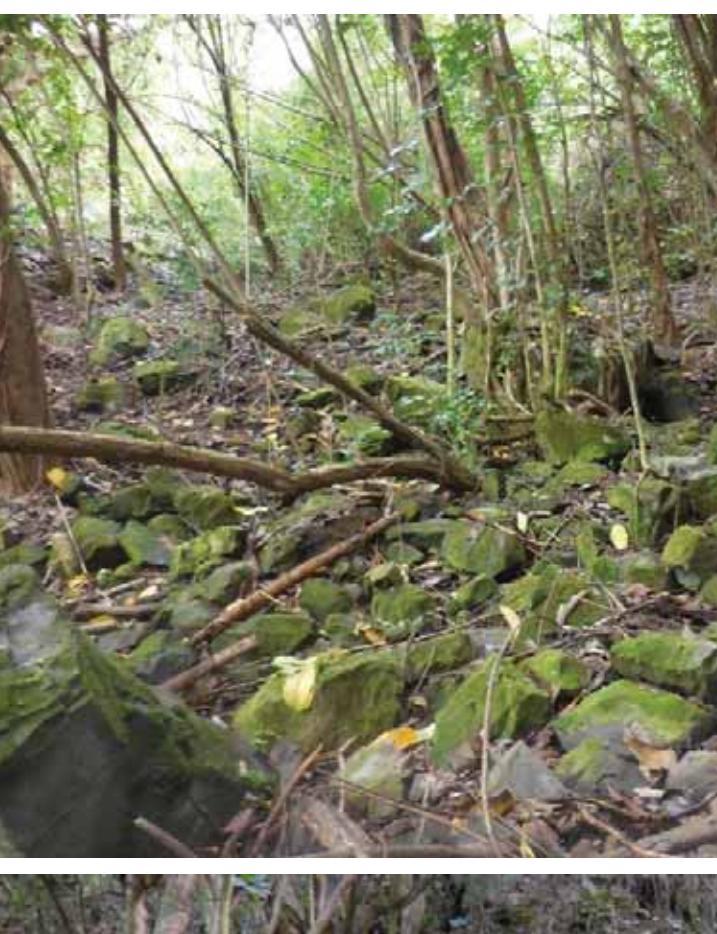
Photograph No. 9: (2576) Fractured and highly weathered rock outcropping on a side slope of a shallow ravine at the northern boundary of the PRSA-1 area shown on the Site Plan, Plate 2. (Wpt. OC8-1).

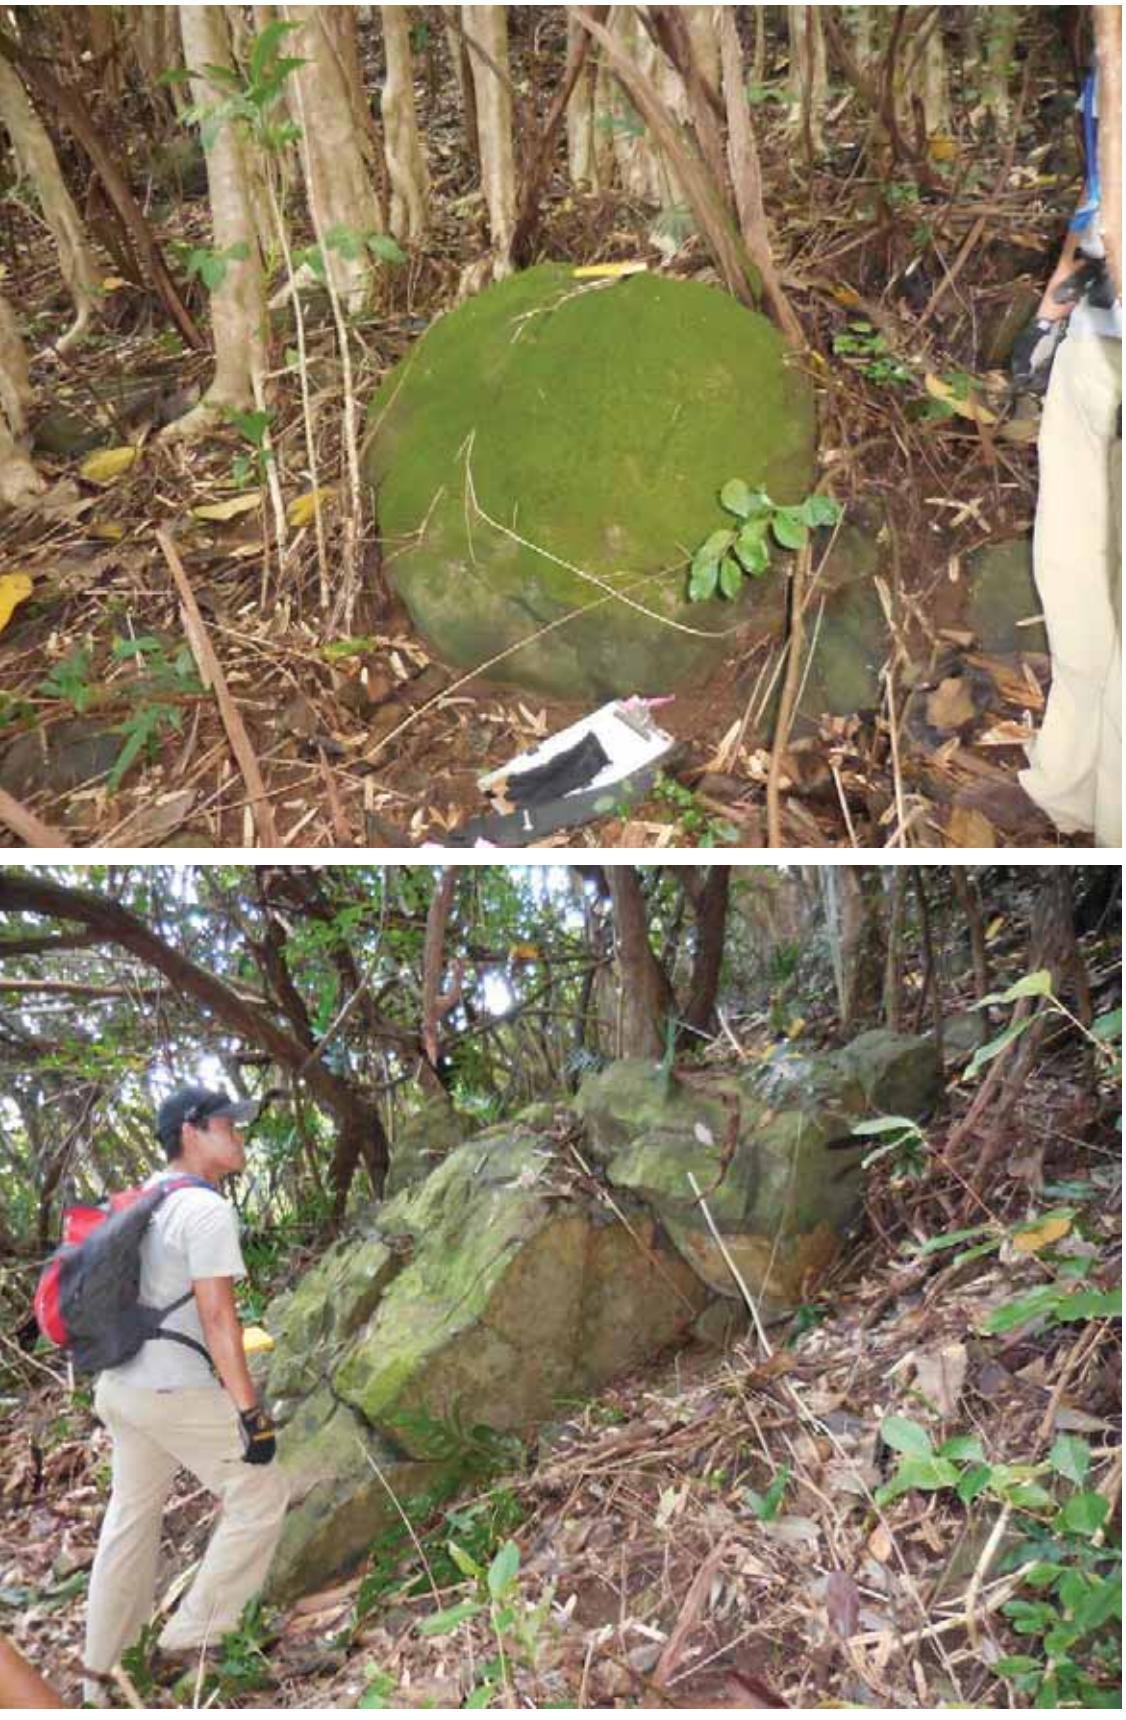
Photograph No. 25: (2376) Flat low relief rock outcropping with very limited rockfall potential at the western side of the PRSA-2 area shown on the Site Plan, Plate 2. (Wpt. OC1A).

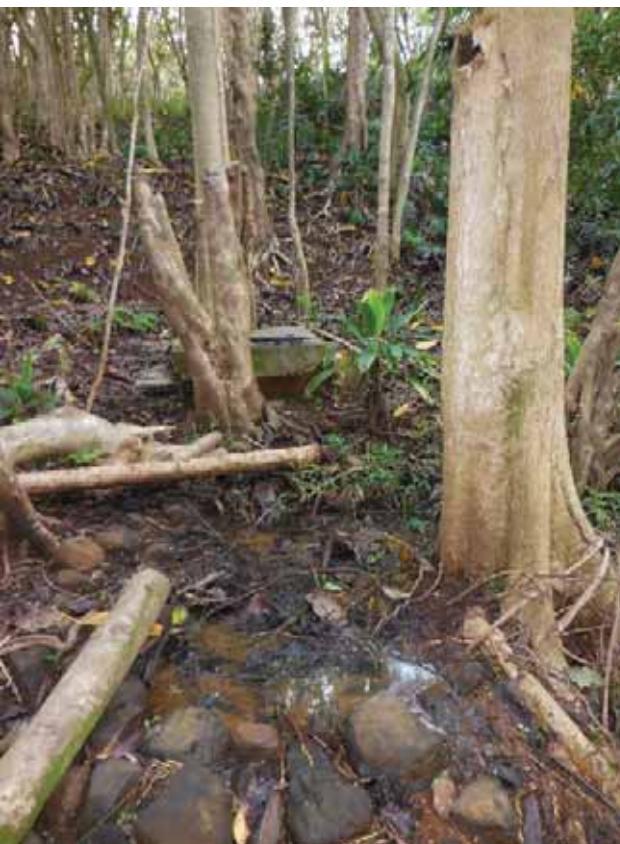
Photograph No. 43: (2587) Fractured and highly weathered rock outcropping at the eastern portion of the PRSA-2 area shown on the Site Plan, Plate 2. (Wpt. OC11).

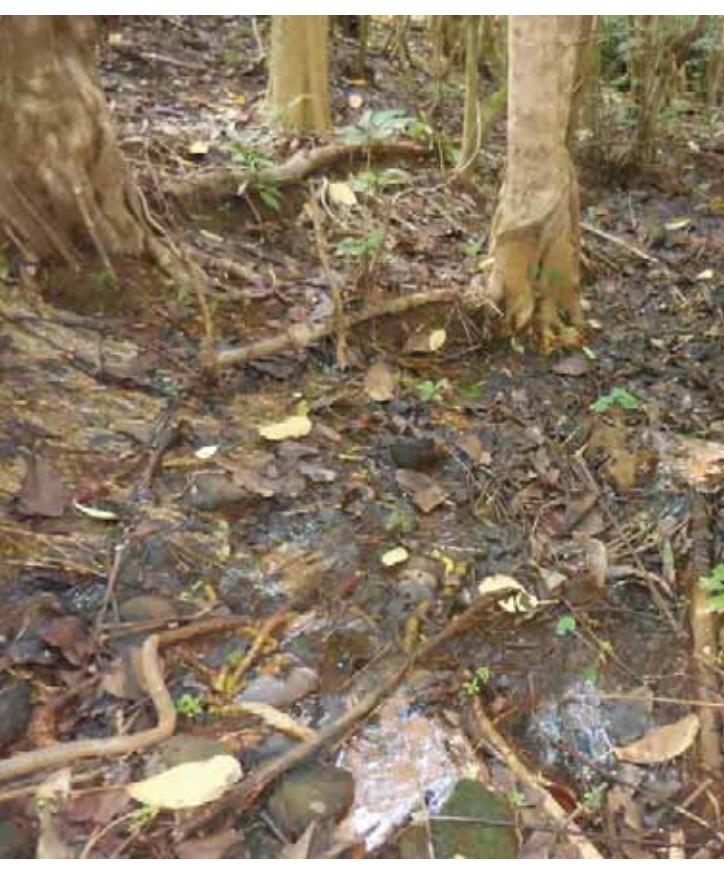
Photograph No. 44: (2586) Isolated, fractured and highly weathered rock outcropping at the eastern portion of the PRSA-2 area shown on the Site Plan, Plate 2. (Wpt. OC10).

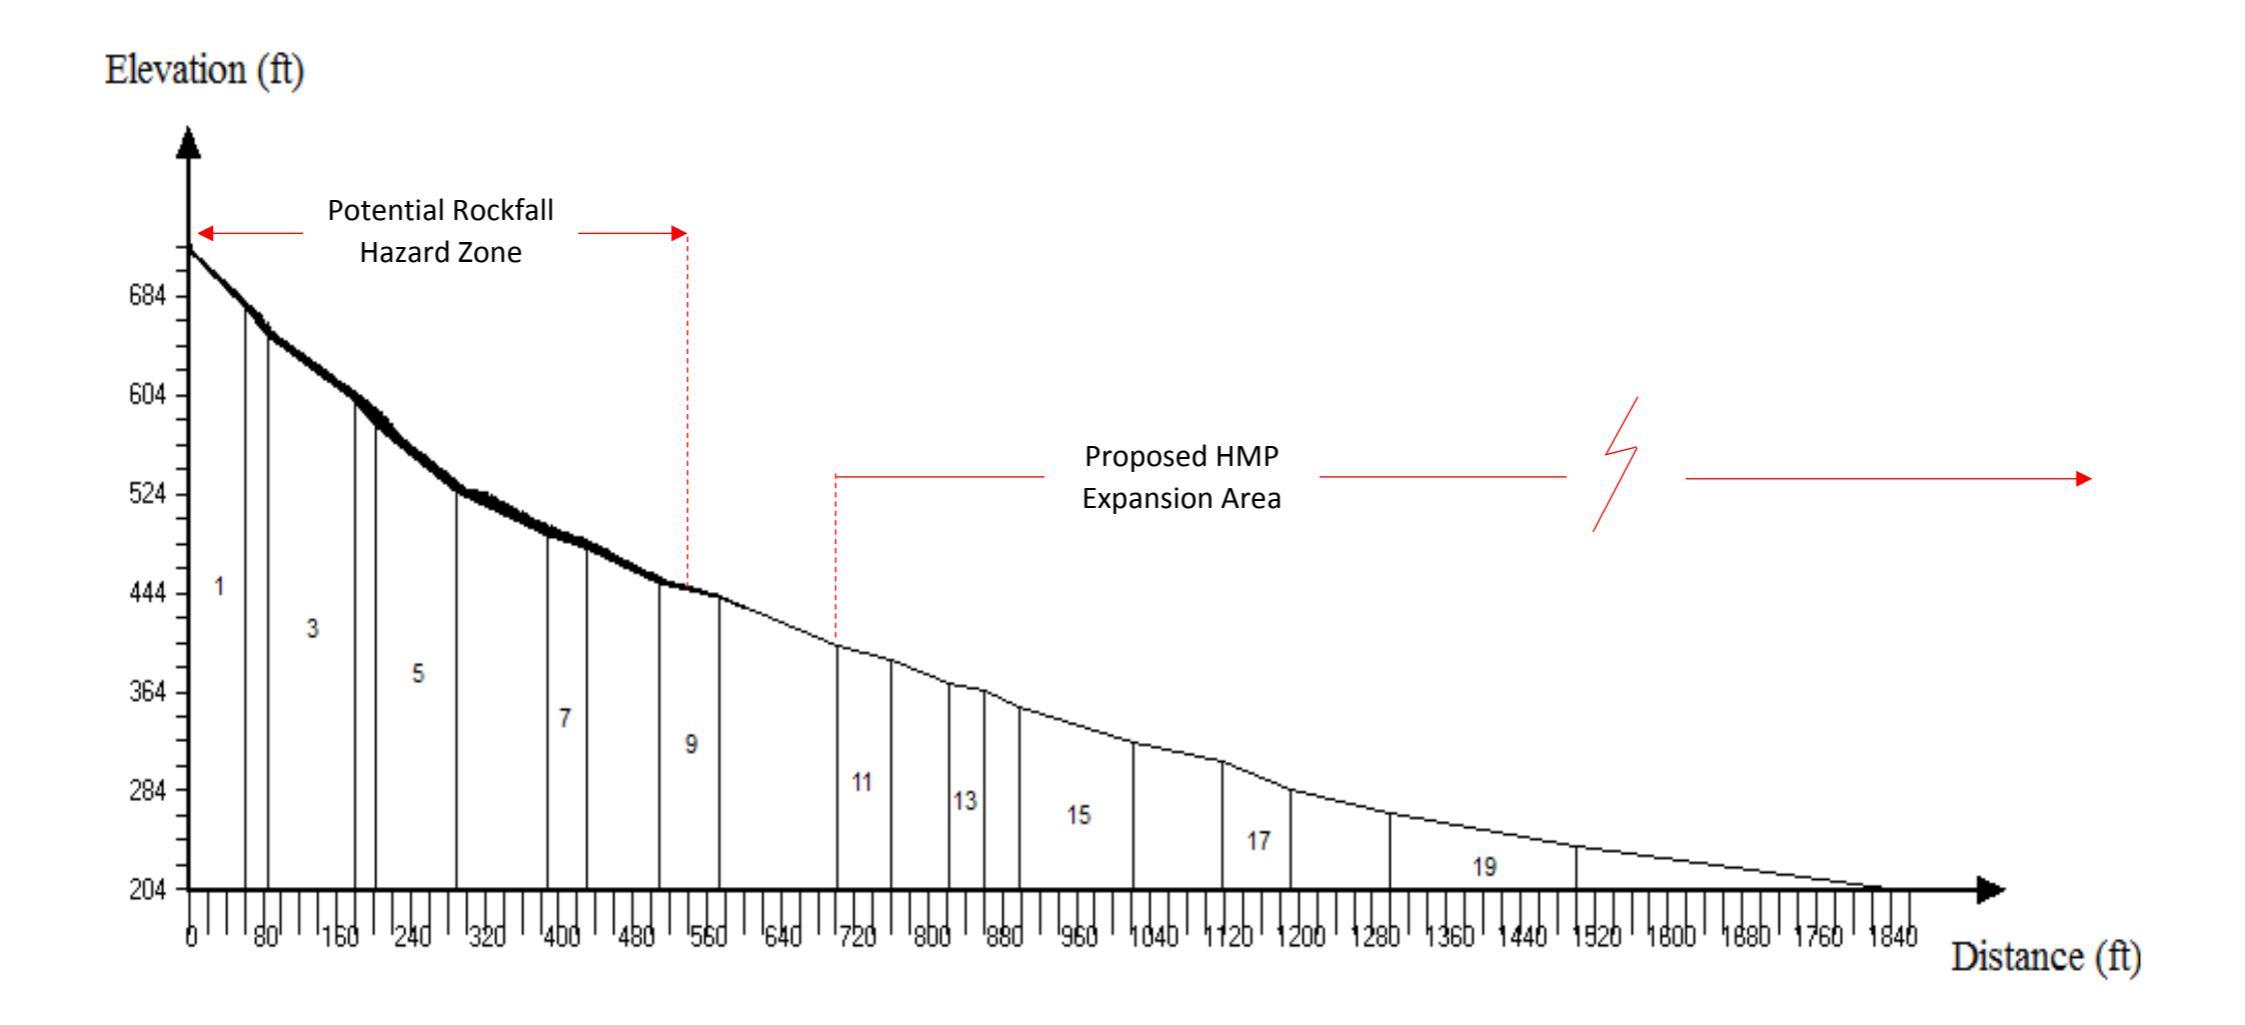
POTENTIAL ROCKFALL SIMULATION – SLOPE PROFILE "C" NOT TO SCALE

boundary with no rockfall mitigation in place.

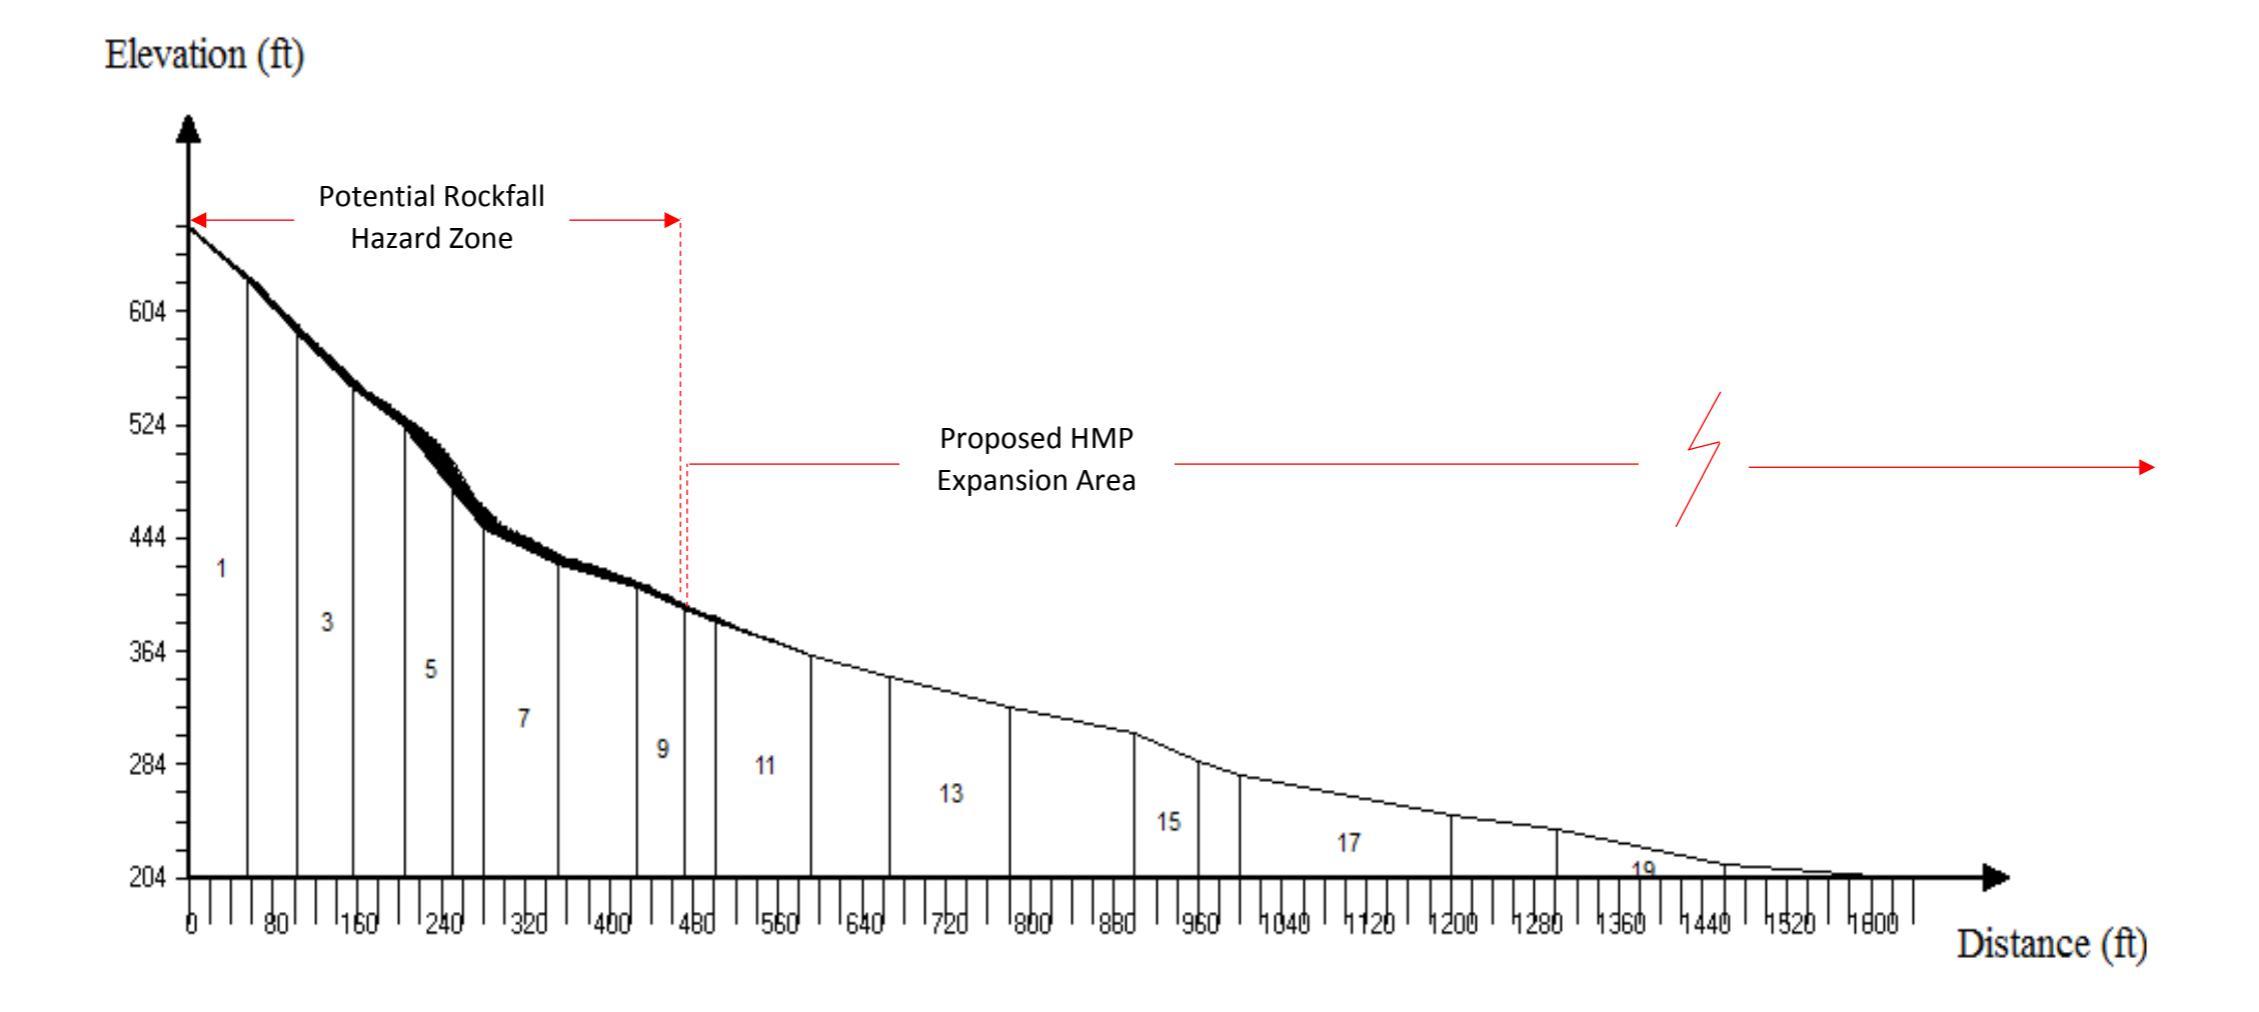
POTENTIAL ROCKFALL SIMULATION - SLOPE PROFILE "D"

• No simulated rockfall is shown to pass the upslope cemetery expansion

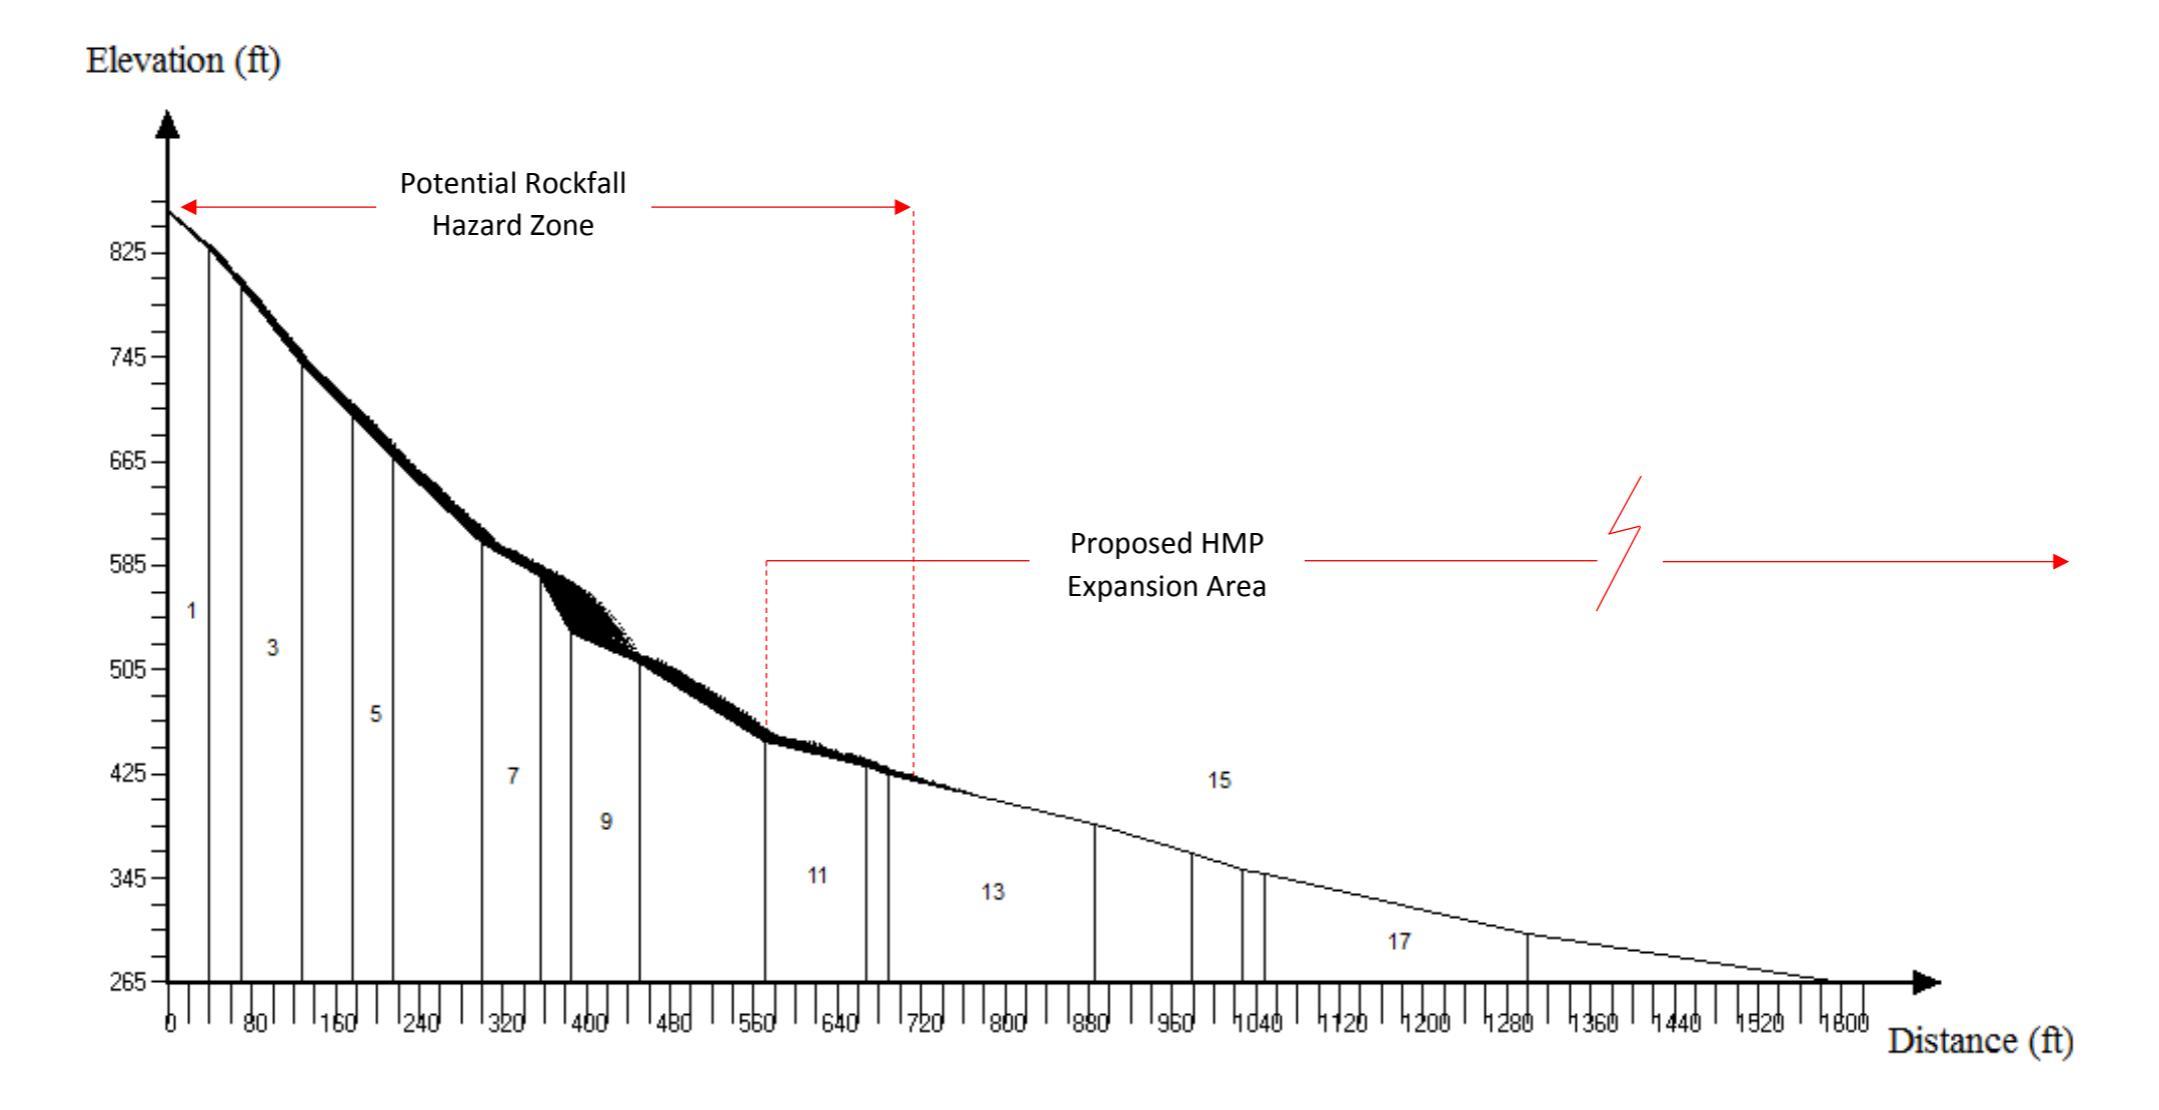
POTENTIAL ROCKFALL SIMULATION - SLOPE PROFILE "E"

• Less than 10 percent of simulated falling rocks is shown to pass the upslope cemetery expansion boundary with no rock fall mitigation in place.
