Appendix 2: Coastal Erosion and Volcanic Hazards Report

Coastal Erosion and Volcanic Hazards Report
Barry Property
Hawaiian Paradise Park
Puna, Hawai'i
TMK: (3) 01-5-059:059

J.P. Lockwood, Ph.D.

January 2019

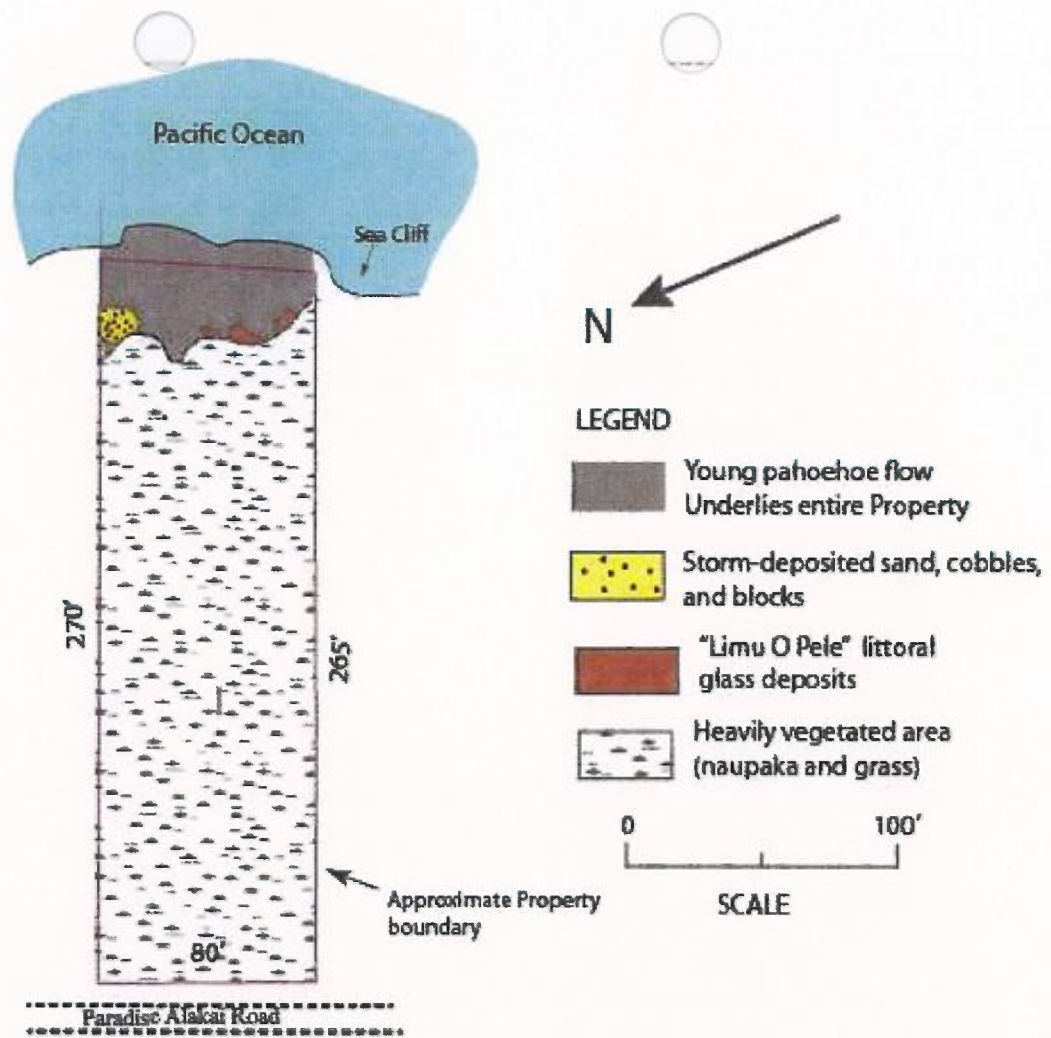
FIGURE 2. Location of Property relative to the coastline and geologic sketch map.

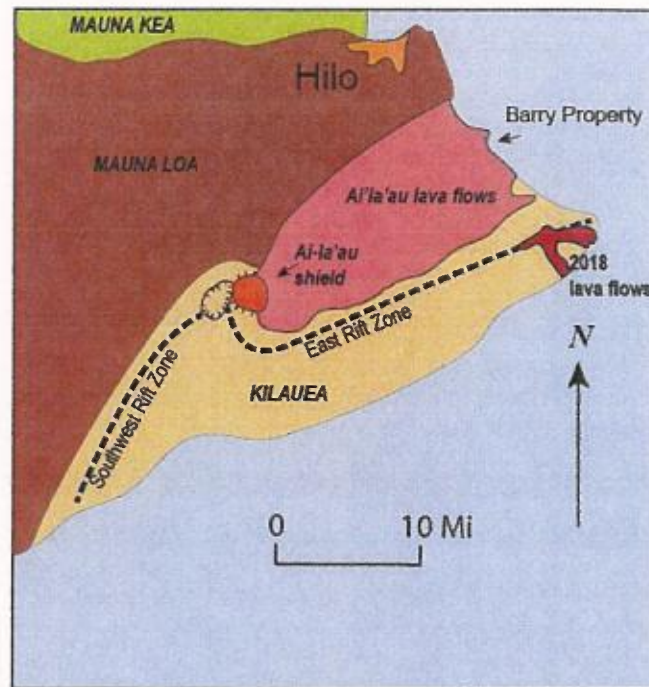
The Property is not subject to lava inundation from Kilauea's middle or lower East Rift Zone, as that eruptive zone is located ten miles to the south, and does not present any threat (Figure 11). As has been discussed above, the lavas underlying the Property were emplaced during the brief life of the 'Ai-la'āu shield, a satellite on the east margin of Kilauea caldera that erupted between about CE 1350 and 1470 (Holcomb, 1987). It would be unprecedented for another eruptive vent to open on this extinct marginal shield in this same area, and the high ground of the shield itself forms a high barrier to prevent any overflows from Kilauea volcano to the east.

Figure 11. Relationship of the Property to Hawai'i volcanoes, to Kilauea's East Rift Zone, and to the destructive lava flows of 2018.
