Section 5 Historic Property Descriptions

5.1 SIHP # 50-80-08-5593

5.2 SIHP # 50-80-09-2268 Waiahole Ditch System/ post-Contact Irrigation Ditch

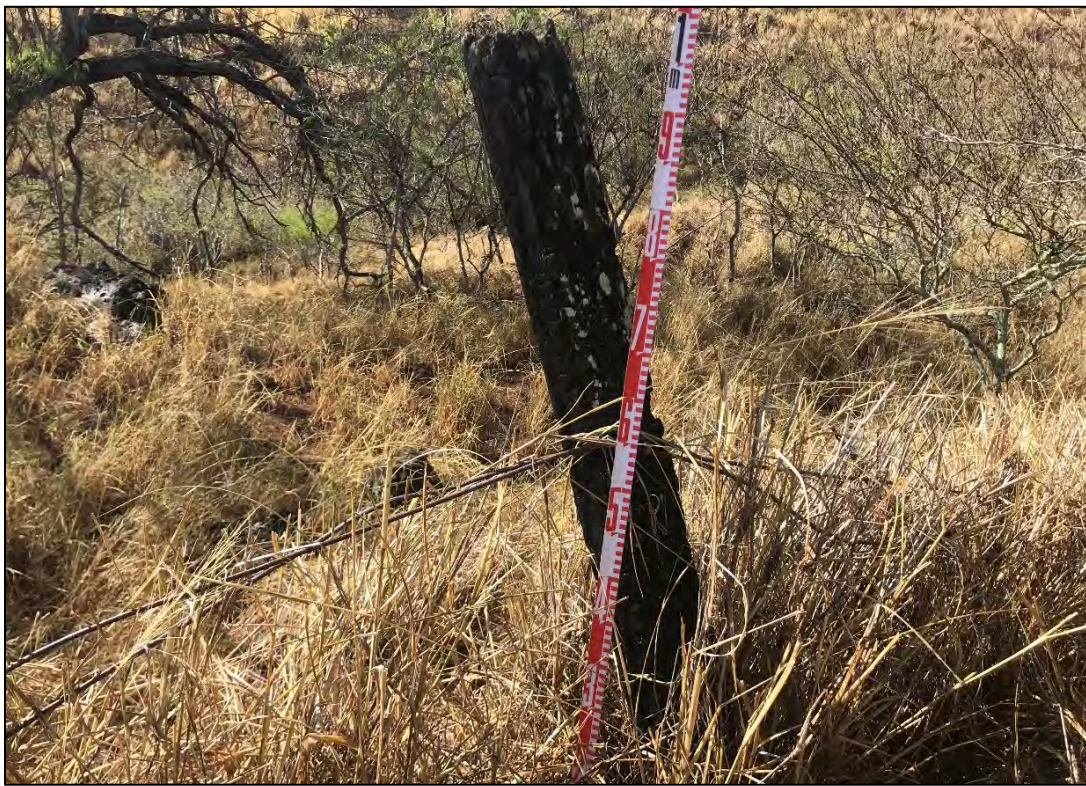
Figure 30. Representative photo of fence posts noted in southwest portion of project area, view to southeast

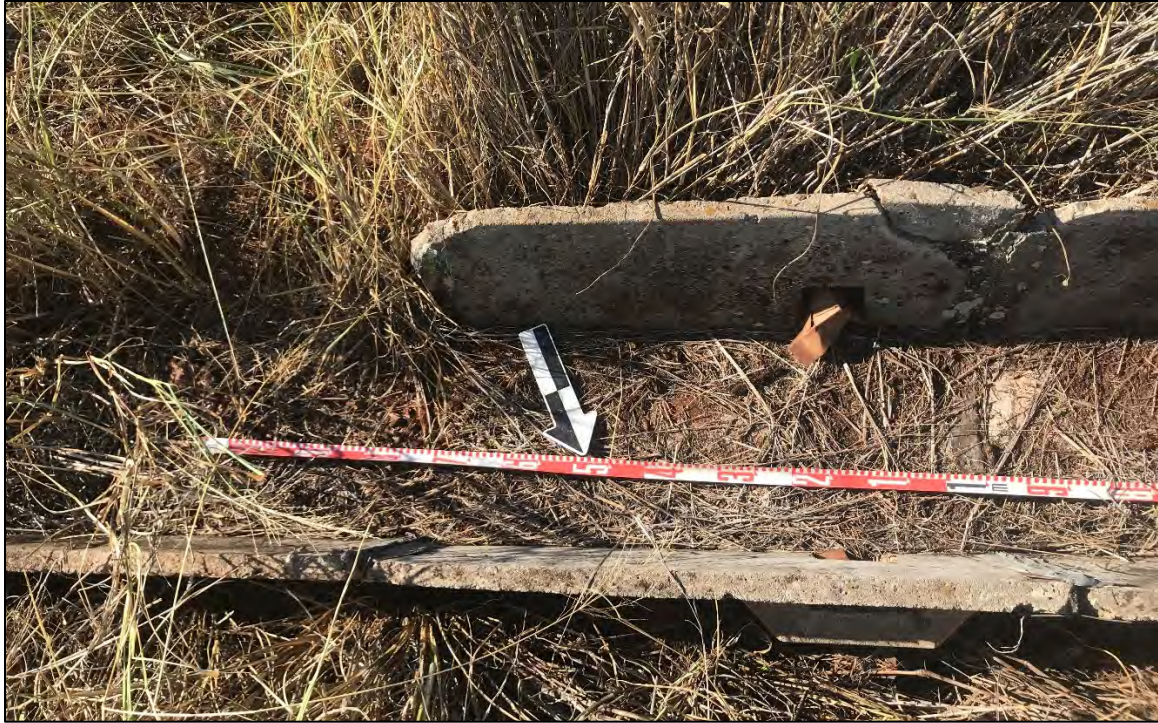
An additional, more intact concrete flume was identified *mauka* (northwest) of SIHP # -2268 Feature H, of similar composition to those noted in the western project area. Oriented east/west, this flume extends for 21 m in length, with each segment measuring 75 cm long, 45 cm wide, and 30 cm tall (Figure 38). Each concrete segment has a square hole near the base on each side, with a metal L-shaped insert, likely used for controlling water flow out of the flume (Figure 39). Again, this flume appears to have been used for water diversion related to the access roads.

Figure 39. Plan view of concrete flume in central northern project area

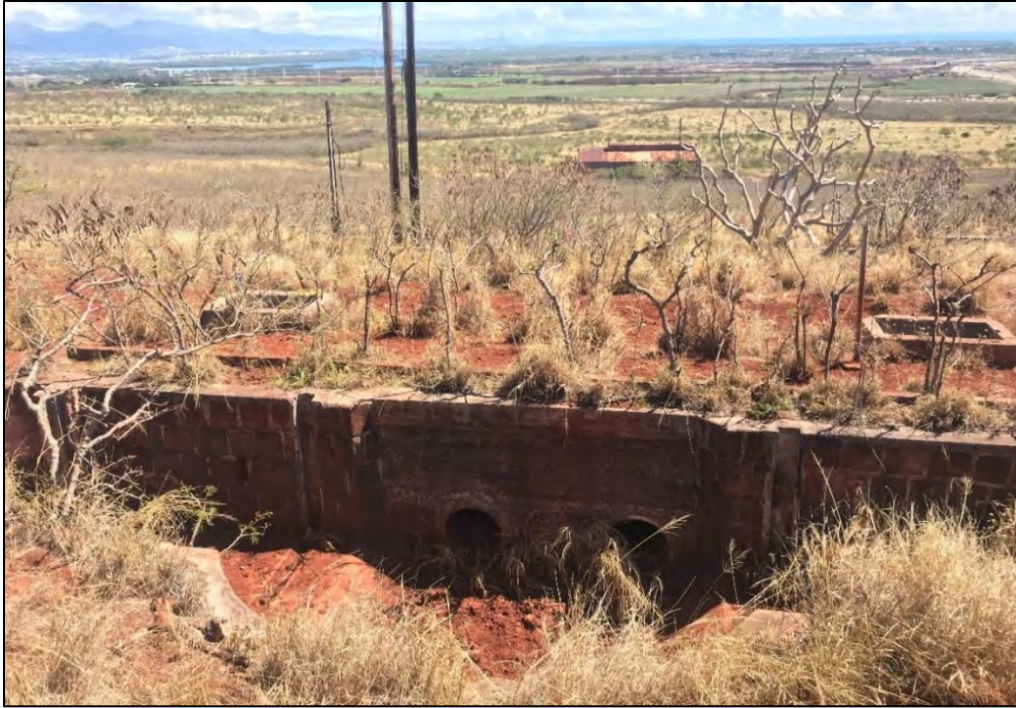
SIHP # 50-80-08-5593 Feature 2A, the uppermost portion of the complex, consists of various water catchment features attached to a portion of the Waiahole Ditch, related to the mill and pump house at the base of the slope (see Figure 51, Figure 52, and Figure 62). This portion is oriented northeast-southwest, and constructed of basalt, concrete, and metal pipes. The Feature 2A complex is situated on the northwest boundary of the project area. Portions of this upper complex contain modern rubbish (modern bottles and cans), as well as a cow skeleton, likely a livestock animal that fell, died, and decayed in place. The northeast portion of this section of the Waiahole Ditch consists of a concrete-lined ditch 140 cm wide and 163 cm deep. As it extends toward the Feature 2A complex, there is an overlying addition of mortared basalt three courses high, a portion of which bears the date inscription "MAR 1939" (Figure 53). The ditch then feeds into a large catchment basin measuring a maximum of 4.0 m long and 3.2 m wide, with a maximum depth of 180 cm. The basin is flanked by notches in the concrete on both sides, for former sluice gates which are no longer intact. The basin would have fed into the two drain pipes at the base of the southeast wall of the structure (Figure 54). These pipes extend down the slope to the pump house and mill. Portions of these pipes are exposed on the slope's surface, and much of the pipes are likely intact underground.

Figure 51. Overview of SIHP # 50-80-09-2268 Waiahole Ditch portion, and SIHP # 50-80-08-5593 Feature 2A complex, with the pump house and mill building at the base of the slope, view to southeast

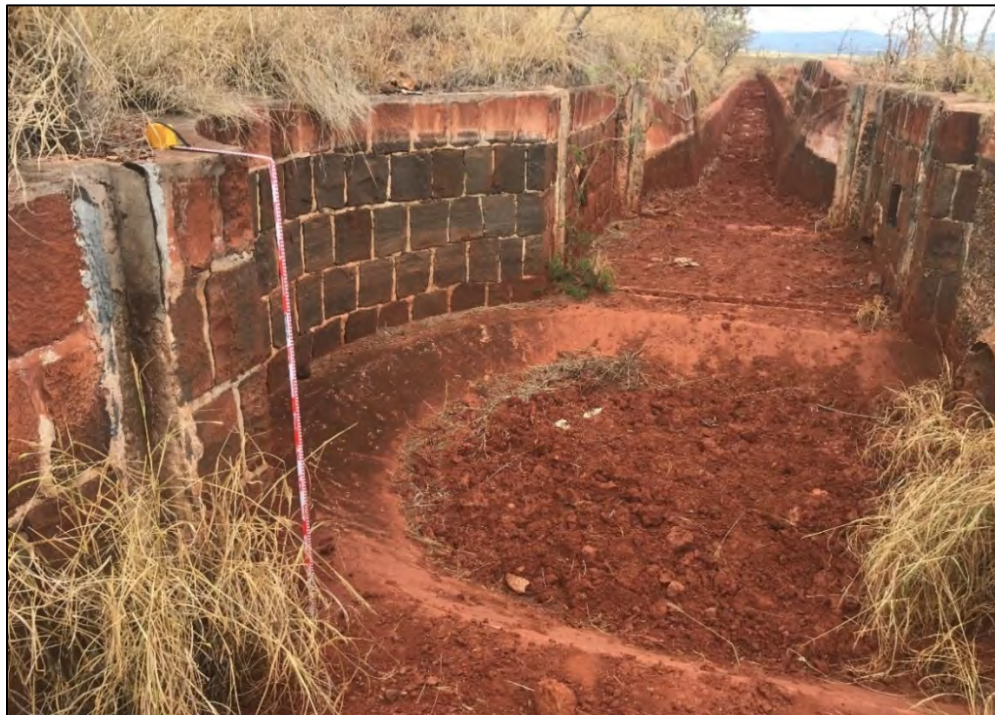
Figure 52. Overview of SIHP # 50-80-09-2268 Waiahole Ditch portion, and SIHP # 50-80-08-5593 Feature 2A complex, view to north

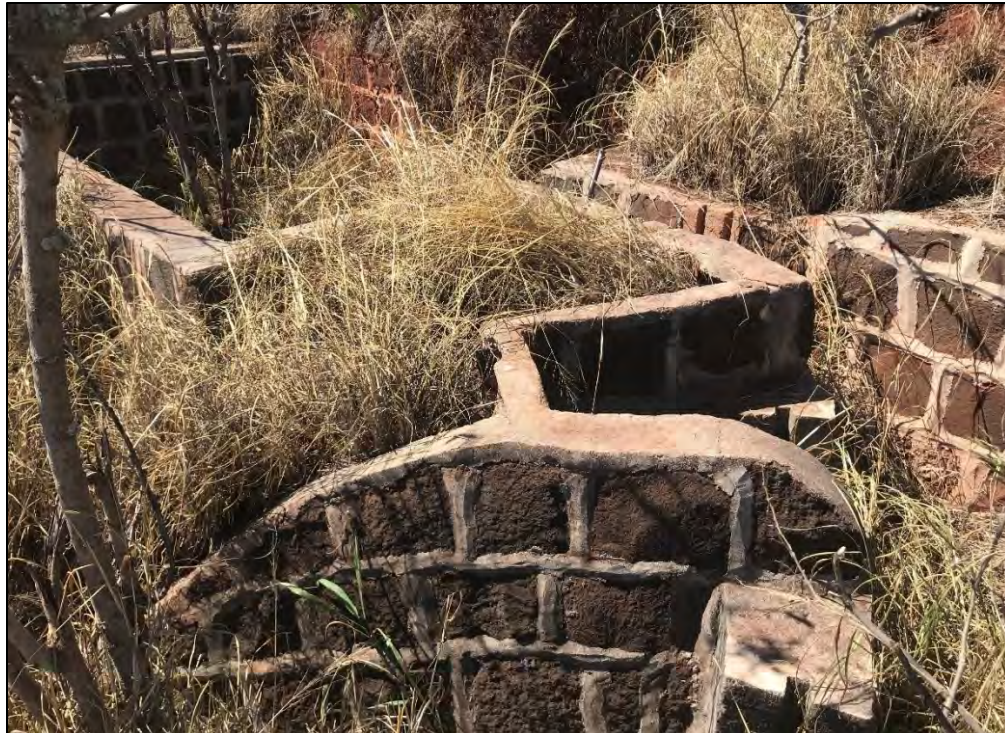
An additional water retention component is positioned directly northwest of this basin. This portion consists of a rectangular mortared basalt catchment area measuring 5.1 m long by 3.8 m wide (Figure 55), feeding into an oval catchment area measuring 6.3 m long and 2.6 m wide (Figure 56), with notches for a sluice gate feature in between (gate not intact). It is possible these catchment areas are gravel traps, which would have served to trap silt and clay (Reeves 1954). This function is suggested based on the complex shape of the structure, which is somewhat similar to a gravel trap from the Iao-Maniania Ditch pictured in a publication on plantation ditches (Figure 57; Wilcox 1996). Three flumes feed from the upper catchment areas into the Waiahole Ditch (Figure 58 and Figure 59). The flumes are oriented north-south and northwest-southeast. The eastern flume

Figure 55. Upper water retention area of SIHP # 50-80-08-5593 Feature 2A complex, view to west

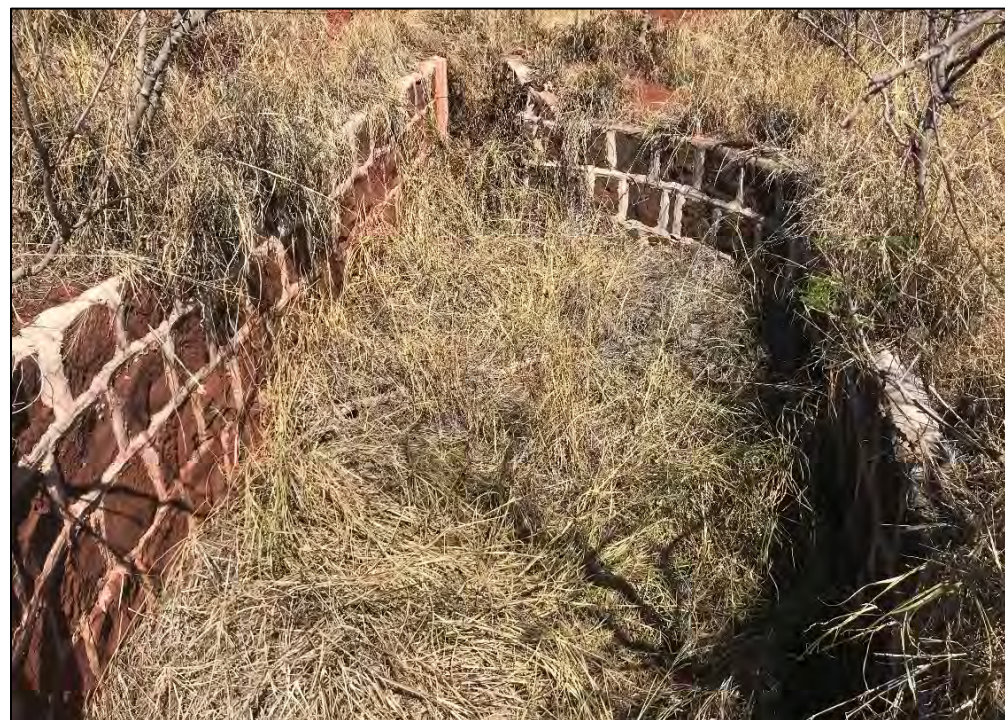
Figure 56. Upper water retention areas (eastern portion) of SIHP # 50-80-08-5593 Feature 2A complex, view to northeast

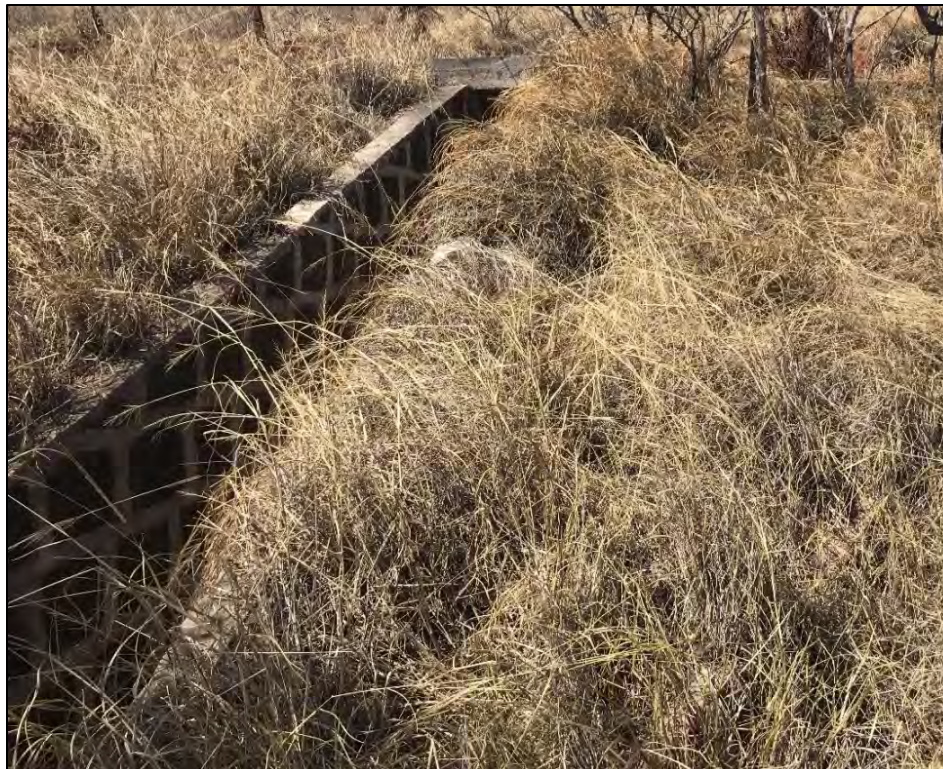
Figure 58. Center flume of SIHP # 50-80-08-5593 Feature 2A complex extending from upper catchment area into SIHP # 50-80-09-2268 Waiahole Ditch, view to west

measures 11.0 m long and 0.6 m wide, the center flume measures 12.8 m long and 0.6 m wide, and the western flume measures 7.1 m long and 0.6 m wide.

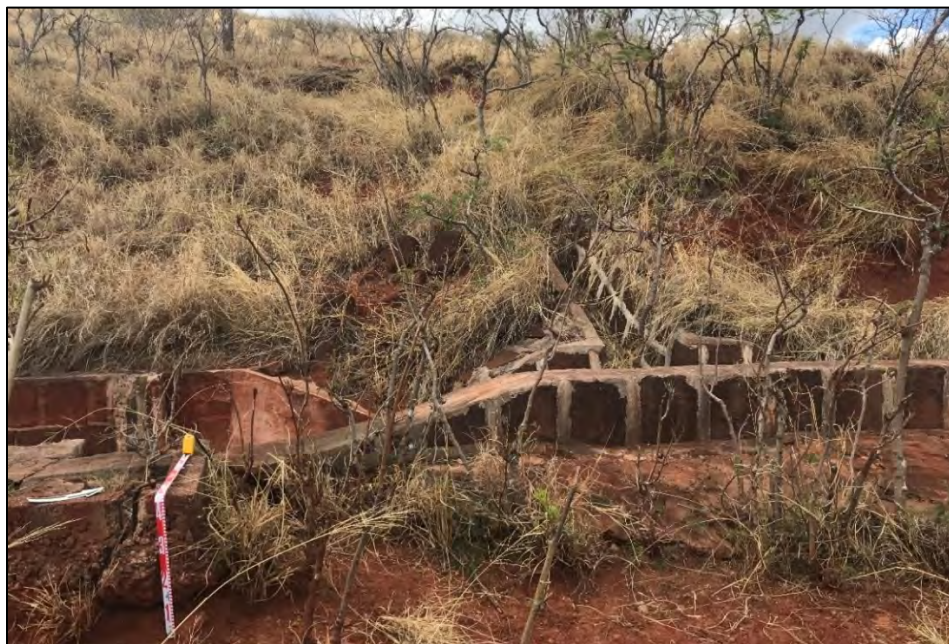
Figure 59. Overview of SIHP # 50-80-08-5593 Feature 2A complex with eastern flume (right), extending into SIHP # 50-80-09-2268 Waiahole Ditch, view to northwest

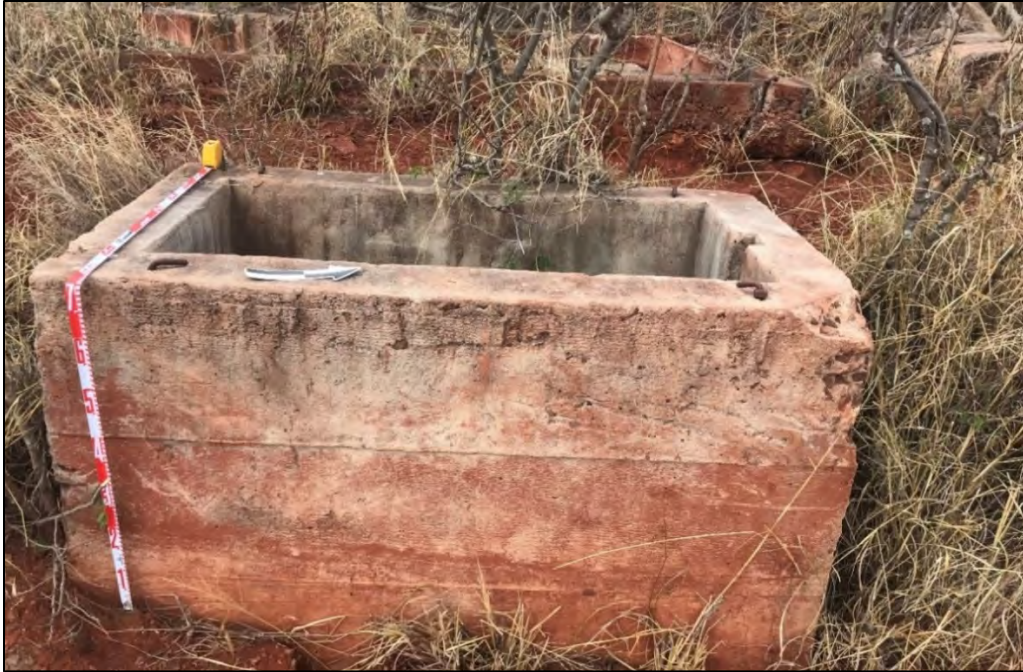
Figure 60. Water retention component of SIHP # 50-80-09-5593 Feature 2A complex, view to west

The final components of the Feature 2A complex are two small rectangular water retention features, each measuring 152 cm long, 90 cm wide, and 118 cm deep, with 16-cm thick walls (see Figure 60). The south wall of the southwest retention feature contains a slit in the concrete that has a wood insert with an attached steel measuring rod (see Figure 61). The wood and steel components no longer exist in the northeast retention feature, but the slit in the concrete remains on the south wall of this component.

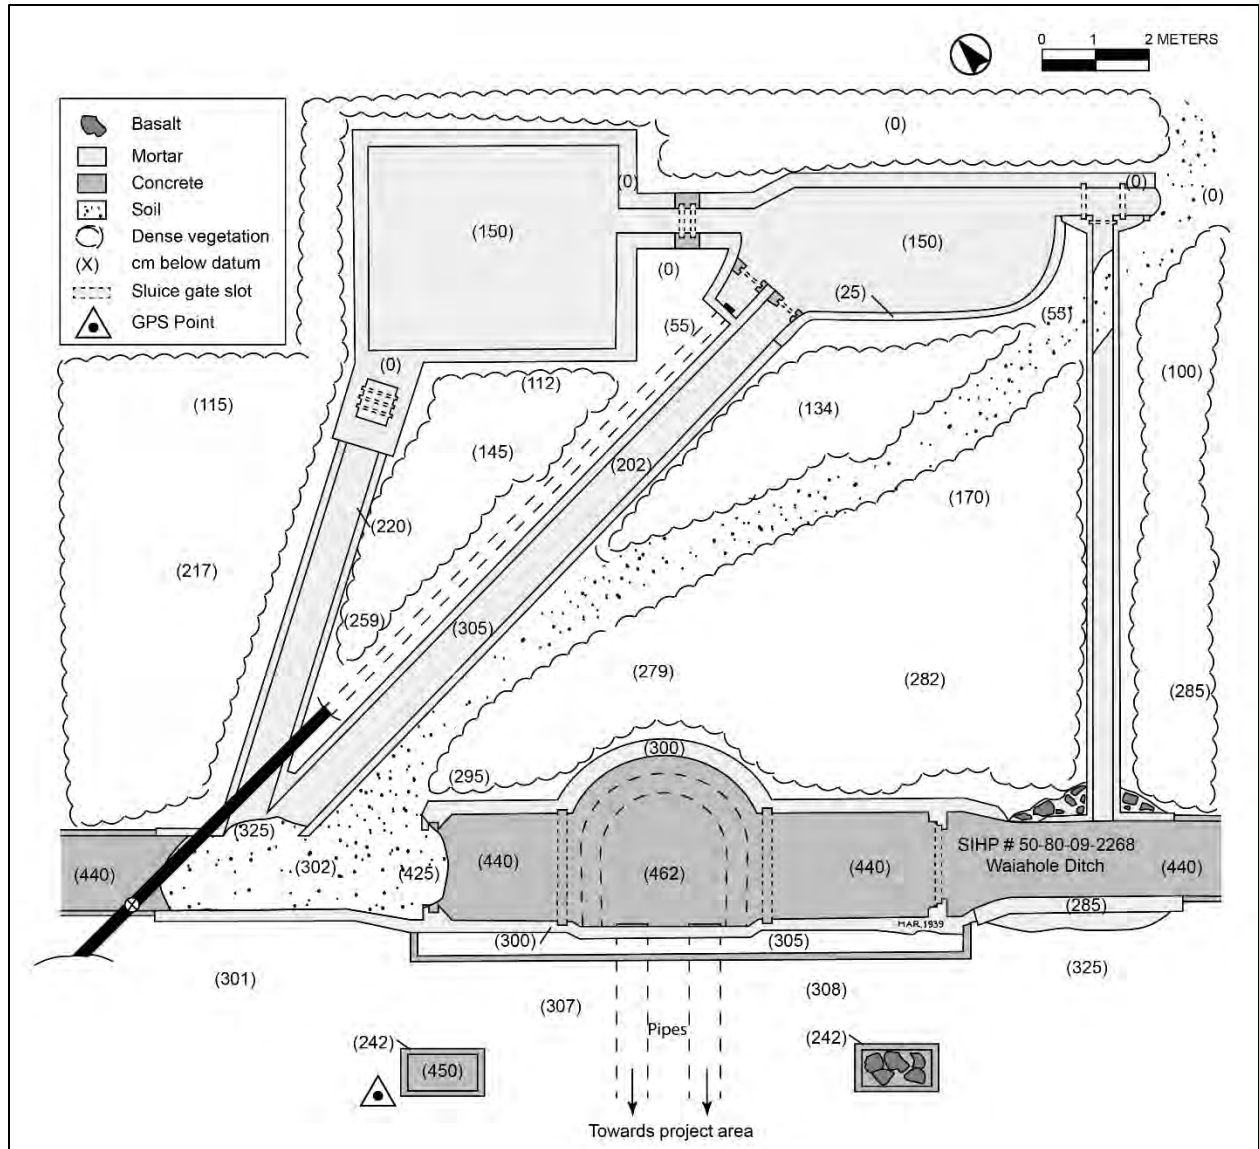
Figure 62. Plan map of SIHP # 50-80-08-5593 Feature 2A water diversion complex (just northwest of project area)

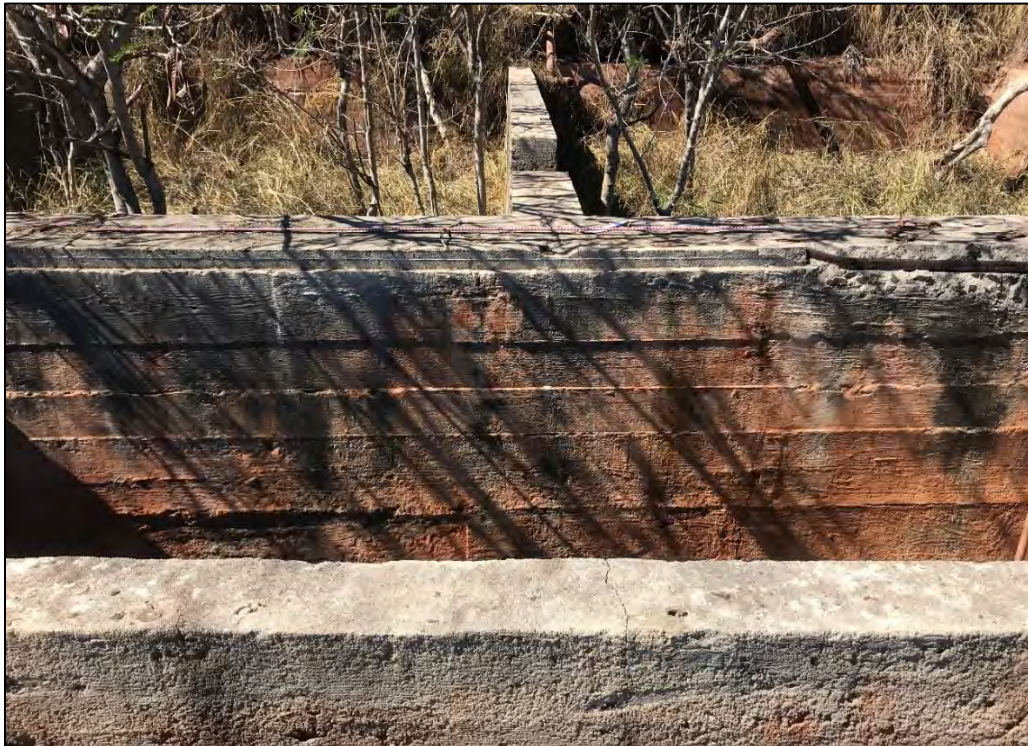
SIHP # 50-80-08-5593 Feature 2B is a rectangular water retention structure into which water from the upper Feature 2A complex/Waiahole Ditch would have been channeled (Figure 63 through Figure 66). Feature 2B measures approximately 15.2 m long, 10.6 m wide, extends 1.38 m above surface, and is a maximum depth of 3 m deep from top to bottom (see Figure 63 and Figure 64). The main structure, constructed entirely of concrete, consists of a large rectangular structure divided into two open rectangles by a concrete wall extending through the middle. The walls of the structure measure 25 cm wide, and the three northwest-southeast oriented walls have notches cut out of the surface that are 18 cm deep and range from 30 cm to 150 cm long. Two metal pipes extend out of the earth into the northeast half of the structure, at one time transporting water from the upper portion of the complex into this retention feature. Attached to the larger structure is a small rectangular portion, measuring 4.25 m long and 2.05 m wide, and containing a metal rung ladder descending into the structure and several metal pipes, which presumably continued transporting the water down the hillside (see Figure 65).

Figure 64. Overview of SIHP # 50-80-08-5593 Feature 2B, showing two large water storage compartments (background) and smaller compartment containing pipes and valves (foreground), view to northwest

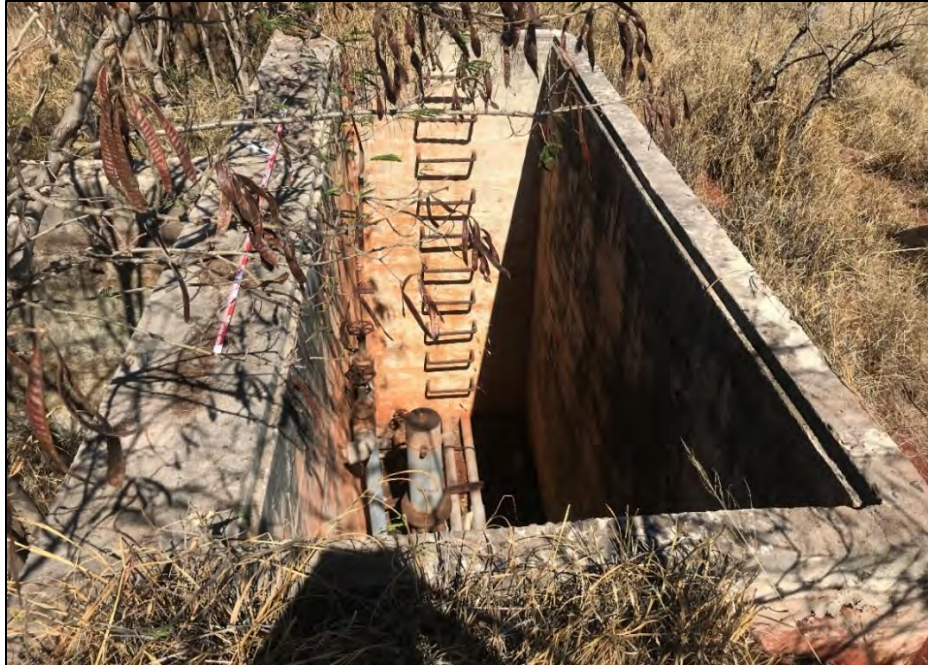
Figure 65. Overview of SIHP # 50-80-08-5593 Feature 2B, smaller southeast portion, view to northeast

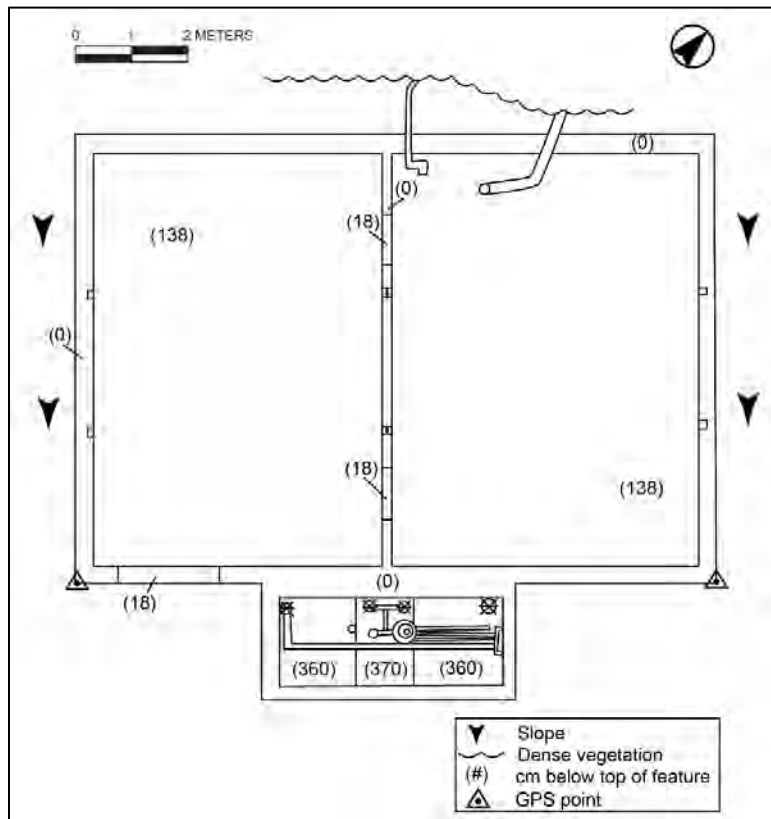
Figure 66. SIHP 3 50-80-08-5593 Feature 2B plan map

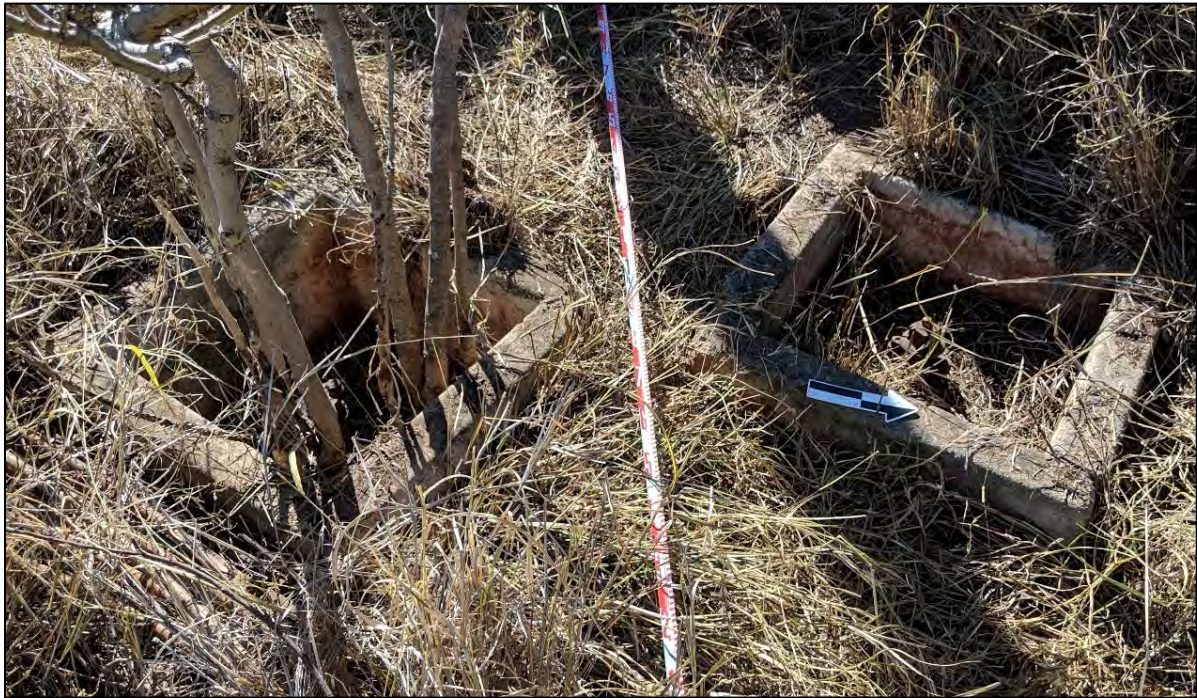
SIHP # 50-80-08-5593 Feature 2C consists of water tank remnants and related components (Figure 67 through Figure 71). The water tank was constructed of a concrete foundation with a wooden structure held together with steel cables. The wooden structure is no longer in place, leaving behind the 11 steel cables, concrete foundation, and several metal pipes (see Figure 67). The connected circular cable remnants measure a maximum 6.2 m in diameter, and the entirety of the remnants cover an area measuring 7.8 m long and 7.4 m wide. Two concrete squares measuring 80 cm by 80 cm and containing valves were documented immediately southwest of the water tower remnants (see Figure 68). A smaller related structure is 2.6 m northwest of the water tower remnants, which consists of a rectangular concrete structure measuring 3.0 m long and 2.8 m wide (see Figure 69). The northeast half of the structure is a solid concrete slab, and the southwest half of the structure is an open concrete rectangle containing metal pipes. The solid slab likely contains additional pipes related to the water control complex. Another 2.8 m northwest is an additional structure of concrete slabs and pipes, measuring 5.2 m long and 3.8 m wide. Additionally, approximately 7.4 m southwest of the water tower remnants is a damaged concrete component (see Figure 70). This concrete feature consists of three concrete walls—15 cm thick and a maximum 80 cm tall—that have broken and collapsed into a triangle shape. One metal pipe remains inside the collapsed walls. The tank is not noted on the 1943 Army War Department terrain map but appears on the 1953 Ewa and Schofield Barracks topographic quadrangles as a

Figure 68. Concrete valve components of SIHP # 50-80-08-5593 Feature 2C, view to west

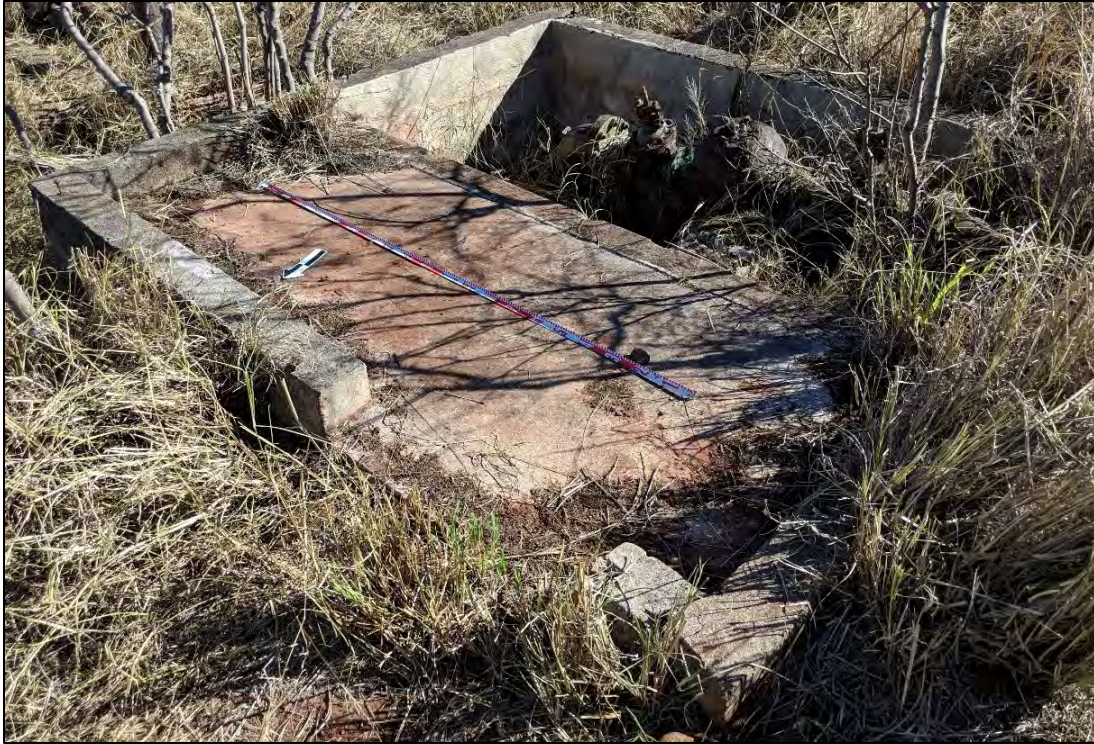
Figure 69. Overview of concrete foundation and pipes component of SIHP # 50-80-08-5593 Feature 2C, view to southeast

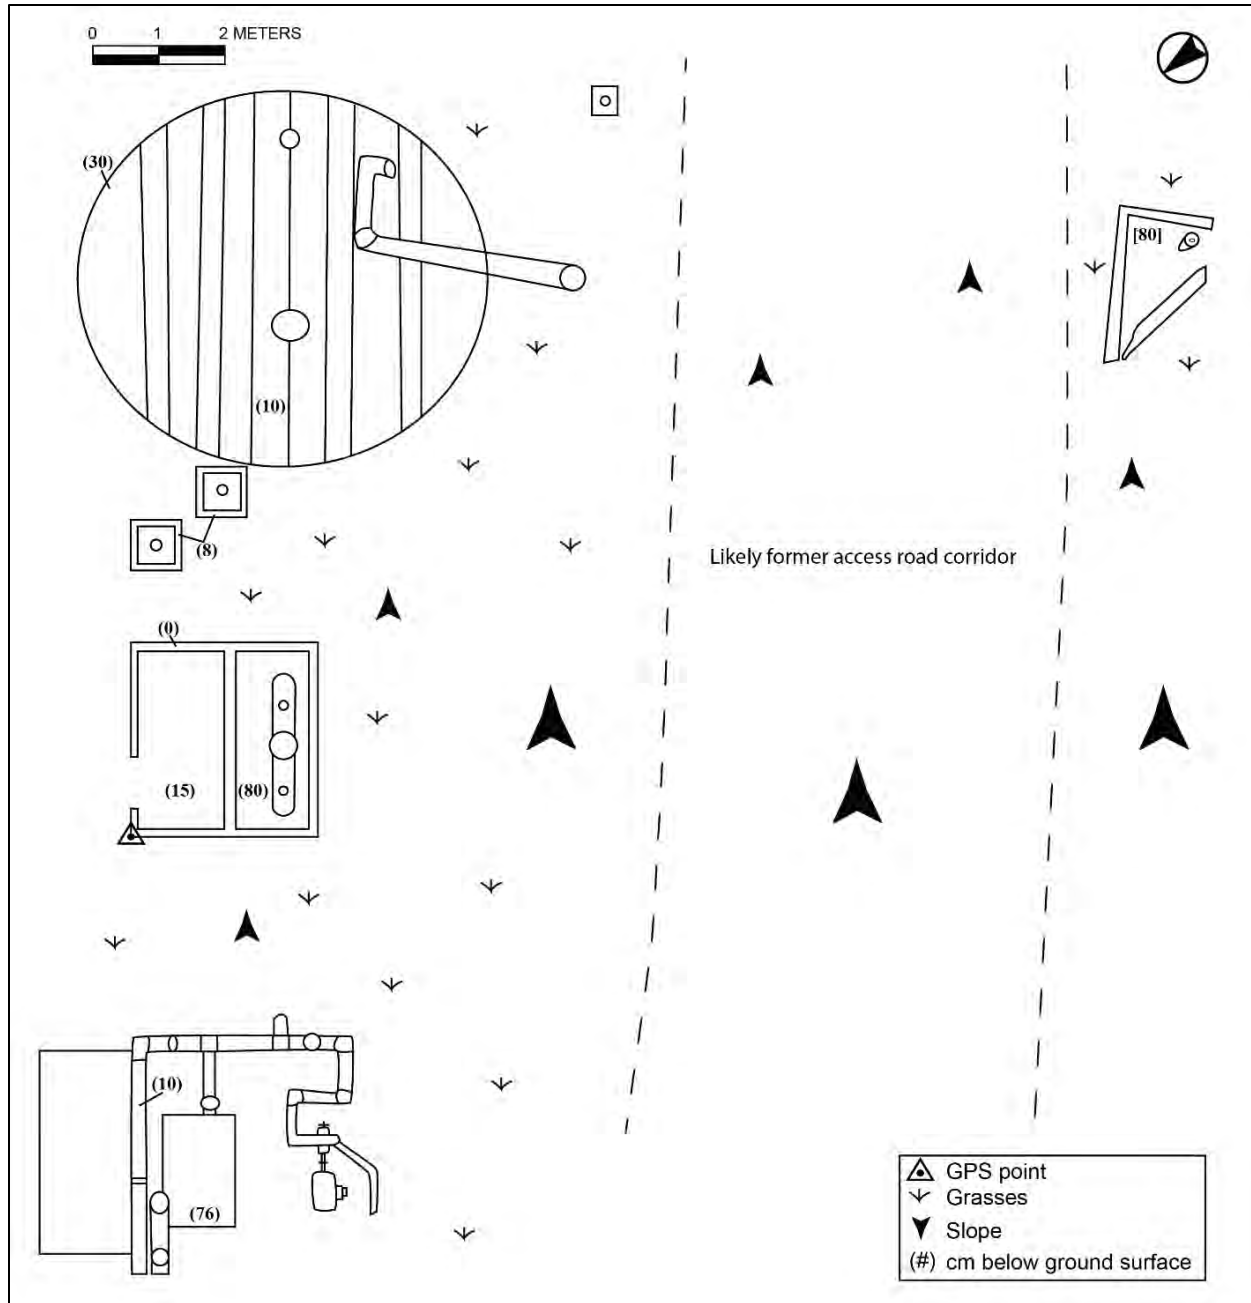
Figure 71. Plan map of SIHP # 50-80-08-5593 Feature 2C, water tank remnants and associated components

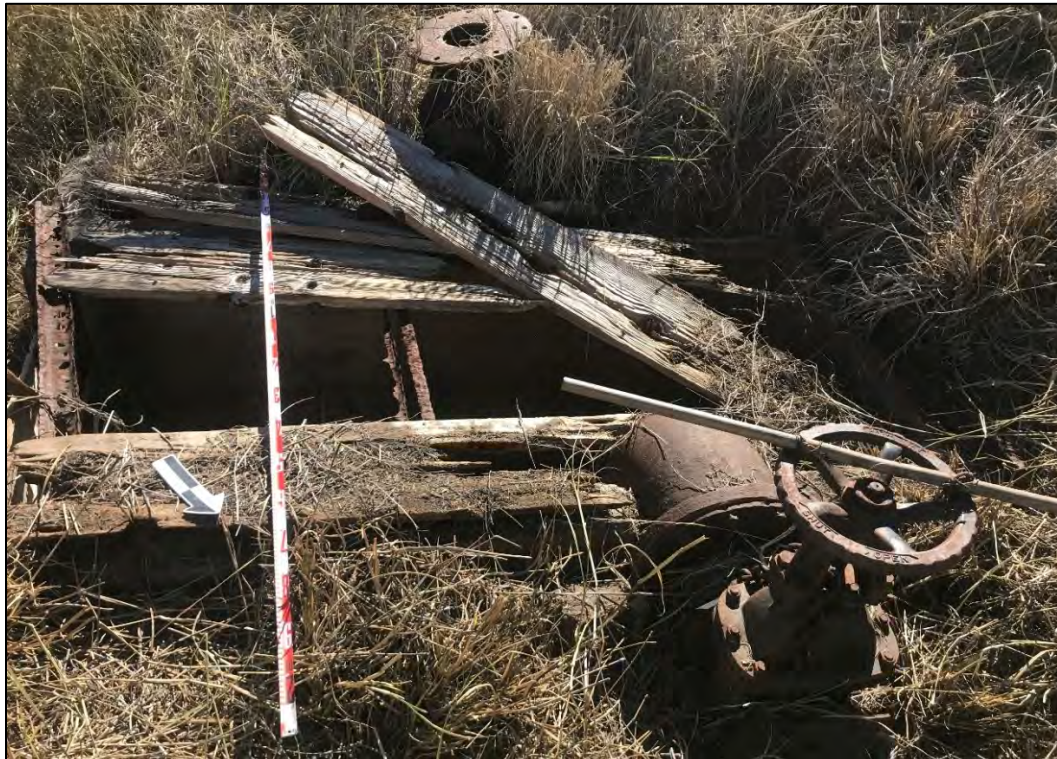
SIHP # 50-80-08-5593 Feature 2D, a rectangular-shaped likely water retention feature, is situated near the base of the slope toward the pump house and mill building (Figure 72 through Figure 76). This is constructed of concrete, metal, and wood. The feature has three components: two rectangular shafts and one concrete culvert. The first portion measures 2.4 m long and 2.0 m wide, consisting of a rectangular shaft extending to a maximum depth of 215 cm with an attached small square shaft extending to a maximum depth of 205 cm (see Figure 72). A metal pipe oriented north-south extends from inside the rectangular shaft out above ground for 3.6 m before extending downward into the shaft of the second rectangular component. The second rectangular shaft measures 2.1 m long and 1.2 m wide, extending to a maximum depth of 215 cm (see Figure 73). This second retention shaft includes notches for an intact wooden sluice gate on the east edge, which leads out into a sloped, mortared basalt channel, possibly for overflow runoff (see Figure 74 and Figure 75). The mortared basalt portion measures 3.6 m long by 1.4 m wide and is two courses high (exposed portion is 50 cm tall on average). This feature may be connected to Feature 2E, described below, as a pipe in the squared shaft on the northeast end appears to extend in the direction of Feature 2E (see Figure 75). Apparent infrastructure is observed in the vicinity of this feature in a 1951 aerial photograph (see Figure 18; UH MAGIS 1951).

Figure 73. Overview of SIHP # 50-80-08-5593 Feature 2D, southwest valve box, view to southwest

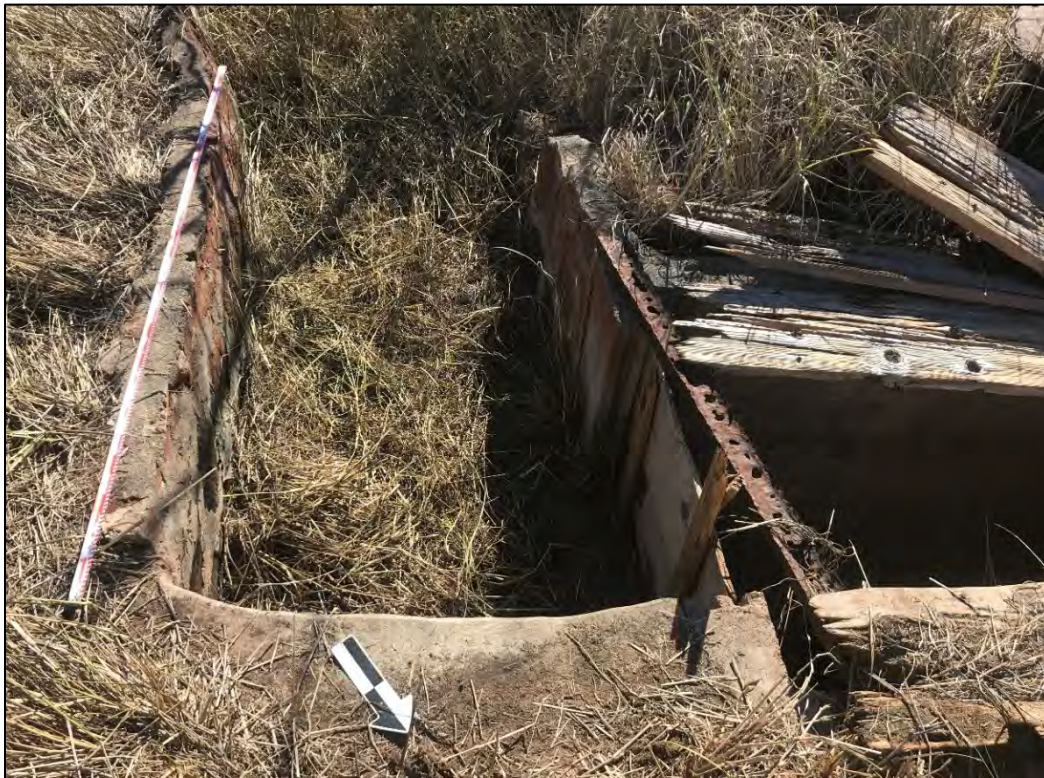
Figure 75. Feature 2D plan view of southern retention area with sluice gate and possible overflow channel, view to southwest

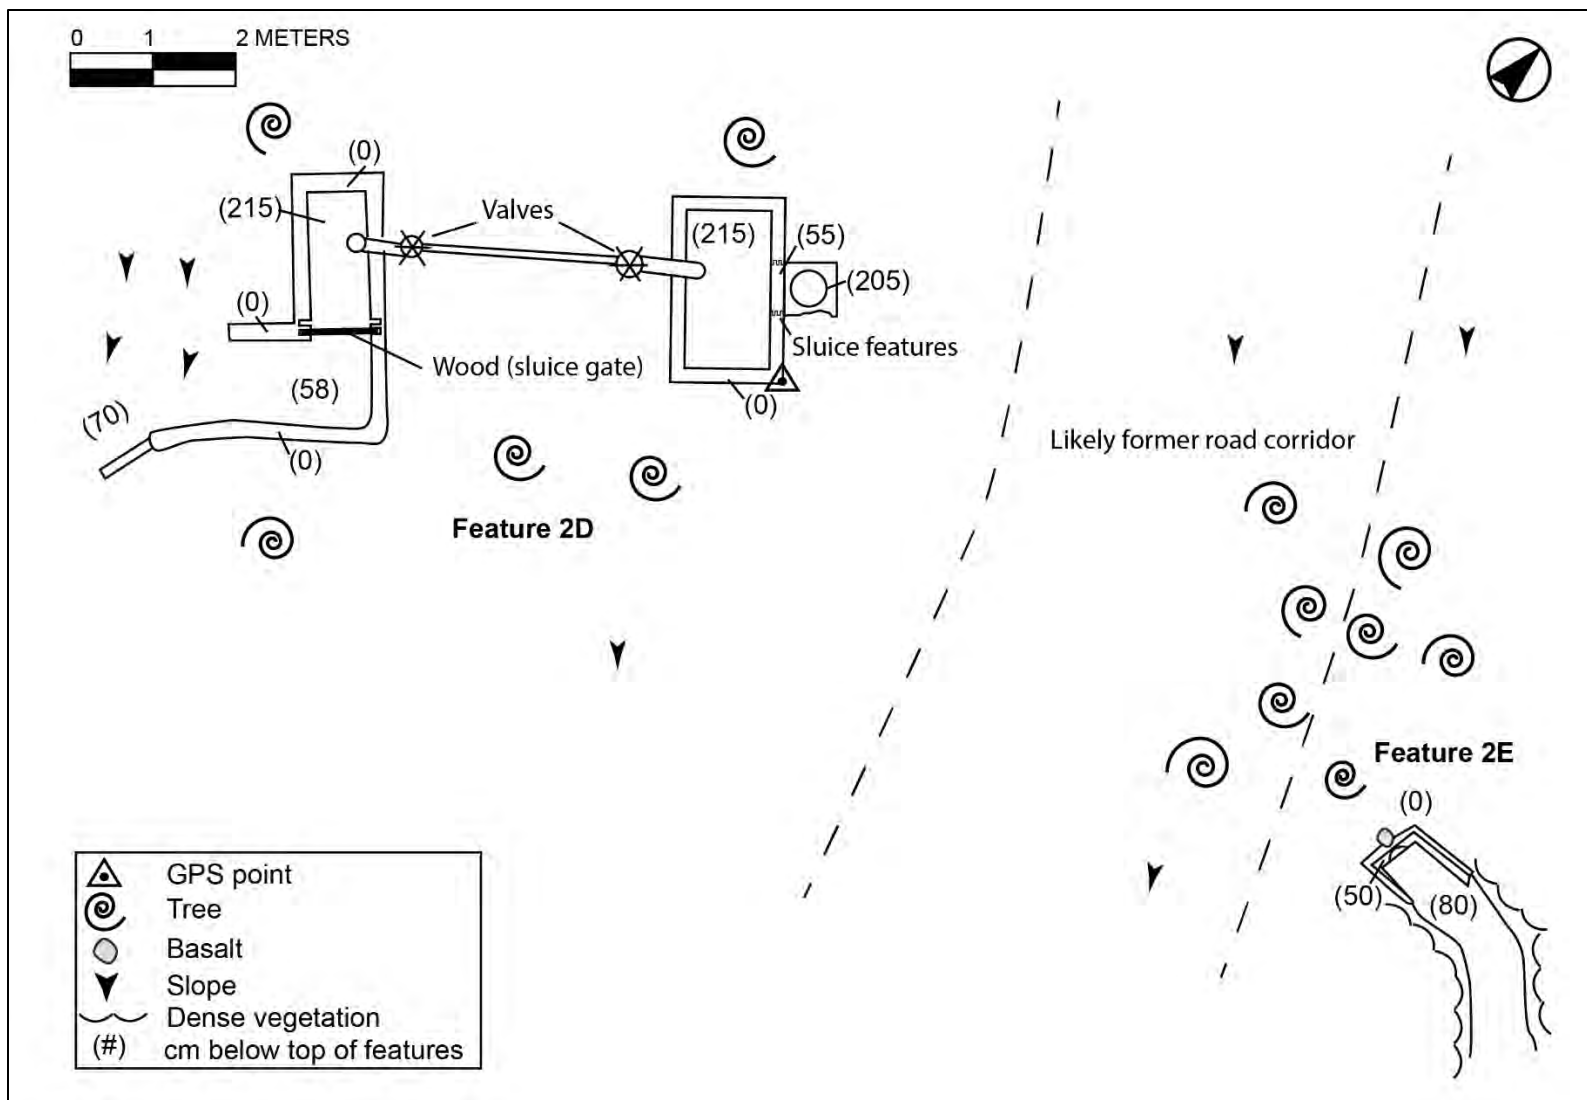
SIHP # 50-80-08-5593 Feature 2E consists of a remnant concrete culvert (see Figure 76 through Figure 78). Feature 2E is in poor condition and measures 2.4 m long and 0.75 m wide. Feature 2E is in the lower portion of the project area and appears to have been used to help channel water overflow runoff. A pipe was observed in a shaft of Feature 2D extending in the direction of 2E, suggesting water overflow was channeled from the retention feature out of Feature 2E.

Figure 76. SIHP # 50-80-08-5593 Feature 2D, northeast and southeast valve boxes (top left), and Feature 2E runoff channel (bottom right) plan map
