Figure 39. 2013 Ewa and Schofield Barracks USGS topographic quadrangles showing the historic properties identified during the AIS: SIHP # 50-80-08-2268 Feature E through Feature K (shown in green) and SIHP # 50-80-08-5593 Feature 1, Features 2A through 2E, and Features 3A through 3C (shown in orange) and SIHP # 50-80-08-5593 Features 4A through 4F shown in yellow; Features A through D of SIHP # -2268 identified in previous studies nearby the project area were included for reference

### 5.1.1 Description of SIHP # -5593 by Dega et al. 1998

### **5.1.2 Description of SIHP # -5593 within and adjacent to the Current Project Area**

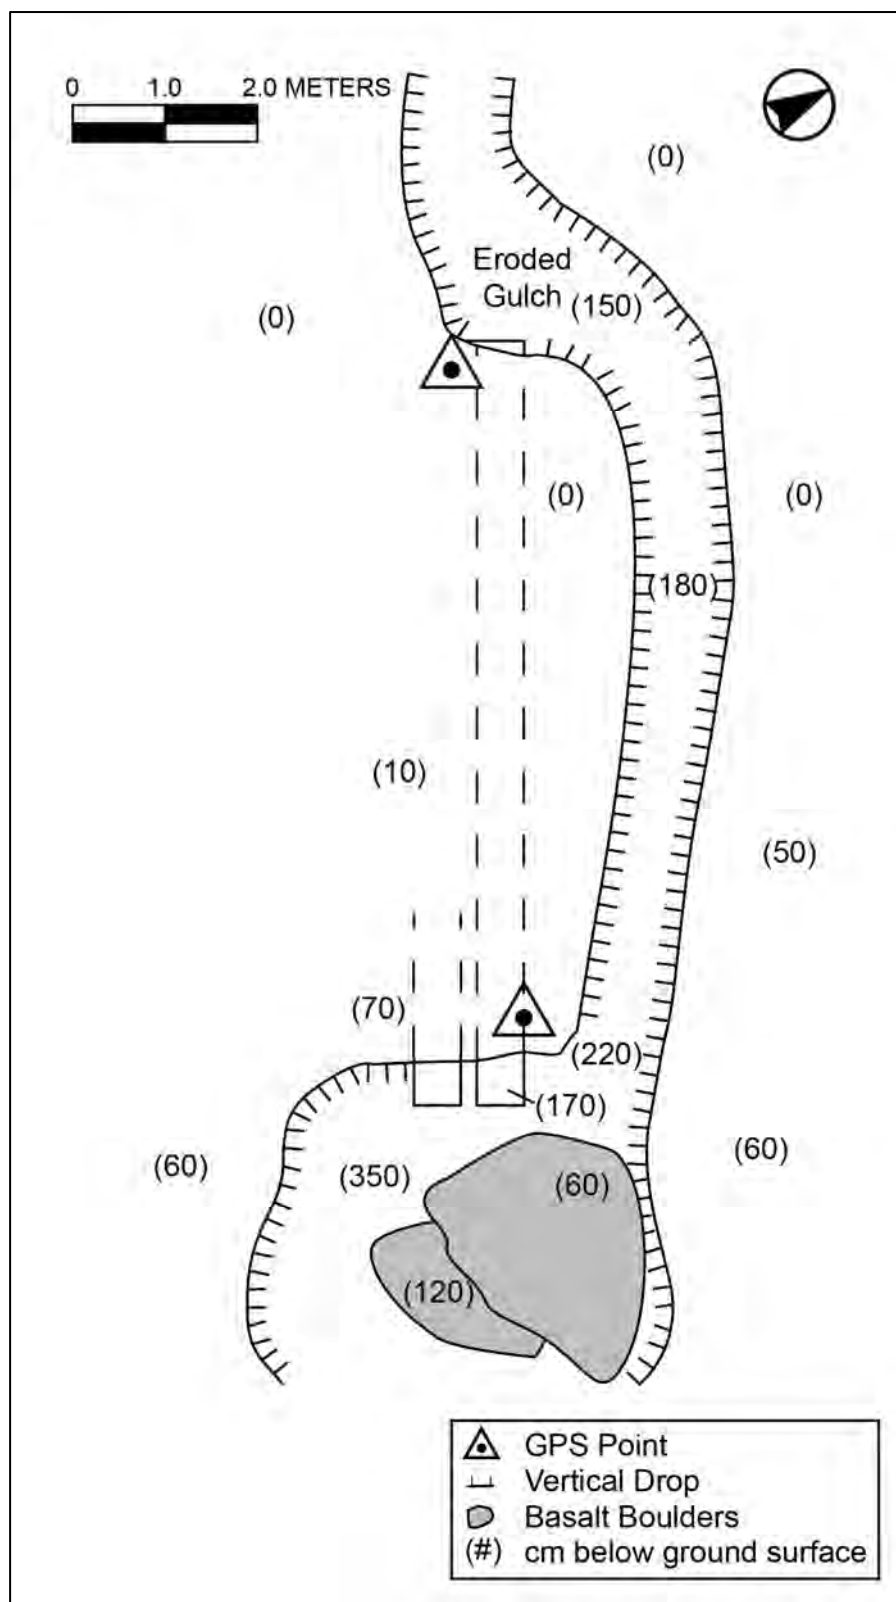
Figure 48. SIHP # 50-80-08-5593 Feature 1 plan map

**SIHP # 50-80-08-5593 Feature 1** consists of plantation-era drain pipes located within a ditch in the northeast portion of the project area (see Figure 40 for location). It is possible this feature was identified during the Dega et al. (1998) study, however, this could not be definitively discerned based on that documentation. The upper/west end of this feature consists of a single observable concrete pipe approximately 35 cm in diameter (the second pipe is likely obscured by collapsed earth) with overlying concrete rubble and stacked basalt, three stones wide and two to three courses high (Figure 46). This upper portion measures 82 cm tall and 90 cm wide.

The east/lower end of Feature 1 consists of two steel pipes (Figure 47 and Figure 48), each approximately 35 cm in diameter, and the exposed portions approximately 40 cm tall. The function of this feature is related to agriculture and water control. Feature 1 is in fair condition, as much of the area is overgrown and heavily eroded.

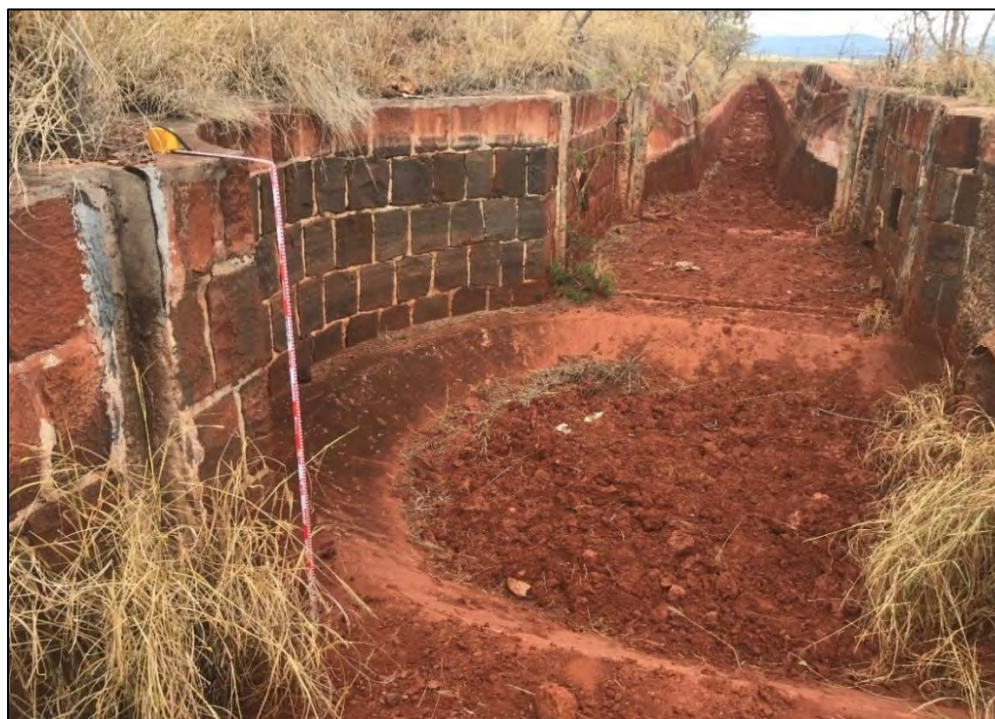
**SIHP # 50-80-08-5593 Feature 2A**, the uppermost portion of the complex, consists of various water catchment features attached to a portion of the Waiahole Ditch, related to the mill and pump house at the base of the slope (see Figure 49, Figure 50, and Figure 60). This portion is oriented northeast-southwest, and constructed of basalt, concrete, and metal pipes. The Feature 2A complex is situated on the northwest boundary of the project area. Portions of this upper complex contain modern rubbish (modern bottles and cans), as well as a cow skeleton, likely a livestock animal that fell, died, and decayed in place. The northeast portion of this section of the Waiahole Ditch consists of a concrete-lined ditch 140 cm wide and 163 cm deep. As it extends toward the Feature 2A complex, there is an overlying addition of mortared basalt three courses high, a portion of which bears the date inscription "MAR 1939" (Figure 51). The ditch then feeds into a large catchment basin measuring a maximum of 4.0 m long and 3.2 m wide, with a maximum depth of 180 cm. The basin is flanked by notches in the concrete on both sides, for former sluice gates which are no longer intact. The basin would have fed into the two drain pipes at the base of the southeast wall of the structure (Figure 52). These pipes extend down slope to the pump house and mill. Portions of these pipes are exposed on the slope's surface, and much of the pipes are likely underground.

Figure 50. Overview of SIHP # 50-80-09-2268 Waiahole Ditch at the intersection with SIHP # 50-80-08-5593 Feature 2A complex, view to north (see Figure 60 plan view)

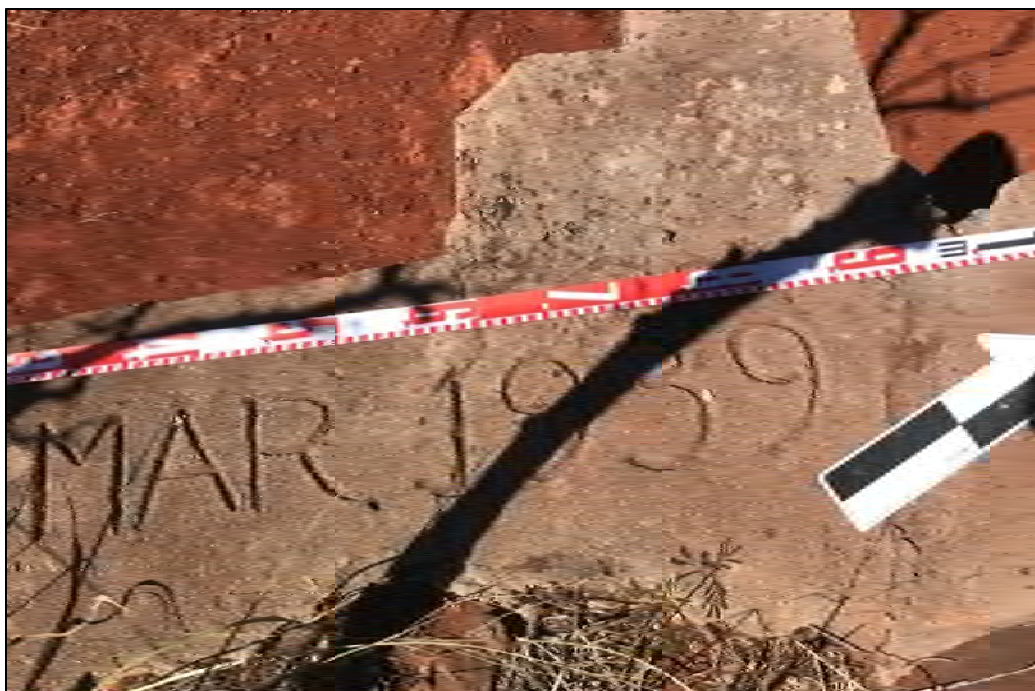
Figure 51. Plan view showing inscription in SIHP # 50-80-08-5593 Feature 2A complex

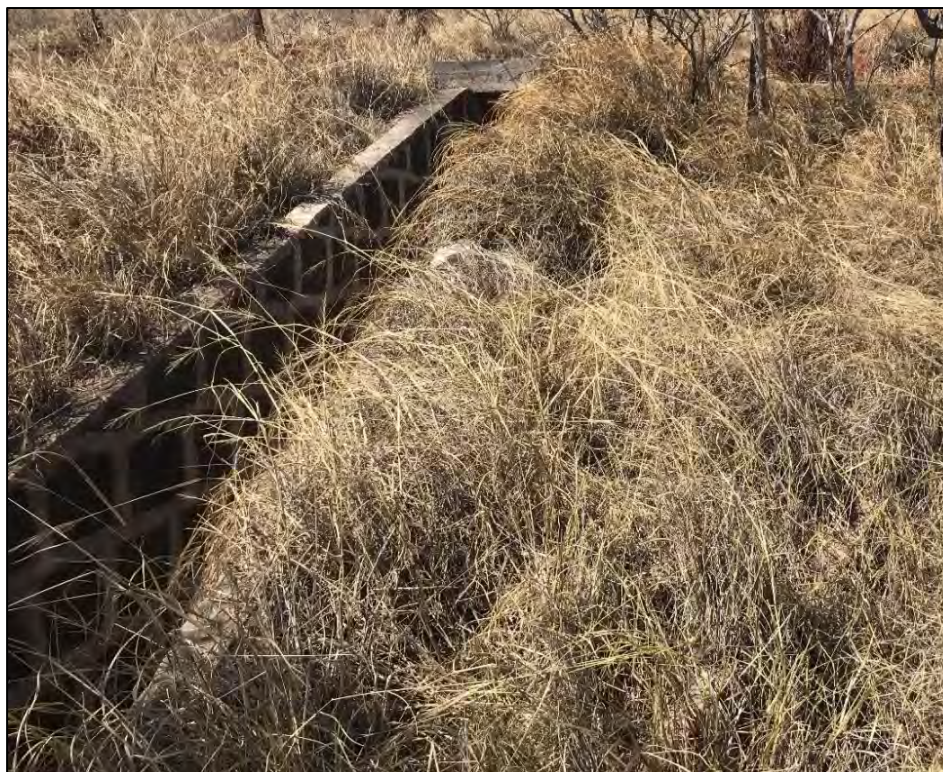
An additional water retention component is positioned directly northwest of this basin. This portion consists of a rectangular mortared basalt catchment area measuring 5.1 m long by 3.8 m wide (Figure 53), feeding into an oval catchment area measuring 6.3 m long and 2.6 m wide (Figure 54), with notches for a sluice gate feature in between (gate not intact). It is possible these catchment areas are gravel traps, which would have served to trap silt and clay (Reeves 1954). This function is suggested based on the complex shape of the structure, which is somewhat similar to a gravel trap from the Iao-Maniania Ditch pictured in a publication on plantation ditches (Figure 55; Wilcox 1996). Three flumes feed from the upper catchment areas into the Waiahole Ditch (Figure 56 and Figure 57). The flumes are oriented north-south and northwest-southeast. The eastern flume

Figure 56. Center flume of SIHP # 50-80-08-5593 Feature 2A complex extending from upper catchment area into SIHP # 50-80-09-2268 Waiahole Ditch, view to west

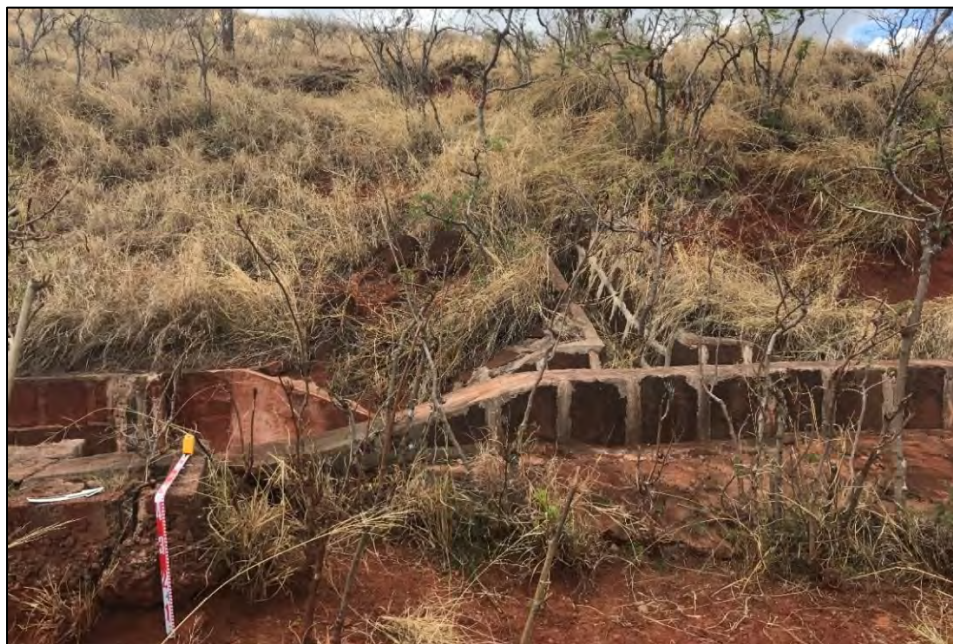
Figure 57. Overview of SIHP # 50-80-08-5593 Feature 2A complex with eastern flume (right), extending into SIHP # 50-80-09-2268 Waiahole Ditch, view to northwest

measures 11.0 m long and 0.6 m wide, the center flume measures 12.8 m long and 0.6 m wide, and the western flume measures 7.1 m long and 0.6 m wide.

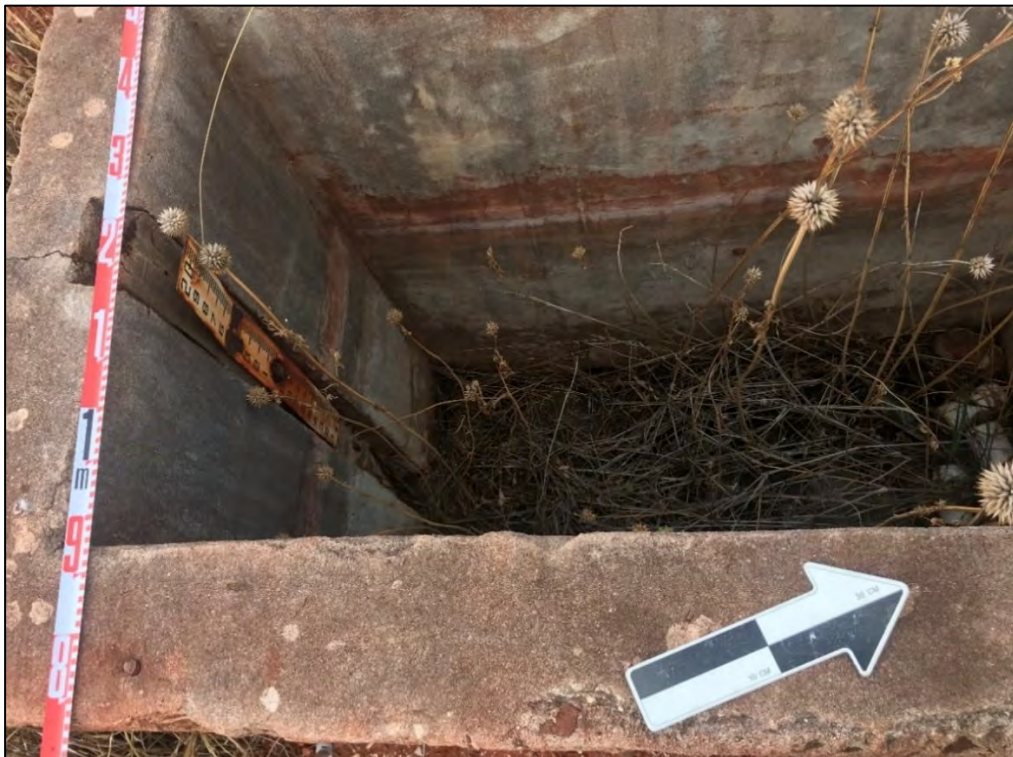
Figure 59. Plan view of SIHP # 50-80-09-5593 Feature 2A complex, water retention component, view to northwest

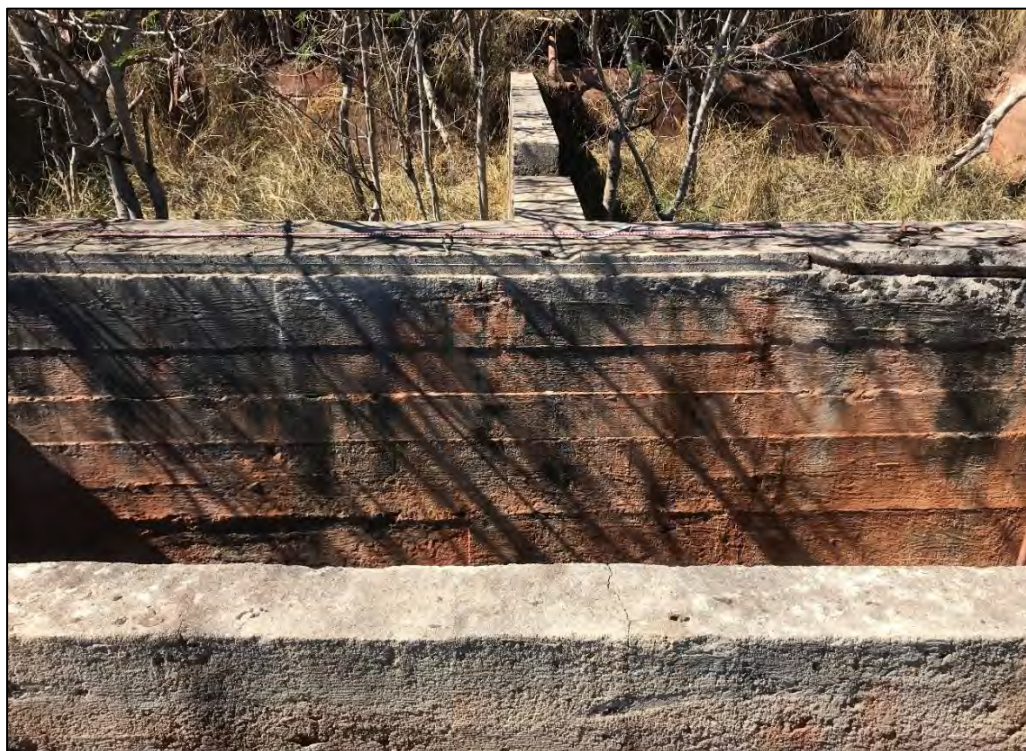
**SIHP # 50-80-08-5593 Feature 2B** is a rectangular water retention structure into which water from the upper Feature 2A complex/Waiahole Ditch would have been channeled (Figure 61 through Figure 64). Feature 2B measures approximately 15.2 m long, 10.6 m wide, extends 1.38 m above surface, and is a maximum depth of 3 m deep from top to bottom (see Figure 61 and Figure 62). The main structure, constructed entirely of concrete, consists of a large rectangular structure divided into two open rectangles by a concrete wall extending through the middle. The walls of the structure measure 25 cm wide, and the three northwest-southeast oriented walls have notches cut out of the surface that are 18 cm deep and range from 30 cm to 150 cm long. Two metal pipes extend out of the earth into the northeast half of the structure, at one time transporting water from the upper portion of the complex into this retention feature. Attached to the larger structure is a small rectangular portion, measuring 4.25 m long and 2.05 m wide, and containing a metal rung ladder descending into the structure and several metal pipes, which presumably continued transporting the water down the hillside (see Figure 63).

Figure 62. Overview of SIHP # 50-80-08-5593 Feature 2B, showing two large water storage compartments (background) and smaller compartment containing pipes and valves (foreground), view to northwest

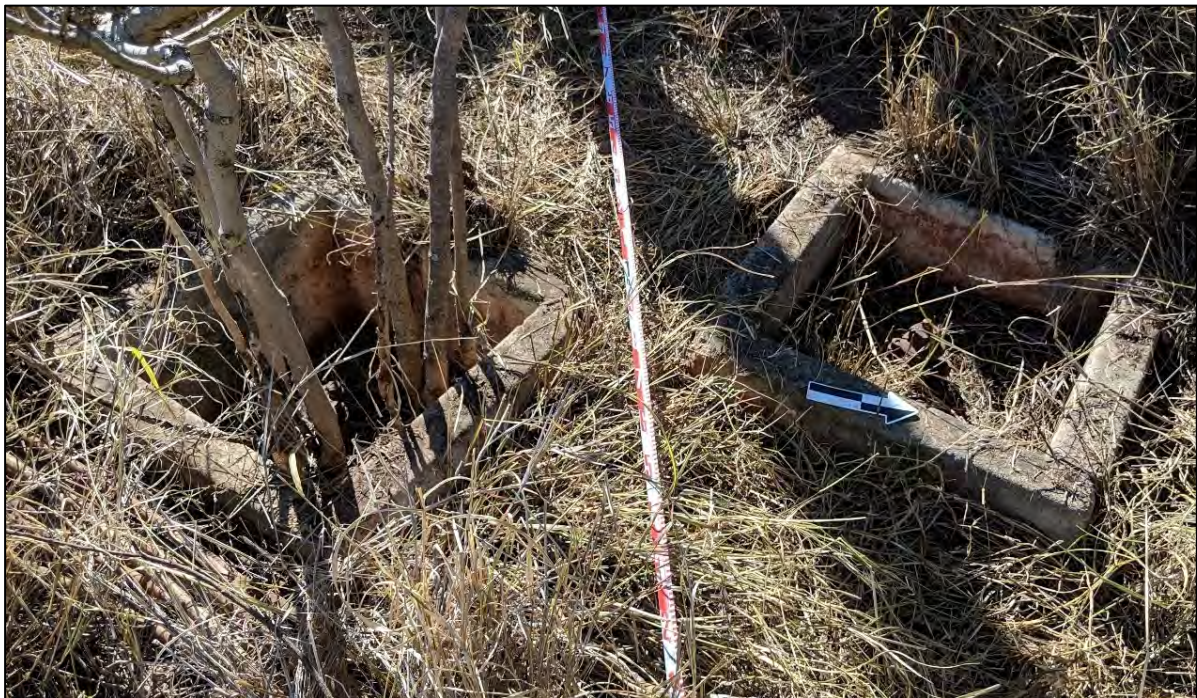
**SIHP # 50-80-08-5593 Feature 2C** consists of water tank remnants and related components (Figure 65 through Figure 69). The water tank was constructed of a concrete foundation with a wooden structure held together with steel cables. The wooden structure is no longer in place, leaving behind the 11 steel cables, concrete foundation, and several metal pipes (see Figure 65). The connected circular cable remnants measure a maximum 6.2 m in diameter, and the entirety of the remnants cover an area measuring 7.8 m long and 7.4 m wide. Two concrete squares measuring 80 cm by 80 cm and containing valves were documented immediately southwest of the water tower remnants (see Figure 66). A smaller related structure is 2.6 m northwest of the water tower remnants, which consists of a rectangular concrete structure measuring 3.0 m long and 2.8 m wide (see Figure 67). The northeast half of the structure is a solid concrete slab, and the southwest half of the structure is an open concrete rectangle containing metal pipes. The solid slab likely contains additional pipes related to the water control complex. Another 2.8 m northwest is an additional structure of concrete slabs and pipes, measuring 5.2 m long and 3.8 m wide. Additionally, approximately 7.4 m southwest of the water tower remnants is a damaged concrete component (see Figure 68). This concrete feature consists of three concrete walls—15 cm thick and a maximum 80 cm tall—that have broken and collapsed into a triangle shape. One metal pipe remains inside the collapsed walls. The tank is not noted on the 1943 Army War Department terrain map but appears on the 1953 Ewa and Schofield Barracks topographic quadrangles as a marked circular feature labeled “Water Tank” in the same location as the documented Feature 2C (see Figure 17 and Figure 19). Structures are visible in this general area as late as 1968, including an apparent circular structure, which is likely the water tank (see Figure 21; UH MAGIS 1968).

Figure 66. Concrete valve components of SIHP # 50-80-08-5593 Feature 2C, view to west

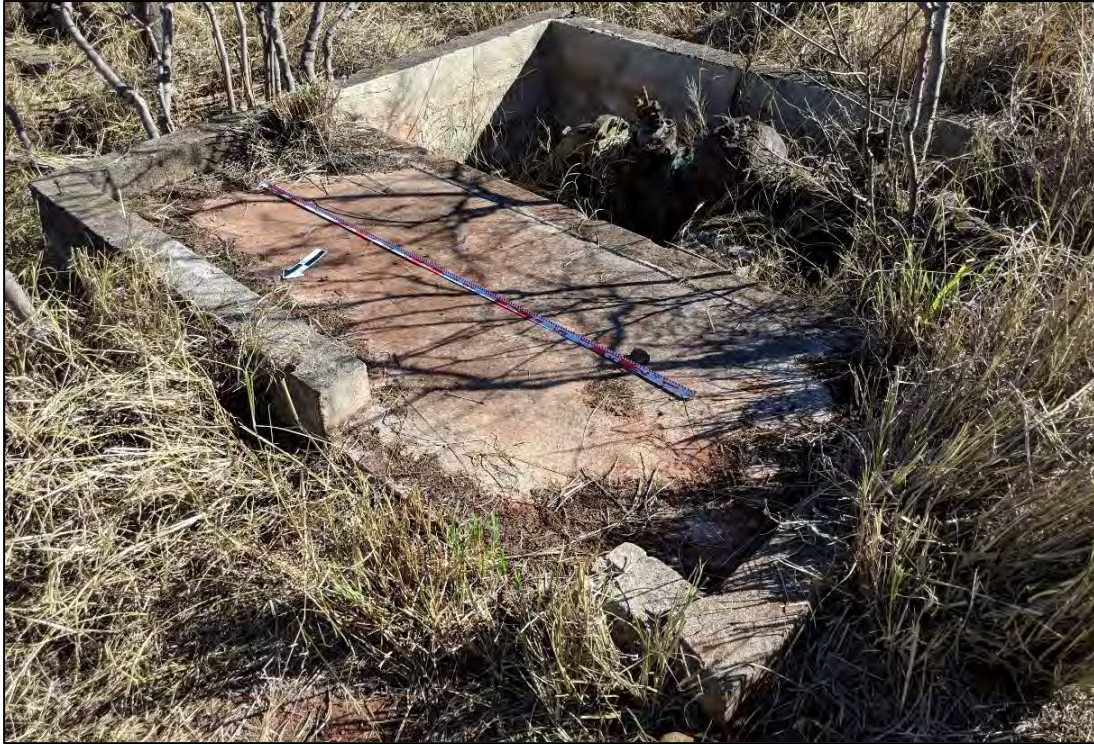
Figure 67. Overview of concrete foundation and pipes component of SIHP # 50-80-08-5593 Feature 2C, view to southeast

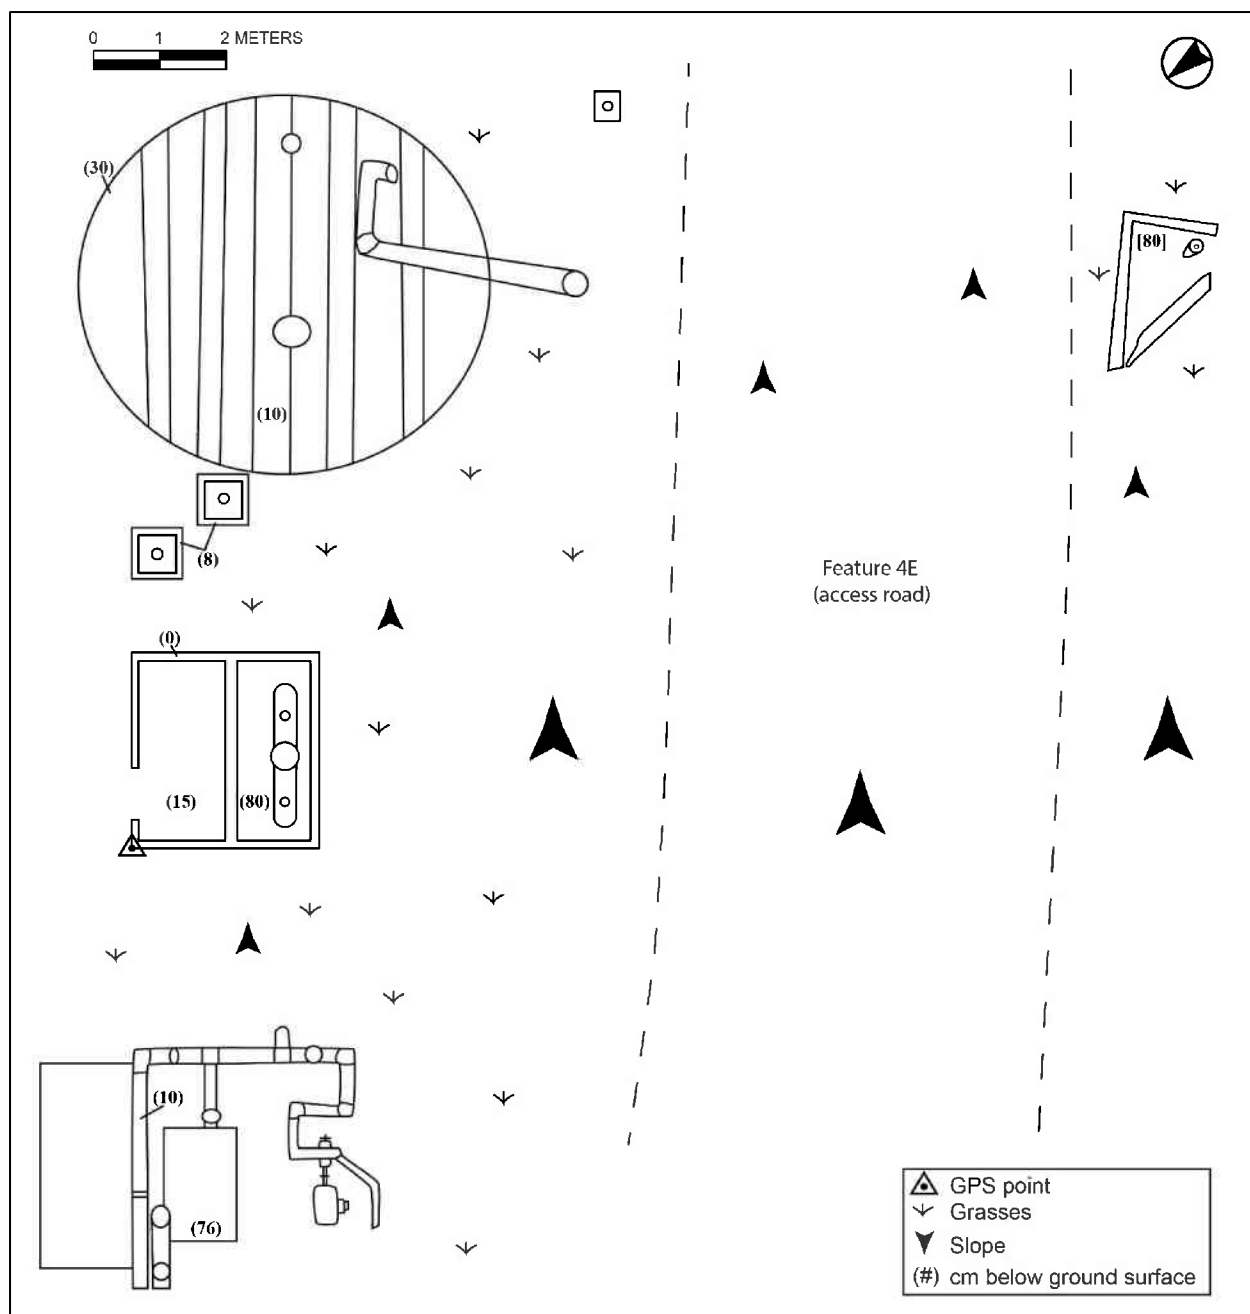
Figure 69. Plan map of SIHP # 50-80-08-5593 Feature 2C, water tank remnants and associated components

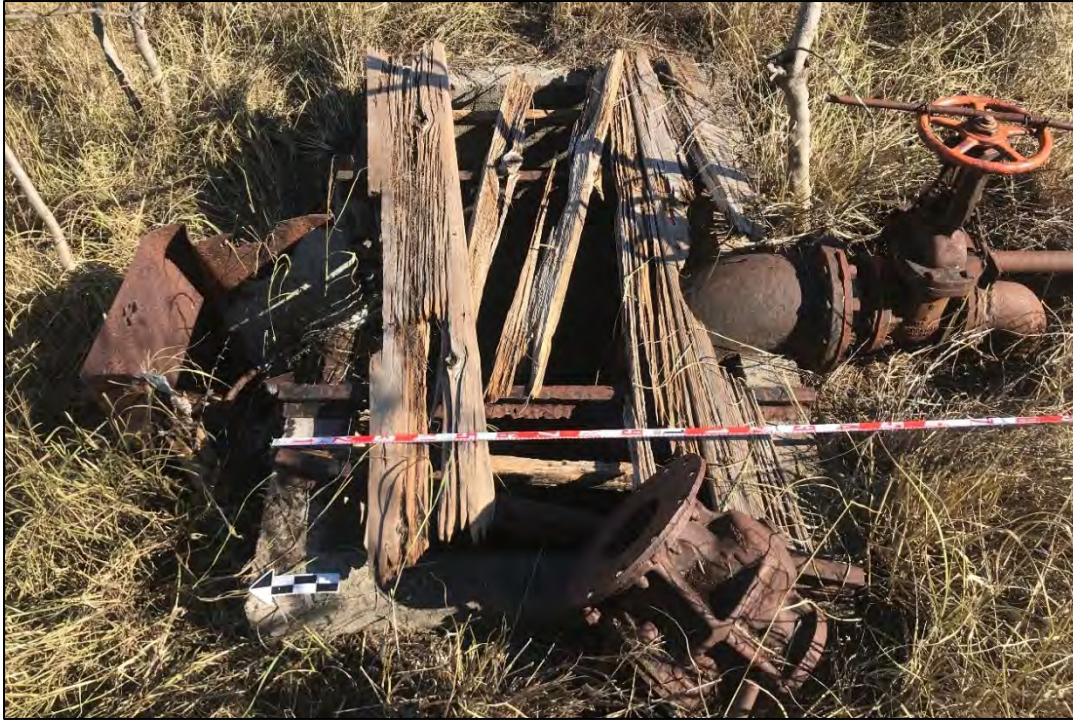
**SIHP # 50-80-08-5593 Feature 2D**, a rectangular-shaped likely water retention feature, is situated near the base of the slope toward the pump house and mill building (Figure 70 through Figure 74). This is constructed of concrete, metal, and wood. The feature has three components: two rectangular shafts and one concrete culvert. The first portion measures 2.4 m long and 2.0 m wide, consisting of a rectangular shaft extending to a maximum depth of 215 cm with an attached small square shaft extending to a maximum depth of 205 cm (see Figure 70). A metal pipe oriented north-south extends from inside the rectangular shaft out above ground for 3.6 m before extending downward into the shaft of the second rectangular component. The second rectangular shaft measures 2.1 m long and 1.2 m wide, extending to a maximum depth of 215 cm (see Figure 71). This second retention shaft includes notches for an intact wooden sluice gate on the east edge, which leads out into a sloped, mortared basalt channel, possibly for overflow runoff (see Figure 72 and Figure 73). The mortared basalt portion measures 3.6 m long by 1.4 m wide and is two courses high (exposed portion is 50 cm tall on average). This feature may be connected to Feature 2E, described below, as a pipe in the squared shaft on the northeast end appears to extend in the direction of Feature 2E (see Figure 73). Apparent infrastructure is observed in the vicinity of this feature in a 1951 aerial photograph (see Figure 18; UH MAGIS 1951).

Figure 70. Overview of SIHP # 50-80-08-5593 Feature 2D, northeast valve box, view to east

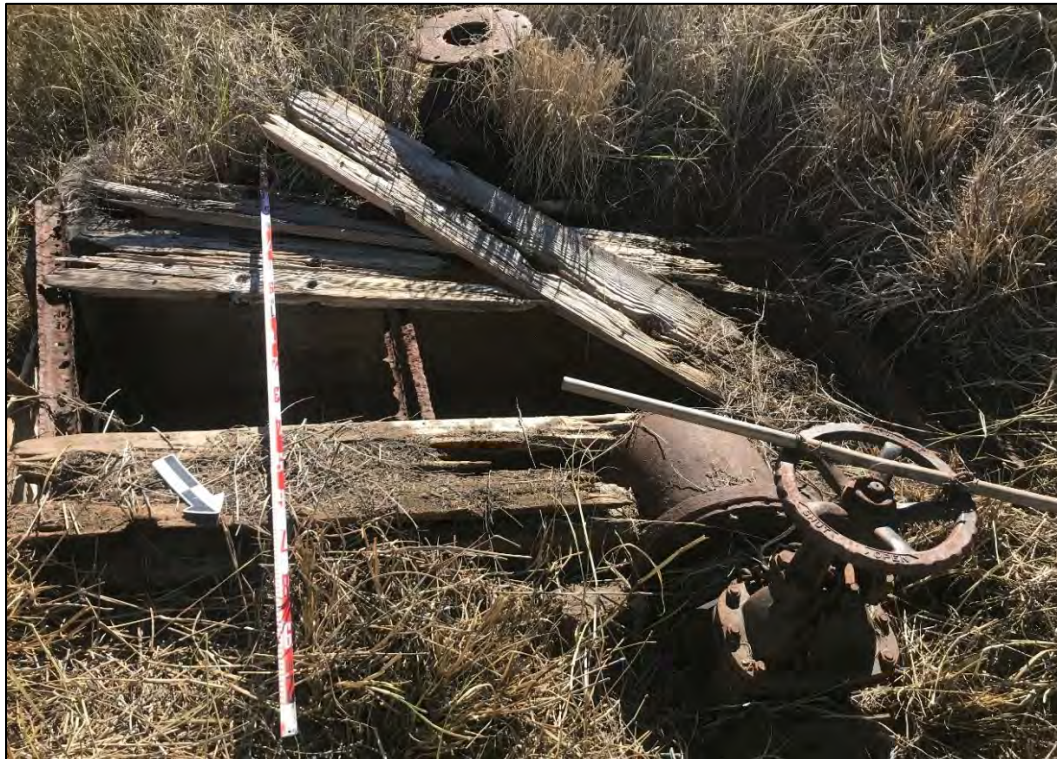
Figure 71. Overview of SIHP # 50-80-08-5593 Feature 2D, southwest valve box, view to southwest

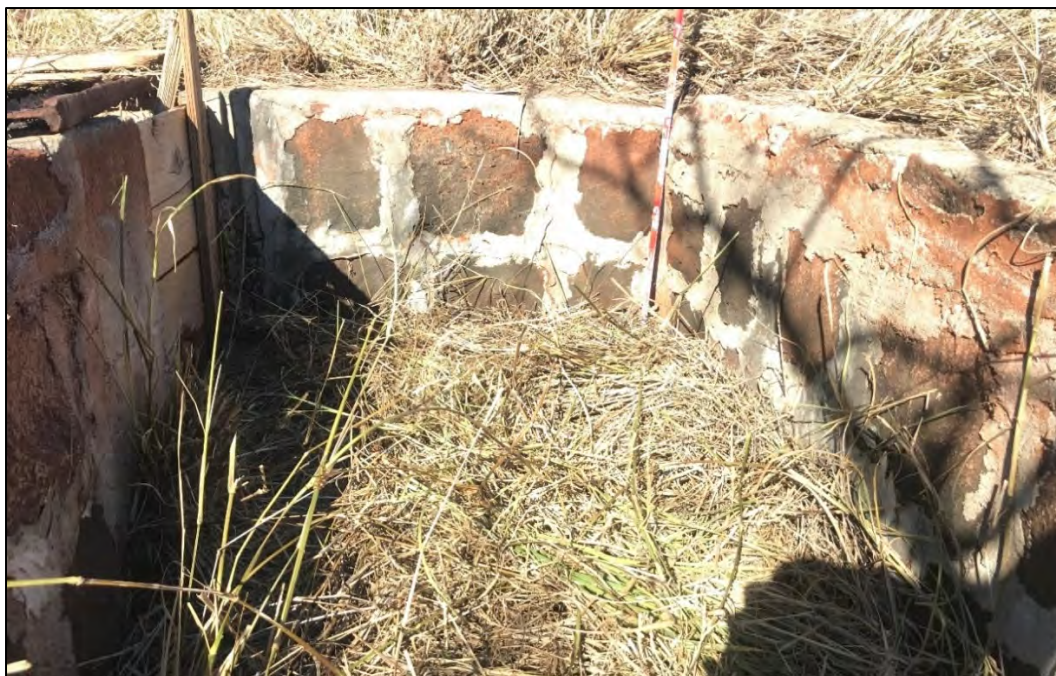
Figure 72. SIHP # 50-80-08-5593 Feature 2D sluice gate and possible water overflow channel, view to northeast

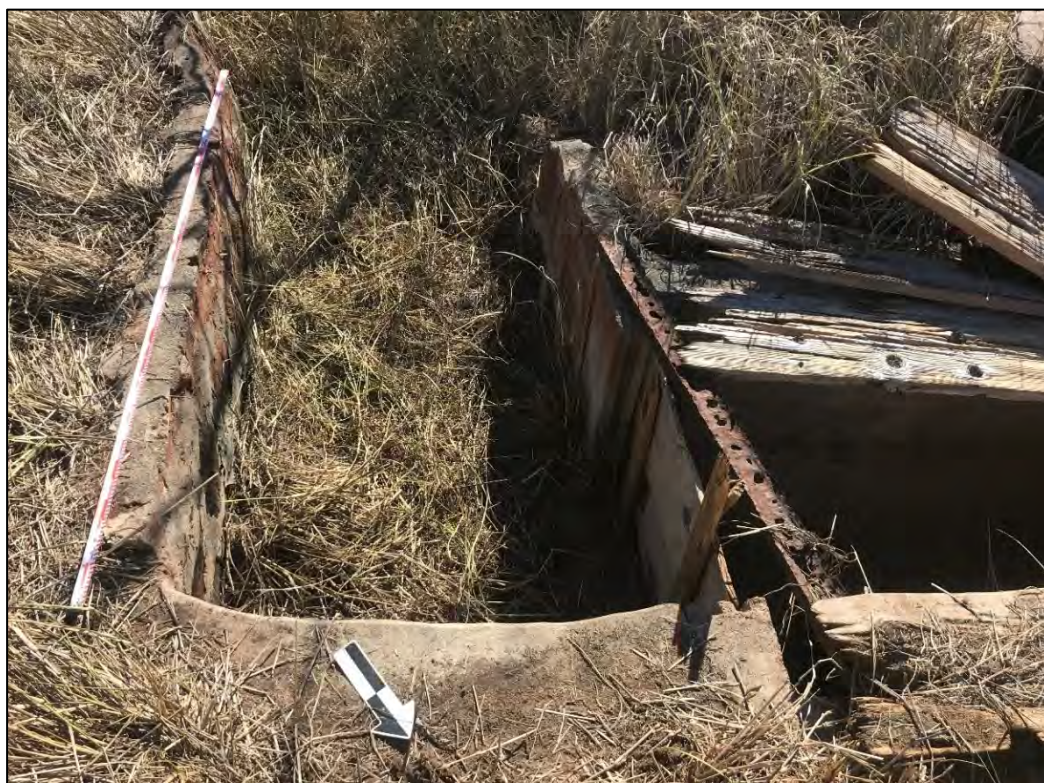
Figure 73. Feature 2D plan view of southern retention area with sluice gate and possible overflow channel, view to southwest

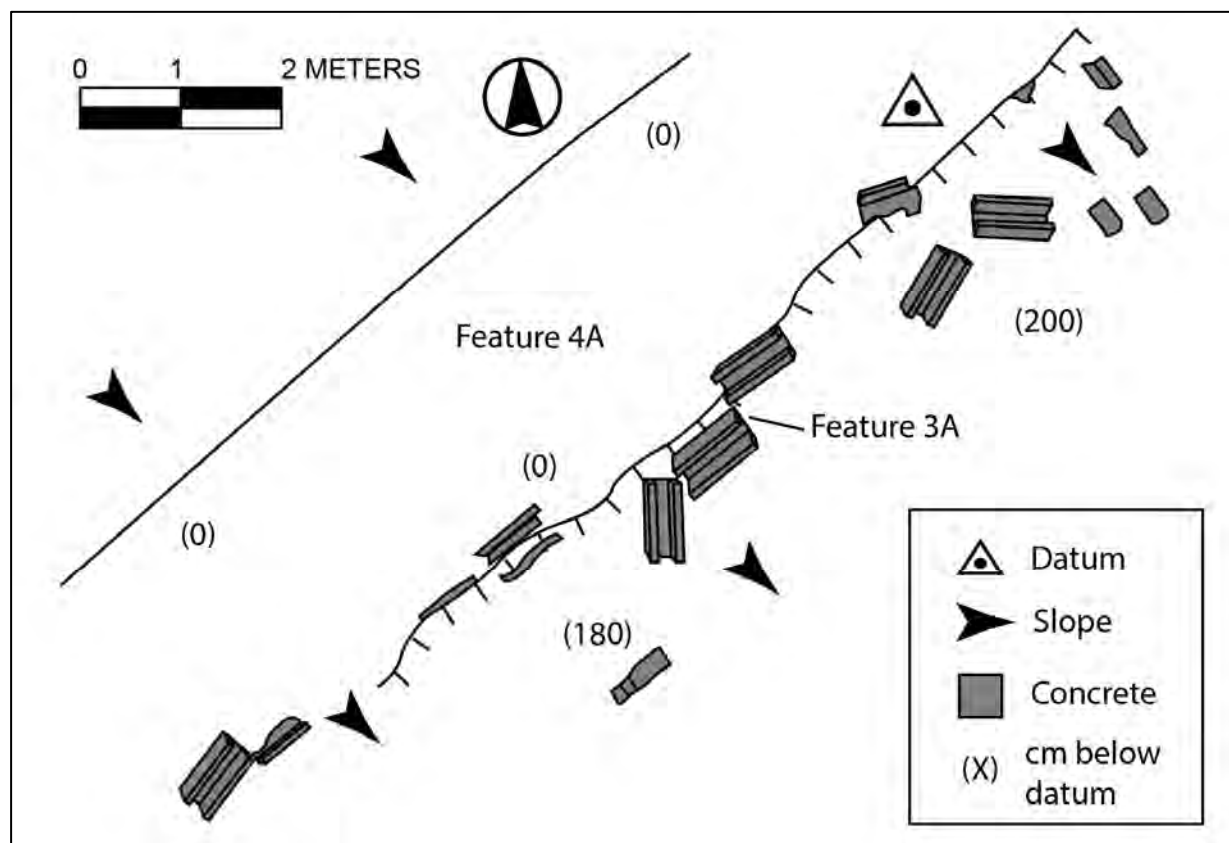
**Feature 3A** consists of a heavily disturbed remnant portable concrete flume along the *makai* side of SIHP # -5593 Feature 4A (see Figure 38, Figure 77 and Figure 78). The feature is disconnected and displaced, with many sections downslope from their original alignment. The documented portion spans approximately 10.6 meters long and is oriented northeast to southwest. The sections are fragmented but those that are intact are U-shaped and measure between 90 cm and 75 cm in length, and are 45 cm in width and 30 cm in height. Many of the sections had a trapezoidal protrusion on the sides with a square hole and steel plate that extended into the hole through a small slit. This is likely designed to allow water to flow out of the portable ditch segments into fields or small field ditches.

Figure 78. Plan map SIHP # 50-80-08-5593 Feature 3A, with Feature 4A (access road)

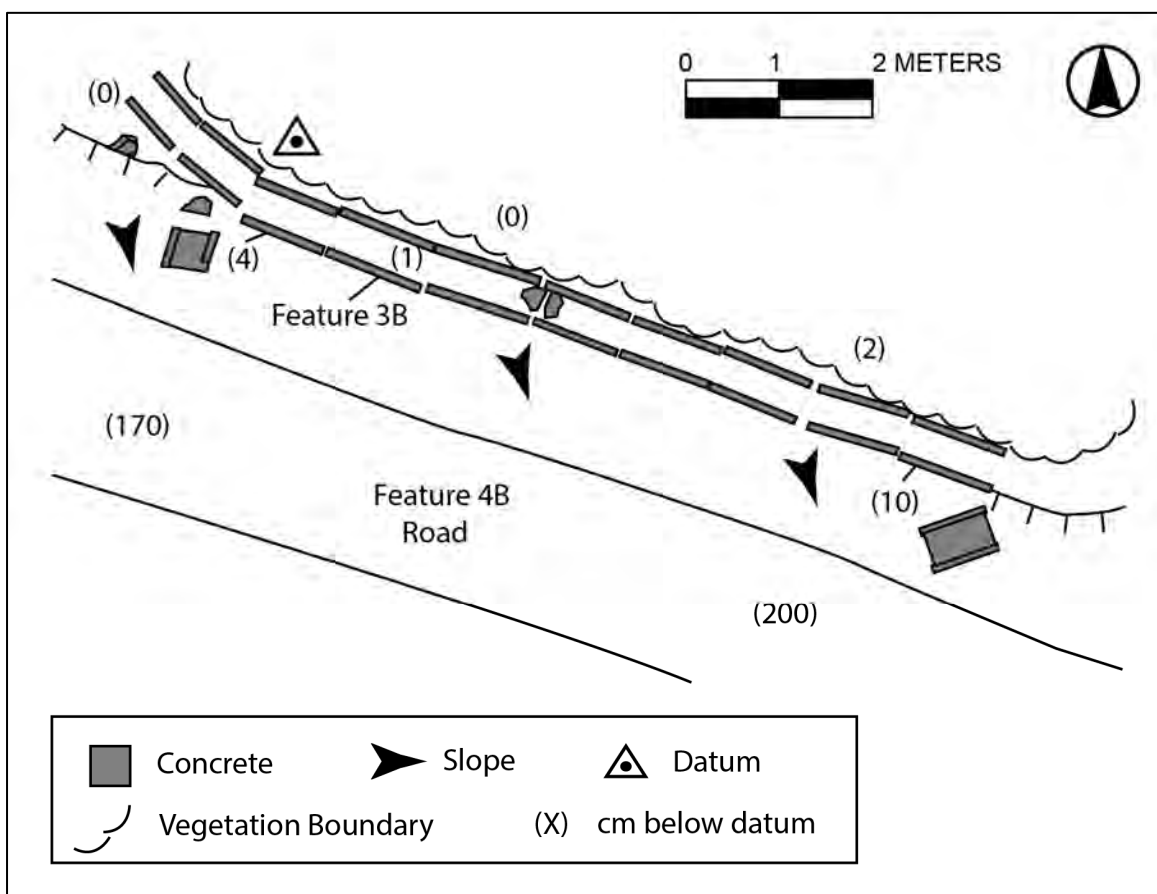
**Feature 3B** consists of the same form and type of concrete U-shaped segments as Feature 3A. Feature 3B is along the north side of SIHP # -5593 Feature 4B on a raised slope at what likely was a field edge (see Figure 38). The feature is approximately 10.5 meters in length and is oriented east to west (Figure 79 and Figure 80). There are 10 somewhat contiguous sections with the east end turning slightly south. One displaced segment is lying just north of the west end near the road (Feature 4B). The downslope side of the feature is eroding.

Figure 80. Plan map SIHP # 50-80-08-5593 Feature 3B, with Feature 4B (access road)

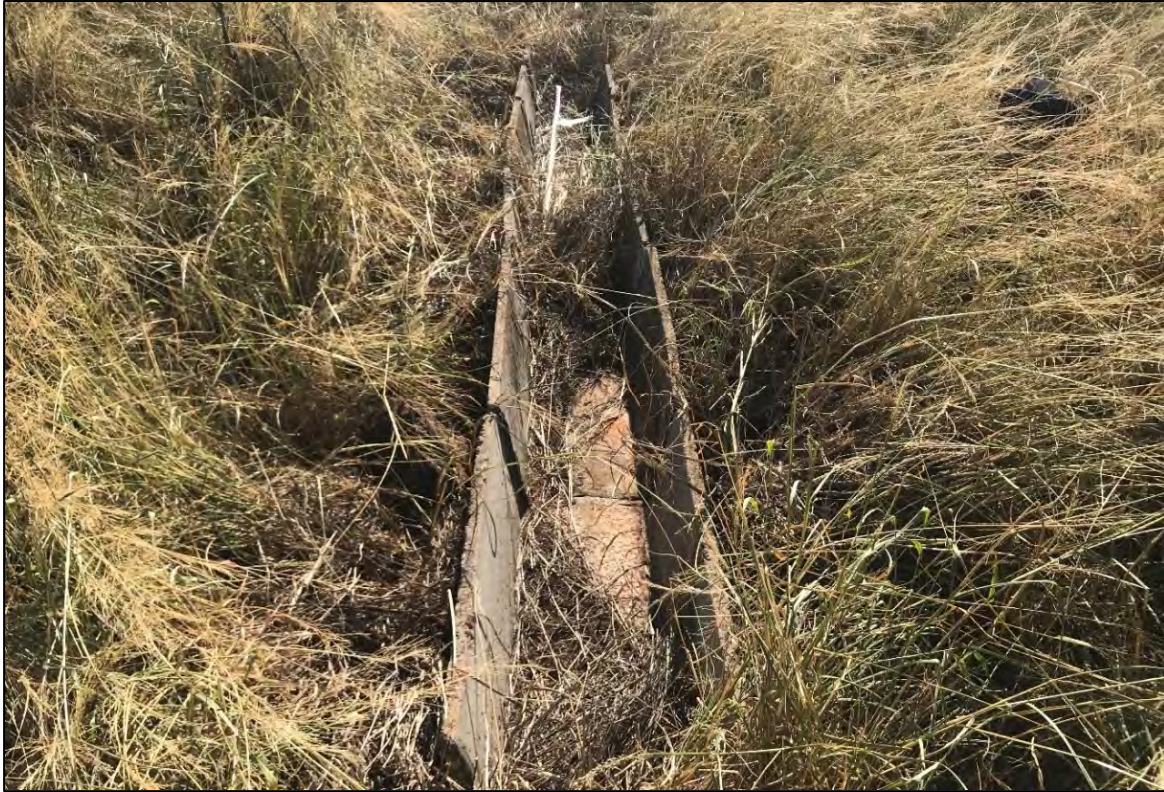
**Feature 3C** consists of another section of concrete U-shaped segments within a former field northeast of SIHP # -2268 Feature J (see Figure 38, Figure 81 and Figure 82). Unlike Feature 3A and 3B, a road was not visible near the feature; However, a possible road, ditch or field boundary is located in the general vicinity on a 1977 aerial photograph (see Figure 22). The feature consists of mostly intact and congruous sections that measure 21 m in length, with each segment measuring between 75 and 90 cm in length, and 45 cm in width and 30 cm in height.

Figure 81. Overview of SIHP # 50-80-08-5593 Feature 3C, view to southeast

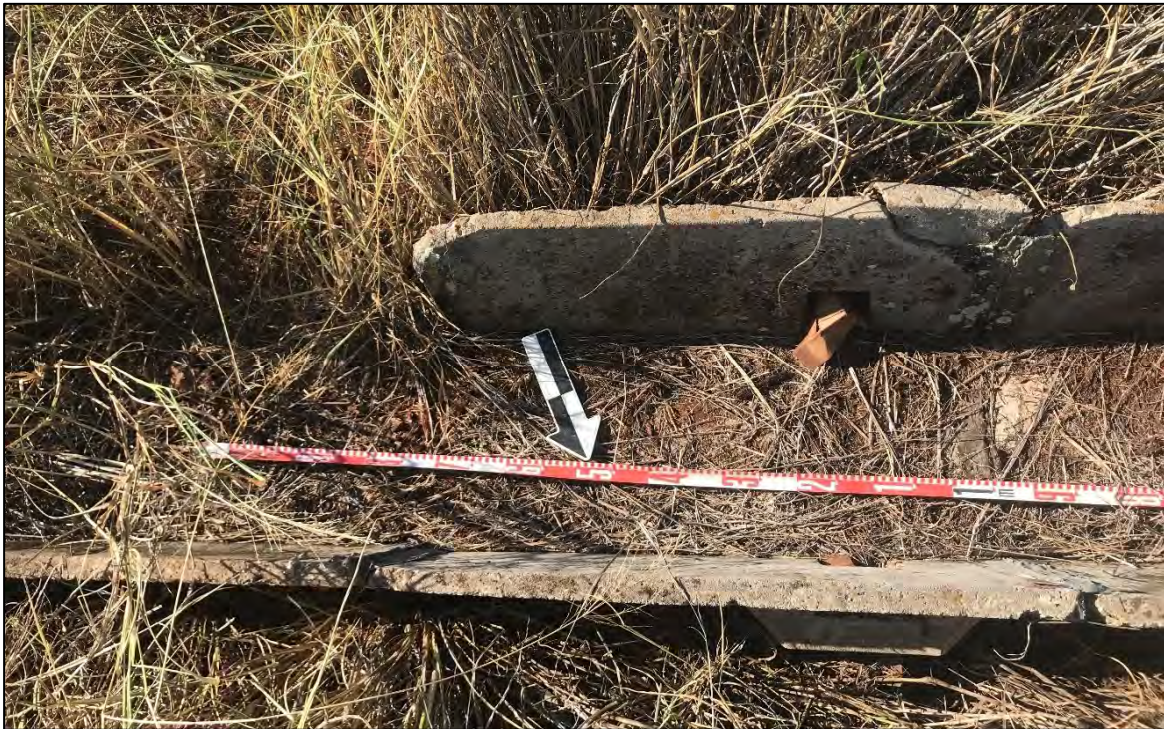
Figure 82. Plan view of SIHP # 50-80-08-5593 Feature 3C
