### **SIHP # 50-80-09-2270: Roads and Railroad Rights-of-Way**

FORMAL SITE TYPE:	Roads and Railroad Rights-of-Way
NO. OF FEATURES:	28 (in the project area) <sup>11</sup>
DIMENSIONS:	See Table 4 for individual feature dimensions
CONDITION ABOVE GROUND:	Varies from Good to Poor
FUNCTIONAL INTERPRETATION:	Transport of Crops, Materials & People
AGE INTERPRETATION:	Historic Period— Early to Middle 20 <sup>th</sup> Century

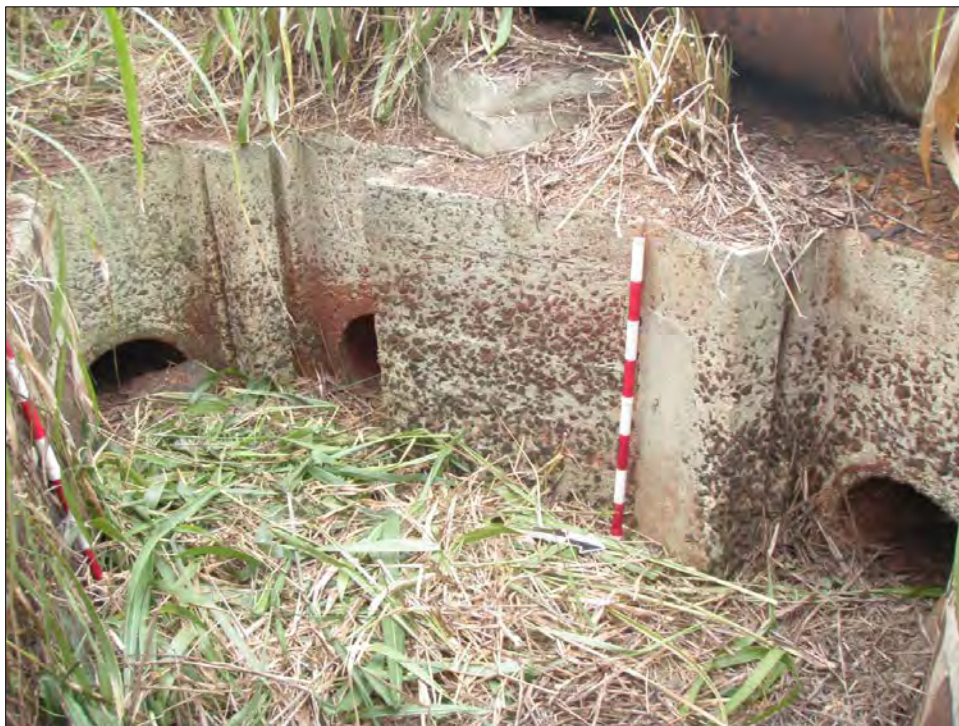
**Figure 16. Main basin at Feature 1, Site 2273, showing large hand-operated valves (intact at left, ruined at right); view southwest; basalt and mortar walls are 107-108 cm high**

earthen ditch to the north (upslope). A smaller basin is located on the east side of Feature 1. This, too, grades into an earthen ditch to the north (upslope). Feature 1 occupies an overall area of approximately 10.0 m (NE/SW) by 7.5 m (NW/SE). The main basin is approximately 6.0 m long, 4.0 m wide and 1.0 m deep. The smaller basin to the east is approximately 12.0 m long, 2.0 m wide and 75–85 cm deep. This feature is a relatively complex water-distribution device with connections to at least two upslope siphons, another downslope siphon (the one that is buried on the south side), and two earthen catchment ditches on the upslope side. Most of this feature is in good physical condition.

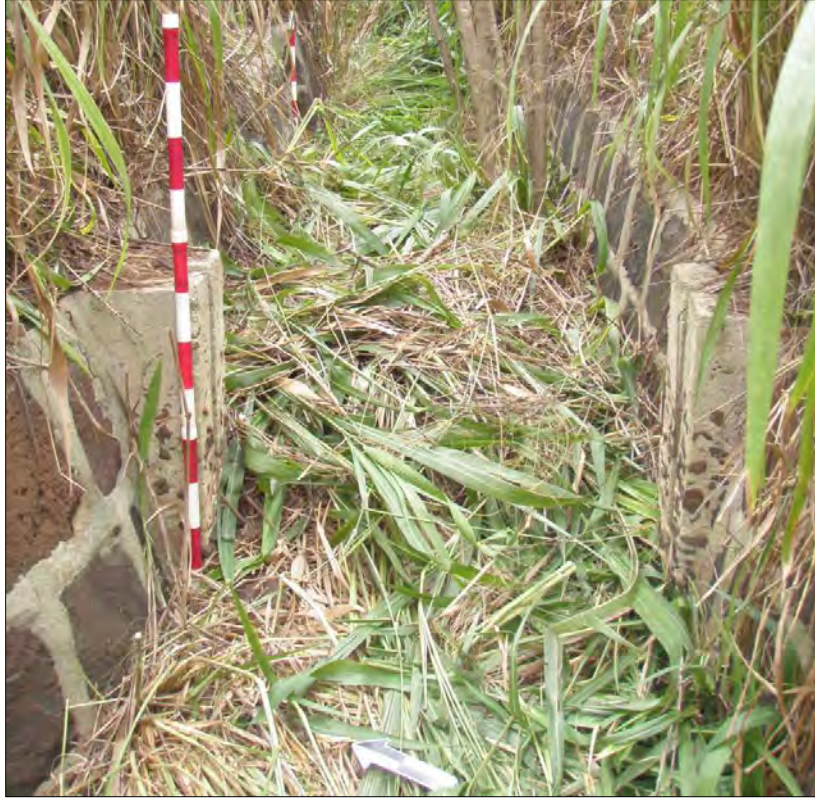
**Figure 17. Smaller water-distribution basin, east side of Feature 1, Site 2273; view west-southwest; scale bar to the right is 80 cm high; portion of siphon (Feature 2, Site 2273) is visible at top of image**

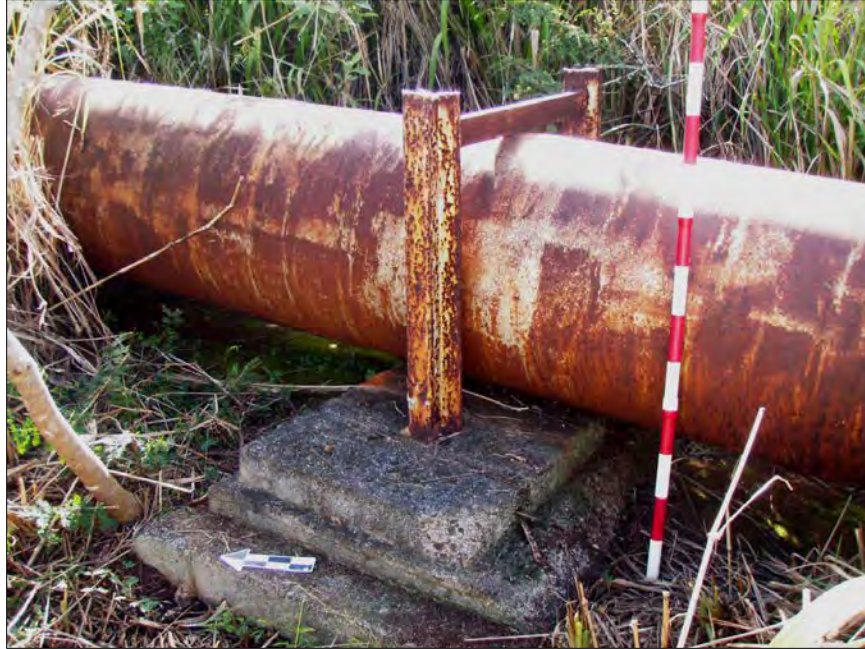
**Figure 19. Feature 2, Sub-feature A, Site 2273, showing concrete pad and metal brackets, east side of road, view east; scale bar marked in 10-cm increments; top of siphon is 90 cm above ground surface**

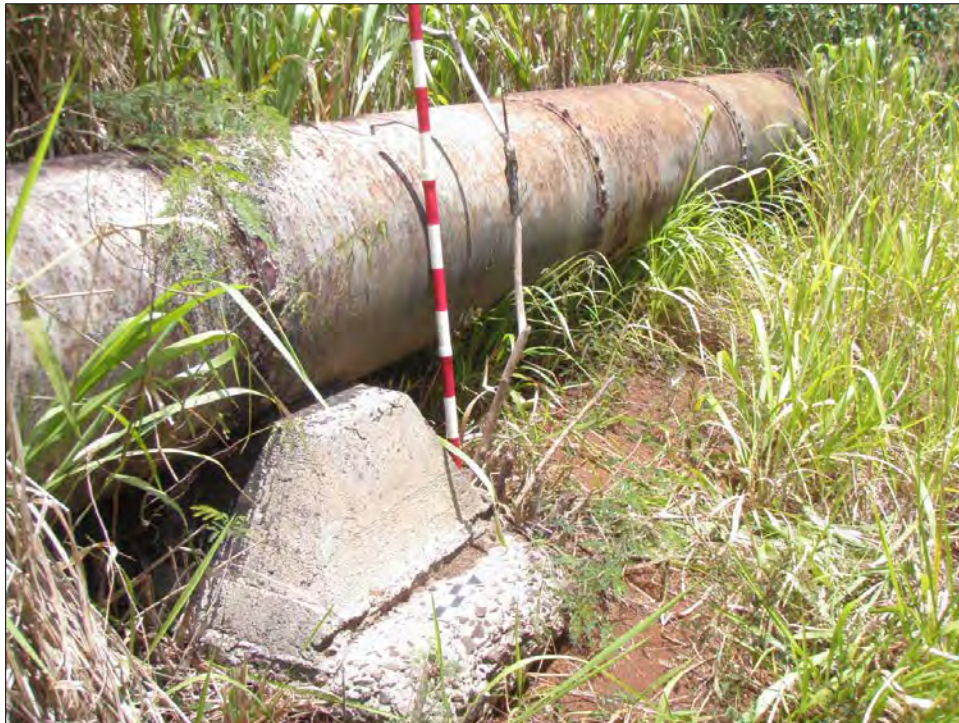
**Figure 20. Feature 2, Sub-feature A, Site 2273, showing concrete pad without ferrous-metal brackets, west side of the road, view north-northwest; scale bar marked in 10-cm increments; top of siphon is 90 cm above ground surface**

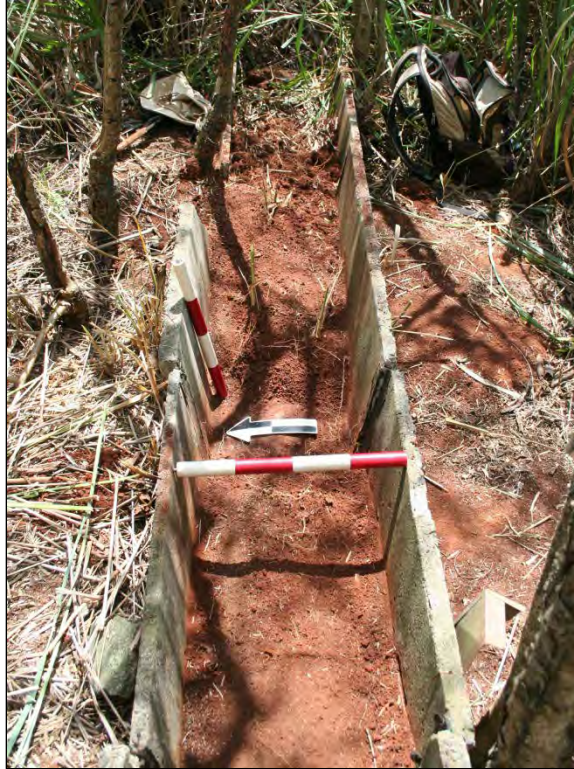
**Feature 5** is a short section of prefabricated flume oriented across the slope (NE/SW) on the south side of a mauka-makai earthen road (Feature 10, Site 2270) leading to the area around Reservoir 3 (Figure 25). The flume is identical to Feature 4 in terms of its constituent materials and cross-section dimensions; it is constructed of cast concrete sections with a flared, U-shaped cross section. The individual sections are held together by metal clips and sealed with caulking. The side openings (small sluice gates) could be closed by sliding down a piece of fitted sheet metal into the slotted opening. The overall length of this feature is 20.5 m. This feature is in fair physical condition. According to Goodman and Nees (1991), this type of above-ground flume was portable, capable of being moved around the plateau lands to distribute water through its small sluice gates. Feature 5 is complete on its west end, which is a constructed opening where water collected into the flume to head east; its east end, however, is broken and incomplete, possibly having been bulldozed to make way for an earthen road into what was once a military storage area to the south. The earthen road can no longer be identified on the ground, but historic maps from the 1930s and 40s indicate its previous presence in this general area.

**Figure 25. Representative section of Feature 5, Site 2273, view east; scale bars marked in 10-cm increments**

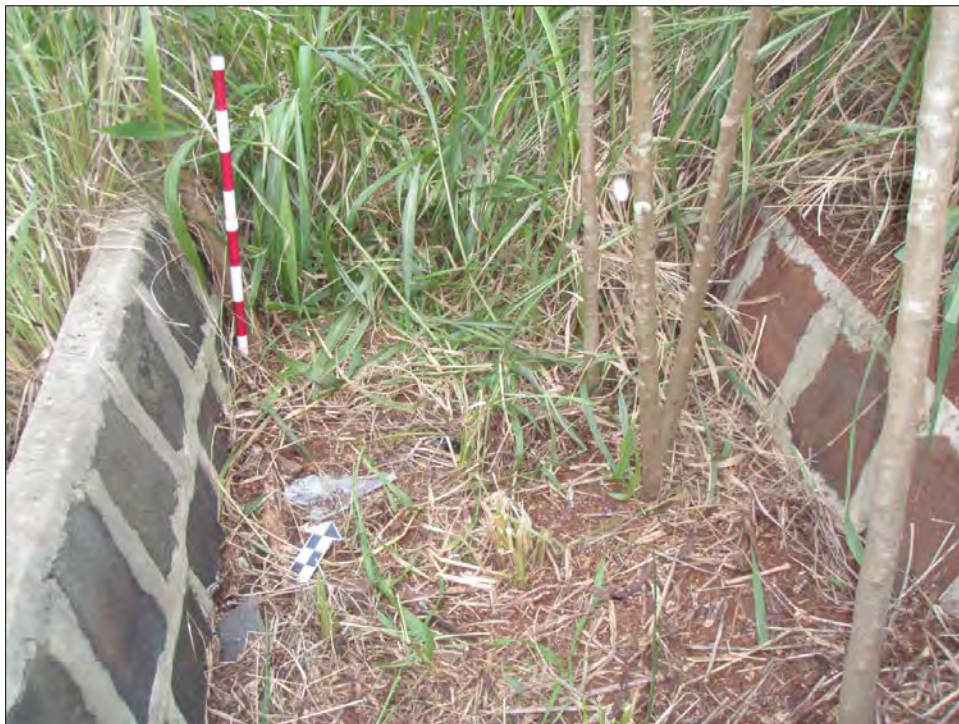
**Feature 8** is another cross-slope ditch with cut basalt and mortar sides and a constructed cut basalt and mortar base on the west side of the main road (Feature 1, Site 2270) (Figure 28). On its west end, according to historic maps from the 1930s, Feature 8 originally started at the south end of Reservoir 2; the ditch at this west end is visible but partially buried under modern sediment. The east end of the ditch intersects with a ruined section of the top (upslope end) of siphon pipe Feature 3, where a hand-operated siphon valve (manufacturer's stamp includes the word "CRANE") similar to those at Feature 1 is located (Figure 29 and Figure 30) in a bulldozed context. This entire area east of ditch Feature 8 is disturbed by modern road maintenance. Paralleling this ditch on its upslope (north) side is another earthen road (Feature 3, Site 2270). The interior dimensions of the ditch are 135 cm wide at the base flaring up to 145 cm wide at the top. The depth of this ditch is currently 50 cm, but it was originally approximately 1.0 m deep. Currently, the overall length of the extant portion of this ditch is approximately 330 m.

**Figure 28. Representative section of cross-slope cut basalt and mortar ditch, Feature 8, Site 2273; view north; vertical scale bar in the base of the ditch is 80 cm long**

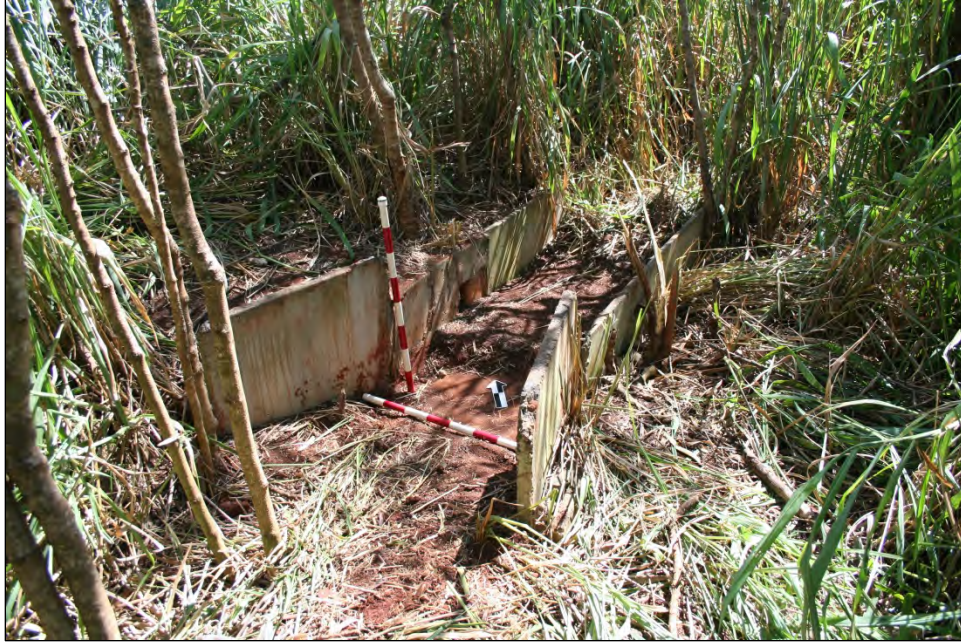
**Feature 9** is a 5-m long section of prefabricated flume on the south side of road Feature 10 (Site 2270) leading to Reservoir 3. Feature 9 is similar to Feature 5 in terms of its orientation (NE/SW) and position on the landscape, but the two flumes are distinct from each other. Feature 9 is wider than the others described above (Features 4 and 5), but it is otherwise identical to them in terms of its constituent materials and design. Not including its west end, which is the widest part of this feature, its base is 60 cm (interior) to 70 cm (exterior) wide. At the top, its width is 76 cm (exterior) and 66 cm (interior) (Figure 31). Feature 9, which is in fair physical condition, is complete on its west end, a constructed (flared) opening designed to capture surface water; its east end, however, is broken and incomplete.

**Figure 31. Feature 9, Site 2273, view northeast; scale bars marked in 10-cm increments**

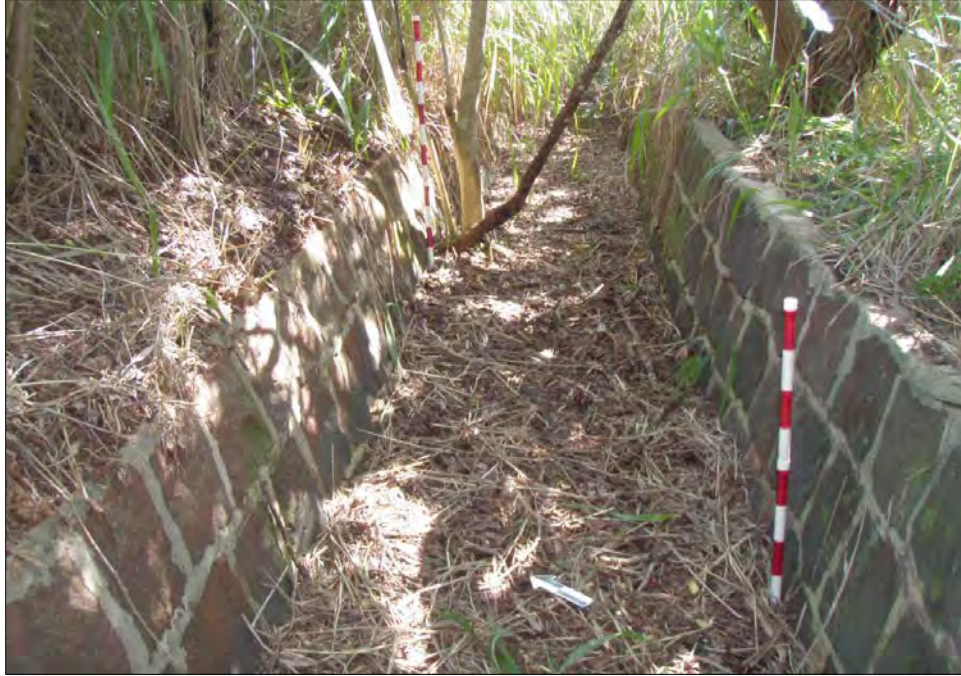
Sub-feature A, the main ditch, is oriented across the slope (E/W), starting from Reservoir 1-A in the east and exiting the project area in the west, a distance of approximately 1.5 km. Its eastern half follows along upslope (north) of Gulch B. When in operation, this ditch was fed by Reservoir 1-A. Its maximum exterior width is 185 cm; the interior top of the feature measures 160 cm across; the interior base is 130 cm wide (Figure 35). Depending on the amount of post-abandonment sedimentary deposition within the ditch, its interior height ranges from 60–80 cm. Its depth was originally approximately 1.0 m.

**Figure 35. Representative section of Feature 13, Sub-feature A, Site 2273, view northeast; vertical scale bar in foreground is 80 cm high**

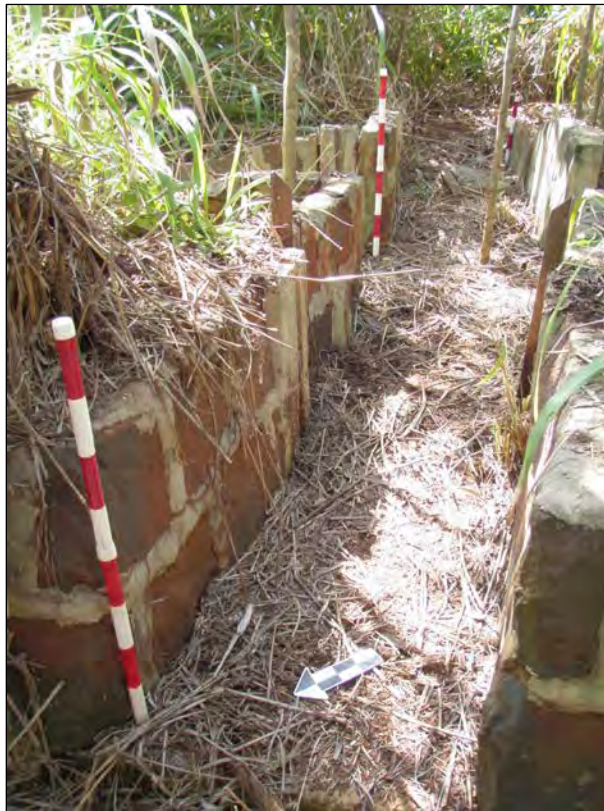
Sub-feature B, a cut basalt and mortar sluice gate (Figure 36 and Figure 37), extends to the southeast approximately 5.0 m and has three separate openings to the northeast, southeast and south. The northeast opening, which has metal brackets framing its sluice gate grooves, appears to have served as a water intake (rather than an outlet) from an earthen ditch just upslope feeding into it. The southeast opening and the south opening, which is the only one with no formal sluice gate grooves or structures, appear to be outlets that send water over the ground surface. Sub-feature B is approximately 65 cm wide and high.

**Figure 36. Feature 13, Sub-feature B, Site 2273, view southeast; constructed sluice gate oriented to the southeast off the main ditch (Sub-feature A), foreground; scale bar is 80 cm high**

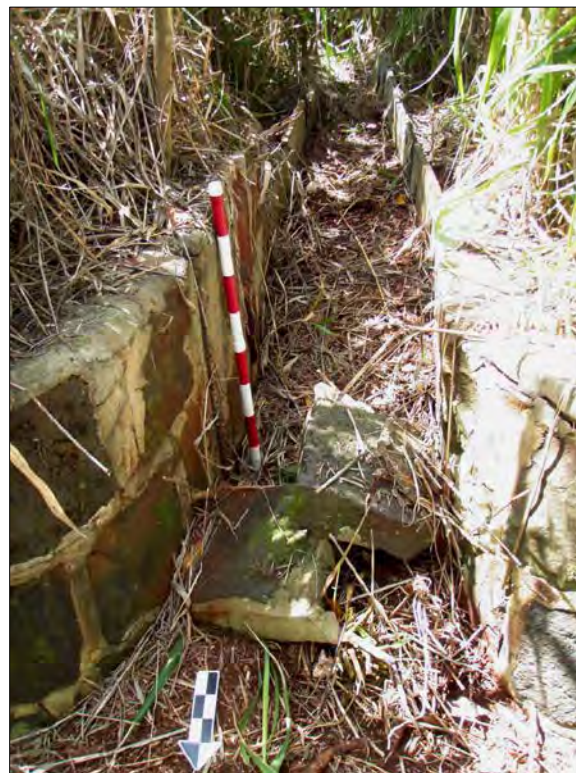
Sub-feature C, another cut basalt and mortar sluice gate (Figure 38), changes into a prefabricated concrete flume (a later modification) as it heads south for another 4.0 m. From the main ditch (Sub-feature A) to the end of the flume, Sub-feature C is approximately 7.5 m long, 55–60 cm wide and 70–75 cm high.

Figure 38. Feature 13, Sub-feature C, Site 2273, view south; sluice gate grooves are in front of scale bar; scale bar is 80 cm high; note, prefabricated concrete flume in background

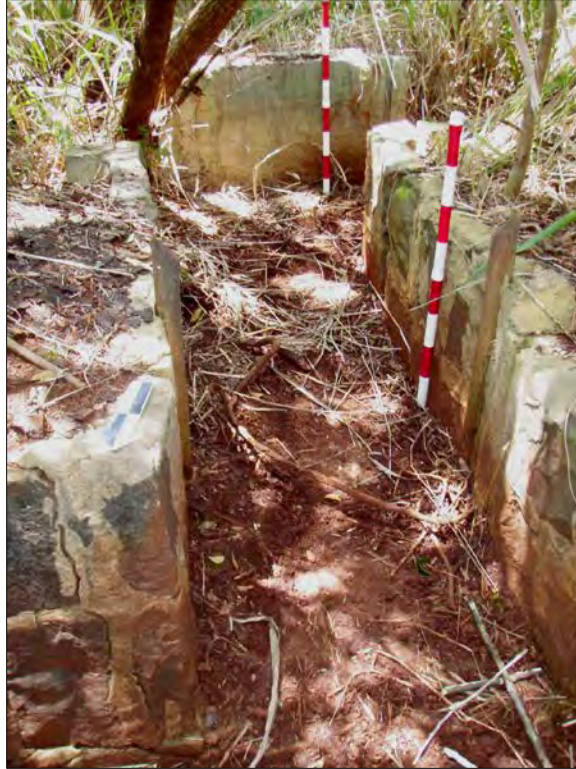
Sub-feature D, another constructed sluice gate opening, shows a more complex design where the diversion channel heads south into a short deflection wall/ T-shaped intersection that distributes water in both east and west directions (Figure 39). From the main ditch (Sub-feature A) to the end of the flume, Sub-feature D is approximately 5.5 m long, 55–60 cm wide and 50–55 cm high.

**Figure 39. Feature 13, Sub-feature D, Site 2273, view south; sluice gate grooves are in front of the foreground scale bar; cut basalt and mortar opening leads into a short deflection wall/ T-shaped intersection (background); scale bars are 80 cm high**

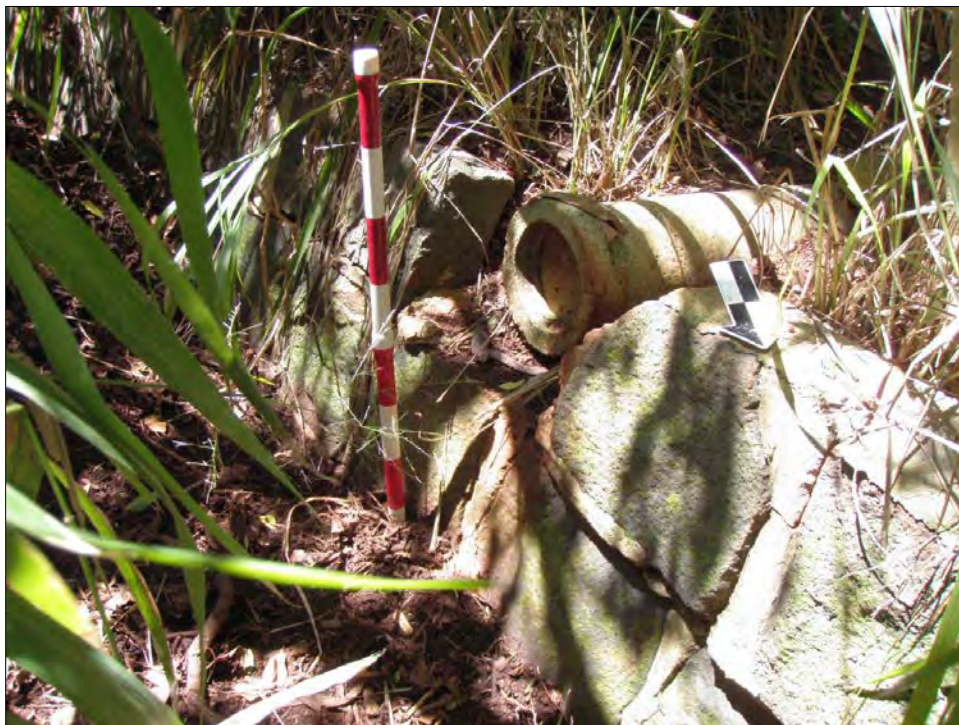
Sub-feature E, yet another sluice gate variation, interpreted as a later modification to the ditch's original structure (Figure 40), shows a concrete pipe (20-cm diameter) placed into an opening along the top of the cut basalt and mortar wall. Sheet metal was fitted into a slot at the end of the pipe, which distributes water to the downslope side. The concrete pipe is approximately 2.0 m long.

**Figure 40. Feature 13, Sub-feature E, Site 2273, view south; concrete pipe with a sheet metal sluice gate through its end, placed into opening along the top of ditch; scale bar is 80 cm high**

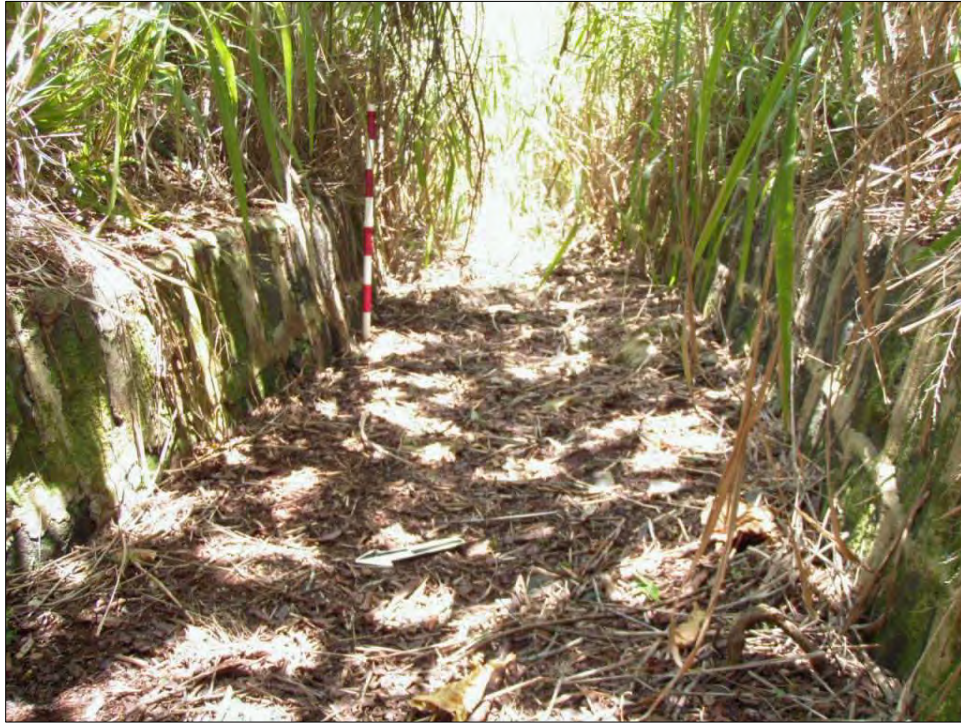
Sub-feature A, the main ditch, is oriented (like Feature 13, which is just upslope) generally east to west across the project area, starting from Reservoir 1-A in the east and eventually exiting the project area in the west. Unlike Feature 13, the east end of Feature 14 is more complex as it makes one large “switch back” between Reservoir 1-A and Reservoir 1-B. The eastern portion of Feature 14, from the south end of Reservoir 1-A, then passing by the east side of Reservoir 1-B, eventually meets up with a mauka-makai oriented irrigation ditch (Feature 17) heading down to Reservoir 3. The west end of Feature 14, as it nears the project area boundary, disappears and may be buried under sedimentary deposition. The entire length of Feature 14, as can be currently identified on the landscape, is approximately 3.4 km (0.8 km on the west side of road Feature 6, and 2.6 km on the east side of this road). Portions of Feature 14 follow along parts of the upper (north) edge of Gulch B. When in operation, the Feature 14 ditch connected with both Reservoir 1-A and Reservoir 1-B. Its maximum exterior width is 185 cm; the interior top of the feature measures 160 cm across; the interior base is 130 cm wide. Depending on the amount of post-abandonment sedimentary deposition within the ditch, its interior height ranges from 60–80 cm. Its depth was originally approximately 1.0 m (Figure 41). Other than being partially buried by sediment in some places, this sub-feature is generally in good physical condition.

**Figure 41. Representative section of Feature 14, Sub-feature A, Site 2273; view southeast; scale bar is 80 cm high**

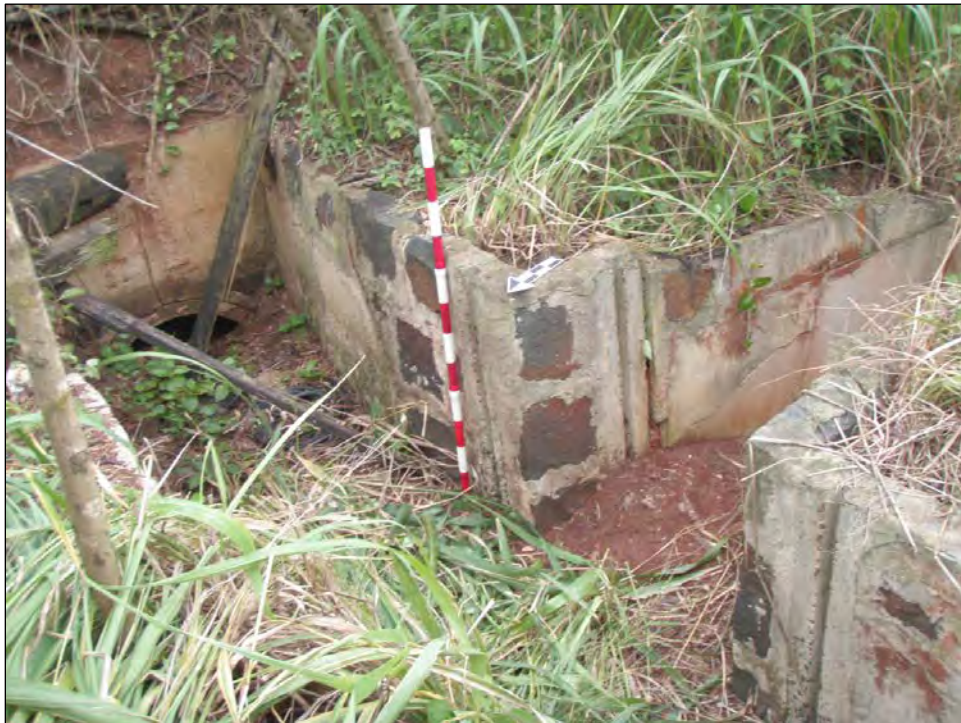
Sub-feature B is a culvert under the road Feature 6 (Site 2270) and a cut basalt and mortar sluice gate on the south side of the main ditch (Figure 42). The 80-cm (diameter) concrete pipe underneath the road is nearly completely filled in with sediment. The constructed sluice gate heading south extends for approximately 3.0 m then transitions into an earthen ditch. Both the formal sluice gate and the earthen ditch parallel the road (Feature 6, Site 2270). From the main ditch (Sub-feature A) to the end of the cut basalt and mortar sluice gate, Sub-feature B is approximately 3.0 m long, 65–70 cm wide and 80–85 cm high. This sub-feature is in good physical condition. A pair of sluice-gate grooves are located on either side of the north end of the Sub-feature B sluice gate, and the main ditch (Sub-feature A) also has a set of sluice-gate grooves on either side of the opening to the sluice gate.

**Figure 42. Feature 14, Sub-feature B, Site 2273, view southeast; culvert under road Feature 6 (Site 2270) is to the left, downslope sluice gate (paralleling the road) is to the right; main ditch (Sub-feature A) continues to the west (lower right in this image); scale bar is 120 cm high**

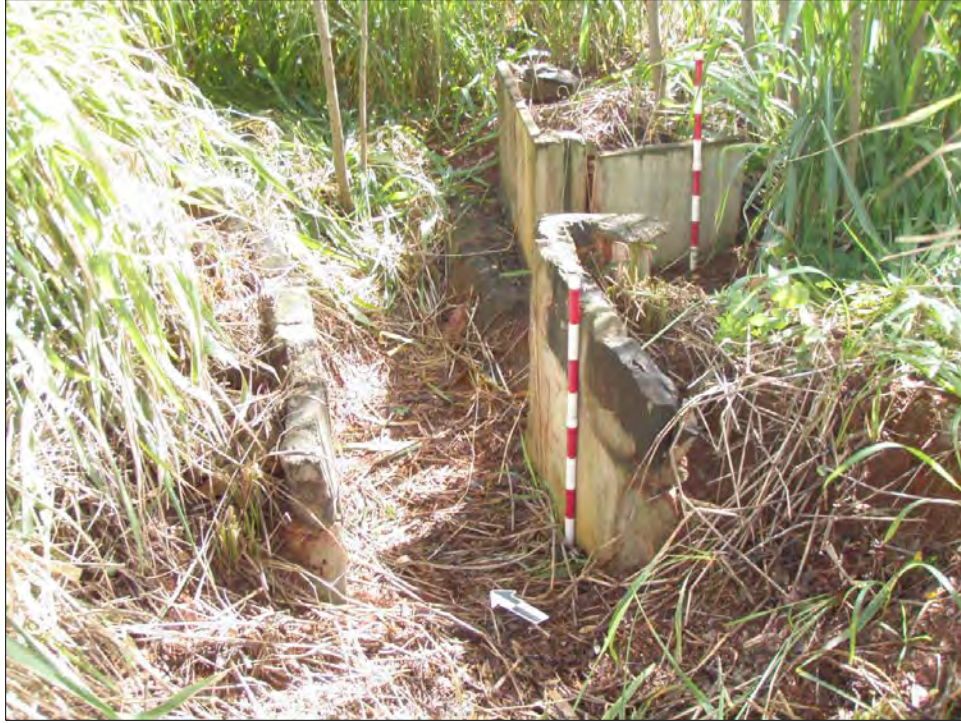
**Feature 15**, an earthen ditch on the north side of a modern (non-historic) earthen road ending at a 4-way sluice structure, consists of two sub-features. Sub-feature A, an approximately 47.0-m long earthen ditch oriented mauka-makai (NE/SW), is 1.0 m wide and 50–75 cm deep. Sub-feature B, a 4-way sluice intersection at the south end of the ditch (Figure 46), is built of concrete slabs with some cut basalt and mortar; it occupies an area of 3.0 m (N/S) by 2.0 m (E/W). Its maximum height is 50–75 cm. In addition to the ditch on the north side of Sub-feature B, shallow earthen channels emanate from its other three sides. The channel to the south-southwest extends only a few meters. To the east and west of Sub-feature B, the channels are shallow and filled with sediment. Because the ditch and channels contain no structural rock work, and due to soil erosion and vegetation growth, it is difficult to determine their original dimensions. Sub-feature B is in poor physical condition.

**Figure 46. Feature 15, Site 2273, 4-way sluice structure built of both cut basalt and mortar and concrete; view northeast; scale bar in foreground is 80 cm high**

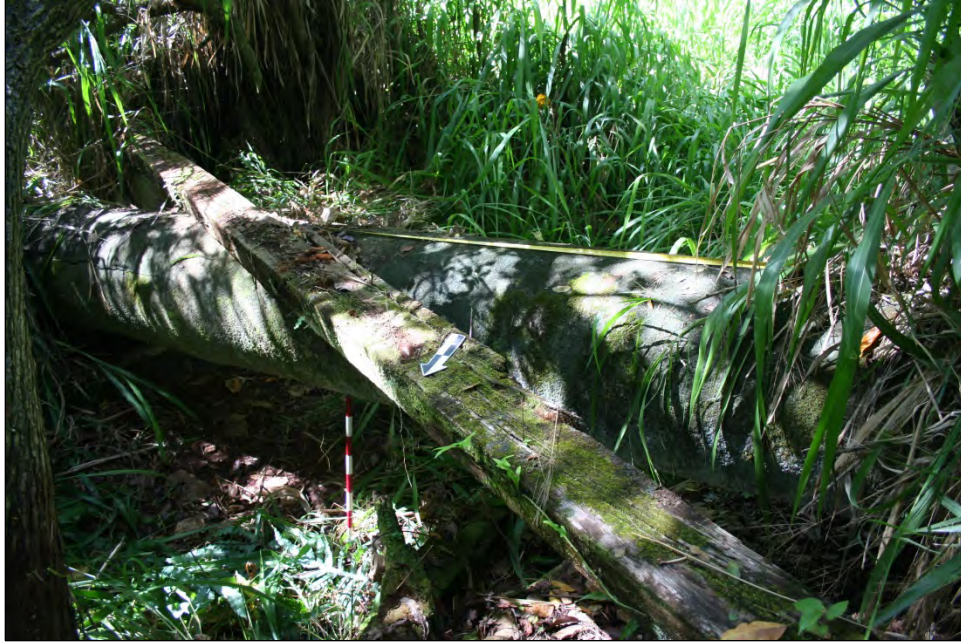
Sub-feature B, a siphon oriented east to west, is approximately 300 m long. It is in poor to fair physical condition with damage from flooding in Gulch A. Figure 47, a plan view of a representative section of the siphon where it crosses the drainage bottom, illustrates some of its design features. The ferrous-metal siphon (80-cm diameter), riveted together in sections, was sealed and weatherized with an outer layer of concrete (Figure 48 and Figure 49). The top of the siphon is 170 cm above the ground surface; its bottom is 80 cm above the ground surface. A pair of wooden railroad ties and smaller lumber once nailed together served as a foot bridge across the drainage. The top of the railroad ties, one of which rests atop the siphon, is 190 cm above the ground surface. The drainage channel passing under the siphon was formalized and stabilized with low cut basalt and mortar sides. This ditch, which measures 6.0 m (N/S) by 1.0 m (E/W) by 0.30 m deep, was built to ensure the meandering gulch channel did not undermine the siphon. Four, small concrete footings were placed to support the siphon across the drainage. Each of the four footings is approximately 60 cm high. The west end of the siphon enters a concrete culvert that crosses under the adjacent (to the west and upslope) earthen road (Feature 12, Site 2270).

**Figure 48. Portion of Feature 16, Sub-feature B, Site 2273, view south-southeast; scale bar is 80 cm high**

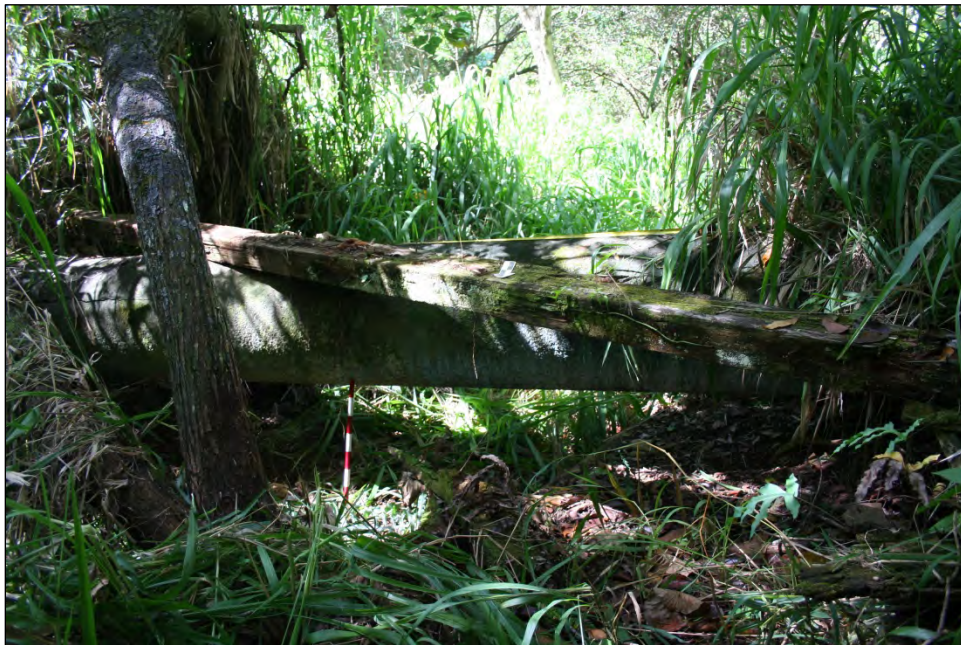
**Figure 49. Another view of a portion of Feature 16, Sub-feature B, Site 2273, view south; same scale as above**

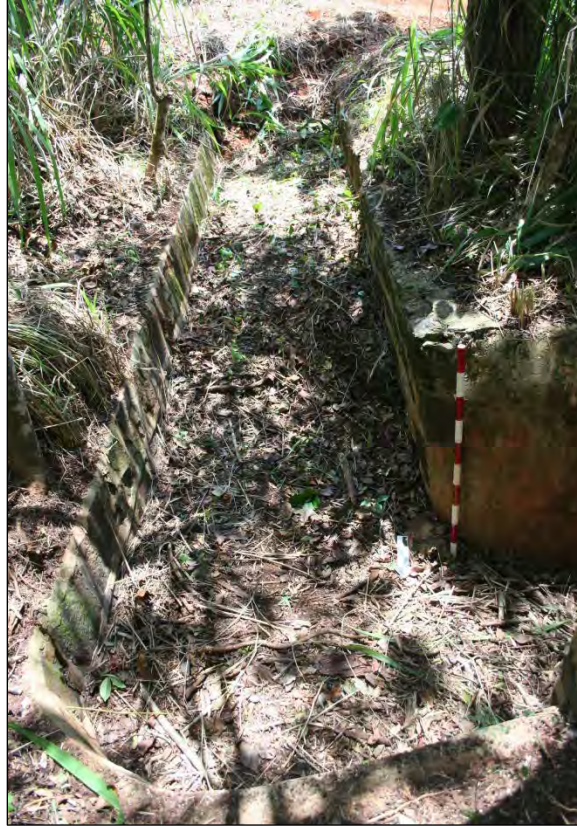
Sub-feature B is a right angle-shaped cut basalt and mortar ditch connecting the main ditch (Sub-feature A) with the east end of Reservoir 1-A (Figure 50 and Figure 51). The south end of this connector, along road Feature 7 (Site 2270), once had a culvert that went under the road; however, any evidence of a culvert has been destroyed or buried by earth movement associated with the remodeling of the old reservoir for flood-control purposes. The connector ditch extends north from the road 6.0 m where it makes a right-angle turn to the left (west) down another 5.0 m into the old reservoir. The height of this feature, measured from within the ditch, varies from only 30–50 cm at the south end to over 110 cm at the west end (entering the reservoir). The N/S portion of Sub-feature B is wider (100 cm) than the E/W portion (70 cm). Part of the north side wall of the west portion has been repaired with standard kiln-fired (red) bricks and mortar. This sub-feature is in good physical condition.

**Figure 50. Feature 17, Sub-feature B, Site 2273, road Feature 7 (Site 2270) is red dirt visible in the background (top of the image); view south; scale bar is 1.0 m high**

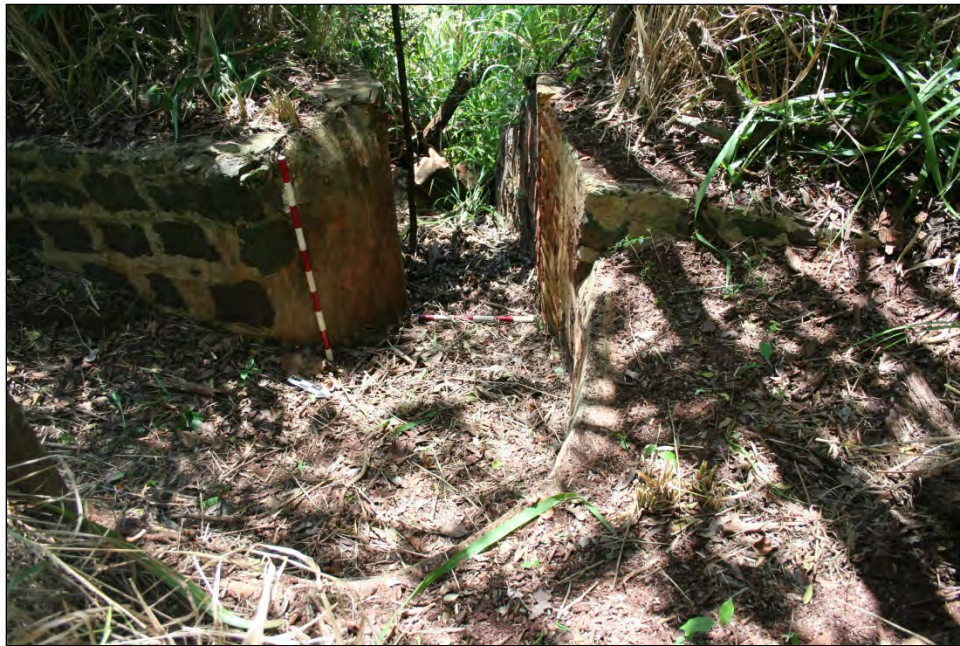
**Figure 51. Another view of Feature 17, Sub-feature B, Site 2273, view west; vertical scale bar is 1.0 m high; water once flowed to the west (background in this view) directly into Reservoir 1-A (tall grass)**

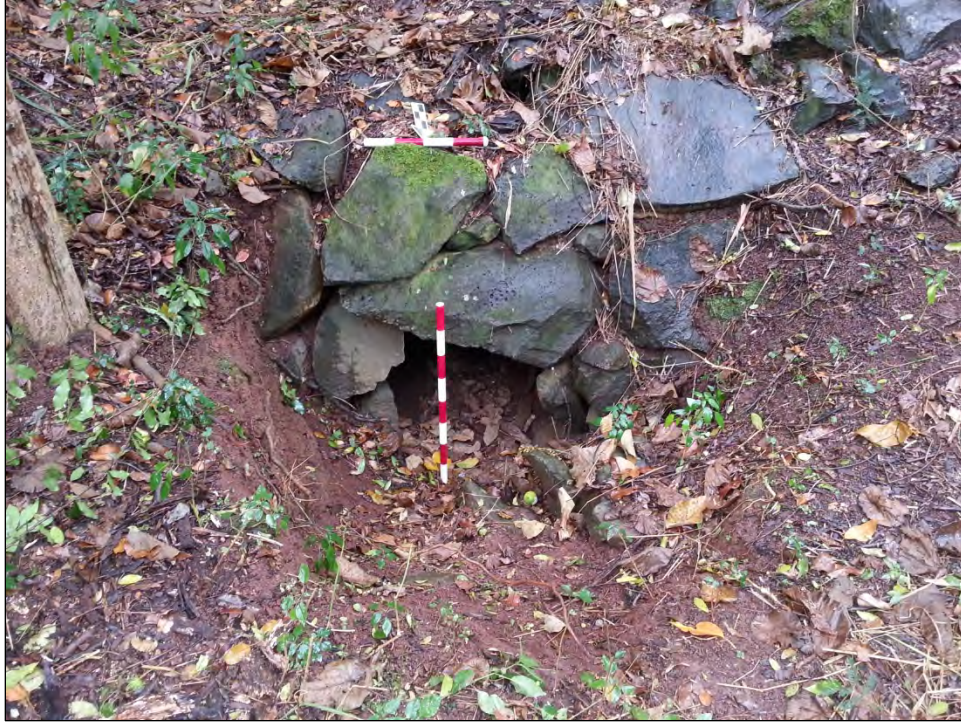
Sub-feature B, a culvert passing under Sub-feature A from north to south, has an intake/ opening constructed of shaped basalt slabs and a water conduit constructed of a ferrous-metal siphon (pipe) measuring 80 cm in diameter and 22.5 m long (N/S) (Figure 60). The opening of the culvert on the north side of Sub-feature A is a semi-circular, earthen depression measuring approximately 150 cm in diameter and 140 cm deep. This was once a water catchment where excess gulch water drained through the culvert to the other side of the retaining structure where it collected in a small earthen pool to be siphoned further down the plateau south of Feature 19.

**Figure 60. Feature 19, Sub-feature B (constructed culvert opening), Site 2273, view south; scale bar is 80 cm high**

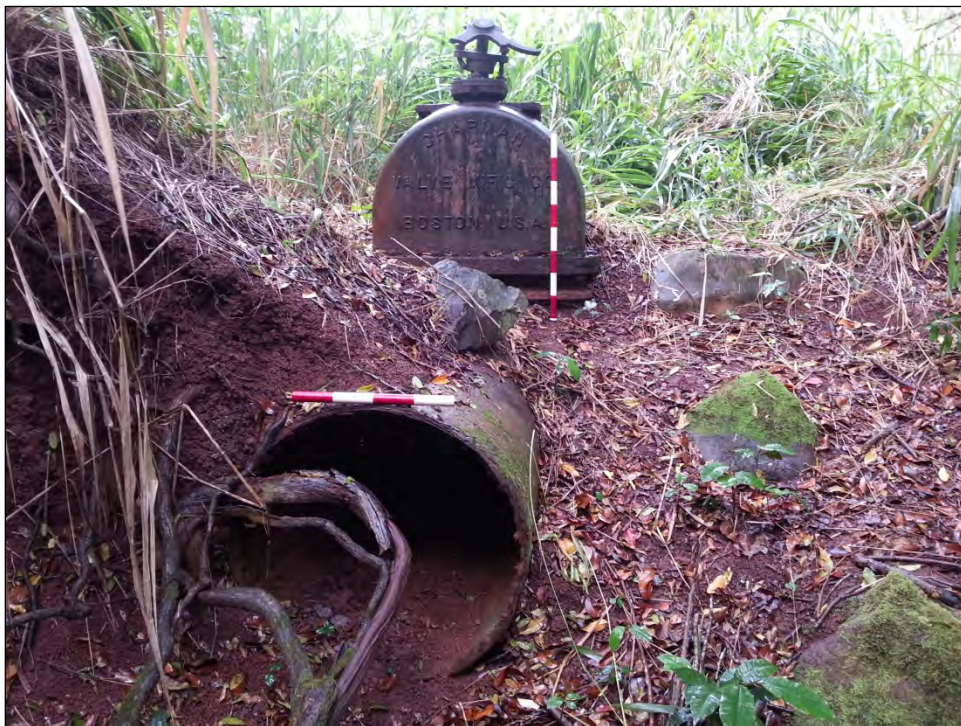
Sub-feature C is a large, hand-operated valve that appears to be made of iron (Figure 61). A manufacturer's stamp on this valve reads as follows: "CHAPMAN VALVE M.F.G. CO., BOSTON, U.S.A." The area between this valve and the back (south) side of Sub-feature A is heavily eroded and channelized. A gently-sloping, partially level soil area immediately west of this valve appears to be the remnants of an old bulldozed access road. The area in and around this possible road is heavily eroded and difficult to definitively describe. We did not find the other (south) end of the siphon that goes through this valve; we presume its other end is buried downslope under modern sedimentary deposition in heavy vegetation.

**Figure 61. Feature 19, Sub-feature C, Site 2273, view south; vertical scale bar is 80 cm high**

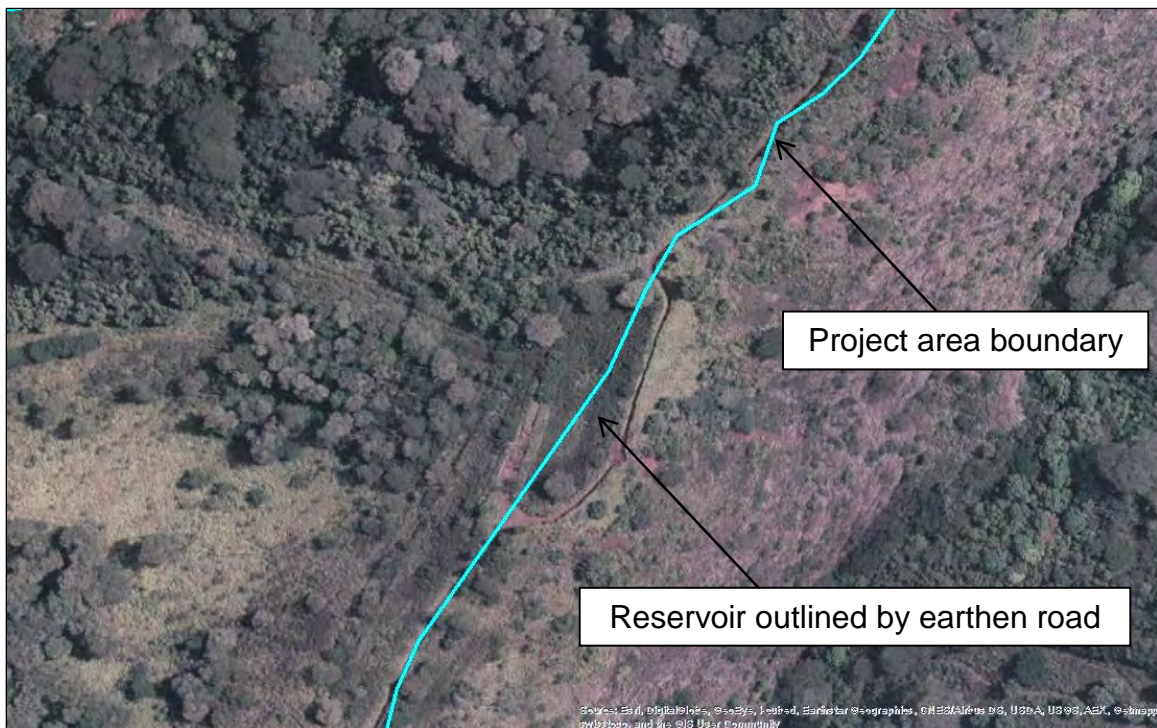
**Feature 21** is an abandoned (now empty) reservoir, labelled Reservoir 2-B on historic maps from the 1930s, in the northeast corner of the project area on the ridge separating Gulch A from the Waiawa Stream (which is out of the project area to the east) (Figure 63). The reservoir measures approximately 110 m (N/S) by 30 m (E/S) by 2.0 m (depth). It is roughly rectangular/ oval in plan view; its long axis is oriented NNE/SSW. Road Feature 1 (Site 2270) circumscribes this reservoir as a kind of loop road. Feature 21 is the only reservoir in the project area formally defined on all sides by constructed material (rather than natural sediment): it is sealed around its edges (similar to a swimming pool) with concrete. Its bottom is level sediment with no constructed material. The project area boundary bisects this feature such that its eastern half is actually out of the project area.

Figure 63. Feature 21, Site 2273 (Reservoir 2-B) on ESRI aerial image showing project area boundary; image is oriented with true north straight up (see text for feature dimensions and description)

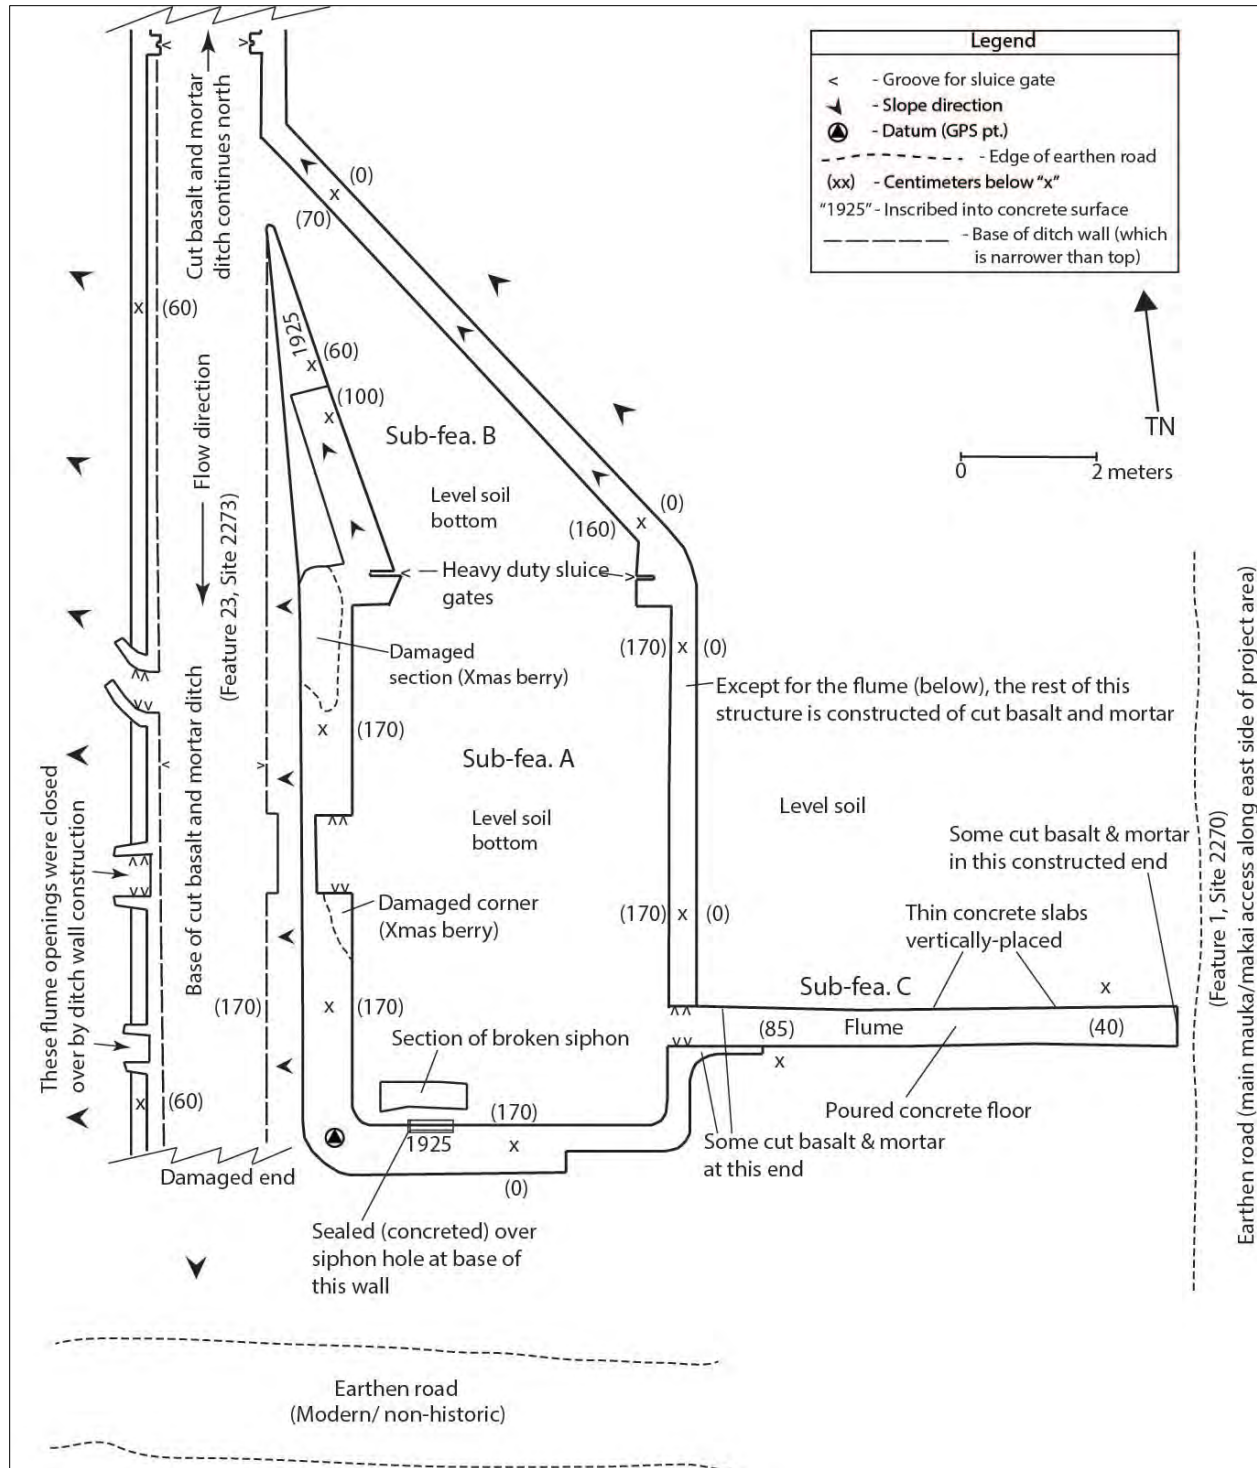
Figure 64. Plan view Feature 22, Site 2273

**Feature 22** is a large, formally-constructed water-distribution and -retention basin built of cut basalt and mortar in the northeast corner of the project area, on the elevated plateau east of the drop off into Gulch A and west of a mauka-makai earthen road (Feature 1, Site 2270) (Figure 64). Feature 22 connects with two other major components of the historic-era irrigation system: (1) a cut basalt and mortar ditch (Feature 23) oriented north to south; and (2) a siphon (Feature 2) oriented north to south that traverses nearly the entire east side of the project area. Feature 22 is inscribed with the date “1925,” and represents one of the earliest large-scale components put in place to irrigate the project area for commercial sugarcane following the completion of the Waiāhole Ditch in 1916. Feature 22 consists of three sub-features, and occupies a maximum area of 16.0 m (N/S) by 13.0 m (E/W). Feature 22 is in good physical condition, exception for a few areas of minor damage by vegetation growth. Other than California grass and koa haole, vegetation at this feature includes several large Christmas berry trees.

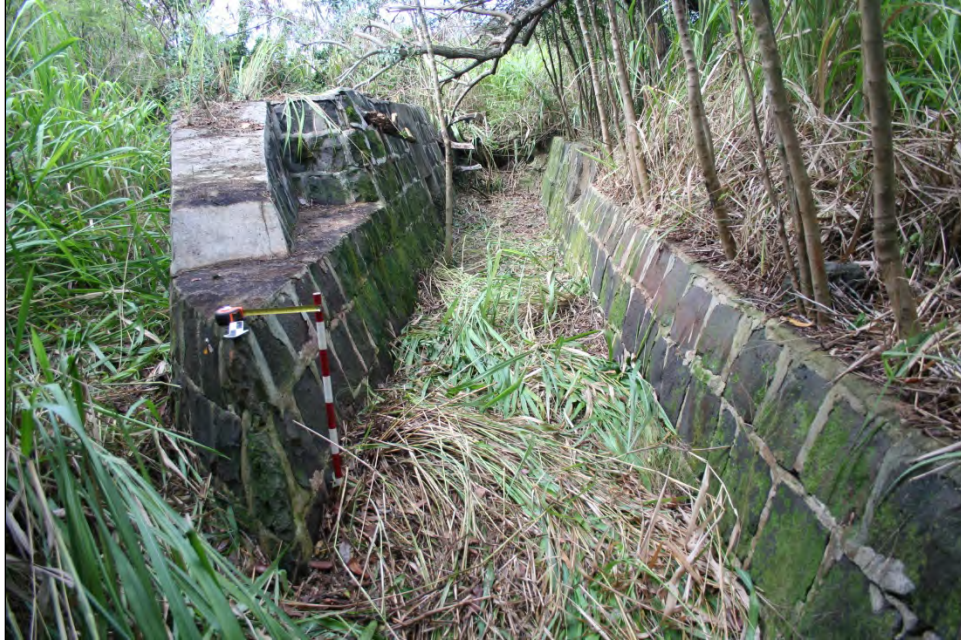
Sub-feature A, a rectangular cut basalt and mortar basin measuring 9.0 m (N/S) by 6.0 m (E/W), is connected with a section of flume (Sub-feature C) on its east side and Feature 23—a cut basalt and mortar ditch oriented north to south—on its west side (Figure 65). The height of this sub-feature’s walls is 170 cm above the ground surface. On its east and southeast sides, the wall face is vertical (plumb) and 40 cm thick. The wall flares (tapers out at the base) on the west side, where it is 90 cm thick at the top and 130 cm thick at the base. The southwest wall, where the date “1925” is inscribed in mortar, is 90 cm thick. An old section of displaced ferrous-metal siphon is on the ground surface in the southwest (interior) corner of Sub-feature A, next to an outlet at the base of the wall, now closed up and sealed over with concrete, that once housed the siphon. There is a rectangular sluice-gate opening along the west wall with two sets of sluice-gate grooves (each is 4 cm thick) (Figure 66). These would have controlled water flow between Sub-feature A and the adjacent ditch (Feature 23). Portions of the west wall have been damaged by Christmas berry growth into its constituent rock and mortar. Another set of larger sluice-gate grooves (each is 5 cm thick) is located at the north end of this sub-feature, where Sub-feature B begins.

**Figure 65. Cut basalt and mortar ditch (Feature 23, Site 2273) running parallel to Feature 22 and connecting with it by way of the sluice gate at Sub-feature A and the large opening to the left (tall grass) into Sub-feature B, view south; vertical scale bar is 80**
