### **SIHP # 50-80-09-2270: Roads and Railroad Rights-of-Way**

FORMAL SITE TYPE:	Roads and Railroad Rights-of-Way
NO. OF FEATURES:	28 (in the project area) <sup>11</sup>
DIMENSIONS:	See Table 4 for individual feature dimensions
CONDITION ABOVE GROUND:	Varies from Good to Poor
FUNCTIONAL INTERPRETATION:	Transport of Crops, Materials & People
AGE INTERPRETATION:	Historic Period— Early to Middle 20 <sup>th</sup> Century

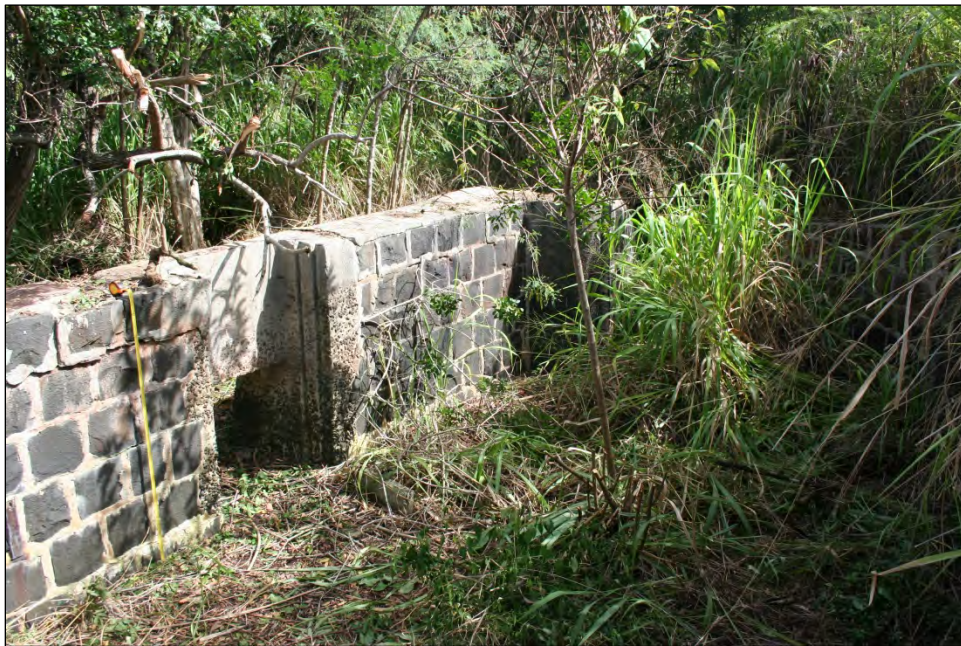
**Figure 66. Portion of the west wall, Feature 22, Sub-feature A, Site 2273, view northwest; measuring tape is 170 cm high**

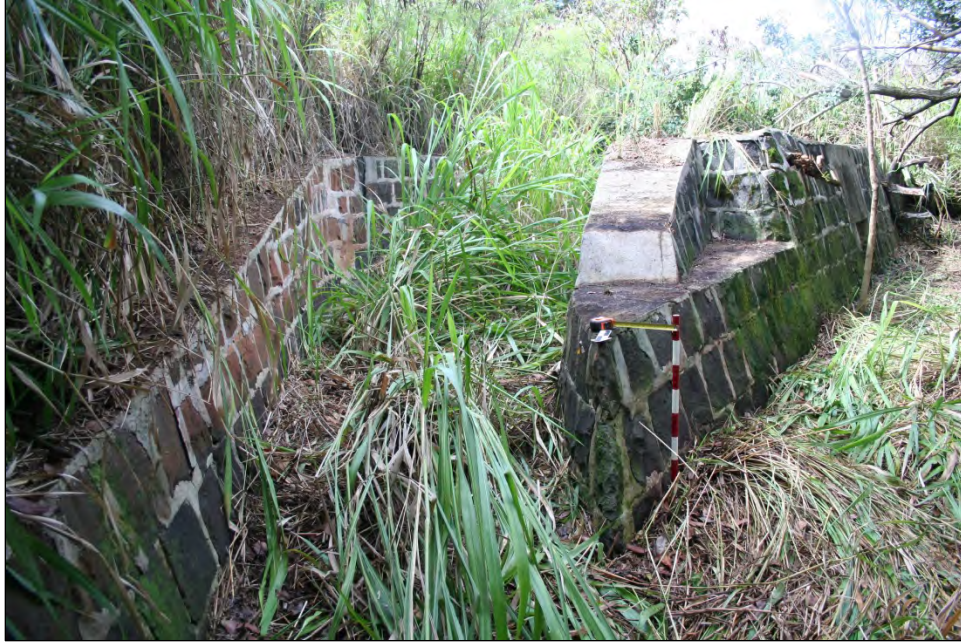
Sub-feature B, a triangular cut basalt and mortar connector between the rectangular basin (Sub-feature A) and the adjacent ditch (Feature 23), tapers down from a height of 170 cm above the ground surface (at its south end) to 60 cm above ground surface (at its north end), where it opens into the ditch designated Feature 23 (Figure 67). The west wall of Sub-feature B is constructed in a very unique way, tapering down to a sharp point in both plan and profile perspectives. Another inscribed “1925” is located atop this west wall (Figure 68).

**Figure 67. Opening to the north end of Sub-feature B, view south-southwest; vertical scale is 80 cm high**

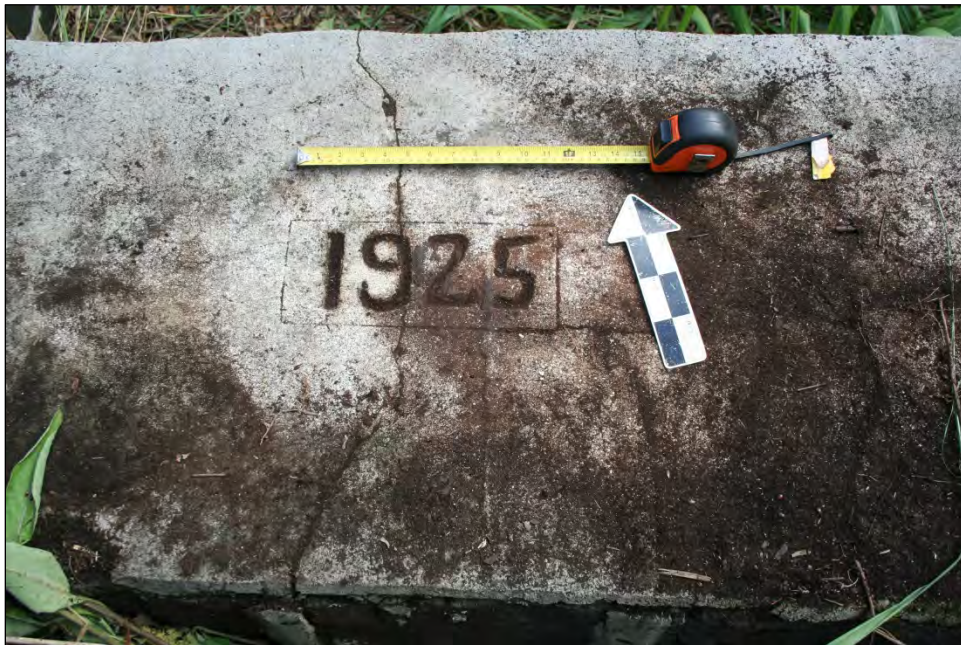
**Figure 68. Inscription on the top of the south wall at Sub-feature A**

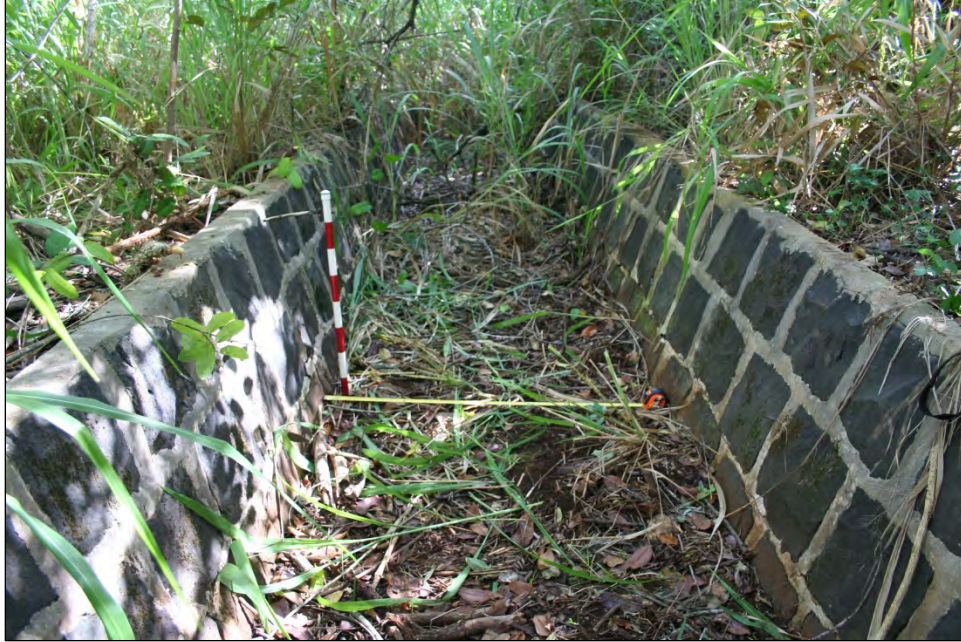
**Feature 23** (Figure 69, and see Figure 65), a typical cut basalt and mortar ditch, is approximately 360 m long from its south end at the large retention basin described above (Feature 22) to where it continues out of the project area to the north. This ditch is relatively narrow, compared with others in the project area; it is approximately 100 cm wide at its interior base, increasing to 130 cm at its interior top. It is currently approximately 80 cm deep, from the top of its structural work to the ground surface in the ditch. When originally constructed, it was about 1.0 m deep. The plan view of its south end (see Figure 64) shows it has been damaged and truncated by a modern earthen road to the south. The plan view also depicts three small flume openings that would have sent water over the ground surface to the west. Two of these flume openings were constructed over (sealed up) by rock work and mortar in the past.

**Figure 69. Representative portion of Feature 23, Site 2273, view north; vertical scale bar is 80 cm high, horizontal measuring tape is 100 cm long**

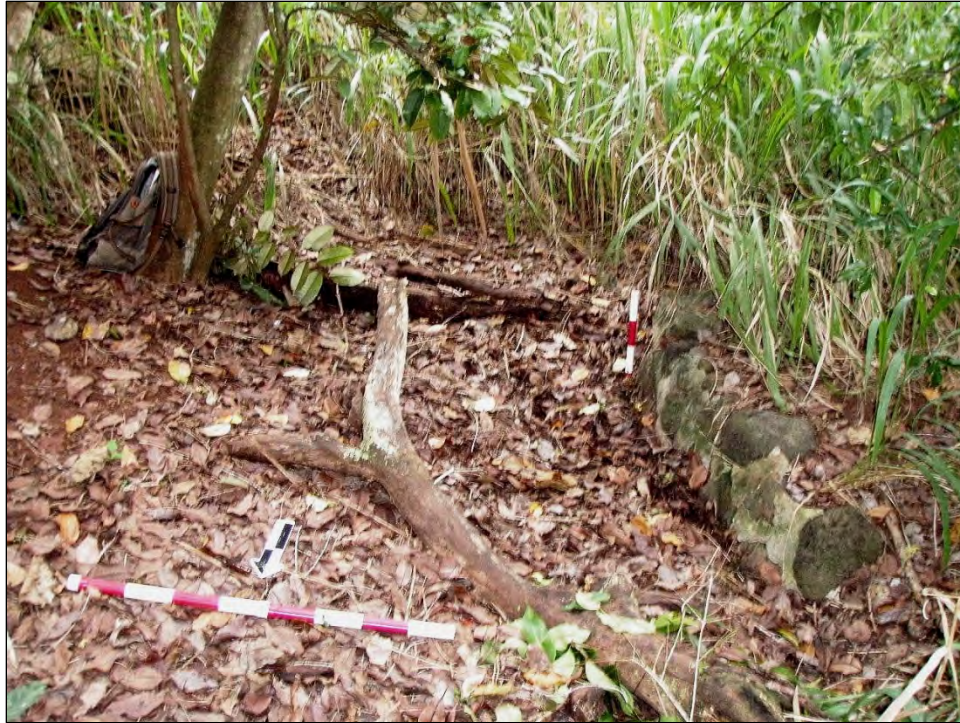
Sub-feature B is a section of ditch near the top of the feature, where it takes a sharp turn to the northwest before the area of the old pineapple cannery and camp. At this point, the ditch is almost completely buried by modern sedimentary deposition (Figure 70).

**Figure 70. Representative portion of mostly buried Feature 24, Sub-feature B, Site 2273 (basalt and mortar ditch section to the right), view south; scale bars in 10-cm increments**

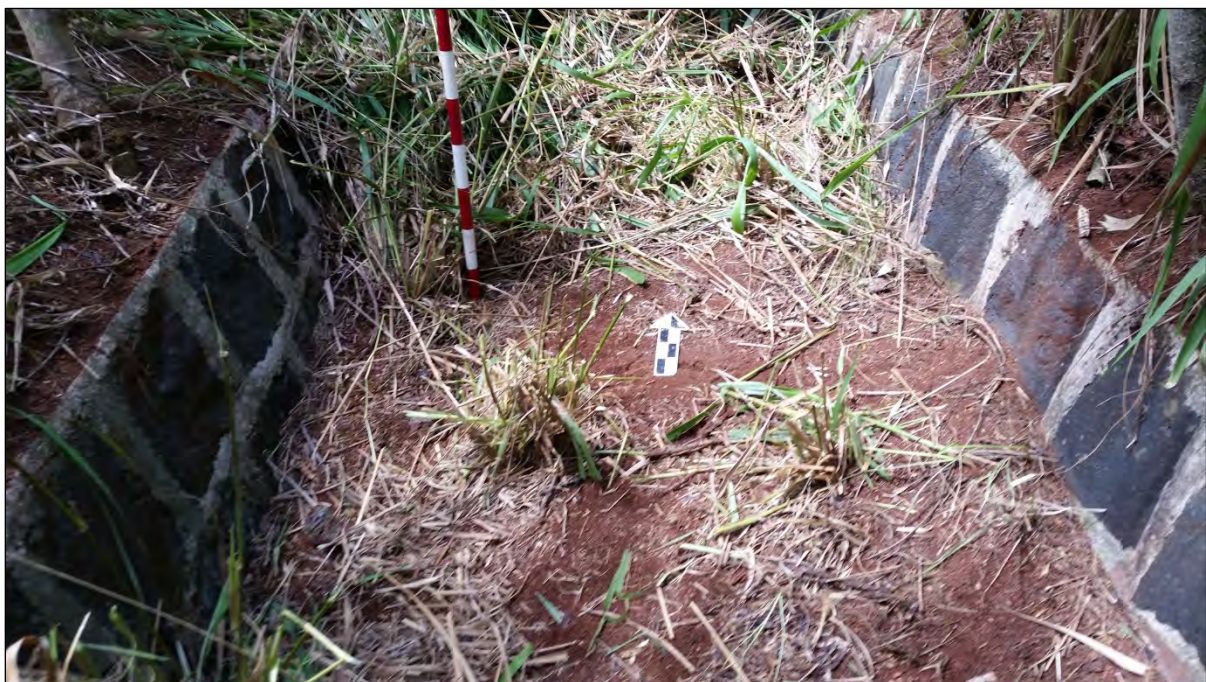
Sub-feature A, the main cut basalt and mortar ditch starting at the south end of Reservoir 3, is currently approximately 1.1 km long, extending from near the old reservoir (which has been completely impacted and transformed by a flood-control project such that the north end of Sub-feature A is no longer extant) to road Feature 27, snaking between these two ends along the east side of Gulch C. A representative photograph of Sub-feature A near the east edge of Gulch C (Figure 71) shows it is nearly completely filled with sediment due to a lack of maintenance. It is approximately 140 cm wide at its interior base, increasing to 150 cm at its interior top. It is currently 35–45 cm deep, from the top of its structural work to the ground surface in the ditch. When originally constructed, it was about 1.0 m deep.

**Figure 71. Representative portion of Feature 25, Sub-feature A, Site 2273, view north; scale bar is in 10-cm increments**

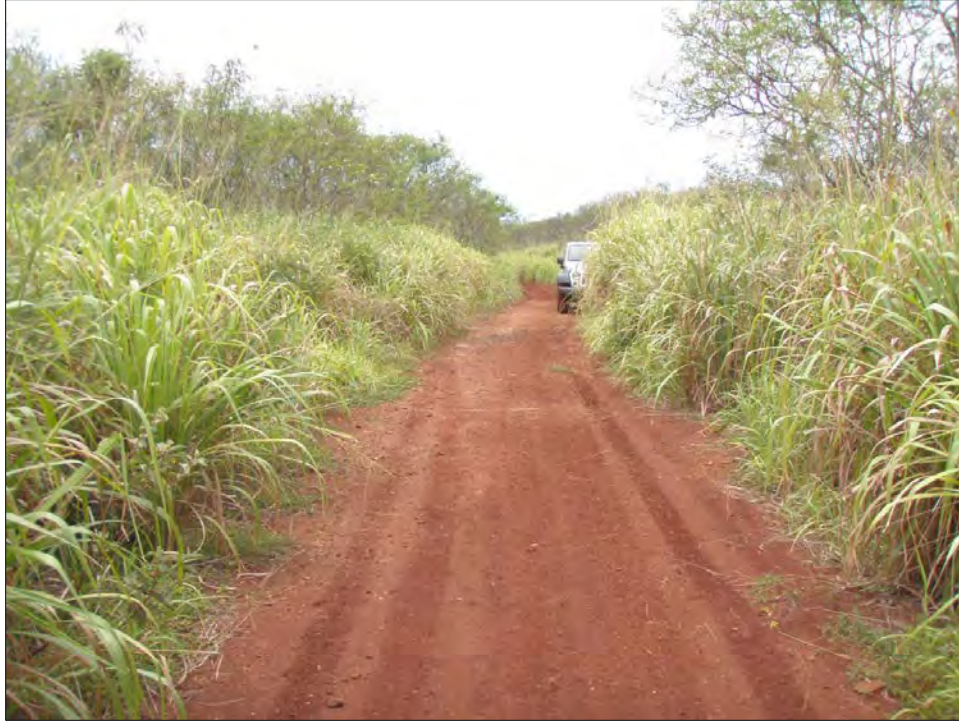
**Feature 1** is the long earthen road that traverses the entire east side of the project area from south (downslope) to north (upslope). Like the rest of the roads we identified in the current project area, other than occasional earthen berms along its sides, this road has no other defining structural features such as curbing or alignments (Figure 72). The road is 3.5 km long. Feature 1 is relatively narrow, ranging from 2.0–2.25 m wide. This is an actively used road. It is in fair to poor physical condition as it is washed out and partially eroded in places, particularly in its upper (northern) reaches. The lower end of Feature 1 connects with another mauka-makai road (Feature 27). The upper end of Feature 1 continues out of the current project area to the north after passing by Reservoir 2-B.

**Figure 72. Feature 1, Site 2270, view south; note, Jeep in background for scale**
