Section 6 Historic Property Descriptions

6.1 SIHP # 50-30-11-B006

6.2 SIHP # 50-30-11-2179

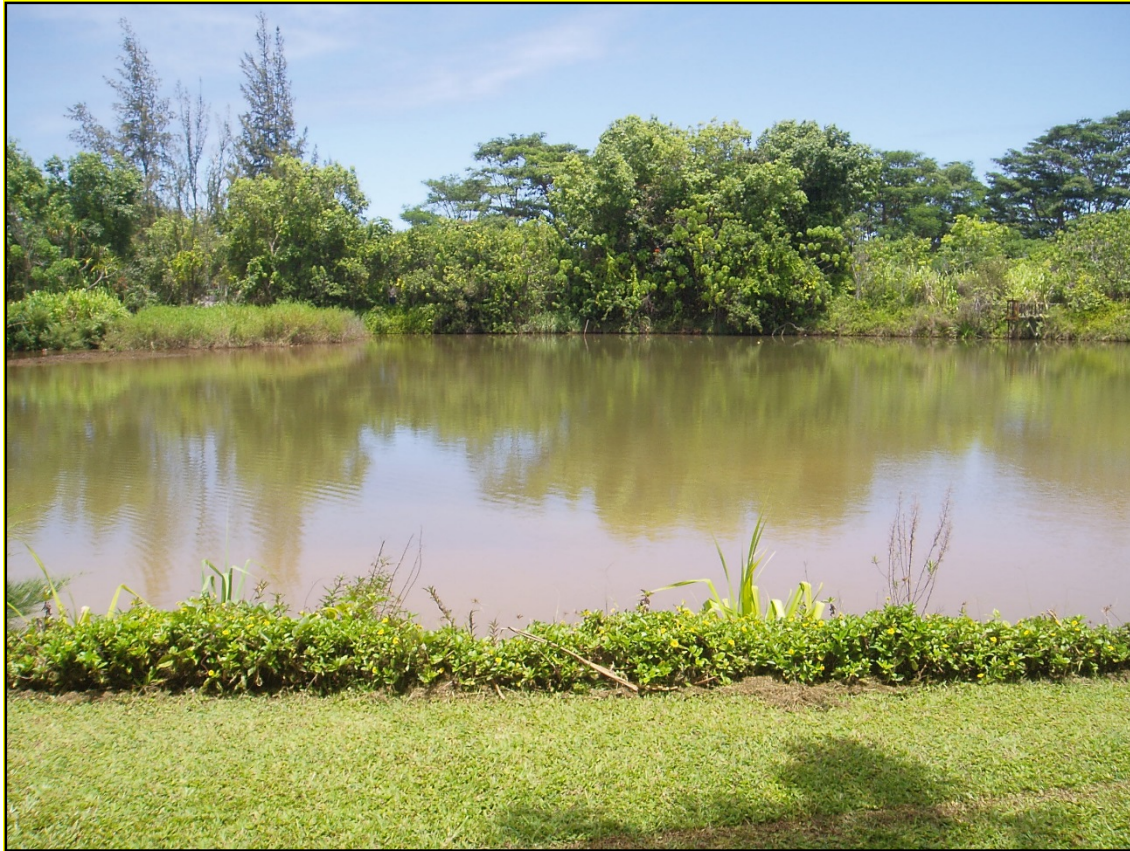
Figure 102. Photo of SIHP # -2179 Feature A, reservoir adjacent to (but outside of) the project area, view to south (Hunkin et al. 2014)

Feature A is a reservoir located adjacent to and northeast of the gate at the Island School campus road entrance. The reservoir is not part of Island School property and is located outside of the project area, but is almost completely surrounded by the project area. A 1941 map of Lihue Plantation Co. shows the Feature A reservoir between the boundaries of fields 39A and 39B (see Figure 19). The 1963 U.S. Geological Survey map (see Figure 21) shows a portion of the 'Upper Lihue Ditch' that corresponds with the separation between field 39A and 39B; indicating that Feature A was likely associated with the Upper Lihue Ditch system. The reservoir also appears on the 1910 U.S. Geological Survey (see Figure 10) although its associated ditches are not evident. No modification to Feature A is planned as part of the proposed development project.

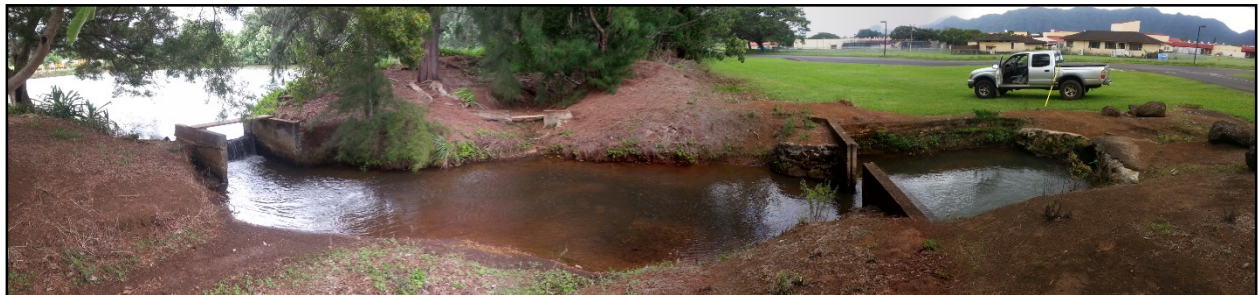
Figure 103. Photo of the overflow area of SIHP # -2179 Feature A, including the four sub-features (Features A1–A4) (Hunkin et al. 2014)

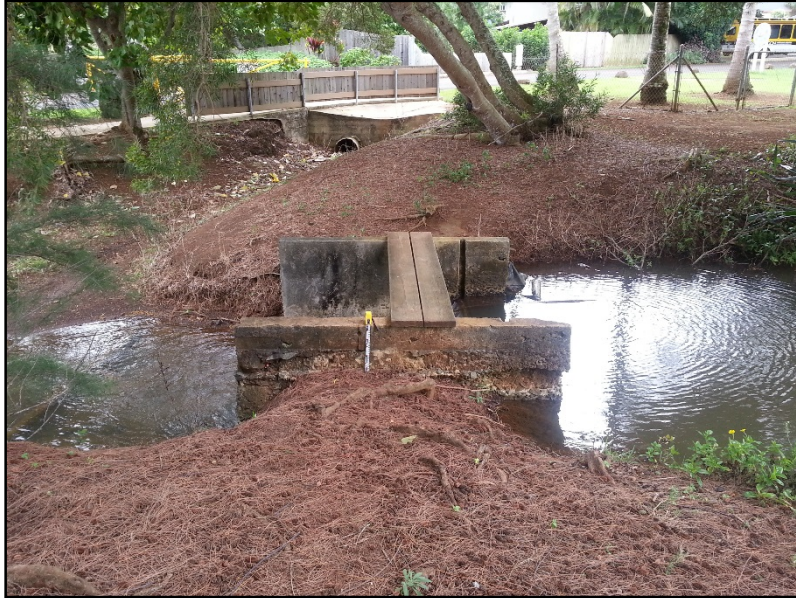
Figure 105. Photo of SIHP # -2179 Feature A1, sluice gate at the northern end of the overflow area, view to northwest (Hunkin et al. 2014)

Sub-feature A1 . . . designates an active vertical rising sluice gate at the northern edge of the Feature A reservoir overflow area contains two pre-cast concrete wing walls and a gate composed of three wooden boards (see Figure 105 and Figure 106). The sluice gate opening measures 1.8 m wide, with a maximum height of 1.18 m. Two 2 in x 7 in pieces of lumber straddle the sluice gate (see Figure 105).

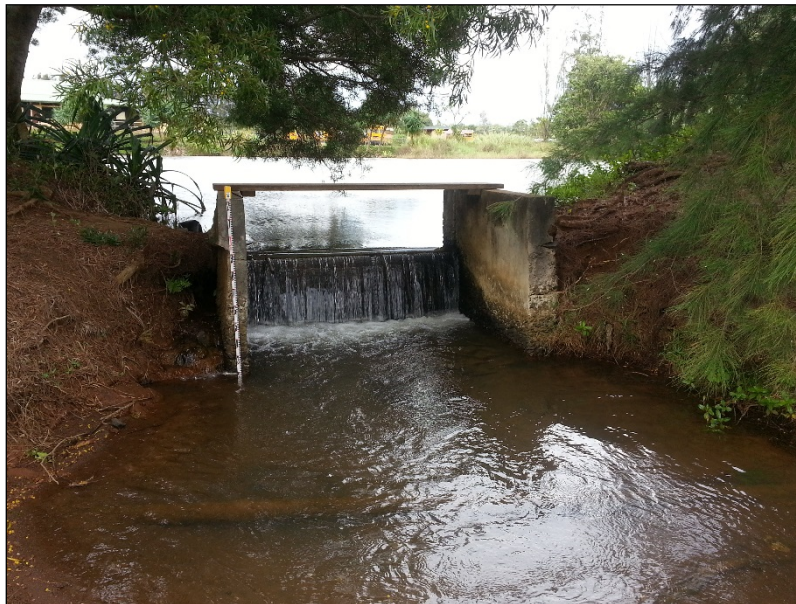
Figure 106. Photo of SIHP # -2179 Feature A1, sluice gate at the northern end of the overflow area, view to north (Hunkin et al. 2014)

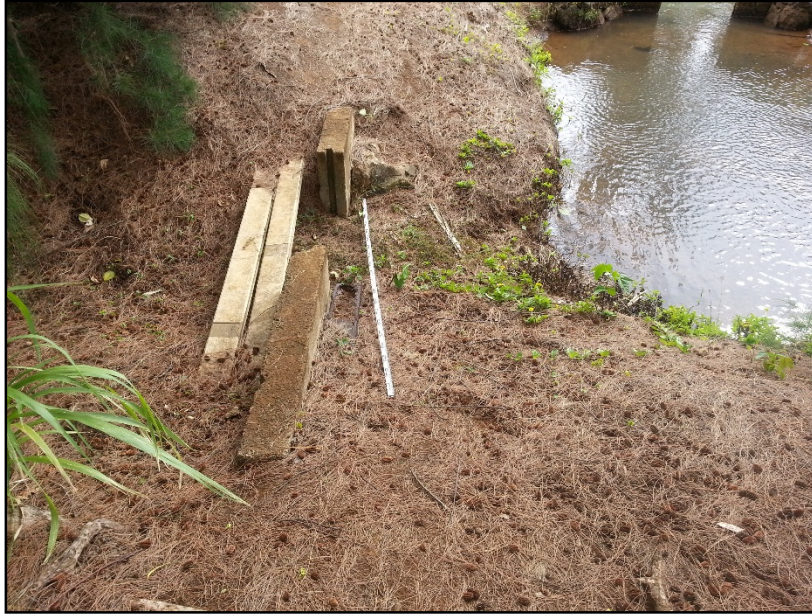
Figure 107. Photo of SIHP # -2179 Feature A2, sluce gate at the easternmost edge of the Feature A overflow area, view to south (Hunkin et al. 2014)

Feature A2 is an abandoned vertical rising sluice gate with two pre-cast concrete wing walls lies 0.70 m from the edge of the water on the easternmost edge of the Feature A overflow area (see Figure 104 for location) and is approximately 0.15 m higher than the water in elevation (see Figure 107 and Figure 108). The opening of the sluice gate measures 0.90 m wide, with a maximum height of 0.44 m. Two tongue and groove wooden panels are on the east side of the gate.

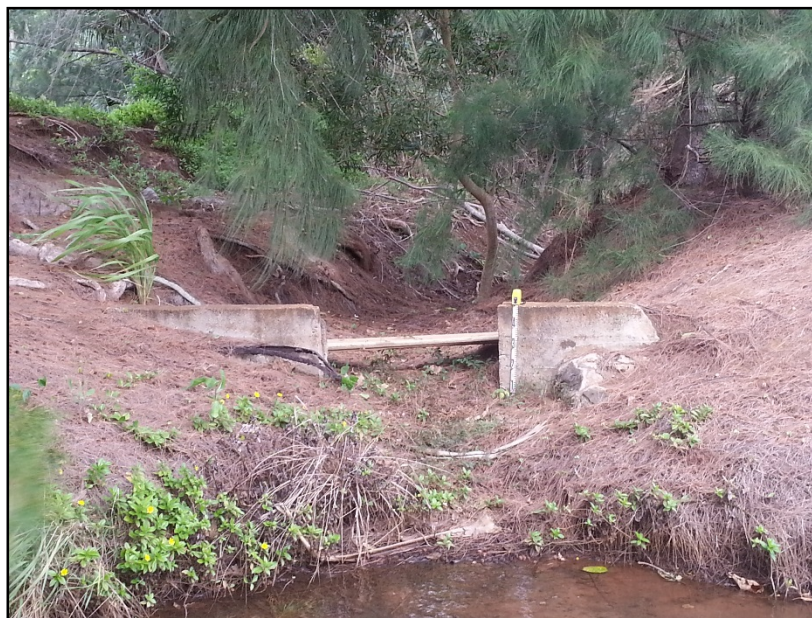
Figure 108. Photo of SIHP # -2179 Feature A2, sluce gate at the easternmost edge of the Feature A overflow area, view to east (Hunkin et al. 2014)

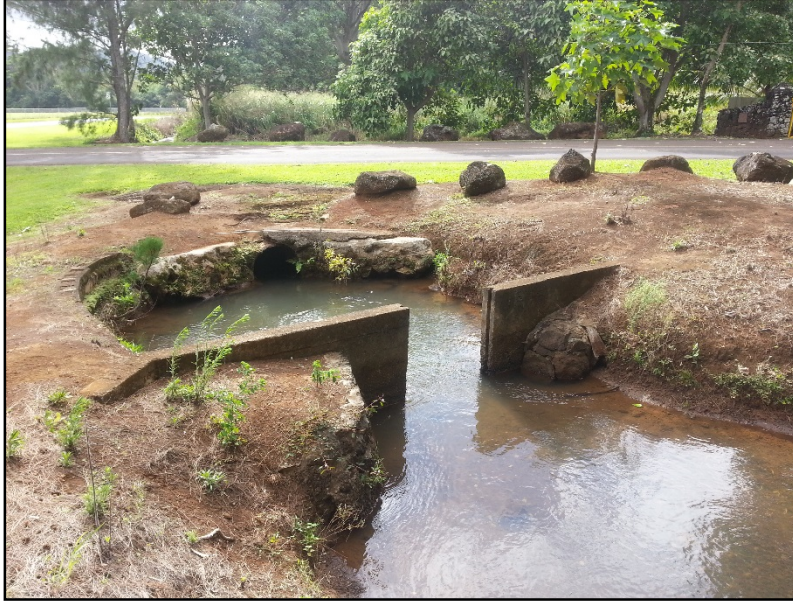
Figure 109. Photo of SIHP # -2179 Feature A3, sluice gate at the southwest side of the Feature A overflow area, water flows through the pipe in background, under the Island School road, into Feature F, irrigation ditch, view to southwest (Hunkin et al. 2014)

Feature A3 is a formed, slotted concrete sluice gate frame constructed of two pre-cast concrete wing walls is at the southwest side of the Feature A overflow area (see Figure 104 for location and Figure 109 and Figure 110). The wooden gate is missing. Water flows from the reservoir through the gate frame to the west to an area outside of the project area and within the Kaua'i Community College campus. This is the reservoir's only outlet.

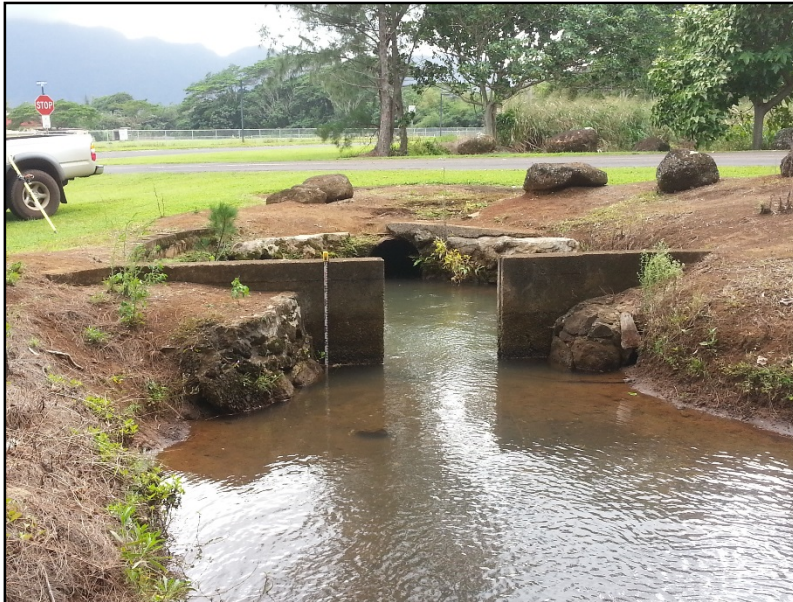
Figure 110. Photo of SIHP # -2179 Feature A3, sluice gate at the southwest side of the Feature A overflow area, view to south (Hunkin et al. 2014)

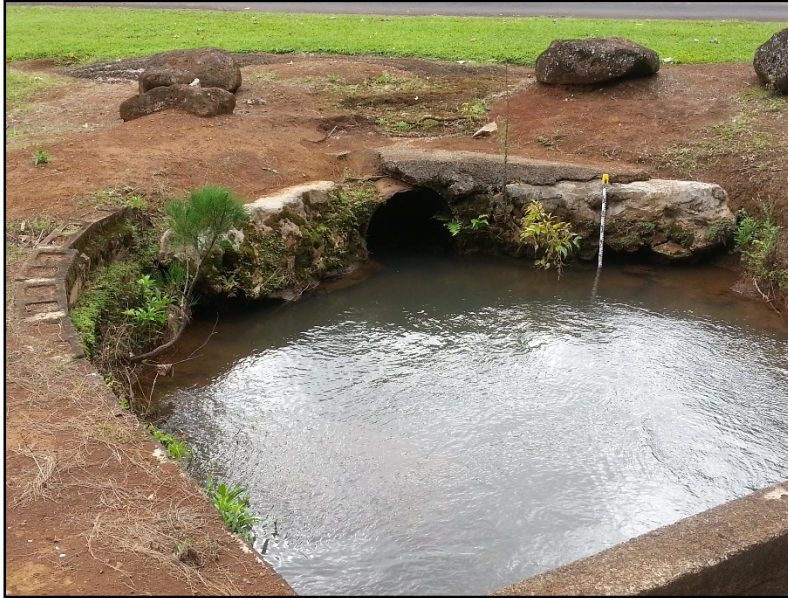
Figure 111. Photo of SIHP # -2179 Feature A4, modern culvert at the south end of the Feature A overflow area, view to southwest (Hunkin et al. 2014)

Feature A4 is a modern culvert enters the reservoir at the south side of the Feature A overflow area running NE/SW and is composed of a large metal pipe with an opening approximately 0.65 m in diameter, and head and wing walls constructed of basalt boulders and cobbles with mortar fill, which have been partially capped with concrete (see Figure 111). Feature A4 has a maximum height of 1.14 m. An inscription reading '10-29-69' was observed on the east wing wall (see Figure 112). [Hunkin et al. 2014:93–101]

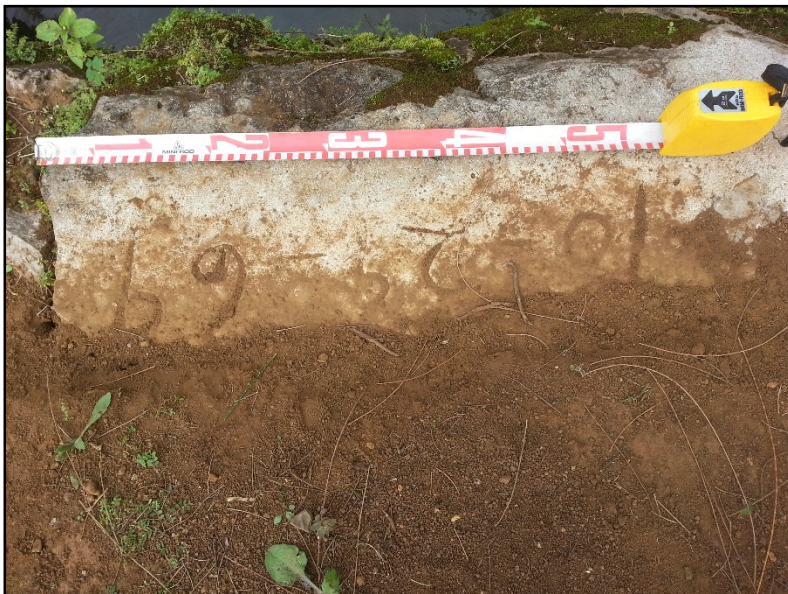
Figure 112. Photo of SIHP # -2179 Feature A4, modern culvert, showing the inscription reading "10-29-69," view down (Hunkin et al. 2014)

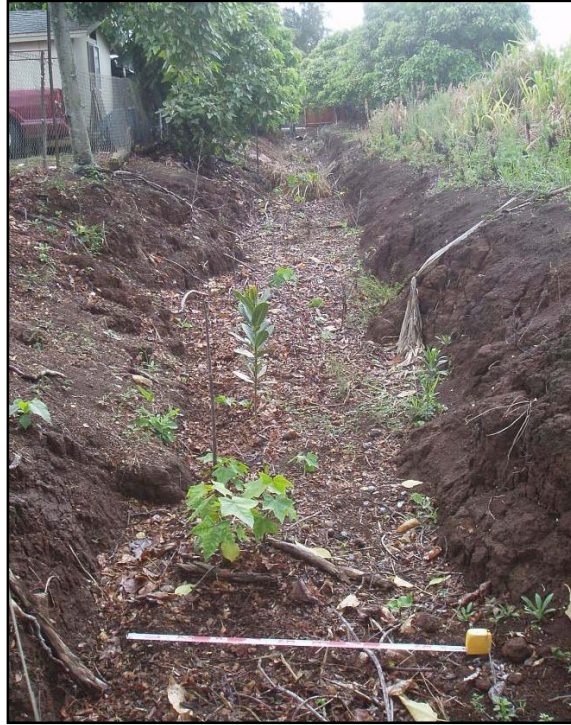
Figure 113. Photo of SIHP # -2179 Feature B, earthen irrigation ditch, view to east (Hunkin et al. 2014)

Feature B is an irrigation ditch (Figure 113 and Figure 114) forming the west, southwest, and a portion of the south boundary of the project area (see Figure 104 for location). The earthen ditch is 703 m long, 0.9 m deep with a maximum width of 2.0 m . . . The ditch walls are sloped resulting in a bottom width of 1.0 m. The ditch is not currently used for irrigation but collects storm drainage and surface runoff from the Island School campus and its athletic fields.

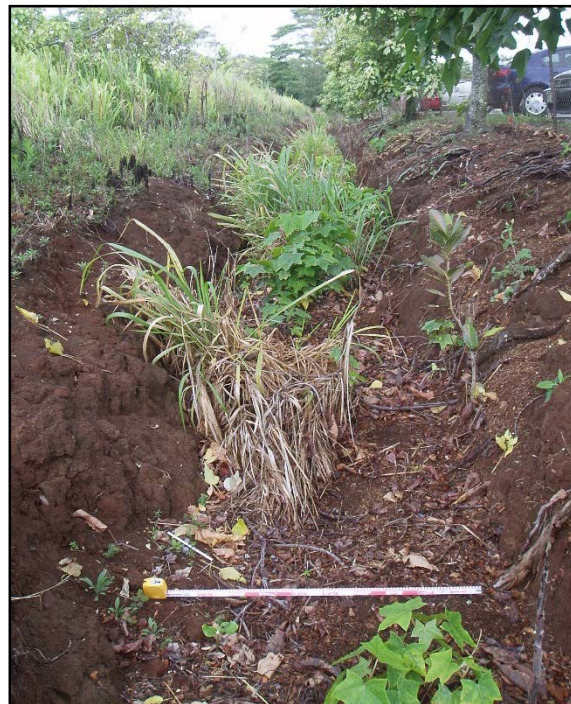
Figure 114. Photo of SIHP # -2179 Feature B, earthen irrigation ditch, view to west (Hunkin et al. 2014)

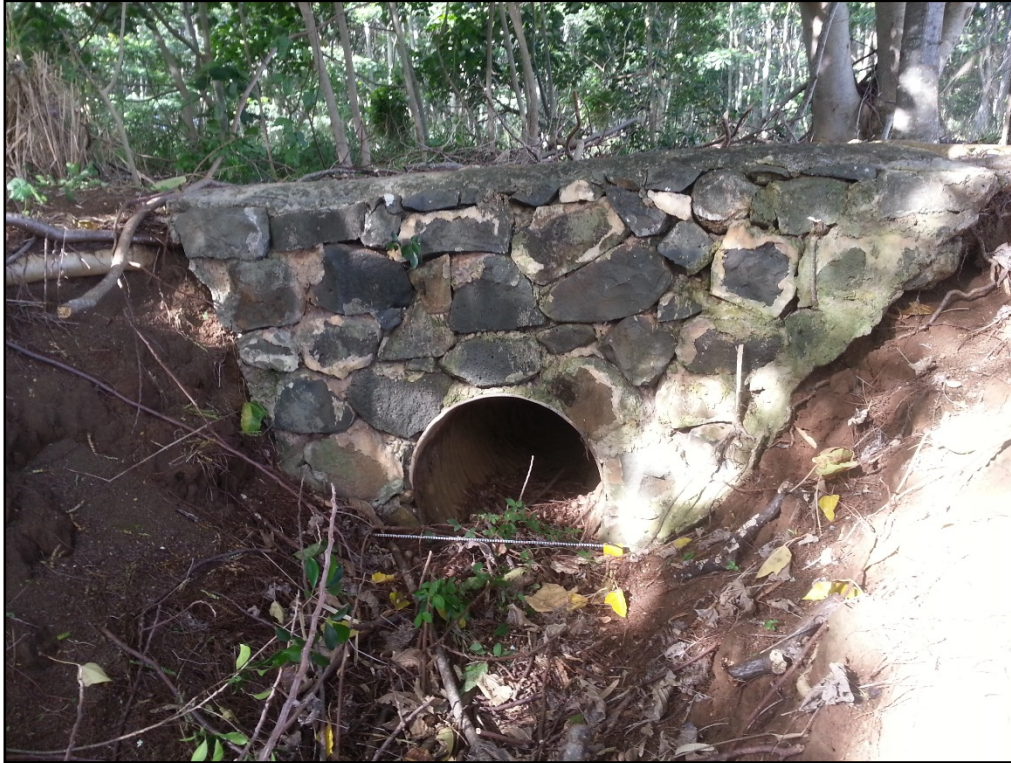
Figure 121. Photo of SIHP # -2179 Feature B1, eastern culvert, view to west (Hunkin et al. 2014)

The eastern culvert has only a head wall constructed of stacked small to large sub-angular and angular basalt boulders and cobbles filled with mortar. The head wall is capped with concrete. The eastern culvert is approximately 3.10 m long and 0.70 m wide, with a total height of 1.84 m (Figure 121 and Figure 124).

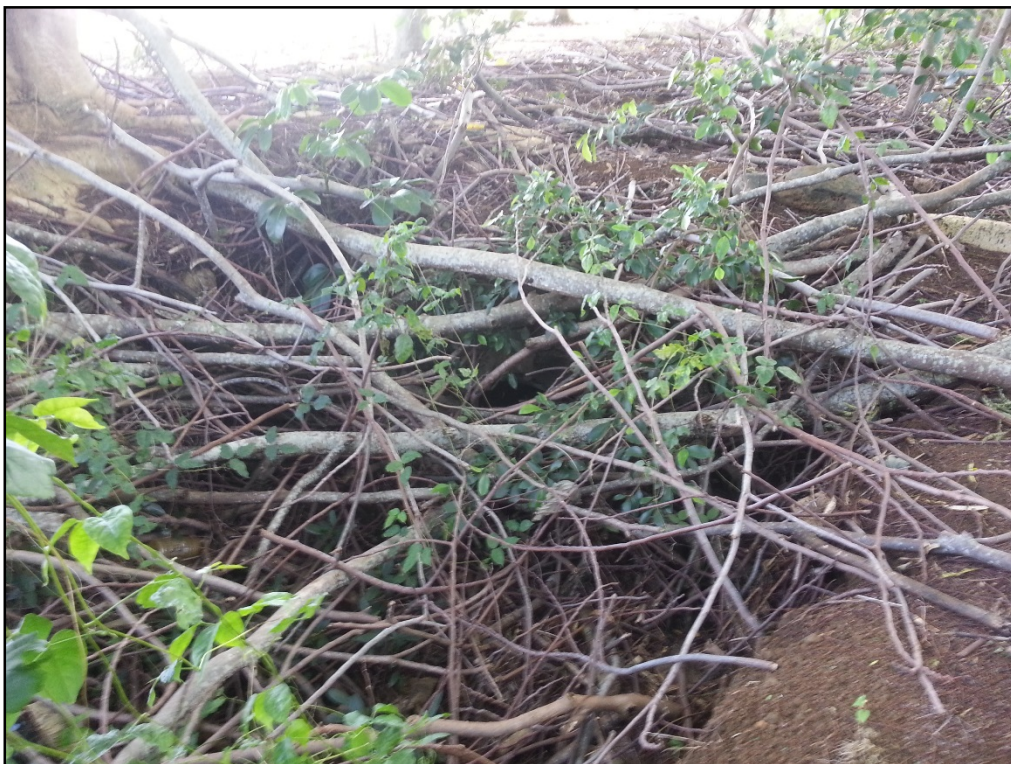
Figure 122. Photo of SIHP # -2179 Feature B1, western culvert, view to east (Hunkin et al. 2014)

The western culvert was not visible due to tree branch pilings in the ditch. A small strip of a concrete cap was visible through the branches (Figure 122). [Hunkin et al. 2014:101–106]

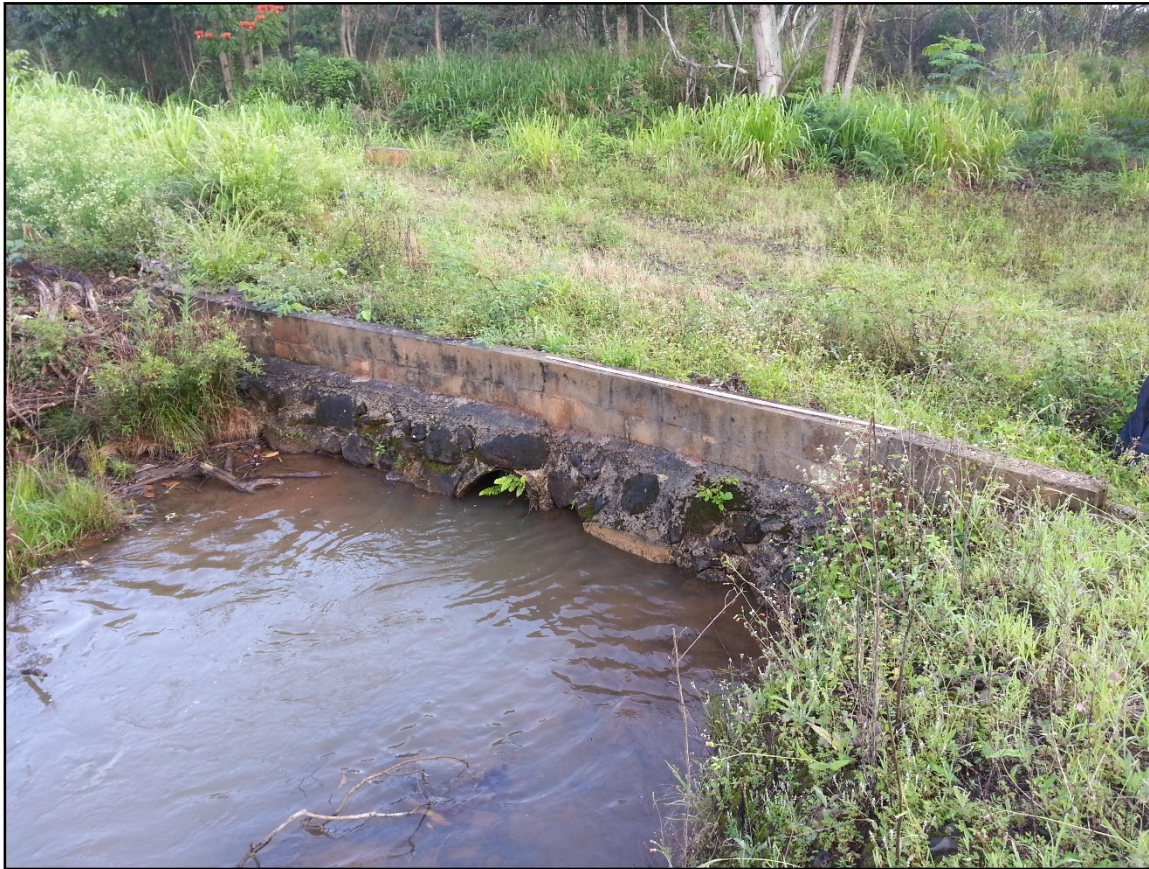
Figure 131. Photo of SIHP # -2179 Feature C1, culvert at northernmost section, view to north (Hunkin et al. 2014)

Feature C1. The northernmost end of SIHP # -2179 Feature C is a slightly curved culvert (Figure 131). At this end, its height averages approximately 0.90 m. The base of the culvert is constructed of concrete and small to medium angular and sub-angular basalt boulders. The culvert itself is a large deteriorating steel pipe approximately 0.60 m wide at the opening. The upper portion of the culvert is constructed of concrete-filled hollow blocks with an average height of 0.40 m on the south (ditch) side and 0.10 m on the north (surface) side (Figure 132 and Figure 133). No definite date of construction can be determined, but the difference in construction materials suggests that the culvert is historic but later modified, although the time span between original construction and later modification is indeterminate.

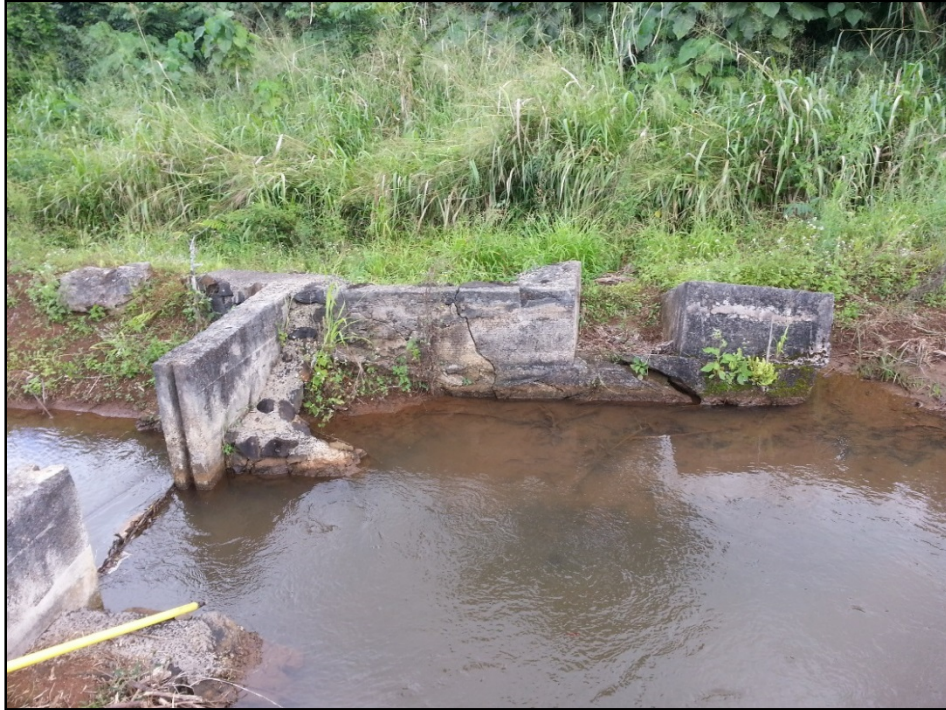
Figure 134. Photo of SIHP # -2179 Feature C2, consisting of one active and one abandoned vertical rising sluice gate, somewhat perpendicular to each other, view to east (Hunkin et al. 2014)

Feature C2. Feature C2 consists of one active and one abandoned vertical rising sluice gate, somewhat perpendicular to each other (see Figure 134, Figure 135, and Figure 136).

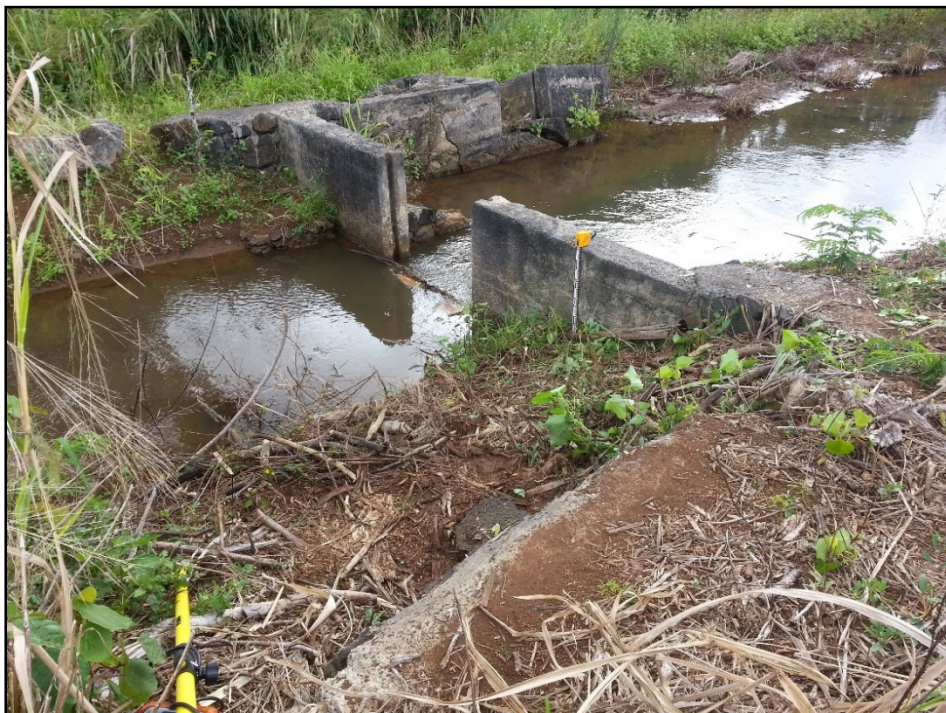
Figure 135. Photo of SIHP # -2179 Feature C2, view to southeast (Hunkin et al. 2014)

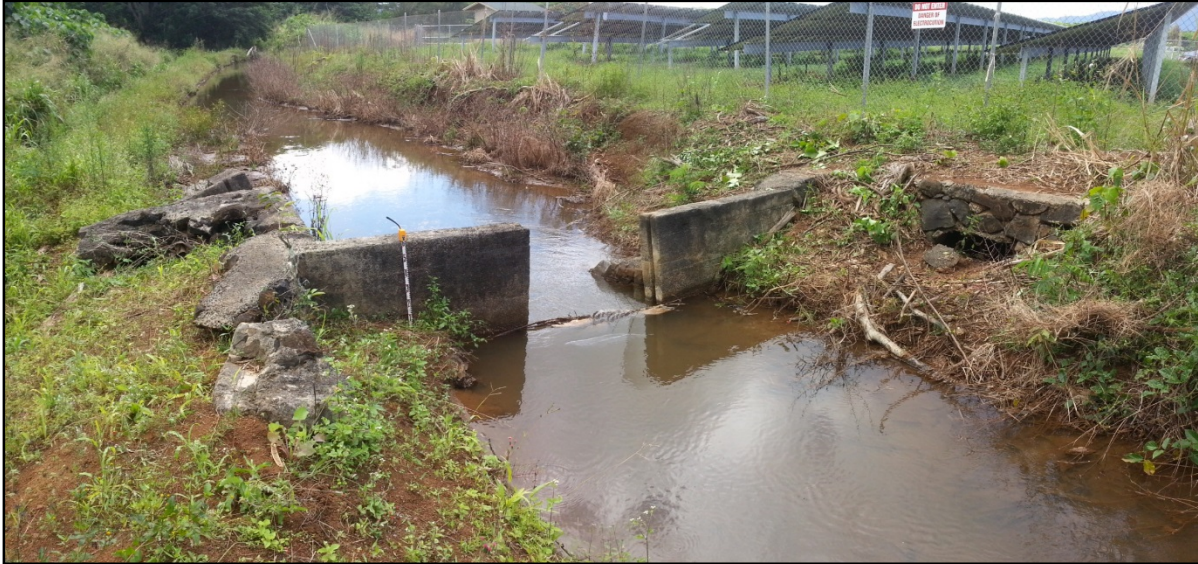
Figure 137. Photo of SIHP # -2179 Feature C3, an abandoned culvert located approximately 0.80 m north of Feature C2, view to southwest (Hunkin et al. 2014)

Feature C3. Feature C3 is an abandoned culvert located approximately 0.80 m north of Feature C2 (see Figure 136 and Figure 137). The culvert includes a large corrugated metal pipe measuring approximately 0.65 m wide at the opening. Around the sides and on top of the pipe are stacked angular and sub-angular basalt boulders and cobbles with concrete fill. The culvert is capped with concrete. The whole structure is approximately 0.67 m high and 1.59 m wide (Figure 138 and Figure 139).

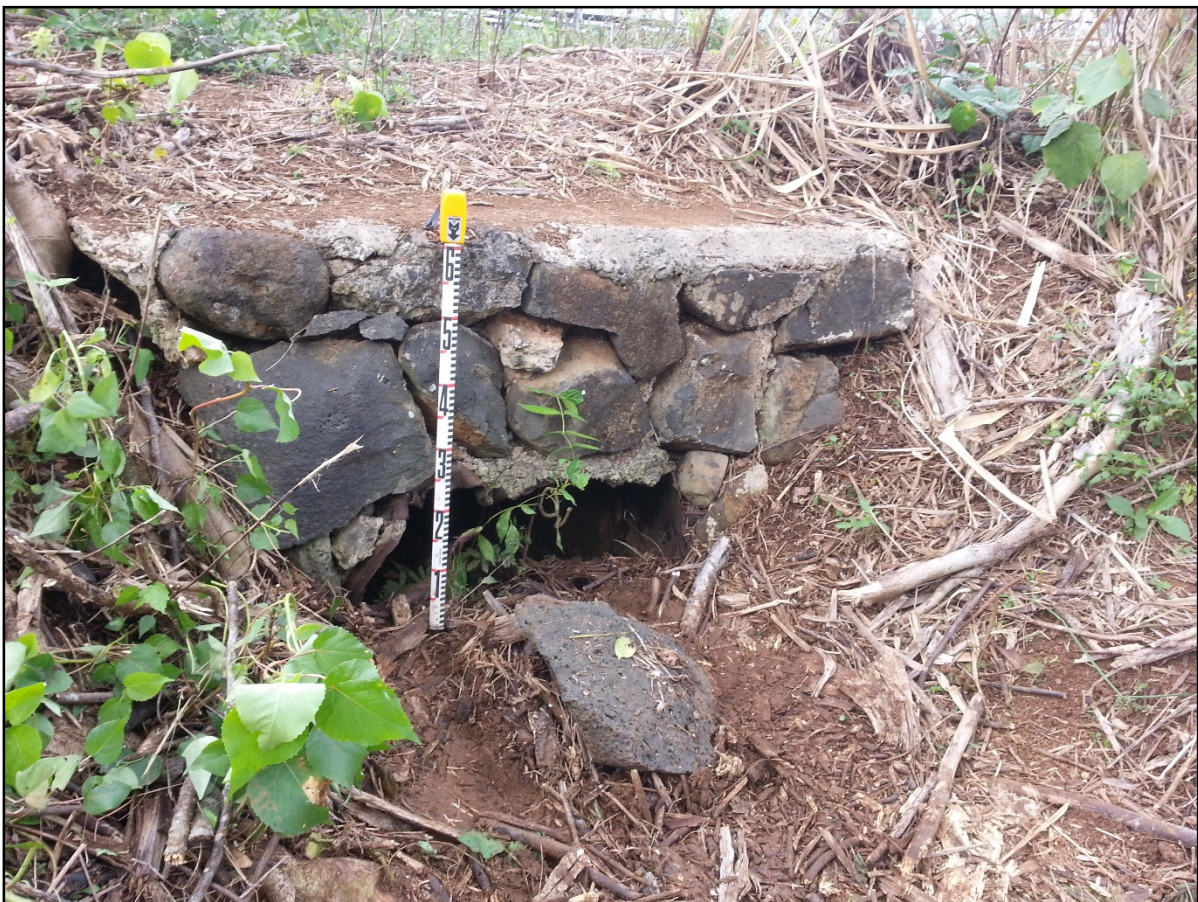
Figure 138. Photo of SIHP # -2179 Feature C3, an abandoned culvert, view to northwest (Hunkin et al. 2014)

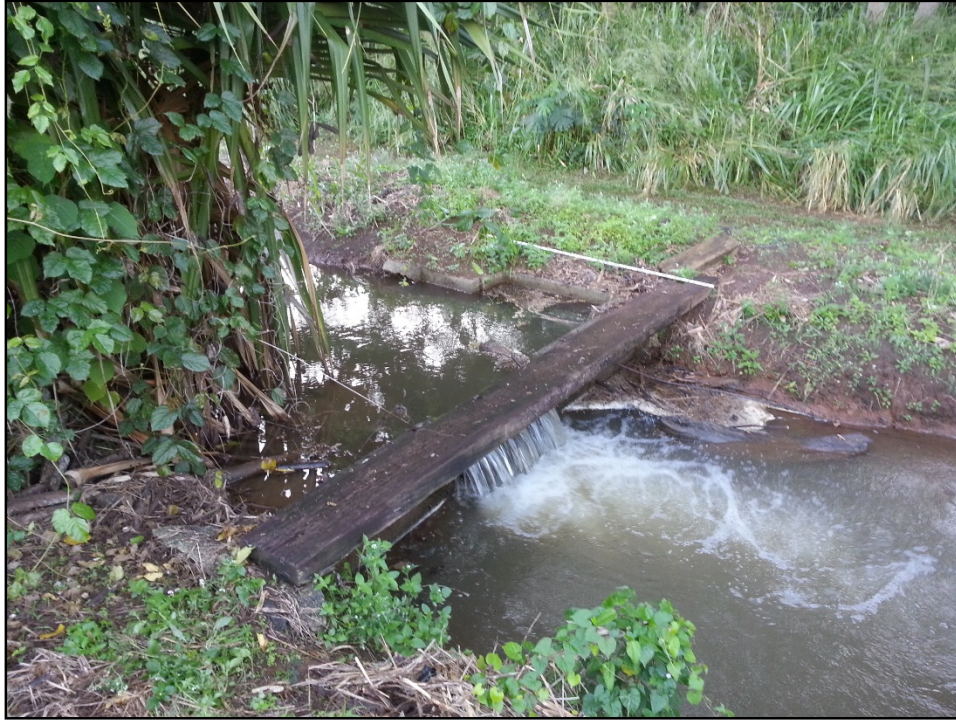
Figure 140. Photo of SIHP # -2179 Feature C4, one active and one abandoned vertical rising sluce gate, view to northwest (Hunkin et al. 2014)

Feature C4. Two vertical rising sluice gates, one active and one abandoned, constitute Feature C4 (Figure 140 and Figure 142).

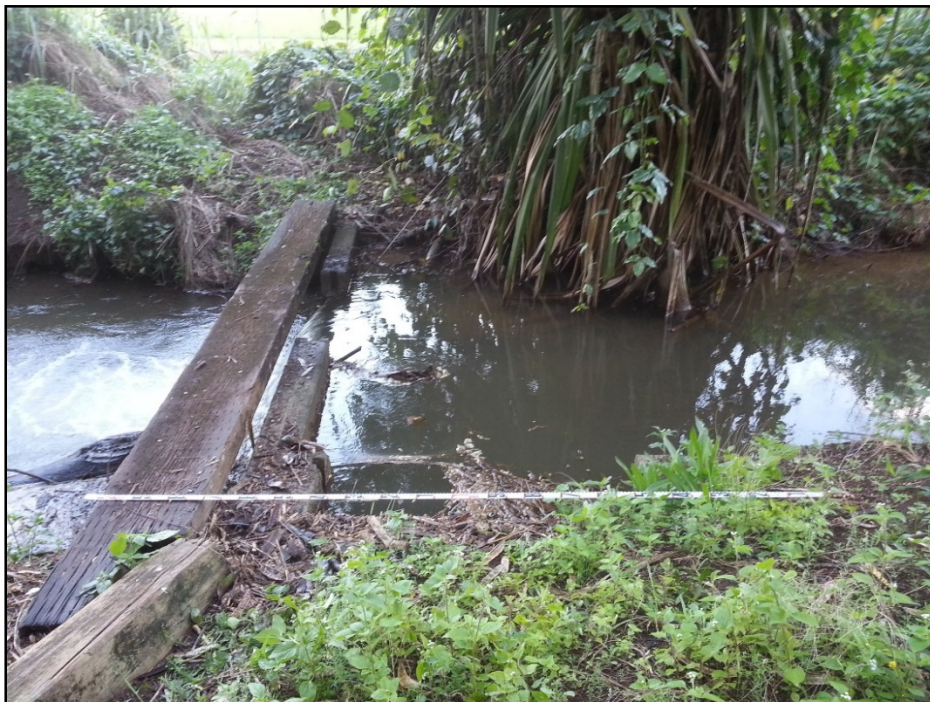
Figure 141. Photo of SIHP # -2179 Feature C4, showing the 4-inch by 12-inch board of treated wood just southwest of (nearly atop) the active gate, view to west (Hunkin et al. 2014)

The active sluice gate is aligned in a roughly NW/SE direction across SIHP # -2179 Feature C (the ditch). The gate has two pre-cast concrete wing walls and a vertical rising gate composed of two wooden boards. The gate opening measures approximately 0.80 wide and 1.20 m high. A large 4 in x 12 in board of treated wood straddles the ditch just southwest of (nearly atop) the active gate (Figure 141).

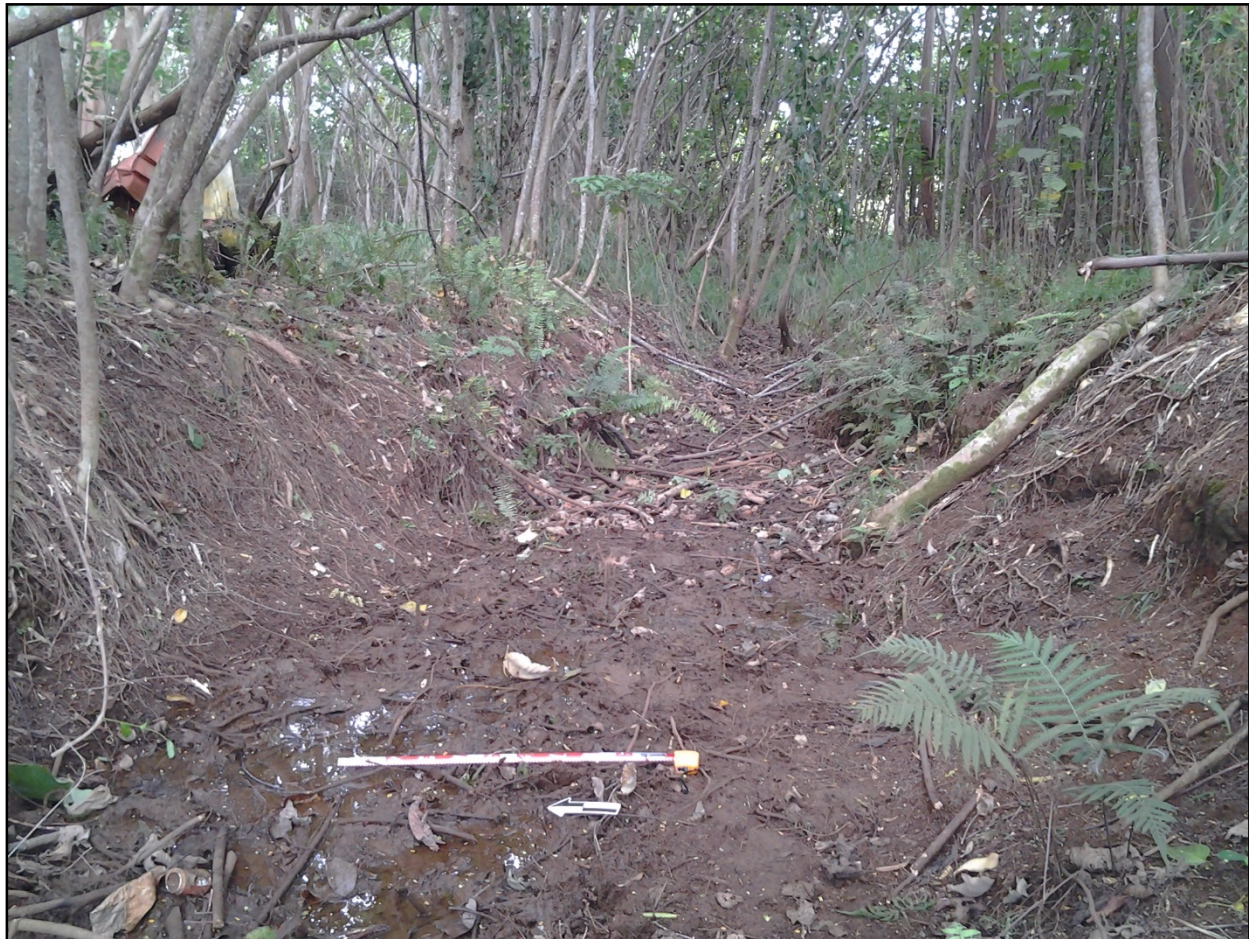
Figure 144. Photo of SIHP # -2179 Feature D, Cross Section 1, view to east (Hunkin et al. 2014)

CS1 was documented at Feature D's westernmost portion (Figure 143 and Figure 144). CS2 was documented at the central portion of Feature D (Figure 145 and Figure 146). CS3 represents the easternmost portion of Feature D (Figure 147 and Figure 148).

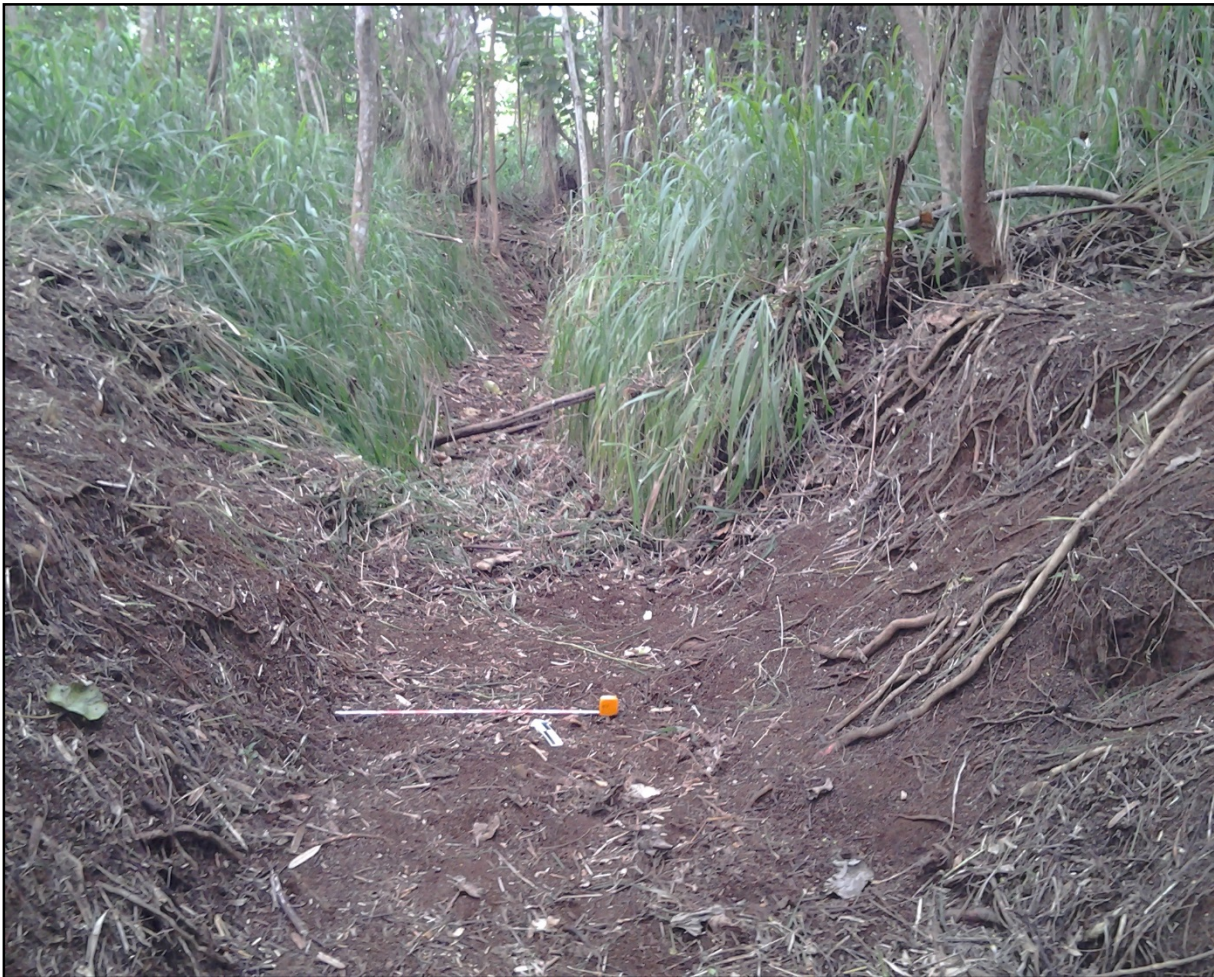
Figure 146. Photo of SIHP # -2179 Feature D, Cross Section 2, view to northeast (Hunkin et al. 2014)

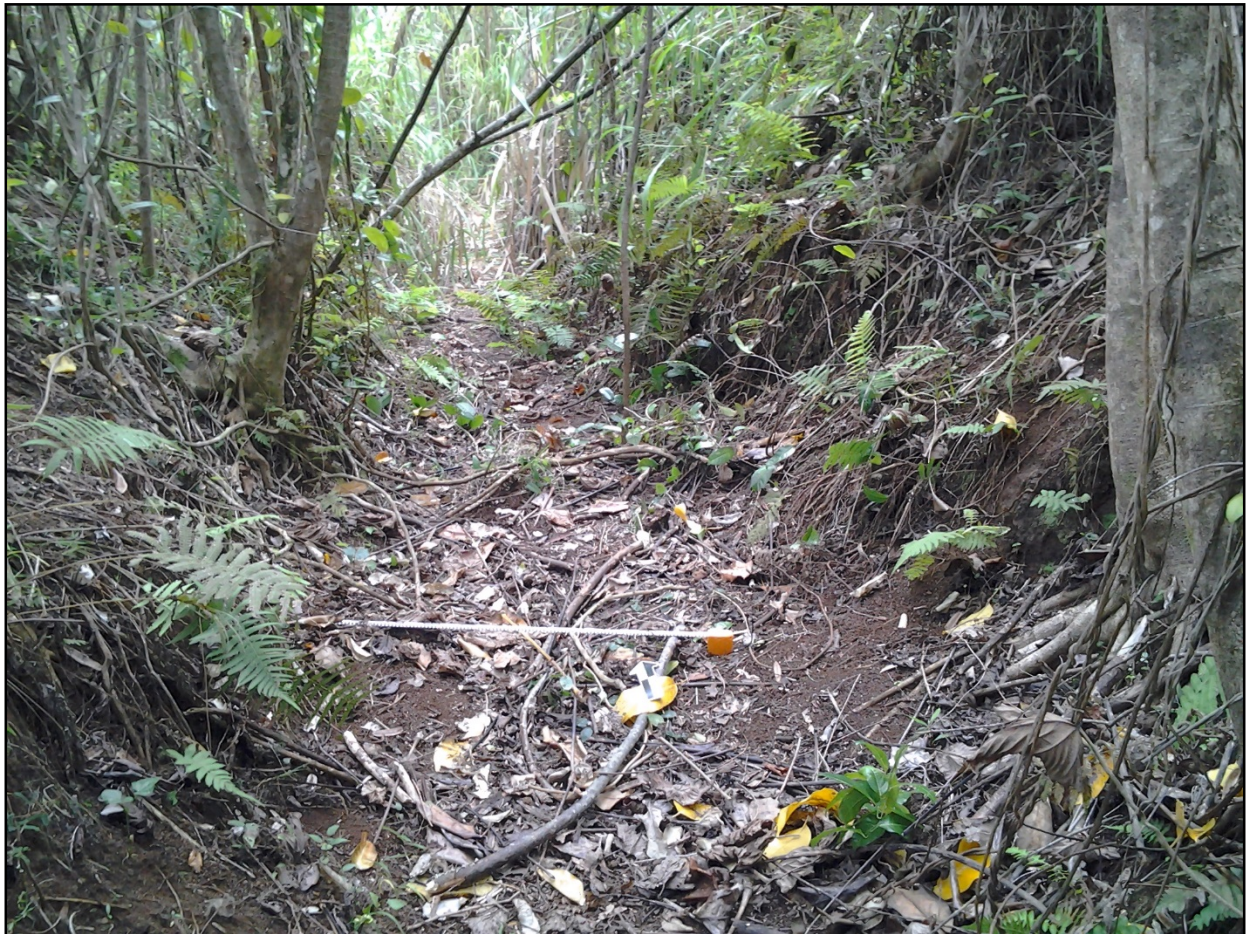
Figure 148. Photo of SIHP # -2179 Feature D, view to north (Hunkin et al. 2014)

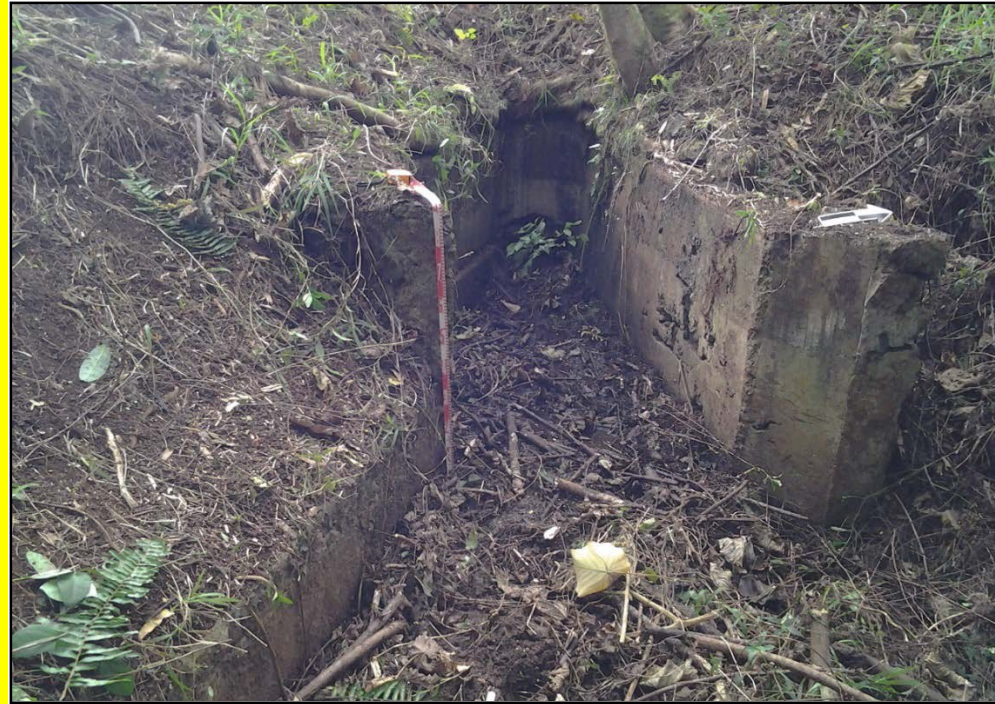
Figure 149. Photo of SIHP # -2179 Feature D1, outlet at the westernmost end of Feature D, which indicates water from Feature A was diverted and fed into Feature D to be transported to feed cane fields to the east (slightly down slope from Features C and A), the original Lihue Plantation Company's cane field 39A, view to west (Hunkin et al. 2014)

An outlet at the westernmost end of Feature D, designated as Feature D1 allowed water to flow from the Feature A reservoir into the Feature D ditch channel (Figure 149, Figure 151, and Figure 150). [Hunkin et al. 2014:123]

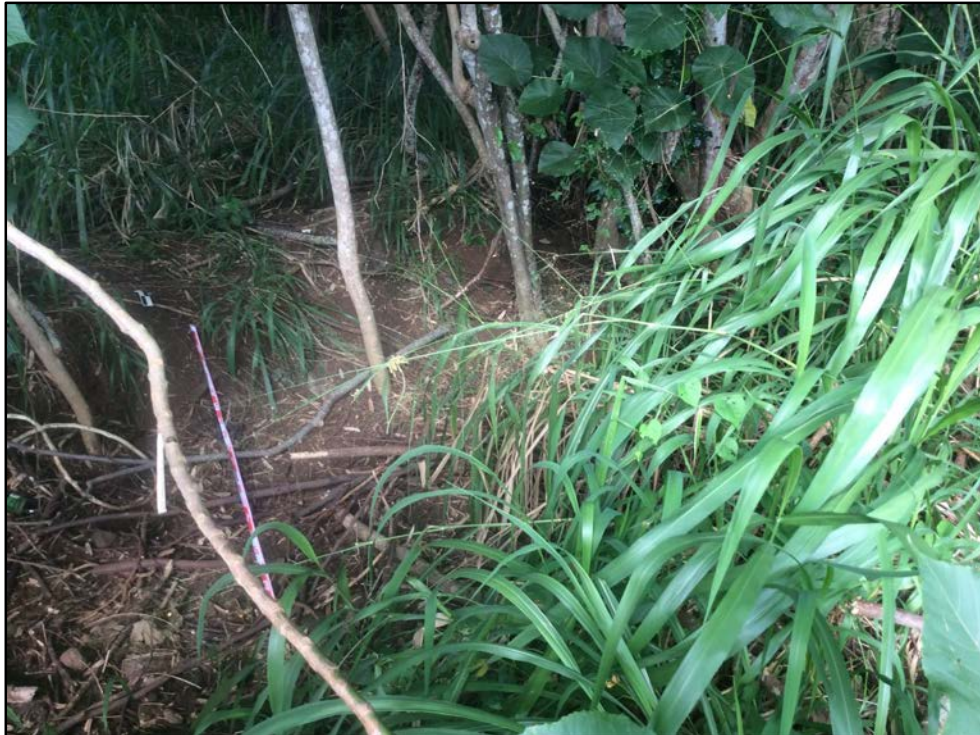
Figure 152. SIHP # -2719 Feature E, abandoned irrigation ditch, view to north

Feature E is an abandoned plantation era earthen irrigation ditch (Figure 152 through Figure 156) measuring 852.3 m long by 1.6 m wide and 0.8 m deep (see Figure 96) that bordered the southwest portion of field 39A, as shown on a 1941 map of Lihue Plantation Company (see Figure 19). The southern portion of SIHP # -2179 Feature E does not appear to correspond to the plantation boundary. The ditch began at a berm at the southwest side of a reservoir adjacent to and northeast of the project area. It is likely the berm is a more modern feature to not allow water to flow into Feature E. The abandoned ditch continues in a southeasterly direction forming the southeastern boundary of the proposed project area.

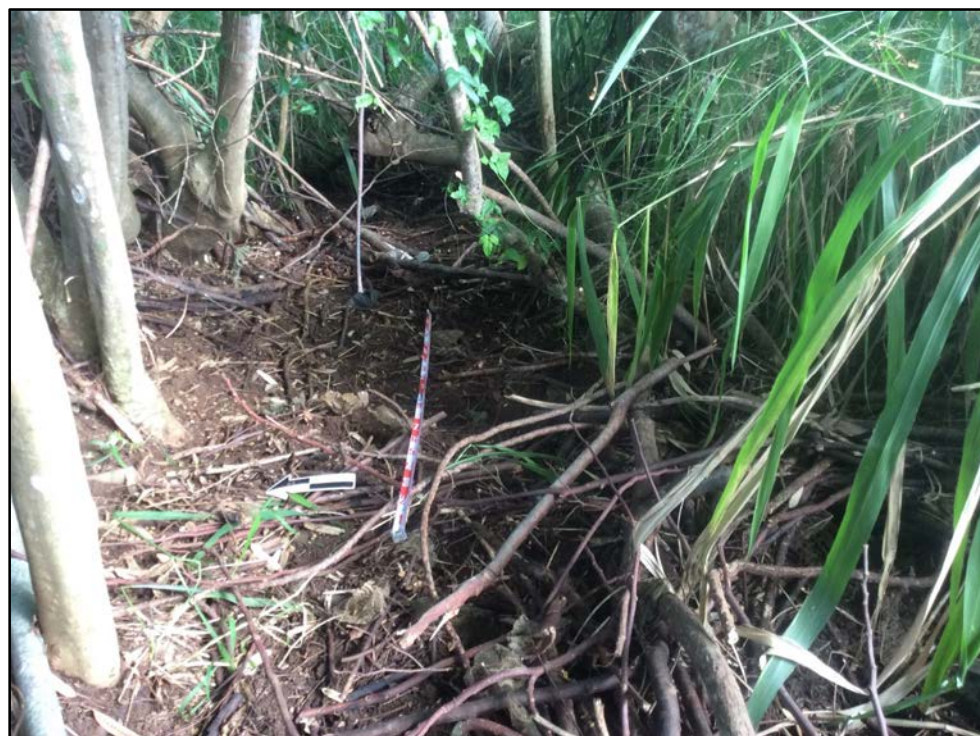
Figure 153. SIHP # -2719 Feature E, abandoned irrigation ditch, view to east

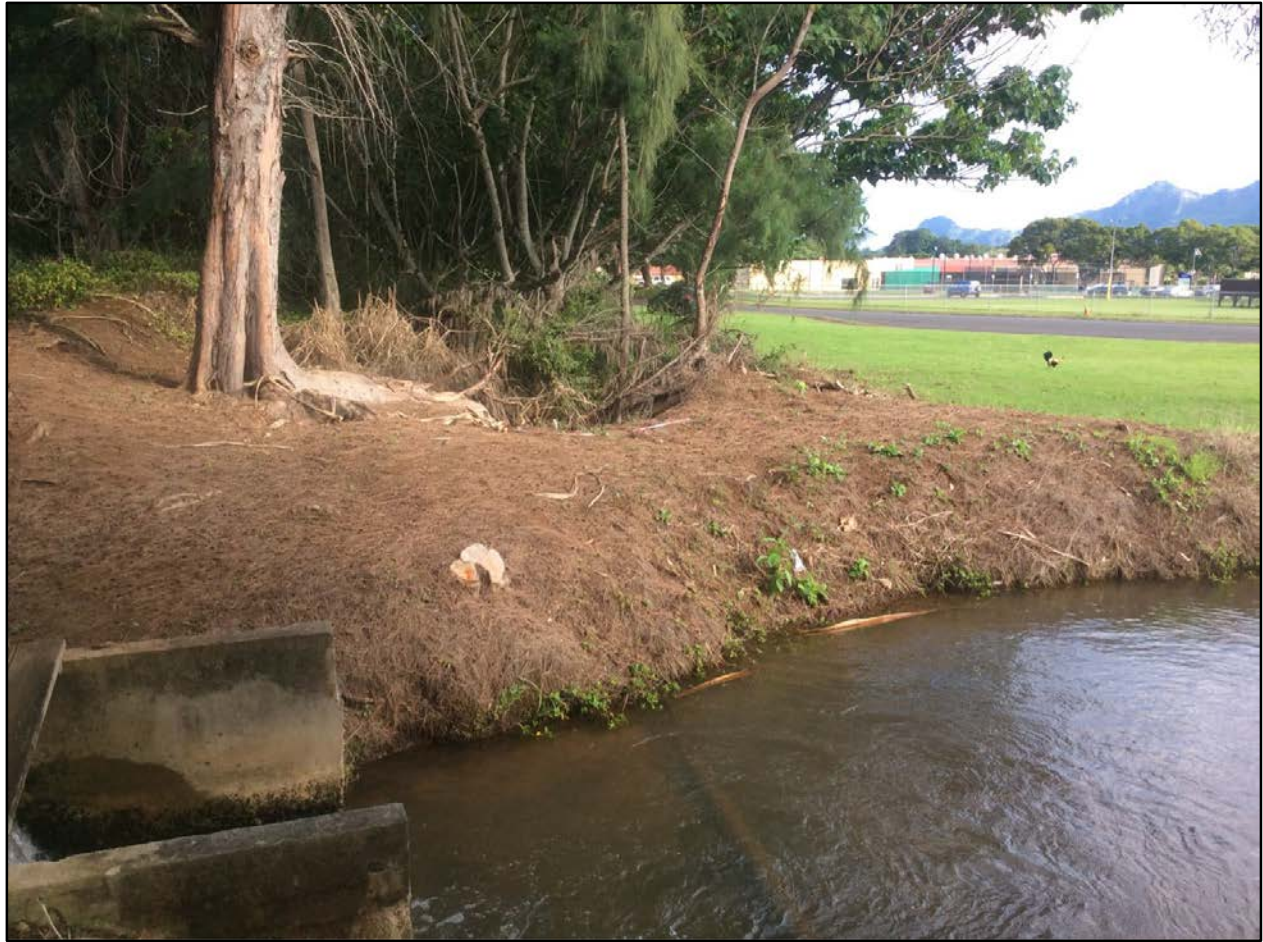
Figure 154. Small berm separating SIHP # 2179, Feature A (foreground) from SIHP # -2179 Feature E (background), view to southwest
