Section 6 Historic Property Descriptions

6.1 SIHP # 50-30-11-B006

6.2 SIHP # 50-30-11-2179

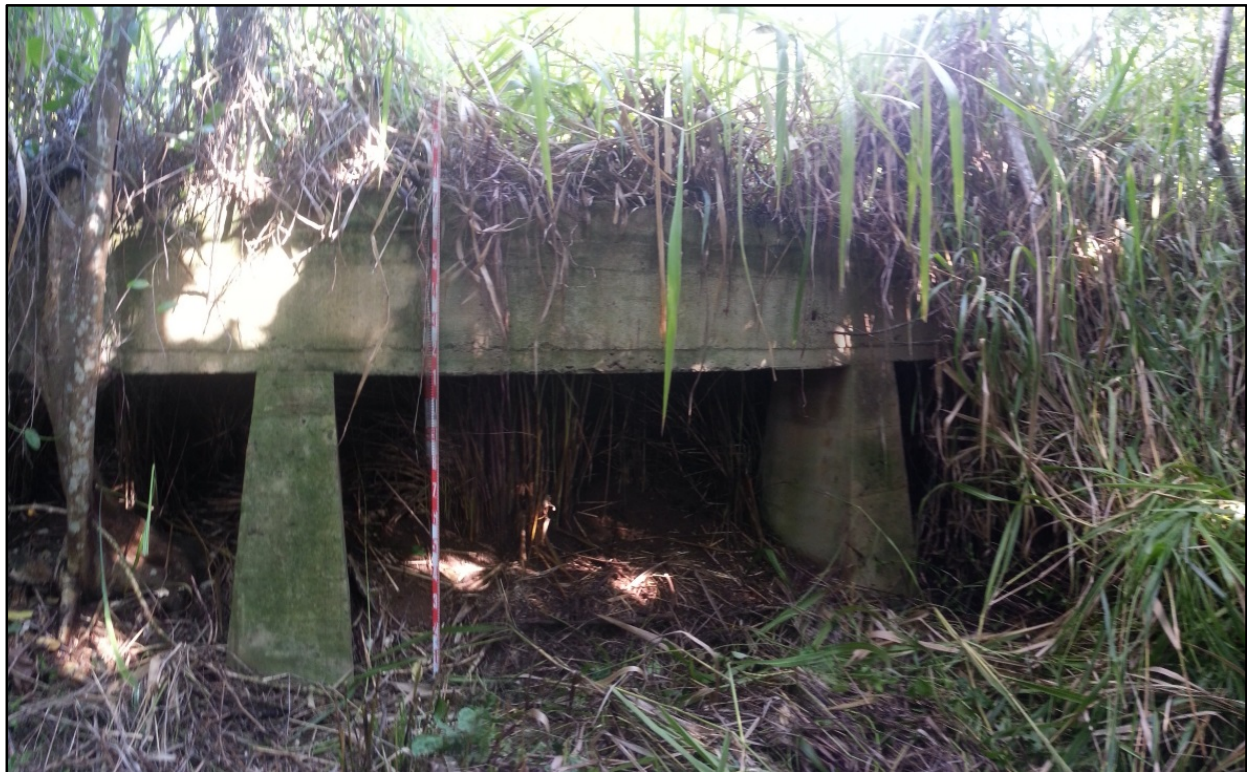
Figure 157. SIHP # -2179 Feature E1, flume, showing concrete footings, view to northwest

Sub-feature E1 is a formed concrete flume that extends along an 82-m section on the north side of the ditch (Figure 158 through Figure 161). A portion of the flume and a cross-section was documented (see Figure 160 and Figure 161). The flume is 0.6 m wide by 0.7 m high and rests on intermittent concrete footings that are from 0.1 to 0.6 m high (see Figure 158). Water was apparently diverted into the flume at one time with remnants of the ditch extant near the flume.

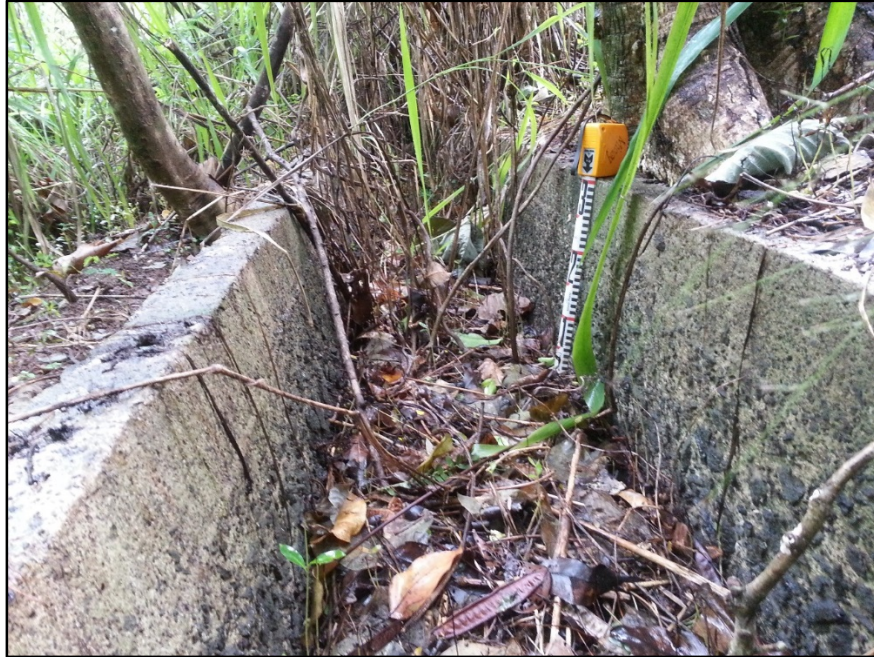
Figure 158. Portion of flume, SIHP # -2179 Feature E1, view to northwest

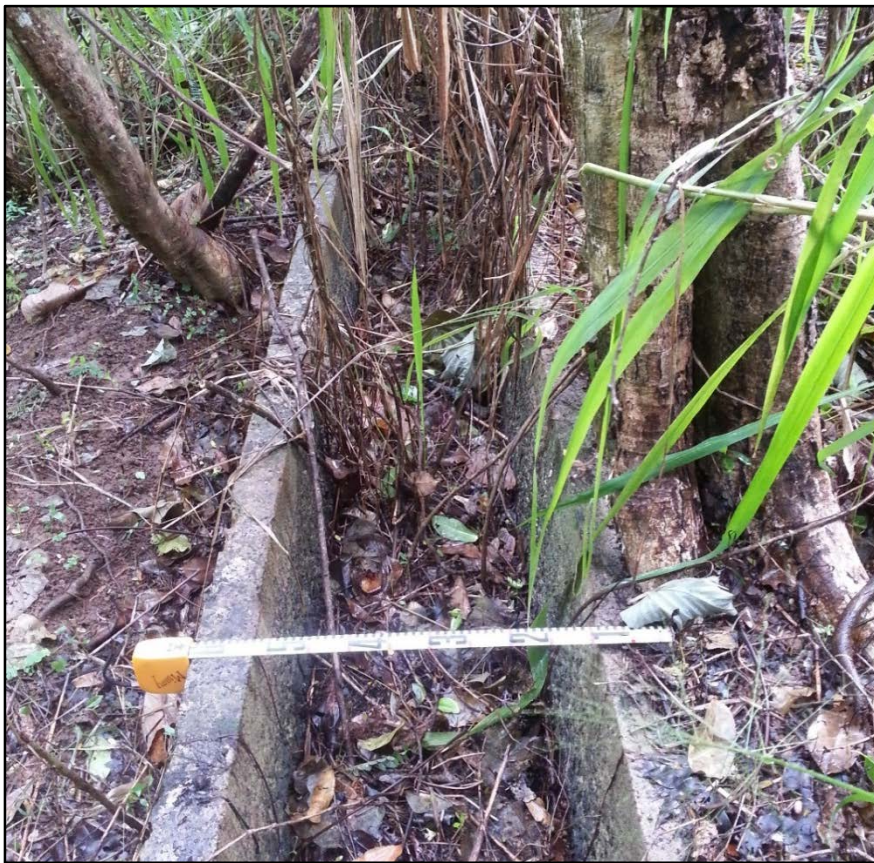
Figure 159. Portion of SIHP # -2179 Feature E1, view to east

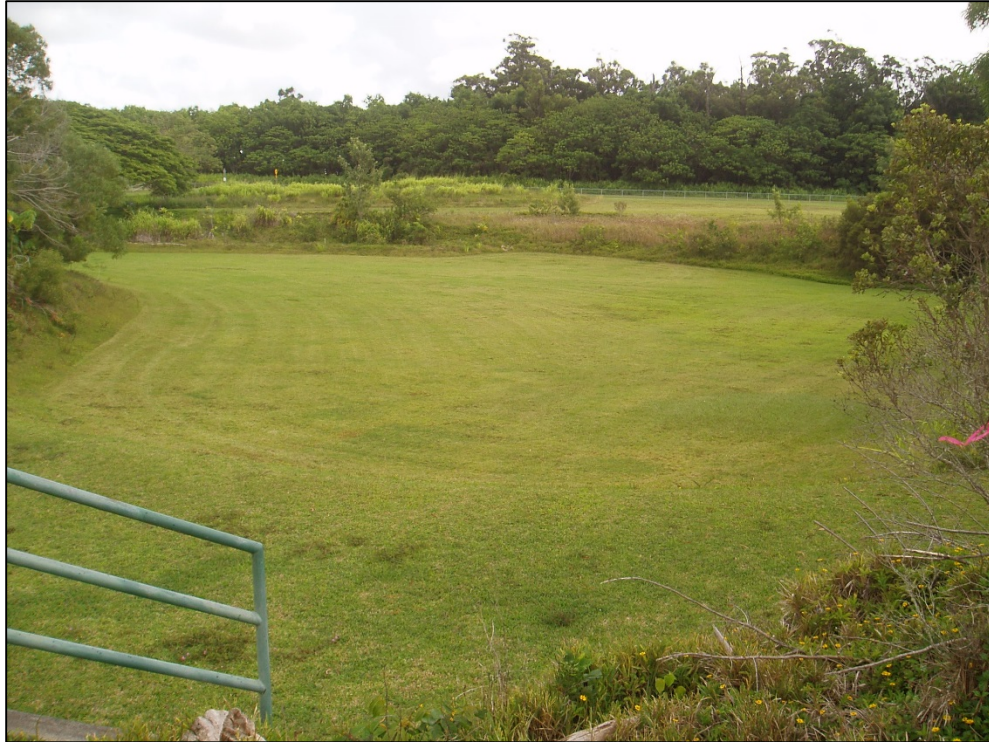
Figure 162. SIHP # -2179 Feature F former reservoir, view to northeast

Feature F has been terraced except for the area near the old gate and the north side (Figure 162). A depression that enters the former reservoir from the north side may have marked the alignment of the original feeder ditch, but is now a modern flood control feature dug into the reservoir floor. Other modern modifications include several storm drain outlets that flow into the reservoir, and a concrete overflow drain on the southwest side. Feature F is shown as an intermittent lake/pond on the 1996 Lihue USGS quadrangle (see Figure 1). The reservoir is also shown on the 1910 and 1963 Lihue USGS quadrangles (see Figure 10 and Figure 21).

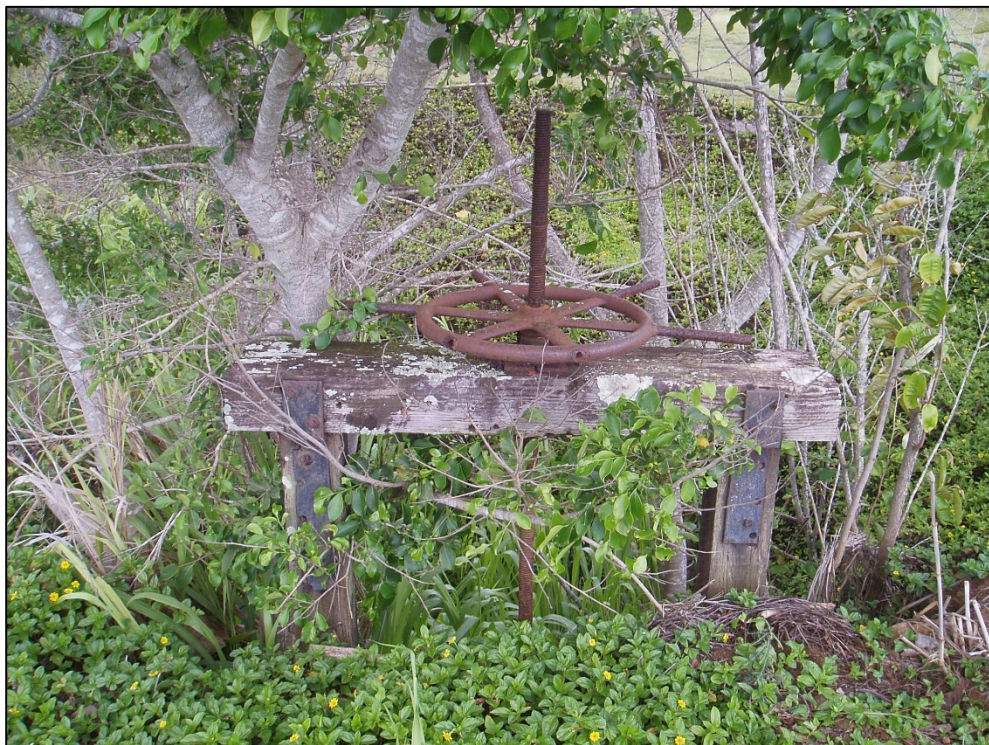
Figure 163. Sluice gate (Sub-feature F1) associated with Feature F, view to north

Sub-feature F1 is a sluice gate at the southeast side of Feature F (Figure 163 through Figure 166). The sluice gate is associated with a square-shaped basalt and mortar retaining wall that is approximately 3 m in length by 0.15 m wide and 4.2 m tall. The sluice gate is not directly on the retaining wall but is rather on a wooden structure attached to the retaining wall. Wooden posts and crossbeams make up the structure that holds the sluice gate. The sluice gate is composed of a metal plate that currently seals the inflow tunnel, and grooved metal rod that extends to a wheel approximately 82 cm above the top of the mortared basalt retaining wall.

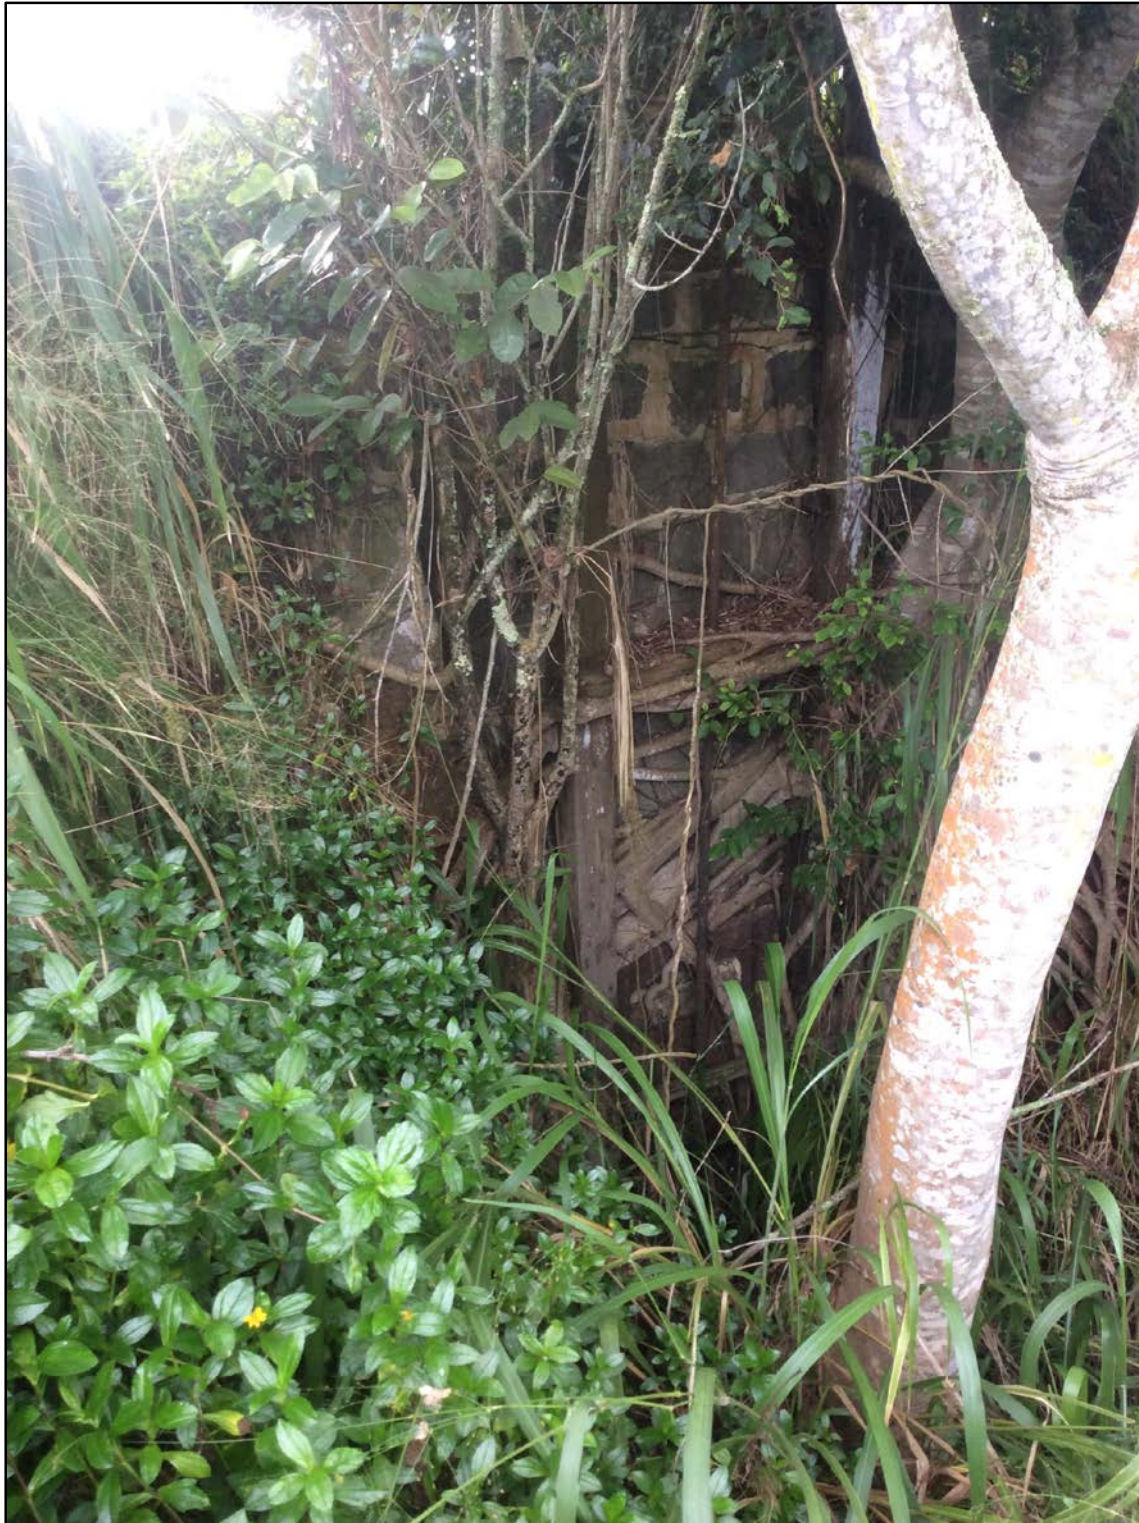
Figure 164. SIHP # -2179 Sub-feature F1 showing mortared basalt retaining wall and wooden beam structure holding sluice gate, view to southeast

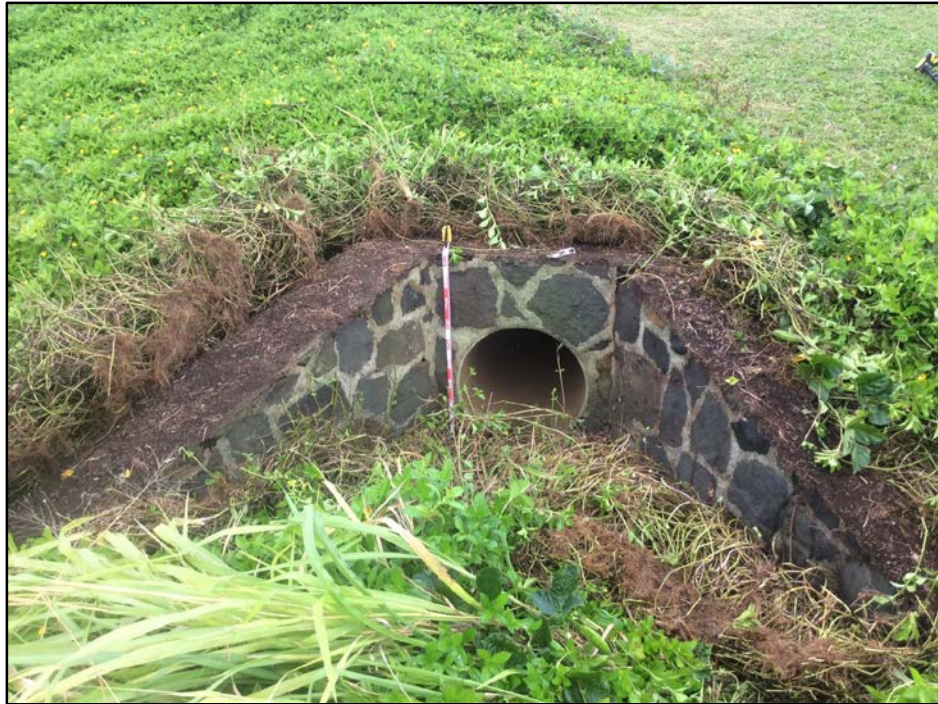
Figure 167. SIHP # -2179 Sub-feature F2, view to northwest

Sub-feature F2 is the culvert that is likely the outflow of Sub-feature F1 (Figure 167 through Figure 169). Sub-feature F2 is located south of Feature F and connects to a modern flood-control channel that extends toward the highway. The concrete-capped mortared basalt culvert is of similar materials and style as Sub-feature F2 and consists of a center portion and two angled and sloped sidewalls that extend outward in a V-shape from the center portion. The center portion is 1.2 m long and 0.3 m wide. The angled and sloped sidewalls are approximately 2.7 m in length and 0.3 m wide. The use of a concrete pipe and the general design characteristics suggests this culvert is more modern than Sub-feature F2 and likely was constructed when the reservoir was reconstructed into a flood control basin.

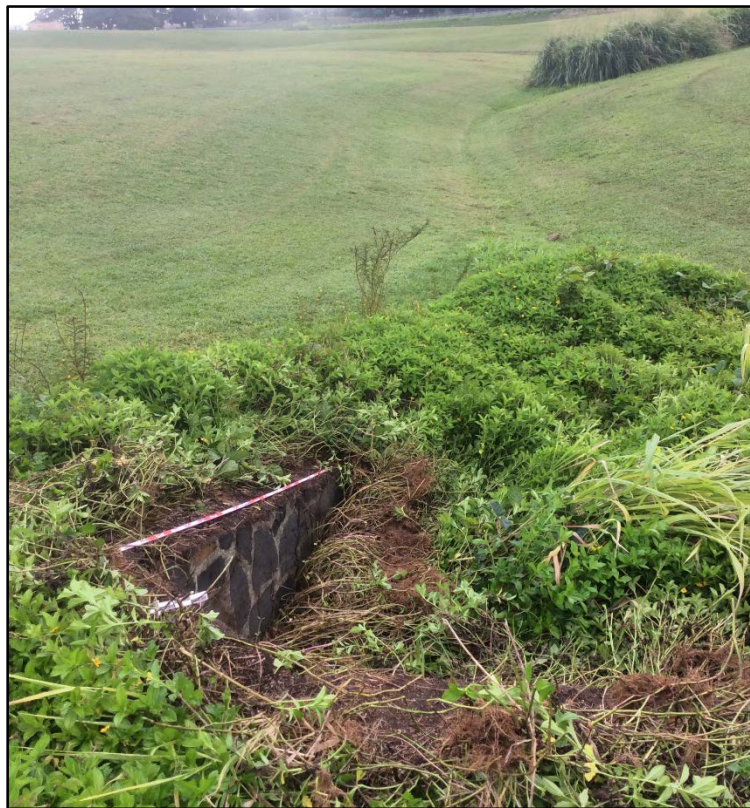
Figure 168. SIHP # -2179 Sub-feature F2, showing channel for floodwaters, view to southeast

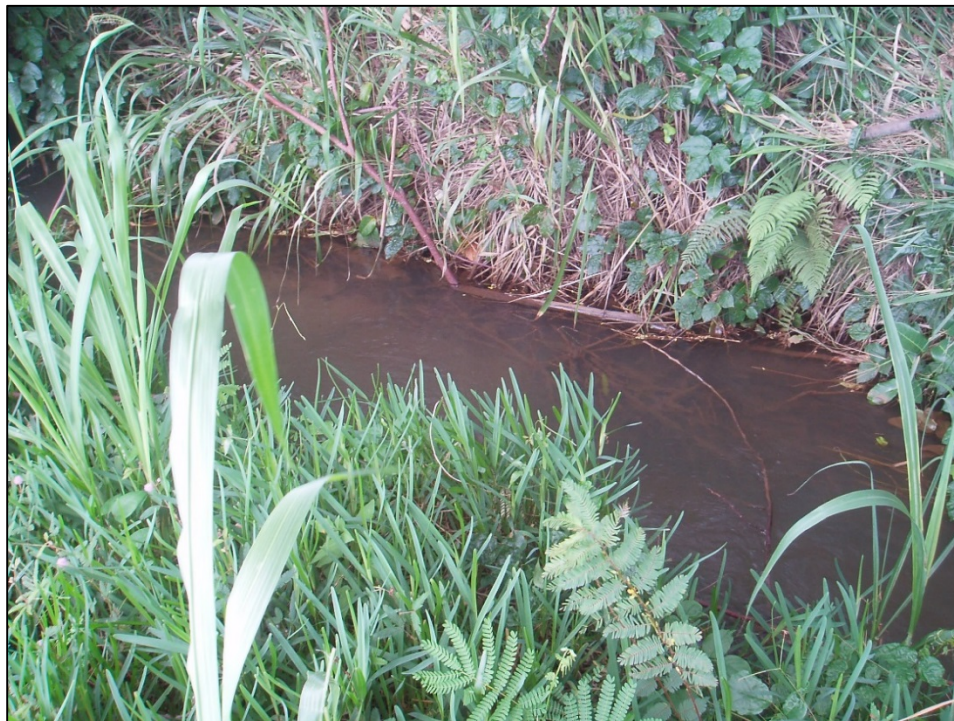
Figure 170. SIHP # 2179 Feature G, irrigation ditch, view to northwest

Feature G is a plantation-era irrigation ditch measuring approximately 400 m long that courses from a reservoir (Feature A) adjacent to the east boundary of KCC and terminates at a reservoir (Feature H) (Figure 170 and Figure 171). From Feature A, the ditch flows west along the north side of the road that encompasses the presently developed KCC campus. The ditch then continues south, where it meets up with Feature M (Figure 172), then terminates at Feature H (see Figure 96). The feature consists of one primary feature consisting of an irrigation ditch (Feature G), and two sub-features consisting of a sluice gate remnant (Sub-feature G1) and a culvert (Sub-feature G2).

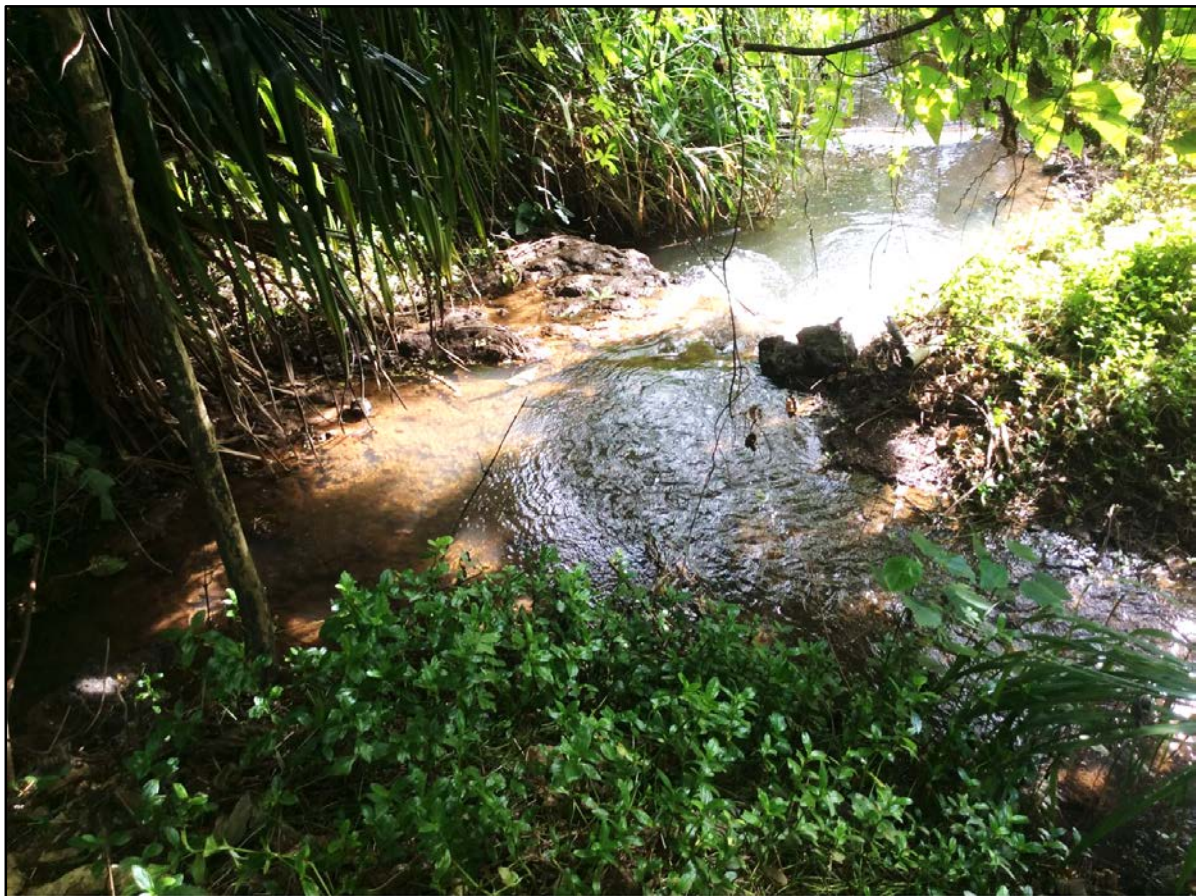
Figure 172. View of the confluence of SIHP # -2179 Features G and M, view to southwest

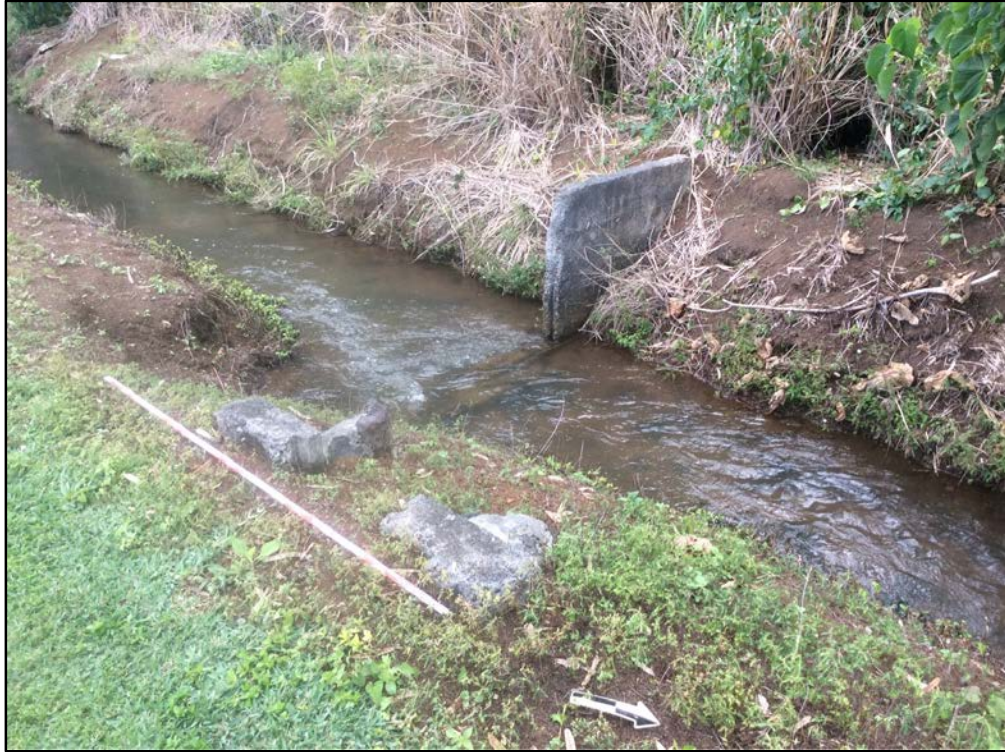
Figure 173. SIHP # -2179 Sub-feature G1, sluice gate remnant, view to west

Sub-feature G1 is an abandoned sluice gate remnant observed in the ditch's westward flowing portion. The remnants consist of three individual portions: a large concrete wall bisecting a portion of the ditch, and two former sluice gate structures that run parallel to the ditch (Figure 173 and Figure 175). The concrete wall portions consist of a wall with a notch for a sluice gate. The wall is 105 cm long by 15 cm wide and 128 cm tall at its maximum extents. The concrete wall drops at the south end, where a lower 15-cm wide concrete wall was observed. It is likely the sluice gate was located on this short wall. The wall is broken and likely met up with a wall on the south side similar to the northern wall. Along the south berm of Feature G are two buried sluice gate features. The features are broken and buried in the current berm. The two concrete 50-cm long by 15-cm wide features have sluice gate notches which suggests the two concrete features are former concrete housing for a sluice gate. These two concrete structures were likely a water diversion for irrigation of the southern fields (now the developed portion of the KCC campus).

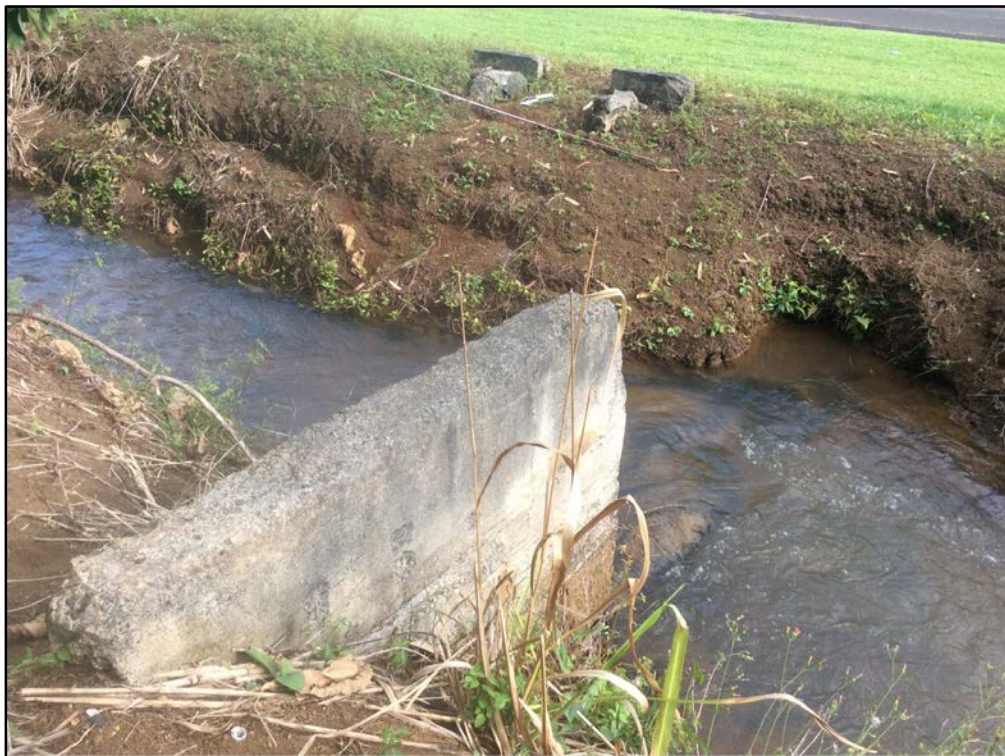
Figure 174. SIHP # -2179 Sub-feature G1, sluice gate remnants, view to east

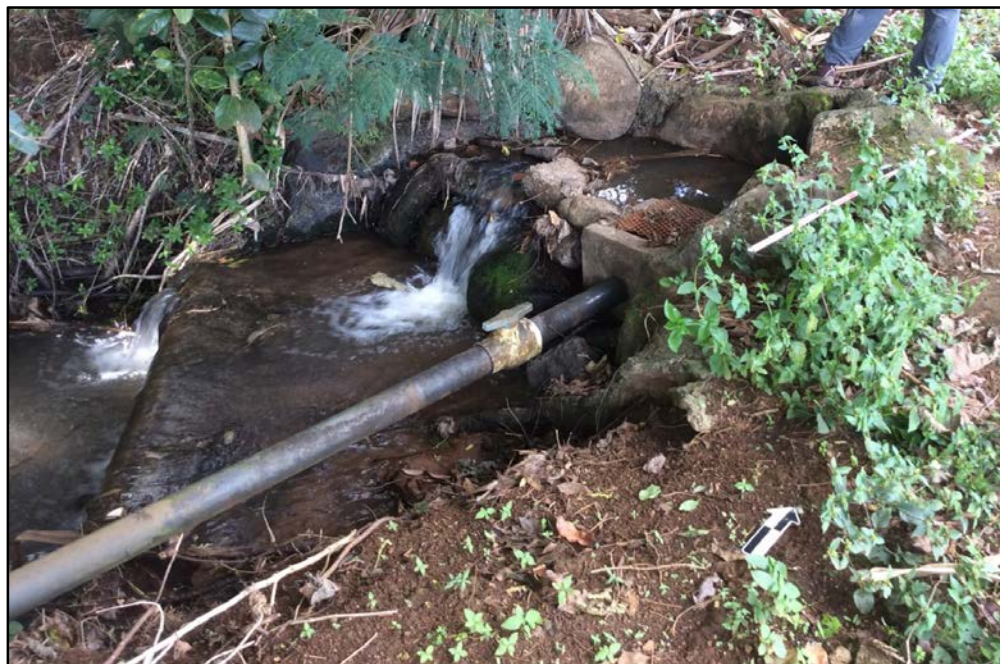
Sub-feature G2 is a culvert located where the former cane haul road extends north from the previously discussed paved road (Figure 176 and Figure 178). The feature consists of a U-shaped basalt retaining wall that channels the water into a metal pipe which carries the water to a second U-shaped basalt retaining wall. A modified cinder block connected to a plastic pipe diverts a portion of the water through a pipe to an unknown location. The majority of the water that flows through the culvert continues to the confluence with Feature M, until it meets with Feature H. The sub-feature is not shown on any maps or photographs; however, the road that passes over the culvert is shown crossing the ditch on a 1933 Land Court Application 1087 Map 1. It is possible Sub-feature G2 was extant at the time the map was created. The feature is still in use.

Figure 176. SIHP # -2179 Feature G2, west end of culvert showing modern pipe for diverting and transporting water, view to northwest

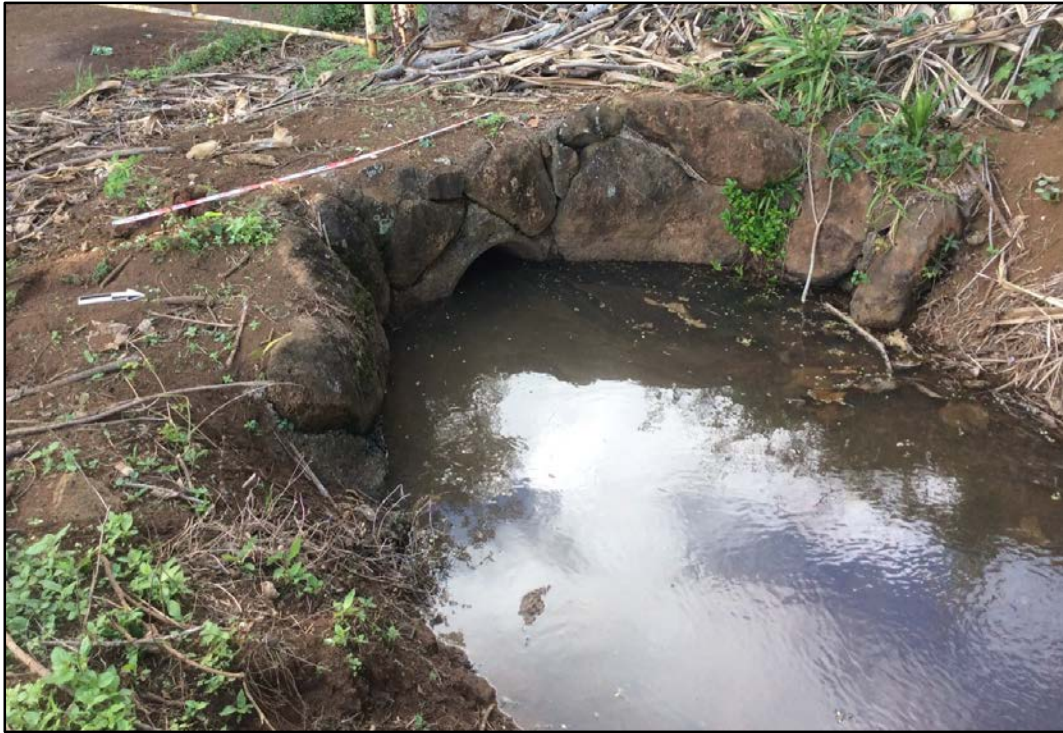
Figure 177. SIHP # -2179 Feature G2, east end of culvert, view to west

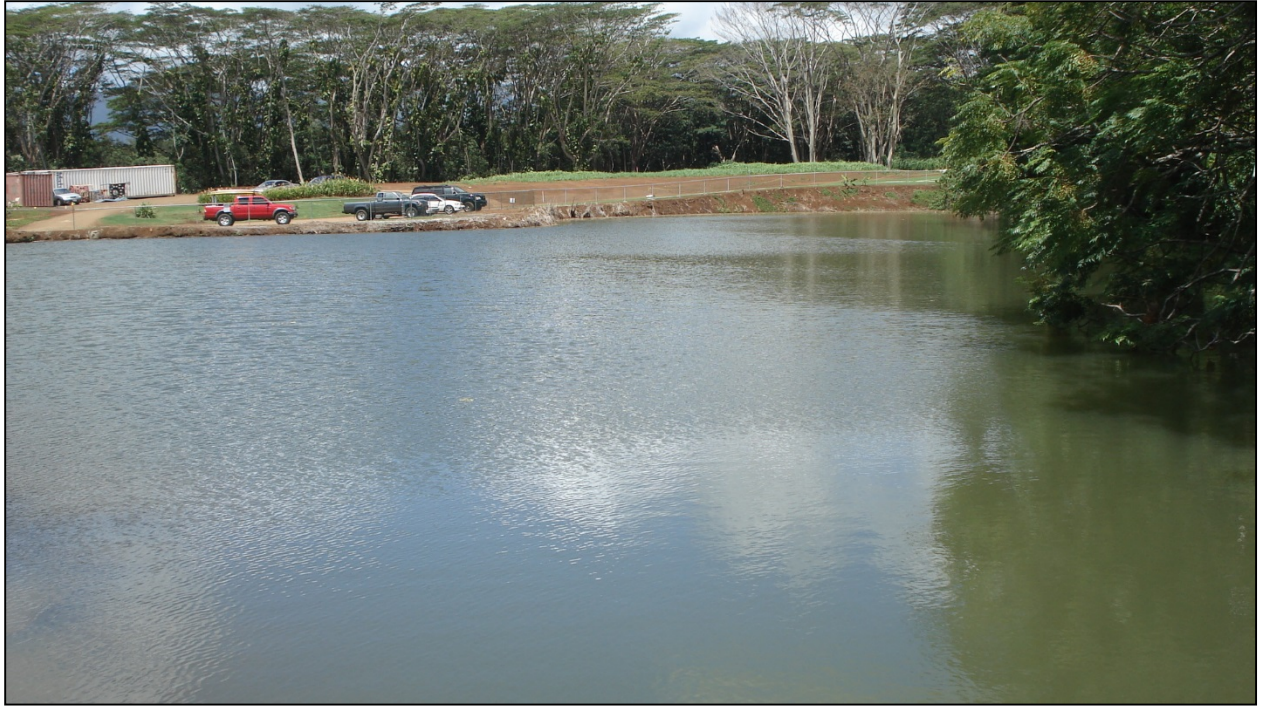
Figure 179. SIHP # -2179 Feature H, reservoir in center of project area at fullest extent, view to north

Feature H is a plantation-era reservoir located just to the east of Pūnana Leo Pre-School and Kawaikini Charter School within the project area (Figure 179 and Figure 180). The active reservoir is situated in the center of the project area (see Figure 96). The feature consists of one primary feature consisting of an in-use reservoir (Feature H), and one sub-feature consisting of a concrete and metal water control gate and flume (Sub-feature H1).

Feature H measures approximately 126 m by 56 m. The water level fluctuates drastically on a regular basis, with water levels during the course of fieldwork ranging from full to approximately 2 m below the highest water level. Drastic variations were observed within days. A symbol for a reservoir is shown in the location of Feature H on the 1910 (see Figure 10), the 1963 (see Figure 21), and the 1996 (see Figure 1) Lihue USGS maps. The reservoir may be associated with the "Mauka Ditch" as illustrated on an undated Grove Farm map (see Figure 20).

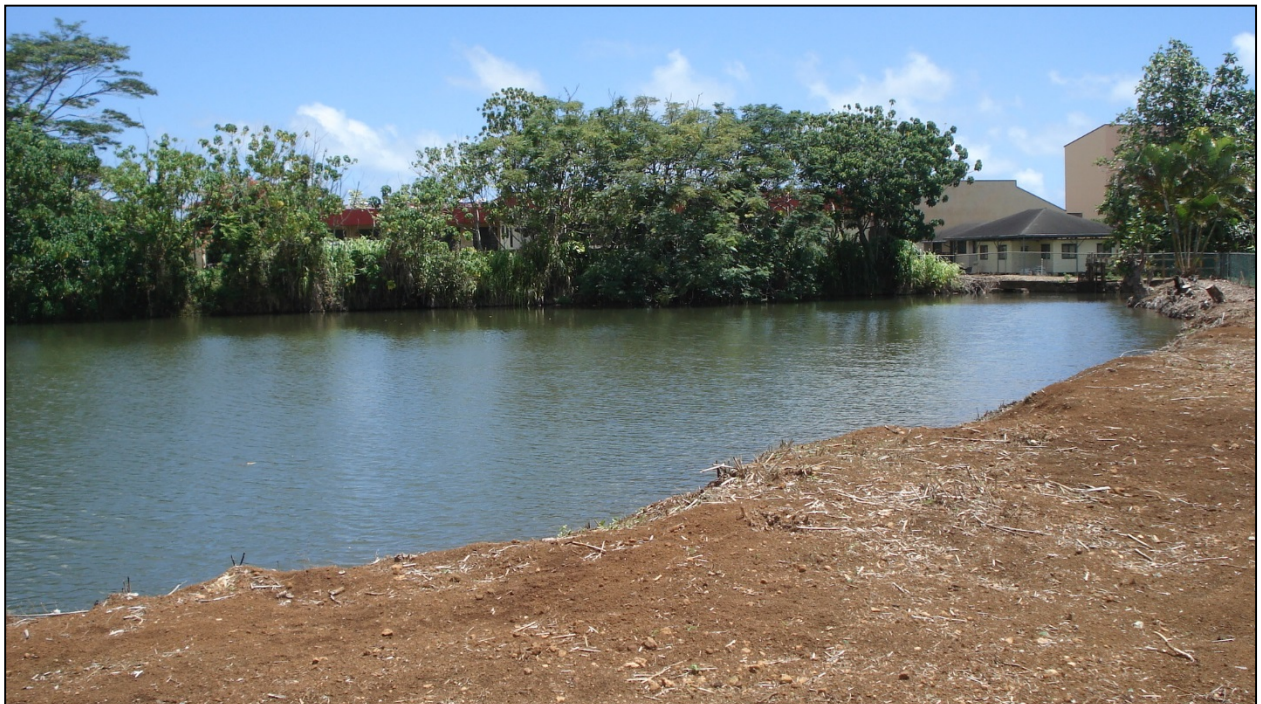
Figure 180. SIHP # -2179 Feature H, reservoir in center of project area, showing Sub-feature H1 in background, view to southeast

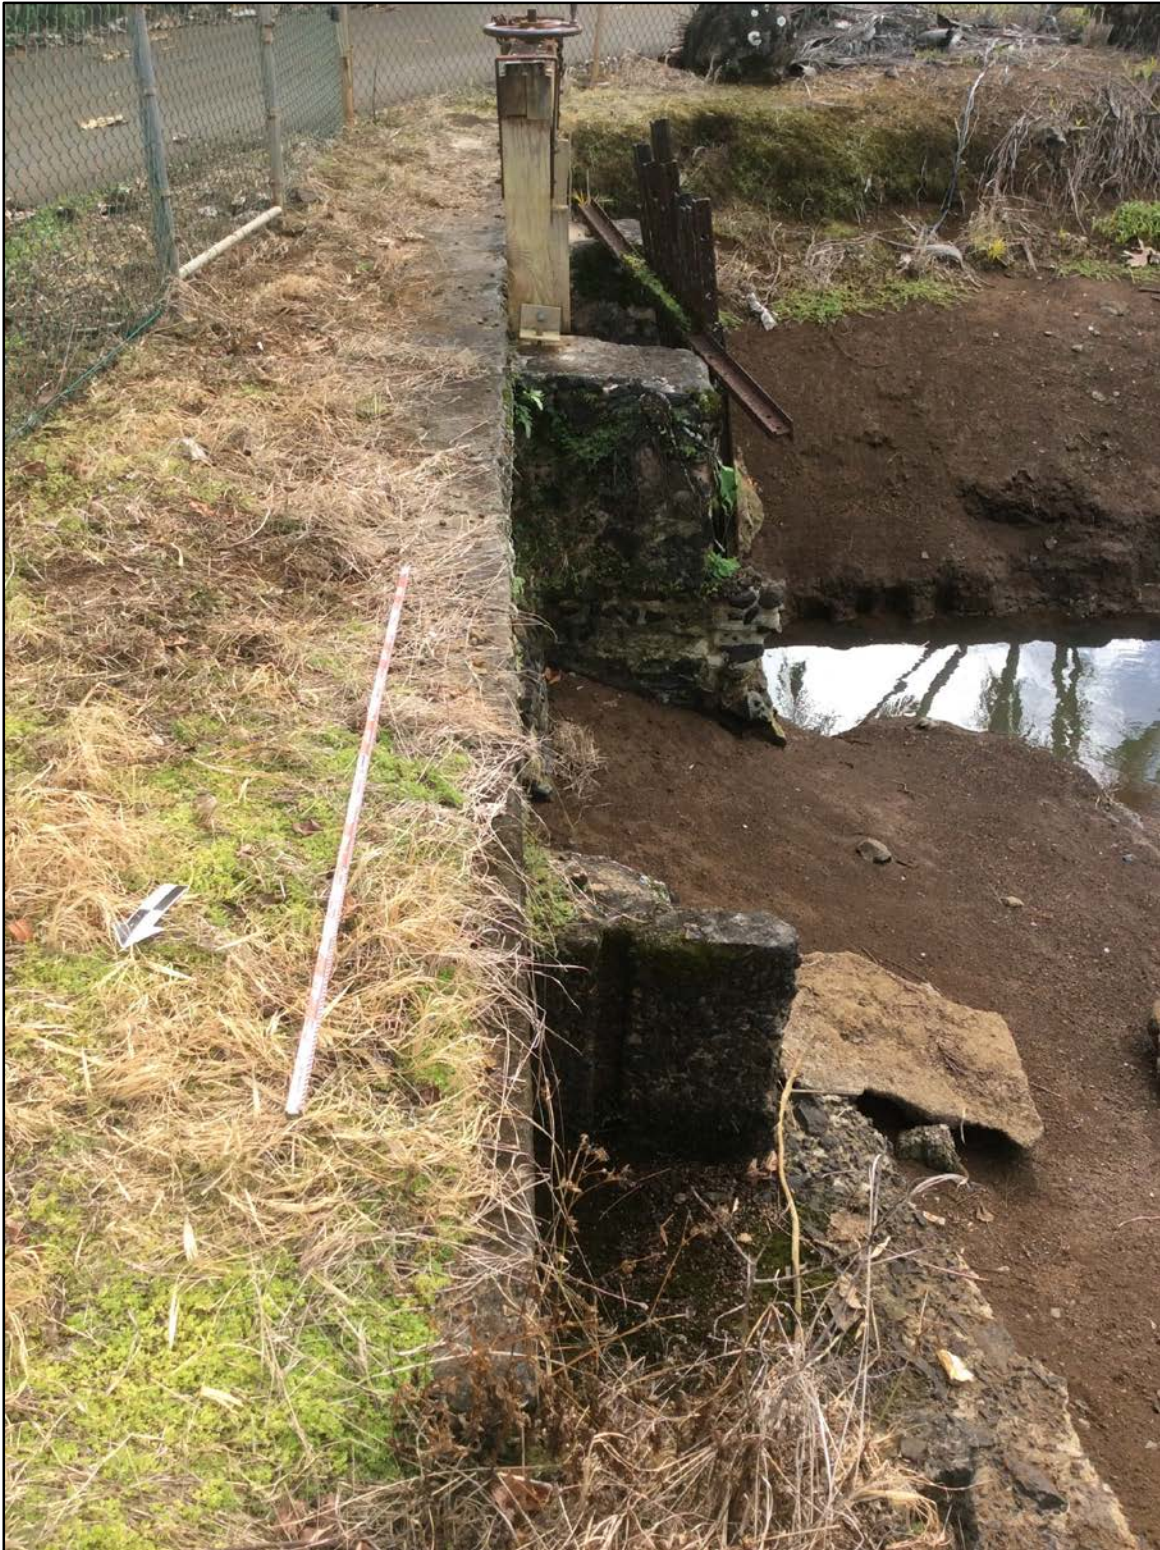
Figure 181. SIHP # -2179 Sub-feature H1, retaining wall, view to south

Sub-feature H1 consists of a mortared basalt, concrete and metal water control sluice gate and concrete flume (Figure 181 through Figure 187). The structure is located along the south side of the reservoir (see Figure 96). Water from the reservoir flows out through the gate under the road that leads to Pūnana Leo Pre-School and exits in a concrete flume to flow down into Feature I, an in-use earthen ditch (see Figure 186 and Figure 187). The sluice gate and the intake for the flume are located at a retaining wall structure constructed of mortared basalt that measures 10.5 m by

0.7 m and has a maximum height of 4.2 m. The water control sluice gate is located on the north portion of the wall. The sluice gate is constructed of metal, including a gate, grooved pole, and wheel that is housed on atop wooden beams secured to the retaining wall. There are 12 steel rails resting against a horizontal rail, with the probable function of preventing debris from clogging the pipe that extends under the road. The rails are likely reused from the plantation railroads. Two short mortared basalt walls extend into the reservoir on either side of the gate feature, likely installed to help channel the water. A modern concrete retaining wall was observed adjacent to the roadway on the west side, however, this wall is not associated with the sub-feature.

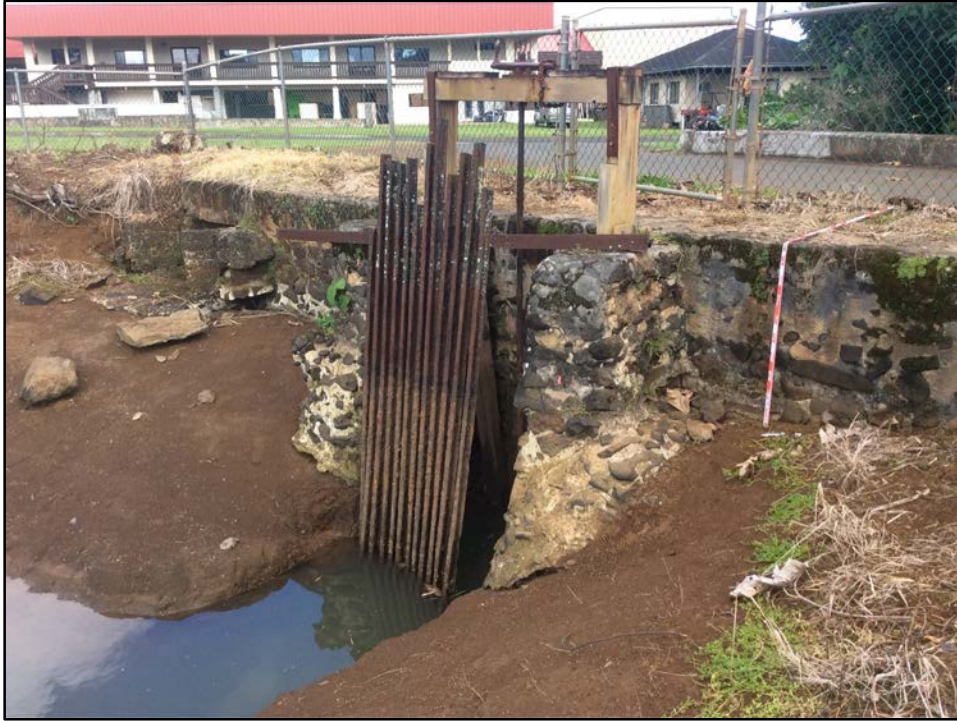
Figure 182. SIHP # -2179 Sub-feature H1, showing retaining wall, sluice gate (right), and flume (left) with lower water level in Feature H, view to northeast

The flume associated with Sub-feature H1 is located on the south end of the retaining wall and extends under the paved road, and meets up with Feature I. The intake for the flume is located substantially higher than the gate, likely a flood control feature, to prevent the reservoir from overflowing its banks. The flume measures about 26 m long by 1 m wide with a maximum height of 3.9 m where it drops down into Feature I. The flume appears to post-date the retaining wall and sluice gate structure and abuts the retaining wall. The flume is constructed of basalt gravel and mortar. The stones are substantially smaller than the adjacent structure. The intake is approximately 1 m wide by 0.7 m tall. The date "1938" is engraved on the concrete sidewall of the intake (see Figure 184). On the west side of the road the flume is an open trough that extends in a north-south direction for approximately 2 m, before dropping into Feature I. The water from the previously described sluice gate flows through the base of the flume at this location as well.

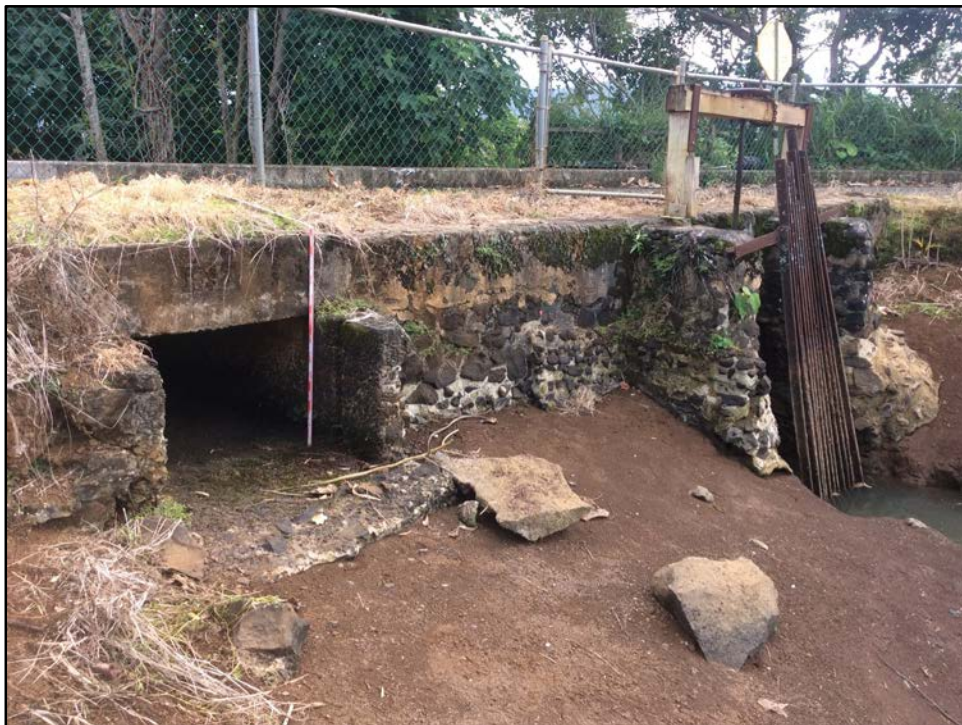
Figure 183. SIHP # -2179 Sub-feature H1, showing retaining wall, sluice gate (right), and flume (left) with lower water level in Feature H, view to southeast

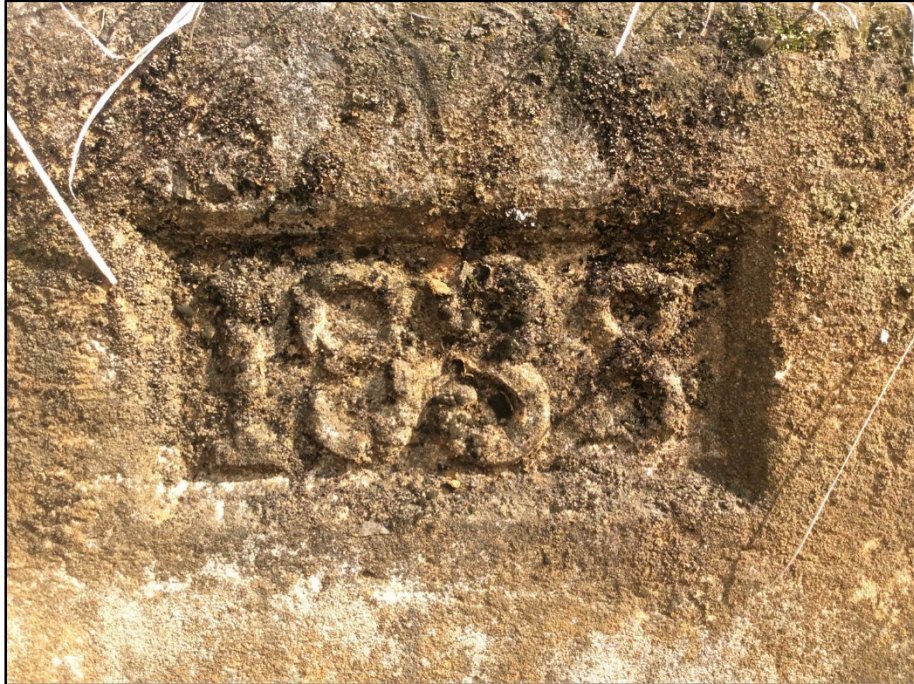
Figure 184. Date engraved in flume associated with SIHP # -2179 Sub-feature H1

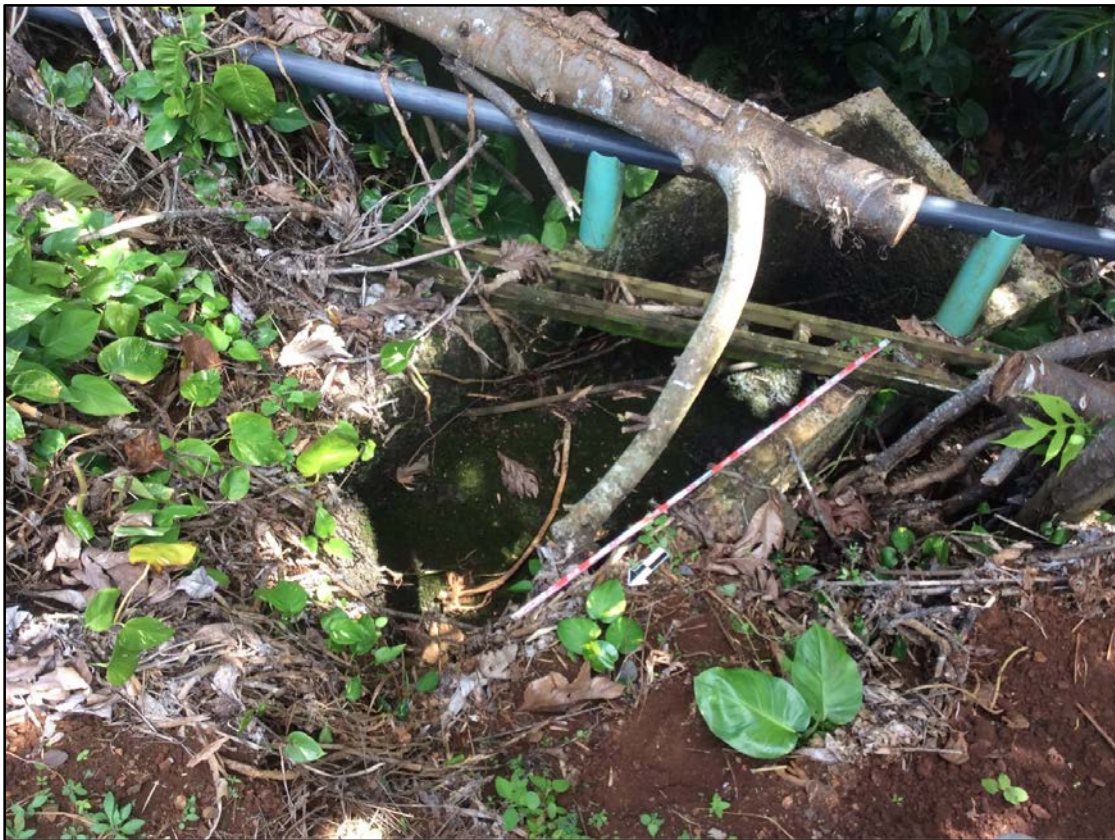
Figure 185. SIHP # -2179 Sub-feature H1, flume on west end of road, view to southeast
