Section 6 Historic Property Descriptions

6.1 SIHP # 50-30-11-B006

6.2 SIHP # 50-30-11-2179

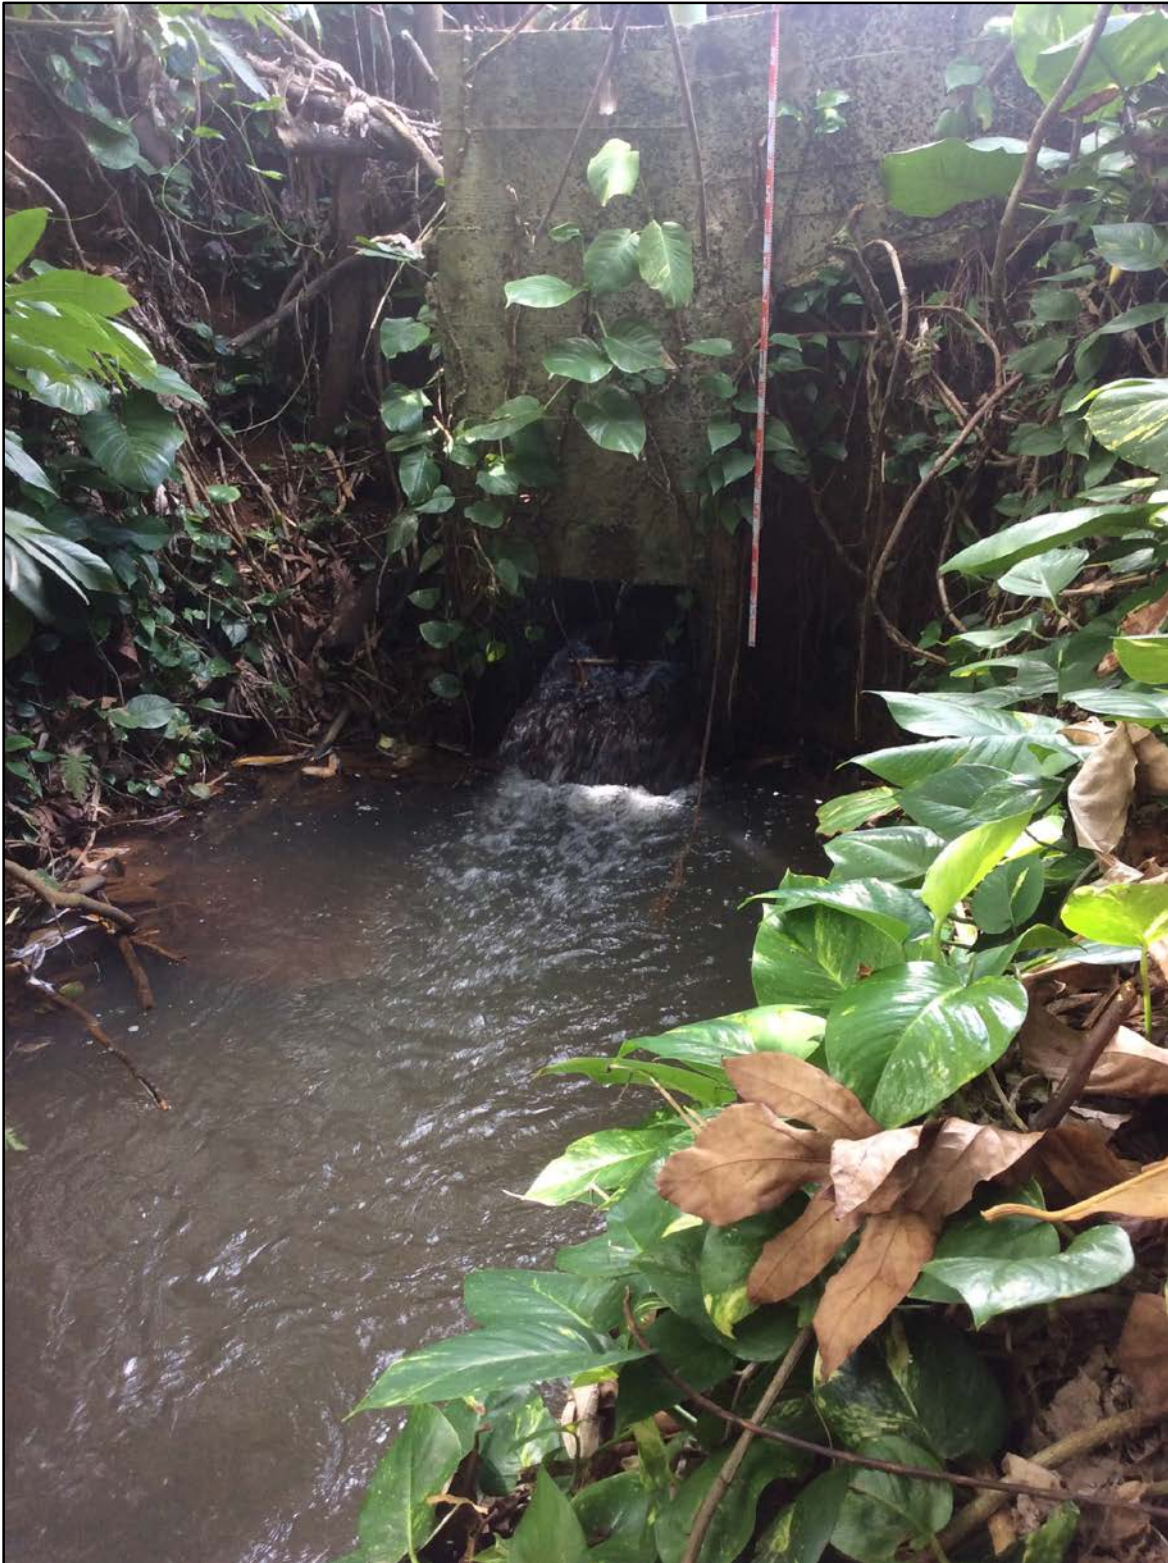
Figure 186. Profile view of sluice gate outtake and flume at the origin of Feature I, irrigation ditch, view to west

Sub-feature H1 consists of a mortared basalt, concrete and metal water control sluice gate and concrete flume (Figure 181 through Figure 187). The structure is located along the south side of the reservoir (see Figure 96). Water from the reservoir flows out through the gate under the road that leads to Pūnana Leo Pre-School and exits in a concrete flume to flow down into Feature I, an in-use earthen ditch (see Figure 186 and Figure 187). The sluice gate and the intake for the flume are located at a retaining wall structure constructed of mortared basalt that measures 10.5 m by

The flume associated with Sub-feature H1 is located on the south end of the retaining wall and extends under the paved road, and meets up with Feature I. The intake for the flume is located substantially higher than the gate, likely a flood control feature, to prevent the reservoir from overflowing its banks. The flume measures about 26 m long by 1 m wide with a maximum height of 3.9 m where it drops down into Feature I. The flume appears to post-date the retaining wall and sluice gate structure and abuts the retaining wall. The flume is constructed of basalt gravel and mortar. The stones are substantially smaller than the adjacent structure. The intake is approximately 1 m wide by 0.7 m tall. The date "1938" is engraved on the concrete sidewall of the intake (see Figure 184). On the west side of the road the flume is an open trough that extends in a north-south direction for approximately 2 m, before dropping into Feature I. The water from the previously described sluice gate flows through the base of the flume at this location as well.

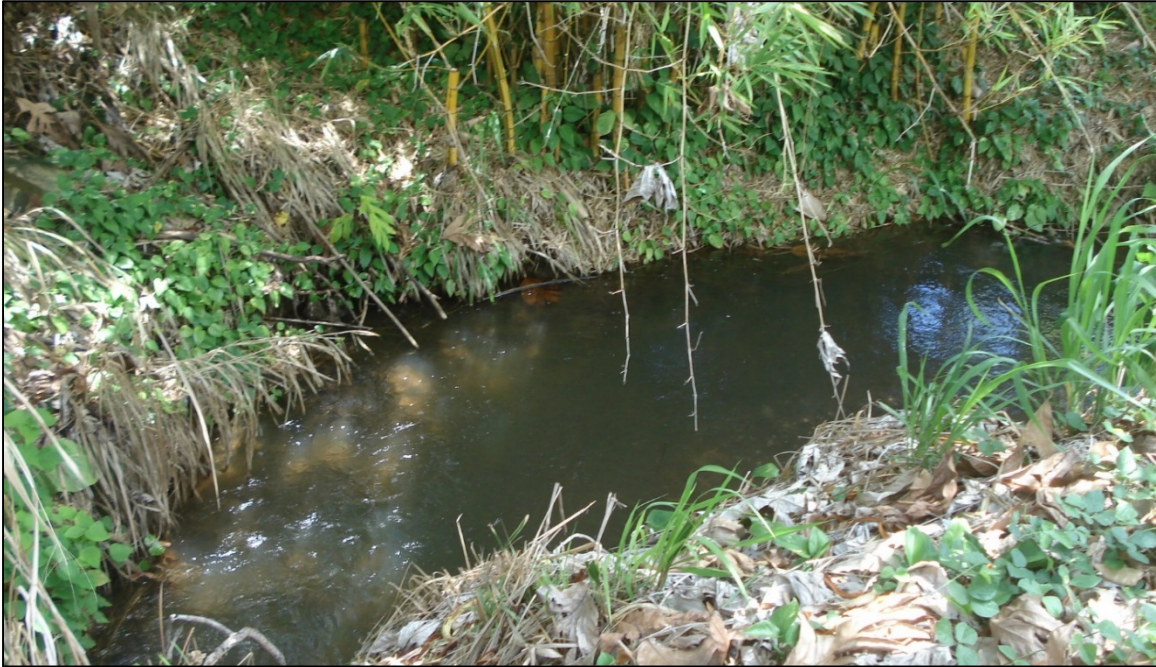
Figure 188. SIHP # -2179 Feature I, showing bend in ditch southwest of Sub-feature H1 and northeast of Sub-feature II, view to west

Feature I primarily follows a natural hollow that has been modified for use as an irrigation ditch (Figure 188 and Figure 189). The ditch follows the natural contours of the area. The length of the ditch measures 314.5 m with widths that vary from 1.0 m to 3.5 m and depths that vary from 0.7 m to 1.5 m. The ditch is observed in its current extent on the 1930 Plan of Puhī Camp by W.M. Moragne (see Figure 11) and the 1933 Land Court Application 1087 Map 1 (see Figure 16). A stream or ditch is illustrated on the 1901 Wall map of Grove Farm (see Figure 8); however, the illustrated stream is shorter and in a slightly different path from the current Feature I. It is unclear whether this stream is Feature I, or a natural intermittent stream that follows the previously described natural hollow. The ditch meanders southeast from Feature H and flows to Sub-feature I1.

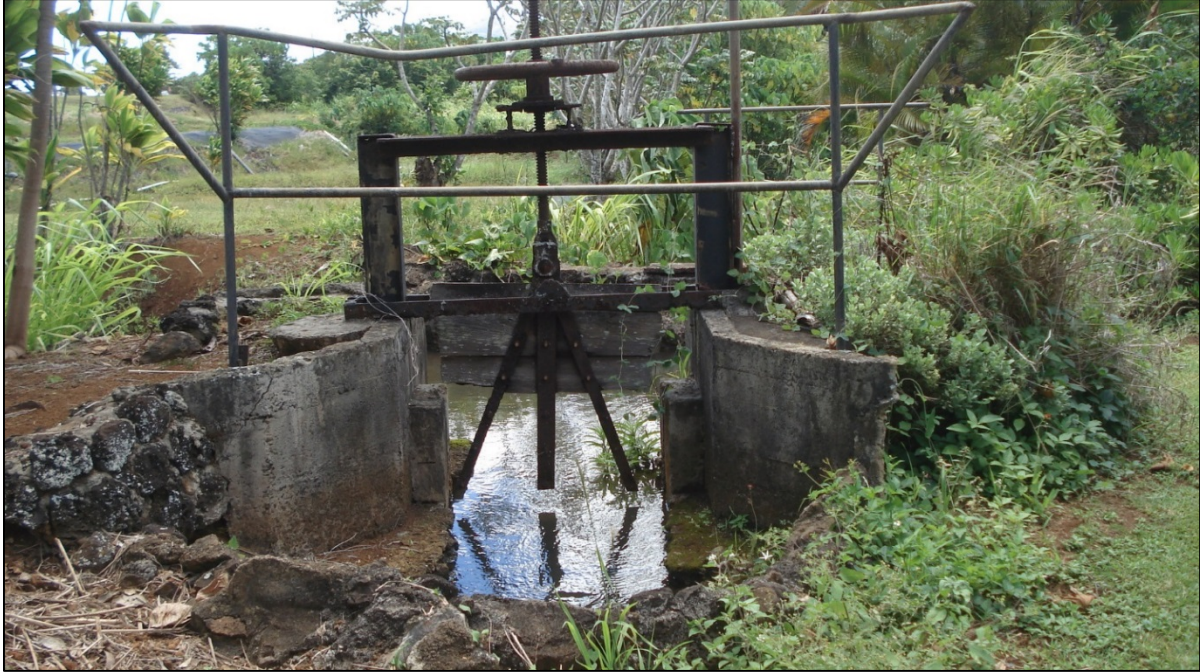
Figure 190. SIHP # -2179 Sub-feature I1, north sluice gate, diverting water to pipe that flows under grass road to Feature J, view to east, photo adapted from Groza and Hammatt 2010 (note wooden bridge over the south sluice gate had not yet been constructed)

Sub-feature I1 consists of two sluice gates that divert a portion of the water flow of Feature I into Feature J, a pond and former ditch (Figure 190 through Figure 193). The sluice gates are located on the north side of Feature J, approximately 55 m south of Feature H. The sub-feature is

L-shaped measuring approximately 2.85 m long by 1.0 m wide on the north end and 2.0 m wide on the south end. The walls of the feature are approximately 60 cm above the grass road surface to the west. The north sluice gate allows water flow to Feature J, and the south sluice gate allows water flow to continue within Feature I.

The north vertical rising sluice gates are intact, constructed of wood and metal and comprised of a metal plate, screw and hand-cranked wheel, housed on a wooden frame. The frame is mounted atop a concrete foundation structure. The metal screw rises 2.0 m above the concrete foundation with the gate opened. The water flows from Feature I, through the north sluice gate into a small basalt cobble-lined reservoir where the water flows through a metal pipe under the grass road and into Feature J. The south sluice gate is comprised of a wooden gate that currently acts as a weir, held in place by an in-channel recessed groove within the approximately 2.0-m long by 0.15-m wide and 2.75-m tall concrete foundation and retaining wall. The water that continues to flow within Feature I flows over the gate and drops approximately 1.4 m into a deep channel. The concrete foundation of the sluice gate also functions as a retaining wall. A basalt cobble wall with concrete infill comprises the west wall connecting the two sluice gate foundations. A modern wooden bridge was constructed atop the south wall to allow for pedestrian traffic over the sub-feature. On the 1930 map, the diversion of Feature I is illustrated which shows the continuation of Feature I, as well as a ditch that follows a similar path as Feature J, a third ditch which flowed from Feature H, a ditch which flowed west from Sub-feature I1 to the gulch edge and then south to the highway, and a ditch that went east from Feature H, likely terminating at Feature F. No remnants of the latter three ditches were observed during the current AIS. Sub-feature I1 was likely constructed at the time this ditch complex was constructed, suggesting the sub-feature pre-dates 1930; however, it may be a more modern modification.

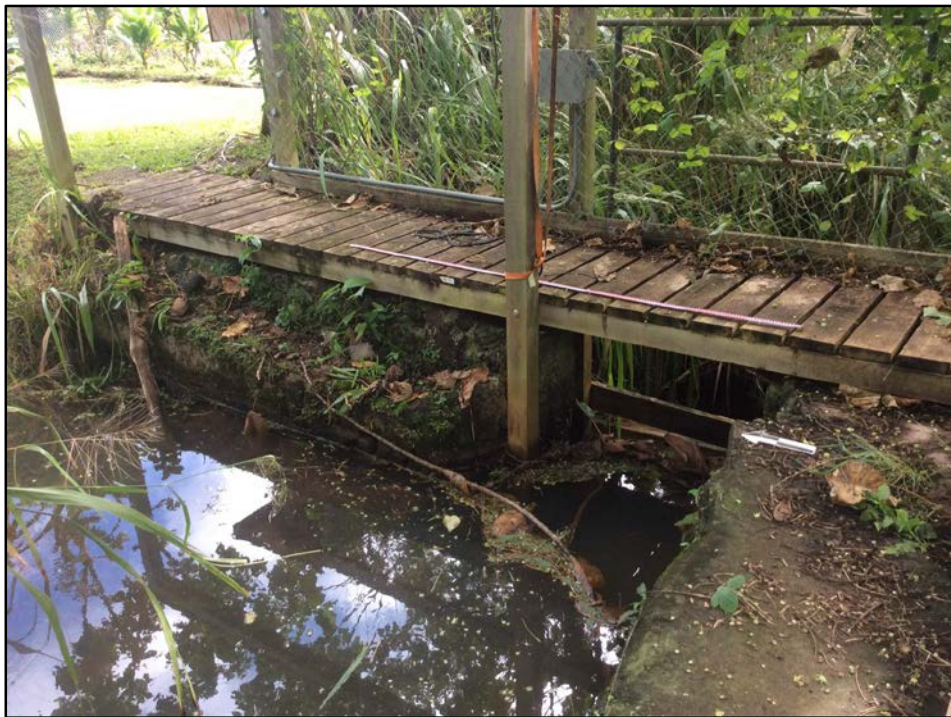
Figure 191. SIHP # -2179 Sub-feature I1, south sluice gate and modern wooden bridge, maintaining water flow to Feature I, view to northeast

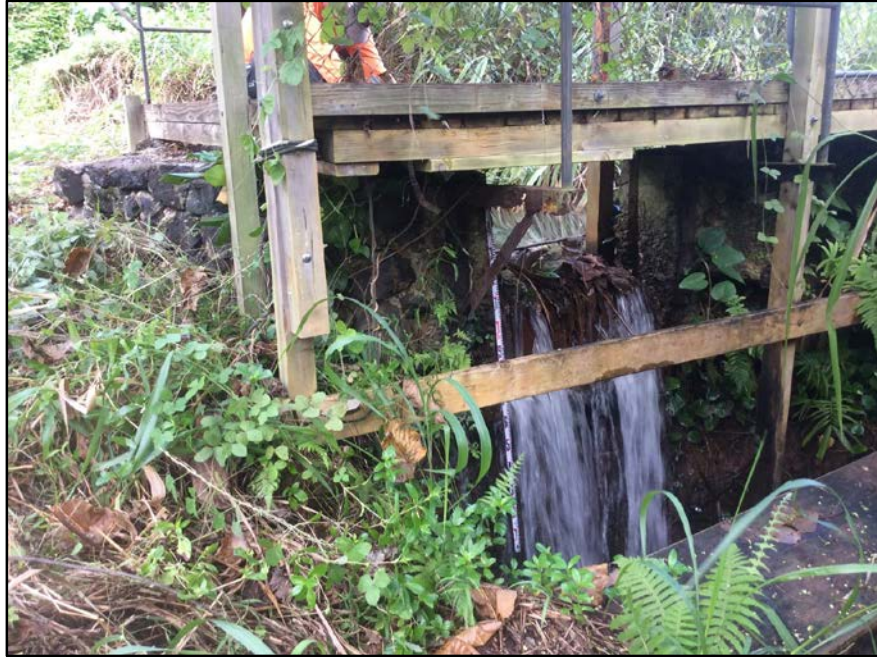
Figure 192. SIHP # -2179 Sub-feature I1, south sluice gate, maintaining water flow through Feature I, view to north

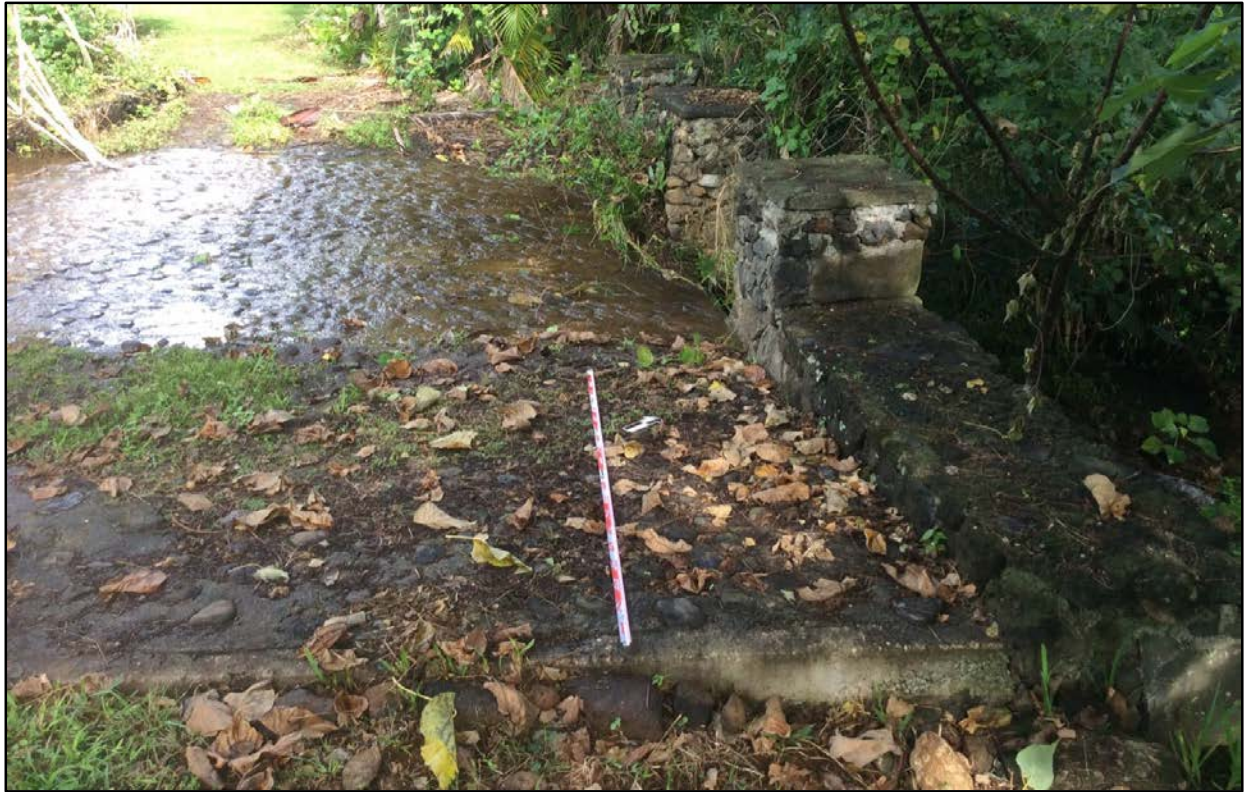
Figure 194. SIHP # -2179 Sub-feature I2, stream ford, view to northwest

Sub-feature I2 consists of a mortared basalt stone stream ford and associated retaining wall (Figure 194 through Figure 197). The stream ford is located on the south side of Feature J, approximately 22 m southwest of Sub-feature I1 on the west side of Feature I. The stream ford structure is rectangular, 9.2 m long by 7.7 m wide with a maximum height of 2.0 m. The central portion of the sub-feature is even with the grass road and slopes to a maximum depth at the center of the structure of 25 cm below the grass road. The water diverted into Feature J and Sub-feature I1 flows across the structure in this area perpendicular to the grass road to reunite with Feature I. Two square short pillar-like structures were observed on the southwest side, and act to divert the water into the center of the structure. A short ramp was observed between the two short pillars rising approximately 25 cm from the bottom of the pond to also facilitate in water flow. The water, after passing across the roadway, is then diverted into two openings in the retaining wall on the northeast side. The retaining wall has a maximum height of 45 cm from the road surface (southwest side) and 155 cm on the northeast side. The two openings that allow water to flow to Feature I are created by three mortared basalt stone pillars. The pillars have a maximum height of 85 cm on the southwest side and 200 cm on the northeast side and are approximately 0.6 m long by 0.8 m wide. In between each of the pillars is a step, 60 cm below the road surface. The water flows over the step and into a mortared, stone-lined channel that terminates perpendicular to Feature I. The confluence of Features J and I at this location is shown on the 1930 Moragne map of Puhi Camp (see Figure 11). Sub-feature I2 was likely constructed at the same time as this ditch complex, suggesting the ford pre-dates 1930; however, it may be a more modern modification.

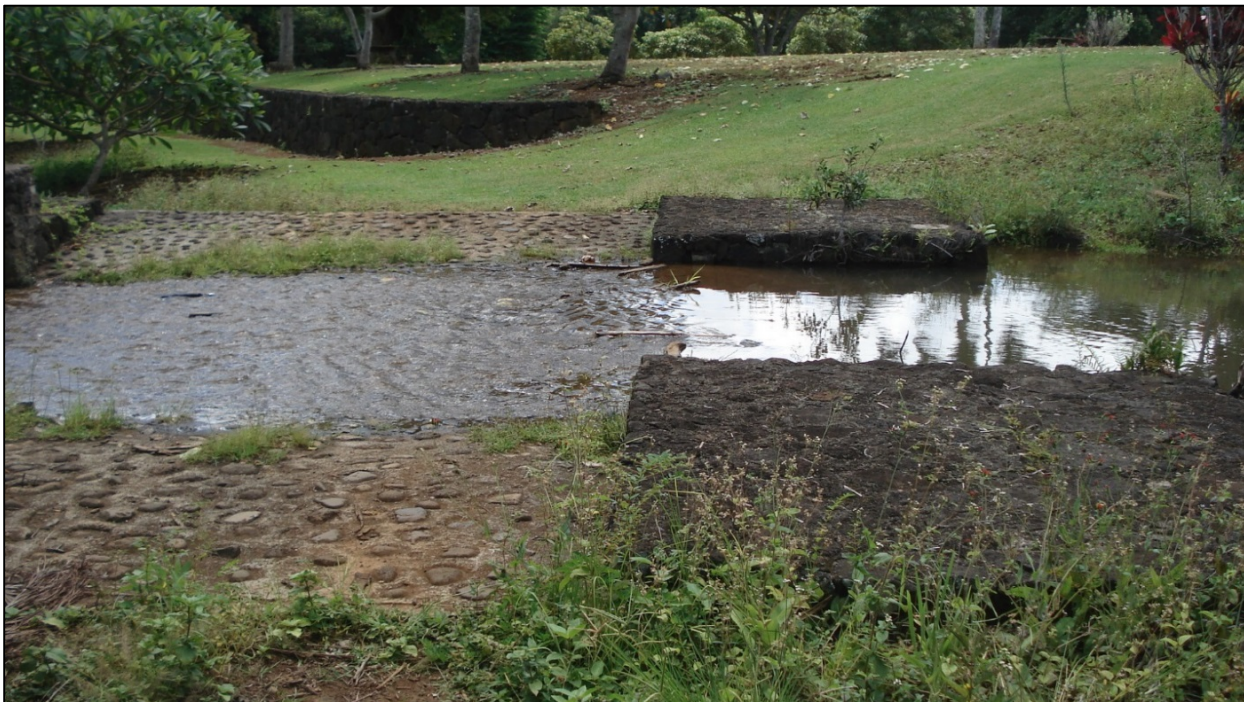
Figure 195. SIHP # -2179 Sub-feature I2, stream ford, view to southeast

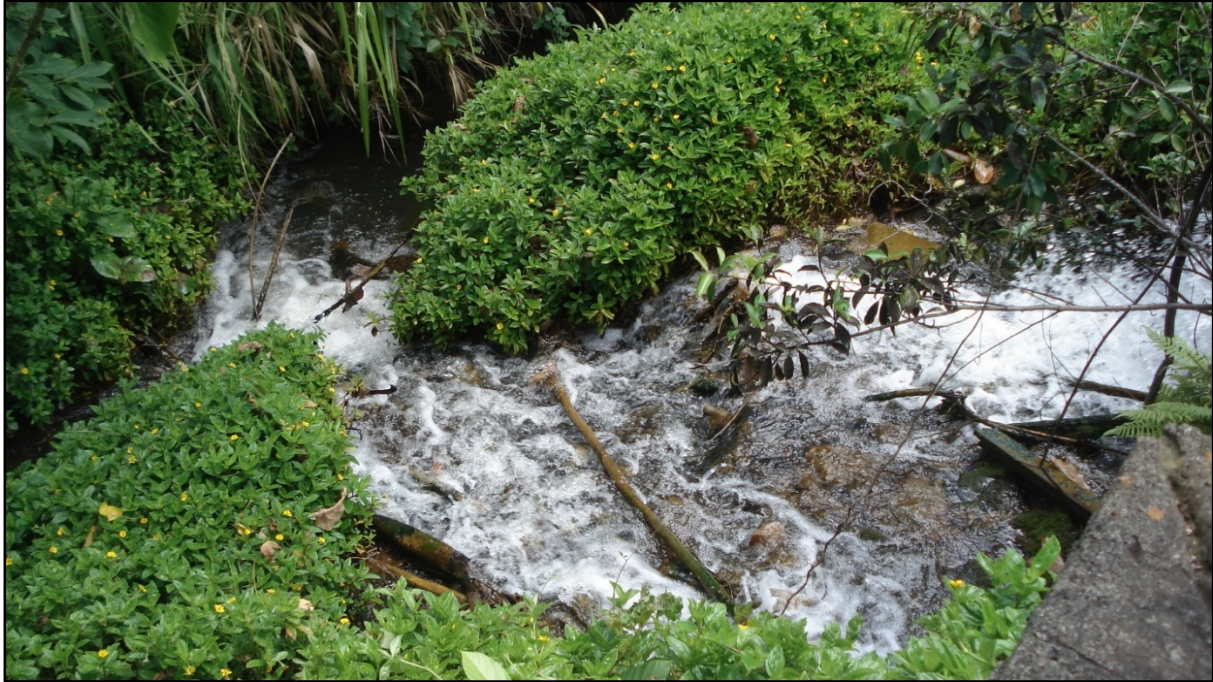
Figure 196. Sub-feature I2, showing water flowing from Sub-feature I2 to Feature I, view to south

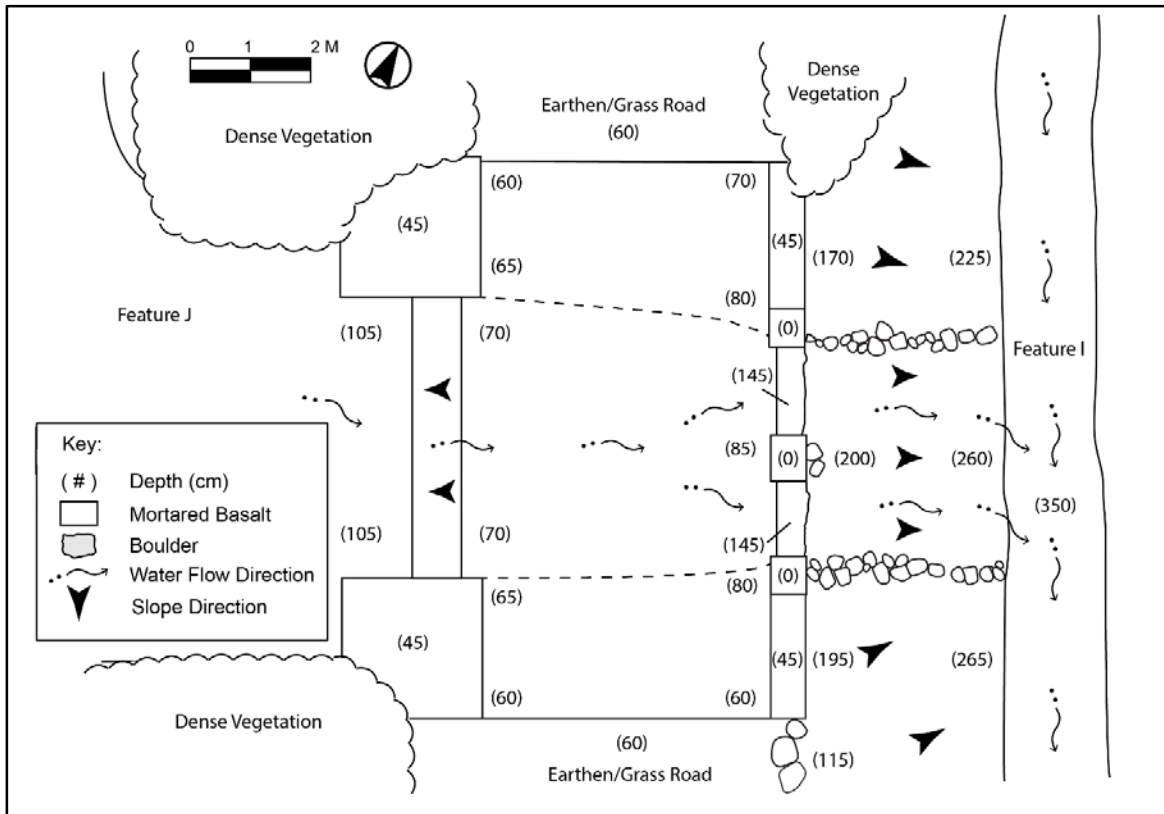
Figure 197. Plan map of Sub-feature I2, showing Feature 1 and Feature J

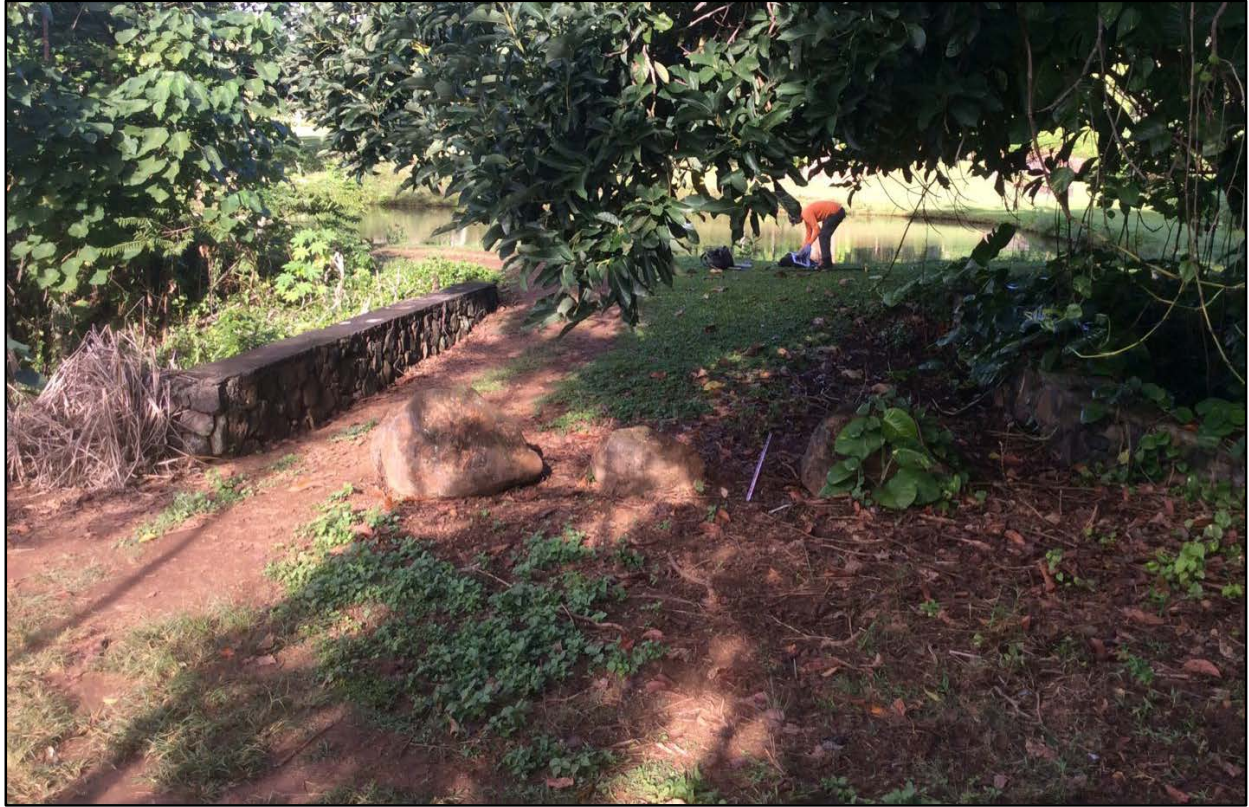
Figure 198. SIHP # -2179 Sub-feature I3, showing modern pond in background, view to west

Sub-feature I3 consists of a mortared basalt stone culvert (Figure 198 through Figure 201). The culvert was constructed to allow vehicular traffic to cross over Feature I. The culvert is located south of two modern ponds. The culvert consists of two retaining walls approximately 8.8 m long and 0.42 m wide that extend parallel to each other approximately 6.25 m apart. Short wing walls extending outward are located on the south end of the parallel walls. The earthen/grass covered roadway, which extends between the two walls of the culvert is large enough to allow two lanes of traffic across the culvert, and slopes upward toward the two modern ponds. The heights of the walls on the interior of the culvert range from a maximum height of 70 cm to a minimum of 40 cm. The heights of the walls of the culvert on the exterior side range from 95 cm to 340 cm. The walls are concrete capped. The culvert tunnel, which allows Feature I to pass under the road is a concrete-lined tunnel approximately 1.8 m in width. The culvert is likely associated with the former road associated with Puhi Camp shown on the 1930 Moragne map of Puhi Camp (see Figure 11). The road was likely utilized regularly until the 1980s when the camp was demolished. Three large stone boulders now block the south entrance to the culvert.

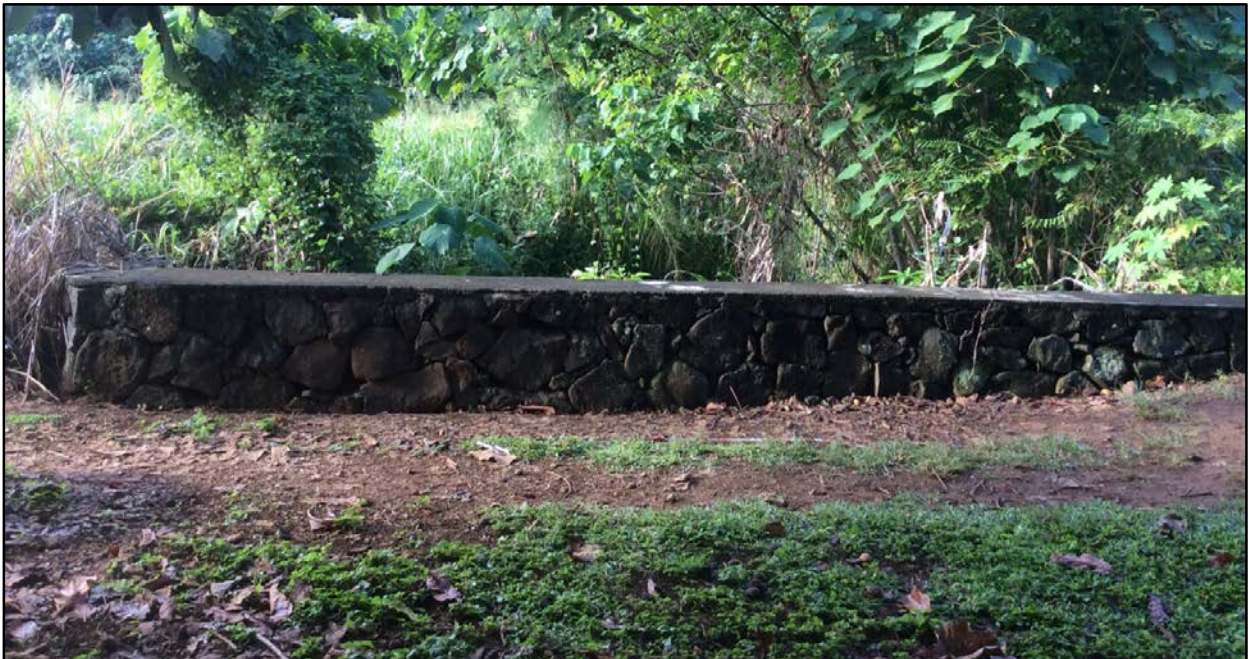
Figure 199. Sub-feature I3, retaining wall of culvert on south end, view to south

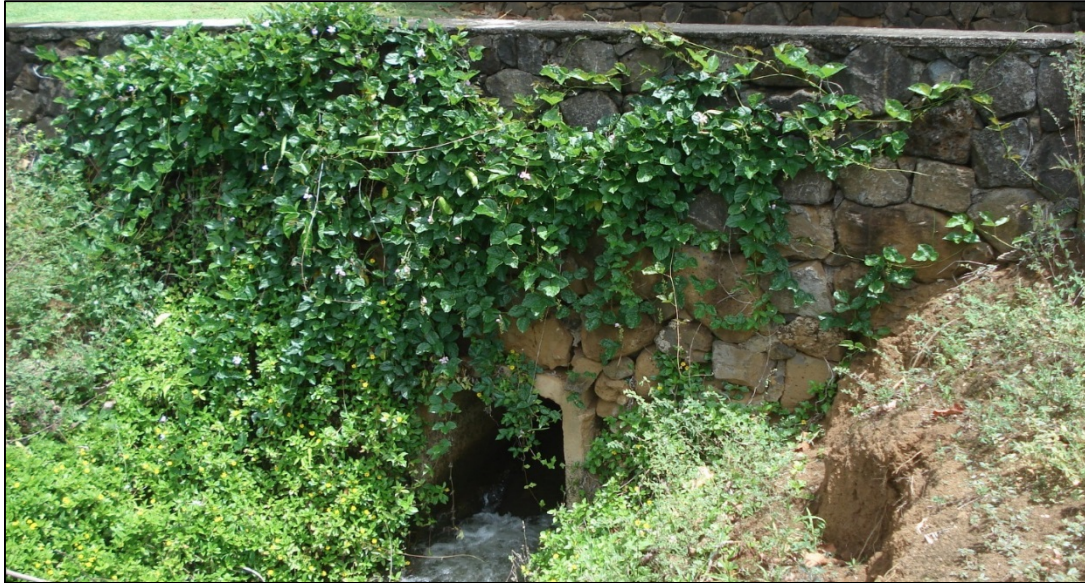
Figure 200. Sub-feature I3, view of concrete-lined culvert for Feature I, view to north

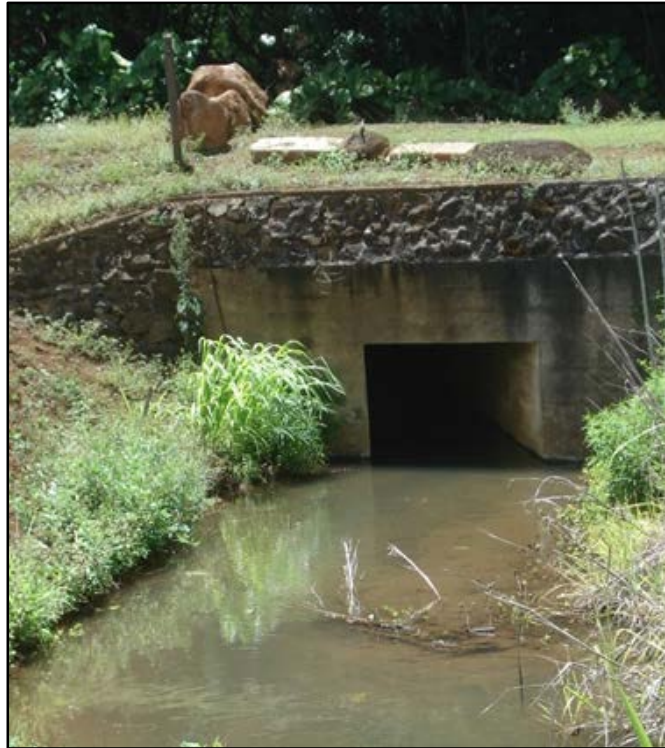
Figure 202. SIHP # -2719 Feature I4, showing concrete culvert and mortared basalt retaining wall, photograph adapted from Groza and Hammatt 2010, view to south

Sub-feature I4 consists of a mortared basalt stone and concrete culvert (Figure 202 through Figure 206). The culvert was constructed to allow vehicular traffic to cross over Feature I. The culvert is located approximately 80 m southeast of Sub-feature I3, south of a natural meander of Feature I. The culvert consists of two retaining walls approximately 6.4 m long and 0.20 m wide that extend parallel to each other approximately 8.0 m apart. The primarily earthen/grass-covered roadway, which extends between the two walls of the culvert, is large enough to allow two lanes of traffic across the culvert and slopes upward toward the KCC campus. A small patch of asphalt was observed in the center of the roadway, but appears to be fragmented and highly disturbed. The heights of the walls on the interior of the culvert are even with the ground surface, with the wing walls sloping 50 cm below the main height of the wall. The heights of the walls of the culvert on the exterior side range from 80 cm to 330 cm. The walls are concrete capped. The culvert tunnel, which allows Feature I to pass under the road, is constructed of concrete approximately 0.8 to 1.0 m thick with a tunnel approximately 2 m in width. The culvert is likely associated with the former road associated with Puhi Camp first shown on a 1950 aerial photograph (see Figure 22). The road was not illustrated on any of the earlier maps and photographs. The road was likely utilized regularly until the 1980s when the camp was demolished. Multiple large stone boulder, concrete blocks, and chained gates now block the east entrance to the culvert.

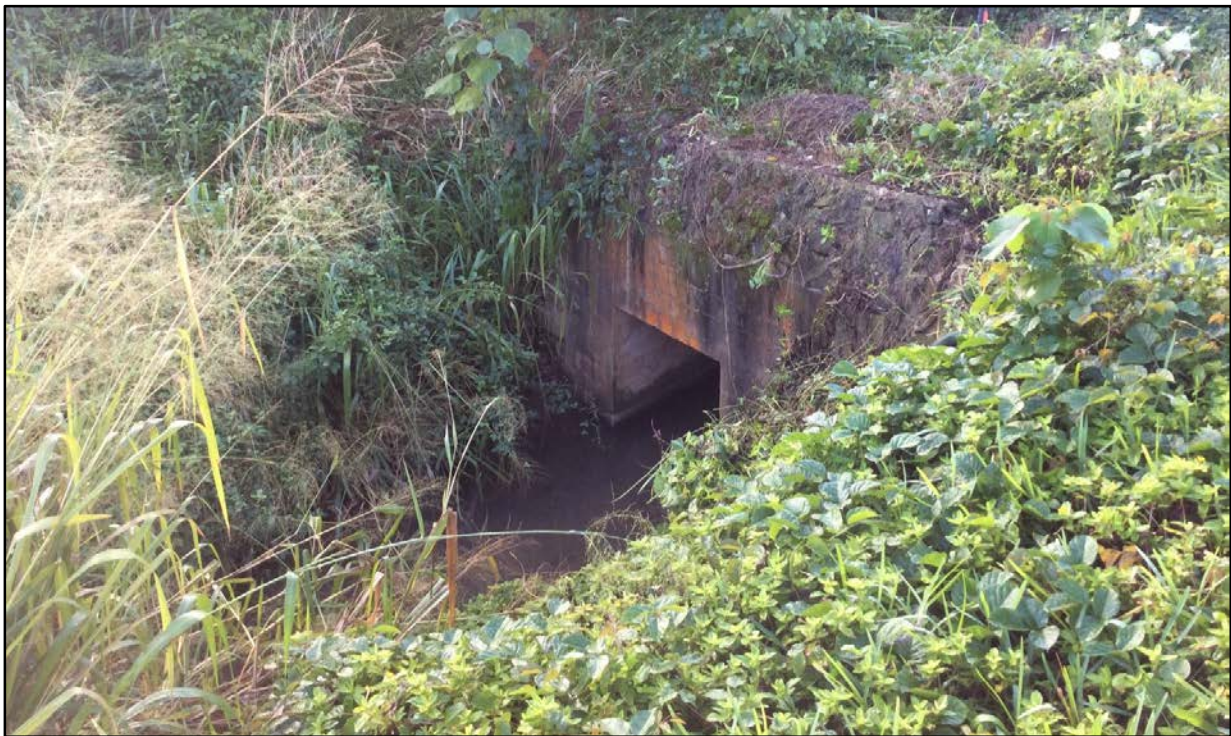
Figure 203. Sub-feature I4, showing current condition of culvert, view to southeast

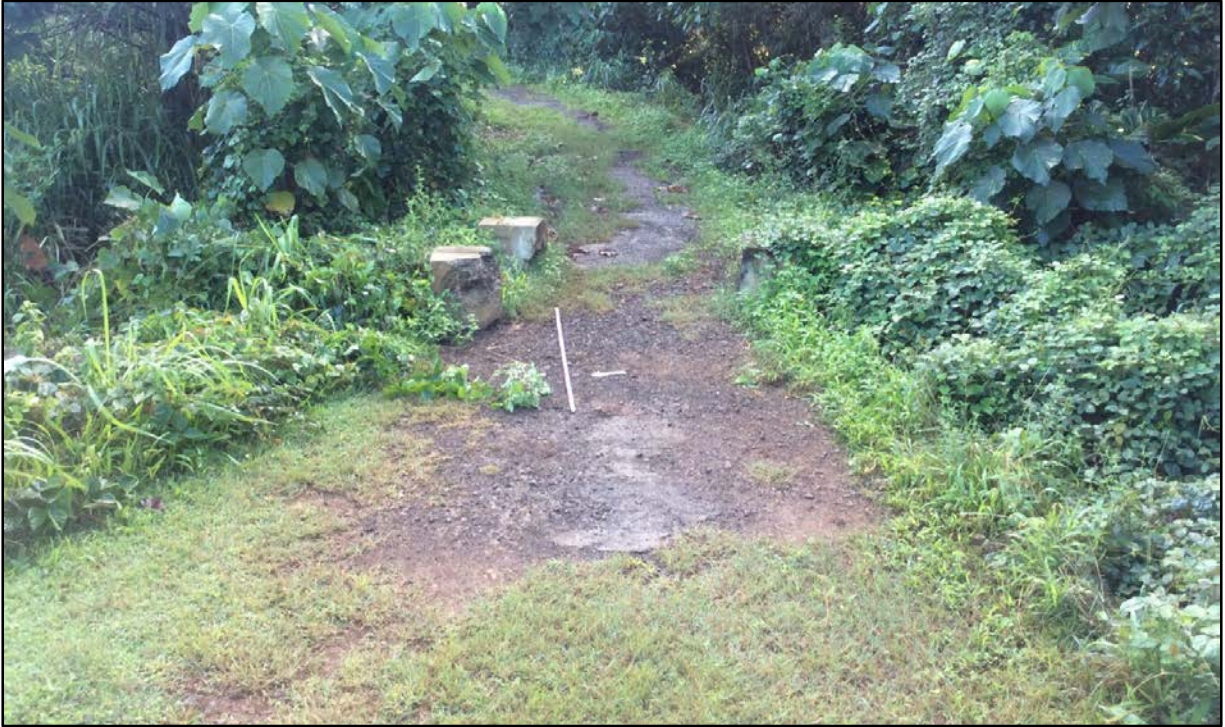
Figure 204. View of roadway above Sub-feature I4, showing patches of asphalt, view to east

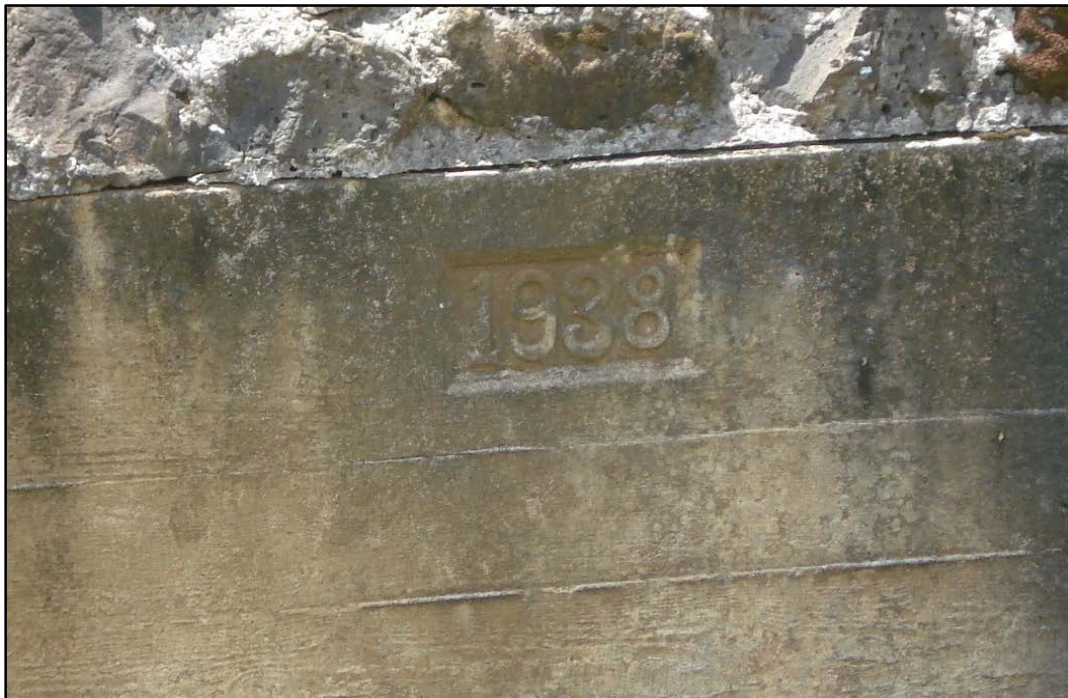
Figure 205. Date "1938" located on Sub-feature I4, view to south

Feature I is the only remaining in-use irrigation ditch in the current project area that transports water beyond the project area. The features and sub-features are in good to fair condition. Based on background research (see Section 3.1.5), the ditch is likely a modified natural stream and was likely constructed between 1901 and 1933. It is likely the associated culverts and sluice gates (Sub-features I1 through I3) were constructed at the same time, however, they may be later modifications. Sub-feature I4 is a later modification, constructed in 1938.

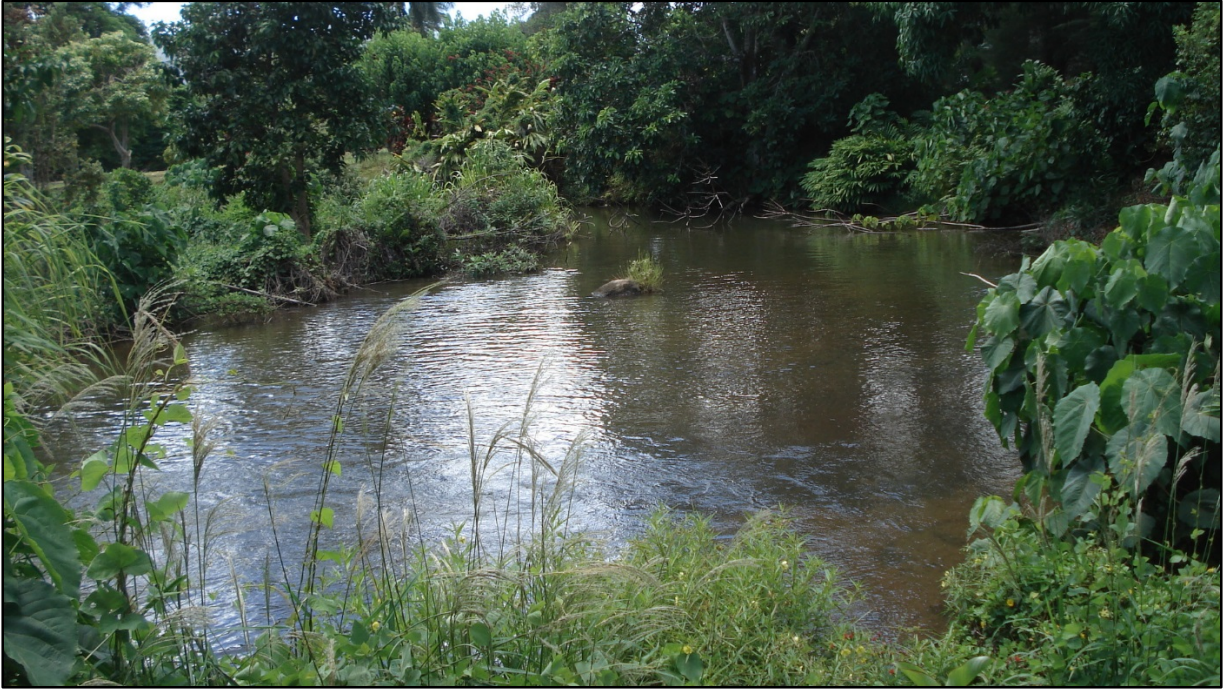
Figure 207. SIHP # -2179 Feature J, north section, view to south

Feature J is a plantation-era pond located south of Pūnana Leo Pre-School and Kawaikini Charter School within the project area (see Figure 96). The in-use pond is situated in between Sub-features I1 and I2. The earthen pond has a maximum length of 40 m and a maximum width of 16 m (Figure 207 through Figure 209). The pond is likely a modified ditch seen on the 1930 Moragne map of Puhi Camp (see Figure 11). On the Moragne map, three ditches are

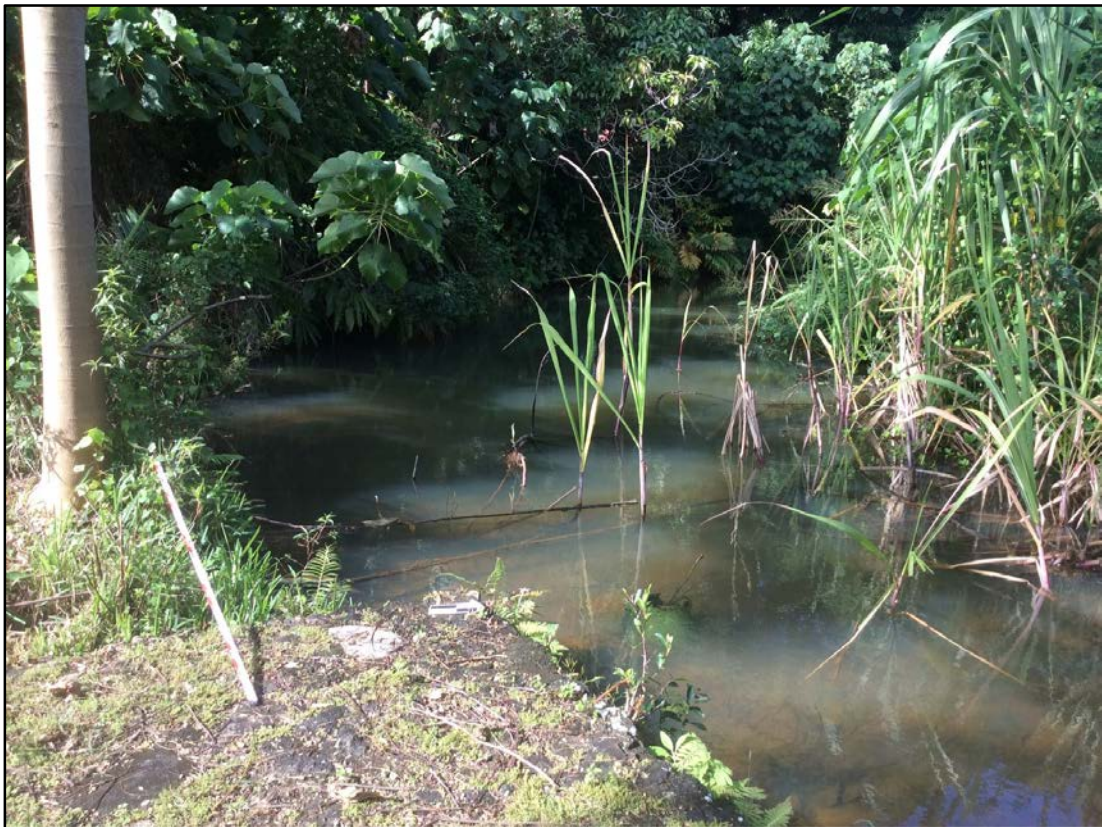
Figure 208. Feature J, south section at Sub-feature I2, view to west

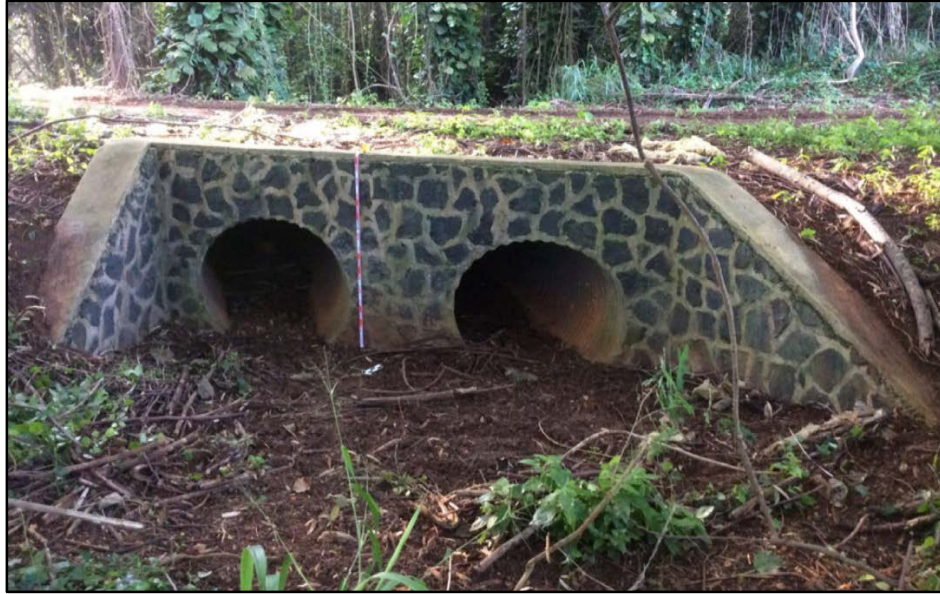
Figure 210. Sub-feature K1, north end of culvert, view to southeast

Sub-feature K1, the northernmost culvert, is located along the former cane haul road, near a modern water tank (see Figure 96). The culvert is a mortared basalt with concrete capped structure, with two wing walls to channel water into two concrete pipes (Figure 210 through Figure 214). The north wall is approximately 5 m long with the west and east wing walls approximately 2 m long. The structure is 0.5 m wide with a maximum height of 1.5 m. The two concrete pipes are approximately 1.2 m in diameter. The south wall is located 12 m southeast of the north wall. The south wall is approximately 5 m long with the wing walls approximately 3 m long on the west side and 1 m long on the east side. It is possible the east wing wall continues, however, the wall is covered with dirt and a large tree is located near the wing wall obscuring the structure. The south wall is approximately 21 m northwest of a portion of Feature M, an in-use irrigation ditch. The culvert's function is to allow runoff to travel under the road and into the irrigation ditch.

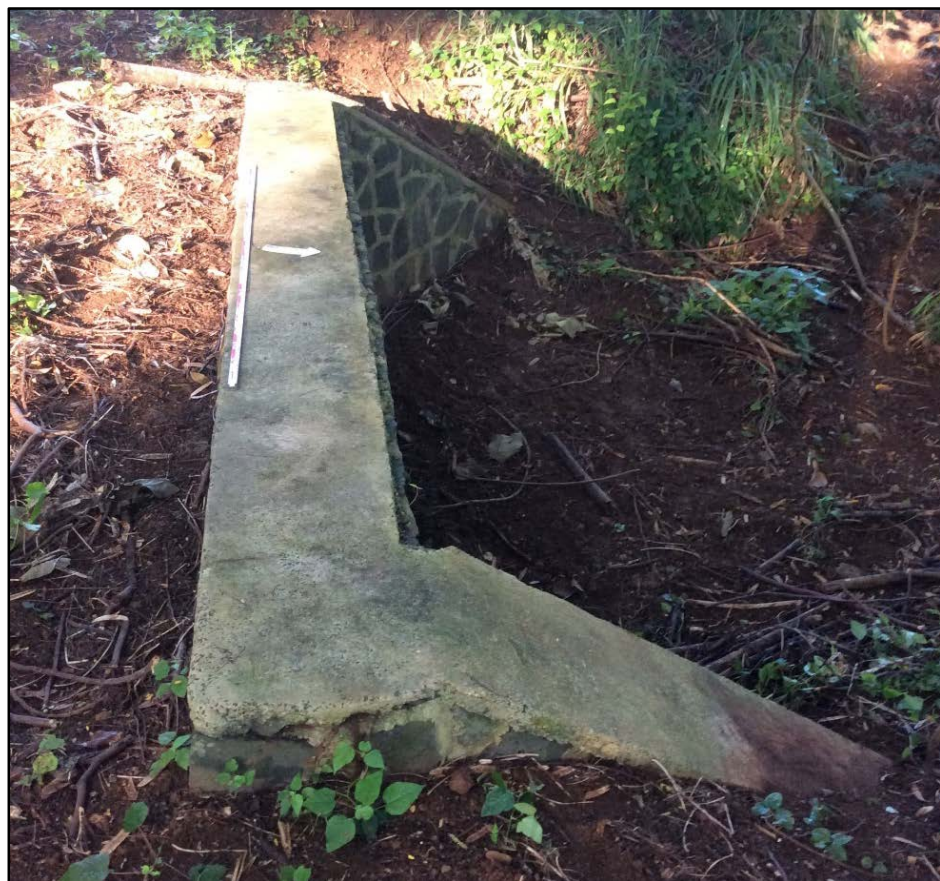
Figure 211. Plan view of Sub-feature K1, north end, view to west

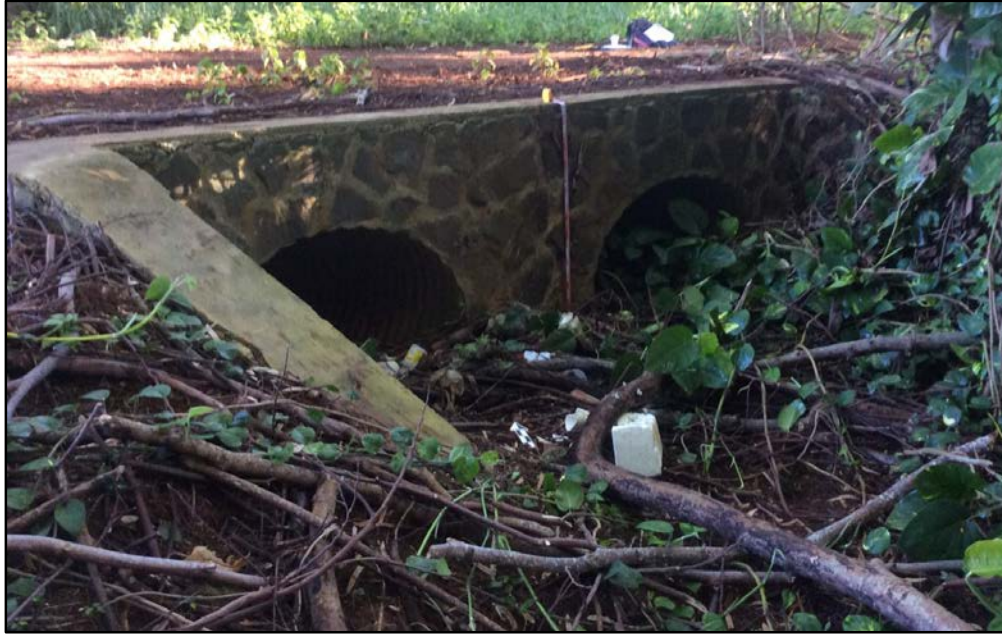
Figure 212. Sub-feature K1, south end, view to northeast

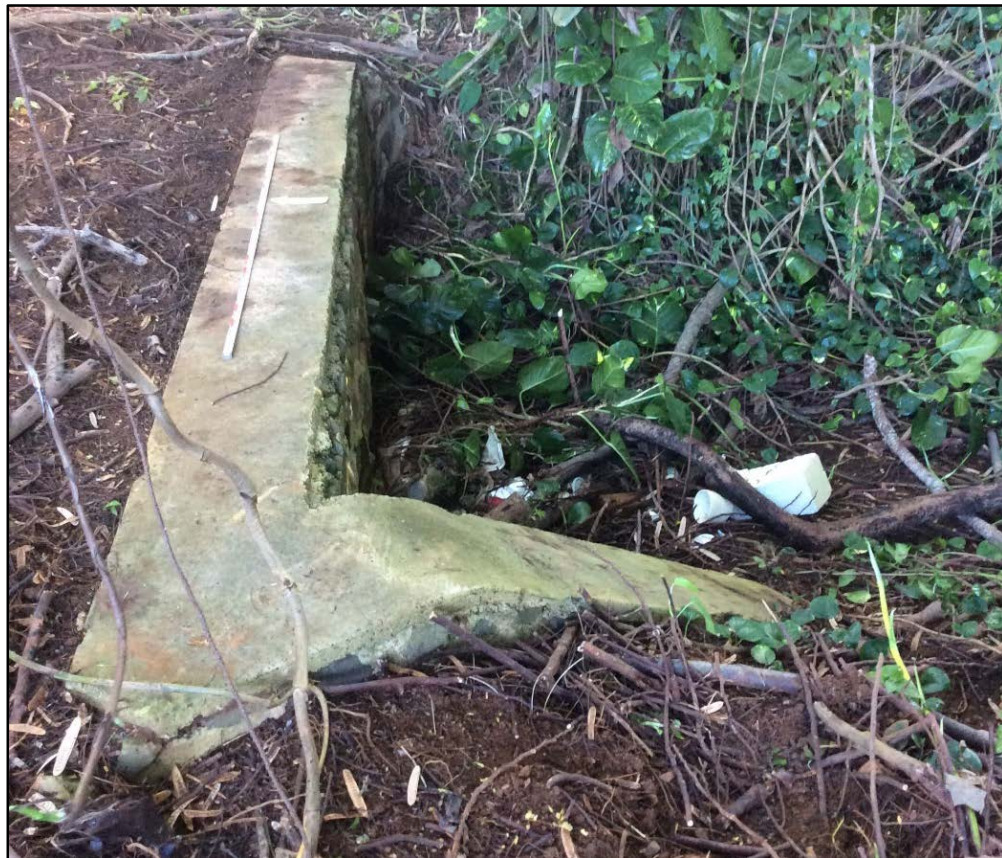
Figure 213. Plan view of Sub-feature K1, south end, view to east
