Section 6 Historic Property Descriptions

6.1 SIHP # 50-30-11-B006

6.2 SIHP # 50-30-11-2179

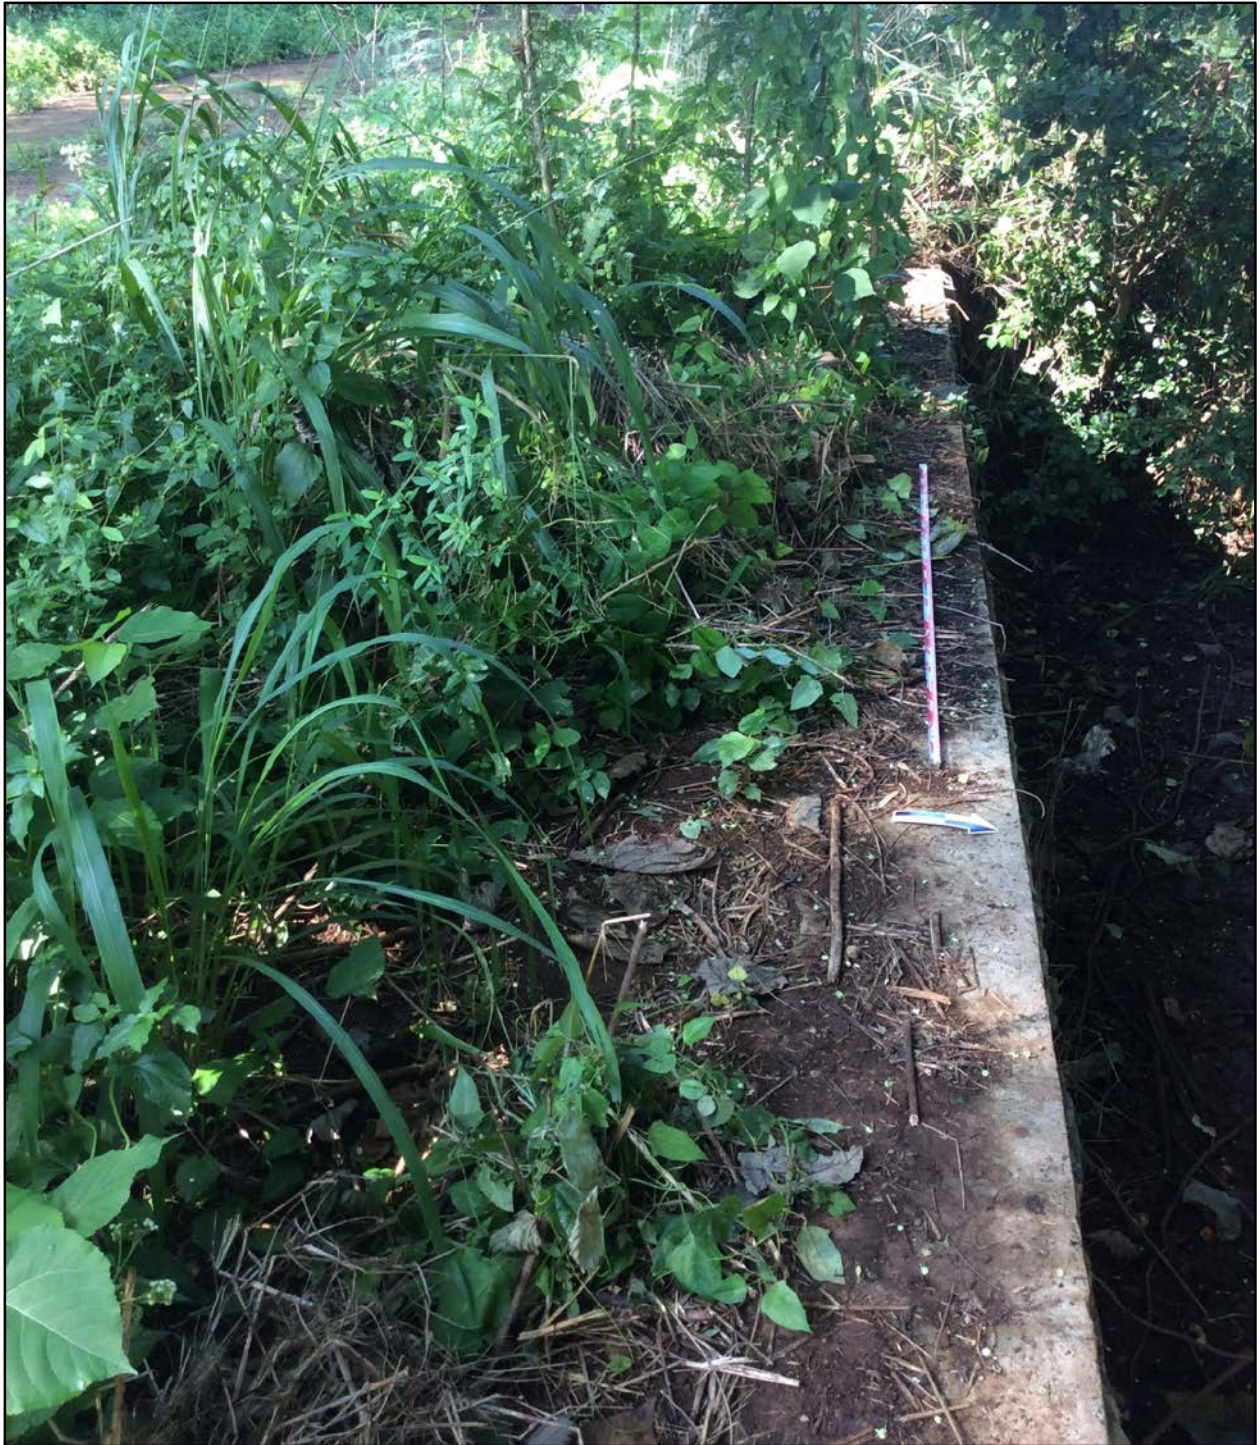
Figure 215. Plan view of Sub-feature K2, north end, view to west

Sub-feature K2 is located 250 m southwest of Sub-feature K1 (see Figure 96). The culvert is of similar construction to Sub-feature K1 (Figure 215 through Figure 221). The mortared basalt and concrete capped culvert, however, has mortared basalt ripraps instead of wing walls. The ripraps are triangular and angled along the slope of the hill. The ripraps on the west wall were obscured by dense vegetation and dirt accumulation. Two concrete pipes approximately 2.0 m in diameter allow water to flow under the bridge, ultimately flowing into Feature M, an in-use irrigation ditch. The east wall is approximately 13 m long and 0.45 m wide. The maximum height of the wall is 1.72 cm above surface. The west wall is slightly concave and measures approximately 15.5 m long by 0.55 m wide with a maximum height of 1.77 m above surface. The ripraps on the west wall extend approximately 3 m to the west of the wall. A metal pipe, likely a drain pipe, was observed extending from the wall on the south end. No intake for the pipe was observed on the east wall. It is likely this pipe is a drain feature associated with an external drainage or irrigation system.

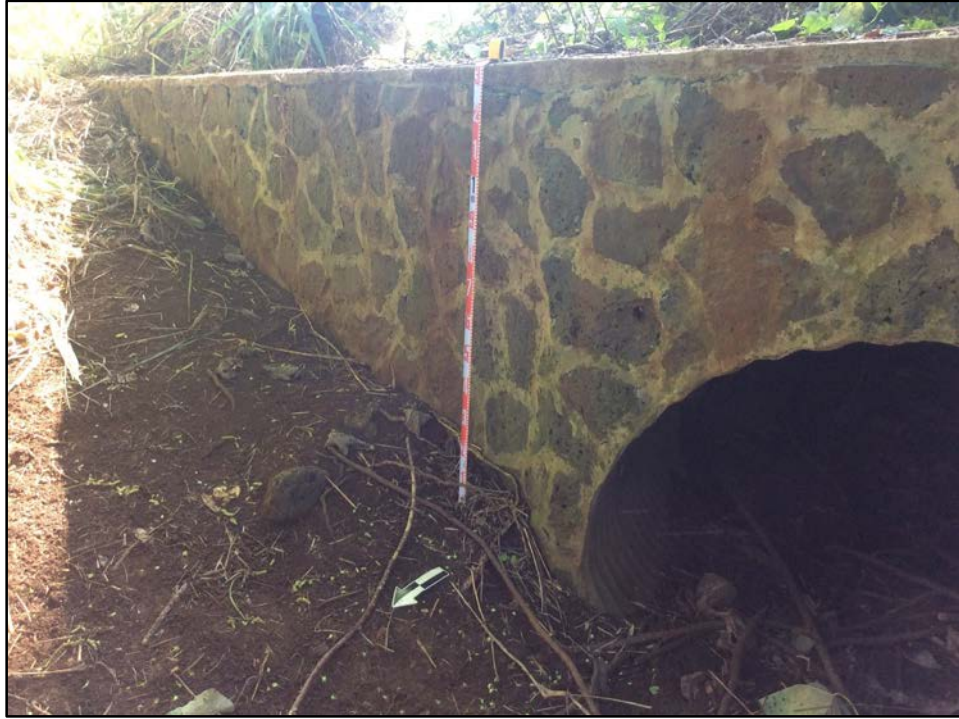
Figure 216. Sub-feature K2, north end, soil accumulation obscuring riprap, view to southeast

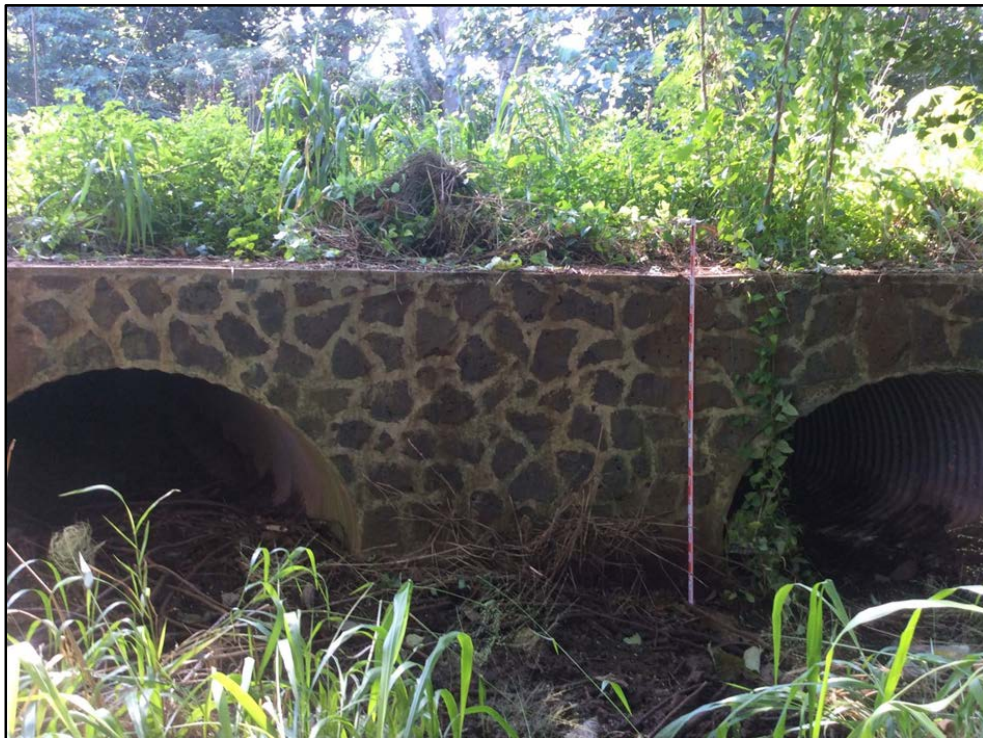
Figure 217. Sub-feature K2, north end, view to south

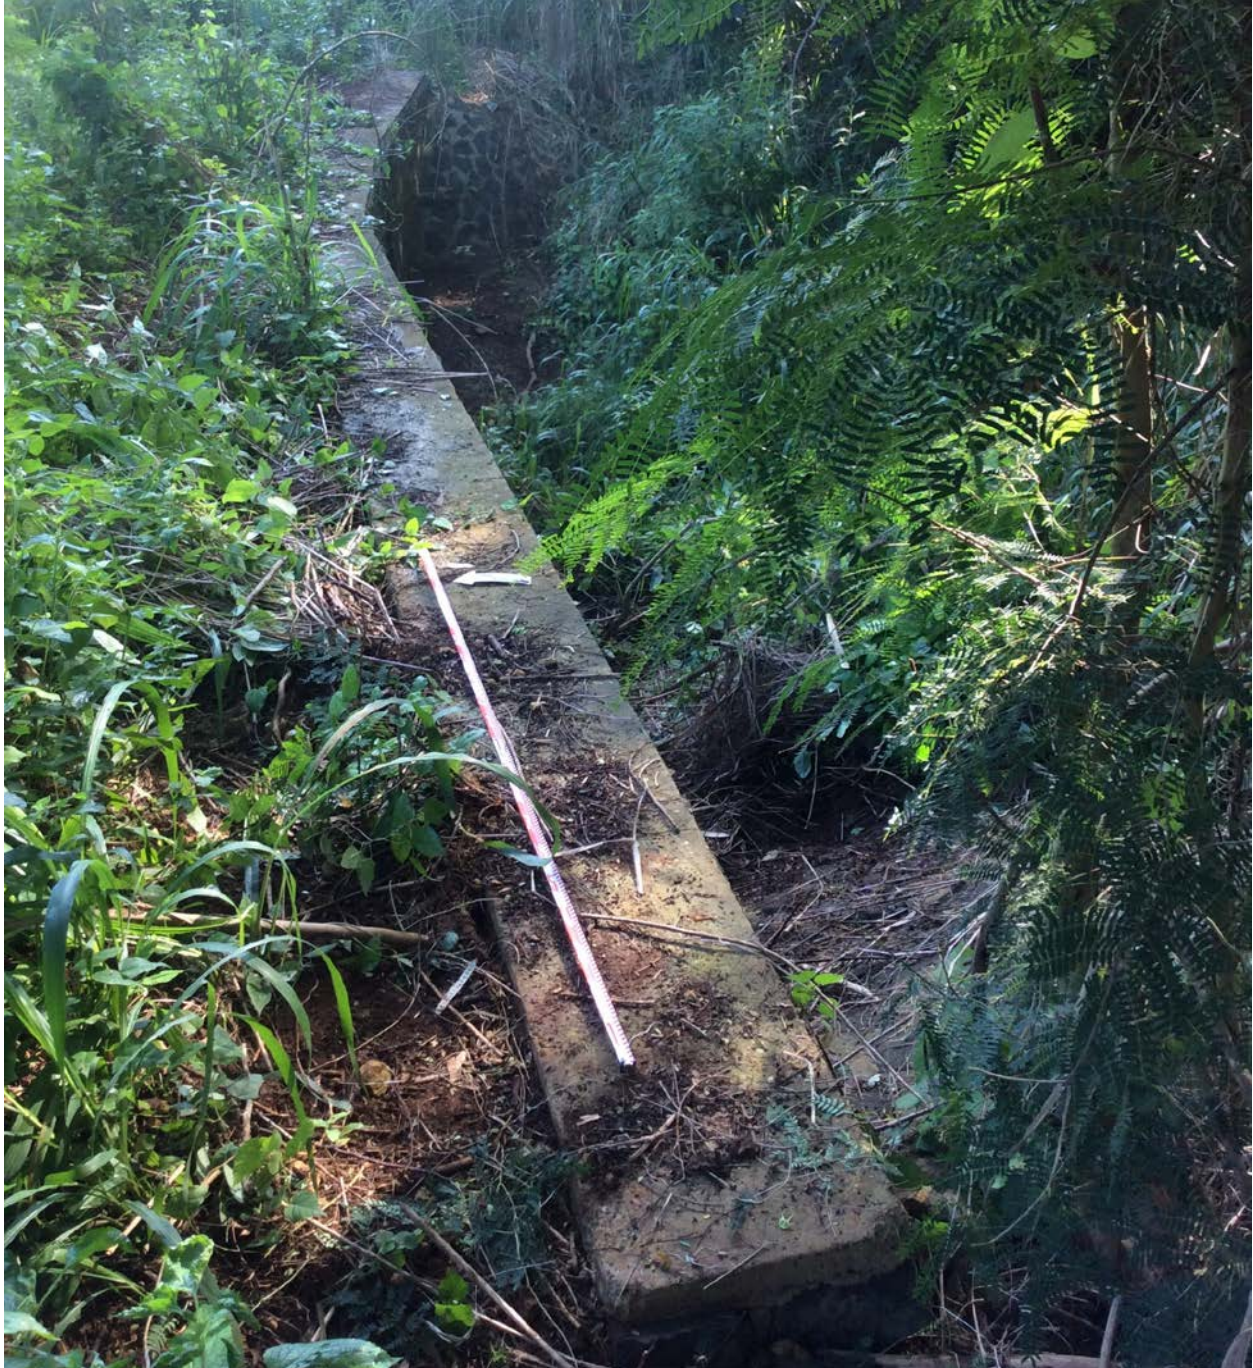
Figure 218. SIHP # -2179 Sub-feature K2, south end, view to east

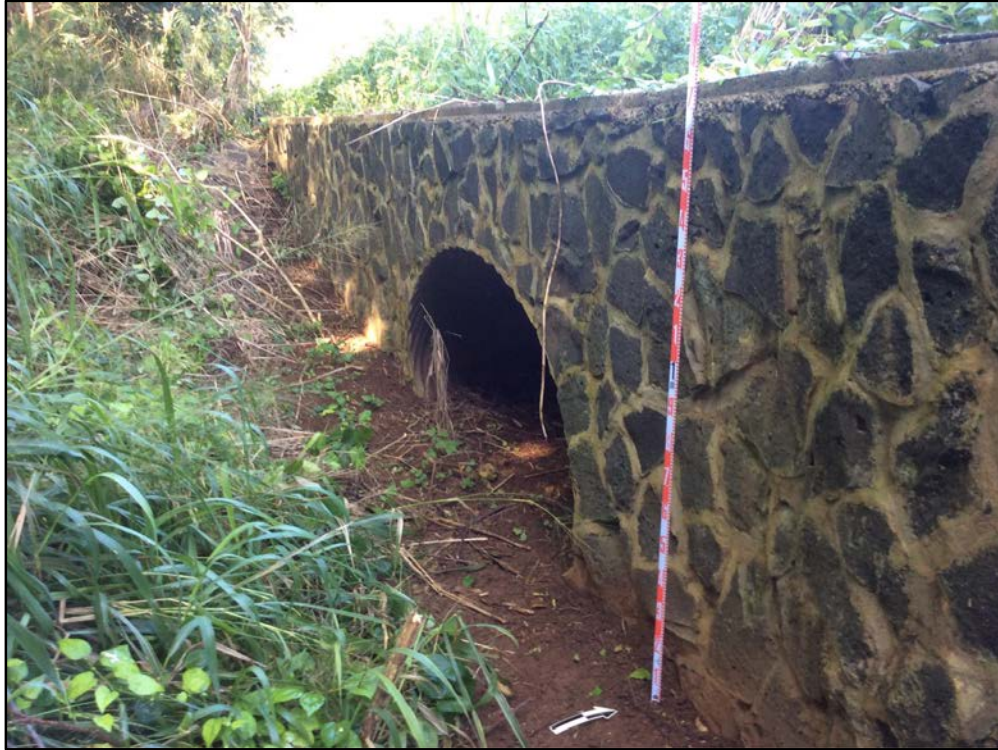
Figure 219. Sub-feature K2, south end showing riprap on west end, view to northwest

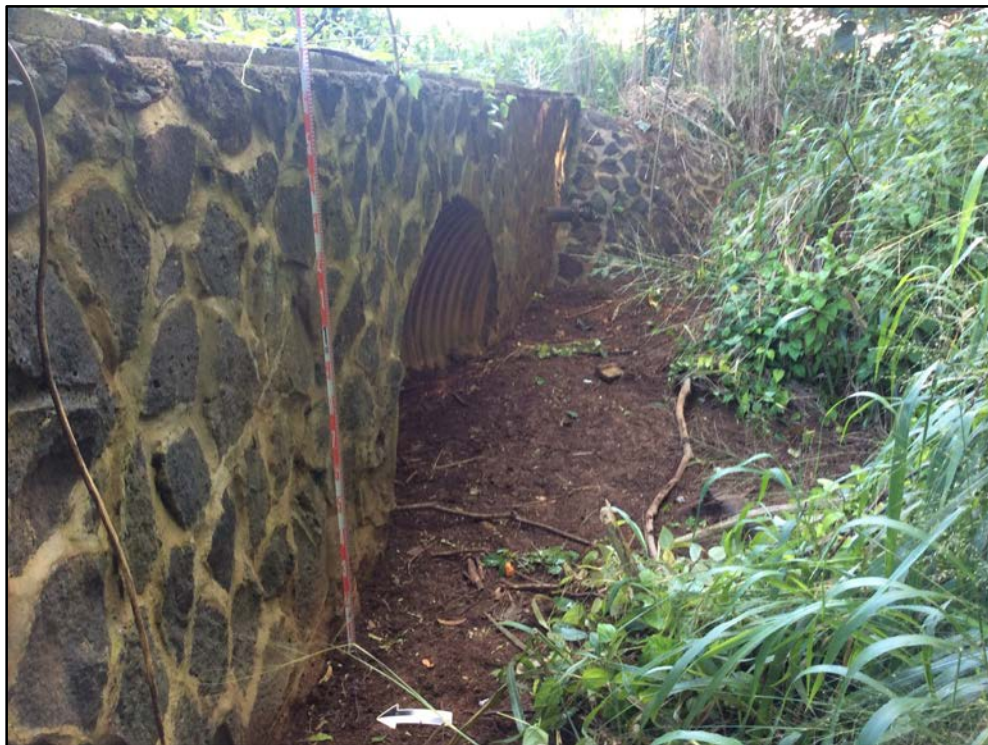
Figure 220. Sub-feature K2, south end showing riprap at east end and metal pipe, view to east

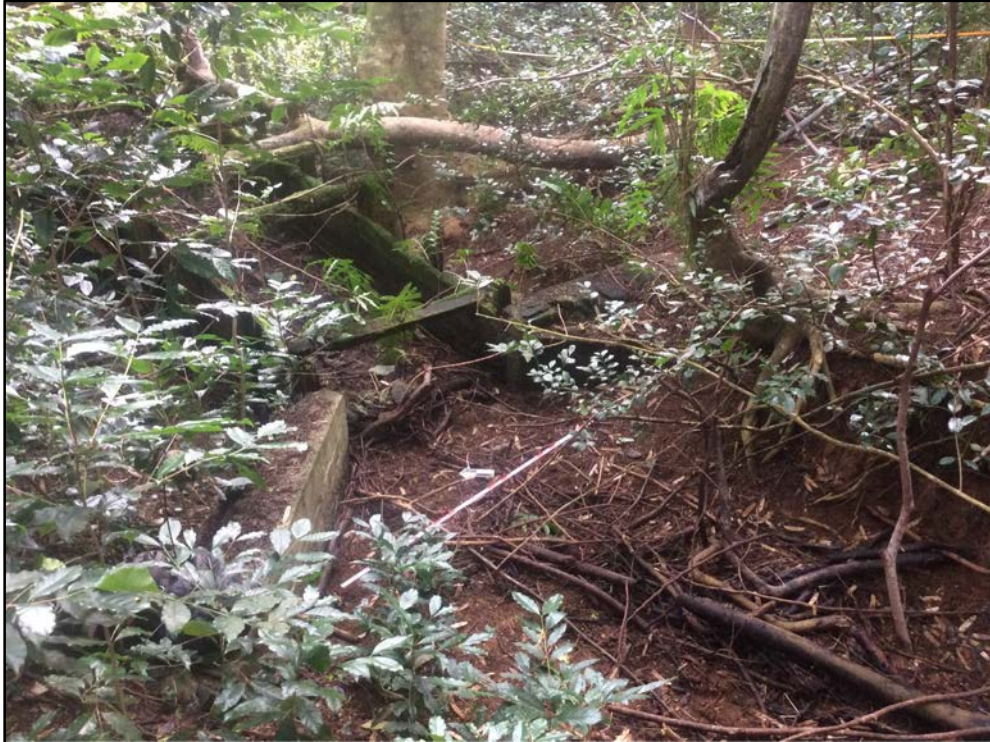
Figure 222. SIHP # -2179 Feature L, flume, showing west portion mostly intact, view to east

Feature L originally spanned the gulch, transporting water from west to east (see Figure 96). The flume is constructed primarily of wooden beams and boards anchored by concrete foundations and mortared basalt retaining wall foundations on the steeply sloped hillsides (Figure 222 through Figure 231). Two sluice gate and wing wall features were observed on the ends of the flume to control water flow across the flume. The flume measures approximately 29.5 m long from sluice gate to sluice gate. The flume is 0.75 m across with the cross-beams extending out 1.0 m. The maximum height of the flume, from the bottom of flume to ground surface is 4.15 m. Concrete foundations measured 0.3 m by 0.3 m and ranged in height from 0.15 to 0.45 m.

The west end of the flume is mostly intact. The central section, the portion that spans the gulch floor, was documented as mostly intact, with only a small portion missing during the project's associated LRFI (Groza and Hammatt 2010). During the 2016 fieldwork, it was documented that the entire portion spanning the gulch floor has collapsed. The concrete foundations were observed in place, however, wooden beams and debris were observed throughout the gulch floor in the area. It also appeared that a large amount of the debris was likely looted and removed from the area. The cause of collapse is unknown, however, it appeared as though a flooding event and collapsing trees, likely caused by a large storm, may have caused the collapse. The eastern portion had fallen but mostly remained together as several large pieces. The concrete foundations and mortared basalt retaining walls were observed in place.

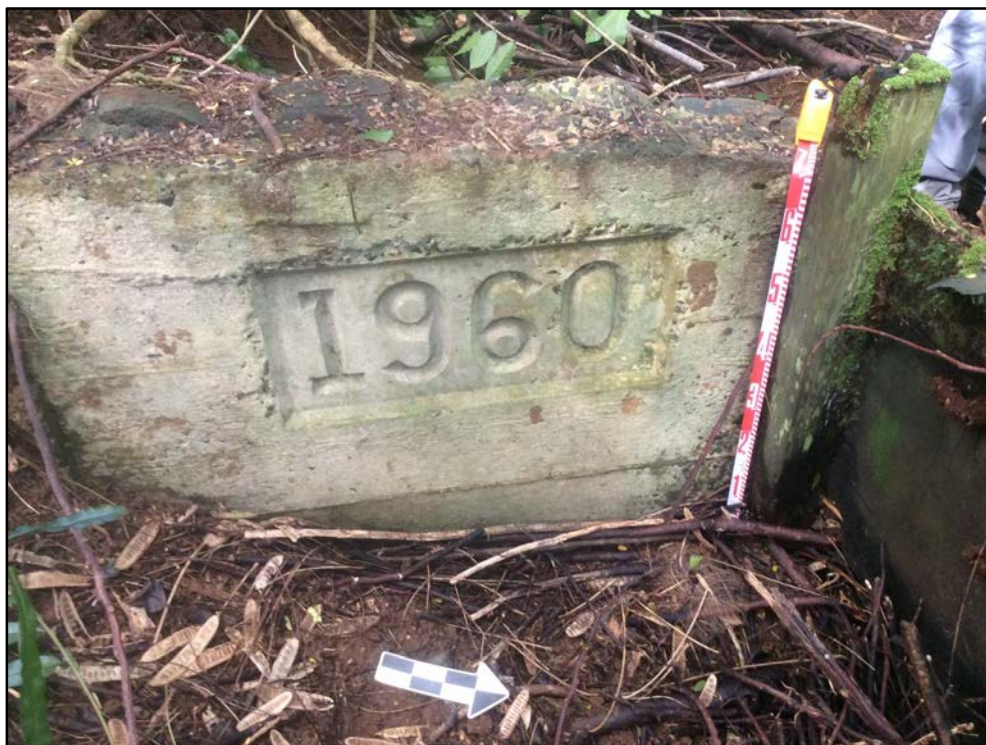
Figure 223. Sluice gate foundation with date “1960,” view to west

The sluice gate concrete foundations on the west end of the flume are angled to channel water into the flume. The foundations were between 1.0 and 1.35 m in length and were the same height as the flume opening approximately 50 cm above the bottom of the flume. The date "1960" was stamped on the southern foundation. A retaining wall was observed on the west slope of the gulch to provide additional stability to the structure. The retaining wall was constructed of mortared basalt 0.25 m thick. The retaining wall was approximately 1.45 m in height. The sluice gate concrete foundations on the east slope are approximately 0.5 m in length and are of similar height. The foundations are also angled outward. Two retaining walls were observed on the east slope. The lower retaining wall is approximately 0.25 m thick with a maximum height of 0.8 m. The upper retaining wall is 0.3 m thick with a maximum height of 0.95 m. A rectangular foundation was observed just west of the upper retaining wall.

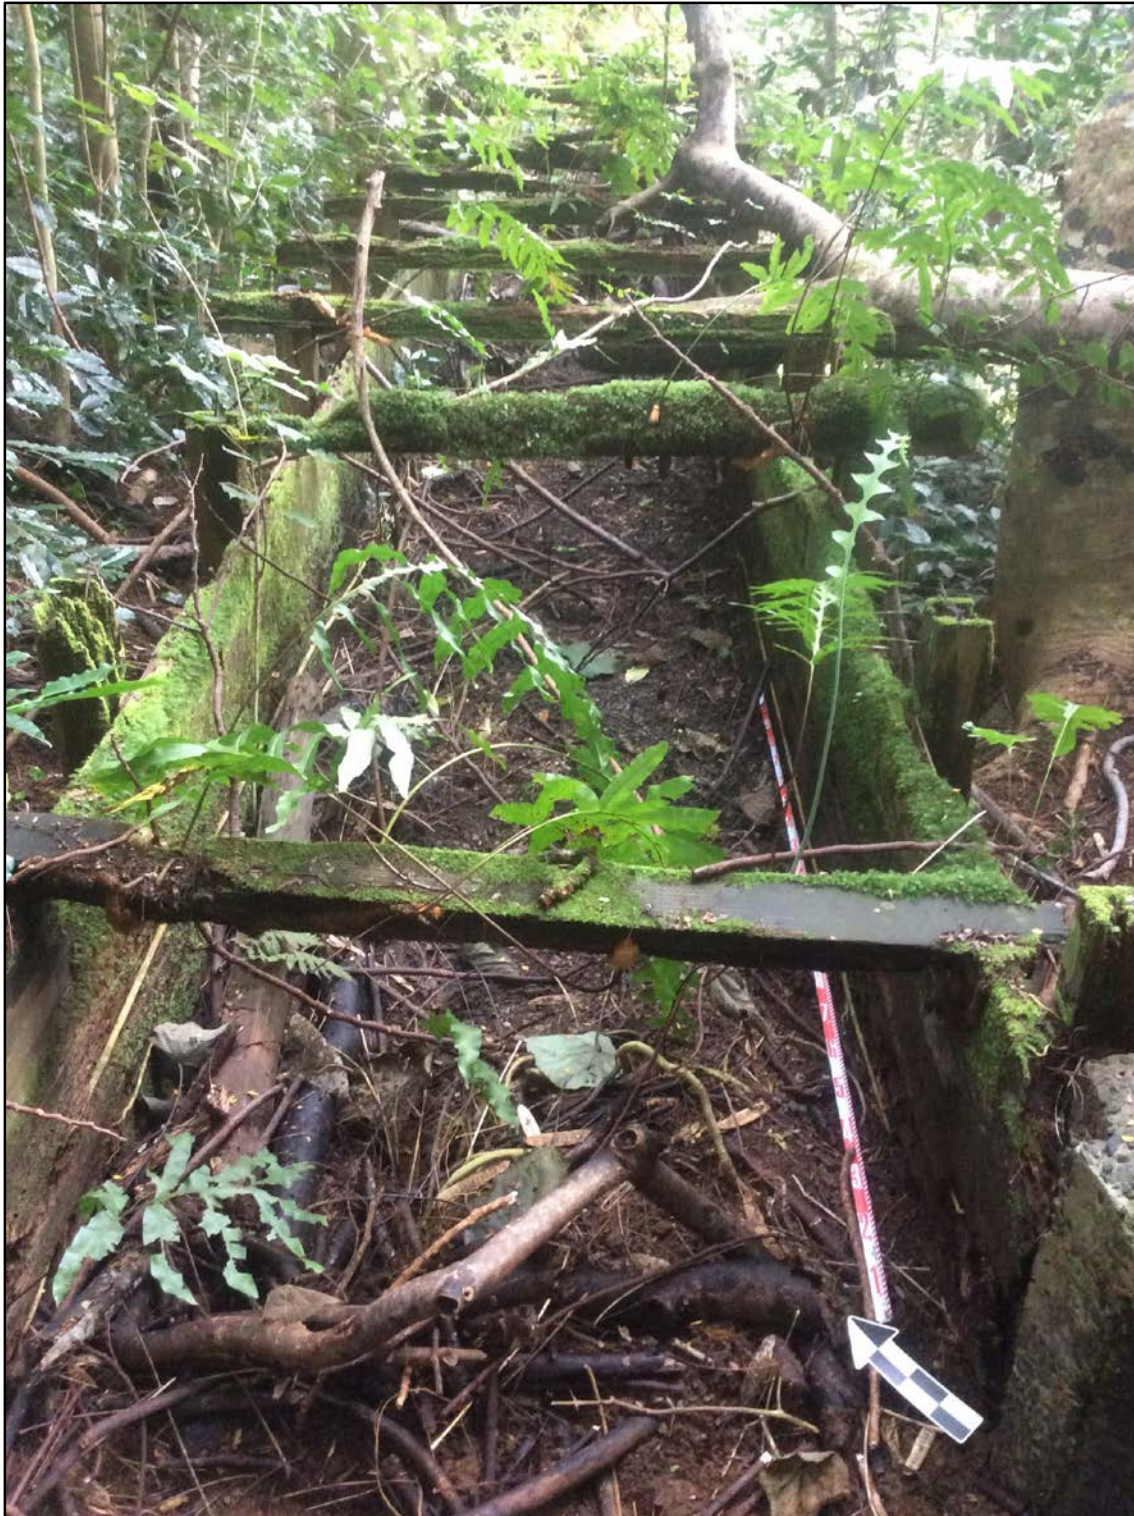
Figure 224. West portion of Feature L, showing general construction design, view to northeast

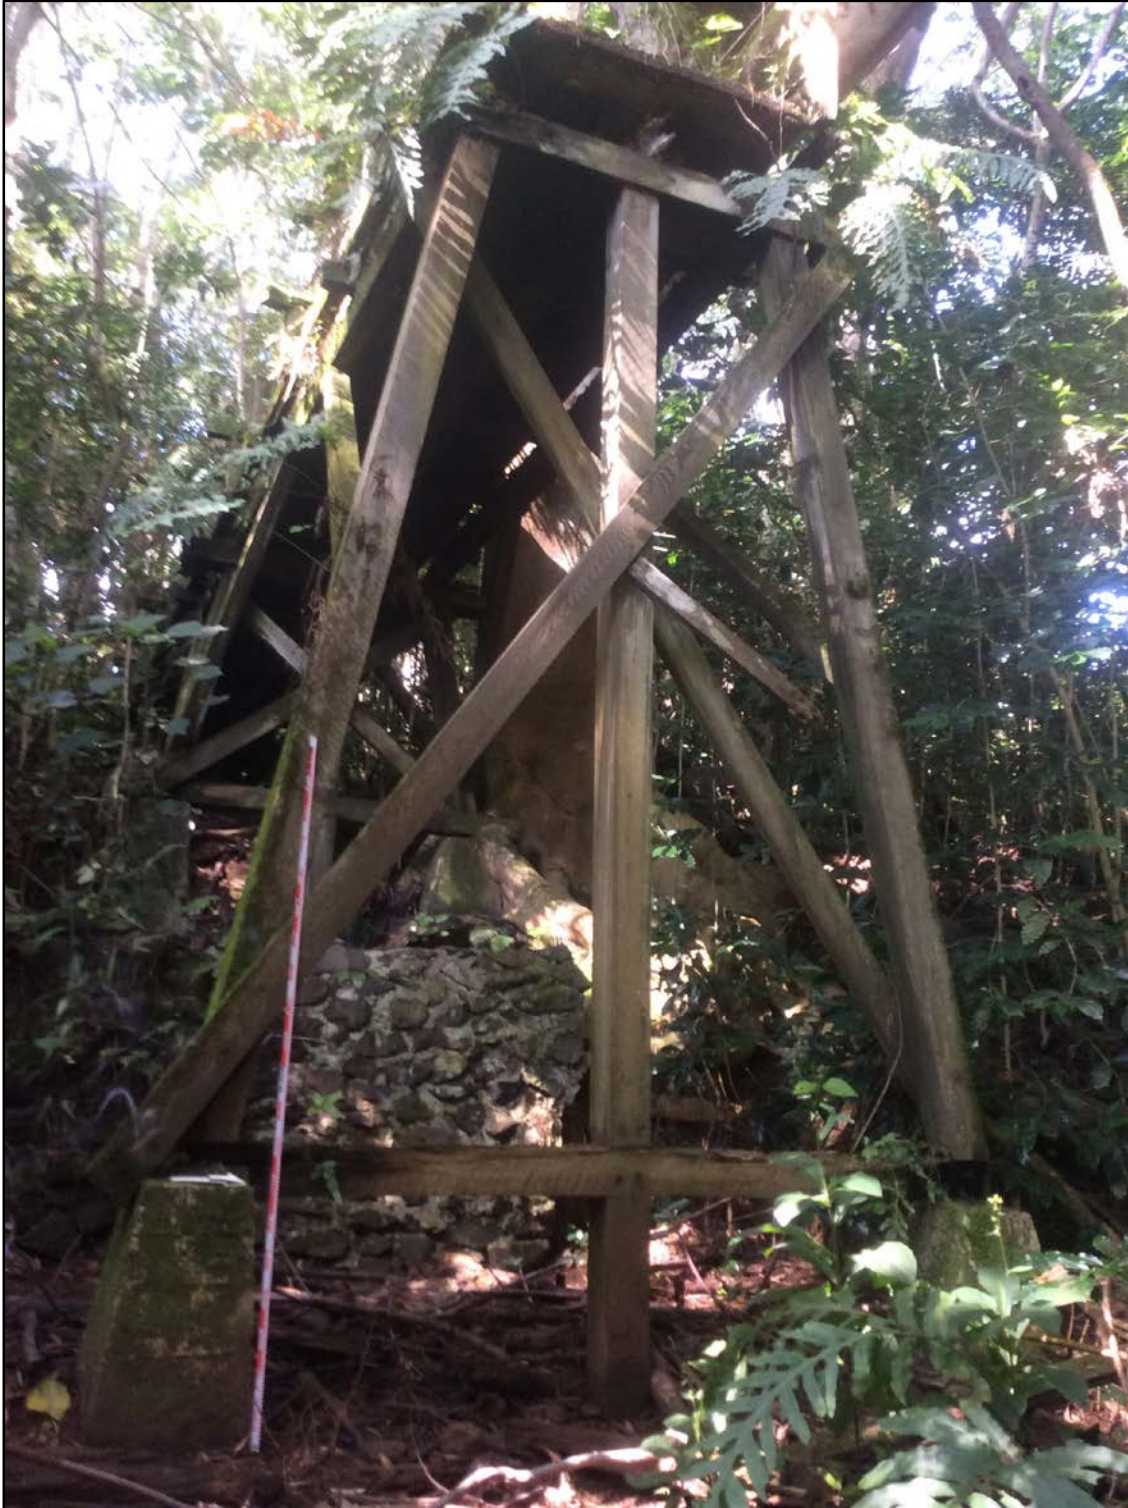
Figure 225. West portion of Feature L, showing support structure including wooden beams, concrete foundations, and mortared basalt retaining walls, view to west

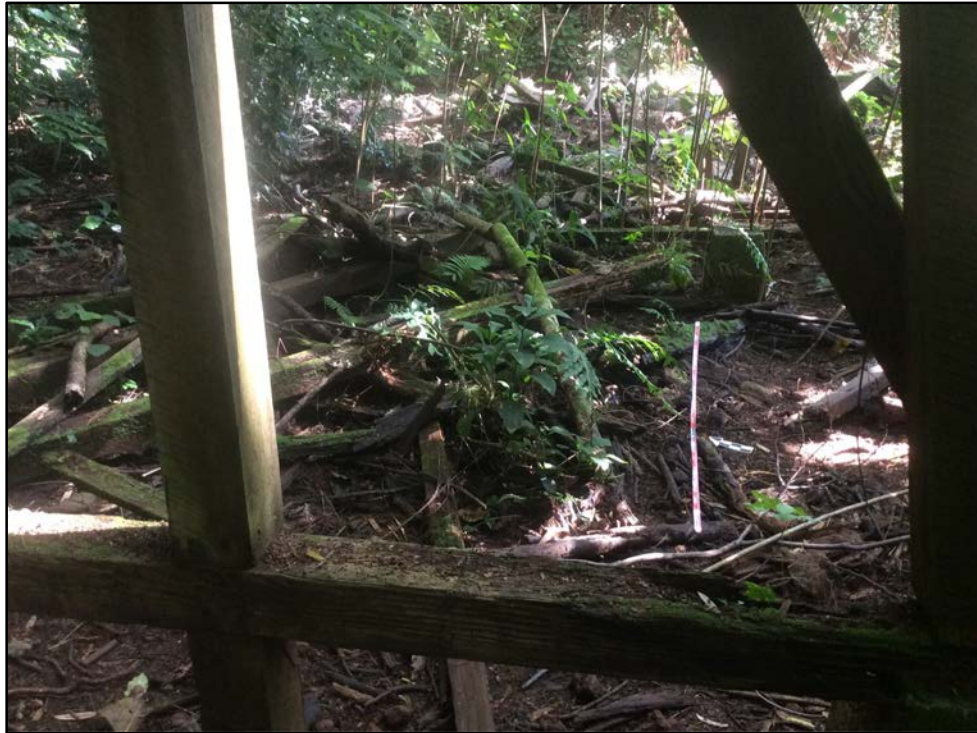
Figure 226. Debris from collapse of center portion of Feature L, view to northeast

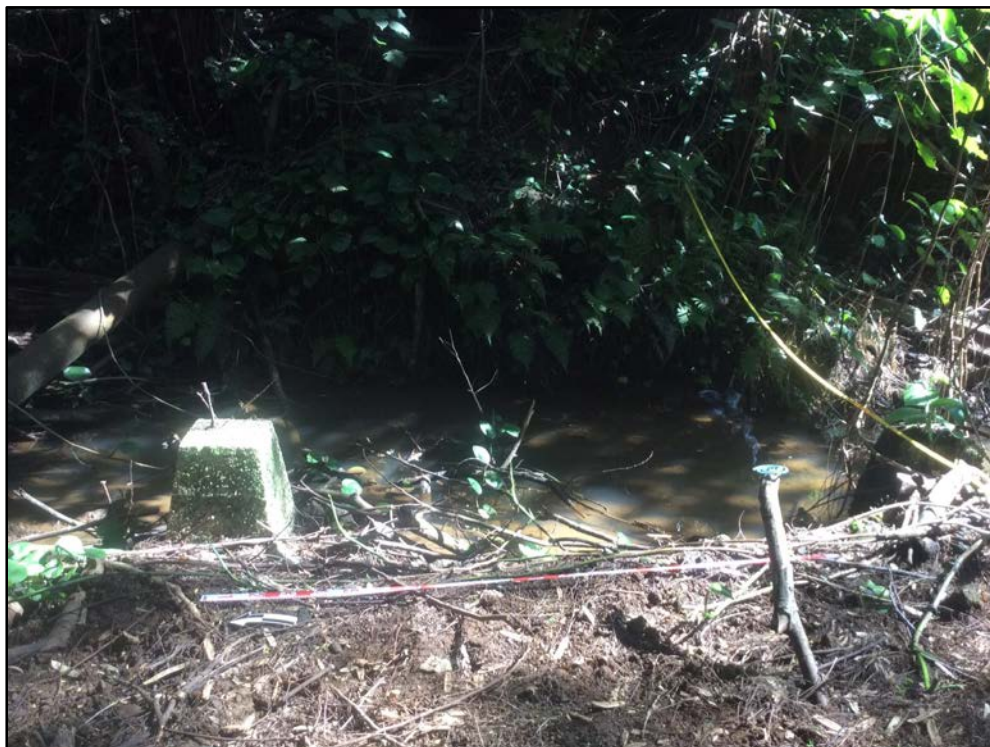
Figure 227. Feature M crossing path of Feature L, note concrete foundations on left and right, view to east

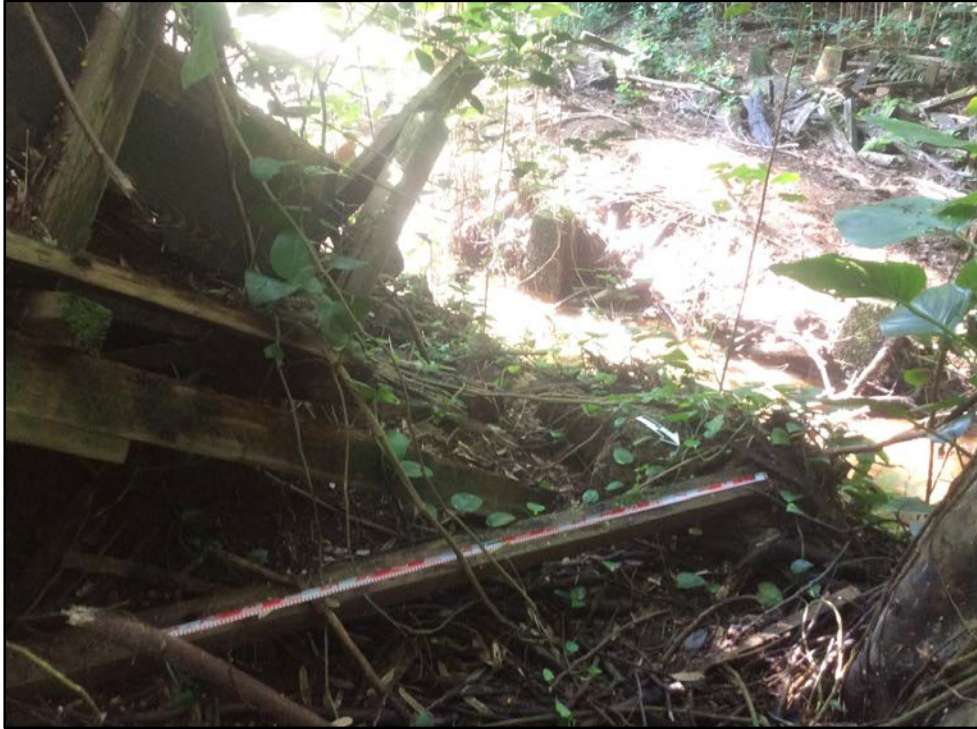
Figure 228. Feature M crossing over central portion of Feature L, collapsed section of east portion in foreground, view to southwest

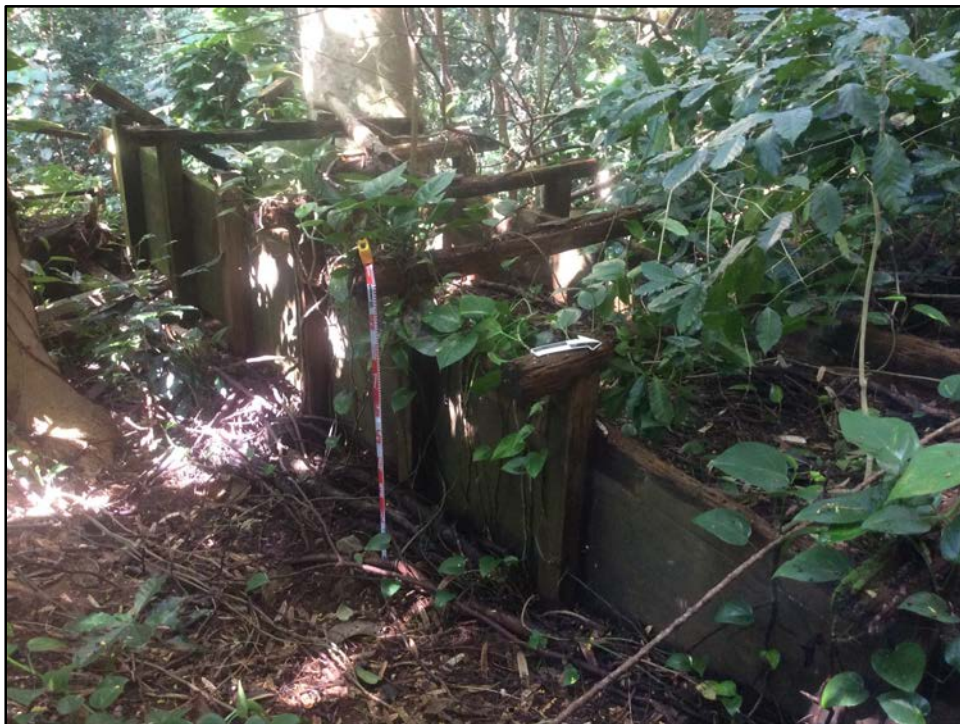
Figure 229. Intact section of east portion, showing general construction, view to west

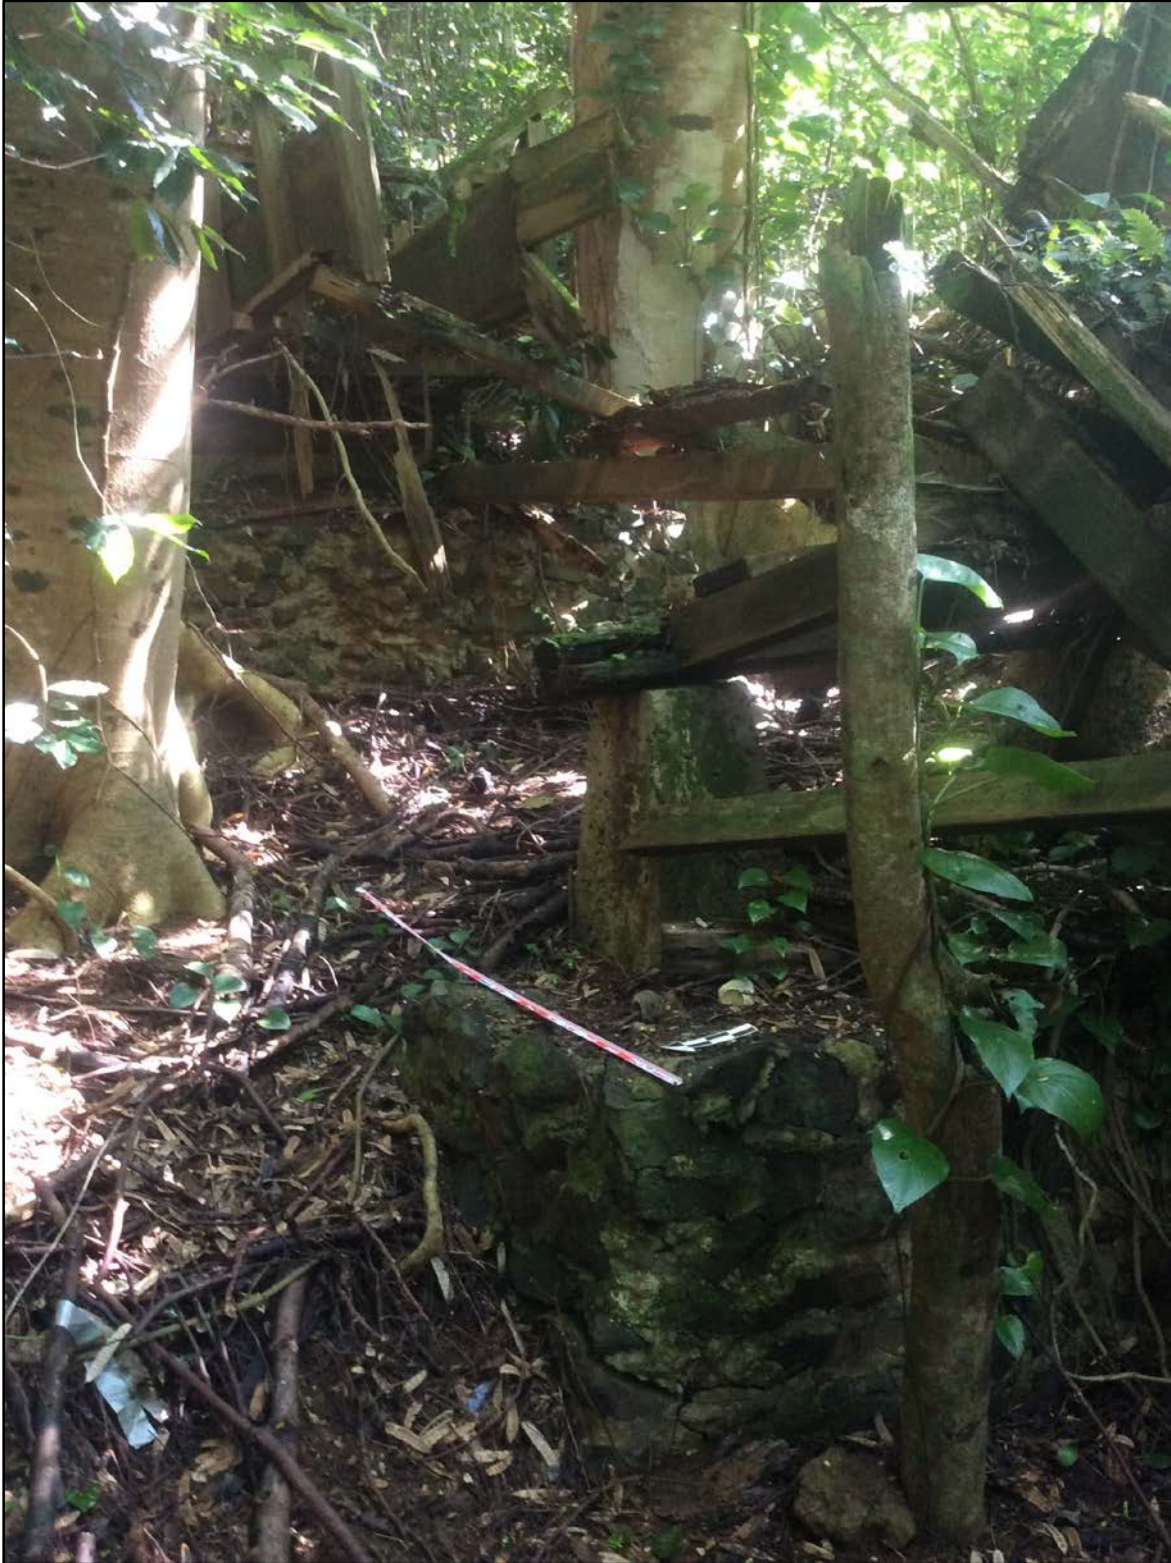
Figure 230. Remnants of support structure of east portion of Feature L including wooden beams, concrete foundations, and mortared basalt retaining walls, view to southeast

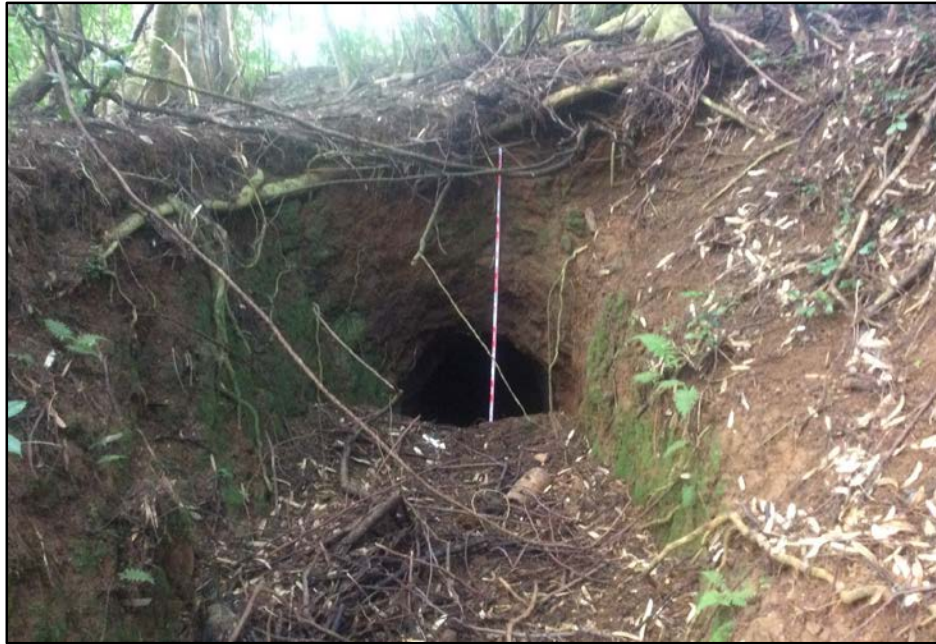
Figure 232. Sub-feature L1, showing dirt accumulation at tunnel opening, view to southwest

Sub-feature L1 consists of an earthen ditch tunnel opening serving as the outflow for a ditch that flows across the flume (Figure 232 and Figure 233). Dirt accumulation, likely due to erosion and collapse, was observed at the opening of the tunnel. The parabolic tunnel opening was approximately 1 m in width with a maximum height of 0.8 m above the ground surface. Substantial dirt accumulation was observed at the tunnel opening. Within the tunnel the maximum height was approximately 1.3 m.

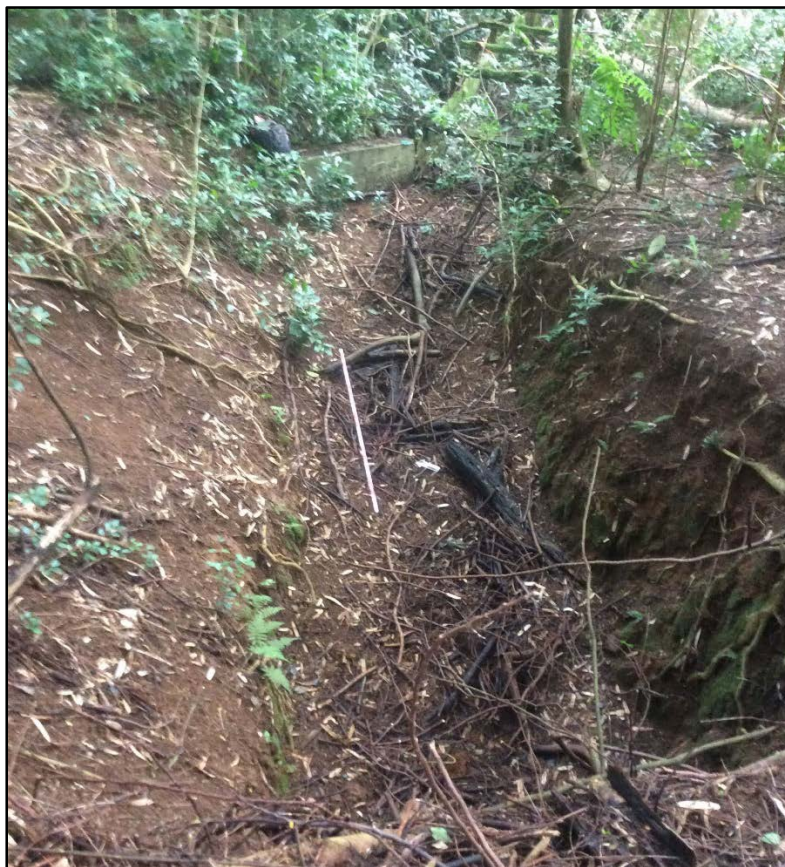
Figure 233. View of Feature L and ditch from Sub-feature L1, view to northeast

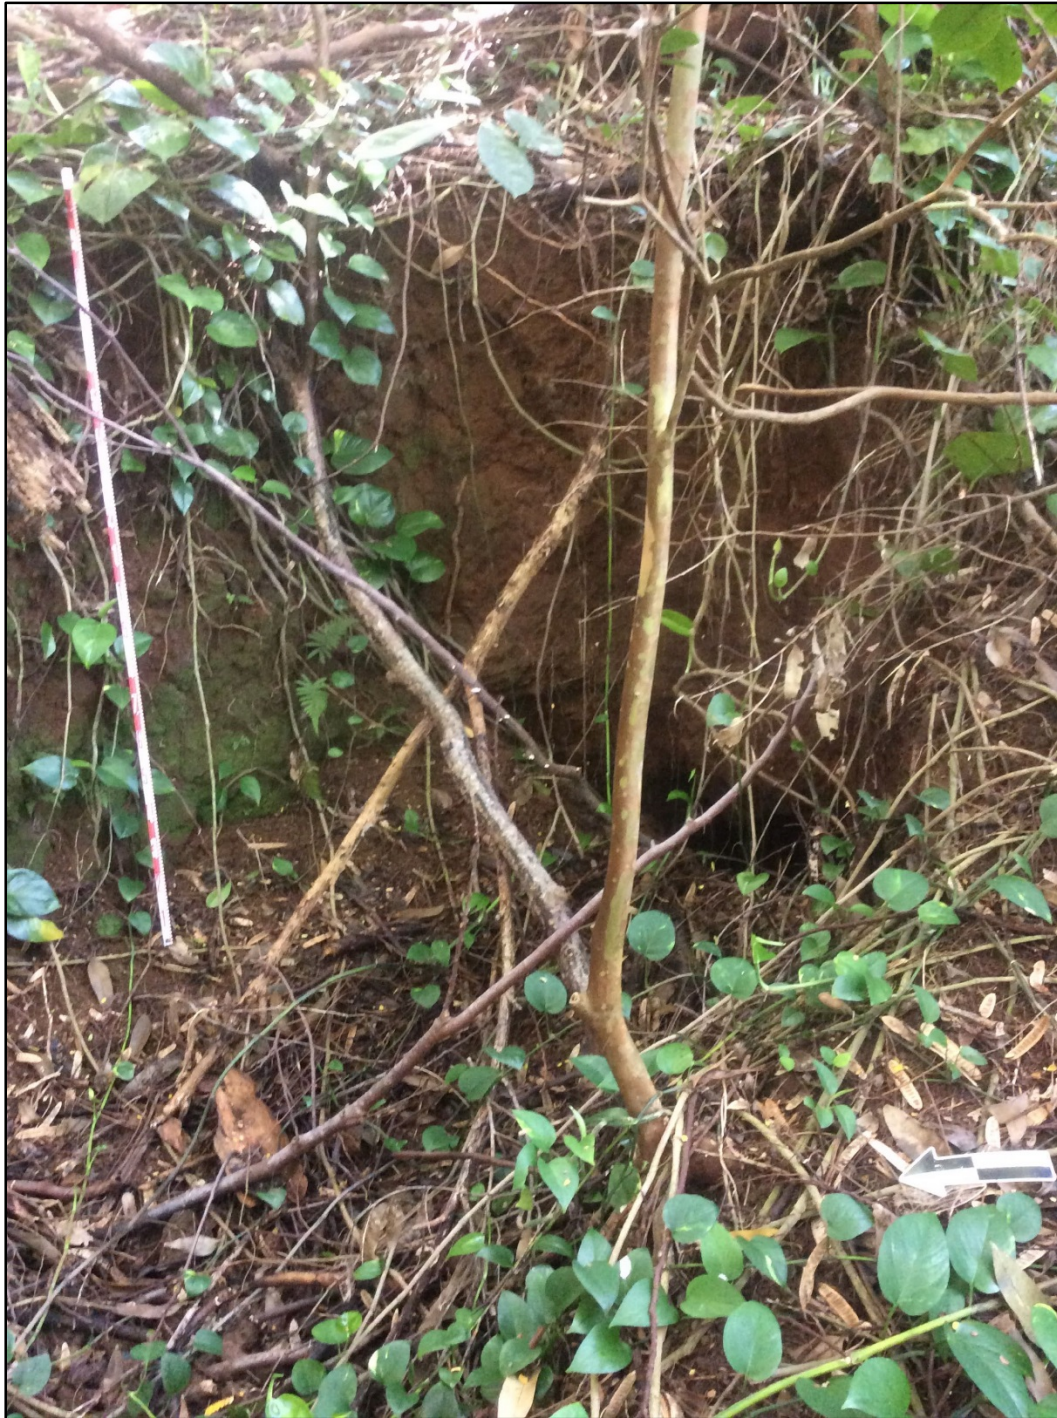
Figure 234. Sub-feature L2, showing heavy dirt accumulation at entrance, view to east

Sub-feature L2 consists of an earthen ditch tunnel opening that allows water to flow back into an earthen tunnel system after flowing across the flume (Figure 234). The tunnel was more heavily disturbed than Sub-feature L1 and substantial dirt accumulation was observed at the opening of the tunnel. The parabolic tunnel opening was approximately 1 m in width with a maximum height of 0.3 m above the ground surface. Substantial dirt accumulation was observed at the tunnel opening. It is likely the tunnel is of similar size and shape as was documented at Sub-feature L1.

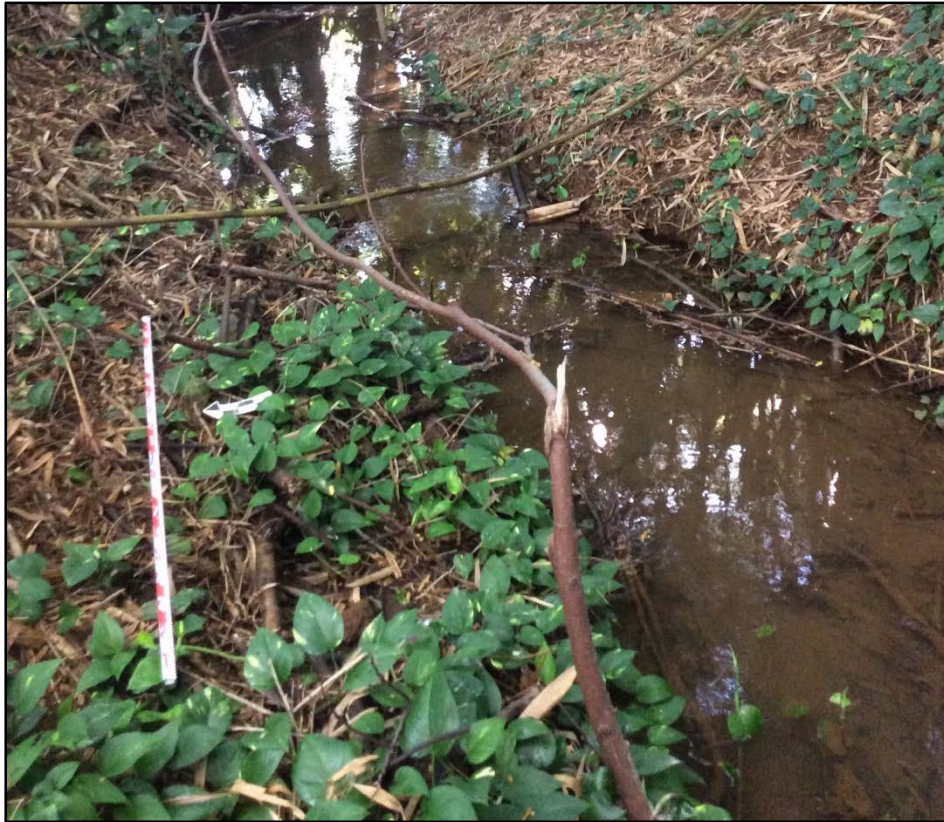
Figure 235. SIHP # -2179 Feature M, southwest of Feature K2, view to east

Feature M enters the project area on the Puhī Stream Gulch floor. The ditch crosses under a flume (Feature L) and flows along the east side of the gulch. The ditch then enters a tunnel at Sub-feature M1. The feature was observed exiting the outflow of the tunnel (Sub-feature M2). The ditch then meanders south toward the Puhī Camp Cemetery (SIHP # -B006), wraps around the west, south, and east boundaries of the cemetery and terminates at Feature G. A sluice gate (Sub-feature M3) was observed southeast of the cemetery, and an earthen tunnel (Sub-feature M4) acting as a bridge for the cemetery road was observed just northeast of Sub-feature M3. The ditch is the only in-use irrigation ditch present within the gulch and transports water from the gulch floor to the tablelands above. The exposed portion of Feature M is approximately 148 m long within the gulch and 510 m long on the tablelands (Figure 235 through Figure 238). The ditch tunnel openings (Sub-features M1 and M2) are approximately 290 m apart to the southeast suggesting the minimum possible length of the feature within the project area is approximately 948 m. The ditch measures between 2 m and 3 m in width and 0.3 to 0.8 m in depth. The feature primarily uses the hillside to form the upslope wall of the ditch and in most areas contains a man-made berm on the downslope side of the ditch.

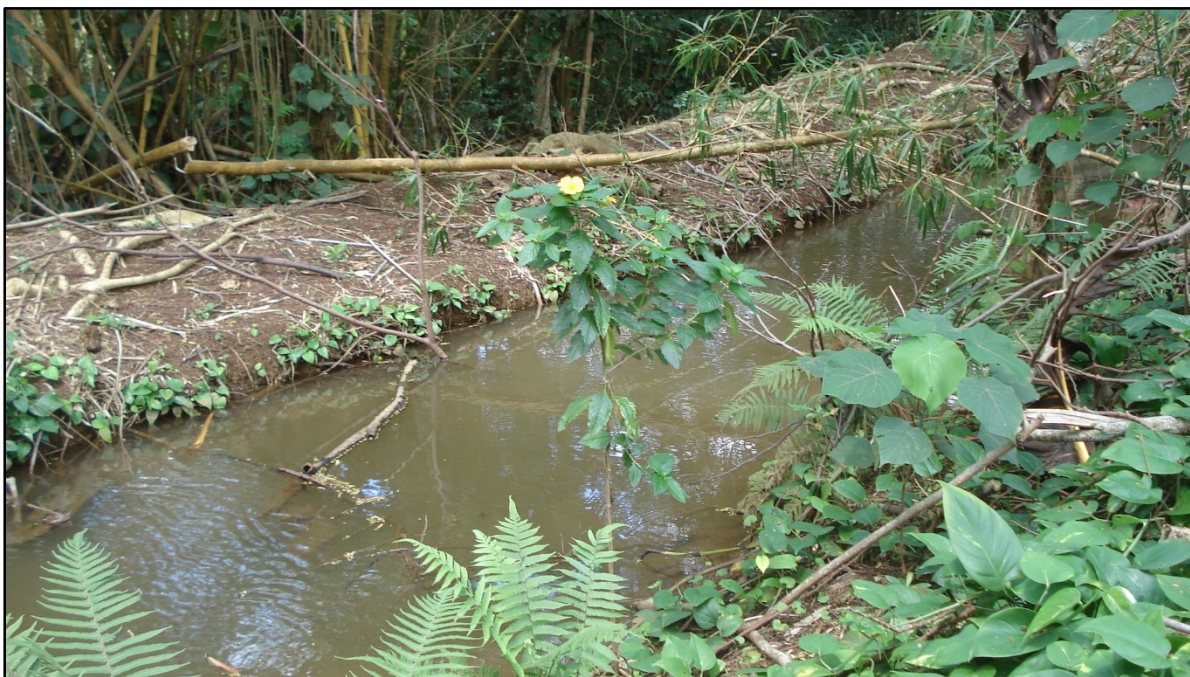
Figure 236. Feature M near cemetery (SIHP # -B006), view to west
