Section 6 Historic Property Descriptions

6.1 SIHP # 50-30-11-B006

6.2 SIHP # 50-30-11-2179

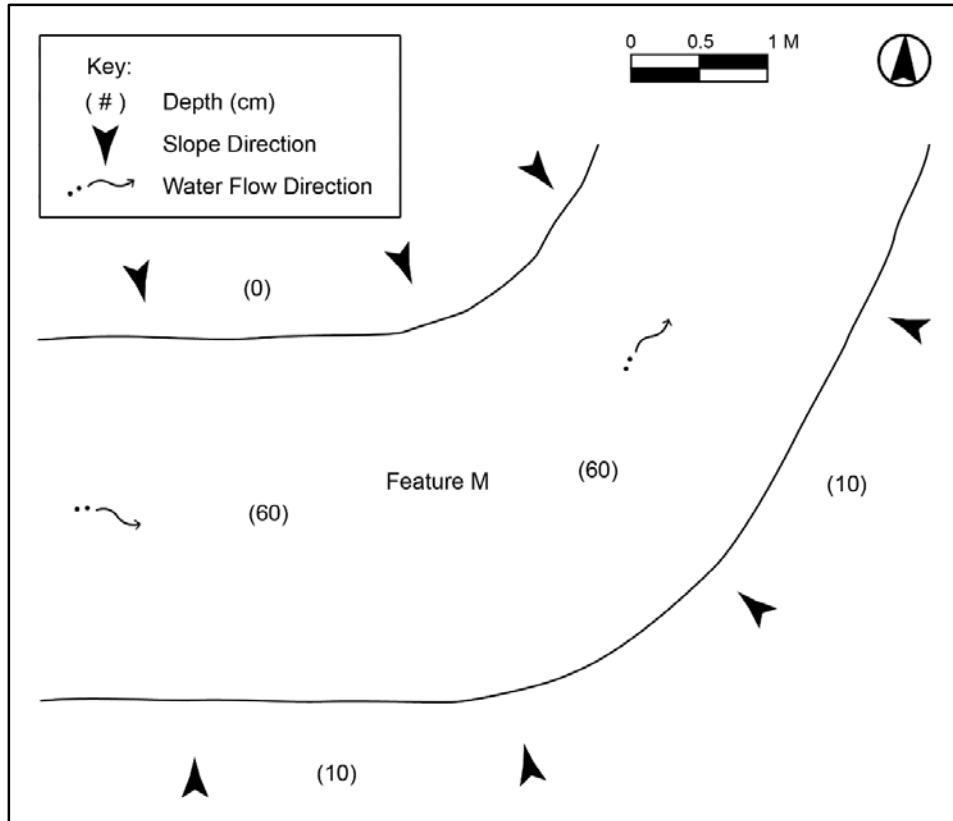
Figure 237. Plan map of SIHP # -2179 Feature M

Feature M enters the project area on the Puhī Stream Gulch floor. The ditch crosses under a flume (Feature L) and flows along the east side of the gulch. The ditch then enters a tunnel at Sub-feature M1. The feature was observed exiting the outflow of the tunnel (Sub-feature M2). The ditch then meanders south toward the Puhī Camp Cemetery (SIHP # -B006), wraps around the west, south, and east boundaries of the cemetery and terminates at Feature G. A sluice gate (Sub-feature M3) was observed southeast of the cemetery, and an earthen tunnel (Sub-feature M4) acting as a bridge for the cemetery road was observed just northeast of Sub-feature M3. The ditch is the only in-use irrigation ditch present within the gulch and transports water from the gulch floor to the tablelands above. The exposed portion of Feature M is approximately 148 m long within the gulch and 510 m long on the tablelands (Figure 235 through Figure 238). The ditch tunnel openings (Sub-features M1 and M2) are approximately 290 m apart to the southeast suggesting the minimum possible length of the feature within the project area is approximately 948 m. The ditch measures between 2 m and 3 m in width and 0.3 to 0.8 m in depth. The feature primarily uses the hillside to form the upslope wall of the ditch and in most areas contains a man-made berm on the downslope side of the ditch.

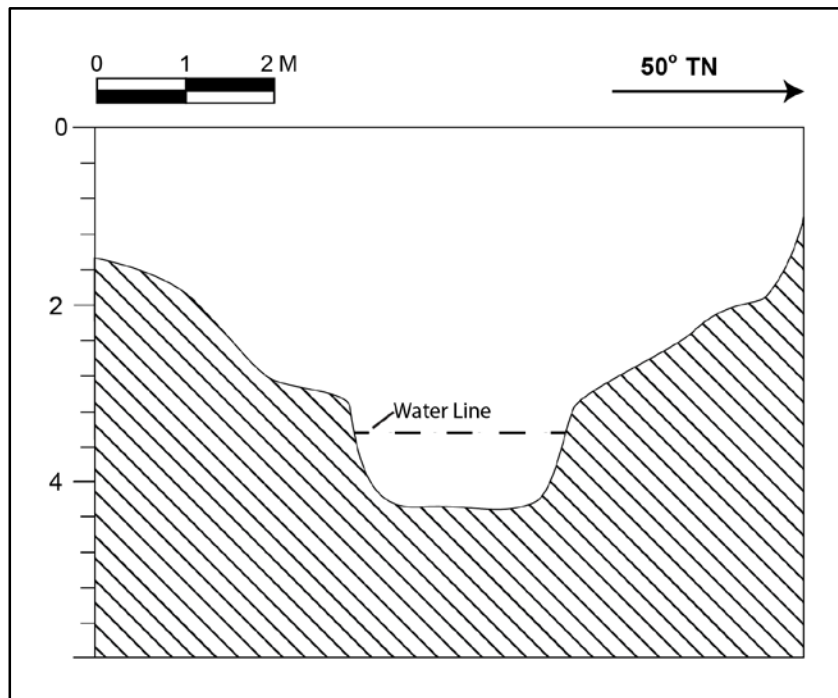
Figure 238. CS-13, cross-section of Feature M

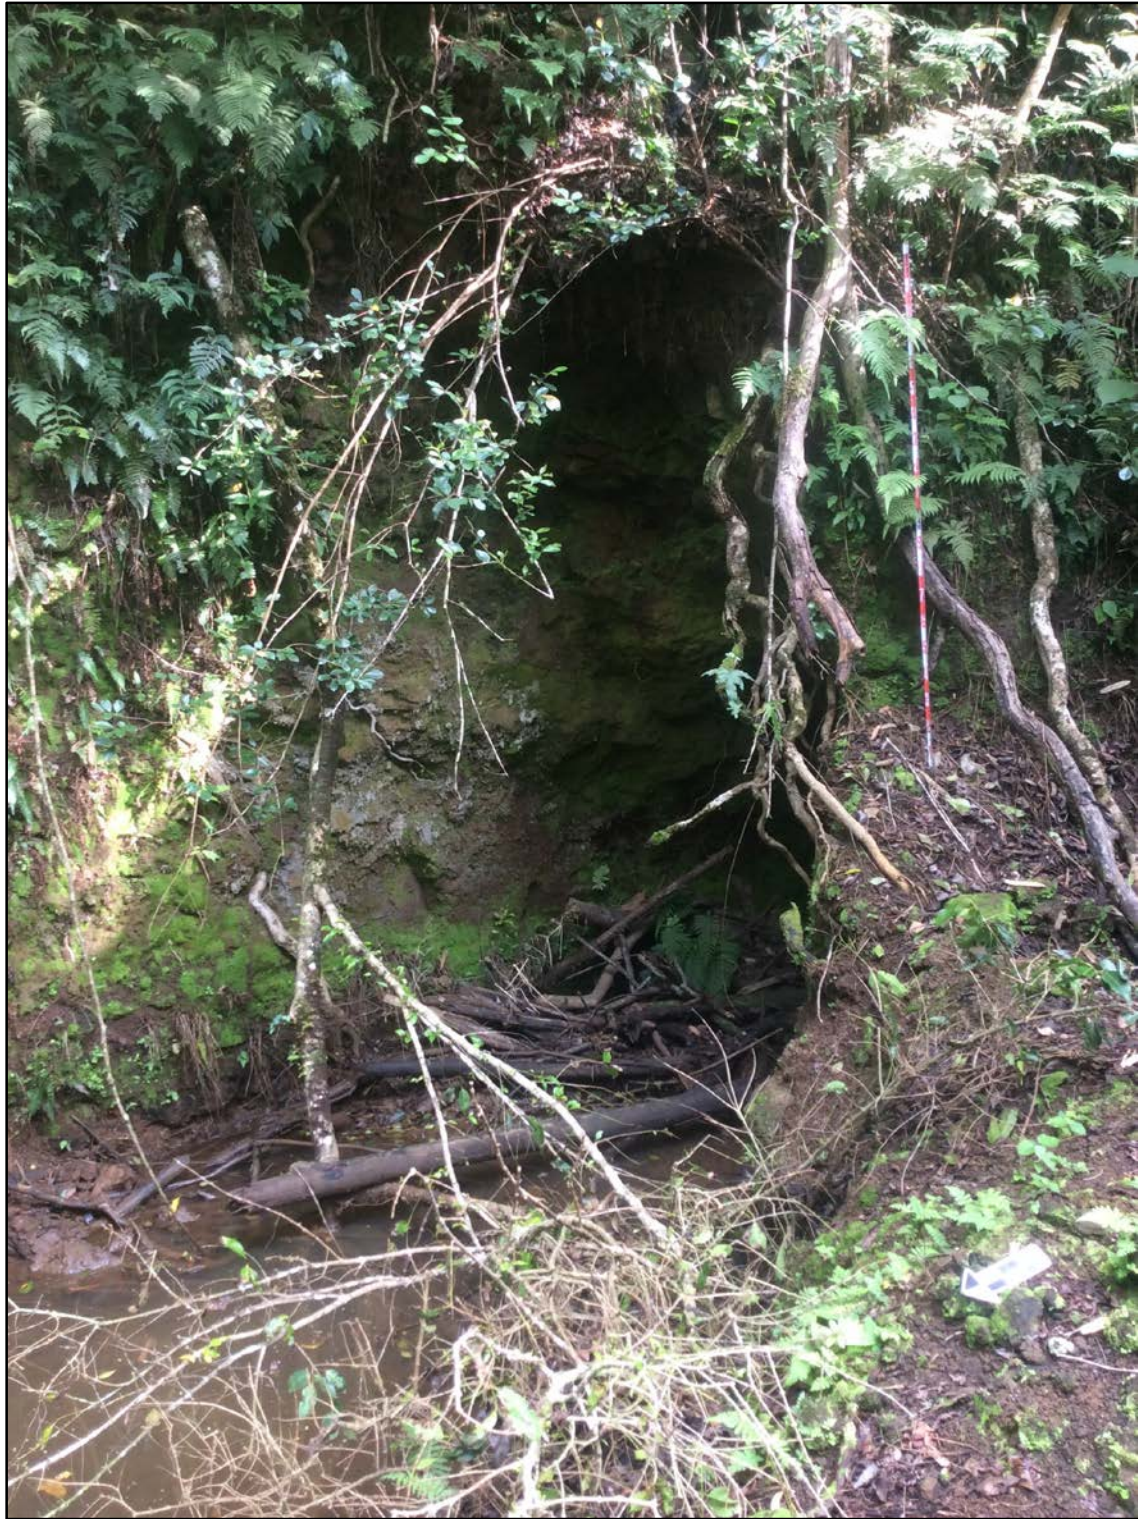
Figure 239. Sub-feature M1, showing Feature M flowing into tunnel, view to southeast

Sub-feature M1 consists of an earthen ditch tunnel opening that serves as the intake for the earthen ditch tunnel associated with Feature M (Figure 239 and Figure 240). The ditch tunnel is located south of Feature L on the east slope of the gulch. The ditch tunnel opening measures 1.7 m wide. The tunnel is parabolic and with a maximum height of 1.9 m at the opening. The top of the opening is approximately 2.4 m below the ground surface, which slopes drastically to the west of the feature. No evidence of the date of construction was observed.

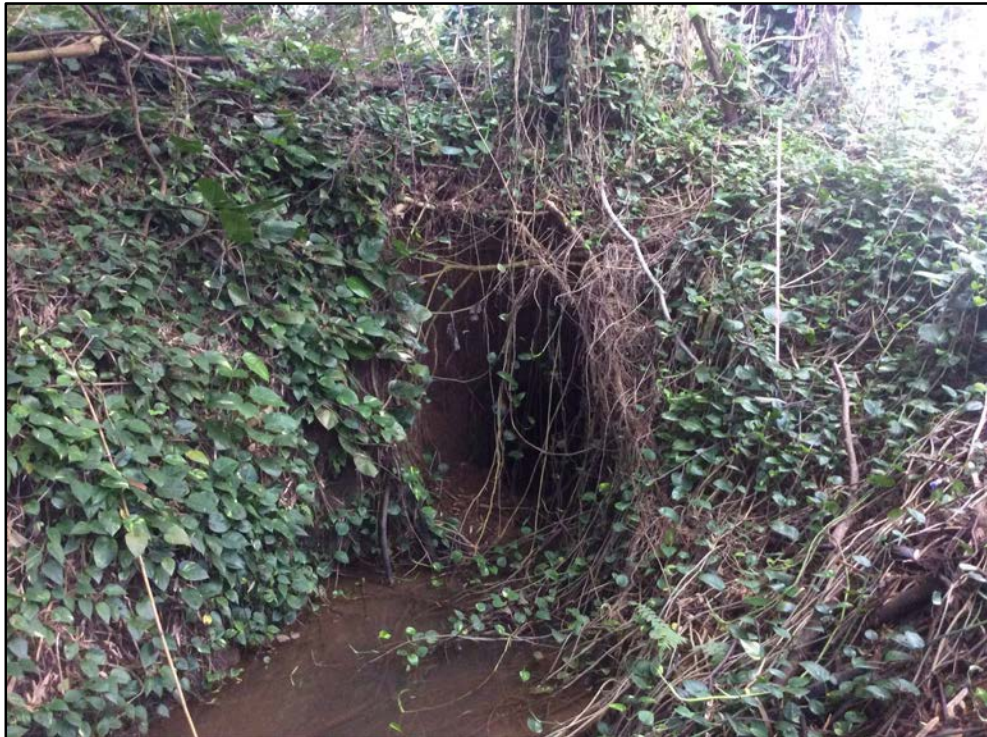
Figure 241. Sub-feature M2, irrigation ditch tunnel outflow, view to southwest

Sub-feature M2 consists of an earthen ditch tunnel opening that serves as the outflow for the earthen ditch tunnel associated with Feature M (Figure 241 and Figure 242). The ditch tunnel is located south of Feature K1 on the tablelands to the east of the gulch. The ditch tunnel opening measures 2.0 m wide. The tunnel is parabolic and with a maximum height of 2.1 m at the opening. The top of the opening is approximately 0.95 m below the ground surface which slopes drastically upwards. No evidence of the date of construction was observed.

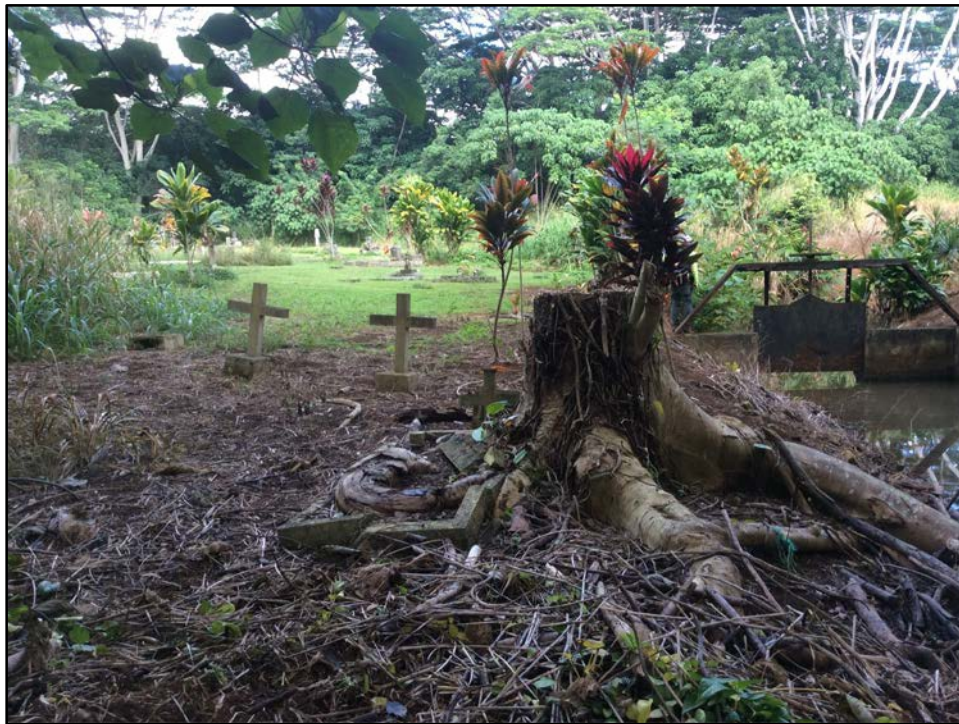
Figure 243. Feature M3, sluice gate, showing close proximity to SIHP # -B006, view to northeast

Sub-feature M3 is a sluice gate which functions to control water flow of Feature M (Figure 243 through Figure 248). The sluice gate is L-shaped with two gate features on the two perpendicular sides. The gates are housed on a concrete foundation, with mortared basalt wing

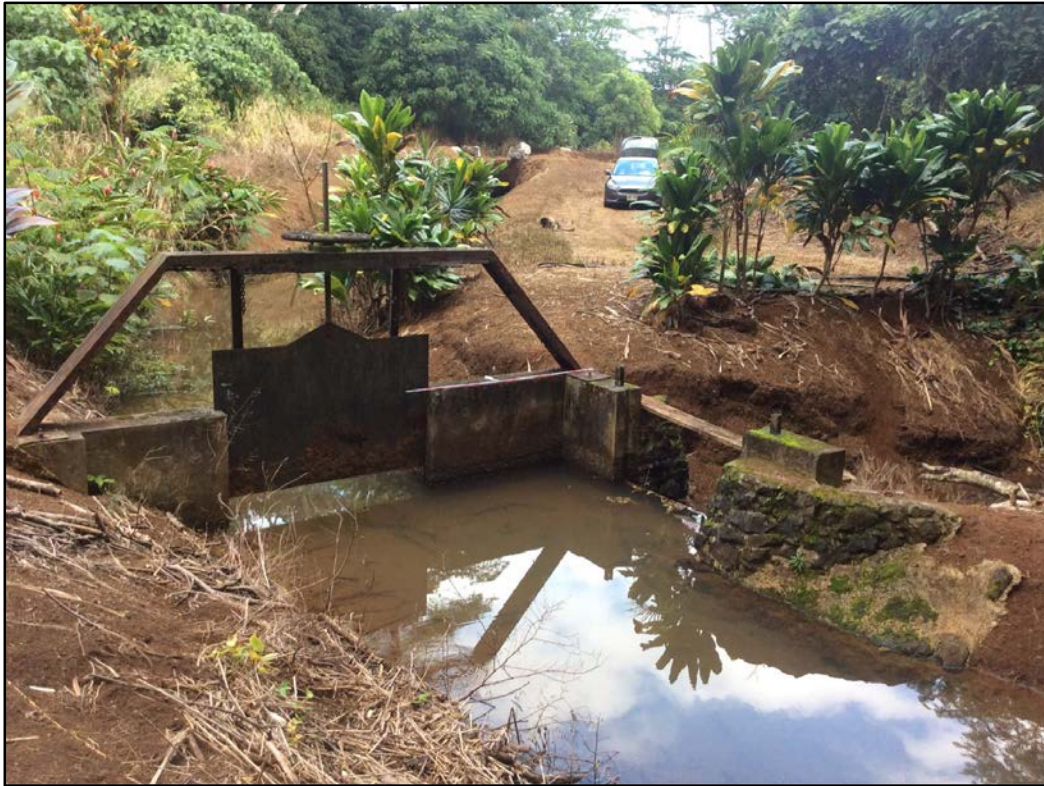
Figure 244. Sub-feature M3 showing north gate (left) and east gate (right), view to northeast

walls. The foundations contain grooves to allow for the individual gates to be held in place. The north sluice gate is a metal vertical rising gate that is made up of a metal plate, attached to a screw and hand-crank wheel. The sluice gate is connected to the concrete foundation by two diagonal steel beams and one cross beam that extend from the outer corners of the concrete foundation. The structure that holds the gate is 4.95 m long by 0.3 m wide. The wheel is attached to the screw approximately 1.35 m above the concrete foundations. The plate fills the 1.8 m gap in the concrete foundations.

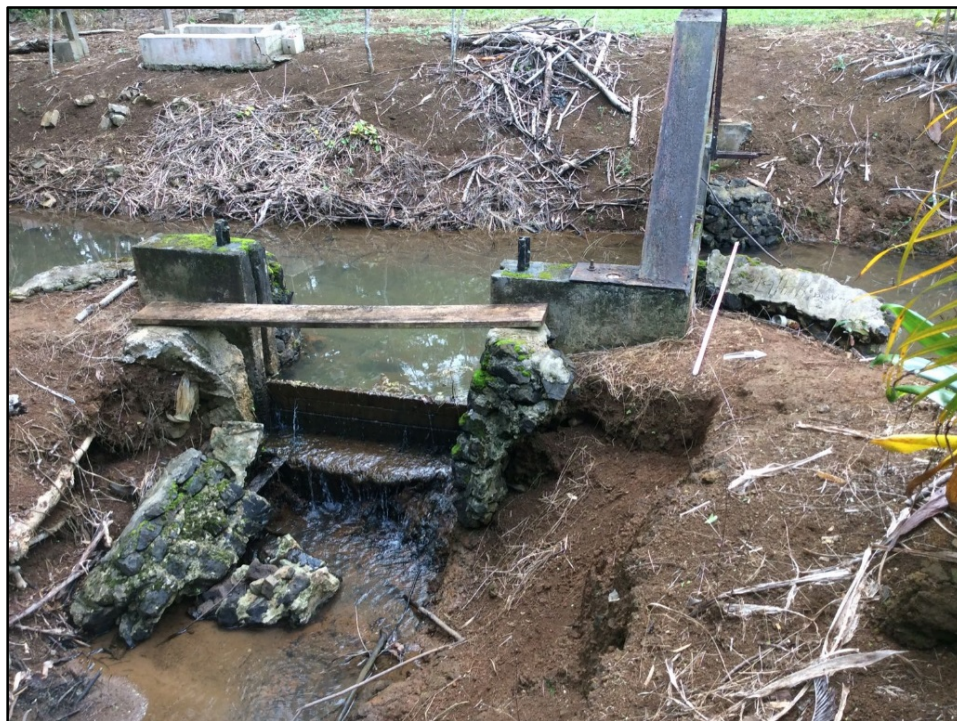
Figure 245. Sub-feature M3, east gate, view to west

The east gate feature is disturbed, likely due to erosion. A mortared basalt wall approximately 20 cm below the concrete foundation raps around the west side of the foundation and mortared basalt wing walls were observed on the east side of the concrete foundation. The south wing wall has collapsed, portions of which are lying the drainage ditch. The gate is not as elaborate as the north gate and consists of placing wooden boards within the notches on the foundations. The concrete foundations are similar in width, but are not as long as the north gates foundations. The gap between the two foundations that allow water to pass through is approximately 1.5 m wide. Writing was observed Water flows over the boards which acts more like a weir. A drainage ditch was observed as heading downhill. It is likely the east gate was constructed to allow for the outflow of excess water, through the drainage ditch meeting up with the Puhi Stream in the gulch below.

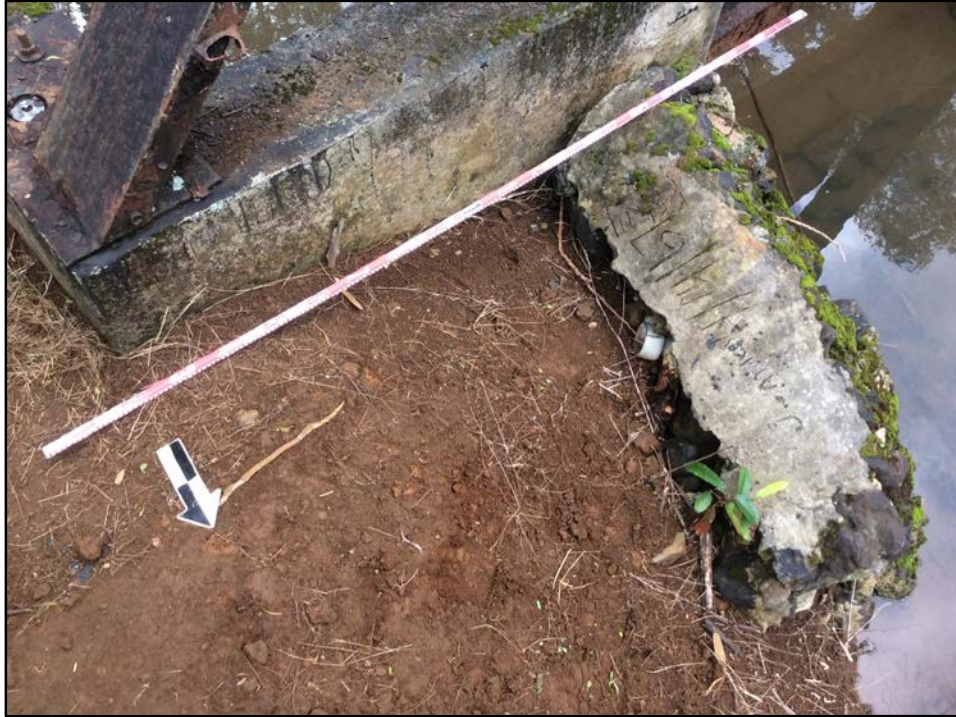
Figure 246. "J.Andres 4/14/67 FEB 14" inscribed on wing wall

Along the mortared basalt wing walls, inscriptions were observed on the concrete caps (see Figure 246 and Figure 247). The inscriptions were located on all the concrete capped walls and had the name "J.Andres" inscribed on them and numerous instance of the dates: "4/14/67" and "FEB 14" inscribed as well. It is likely the mortared basalt walls are a later modification of the sluice gates and the concrete foundations and metal gates were constructed prior to 1967.

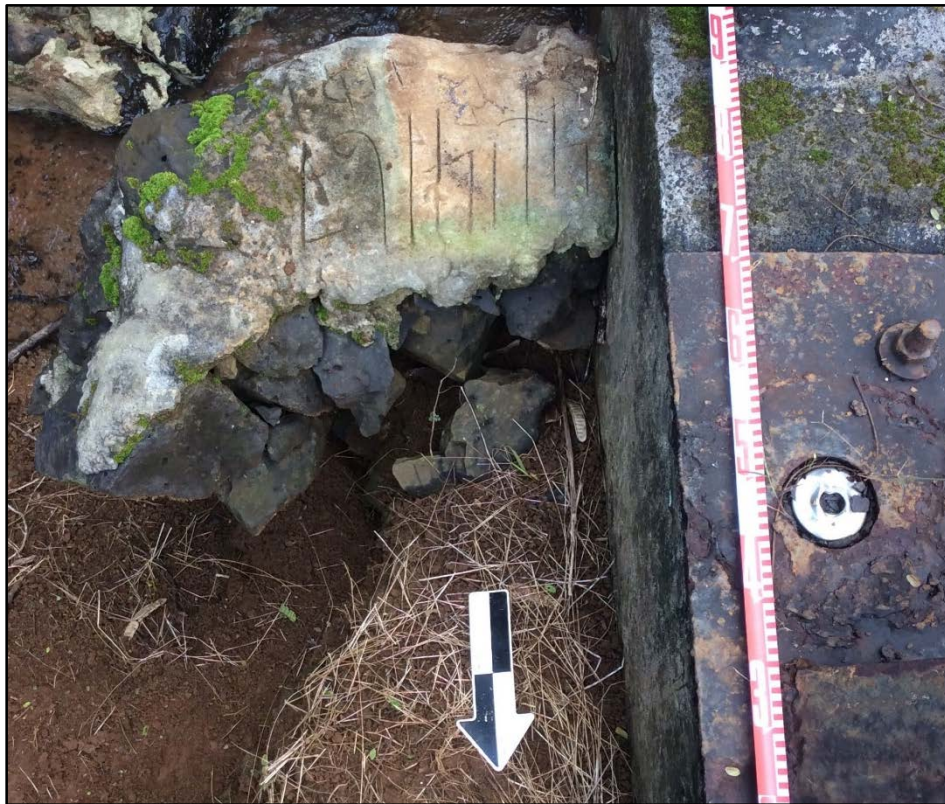
Figure 247. "4/14/67 FEB 14" inscribed on wing wall

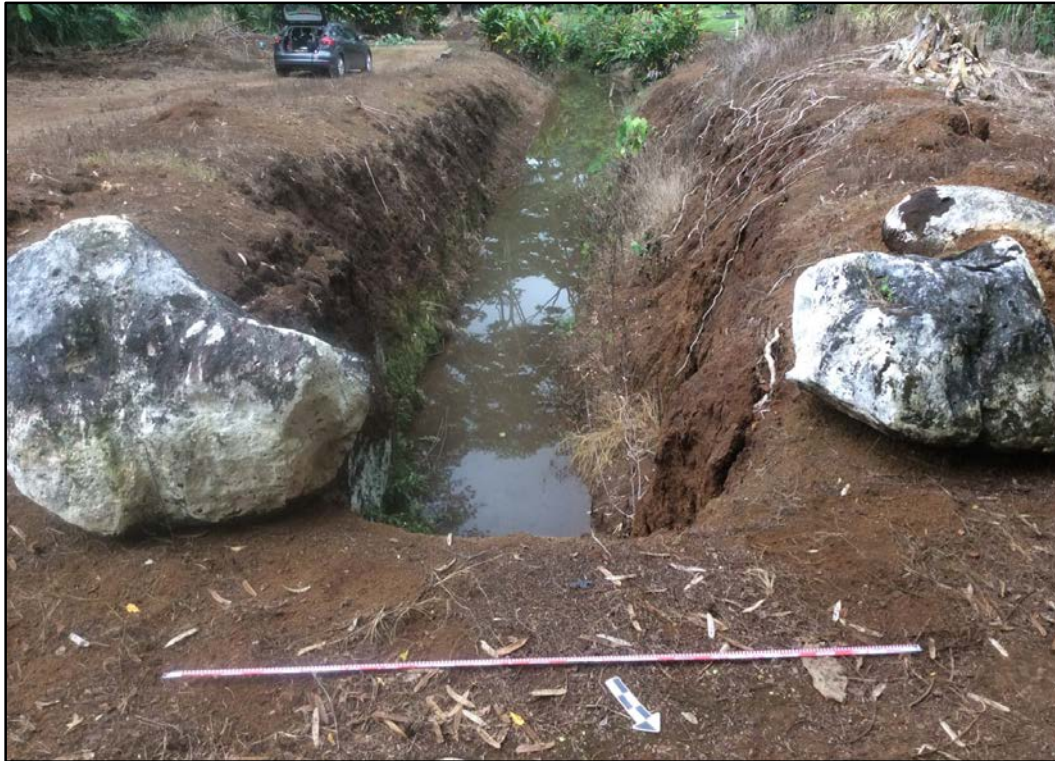
Figure 249. Sub-feature M4, from cemetery road, view to south towards Sub-feature M3

Sub-feature M4 is an earthen ditch tunnel that serves as a bridge for the cemetery road (Figure 249 through Figure 253). The tunnel is approximately 45 m northeast of Sub-feature M3. Feature M flows northeast towards the tunnel through a steep canal, then flows through the tunnel for approximately 17 m. The tunnel is parabolic and measures approximately 2 m wide with a maximum height of 2.1 m. The apex of the tunnel was located approximately 2 m below the road surface. Some minor collapse of the internal structure was observed, however, water is still able to flow through the tunnel. The tunnel is illustrated on a 1933 LCA 1087 Map 1 (see Figure 16).

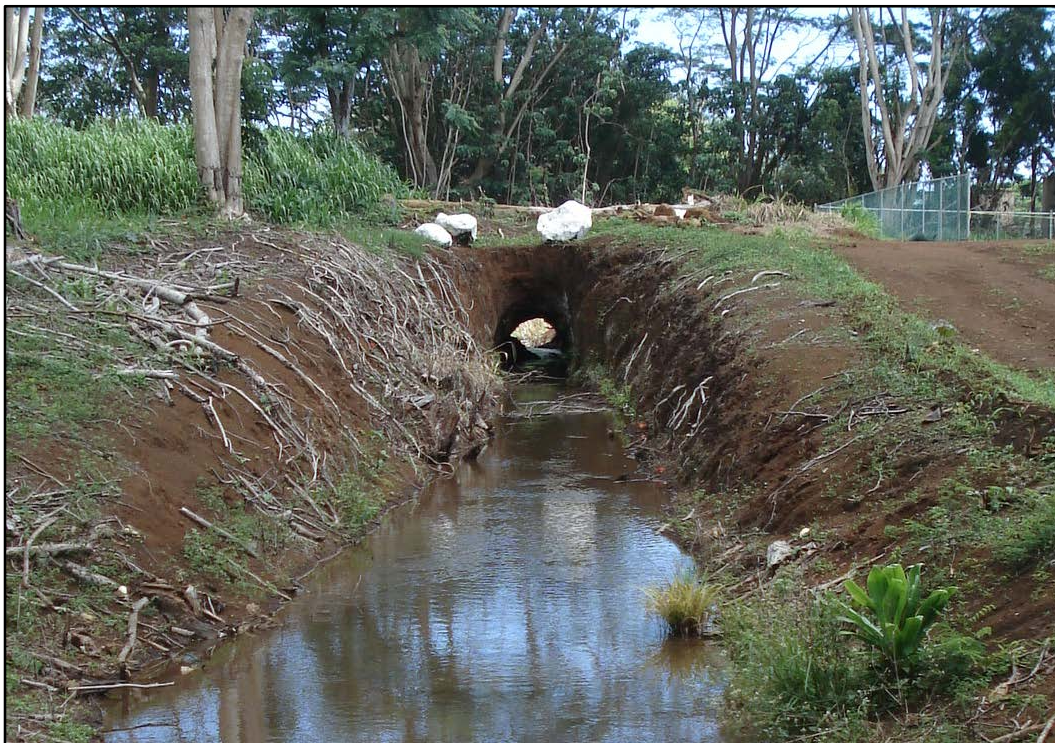
Figure 250. View of tunnel and roadway associated with Sub-feature M4, view to north

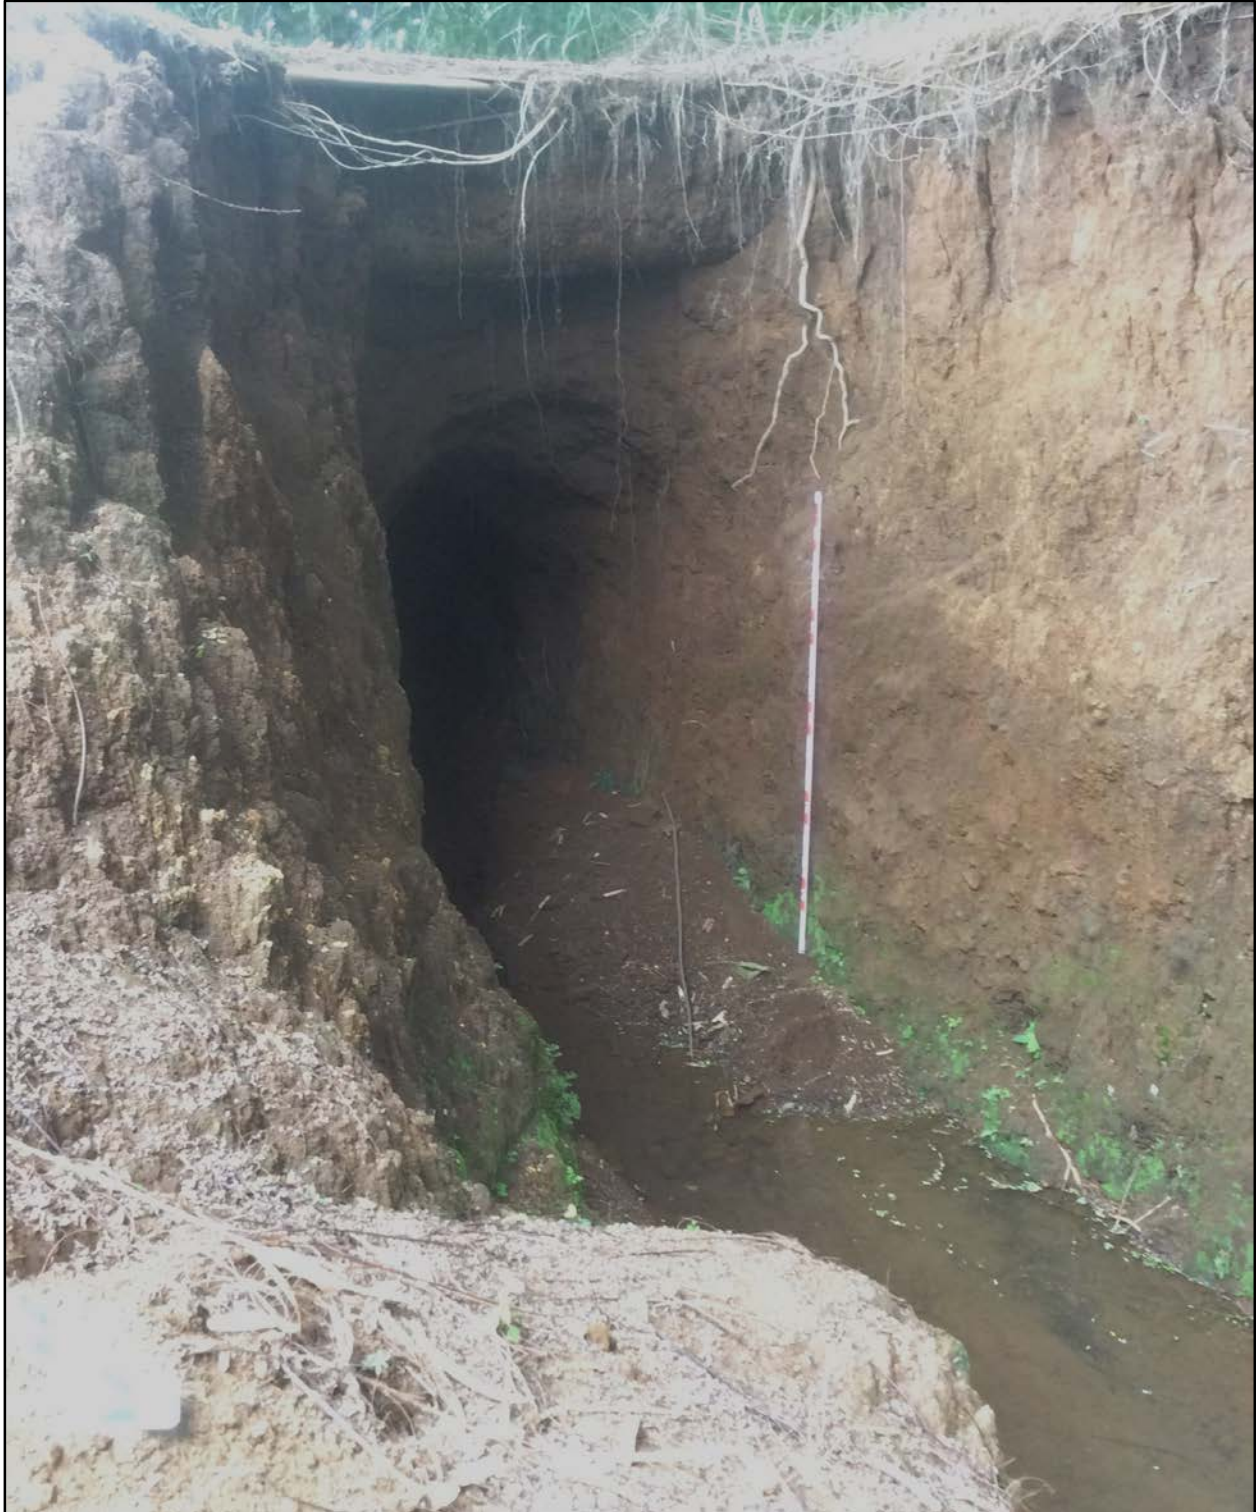
Figure 251. North end of Sub-feature M4, view to southwest

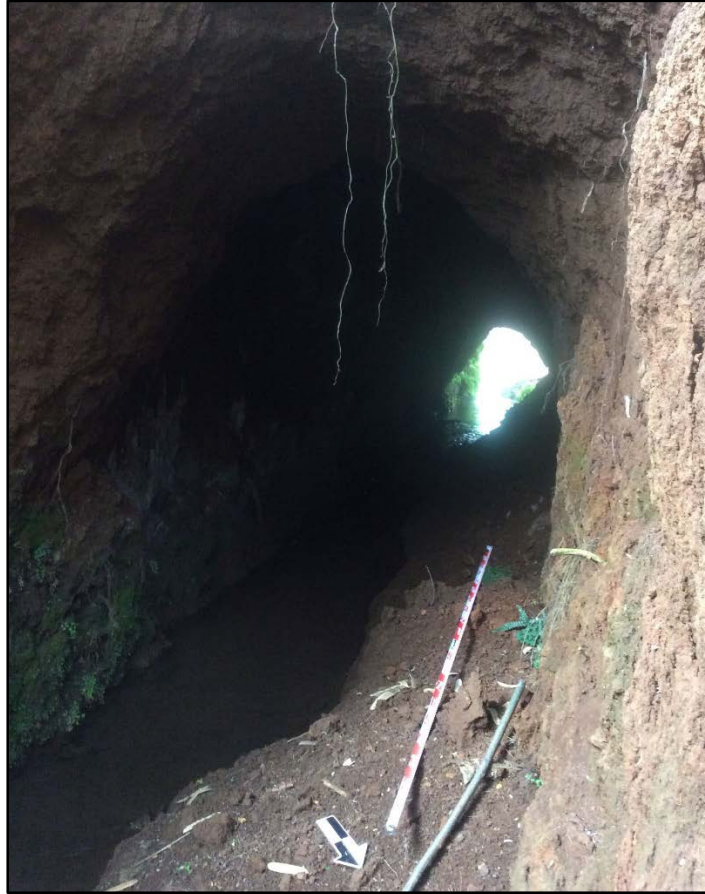
Figure 252. Sub-feature M4, showing collapse on in interior, view to south

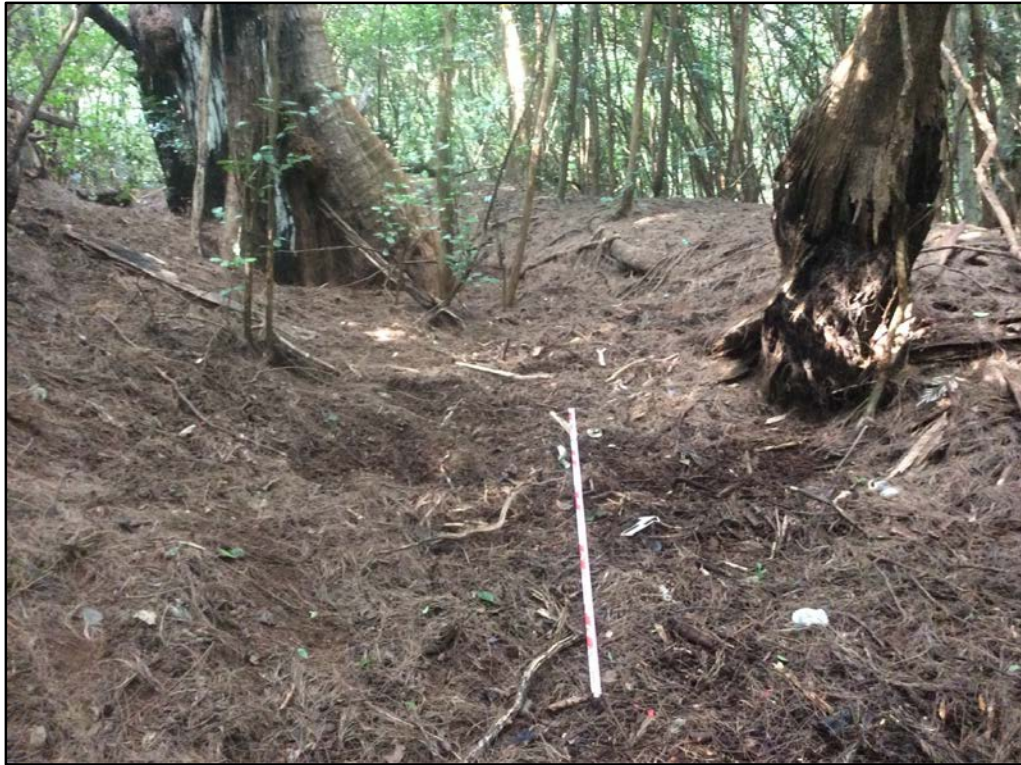
Figure 254. Feature N, showing berm of right side of photo, view to northwest

Feature N is an abandoned earthen irrigation ditch that enters the project area from the west via an earthen ditch tunnel (Sub-feature N1), extending north along the west slope of the gulch. The feature then bends east, and then south, passing through two sluice gates (Sub-features N2 and N3 on either side of the Puhi Stream, and extends southeast along the east slope of the gulch. The remnant ditch is characterized by a steep side wall on the upslope side of the ditch, and a man-made berm on the downslope side of the ditch. Erosion and dirt accumulation has created flat areas of the ditch, however, areas are more greatly defined with maximum depths of 0.6 m. The remnant ditch measures 648.5 m long and is on average 1.7 m wide. The ditch is illustrated on a 1933 LCA 1087 Map 1 (see Figure 16) as following the current known extent, then meeting with the current alignment of Feature M near the cemetery.

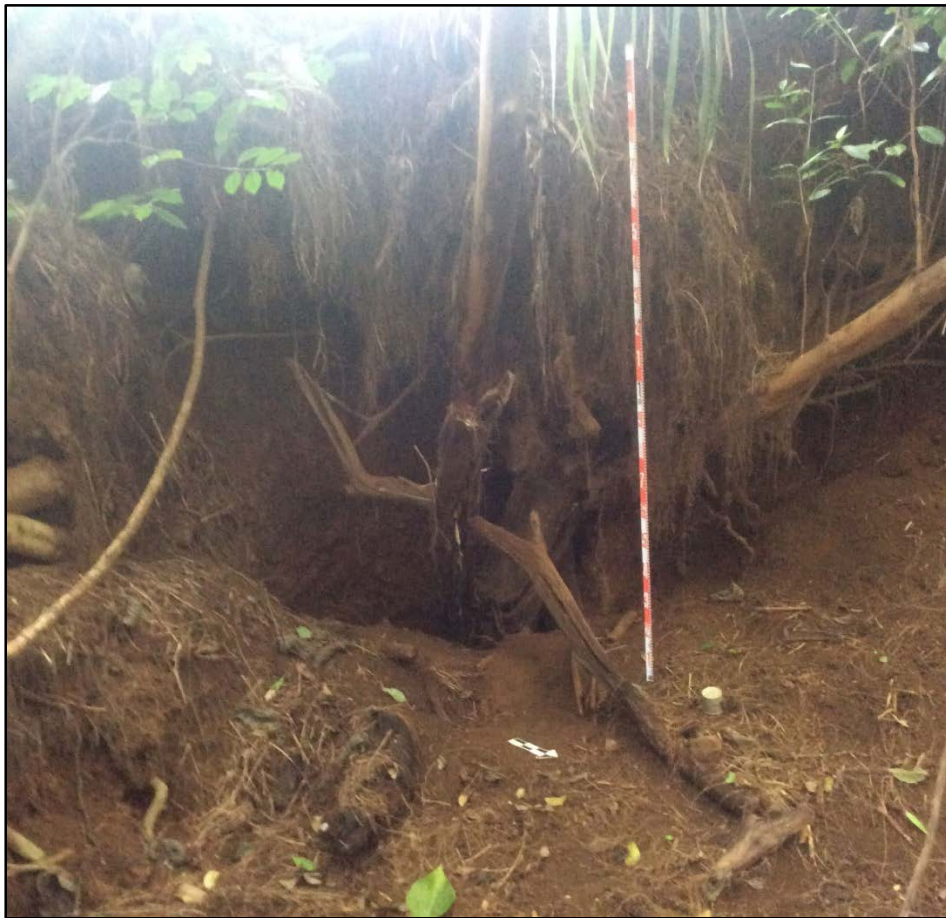
Figure 257. Sub-feature N1, abandoned earthen tunnel, view to southwest

Sub-feature N1 is an abandoned earthen tunnel opening that functioned as the outflow for Feature N. The ditch tunnel is located on the west slope of the Puhi Stream Gulch near the gulch rim. The ditch tunnel opening measures 1.4 m wide. The tunnel is parabolic and with a maximum height of 90 m at the opening. The top of the opening is approximately 1.9 m below the ground surface which slopes slightly towards the tablelands. No evidence of the date of construction was observed.

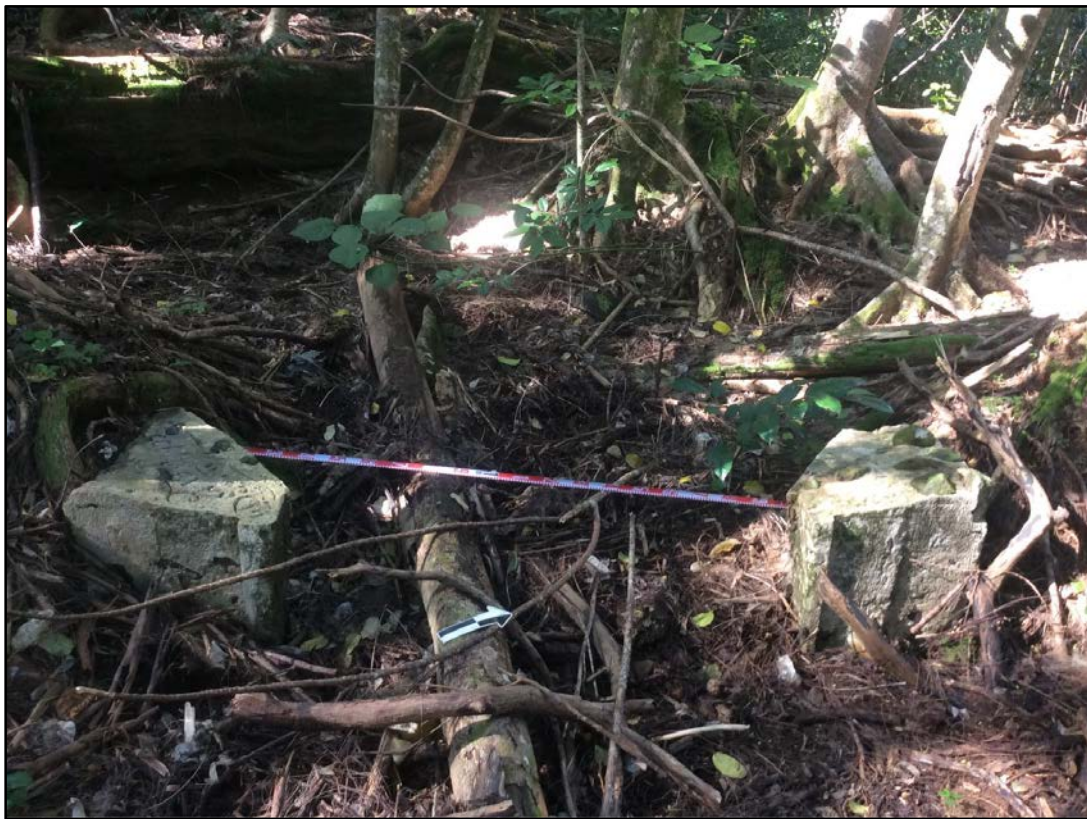
Figure 259. Sub-feature N2, abandoned sluice gate, view to northwest

Sub-feature N2 is an abandoned sluice gate feature. The gate is likely were associated with a flume that allowed the irrigation ditch to cross over Puhi Stream. No evidence of the flume was observed. The gates consist of two similar concrete and basalt foundations with a diagonal edge to channel water and a notch, likely for water control. The foundations are partially buried and were observed 40 cm above the current ground surface. The gates are approximately 60 cm long by 50 cm wide on the outside edges. The gates are approximately 1.4 m apart and are parallel to each other. The date "DEC. 13th 1905" was inscribed in the west foundation. It is likely this sub-feature is associated with one of the early ditches associated with Grove Farm.

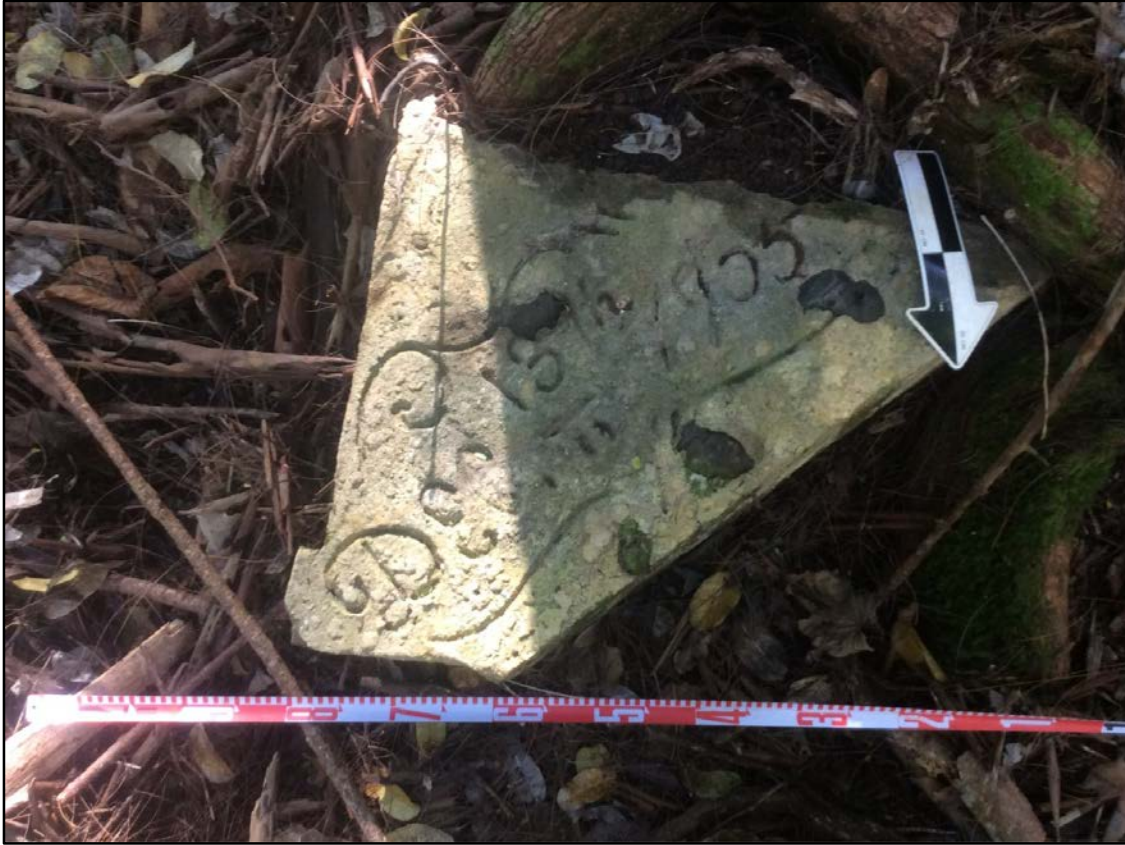
Figure 260. Date “DEC. 13th 1905” inscribed on east concrete foundation of Sub-feature N2

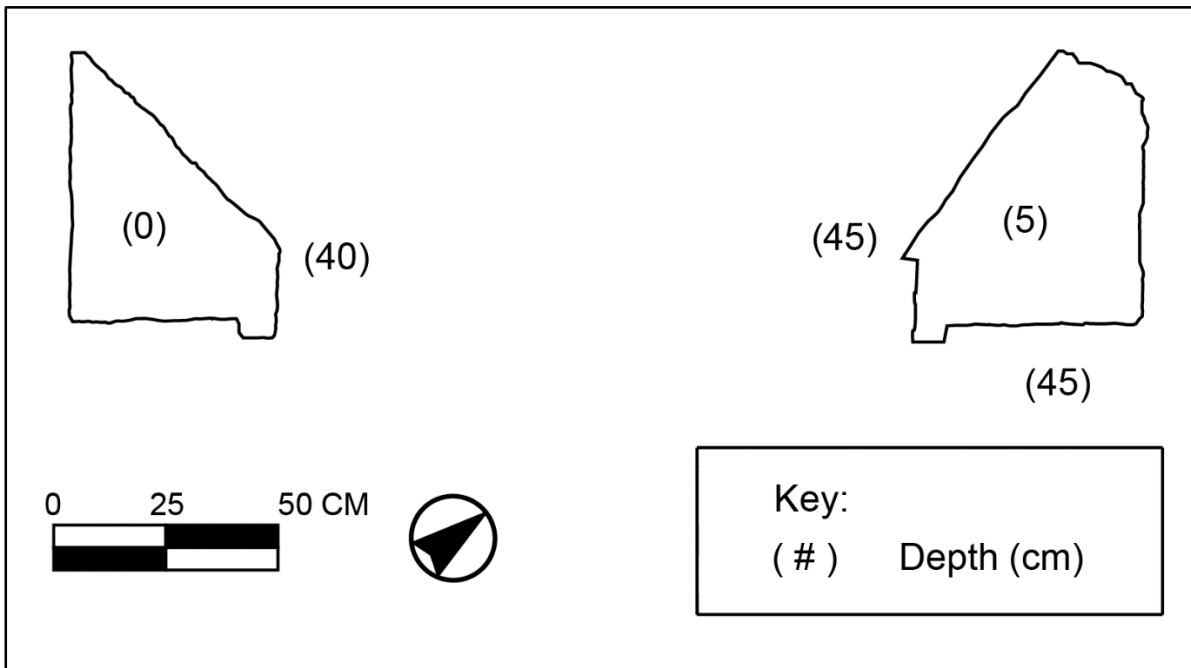
Figure 261. Plan map of Sub-feature N2

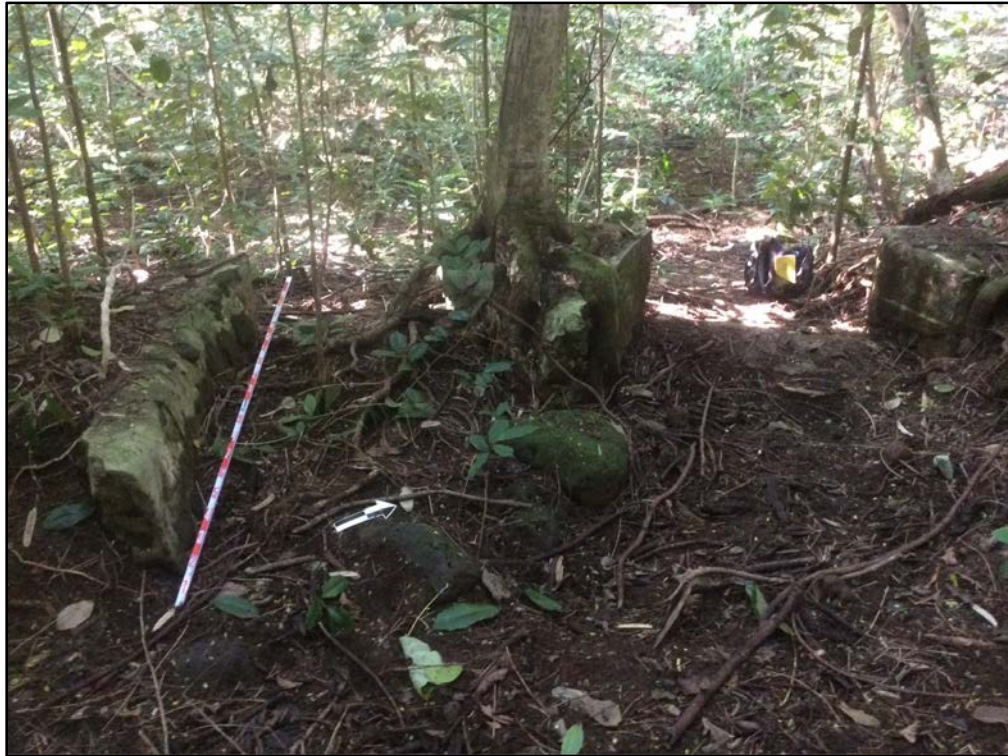
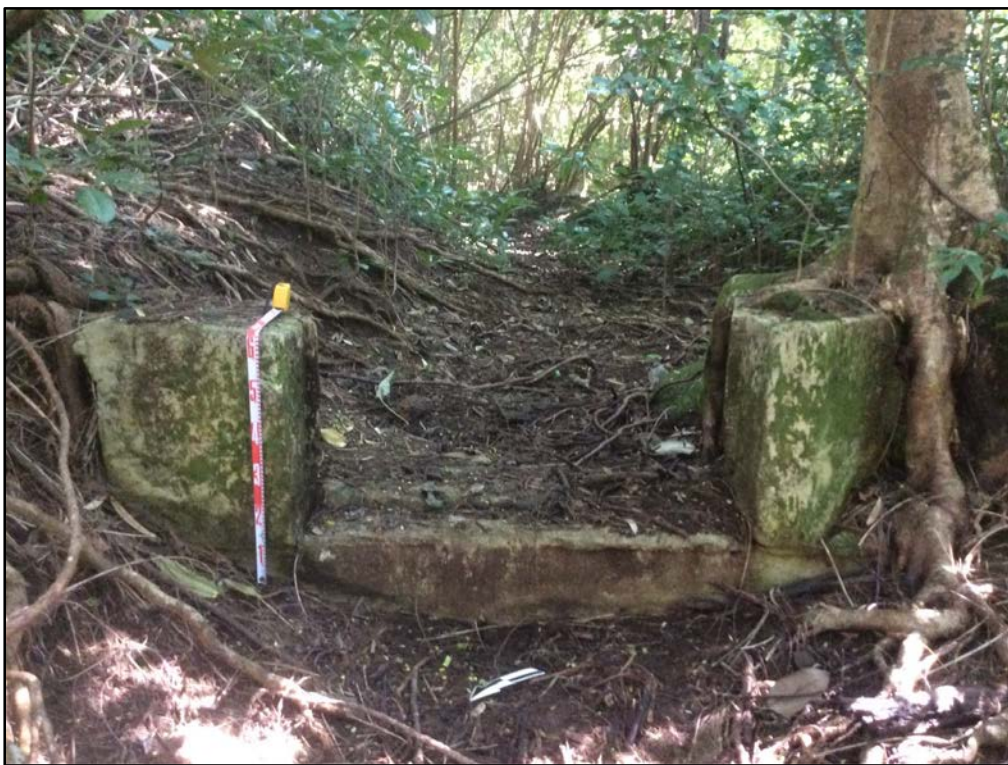
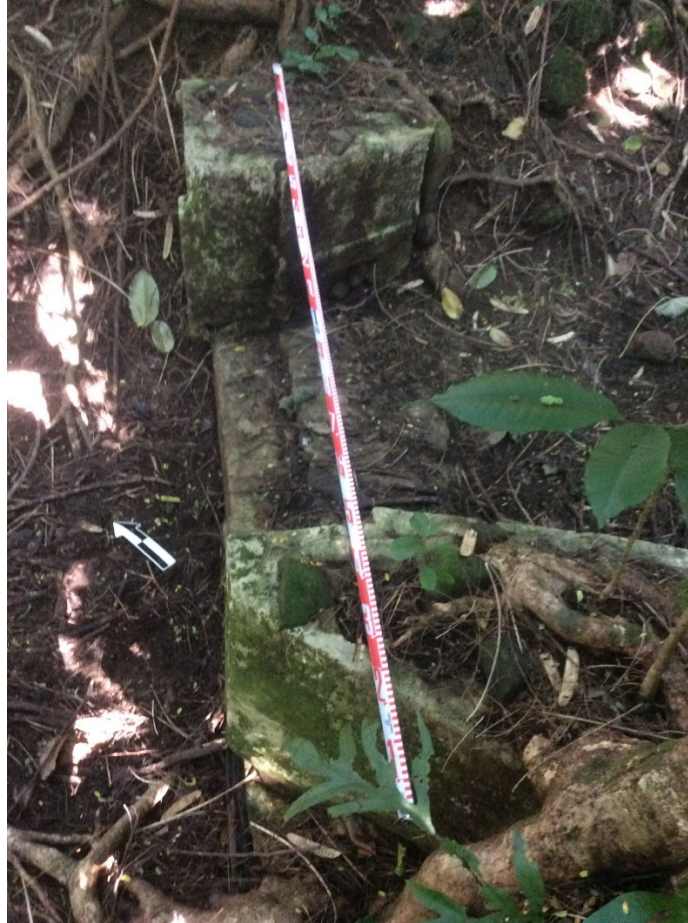
Figure 262. Sub-feature N3, showing two sluice gates, view to northwest

Figure 263. East portion of Sub-feature N3, view to southeast

Figure 264. Close-up of east portion of Sub-feature N3, view to northeast

Sub-feature N3 is an abandoned sluice gate feature consisting of two gates connected by a wedge shaped foundation. The gates likely were associated with a flume that allowed Feature N to cross over Puhi Stream. No evidence of the flume was observed. The gates consist of three concrete and basalt sluice gate foundations attached on a single concrete slab. The northernmost foundation is similar to those observed in Sub-feature N2. The structure measures 65 cm long by 45 cm wide and is approximately 50 cm above the concrete slab. The structure has a similar diagonal edge and notch as Sub-feature N3. The center foundation is 1.1 m southwest of the northern foundation. The center foundation is wedge shaped and constructed of concrete and basalt. The foundation measures 1.25 m long by 0.95 m wide at its greatest extent. Approximately 0.95 m to the south of the center foundation is a 1.2 m long and 0.5 m wide concrete and mortared basalt retaining wall that extends in an east to west direction. The two gates suggest a second ditch may have once joined the ditch at this location. It is likely this sub-feature is associated with one of the early ditches associated with Grove Farm.

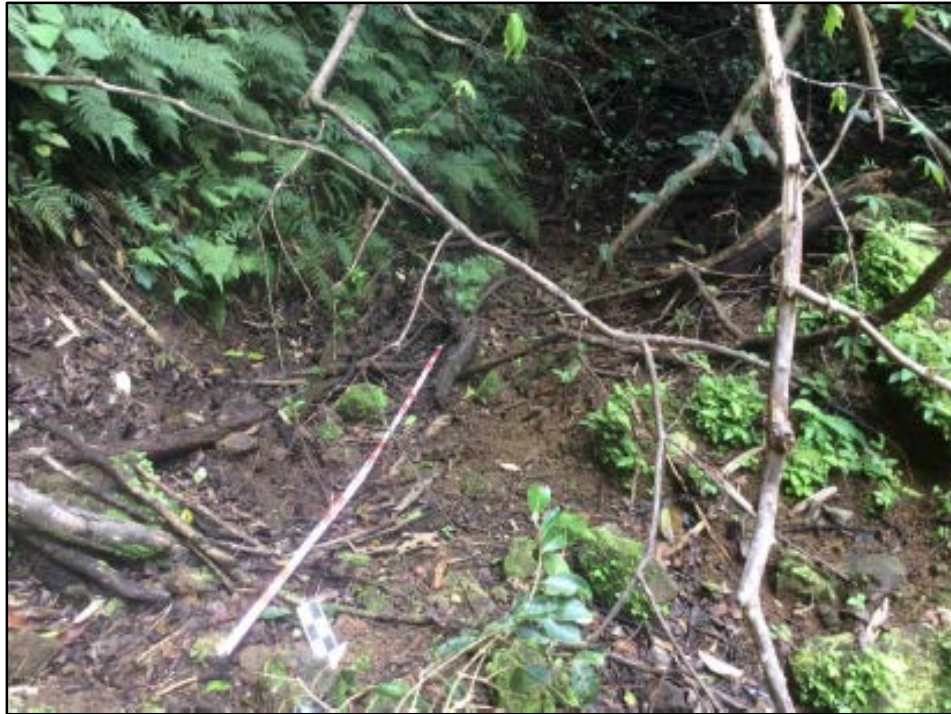
Figure 266. Feature O, abandoned remnant of an irrigation ditch connecting Features M and N, view to south

Figure 267. Plan map of Feature O

Figure 268. CS-15, cross section of Feature O

Feature O is a short abandoned ditch that extends from Sub-feature M1 to Sub-feature N3 (Figure 266 through Figure 268). The ditch connects once connected Feature M with Feature N. Feature O is an earthen ditch characterized by a steep wall on the upslope side of the ditch and a man-made berm on the downslope side of the ditch. Feature O measures 42.5 m in length and is approximately 1.0 to 1.5 m wide and 0.2 to 0.5 m deep. It is likely that Feature M once fed into Feature N and later was redirected through the tunnel between Sub-features M1 and M2, when Feature N was abandoned. It is also possible that the ditch acted as a temporary channel for redirecting water during the many modifications of the Grove Farm ditch system.
