Section 6 Historic Property Descriptions

6.1 SIHP # 50-30-11-B006

6.2 SIHP # 50-30-11-2179

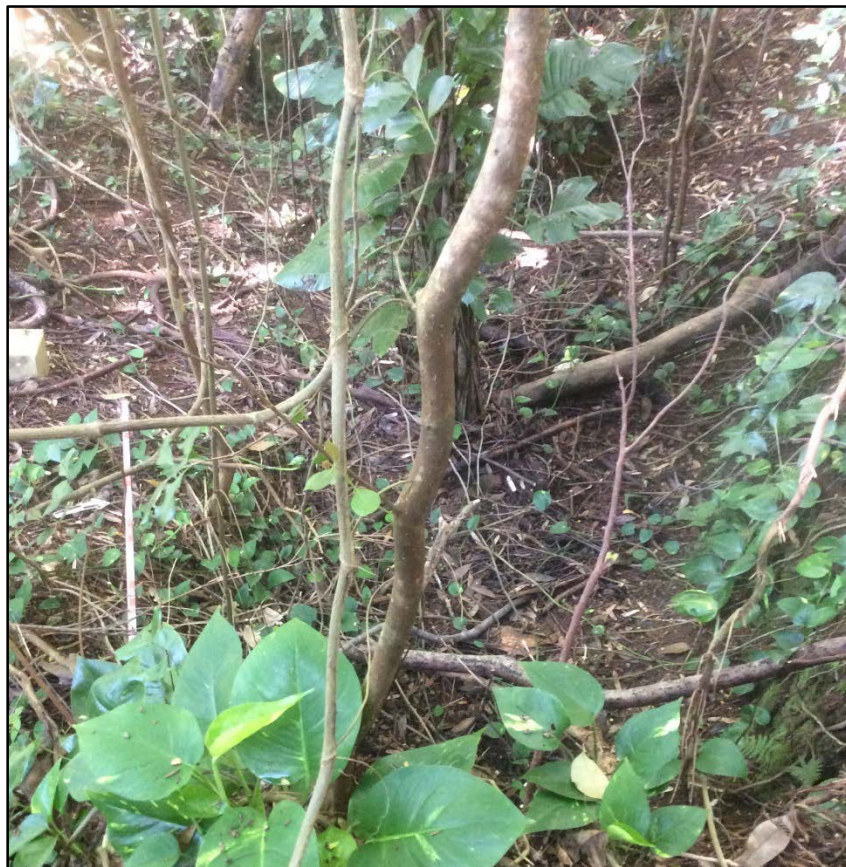
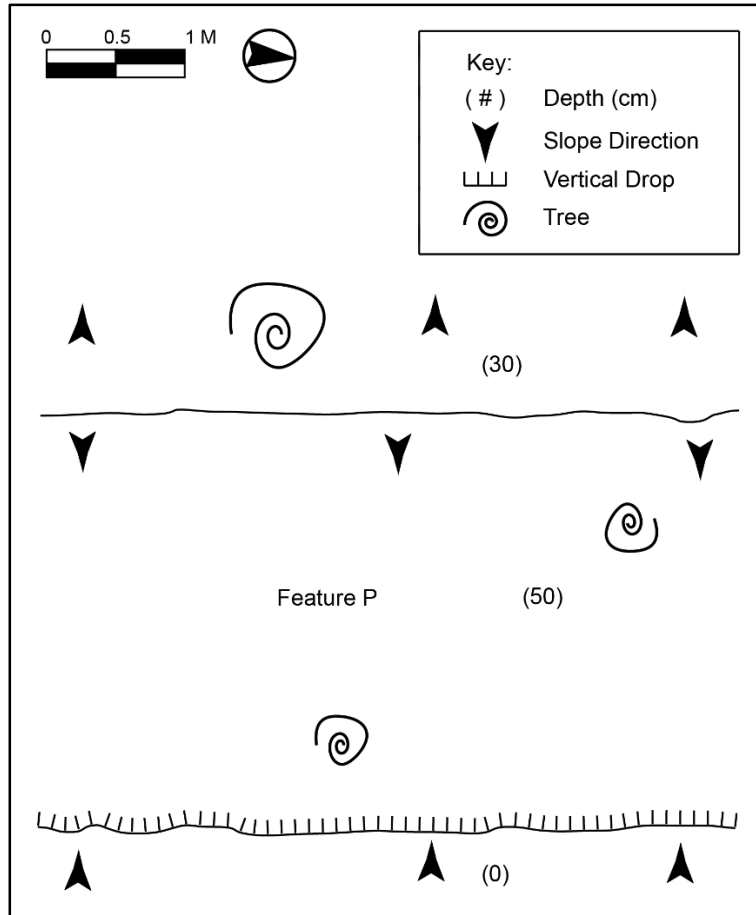
Figure 269. Feature P, view to northwest

Figure 270. Plan map of Feature P

Figure 271. CS-16, cross-section of Feature P

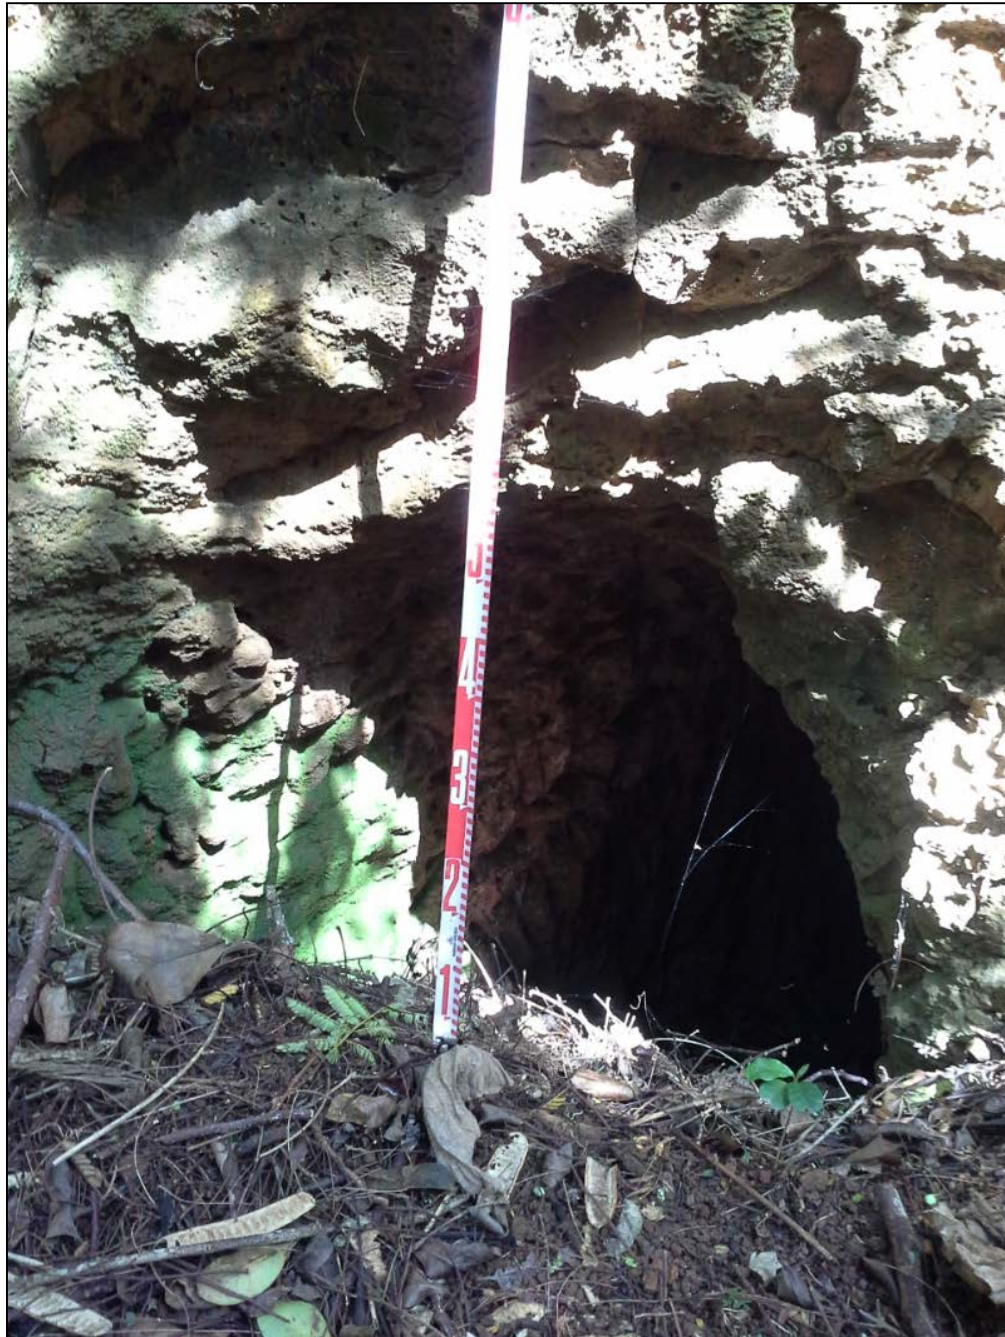
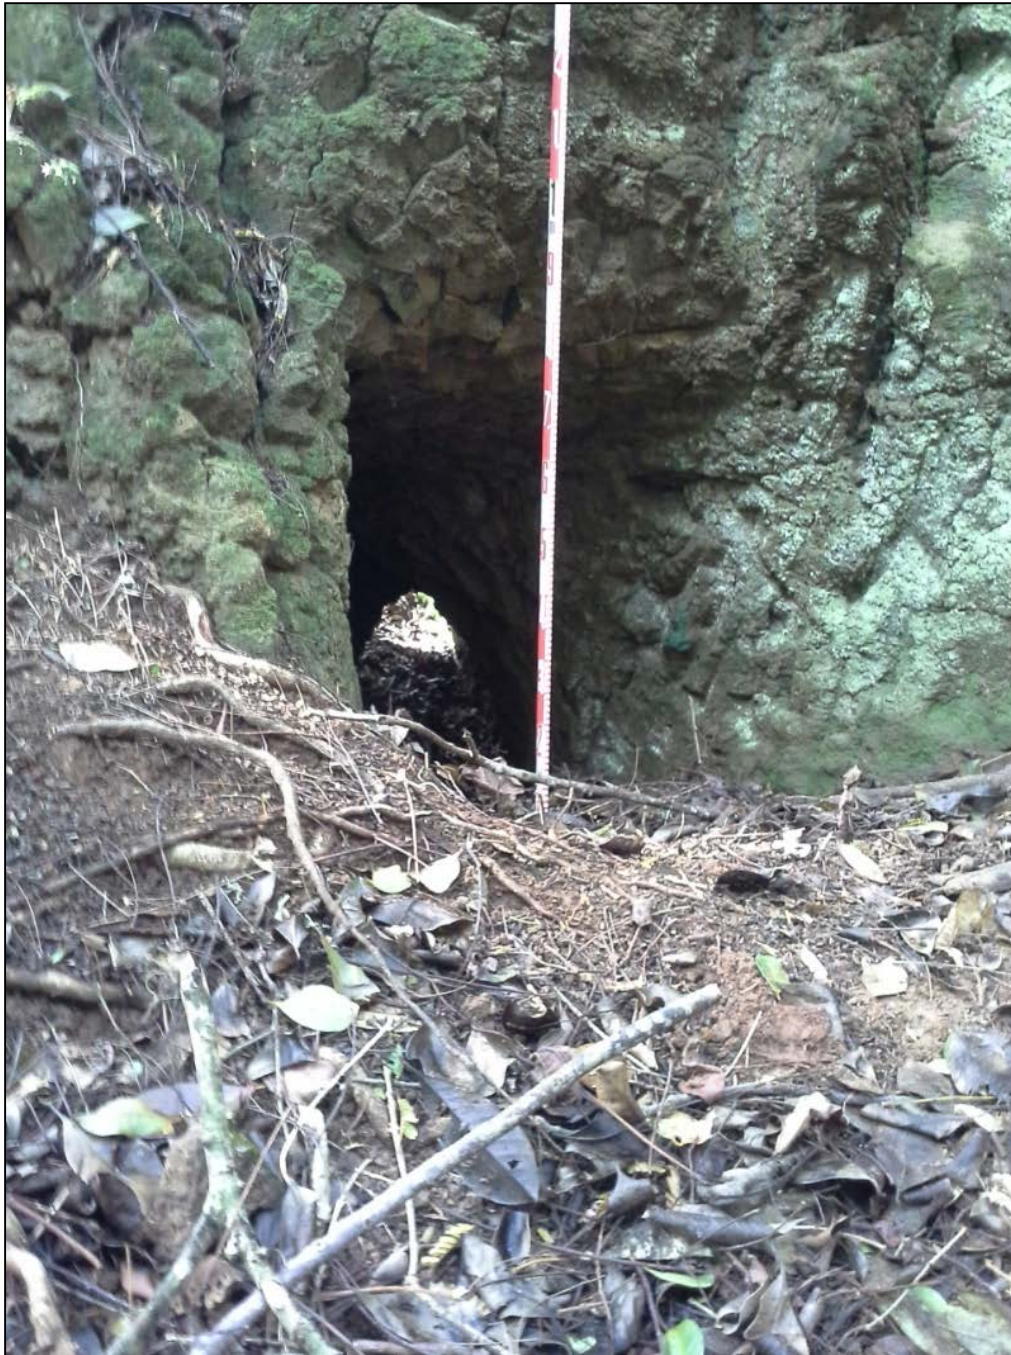
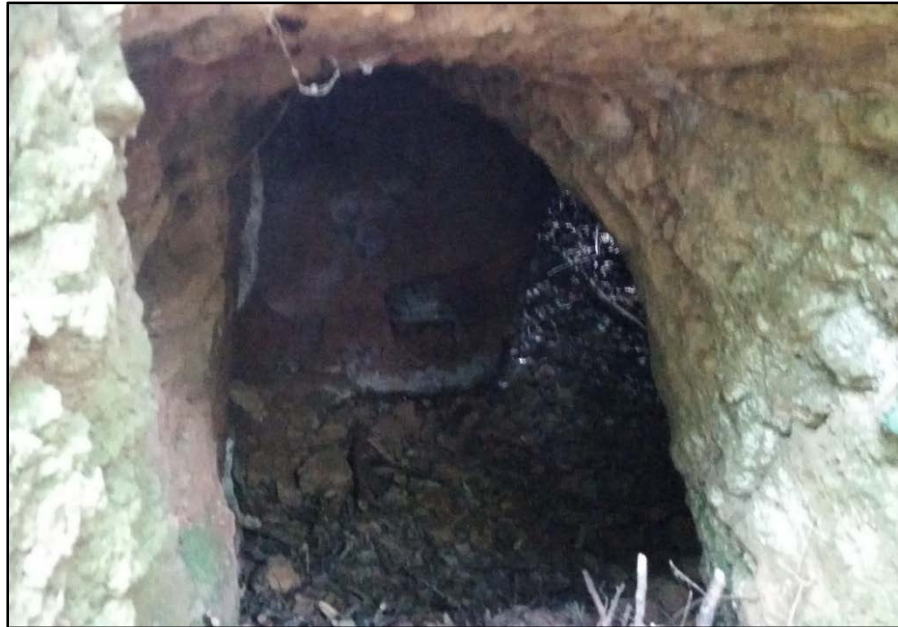
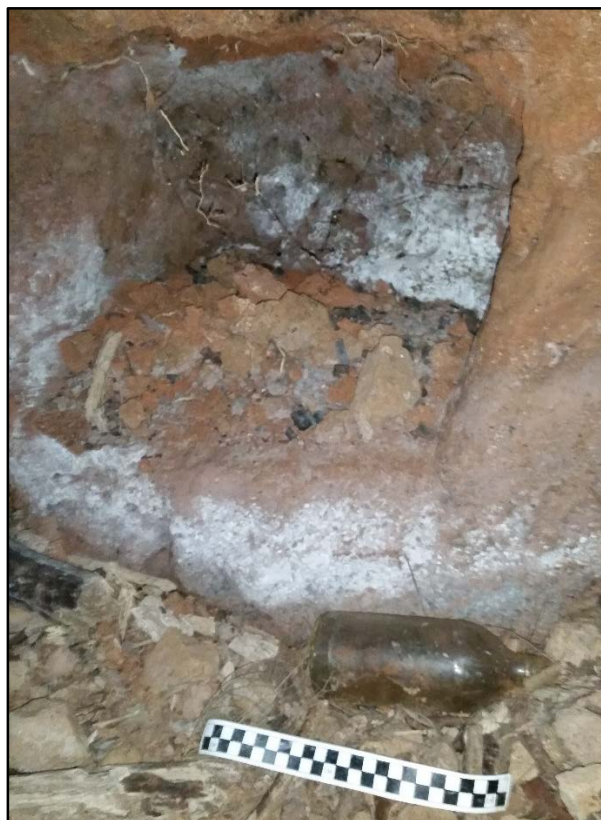
Figure 272. Photo of southeast tunnel opening (Sub-feature P1), view to southwest

Figure 273. Photo of northwest tunnel opening (Sub-feature P1), southeast opening in the background, view to southeast

Figure 274. Inside of ditch tunnel (Sub-feature P1) showing hearth feature, view to southeast

Figure 275. Hearth and bottle observed in ditch tunnel (Sub-feature P1), showing past use of abandoned tunnel, view to east

Figure 276. Plan map of Sub-feature P1, showing modern access road

Sub-feature P1 is a tunnel in a cliff face along the western side of a modern access road). The tunnel measures 6 m in length and runs in a northwestern/southeastern direction. The southeast opening measures 0.90 m in height with a width of 0.60 m; the northwest opening measures 1.0 m in height and 1.0 m in width. The maximum interior height of the tunnel measures 1.3 m. The interior of the tunnel slopes downward toward the middle of the tunnel, as dirt has accumulated due to erosion and the creation of the modern access road. A hearth was observed on a thin ledge on the northern side inside the tunnel; it measures 0.40 m in width, height, and depth. Ash residue was observed in the hearth. Also observed was a glass bottle situated on the tunnel floor in front of the hearth. It is likely the hearth was constructed after the tunnel was abandoned. Residents of Puhi Camp, such as children, are documented as playing in the tunnels in the gulch. The hearth may be a result of this activity or could be more modern vagrant activities.

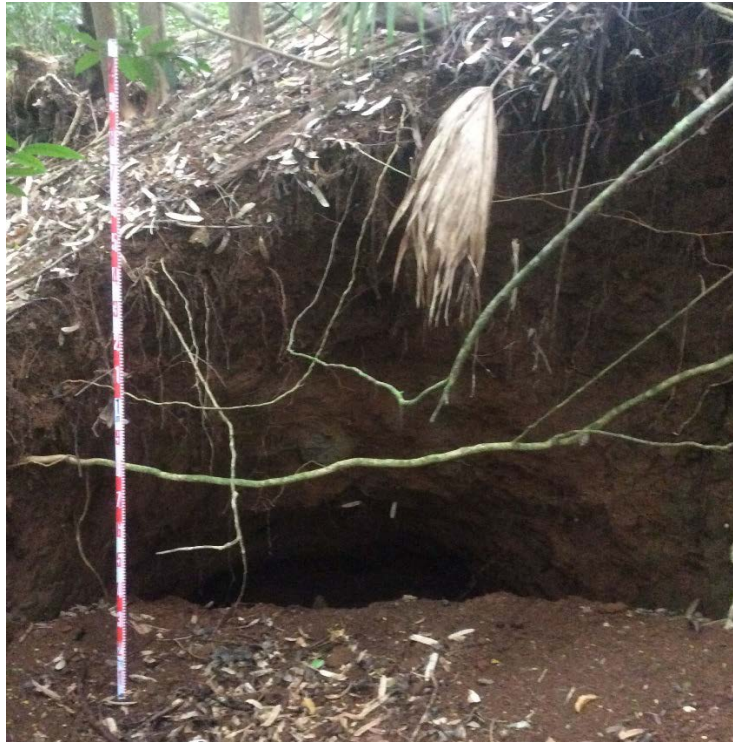
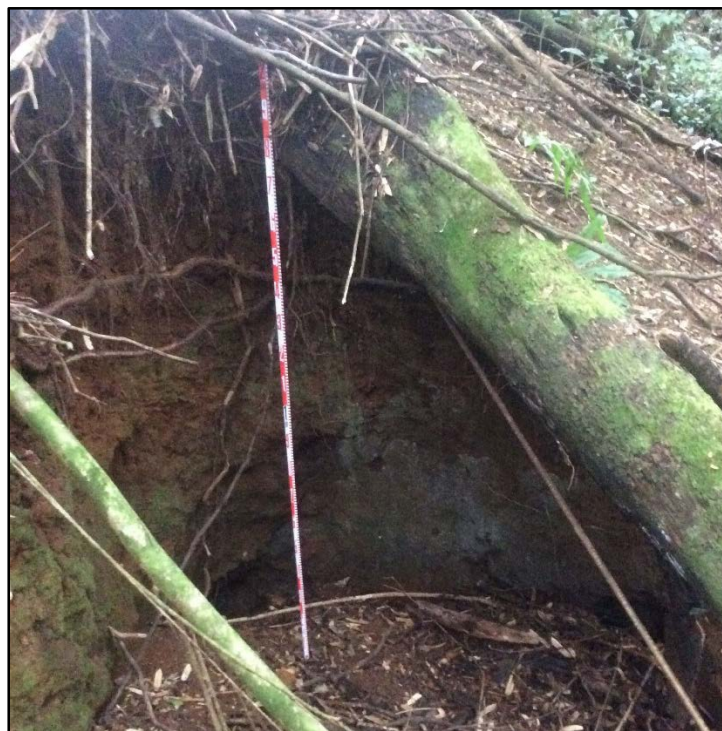
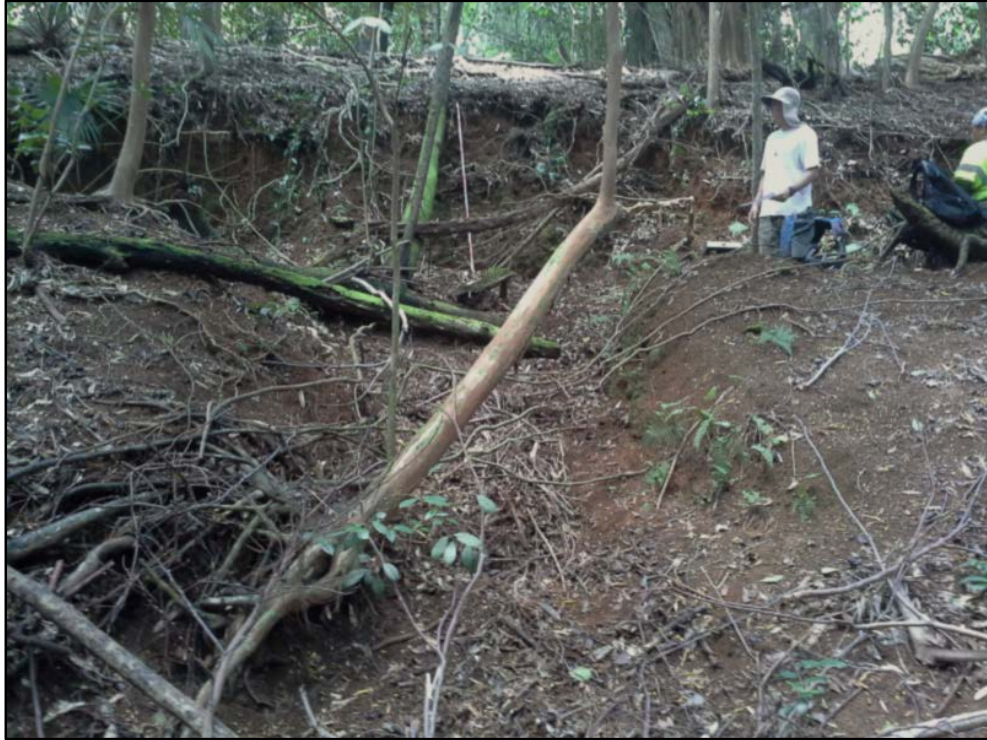
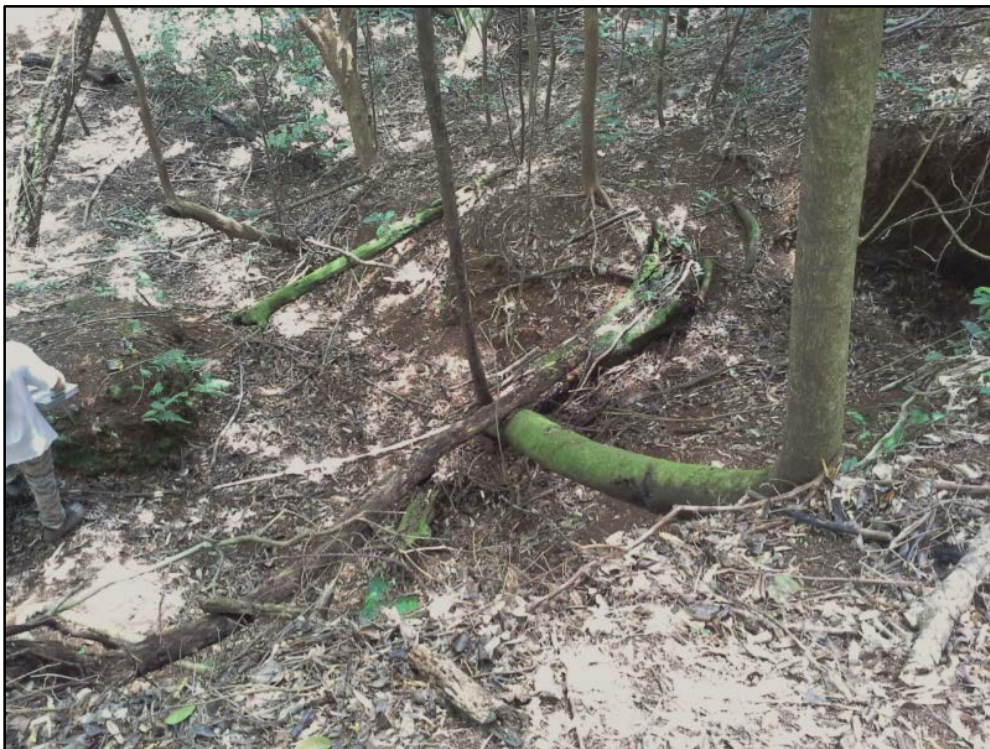
Figure 277. South end of Sub-feature P2, showing the top portion of the ditch tunnel, and dirt accumulation from the collapse, view to south

Figure 278. North end of Sub-feature P2, ditch tunnel not visible, view to north

Figure 279. View of Sub-feature P2 from modern access road, view to northwest

Figure 280. Sub-feature P2 showing collapse and eroded drainage channel in upper left corner, view to east

Figure 281. Plan view of Sub-feature P2

Sub-feature P2 consists of a collapsed irrigation ditch tunnel located approximately 300 m south of Sub-feature P1 on the west side of the modern access road. The collapsed dirt near the two ends of the feature sloped downwards, likely due to the dirt flowing outwards into the tunnel. The tunnel itself was not observed. On the east end of the bunker is a short “ditch-like” cut that slopes to the east, toward the gulch; it measures 4.2 m in length by 2.4 m in width with a depth of 0.69 m. It appears the cut is the cause of erosion during rainstorms. The collapse measures 8.5 m in length (north/south direction) and 2.3 m in width (east/west direction) with a maximum depth

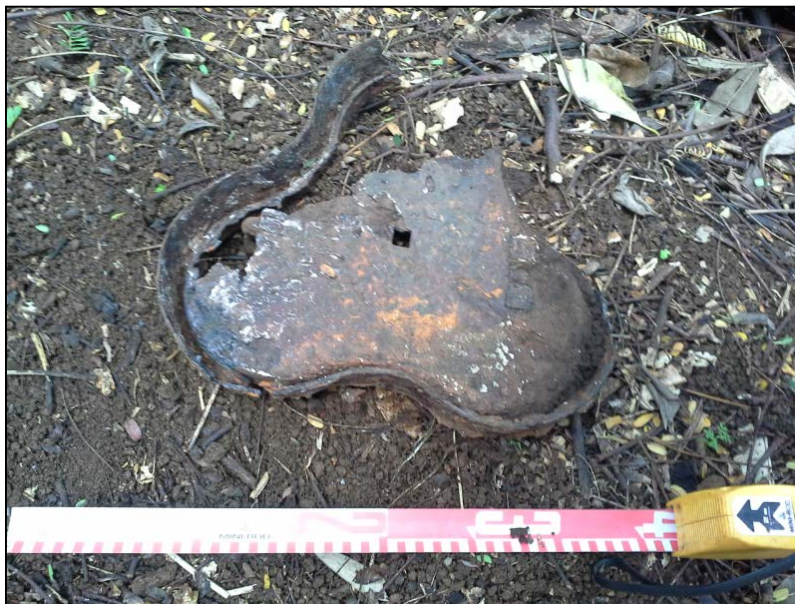
Figure 282. Photo of 105 mm cloverleaf end cap, downward view

of 1.55 m on the west interior. A rusty piece of a cloverleaf end cap was discovered on the north side

of the tunnel on the slope of the gulch face; however, the gulch is heavily littered and it is unclear if the end cap is associated with the feature.

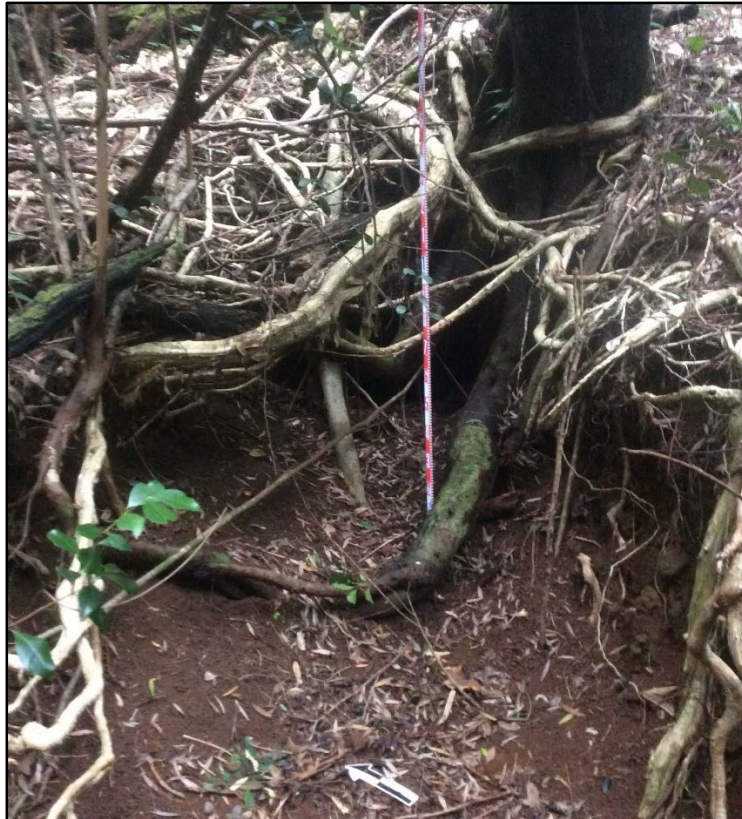
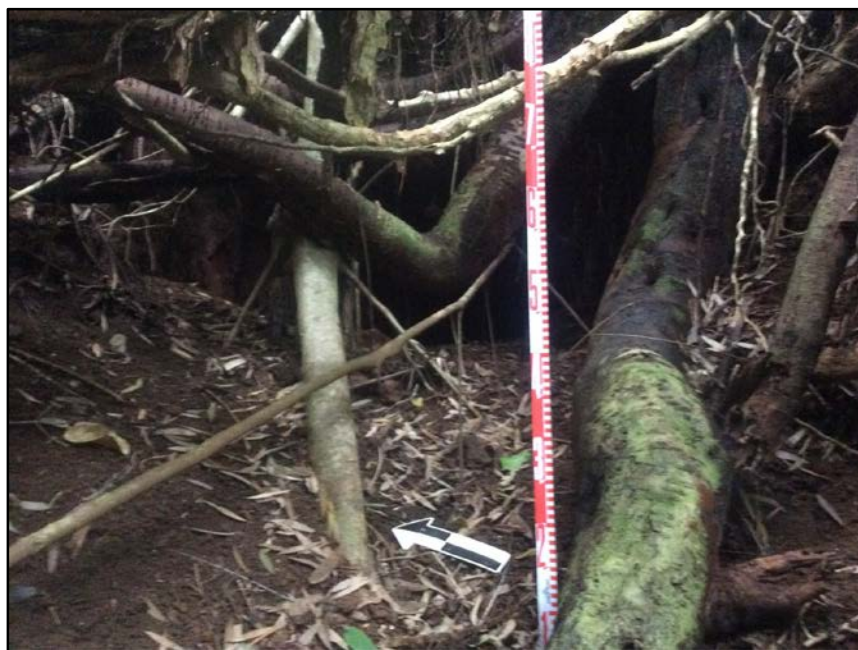
Figure 283. Sub-feature P3, abandoned ditch tunnel, view mostly obscured by tree and roots, view to northeast

Figure 284. Close-up of tunnel opening, view to northeast

Figure 285. Plan map of Sub-feature P3, showing Feature P

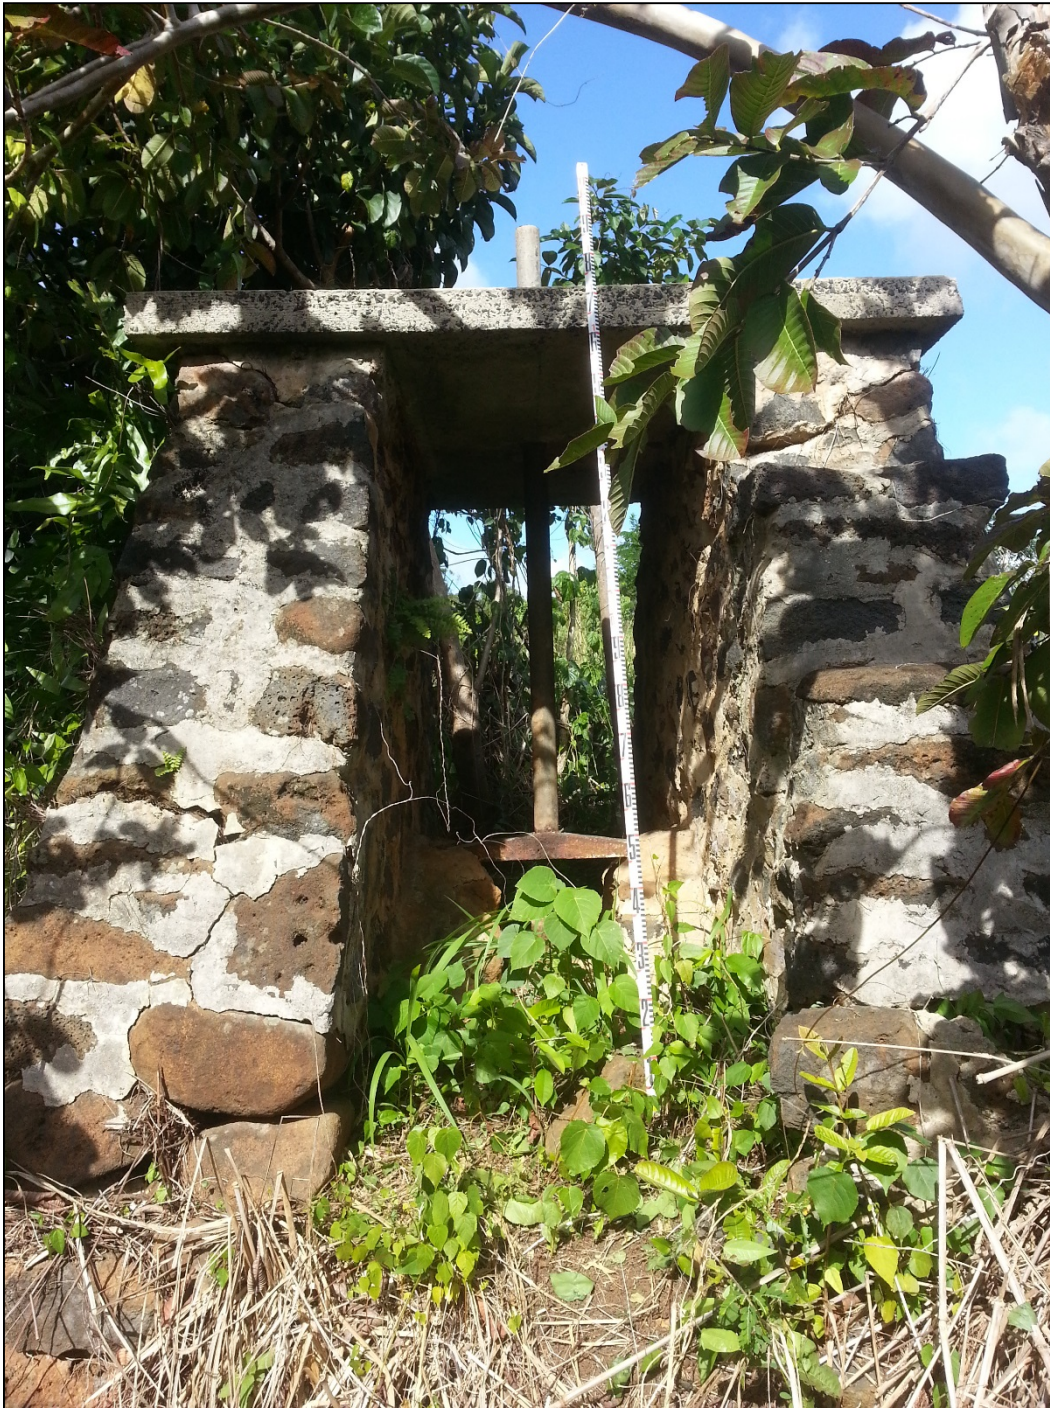
Figure 286. Photo of SIHP # -2220, showing the short protruding inner walls supporting the metal structure with a base and pipe that runs all the way to and through the concrete slab at the top

On the inside of the east and west walls, at the base, are short protruding walls made of basalt boulders and mortar, the same construction as the main outer walls. The two small walls support the metal base of a structure that includes the metal pipe that runs all the way to and through the concrete slab at the top of the larger structure (see Figure 286). This metal base and pipe component is directly over the survey marker (Figure 289 and Figure 290).

The structure appears to have functioned as a viewing or mapping platform. The metal pipe above the marker (see Figure 286, Figure 287, Figure 291 and Figure 292) could have allowed a surveyor to set up a transit in such a way as to center a plumb bob above the marker. “KAUAI NORTH BASE” and survey symbol is shown at the location of SIHP # -2220 on the 1939 Lihue Plantation map (see Figure 18), an undated Lihue Plantation map (see Figure 17), a 1933 Land Court Application 1087 map (see Figure 16), the TMK map (see Figure 2), 1963 (see Figure 10) and the 1996 (see Figure 1) Lihue USGS maps. No new features were observed during this current project for SIHP # -2220.

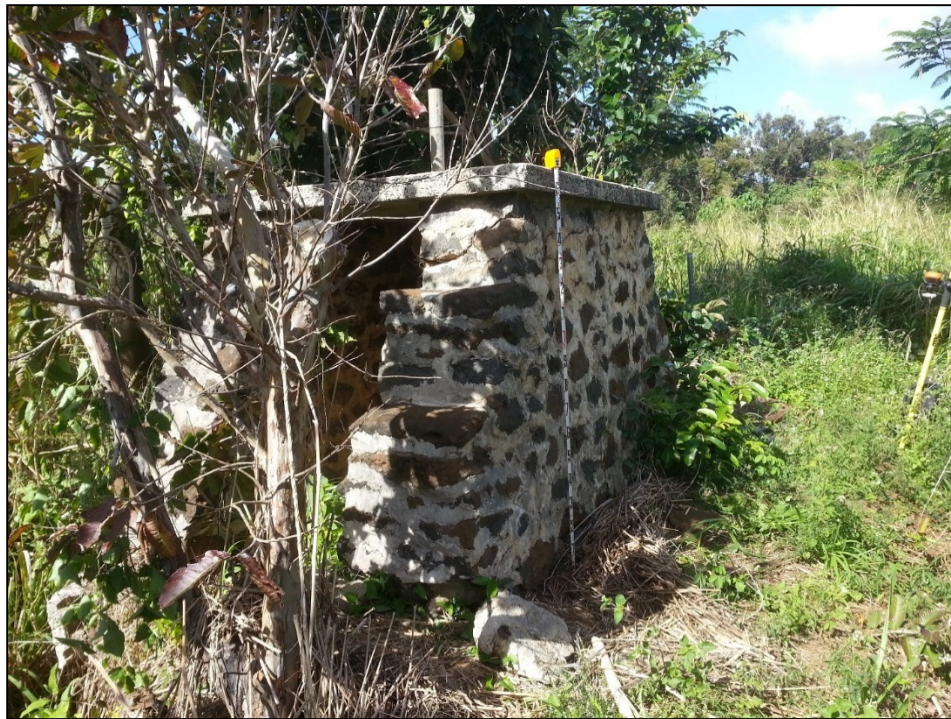
Figure 287. Photo of SIHP # -2220, showing the overall structure, including the trapezoid-shaped walls, the steps on the east wall, the square concrete slab topping the structure, and the metal pipe protruding outward from the top

SIHP # -2220 is a basalt and concrete structure built over a Hawaii Territory survey marker previously identified by Hunkin et al. (2014). The structure is located on the east bank of SIHP # -2179 Feature B (see Figure 96, Figure 286, and Figure 287). The structure is approximately 2.70 m long and 1.98 m wide, with a maximum height of 1.72 m. The purpose of the structure is not completely clear (it is rather elaborate for protecting the survey marker) but almost certainly served as a transit station as well as a survey marker (Figure 291).

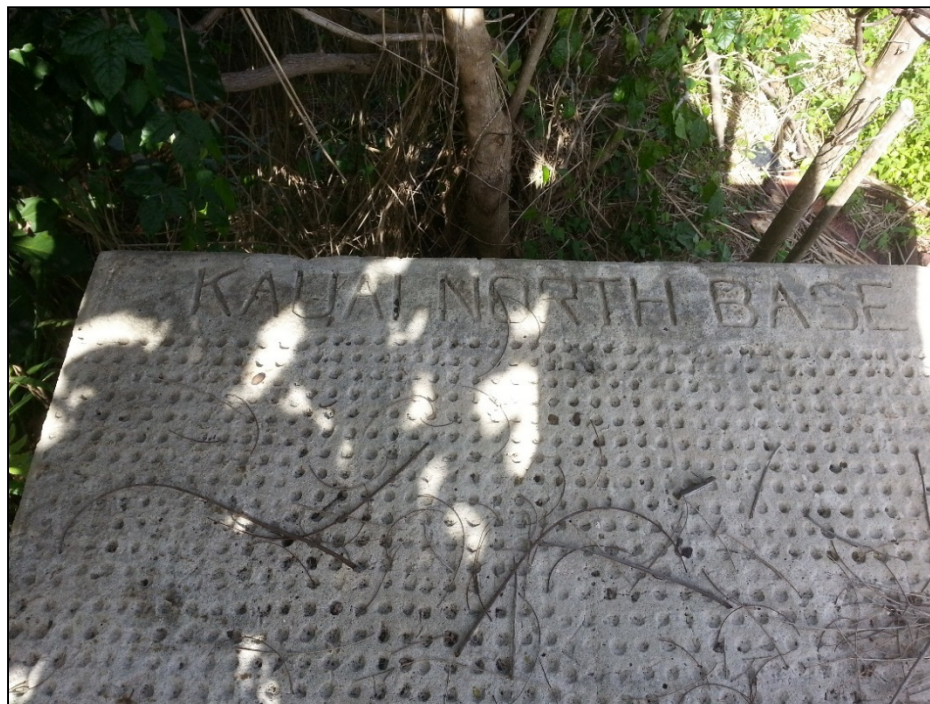
Figure 288. Photo of SIHP # -2220, showing the top of the cement slab with the words “KAUAI NORTH BASE” and many divots, downward view to north

The walls are composed of stacked small to large sub-angular basalt boulders and mortar. The east and west walls are trapezoid-shaped, and the south end of the east wall has two built-in steps. Part of the bank has eroded, exposing part of the west wall base. The structure is topped with a square concrete slab with sides measuring approximately 1.85 m. At the center of the concrete slab is a “bump” with a hole and a metal pipe protruding upward from the hole. The top of the slab is also covered with hundreds of divots or small depressions (Figure 288). An inscription at the northern end of the slab reads, “KAUAI NORTH BASE 5-10-33-RTM.”

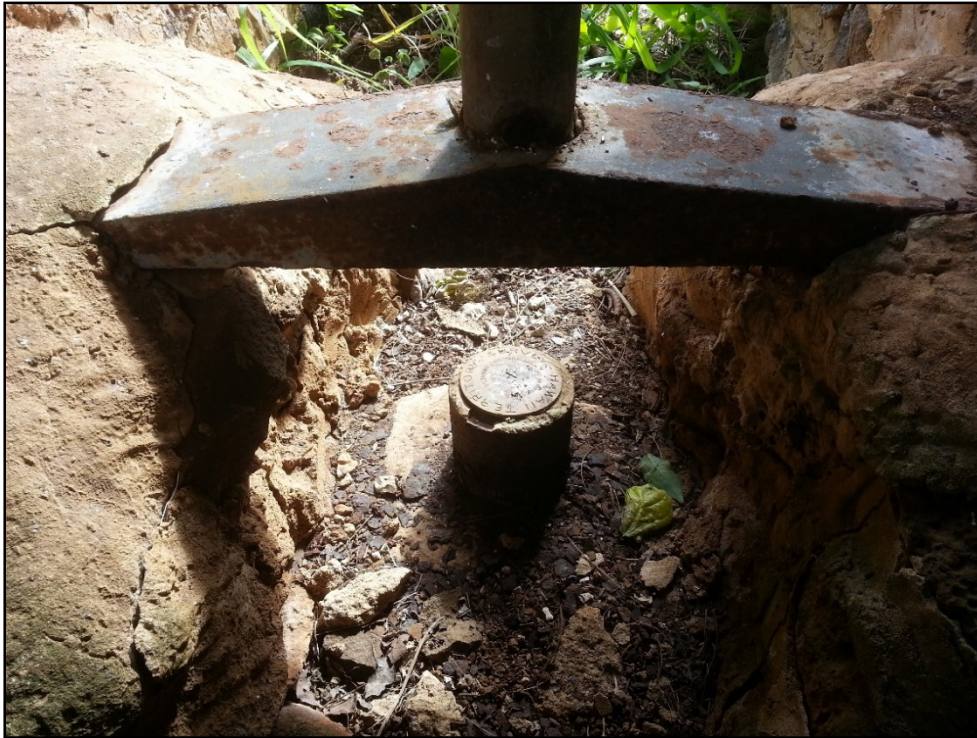
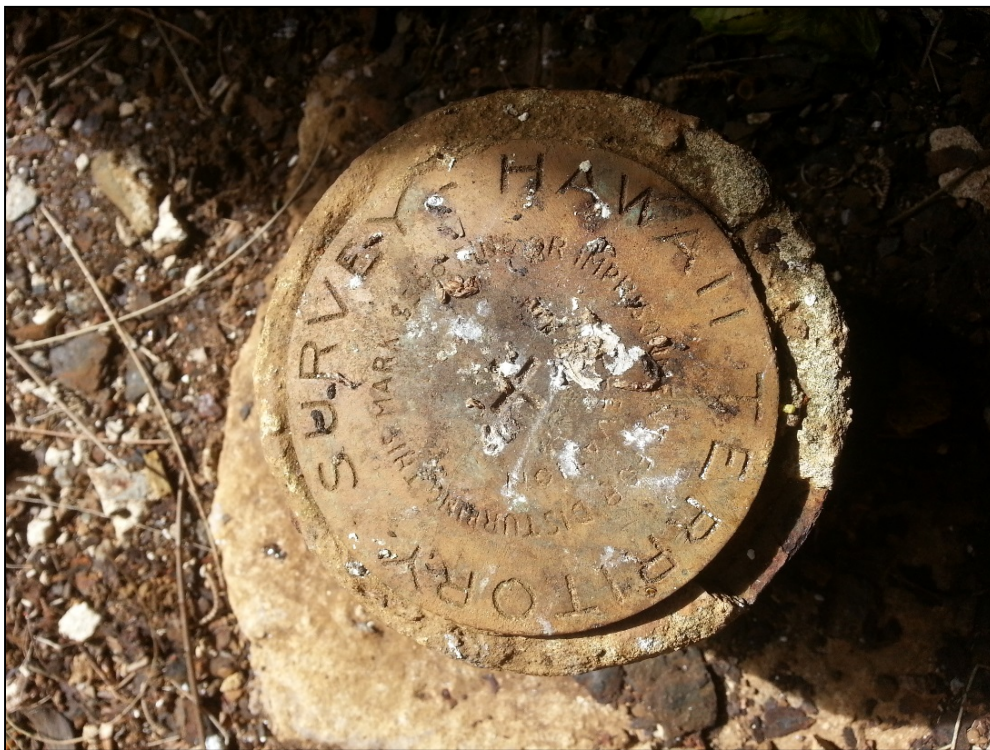
Figure 289. Hawaii Territory Survey marker shown underlying metal pipe, view to east

Figure 290. Photo of SIHP # -2220, showing the Hawaii Territory Survey marker that the structure covers, downward view

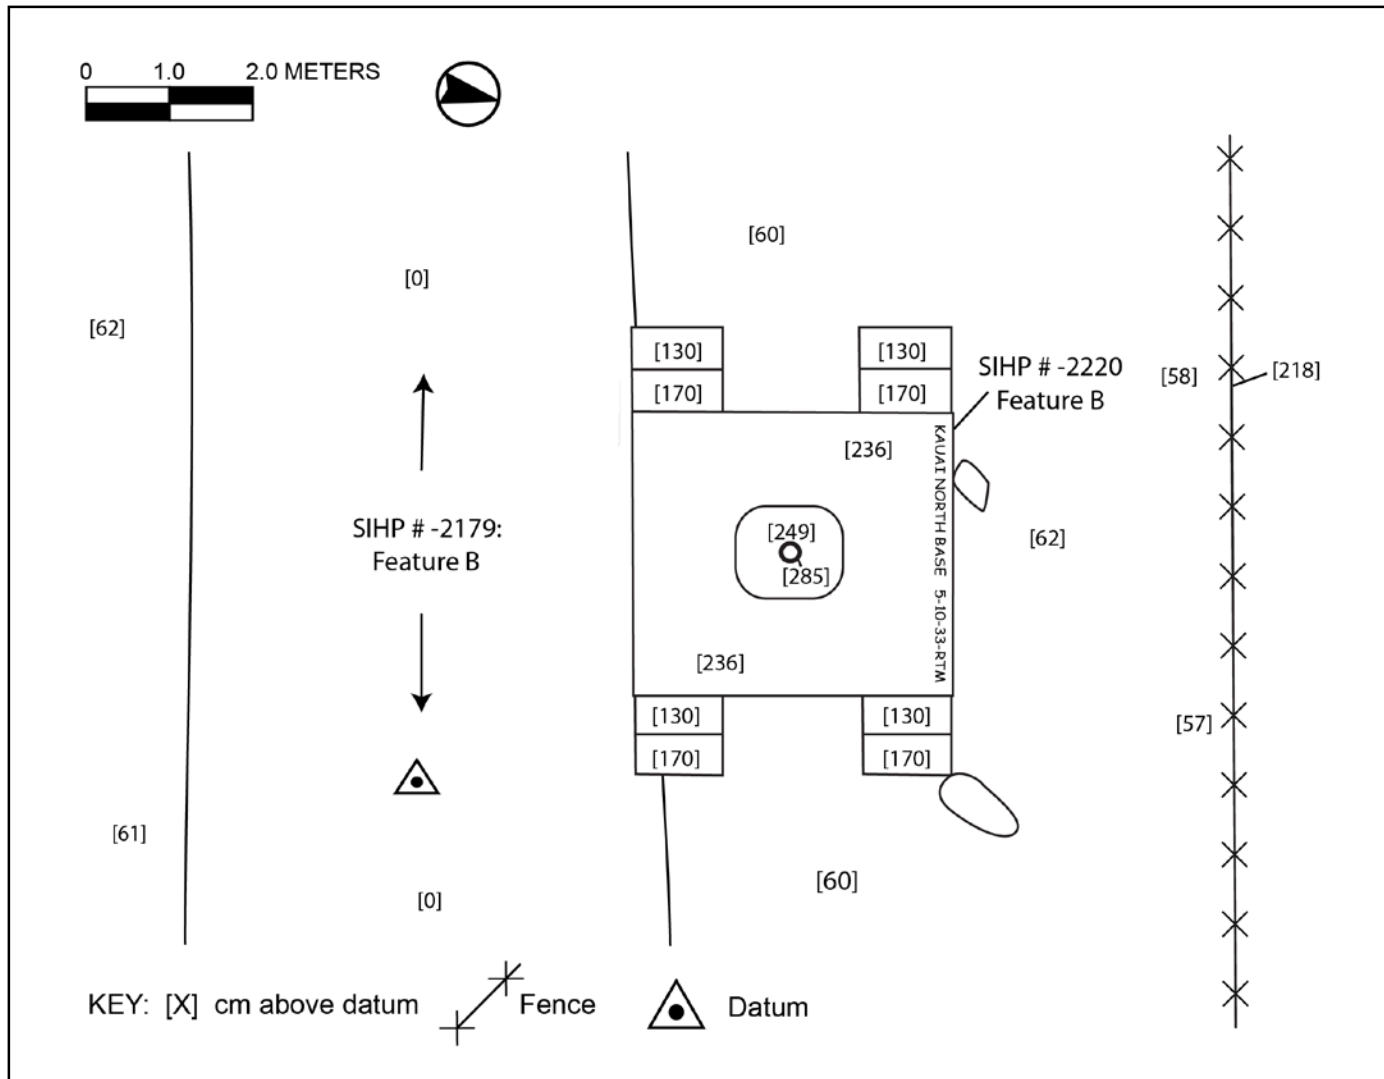
Figure 292. Plan map of SIHP # -2220 showing SIHP # -2179: Feature B in relation to survey station (SIHP # -2220)
