CHAPTER 3: NATURAL ENVIRONMENT

Hawaiian Memorial Park Cemetery Expansion Project Draft Environmental Impact Statement Kāne'ohe, Oʻahu, Hawai'i In order to achieve the desired finish grades, the lower flank slopes of the Oneawa Hills on the western end of the site would need to be cut. The majority of this western hillside would be excavated reducing it up to 40 feet in height; however, the areas near the top of the hillside would reduce it up to 100 feet in height. This western section is where the most significant changes to existing topographic conditions would occur. Figure 2.4 in Chapter 2 includes a section view showing the existing and proposed topographic change. A smaller ridge line below this hillside in the area generally between Lipalu Street and Ohaha Place would also be excavated up to 60 feet.

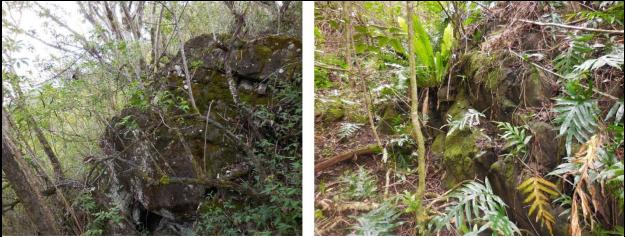
Large Block Type Rock Outcropping NearFractured Rock Outcropping WithinRidgeline Summit Above Cultural Preserve AreaCentral Area of Cemetery ExpansionExhibit 3.5Rock Material Within Upslope Areas

Widely scattered to scattered surface level hard rock outcroppings were observed, primarily on steeper mountain slope segments upslope of the Petition Area. Three general types of basalt rock outcroppings related to the Kailua Volcanic Series lavas and dike rock were observed on upland slopes as discussed below.
