CHAPTER 3: NATURAL ENVIRONMENT

3.1 TOPOGRAPHY AND SOILS

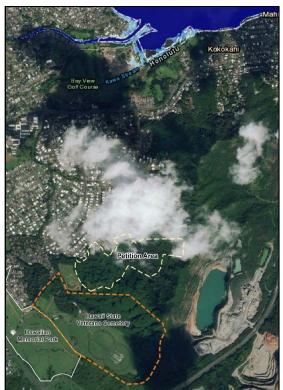
The Sea Level Rise and Coastal Land Use Policy Toolkit published by the UH Sea Grant in 2011 suggests, "the governor or state legislature should direct state agencies to incorporate a sea-level rise benchmark of 1-foot-by-2050 and 3-feet-by-2100 in planning and permitting processes and decision-making" (CICAP, 2011). Geographic Information System data available from NOAA's web viewer for sea level rise and coastal flooding shows that a 1-foot projected sea level rise would not impact the Petition Area. A 3-foot projected sea level rise similarly would not impact existing portions of HMP or the Petition Area, as indicated in Exhibit 3.8.

Exhibit 3.8 NOAA Projected 3-Foot Sea Level Rise Source: http://coast.noaa.gov/slr/
