5.2 SIHP # 50-80-09-2268 Waiahole Ditch System/ post-Contact Irrigation Ditch

SIHP # 50-80-09-2268 consists of the entire Waiahole Ditch System, a post-Contact irrigation ditch dating from 1916. The historic property spans approximately 22 miles (Figure 79) transporting water from the windward side of the Ko'olau Range through the Ko'olau Range by a system of tunnels, across central O'ahu and on to the 'Ewa Plain (Condé and Best 1973). Approximately 380 linear m of the Waiahole Ditch was identified in the northern and western portions of the project area. The ditch extends along the northern boundary, crossing the central project area as it extends southwest down the natural sloping landscape, exiting the southern boundary and continuing to extend southwest away from the project area (Figure 80).

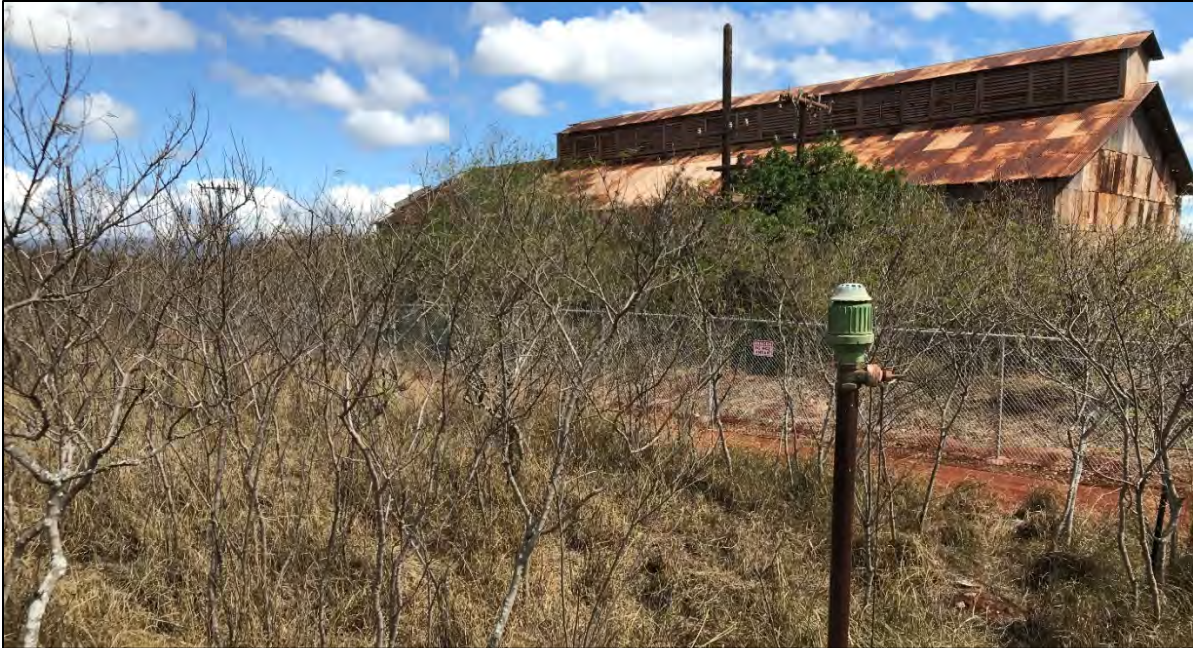
Figure 46. Mill building immediately southeast of the project area boundary (downslope of Feature 2A complex), view to east

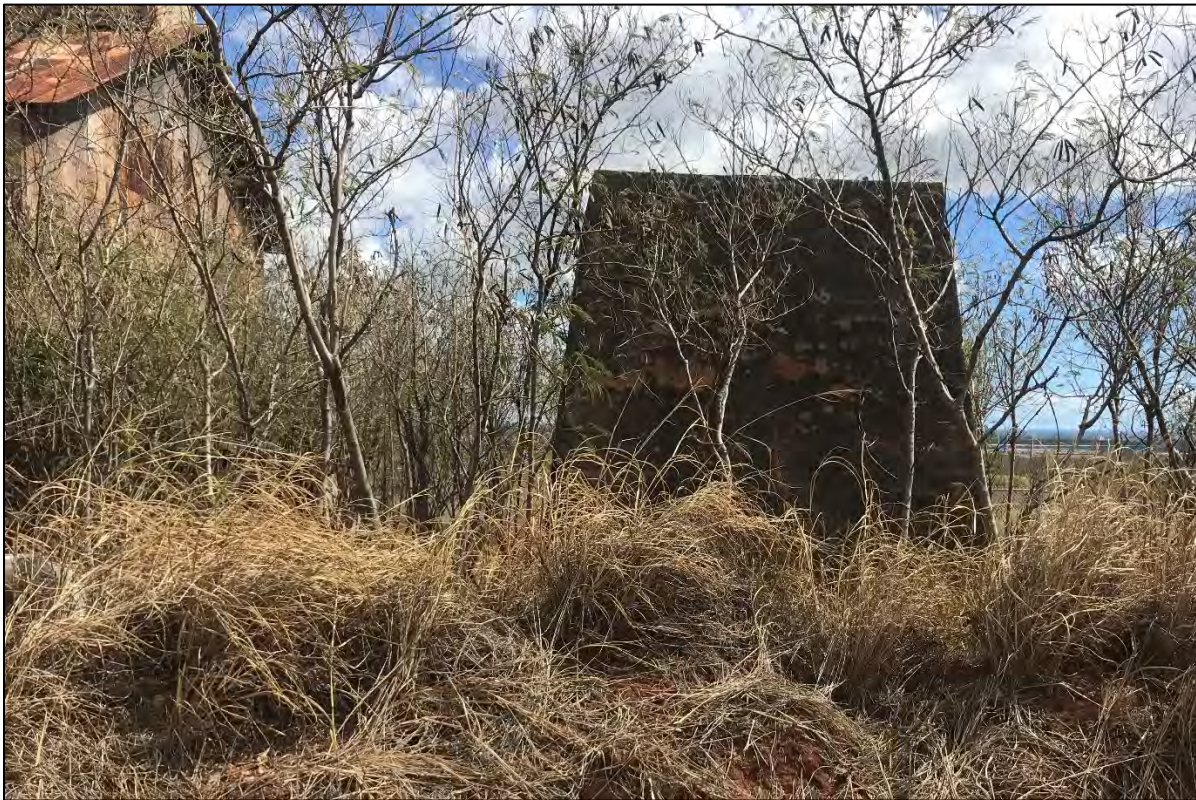
Figure 47. Pump House No. 12, southeast of the project area (mill building to the left), view to southeast

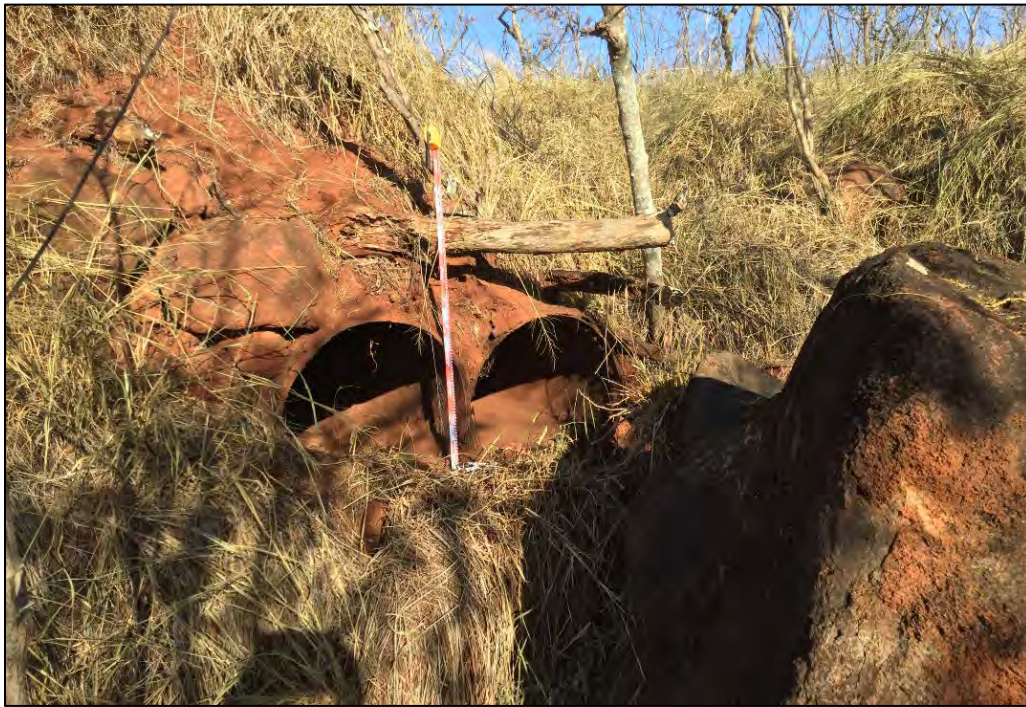
Figure 49. Lower portion of SIHP # 50-80-08-5593 Feature 1 showing metal pipes, view to northwest

SIHP # 50-80-08-5593 Feature 1 consists of plantation-era drain pipes located within a ditch in the northeast portion of the project area (see Figure 42 for location). It is possible this feature was identified during the Dega et al. (1998) study, however, this could not be definitively discerned based on that documentation. The upper/west end of this feature consists of a single observable concrete pipe approximately 35 cm in diameter (the second pipe is likely obscured by collapsed earth) with overlying concrete rubble and stacked basalt, three stones wide and two to three courses high (Figure 48). This upper portion measures 82 cm tall and 90 cm wide. The east/lower end of Feature 1 consists of two steel pipes (Figure 49 and Figure 50), each approximately 35 cm in diameter, and the exposed portions approximately 40 cm tall. The function of this feature is related to agriculture and water control. Feature 1 is in fair condition, as much of the area is overgrown and heavily eroded.

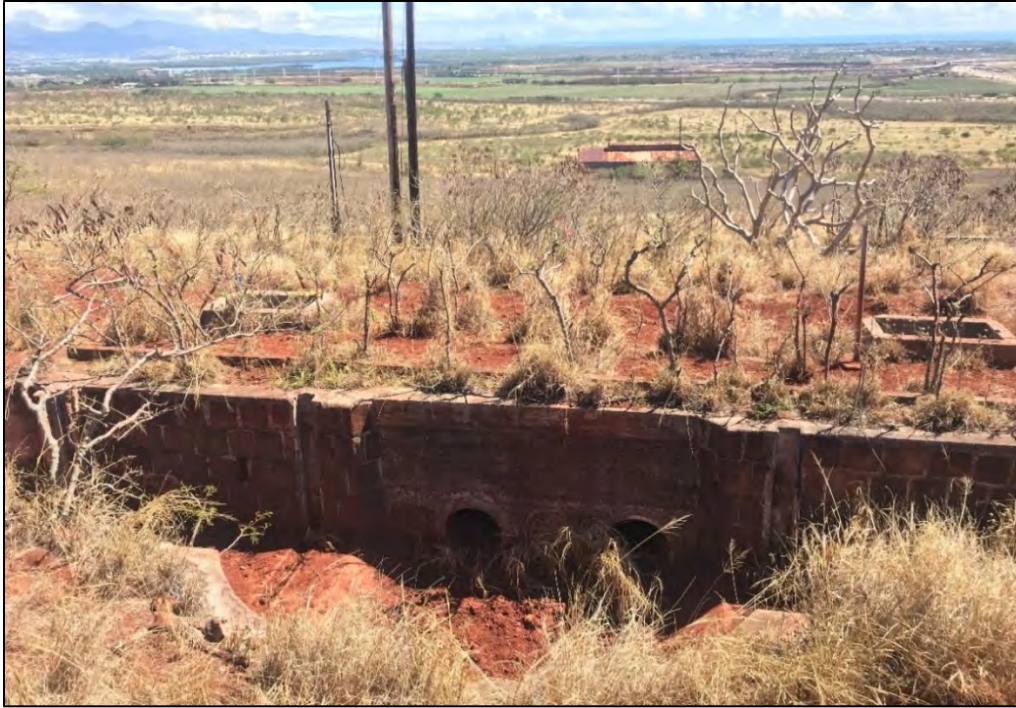
Figure 51. Overview of SIHP # 50-80-09-2268 Waiahole Ditch portion, and SIHP # 50-80-08-5593 Feature 2A complex, with the pump house and mill building at the base of the slope, view to southeast

SIHP # 50-80-08-5593 Feature 2 is a complex encompassing six structures (Features 2A through 2F) associated with the mill building and Pump House 12 (see Figure 42 for location, and Figure 51 through Figure 62). The Feature 2 complex begins at the northern boundary of the project area and extends southeast through the central portion of the project area down the natural slope. The complex is made up of six structures designed to move water from the Waiahole Ditch down the hillside to the pump house and mill building. According to Dega et al. (1998), steam engine pumps would disperse the water to sugarcane fields, likely those situated both above and below the pump house and mill. The entire complex measures approximately 240 m in length.

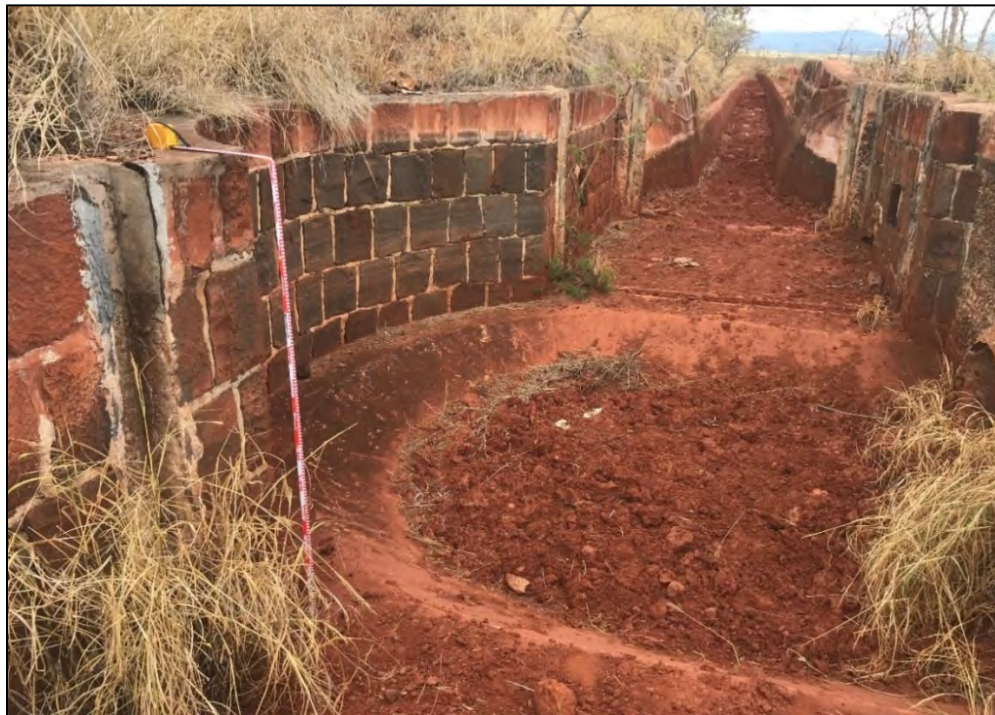
Figure 52. Overview of SIHP # 50-80-09-2268 Waiahole Ditch portion, and SIHP # 50-80-08-5593 Feature 2A complex, view to north

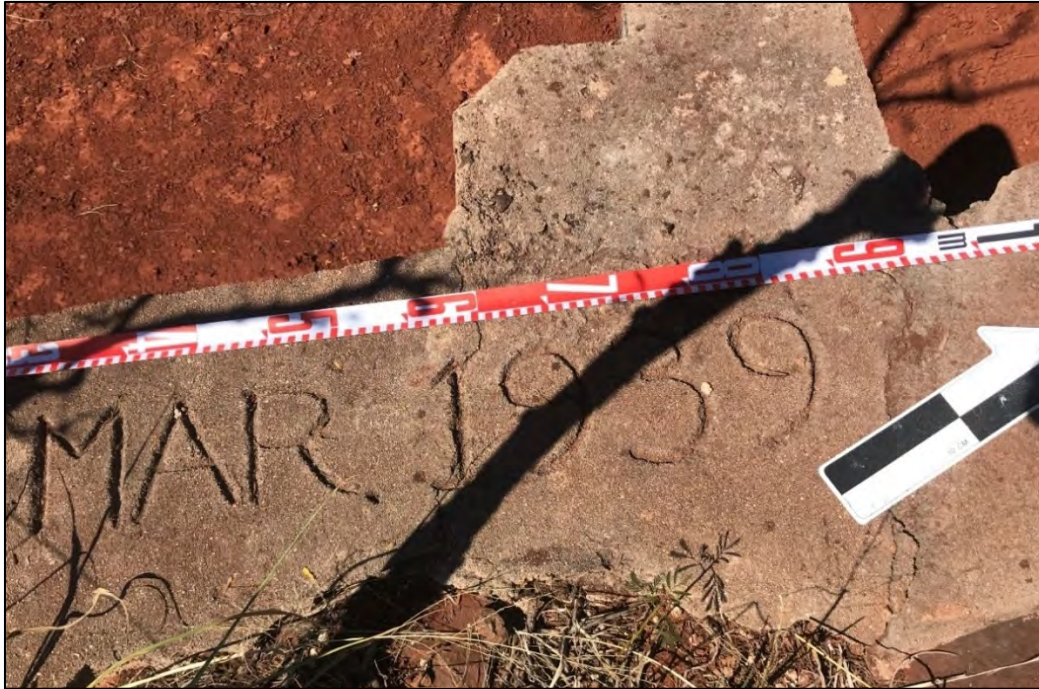
Figure 53. Plan view showing inscription in SIHP # 50-80-08-5593 Feature 2A complex

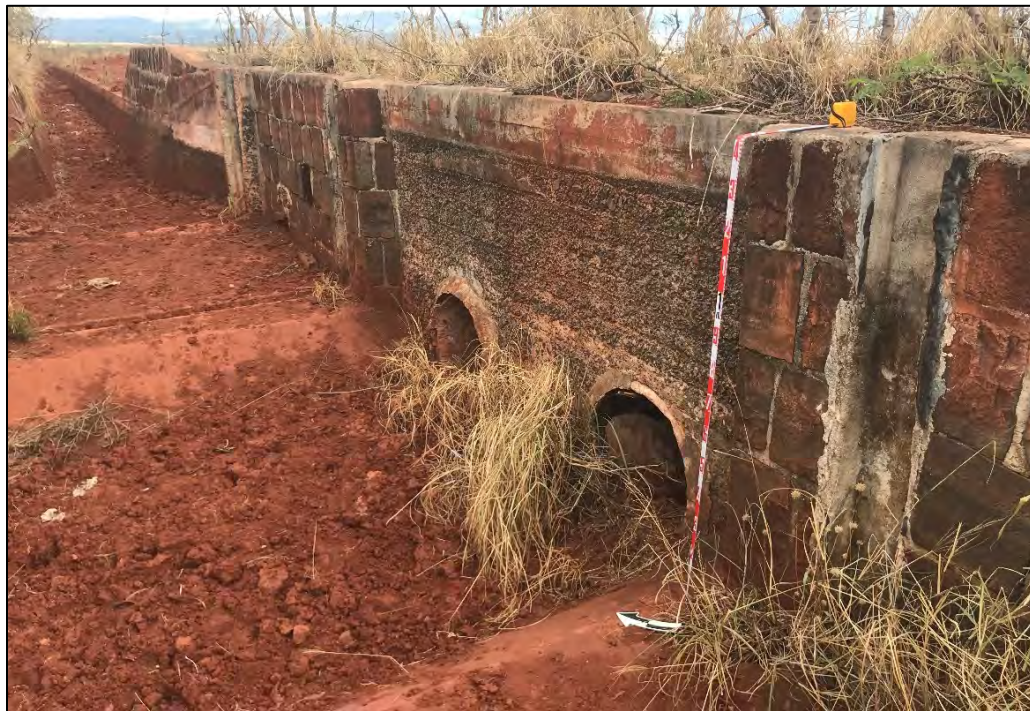
Figure 54. Overview of SIHP # 50-80-08-5593 Feature 2A and SIHP # 50-80-09-2268 Waiahole Ditch portion, with catchment basin (foreground) and drain pipes, view to east

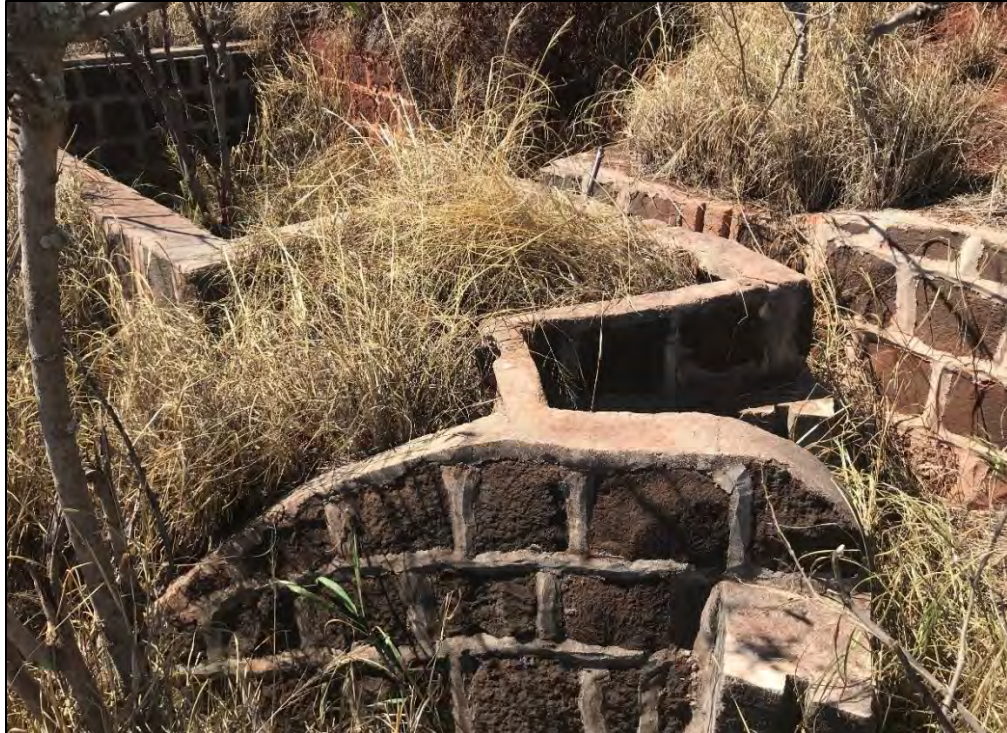
Figure 55. Upper water retention area of SIHP # 50-80-08-5593 Feature 2A complex, view to west

An additional water retention component is positioned directly northwest of this basin. This portion consists of a rectangular mortared basalt catchment area measuring 5.1 m long by 3.8 m wide (Figure 55), feeding into an oval catchment area measuring 6.3 m long and 2.6 m wide (Figure 56), with notches for a sluice gate feature in between (gate not intact). It is possible these catchment areas are gravel traps, which would have served to trap silt and clay (Reeves 1954). This function is suggested based on the complex shape of the structure, which is somewhat similar to a gravel trap from the Iao-Maniania Ditch pictured in a publication on plantation ditches (Figure 57; Wilcox 1996). Three flumes feed from the upper catchment areas into the Waiahole Ditch (Figure 58 and Figure 59). The flumes are oriented north-south and northwest-southeast. The eastern flume

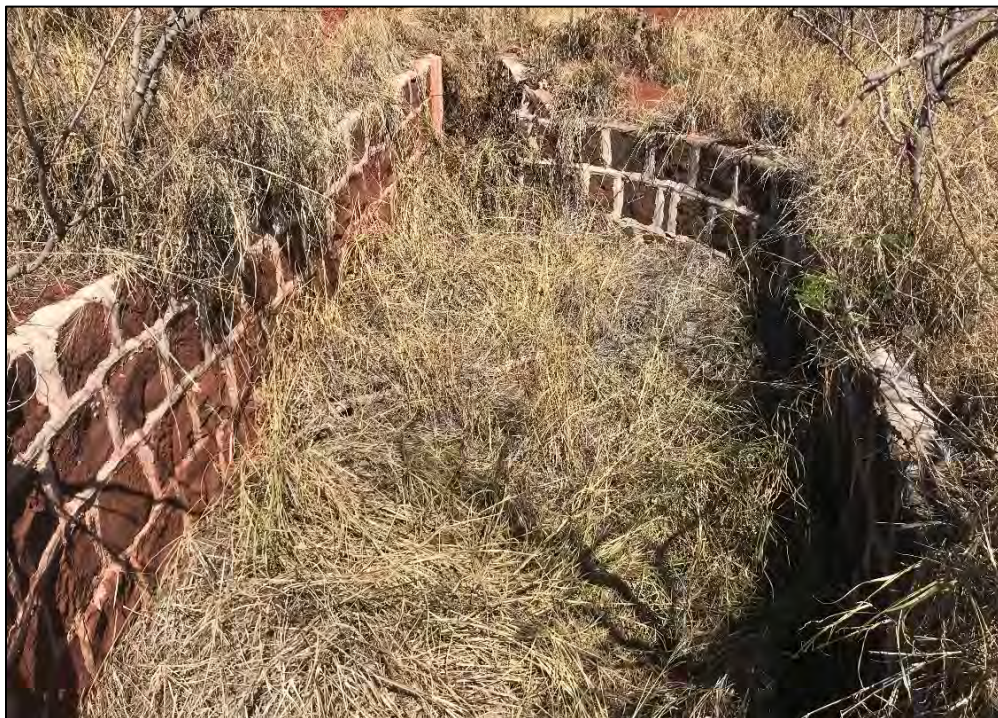
Figure 56. Upper water retention areas (eastern portion) of SIHP # 50-80-08-5593 Feature 2A complex, view to northeast

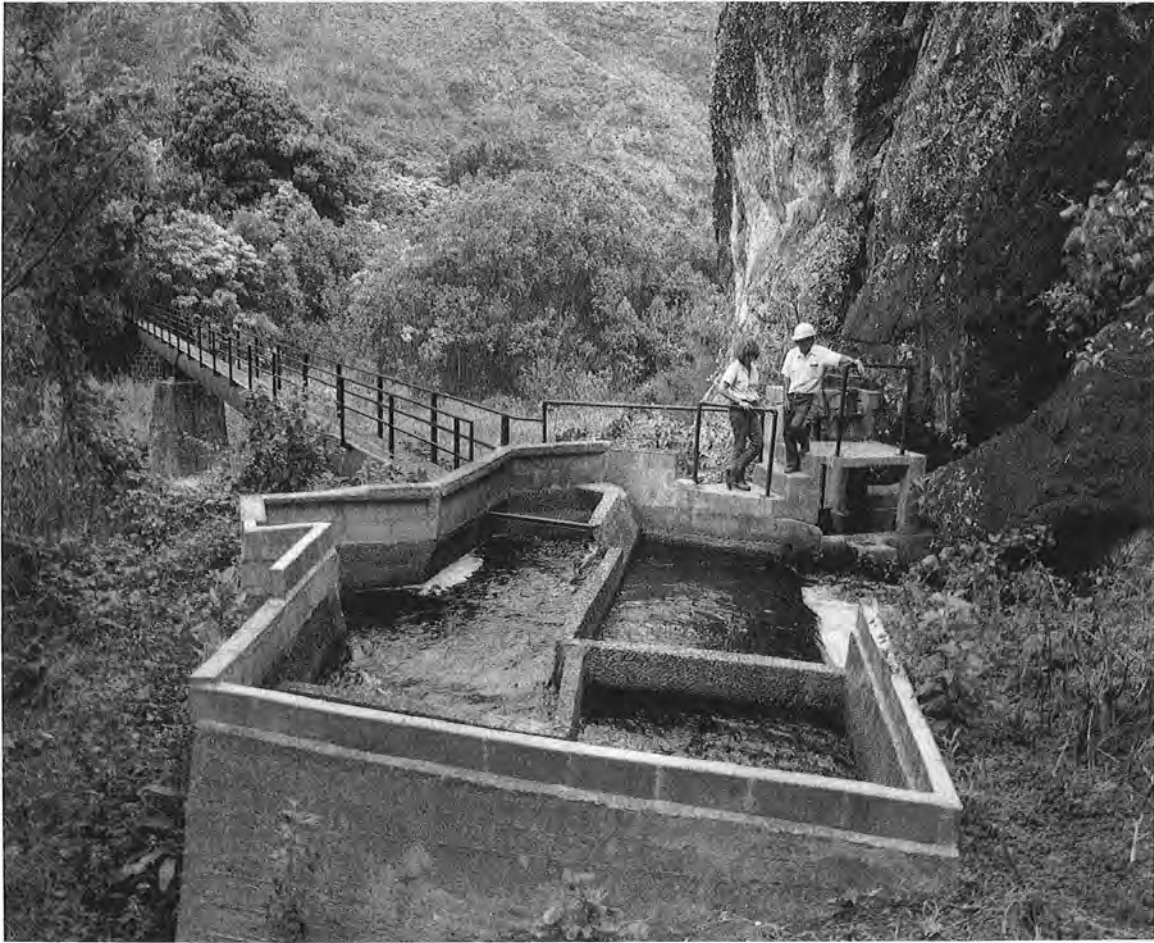
Water is collected in this gravel trap before being sent on its way in the Iao-Maniania Ditch. (Photo: D. Franzen.)

Figure 57. Figure showing an example of a gravel trap on the Iao-Maniania ditch system on Maui (from Wilcox 1996:125)

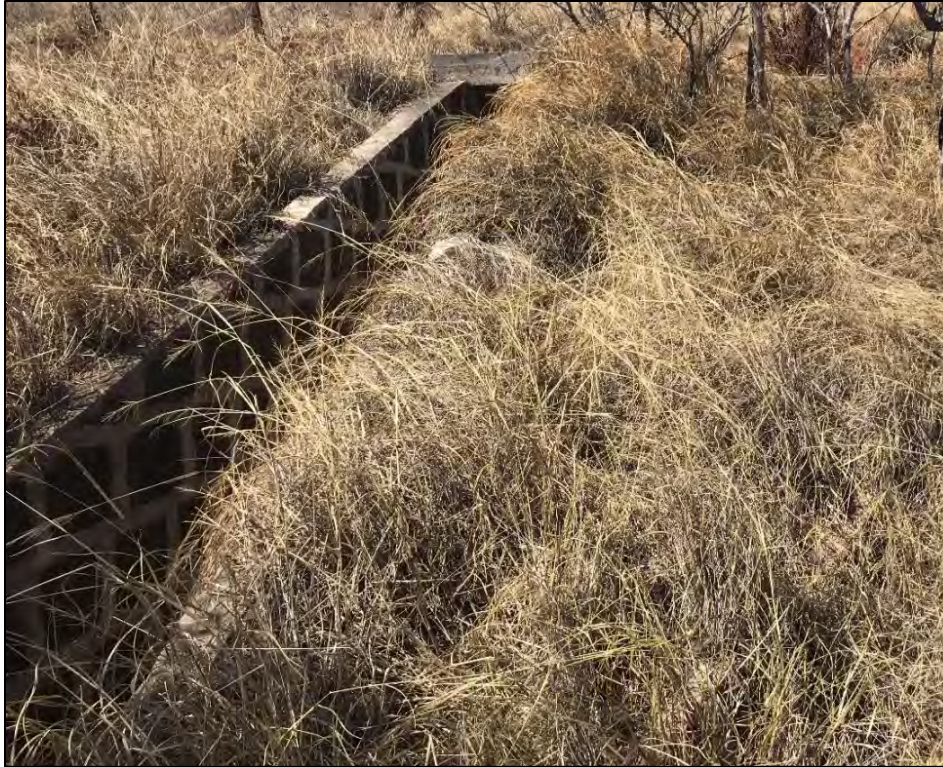
Figure 58. Center flume of SIHP # 50-80-08-5593 Feature 2A complex extending from upper catchment area into SIHP # 50-80-09-2268 Waiahole Ditch, view to west

measures 11.0 m long and 0.6 m wide, the center flume measures 12.8 m long and 0.6 m wide, and the western flume measures 7.1 m long and 0.6 m wide.

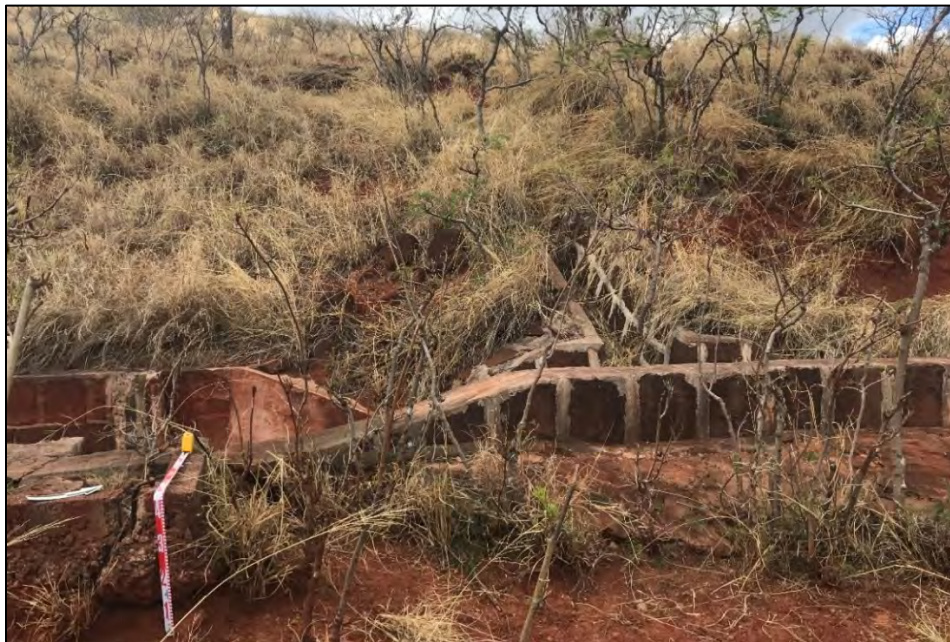
Figure 59. Overview of SIHP # 50-80-08-5593 Feature 2A complex with eastern flume (right), extending into SIHP # 50-80-09-2268 Waiahole Ditch, view to northwest

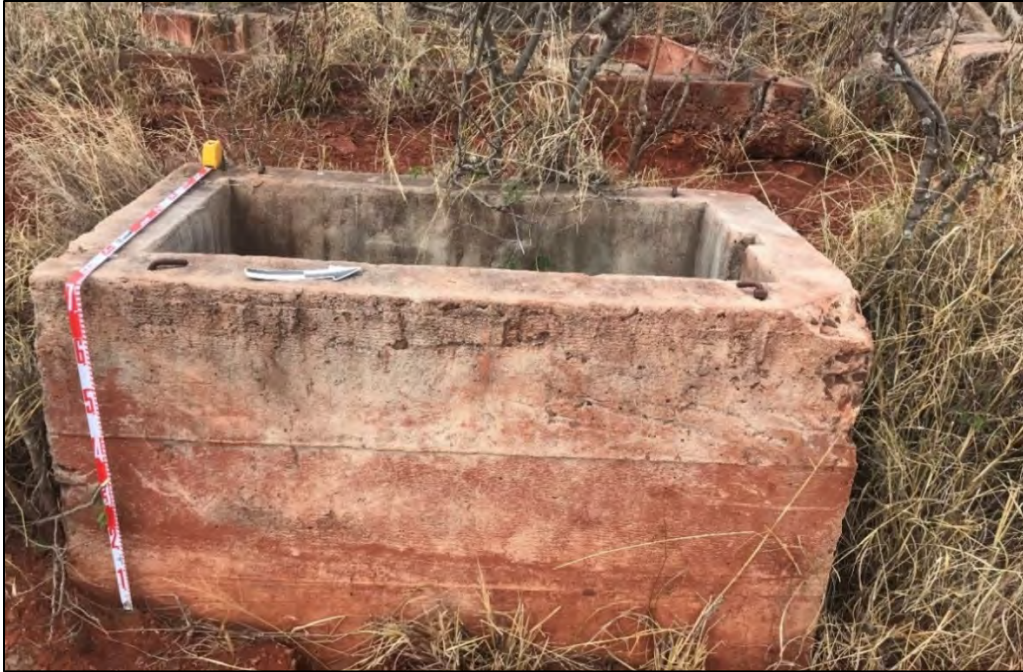
Figure 60. Water retention component of SIHP # 50-80-09-5593 Feature 2A complex, view to west

The final components of the Feature 2A complex are two small rectangular water retention features, each measuring 152 cm long, 90 cm wide, and 118 cm deep, with 16-cm thick walls (see Figure 60). The south wall of the southwest retention feature contains a slit in the concrete that has a wood insert with an attached steel measuring rod (see Figure 61). The wood and steel components no longer exist in the northeast retention feature, but the slit in the concrete remains on the south wall of this component.

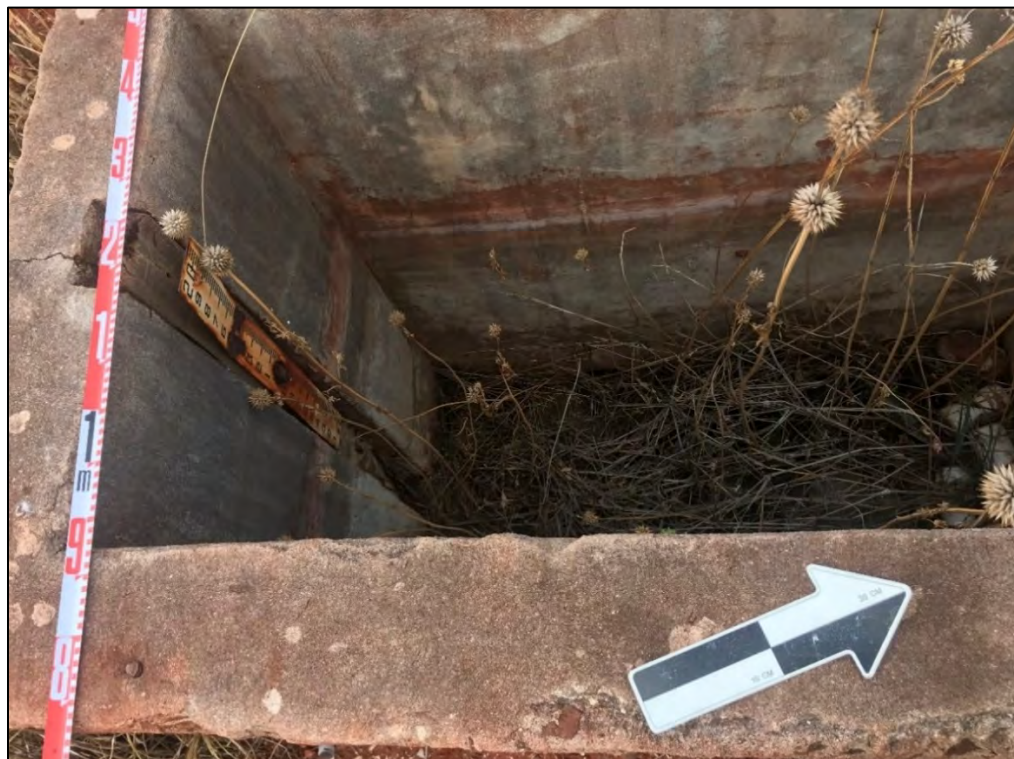
Figure 61. Plan view of SIHP # 50-80-09-5593 Feature 2A complex, water retention component, view to northwest

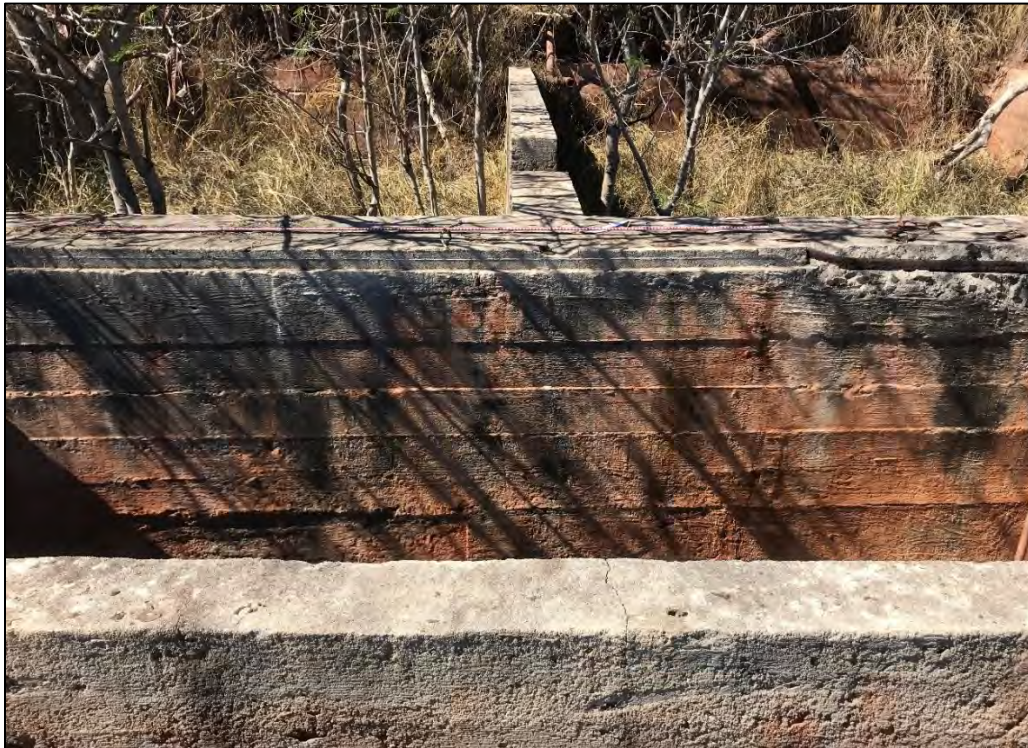
Figure 64. Overview of SIHP # 50-80-08-5593 Feature 2B, showing two large water storage compartments (background) and smaller compartment containing pipes and valves (foreground), view to northwest

SIHP # 50-80-08-5593 Feature 2B is a rectangular water retention structure into which water from the upper Feature 2A complex/Waiahole Ditch would have been channeled (Figure 63 through Figure 66). Feature 2B measures approximately 15.2 m long, 10.6 m wide, extends 1.38 m above surface, and is a maximum depth of 3 m deep from top to bottom (see Figure 63 and Figure 64). The main structure, constructed entirely of concrete, consists of a large rectangular structure divided into two open rectangles by a concrete wall extending through the middle. The walls of the structure measure 25 cm wide, and the three northwest-southeast oriented walls have notches cut out of the surface that are 18 cm deep and range from 30 cm to 150 cm long. Two metal pipes extend out of the earth into the northeast half of the structure, at one time transporting water from the upper portion of the complex into this retention feature. Attached to the larger structure is a small rectangular portion, measuring 4.25 m long and 2.05 m wide, and containing a metal rung ladder descending into the structure and several metal pipes, which presumably continued transporting the water down the hillside (see Figure 65).

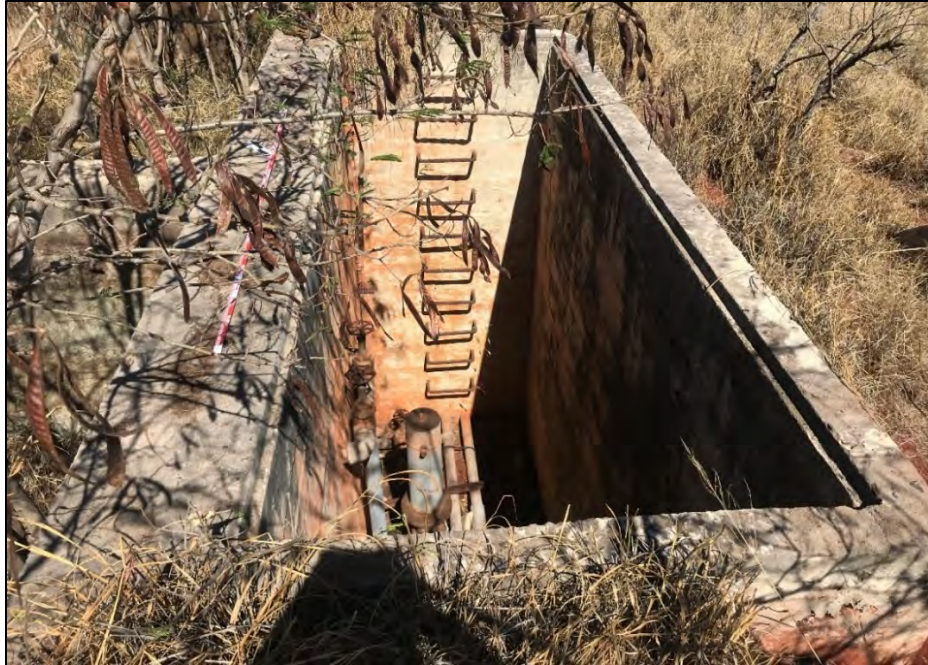
Figure 65. Overview of SIHP # 50-80-08-5593 Feature 2B, smaller southeast portion, view to northeast

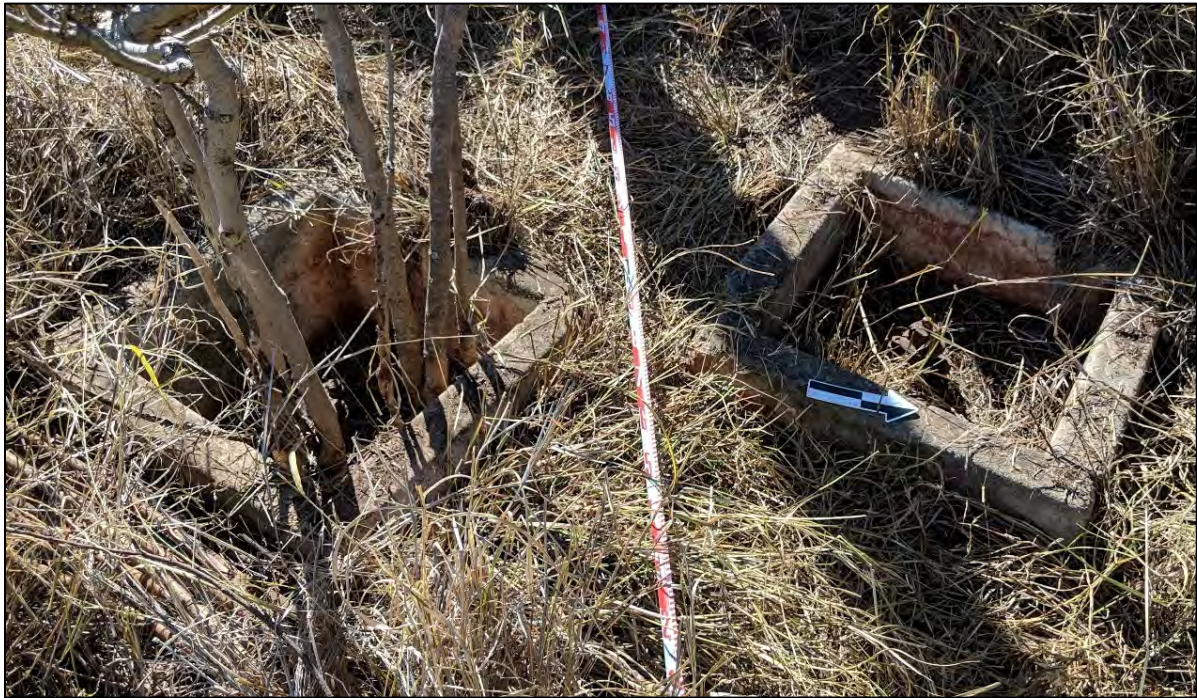
Figure 68. Concrete valve components of SIHP # 50-80-08-5593 Feature 2C, view to west

SIHP # 50-80-08-5593 Feature 2C consists of water tank remnants and related components (Figure 67 through Figure 71). The water tank was constructed of a concrete foundation with a wooden structure held together with steel cables. The wooden structure is no longer in place, leaving behind the 11 steel cables, concrete foundation, and several metal pipes (see Figure 67). The connected circular cable remnants measure a maximum 6.2 m in diameter, and the entirety of the remnants cover an area measuring 7.8 m long and 7.4 m wide. Two concrete squares measuring 80 cm by 80 cm and containing valves were documented immediately southwest of the water tower remnants (see Figure 68). A smaller related structure is 2.6 m northwest of the water tower remnants, which consists of a rectangular concrete structure measuring 3.0 m long and 2.8 m wide (see Figure 69). The northeast half of the structure is a solid concrete slab, and the southwest half of the structure is an open concrete rectangle containing metal pipes. The solid slab likely contains additional pipes related to the water control complex. Another 2.8 m northwest is an additional structure of concrete slabs and pipes, measuring 5.2 m long and 3.8 m wide. Additionally, approximately 7.4 m southwest of the water tower remnants is a damaged concrete component (see Figure 70). This concrete feature consists of three concrete walls—15 cm thick and a maximum 80 cm tall—that have broken and collapsed into a triangle shape. One metal pipe remains inside the collapsed walls. The tank is not noted on the 1943 Army War Department terrain map but appears on the 1953 Ewa and Schofield Barracks topographic quadrangles as a

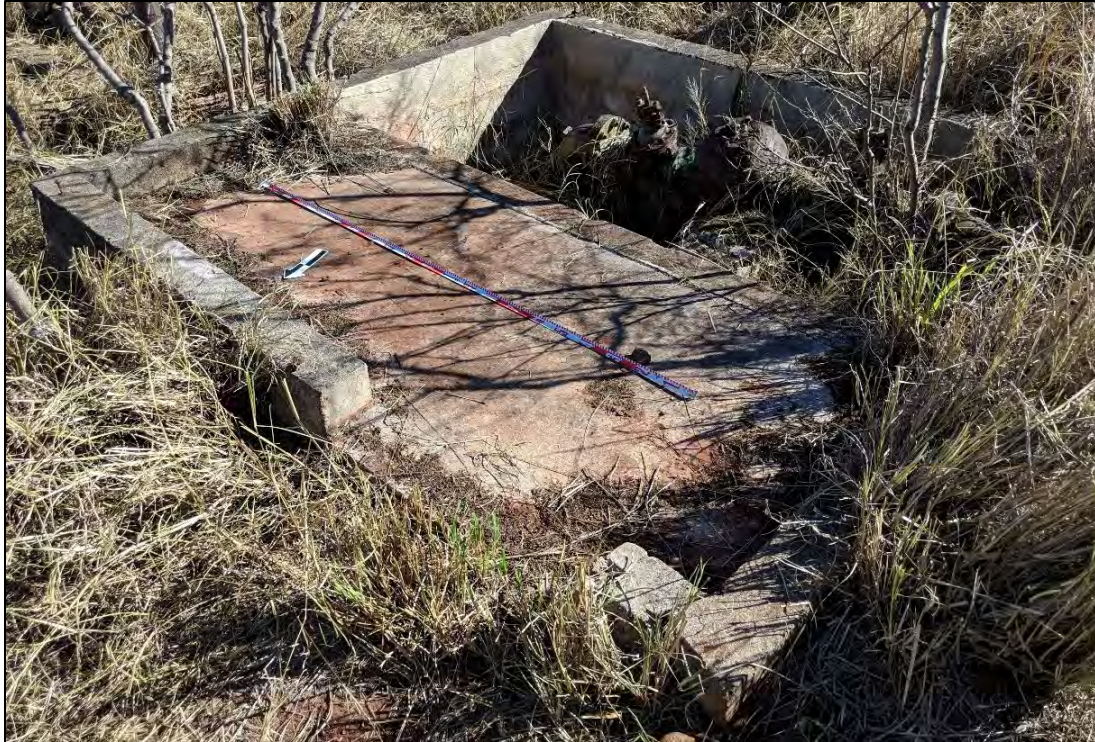
Figure 69. Overview of concrete foundation and pipes component of SIHP # 50-80-08-5593 Feature 2C, view to southeast

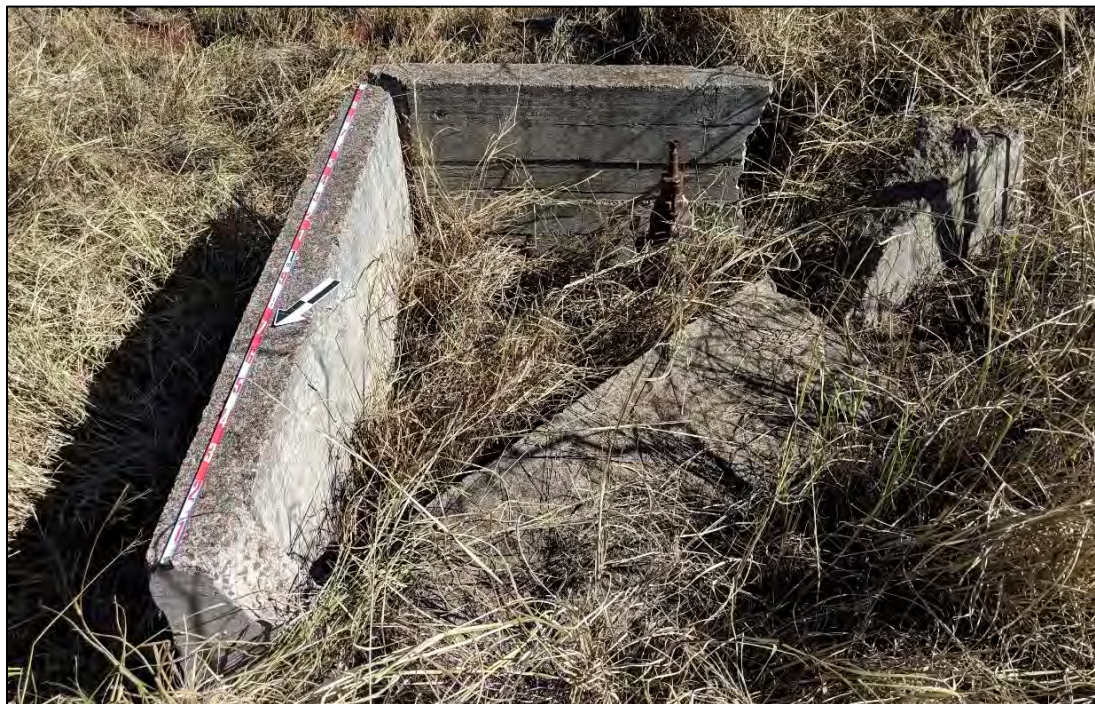
Figure 70. Collapsed walls with pipe, component of SIHP # 50-80-08-5593 Feature 2C, view to southeast

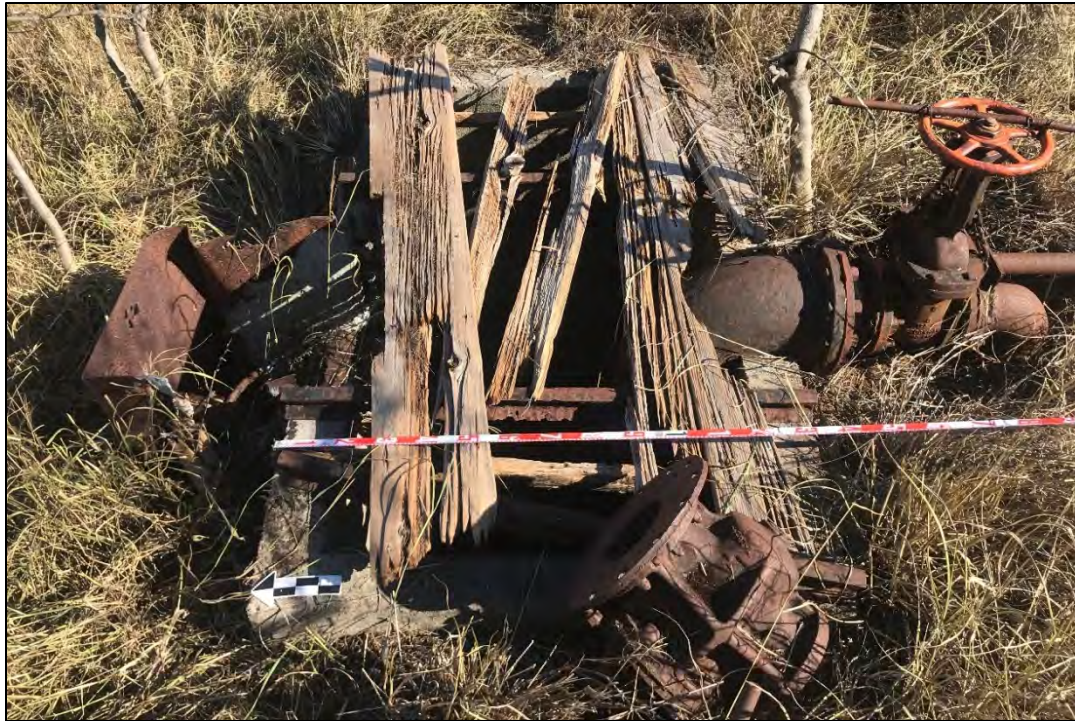
Figure 72. Overview of SIHP # 50-80-08-5593 Feature 2D, northeast valve box, view to east

SIHP # 50-80-08-5593 Feature 2D, a rectangular-shaped likely water retention feature, is situated near the base of the slope toward the pump house and mill building (Figure 72 through Figure 76). This is constructed of concrete, metal, and wood. The feature has three components: two rectangular shafts and one concrete culvert. The first portion measures 2.4 m long and 2.0 m wide, consisting of a rectangular shaft extending to a maximum depth of 215 cm with an attached small square shaft extending to a maximum depth of 205 cm (see Figure 72). A metal pipe oriented north-south extends from inside the rectangular shaft out above ground for 3.6 m before extending downward into the shaft of the second rectangular component. The second rectangular shaft measures 2.1 m long and 1.2 m wide, extending to a maximum depth of 215 cm (see Figure 73). This second retention shaft includes notches for an intact wooden sluice gate on the east edge, which leads out into a sloped, mortared basalt channel, possibly for overflow runoff (see Figure 74 and Figure 75). The mortared basalt portion measures 3.6 m long by 1.4 m wide and is two courses high (exposed portion is 50 cm tall on average). This feature may be connected to Feature 2E, described below, as a pipe in the squared shaft on the northeast end appears to extend in the direction of Feature 2E (see Figure 75). Apparent infrastructure is observed in the vicinity of this feature in a 1951 aerial photograph (see Figure 18; UH MAGIS 1951).

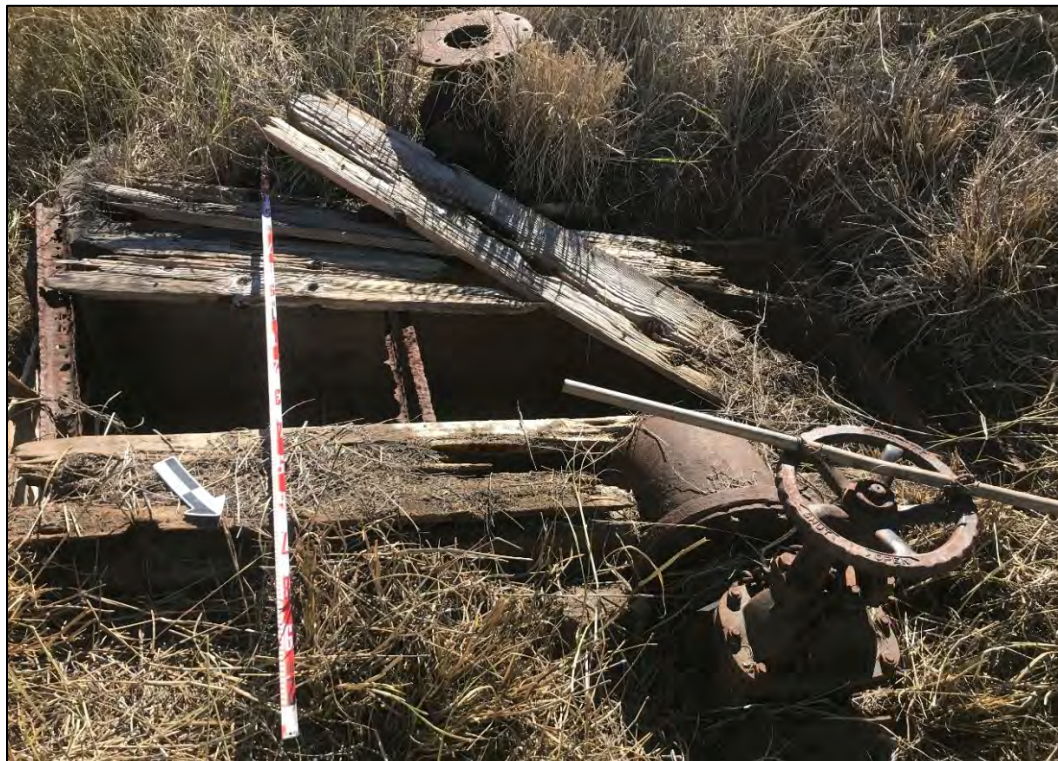
Figure 73. Overview of SIHP # 50-80-08-5593 Feature 2D, southwest valve box, view to southwest

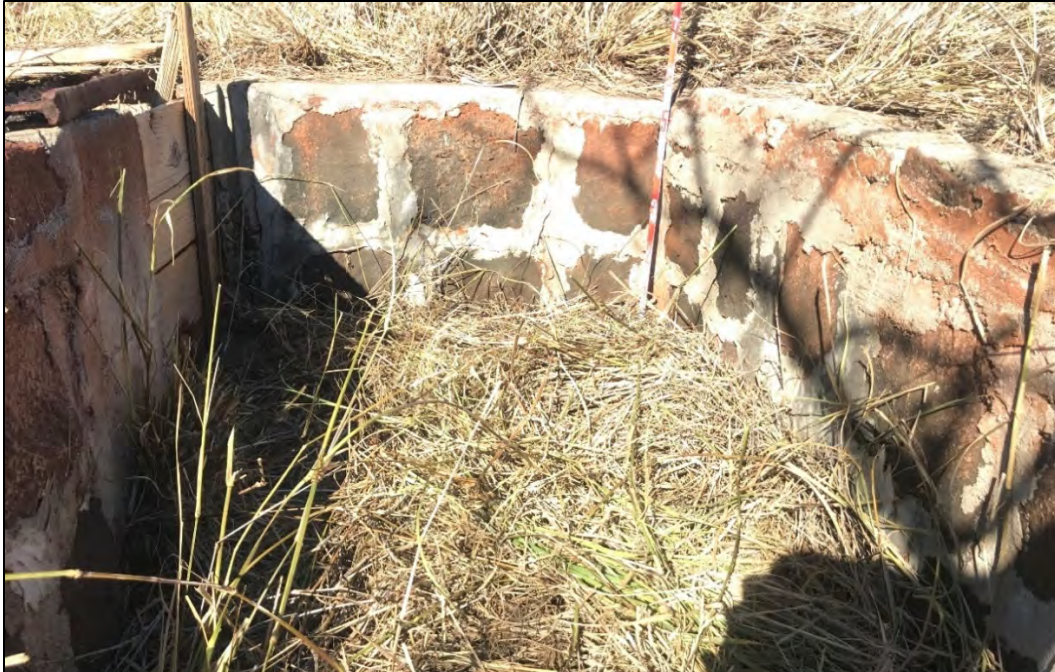
Figure 74. SIHP # 50-80-08-5593 Feature 2D sluice gate and possible water overflow channel, view to northeast

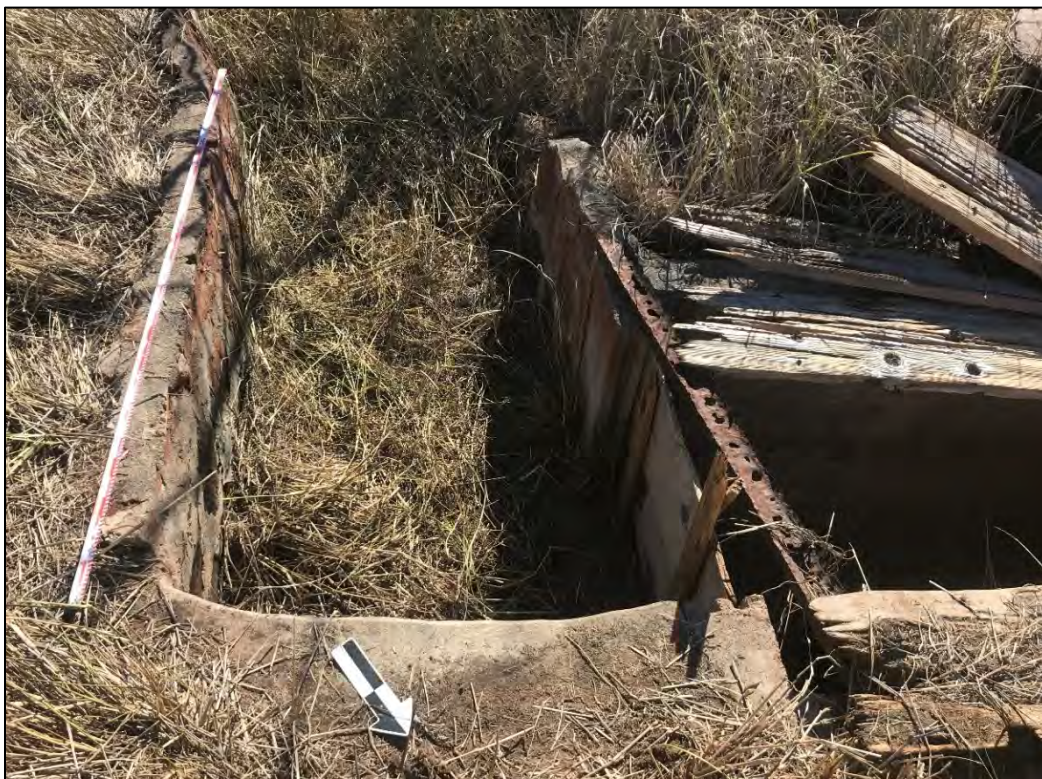
Figure 75. Feature 2D plan view of southern retention area with sluice gate and possible overflow channel, view to southwest

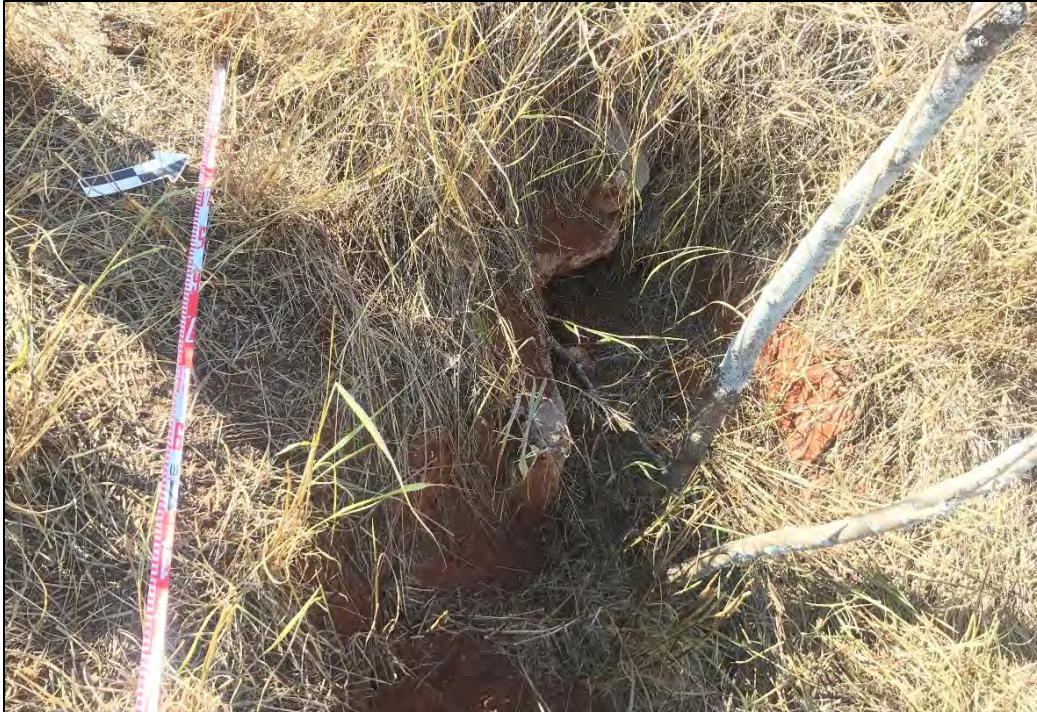
Figure 77. SIHP # 50-80-08-5593 Feature 2E, culvert remnants, view to northwest

SIHP # 50-80-08-5593 Feature 2E consists of a remnant concrete culvert (see Figure 76 through Figure 78). Feature 2E is in poor condition and measures 2.4 m long and 0.75 m wide. Feature 2E is in the lower portion of the project area and appears to have been used to help channel water overflow runoff. A pipe was observed in a shaft of Feature 2D extending in the direction of 2E, suggesting water overflow was channeled from the retention feature out of Feature 2E.

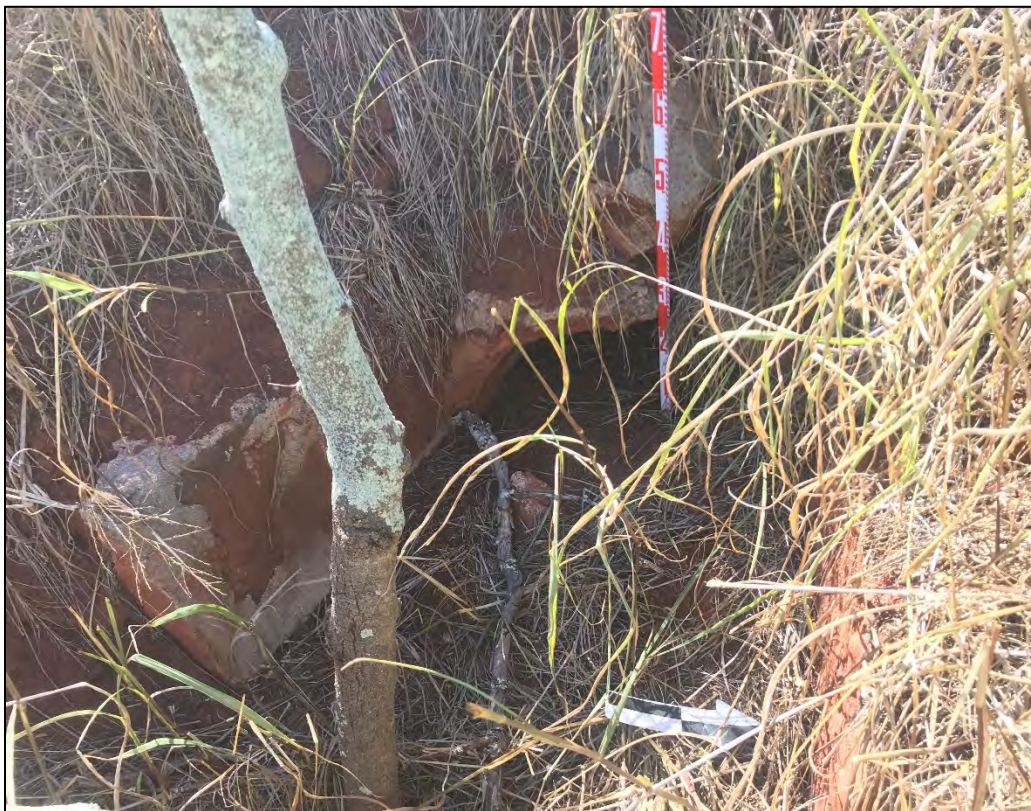
Figure 78. SIHP # 50-80-08-5593 Feature 2E, close-up of culvert remnants, view to west
